Corrosion-Induced Durability Issues and Maintenance Strategies for Post-Tensioned Concrete Bridges

PUBLICATION NO. FHWA-HRT-22-090

SEPTEMBER 2022

U.S. Department of Transportation
Federal Highway Administration

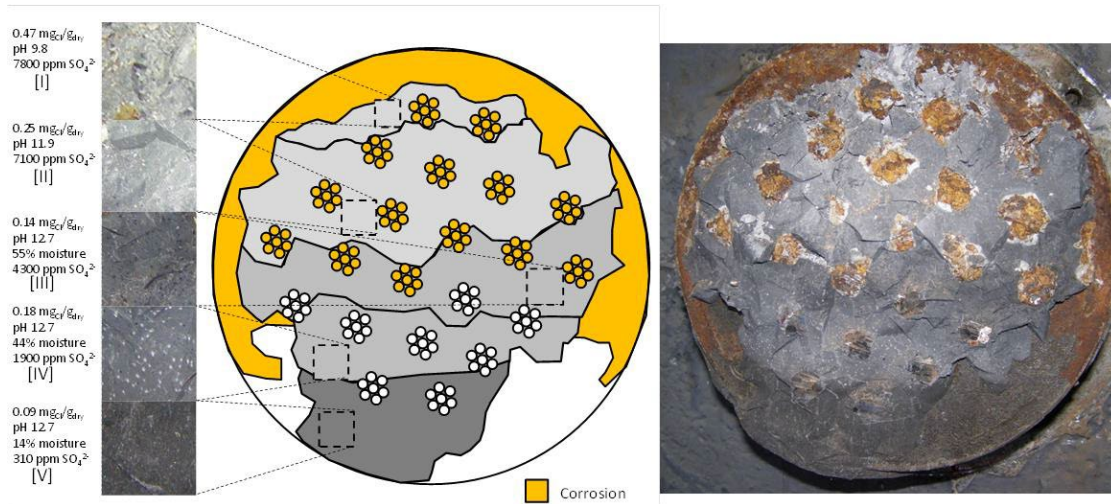
Figure 84. Photos. Distribution of moisture, pH, and anions in grout samples: Actual grout photos, schematic grout condition, actual anchor plate.⁽⁵⁰⁾

Sulfate concentration and moisture content varied significantly, and segregated grout had much higher concentrations of sulfate, potassium, and sodium ions and lower concentrations of calcium ions than nonsegregated grout. The pH values of the segregated grout, determined by the ex-situ leaching method, were lower than those of the hardened grout.

As the degree of segregation got worse, sulfate concentration and moisture content increased, and pH decreased accordingly. The sulfate profile shown in figure 85-A, in conjunction with the appearance of corrosion, may suggest a sulfate threshold for corrosion. Based on this assumption, the researchers constructed a cumulative plot of the experimentally determined Ringling Bridge's sulfate to hydroxyl ratios ($[\text{SO}_4^{2-}]/[\text{OH}^-]$). This plot is shown in figure 86.

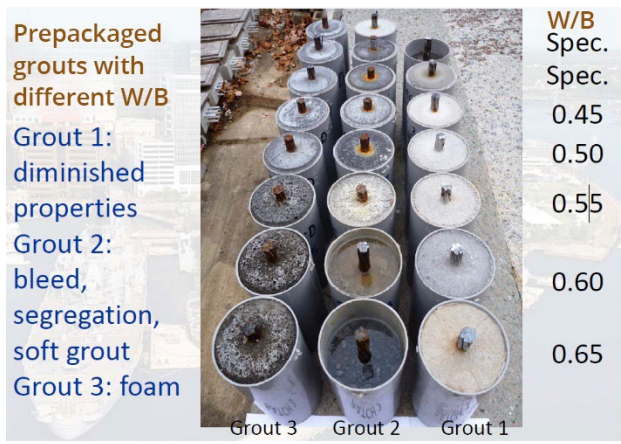
A series of laboratory tests, including sieve analysis, were conducted for three prepackaged grout products at VTRC in 2012 to determine the effect of mixing water content on the segregation, length change, and compressive strength. Even though all the grout products passed the laboratory tests, they began to segregate when the mixing water above the manufacturer's recommended amount was added. All of them were badly segregated at a water-cement ratio of 0.65. Figure 87 shows a group photograph of three grout products at different water-grout powder ratios, and table 4 summarizes the sieve analysis results of grout products 2 and 3.

Figure 87. Photo. Grout conditions at different water-to-grout powder ratios.⁽³⁶⁾

As an important verification step, the investigators recommended a full mockup experiment to prescreen potential grout-related problems in advance of any major PT projects involving grout. The mockup should include the most critical tendon situation (i.e., the greatest height change and length) using the same grout proposed for the project. During batching and grouting, the amount of mixing water in each batch must be carefully measured, and the grout bags should be weighed to provide the required water-grout powder ratio.

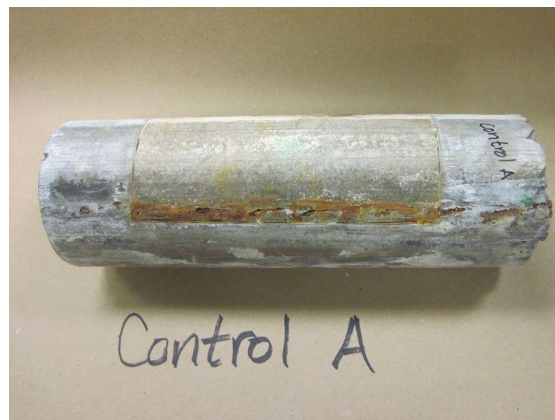
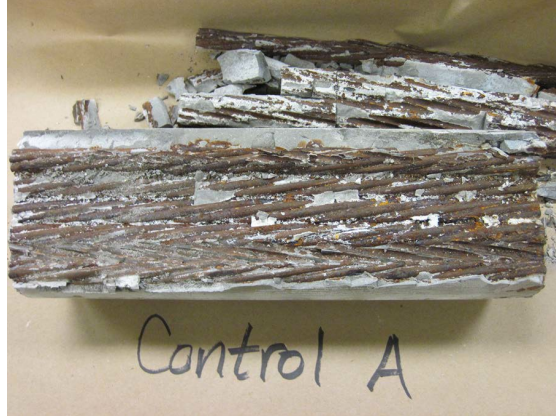
Figure 90. Photos. Control specimen exposed to salt fog chamber.⁽¹¹²⁾

The accelerated corrosion testing in the salt fog chamber and saltwater ponding induced severe corrosion to the control specimens such that corrosion products were observed on all of their exterior surfaces even before the autopsy. On the other hand, the inhibitor-treated specimens exhibited virtually corrosion-free exterior surfaces.

When each specimen was split open to observe the condition of the embedded strands inside, all the control specimens had significant corrosion, but the treated specimens did not. One exception was observed at one end of treated specimen 3, which exhibited minor corrosion on about five percent of the strands near the exposed end, as shown in figure 93-B. The actual conditions of the specimens observed during the autopsy reflected the electrochemical data.

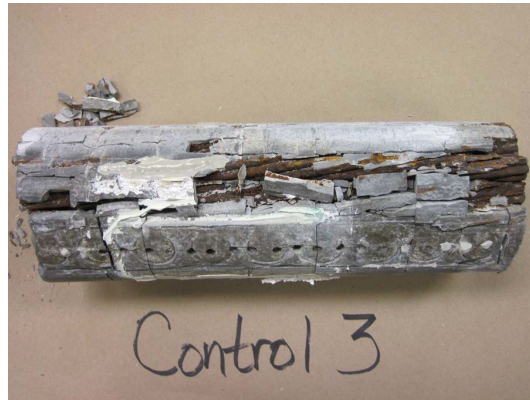
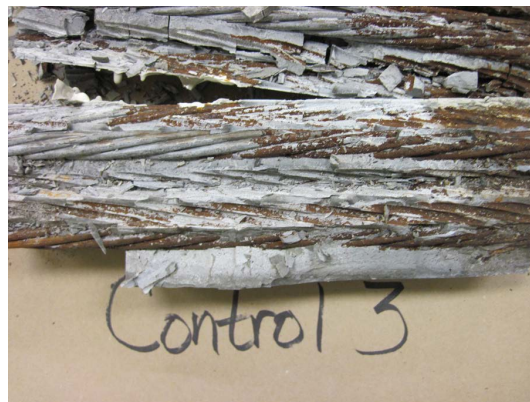
Figure 91. Photos. Control specimen exposed to saltwater ponding.⁽¹¹²⁾

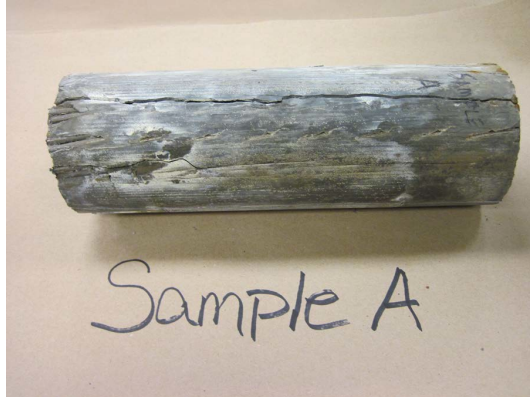
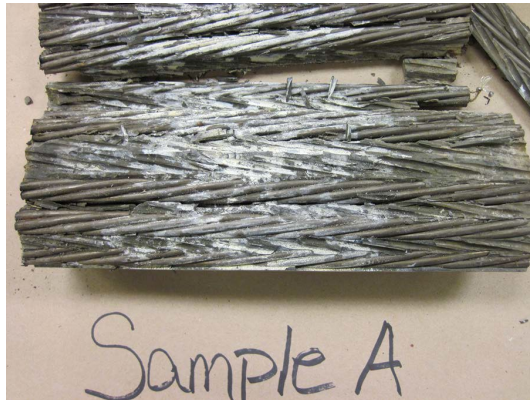
Figure 92. Photos. Treated specimen exposed to salt fog chamber.⁽¹¹²⁾

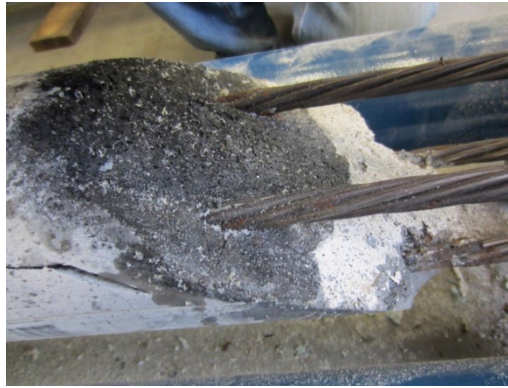
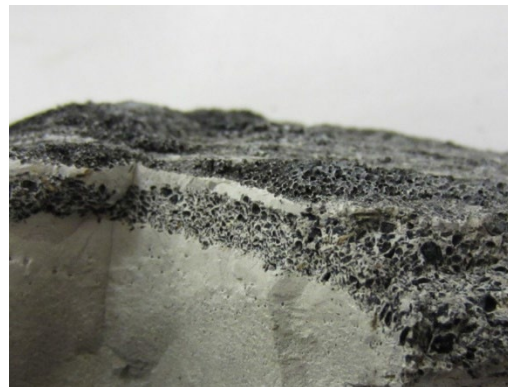
Figure 95. Photos. Chloride-free multistrand specimen.⁽⁷²⁾

A. Strands at grout/void interface.

B. Cross-section of the interface.

The interface was covered with a thick black deposit (see figure 95-A), which penetrated the top layer of the interface (see figure 95-B). The black deposit layer was porous and contained numerous small black particles. They appeared to be remnants of grout segregation. Figure 96 shows a closeup of corroded wires after a strand segment in contact with the porous grout layer shown in figure 95-A was removed and dismantled.

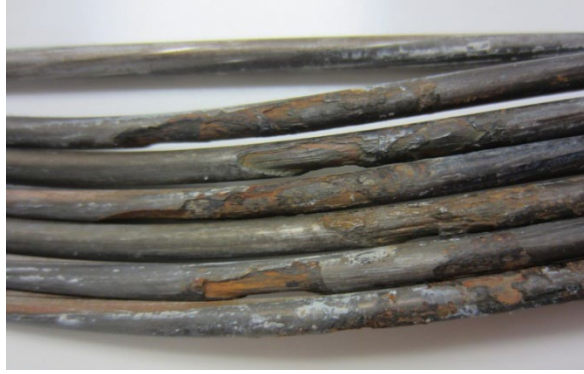
Figure 96. Photo. Close-up of corroded wires from a strand segment that came into contact with the porous grout layer.⁽⁷²⁾

Severe corrosion damage can be seen in the area near the grout/void interface despite a chloride-free condition. Figure 97 shows another severely corroded strand in the 0.4 percent chloride multistrand specimen. Its deterioration was revealed only after the bottom section of the void/grout interface was broken off during the de-tensioning process.

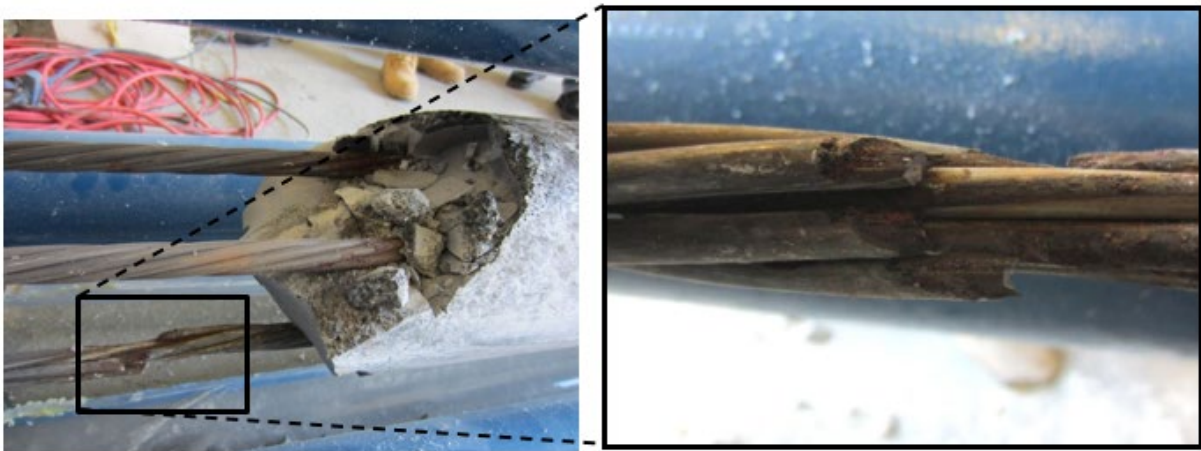
Figure 97. Photos. Severely corroded strand in a 0.4 percent chloride multistrand specimen: Opening the interface and three broken wires.⁽⁷²⁾

Three wires of one stressed strand were fractured by excessive stress concentrated in the corroded areas with significant section loss (see figure 97-B). The interfacial grout looked identical to the grout fragment of the chloride-free multistrand specimen shown in figure 95.

The grout fragments of the 0.4 percent chloride multistrand specimen did not contain sufficient black deposit material to perform ion chromatography analysis, so it could not be determined whether excessive water-soluble sulfate ions on its interface were also responsible for the fracture of the three wires shown in figure 97. The other grout samples taken from the areas free of the black deposit layer contained negligible water-soluble sulfate ions. The remaining sulfate analysis data indicated that the sulfate ions resided in the normally hardened grout samples were chemically bound evenly in the cement paste, and little could be leached out.

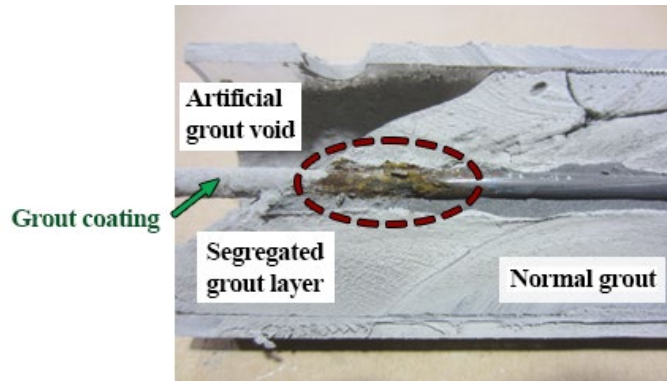
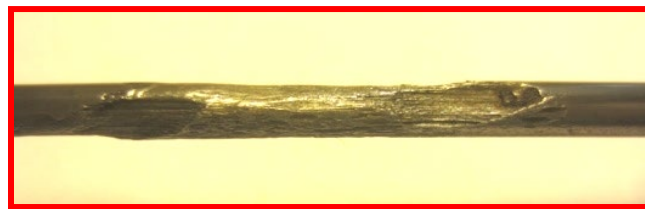
All visible corrosion damages were concentrated at or near the grout/void interface. In figure 98, for example, figure 98-A shows a severely corroded wire near a segregated grout/void interface within a two-inch-diameter, 12-inch-long grouted specimen that was longitudinally cut in half along its length. Figure 98-B shows a closeup of the corroded wire after it was cleaned. This particular wire specimen (diameter = 0.205 inches) had been stressed at 60 percent GUTS and periodically exposed to a 0.8 percent sulfate concentration dissolved in recharging water with a pH of 8 for 200 d at 104 °F.

Figure 98. Photos. Corroded wire in segregated grout/void interface.⁽¹¹⁴⁾

other words, the rate of macrocell corrosion is largely determined by the surface area ratio between the macro-anode and the macro-cathode. Severe corrosion damage can occur at the macro-anode if the surface area ratio of the macro-anode to the macro-cathode becomes small, a so-called “small anode-large cathode” situation. A good example of severe macrocell corrosion damage is shown in figure 98.

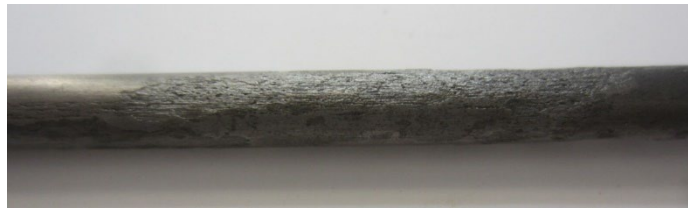
Uniform corrosion typically causes negligible to minor section loss and is not usually critical to load-carrying capacity. If measurable corrosion damage is observed, a digital micrometer may be used to quantify section loss. Figure 114 shows an example of uniform corrosion damage.

Figure 114. Photo. Uniform corrosion damage on an outer wire.⁽⁸⁴⁾

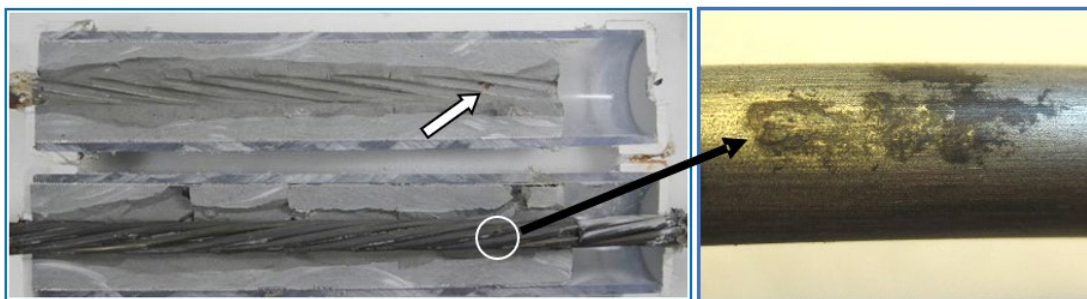
On the other hand, a localized attack by pitting corrosion or crevice corrosion can be critical because of the significantly reduced cross-sectional area. Pitting corrosion initiates at discrete spots where the protective passive film is compromised, or other imperfect surface conditions exist. Figure 115 shows autopsy photographs of a single strand specimen that was buried in a 0.4 percent chloride-contaminated grout for six months.⁽⁷²⁾ Figure 115-A shows the as-opened condition. A small rust spot matching the pit development indicated by a red arrow can be seen. Figure 115-B shows a magnified small pit formed on the circled strand surface after it was cleaned.

Figure 115. Photos. Pitting corrosion on a single strand specimen: Opened single strand specimen and closeup of a pit.⁽⁷²⁾

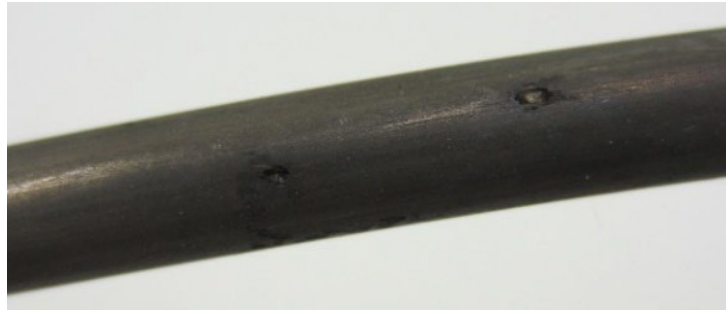
Figure 116 shows two small pits (see figure 116-A) and several shallow pits (see figure 116-B) formed on two outer wires exposed to a 0.8 percent chloride grout. These photographs show discrete and shallow pits associated with the initial stage of pitting corrosion damage.

A. Two small pits.

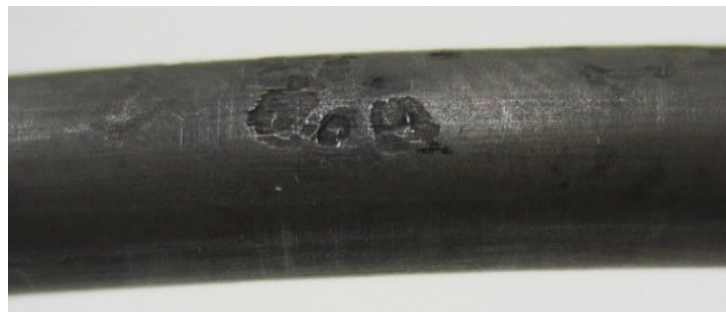
B. Several shallow pits.

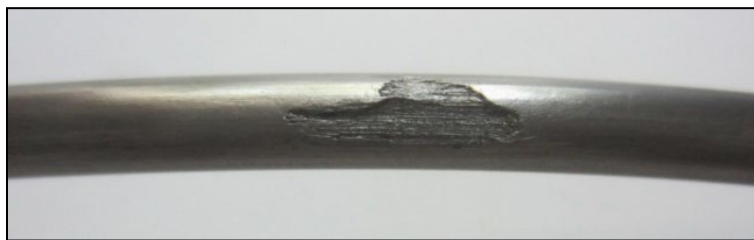
A. Growing pitting damage.

Figure 117-A shows pitting corrosion damage from the merging of multiple small pits, similar to those in figure 116-B. Figure 117-B shows more advanced damage from figure 117-A. Figure

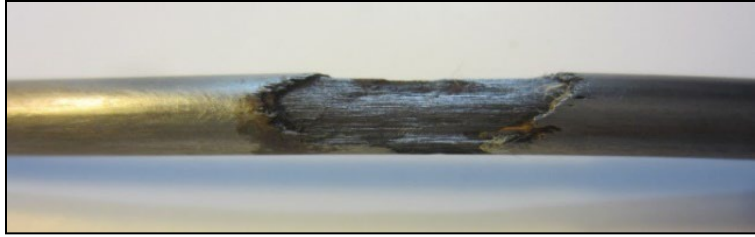
B. Elongated pitting damage.

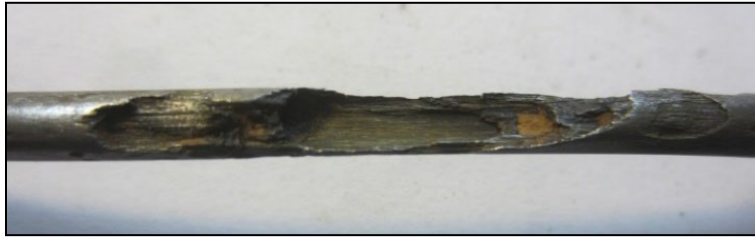
C. Severe pitting damage.

117-A and figure 117-B also show the fibrous texture of corrosion damage due to preferential mass consumption along the wire drawing direction. Figure 117-C shows a nearly fractured wire due to an intensive pitting attack. Figure 117-D and figure 117-E show different views of two wires that were finally fractured by pitting corrosion, which is the ultimate form of corrosion damage and developed from the intensive pitting attack shown in figure 117-C.

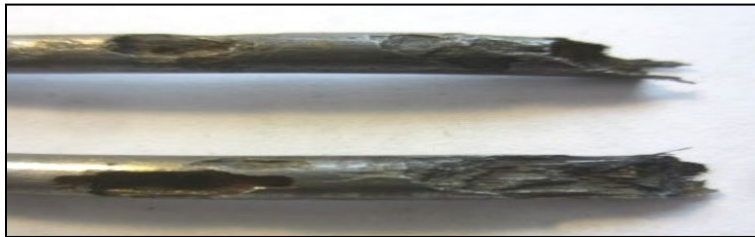
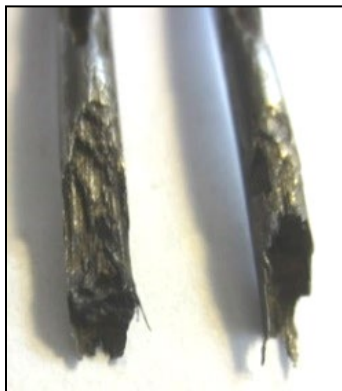
D. Fractured wires—Plan view.

E. Fractured wires—Front view.

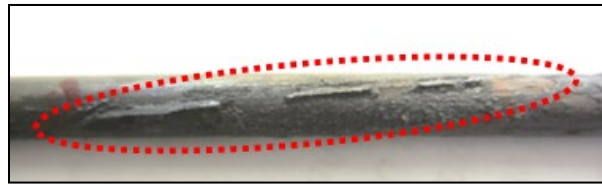
A. Before removing grout residues.

Figure 118-A shows dried grout residues adhered to a center wire along a spiral interstitial site. Figure 118-B shows crevice corrosion damage beneath the grout residues after they were removed. Figure 119 shows close-up photographs of five wires exhibiting different stages of crevice corrosion damage after cleaning. The wires were from randomly selected 7-wire strands.

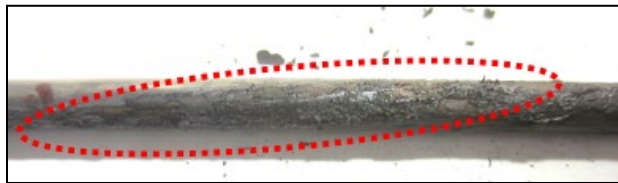
B. After removing grout residues.

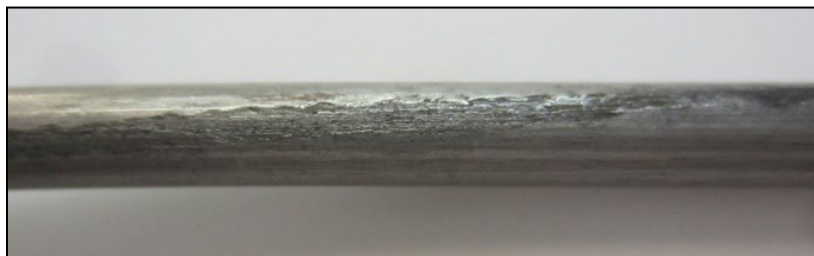
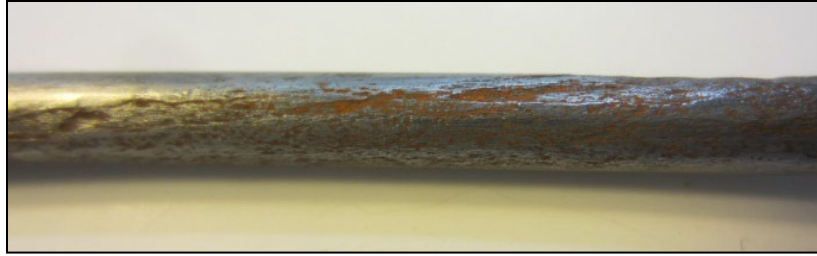
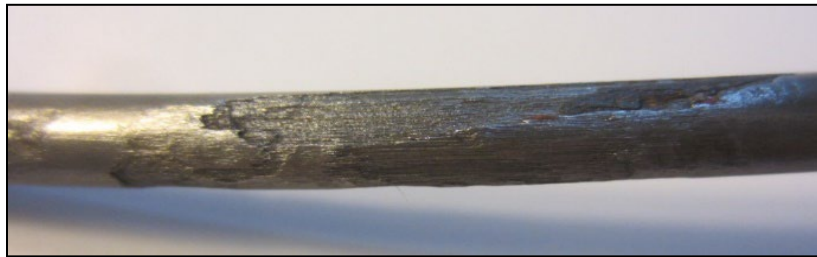
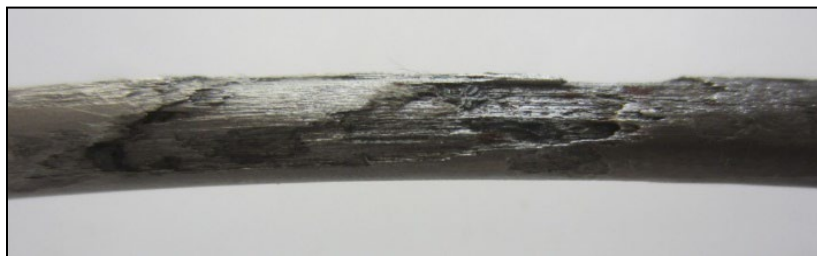
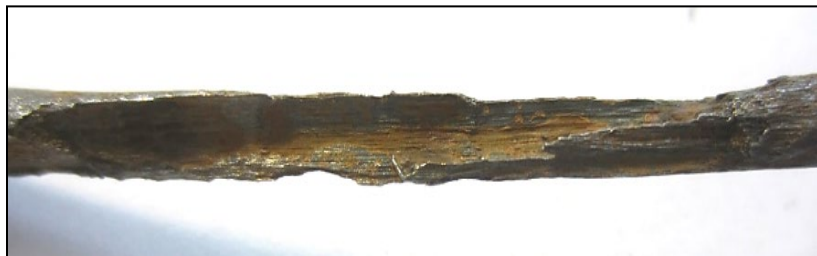
Figure 119. Photos. Examples of progressive crevice corrosion damage.⁽⁸⁴⁾

Figure 119-A shows slightly indented, shallow corrosion damage along a spiral interstitial site. Figure 119-B through figure 119-E show progressively advancing corrosion damage from the condition shown in figure 119-A. These examples illustrate how crevice corrosion progresses on individual wires and eventually results in wire fractures.

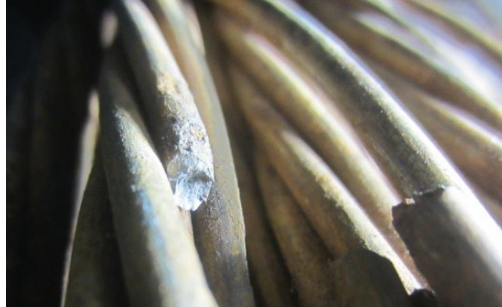
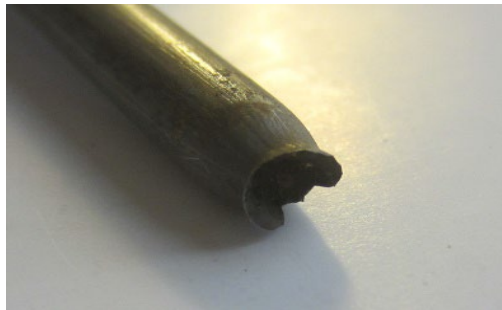
When corrosion of the wires and ultimately the strands cause a tendon to fail, some wires corrode in two, and the remaining wires rupture by necking. This type of ductile fracture is caused by overstressing and shows cup-and-cone-shaped fracture ends. Two examples of the cup-side fracture are shown in figure 120.

Figure 120. Photos. Wire ends showing ductile fracture.⁽⁸⁴⁾

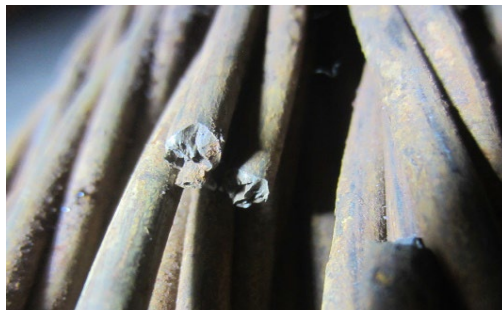
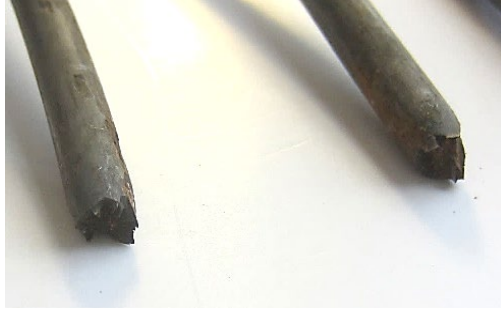
In some cases, the fractured wires show a zig-zag-shaped texture without recognizable reduction of the cross-sectional area. Two representative examples are shown in figure 121.

Figure 121. Photos. Fractured wire ends showing little area reduction.⁽⁸⁴⁾

Although these examples were not scientifically determined to be caused by brittle fracture, they resembled brittle fracture. It is important to recognize the possibility that the brittle fracture can occur by EIC, i.e., SCC, corrosion fatigue, and by HE. Some instances of EIC in PT tendons have been reported.^(74,118)

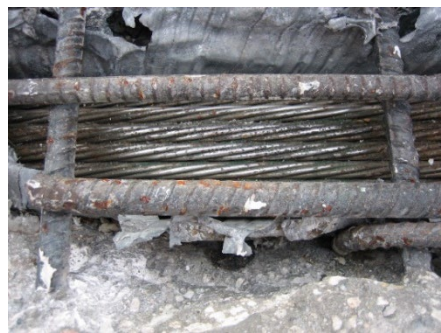
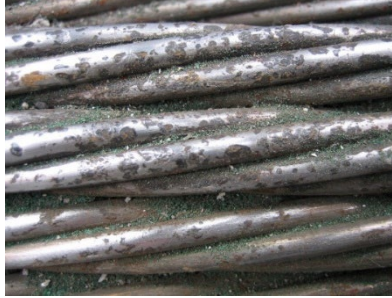
A. An excavated tendon.

B. Closeup of pitting corrosion.

The most effective, proven method for temporary corrosion protection is to seal the tendons as quickly as is practicable during the duration between the completion of stressing and the initiation of grouting. Once the tendon is stressed, all tendon ends and vents should be sealed to avoid the ingress of water into the duct system before cementitious grout quickly fills the tendons. Leaving prestressing steel inside the duct without temporary or permanent corrosion protection for an extended time can create durability problems, including tendon failures. Figure 128 shows pitting corrosion observed during construction on stressed strands that were exposed to moist air in an empty duct for an extended period before grouting.
