Test Report No. 440592

**DEVELOP GUIDELINES FOR INSPECTION, REPAIR, AND USE OF
PORTABLE CONCRETE BARRIERS—VOLUME 2: CRASH REPORT
COOPERATIVE RESEARCH PROGRAM**

Texas Department of Transportation
<https://tti.tamu.edu/documents/0-7059-R1-Vol2.pdf>

Report 0-7059-R1-Vol2
Project 0-7059

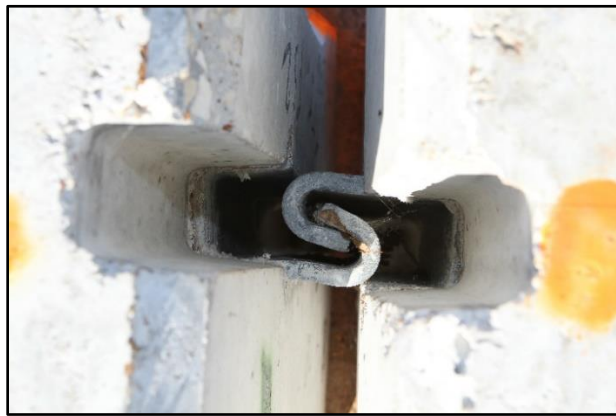
(e)

For the first test (440592-1), Barrier 3 was selected due to a large 6-mm wide crack located on the field side of the installation that ran vertically 246 inches downstream from the joint of barriers 2 and 3. The downstream JJ hook on barrier 2 was bent 8 degrees. The upstream JJ hook on barrier 3 was not damaged, and the downstream JJ hook was bent 12 degrees. The upstream JJ hook on barrier 4 was not damaged.

Figure 2.1. Damaged Portable Concrete Barriers prior to Test No. 440592-1.

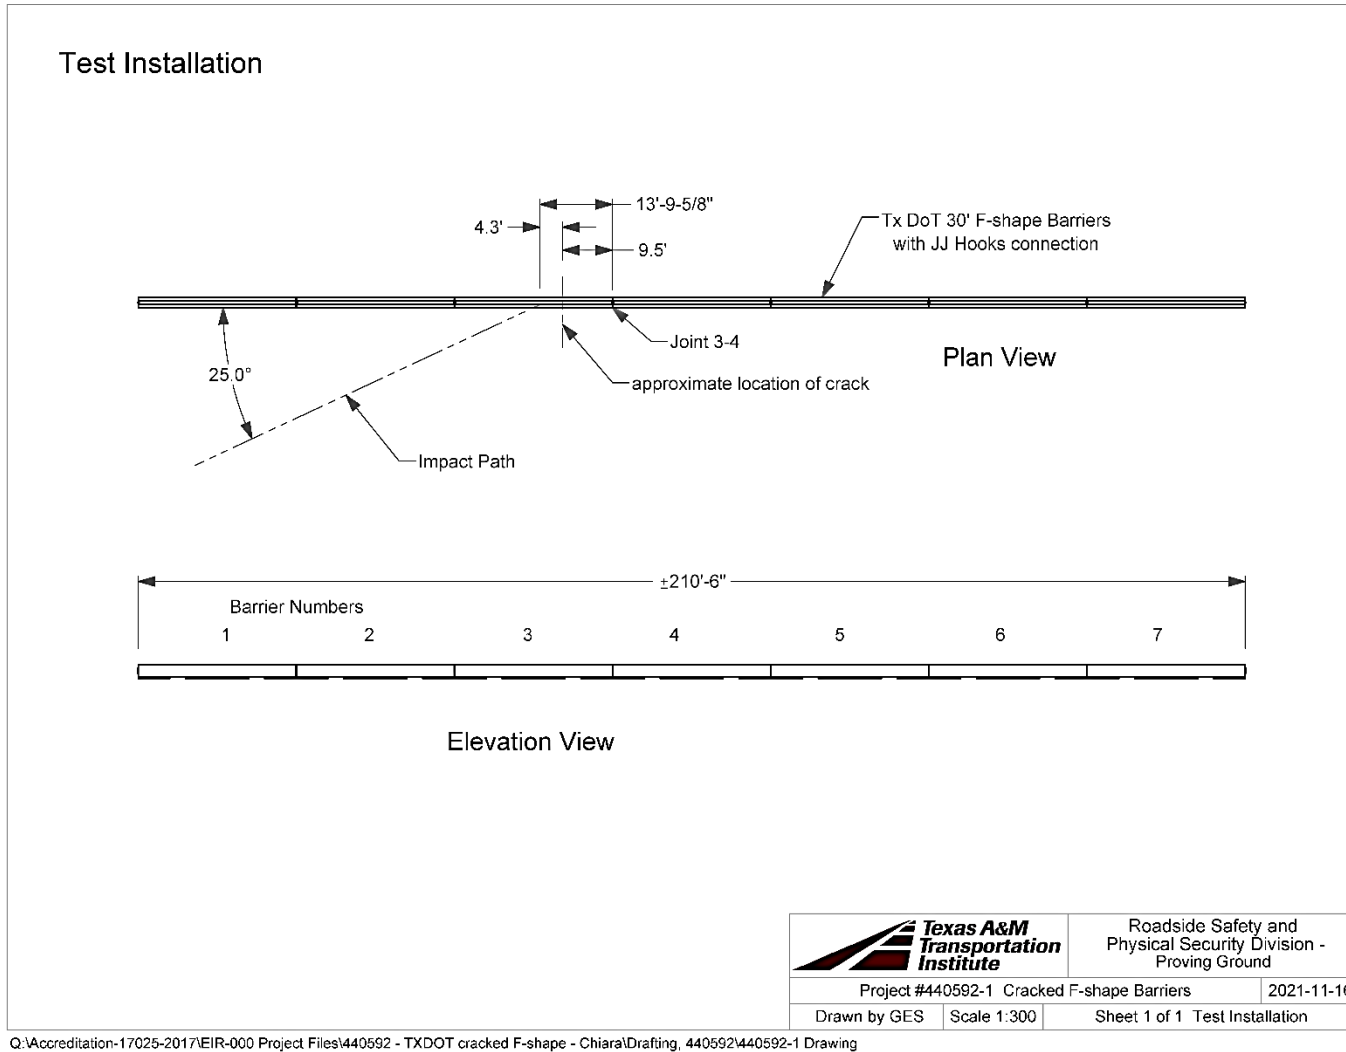
Figure 2.3. Details on Damaged Portable Concrete Barriers.

Each installation consisted of seven 30-ft long, 32-inch tall, F-shape barriers connected end to end with JJ hook connections, for a total length of 210 ft 6 inches. For both tests, the barrier segments were specifically selected based on their existing damage modes, which included concrete spalling, concrete cracks, and segment connection deformations.

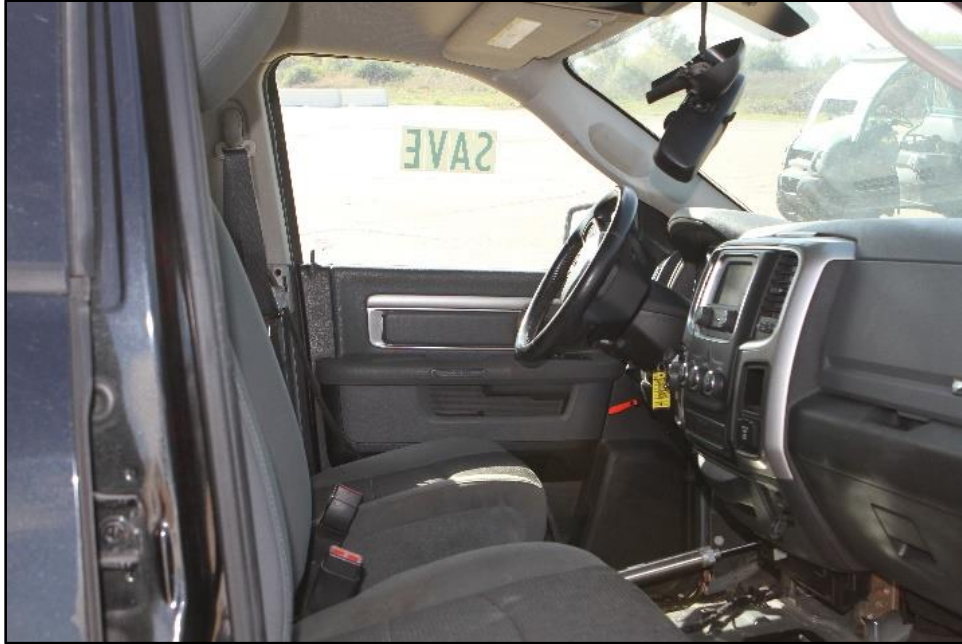
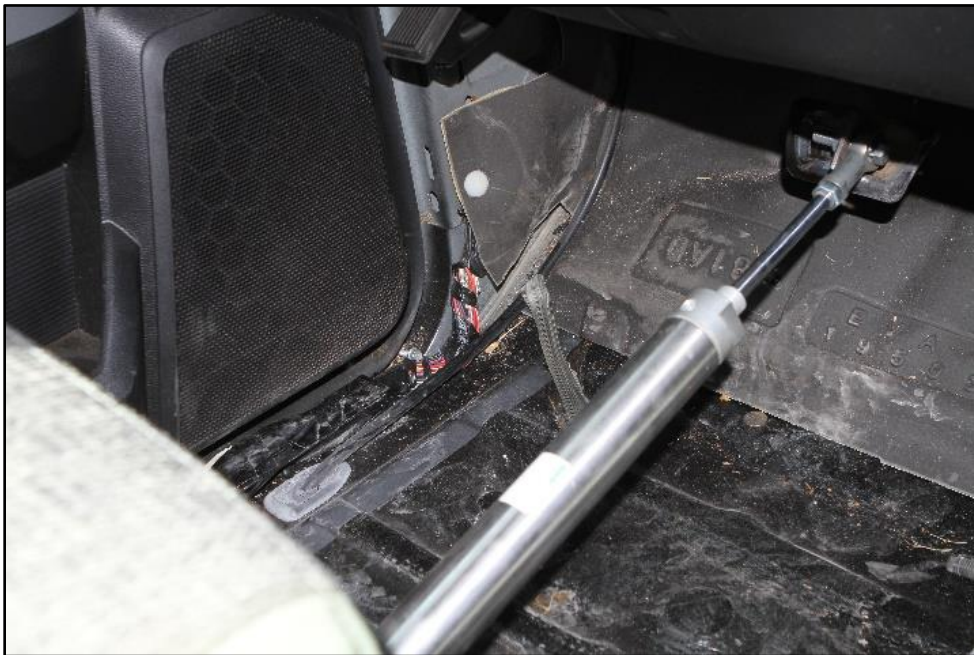
Figure 5.7. Interior of Test Vehicle after Test No. 440592-1.

Figures C.2 and C.3 in Appendix C.1 provide exterior crush and occupant compartment measurements. Figure 5.6 shows damage to the test vehicle exterior, and Figure 5.7 shows damage inside the test vehicle. Table 5.8 lists the occupant compartment intrusion measurements, and Table 5.9 lists damage to the vehicle.

Occupant Risk Values	Longitudinal OIV	12.3 ft/s
	Lateral OIV	21.5 ft/s
	Longitudinal RDA	5.0 g
	Lateral RDA	12.6 g
	THIV	7.7 m/s
	ASI	1.6
Max. 0.050-s Average	Longitudinal	-6.6 g
	Lateral	11.8 g
	Vertical	-3.8 g
Post-Impact Trajectory	Stopping Distance	203 ft downstream, 10 ft on field side
Vehicle Stability	Maximum Roll Angle	17°
	Maximum Pitch Angle	16°
	Maximum Yaw Angle	61°
	Vehicle Snagging	No indication of snagging
	Vehicle Pocketing	No indication of pocketing
Test Article Deflections	Dynamic	61 inches
	Permanent	61 inches
	Working Width	85 inches
	Height of Working Width	3 inches
Vehicle Damage	VDS	11LFQ5
	CDC	11FLEW3
	Max. Exterior Deformation	12 inches at left front bumper
	Max. Occupant Compartment Deformation	1 inch at left kick panel area, and 1 inch at lower left front door

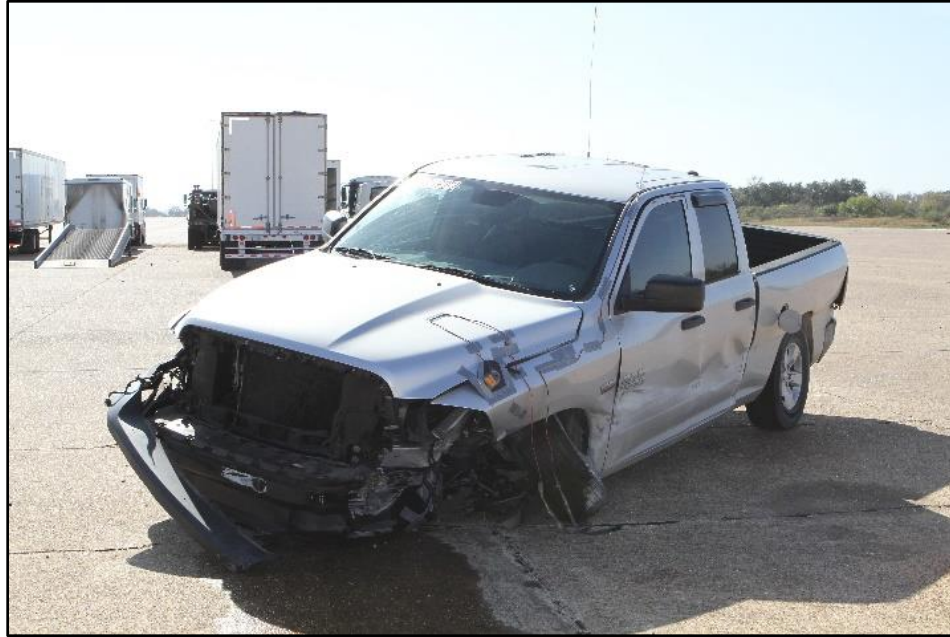
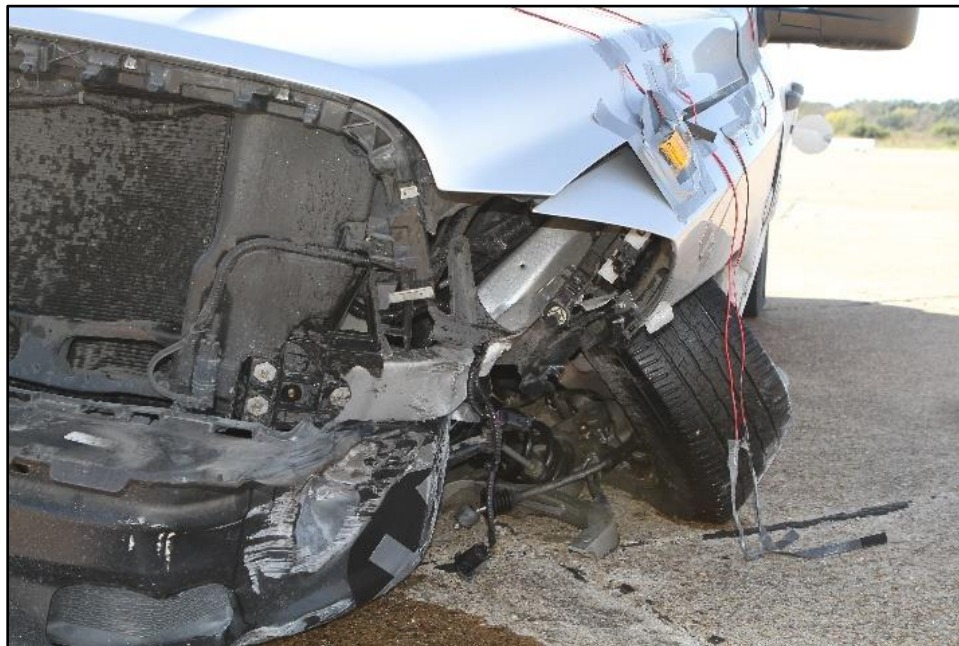
Figure 6.6. Test Vehicle after Test No. 440592-2.

Figures D.2 and D.3 in Appendix D.1 provide exterior crush and occupant compartment measurements. Figure 6.6 shows exterior damage to the test vehicle, and Figure 6.7 shows damage inside the test vehicle. Table 6.8 lists the occupant compartment intrusion measurements, and Table 6.9 lists damage to the vehicle.

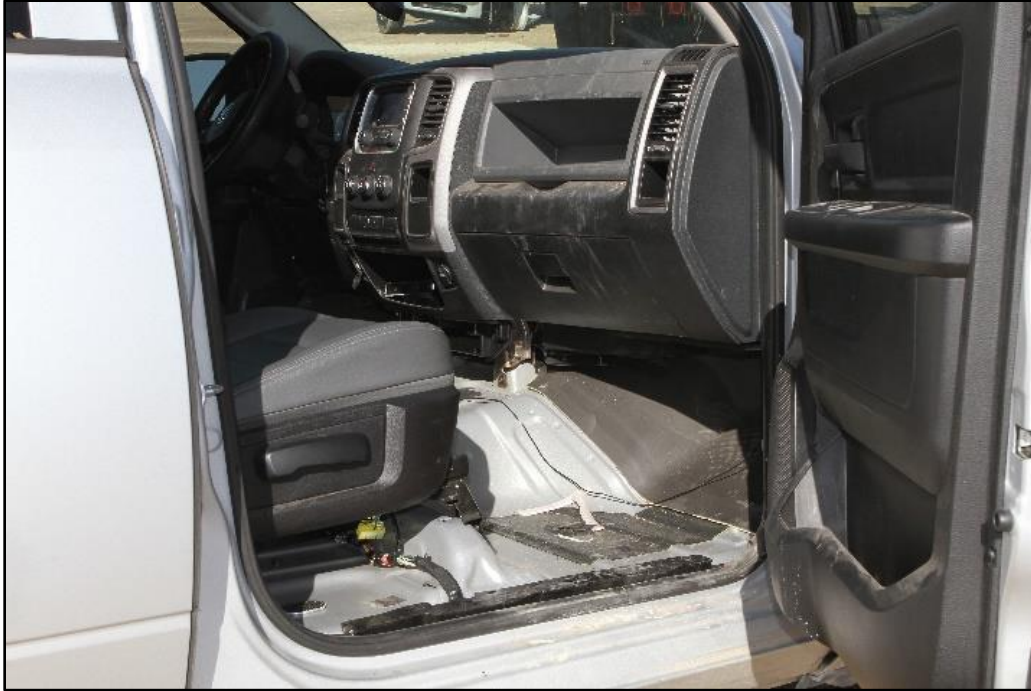
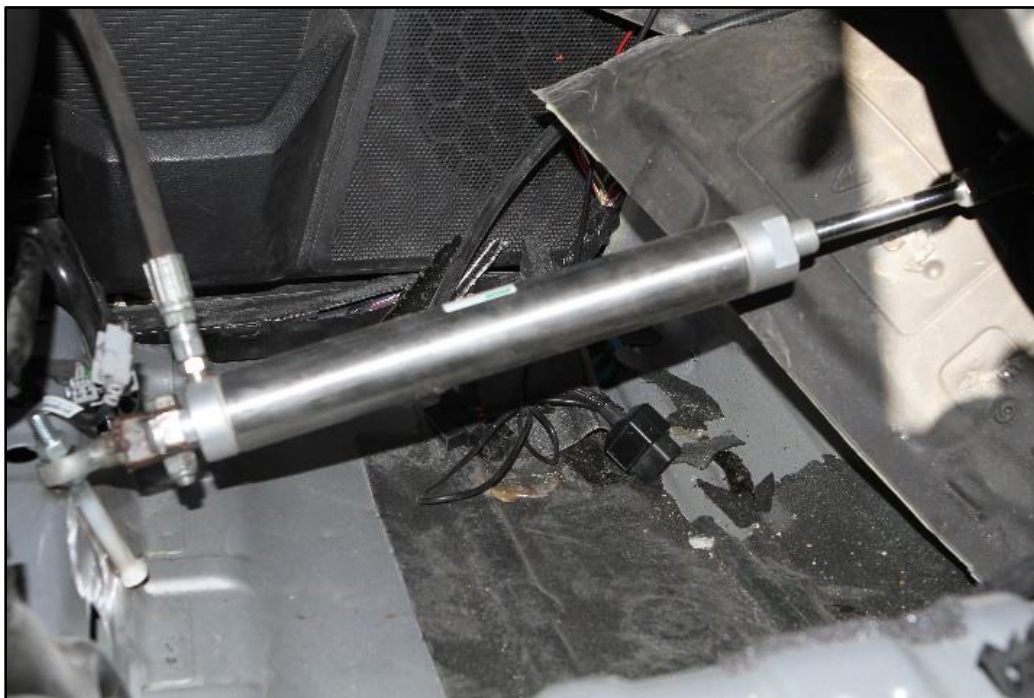
Figure 6.7. Interior of Test Vehicle after Test No. 440592-2.

Occupant Risk Values	Longitudinal OIV	19.6 ft/s
	Lateral OIV	23.1 ft/s
	Longitudinal RDA	5.1 g
	Lateral RDA	9.9 g
	THIV	9.1 m/s
	ASI	1.6
Max. 0.050-s Average	Longitudinal	-9.2 g
	Lateral	12.3 g
	Vertical	-3.3 g
Post-Impact Trajectory	Stopping Distance	440 ft downstream, 95 ft on traffic side
Vehicle Stability	Maximum Roll Angle	14°
	Maximum Pitch Angle	11°
	Maximum Yaw Angle	40°
	Vehicle Snagging	No indication of snagging
	Vehicle Pocketing	No indication of pocketing
Test Article Deflections	Dynamic	56 inches
	Permanent	56 inches
	Working Width	79.9 inches
	Height of Working Width	3 inches
Vehicle Damage	VDS	11LFQ5
	CDC	11FLEW3
	Max. Exterior Deformation	14 inches at left front bumper
	Max. Occupant Compartment Deformation	8½ inches, left toe pan area

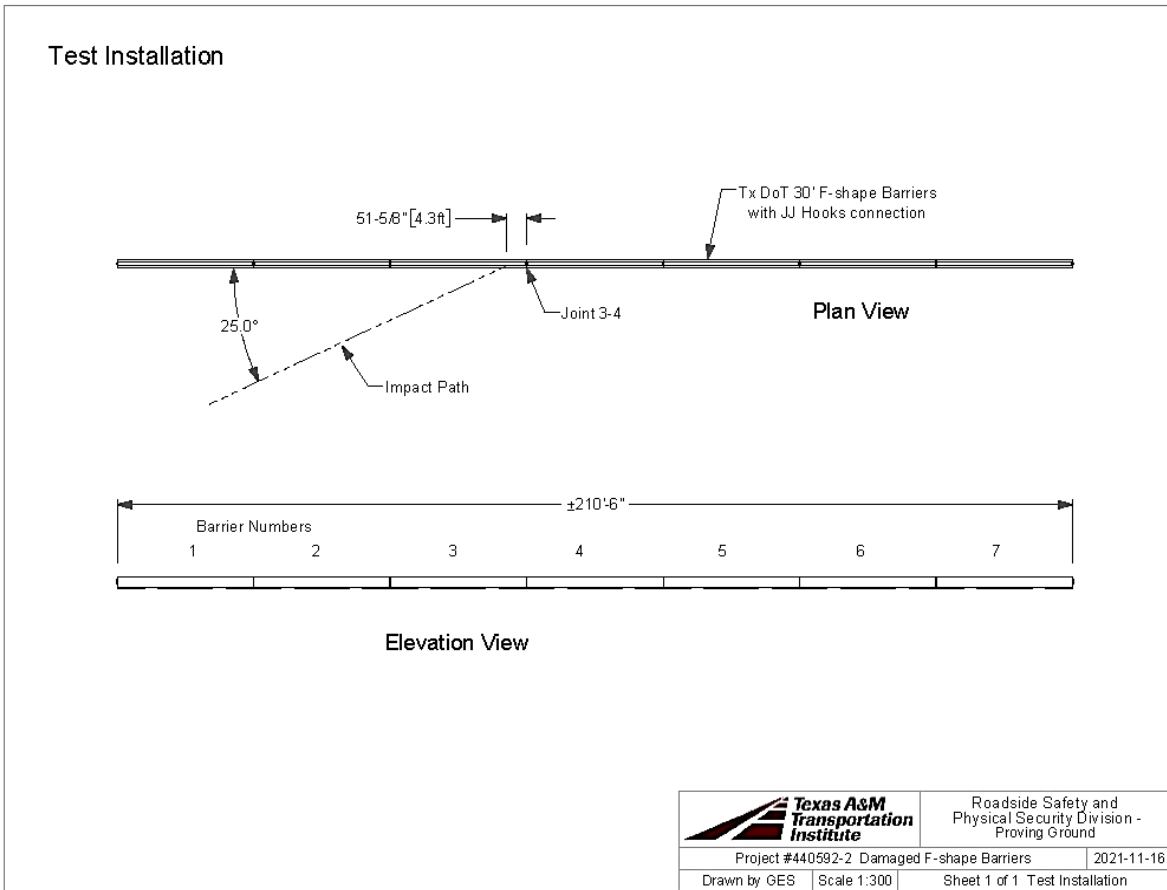
Figure A.2. Layout Drawing for Test No. 440592-2.

For the second test (440592-2), spalling was manufactured by Texas A&M Transportation Institute (TTI) personnel on the traffic side toe of barriers 3 and 4 at their joint. Each had a spall measuring approximately $3\frac{3}{4}$ inches wide \times 13 inches high \times 2 inches deep. At the same joint on the field side, the toe of barrier 4 was intentionally spalled and measured approximately 24 inches wide \times 5 inches high \times 2 inches deep. The JJ hooks at the joint of barriers 2 and 3 were not damaged. The downstream JJ hook on barrier 3 was bent 19 degrees, and the upstream JJ hook of barrier 4 was bent 15 degrees.

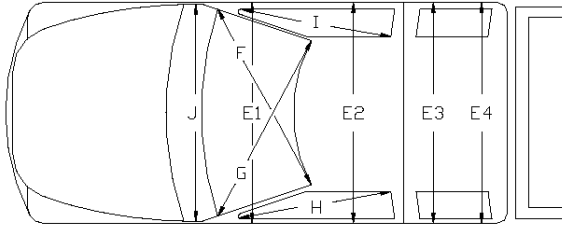
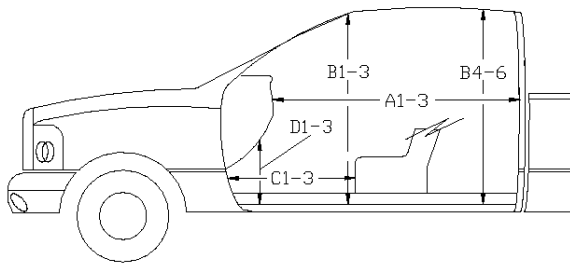
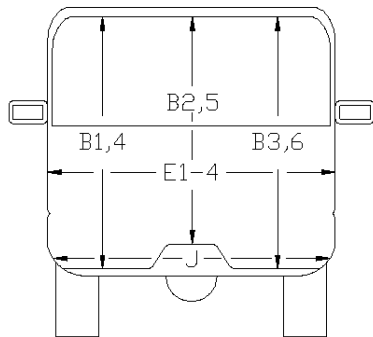
Figure C.3. Occupant Compartment Measurements for Test No. 440592-1.

Before	After (inches)	Differ.
A1	65.00	65.00	0.00
A2	63.00	63	0.00
A3	65.50	65.50	0.00
B1	45.00	45.00	0.00
B2	38.00	38.00	0.00
B3	45.00	45.00	0.00
B4	39.50	39.50	0.00
B5	43.00	43.00	0.00
B6	39.50	39.50	0.00
C1	26.00	26.00	0.00
C2	0.00	0.00	0.00
C3	26.00	26.00	0.00
D1	11.00	11.00	0.00
D2	0.00	0.00	0.00
D3	11.50	11.50	0.00
E1	58.50	57.5	1
E2	63.50	64.5	1
E3	63.50	63.50	0.00
E4	63.50	63.50	0.00
F	59.00	59.00	0.00
G	59.00	59.00	0.00
H	37.50	37.50	0.00
I	37.50	37.50	0.00
J*	25.00	25.00	0.00

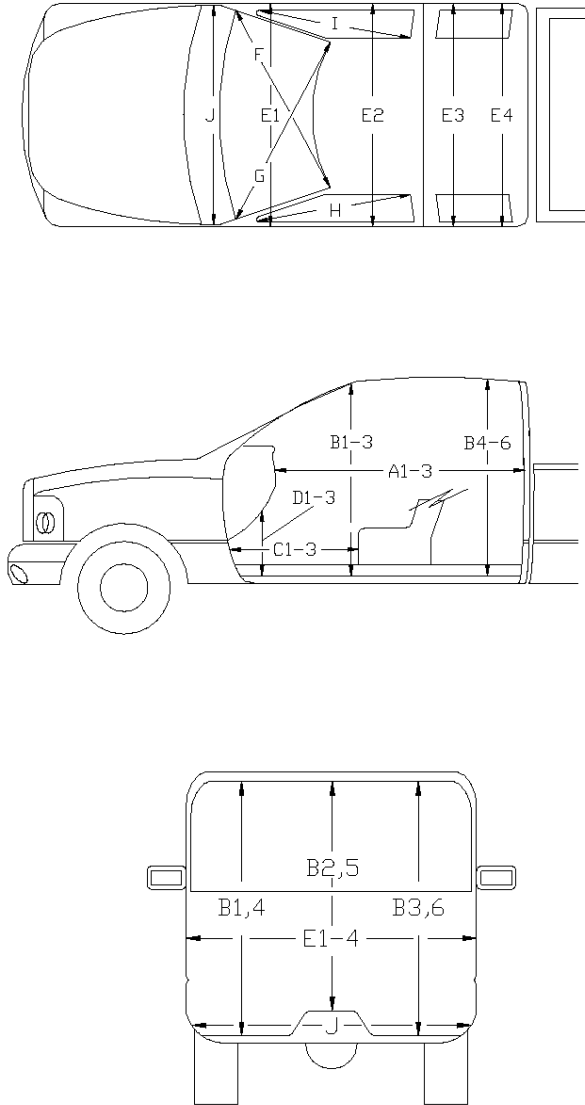
Figure D.3. Occupant Compartment Measurements for Test No. 440592-2.

Before	After (inches)	Differ.
A1	65.00	65.00	0.00
A2	63.00	63	0.00
A3	65.50	65.50	0.00
B1	45.00	45.00	0.00
B2	38.00	38.00	0.00
B3	45.00	45.00	0.00
B4	39.50	39.50	0.00
B5	43.00	43.00	0.00
B6	39.50	39.50	0.00
C1	26.00	17.5	8.5
C2	0.00	0.00	0.00
C3	26.00	26.00	0.00
D1	11.00	11.00	0.00
D2	0.00	0.00	0.00
D3	11.50	11.50	0.00
E1	58.50	59.5	1
E2	63.50	64.5	1
E3	63.50	63.50	0.00
E4	63.50	63.50	0.00
F	59.00	59.00	0.00
G	59.00	59.00	0.00
H	37.50	37.50	0.00
I	37.50	37.50	0.00
J*	25.00	21.5	3.5
