## EXPERIMENTAL PROJECTS FINAL REPORT

### CONTECH® A-2000 POLYVINYL CHLORIDE (PVC) PLASTIC PIPE

**Project Name:** Checkerboard - Martinsdale (CN 4803000)

**Project Number:** STPP 14-2(20)63

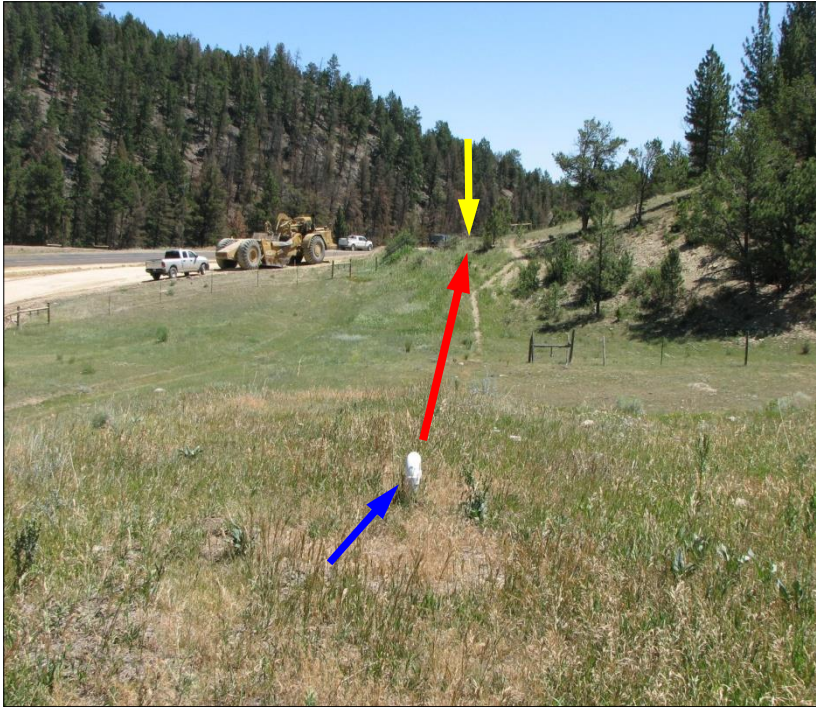
← Image shows the beginning of the 18" A-2000 installation (yellow arrow), view east. The flow runs from west to east.

The red arrow indicates the existing lay of the 15" (38 cm) PVC irrigation line (off ROW).

The white pipe in the image is the irrigation vent tube (blue arrow).

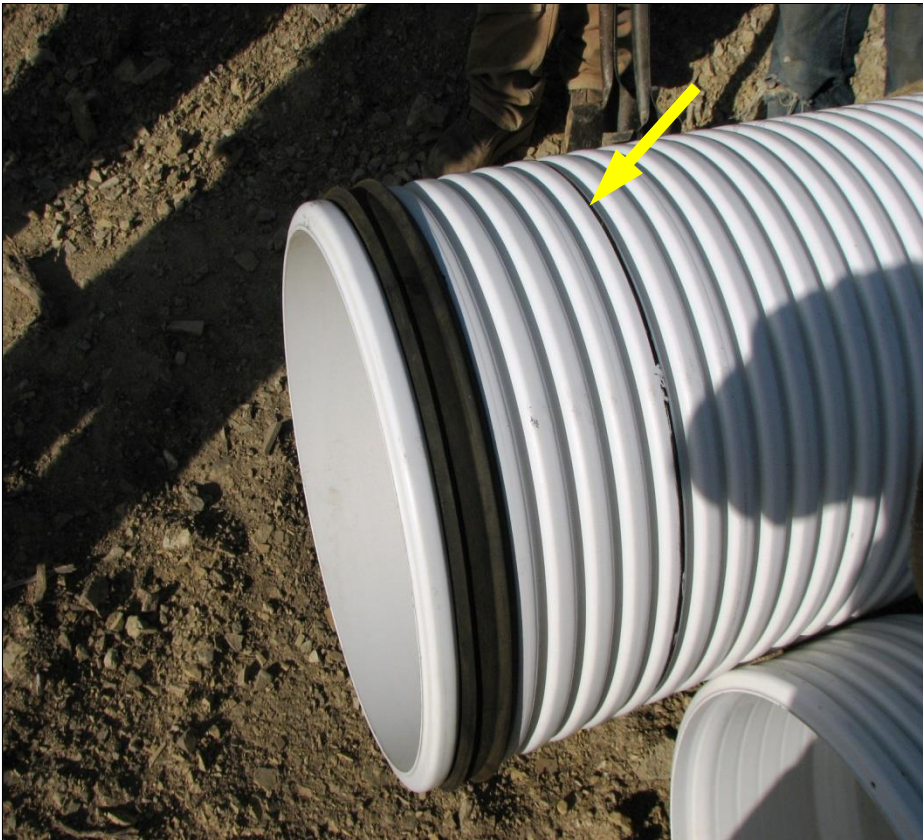
← The spigot end with the (double sealing surface) gasket is placed on the first two pipe corrugation valleys.

The gasket is shipped separately from the pipe and attached on site.

Note the black ring located approximately one foot from the spigot end (yellow arrow).

When the bell end of the pipe reaches this *home* mark within one corrugation it is seated correctly.

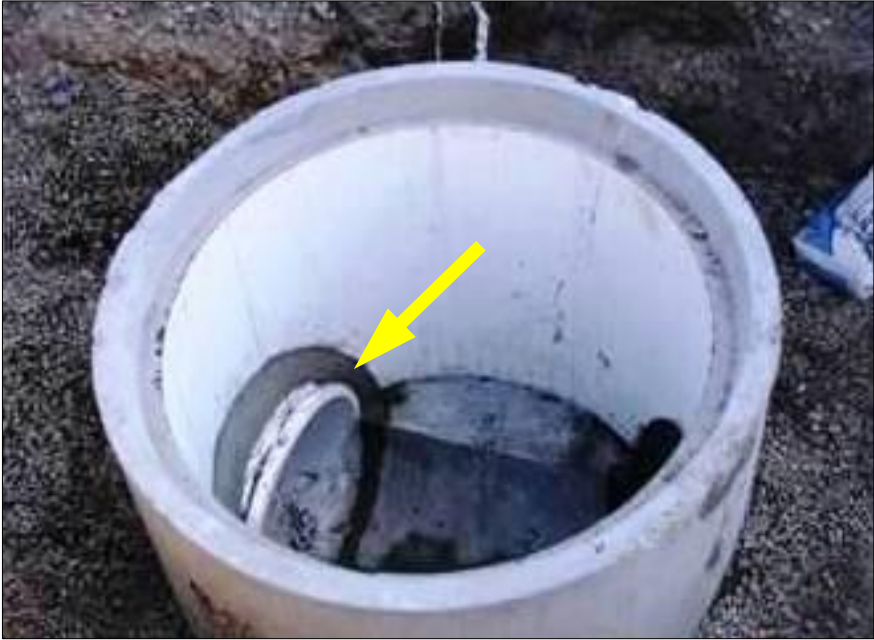
← Research was unable to capture the grouting procedure of the pipe to the manhole on-site.

This file photo is an example of what a completed grouting will look like (yellow arrow).

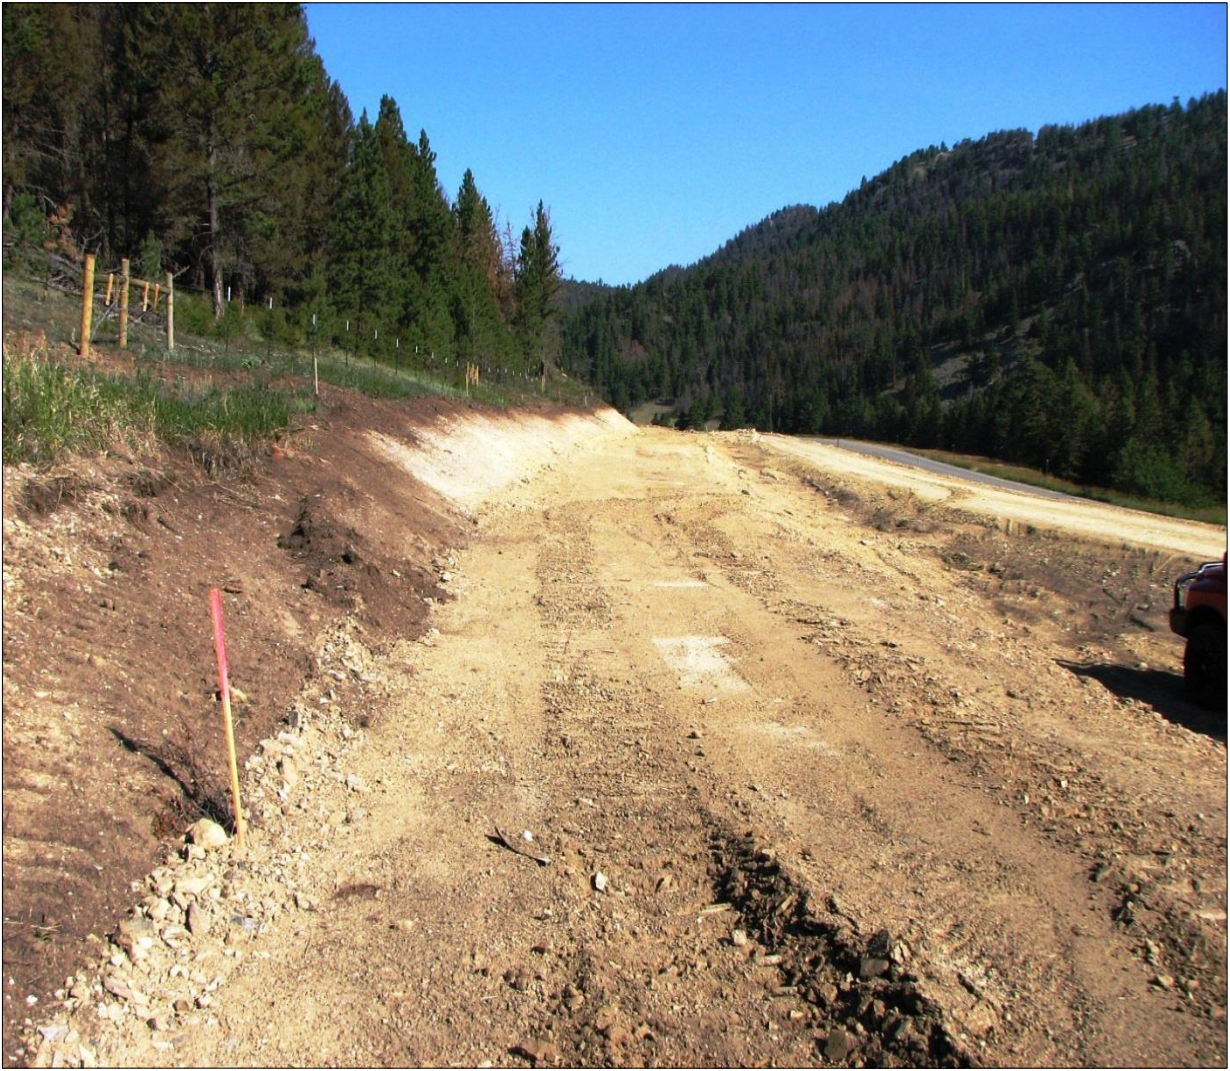
↑ Representative image of the completed A-2000 18" installation (view west).

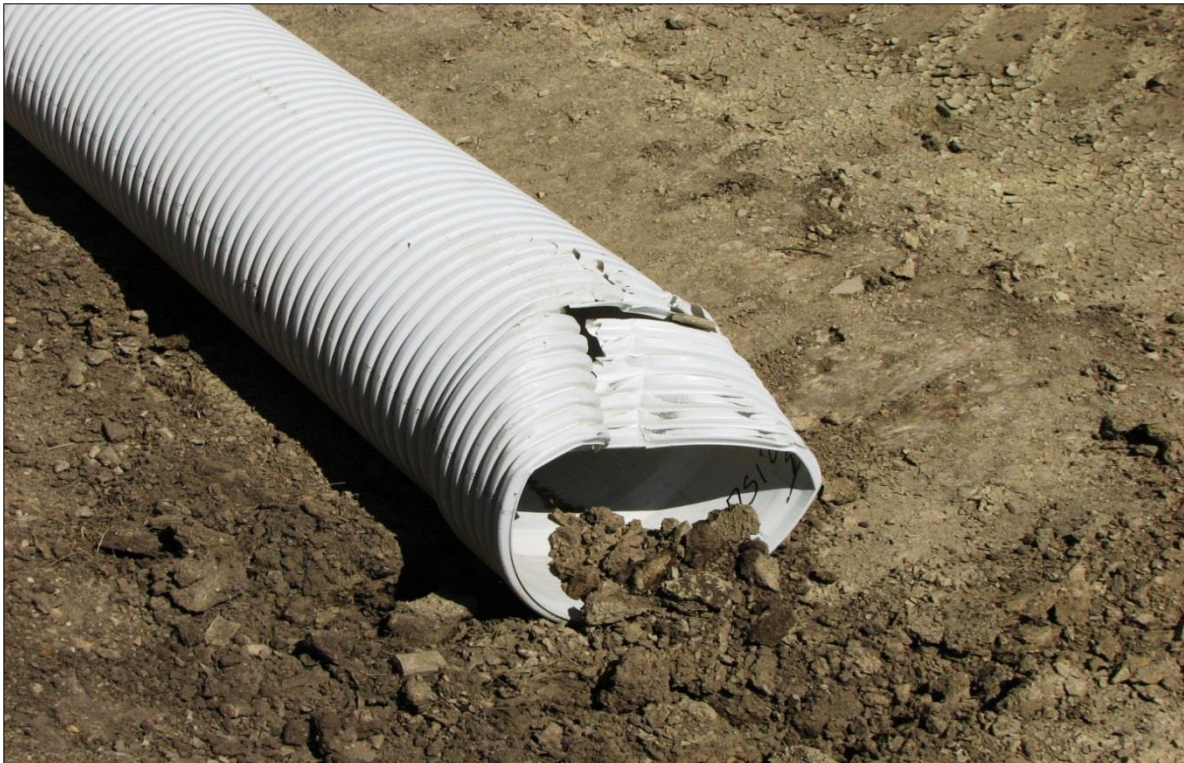
- ↑ Sample image of how pipe sections were shortened on site using a portable saw.
- ↓ Damaged pipe are saved and used when shorter sections are required during installation.

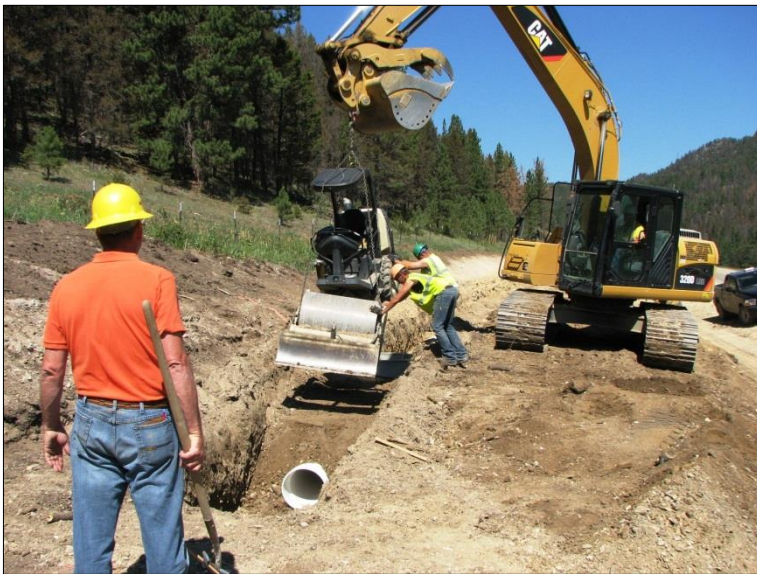
← The excavator is used to lower the single drum vibratory roller on top of the filled pipe section.

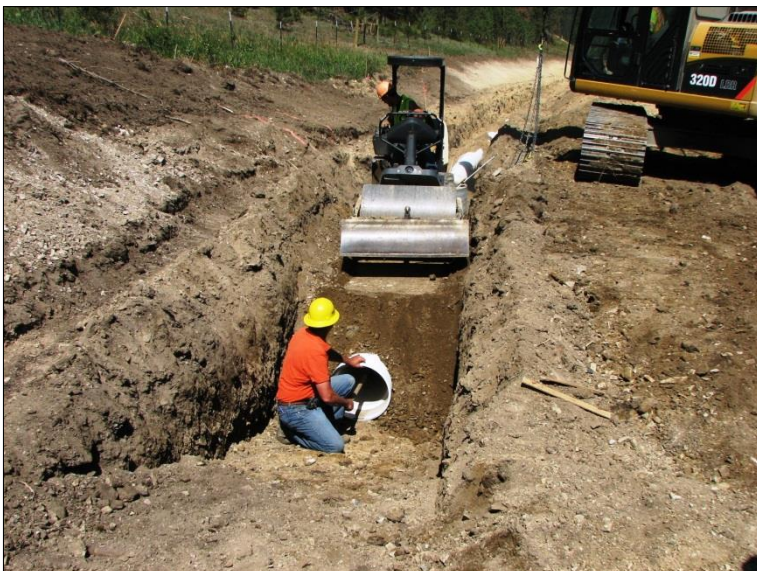
← The roller makes several passes using both static and dynamic modes to represent how it would be normally done throughout the project.
