# JOINT TRANSPORTATION RESEARCH PROGRAM

## Assessment of Bridges Subjected to Vehicular Collision

Wang, Y., & Thrall, A. P. (2019). *Assessment of bridges subjected to vehicular collision* (Joint Transportation Research Program Publication No. FHWA/IN/JTRP-2019/01). West Lafayette, IN: Purdue University. <https://doi.org/10.5703/1288284316870>

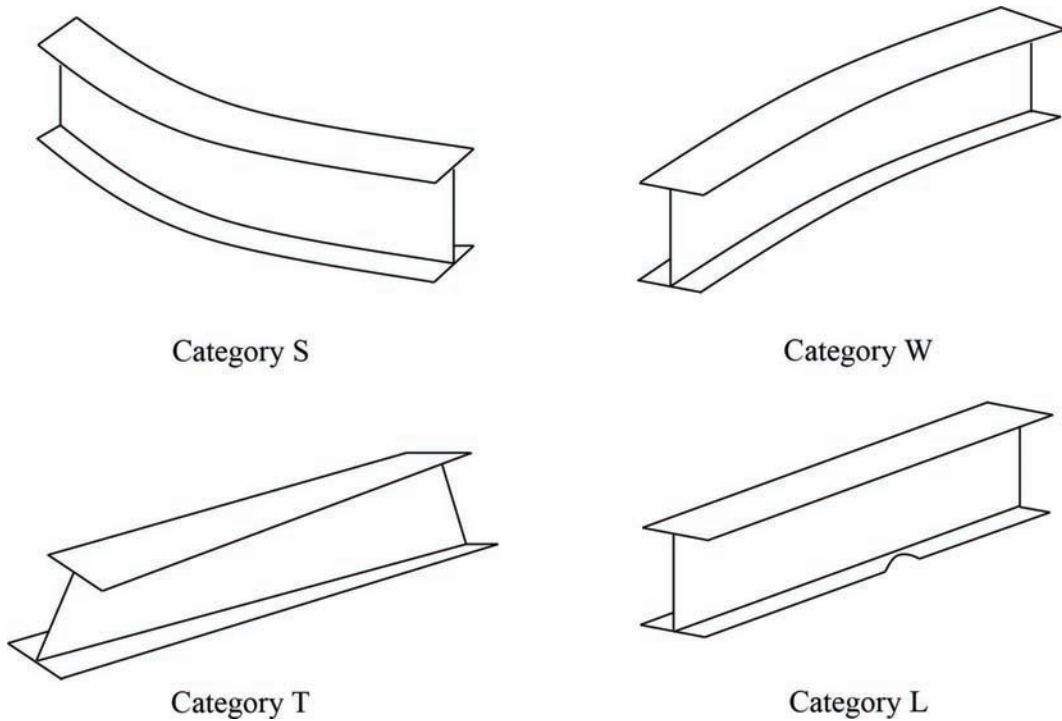
**Figure 1.3** Categories of damage (adapted from FHWA, 2015).

as: (1) strong or major axis bending (Category S), (2) weak or minor axis bending (Category W), (3) torsion about the longitudinal axis (Category T), and (4) local damage including flange bulges and web buckles (Category L) (Figure 1.3). Events typically cause damage that is as a combination of these categories (FHWA, 2015). Category T and L damage is most frequently observed for composite bridges, while Category W and L is more likely for non-composite bridges (Varma & Kowalkowski, 2004). After damage, an engineer must determine if repair is necessary, and if so, what type of repair should be performed (FHWA, 2015). There are currently no available guidelines for bridge inspectors to assess damage and to make repair decisions.

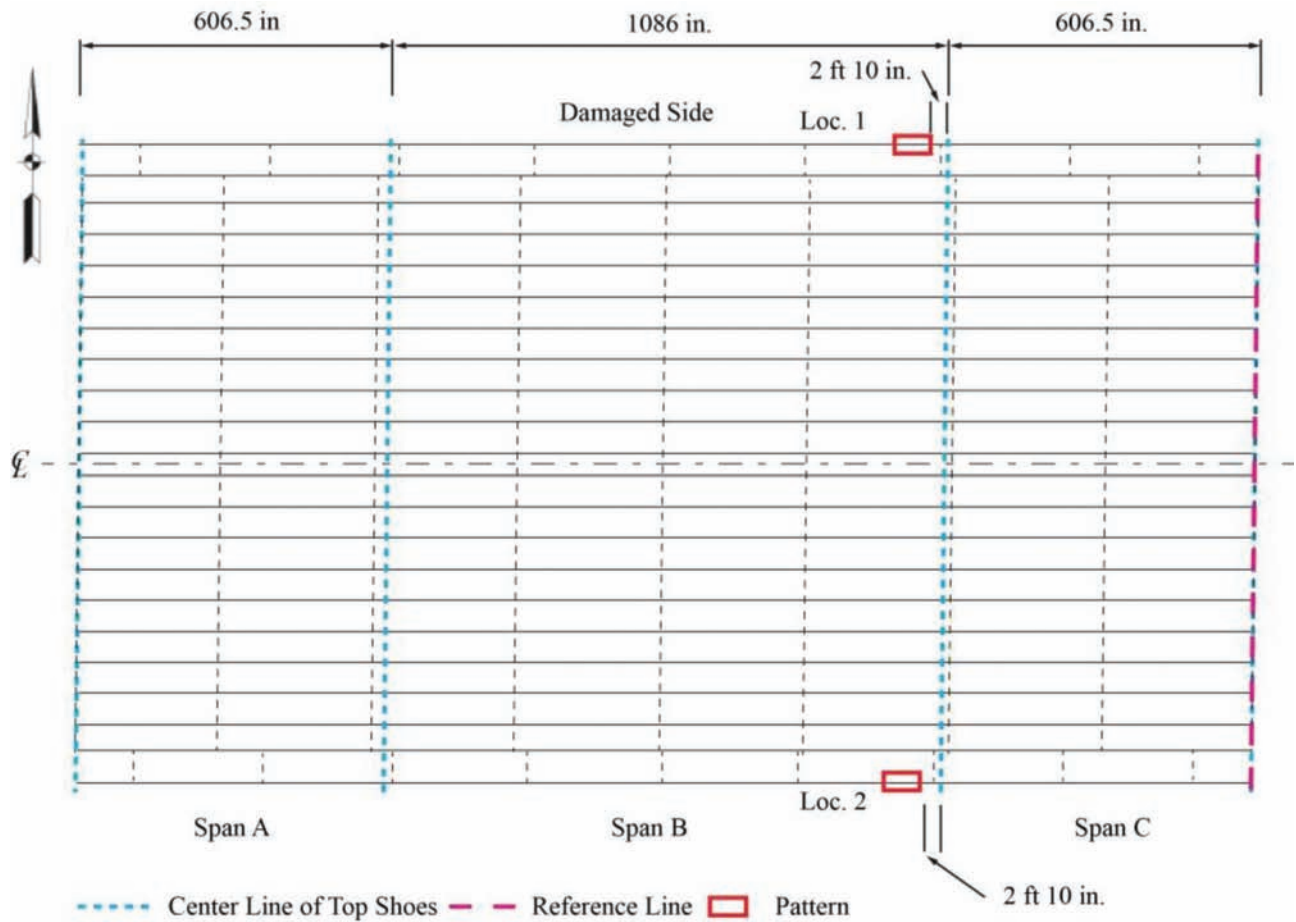
Figure 4.3 Framing plan and pattern locations for Asset 020-71-04052.

Asset 020-71-04052 (Figure 4.2 and Figure 4.3) is a three-span (50 ft. 6 in., 90 ft. 6 in., 50 ft. 6 in. spans) continuous composite bridge in South Bend, IN, built in 1966 and reconstructed in 1997. In 2016, 14 of the 22 girders were damaged near the East pier by a collision from an equipment hauler, with the heaviest damage incurred by the North exterior girder (Figure 4.4). Because of the vehicular collision, the lower flange was plastically deformed with a sweep of approximately 16 in. The bearing was also kicked out and retrofitted with a wedge.

Two girders were monitored (Figure 4.3): (1) severely damaged exterior girder (Location 1) and (2) less damaged symmetric exterior girder (Location 2). Location 1 is the location of the worst damage. Location 2 was selected as a symmetric location on a less damaged girder for comparison. Ideally, a symmetric undamaged girder would have been monitored. However, this was not possible, as some collision damage had occurred at Location 2. The behavior of the webs and bottom flanges were monitored. At Location 1, the bottom of the bottom flange and the North face of the web were monitored. At Location 2, the top of the bottom flange and the South face of the web were monitored.

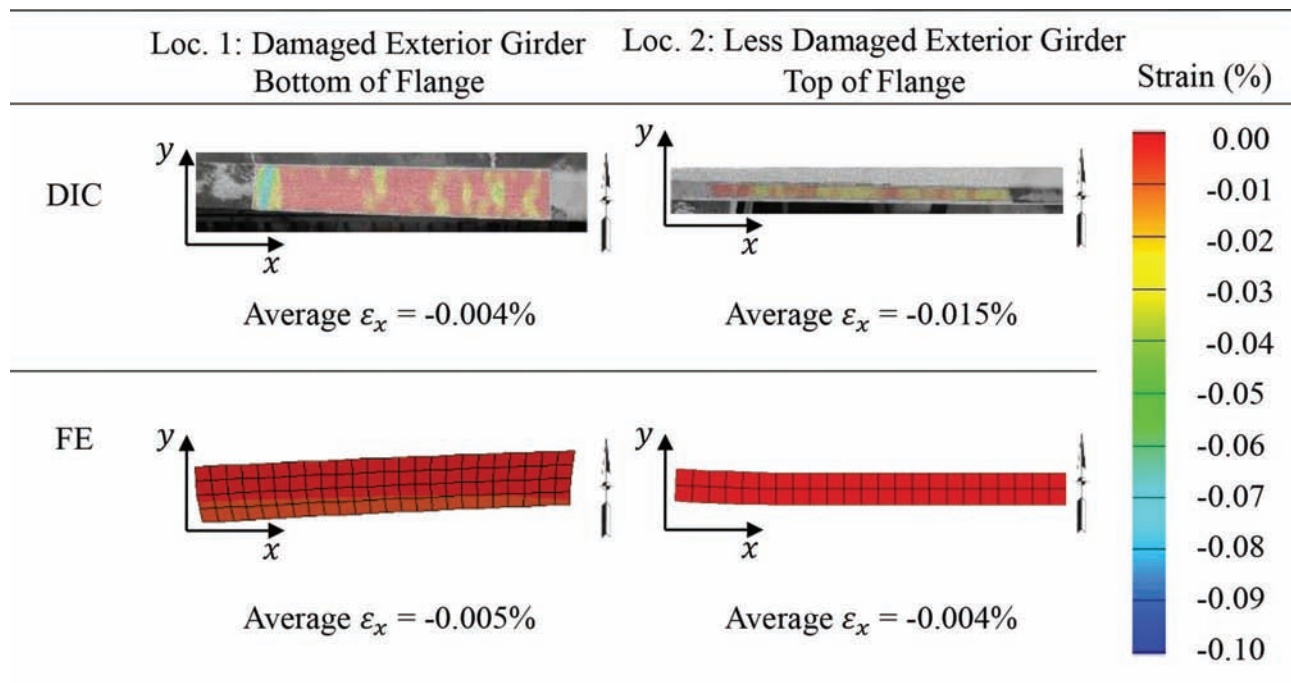
**Figure 4.6** Measured and FE predictions (tied model) of strains in the bottom flanges of Asset 020-71-04052 under peak negative moment.

Figure 4.6 and Table 4.3 show the DIC measured strains and the FE predictions under peak negative moment. For the damaged exterior girder (Location 1), two types of behavior between the damaged girder and the deck are considered: (1) in the center span and the East side span the girder and deck are composite (tied); (2) in the center span and the East side span the girder

Figure 4.6 and Table 4.3 show that strain in both girders is very small, demonstrating conservatism in design. The measured strain in the damaged girder (Location 1) is much smaller than the less damaged symmetric girder (Location 2). This suggests that load is being redistributed away from the damaged girders. Railing participation is likely an important considera-

tion in this redistribution, as well as participation of adjacent girders. The FE prediction for the damaged girder using the tied model matches the measured data very well (full-field maps shown in Figure 4.6). The untied scenario results in smaller strains in the damaged girder. For the undamaged side, the FE prediction is less than the measurement. This is because the exterior girder on the undamaged side is also damaged and deformed inward. Figure 4.7 shows the FE strain distribution in the monitored region. Compared to the inner side, the monitored region has a lower average strain. This is because the strain distribution is very sensitive to the geometry of the damage. If more information is available on the less damaged side, better agreement could potentially be achieved between FE prediction and measured DIC results.

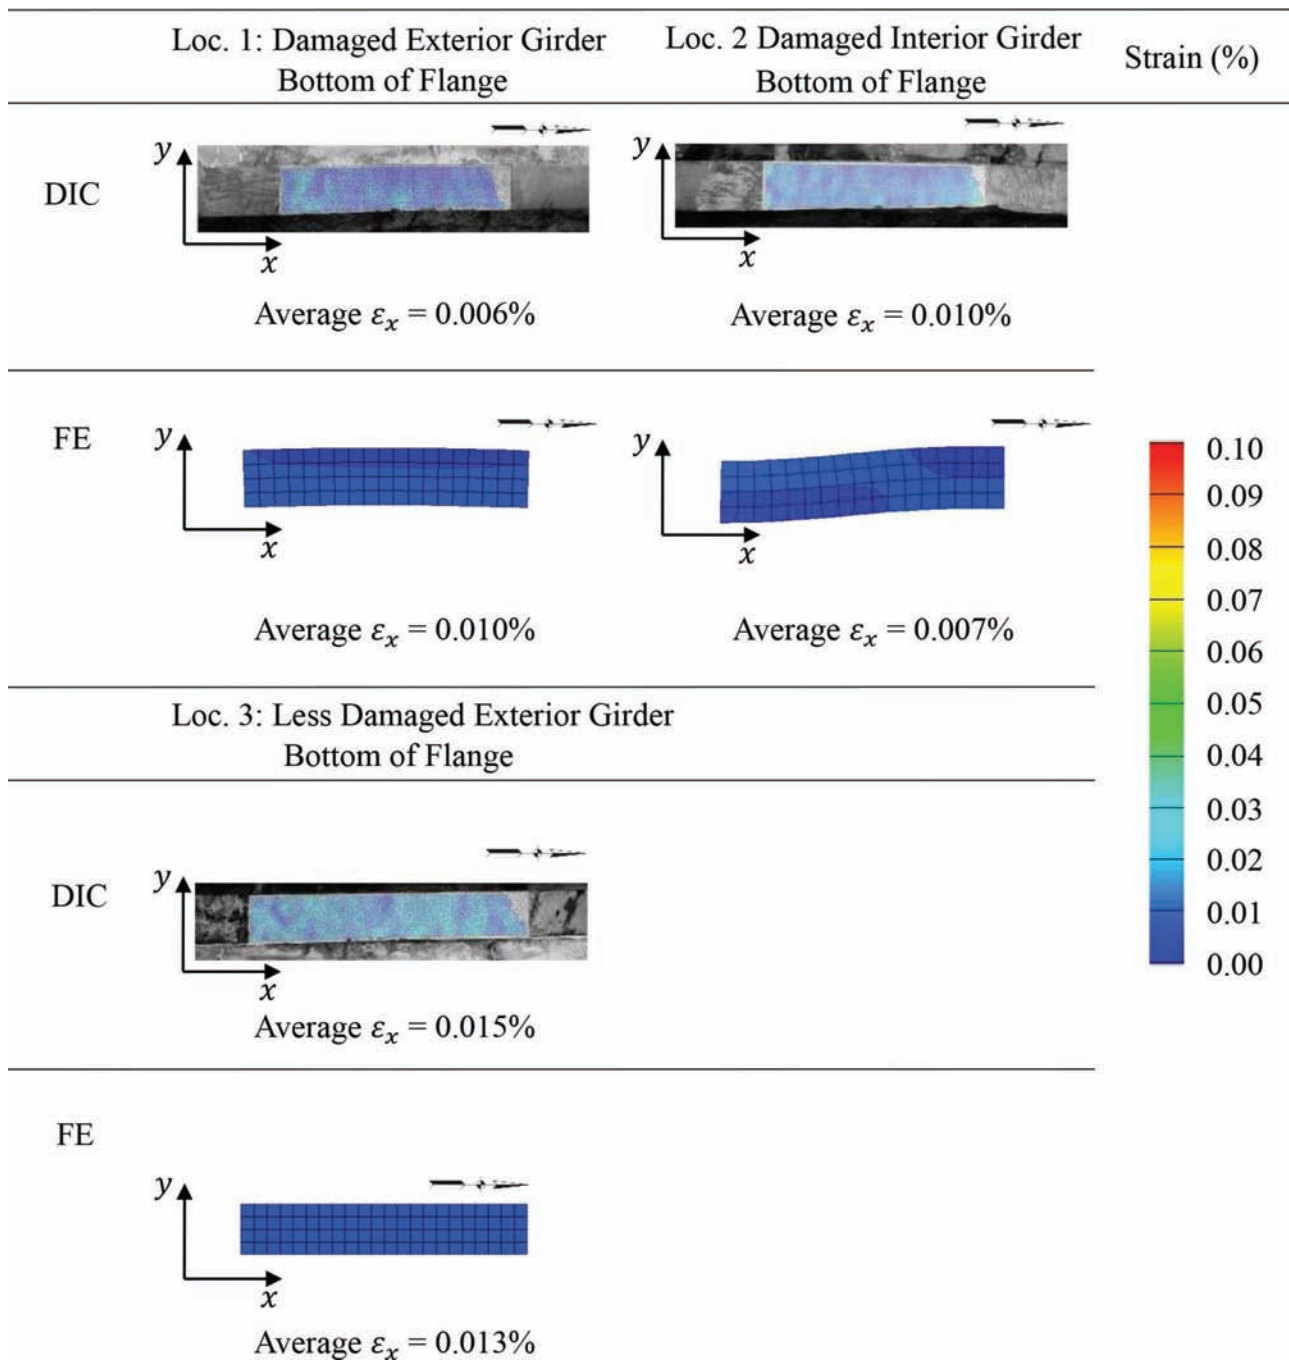
**Figure 4.13** Measured and FE predictions (tied with curb) of strains in the bottom flanges in Asset 030-02-04803 under peak positive moment.

Figure 4.13 and Table 4.5 show the measured DIC strains and FE predictions under peak positive moment. Overall, the strains are very small, again demonstrating conservatism in design. Since the measured strains are so small, the later studies focused on locations corresponding to where peak moment can be induced, as opposed to the location of the worst damage.

Location	DIC	FE with curb	FE without curb
Loc. 1: Damaged Exterior Girder	0.006%	0.010% (tied) 0.011% (untied)	0.014% (tied) 0.018% (untied)
Loc. 2: Damaged Interior Girder	0.010%	0.007% (tied) 0.009% (untied)	0.009% (tied) 0.011% (untied)
Loc. 3: Undamaged Exterior Girder	0.015%	0.013% (tied) 0.018% (untied)	0.020% (tied) 0.026% (untied)
Undamaged Interior Girder	N/A	0.009% (tied) 0.010% (untied)	0.012% (tied) 0.014% (untied)

Measured strains in the web of Location 3 under peak positive moment were negligible and no crack opening was observed.

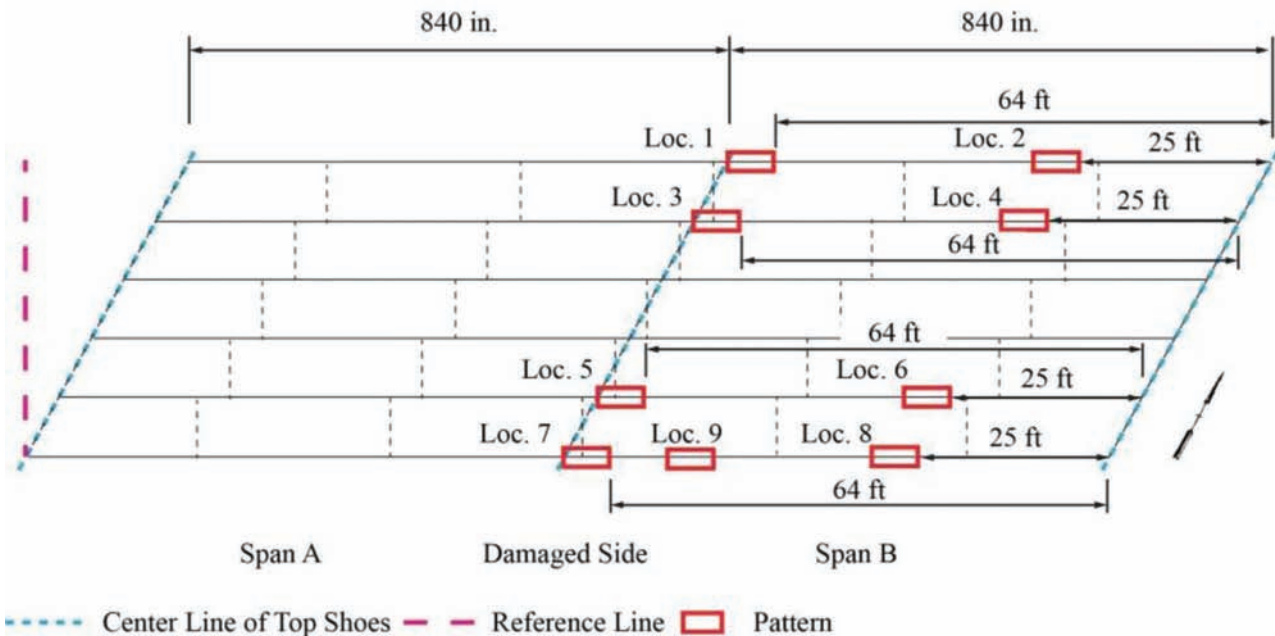
Figure 4.15 Framing plan and pattern locations for Asset 037-55-05265.

Four girders were monitored (Figure 4.15): (1) an undamaged exterior girder (Locations 1 and 2), (2) an undamaged interior girder adjacent to the undamaged exterior girder (Locations 3 and 4), (3) an undamaged interior girder adjacent to the damaged exterior girder (Locations 5 and 6), and (4) a damaged exterior girder (Locations 7, 8, and 9). Locations 1, 3, 5, and 7 were monitored as peak negative moment can be induced at these locations. Locations 2, 4, 6, and 8 were monitored as peak positive moment can be induced at these locations. Location 9 corresponds to the worst damage. The bottom of the bottom flanges were monitored.

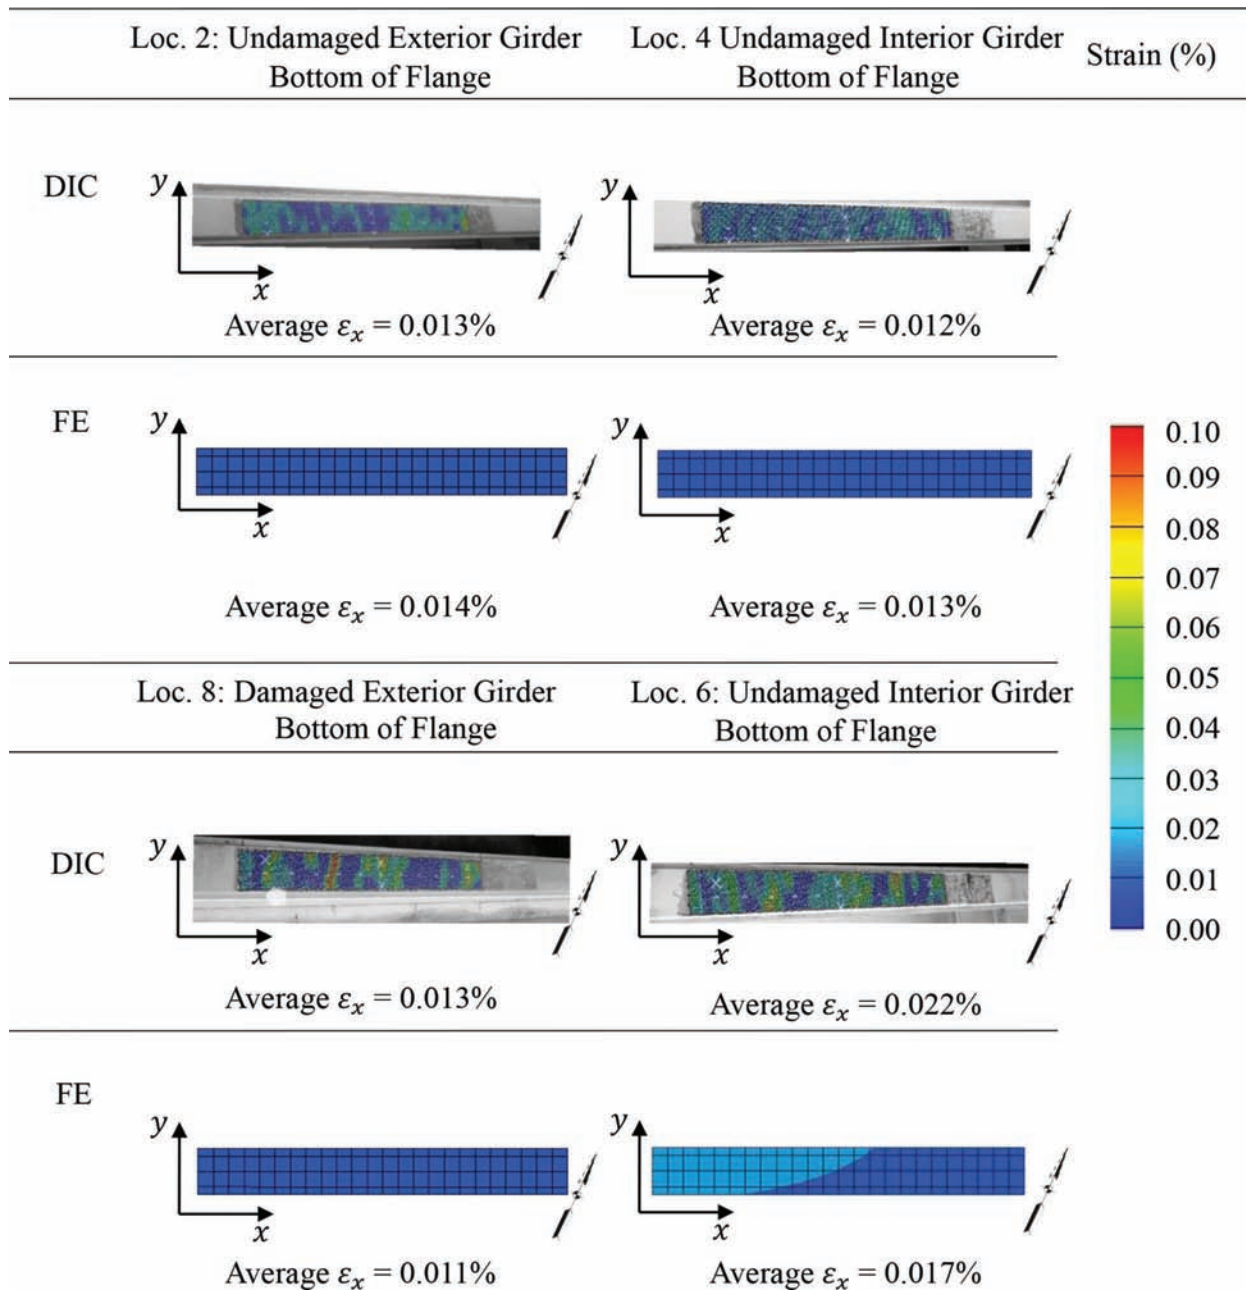
**Figure 4.18** Measured and FE predictions (with damaged girder untied over the entire damaged span) of strains in the bottom flanges in Asset 037-55-05265 under peak positive moment.

Figure 4.18 and Table 4.7 show the measured and predicted strains under peak positive moment. Again, the measured strains are small, indicating conservatism. The measured strains in the exterior girders (i.e., Locations 2 and 8) are comparable. However, the interior girder adjacent to the damaged girder (i.e., Location 6) carries more strain than any of the other girders. This demonstrates that the damaged girder is shedding its load to the adjacent girder. On the damaged side, different interactions between the concrete deck and the damaged girder were investigated numerically: (1) the damaged girder and the deck are acting compositely (tied); (2) the damaged girder and the deck are acting as non-composite between the 3rd and 5th diaphragm from the West and the coefficient of friction is 0.65 (untied 1); (3) the damaged girder and the deck are acting as non-composite in the damaged span and the coefficient of friction is 0 (untied 2); (4) the damaged girder and

the deck are acting as non-composite in the damaged span and the coefficient of friction is 0.65 (untied 3). By removing the composite behavior over the entire damaged span and assuming no friction between the top flange and the deck (i.e., untied 2), the FE predictions most closely match the DIC measurements and are featured in Figure 4.18. This demonstrates that the shear connection between the girder and the deck may be damaged due to vehicular collision.

Location	DIC	FE
Loc. 2: Undamaged Exterior Girder	0.013%	0.014%
Loc. 4: Undamaged Interior Girder	0.012%	0.013%
Loc. 6: Undamaged Interior Girder	0.022%	0.013% (tied) 0.014% (untied 1) 0.017% (untied 2) 0.016% (untied 3)
Loc. 8: Damaged Exterior Girder	0.013%	0.015% (tied) 0.014% (untied 1) 0.011% (untied 2) 0.012% (untied 3)

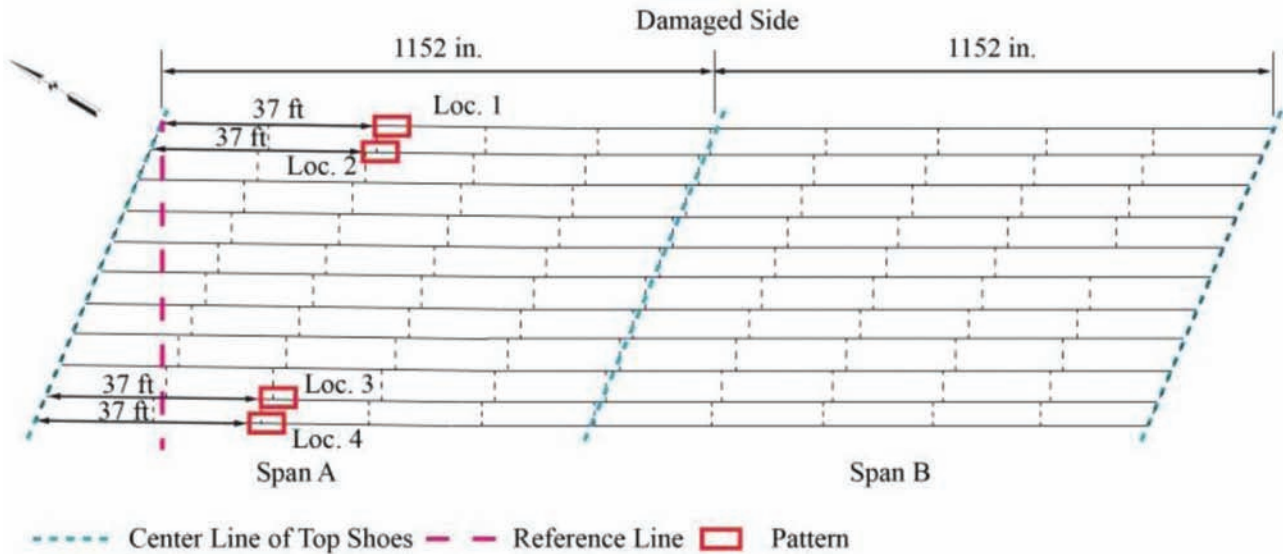
Figure 4.20 Framing plan and pattern locations for Asset (45)46-53-05993.

Four girders were monitored (Figure 4.20): (1) a damaged exterior girder (Location 1), (2) an undamaged interior girder adjacent to the damaged girder (Location 2), (3) an undamaged interior girder (Location 3), and (4) an undamaged exterior girder (Location 4). Monitored regions were selected as peak positive moment

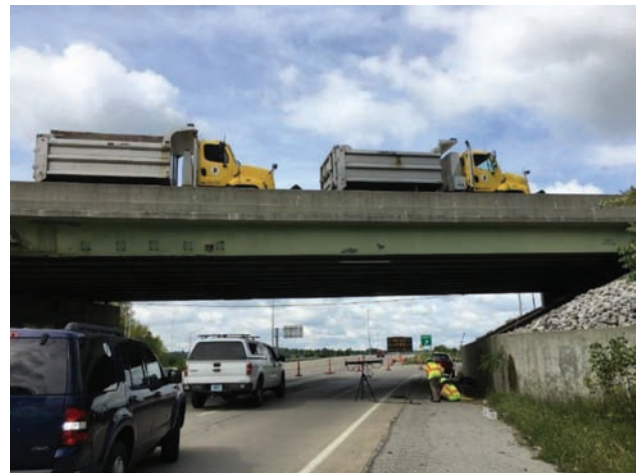
Figure 4.22 Load testing for Asset (45)46-53-05993.

Seymour District Maintenance Crews and Bridge Inspectors—on September 12, 2018, with both pattern application and monitoring occurring in the same day (Figure 4.22). While all other studies waited 48 hours between pattern application and monitoring to ensure cure time for the tape adhesive, this work was all performed in a single day. Tensile testing demonstrated that the adhesive provided sufficient bond immediately and therefore that monitoring could be performed immediately.

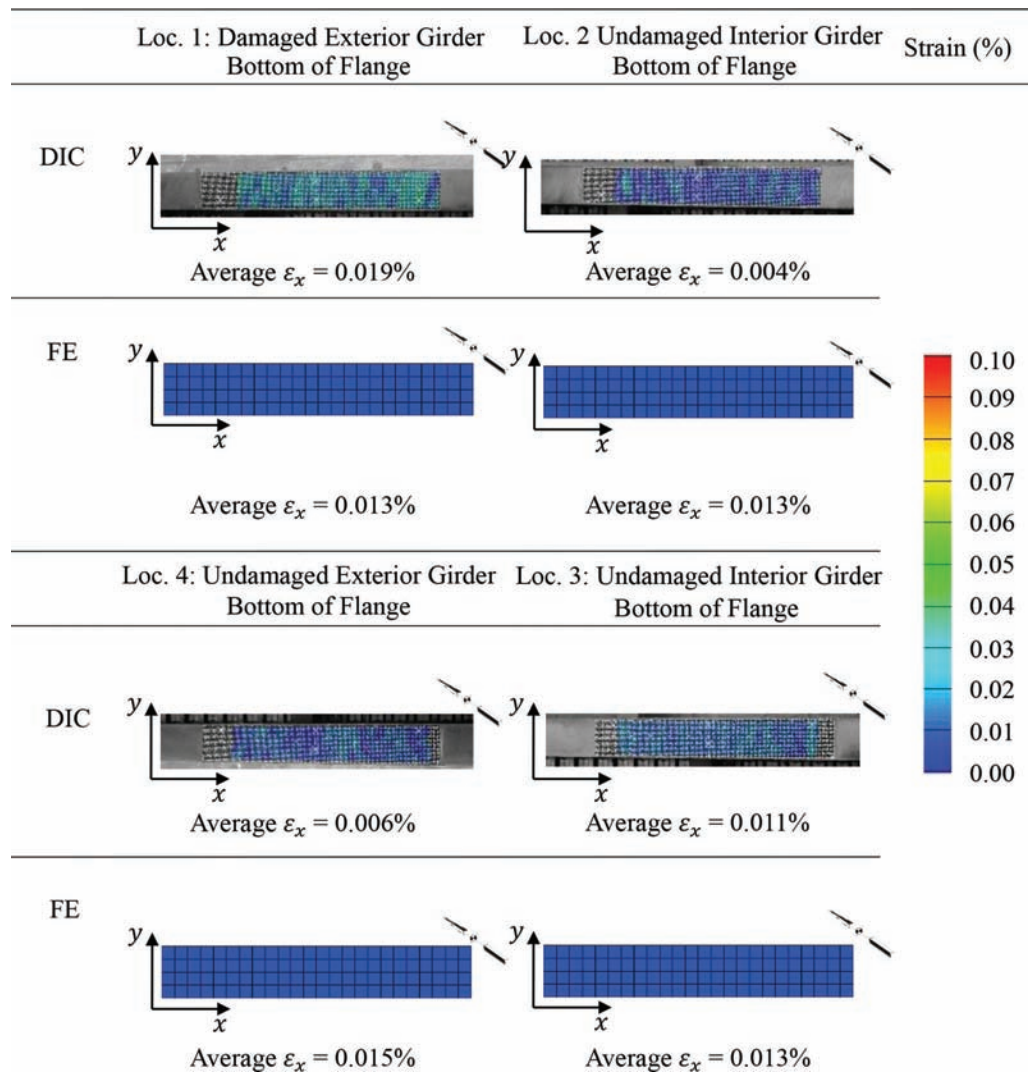
Figure 4.23 Measured and FE predictions (tied with cracks) of strains in the bottom flanges in Asset (45)46-53-05993 under peak positive moment.

Figure 4.23 and Table 4.9 shows the measured and predicted strains under peak positive moment. Again, the strains are small, indicating conservatism. A notable

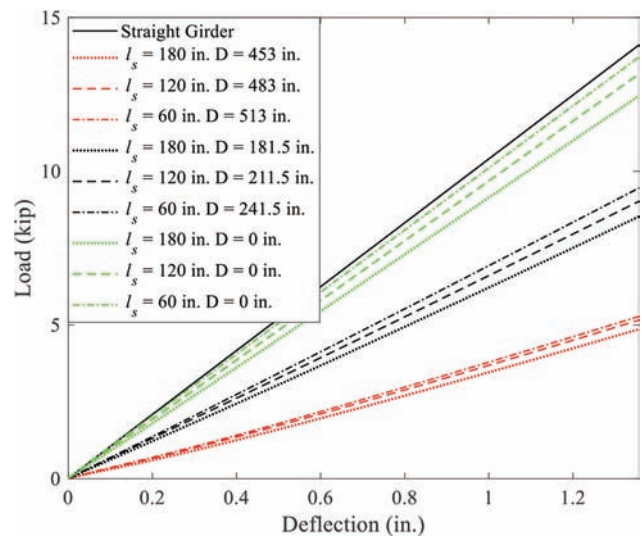
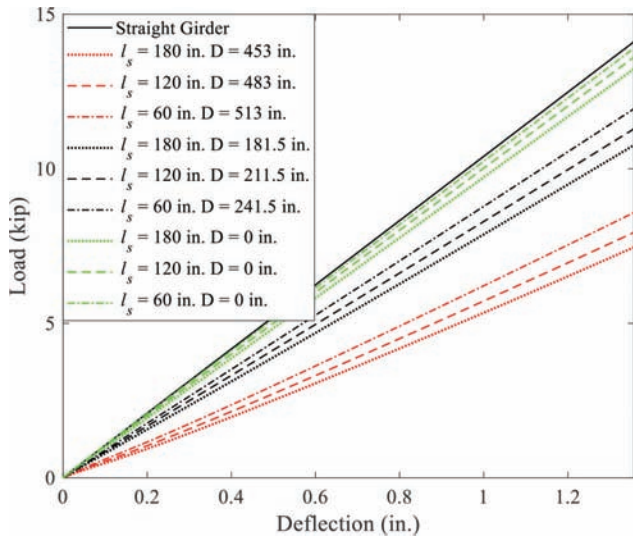
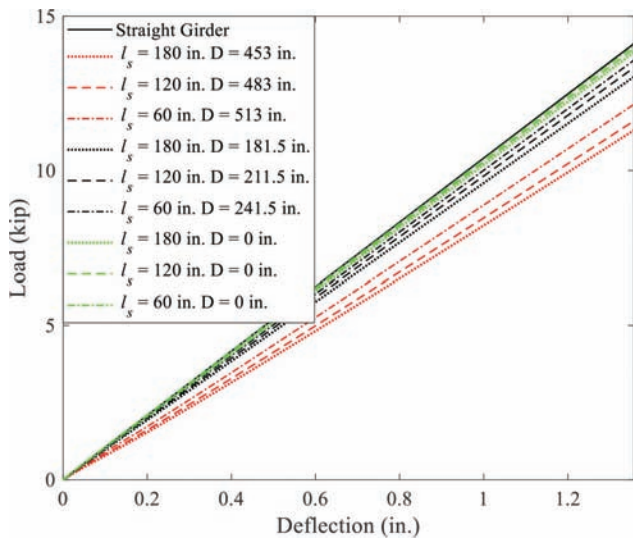
Generally, damage reduces the stiffness of the girder (Table 5.2, Figures 5.1, 5.2, and 5.3). The greater the

$\alpha=10^\circ$	$\alpha=20^\circ$	$\alpha=30^\circ$
$l_s=180$ in. (C)	80.1	52.9	34.6
$l_s=180$ in. (Q)	92.4	76.3	60.5
$l_s=180$ in. (E)	98.0	93.8	88.3
$l_s=120$ in. (C)	82.2	56.2	36.5
$l_s=120$ in. (Q)	94.5	80.0	63.9
$l_s=120$ in. (E)	98.8	96.5	93.3
$l_s=60$ in. (C)	86.0	60.8	37.5
$l_s=60$ in. (Q)	96.2	84.6	67.0
$l_s=60$ in. (E)	99.5	98.5	97.2

rotation angle ( $\alpha$ ), the greater the reduction in the stiffness. As the damage moves from the edge of the girder to midspan, the effect of damage on the stiffness increases. Longer damaged lengths ( $l_s$ ) also decrease the stiffness. The stiffness can drop up to 34.6% that of a straight beam when damage features a large rotation angle, long damage length, and midspan location.

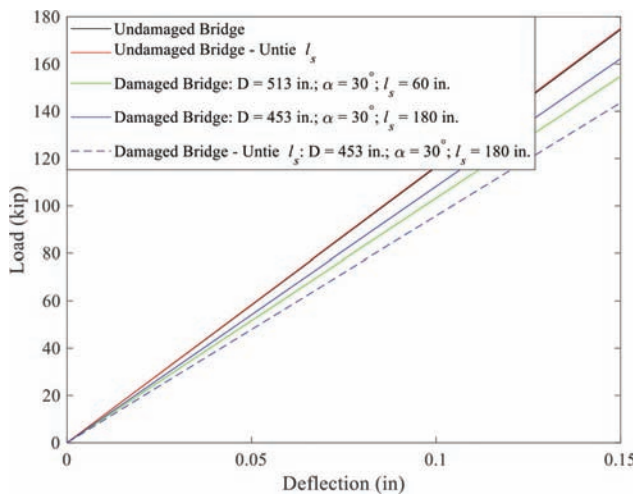
Figure 5.4 Load-deflection behavior of whole bridge.

The damaged girder reduces the stiffness of the entire bridge, compared to a bridge with no damaged girders (Figure 5.4). A shorter damaged length ( $l_s$ ) decreases the stiffness of the bridge more than a longer length. This is in contrast to the findings of the single girder study. It can be attributed to continuity and load redistribution in the entire bridge model, where a longer damaged length is able to redistribute to adjacent girders more effectively than a more localized shorter length. Although damage can cause a significant drop in stiffness, in the single girder study (e.g., for  $\alpha=30^\circ$ ,  $l_s=180$  in.,  $D=S/2-l_s/2$ , the damaged girder only had 34.6% of the stiffness of straight beam). This effect is mitigated in the entire bridge through redistribution to the concrete deck, concrete railing, and adjacent girders (for the same case, the stiffness of the bridge is 92.9% that of an undamaged bridge). The effect of removing the shear connection (or untying the connection between the girder and deck) was also investigated. This had a negligible effect on the undamaged bridge model, but resulted in a drop in stiffness from 92.9% for the undamaged bridge to 82.2% for  $\alpha=30^\circ$ ,  $l_s=180$  in.,  $D=S/2-l_s/2$ .
