Guidelines for Detection, Analysis, and Treatment of Materials-Related Distress in Concrete Pavements Volume 3: Case Studies Using the Guidelines

PUBLICATION NO. FHWA-RD-01-165

AUGUST 2002

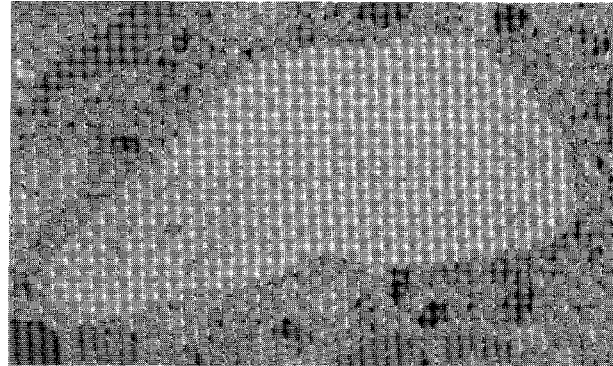
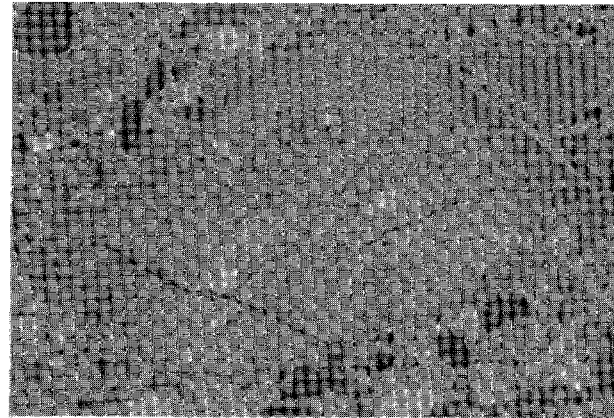
The sodium cobaltinitrite/rhodamine B staining tests were applied and a number of aggregates were identified as being susceptible to alkali-silica reactivity (ASR). The phenolphthalein staining method was used to determine the depth of carbonation on freshly cut surfaces. Slabs cut from the analyzed cores were tested for depth of carbonation with no core having a depth of carbonation greater than 2 mm below the road surface. Barium chloride/potassium permanganate stain was used to identify sulfate minerals. Examples of the stained slabs are presented in figures 3-8 through 3-11.

(b) Stereo optical micrograph of reactive porous siltstone particle

(c) Stereo optical micrograph of reactive volcanic particle

Figure 3-8. Slab 1B stained with sodium cobaltinitrite/rhodamine B from SD-090-019-001.

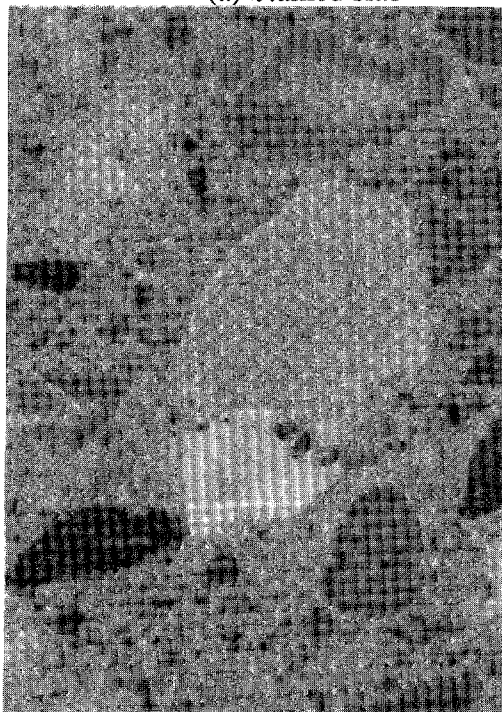
(c) ASR gel filled void

Figure 3-10. Slab 2B stained with sodium cobaltinitrite/rhodamine B from SD-090-019-002.

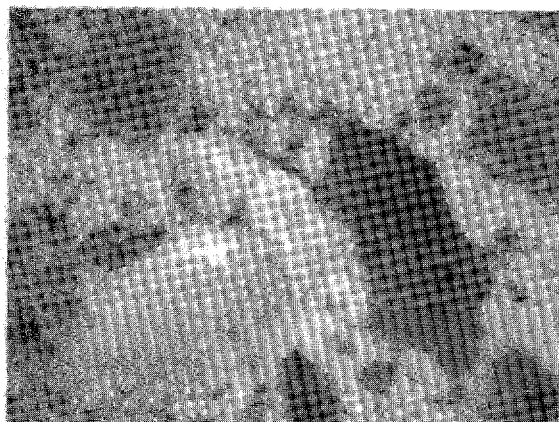
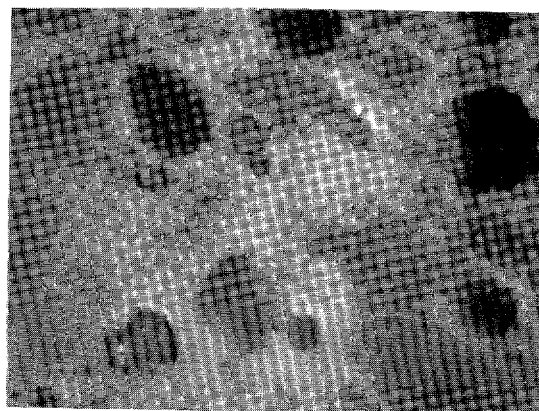
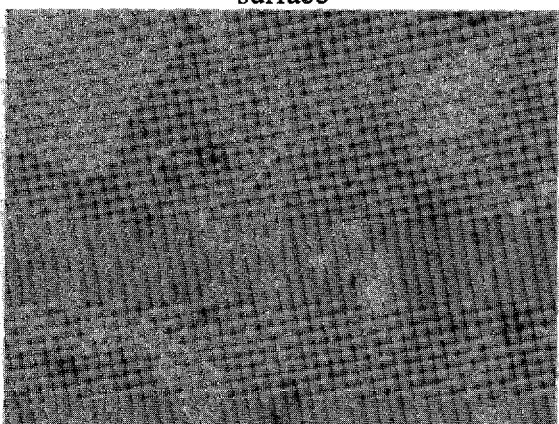
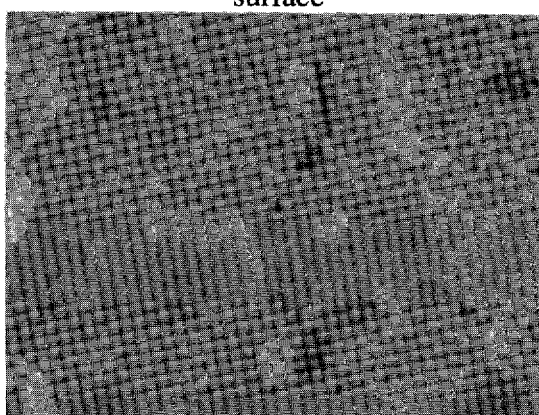
(a) Ettringite filled voids on polished surface

(b) Ettringite filled voids on polished surface

(c) Ettringite filled voids on unpolished surface

(d) Ettringite filled voids on unpolished surface

Figure 3-11. Stereo optical micrographs of air voids filled with sulfate minerals stained with potassium permanganate (note differences due to polishing).

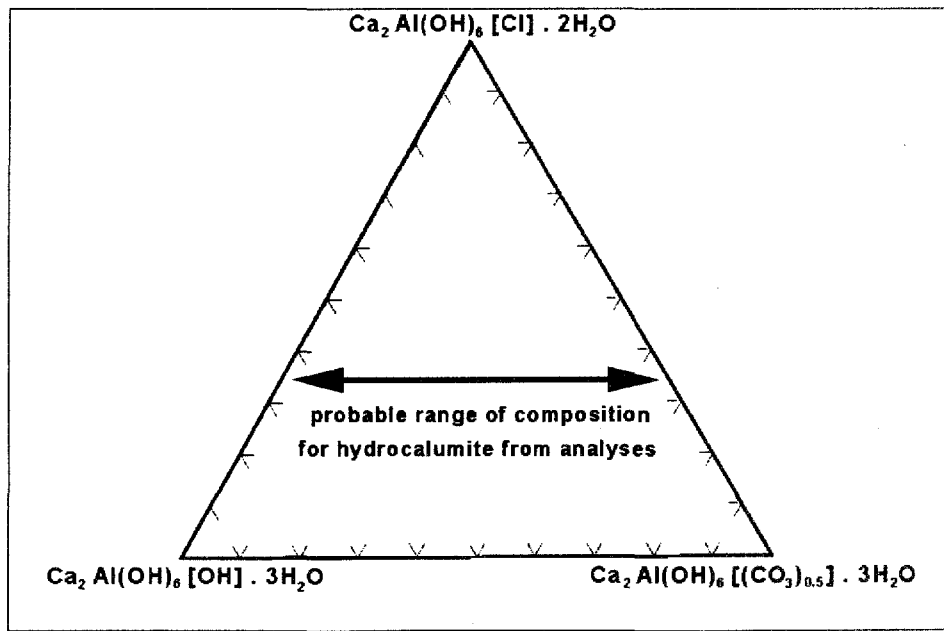
Figure 3-15. Ternary diagram showing the probable range of composition for the hydrocalumite deposits analyzed from SD-090-019.

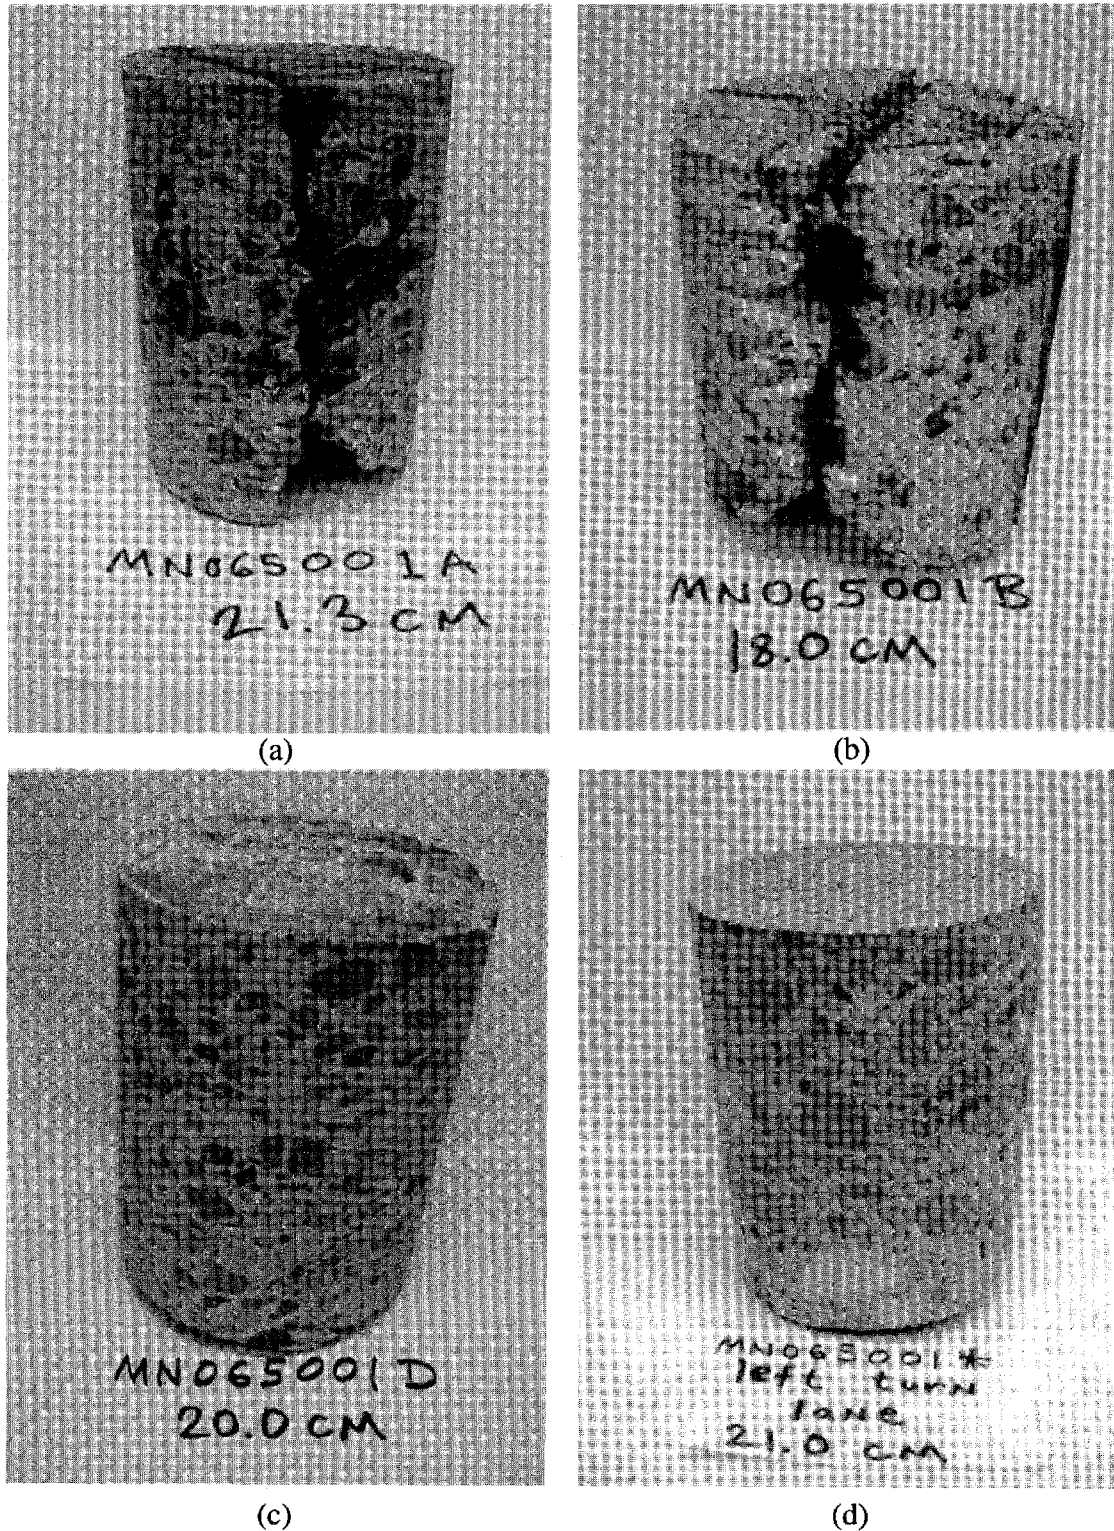
Based on the field survey and site inspection by researchers, the distress was determined to be concentrated at the transverse joints. In addition, the northbound turning lane was recognized as being in good condition even though it was approximately 40 years older than the badly distressed northbound Section 001. The guidelines for sampling were applied and four cores were retrieved from each section. Also, one mid-panel core (core D in standard pattern) was retrieved from the northbound (Section 001) left-turn lane. The cores selected for laboratory analysis were A from Section 002, cores B and D from Section 001, and core D from the left-turn lane. Pictures of these cores are shown in figure 3-22.

Figure 3-22. Cores evaluated for MN-065-064.

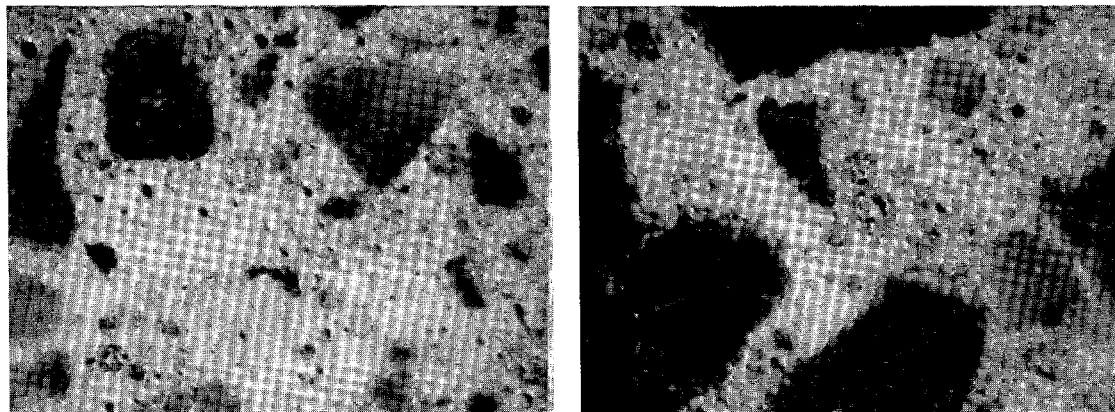
The rock type for the coarse aggregate was characterized as varying, but was dominantly mafic rock types typical of the Superior Lobe. The fine aggregate was the same, but with more quartz. No unusual alteration of the aggregate was observed. For this study, the most useful role for the stereo microscope was for observing stained specimens and determination of the hardened air content. The barium chloride/potassium permanganate stain described in Guideline II colors sulfate minerals a brilliant pink to purple hue as shown in figure 3-23.

Figure 3-23. Stereo optical micrographs showing sulfate minerals filling air voids.

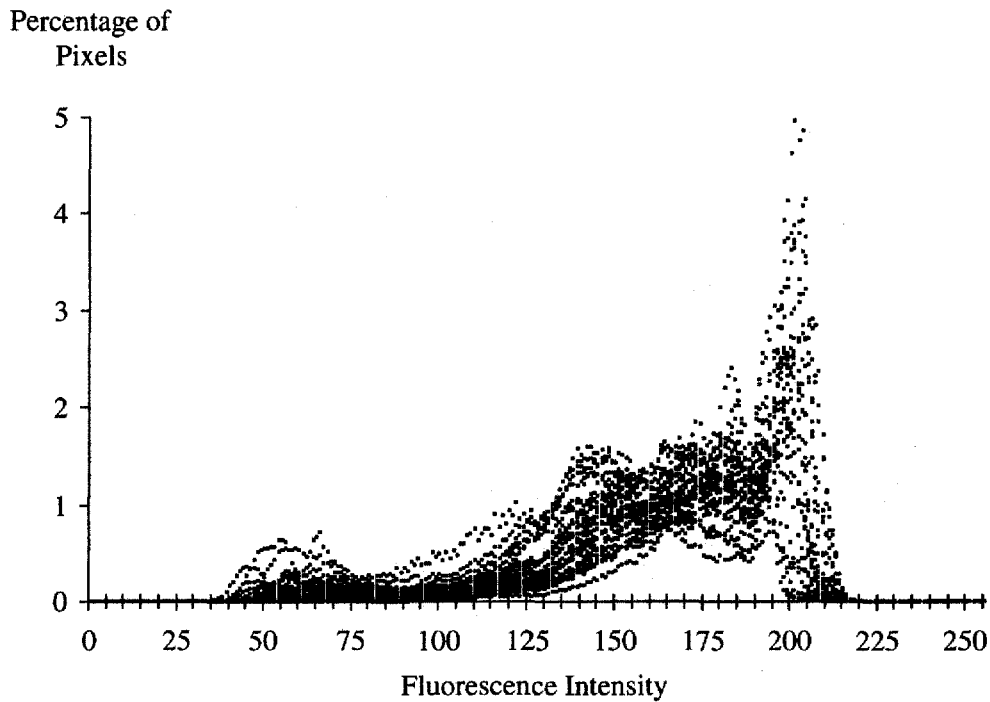
Figure 3-33. Histogram of fluorescence measurements from 1950 concrete from mid-panel of the left-turn lane of site MN-065-064-001.

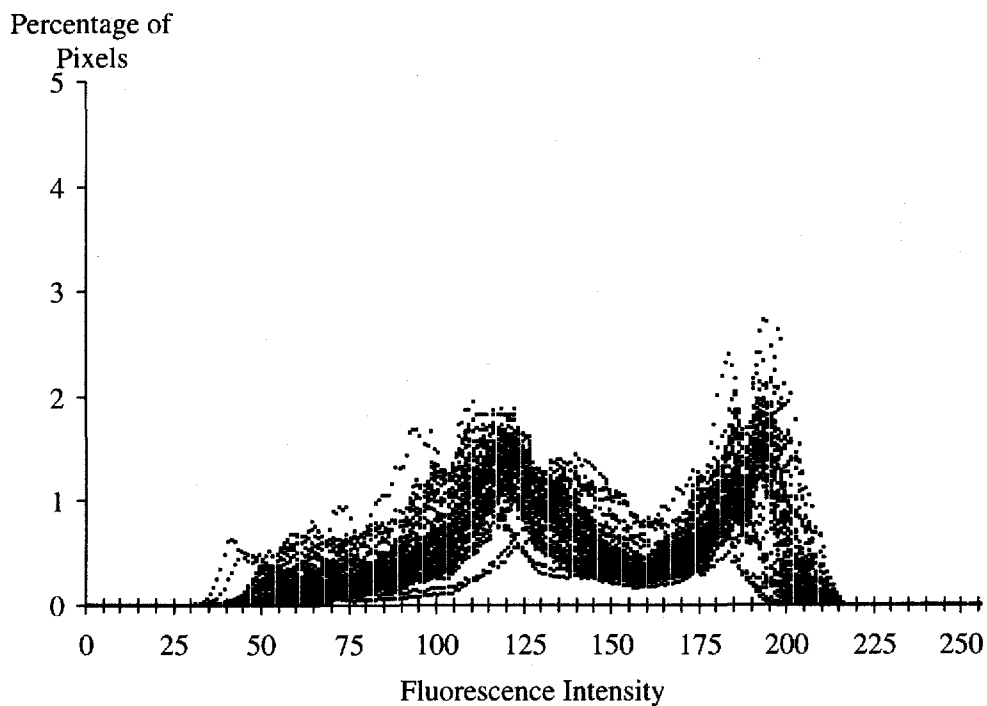
Figure 3-34. Histogram of fluorescence measurements from 1990 concrete from mid-panel of the traffic lane of site MN-065-064-001.

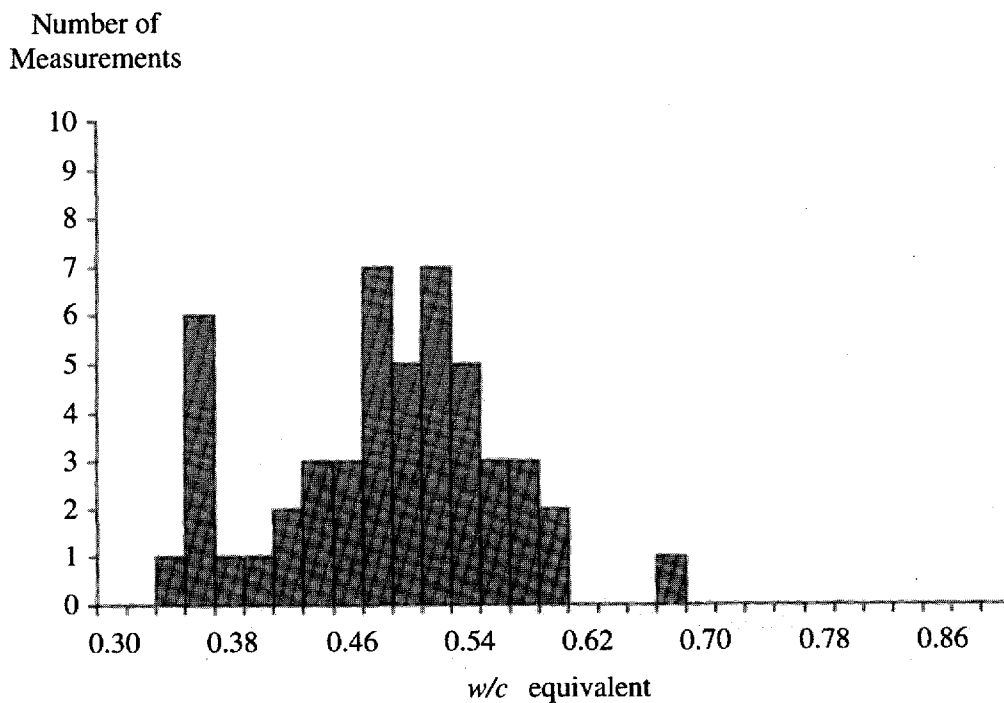
Figure 3-35. Distribution of the w/c values from the 1950 concrete from mid-panel of the left-turn lane of site MN-065-064-001.

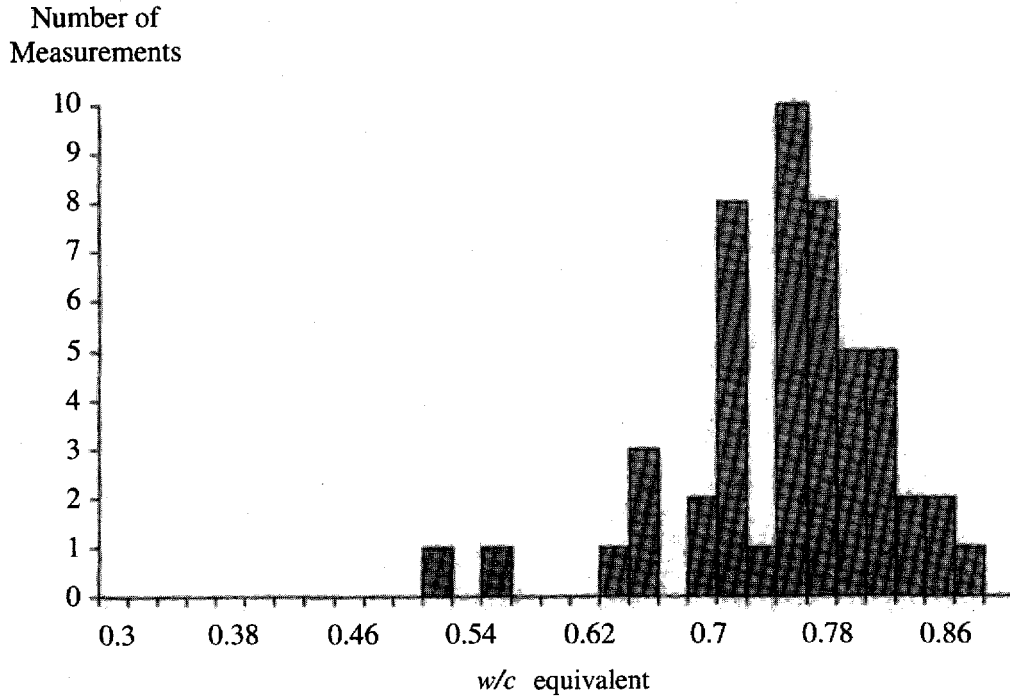
Figure 3-36. Distribution of the w/c values from the 1990 concrete from mid-panel of the traffic lane of site MN-065-064-001.

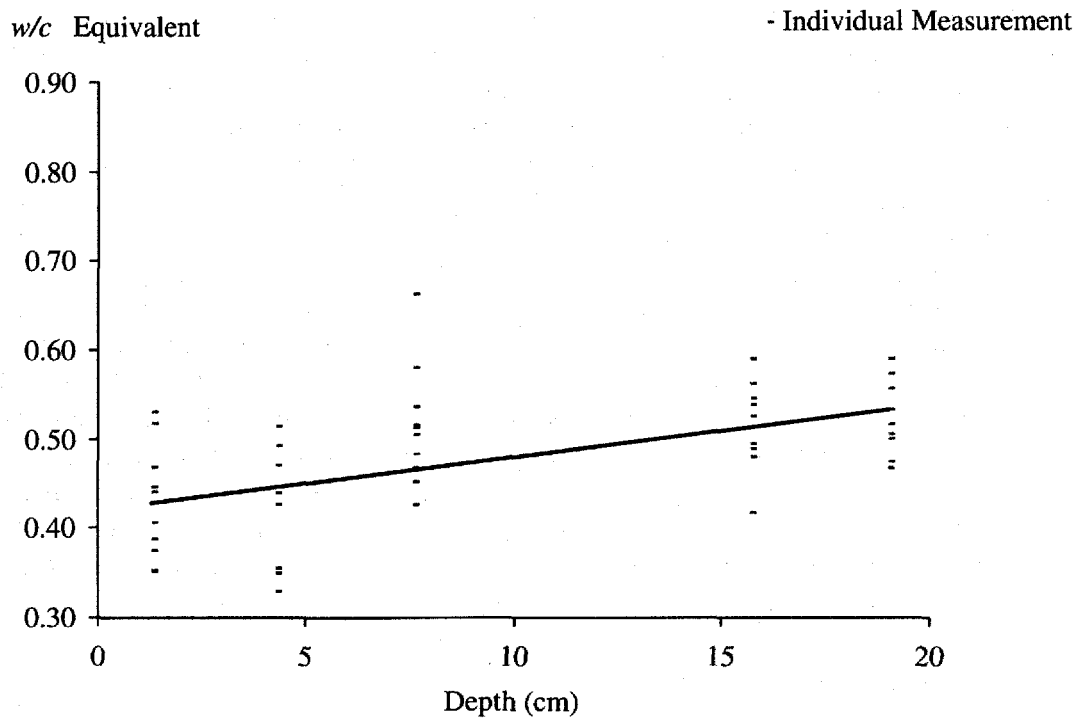
Figure 3-37. The w/c values versus depth from the 1950 concrete from mid-panel of the left-turn lane of site MN-065-064-001.

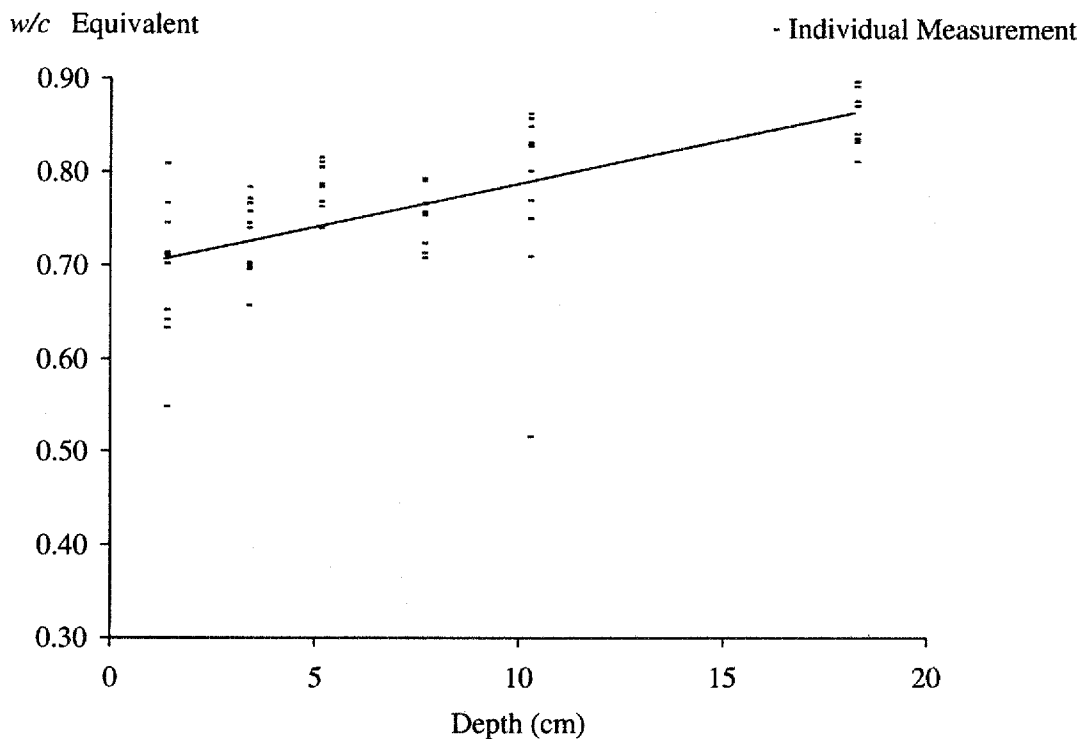
Figure 3-38. The w/c values versus depth from the 1990 concrete from mid-panel of the traffic lane of site MN-065-064-001.

Paste Freeze-Thaw – Clearly, there were two distinguishing features of this distressed concrete. The first was the softness and high effective *w/c* for this concrete. The porous paste was evident even in the mid panel when compared to the passing lane constructed with similar aggregates but approximately 40 years before the failed concrete. Of course, changes in cement characteristics and other factors may be contributors to the observed paste characteristics. However, it is unlikely that these factors would result in a difference of the magnitude seen in these pavement sections. It is most probable that a high *w/c* contributed to the observed distress. In addition, the original air system was marginal and once infilling occurred; the hardened air system became inadequate to protect the weakened paste.

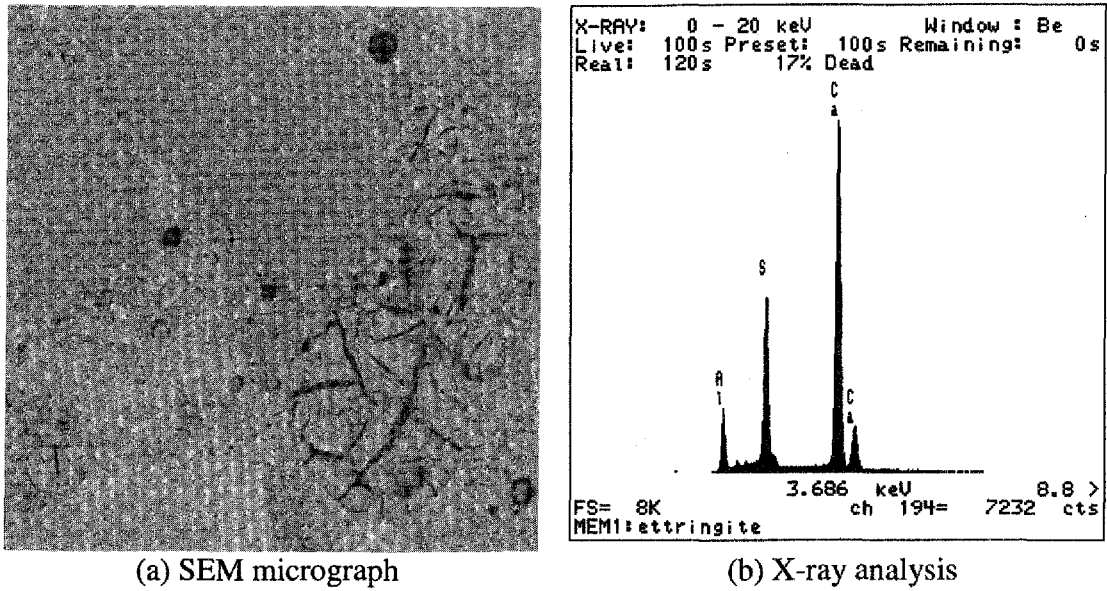
SEM was used to identify infilling material in voids and cracks. As indicated earlier, the principal materials identified were ettringite and hydrocalumite as shown in the typical SEM micrographs and x-ray analyses presented in figures 3-39 and 3-40.

Figure 3-39. Typical SEM micrograph and x-ray analysis for ettringite infilling air void.

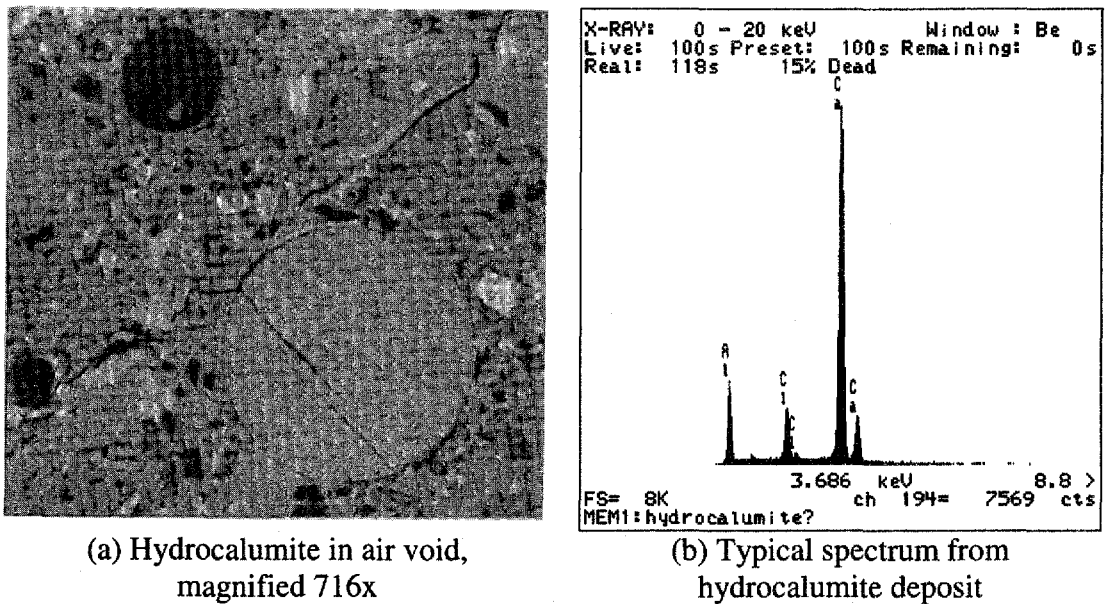
Figure 3-40. Typical SEM micrograph and x-ray analysis for hydrocalumite infilling air void.

Deicer Attack – This MRD may be opportunistic or it may be a contributor. Given the degree of distress seen near the joint, it is reasonable to infer that deicer attack was a factor. Also, the presence of hydrocalumite is an indicator that this concrete was exposed to a high chloride environment, given the necessary high chloride concentration required for this phase to precipitate.

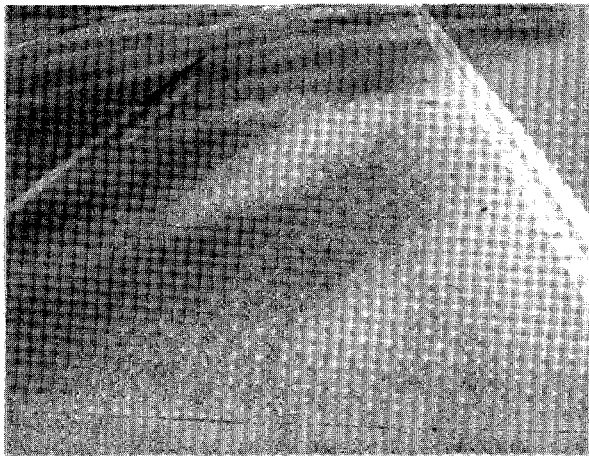
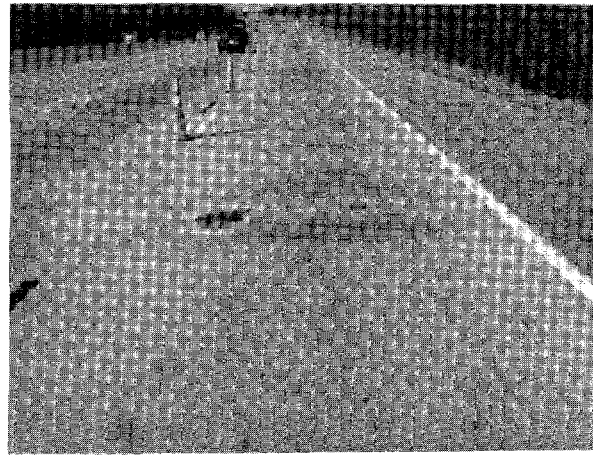
The primary distress, and the reason this section was selected as part of this project, is the extensive surface cracking exhibited over the entire pavement area. These hairline cracks run parallel to the longitudinal joints and are more prevalent near the outer edge of the slab (i.e., near the longitudinal joints). Some cracks are stained immediately around the cracks, which further highlights the presence of the cracks. The staining is typically dark gray areas around the crack; no exudate appears to be present in the cracks.

Figure 3-46. Typical cracking pattern at NC-444-015. Note distress over entire slab length with spalling occurring at joints.

For the most part, these surface cracks are not causing any immediate concerns or problems. At a few joints and at the two transverse cracks, the surface cracks have begun to deteriorate and create loose pieces and some large spalls were seen on the side of the road. These areas have been patched with AC. Otherwise, the cracks are not adversely affecting the ride quality.

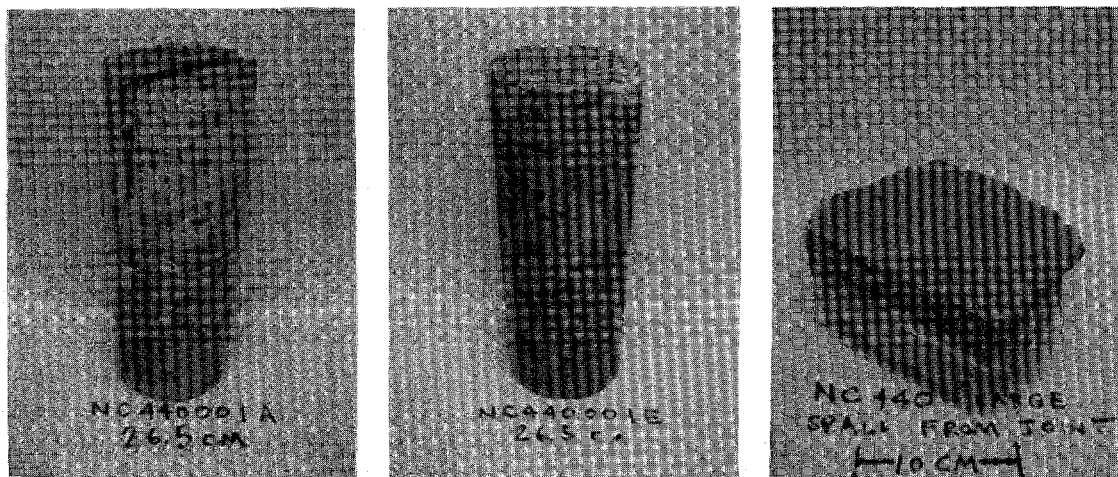
Figure 3-47. Cores and specimens evaluated from NC-440-015.

As with the other sites, mix proportions were not documented in the construction records and were only noted in the visual inspection as being normal. The concrete cores were 265 mm in depth, considerably greater than the design thickness of 250 mm. The concrete was well consolidated with no apparent segregation or parallelism of the aggregates. No scaling was present and there was no evidence of sub-parallel cracking or entrapped water voids under aggregates and surface cracking was seen in the cores that was thought not to be shrinkage cracks. Cracks extended from aggregates and through the paste. Secondary deposits were seen in some entrapped air voids and darkened rims were seen on coarse aggregate particles.

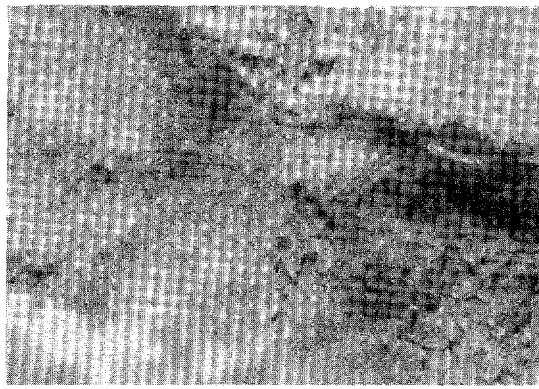
(a) Desiccated ASR gel lining large entrapped air void.

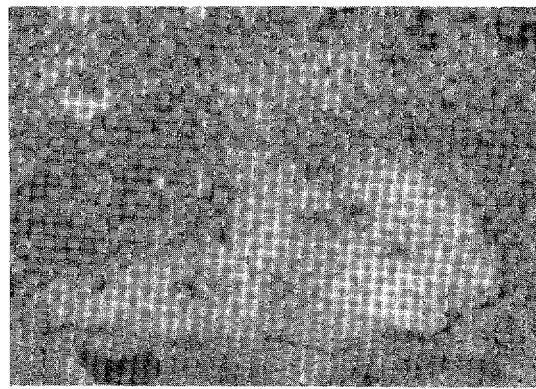
(b) Granite coarse aggregate that picked up the stain, especially in cracks within the aggregate. Matching face from this aggregate prepared in thin section to examine material in cracks.

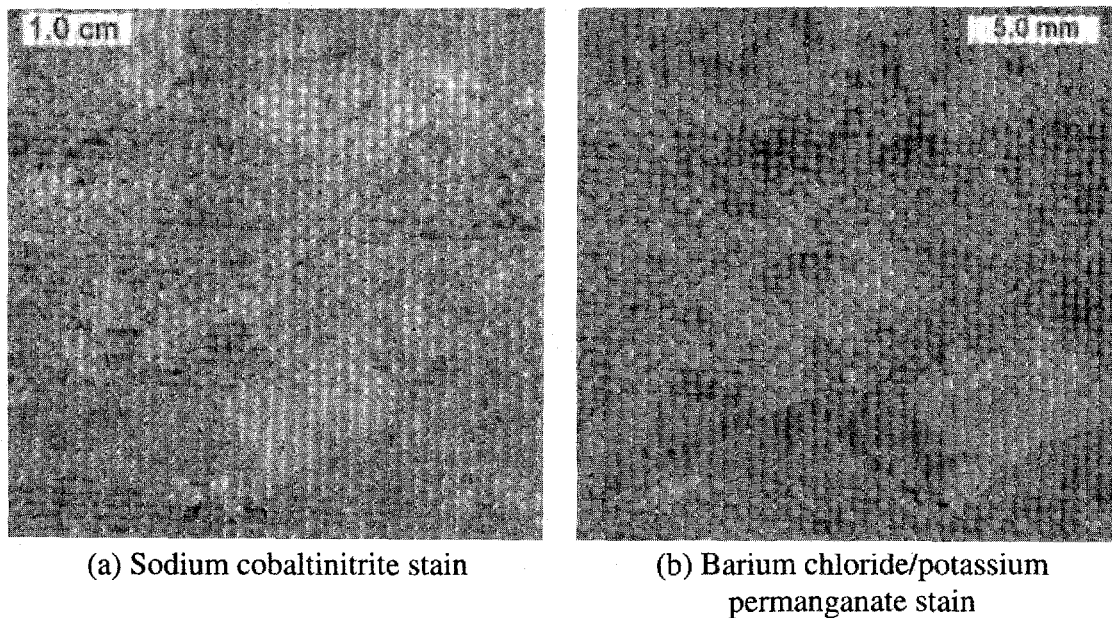
Figure 3-49. Typical stereo optical micrographs of stained concrete. Note that the broad banding occurs from the montage process to create a single image.

The results of staining indicate that both sulfate minerals and ASR gel are present as infilling material in cracks and voids. Figure 3-49 below shows some typical results for these tests. The characteristic yellow of the sodium cobaltinitrite stain is seen on the left and the brilliant purple color associated with the barium chloride/potassium permanganate is seen on the right. The phenolphthalein stain indicated a depth of carbonation of approximately 5 mm at the road surface and at the bottom of the slab.

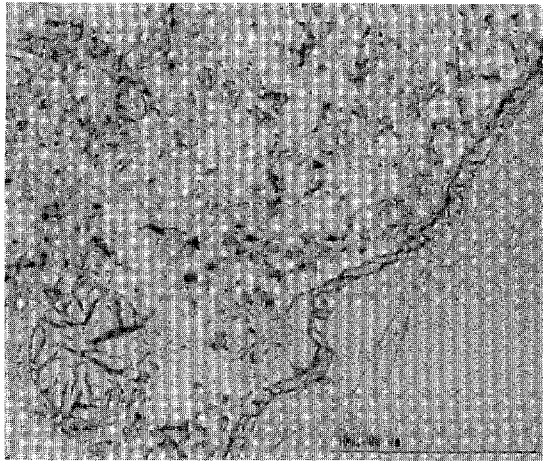
(a) Ettringite in entrained air void, and in crack along contact between cement paste and coarse aggregate.

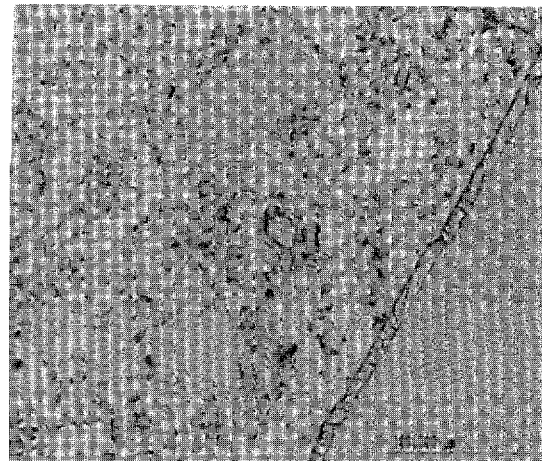
(b) Ettringite in entrained air void, and in crack along contact between cement paste and coarse aggregate. Large relict cement grain also visible.

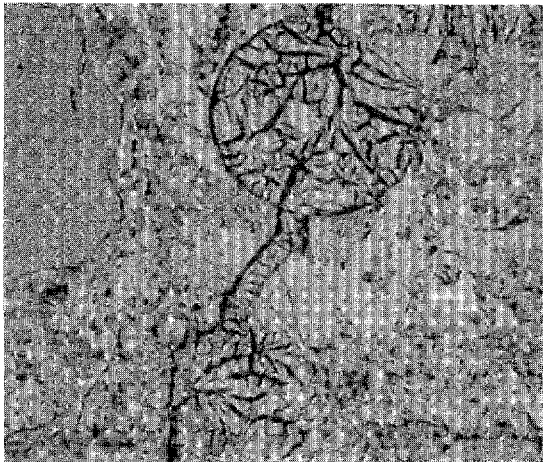
(a) Two ettringite filled air voids connected by a crack, also filled with ettringite.

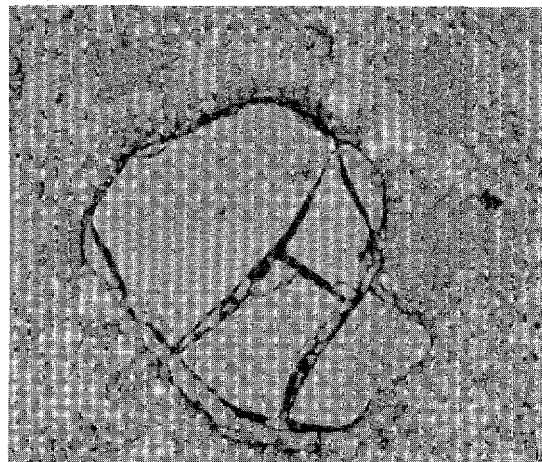
(b) ASR "gel blob" associated with fine aggregate. Spectrum shown in figure 3-57 contain data collected from this deposit.

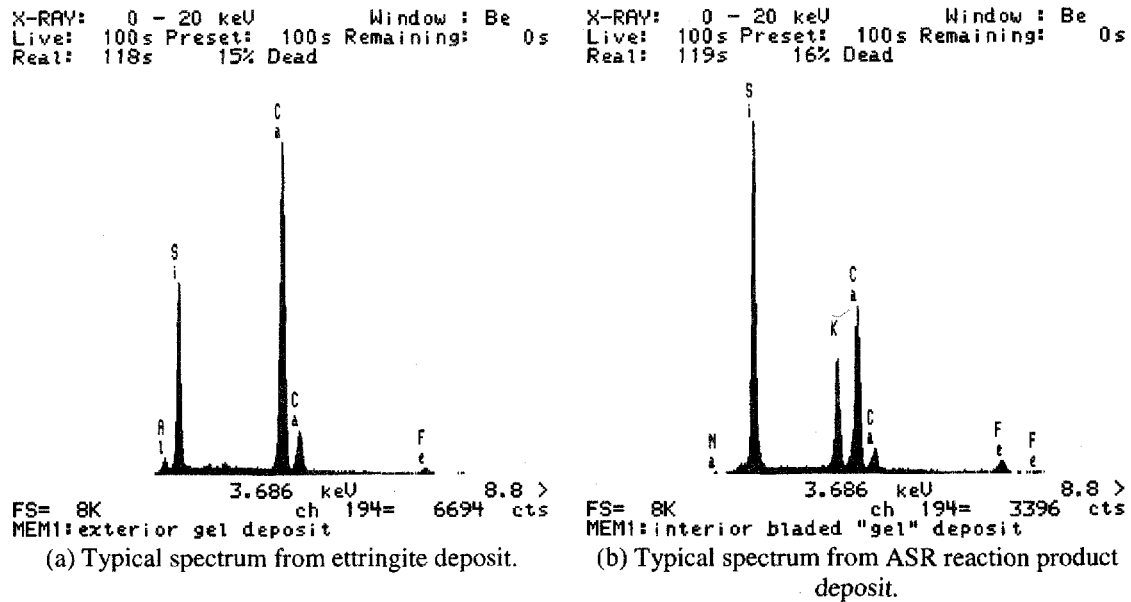
Figure 3-57. Typical spectra for ettringite and ASR reaction product.

Using the SEM, quantitative measurements of ettringite and ASR “gel” compositions were made. Ettringite deposits were extensive and found both in entrained air voids and in cracks in the cement paste and in cracks along the contact with coarse aggregates. Measurements were made of the coarse aggregate ASR product pictured in figure 3-54, both within the crack in the coarse aggregate, and in the region where the crack comes into contact with the cement paste. Measurements were also made of the gel blobs associated with the fine aggregates. The presence of small amounts of iron in the ASR product is unusual. Figures 3-55 and 3-56 are SEM micrographs of ettringite and ASR reaction product. Figure 3-57 shows the typical spectra for ettringite and ASR reaction product.

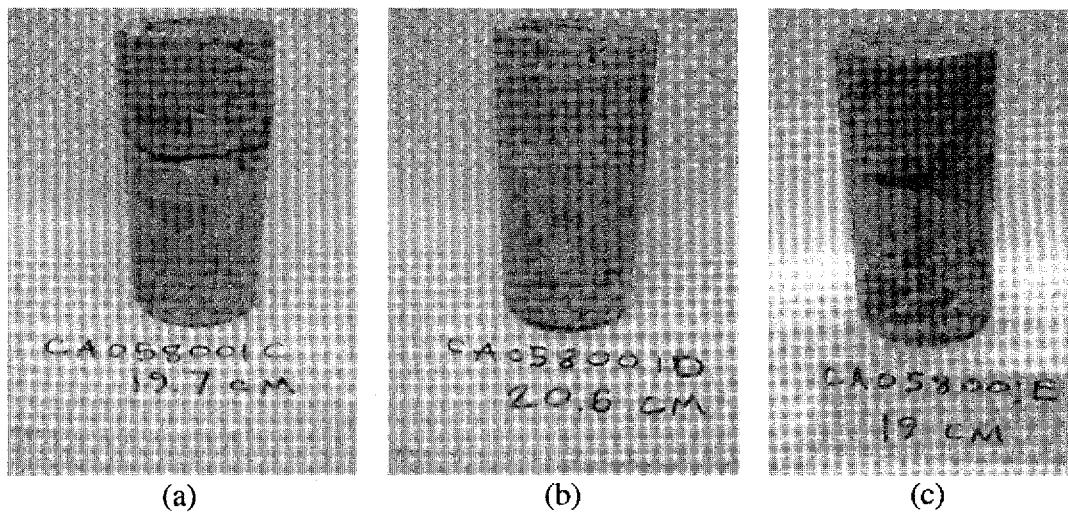
Figure 3-64. Photographs of core specimens analyzed from CA-058-141.

Based upon the field survey, distress was widespread. The joints were badly deteriorated and coring at the transverse joint produced pieces rather than an intact core. Cores C, D, and E were relatively intact and were thus analyzed. Photos of these cores are shown in figure 3-64. All cores were cut to produce slabs for examination with stains.

Mix proportions were estimated by inspecting the cores visually before and after slicing. In this case, construction records were unavailable to verify the mix design. The concrete was well consolidated with no apparent segregation or parallelism of the aggregates. No scaling or sub-parallel cracking was apparent on these sites. No entrapped water voids were seen under aggregates or embedded steel. Surface cracking was apparent that was not plastic shrinkage cracking. Darkened reaction rims were seen around some of the coarse aggregates. Abundant cracks filled with white deposits were visible with the unaided eye. The coarse aggregates used were a natural igneous (both intrusive and extrusive) and the natural fine aggregate used appear to be similar in lithology.

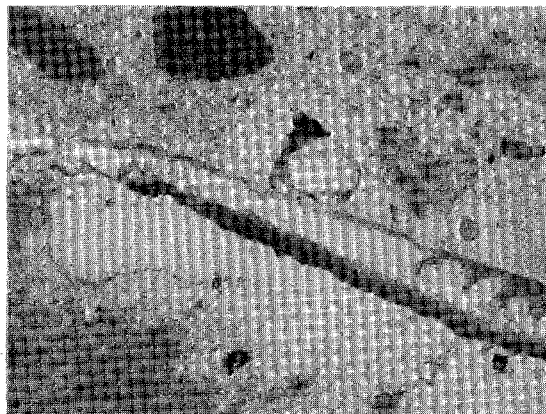
Cores C and D were slabbed and stained using the sodium cobaltinitrite stain for identifying ASR reactive aggregates and reaction products. Also, slabs were stained with the potassium permanganate/barium chloride stain for identifying sulfate minerals. ASR reaction product was seen in cracks associated with the coarse aggregate. Ettringite was common in cracks and voids, and actually was more common than ASR reaction product. Examples of these stains as applied are shown in figure 3-65.

(a) Sodium cobaltinitrite yellow stain picked up in crack within felsic volcanic coarse aggregate

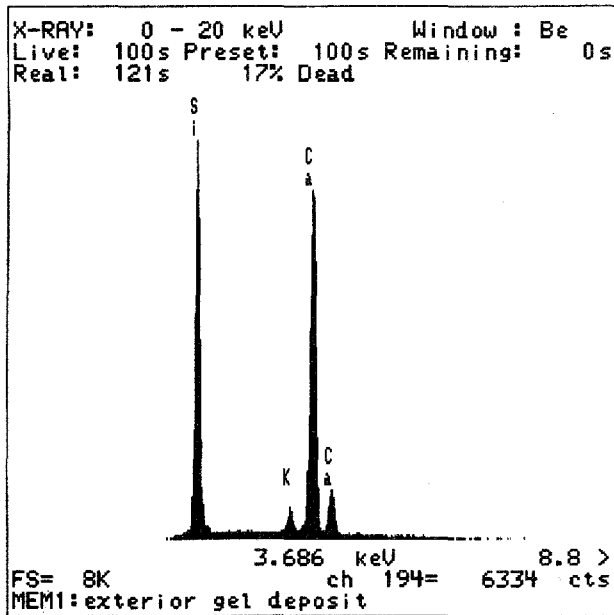
In this case, the SEM was used simply as a means of confirming the results of the petrographic optical microscopy, stereo optical microscopy, and visual inspection. Using x-ray microanalysis, the ASR gel deposits shown in figure 3-68 were analyzed and these results are summarized in table 3-28. Many ettringite filled cracks were observed and an example is shown in the back-scattered electron (BSE) micrograph shown in figure 3-68.

(a) Typical spectrum from ASR gel adjacent to volcanic aggregate pictured in (b).

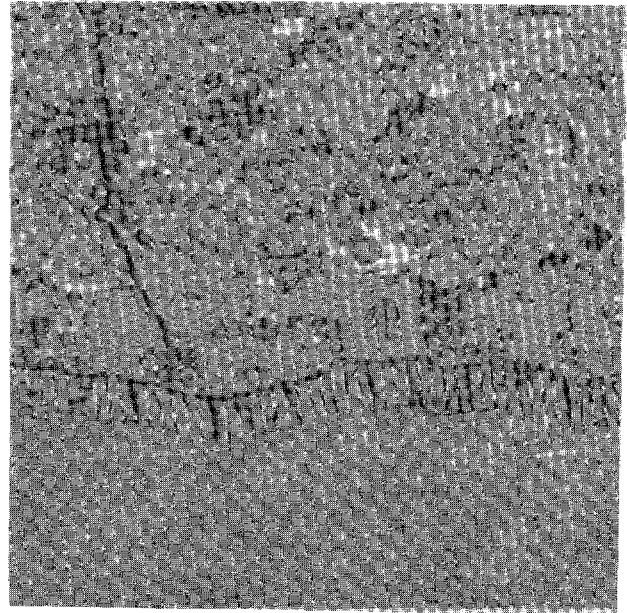
(b) BSE image of ettringite filling a crack along the contact between a coarse aggregate and the cement paste.

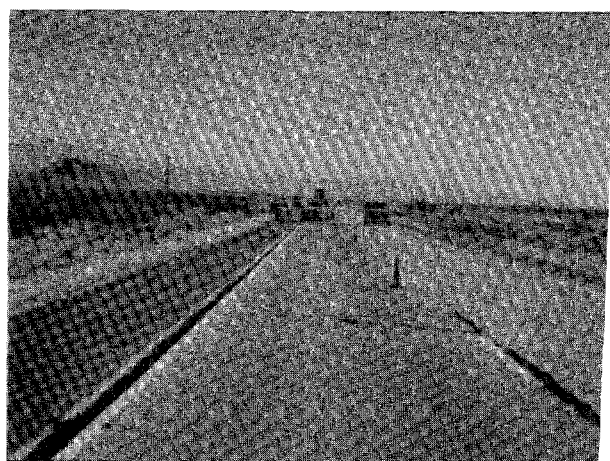
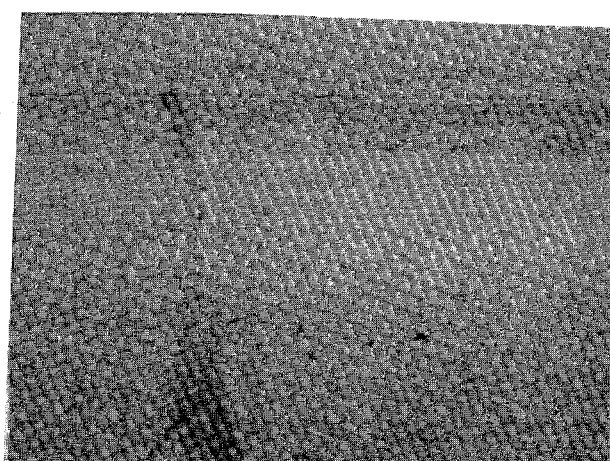
Figure 3-74. Typical conditions at CA-014-011.

The potential MRD is characterized by map cracking over the entire pavement surface. These cracks, made up of multiple interconnecting surface cracks, form a honeycomb pattern on the pavement surface. The cracks are generally hairline cracks but are more visible in the wheel paths because they are slightly more open. No staining or exudate was observed within or surrounding the cracks and joints. Figure 3-74 shows the typical site conditions.

(a) Section overview

(b) Close up of observed map cracking

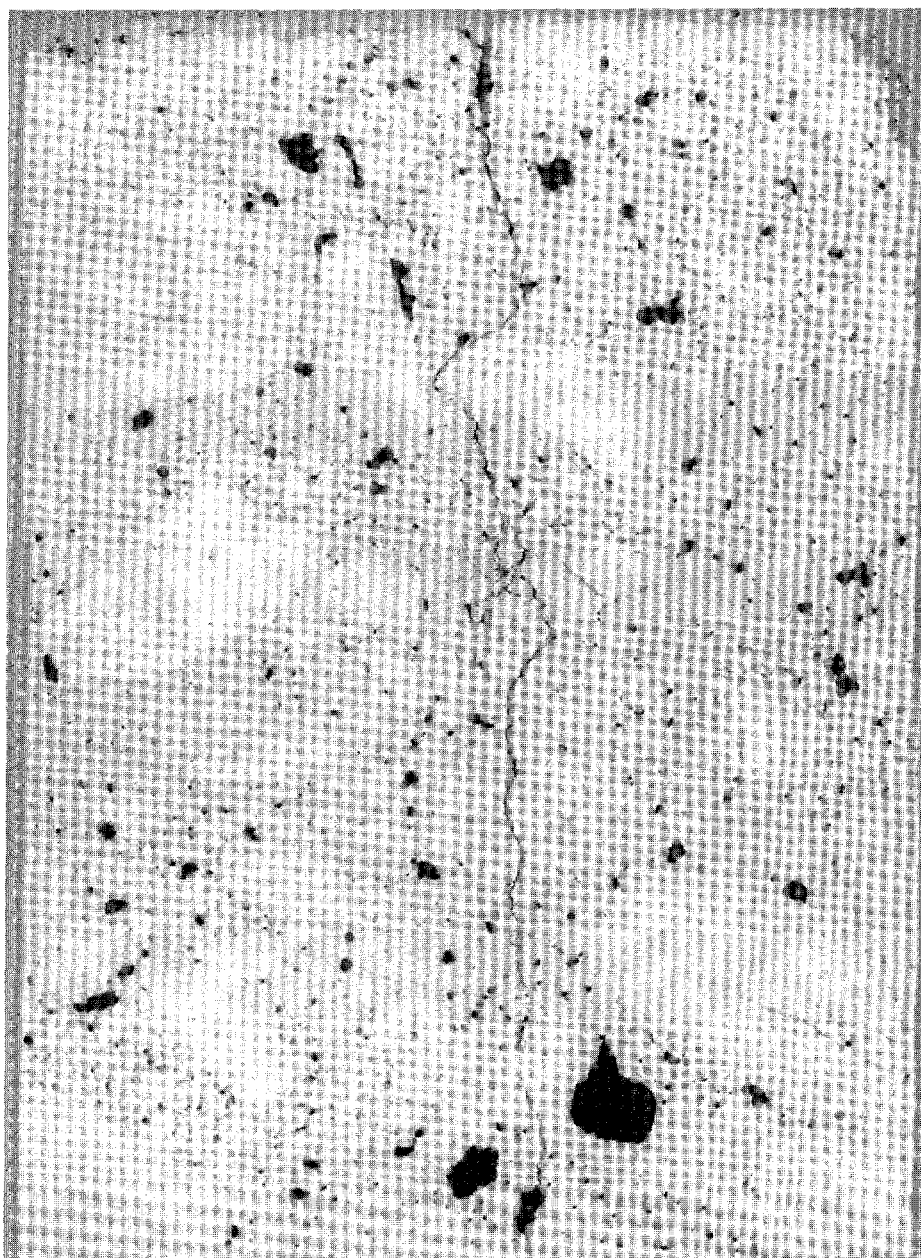
In figure 3-76, a crack is seen that runs the length of the image. It starts wide at the top and narrows as it goes deeper into the concrete, jogging around one large aggregate grain. That portion of the crack is typical of plastic shrinkage, wide and irregular at the pavement surface, where the paste was soft and cracked preferentially. The rest of the crack is more typical of drying shrinkage where much larger stresses are applied to the aggregates as the paste hardens with time. Stresses build to the point where the crack already started at the surface propagates through an aggregate and continues. Figure 3-77 is a normal scan of the same specimen. Some darkened rims are evident on the coarse aggregate, which is typical of ASR.

Figure 3-76. Inverse image of polished cross section of core CA-014-011-001E, through pavement, after painting the surface black and pressing white powder into the voids and cracks (magnified 1.5x).

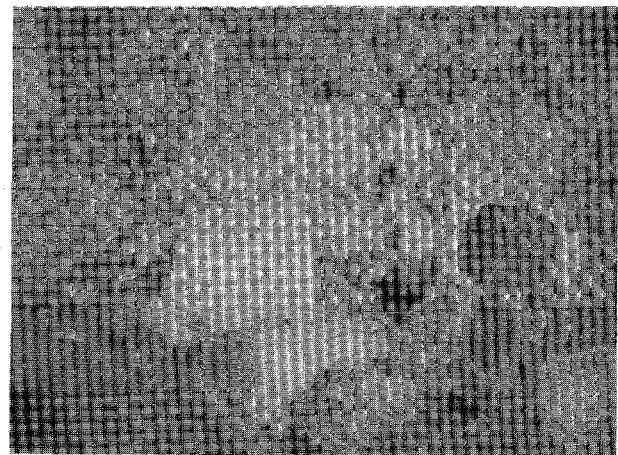
Figure 3-78. Results of staining test applied to core CA-058-011-001E.

The sodium cobaltinitrite and barium chloride/potassium permanganate stains were applied and both were positive meaning ASR reaction products and sulfate minerals were present in the concrete. Micrographs showing ASR reactive particles and ettringite inclusions are shown below in figure 3-78. Also the phenolphthalein stain was used to determine the depth of carbonation. This slab was scanned and is shown in figure 3-79. Note the areas of deeper carbonation in the vicinity of the plastic shrinkage crack, indicating the increased permeability of the cracked surface.

(b) Ettringite filled air voids that have picked up the purple to pink stain from the solution of barium chloride and potassium permanganate
