Guidelines for Detection, Analysis, and Treatment of Materials-Related Distress in Concrete Pavements Volume 3: Case Studies Using the Guidelines

PUBLICATION NO. FHWA-RD-01-165

AUGUST 2002

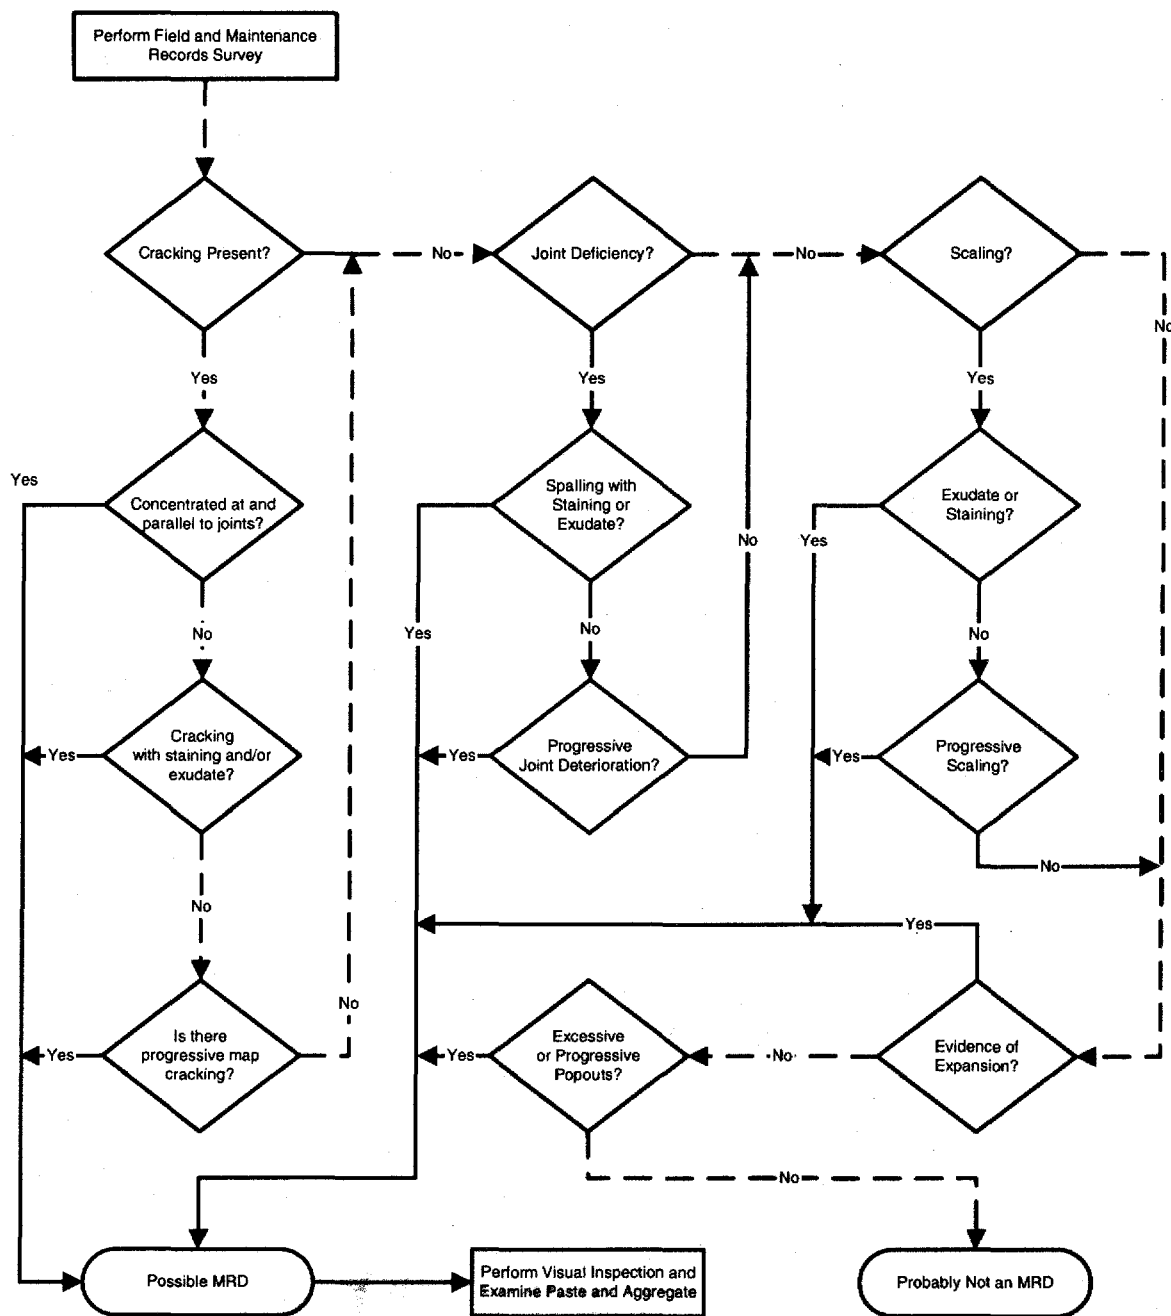
This site provides an excellent case for demonstrating the value of the guidelines. First, through the rigorous field inspection, it was decided that an MRD was likely not the cause of the observed distress. The logic for this conclusion is shown in figure 3-80. But it was believed that laboratory work should be conducted to verify this conclusion. As discussed in Guideline II, to reach a diagnosis, the concrete must be observed using stereo microscopy. Because of this examination, the true nature of the surface cracking was documented, confirming the field evaluation. In addition, it was determined that there were diagnostic features of MRD, specifically ASR reaction products. Mild infilling of air voids and cracks with ettringite was also observed but not considered significant.

Figure 3-80. Flowchart for assessing the likelihood of MRD causing the observed distress in the pavement as applied to CA-014-011.

ASR - ASR is certainly occurring in this pavement, but at this time there is little to no distress resulting from ASR. Additionally, there are no cracks associated with the ASR reaction products found in this concrete. These reaction products are filling adjacent voids and cracks within the aggregate. It is thus concluded that the ASR is not currently deleterious and is not a major contributor to the distress of this pavement at this time. Monitoring the pavement condition over time will demonstrate whether this distress is progressive, possibly helping engineers in planning maintenance schedules if the ASR does become deleterious.

In summary, applying the guidelines as proposed provided information for engineers that can help establish a maintenance program for this pavement, thereby extending its life. Specifically, shrinkage cracks propagating with time and applied load are the most probable cause of the distress. As the concrete becomes more permeable as a result of the cracking, opportunistic MRDs occur such as ASR. Some mitigation of ASR may be appropriate.

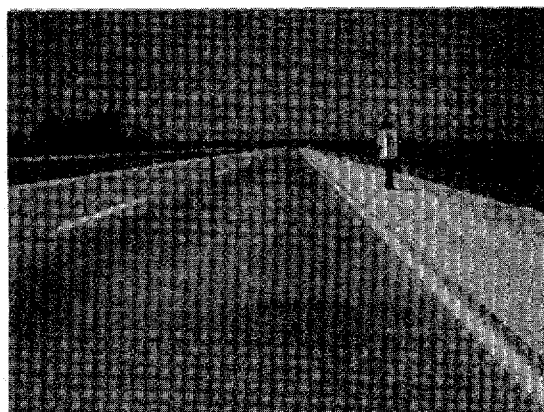
Figure 3-81. Site conditions at IA-002-002.

A characterization of potential MRD was conducted in the field to assist in the diagnosis of the type and cause of the distress. The potential MRD on both sections is the presence of short longitudinal cracks throughout the sections. These cracks are generally confined to the wheel paths and in many cases initiate at a transverse joint. There is some slight staining, which is brownish-gray in appearance, around transverse joints and in the wheel paths. There is no exudate observed at the cracks. Table 3-37 provides a summary of the MRD characteristics for this project. Figure 3-81(a) shows staining along longitudinal cracks and at the transverse joints. Figure 3-81(b) shows closeup views of the hairline cracks. Additional site conditions are shown in figure 3-82.

(b) Staining along transverse joints

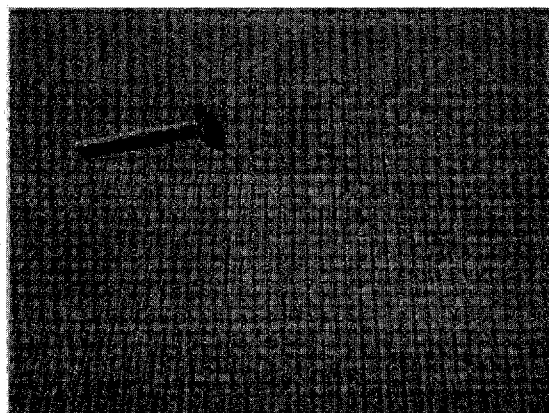
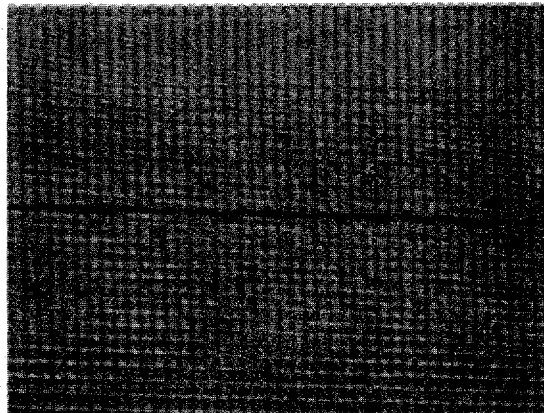
Figure 3-82. Closeup view of longitudinal hairline cracks.

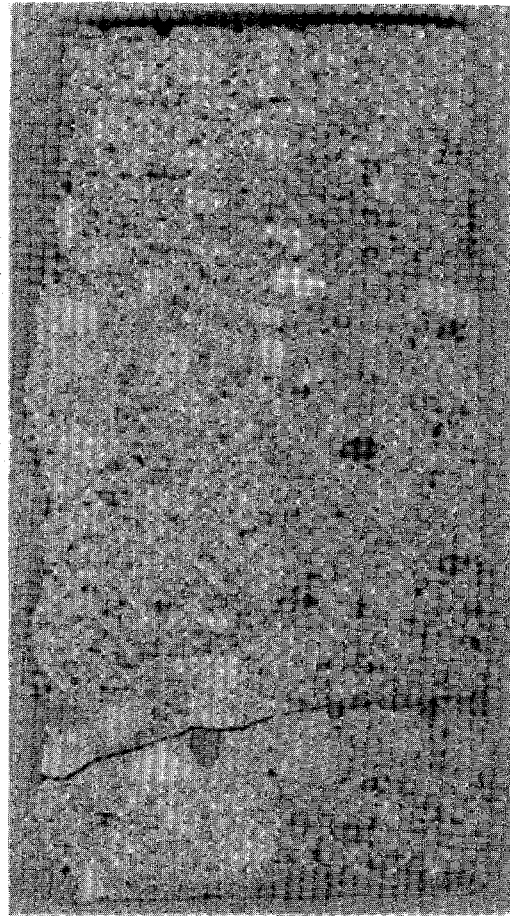
The distresses observed at both sections were similar, and appeared to be concentrated at the joints. Core A was selected from Section 001 for analysis. Core A exhibited hairline cracking at the pavement surface, and a large crack near the base running parallel to the subbase contact. Figure 3-83 shows a polished slab from core A. Other than the visible cracks, the concrete seemed in good condition. The coarse aggregate consisted of a blend of a quarried limestone and pink granite.

Figure 3-83. Polished slab from core IA-002-002-001A. The irregular surface along the left-hand side of the core is a cross-sectional view of the transverse joint texture.

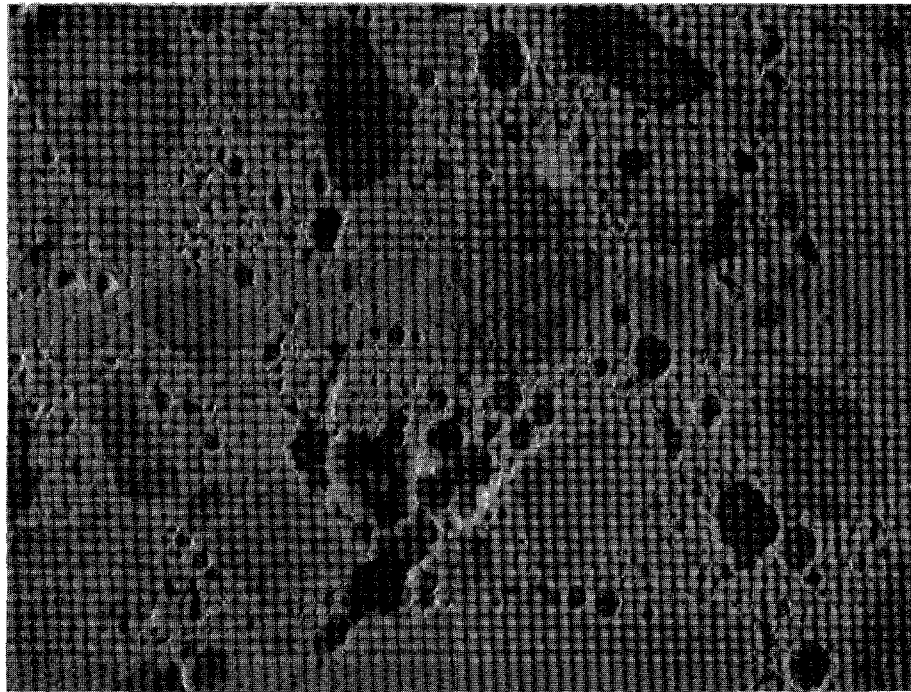
The most striking feature of the concrete was the abundance of small, entrained air voids, as shown in figure 3-84. Although the concrete did contain a large percentage of air, the specific surface and spacing factors were within reasonable values. A summary of the Modified Point Count is included in table 3-38. There was moderate infilling of the void structure by secondary ettringite. Some isolated alkali-silica gel deposits were observed with some of the fine aggregate particles. The gel deposits were found filling air voids near the reactive particles, and were not associated with any cracking. The coarse aggregates were intact, and did not appear to be reactive.

Figure 3-84. Stereo micrograph showing air void structure of IA-002-002-001A, magnified 7.5x.

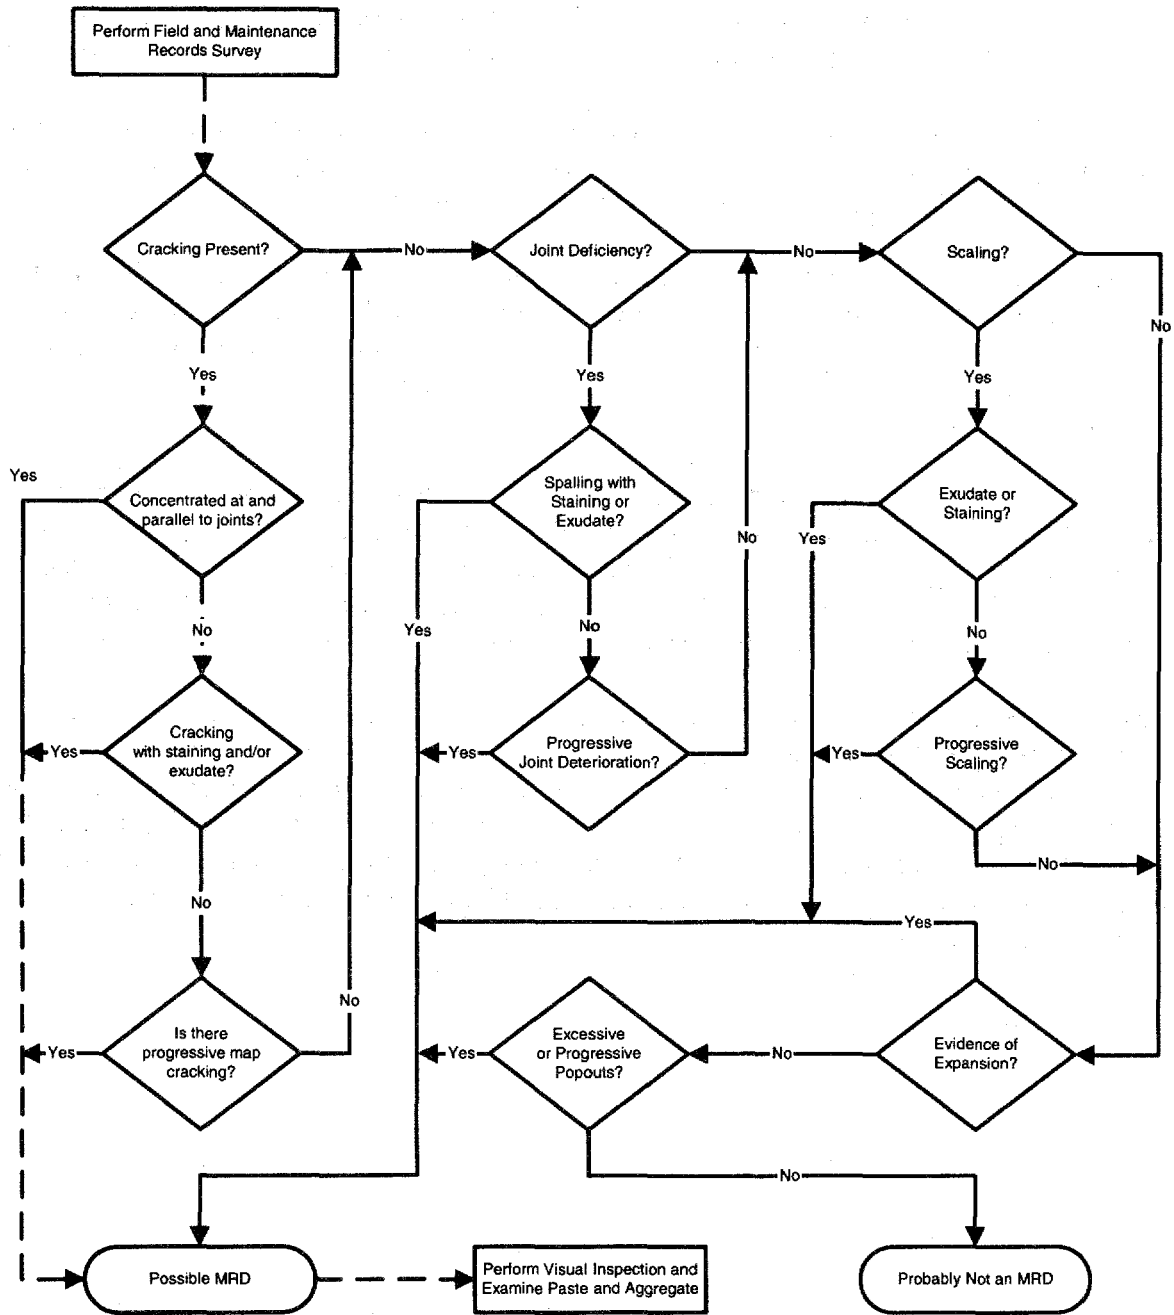
Having performed the described laboratory analyses and applied the diagnostic flowcharts, as shown in figures 3-86 through 3-90, three possible MRDs were identified in IA-002-002, including paste freeze-thaw, ASR and sulfate attack with none being dominant or extensive. To

In summary, the exact nature of the observed distress is not known. The unusual air-void structure may be a contributor but the exact mechanism could not be discerned from this analysis. It is noted that the concrete had a very fine coarse aggregate grading, which may also be a contributing factor but, again, no evidence of a specific mechanism for the observed distress was seen related to this gradation. The guidelines do help rule out the obvious types of MRD but in the end, this is an example of a pavement that cannot be absolutely diagnosed using the developed guidelines.

Figure 3-86. Flowchart for assessing the likelihood of MRD causing the observed distress in the pavement as applied to IA-002-002.
