Water Intrusion in Base/Subgrade Materials at Bridge Ends: Final Report

Department of Civil Engineering
Texas Tech University

Report No. 0-5096-1

October 2005

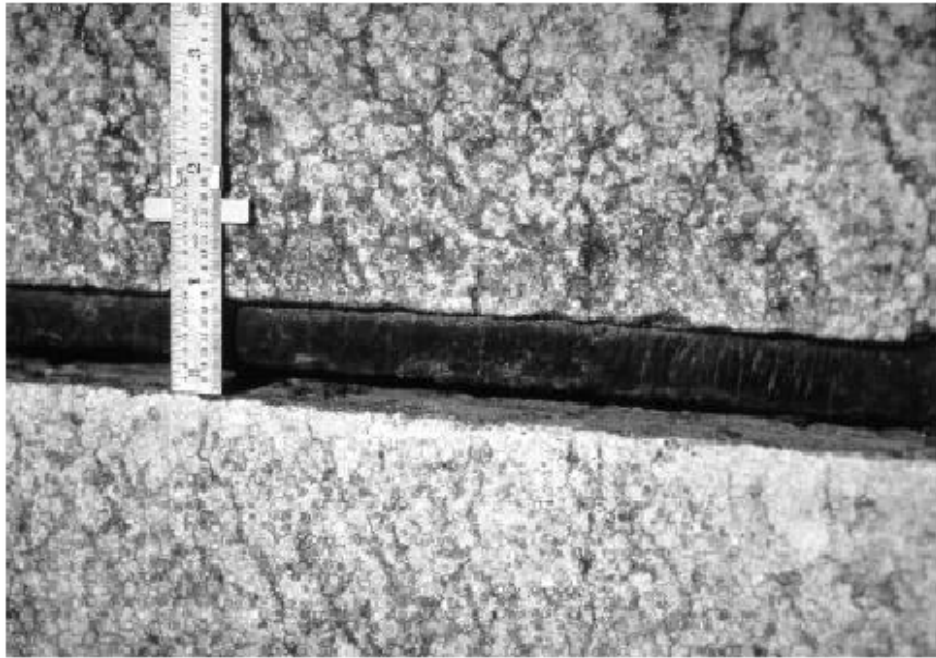
Joint sealants split open either by losing bond with the sidewalls of the joint reservoir (Figure 2.9), by losing internal bonding (Figure 2.10) spalling and torn/missing sealant. Case studies have shown that the predominant distresses in pavement joints sealants are adhesion loss and spall failure.

Figure 2.9: Sealant Adhesion Failure
(Taken from FHWA Report No. FHWA-RD-99-146)

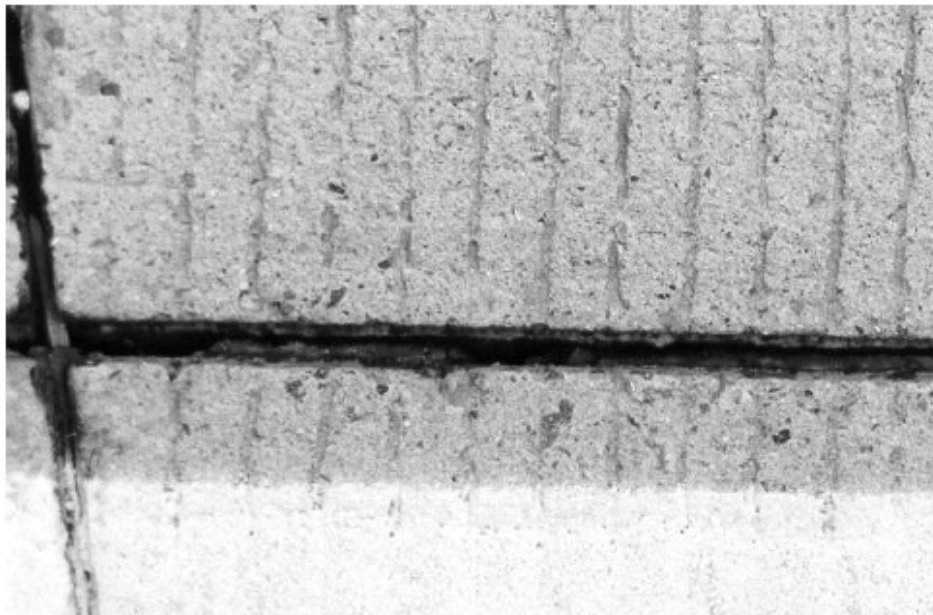
Figure 2.10: Full Depth Cohesion Failure
(Taken from FHWA Report No. FHWA-RD-99-146)

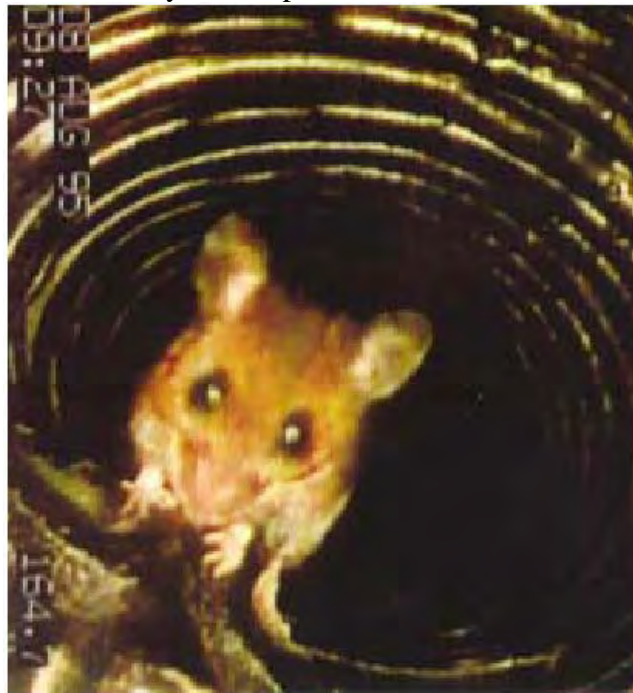
life. Without regular inspection and maintenance, edgedrains can even prove more harmful to the pavement. Surveys in the past have shown that only one-third of the edge drains in existing pavements function as designed. The main problems associated with edgedrains are: vegetative growth, debris and fines discharging from the pavement system. In some instances, inspection by a snake camera has even shown the edgedrain outlet pipes to be blocked by rodent nests (Figure 2.13).

Figure 2.13: Rodent in Subsurface Drain (Taken from “Making Edge Drains Work, Kuennen, Tom)

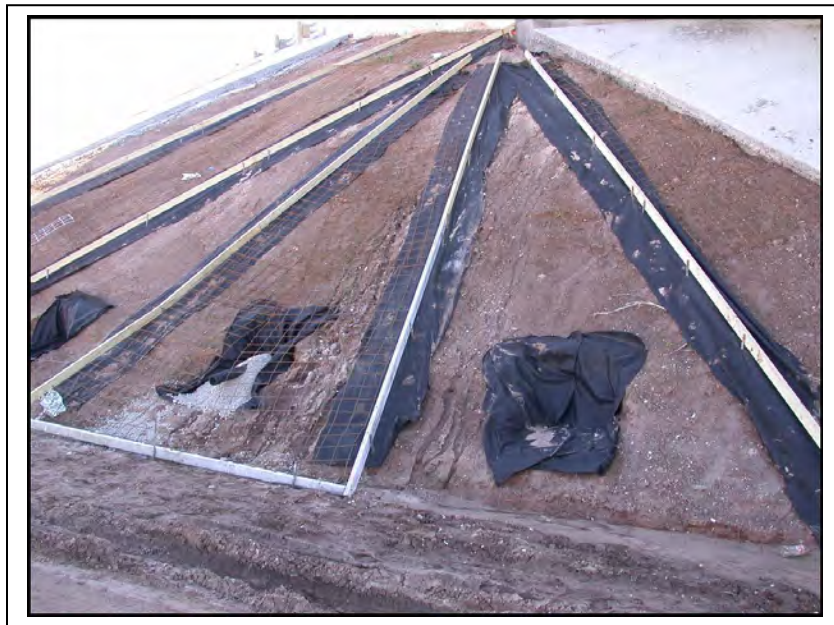
Figure 4.5 Filter Fabric at Joint in Riprap Slab during Construction

The Lubbock District now places filter fabric beneath joints in the riprap slabs to prevent the loss of fines as shown in Figure 4.5. Filter fabric is also placed near any point that might become a location for loss of fine materials (Figure 4.6). Details for the use of the filter fabric are provided in Appendix (Filter Fabric).

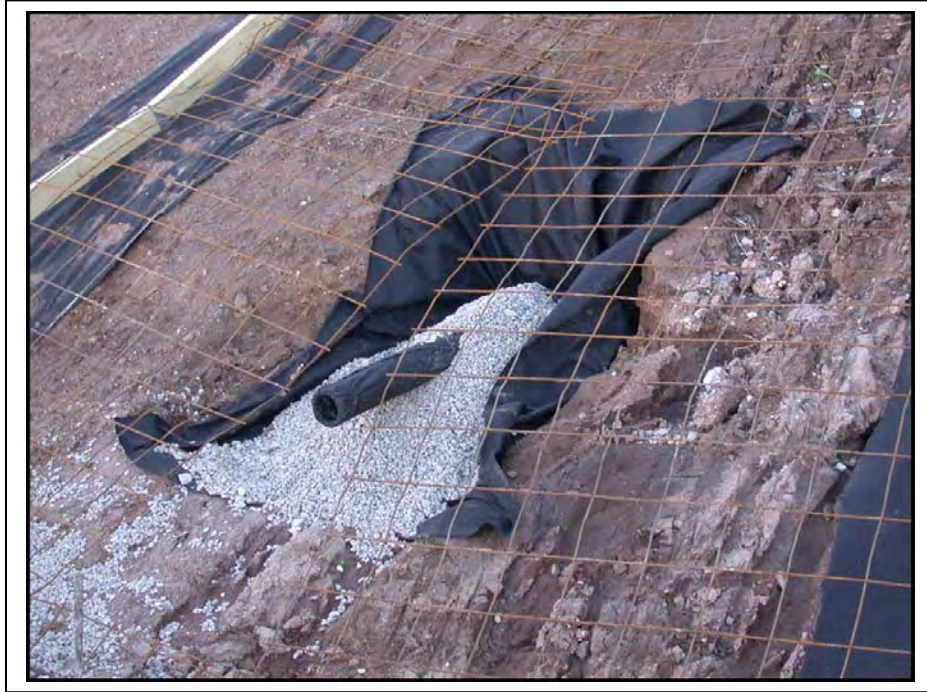
Figure 4.6 Filter Fabric at Drain in Riprap Slab during Construction

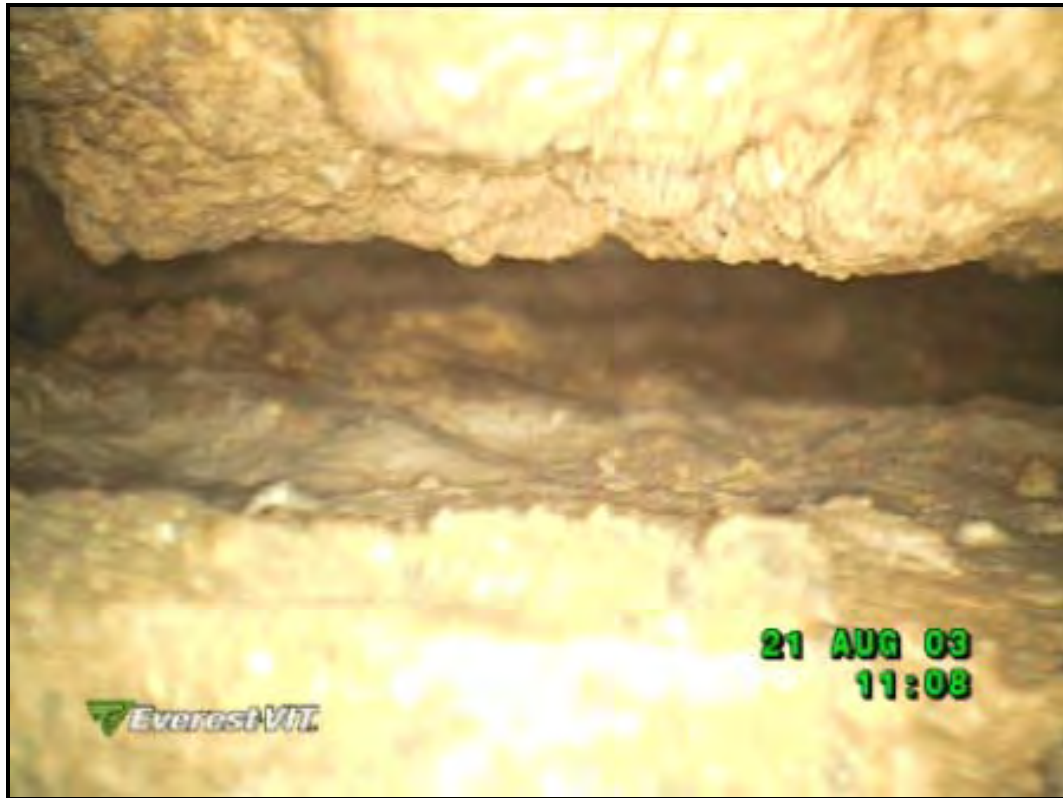
- (c) *Probe Drilling and Video Borescope Probing*: Probe drilling is useful for confirmation of findings from the non-invasive techniques described previously. Video borescope probing takes this a step further by allowing the maintenance engineer to directly observe the voids. It provides visual images that may be captured in VHS or JPEG formats. Figure 5.15 shows a borescope still shot.

Figure 5.15 Borescope Stillshot

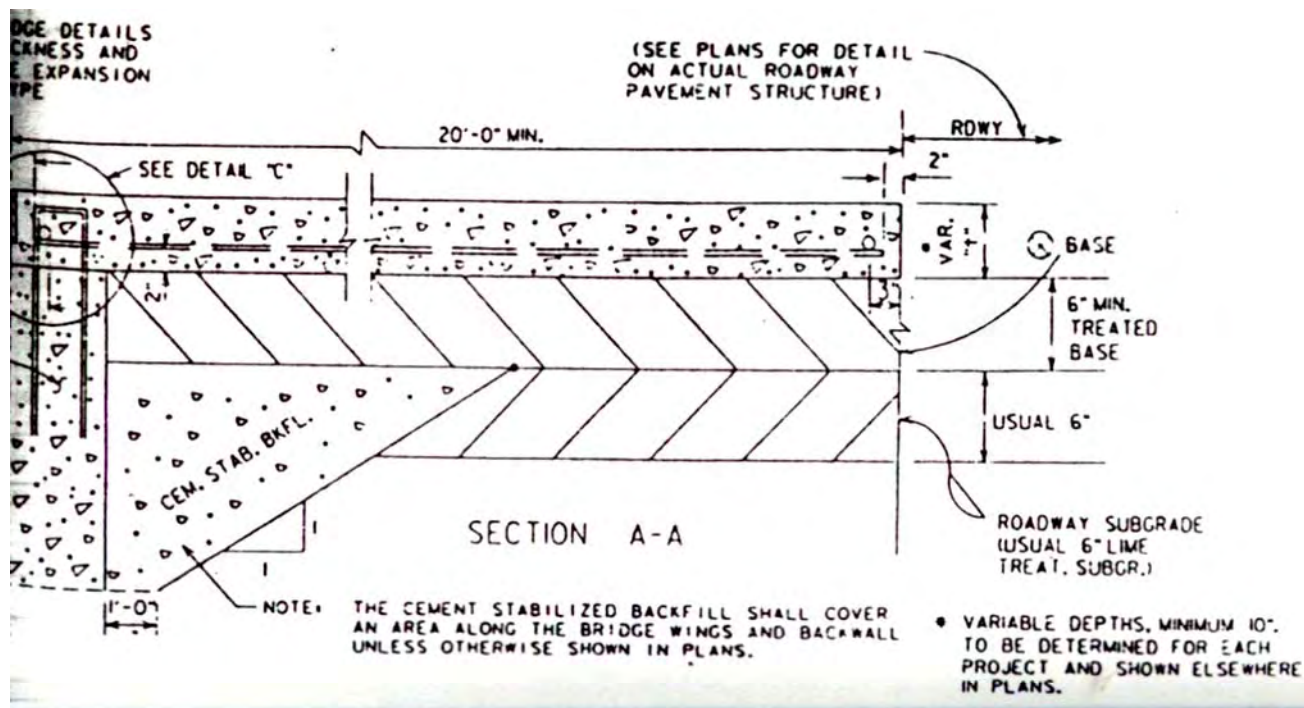
Figure 5.24 Bridge End Detail Showing Cement Stabilized Sand (CSS) Wedge Behind Abutment

approach design with a CSS wedge. In some districts, this has now become the standard practice. The performance of bridge approaches that have been constructed according to this design has been very good.

Many of the problems commonly encountered in bridge approaches may be overcome by using a wedge of cement stabilized material immediately behind the bridge abutment. Cement stabilized material offers a number of advantages over conventional backfill. First of all, cement stabilized sand backfill has better flowability and therefore, is capable of filling any small void spaces that may be present. Secondly, it does not require compaction to gain necessary strength and thus overcomes the difficulties associated with achieving adequate compaction behind the abutment. Once the cement stabilized material hardens, it will not be sensitive to moisture changes and will not erode. Therefore, the use of a cement stabilized sand (CSS) "wedge" in the zone behind the abutment is encouraged in the TxDOT bridge design manual. Figure 5.24 shows a bridge

For the reasons given above, the option of using a CSS wedge behind the abutment should be given serious consideration in new bridge construction and approach reconstruction projects. As mentioned previously, CSS wedge has the potential to overcome many problems experienced at bridge approaches. However, it should be noted that this material does not have the capability to transmit water efficiently, and therefore, CSS will not function as a subdrain system. Therefore, water that enters the approach through joints and cracks in the approach slab and pavements may still cause damage in areas in which CSS material is not present.

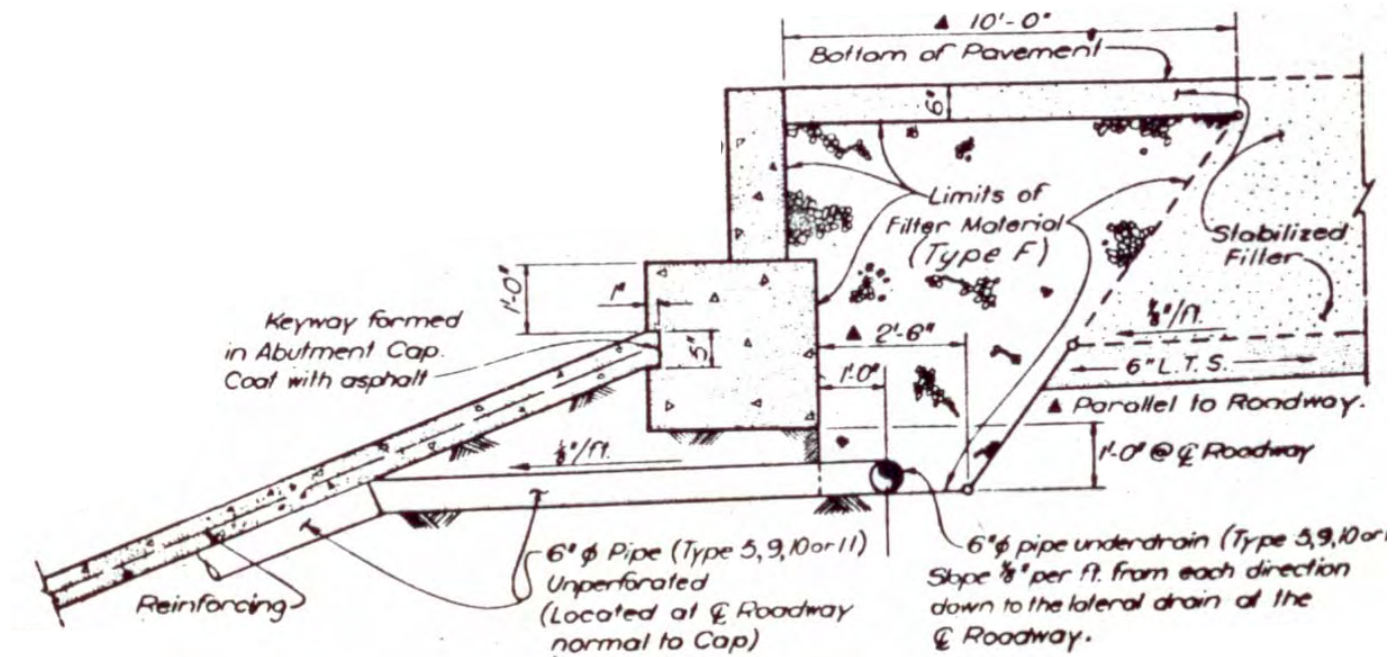
Figure 5.25 Bridge End Detail Showing Subdrain System Used in the Houston District

In Texas, the use of a subdrain system underneath the bridge approach slab is not standard practice at the present time. However, in some TxDOT districts such as Houston, it was common practice many years ago (personal communications with Michael Alford, Director of Maintenance, Houston District, TxDOT). The subdrain system design used by the Houston District previously is shown in Figure 5.25. Other districts, such as Lufkin have also used subdrain systems for some of their bridges. Figure 5.26 shows a drainage detail that was once used in the ABL district (behind an abutment wall). It should be noted that this drainage system is not currently being used in the Abilene District. The purpose of the subdrain (or underdrain) is to collect water that leaks through cracks and joints in the pavement and the approach slab and carry it away from the bridge end so that it would not cause damage by soil erosion and subgrade saturation.

Providing a subdrain system underneath the approach slab and pavement is best accomplished during the initial construction of the bridge approach rather than during repair. Most of the repair strategies discussed in this section would not allow the installation of such a subdrain system. However, this would be possible in many approach reconstruction projects. A more complete collection of different subdrain system designs that may be considered is found in Appendix A.

There are two important points that must be considered when arriving at a decision with regard to the installation of a subdrain system. First, if it becomes necessary to use slab stabilization or slab jacking during future maintenance operations, the grout that is pumped will likely clog the subdrain and make it ineffective. Second, subdrain systems require regular maintenance to ensure that they function properly. Adequate cleanout features or access points should be provided during design and construction.

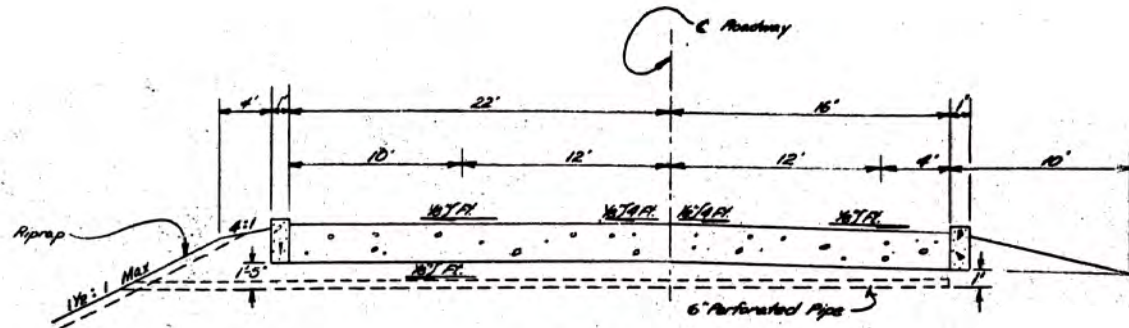
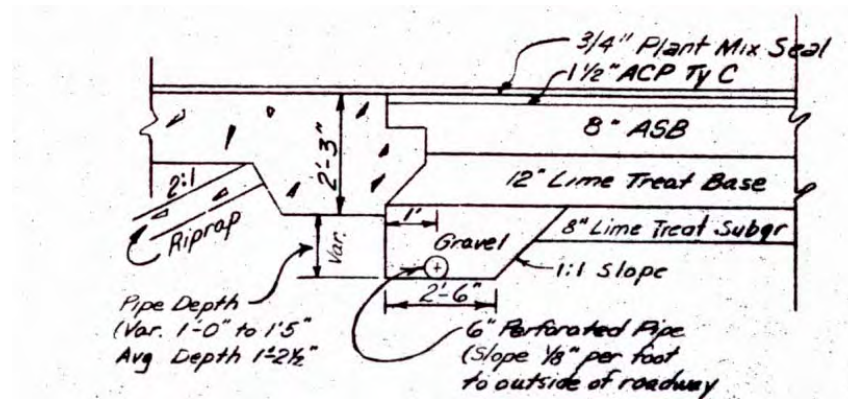
Figure 5.26 Bridge End Detail Showing Subdrain System Previously Used in the Abilene District

Bridge sites in four TxDOT districts were investigated for possible sources of water intrusion. One site, in the Abilene district, exhibits a continuing seepage problem indicative of water beneath the pavement surface. Researchers performed thorough field and laboratory investigations to determine the source of the water intrusion. The major source of the water intrusion was found to be inflow from surface water, although capillary action at the site keeps fill material in the embankment in a near saturated condition.

A detailed design of a repair and installation of a underdrain should be accomplished for the US 83 overpass of Antilley Road in Abilene. The underdrain design should be similar to the detail provided by the Tyler district.
