Reasons for Drivers Failing To Yield at Multi-Lane Roundabout Exits: Transportation Pooled Fund Study Final Report

PUBLICATION NO. FHWA-HRT-23-023

MARCH 2023

U.S. Department of Transportation
Federal Highway Administration

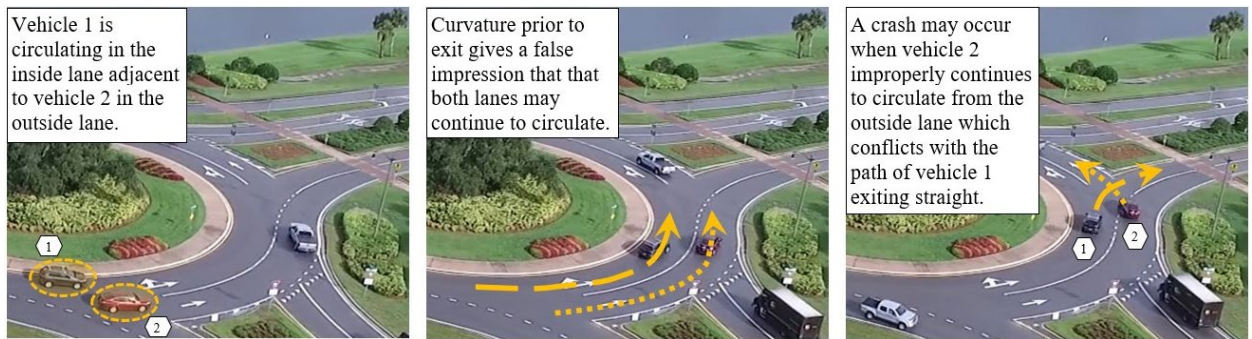
- Failure of entering vehicles to yield to vehicles in both circulating lanes (figure 3).
- Left-turn movement from the incorrect outside lane (figure 4).
- Right-turn movement from the incorrect inside lane (figure 5).

Figure 4. Photo. Left turn from incorrect lane.

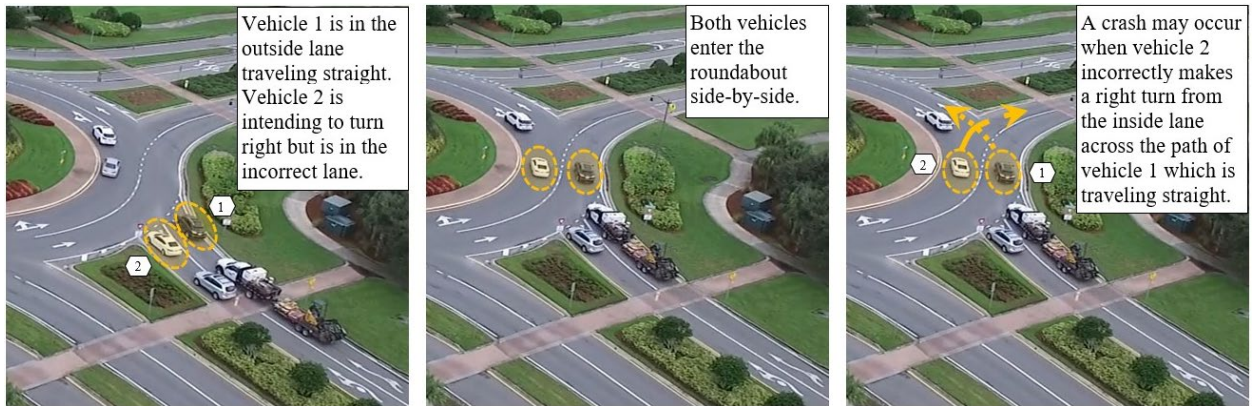
Figure 5. Photo. Right turn from incorrect lane.

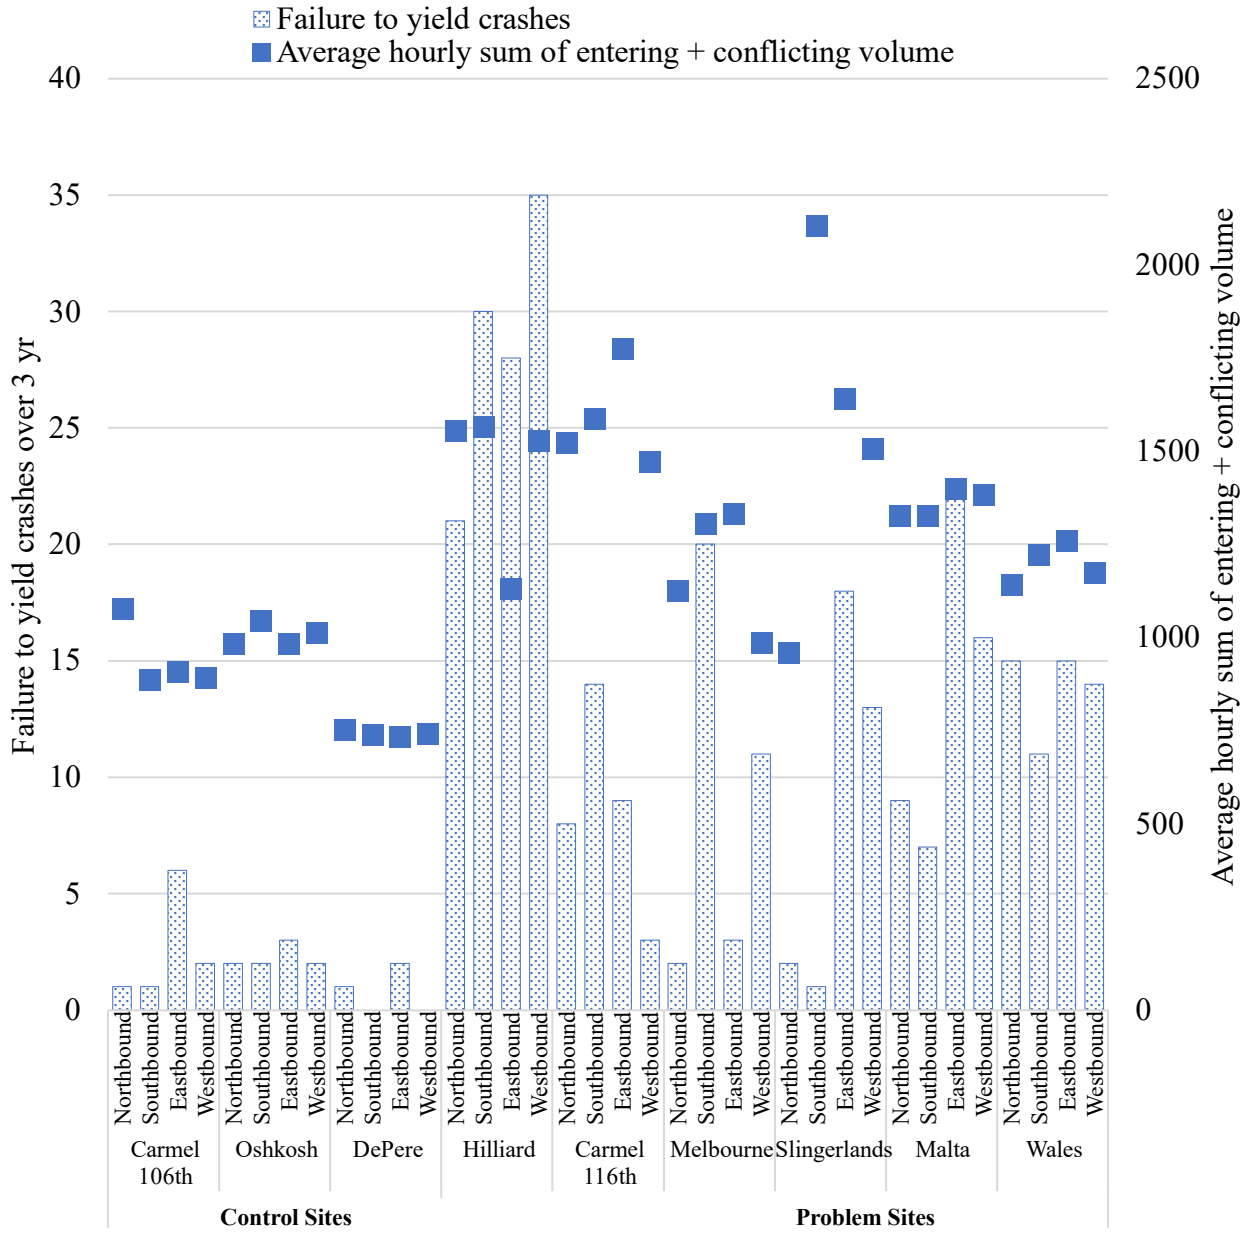
The project team investigated possible explanations for the higher-than-desired number of failure-to-yield crashes at the problem sites. When looking at the entering and conflicting volumes, the control sites generally had lower volumes, both entering and conflicting, than the problem sites. These data emerged as one potential explanation for the number of failure-to-yield crashes. Figure 23 shows the number of failure-to-yield crashes by intersection approach and the 1-h average of the entering and conflicting volume sum on the same approach. As shown, the 1-h average sum of the entering and conflicting volumes is relatively uniform and consistently between 600 vehicles per hour and 1,200 vehicles per hour for the control sites. However, the problem sites have 1-h average sums of entering and conflicting volumes ranging between 900 vehicles per hour and just over 2,100 vehicles per hour, with less uniformity across the intersection approaches.

Figure 23. Graph. Number of crashes over 3 yr involving failure to yield and sum of entering plus conflicting volume, by intersection approach.

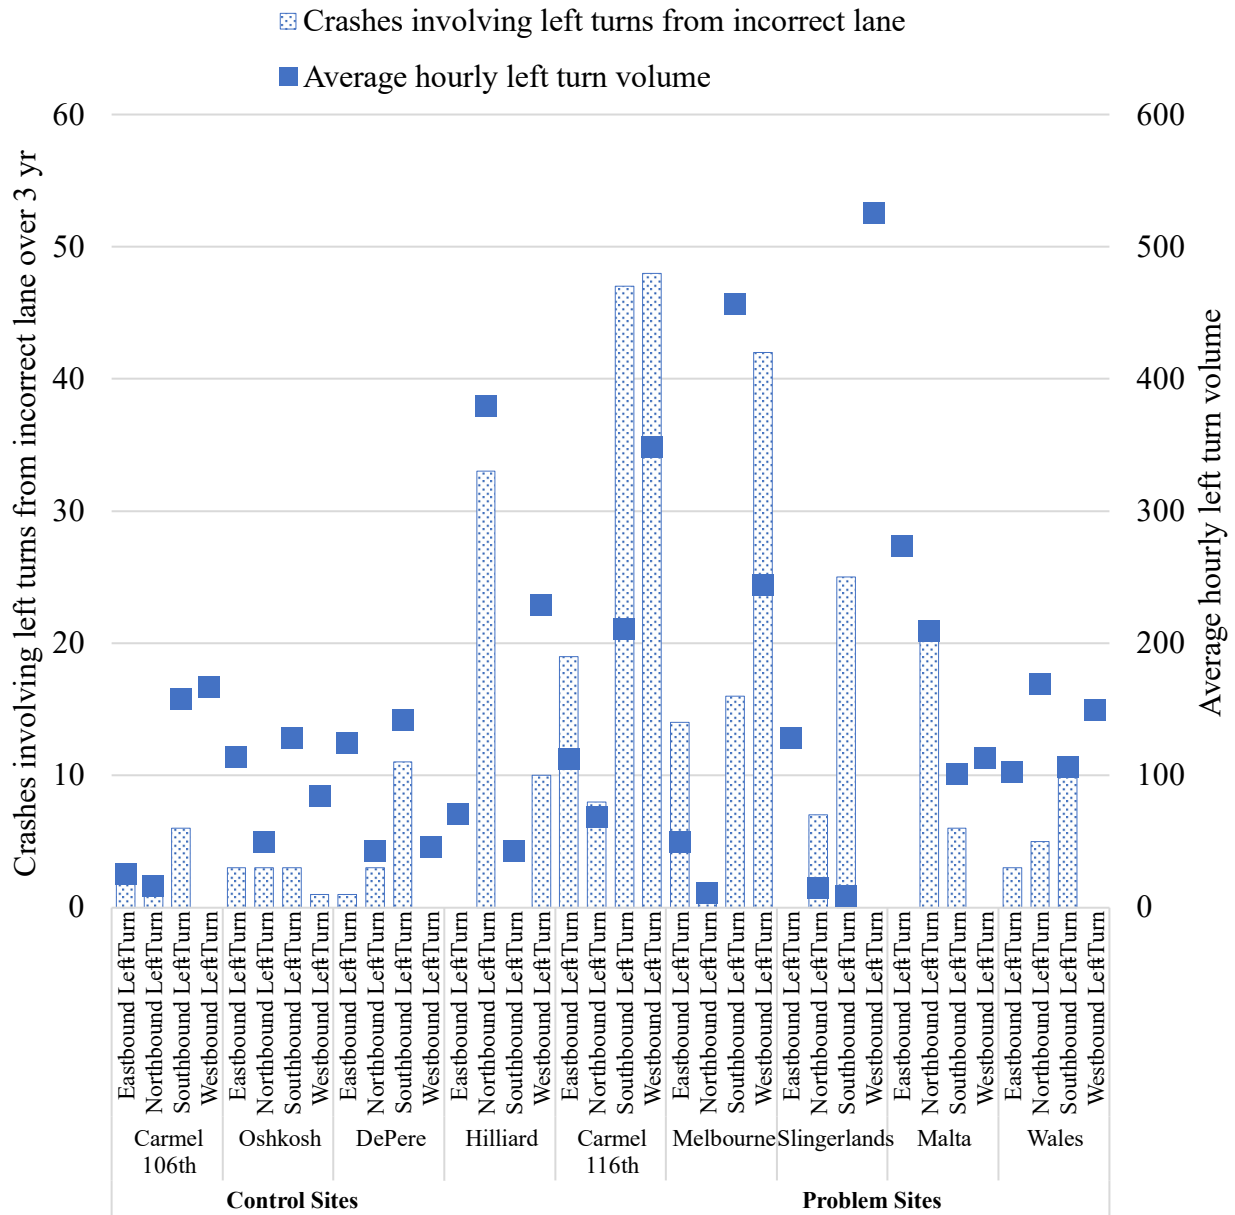
Figure 27 shows the number of crashes involving left turns from incorrect lanes by left-turn movement and the 1-h average of the left-turn volumes for the same movement. As shown, the 1-h average of the left-turn volumes is relatively uniform and consistently under 200 for the control sites. However, the problem sites have 1-h average left-turn volumes ranging between 9 vehicles per hour and 526 vehicles per hour, with less uniformity across the left-turn movements. The entry with nine left turns (the southbound left turn at Slingerlands) reflected only 1 h of data. This approach had 25 crashes involving left turns from incorrect lanes, which may be due to higher left-turn volumes during other hours. In comparison, the entry with 526 left turns (the westbound left turn at Slingerlands) had zero crashes involving left turns from incorrect lanes.

Figure 27. Graph. Number of crashes over 3 yr involving left turns from incorrect lanes and average 1-h left turn volumes, by left-turn movement.

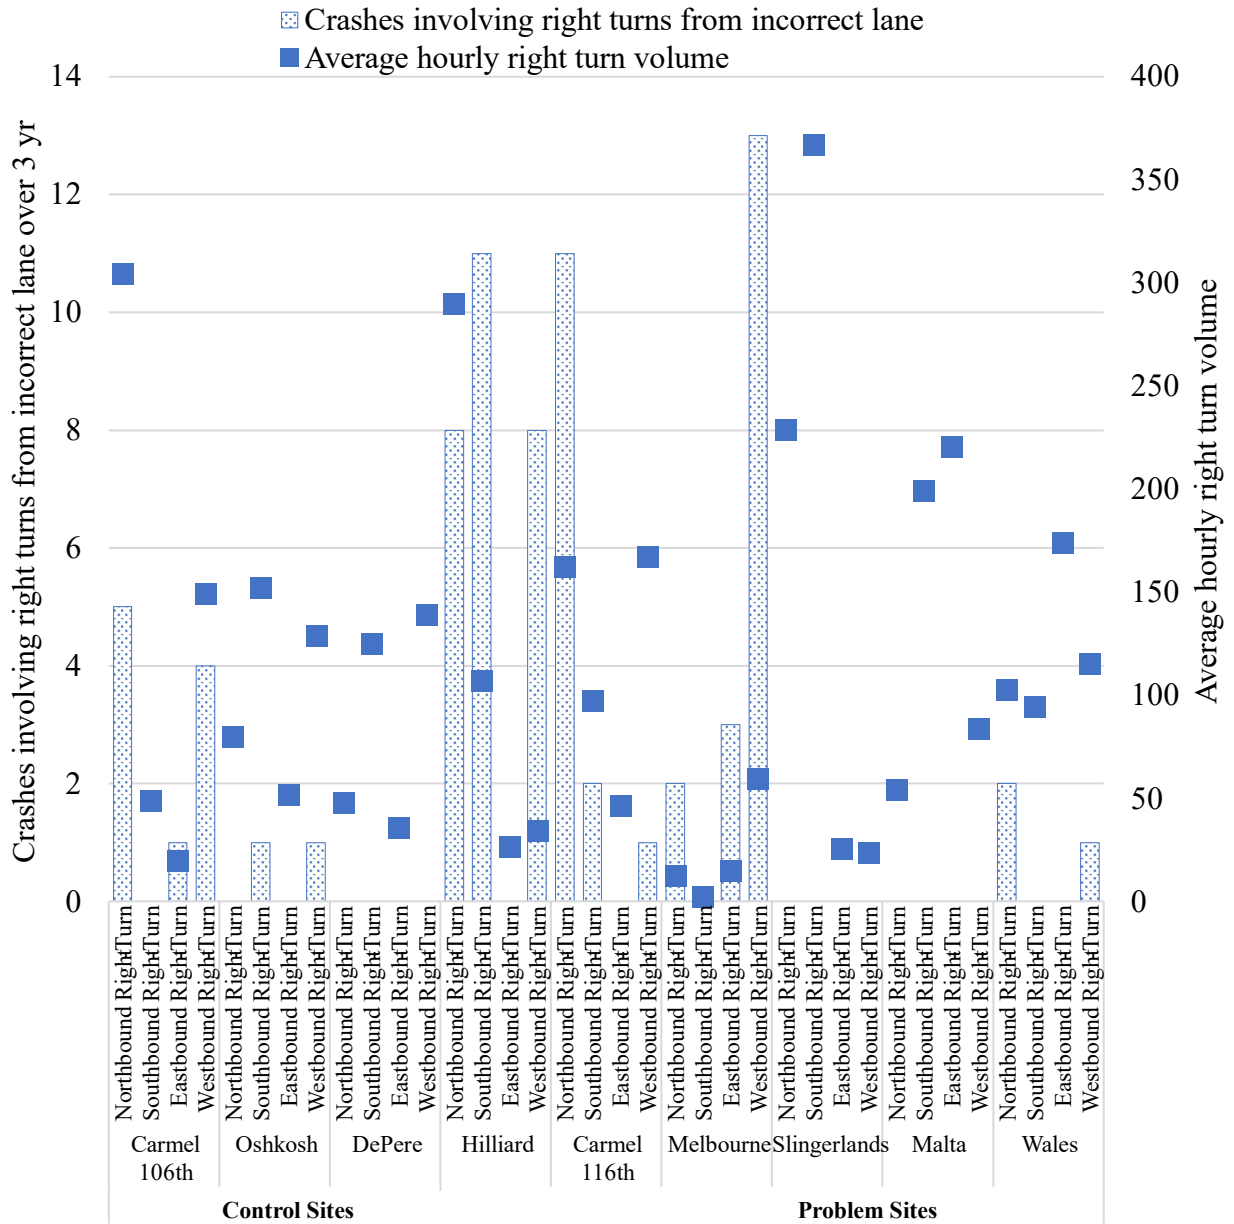
When looking at the right-turn volumes, except for the northbound right-turn movement at Carmel 106th, the average 1-h volumes at the control sites were all lower than 160 vehicles per hour. In contrast, the problem sites had eight approaches, over six sites, with average 1-h right-turn volumes exceeding 160 vehicles per hour. The problem sites generally had more individual entries with higher right-turn movement volumes and a wider range in average 1-h right-turn movement volumes. However, the project team did not find any clear trends between the right-turn movement volumes and the number of crashes involving right turns from incorrect lanes.

Figure 30. Graph. Number of crashes over 3 yr involving right turns from incorrect lanes and average 1-h right-turn volumes, by right-turn movement.

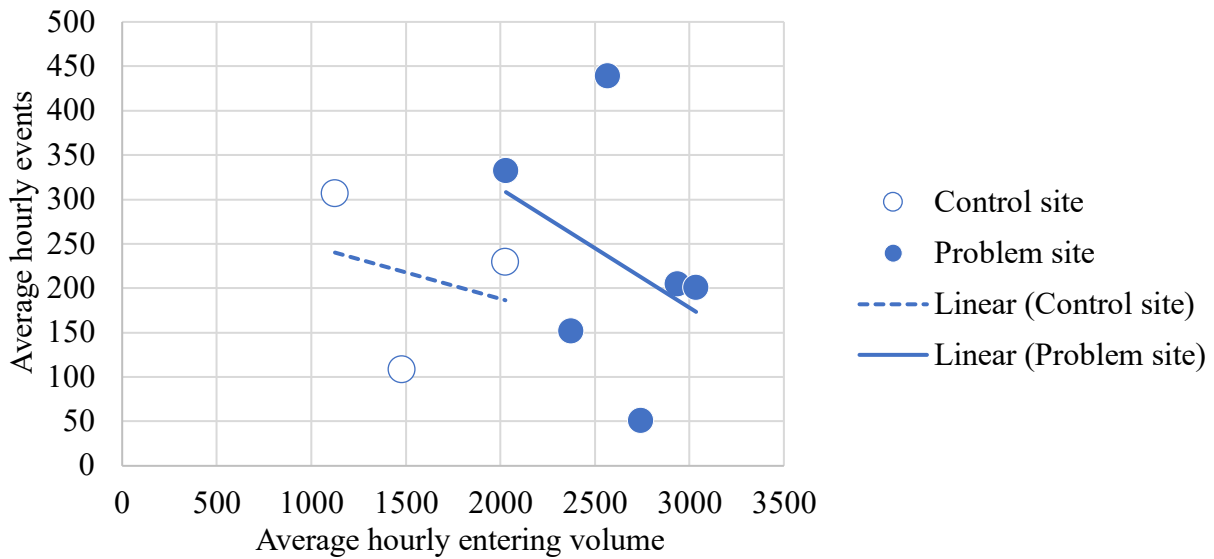
Figure 34. Graph. Average hourly events by entering volume.

Figure 34 shows the average hourly number of events by the average hourly entering traffic volume for control and problem sites. For both control and problem sites, there is a slight trend in which the number of events decreases as the volume increases. Because lane-change violations caused most events, it may be that an increase in volume makes these types of violations less likely to occur because there is less room to maneuver within the roundabout.

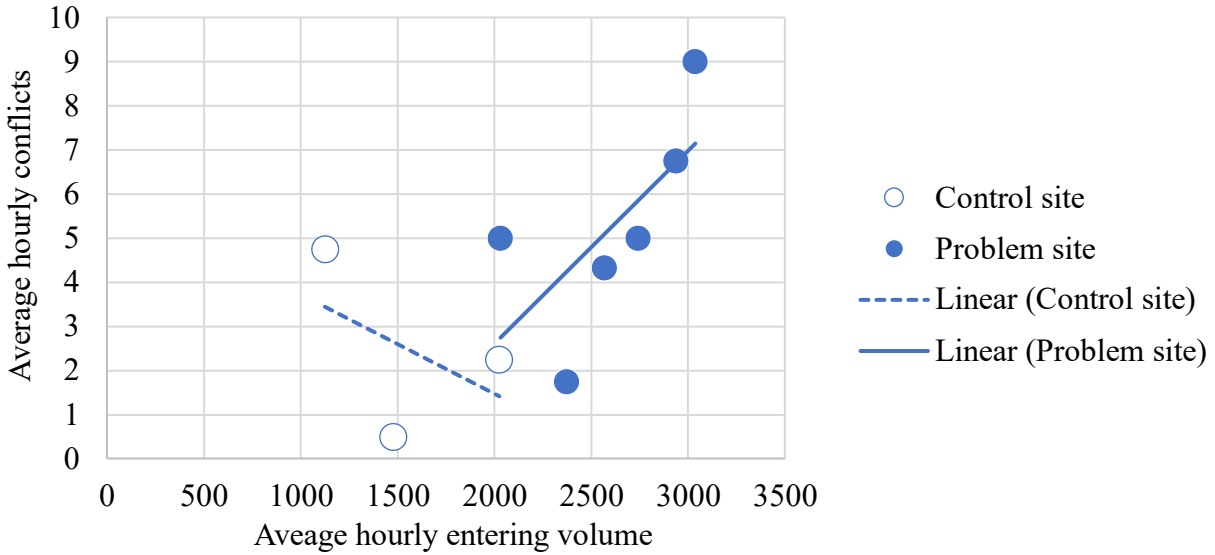
Figure 35. Graph. Average hourly conflicts by entering volume.

Figure 35 shows the average hourly conflicts by the average hourly entering traffic. For the control sites, the number of conflicts decrease as the volume increases. However, at the problem sites, the number of conflicts increase as volume increases. Conflicts were more likely to occur as the result of failure-to-yield violations, which were more common for problem sites. As volume increases, these types of violations may be more likely to occur, as entering drivers have fewer opportunities to enter and may take more risks.

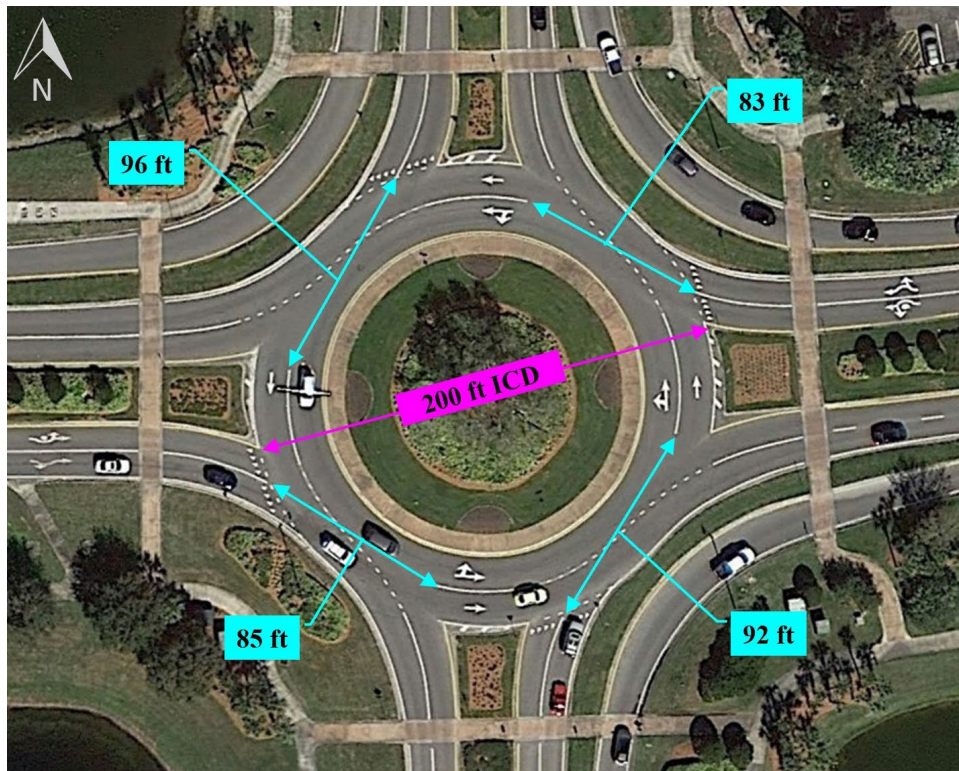
Figure 36. Photo. Melbourne—conflict areas.

As illustrated in figure 36, the Melbourne site has large conflict areas in each of the four quadrants. The large conflict areas are the result of a large ICD of 200 ft, relatively small exit radii, and entry and exit alignments that combine to create over 50 ft of separation (measured along the outside curb) between each entry and the adjacent exit to the right.

Longer distances also make it more difficult for drivers to maintain alignment with the correct circulating lane, which increases the potential for lane changing through the entry. The distances from the yield line to the start of the circulating lane line range from 83 to 96 ft (figure 36). Failure of entering vehicles to yield to both circulating lanes resulted in 37 crashes over 3 yr (20 percent of the intersection total), with the crashes predominantly on the southbound and westbound entries.

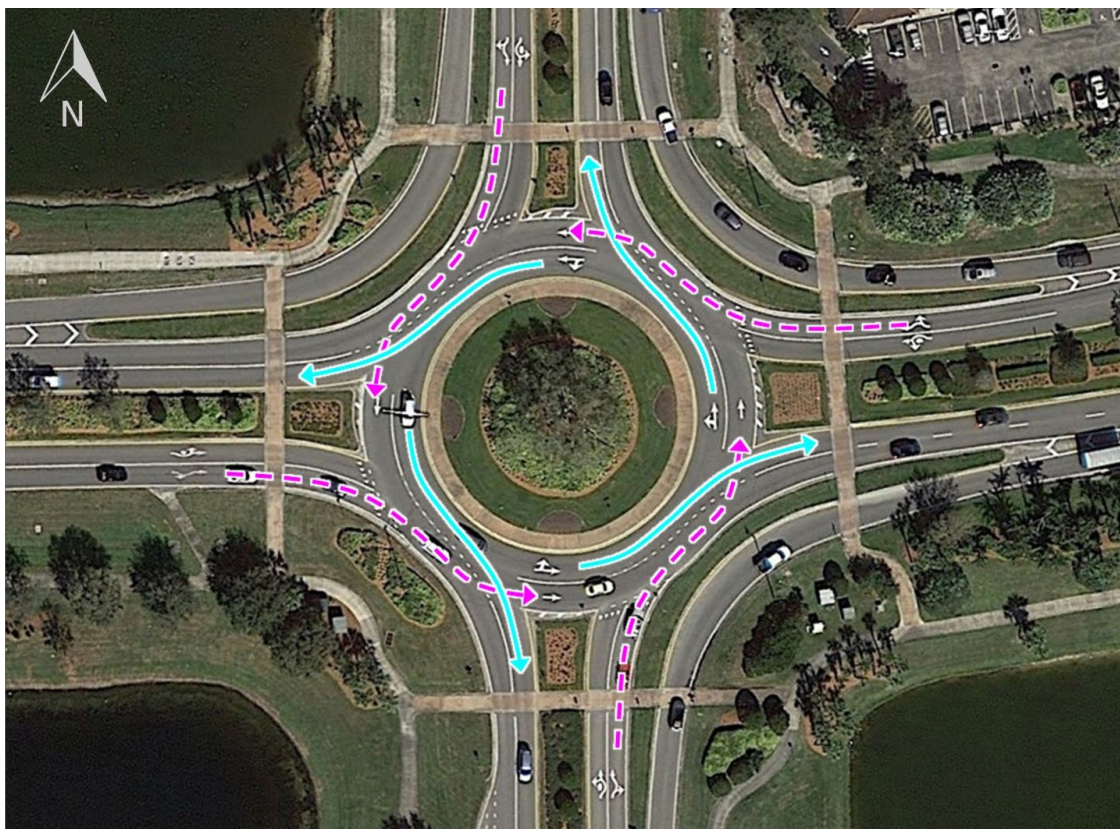
Figure 37. Photo. Melbourne—Failure-to-yield crash patterns associated with large conflict areas.

The distance from the yield line to the start of the circulating lane lines is another indication of the size of the conflict area. The longer the distance of travel through the conflict area, the more likely a driver may be to enter beside another vehicle, as illustrated in figure 37.

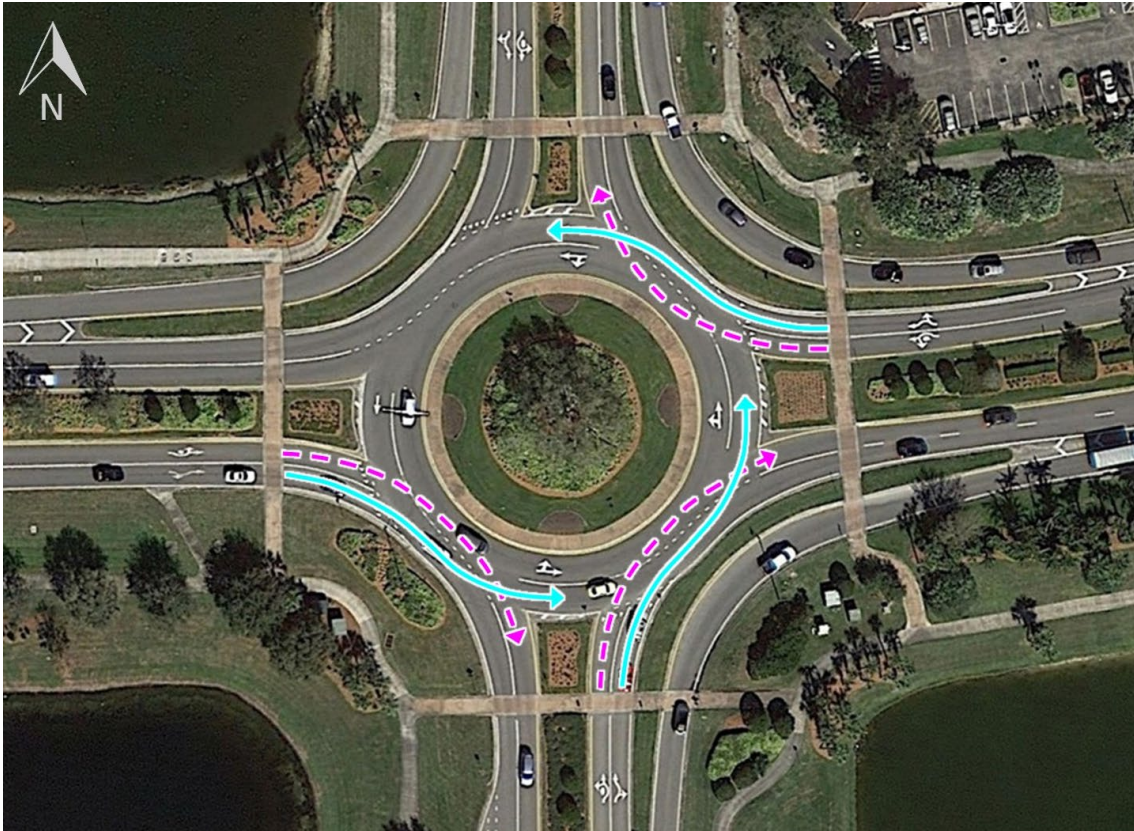
Figure 38. Melbourne—Crash patterns for right turns from incorrect lanes associated with large conflict areas.

The large size of the Melbourne roundabout also appears to influence crashes related to lane changes within the roundabout, right turns from incorrect lanes, and left turns from incorrect lanes. In particular, the large size and exit geometry result in smooth paths for left turns and right turns from incorrect lanes, which may lead to some drivers navigating the roundabout incorrectly without realizing it. Left turns from incorrect lanes account for 40 percent of the intersection crashes and are discussed in more detail in other sections of chapter 5 and chapter 6. Figure 38

illustrates observed locations of crashes related to right turns from incorrect lanes, accounting for 10 percent of the intersection total.

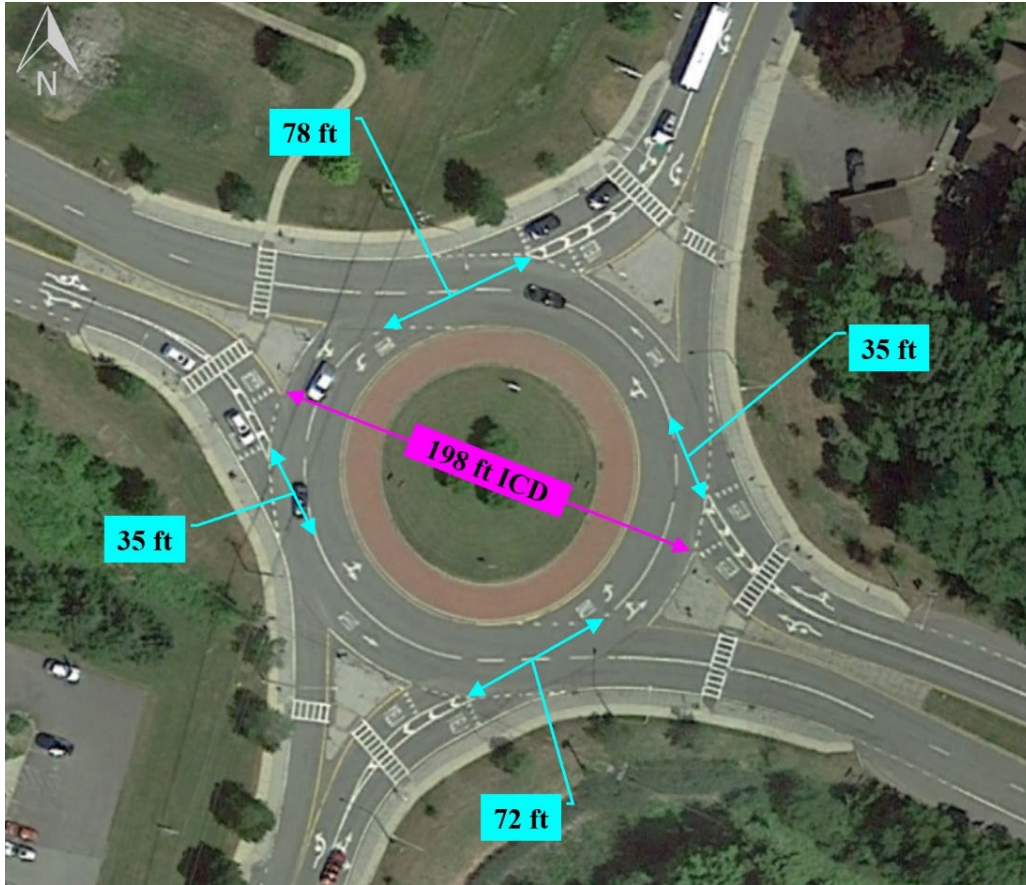
Figure 39. Photo. Slingerlands—conflict areas.

The Slingerlands site has an ICD of 198 ft with exclusive left-turn lanes and corresponding single-lane exits on two legs, as illustrated in figure 39.

However, despite the similar size, the relative alignments of each entry and exit reduce the separation between entries and adjacent exits compared to the Melbourne site. Still, Slingerlands has large conflict areas at two entries, which are influenced by the large ICD in combination with painted spiral markings that result in 72–78 ft of distance between the yield line and the start of the circulating lane line. These 2 entries with the large conflict areas corresponded to the locations with the majority of crashes related to failure of entering vehicles to yield to both circulating lanes (32 crashes over 3 yr).

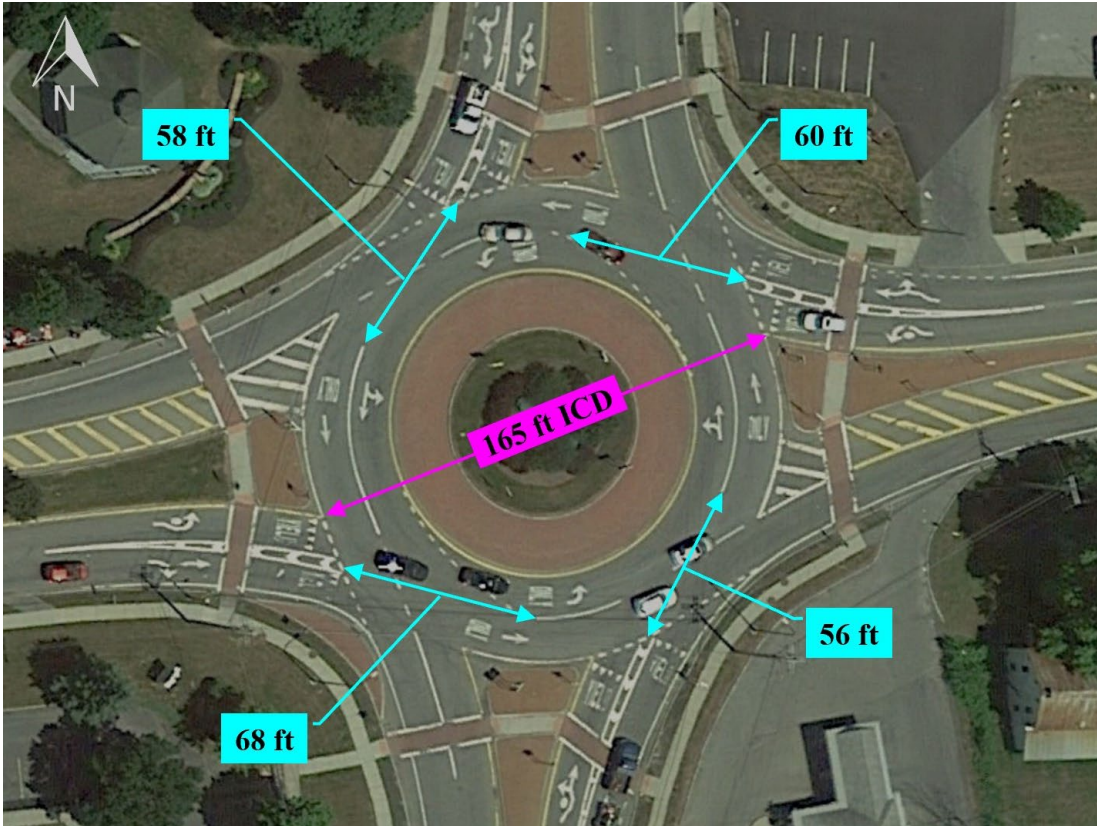
Figure 40. Photo. Malta—conflict areas.

Malta, with an ICD of 165 ft, has a more compact size than the nearby Slingerlands site. However, as part of a previous retrofit, the eastbound and westbound approaches were modified to be exclusive left-turn lanes with single-lane exits, as illustrated in figure 40.

Painted spirals were added to the circulatory roadway to support the modified lane configurations. However, due to the retrofit conditions, the addition of the painted spirals increased the length of conflict areas adjacent to the eastbound and westbound entries to 68 ft and 60 ft, respectively. This increase was observed to adversely affect vehicle alignment and increase lane straddling.

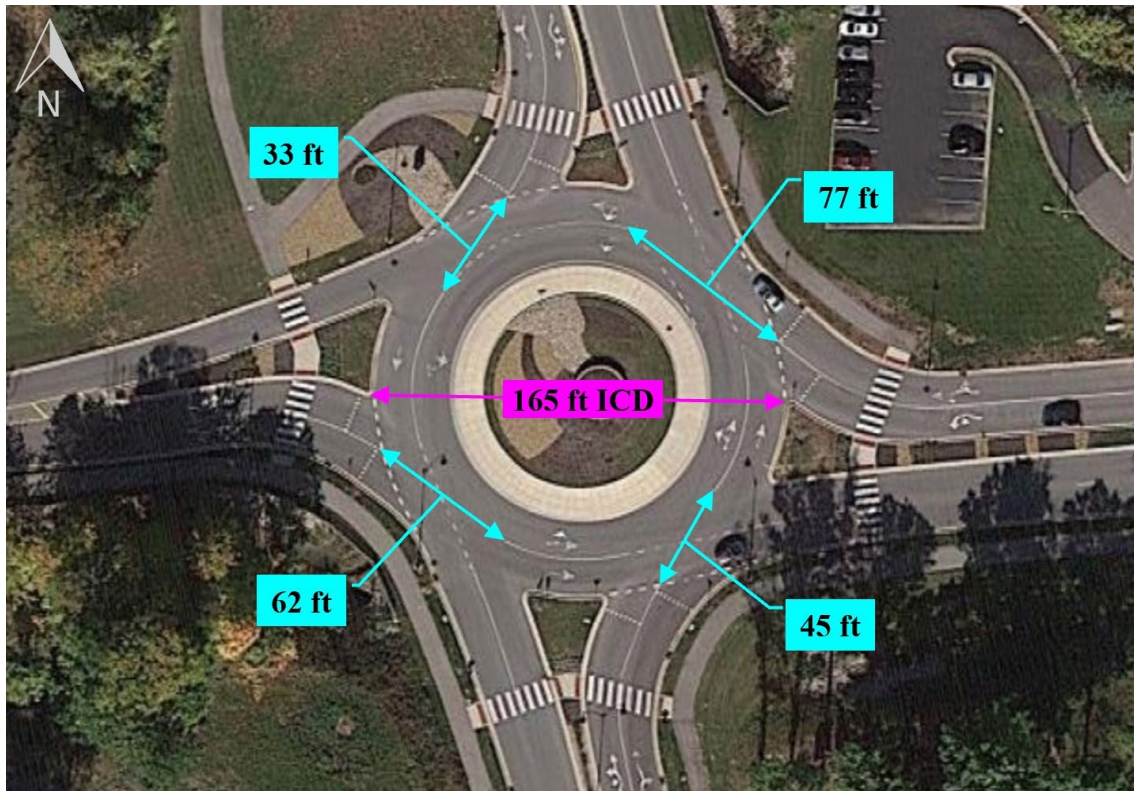
Figure 41. Photo. Carmel 106th—conflict areas.

At Carmel 106th, which has an ICD of 165 ft, the size of the conflict areas varies. Key dimensions are illustrated in figure 41.

At this location, other factors—the angle between legs and the alignment of the entries and exits—appear to have a greater impact on the size of the conflict areas than the ICD. The largest conflict area is adjacent to the westbound entry, which has a distance of 77 ft from the yield line to the start of the circulating lane line. The width of this conflict area is created by a combination of the design of the spiral within the circulatory roadway, the skew angle between legs, and the alignment of the east leg being heavily offset to the left of the roundabout center. The size of the conflict area is likely contributing to observed violations of vehicles crossing and straddling lanes westbound. The two largest conflict areas correspond to the locations of the highest numbers of crashes related to entering drivers failing to yield to both circulating lanes, with six crashes at the eastbound entry and two crashes at the westbound entry. Traffic patterns and network influences also have a major impact on crash patterns at this location; these patterns are further discussed in chapter 6.

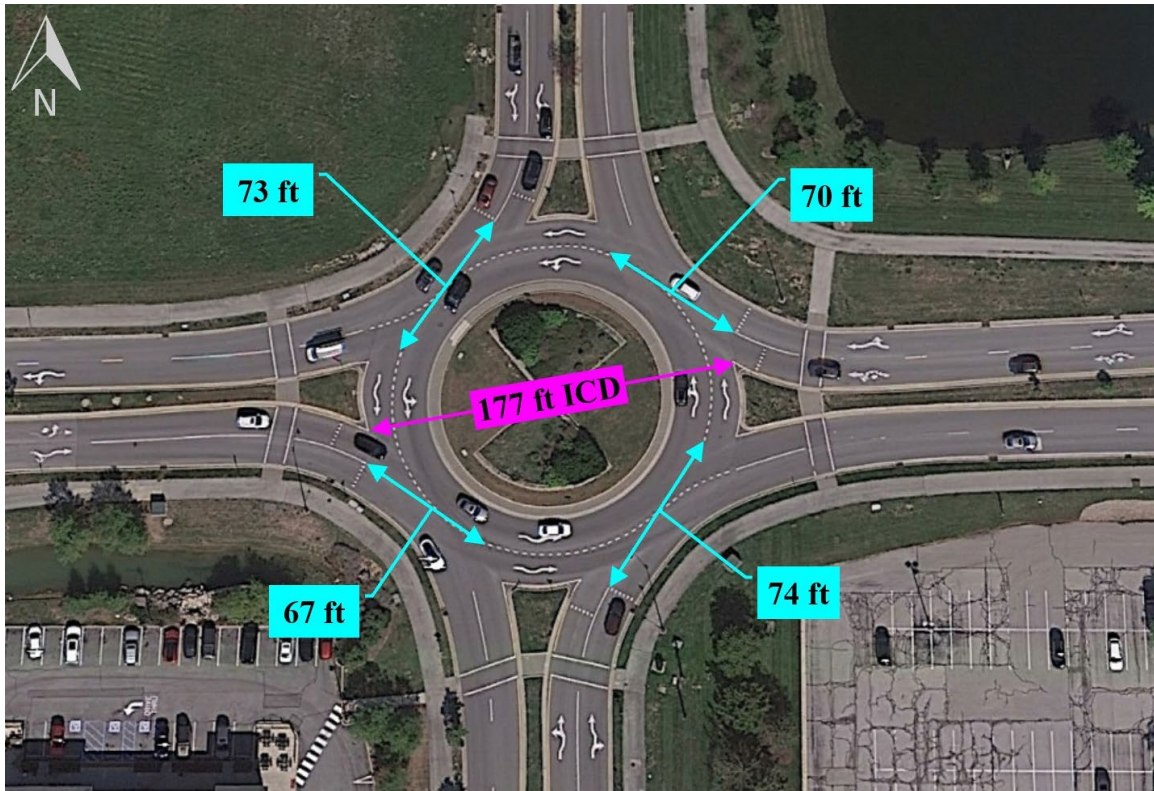
Figure 42. Photo. Carmel 116th—conflict areas.

Carmel 116th has an ICD of 177 ft, which is larger than that for Carmel 106th. The conflict areas at Carmel 116th, illustrated in figure 42, are also larger than those at Carmel 106th, ranging from 67 to 74 ft when measured from the entrance line to the start of the circulating lane lines.

For the northeast and southwest corners of the roundabout, concentric lane markings are present. In these corners, the conflict area was measured to coincide with the edge of the splitter island. The exit geometry influences the size of the conflict areas at this location. Carmel 116th has a higher number of crashes related to failure of entering vehicles to yield to both circulating lanes, with 31 crashes of this type over 3 yr compared to 10 crashes over 3 yr at Carmel 106th. However, this crash type represented 16–20 percent of the total intersection crashes at both locations. At Carmel 116th, the failure-to-yield crashes were distributed between the northbound, southbound, and eastbound entries, with 8–12 crashes over 3 yr per entry. These crashes were also influenced by traffic volume patterns and network considerations, which are discussed further in chapter 6.

At the Carmel 116th site, the team observed a strong pattern of drivers making the westbound left turn through the roundabout destined to the shopping center in the southwest quadrant of the study intersection. As previously illustrated by the blue line in figure 42, the team observed drivers incorrectly using the outside circulating lane when making the left turn to position for the right turn into the shopping center immediately after exiting the roundabout to the south. Vehicles using the correct inside circulating lane to make the westbound-to-southbound left turn frequently crossed over to the outside lane through the exit to position for turning into the shopping center driveway. Westbound vehicles turning left from the incorrect lane represented 25 percent (48 crashes over 3 yr) of the intersection total.

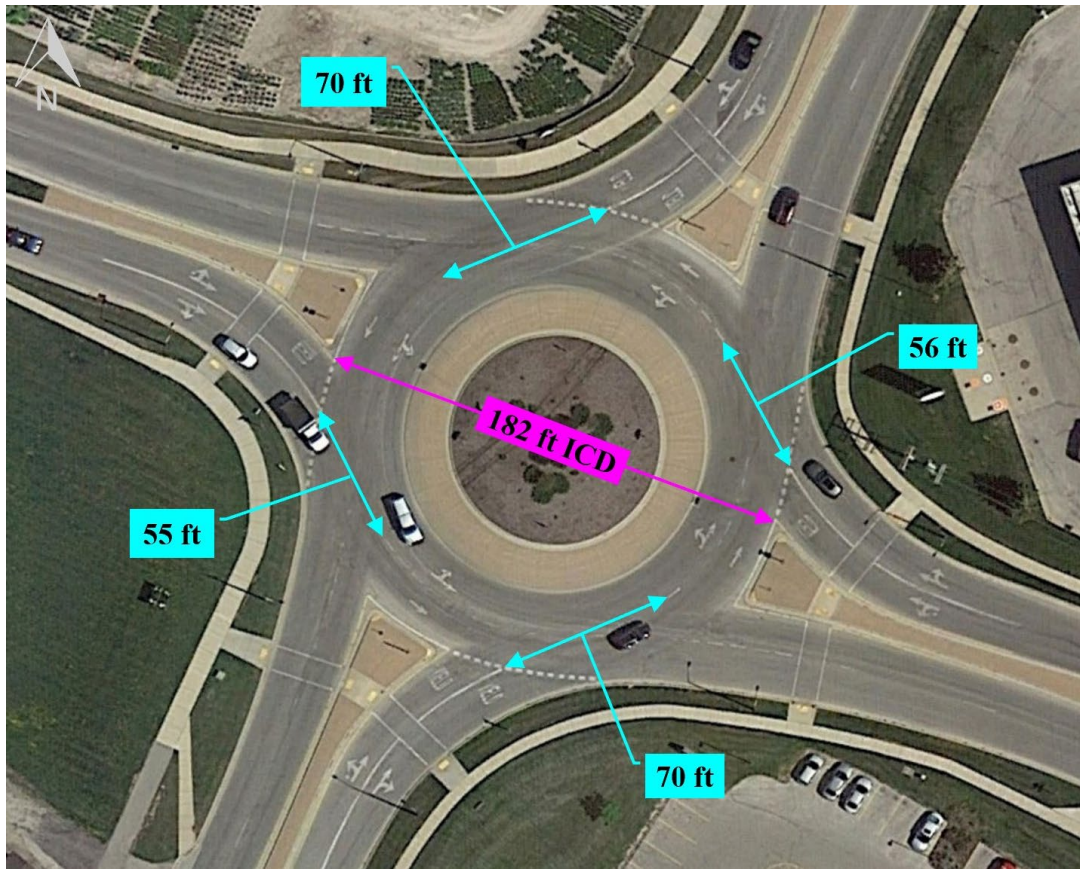
Figure 43. Photo. De Pere—conflict areas.

The control site in De Pere had the fewest crashes and the lowest volumes. This site has an ICD of 182 ft, with a slight skew angle between intersection legs that results in larger conflict areas in front of the southbound and northbound entries, as illustrated in figure 43. However, the size of the conflict areas did not correlate to the location of crashes at De Pere. Over the 3-yr period, 13 of the 23 total crashes occurred in the southwest corner adjacent to the eastbound entry, which has the smallest conflict area. At this site, other factors, such as turning movement patterns and network influences, appear to have a greater impact; these factors are discussed in more detail in chapter 6.

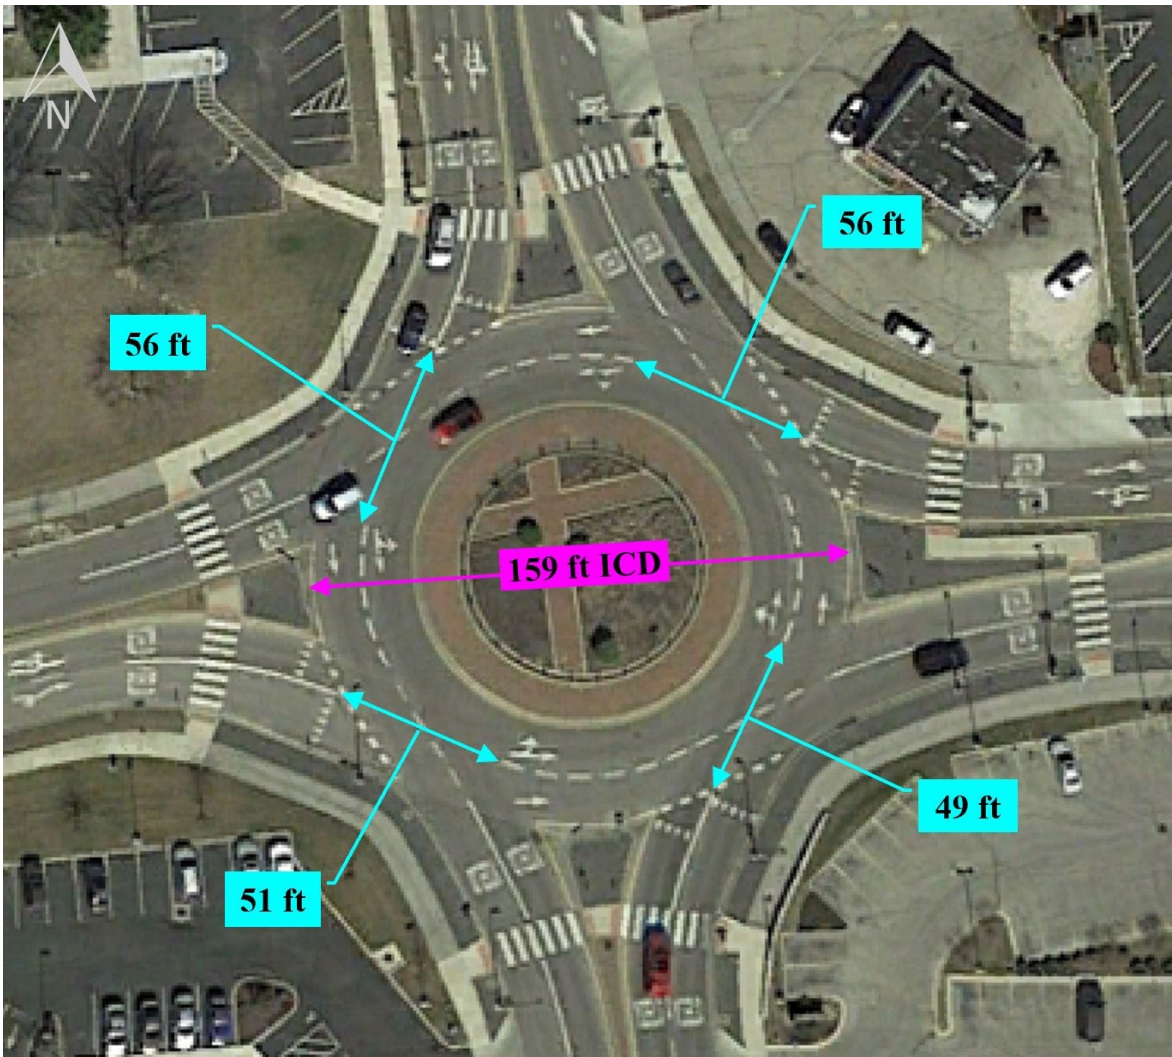
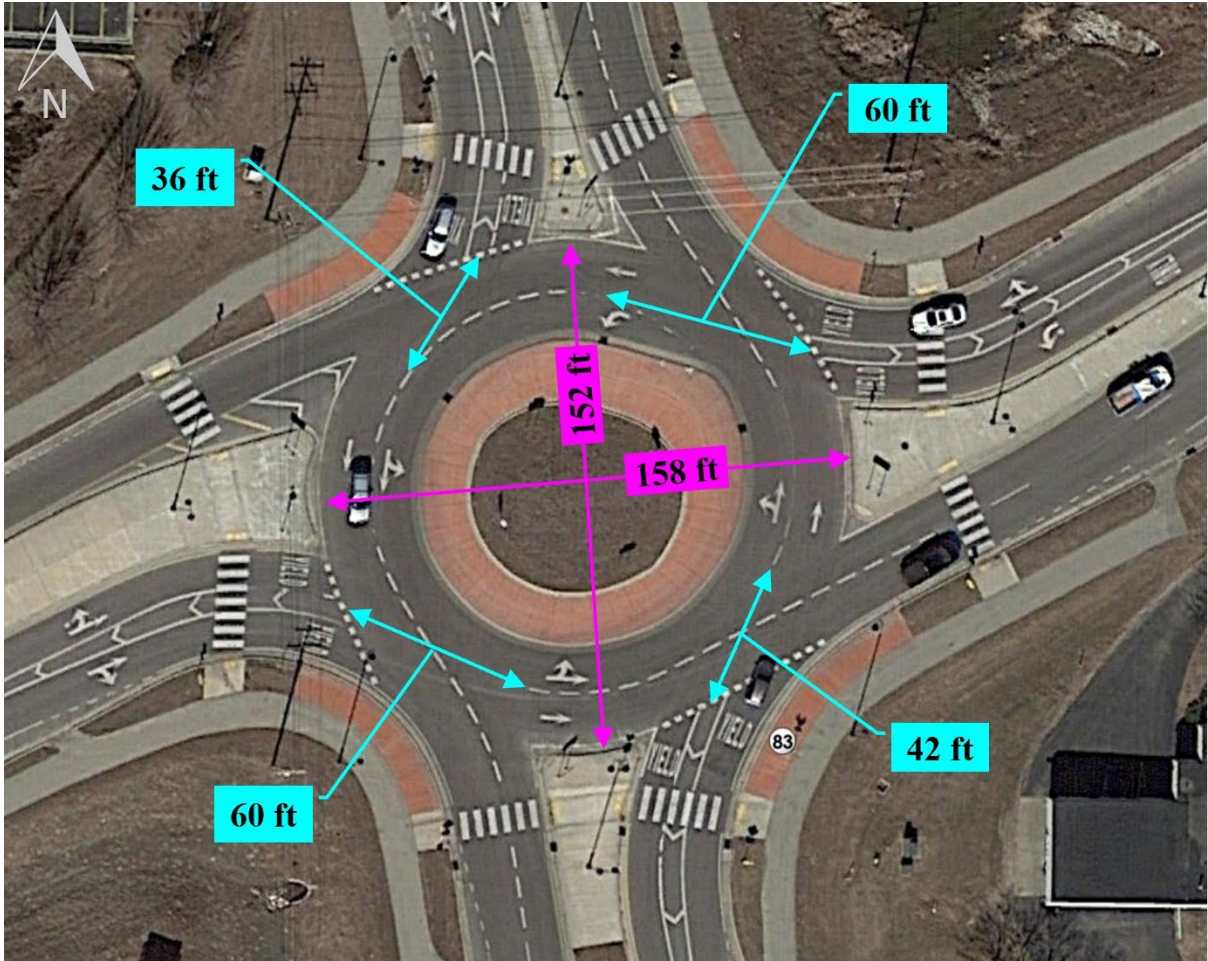
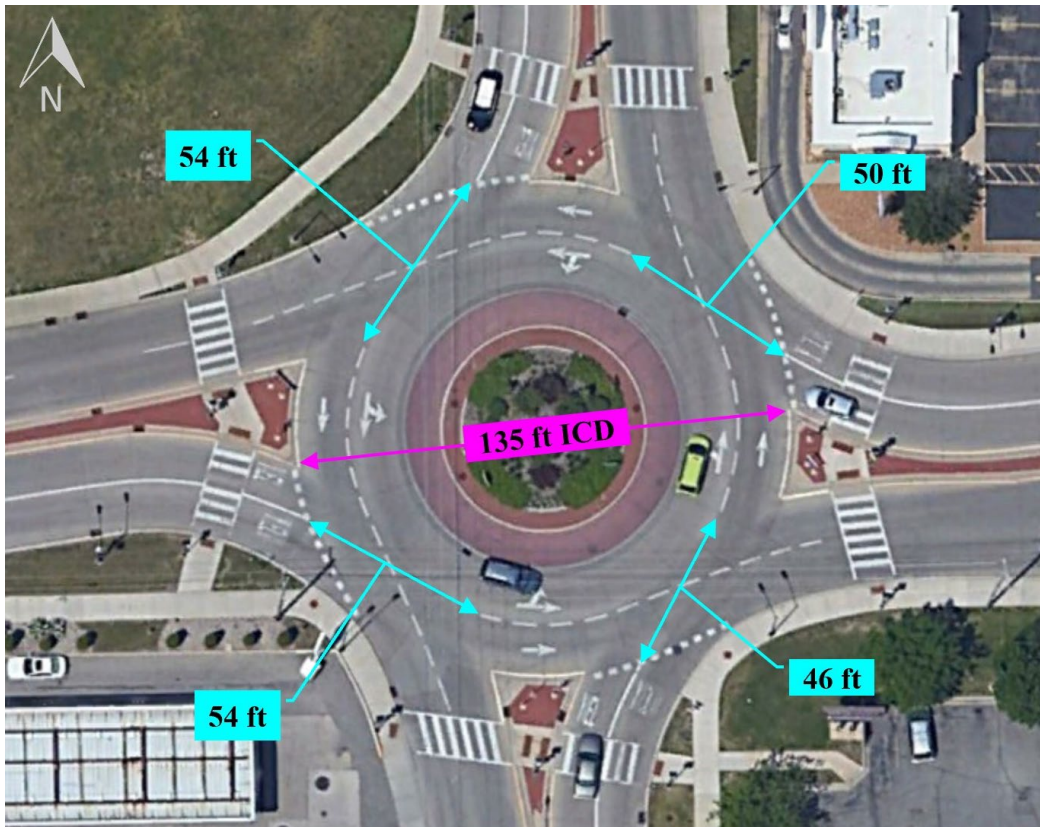
Each of the remaining three sites at Hilliard (figure 44), Wales (figure 45), and Oshkosh (figure 46) have more compact ICDs, ranging from 135 to 159 ft. These reduced ICDs generally result in smaller conflict areas than the other study sites. However, crashes involving failure to yield were the highest at the Hilliard site, which had 21–35 crashes of this type at each entry over 3 yr. At Wales, 11–15 crashes involving failure to yield were reported for each entry over 3 yr, which is comparable with the number of crashes recorded at the other problem sites where large conflict areas were present. In contrast, the Oshkosh site had 1–3 failure-to-yield crashes at each entry over 3 yr. Oshkosh had a smaller ICD than Hilliard and Wales but generally had comparably compact conflict areas. These findings suggest that other factors were likely to contribute to the observed failure-to-yield crashes at Hilliard and Wales.

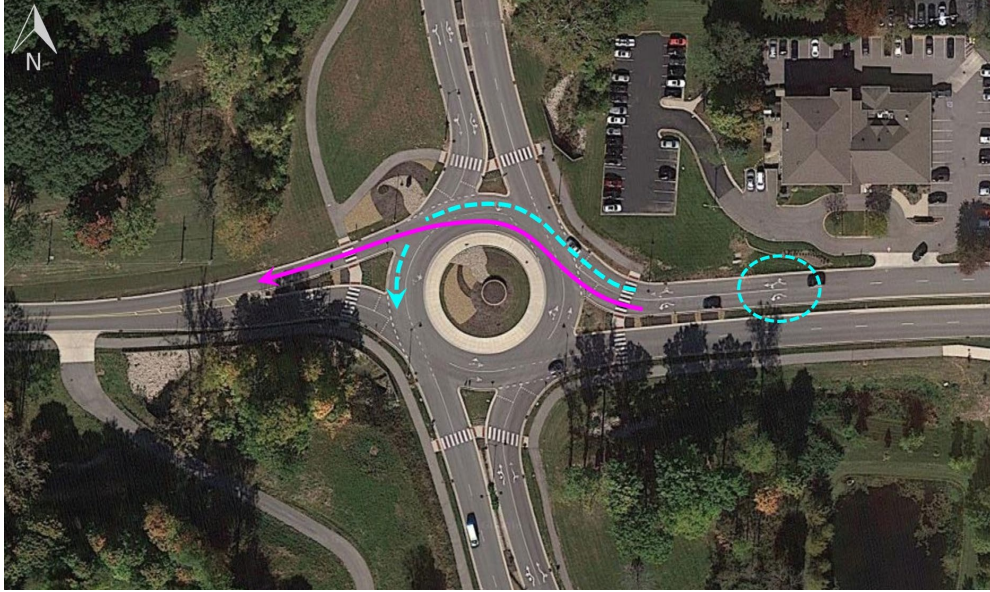
Figure 47. Photo. Carmel 106th—Westbound through from incorrect exclusive left-turn lane.

At the westbound approach to Carmel 106th, there are two approaching lanes; however, the inside lane is an exclusive left-turn lane. The outside lane allows a vehicle to make a left turn, continue straight westbound, or turn right. The combination of the lane drop with the relatively short spacing (685 ft) to the upstream roundabout at the adjacent interchange may be influencing driver lane selection or ability to change lanes during periods of heavier volume. Over 4 h, 194 through vehicles were noted to incorrectly use the inside lane to continue westbound (13-25 percent of westbound through vehicles). These data correspond to a key crash pattern, illustrated in figure 47, associated with vehicles using the incorrect lane to make a through movement and changing lanes at the westbound exit. This crash pattern generated 11 percent (or 5) of the intersection's total crashes.

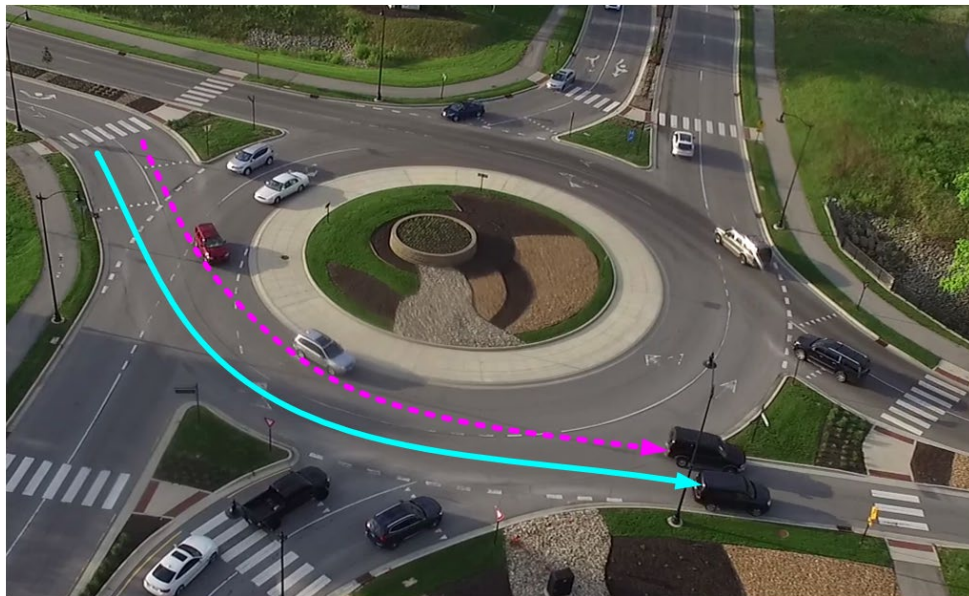
Figure 48. Carmel 106th—Observed near-crash from westbound through from incorrect exclusive left-turn lane (image facing south).

Figure 48 illustrates an observed near-crash on the westbound exit at Carmel 106th. A vehicle incorrectly making a through movement from the exclusive left-turn lane (inside lane) almost collided with an adjacent vehicle making the through movement from the correct outside lane.
