Reasons for Drivers Failing To Yield at Multi-Lane Roundabout Exits: Transportation Pooled Fund Study Final Report

PUBLICATION NO. FHWA-HRT-23-023

MARCH 2023

U.S. Department of Transportation
Federal Highway Administration

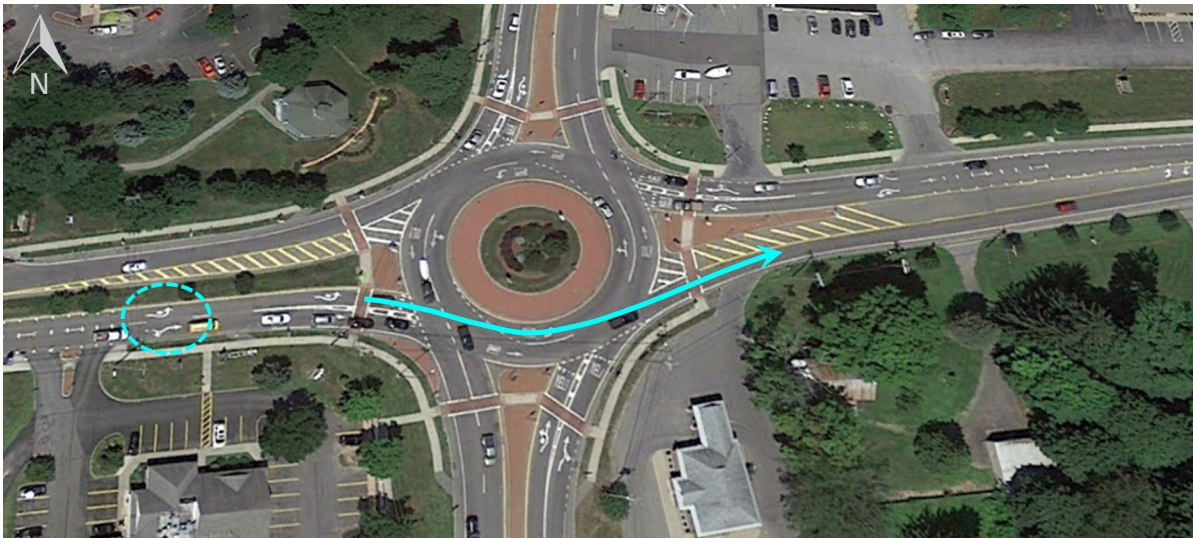
Figure 49. Photo. Malta—Exclusive eastbound left-turn lane.

At Malta, as illustrated in figure 49, the eastbound approach has two continuous lanes, with the inner lane becoming a mandatory left turn only lane at the roundabout. The outer entry lane serves the eastbound through and right-turn movements. During the morning peak hour, high eastbound-to-southbound right turns were observed for vehicles traveling from I-87. Due to the high right-turn demand, there is a substantial lane imbalance, with 69 percent of vehicles in the outside lane. This imbalance resulted in 5 percent of the eastbound through vehicles (10 vehicles) during the morning peak using the incorrect inside lane, which is designated as left-turn only, to make an eastbound through movement. The westbound approach also has a mandatory left turn only lane; however, the second westbound entry lane is developed as a lane addition, as discussed in the next section.

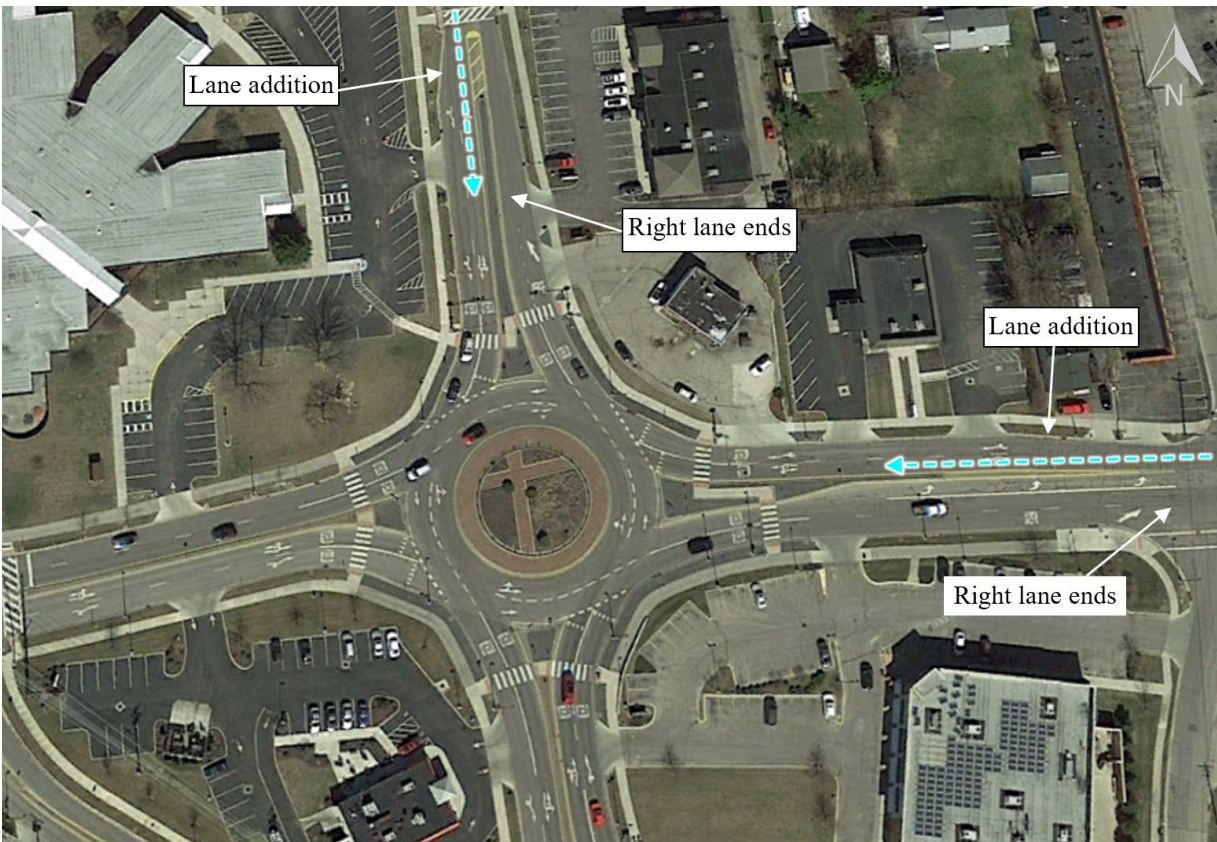
Figure 50. Photo. Hilliard—Lane additions and lane merging.

At Hilliard, the westbound and southbound approaches each have lane additions. Each uses a standard taper to add a shared through-right lane toward the outside. As illustrated in figure 50, the single approach lane is aligned with the inside entry lane that is designated as a shared through-left lane. Each of the northbound, westbound, and southbound entries had between 8 and 11 reported crashes related to right turns from incorrect lanes over 3 yr. These crashes may be attributable, in part, to drivers aligning into the inside left through lane on entry, as well as influences from downstream exit-lane merging in close proximity to the circulatory roadway.

As illustrated in figure 50, the northbound and eastbound exit lanes at Hilliard merge into a single lane immediately beyond the crosswalks. This factor may also be influencing crashes involving right turns from incorrect lanes on the northbound and westbound entries. Some drivers may be using the incorrect lane to avoid the downstream lane drop immediately after their turn. The lane merging northbound and eastbound may also be influencing lane changing through the exits, which was a top source for violations at the Hilliard site.

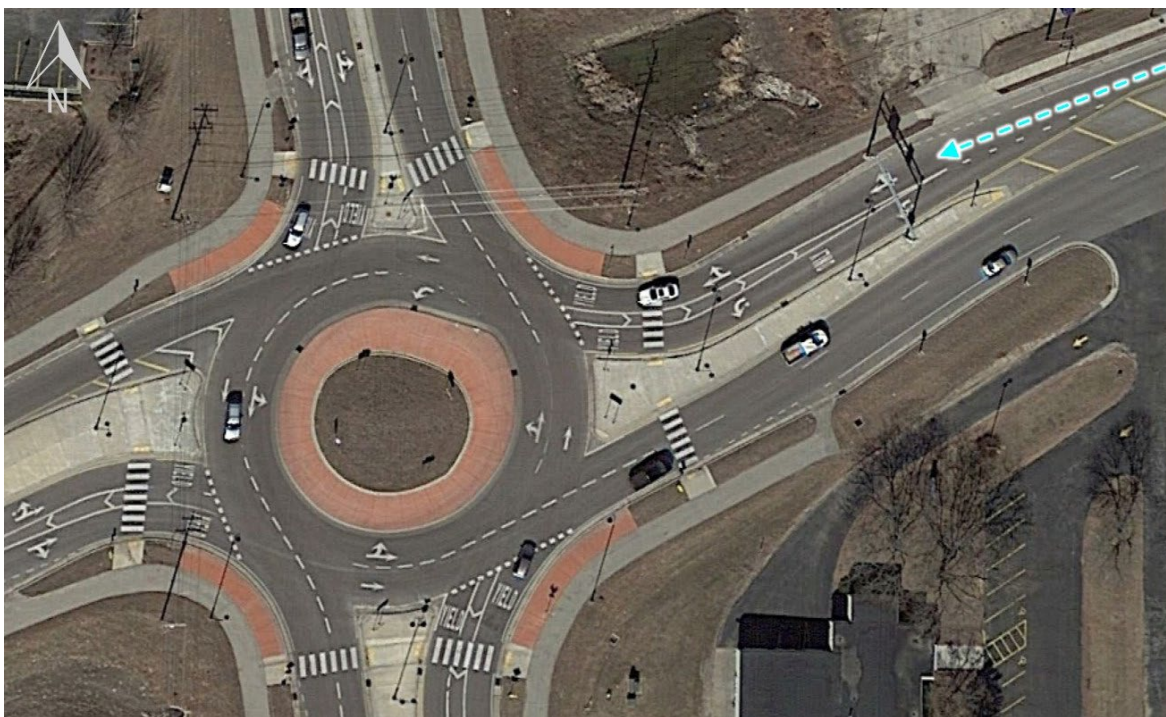
Figure 51. Photo. Wales—Westbound lane addition (plan view).

At Wales, the westbound approach widens from a single approach lane to two entry lanes with the addition of an exclusive left-turn lane. As illustrated in figure 51, the approaching vehicles are aligned into the outside lane, which is designated as a shared through-right lane.

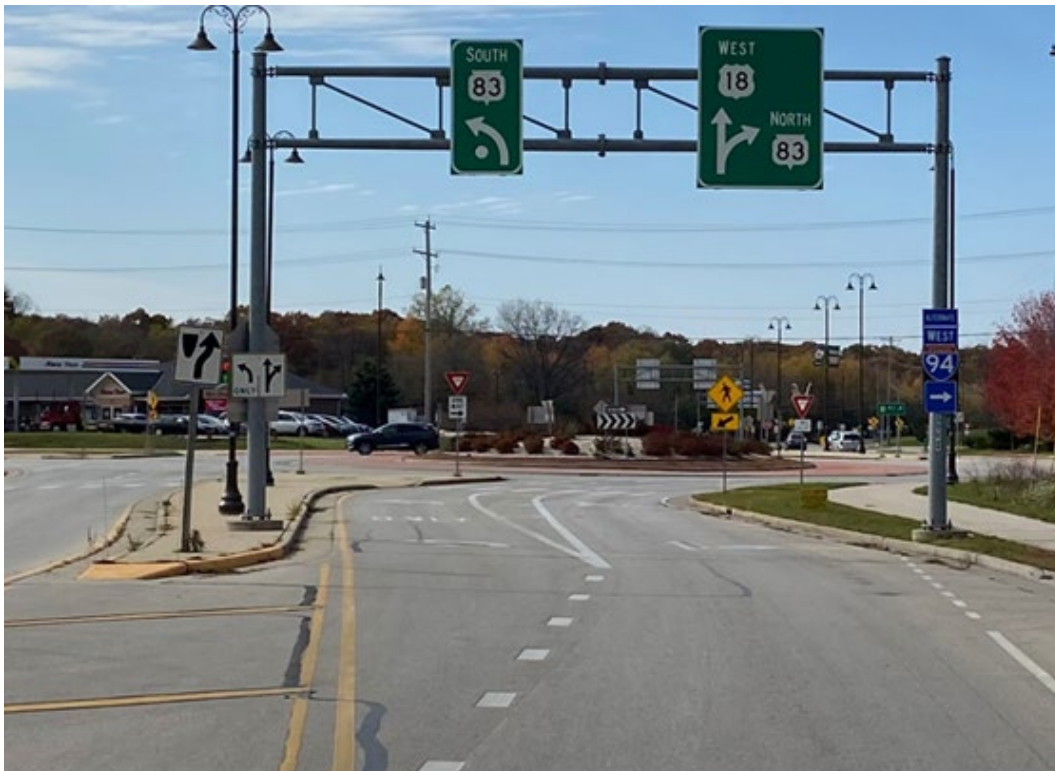
Figure 52. Photo. Wales—Westbound lane addition (ground-level view).

As illustrated in figure 52, an abrupt alignment shift on the westbound approach upstream of the roundabout further directs vehicles into the outside lane and may be contributing to

54 left-turning vehicles over 4 h observed to use the incorrect outside lane from the westbound entry. However, this alignment shift is not translating to a crash pattern related to the inside lane being designated left turn only. While the signing and markings do not allow a left turn from the outside lane, the overall intersection lane configurations would support left turns from both westbound entry lanes. Higher numbers of crashes may be expected with the same westbound entry geometry if the inside lane is designated as a shared through-left with two westbound exit lanes.

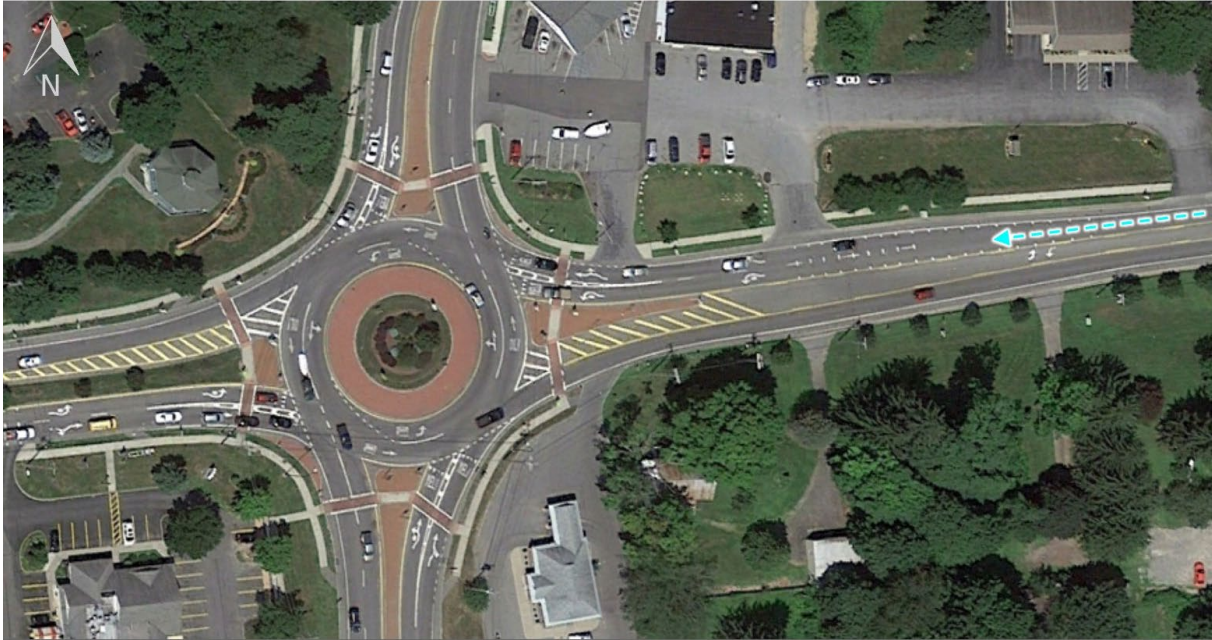
Figure 53. Photo. Malta—Westbound lane addition.

Figure 53 shows Malta, where the westbound approach widens from a single lane to two entry lanes approximately 270-ft upstream of the yield line.

At Malta, the second entry lane is developed by widening toward the outside with a 120-ft taper. Widening toward the outside aligns approaching drivers into the inside entry lane, which is designated as left turn only. Drivers must use the outside entry lane to continue straight toward a downstream interchange, the primary movement on the westbound entry. Compared to the shorter taper used at Hilliard, the longer taper at Malta appears to better support drivers selecting the correct lane for the through movement. During each of the 3 h evaluated at Malta, between 69 and 78 percent of drivers used the outside lane on the westbound entry. During each hour, between 7 and 14 drivers (or 2–6 percent of the westbound through volume) were observed to use the incorrect lane. These instances of incorrect lane use appeared to be influenced by volume imbalances and drivers aligning into the inside lane.

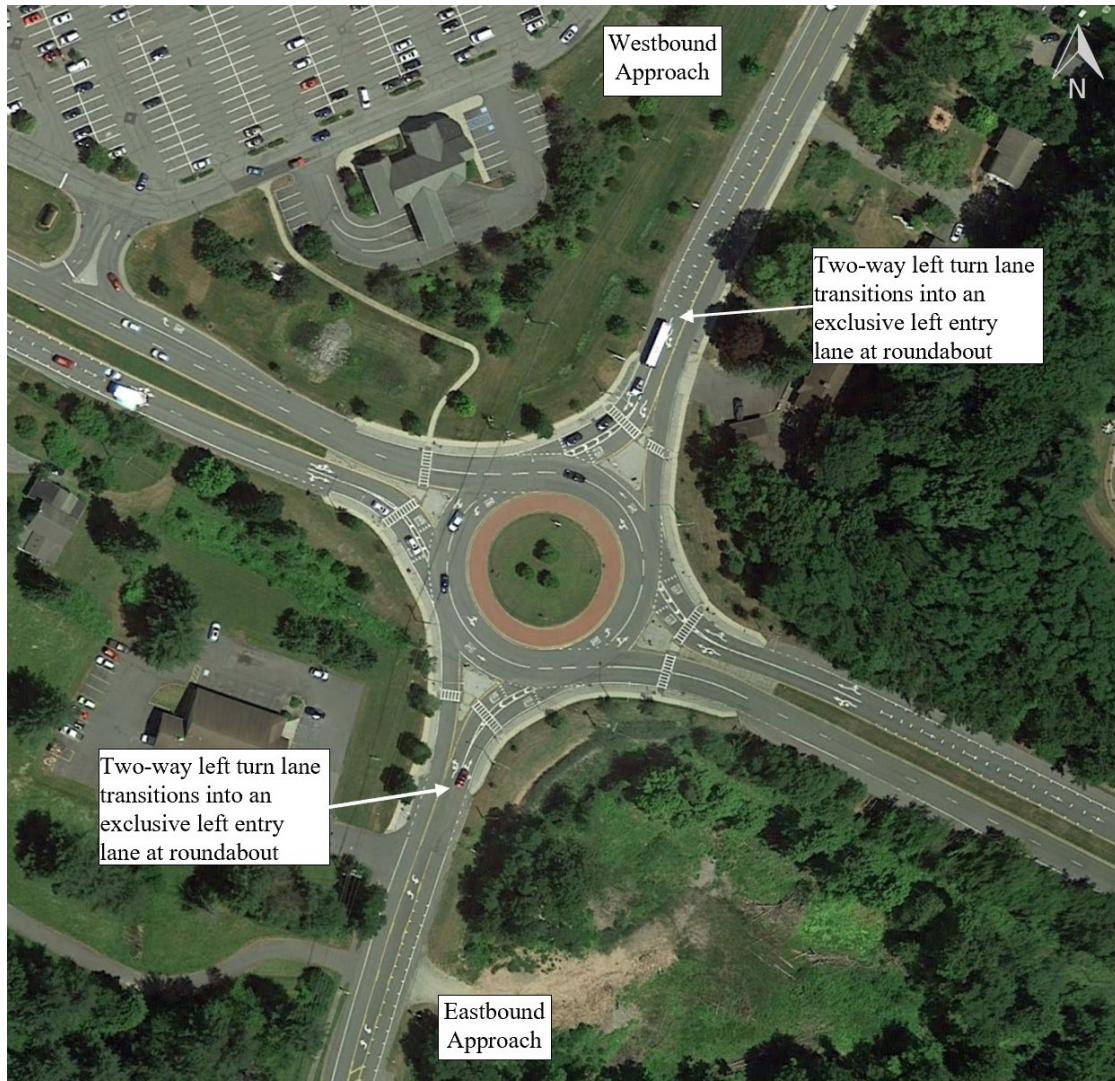
Figure 54. Photo. Slingerlands—Entry lane additions.

Figure 54 shows Slingerlands, where two legs have one travel lane in each direction with a two-way center turn lane. The two-way left-turn lanes transition into exclusive left-turn lanes at the roundabout entry.

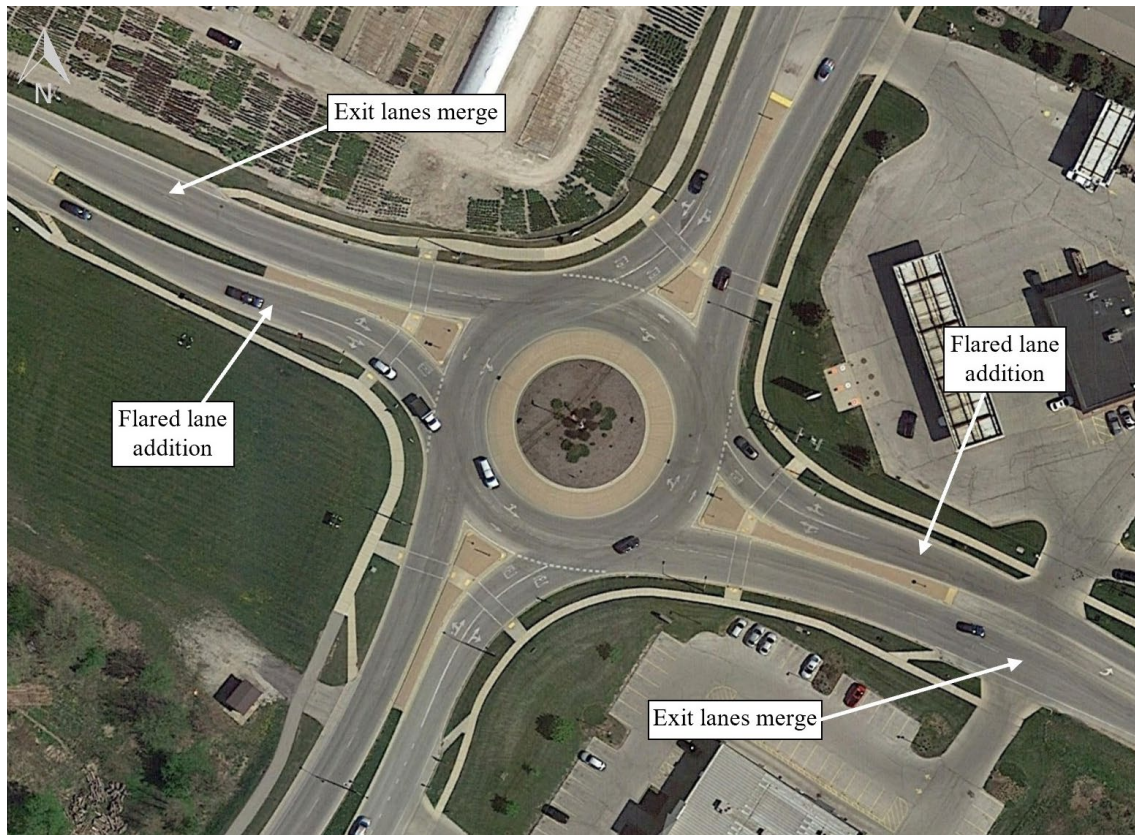
Figure 55. Photo. De Pere—Flared lane additions and lane merging.

Figure 55 shows De Pere, where the eastbound and westbound legs widen from a single approach lane to two entry lanes. This widening is accomplished through a uniform flare to the

left and right to reduce priority being given to one entry lane. Drivers on the westbound approach favored the outside lane (56–65 percent of vehicles during each hour). Meanwhile, drivers on the eastbound approach favored the inside lane (72–75 percent of vehicles during each hour). On the westbound entry, six drivers were observed to use the incorrect lane for either a left-turn or right-turn movement over the 4 h analyzed. Nine drivers used the incorrect lane for the left turn or right turn on the eastbound approach, with most using the incorrect outside lane for the left turns to bypass queuing in the inside lane. At this site, the turning movement patterns appeared to have a greater influence on the lane selection due to the geometry of the entry lane additions.

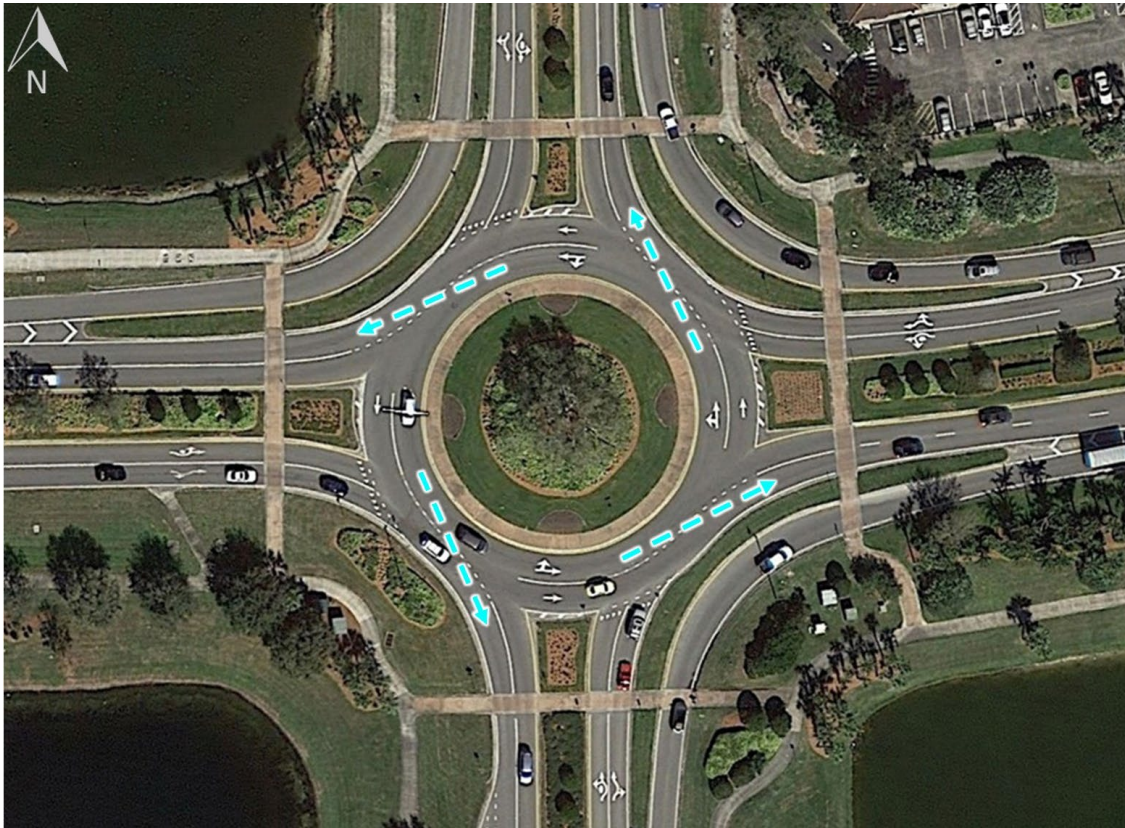
Figure 56. Photo. Melbourne—Lane changing through exit reverse curves (plan view).

Lane changing through the roundabout exits is a common violation identified in the conflict analysis across the study sites. The use of reverse curves through the exits with no tangent provided between the circulating lane line and exit curve appears to be increasing the potential for vehicles to change lanes through the exit.

Melbourne is one example site where this lane changing occurs, with each exit featuring relatively small exit radii and back-to-back reversing curves coming out of the circulatory roadway, as illustrated in figure 56. Over a 4-h period, 237 vehicles were observed to change lanes through the exits when making a left turn, and 59 vehicles were observed to cut across lanes when going straight. Traffic patterns influence the actual number of lane-change violations at each exit; however, the southbound exit was observed to have the highest number of vehicles changing from the inside to the outside lane through the exit.

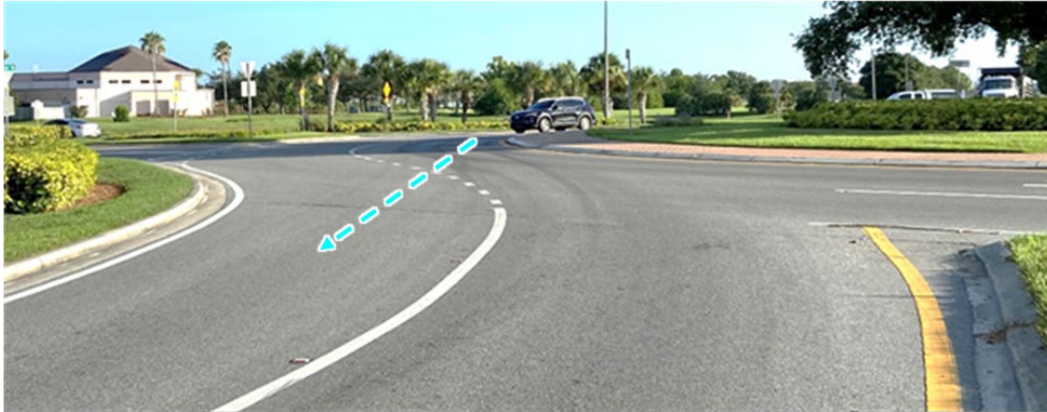
Figure 57. Photo. Melbourne—Lane changing through exit reverse curves (ground view).

Figure 57 provides a ground-level view of a vehicle approaching the exit and the path that the vehicle traveled as it crossed lanes through the exit.

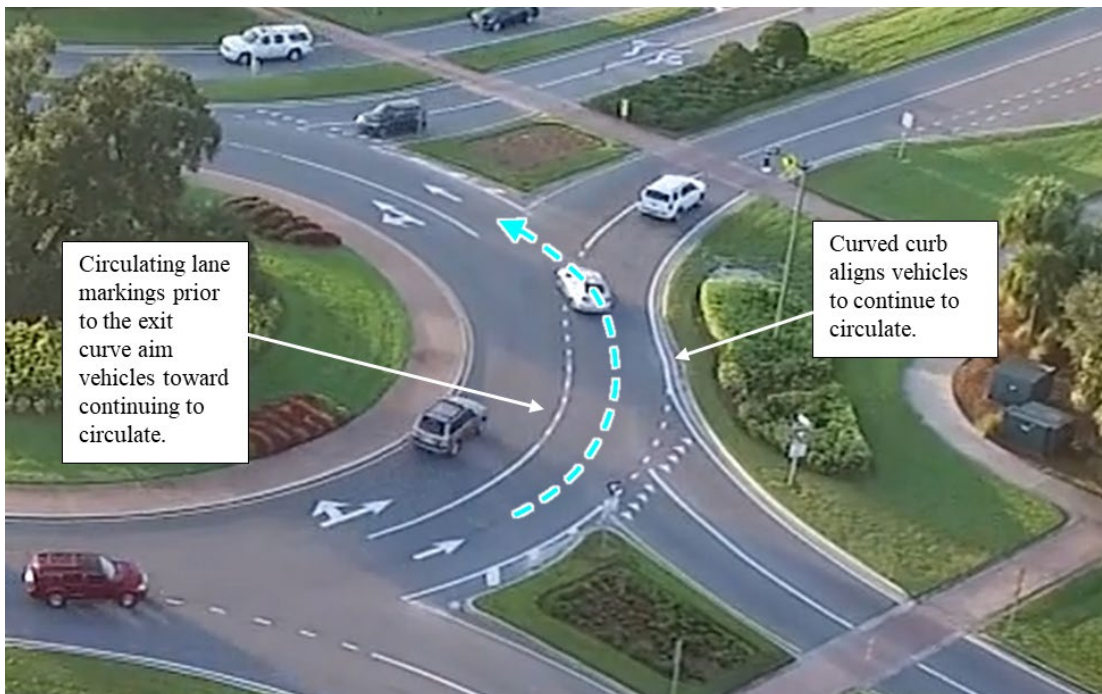
Figure 58. Photo. Melbourne—Exit reverse curves influencing left turns from the incorrect lane.

At Melbourne, drivers become accustomed to the curvature around the central island due to the large 200-ft ICD and often made smooth and natural—but incorrect—left-turn movements using the outside lane. An example is illustrated in figure 58 for southbound left-turning vehicles, where 685 vehicles over a 4-h period were observed to make a left turn from the incorrect lane. Network influences, discussed in chapter 6, contribute to incorrect lane use; however, the smooth left-turn path from the outside lane created by the reverse exit curvature also appeared to influence driver perception of allowable movements at Melbourne.

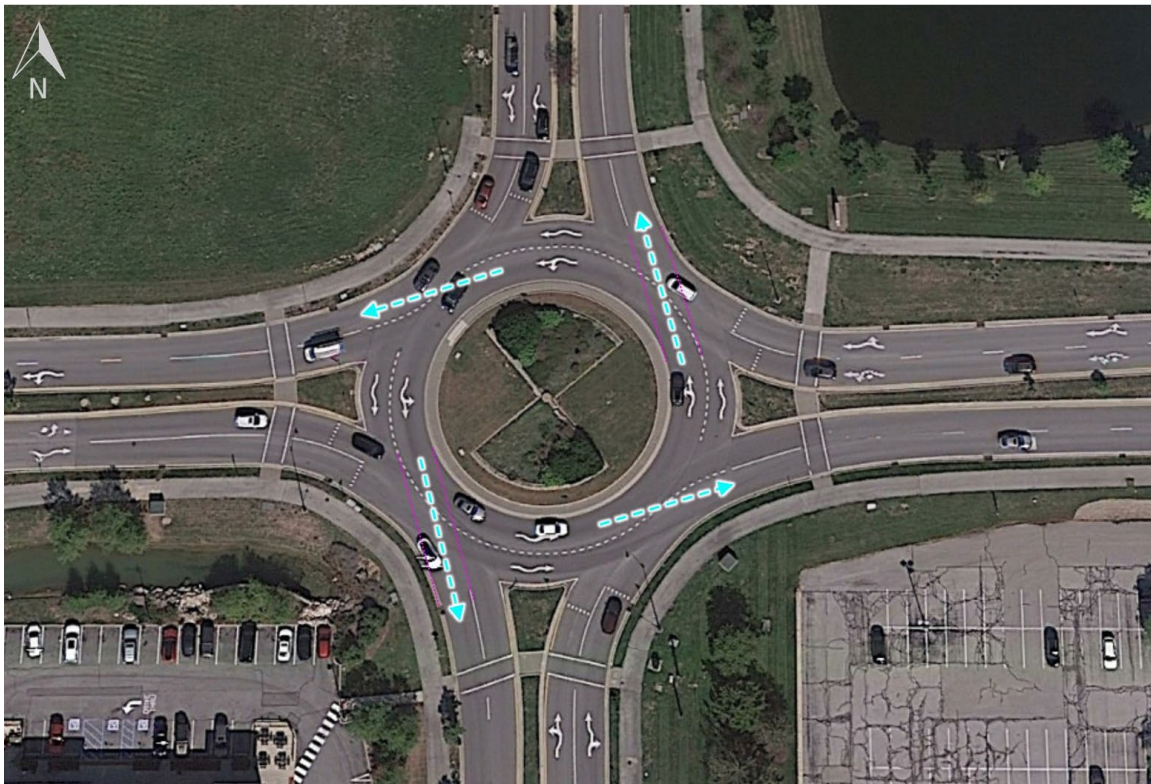
Figure 59. Photo. Carmel 116th—Lane changing through exit reverse curves.

At Carmel 116th, a larger exit radius is used compared to Melbourne. However, the short reverse curves along the lane line leading into the eastbound and westbound exits appear to be influencing higher observed lane-change violations through the exit. On the northbound and southbound exits, concentric lane markings do not provide guidance to drivers to lead them to the correct exit lane. Also, the physical alignment of the exit in relation to the circulatory roadway aligns drivers using the inside circulating lane into the outside exit lane on the northbound and southbound exits, as shown with the solid lines in figure 59. Lane changes through the exits accounted for approximately 55 percent of the total violations recorded at Carmel 116th, with 424 violations recorded over a 4-h period at all exits. The highest instances were on the southbound and eastbound exits, which are also influenced by network considerations that are discussed in more detail in chapter 6.

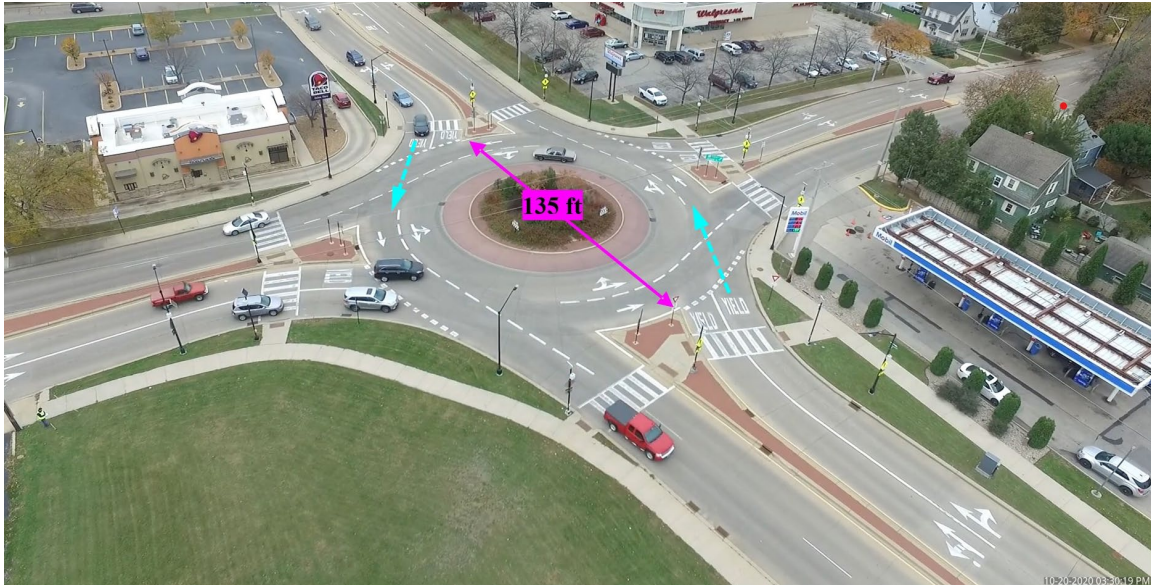
Figure 60. Photo. Oshkosh—Photo from drone facing southeast.

Figure 60 shows Oshkosh, which has the smallest ICD of any study site of 135 ft; all the other study sites have ICDs ranging from 150–200 ft. While Oshkosh was a control site that experienced among the lowest total annual crashes (13 per year), it generated unique patterns of crashes compared to the other sites. A higher proportion (15 percent) of the crashes at Oshkosh were related to sideswiping and lane changing within the circulatory roadway. An additional 10 percent of the crashes at Oshkosh were related to rear-end crashes at the north, west, and east exits.

At Oshkosh, violations related to lane straddling or occupying both lanes accounted for 78 percent of all events. Over a 4-h period, 743 events were recorded related to drivers straddling the lane line in the circulatory roadway or cutting across lanes when going straight. This represents 9.2 percent of the total entering volume. Balancing competing objectives of vehicle alignment and speed control becomes more challenging with very small ICDs. At Oshkosh, the outside entry lane is aligned toward the circulating lane line. This overall design composition is a likely contributing factor to the observed lane straddling. However, despite the high violations, there were no incidents or near-crashes from lane straddling during the analysis period.

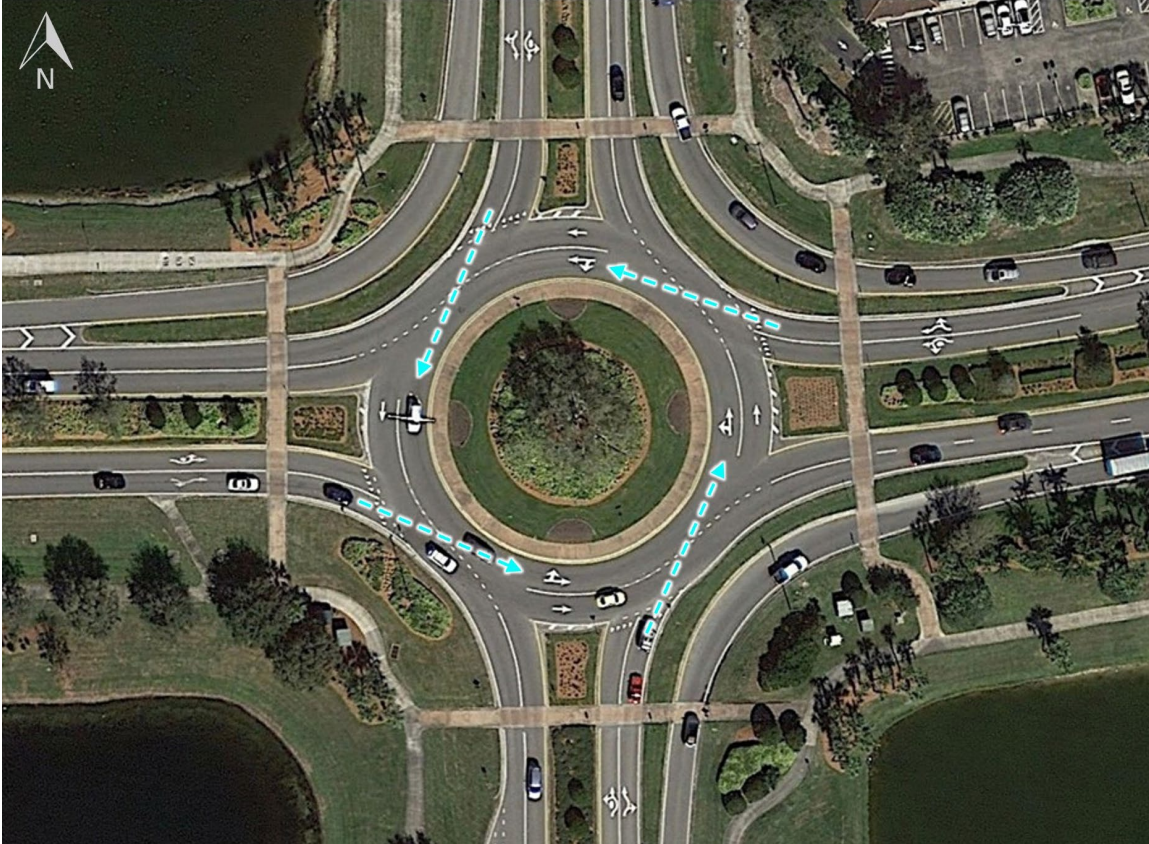
Figure 61. Photo. Melbourne—Entry lane alignment.

Among the study sites, Melbourne had the most severe misalignment. This misalignment resulted from the combination of several geometric elements: a large ICD; a small entry radius; a lack of large radius or tangent near the yield line; and the distance between the entry and downstream exit, which created a long distance between the yield line and the start of the circulating lane line. Figure 61 illustrates the misalignment of the outside entry lane on each approach with the inside circulating lane.

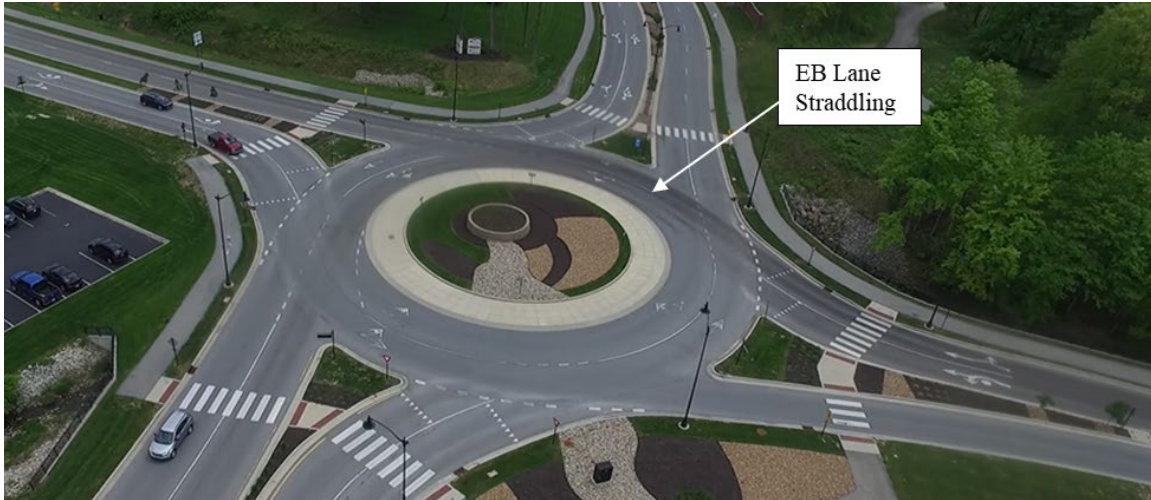
Figure 62. Photo. Carmel 106th—Eastbound lane straddling within circulatory roadway due to entry lane alignment.

On a similar note, at Carmel 106th the eastbound entering lanes are not well-aligned with the corresponding circulating lanes. As a result, vehicles were observed to straddle the circulating lane line when making an eastbound through movement. This trend is consistent with the tire marks visible in figure 62. The large shift to the left for the westbound entry creates a skewed angle of intersection to the adjacent northbound exit. This angle was observed to affect vehicle alignment, particularly when there were not two vehicles side-by-side at the yield line. Vehicles traveling westbound across the northern portion of the circulatory roadway were frequently observed to cross the lane line and encroach into the inside circulating lane.

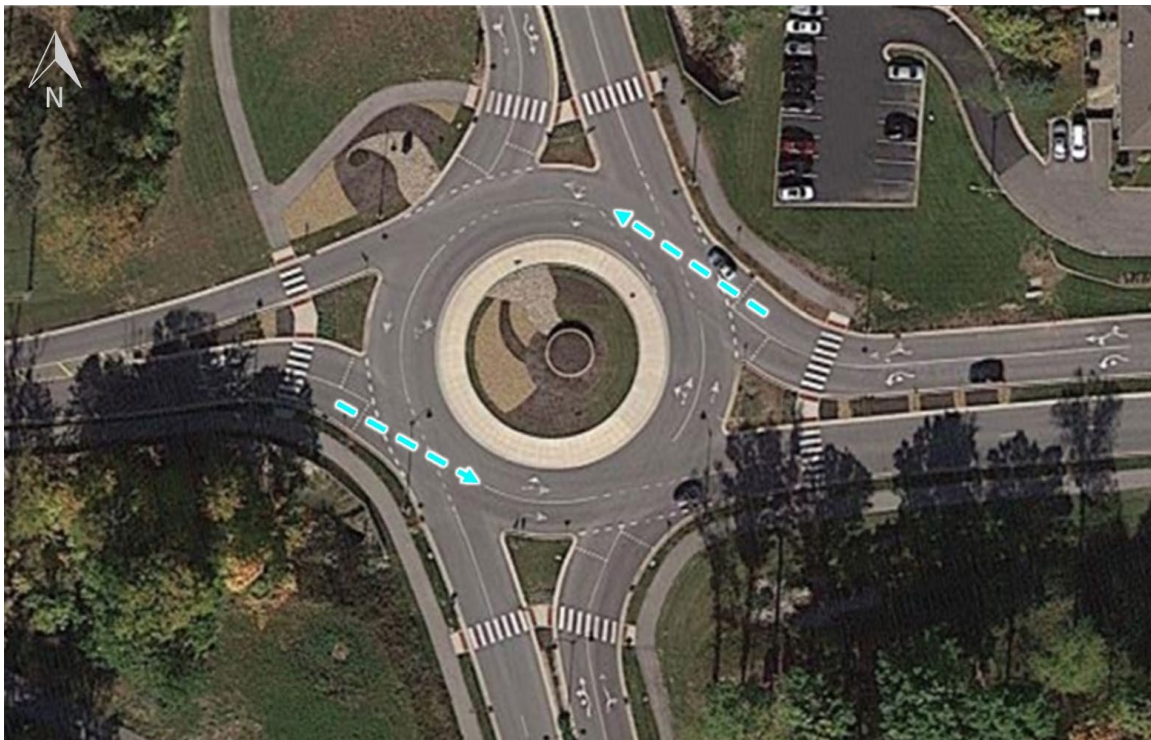
Figure 63. Photo. Carmel 106th—Entry lane alignment.

Figure 63 shows how the entry lane alignment for the eastbound and westbound entries at Carmel 106th guides drivers entering from the outside entry lane into a position that straddles the circulating lane line.

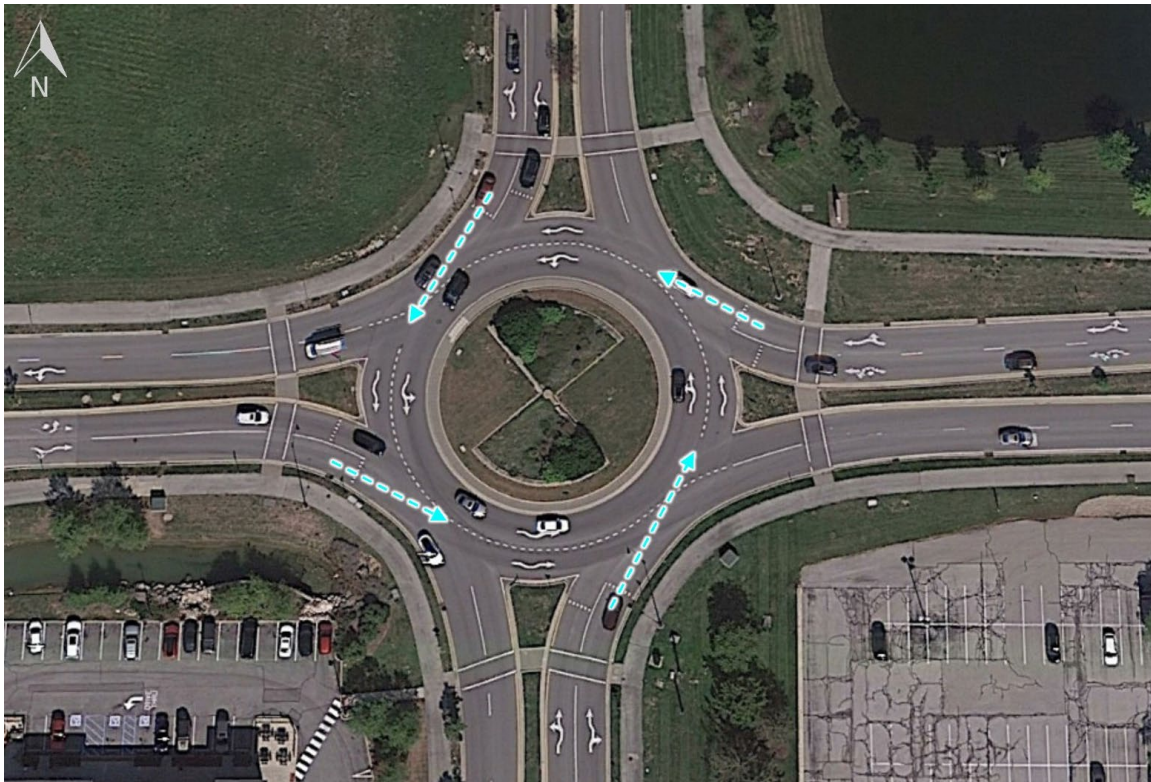
Figure 64. Photo. Carmel 116th—Entry lane alignment.

Like the Carmel 106th eastbound entry, all the approaches at Carmel 116th have entry lane misalignment. The northbound and southbound entries at Carmel 116th have a longer distance between the yield line and the start of the circulating lane line, as illustrated in figure 64, which may influence the potential for poor path alignment. Vehicles were observed to straddle both circulating lanes, particularly in the northbound and southbound directions. The use of a wider inside circulating lane (16 ft) relative to the outside lane may also have contributed to the potential for lane straddling and poor path alignment. Conversely, the eastbound and westbound entries had a shorter distance between the yield line and the start of the circulating lane lines due to the partially concentric striping pattern in the circulatory roadway. This shorter distance and striping pattern appeared to help eastbound and westbound drivers maintain the correct lanes as they entered.

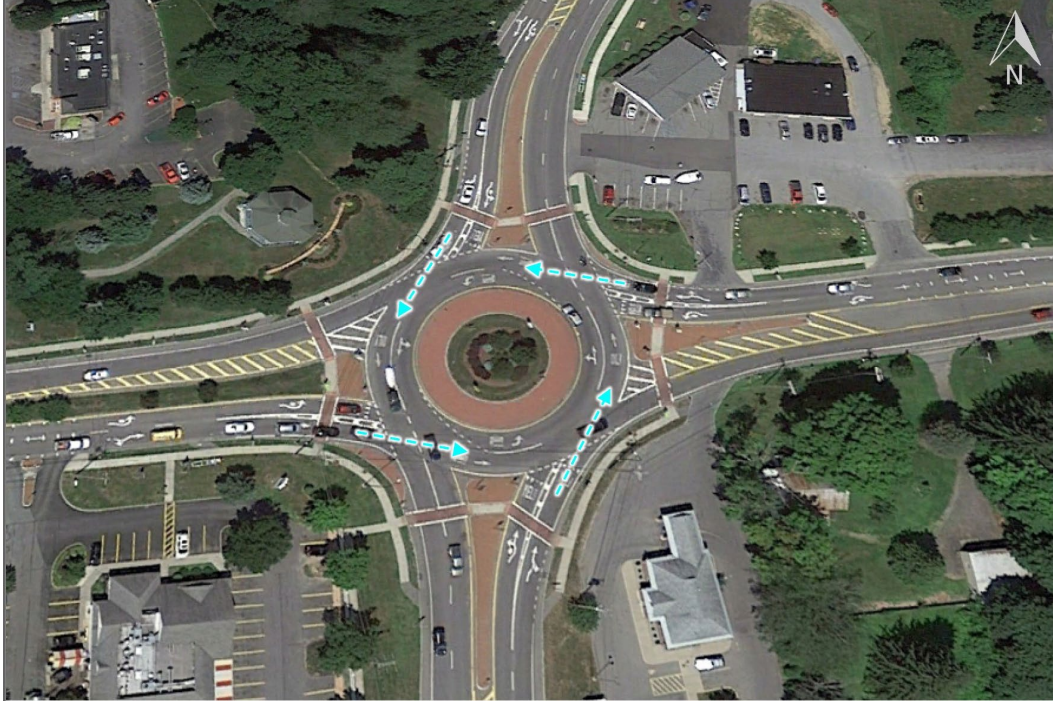
Figure 65. Photo. Malta—Entry lane alignment.

At Malta, the southbound, eastbound, and westbound entries each have varying degrees of misalignment with the corresponding circulating lanes. As illustrated in figure 65, the southbound entry has the strongest misalignment, with vehicles in the outside entry lane generally aligned with the circulating lane line. The team identified 63 southbound through vehicles to be straddling both lanes over the 3-h period analyzed. The eastbound and westbound approaches generally had reasonable alignment; however, the shape of the spiral markings within the circulatory roadway resulted in a larger conflict area, which was observed to affect how well drivers maintained their alignment. Over a 3-h period, 144 eastbound and 157 westbound through vehicles were observed to straddle lanes within the circulatory roadway.

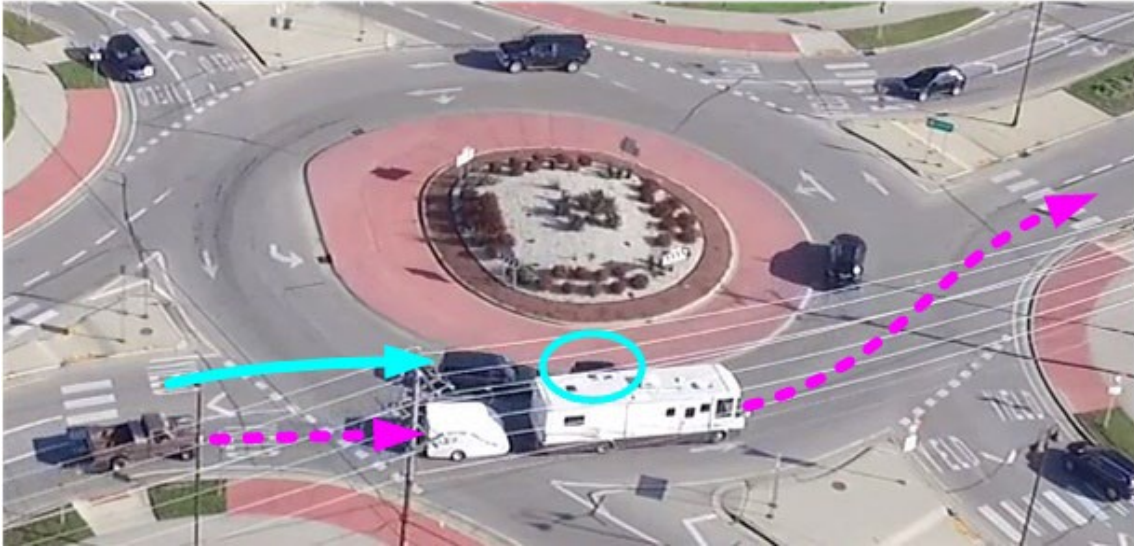
Figure 66. Photo. Wales—Observed lane-straddling conflict.

Each of the Wisconsin sites at Wales, Oshkosh, and De Pere has similar entry lane alignment. The entry geometry at these sites varies slightly, depending on accommodations for trucks, with Wales incorporating gore striping between entry lanes. However, at each site, drivers in the outside entry lane are generally aligned toward the lane line within the circulatory roadway instead of toward the center of the outside circulating lane. As a result, the team observed higher instances of lane straddling. Figure 66 illustrates an example of a near-crash associated with lane straddling for southbound entering vehicles at Wales.

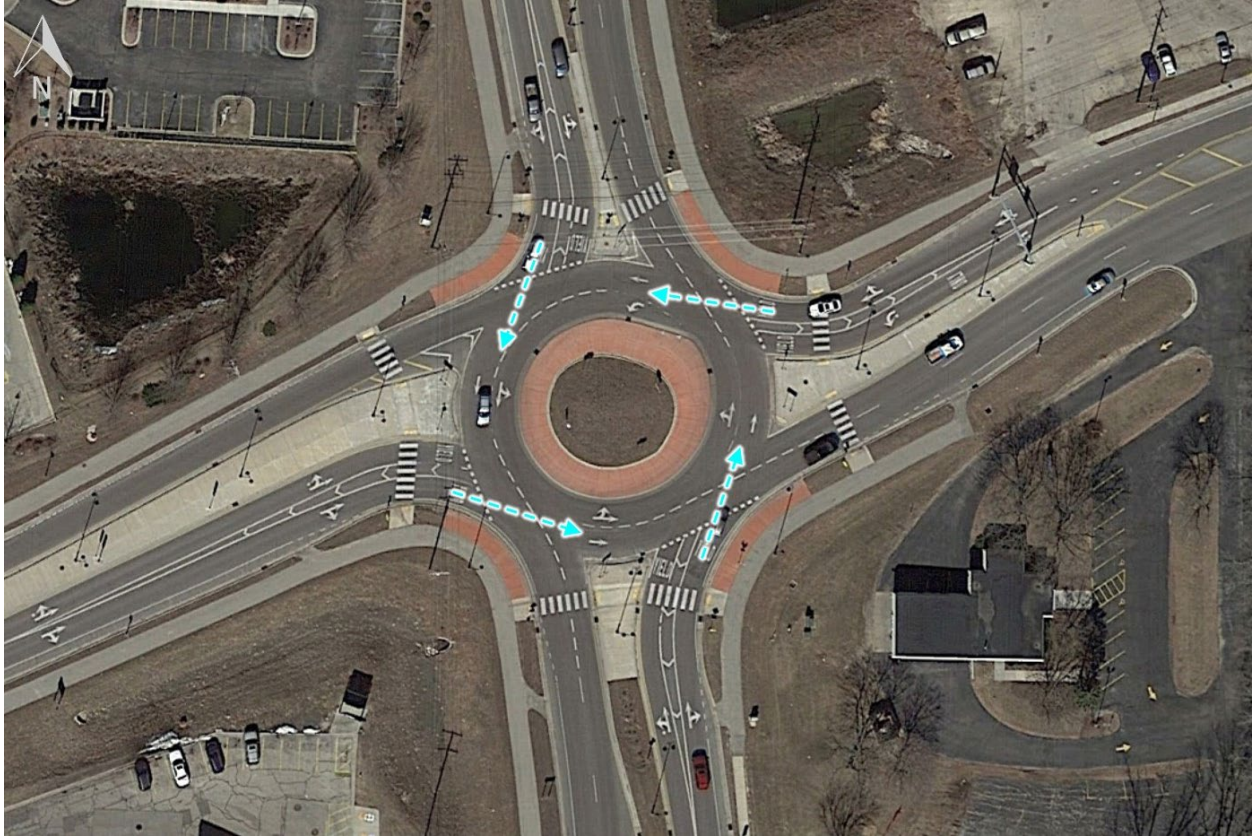
Figure 67. Photo. Wales—Entry lane alignment.

As illustrated in figure 67, the alignment of each entry at Wales generally guides drivers from the outside entry lane toward the correct outside receiving lane. However, at the entrance line, the vehicle path is aligned more toward the circulating lane line, resulting in increased lane straddling. The lane straddling also results in degradation of the lane markings within the circulatory roadway, as illustrated in figure 66, which the team observed from drone video footage. The degradation of the lane markings further complicates the ability of drivers to identify and maintain lanes. Sideswipes and lane changes account for 18 percent of the total intersection crashes (19 crashes over 3 yr), with most of these crashes associated with the northbound, southbound, and eastbound movements. Occupying or straddling both lanes was the leading cause for violations, conflicts, and near-crashes based on conflict analysis. Over a 4-h period, the team noted 309 lane-straddling violations, 10 lane-straddling conflicts or near-crashes, and 62 lane-change violations through the circulatory roadway. Entry alignments may have factored into these events.

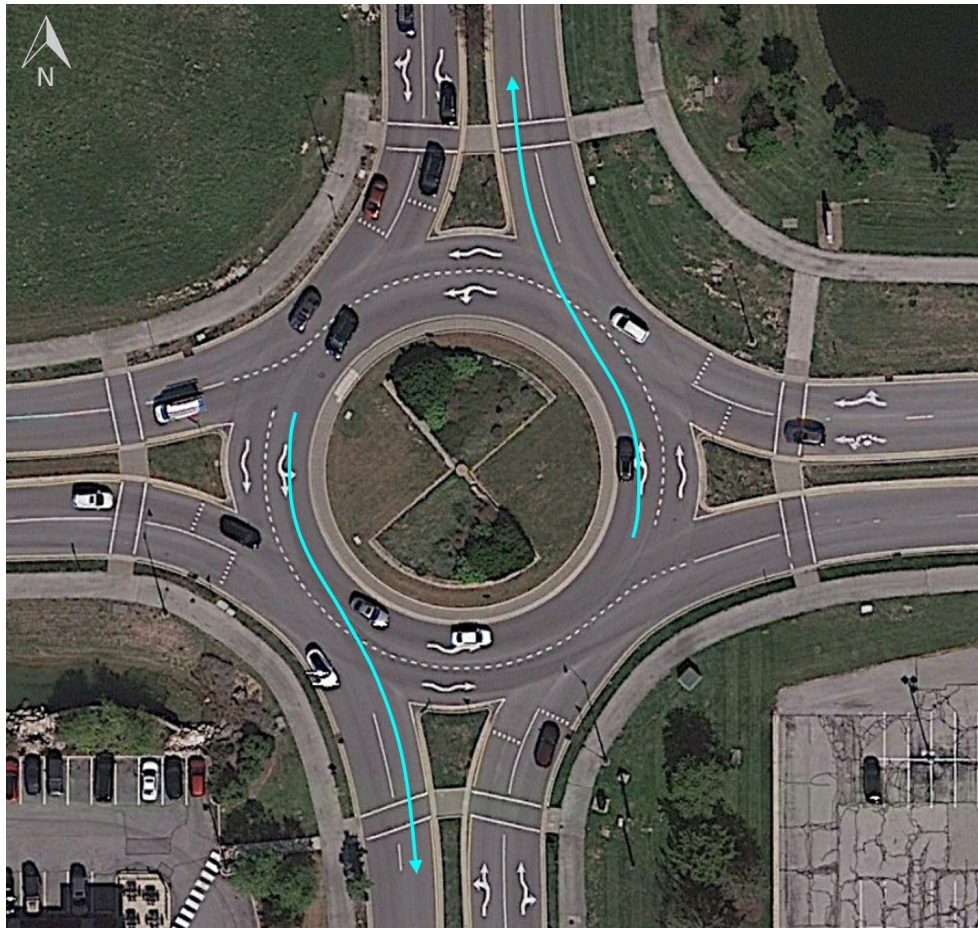
Figure 68. Photo. Carmel 116th—Concentric lane-line markings.

Striping in the northeast and southwest corners of Carmel 116th may contribute to left turns from incorrect lanes. Figure 68 shows the Carmel 116th roundabout and the variation in striping between the northeast and southwest corners and the southeast and northwest corners.

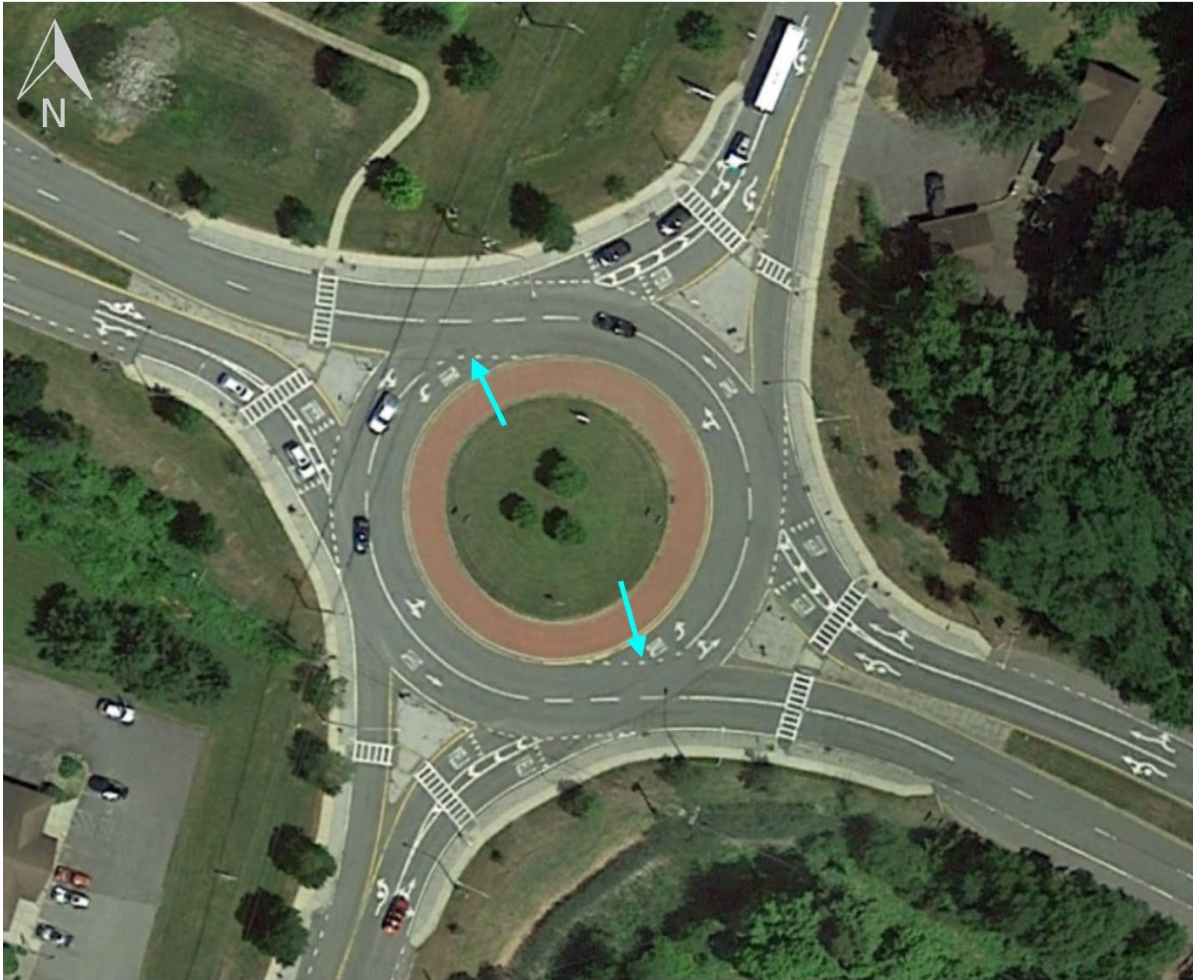
Figure 69. Photo. Slingerlands—Spiral pavement markings.

At Slingerlands, the spiral striping in the northeast and southwest quadrants is developed with only pavement markings and is very abrupt, as shown in figure 69. As a result, many left-turning drivers followed the circular central island curb instead of following the spiral markings, which led them into the inside circulating lane. Once in the inside circulating lane, drivers were required to make a lane change to exit eastbound or westbound. The curvature of the circulatory roadway before the exit may give some drivers the false impression that they may continue to circulate (and make improper left turns) from the outside lane.
