Reasons for Drivers Failing To Yield at Multi-Lane Roundabout Exits: Transportation Pooled Fund Study Final Report

PUBLICATION NO. FHWA-HRT-23-023

MARCH 2023

U.S. Department of Transportation
Federal Highway Administration

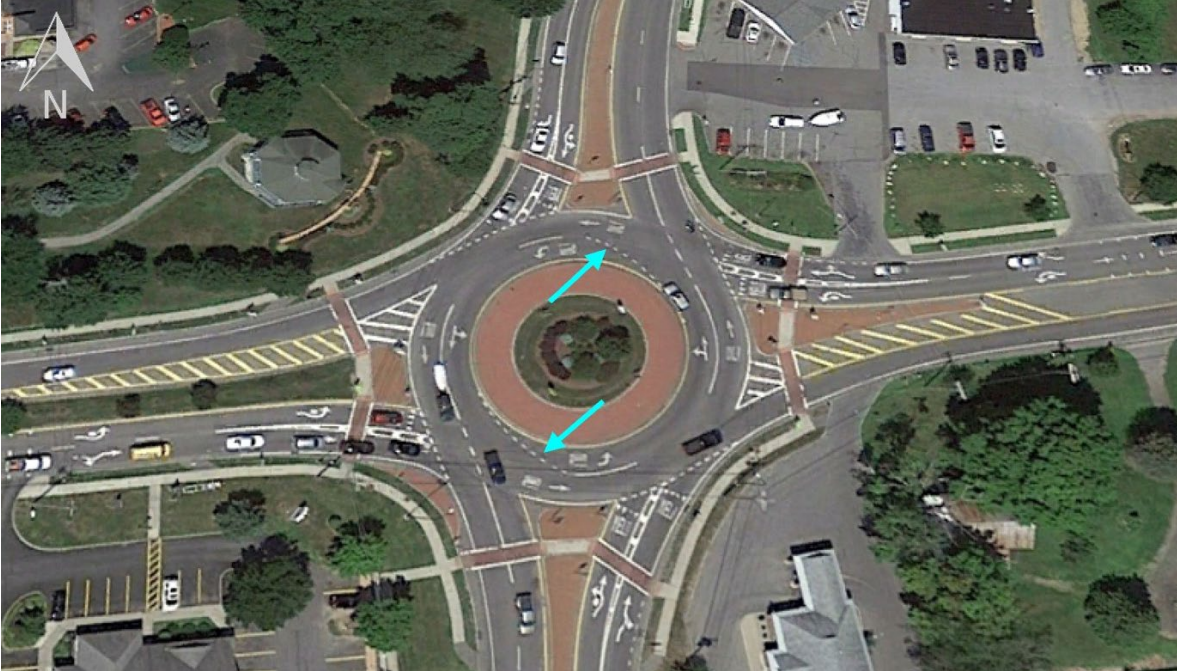
Figure 70. Photo. Malta—Spiral pavement markings.

Similar to Slingerlands, the Malta site has abrupt painted spirals, as shown in figure 70. Many northbound left-turning drivers were observed to continue to follow the circular central island curb instead of following the spiral markings to the intended outside circulating lane. Furthermore, high volumes of traffic make the northbound-to-westbound left-turn movement toward the I-87 interchange throughout the day. The team observed drivers making this movement from the incorrect outside lane during each peak hour.

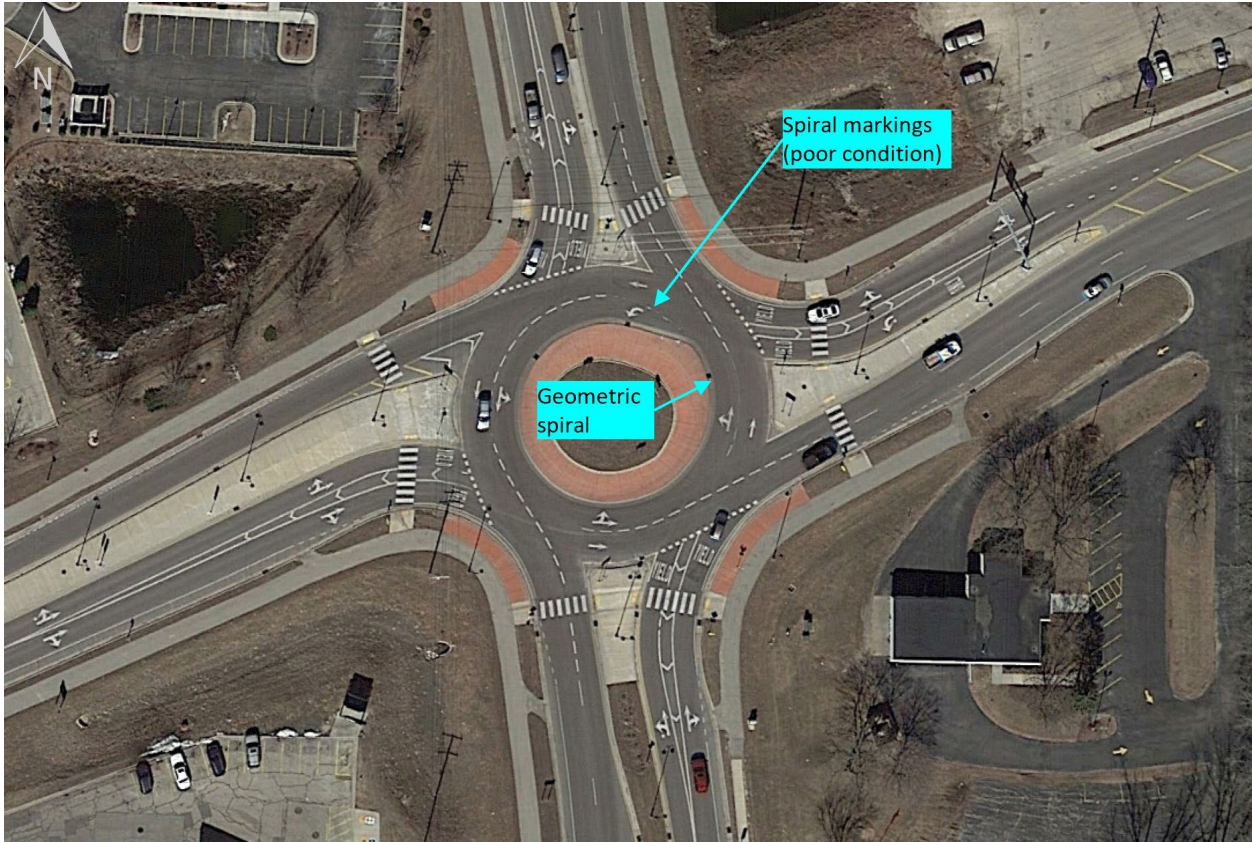
Figure 71. Photo. Wales—Geometric spiral and spiral markings.

Figure 71 shows Wales, where the design explicitly incorporates a geometric spiral into the shape of the central island, giving the central island a noncircular shape. The spiral begins along the east side of the central island to start drivers along the spiral path while they are adjacent to the central island curb. Dotted lane markings continue the spiraled path to guide drivers from the inside lane on the east side of the circulatory roadway to the outside lane on the north side of the circulatory roadway. This design was observed to result in fewer left-turning vehicles failing to follow the intended spiral path. However, over a 4-h period, the team observed 56 northbound left-turning vehicles staying in the inside lane along the north side of the circulatory roadway instead of spiraling to the outside lane. This trend resulted in late lane changes near the westbound exit.

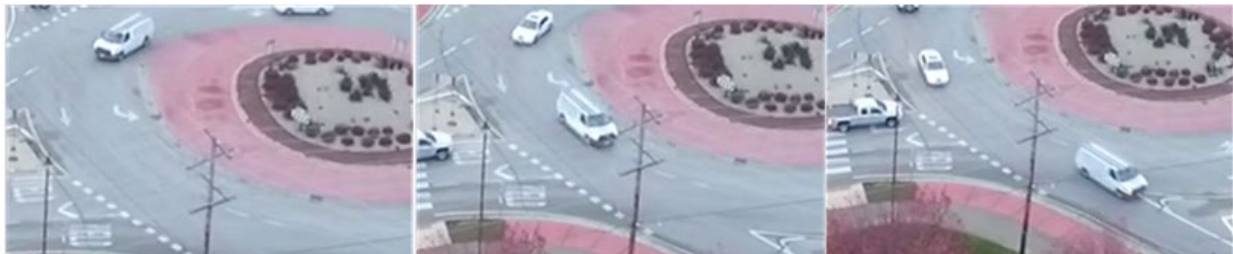
Figure 72. Photo. Wales—Vehicles navigating the northbound left-turn spiral.

As illustrated in figure 72, the condition of the circulating lane markings was poor, which is likely contributing to these observations. Figure 72 shows a sequence of photographs where a northbound left-turning white van follows the geometric portion of the spiral toward the correct outside circulating lane, cuts back toward the inside lane, and eventually changes lanes to exit westbound. It is unclear whether more visible markings would have altered this observed behavior.

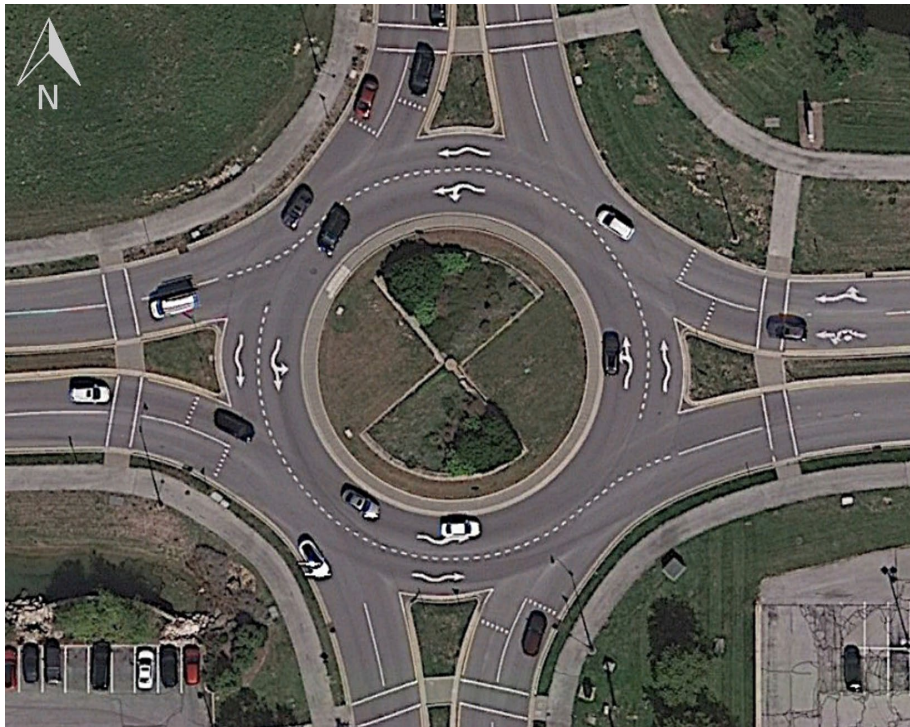
Figure 84. Photo. Carmel 116th—Fishhook arrows within the circulatory roadway.

As described in *NCHRP Report 672* and MUTCD, standard arrows are typically used in the circulatory roadway for legibility.^(7,8) However, as illustrated in figure 84, fishhook arrows were used within the circulatory roadway at Carmel 116th. While the use of fishhook arrows may affect legibility, the team could not isolate their impact on actual crash patterns from other possible factors.

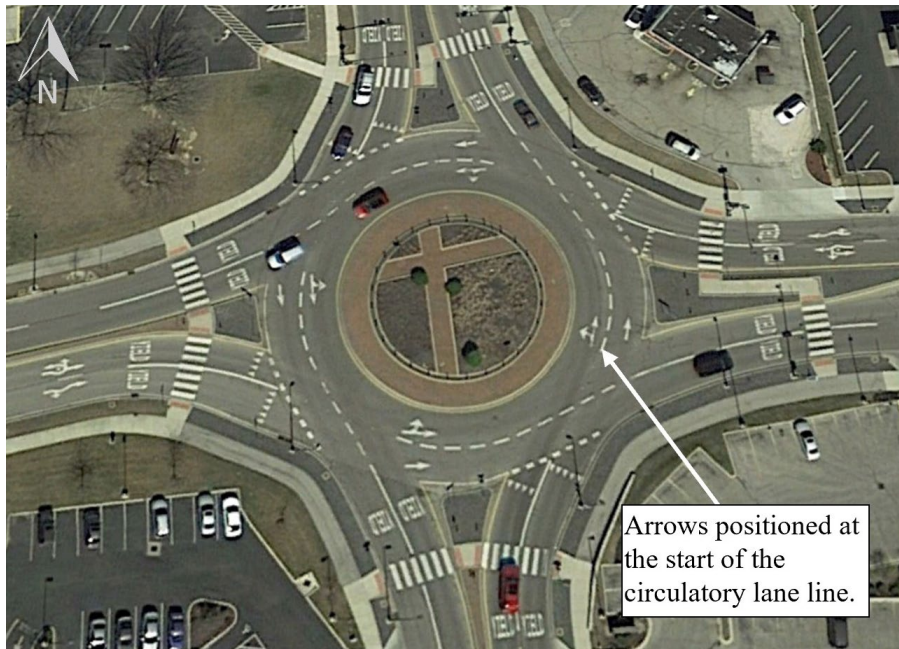
Figure 87. Photo. Hilliard—Observed circulatory lane-use pavement arrows.

As illustrated in figure 87, Hilliard also used standard arrows; however, the arrow position was initially located at the start of the circulating lane line.

As part of modifications implemented after field evaluations were conducted for this TPF study, circulatory lane-use pavement marking arrow positions were shifted closer to the entry side of the splitter island at Hilliard. The purpose of this adjustment was to make the arrows more visible to entering drivers to reinforce the presence of two conflicting circulating lanes. A second through arrow was also added immediately prior to the exit in the outside lane to reinforce the requirement to exit. Figure 88 illustrates the recently implemented modified arrow position at Hilliard.

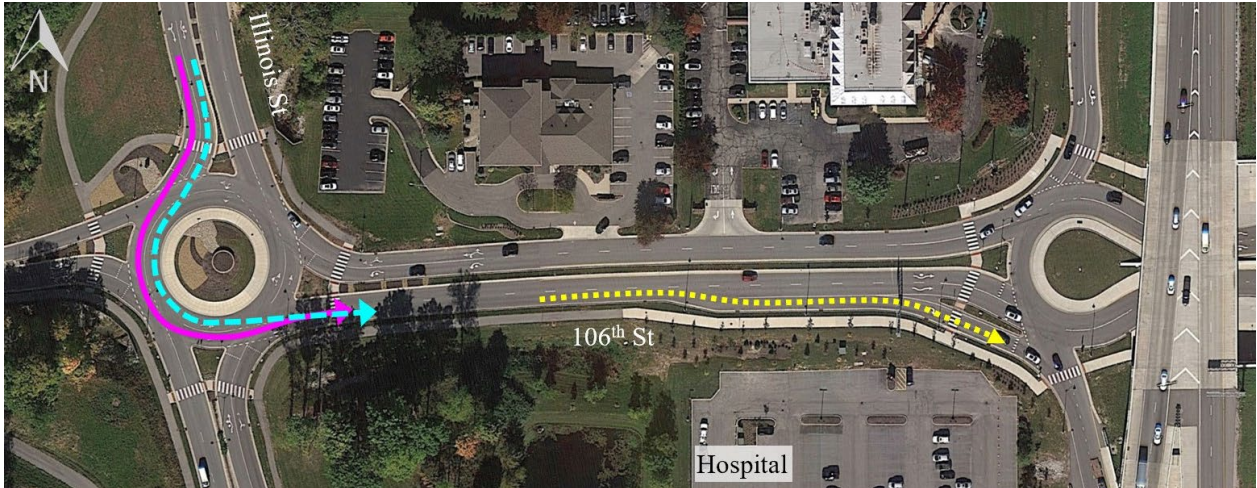
Figure 92. Photo. Carmel 106th—Influences of adjacent interchange ramp.

Note: SB vehicles destined for the downstream freeway entrance ramp (line with short dashes) were frequently observed to either make a left turn using the incorrect lane (solid line) or change lanes through the roundabout exit (line with long dashes).

- For Carmel 106th, 11 percent of southbound left-turning vehicles during the afternoon and evening peak hours entered the roundabout in the incorrect outside lane. This pattern appears to be influenced by the driver's desire to access the freeway entrance ramp, which begins 360 ft from the roundabout exit. Crashes associated with southbound left turns from incorrect lanes comprised 14 percent (6 crashes over 3 yr) of the intersection total. Drivers using the correct inside lane on the southbound entry were also frequently observed changing lanes through the eastbound exit to position for the freeway entrance ramp. This use of the incorrect lane may also be influenced by lane imbalances on the southbound approach, where 61–67 percent of the entering vehicles use the inside lane.

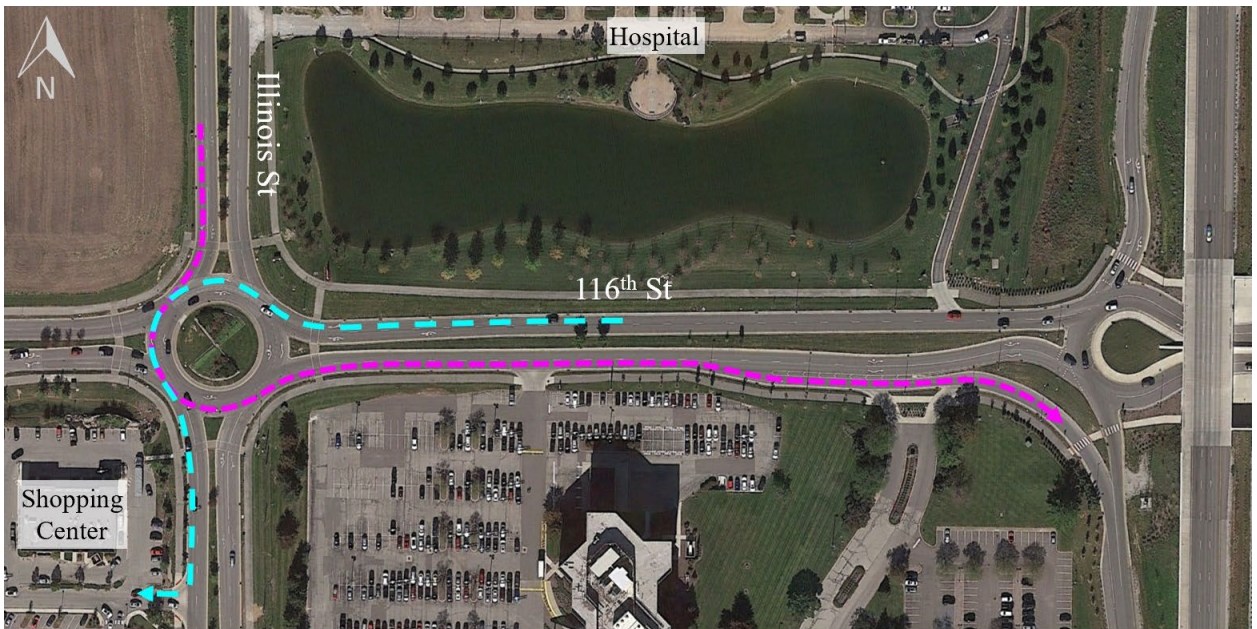
Figure 93. Photo. Carmel 116th—Examples of possible system influences

Note: SB vehicles destined for the downstream freeway entrance ramp were frequently observed to make a left turn using the incorrect lane (line with short dashes) or change lanes through the eastbound exit. Vehicles destined for the adjacent shopping center were frequently observed to make a WB left turn using the incorrect lane (line with long dashes) or change lanes through the southbound exit.

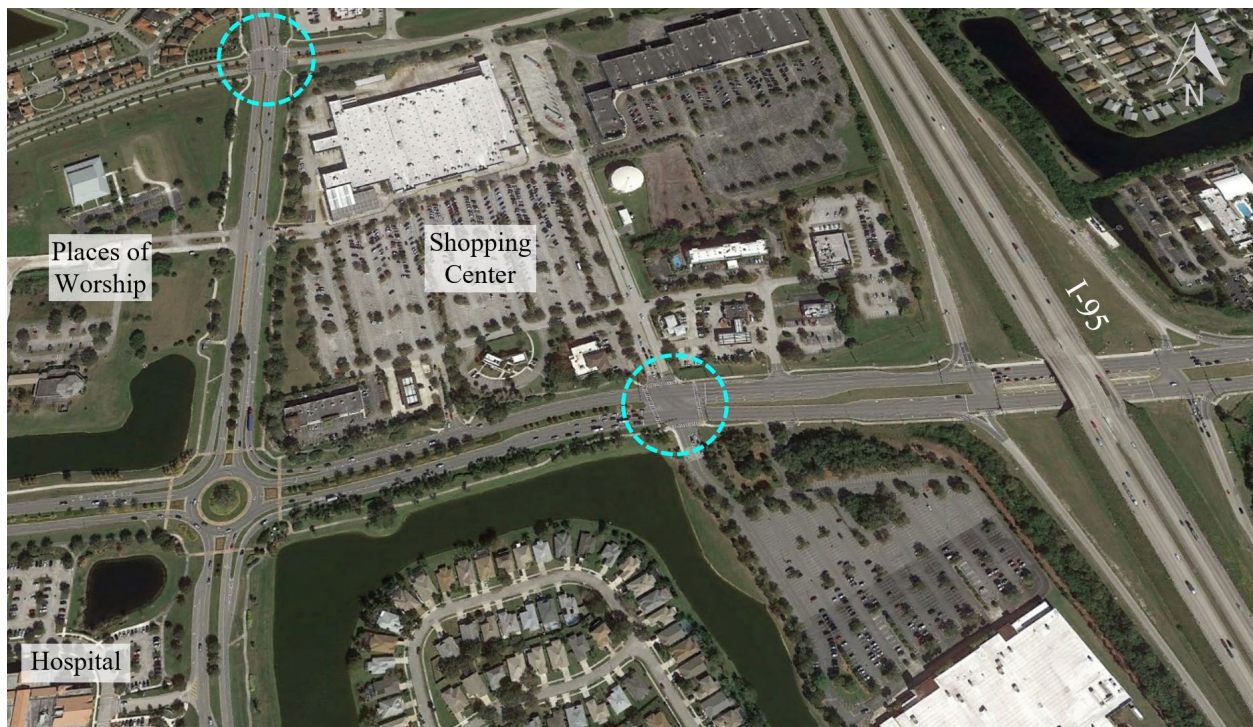
Figure 94. Photo. Melbourne—Roadway network and adjacent signalized intersections.

The Melbourne roundabout and surrounding roadway network are illustrated in figure 94. At the Melbourne site, 685 vehicles (representing 33.5–39.5 percent of the southbound left-turn volume during each hour analyzed) were observed over a 4-h period to use the incorrect outside lane to make the southbound left turn when traveling toward the interchange. These left turns using incorrect lanes likely resulted in 16 crashes over 3 yr near the southbound exit. Due to a heavy southbound left-turn pattern traveling toward the freeway during the noon, afternoon, and evening peak hours, the inside lane on the southbound entry operates as a de facto left turn only lane. Fewer than six through vehicles per hour were observed to use the inside lane for the southbound through movement. This lane use pattern likely helped to limit higher instances of conflicts and crashes near the southbound exit than might be expected with a higher through volume.

The team observed several compounding network influences at Melbourne that may be contributing to the high instances of southbound left turns from incorrect lanes. The predominant southbound left-turn volume creates lane imbalances favoring the inside lane at the southbound entry, which may result in some drivers selecting the incorrect outside lane for the southbound left turn to avoid queues and reduce delay. An upstream signal also creates platoons of arriving vehicles that may make it more difficult for drivers to identify the correct lane for the left-turn maneuver and then change lanes if needed. Drivers destined for I-95 southbound may also be

For the Melbourne site, the adjacent signals illustrated in figure 94 to the east and north had the most significant observed impact on operations among the study sites. As illustrated in figure 103, the signal to the east would consolidate vehicles arriving from the I-95 interchange and then release heavy platoons toward the roundabout. The short intersection spacing and platoon density may be affecting drivers in their ability (or willingness) to identify the correct lane and make the corresponding lane change before reaching the roundabout. The arriving westbound platoons also temporarily cause delay and queuing on the adjacent southbound entry. Given the volume imbalances on the southbound entry favoring left turns, queuing tended to be higher in the inside lane, which could be causing drivers to use the incorrect outside lane for southbound left turns to bypass the standing entry queues. Platooned arrivals on the southbound approach from the upstream signal may also be impacting drivers' abilities to change lanes prior to entry.

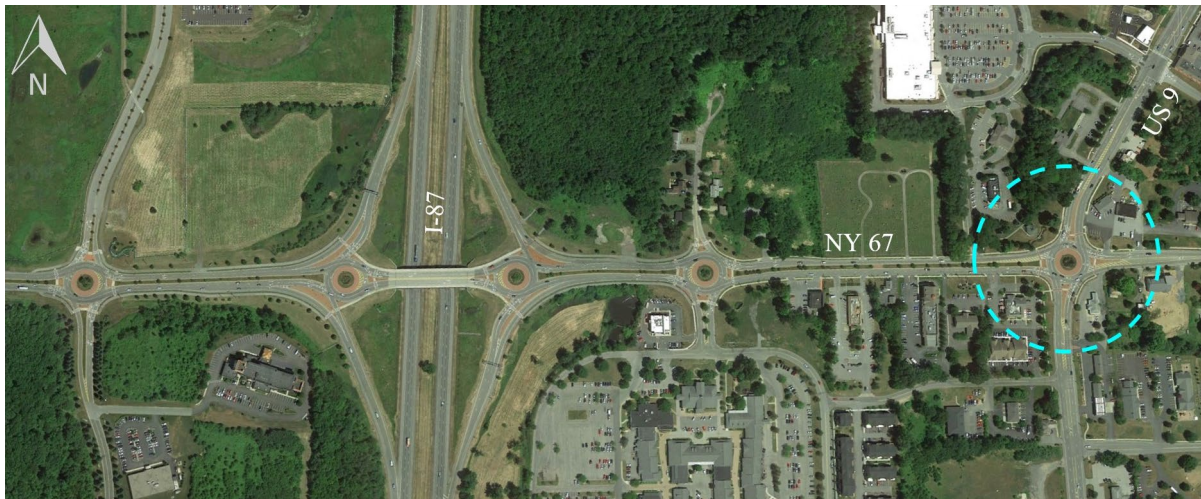
Figure 95. Photo. Malta—Roadway network and adjacent land uses.

Figure 95 illustrates the roadway network and land uses within the vicinity of the Malta site, which is located 0.35 mi from an interchange with I-87. The Malta site is also a major network connection with US 9, which parallels I-87. This network configuration results in regional travel patterns to and from I-87 that influence volume levels for various intersection turning movements throughout the day and may influence potential violations and conflicts. Entry lane imbalances due to increases in turning volumes traveling to and from the interchange may contribute to increased instances of left, right, and through movements from incorrect lanes during individual hours on each leg.

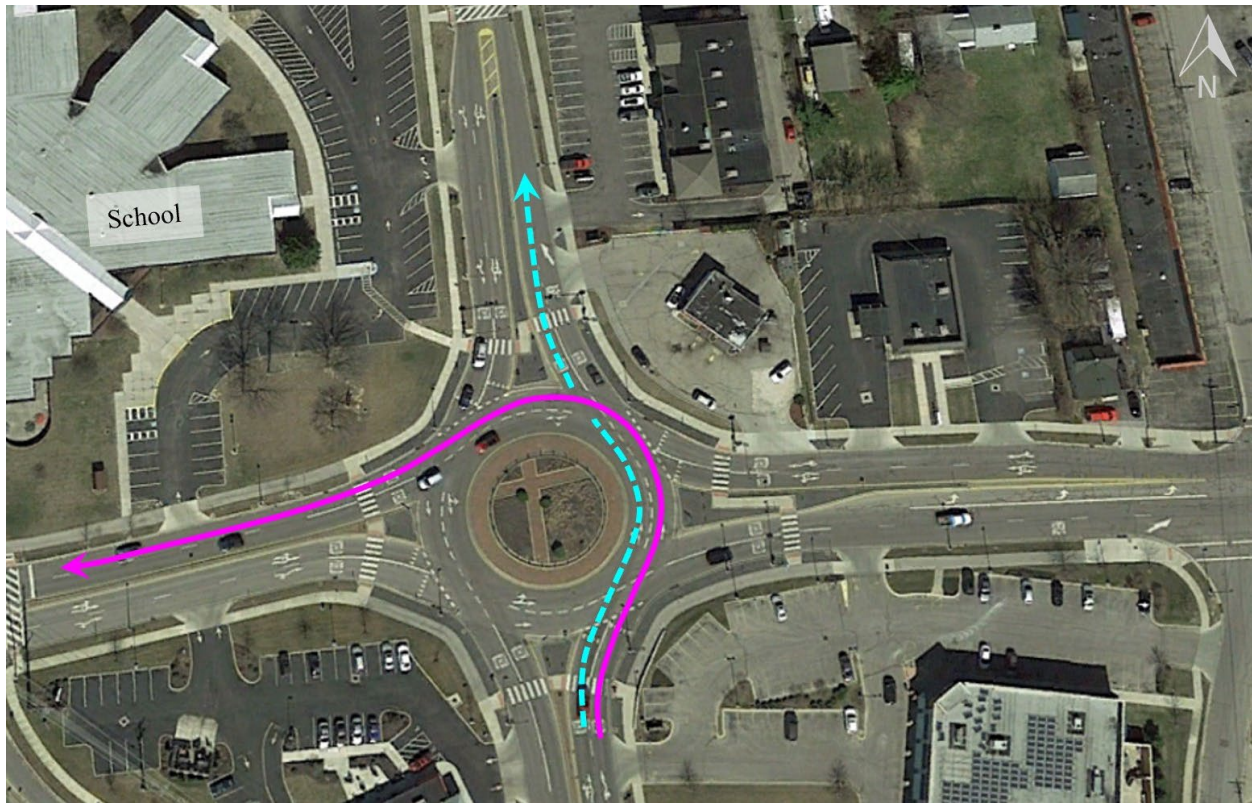
Figure 96. Photo. Hilliard—Left turn from the incorrect lane for trips to school.

At the Hilliard site, an elementary school is adjacent to the northwest quadrant of the roundabout. The school influences traffic patterns, particularly during the morning peak hour (heavier northbound left-turn and westbound through volumes) and during the early afternoon period during school dismissal. During the morning peak, heavy northbound-to-westbound left-turn flows create queuing in the inside lane on the northbound approach. To bypass the queue, multiple northbound left-turning drivers were observed to intentionally use the incorrect outside lane to make a right turn into the school after exiting the roundabout to the west. Crashes associated with northbound left turns from incorrect lanes reflected approximately 4 percent (10 crashes over 3 yr) of the intersection total. This crash pattern is illustrated in figure 96.

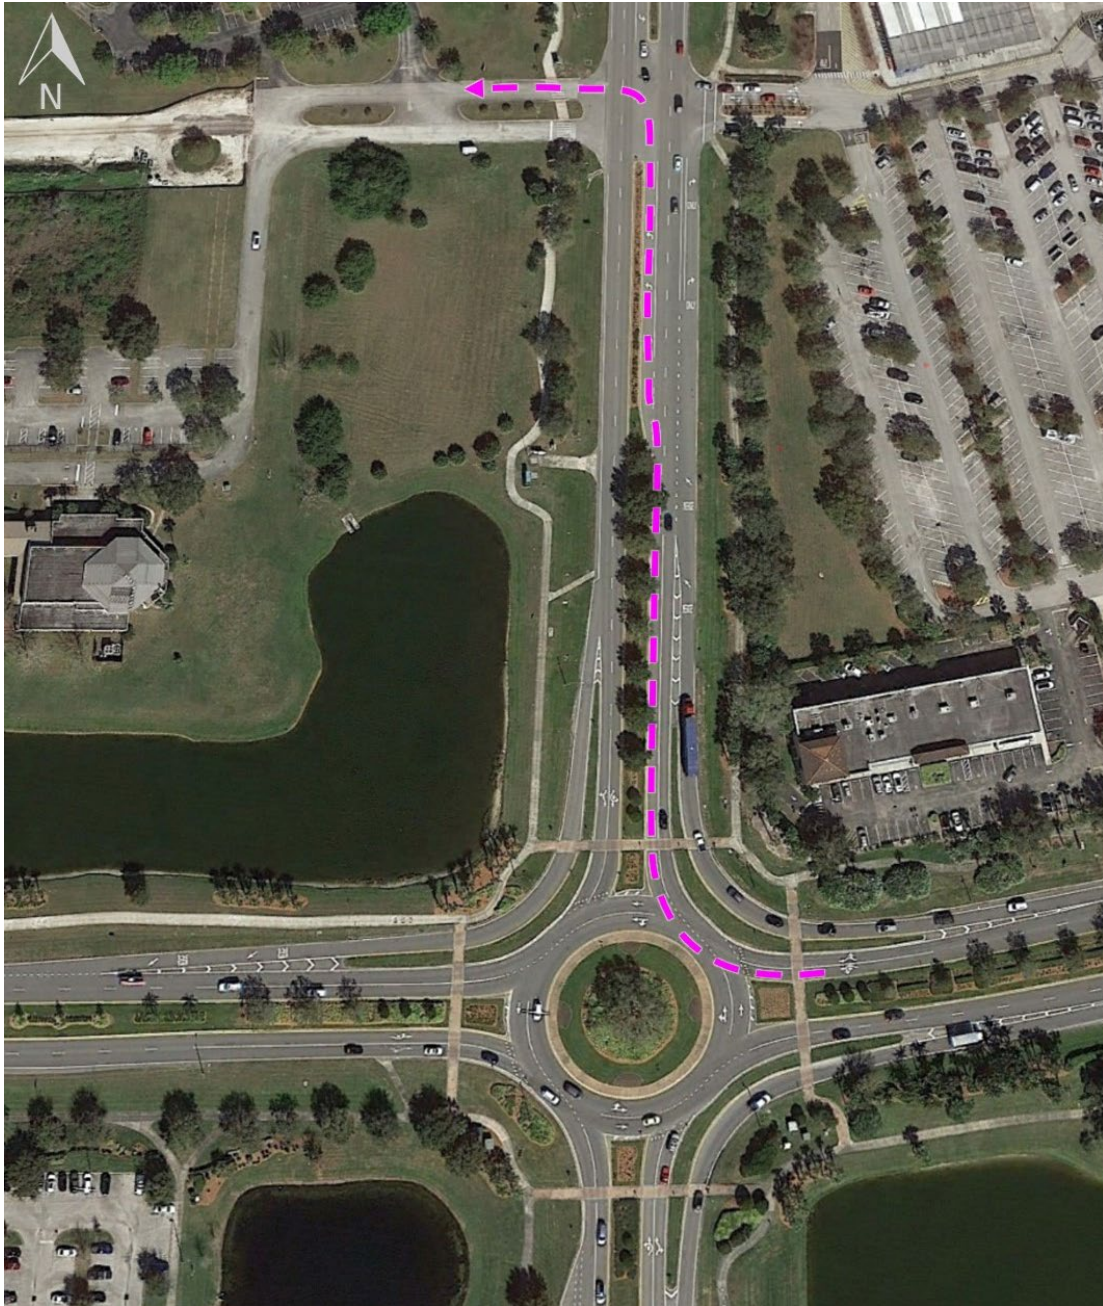
Figure 97. Photo. Melbourne—Improper right turns to access places of worship.

Also at the Melbourne site, two places of worship are adjacent to the northwest corner of the roundabout. Vehicles making a right turn using the westbound-to-northbound right-turn bypass lane are required to make a rapid lane change across three lanes to make a northbound left turn into these properties. Instead, drivers appear to be using the incorrect inside lane on the westbound entry to make a right turn based on their downstream destination, as illustrated in figure 97. This trend may have contributed to up to 15 westbound right-turn crashes that were reported from the incorrect inside lane. Note that activity for these places of worship is likely to
