## **Durability Assessment of Externally Bonded Fiber-Reinforced Polymer (FRP) Composite Repairs in Bridges**

**November 30, 2022**

**Ajay Baniya, Sandra Milev, Rachel Henry, Jovan Tatar  
University of Delaware**

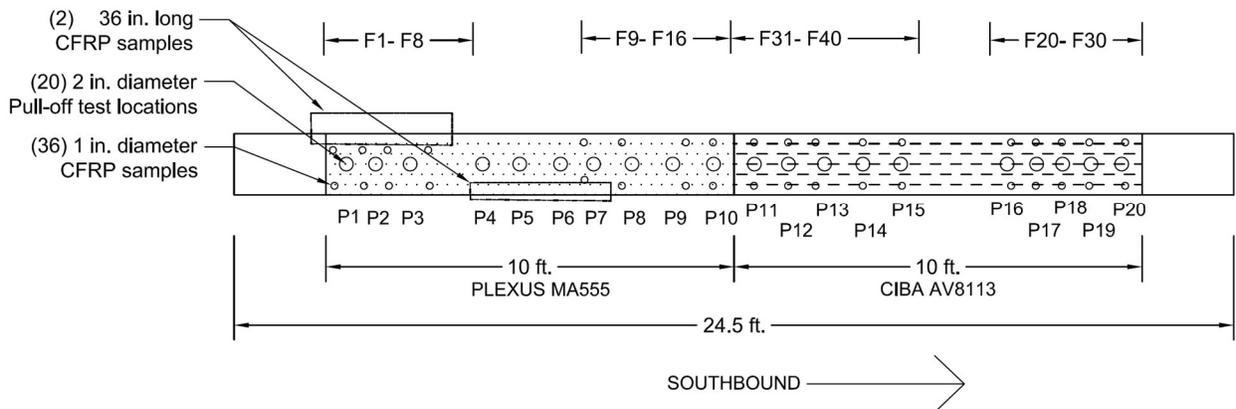
**Figure 62. Bottom view of the girder G5 showing the tentative location of sample collected and pull-off tests.**

The circular CFRP samples (F1 through F40) were spread out evenly along the length of the girder, not further than 2 in. from the edge of the girder, as shown in Figure 62 and Figure 65. The longer CFRP samples (36-in. long) were collected for tensile tests, three-point bending tests, and DMA tests, so it was necessary for the specimen to have at least 10 in. (length) × 1.0 in. (width) × 0.16 in. (thickness) to meet the requirements for all the tests (ASTM D3039, 2017; ASTM D7264, 2015). After multiple attempts at different locations of the girder, the samples meeting minimum requirements could only be collected from two locations, shown in Figure 62.

- Notes: 1. Tentative location of pull-off tests, P1 through P20 (Figure 64). A minimum clear spacing of 6 in. between each test location and a minimum clear distance of 3 in. from the edge is maintained at all test locations.
2. Tentative location of 1-in.-diameter CFRP samples, F1 through F40 (Figure 63). Minimum clear spacing of 3 in. between each location is maintained at all test locations.
3. Figure not drawn to scale.

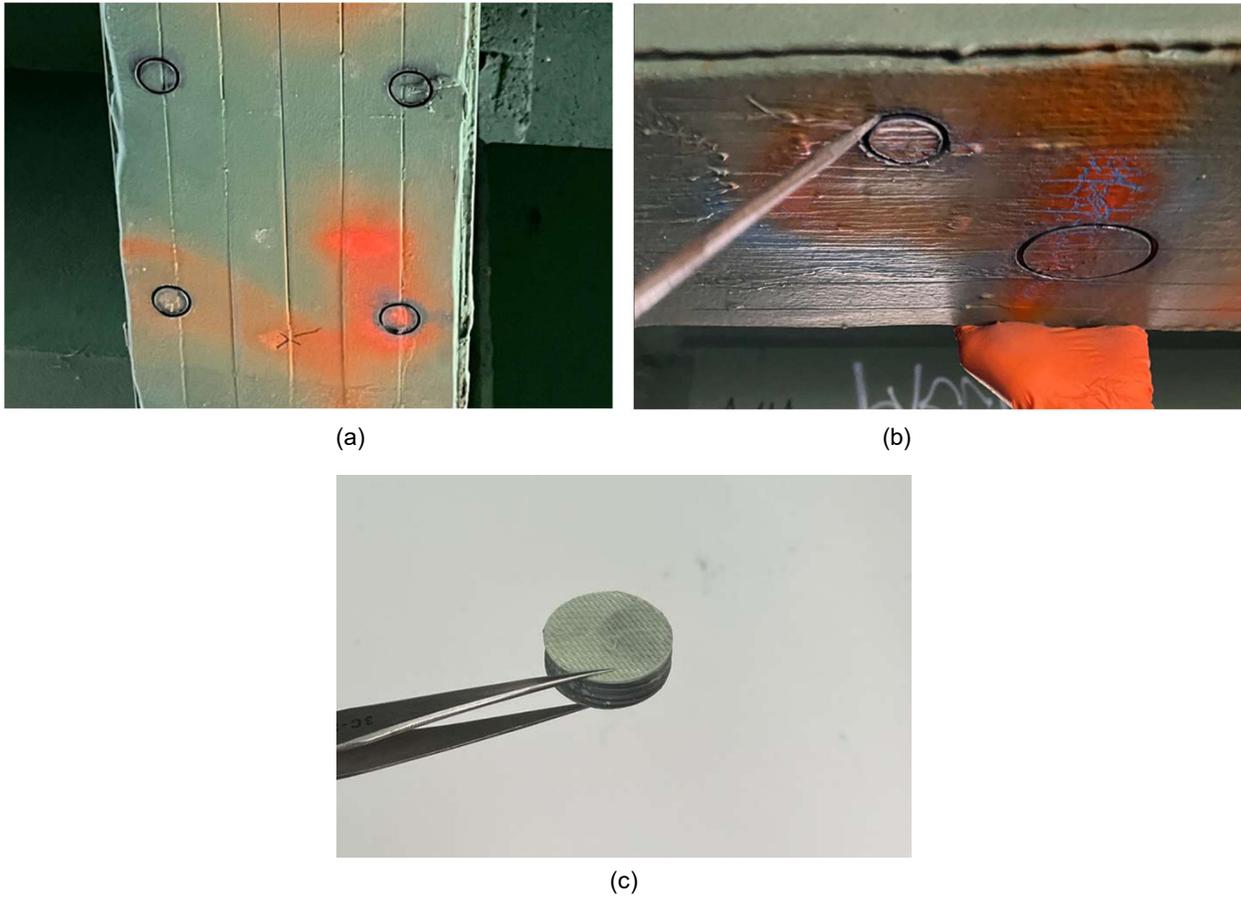
**Figure 65. CFRP sample collection at Br 1-704: (a) CFRP composite drilled using a 1-1/8-in. diamond-coated core saw, (b) sample collection under progress using flat-head screwdriver, and (c) 1-in.-diameter CFRP sample.**

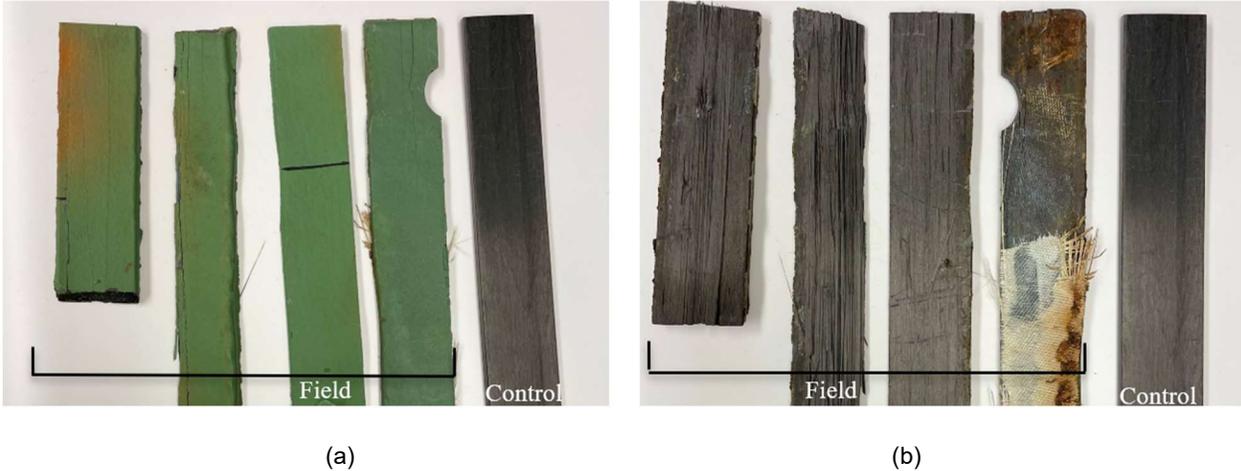
**Figure 66. Field samples from Br 1-704 and control sample : (a) paint side of composite samples shown, and (b) other side of the samples.**

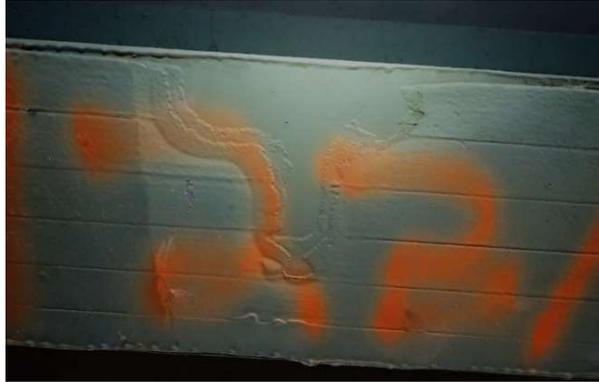
A preliminary visual investigation of the CFRP composite repairs did not indicate the presence of obvious degradation, as shown in Figure 75. However, it was observed that approximately 6×6 in.<sup>2</sup> of CFRP composite was grit blasted, as shown in Figure 76. According to DelDOT, it was grit blasted during the surface preparation work prior to the application of the paint on the soffit of the girder. The accessible part of the girder (Figure 75b,c) was found painted with graffiti paint. The abutments and concrete deck were inspected periodically throughout the year 2021, and it was observed that the moisture infiltrated the abutment during rainy days, as shown in Figure 77. No signs of ingress of direct rainwater runoff from the roadway were observed on the CFRP composite during the inspection.

**Figure 76. Damage to CFRP laminate from grit blasting.**

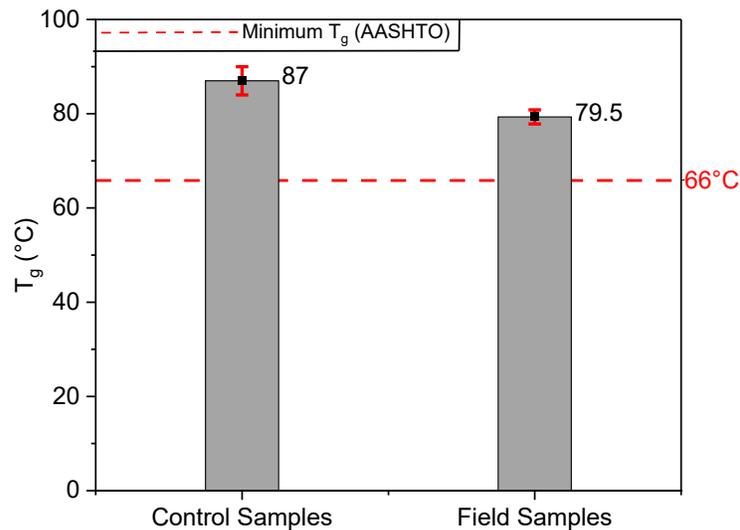
The nomenclature of the sample (e.g., DG5-C/F1) implies the DMA test of control (C) or field (F) samples from girder G5 and sample number 1. The glass transition temperatures of the control and field samples are shown in Table 4. The  $T_g$  of field samples were found lower than the control samples by approximately 9% (Figure 84). Similarly,  $T_l$  and  $T_t$  of field samples were also found lower compared to control samples by 5% and 3%, respectively.

AASHTO (2012) recommends minimum  $T_g$  of the composite system be greater than the in-service temperature plus 40 °F. The maximum design temperature in Delaware for steel girder bridges with concrete deck per AASHTO (2017) is 43 °C, thus the AASHTO (2012) recommended minimum  $T_g$  is approximately equal to 66 °C, which is still lower than the  $T_g$  of the field, as shown in Table 4, by approximately 20%. The reduction in  $T_g$  of field samples compared to controls can be attributed to the potential ingress of moisture at field conditions. The moisture uptake causes the plasticization and hydrolysis over short-term conditioning and long-term conditioning, respectively, through the breakage of ester linkage, resulting in reduced  $T_g$  and softening of vinyl ester, which eventually causes a loss in stiffness and strength of CFRP composite (Chu et al., 2005). In conclusion, some reduction in  $T_g$  was observed after 22 years of environmental exposure due to potential ingress of moisture; however, the reduction was not detrimental, as the  $T_g$  of the field sample was still found to be greater than the AASHTO (2012) recommended minimum temperature.

**Figure 84. Average glass transition temperature of control and field CFRP samples.**

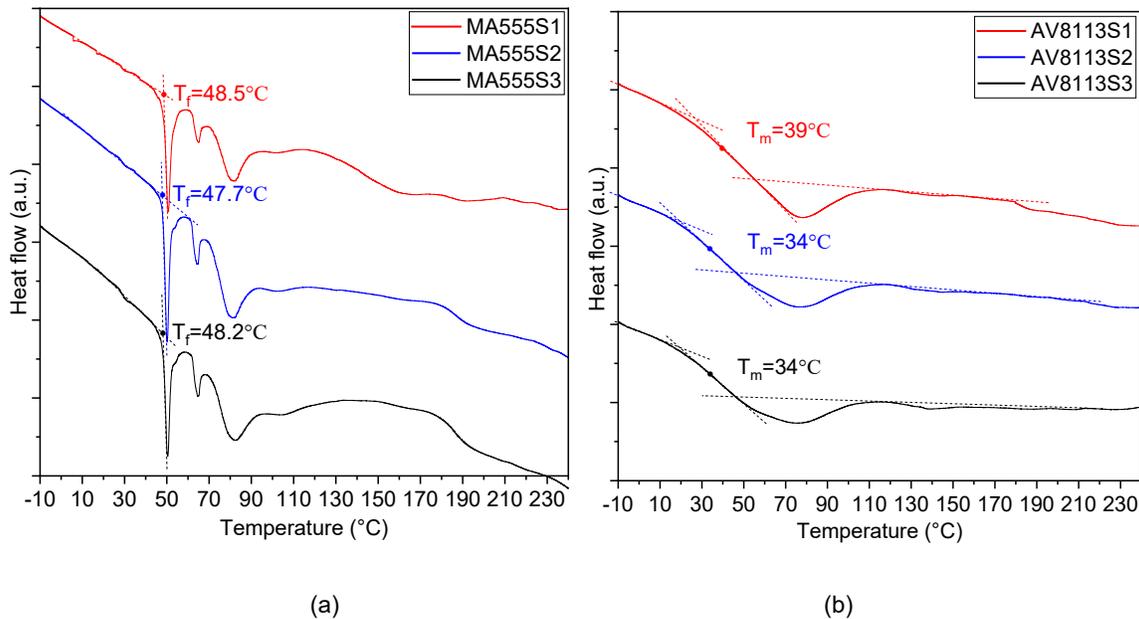
As shown in Figure 85, the heat flow was plotted as a function of the temperature to determine the  $T_g$  of the structural adhesive samples collected from girder G5. The midpoint temperature ( $T_m$ ) was selected as the  $T_g$  for AV8113 structural adhesives, since it is constructed closer to the middle of the temperature range over which the glass transition occurs. The first baseline was constructed to the heat flow curve before the transition temperature, and the linear portion during the phase transition was extrapolated until it intersected the first baseline to determine the  $T_f$  per ASTM E1356-08 (2014). The second baseline was then established to the heat flow curve after the transition temperature. The linear portion during the phase transition was again extrapolated to meet the second baseline; the point of intersection is referred to as extrapolated end temperature ( $T_e$ ). An average midpoint temperature ( $T_m$ ) for AV8113 was  $35.7 \pm 2.4$  °C, which was found significantly lower than the glass transition temperature (i.e., 90 °C) reported by West (2001).

The extrapolated onset temperature ( $T_f$ ) was selected as the  $T_g$  for MA555 structural adhesives because of the inability to establish the second baseline for determination of midpoint temperature. The first baseline was constructed to the heat flow curve before the transition temperature, and the linear portion during the phase transition was extrapolated until it intersected the first baseline to determine the  $T_f$  per ASTM E1356-08. Several endothermic peaks were observed immediately after the phase transition, as shown in Figure 85a. An average extrapolated onset temperature ( $T_f$ ) for MA555 was  $48.1 \pm 0.3$  °C, which was found to be lower than the glass transition temperature (i.e., 103 °C) reported by West (2001).

The  $T_g$  of both structural adhesives were found to be well below the minimum temperature of 66 °C as recommended by AASHTO (2012) and their respective control samples (Figure 86). Some reduction in  $T_g$ , similar to vinyl ester, may be due to moisture ingress. The field samples were cured at the field conditions, but the curing information of the control samples was not known. The higher  $T_g$  of the control samples could be due to the controlled curing at laboratory conditions. In conclusion, the observed  $T_g$  of both structural adhesives were found below the minimum requirement, which is concerning; the  $T_g$  of the field sample may have been reduced due to moisture ingress; however, the cure phenomenon of the

**Figure 85. Glass transition temperature measured on samples from girder G5: (a) MA555 samples and (b) AV8113 samples.**

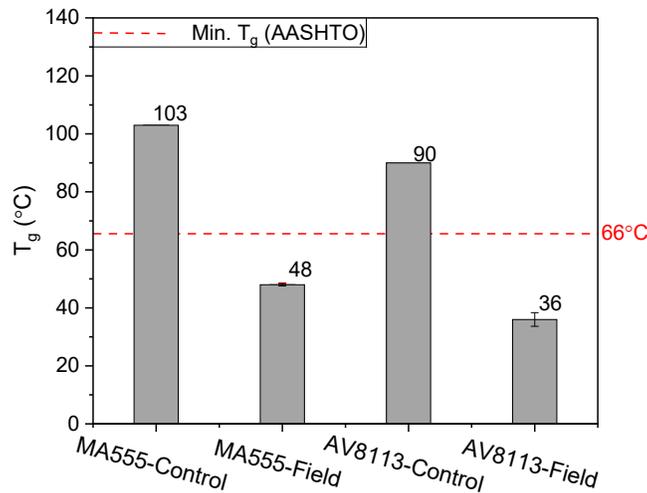
**Figure 86. Average glass transition temperature of control and field structural adhesive samples.**

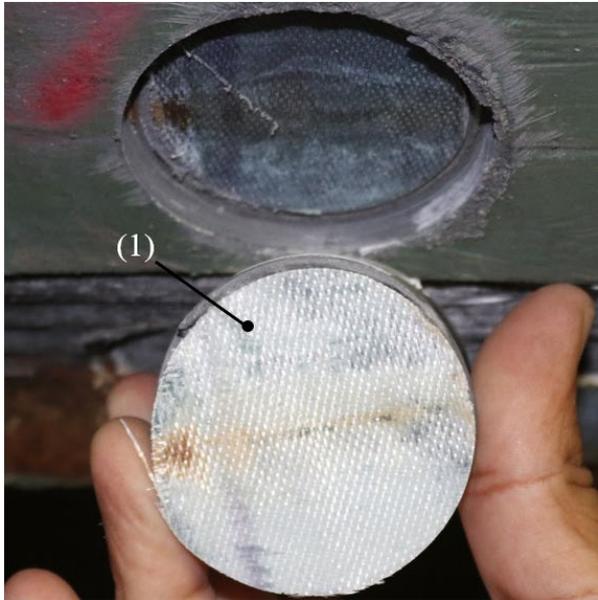
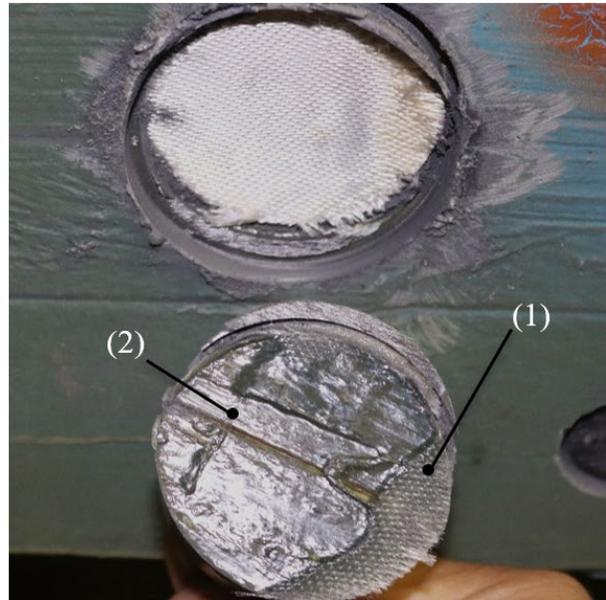
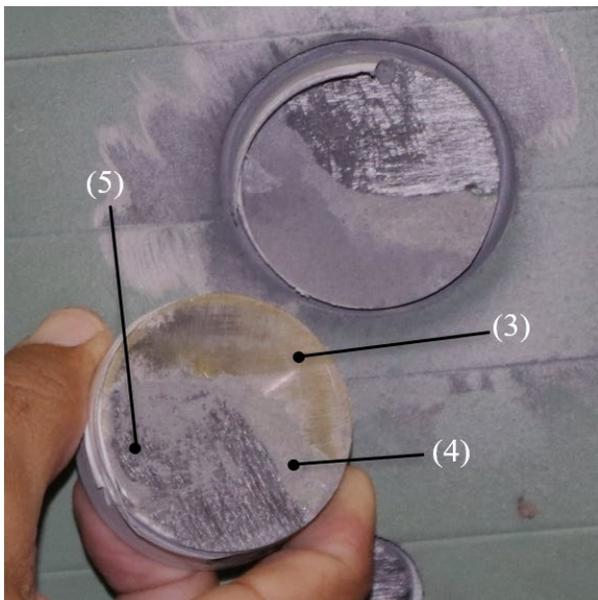
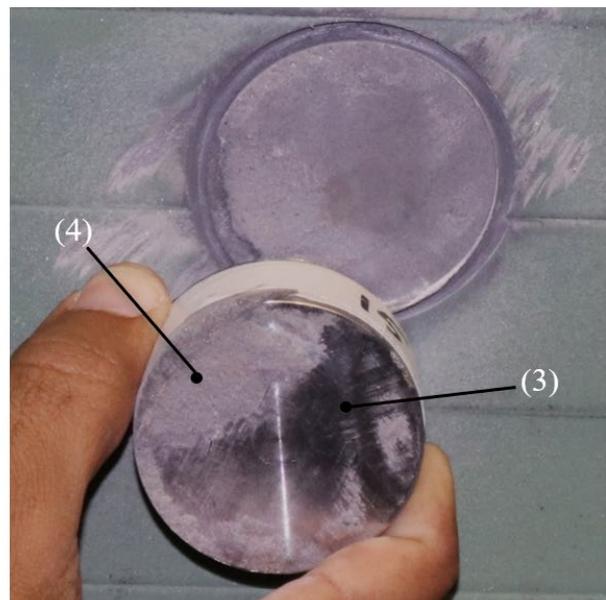
Bond pull-off test results are presented in Table 6, and the photos of observed failure modes are shown in Figure 87. The nomenclature of the sample (e.g., P1) implies the pull-off test at girder G5 and sample number 1. The approximate test locations are shown in Figure 62 and the exact locations are shown in Table 6 with respect to the centerline of the bearing at abutment 2 (Figure 55). A total of 20 tests were performed on the girder, out of which only two samples, P1 and P2, failed in the acceptable mode of failure (Mode C per ASTM D7522, 2021), where the adhesive failure in the adhesive/glass-fabric interface was observed.

An additional two samples, P14 and P15, saw bonding adhesive failure at the loading fixture, which is not an acceptable failure mode per ASTM (2021). The remaining samples did not fail as the capacity of the pull-off tester (1145 psi) was reached.

Table 6 shows that the bond strength for two samples, P1 and P2, was significantly below the minimum recommended bond strength value for various coating or paint system (Table 5). A careful observation at those test locations post-testing indicated inadequately saturated glass-fiber fabric and the presence of air bubbles trapped at the adhesive/glass-fiber fabric interface as shown in Figure 87a,b. Such failure at the adhesive/glass-fabric interface indicates issues with surface preparation, poor workmanship, or a combination thereof. The pull-off bond strengths at all the remaining 16 test samples, except P14 and P15, were found to be significant, as high as 1.6 to 4.6 times above the minimum bond strength values shown in Table 5.

Notes: 1. Glass-fiber fabric observed to be inadequately saturated. 2. Air bubbles trapped at the adhesive/glass-fiber fabric interface. 3. Clean surface of puck visible, no hint of "Sikadur-30" epoxy. 4. Sikadur 30 epoxy residue. 5. Cohesive failure of CFRP composite.

**Figure 87. Failure modes observed at different location of G5: (a) mode C at P1, (b) mode C at P2, (c) mode A at P14, and (d) mode A at P15.**

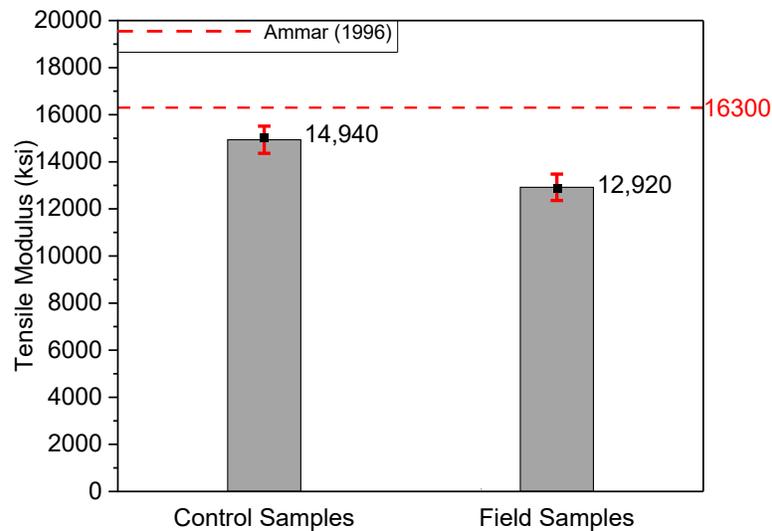
The tensile modulus for six CFRP coupons is shown in Table 7 and Figure 89. The nomenclature of the coupon (e.g., TG5-C/F1) implies the tensile test of control (C) or field (F) coupons from girder G5 and sample number 1. Tensile modulus,  $E_{11}$ , was calculated in the strain range of 0.005 to 0.025% instead of the 0.01 to 0.03% strain range recommended by ASTM D3039/D3039M-08 (2014). Tensile modulus was also calculated using the alternate numerical data method using ASTM E111-17 (2017), per chapter 13.3.2 of ASTM D3039, which was adopted for further analysis. The average tensile modulus of control and field coupons were  $15,815 \pm 538$  ksi and  $13,408 \pm 820$  ksi, respectively, as shown in Table 7. Ammar (1996) performed tensile tests on several 8-in. long x 1.44-in. coupons using Intron 1120 at the University of Delaware to determine the tensile modulus, which yielded a mean value of  $16,300 \pm 300$  ksi. Upon comparison, the average tensile modulus for control and field coupons after 22 years was found to be 3% and 17% less than the tensile modulus determined by Ammar (1996), respectively. The average tensile modulus of control coupons was found to be 15% higher than that of field coupons.

**Figure 89. Tensile modulus of field and control coupons after 22 years of service vs. Ammar (1996).**

Due to the unavailability of design guides to address the environmental reduction factors of CFRP composite bonded on a steel substrate, the test results could only be compared to the reduction factor requirements recommended by various design guides on a concrete substrate. According to ACI440.2R (2017), the environmental reduction factors,  $C_E$ , are applied to determine the design tensile strength and design tensile strain of CFRP composite, which varies between 0.5 and 0.95 depending on the type of fibers and environmental exposure. ACI440.2R recognizes that modulus in some composites may be affected by the environmental exposure, but the guideline does not recommend applying the  $C_E$  factor to modulus. Contrary to this, a 17% reduction in the tensile modulus of the field coupons was observed after 22 years of environmental exposure under bridge Br 1-704.

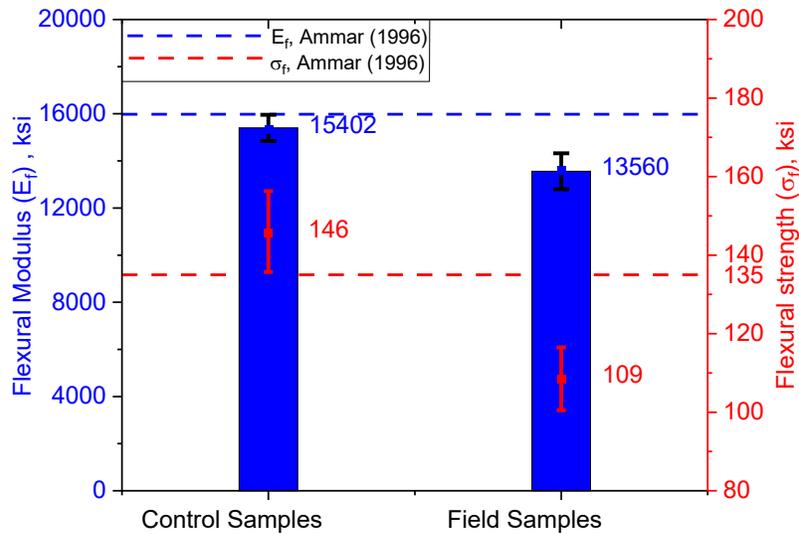
The average flexural modulus of control and field coupons were 15,402±557 ksi and 13,560±765 ksi, respectively, as shown in Table 8. Upon comparison, the average flexural modulus of control and field coupons after 22 years was found to be 4% and 15% less than the flexural modulus obtained from Ammar (1996), respectively. The average flexural modulus of control coupons was found to be 14% higher than that of field coupons. The reduction in flexural modulus for both control and field coupons was found consistent with the reduction in tensile modulus.

Similarly, the average flexural strength of control and field coupons were 146±10 ksi and 108±8 ksi, respectively, as shown in Table 8. Upon comparison, the average flexural strength of control coupons after 22 years was found to be 8% higher than the flexural strength obtained from Ammar (1996), while the average flexural strength of field samples was reduced by 25%. After 22 years of service, the flexural strength of field coupons was found to be lower than the design ultimate flexural strength computed using the  $C_E$  factor of 0.85 recommended by ACI440.2R (2017). Some reduction in strength, similar to tensile modulus, may be due to specimen extraction/manipulation procedures. However, considering the increment in number of peak strain events over the 22 years' service life and reduction in  $T_g$  of the field CFRP composite, it is likely that degradation also occurred. Considering the present data, a  $C_E$  factor of 0.75 may be more adequate within the considered service life (22 years) than the 0.85 value currently recommended by ACI 440.2R.

Figure 90. Flexural modulus and flexural strength of field and control coupons vs. Ammar (1996).

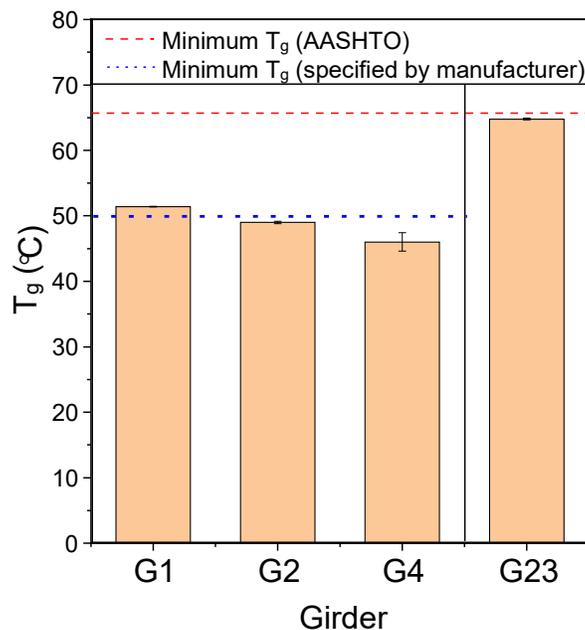
The primary objective of DSC experiments was to determine if environmental exposure during 26-year service life had an effect on the  $T_g$  of the CFRP bridge repairs. Figure 100 shows  $T_g$  of composite samples from girders G1, G2, G4, and G23.  $T_g$  of the CFRP installed in 1994 varied between 46 °C and 51 °C. These values were lower than  $T_g$  of the samples collected from G23 with the  $T_g$  of 65 °C. The lowest  $T_g$  was measured on G4. As shown in Figure 98, CFRP on G1 and G2 seemed more deteriorated compared to other girders. It was expected that the  $T_g$  of composite repairs on G1 and G2 is lower than on G4, since they

seemed more degraded and had more exposure to water, which is related to decreased cross-linking density through polymer chain scission/oxidation/hydrolysis (Lin et al., 2006). Surprisingly, the  $T_g$  values were 10% higher in G1 compared to G4. Lower  $T_g$  observed in G4 could be attributed to different thermal history. It is possible that exterior girders were more exposed to sunlight. Thermal history directly affects the cross-linking density (i.e., exposure to higher temperatures enhances the epoxy-amine reaction and results in stiffer network and higher  $T_g$ ).

Assuming that 50 °C was the initial  $T_g$  value of the FR-E3P resin, it can be concluded that the reduction in  $T_g$  ranged from 0 to 10%. Decrease in  $T_g$  of 10% is lower compared to some results reported on artificially/naturally aged epoxy resin. A decrease in  $T_g$  in the range of 10%–25% was measured during natural exposure in a tropical environment for no longer than 1 year (Lettieri and Frigione, 2011; Belec et al., 2015). Finally, measured  $T_g$  was compared to AASHTO recommendations. Given that maximum design temperature for Delaware is 45 °C, and taking into account AASHTO guidelines (minimum  $T_g$  of 45 °C +21 °C) low values like these are deemed inadequate.

**Figure 100. Glass transition temperature measured on samples from girders G1, G2, G4, and G23.**

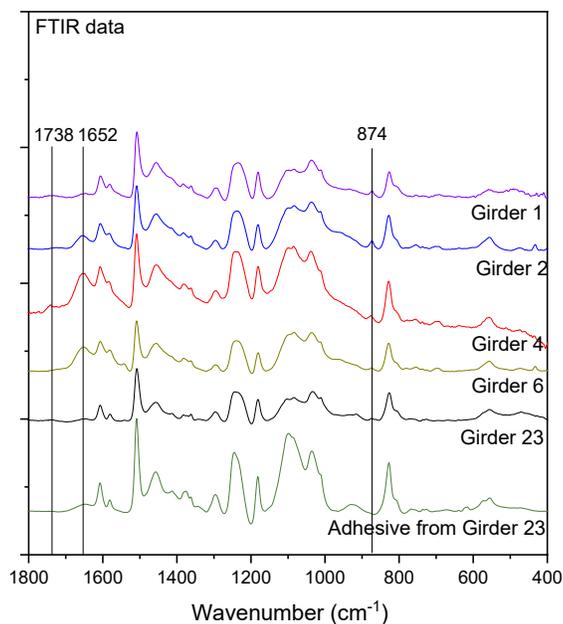
ATR-FTIR spectra are shown in Figure 102. Some differences among the spectra were observed: (1) peak at  $1,658\text{ cm}^{-1}$  is prominent in some samples; (2) peak at  $1,738\text{ cm}^{-1}$  and peak at  $874\text{ cm}^{-1}$  is present in the CFRP samples from G1 and G2, but not in the G6 and G23 samples; and (3) a relatively small peak at  $1,540\text{ cm}^{-1}$  in the spectra of G2 and G6 samples.

Almost all FTIR spectra recorded on G1, G2, G4, and G6 show the presence of the peak at  $1,656\text{ cm}^{-1}$ , which indicates amine cross-linker-related degradation. The appearance of a band around  $1,660\text{ cm}^{-1}$ – $1,670\text{ cm}^{-1}$  is reported in amine-cured epoxies (Delor-Jestin et al., 2006; Meiser and Possart, 2011) after thermal aging, hygrothermal cycling (Lin et al., 2006), and UV exposure and outdoor weathering (Belec et al., 2015; Gu et al., 2005), including thermooxidation under mild conditions ( $70\text{ }^{\circ}\text{C}$ , 80% RH), Morsch et al., 2020). Researchers suggest that the formation of the  $1,657\text{ cm}^{-1}$  band involves a reaction on the phenoxy group and corresponds to quinone methide (Mailhot et al., 2005). According to a different mechanism,  $1,658\text{ cm}^{-1}$  is related to amine cross-linker oxidation. As proposed by Morsch et al., 2020, products of imine hydrolysis contribute to the absorbance at  $1658\text{ cm}^{-1}$  (primary amine N-H bend).

The peak at  $1,738\text{ cm}^{-1}$  was present only in the spectra from G4. This peak was previously reported to correspond to the phenyl formate. The sample from G4 had the lowest  $T_g$ , too (Figure 100). It is difficult to state what would be the underlying mechanism of the observed decrease in  $T_g$ , but the presence of  $1,738\text{ cm}^{-1}$  suggests that the chemical degradation is causing it (possible chain scission reactions in hydroxypropyl ether groups in DGEBA are shown in Figure 101).

**Figure 102. ATR-FTIR spectra of CFRP material samples collected from Foulk Road bridge.**

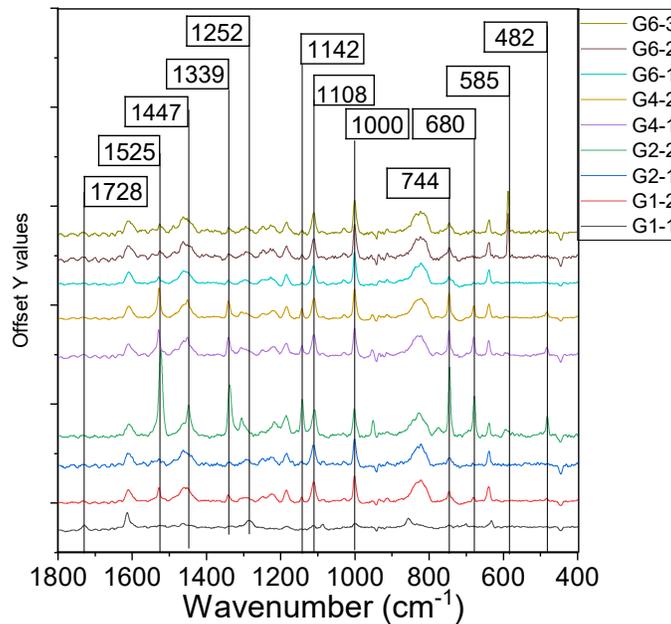
The spectra in the carbonyl range (1,500–1,700) have a poor resolution due to the noise and baseline correction procedures. To provide additional information regarding chemical degradation, Raman spectra were collected. A comparison of Raman spectra recorded on CFRP samples from four different girders are shown in Figure 103. Differences can be noticed at wavenumbers 1,728, 1,525, 1,339, 1,143, 1,000, 744, 680, 585 and 482  $\text{cm}^{-1}$ . Published literature on Raman analysis of epoxy was reviewed to serve as a reference for peak assignment (Daimay, 1991; Fu et al., 2020; Rocks et al., 2004; Vaskova and Kresálek, 2011; Younes et al., 1994; Zapata et al., 2013). Two peaks related to degradation are of particular interest: the peak corresponding to the carbonyl group and the peak corresponding to tertiary amides. Tertiary amides are observed in the Raman spectra in the 700–750  $\text{cm}^{-1}$  range (Daimay, 1991). The issue with using this peak to monitor the degradation of epoxy/amine is that epoxy ring deformation appears in the Raman spectra at 736  $\text{cm}^{-1}$ . Another region of interest is 620–590 related to the skeletal deformation of tertiary amides with R-C(=O)NR<sub>2</sub> type of structure. C=O bands are weak in Raman spectra (Daimay, 1991) and they appear at 1,725  $\text{cm}^{-1}$ . A 1,725  $\text{cm}^{-1}$  peak was observed only in the spectra on G1.

**Figure 103. Raman spectra of CFRP samples - Foulk Road bridge.**

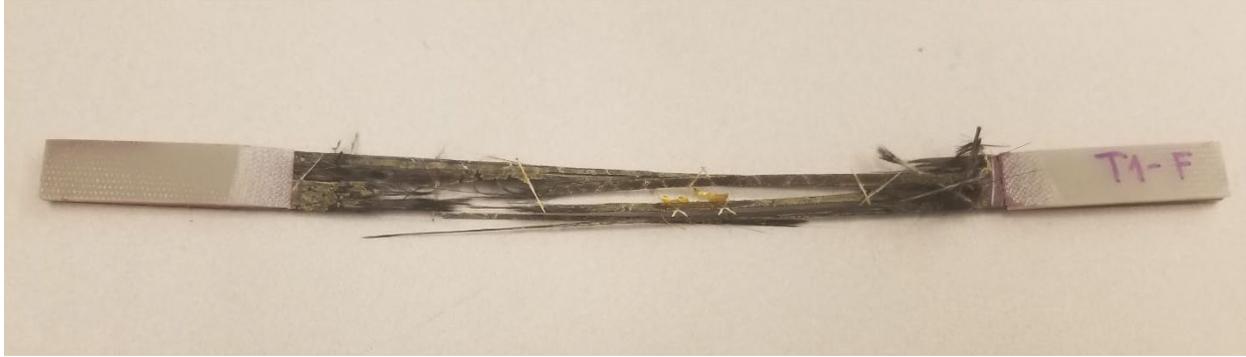
The average tensile strength was 318 ksi, which is 37% less than the value specified in the materials data sheet—483 ksi. Failure mode can be best described as a staggered failure, with fiber pullout and debonding along the fibers (Figure 105). The load vs. time curve in Figure 106 shows the propagation of the failure where bundles of fiber progressively fail at different locations along the coupon length. As shown in the SEM images, there were many defects in the matrix – cracking and matrix erosion. These defects probably decreased composite strength, since there was not enough resin to ensure uniform distribution of stress between the fibers. According to ACI 440.2R, the environmental reduction factors are applied to CFRP properties and vary between 0.85 and 0.95 depending on the environmental exposure. For CFRP installed on bridges, ACI 440.2R recommends an environmental reduction factor of 0.85. The calculated value of  $C_E$  based on strength data in Table 11 was 0.66, which is significantly lower than the value recommended in ACI 440.2R.

Figure 105. Typical failure mode of tensile test coupons.

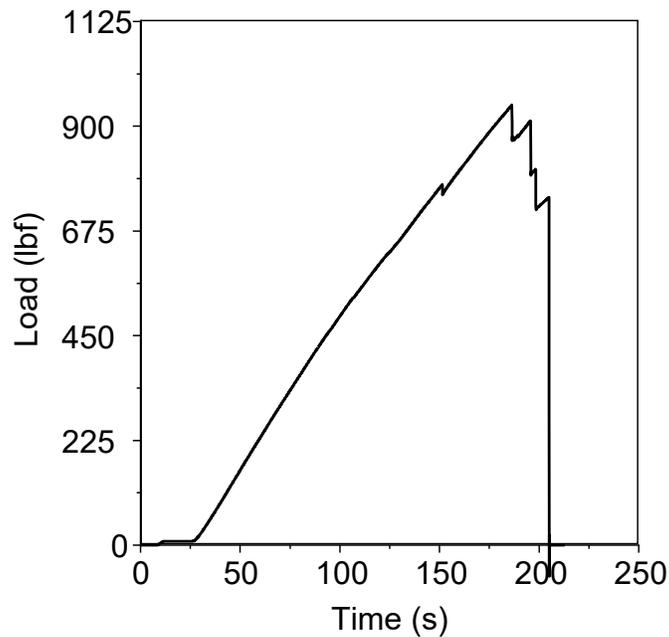
Figure 106. Load vs. time curve (strain gage failed before the coupon failure, so part of the strain data is missing).

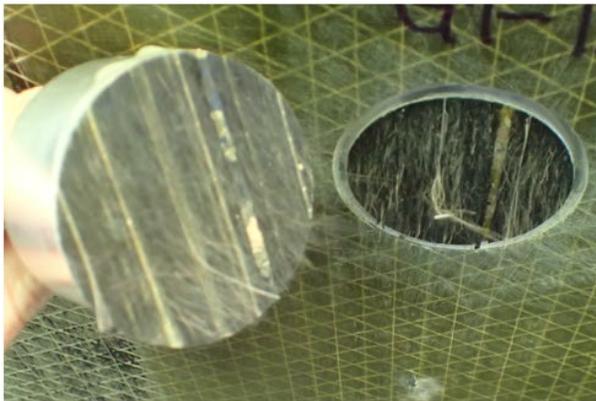
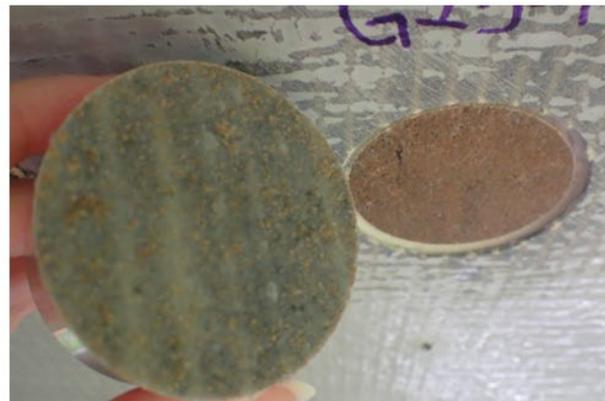
Label	Bond Strength (psi)	Failure Mode	Failure Mode	Interpretation of Failure Mode
G1-U1	354	B	Cohesive failure in CFRP laminate	Indicates that the perpendicular (tension) force that the CFRP composite can withstand is lower than the tensile strength of concrete and epoxy adhesives, and the bond strength at all interfaces. Such failures are likely due to incomplete wet-out of the fibers or plies comprising the laminate or environmental degradation of the CFRP.
G1-U2	409	B	Cohesive failure in CFRP laminate	
G1-U3	312	B	Cohesive failure in CFRP laminate	
G4-UD1	25	B	Cohesive failure in CFRP laminate	
G4-UD2	0	B	Cohesive failure in CFRP laminate	
G23-B1	138	E	Adhesive failure at CFRP/concrete substrate interface	Indicates poor adhesion properties, likely resulting from improper selection of adhesive for concrete substrate, contamination of adhesive, incomplete or improper cure of adhesive, environmental degradation, or improper installation.

G23-B2	194	E	Adhesive failure at CFRP/concrete substrate interface	
G23-B3	637	E	Adhesive failure at CFRP/concrete substrate interface

**Figure 107. Two failure modes observed: (a) mode B on G1-U1, (b) mode E on G23-B1, (c) mode B on G4-UD1, and (d) mode B on G4-UD2.**
