Improving Transportation Infrastructure Resilience against Hurricanes, other Natural Disasters, and Weathering: Part I - Analysis of failure of transportation signs due to Hurricane Maria

FINAL REPORT
June 2022

Transportation Infrastructure Research Center – TIRC
Polytechnic University of Puerto Rico
377 Ponce de Leon Ave, San Juan, PR 00918

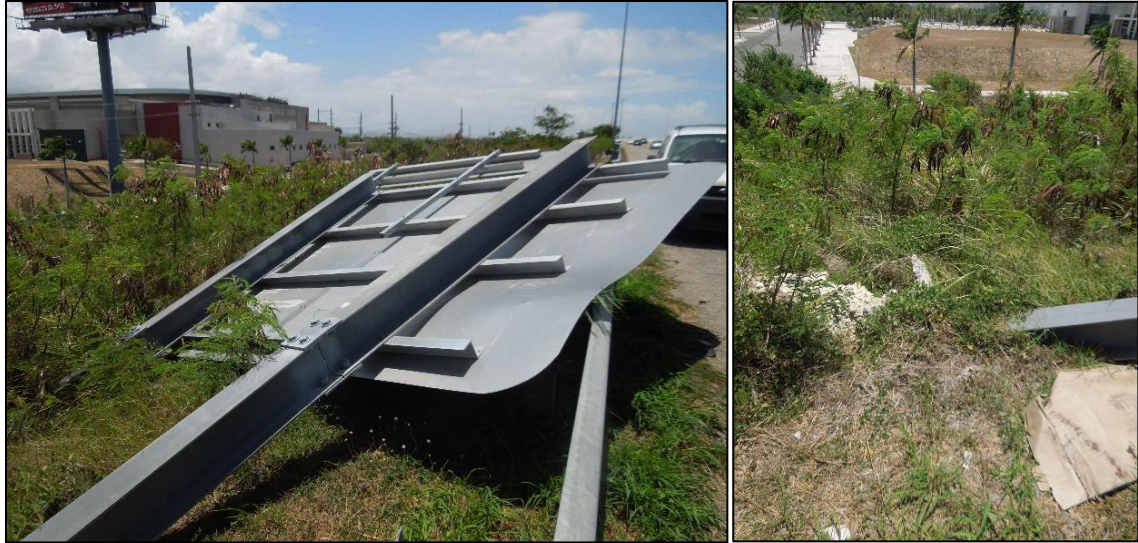
Foundation failure occurs when none of the structural members on top of the foundation initially failed under the wind loads, but one or more of the posts overturns. The overturn could be due to the foundation not being deep enough, to the foundations not being adequately constructed, to the soil being significantly weakened due to the heavy rainfall of a hurricane, or to a combination of these factors. Sign 6, presented in Figure 4.2, was a case of foundation failure in which one of the posts started to overturn. Meanwhile, Sign 5 was another case of foundation failure in which the structure collapse due to the overturning of both posts, as presented in Figure 4.3.

Figure 4.3: Foundation failure of Sign 5

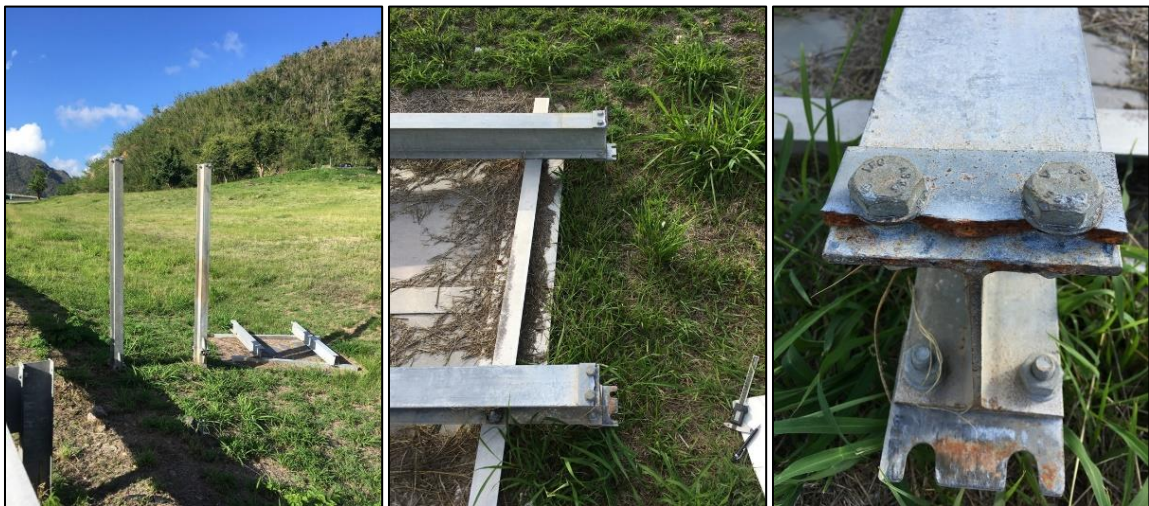
Similarly, Sign 7 was another case of slotted fuse plate slippage, as shown in Figure 4.5. This time, the hinge plate was ruptured, probably because the upper beams are shorter than the lower beams.

Figure 4.5: Slotted fuse plate slippage failure of Sign 7

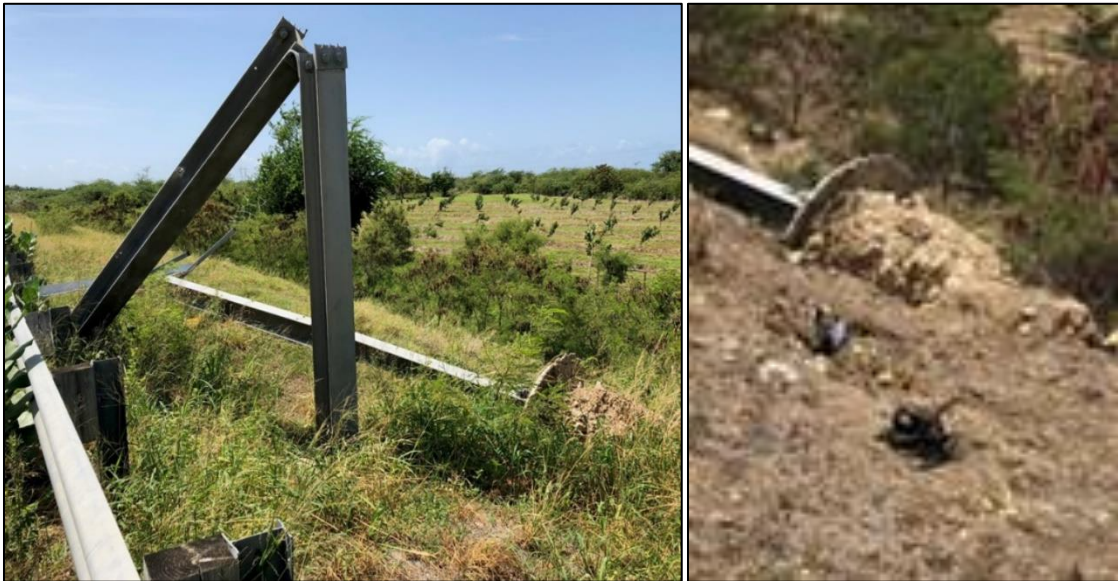
Sign 8, demonstrated a combination foundation failure and fuse plate rupture, as shown in Figure 4.9. It is probable that one of the posts had a foundation failure that lead to the other post having fuse plate rupture.

Figure 4.9: Undetermined mode of failure of Sign 8

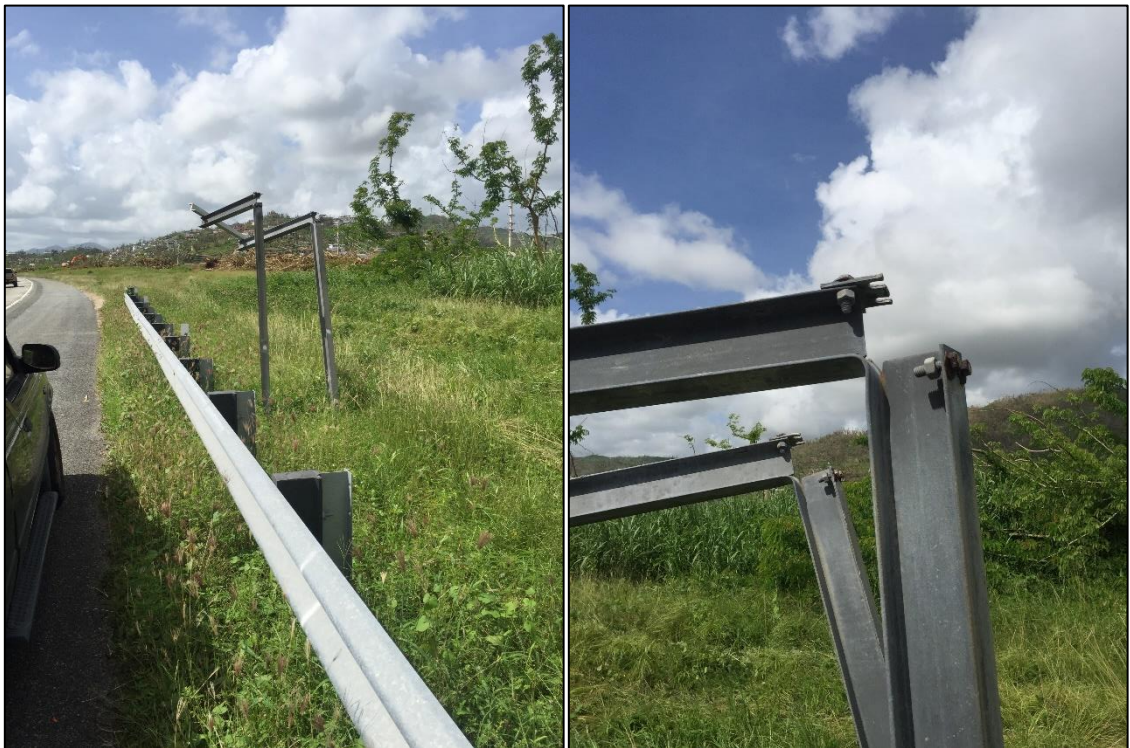
Sign 10, shown in Figure 4.11, experienced a combination of slotted fuse plate slippage and foundation failure. This case did not have a hinge plate, nor were the posts cut into lower and upper beams. Instead, for each post, the web and one of the flanges of the wide-flange section were cut, with the uncut flange acting as the hinge plate.

Figure 4.10: Undetermined mode of failure of Sign 10

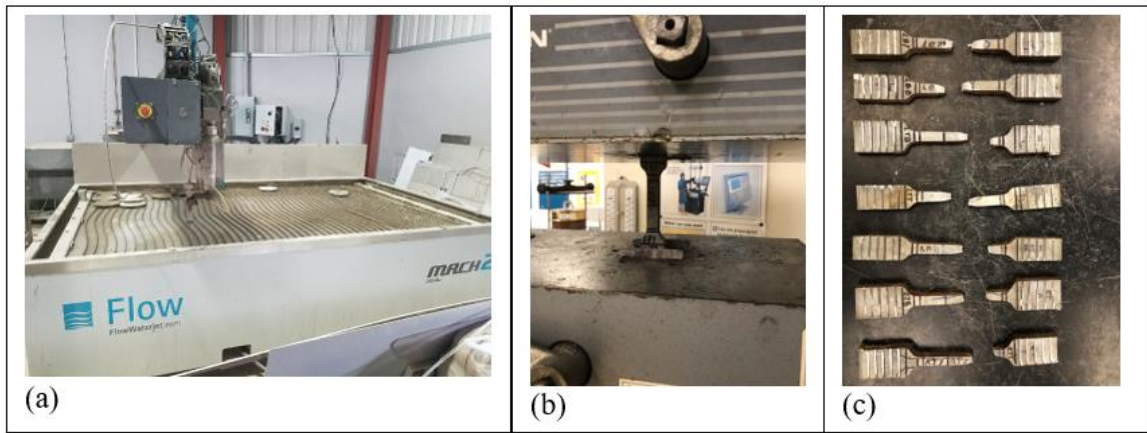
Out of these plates, tension test specimens were cut using a Flow Mach2 waterjet machine, as seen in Figure 5.6(a). Afterwards, tension tests were conducted on the specimens using an Instron 300DX machine, as seen in Figure 5.6(b). Figure 5.6(c) shows some of the specimens after being tested. Calculating the average of the tension tests results presented in Table 5.1, it was assumed that the fuse plates were made of steel with an ultimate strength of $F_u = 63,963$ psi.

Figure 5.6: (a) Waterjet cutting machine, (b) specimens tension tested, and (c) rupture specimens.

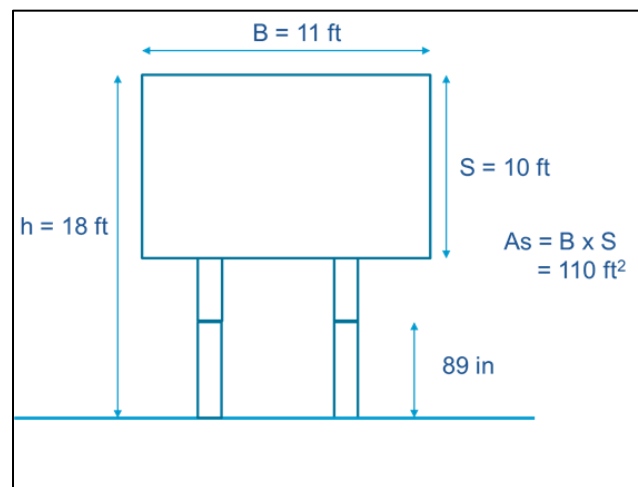
Figure 5.7 Case 1, Scenario A

- Scenario A: The smaller exit number sign attached to the main sign was disregarded, as shown in Figure 5.7.

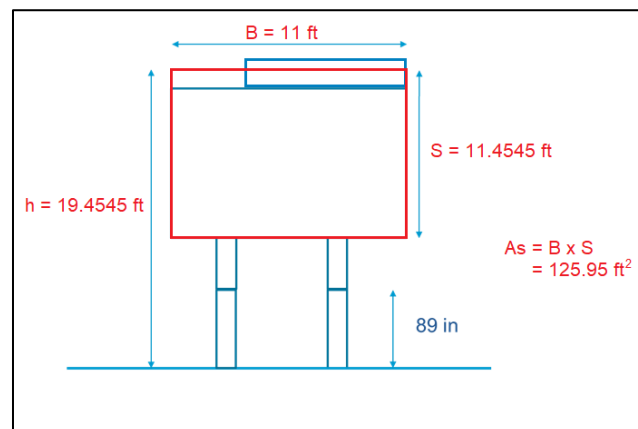
Figure 5.8: Case 1, Scenario B

- Scenario B: The smaller exit number sign was included in the analysis. The area of the exit number sign was computed, then divided by the width (B) of the main sign. The resulting value was added to the height of the main sign to use this as H , as shown in Figure 5.8. The result is an equivalent sign with the same total area of the main sign plus the exit number sign but disregarding small eccentricities. This was done because the ASCE 7 Standard does not offer guidance for the combination of signs.

Again, given the flexibility of the connections of the smaller signs to the main sign, the wind speed that caused the failure is probably between the estimates of the two scenarios.

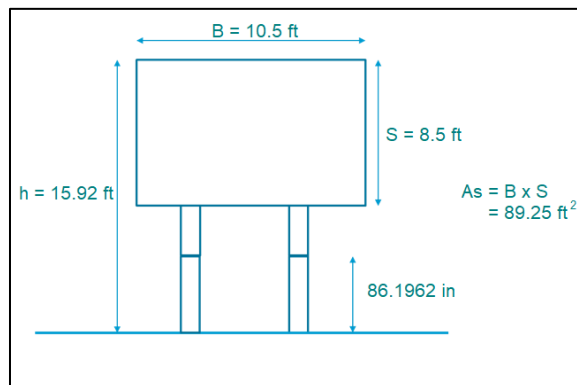
Figure 5.12 Case 2, Scenario A

- Scenario A: The smaller exit number sign attached to the main sign was disregarded, as shown in Figure 5.12.
- Scenario B: The smaller exit number sign was included in the analysis, as shown in Figure 5.13.

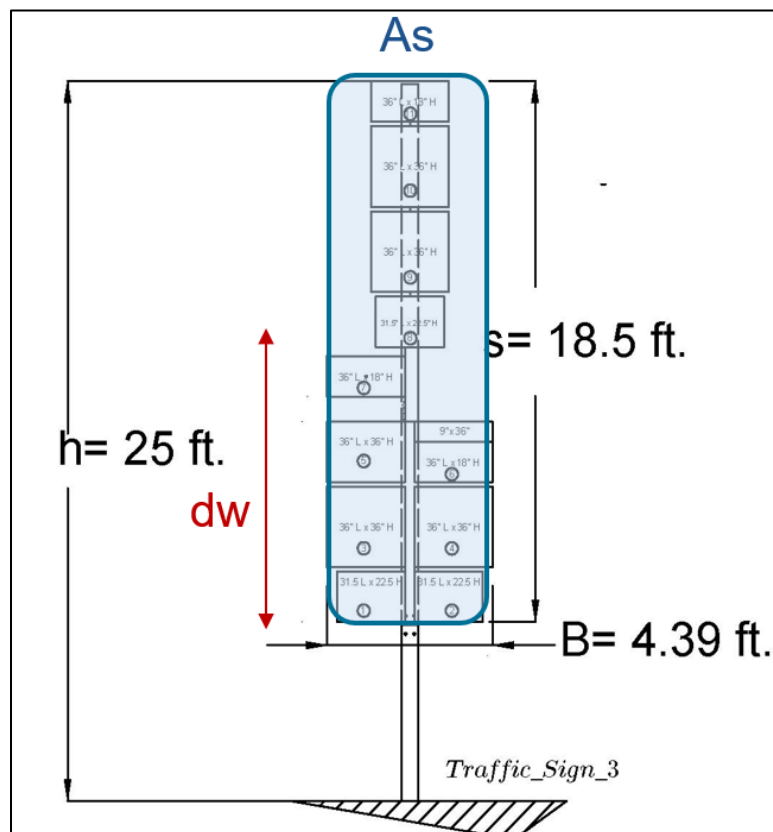
Figure 5.17: Assumed scenario for Case 3

As mentioned before, the ASCE 7 Standard does not offer guidance on how to consider a structure with several signs of assorted sizes. Therefore, it was assumed that all the smaller signs formed a larger sign with a width of 4.39 ft and height of 18.5 ft, as shown in Figure 5.17. The eccentricity of geometry formed by the different signs was disregarded.

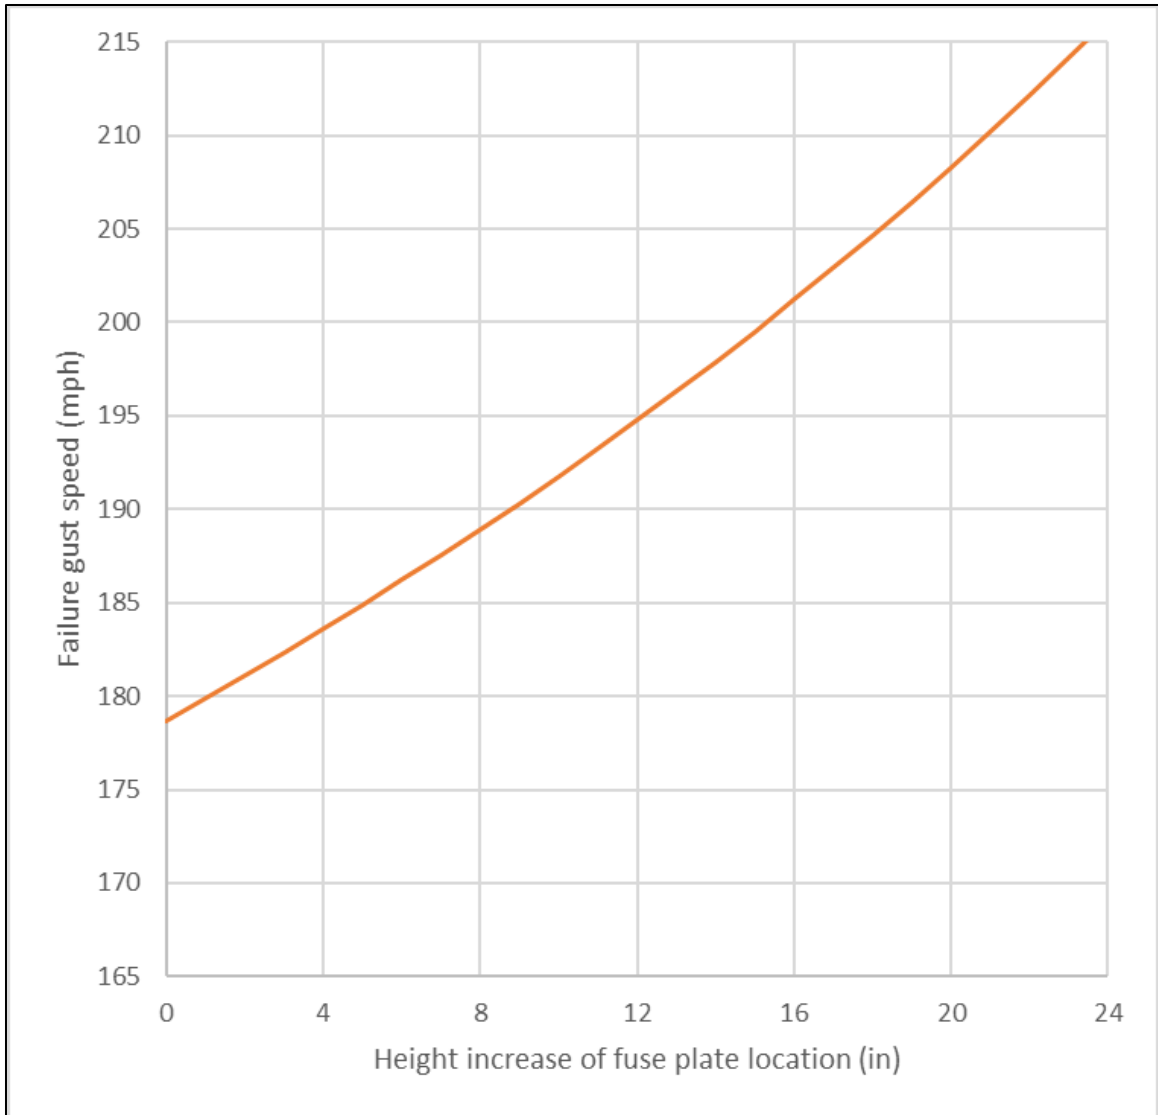
Figure 6.1: Effect of raising the location of fuse plate of Case 1, Scenario B

- Raising the location of the fuse plate as much as possible. This would cause a reduction of moment arm of the wind pressure (d_w). For Case 1, Scenario B, raising the fuse plate 10 inches would have increased the failure speed by about 13 mph, as shown in Figure 6.1.

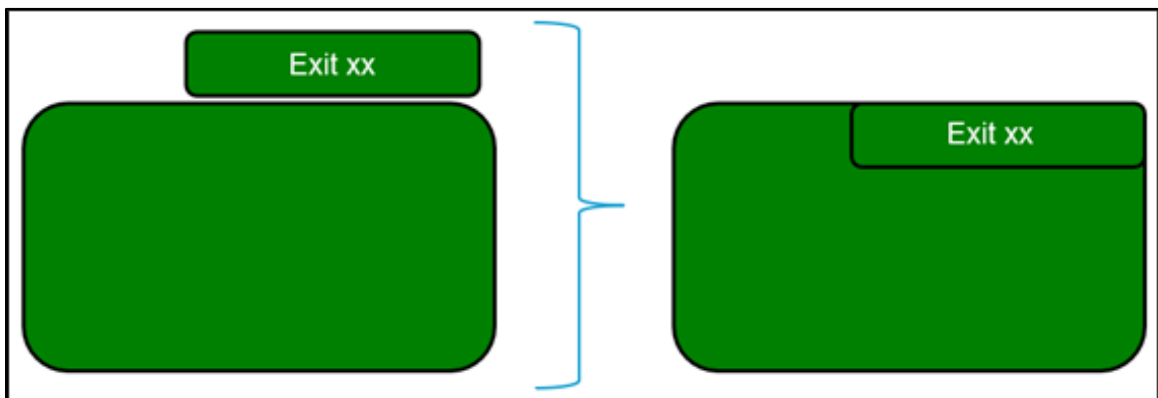
Figure 6.2: Recommendation of inserting exit number into main sign

- Instead of attaching an additional sign to indicate the exit number, insert this information into the main sign, without increasing its size, as shown in Figure 6.2. This is also justified by the comparison of Scenarios A and B for Cases 1 and 2.

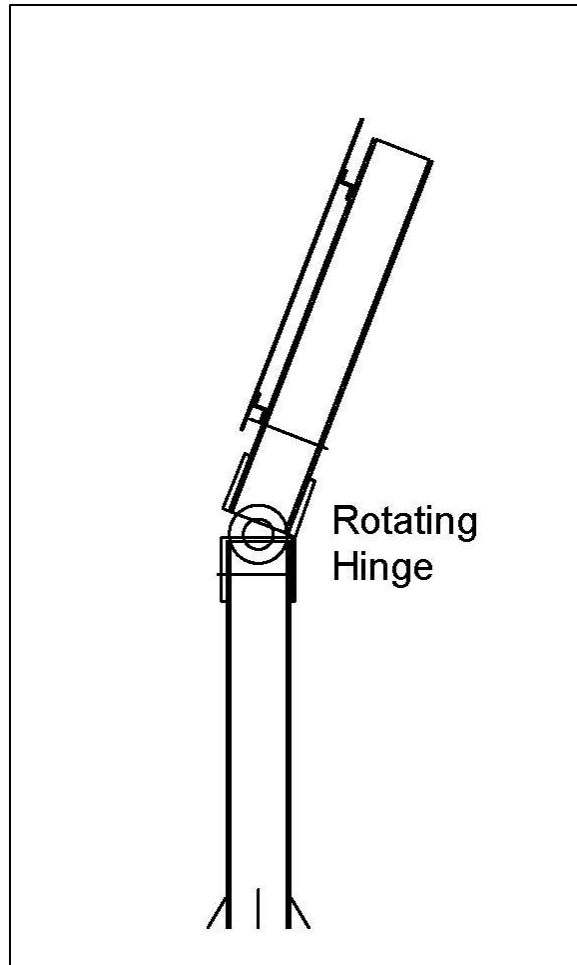
Figure 6.3: Rotating spring-loaded hinge

- Develop a rotating spring hinge mechanism that connects the lower and upper segments of the W10x33 posts, as shown in Figure 6.3. After hurricanes, this type of hinge mechanism could allow the signs to be rotated back to the vertical position, aligned with the lower posts' segments.

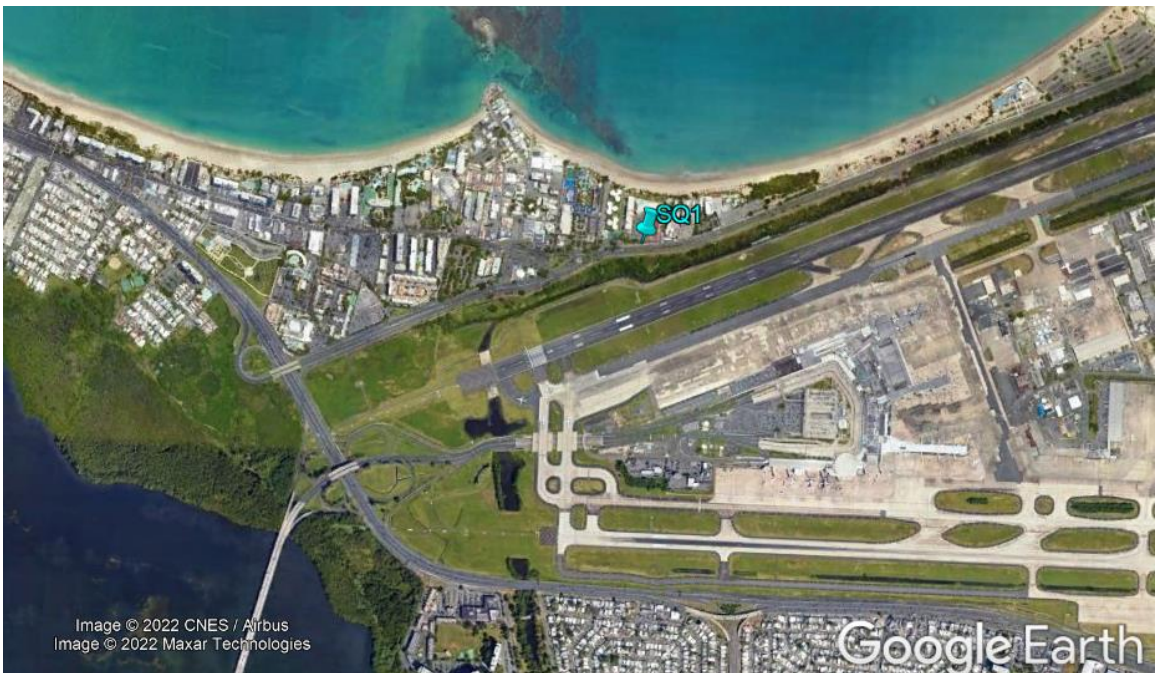
Figure 4.2: Aerial view of SQ1's surroundings

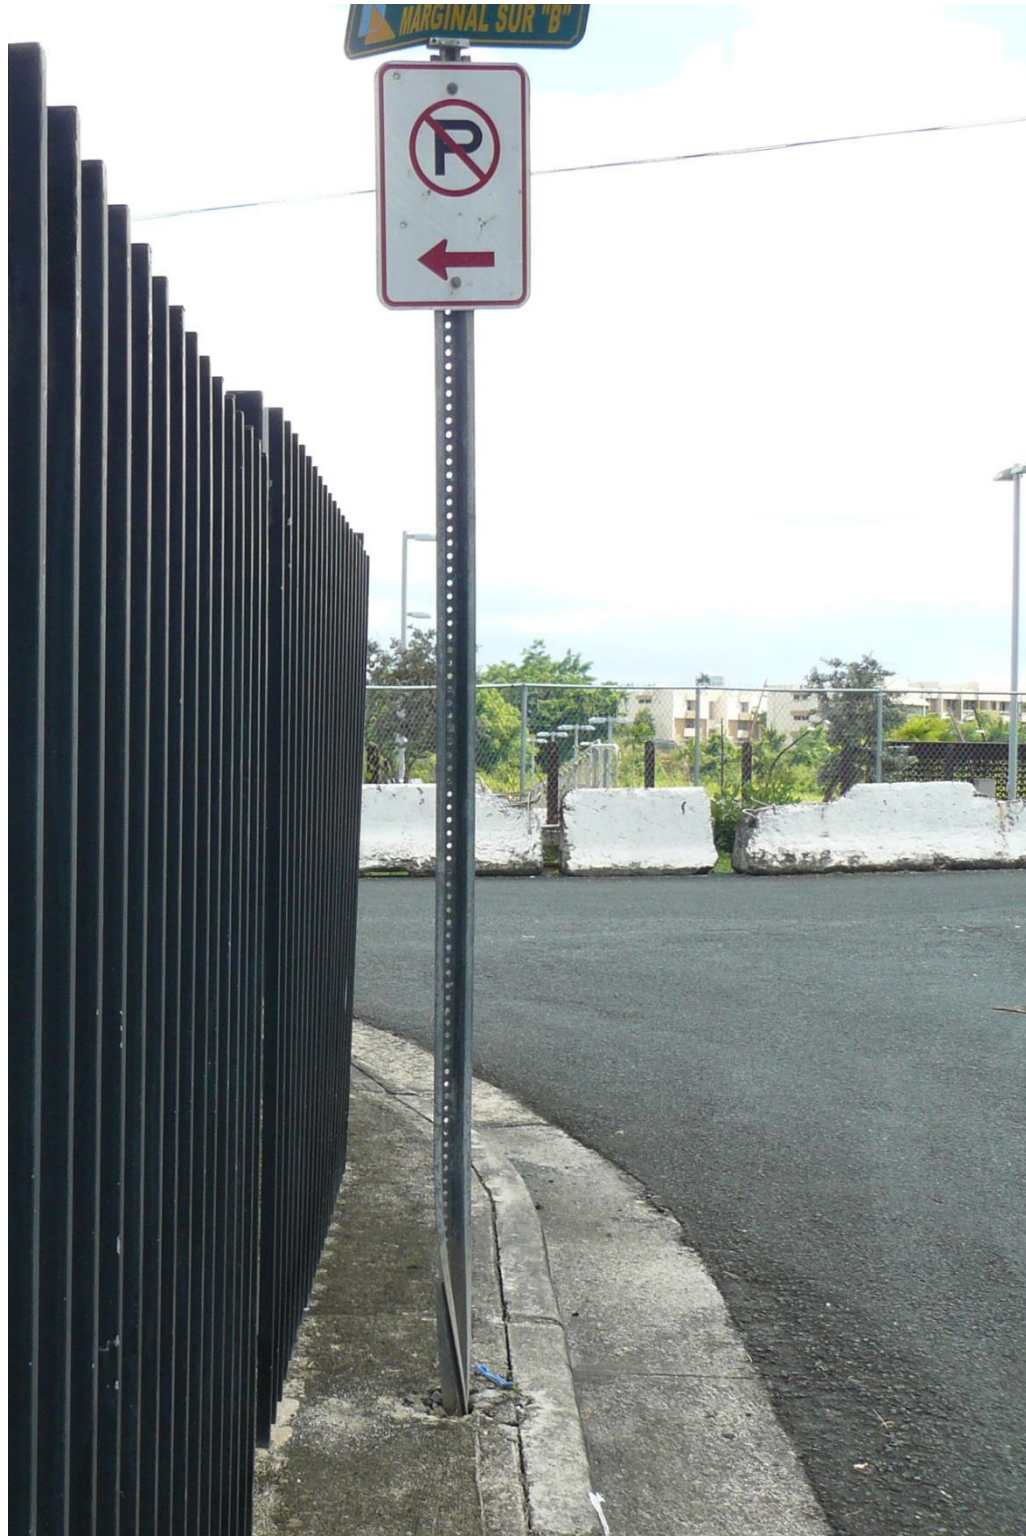
- Permanent twisting deformation: In this mode of failure, the top post twisted near its base, as it can be seen in the examples shown in Figure 4.10. This was the most predominant mode of failure observed. Several posts were found facing the wrong direction due to the deformation (see example in Figure 4.11). In other instances, the sign panel was lost (see example in Figure 4.12). In some cases, the deformation was so severe, that it led to the collapse by post fracture (see example in Figure 4.13). This mode of failure is furthered discussed in Chapter 6, as one of the failed signs was taken as a case study. In that chapter, theories on the mechanism that causes the twisting are offered.

Figure 4.11: Sign facing wrong direction due to permanent twisting deformation

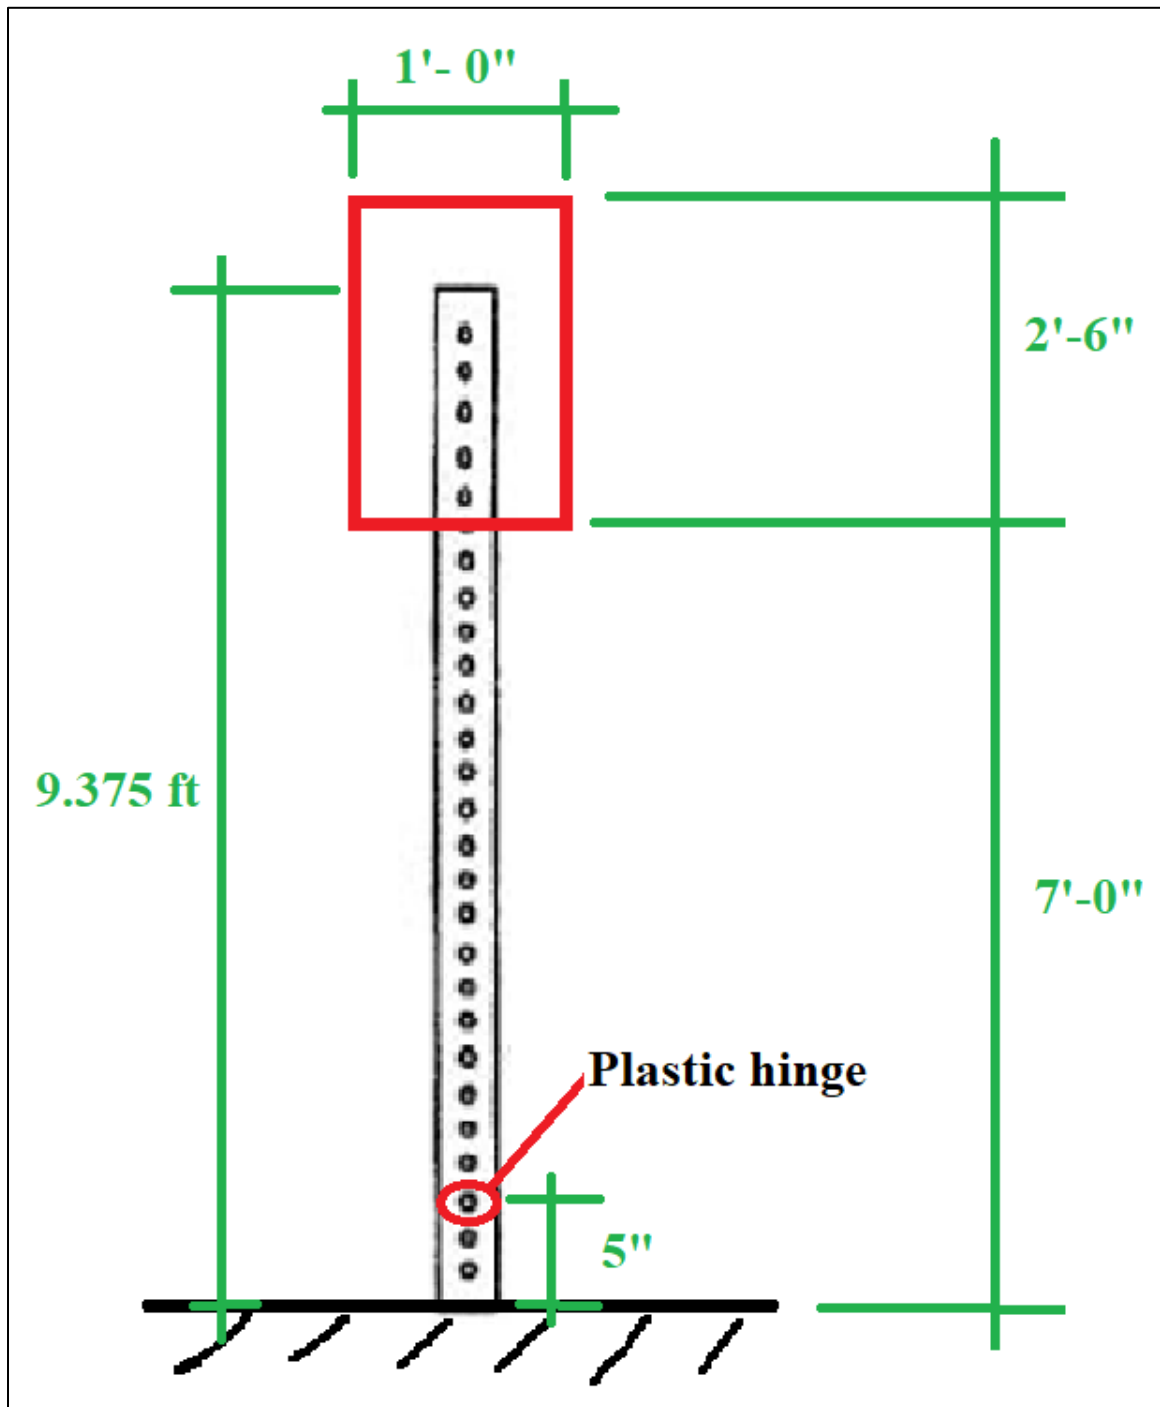
Figure 5.4 shows the geometry of the sign structure, including the dimensions of the sign panel and its elevation above ground. Also included is the location of the plastic hinge, that is, the location where the plastic bending deformation occurred in the square tube post.

Figure 5.4: Case Study 1 geometry

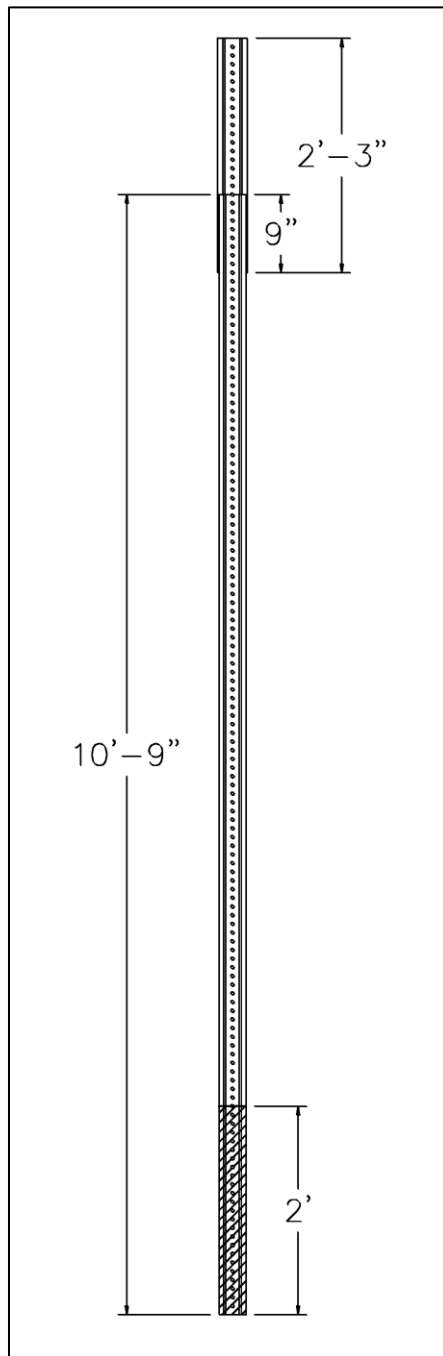
Figure 6.6 shows how the post was installed. What should have been the base post measured 2'-3" and what should have been the top post measured 10'-9". The two posts had an overlap of 9 in, therefore, the total length of the post assembly was 12'-3". The measurement of 2'-0" at the bottom indicate the part of the post that was underground.

Figure 6.6: U-channel post assembly longitudinal dimensions

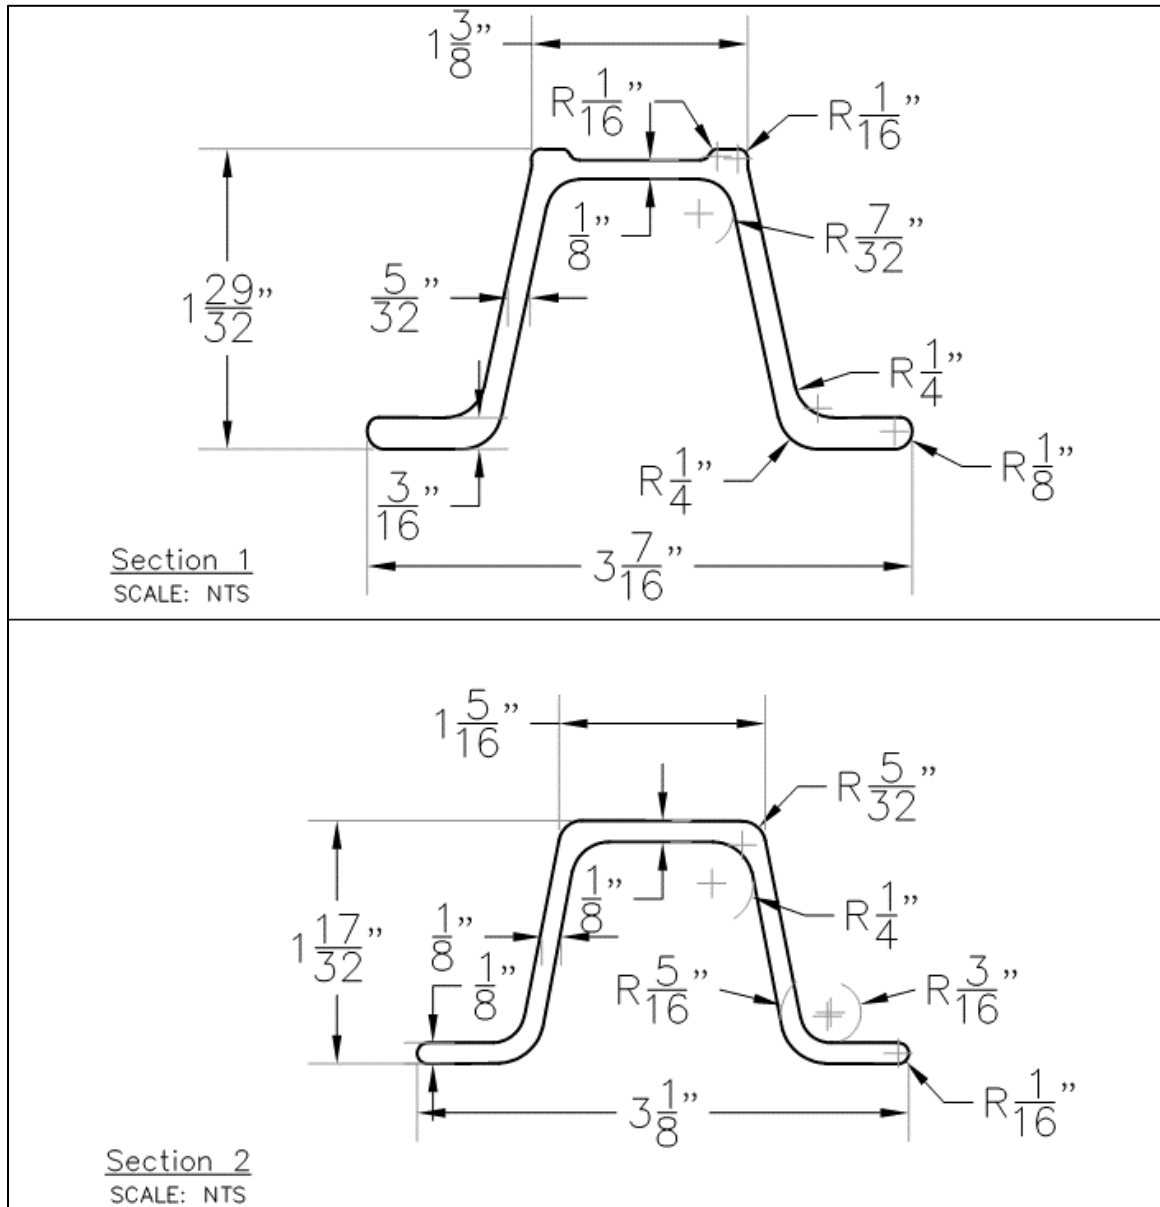
Figure 6.7 shows the dimensions of the cross-sectional areas of the post assembly, as measured in the laboratory. In this figure, Section 1 corresponds to what should have been the base post and Section 2 corresponds to what should have been the top post.

Figure 6.7: U-channel cross-sectional dimensions

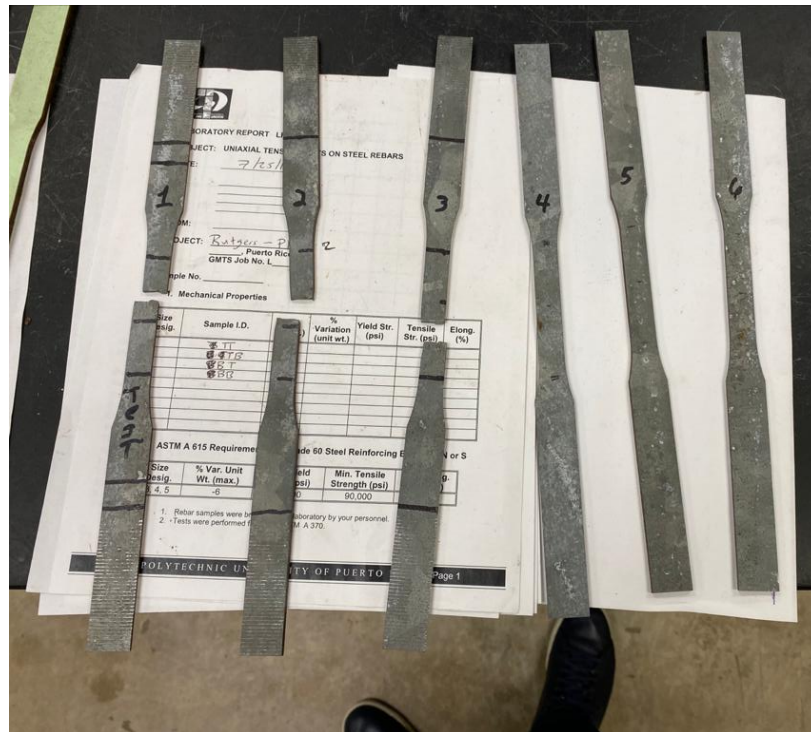
material remained unaffected. The specimens were cut in accordance with ASTM E1575 Standard Practice for Pressure Water Cleaning and Cutting, to then be subjected to tensile tests. Figure 6.8 presents the six specimens, (specimens 1 to 3 had already been tested in tension at the time of the photo). Before the tension test, each specimen was measured for thickness, length, and width; each dimension was taken in three places and then averaged. The results of these measurements are presented in Table 6.1.

Figure 6.8: Specimens extracted from U-channel post

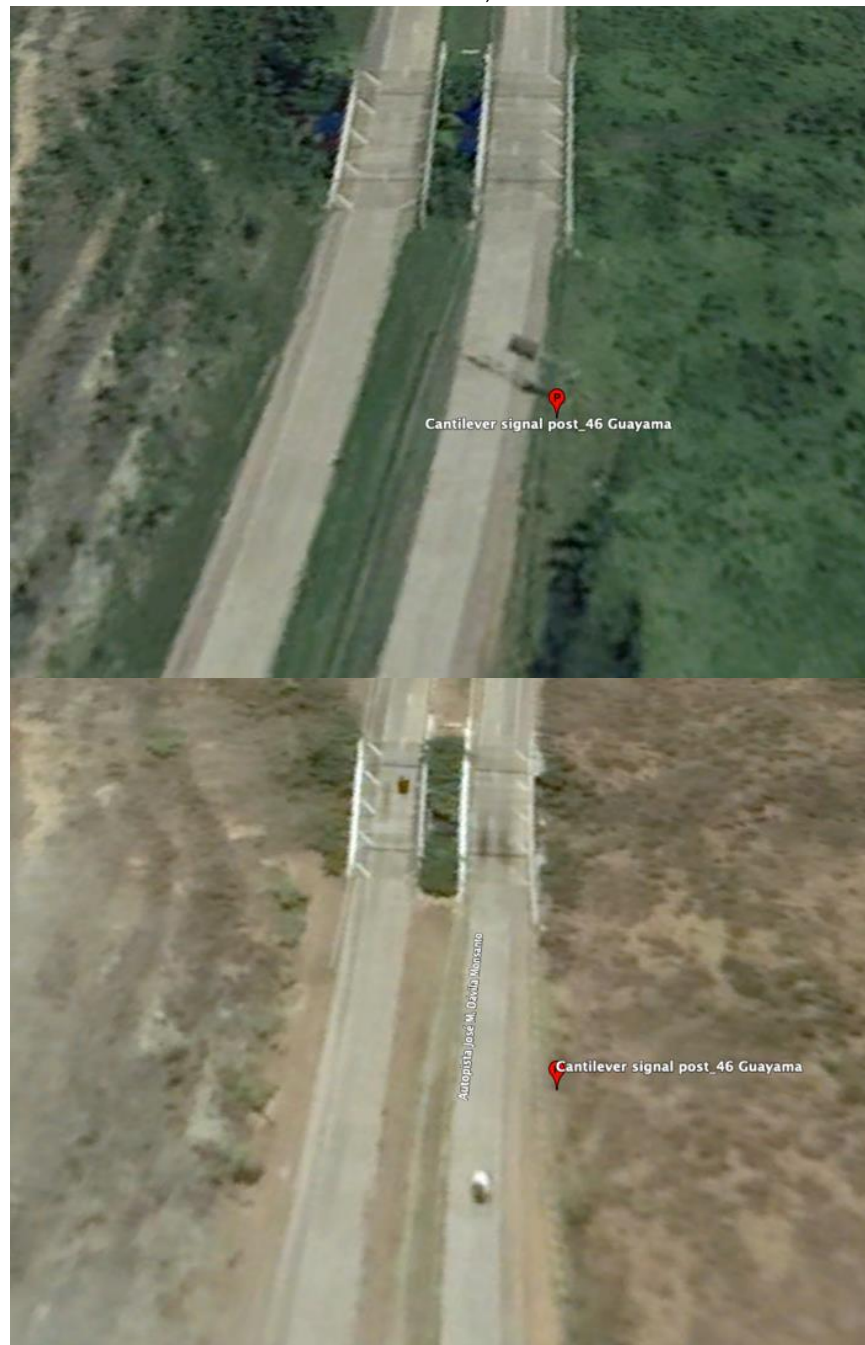
Figure 4-8: Cantilever Sign Post 46 Located in Guayama (Picture 1: 10/2017, Picture 2: 1/2019)

Images in Figure 4-8 were obtained from the research carried out using the program Google Earth Pro, which works with the historical image analysis method, comparing those presented by the 1/2019 program with those of 10/2017. Apparent structural collapse, the sign appeared to be removed from the site.

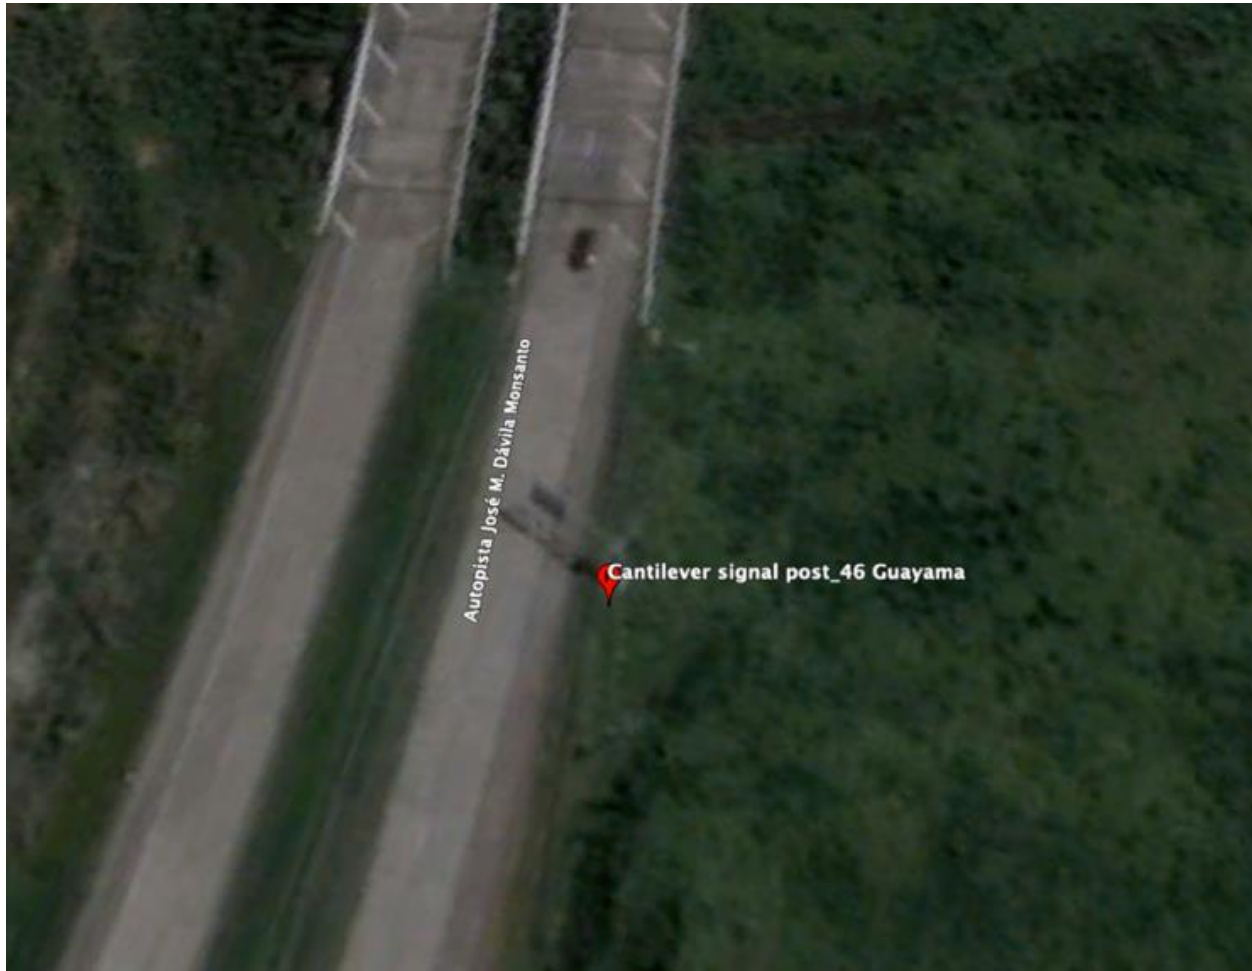
Figure 4-12: Cantilever Sign Post 46 Located in Guayama (Picture 1: 10/2017)

Figure 4-12 were obtained from the research carried out using the program Google Earth Pro, which works with the historical image analysis method, using the image from 10/2017 where the base of the pole identified as P-46 shows a rotation of approximately 20 degrees.

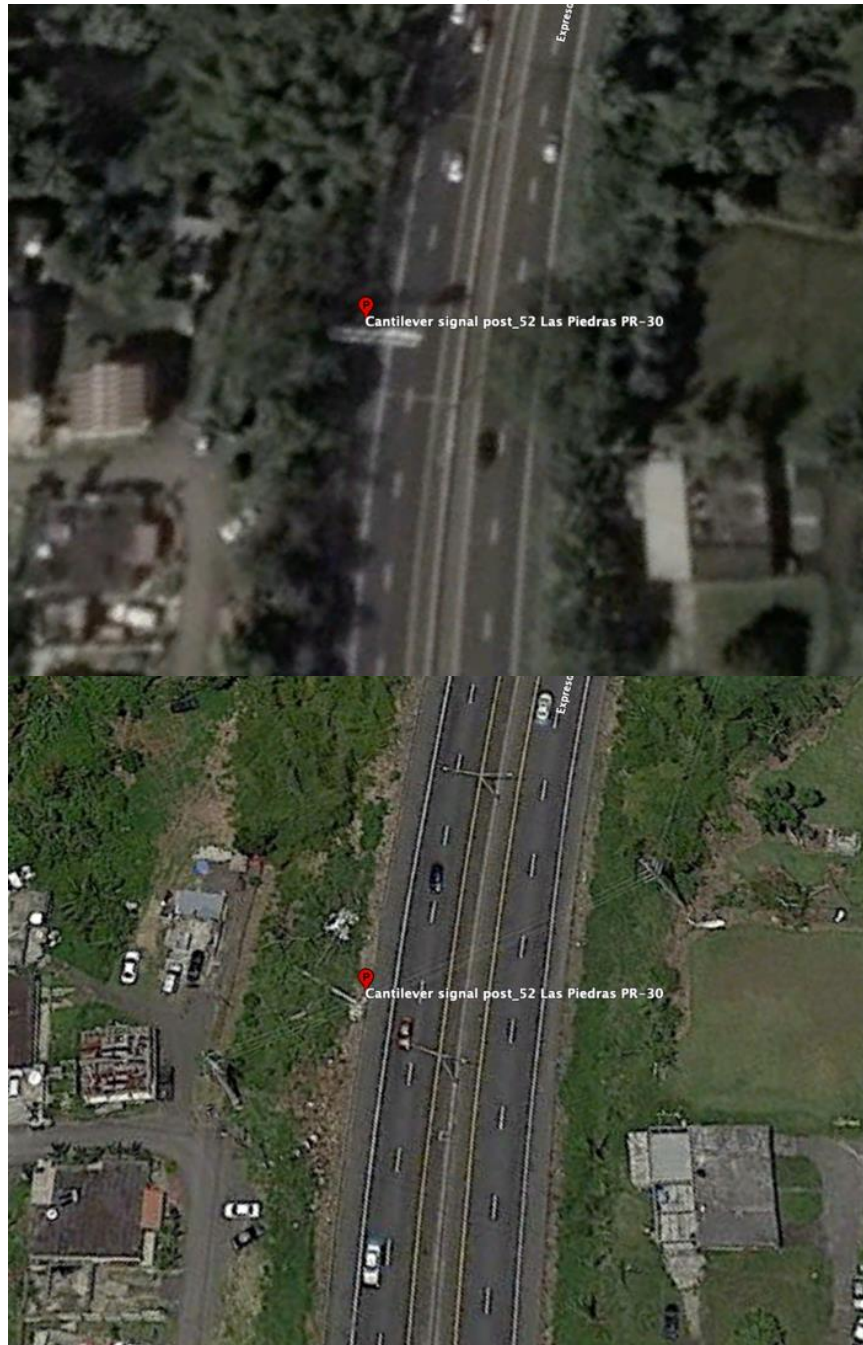
Figure 4-14: Cantilever Sign Post 52 Located in Las Piedras (Picture 1: 1/2014, Picture 2: 4/2018)

Images in Figure 4-14 were obtained from the research carried out using the program Google Earth Pro, which works with the historical image analysis method, comparing those presented by the 4/2018 program with those of 1/2014. This allows to identify a change in position of the post indicating a possible collapse.

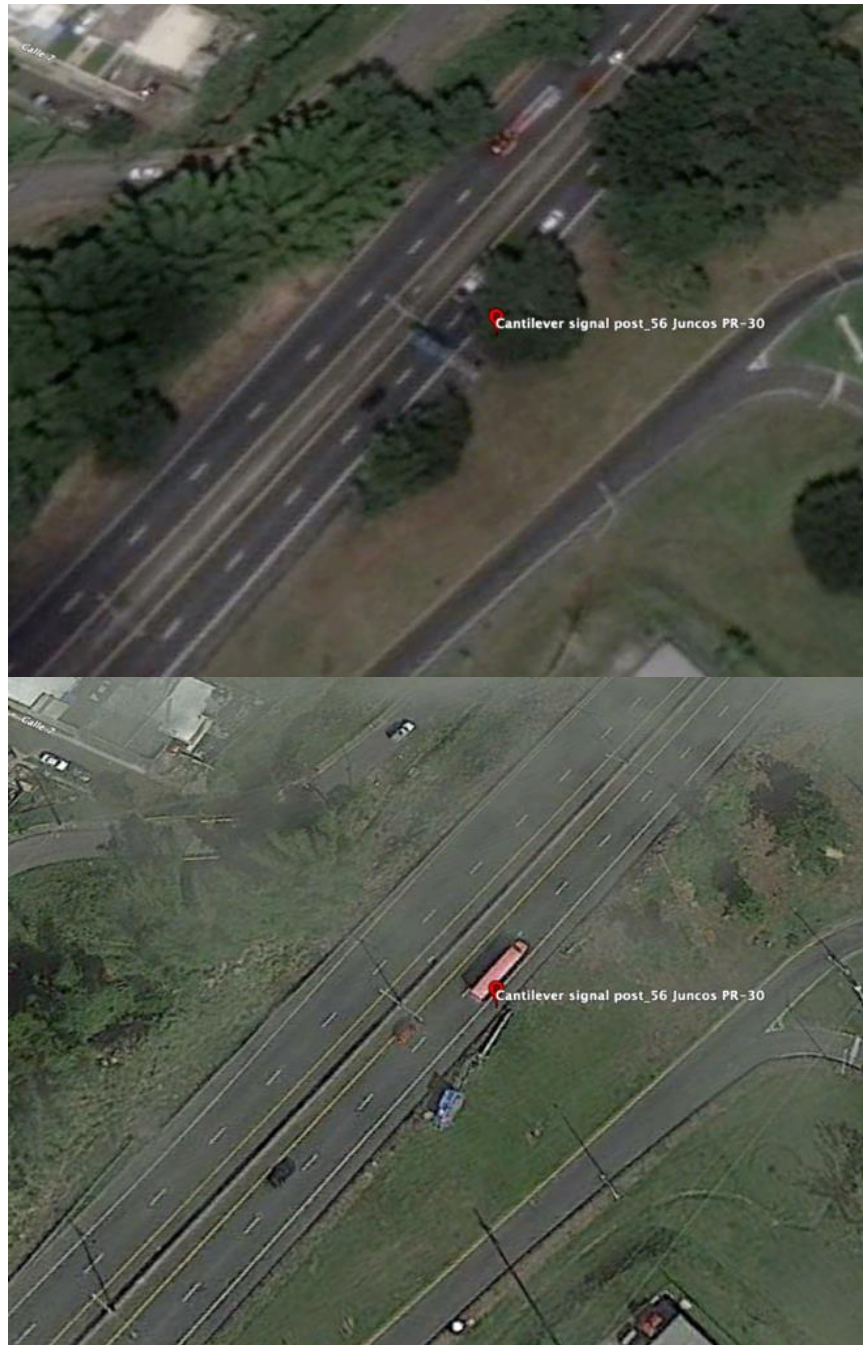
Figure 4-15: Cantilever Sign Post 56 Located in Juncos (Picture 1: 10/2016, Picture 2: 4/2018)

Photos in Figure 4-15 were obtained from the research carried out using the program Google Earth Pro, which works with the historical image analysis method, comparing those presented by the 4/2018 program with those of 10/2016. This allows to identify a change in position of the post indicating a possible collapse.

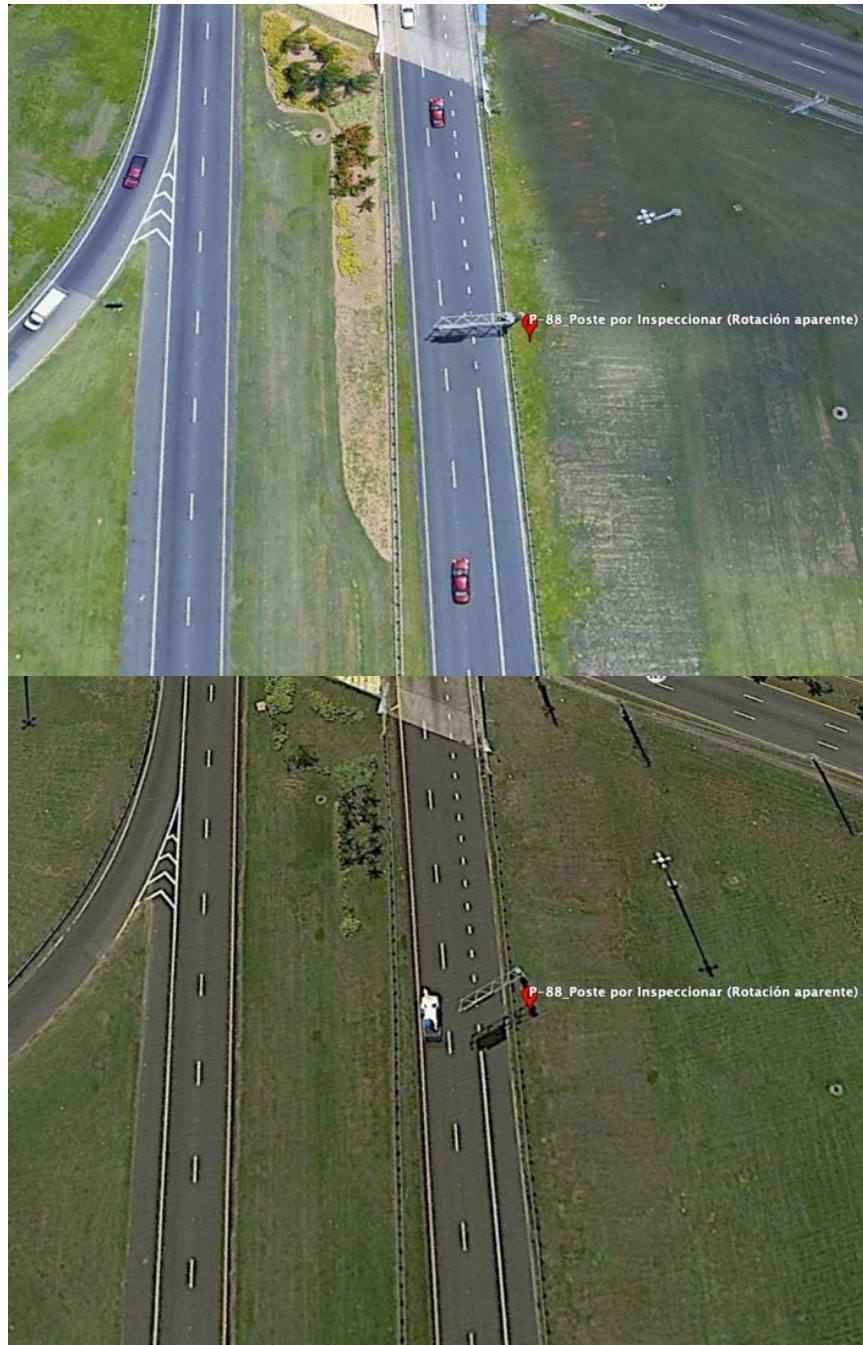
Figure 4-23: Cantilever Sign Post 88 Located in Arecibo (Picture 1: 3/2016, Picture 2 4/2018)

Photos in Figure 4-23 were obtained from the research carried out using the program Google Earth Pro, which works with the historical image analysis method, comparing those presented by the 4/2018 program with those of 3/2016. Cantilever sign foundation failure at P-88 in PR 22_Arecibo. The Cantilever sign rotated approximately 20 degrees.

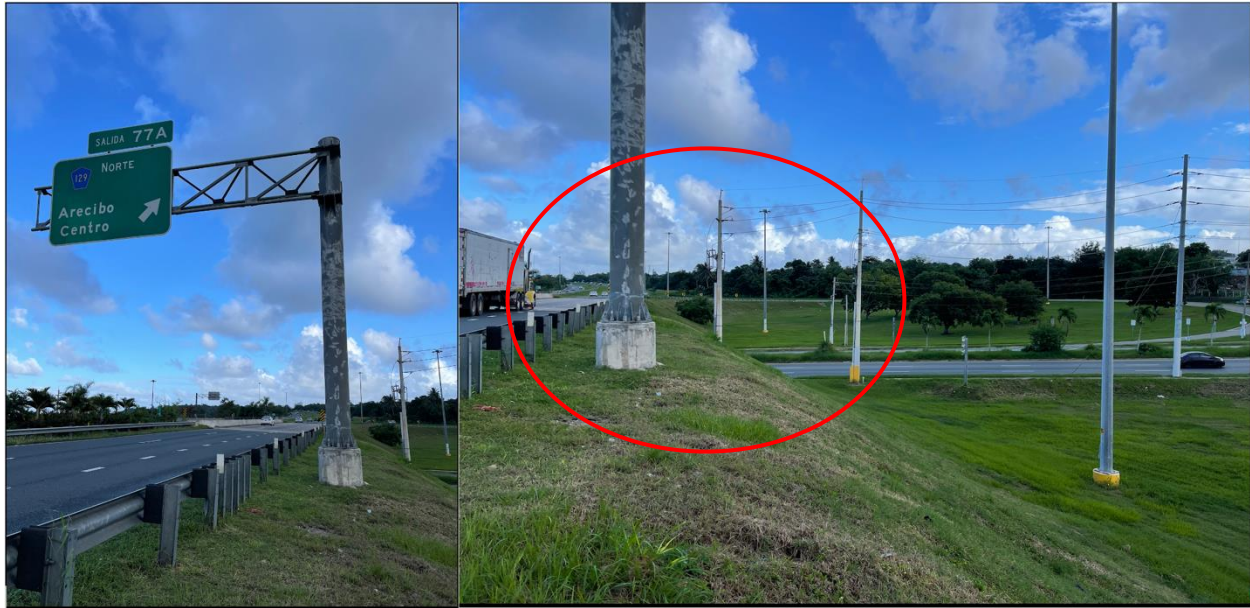
At the time of the field visit no rotation was observed at the base. It appears to have been stabilized and placed in its service position. It was observed that the base of the structure is located at a distance of approximately 2 feet from the beginning of the slope, thus presenting a possible risk of stability in future situations (see Figure 5-16).

Figure 5-16: Cantilever Traffic Sign P-88 at the Time of Inspection
