Improving Transportation Infrastructure Resilience against Hurricanes, other Natural Disasters, and Weathering: Part I - Analysis of failure of transportation signs due to Hurricane Maria

FINAL REPORT
June 2022

Transportation Infrastructure Research Center – TIRC
Polytechnic University of Puerto Rico
377 Ponce de Leon Ave, San Juan, PR 00918

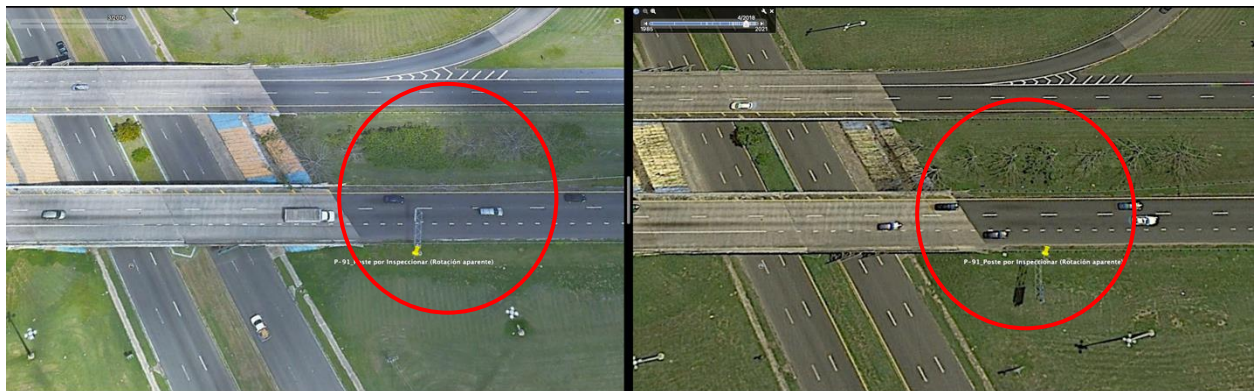
Located along the Highway PR-22 in Arecibo. An image of the traffic sign structure is shown in Figure 5-21, and was obtained from the research carried out using the GIS program (Google Earth Pro) that works with the historical image analysis method, comparing those presented by the 4/2018 program with those of 3/2016. In these an apparent rotation of approximately 180 degrees was identified.

Figure 5-21: Photo of Cantilever Sign Soil Foundation Failure at P-91 Location: 18°27'5.98"N; 66°43'4.13"W (Photo 1 date: 3/2016, Photo 2 date: 4/2018)

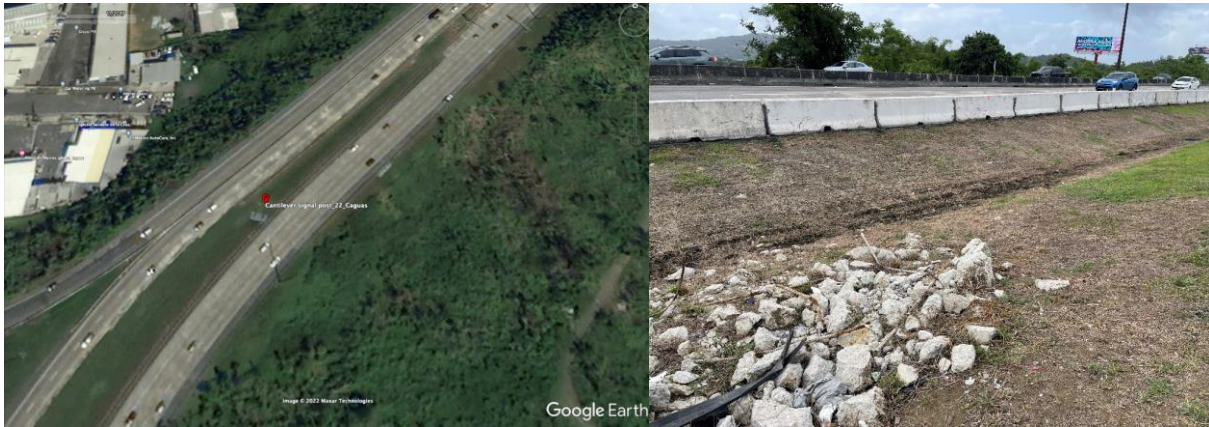
Located along the Highway PR-52 in Caguas, an image of the traffic sign geolocation and the rests of its base foundation structure are shown on Figure 5-27. The sign has been removed at the time of the inspection. The shape of the debris of to the concrete base suggest that large lateral displacement of the anchor bolts due to post torsional rotation took place and trigger the collapse.

Figure 5-27: Photos of Cantilever Traffic Sign Geolocation and Rests of the Post Foundation at P-22. Location: 18.27201944N; -66.03914444W

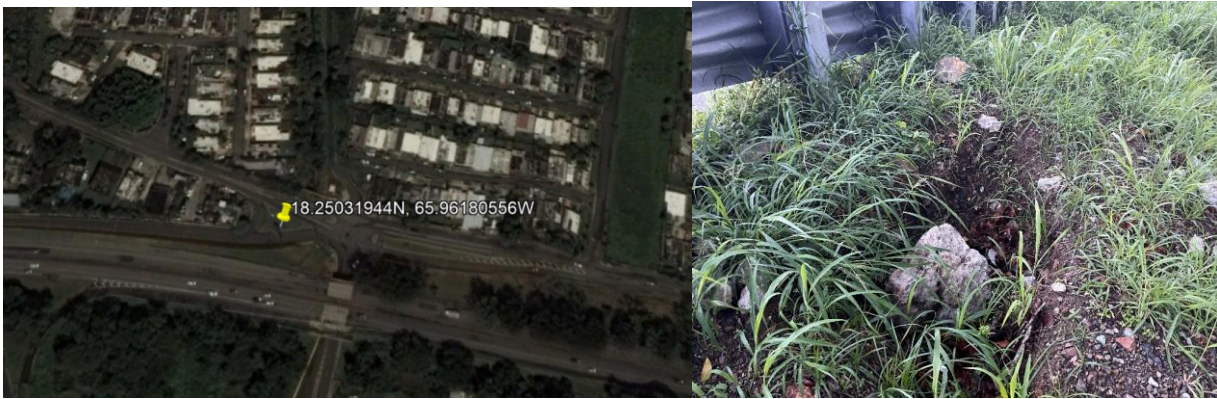
Located along the Highway PR-30 in Gurabo. An image of the traffic sign structure location and the rests of the concrete pedestal are shown on Figure 5-41. At the time of the visit only rests of a concrete pedestal were found. A total collapse due to pedestal structural failure was assumed.

Figure 5-41: Photo of Cantilever Sign Structural Failures on the Pedestal at P-57 Location: 18.25031944°N; 65.96180556°W

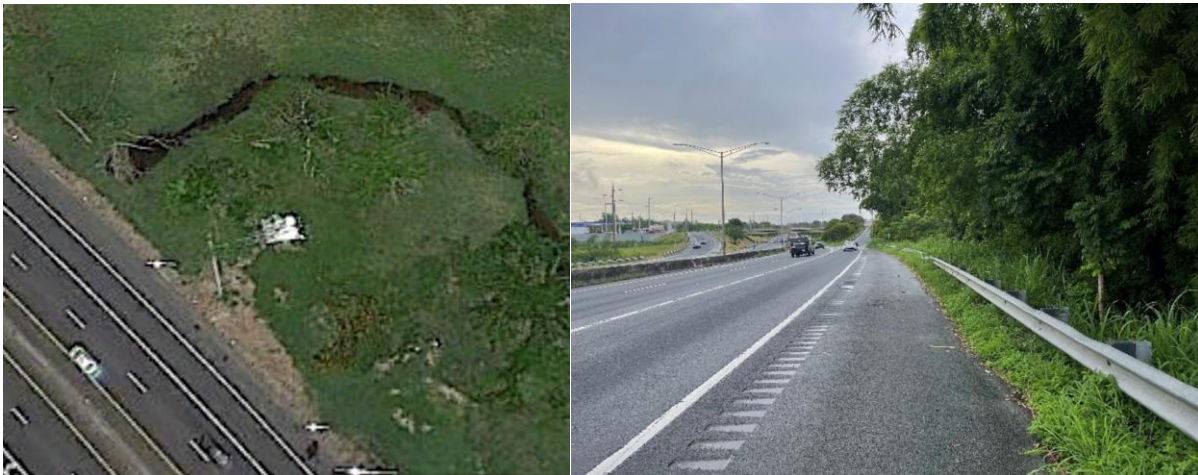
Located along Highway PR-30 in Las Piedras. A satellite image of the traffic sign structure is shown on Figure 5-56. The final position of the traffic sign showed a rotation around the vertical zenith axis and a total collapse. Figure 5-56 also presets that there were impact damages on the traffic barriers, possible due to the collapse of the sign. Due to narrow shoulders and traffic, the site was considered not safe to perform a more detailed inspection, but the post was already removed by the time of the field visit.

Figure 5-56: Photo of Cantilever Sign Collapse at P-99 Location: 18.183386°N; 65.88572°W

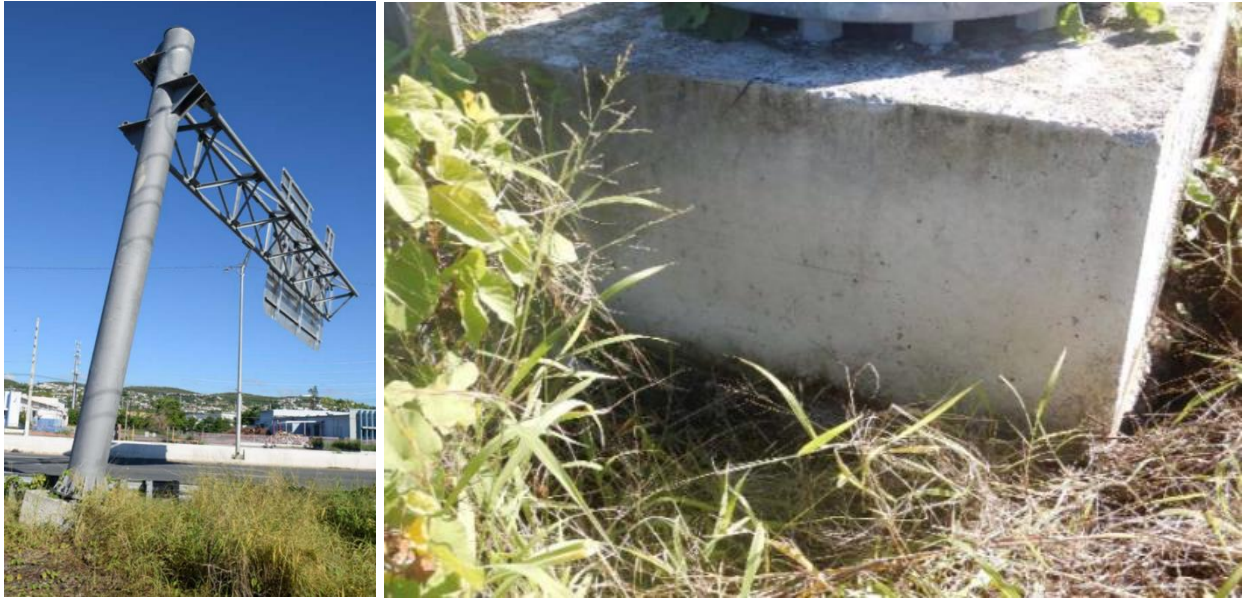
The Cantilever traffic was located just north of the city of Ponce along the southbound lanes of Highway PR-2. An image of the rotated state of this structure is shown on Figure 5-61. The foundation system at this site was not confirmed, as it was only possible to see a square pedestal, as shown in Figure 5-62. The sign was rotated (by about -30 degrees) and a gap between the top pedestal and the surrounding ground was observed, as shown on the images in Figure 5-62, but the concrete pedestal was not damaged, and the anchor bolts did not exhibit noticeable lateral deflections. This behavior leads to the assumptions that its foundation was the same that other exhibiting the same pattern of movement (precast cylindrical drilled shafts).

Figure 5-62: Photo Showing the Rotation of The Traffic Sign and the Foundation Pedestal at P-94

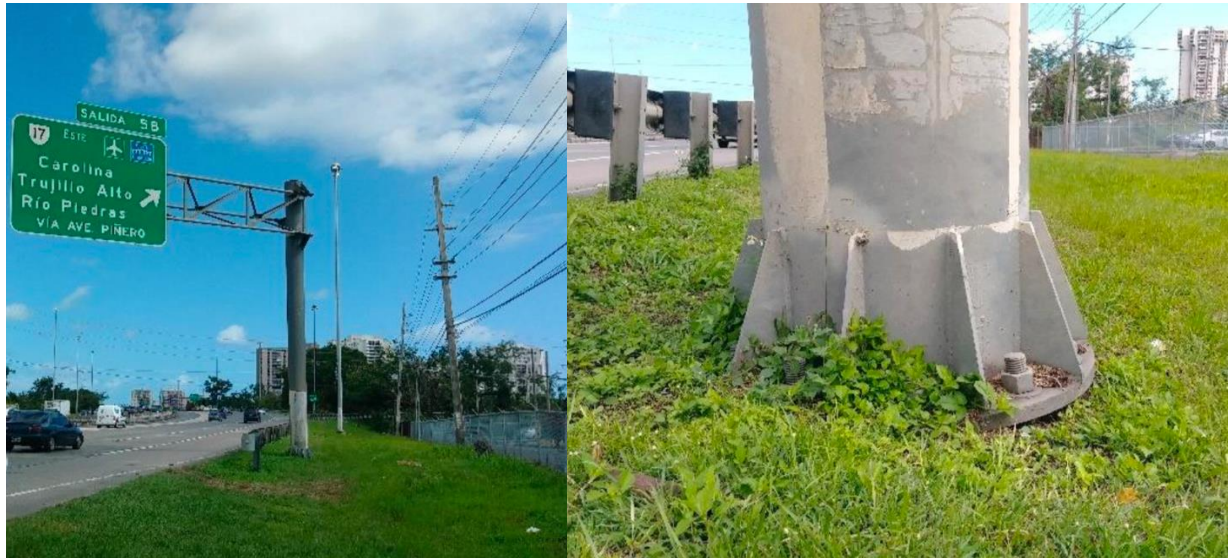
Located along the Highway PR-18 in San Juan. An image of the traffic sign structure is shown on Figure 5-69. The visual inspection revealed that the Cantilever sign rotated approximately 30 degrees about the vertical zenith axis. In addition, the connection of the base to the pedestal did not have the non-shrinkable grout material installed that must be placed between the base plate and the concrete base, to evenly distribute the loads and stresses on the concrete base.

**Figure 5-69: Photo of Cantilever Sign Soil Foundation Failure (Torsional Rotation) at P- 35 Photo Location:
18°24'16.37"N; 66° 4'11.96"W**

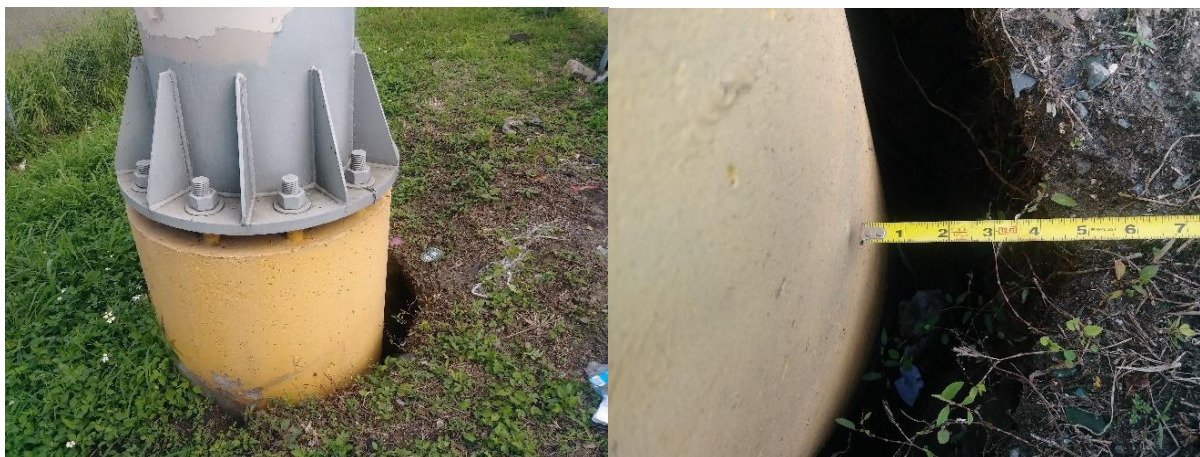
Located along the Highway PR-18 in San Juan. An image of the traffic sign structure is shown on Figure 5-73. The concrete base rotated 90 degrees about the vertical zenith axis, and also reflected an inclination (out of plumb) towards the bottom of the slope. In the visual inspection, it was identified that the base did not have the non-shrinkable grout material installed that must be placed between the base plate and the concrete base, to evenly distribute the loads and stresses on the base of concrete. The base was detached from the ground, creating a gap of around 3.5-4.0 in. This dimension was variable around the perimeter of the cylindrical foundation (See Figure 5-74). The granular fill material or clean sand indicated in the specifications was not identified. It was observed that part of the earth slope had experienced movement downwards (the soil located approximately 0.45 m downslope from the post) (See Figure 5-74).

Figure 5-74: Gap Around the Circumference of the Drilled Shaft, and Soil Movement Downhill

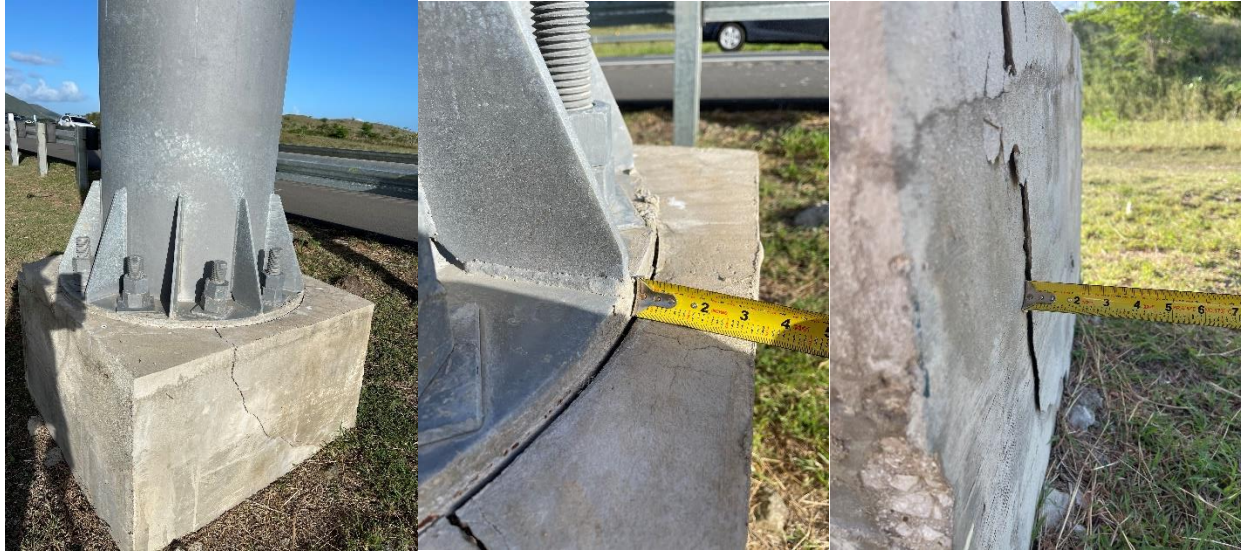
Located along the Highway PR-52 in Santa Isabel. An image of the traffic sign structure is shown on Figure 5-82. The field visit revealed that the pedestal had cracks, as presented in Figure 5-82 and Figure 5-83. These cracks are consistent with the ones produced by anchor bolts and/or base plate movement.

Figure 5-83: Photo of Cantilever Sign Location Pedestal Cracks at P-10

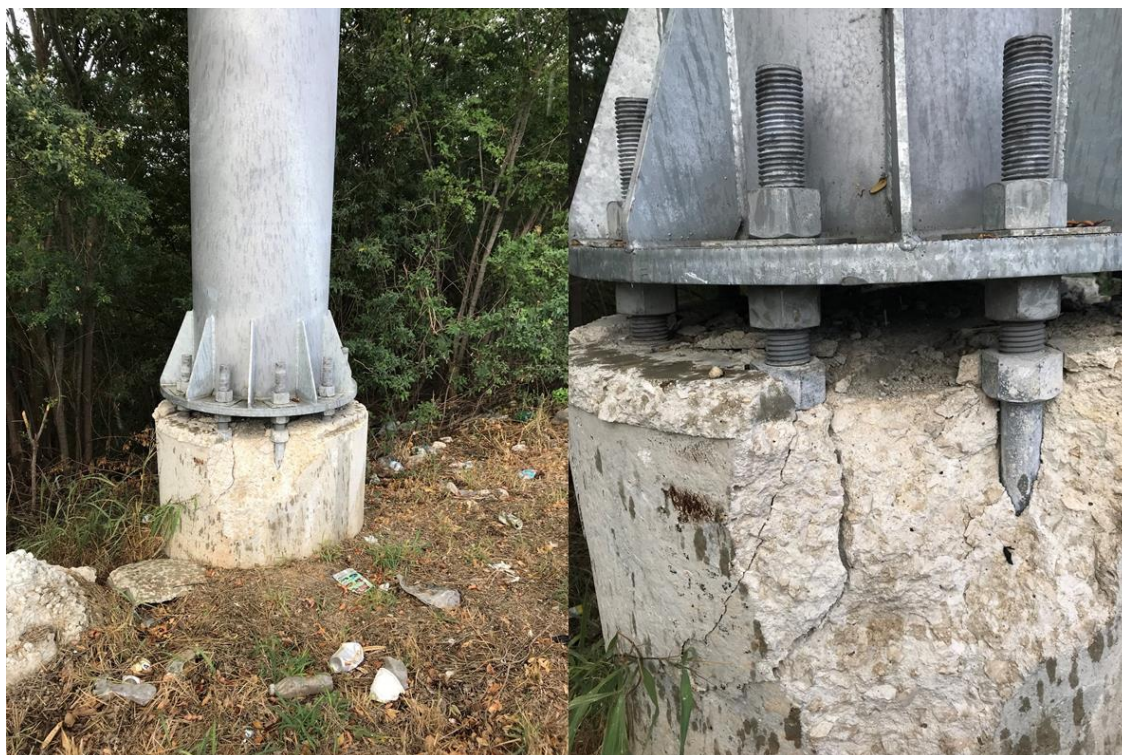
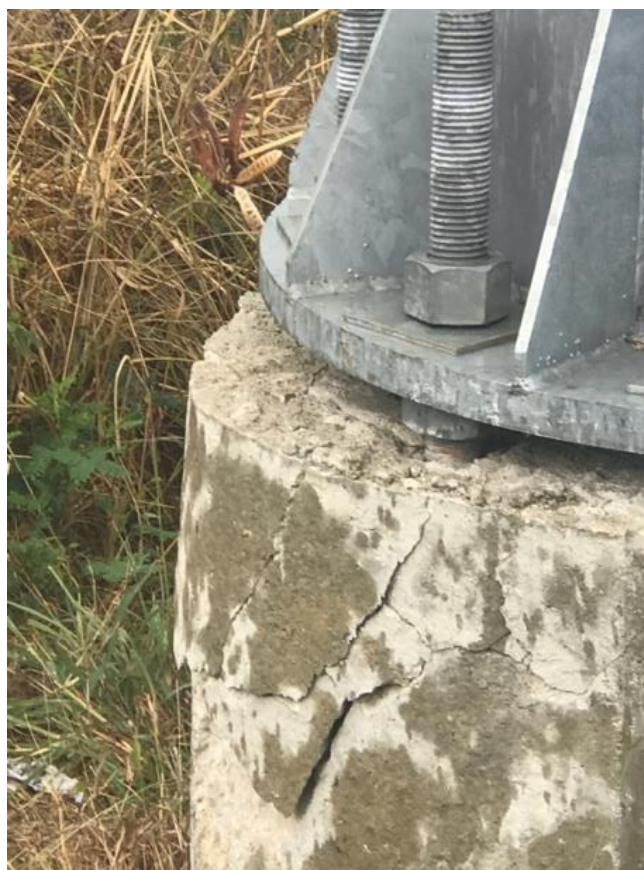
In Figure 6-1, Figure 6-2, and Figure 6-3 one can appreciate the initial stages of pedestal damages due the torsional rotation of the post base plate, presenting cracks and spalls on the concrete triggered by the lateral deflections of the anchor bolts that exerted tension stresses on the concrete. In all these three cases the bolts did not exhibit significant deflections in the plastic regimen.

Figure 6-1: Initial Stages of Concrete Cracks and Spalls due to Lateral Deflections of Anchor Bolts (Sign P-1)

Figure 6-2: Initial Stages of Concrete Cracks and Spalls due to Lateral Deflections of Anchor Bolts (Sign P-3)

Figure 6-3: Initial Stages of Concrete Cracks and Spalls due to Lateral Deflections of Anchor Bolts (Sign P-76)

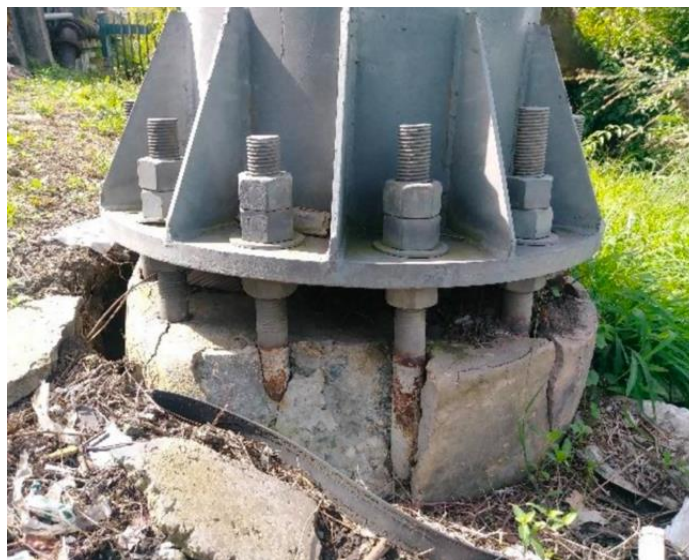
Figure 6-4, Figure 6-5, and Figure 6-6 present more advance situations of pedestal damages due the torsional rotation of the post base plate. In the first two cases the bolts did not exhibit significant defections in the plastic regimen, but in the third one the plastic deformations are present, and the double bending shape of the bolts starts to be identifiable. The large distance between the last stirrup (last lateral support of the anchor bolts) and the base plate also started to be evident.

Figure 6-4: More Advance Stage of Concrete Cracks and Spalls due to Lateral Deflections of Anchor Bolts with Large Unconfined Length (Sign P-38)

Figure 6-5: More Advance Stage of Concrete Cracks and Spalls due to Lateral Deflections of Anchor Bolts with Large Unconfined Length (Sign P-41)

Figure 6-6: More Advance Stage of Concrete Cracks and Spalls due to Lateral Deflections of Anchor Bolts with Large Unconfined Length. Bolts Exhibit Double Bending Shape (Sign P-15)

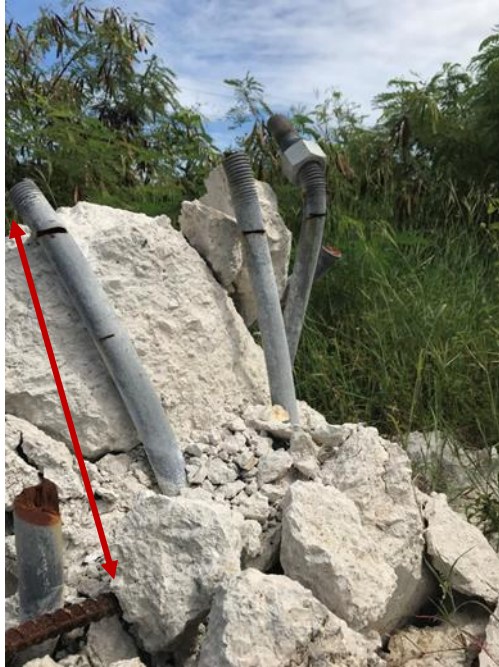
Significantly more advanced situations of damages, presenting extremely large deflections of the anchor bolts on the plastic regimen, large cracks, spalls, and deterioration of the concrete, and partial or total collapse of the traffic sign structure are displayed in Figure 6-7 to Figure 6-11. The images clearly present the double bending of the anchor bolts in the plastic range, and the large distance between the base plate of the post and the first stirrup that provides lateral support to the bolt. The images also show that in some cases the base plate did not only rotate in torsion (about the vertical axis) but also in bending (about the horizontal axis), producing crushing to the concrete, and pull out of the anchor bolts.

Figure 6-8: Large Deflections of Anchor Bolts due to Lack of Lateral Confinement

Figure 6-9: Large Deflections of Anchor Bolts due to Lack of Lateral Confinement (Sign P-12)

Figure 6-10: Large Deflections of Anchor Bolts due to Lack of Lateral Confinement (Sign P-12)

These damages and failures indicate that the confinement of the anchor bolts is essential to avoid damages. And that the specifications for stirrups separation, separation between the last stirrup and the base plate, and details of the top of the pedestal to avoid these lateral movement is of extremely importance. In several cases, the observed distance between the top stirrup and the base plate did not comply with PRHTA specifications (see Appendix C for details); a strict inspection and quality control during sign installation is also imperative.

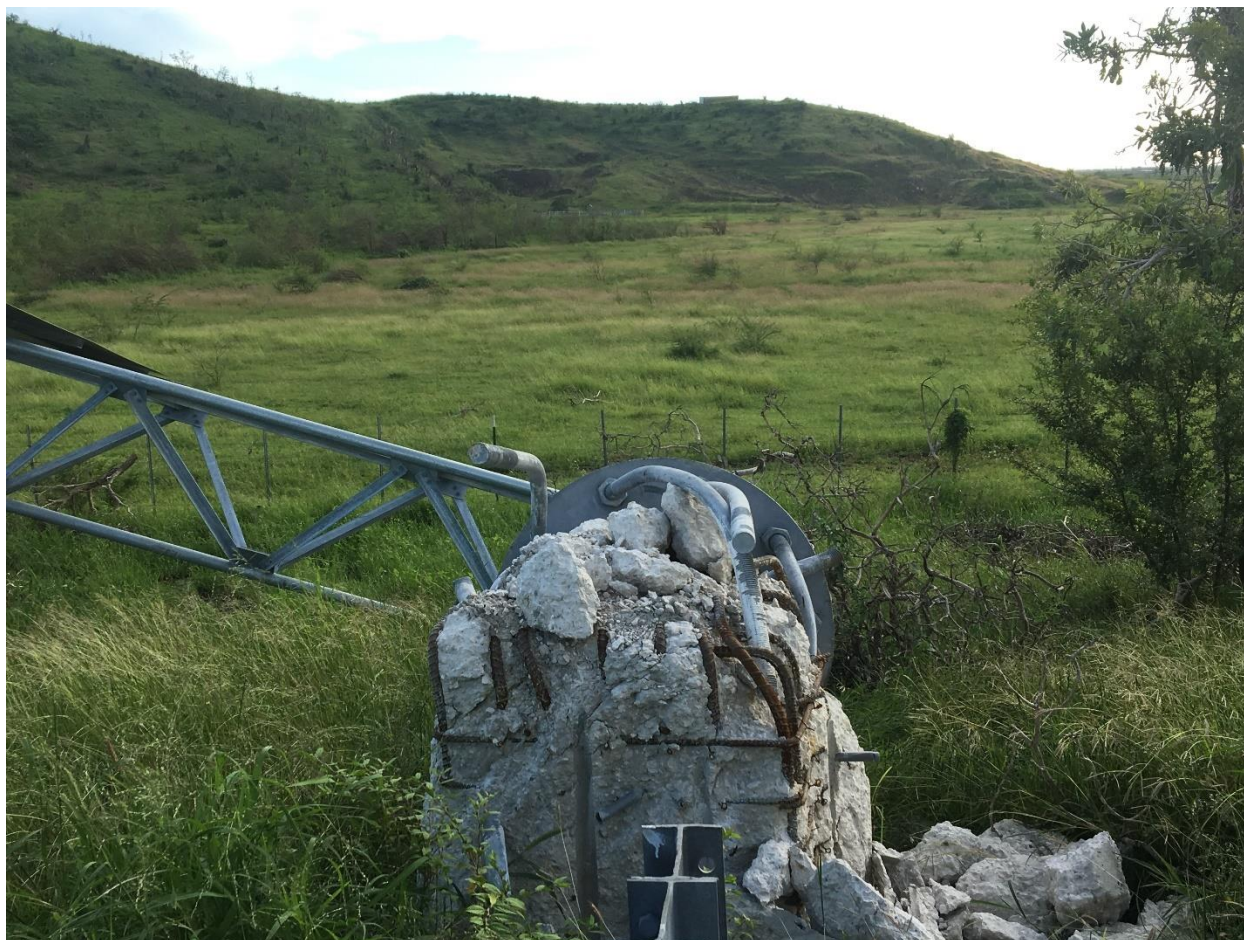
The field inspection also revealed that in several situations the anchor bolts were placed outside the concrete core confined by the stirrups (transverse reinforcement). This condition made these signs more vulnerable. Figure 6-12 to Figure 6-14 are examples of this situation.

Figure 6-13: Some of the Anchor Bolts Outside the Transverse Confinement Steel / Concrete Core (Sign P-100)

The observed location of the anchor bolts strongly suggests that a review of the final proposed design for the foundation of this traffic signs, and a strict inspection and quality control during sign installation are imperative.

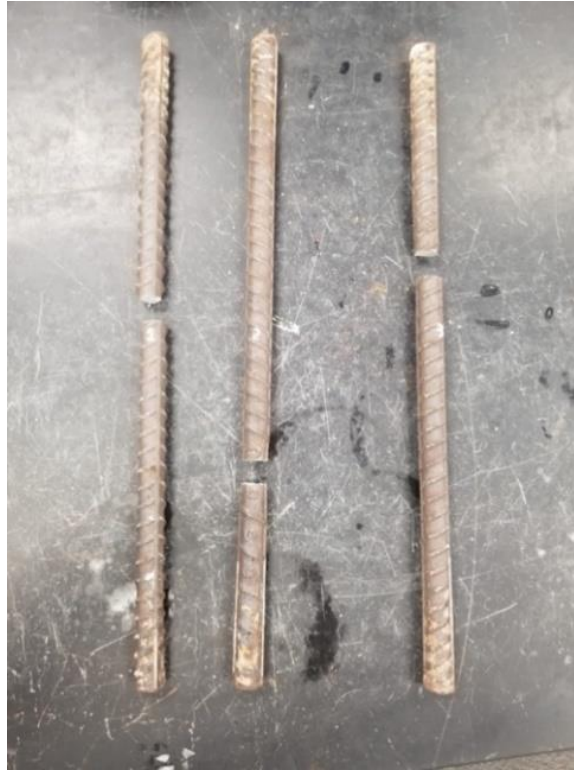
The specimens were subjected to tension until fracture to obtain their maximum capacity (ultimate stress). Figure 8-3 shows the three specimens after the test, where one can appreciate the

typical necking in the vicinity of the rupture surface, while Figure 8-4 presents a partial display of the stress-strain diagram provided by the tension equipment, in the region of yielding.

Figure 8-3: Reinforcing steel specimen after test was conducted

The results of the tests are summarized in Table 8-1. The average ultimate stress resulted 75,762 psi, this being a representative value of a grade 60 reinforcing steel, which is the one required by the PRHTA standards for this type of signs.

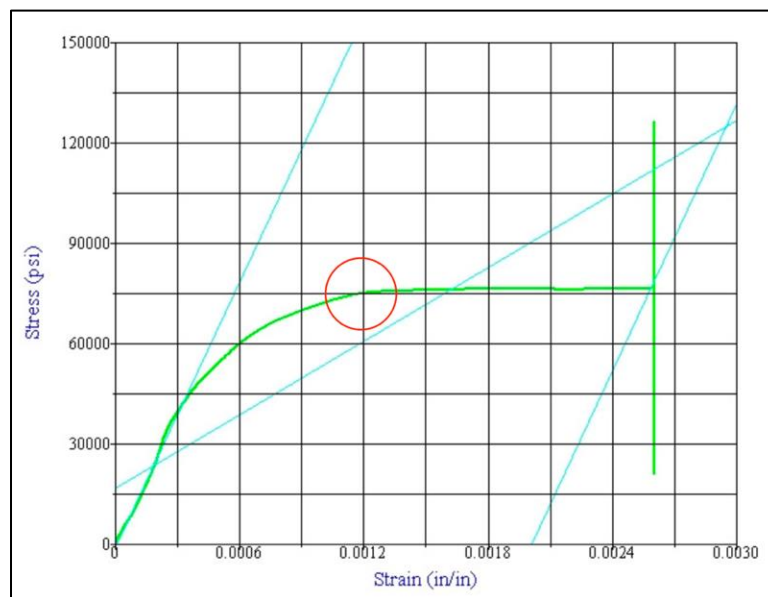
Figure 8-4: Partial Display of the Stress-Strain Diagram for One Rebar #6

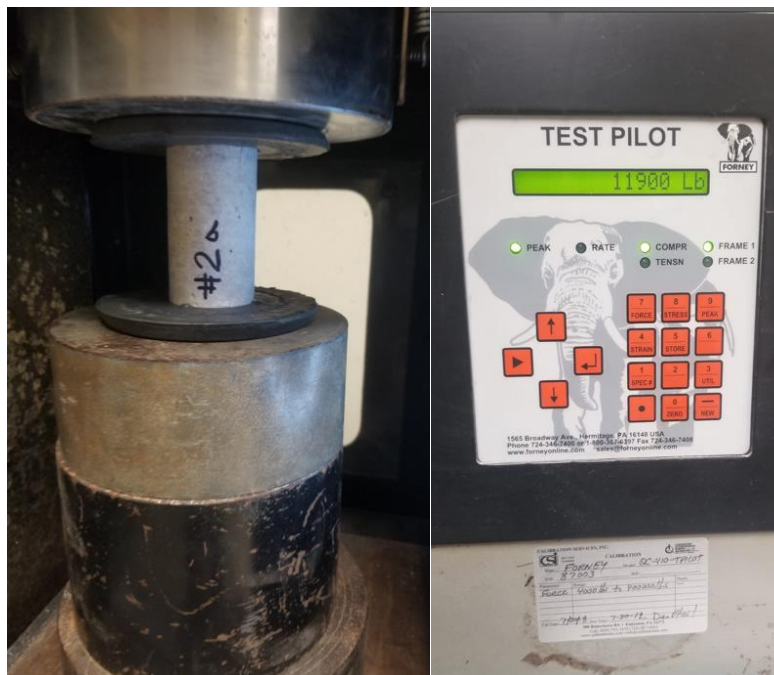
Figure 8-13 Compression Test on Extracted Core

For the interpretation of the results, the estimation of the f'_c was made through the criteria of ACI 318-S14, section 26.12 “Evaluation and acceptance of concrete”. The results of the tests carried out are summarized in Table 8-2; an average f'_c of 3,823 psi was obtained; this strength complies with the specifications in PRHTA standards for the foundations of these signs which requires 3,000 psi.
