Improving Transportation Infrastructure Resilience Against Hurricanes, Other Natural Disasters, and Weathering: Part II - Analysis of Pedestrian Bridges Failures Due to Hurricane Maria

Volume 1

FINAL REPORT
August 2021

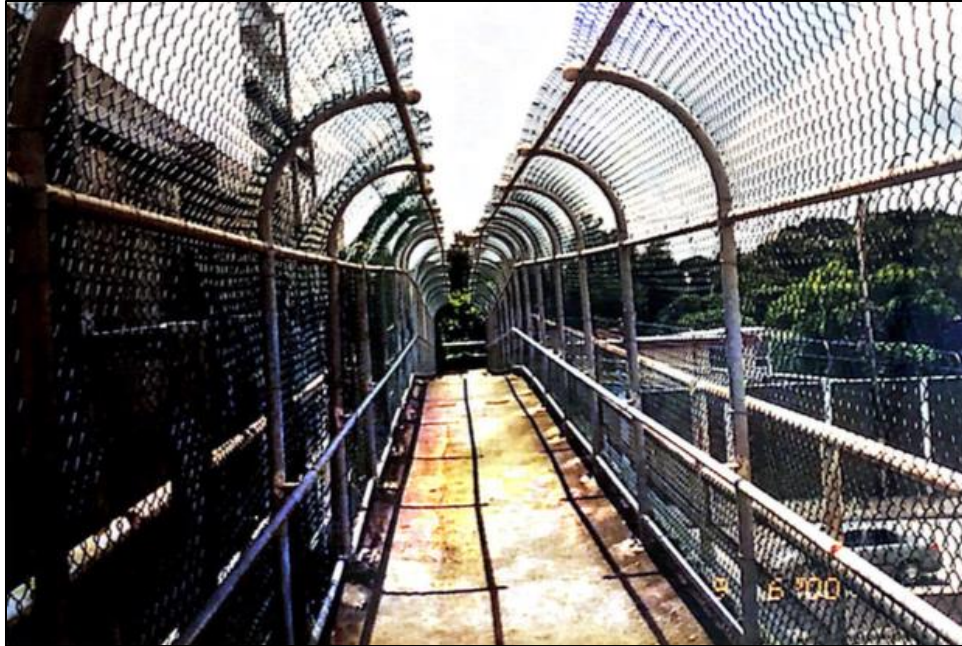
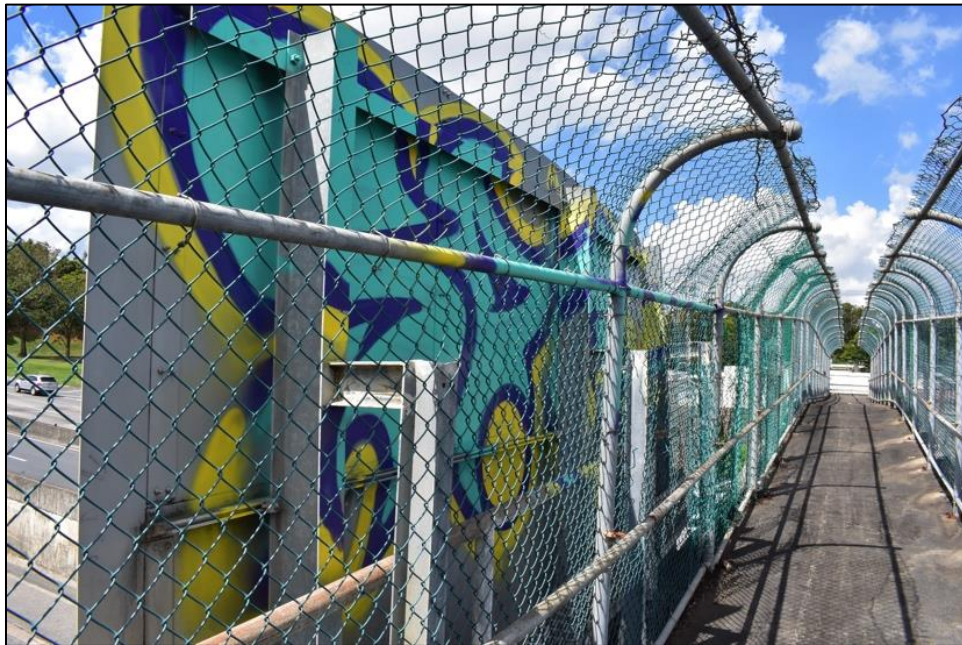
To detect if the bridge suffered any major deformations due to Hurricane Maria, old photographs from PRHTA were compared to pictures taken in 2019. One such comparison can be made between a photo of the walkway from 2000 (Figure 5.9) and a another from 2019 (Figure 5.10). No deformation in the structural elements was detected from the comparison of photographs.

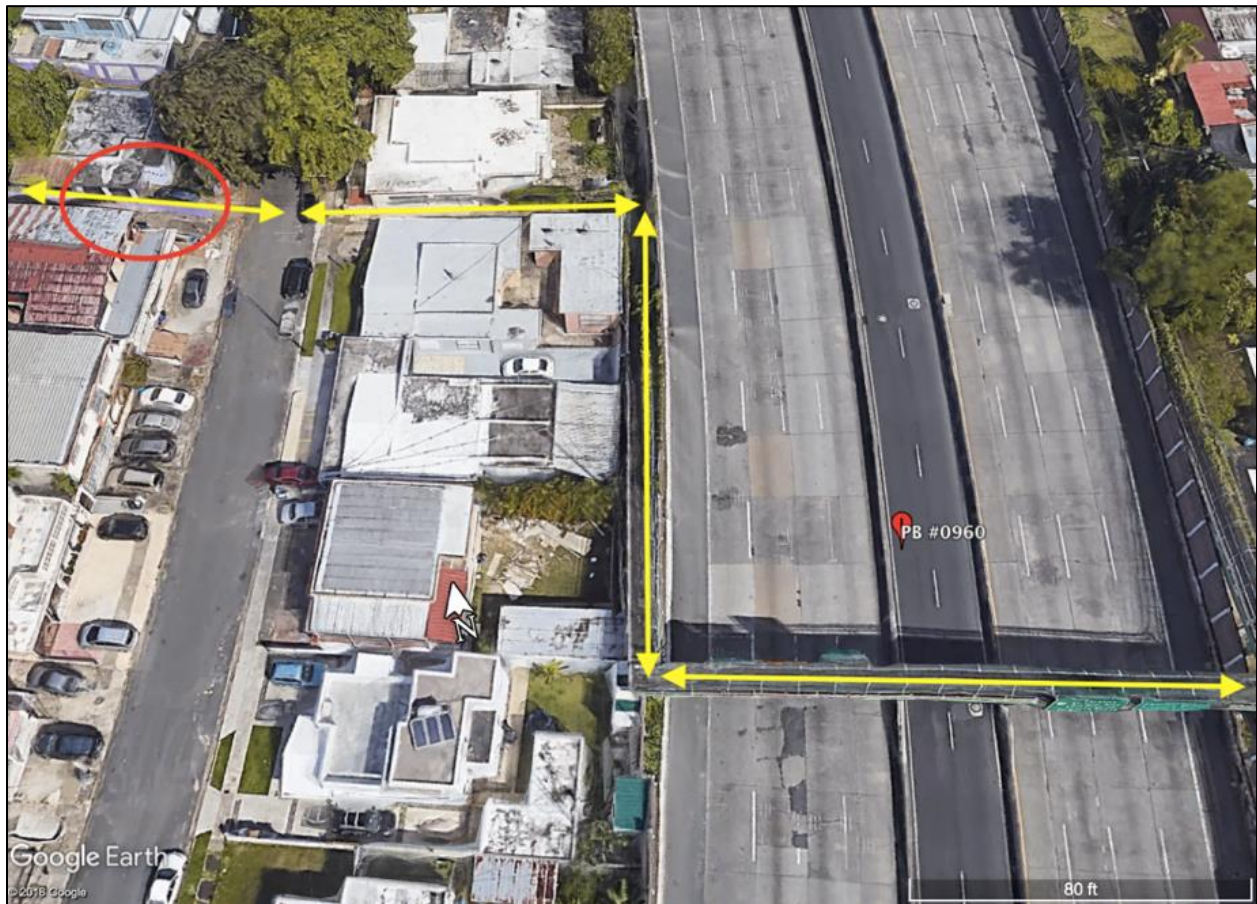
During the visit, a neighbor approached the inspection team and expressed concern for the safety of the people that use the bridge. One of the concerns was that the sidewalk (at the location indicated in Figure 5.11) used to approach the bridge ramp on the west side has a hole with a depth of more than 1 ft. This hole was covered with a pallet, as shown in Figure 5.12. In the same area, a section of the sidewalk has sunk, as shown in Figure 5.13. Other observations made by the inspection team were the growing vegetation on the chain-link fence of the ramp (see Figure 5.14) and presence of corrosion on the support bases of the chain-link fence (see Figure 5.15).

Figure 5.11: Pedestrian path with the red circle indicating location of tripping hazards (Source: Google Earth Pro)

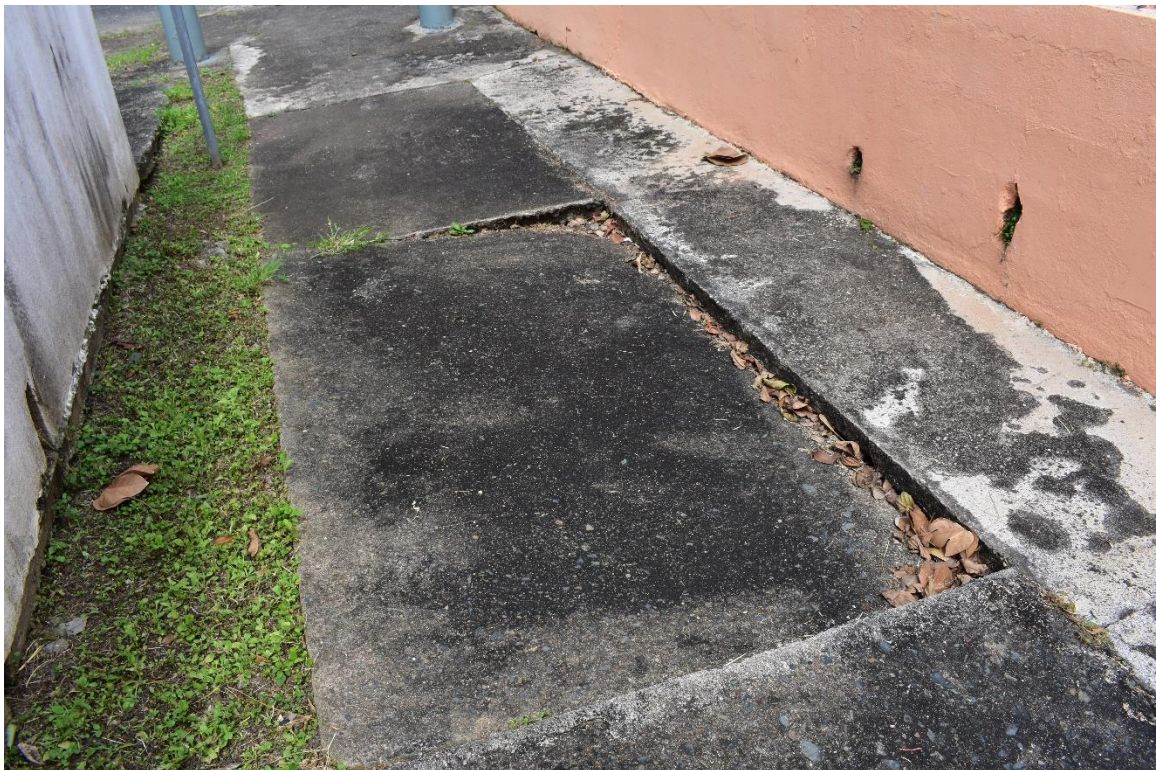
Figure 5.13: Sunk section of sidewalk

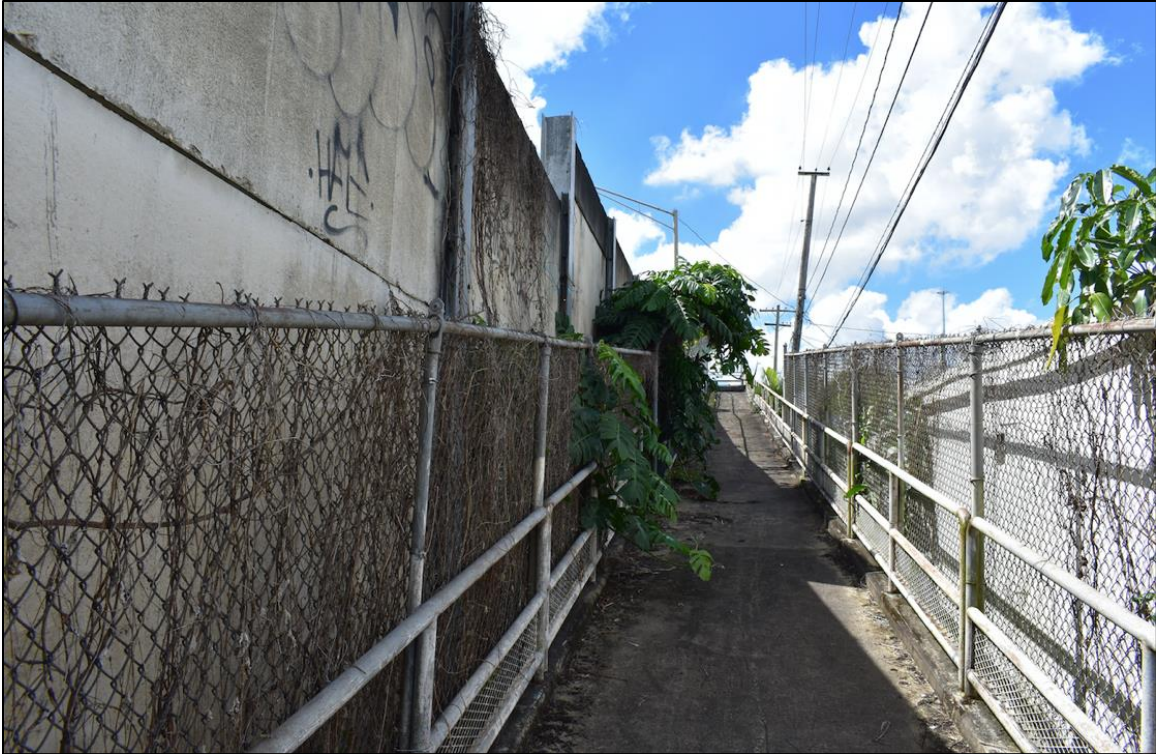
Figure 5.14: Vegetation in chain-link fencing

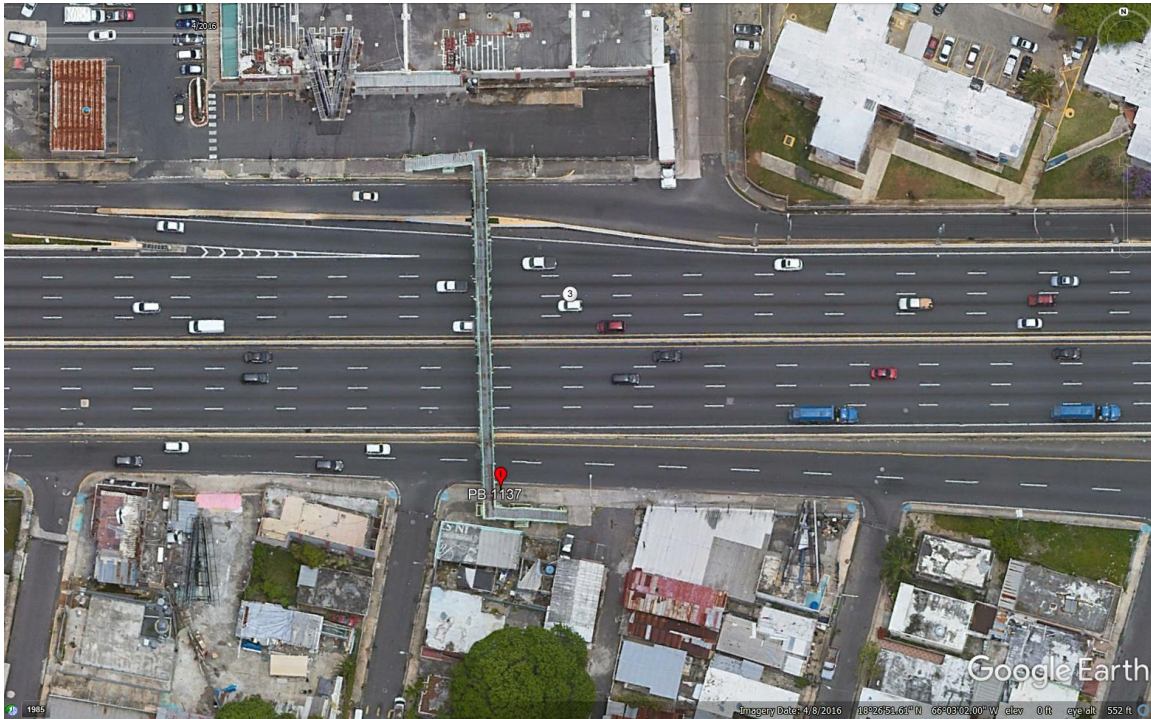
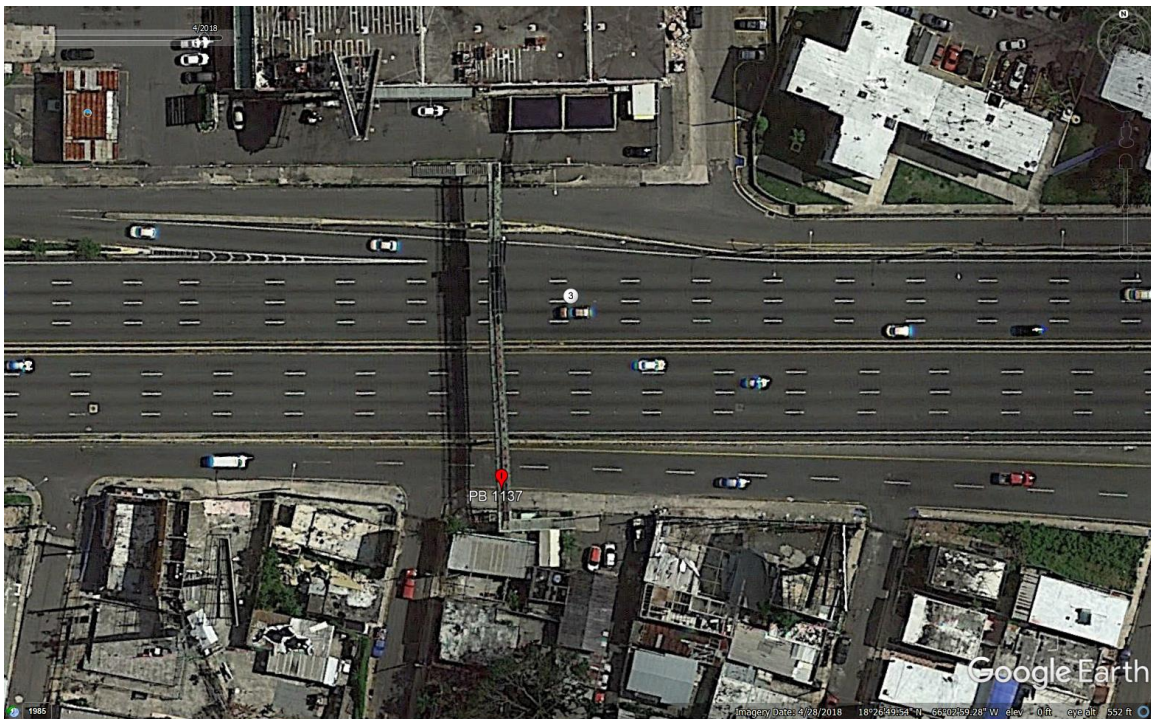
To detect if the bridge suffered any major deformations due to Hurricane Maria, photographs from before and after the hurricane were compared. Examples of these are the comparison that can be made between Figure 5.34 and Figure 5.35, and between Figure 5.36 and Figure 5.37. By the

comparing the photographs, it is appreciated that the bridge experienced lateral deflections in the plastic range.

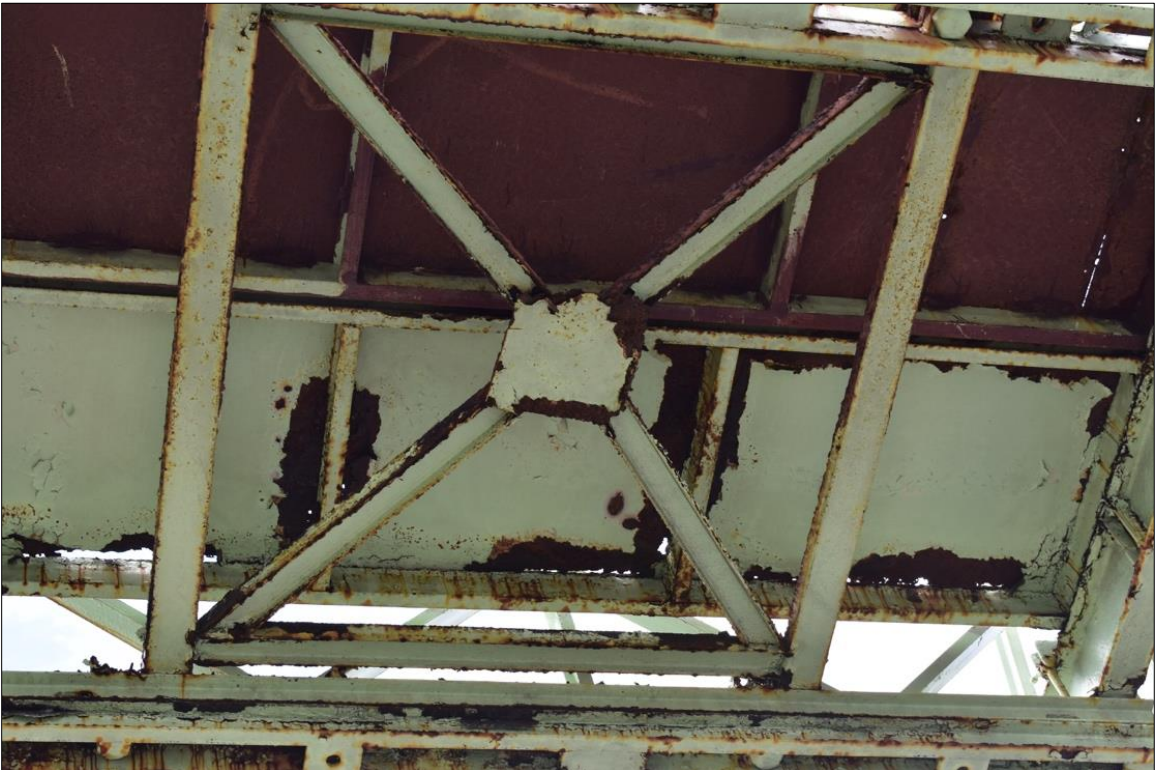
Figure 5.39: Original piece with all elements

During the visit, it was evident that the bridge had corrosion problems in many components. Corrosion had caused holes in the walkway, as shown in Figure 5.38 and Figure 5.39. Some transversal elements were missing, as shown in Figure 5.40. (Further details about the inspection of this bridge can be found in Volume 2 of this document).

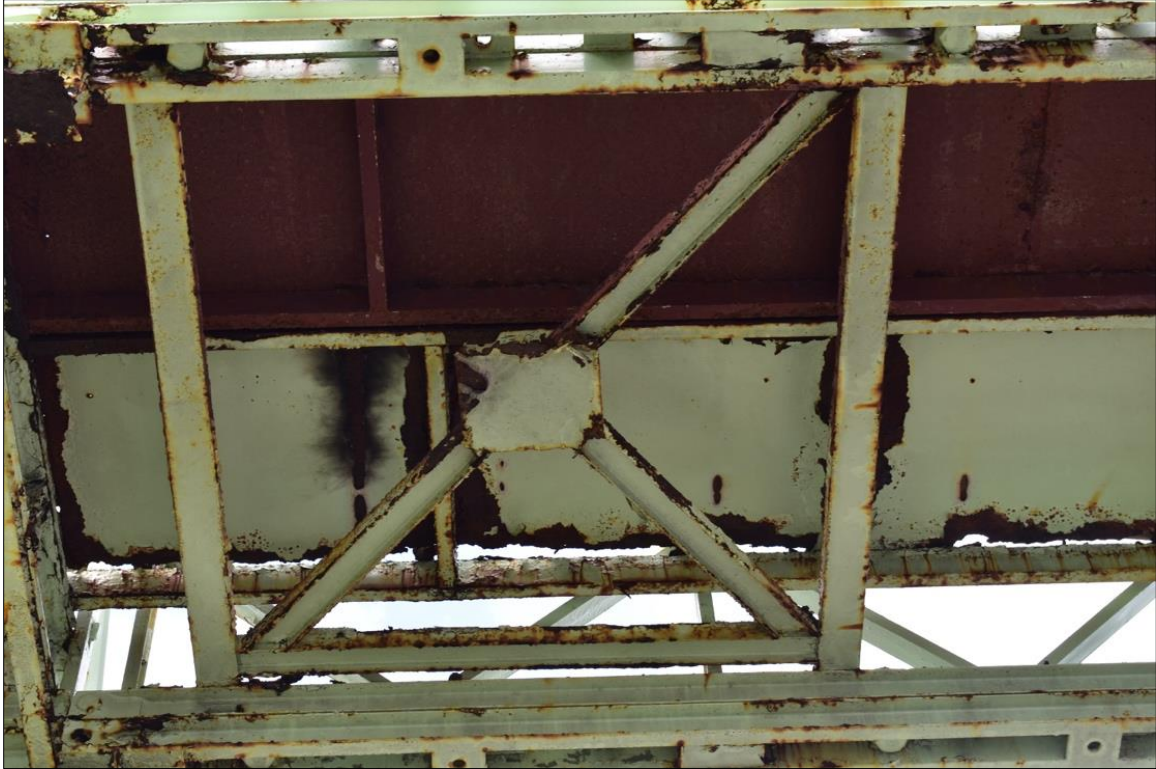
Figure 5.40: Piece without one element

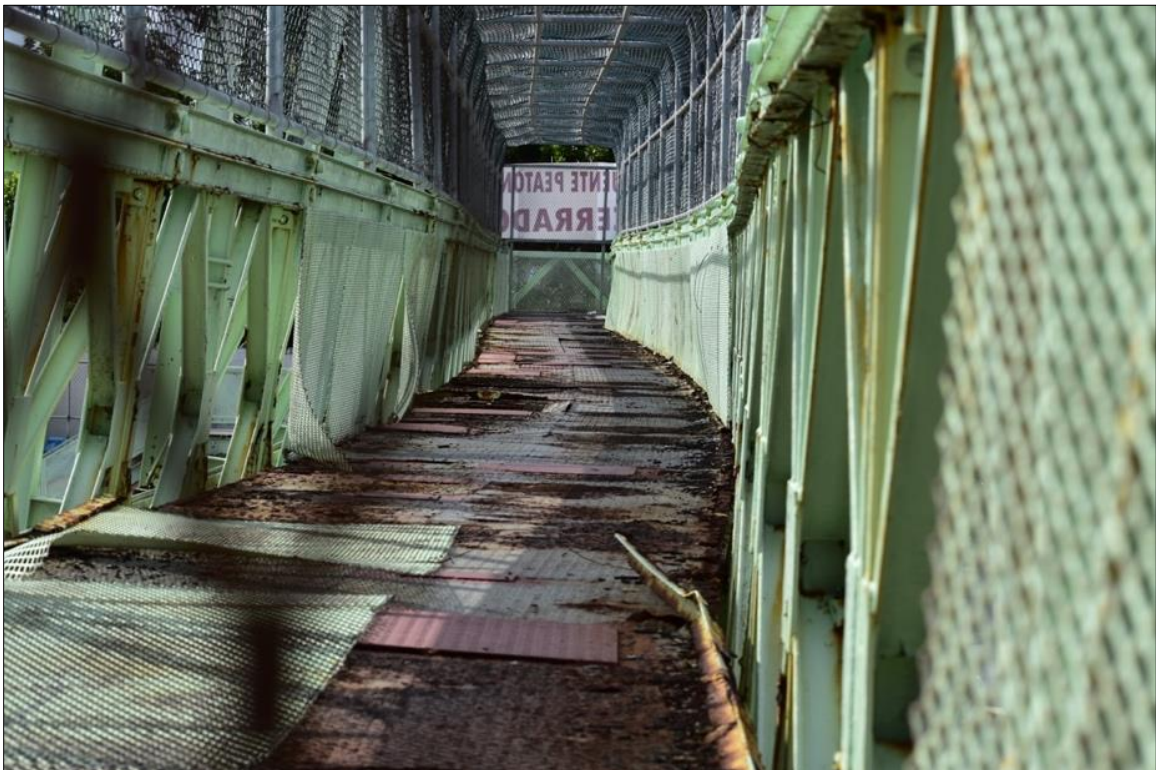
In terms of possible damages caused by Hurricane Maria, it was evident that the bridge had experienced lateral deflections in the plastic range as evidenced by the curvature in the structure that can be appreciated in Figure 5.41 and Figure 5.42. Although the traffic signs that were attached to the bridge had already been removed, the mounting assembly was still present, as shown in Figure 5.43. It was observed that the location of the mounting assembly coincides with the section of the bridge with larger curvature. Therefore, it is theorized that the lateral deflection on the bridge was partly due to the extreme wind loads on the signs during Hurricane Maria. This theory is furthered studied in Volume 2 of this document.

Figure 5.41: Curvature in deck

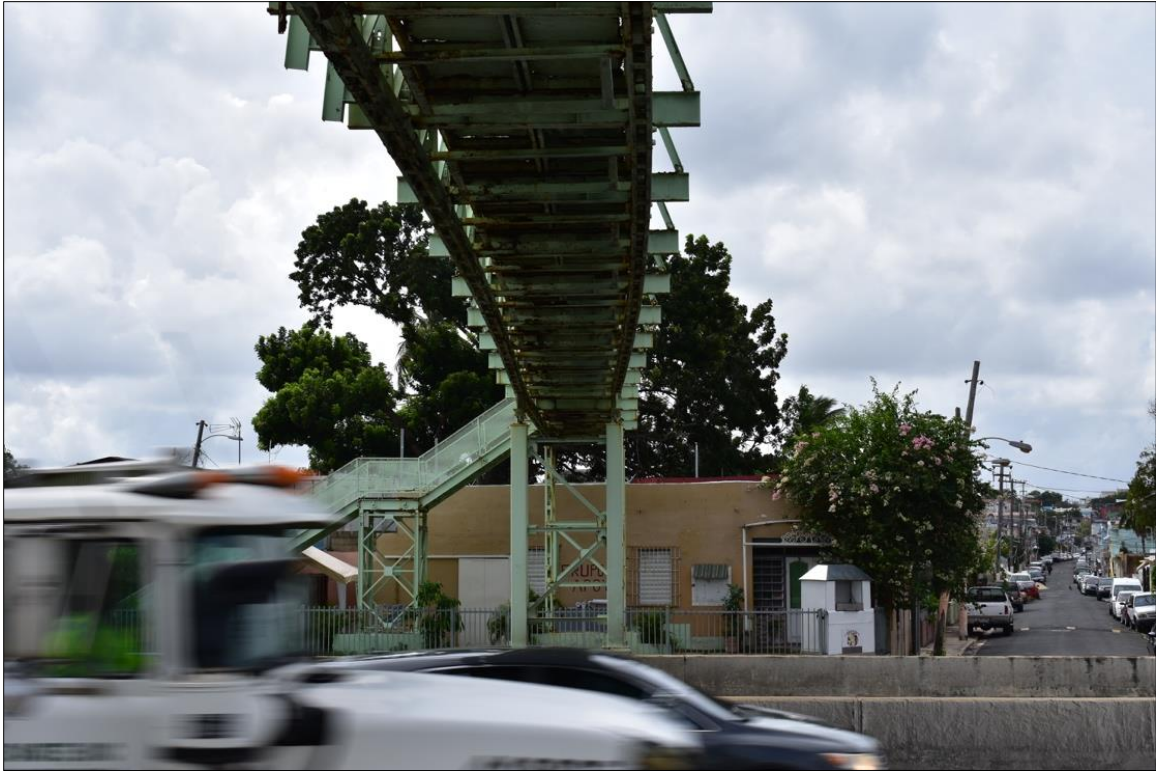
Figure 5.42: Underside view of lateral deflection

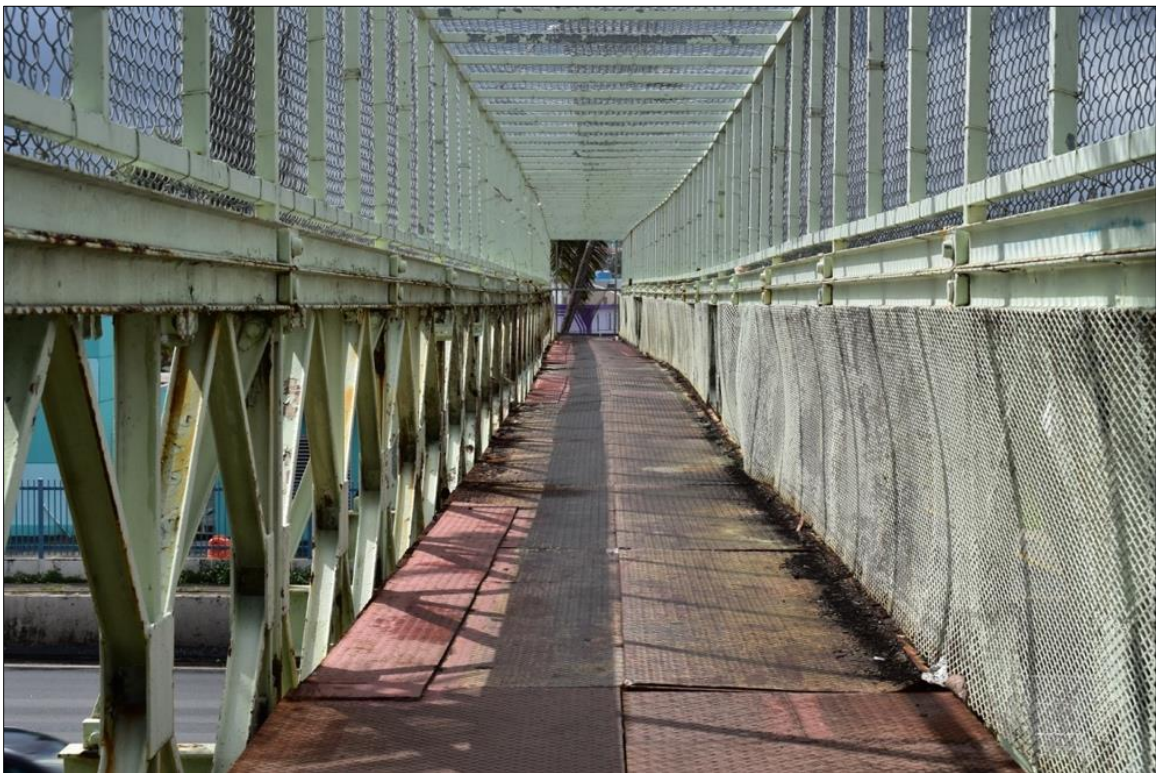
To detect if the bridge suffered any major deformations due to Hurricane Maria, photographs from before and after the hurricane were compared. Examples of these are the comparisons that can be made between Figure 5.57 (taken in 1996) and Figure 5.58 (taken in 2019), and between Figure 5.59 (taken in 1993) and Figure 5.60 (taken in 2019). By the comparing the photographs, it is appreciated that the bridge experienced lateral deflections in the plastic range as evidenced by the curvature exhibited by the deck and the superstructure in the most recent photographs.

Figure 5.58: Deck of PB 1307 after Hurricane Maria (February 28, 2019)

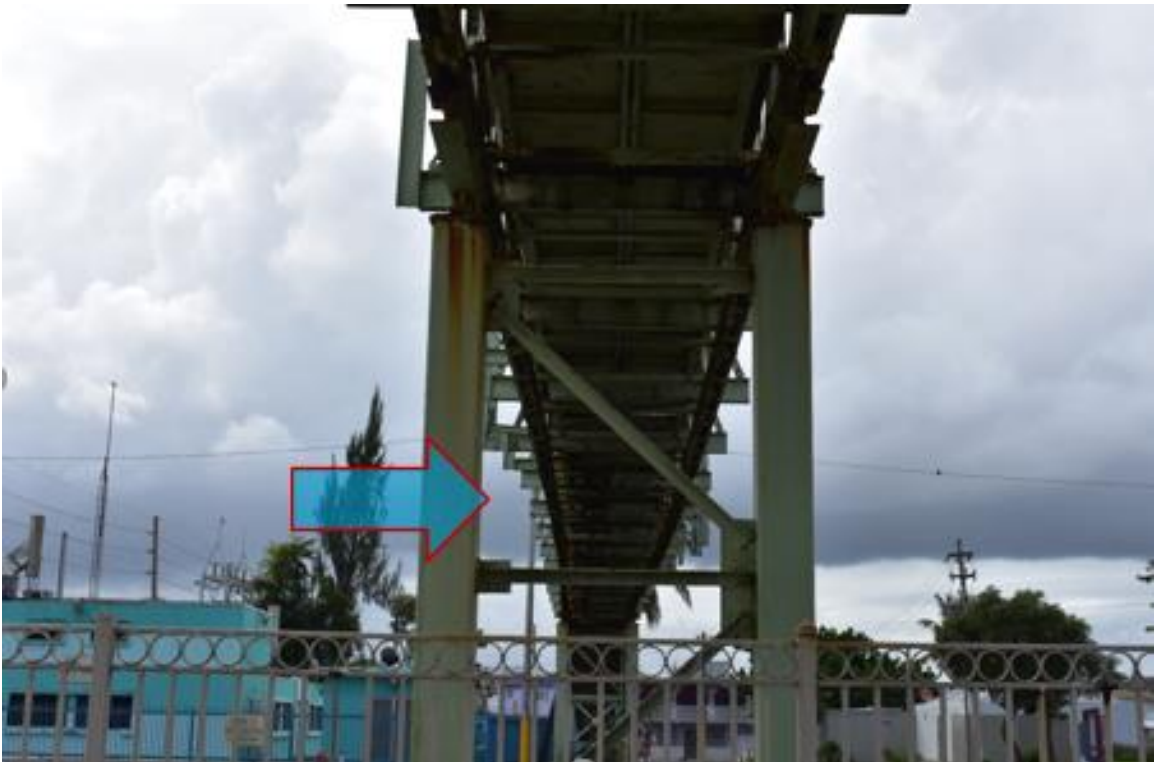
Figure 5.60: Underside of PB 1307 after Hurricane Maria (February 28, 2019)

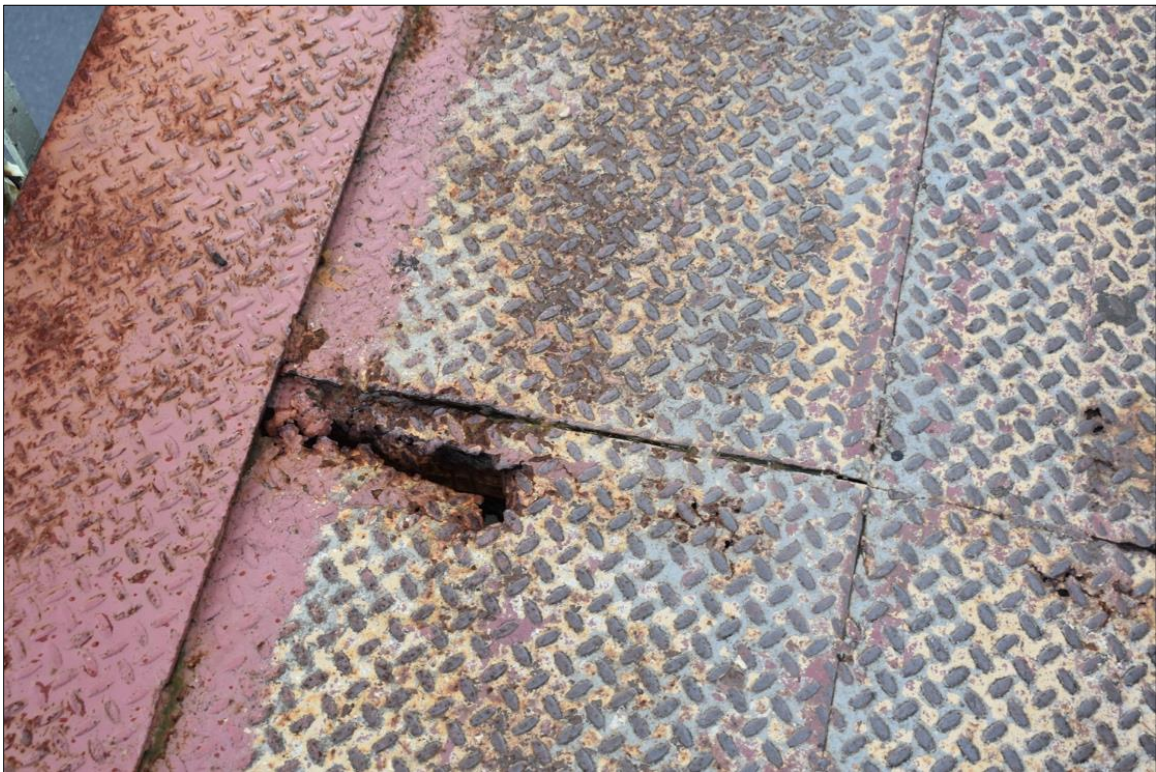
During the inspection, the stairs and deck exhibited corrosion, as shown in Figure 5.61 and Figure 5.62, respectively. It can also be observed in Figure 5.62 that sections of the security meshing attached to the guardrail had fallen off. Gaps and holes in the deck were observed as shown in Figure 5.63 and Figure 5.64.

Figure 5.64: Hole in plates

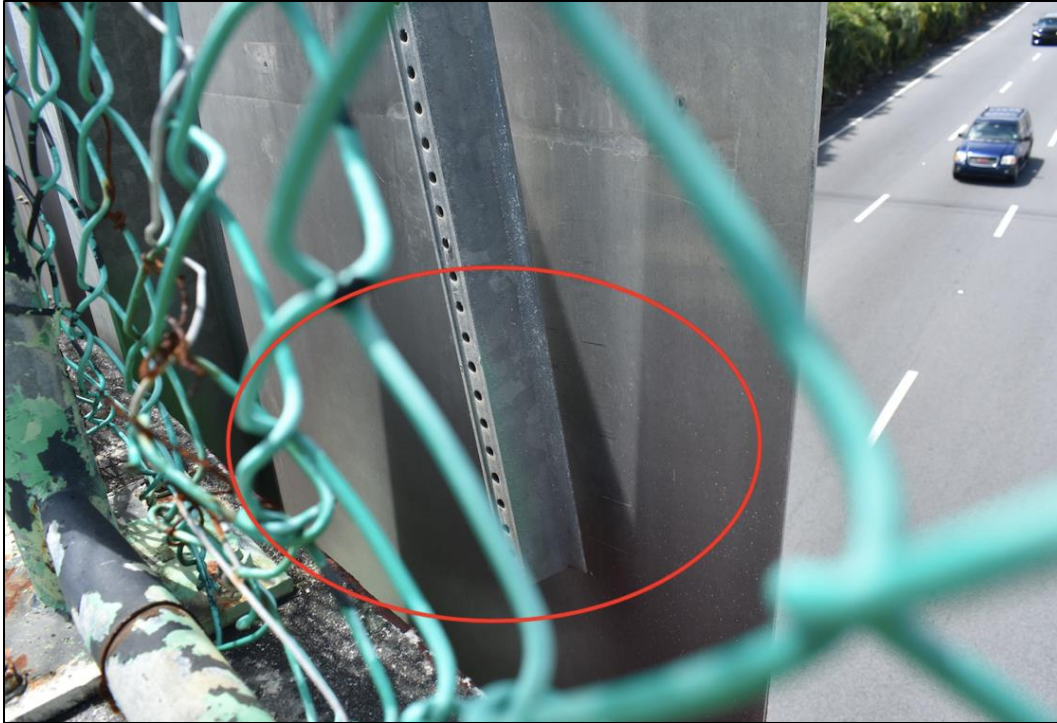
The bridge itself did not appear to have any problems. In terms of possible damages caused by Hurricane Maria, it was observed that one of the traffic signs mounted on the bridge (the larger sign inside the red rectangle indicated in Figure 5.73) detached at the bottom end from the mounting assembly (see Figure 5.74) It is theorized that the detachment was due to wind induced vibrations that occurred during the hurricane. It was also observed that the smaller airport sign has only one support (see Figure 5.75), and it was oscillating and twisting.

Figure 5.74: Transit sign detached from mounting assembly

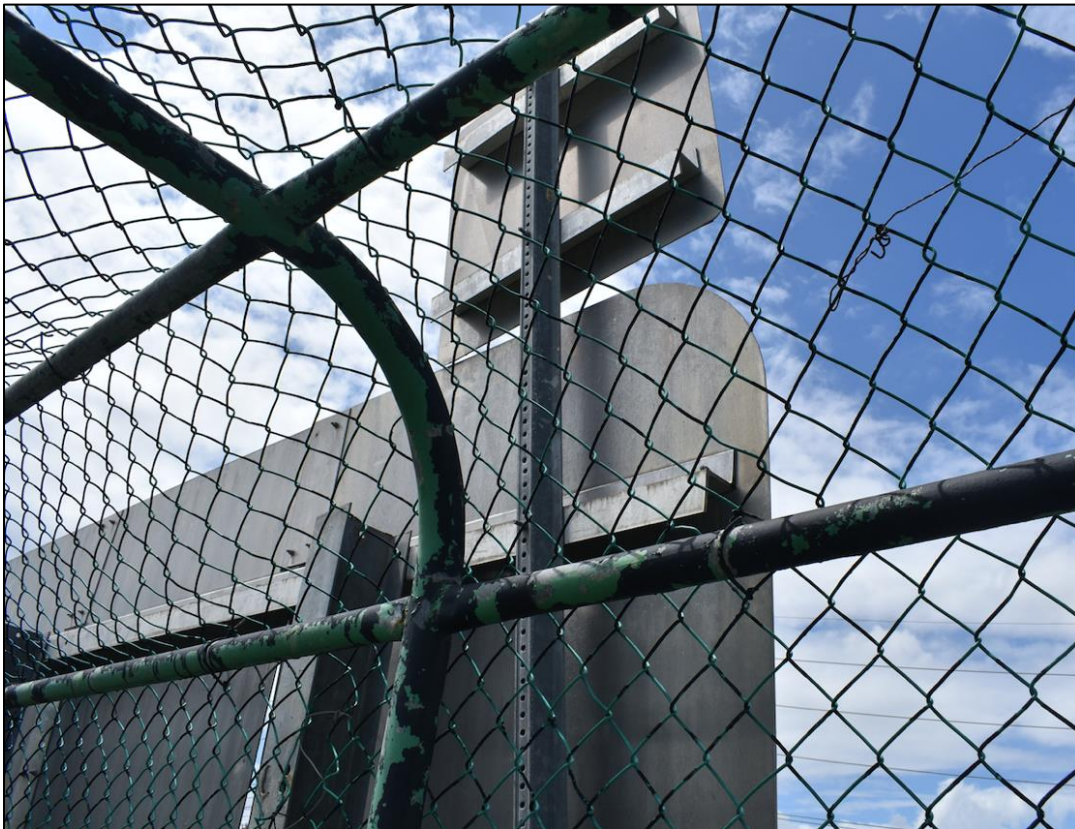
Figure 5.75: Small airport sign on top of larger sign

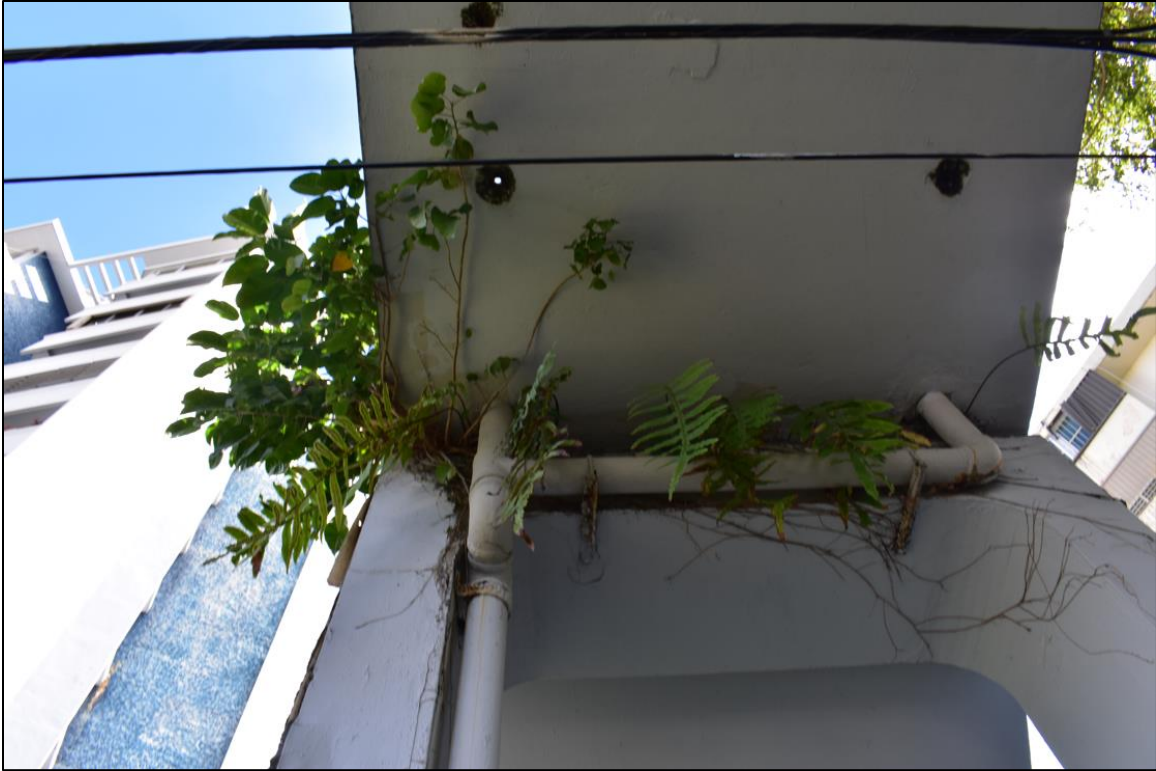
Figure 6.6: Vegetation in PB 0745

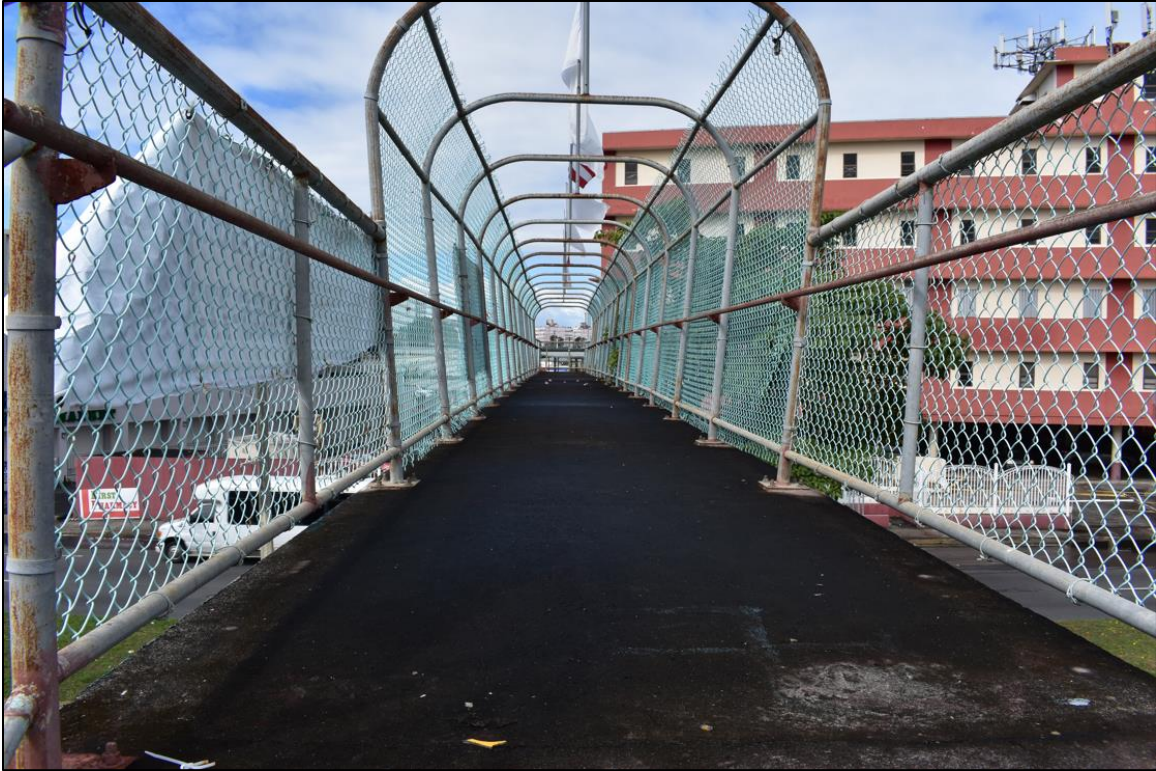
Figure 6.10: Mold and silt on PB 1095

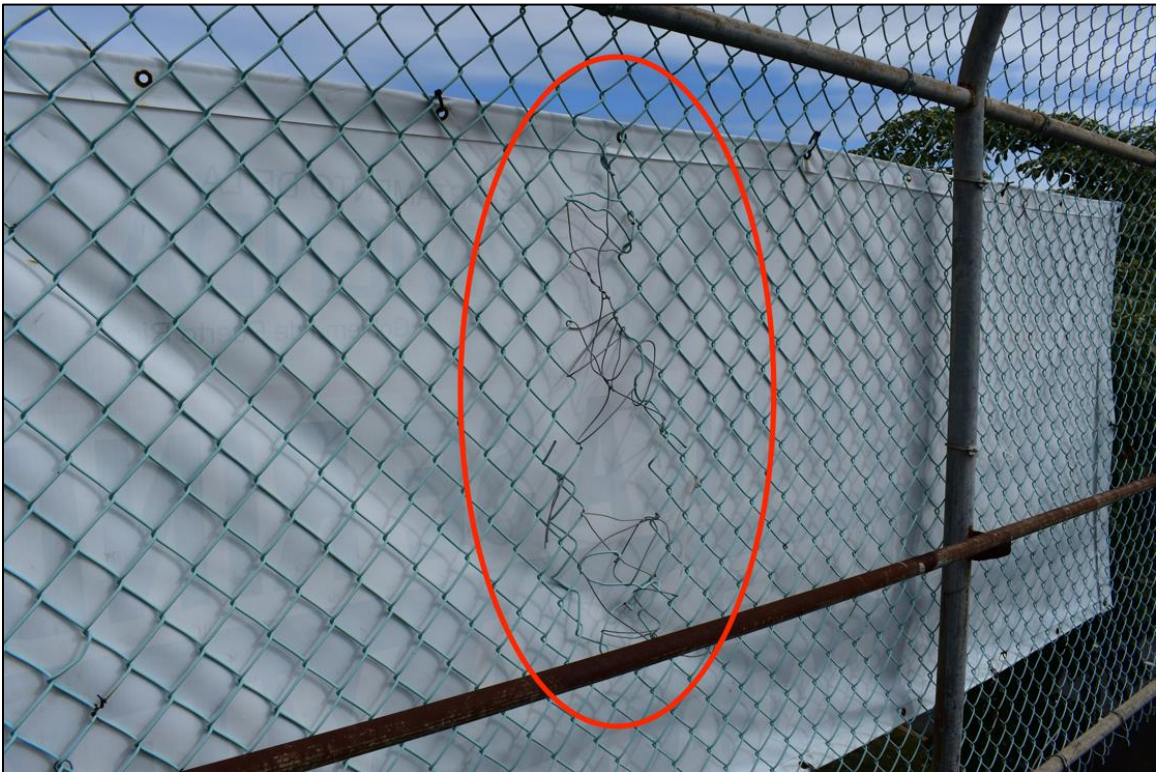
Figure 6.11: Hole in safety fence on PB 1095

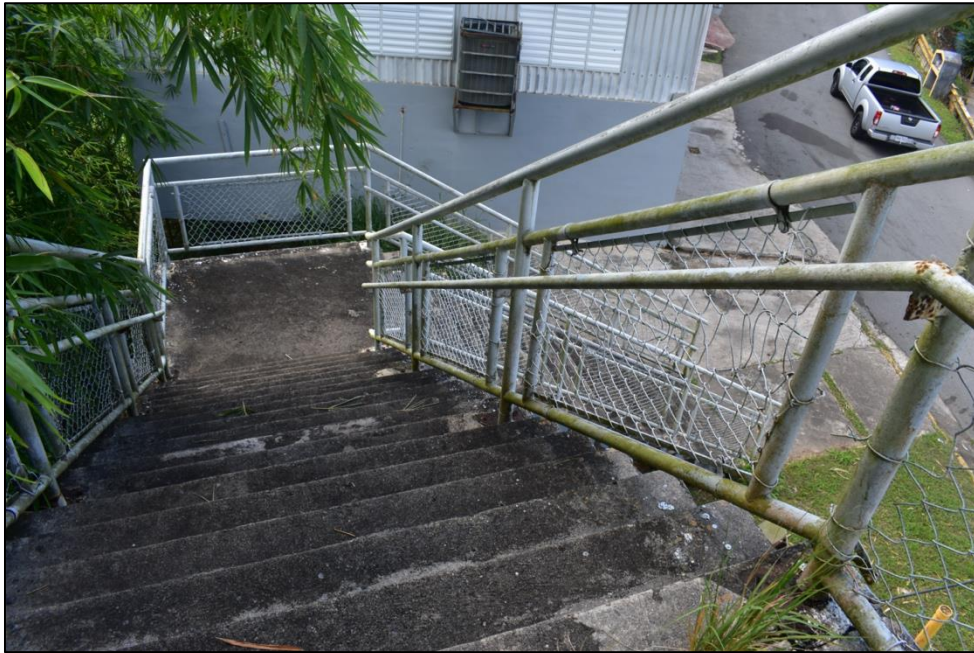
Figure 6.20: Mold and silt on PB 1513

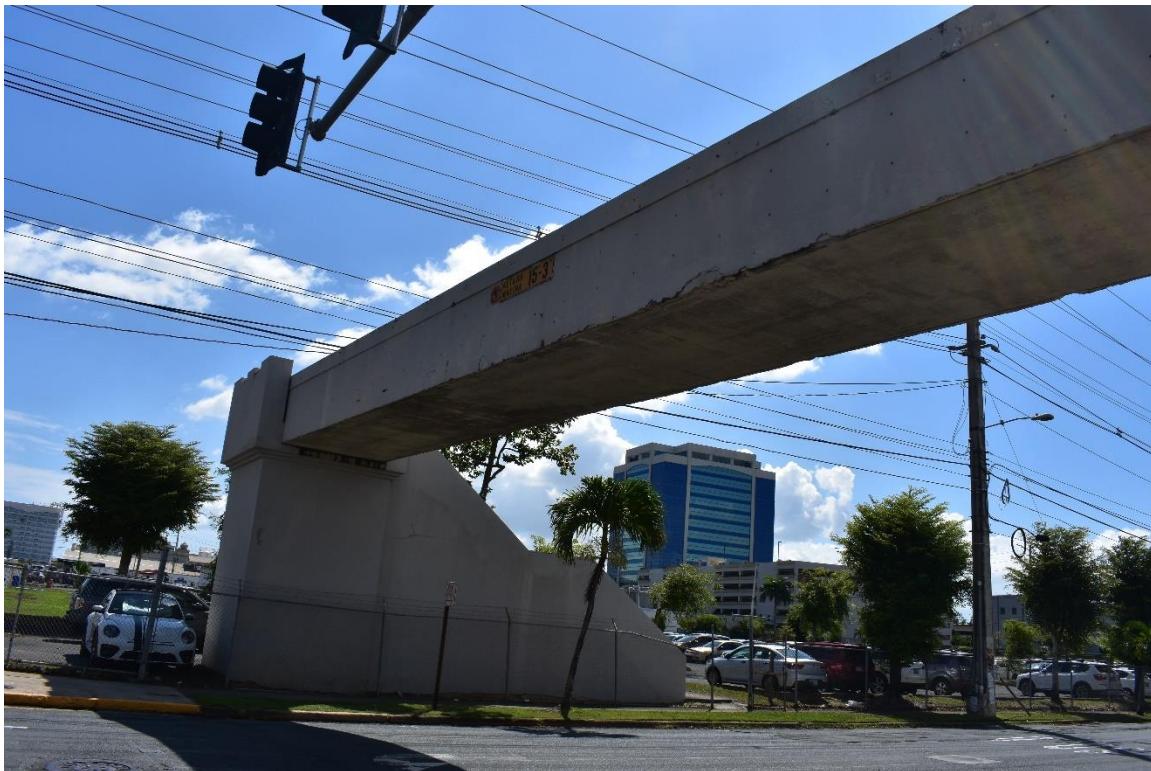
- Electrical cables block the pathway of pedestrians (see Figure 6.28 and Figure 6.29)
- Mold and silt on deck and stairways (see Figure 6.29)

Figure 6.28: Electrical cables passing closely over PB 1926

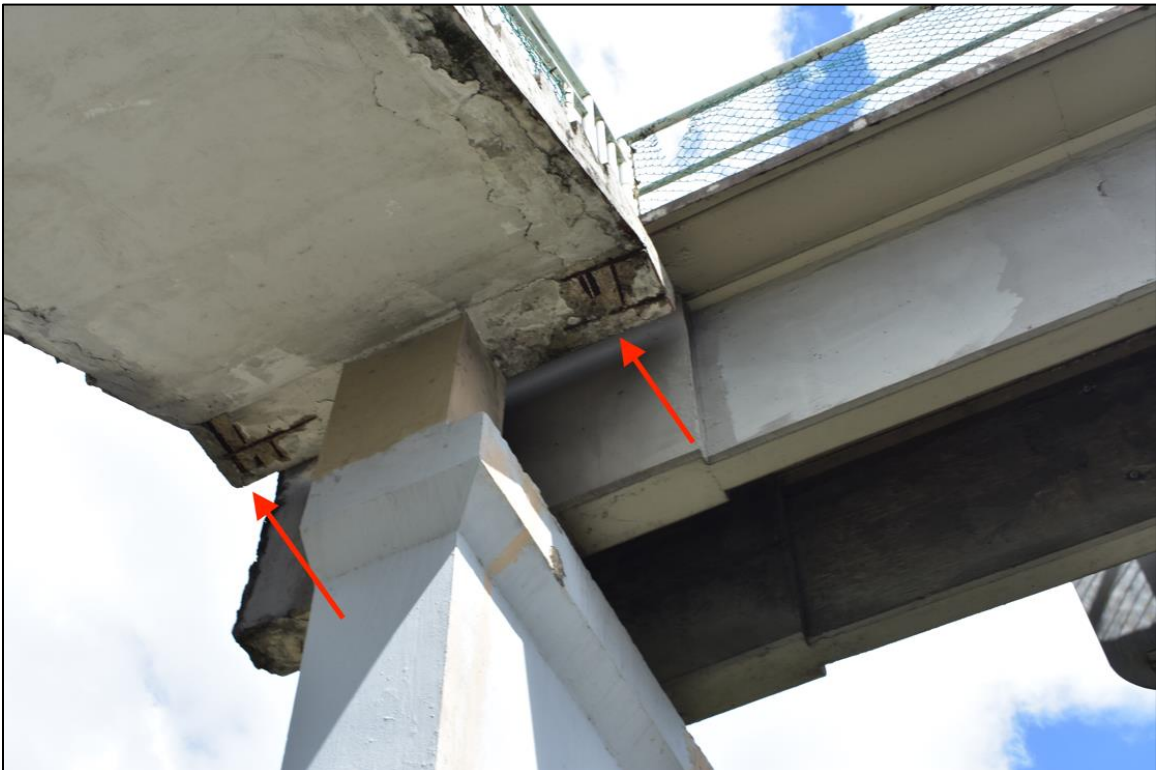
Figure 6.31: Exposed rebars on PB 2087

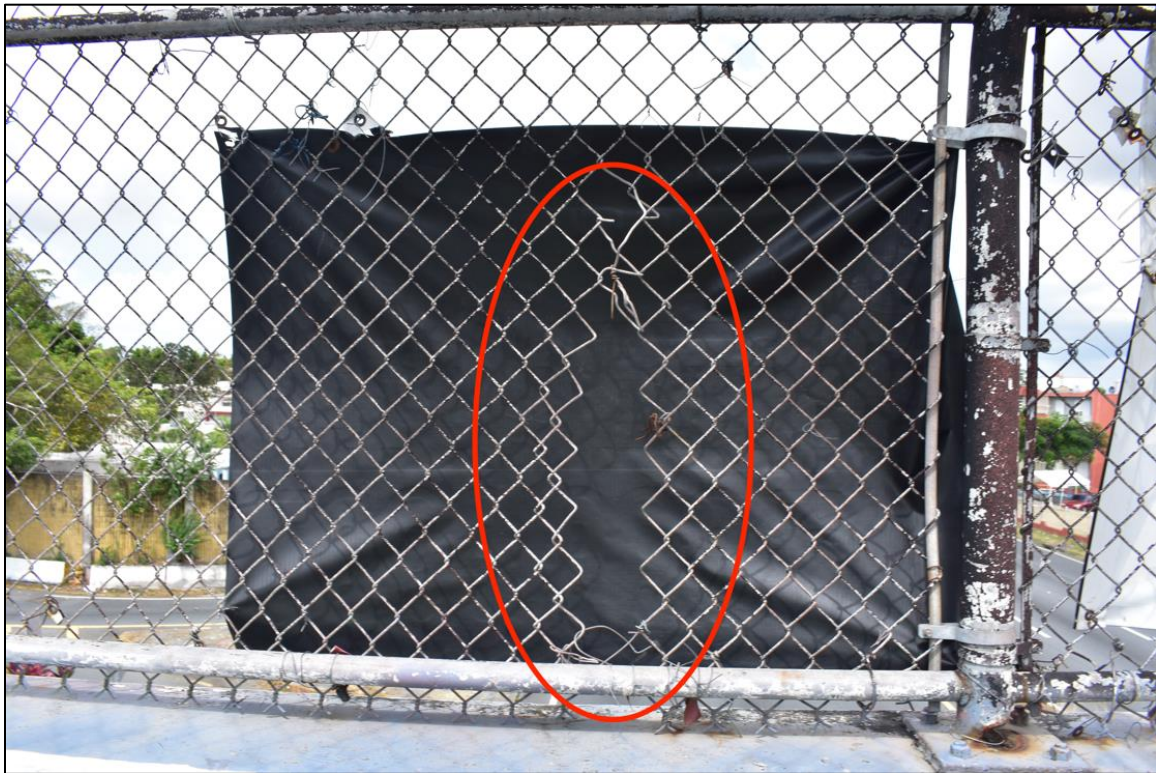
Figure 6.34: Security Fence with holes, Pedestrian Bridge 2355

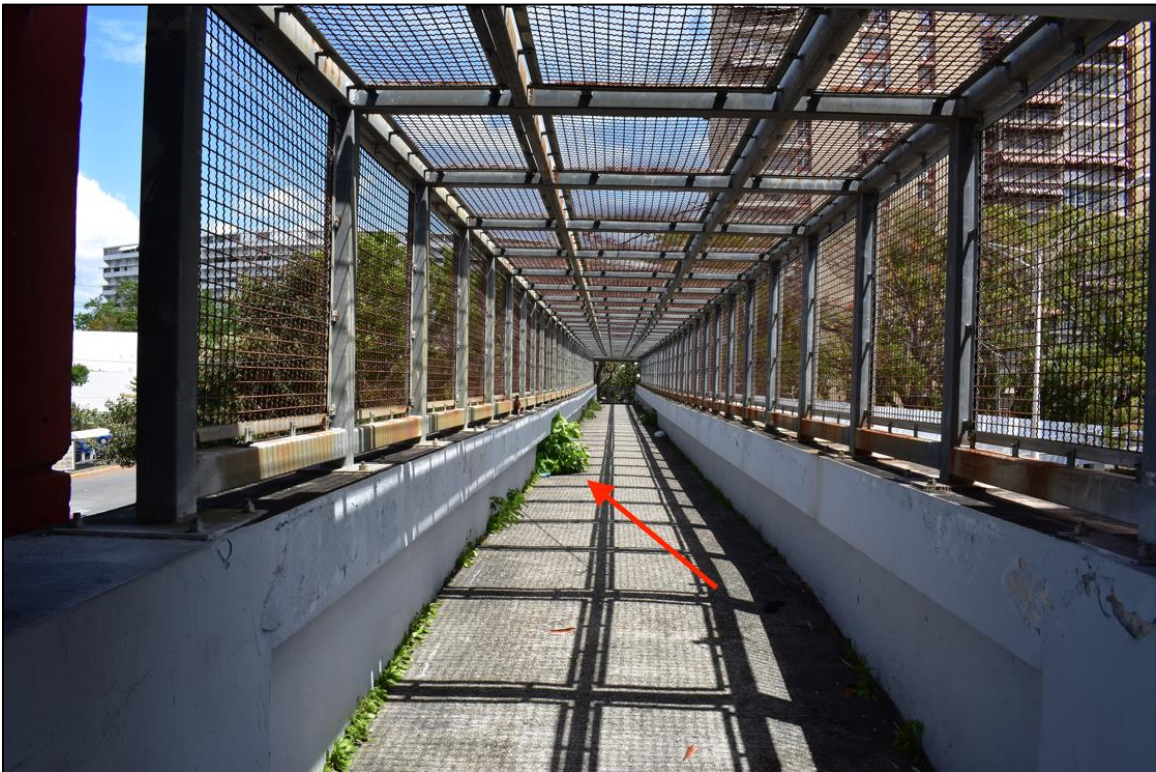
Figure 6.36: Vegetation covered drains on PB 2566

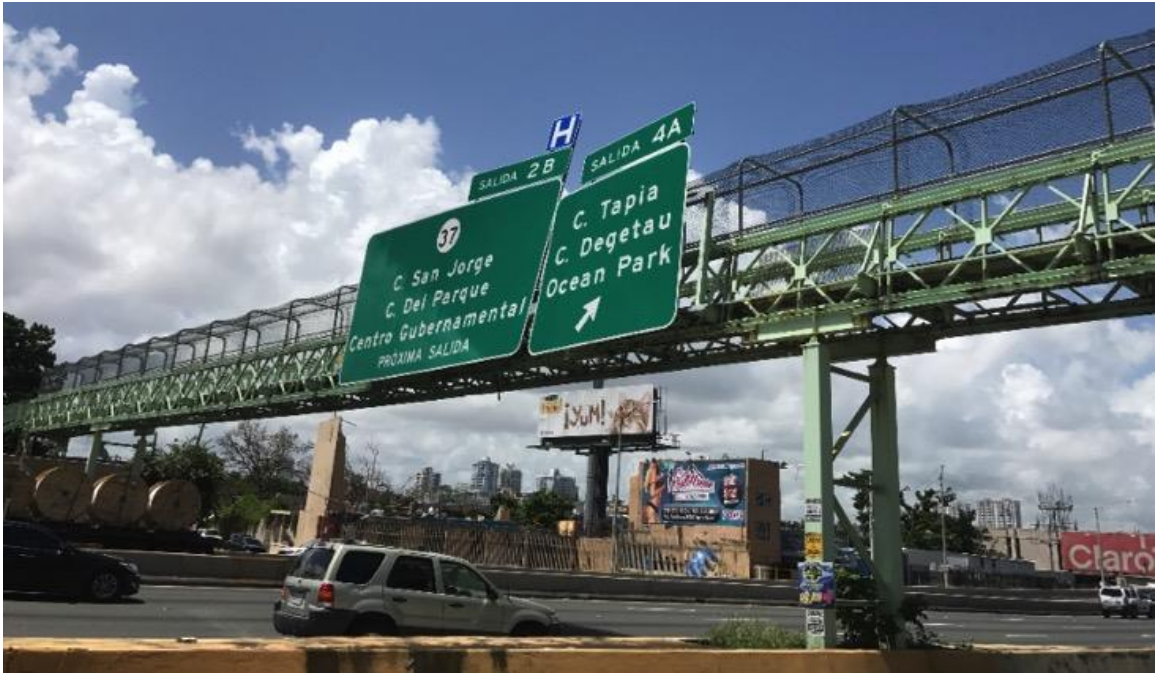
Figure 4.3: Image of the Bridge from September 2018 (Provided by PRHTA)

Figure 4.2 presents a view of the bridge from March 2016, while Figure 4.3 presents a view of the bridge after the damages produced by Hurricane Maria. Notice that at some point between March 2016 and the passage of Hurricane Maria in September 2017, a sign on the bridge was replaced with multiple signs. At the time of the field visit, all the signs had been removed.
