Improving Transportation Infrastructure Resilience Against Hurricanes, Other Natural Disasters, and Weathering: Part II - Analysis of Pedestrian Bridges Failures Due to Hurricane Maria

Volume 1

FINAL REPORT
August 2021

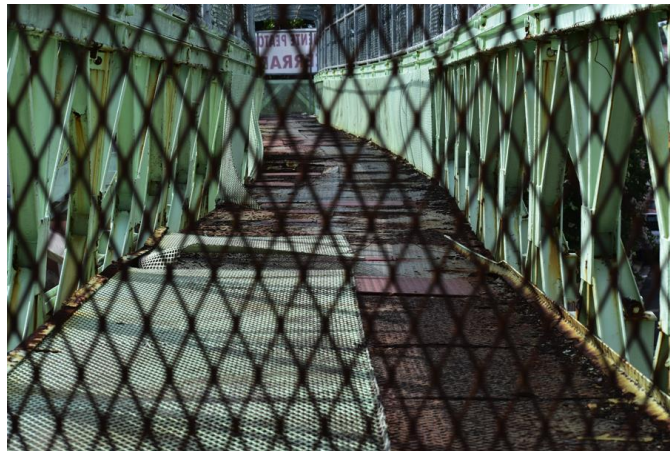
As part of the inspection of the bridge, different site visits were conducted. On the first visit it was observed that the bridge was closed to pedestrians because of its poor structural condition. An expanded metal mesh was welded against the steel frames of the bridge and a banner indicating the bridge was closed was installed, as shown in Figure 5.1 and Figure 5.2. During this visit, different photos of the bridge were taken and the dimensions of the elements that were accessible were measured. In addition, a Total Station (shown in Figure 5.3 and Figure 5.4) was used to take points along the bridge to delineate the bridge's lateral displacement. When the points taken were traced in AutoCAD, no significant deflection was observed, thus not enough points during the measuring process were collected to capture the deformation. Since the deflection was not captured with the Total Station, it was decided that another method had to be used.

Figure 5.1: Metal Mesh Used to Close Pedestrian Bridge

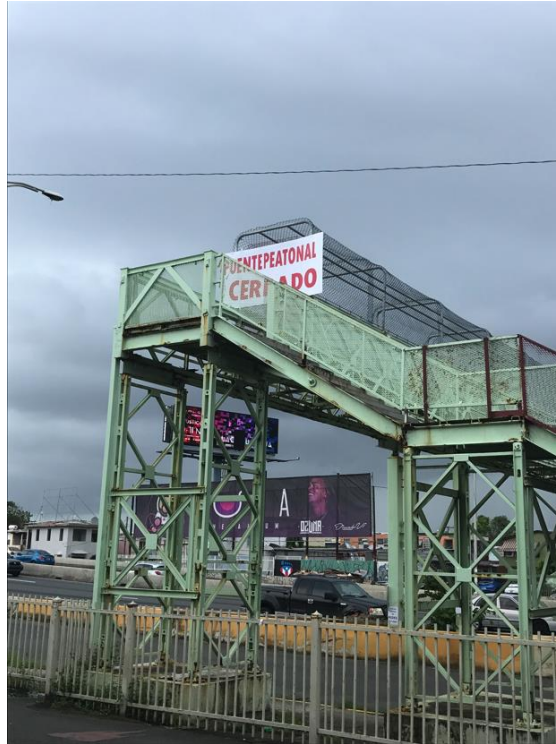
Figure 5.2: Sign Indicating Pedestrian Bridge is Closed

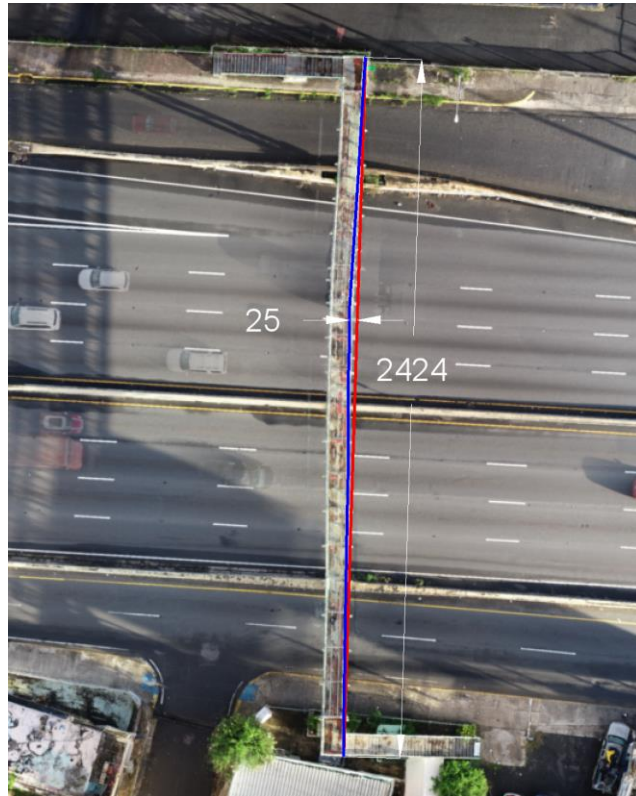
Figure 6.5: Bridge Dimension

Using Google Earth, the dimension of the bridge was verified, as illustrated in Figure 6.4. The length obtained from Google Earth was 202 ft. Considering that the bridge has a length equivalent to 20 truss panels, and every truss panel measures approximately 10 ft, the distance obtained from Google Earth is considered accurate. The distance of 10 feet of the truss panel was verified in the field, and it is also the same length indicated in an old manual for the Bailey Bridge (U.S. War Department, 1943). With the surveyed image imported to AutoCAD, it was scaled to measure the same distance measured using Google Earth. As illustrated in Figure 6.5, the length of the pedestrian bridge was scaled to measure 2,424 inches (202 feet).

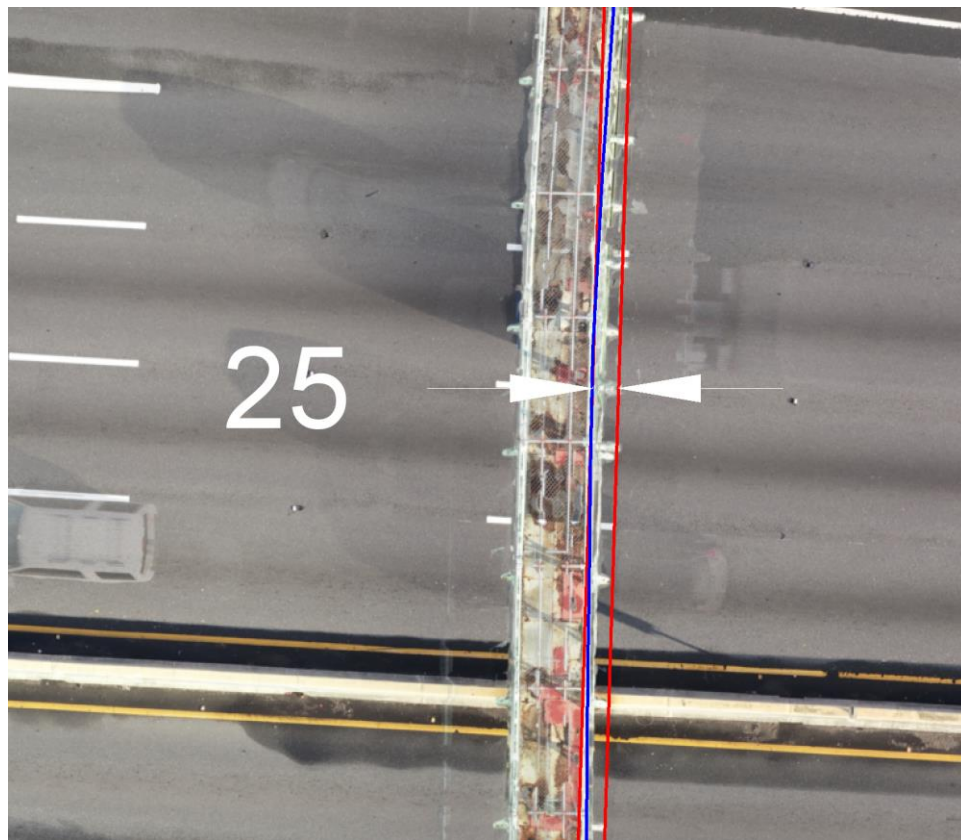
In addition to the bridge length, the deflection was also measured. For this, two colored lines were drawn in AutoCAD and the distance between them was measured (as presented in Figure 6.5 and Figure 6.6). The first line drawn was the red line, which runs straight from north to south of the bridge. The second line drawn was the blue line, which follows the contour of the bridge. Then an offset was given to the red line so that it touched the tangent of the blue line. In the intersection of the tangent point, the distance between the original red line and the blue line measured 25 inches, as illustrated in Figure 6.6. With this dimension, it is understood that the bridge had an approximate lateral deflection of 25 inches in its most critical point. In addition, looking closely, it can be appreciated that this point corresponds to the location of the second to last structural beam that supported the signs.

Figure 6.6: Bridge Maximum Plastic Deflection (in inches)

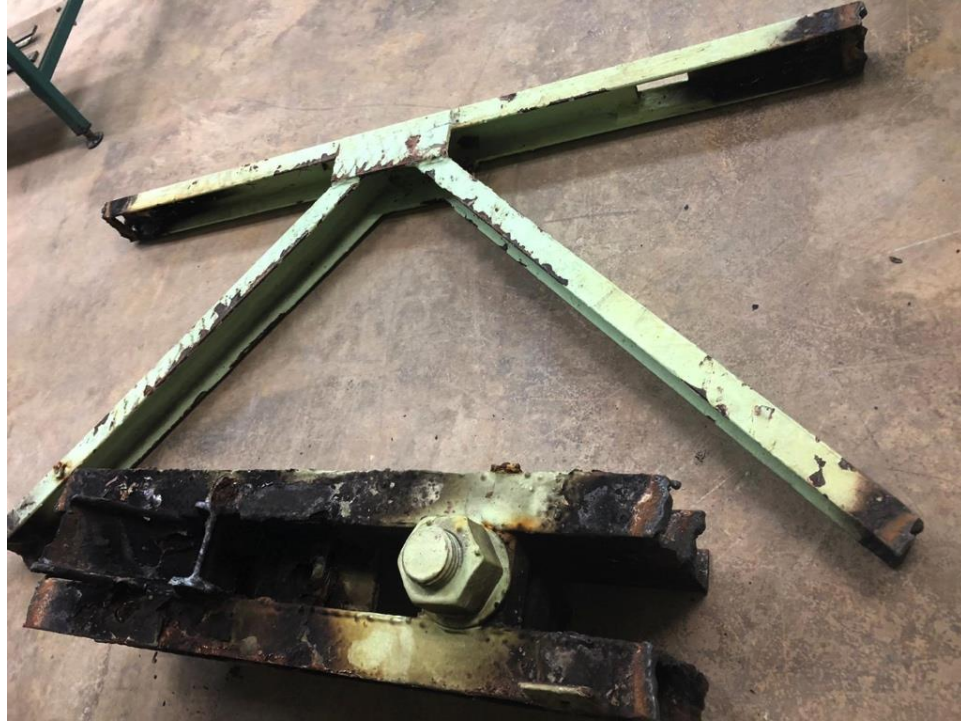
Figure 7.5: Bridge Fragments Recovered

After the bridge had been removed and transported to a yard (see Figure 7.4), the company in charge of the demolition was contacted. A formal letter from the Polytechnic University of Puerto Rico (see Appendix C) was submitted to the demolition contractor requesting bridge fragments to be tested to determine mechanical properties of the bridge

elements. After several months of negotiations, on April 26, 2019, the contractor handed the fragments presented in Figure 7.5.

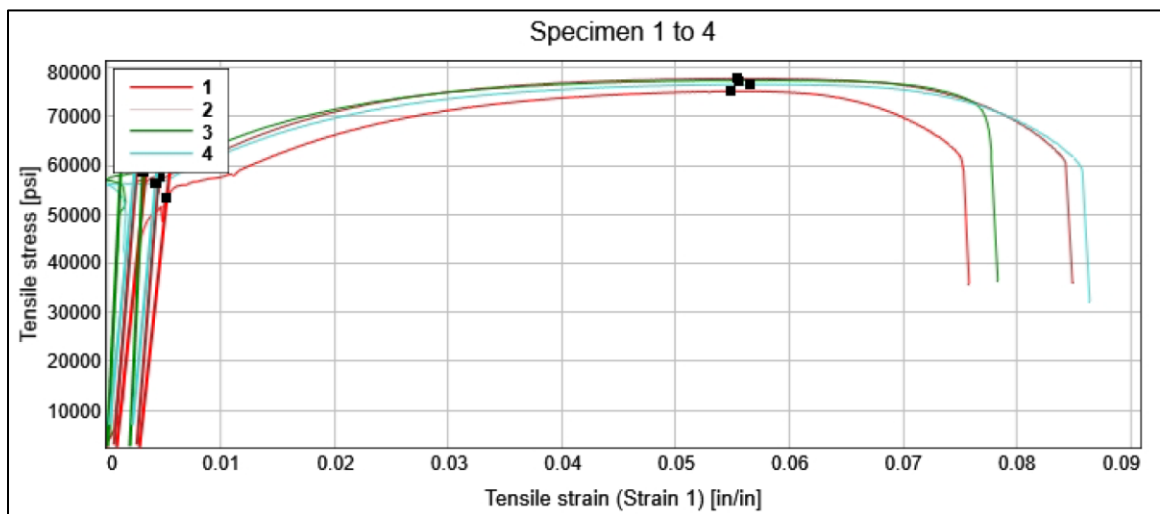
Figure 7.14: Stress vs. Strain Diagrams

Figure 7.14 presents the stress vs. strain diagrams that were obtained from the tension tests. Table 7-2 illustrates the results obtained from each curve. From these results, an average yield strength of 56.58 ksi, was obtained, as presented in Table 7-3. Given the results of the testing tests, it is suspected that the steel used for the construction of the bridge was A572. Still, the average yield stress of 56.6 ksi was used when modeling the bridge to evaluate the impact of wind loads.

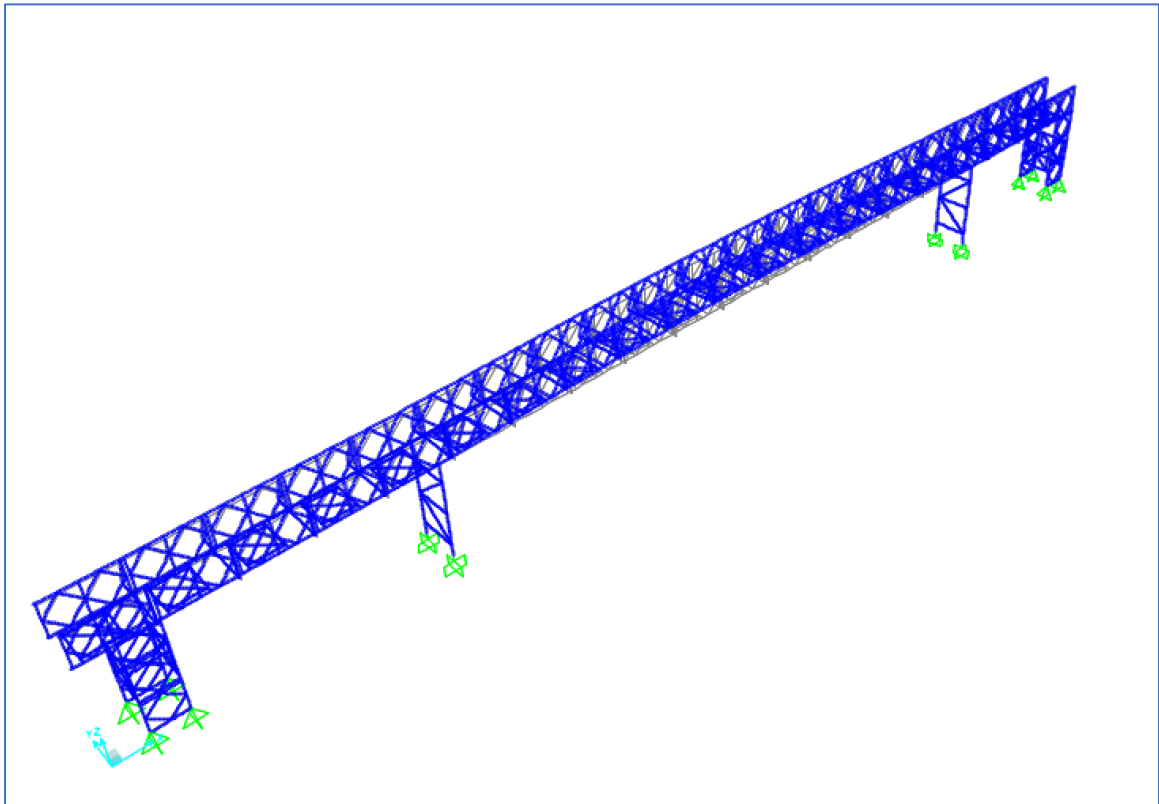
Figure 8.6: Lateral Deflections due to Wind - Without Signs

Figure 8.6 presents an image of the resulting lateral deflections due to wind action, while Figure 8.7 presents the results of the design check, showing that the interaction equation results in most of the elements in the plastic deflected area working at low stress demand.

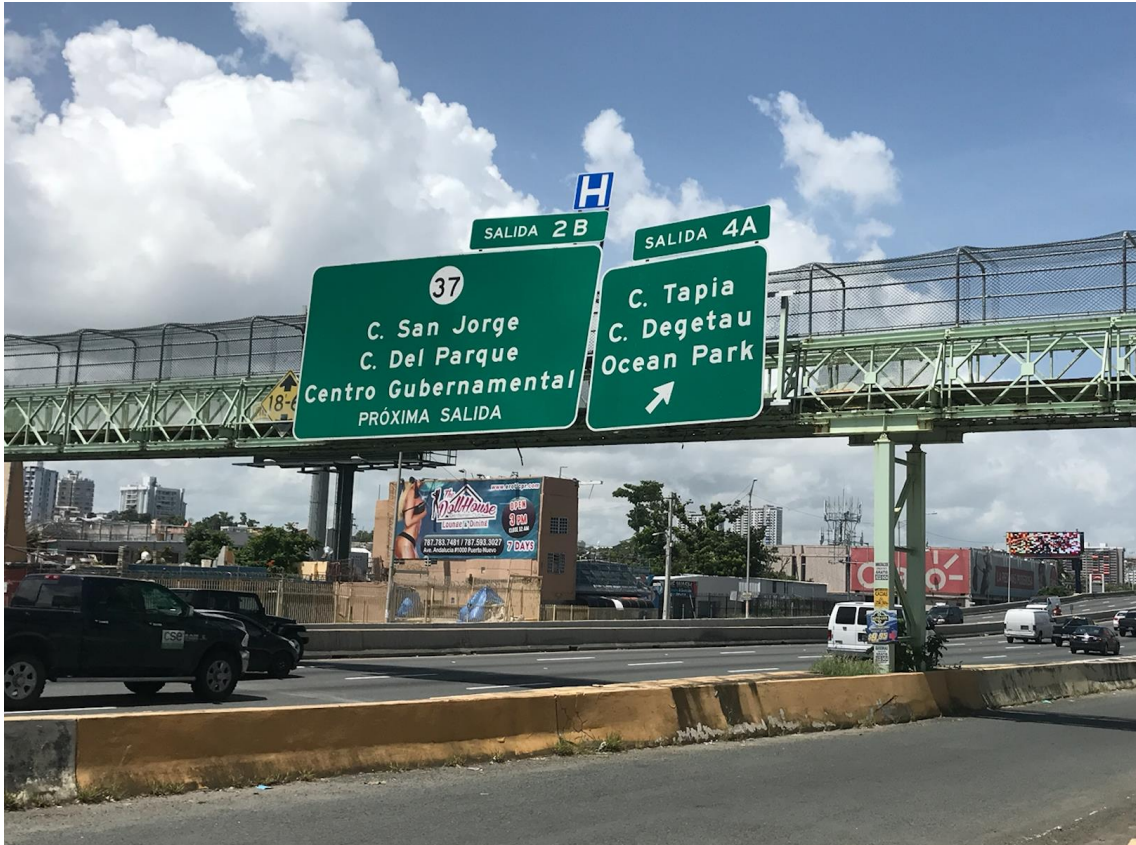
Figure 8.8: Signage Installed at the Pedestrian Bridge

The second model that was created was of the pedestrian bridge with the signage installed. With this model, the bridge can be analyzed to understand the implications that the signage brought to the bridge. Figure 8.8 illustrates the signage that was installed on the bridge at the time Hurricane Maria made landfall in Puerto Rico. Figure 8.9 through Figure 8.11 illustrate the structure that held the signage in place. From Figure 8.11 it was determined that the structure that held the signage in place had 5 vertical beams, and from Figure 8.10 it is evident that the beams were attached to the truss vertical channels with U-bolts in two points.

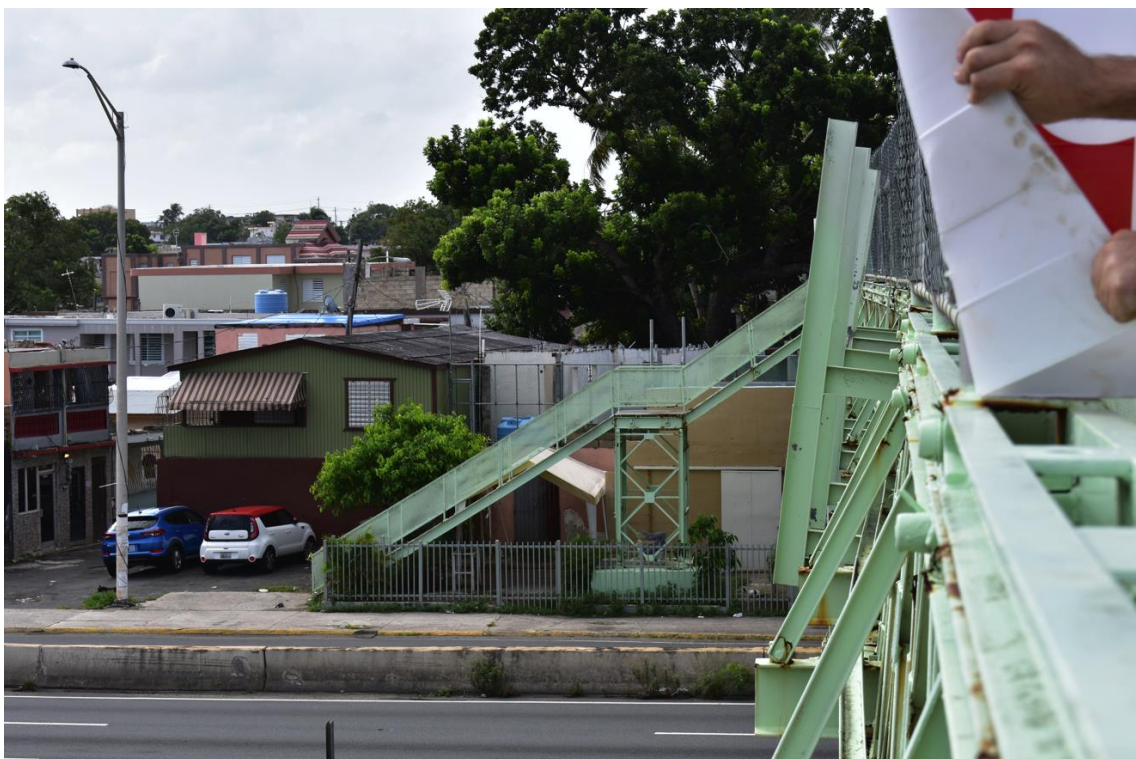
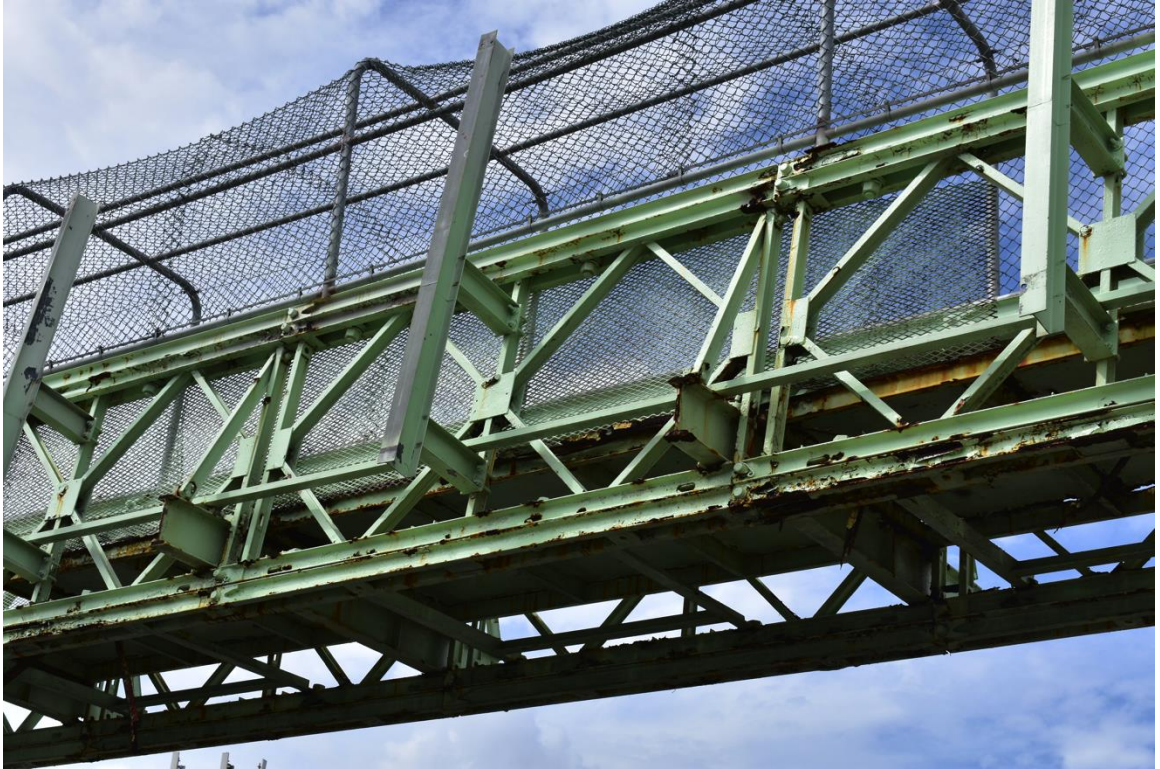
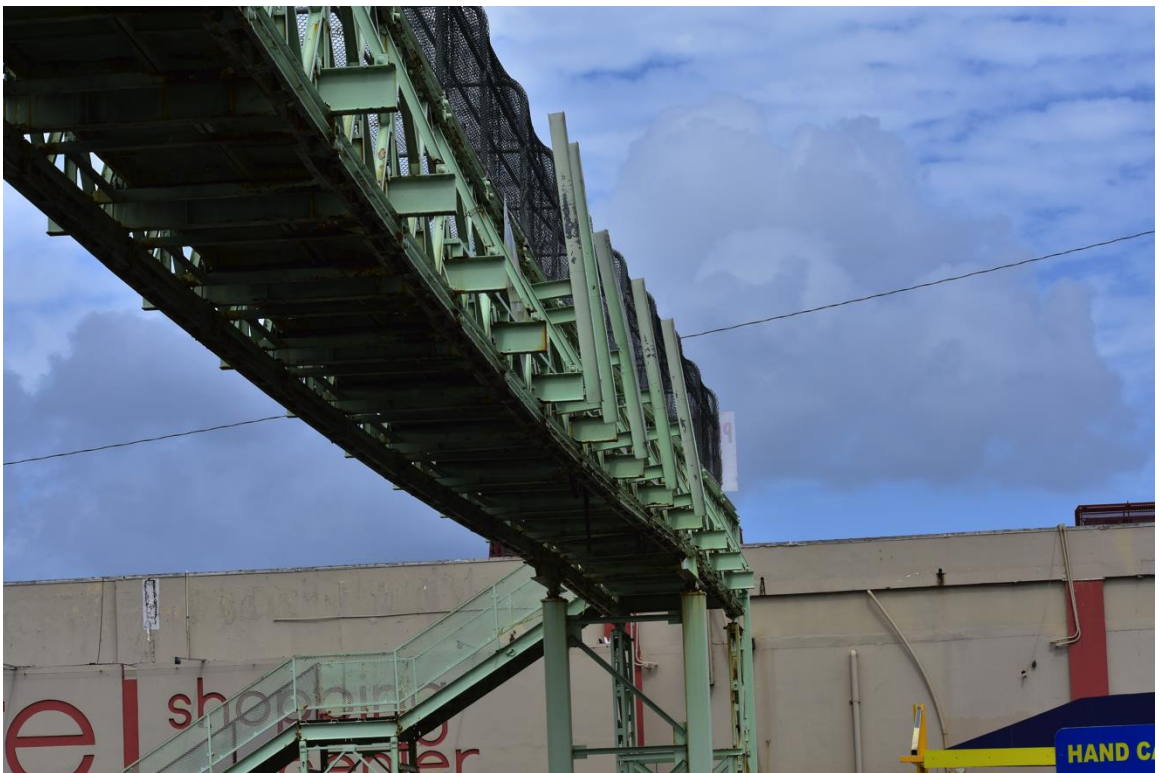
Since the transportation signs had been removed previous to the moment of inspection, the dimensions of the signs were estimated from previous photos as 35-ft wide and 10-ft in height. It was assumed that the distribution of loads to the supporting beams was by tributary areas, and that each beam, in turn, distributed half the load to each support. To evaluate an overall response, instead of a local response, these support loads were applied directly to the top and bottom chord in the connection of the vertical elements to the chord.

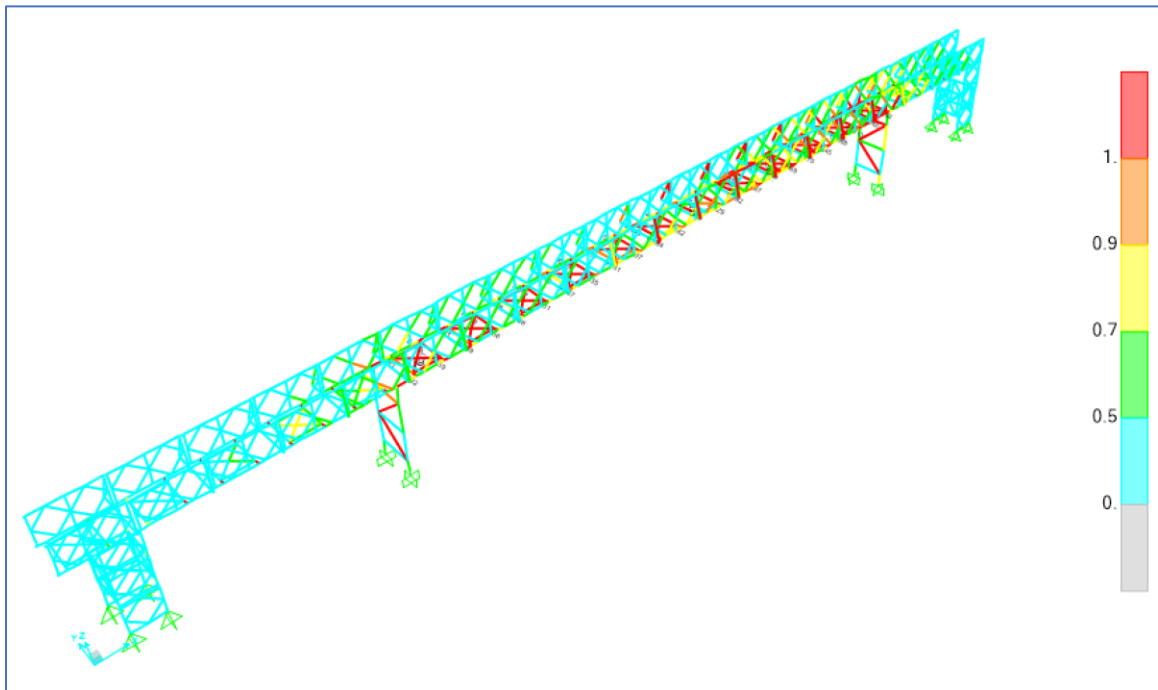
Figure 8.13: Interaction Equation (Strength Demand) Results - With Signs Included

Figure 8.13 displays the results of the design check, showing that the interaction equation results in most of the elements in the plastic deflected area working with a much higher stress demand that the previous analysis. This leads to the conclusion that the installation of the signs had an important role in the lateral inelastic deformations.

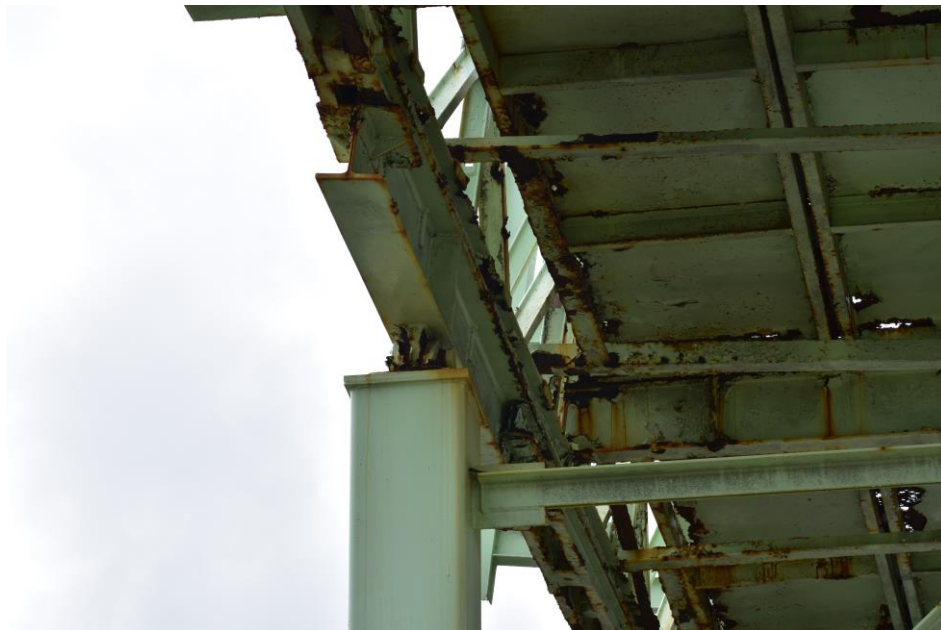
Figure 8.15: Twisted Pin-Plate and Supporting Beam

Figure 8.14 displays that the hinge support plate appeared to have experienced lateral deflection, resulting in twisting of the upper beam. This situation may be probably due to eccentricity between the lateral load applied by chords on top of the beam and the hinge location. Figure 8.15 presents other view of this situation. This condition requires further study to assess a proper design and may be an extension of current project.

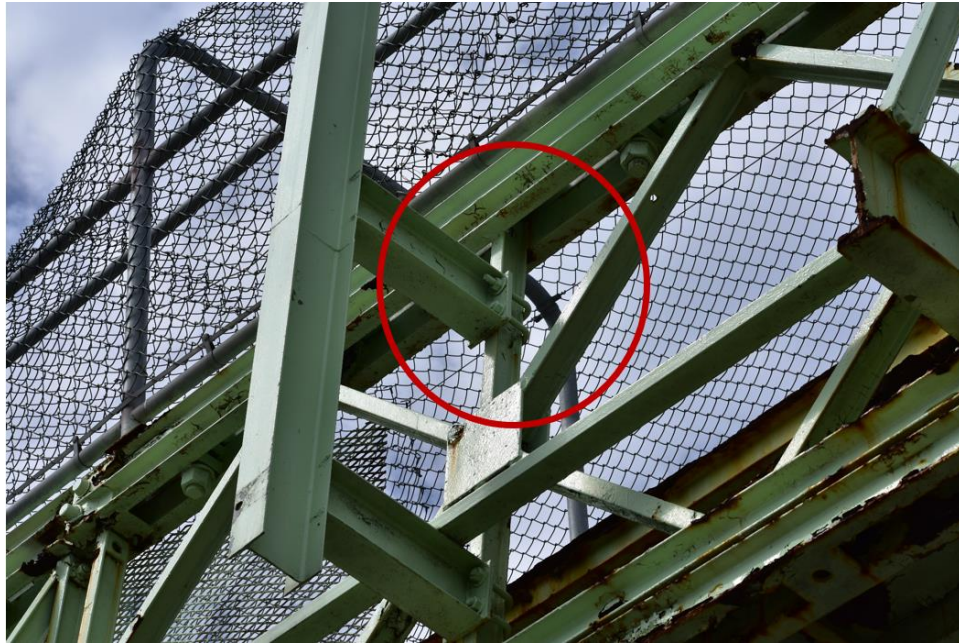
Figure 8.16: Location of the Signs Support

Due to their layout (see Figure 8.16), sign supports applied significant load to the top chord (with lateral bracing through transverse beams and diagonals) that may be responsible of the resulting twisting of the truss panel displayed in Figure 8.17.
