# Non-Cementitious Repair Materials Study

Final Report

WisDOT Project No. 0092-18-02  
June 2019

WISCONSIN HIGHWAY RESEARCH PROGRAM

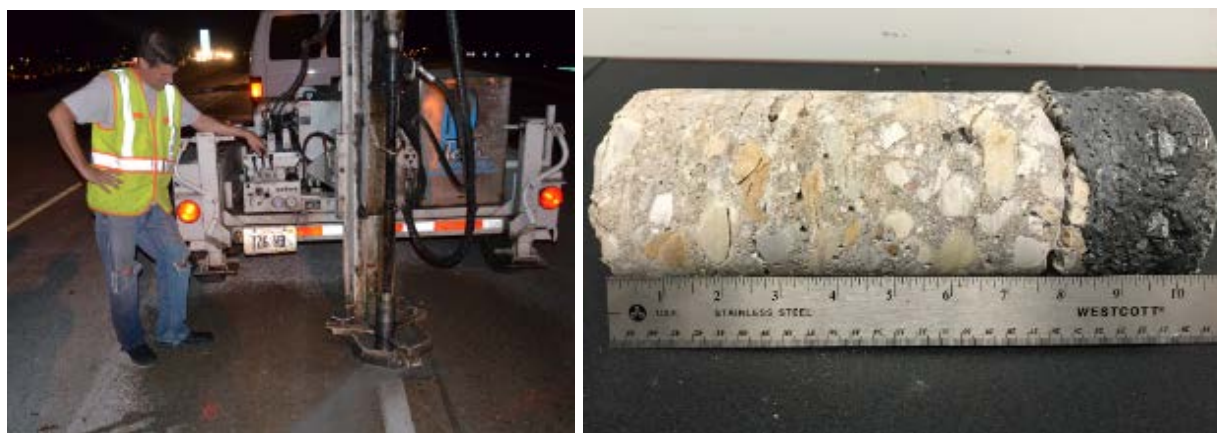
The second core location was also in the left most lane, close to the longitudinal joint. The PDR showed no signs of distress on the surface. The thickness of the RM-1 PDR at this location was around 2.25 inches and the concrete pavement was approximately 7.75 inches thick (see figure 3-5). The RM-1 PDR was debonded from the substrate concrete. Similar to core #1, the debonded core had significant amounts of substrate concrete still bonded to it (see figure 3-6).

Figure 3-5. Coring operation in progress for core #2 (left) and the extracted core #2 (right).

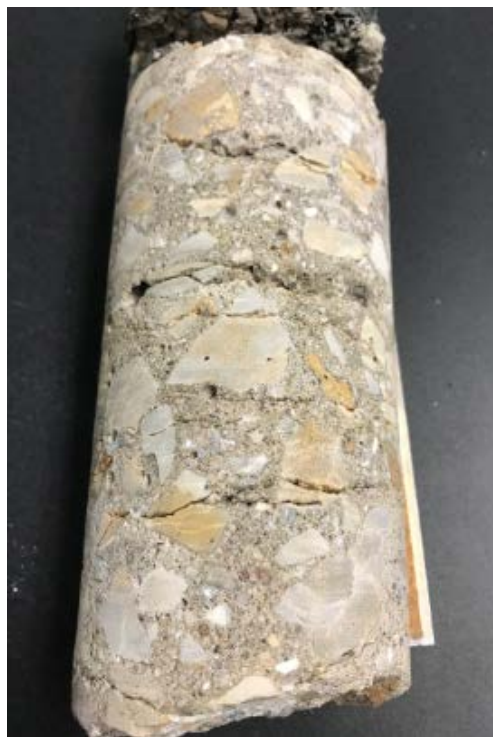
A closer examination of the substrate concrete revealed multiple parallel horizontal cracks through the entire depth of the core (see figure 3-7) and these cracks extend through the coarse aggregates. This potentially suggests freeze-thaw-related damage, however, since petrographic analysis was not performed on the extracted cores, this speculation cannot be confirmed.

Figure 3-7. Multiple parallel horizontal cracks extending through the entire depth of core #2.

It is worth noting the very low UPV value for the substrate concrete core specimen extracted from Site #1 (Core #2). This measurement was on the concrete core that exhibited parallel cracking throughout the entire depth (see figure 3-7.) Interestingly, this core specimen could not withstand the -23 °C temperature and disintegrated before the UPV measurement could be made. This observation further supports the findings from the field investigations that the PDRs are often performed in areas where the substrate concrete is already weak and freeze-thaw cycling during the winter season likely contributes to further deterioration of the substrate concrete and eventually result in the failure of the PDR. Figure 4-22 compares the UPV values measured on the laboratory and core specimens.

One of the core specimens extracted (see figure 3-7; Site #1, Core #2, Madison Beltline) exhibited multiple parallel horizontal cracks through the entire depth of the sample. When this specimen was conditioned at -23 °C for UPV testing, it completely disintegrated. Extremely cold temperatures during the winter seasons could potentially result in deterioration of the substrate concrete in areas where it is already in poor condition. This situation will surely compromise the bond between the repair material and the underlying concrete and can cause the material to pop out of the repair area.

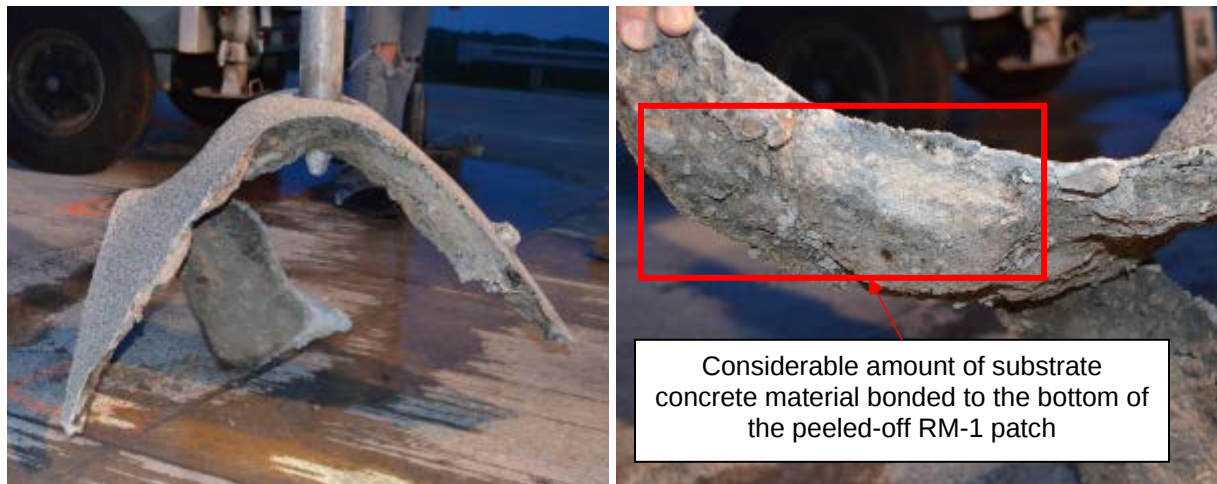
Several other RM-1 PDRs were visually inspected at this site (site #1). On the surface, most of the PDRs showed no signs of damage (see figure 3-9) and the surface condition was noted to be Good to Excellent for most of the PDRs. However, some of the thinner PDRs simply peeled off from the surface (see figure 3-10) when a hydraulic pavement breaker was used to remove the RM-1 PDRs and prepare the repair areas for full-depth repairs using conventional concrete material. Significant amount of substrate concrete material was still bonded to the bottom of the RM-1 PDRs that peeled off. Appendix B includes additional photos from the RM-1 field investigations.

Figure 3-10. RM-1 PDRs peeling off from the concrete pavement.

The observations from the RM-1 site investigations seem to indicate that the reason for the failures may potentially due to the one of more of the following issues: (a) failure to remove all the unsound concrete prior to the placement of the PDRs, (b) continued deterioration of the substrate concrete material due to freeze-thaw cycles, (c) presence of residual deicing chemicals in the repair areas that could compromise bond quality, and (d) carbonation of the substrate concrete in the repair areas. All the issues listed are simply speculations at this point and additional field and laboratory investigations are needed to test these theories.

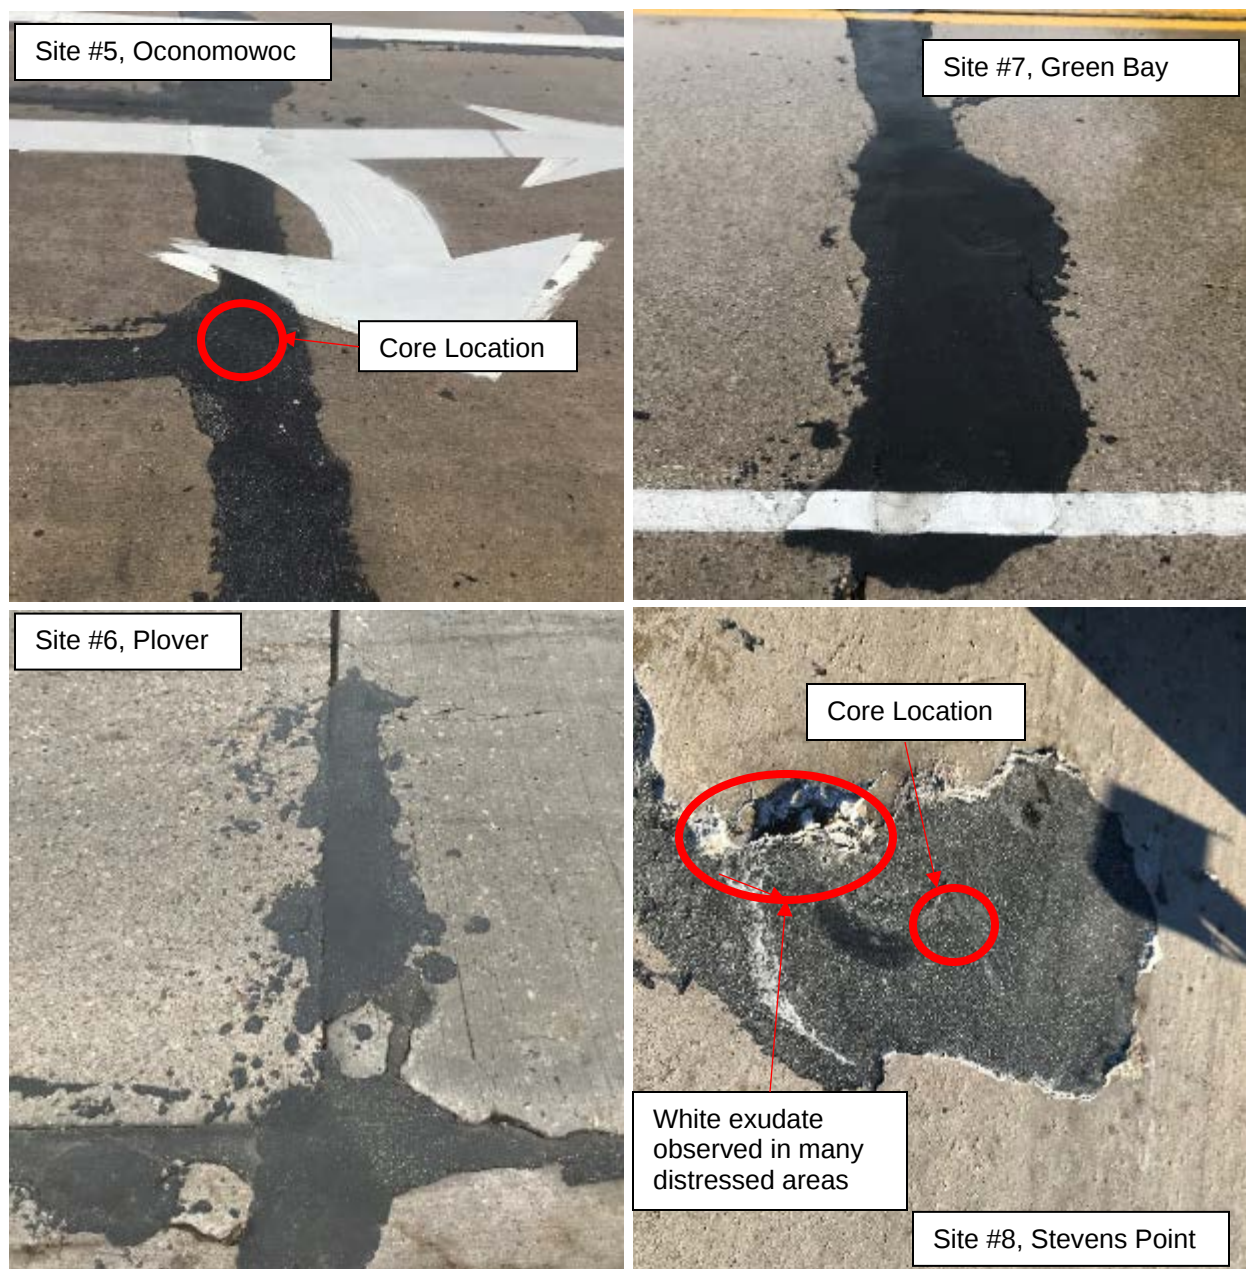
Figure 3-13. RM-3 used in concrete pavement PDR applications.

The field condition of the repaired areas was observed to be Fair to Excellent. The existing concrete pavement at Site #8 was heavily distressed. Severe joint spalling and scaling was widespread on this pavement. Also, many of the spalls and cracks noted on the pavement exhibited white exudate, which could be signs of other types of materials-related distresses. Considering the poor condition of the areas that have been chosen as the candidates for RM-3 applications (particularly on Site #8), the material has exhibited reasonably good performance.

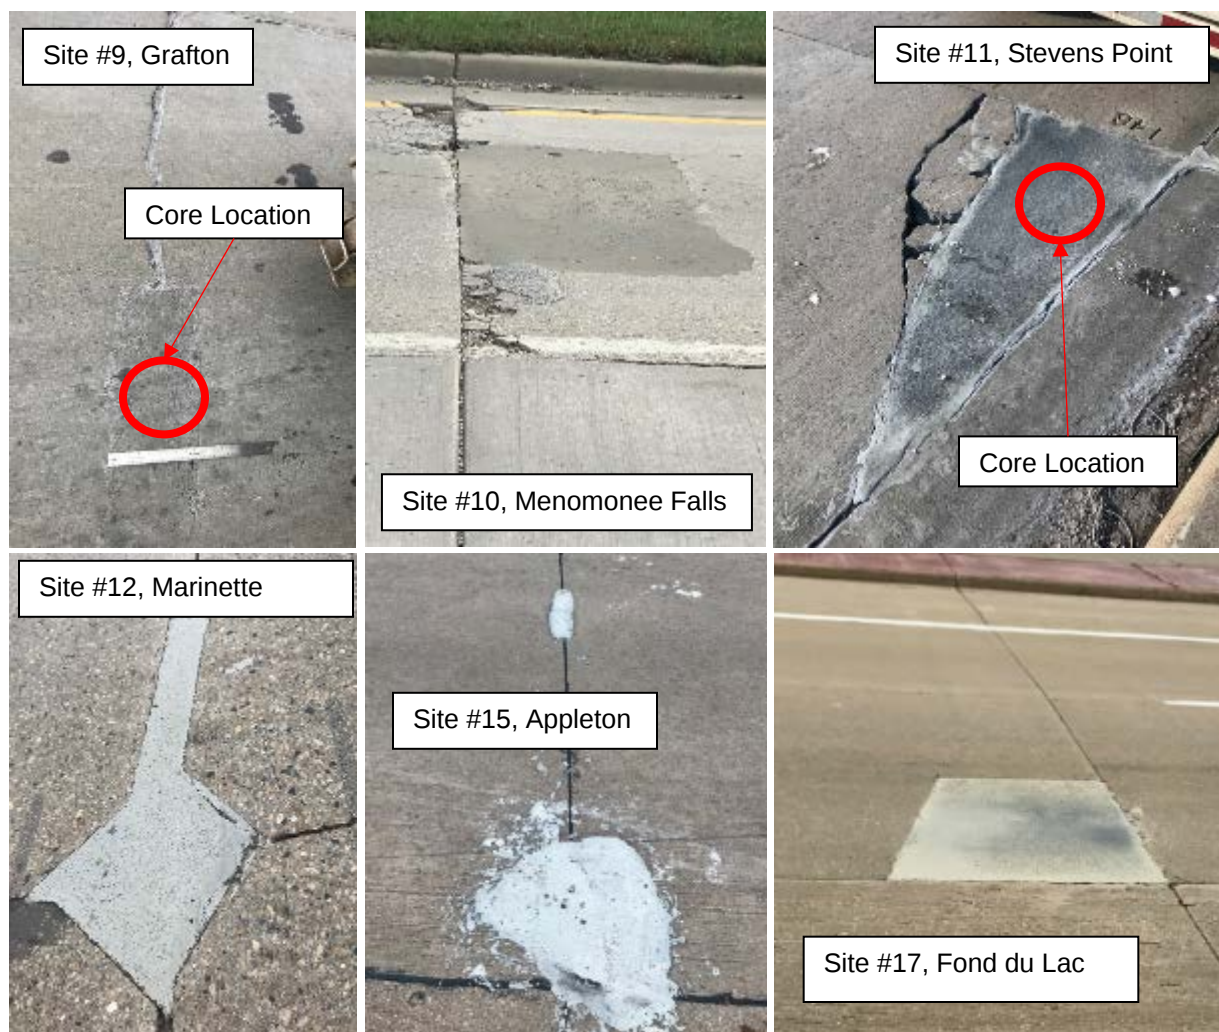
Figure 3-16. RM-4 used in concrete pavement PDR applications.

Two cores were extracted, one each from Sites #9 and #11 (core locations are shown in figure 3-16). RM-4 was used to repair a wide transverse crack at Site #9 and a corner break at Site #11.

The existing concrete around the repaired area at Site #11 has continued to deteriorate (see figure 3-16, top right). Figures 3-17 and 3-18 show photographs of the extracted cores.

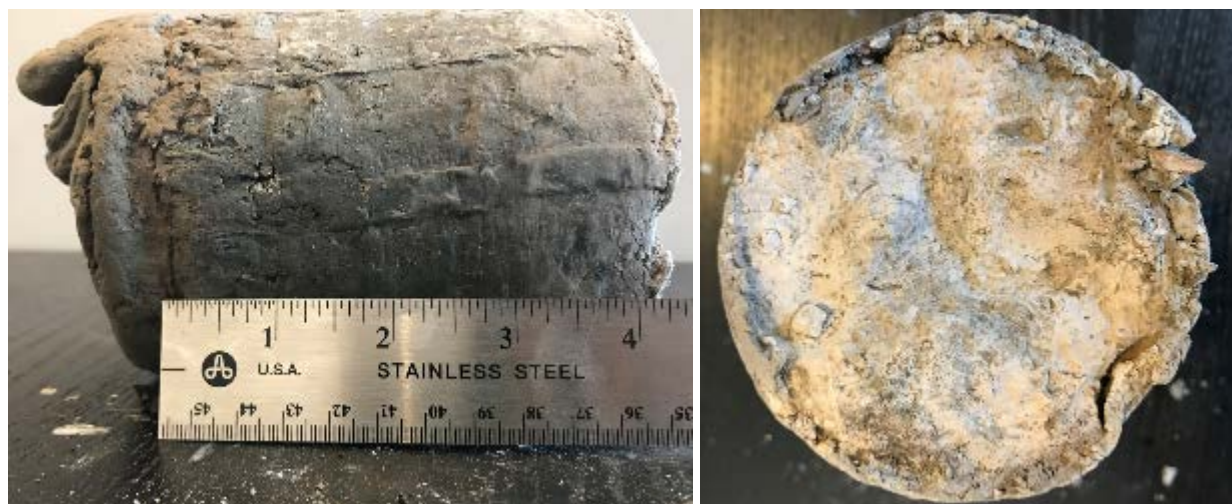
Figure 3-18. RM-4 core from Site #11 (left) and bottom of the core showing substrate concrete material bonded to the repair material (right).

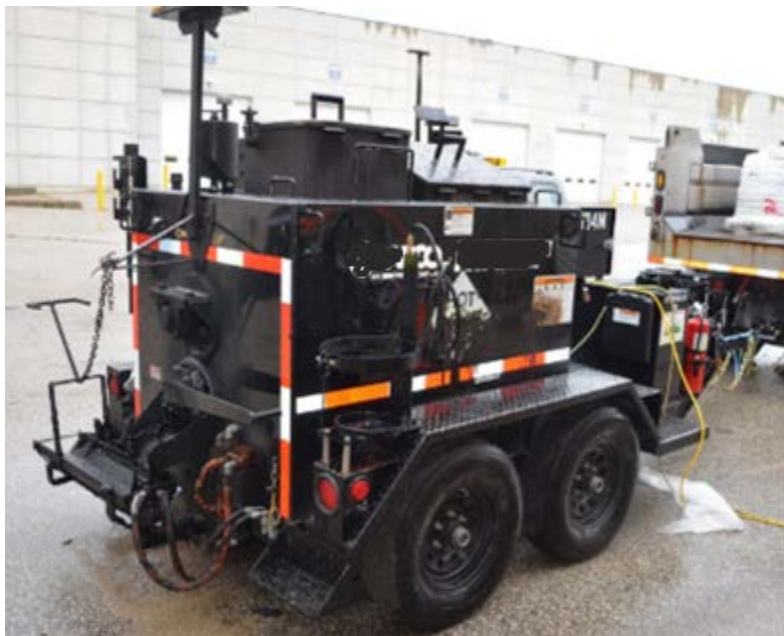
performed at different times and the repair boundaries have been sealed with a flexible sealant material. The material manufacturer claims that all the repairs on Site #16 were performed using RM-4 and attributed the difference in color to contaminants from the mixing equipment. The same mixing equipment (see figure 3-20) is used for both RM-3 and RM-4. The material manufacturer noted that if the equipment is not cleaned properly after using it to mix RM-3, the RM-4 mix produced using the same equipment is expected to have a darker shade.

Figure 3-20. Mixing equipment used for RM-3 and RM-4.

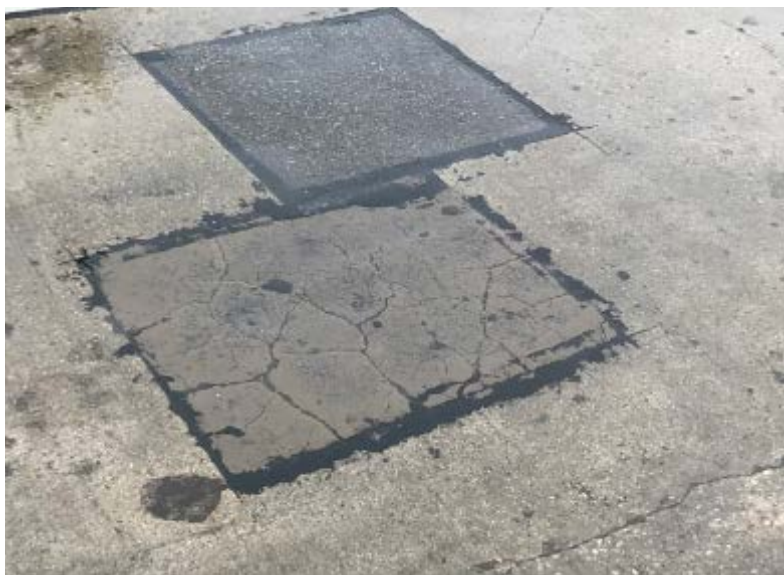
The material with the greyish tint has developed a map cracking pattern on the surface (see figure 3-21). The cracks are tight (no loose pieces found in the PDR) and resemble a shrinkage cracking pattern often seen on newly placed concrete.

Figure 3-21. Surface map cracking pattern observed on some RM-4 PDRs on Site #16.

- Ensure that the surface of the material is covered with surfacing aggregates.
  - Reduce weight and time of the grinding operations. Heavy downward load applied by the grinding machine may remove too much material and this is to be avoided. The grinding head is to be floated over the surface of the repairs so that only the surface material is removed without creating excessive fins.

- Perform the grinding operations during the coolest temperatures possible.
  - Maintain the grinding head as cool as possible.
- The abrupt failures of some RM-1 PDRs (where the entire patch popped out of the repair area) could potentially be attributed to the following factors:

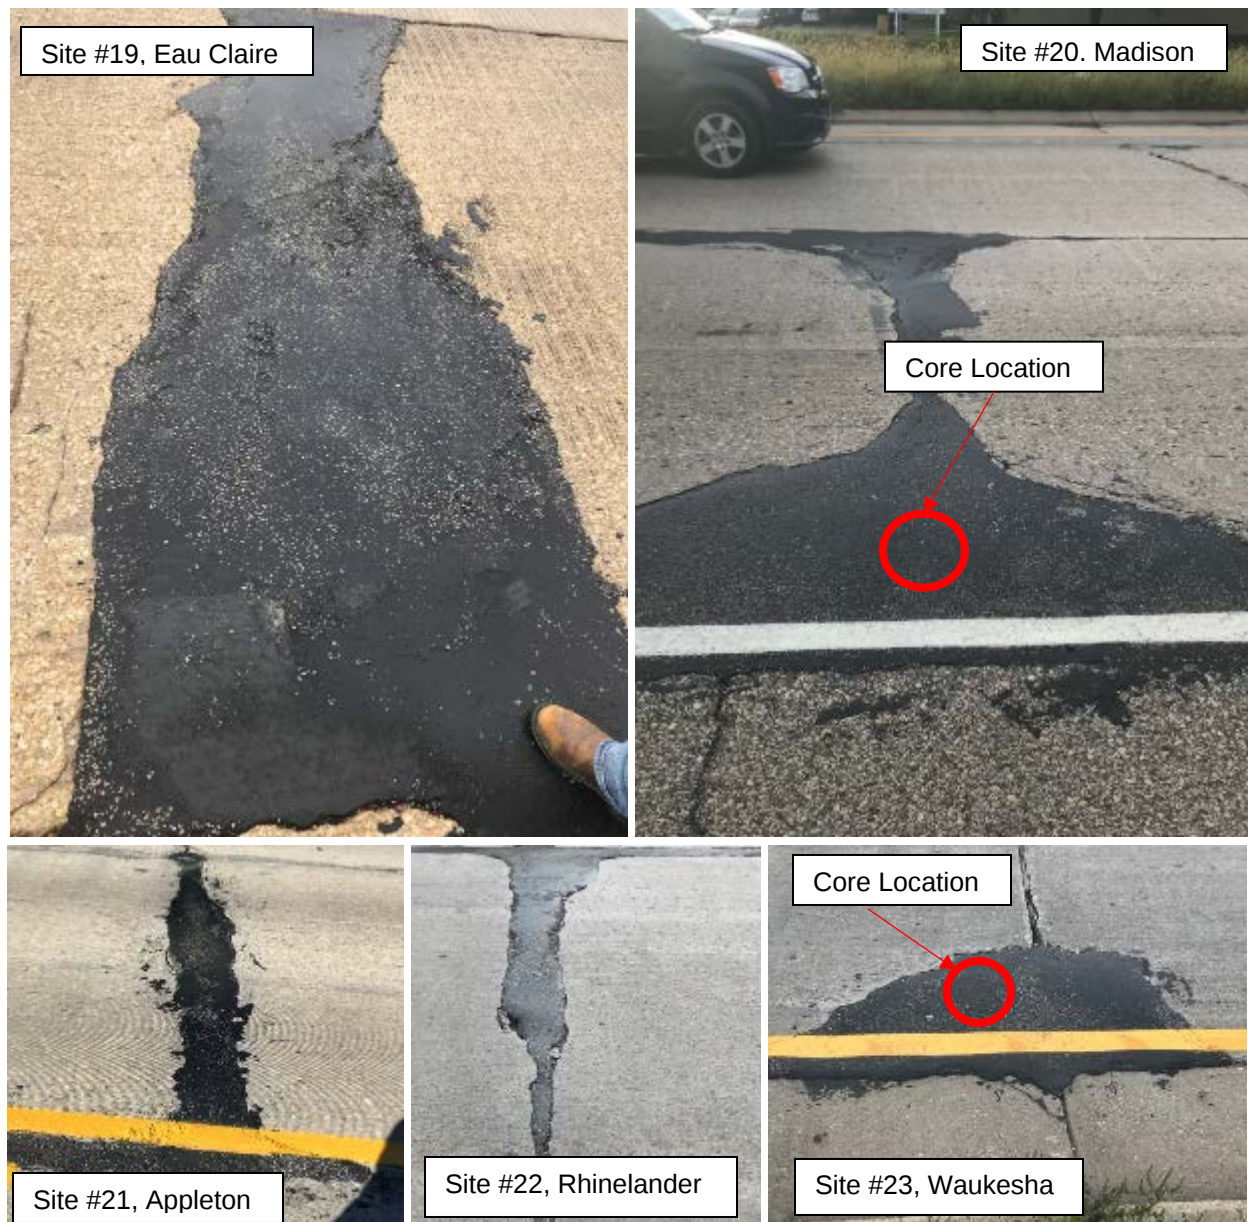
Figure 3-22. RM-5 used in concrete pavement PDR applications.

The repaired areas were observed to be in generally Good condition. While the PDRs exhibited some surface wear from traffic, none of them developed cracking. In a few locations, a small amount of material was missing along the edge of the repaired areas, primarily due to the deterioration of the surrounding concrete pavement.

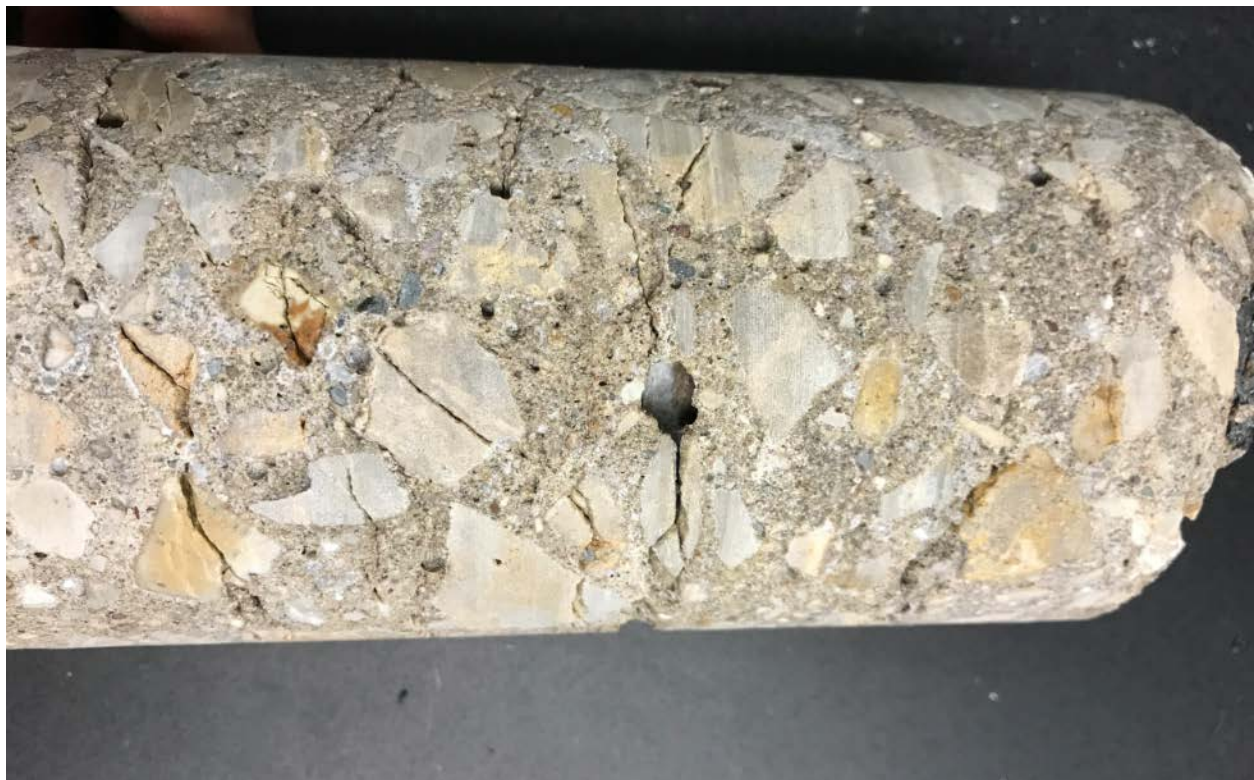
Figure A-6. Site #1, RM-1 Core #2—Closeup of PCC core  
(US 12/18, Madison Beltline).

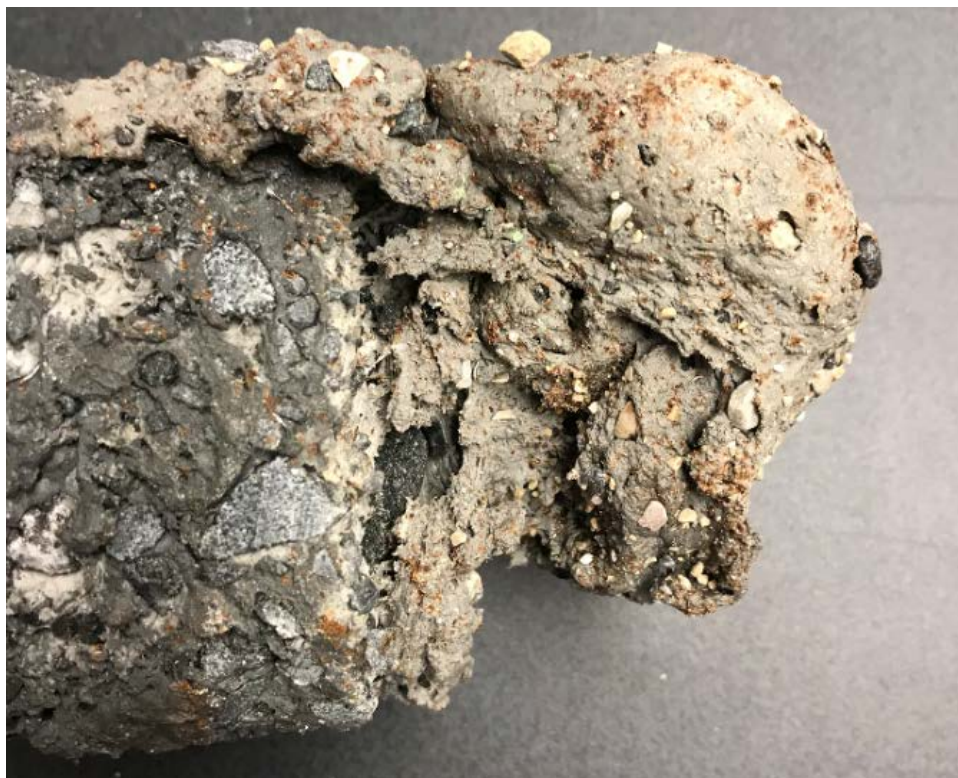
Figure A-10. Site #1, RM-1 Core #3—Closeup of melted material (US 12/18, Madison Beltline).

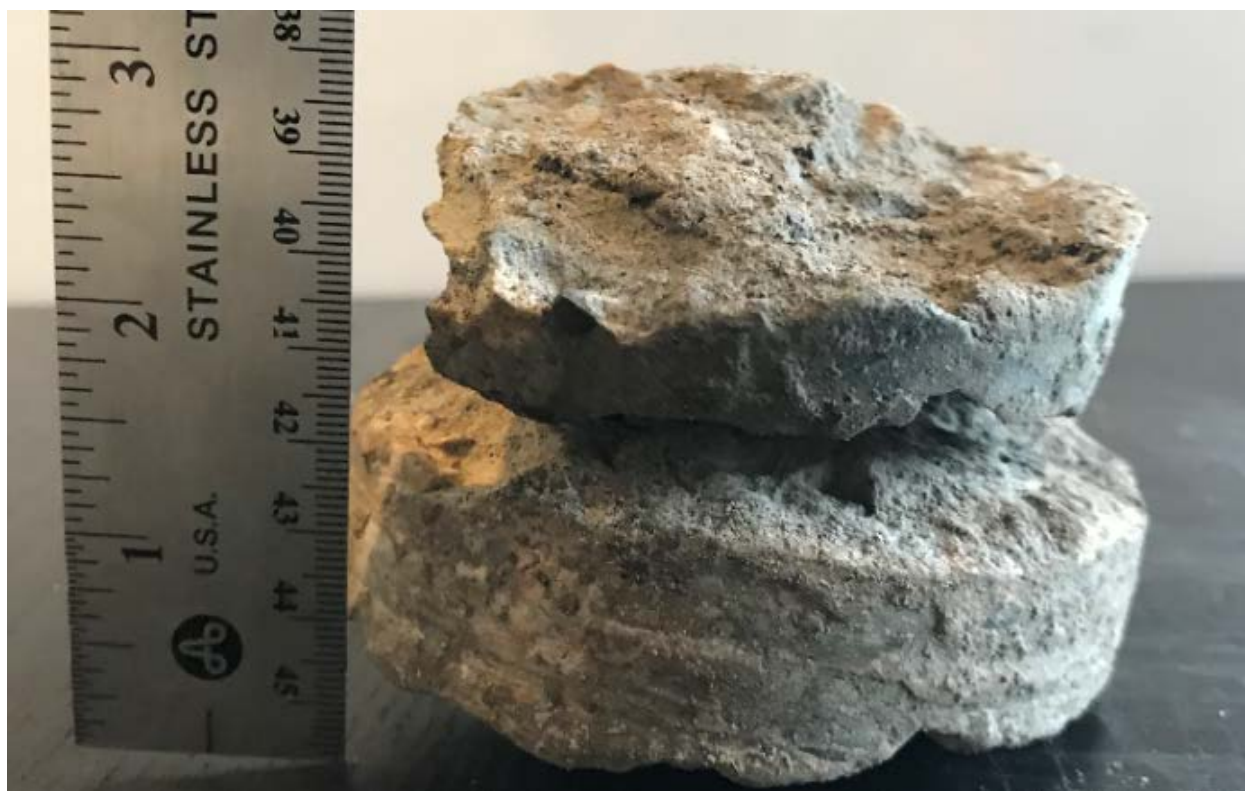
Figure A-14. Site #8, RM-3 Core #1—concrete pavement core pieces  
(State Route 66 SB, Stevens Point).

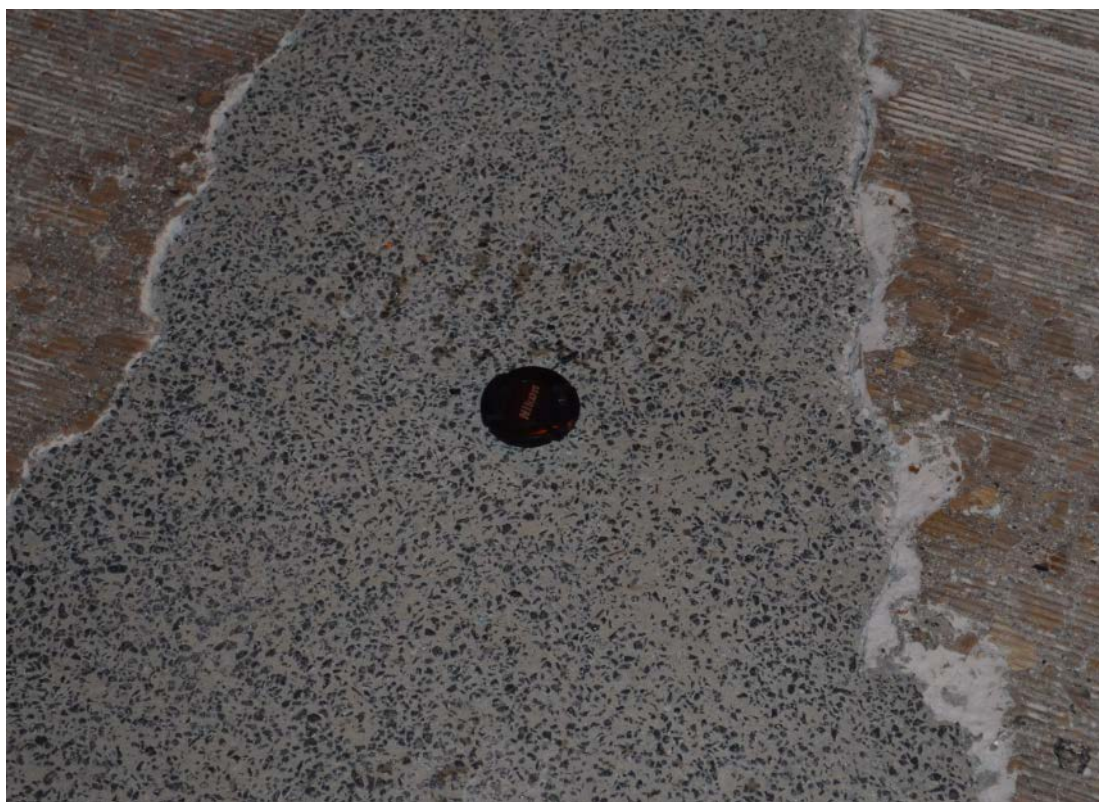
Figure B-8. RM-1 PDR (7)—close-up of repair surface (Site #1, US 12/18, Madison Beltline).

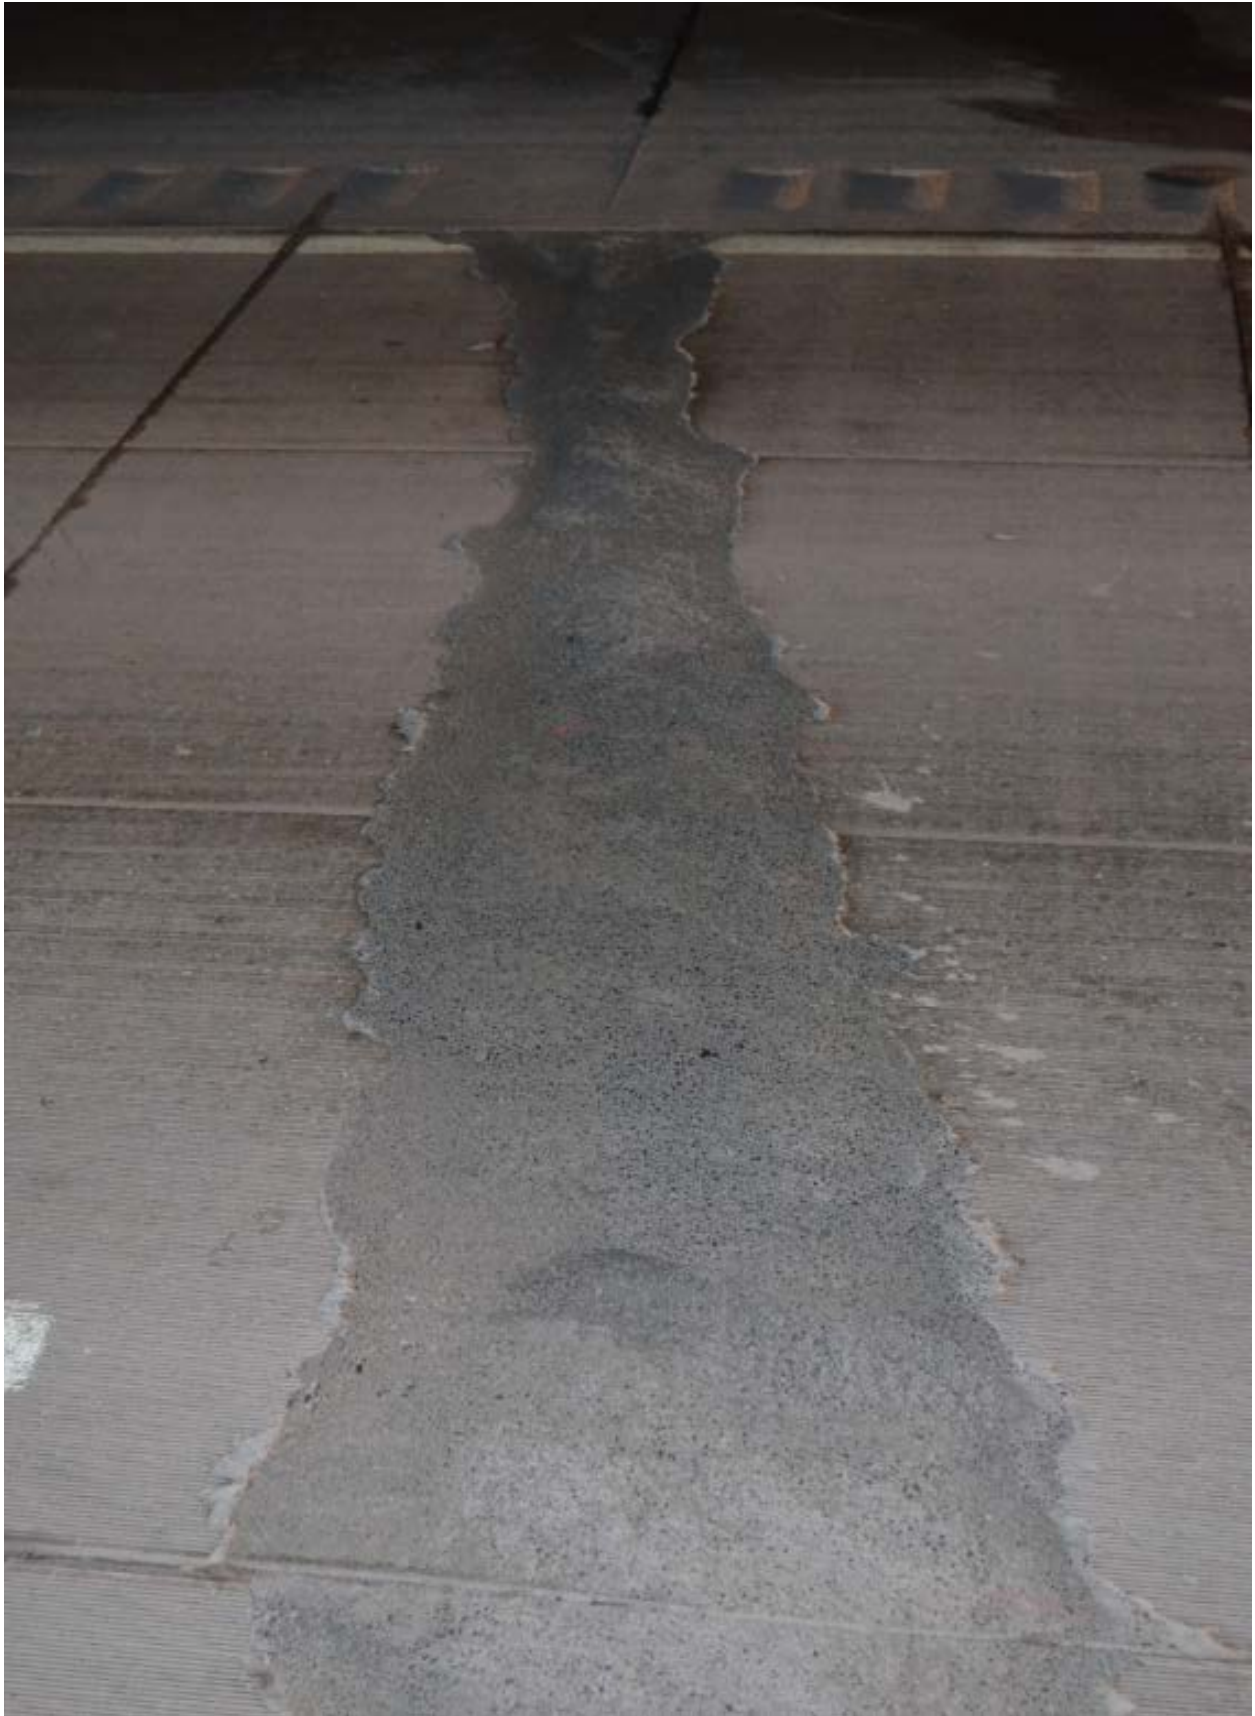
Figure B-9. RM-1 PDR (8)—large, full lane-width patch  
(Site #1, US 12/18, Madison Beltline).

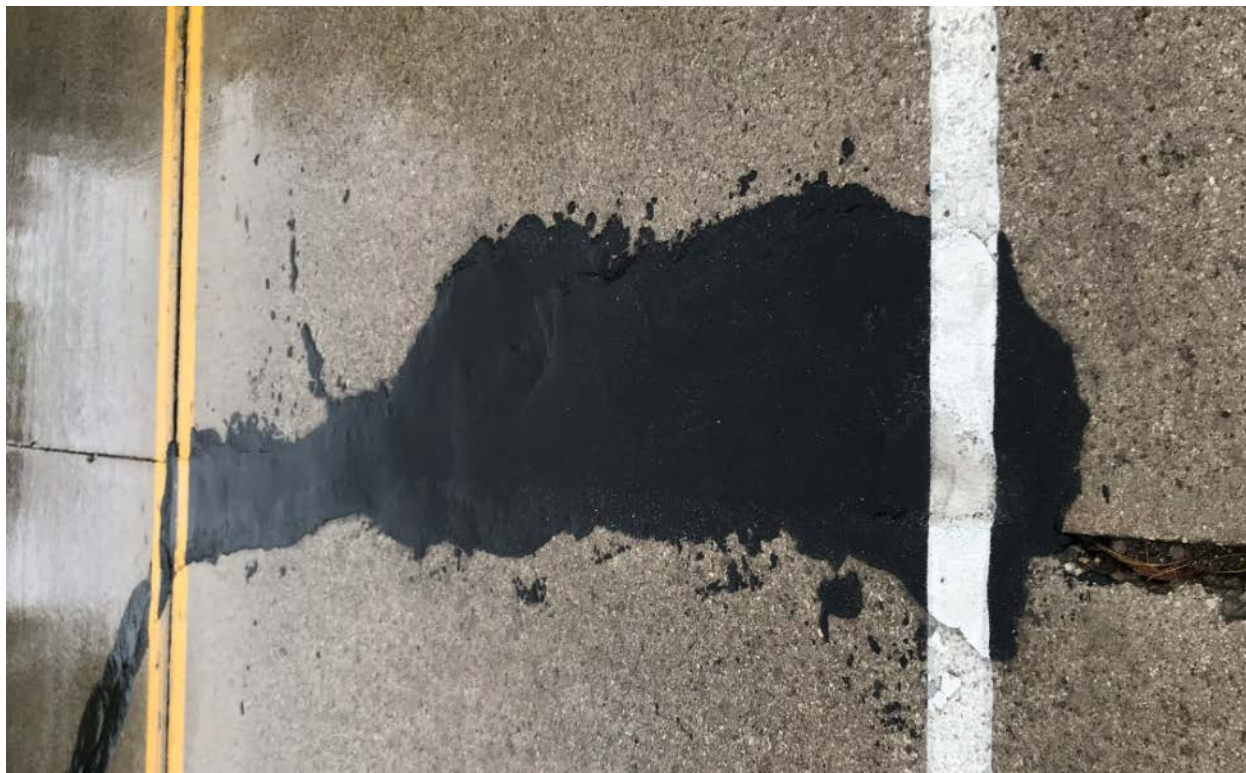
Figure D-6. PDRs along transverse joint  
(Site #7 S. Taylor St., Green Bay).

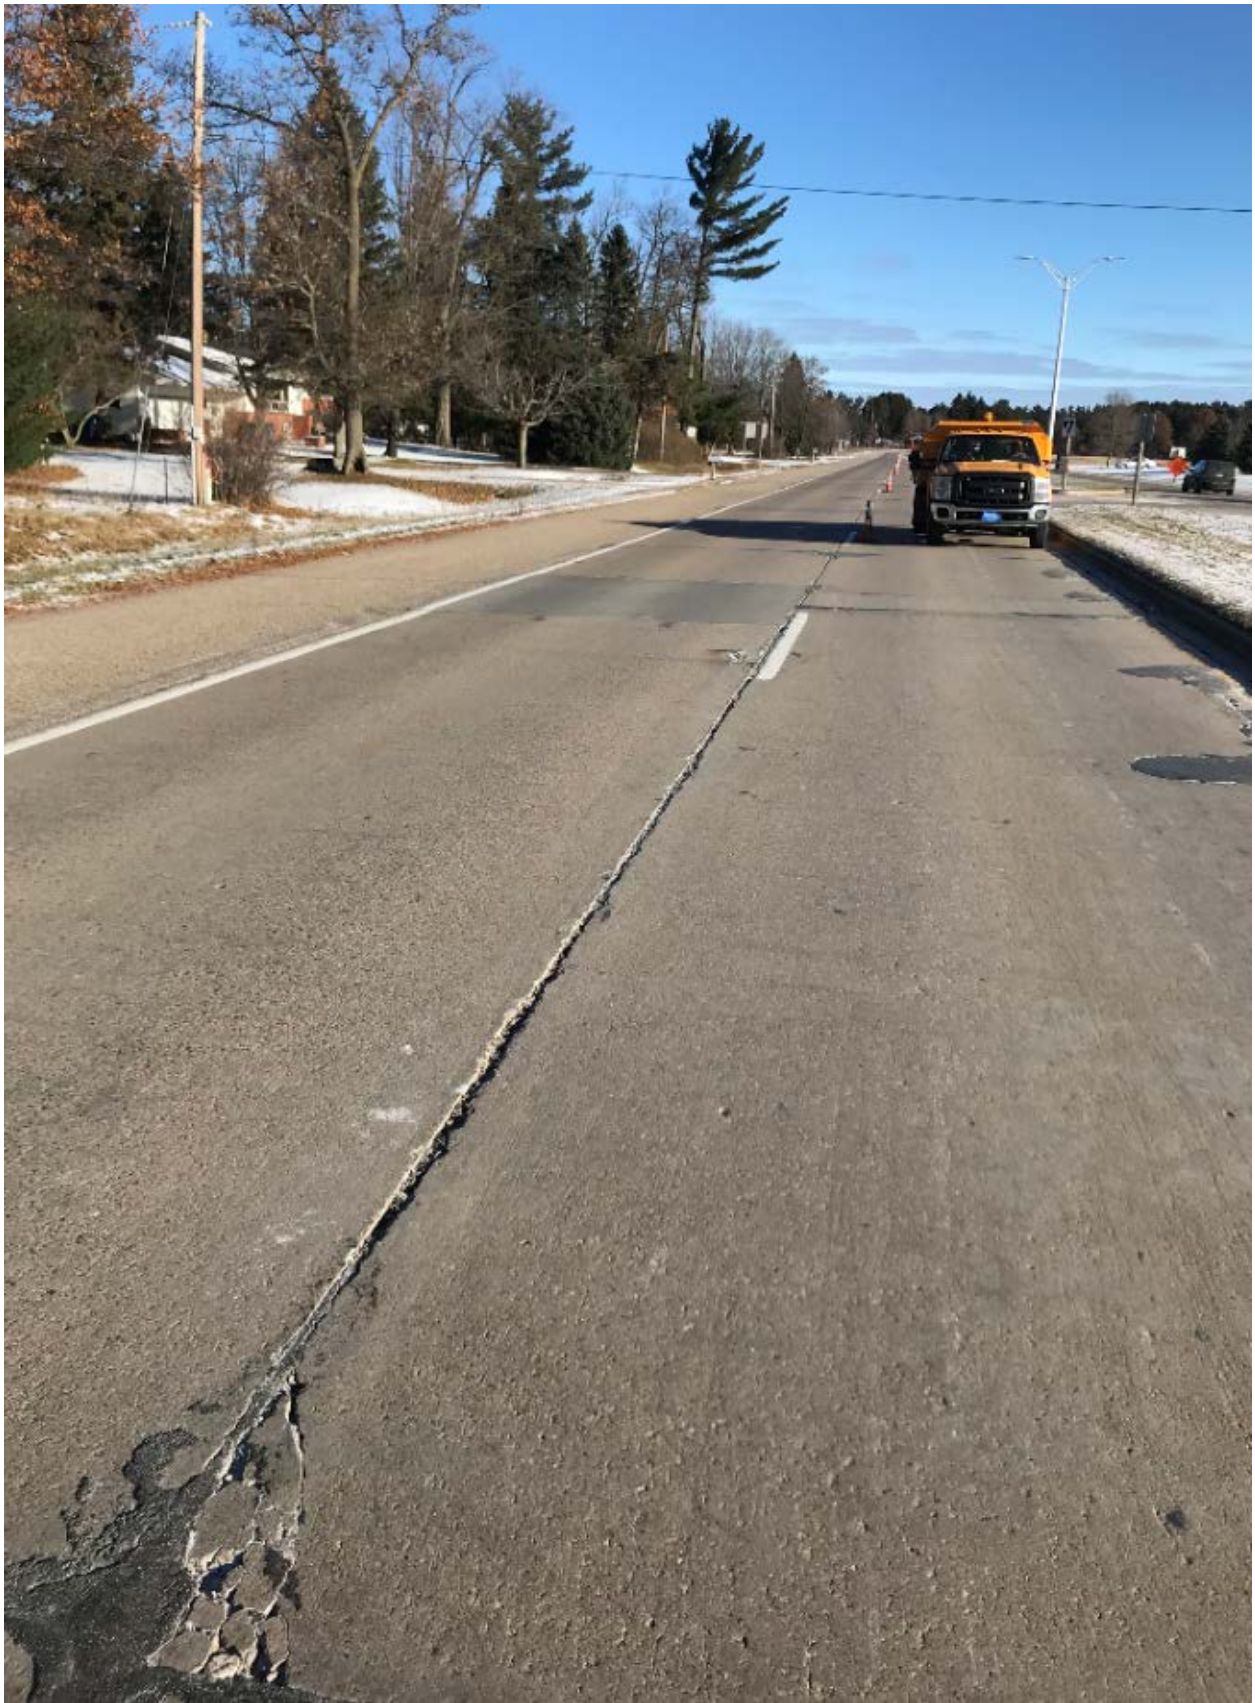
Figure D-7. Overview of existing concrete pavement (Site #8, State Road 66, Stevens Point).

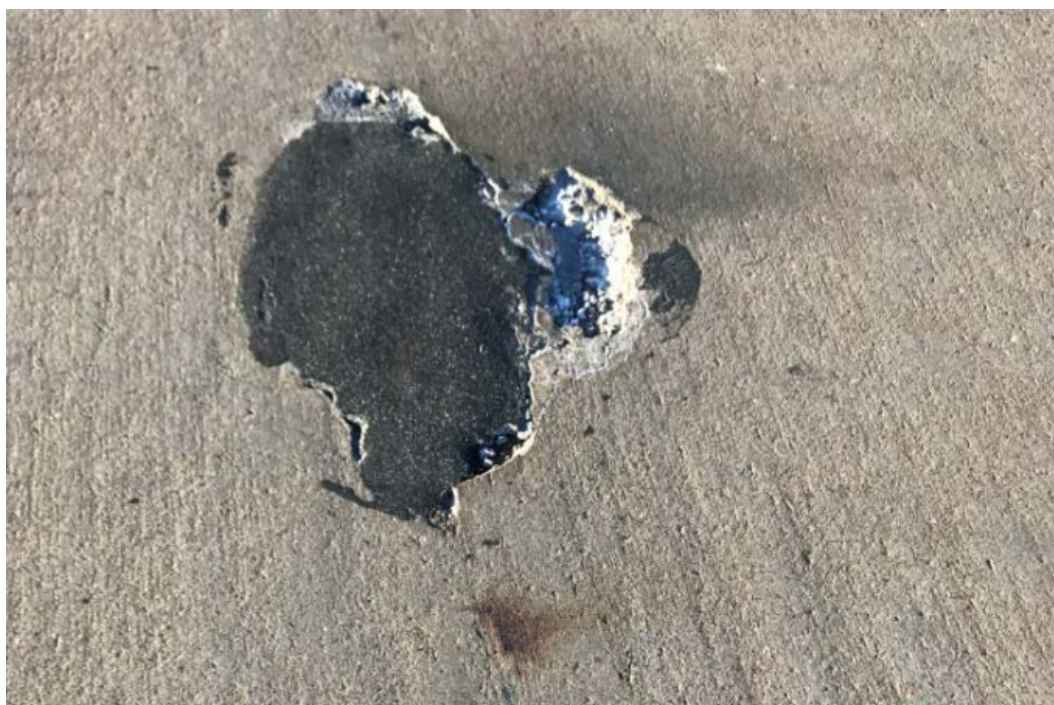
Figure D-9. Small spot repairs in slab interior  
(Site #8, State Road 66, Stevens Point).

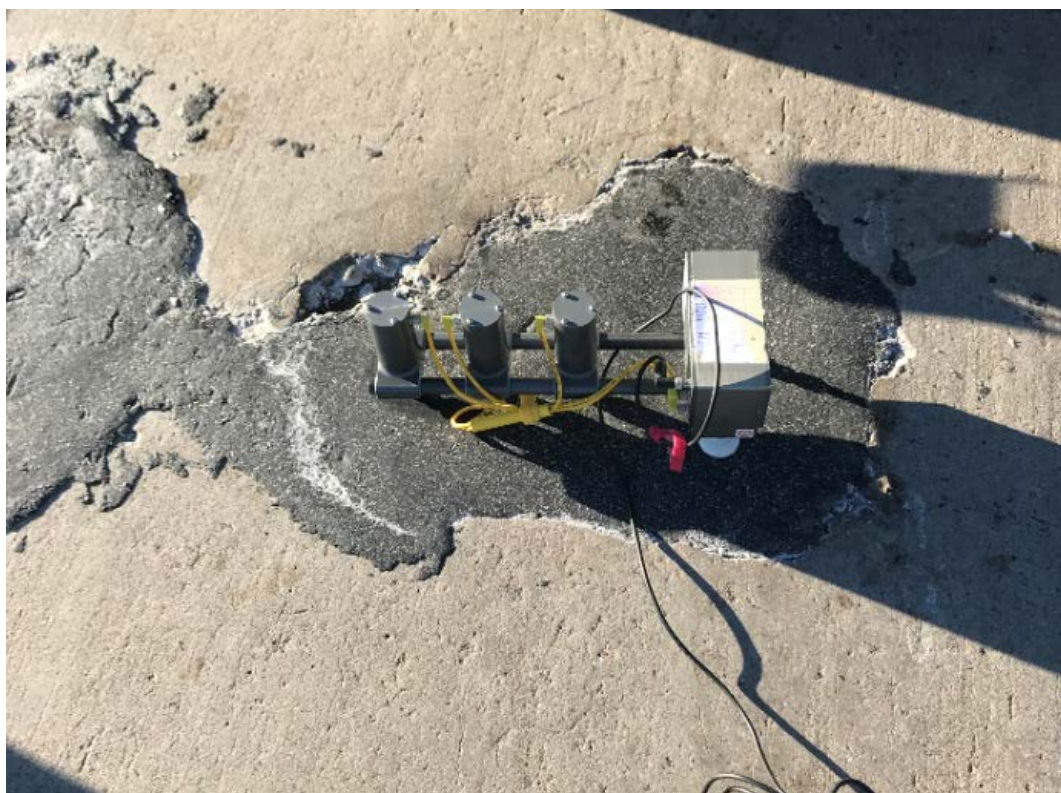
Figure D-10. PSPA testing in progress on PDR in slab interior  
(Site #8, State Road 66, Stevens Point).

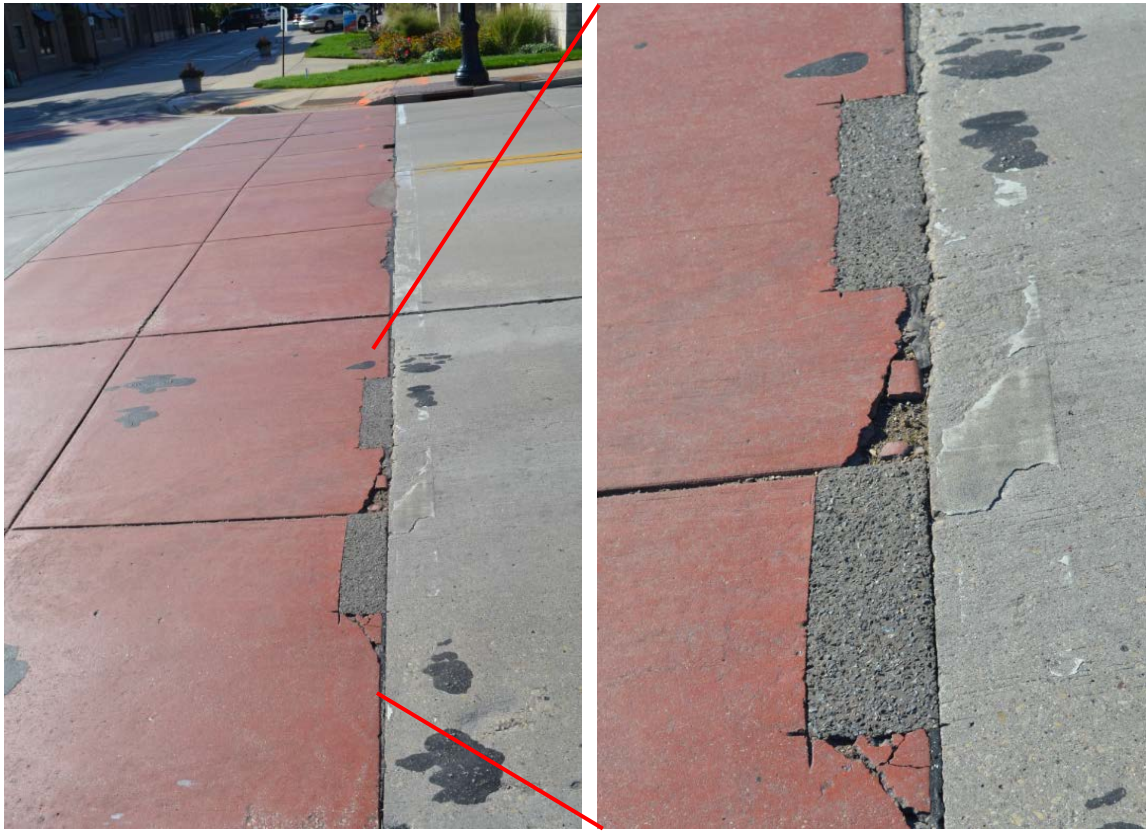
Figure E-1. PDRs along transverse joint  
(Site #9, Washington St., Grafton).

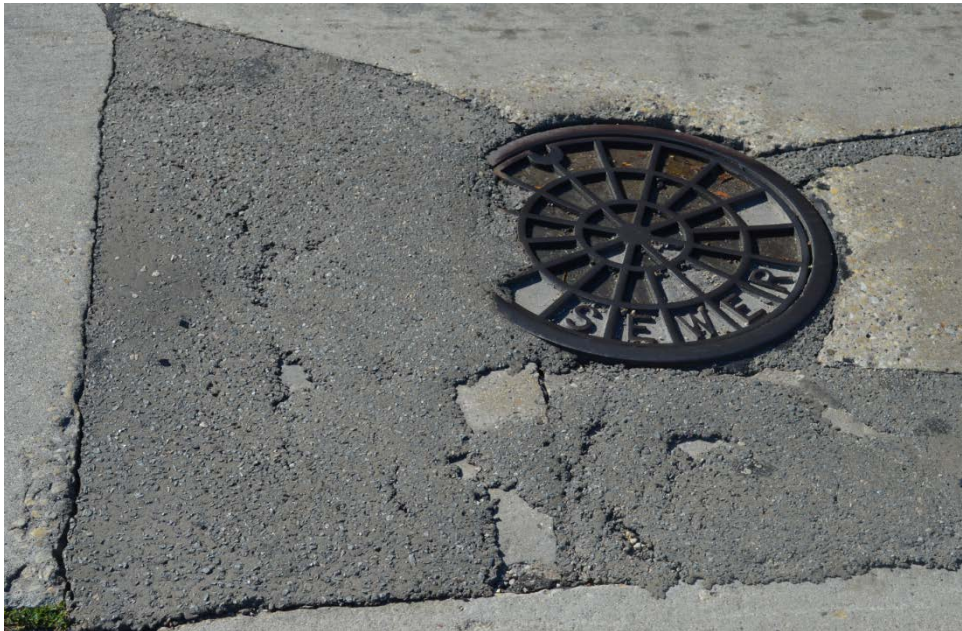
Figure E-2. PDRs to address deteriorated areas around utility hole  
(Site #9, State Road 66, Stevens Point).

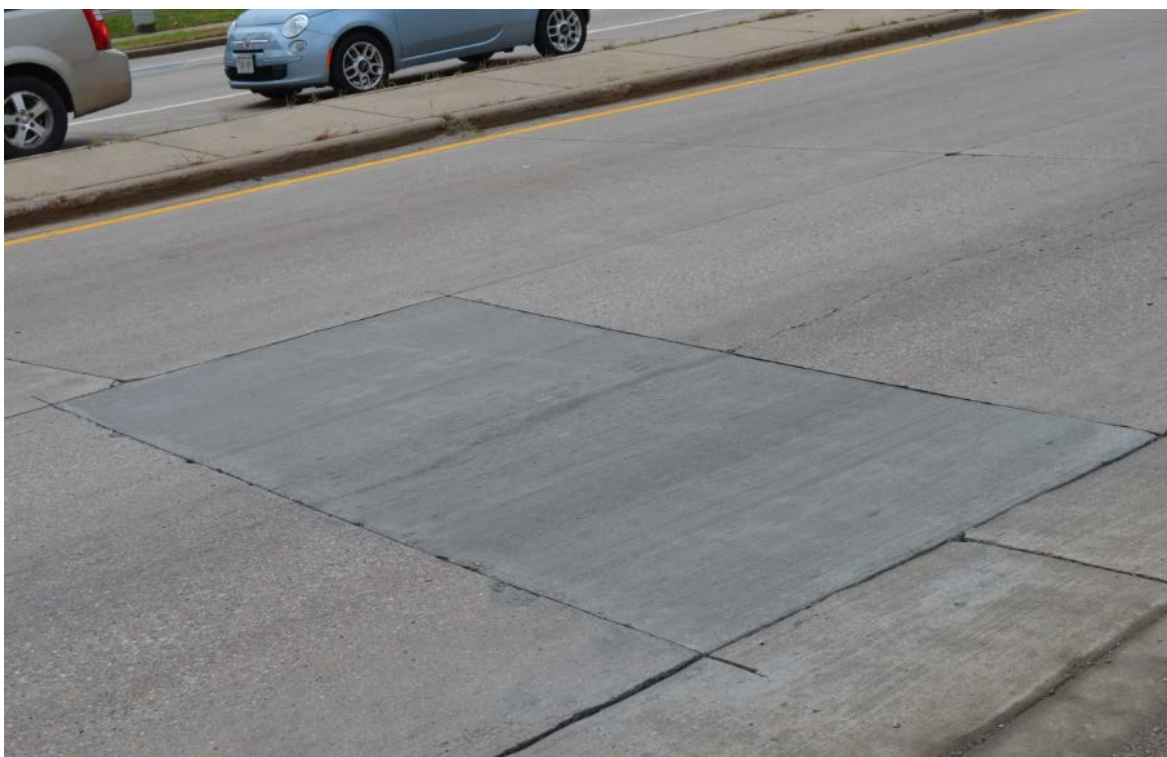
Figure E-11. Full depth repairs in existing concrete pavement (Site #11, US 10, Stevens Point).
