# Non-Cementitious Repair Materials Study

Final Report

WisDOT Project No. 0092-18-02  
June 2019

WISCONSIN HIGHWAY RESEARCH PROGRAM

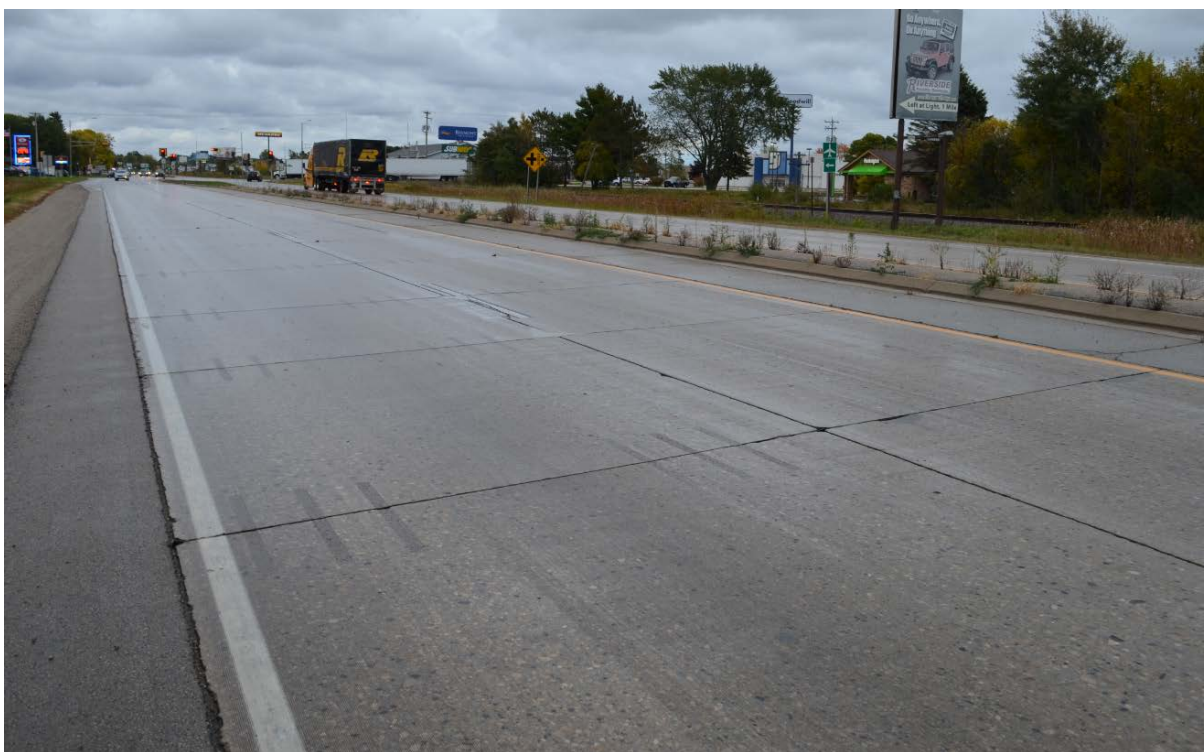
Figure E-14. Overview of existing concrete pavement  
(Site #12, US 41, Marinette).

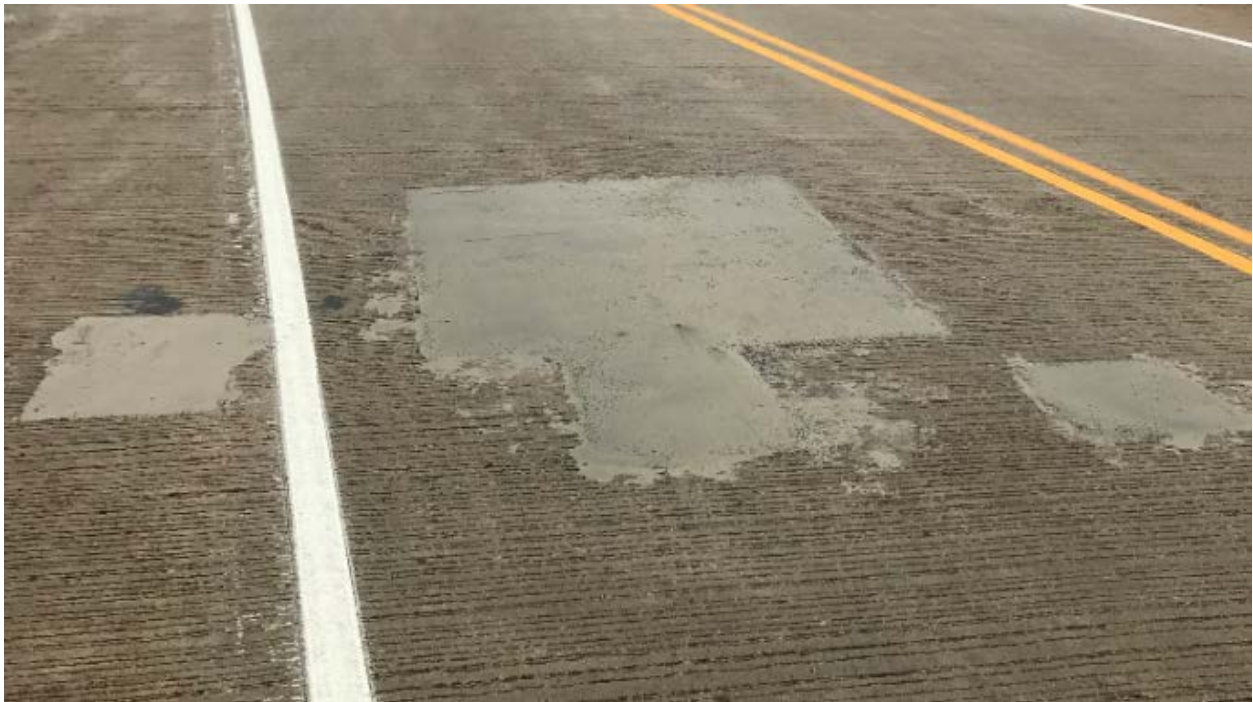
Figure E-18. PDRs on bridge deck (1)  
(Site #13, State Road 32, Mountain).

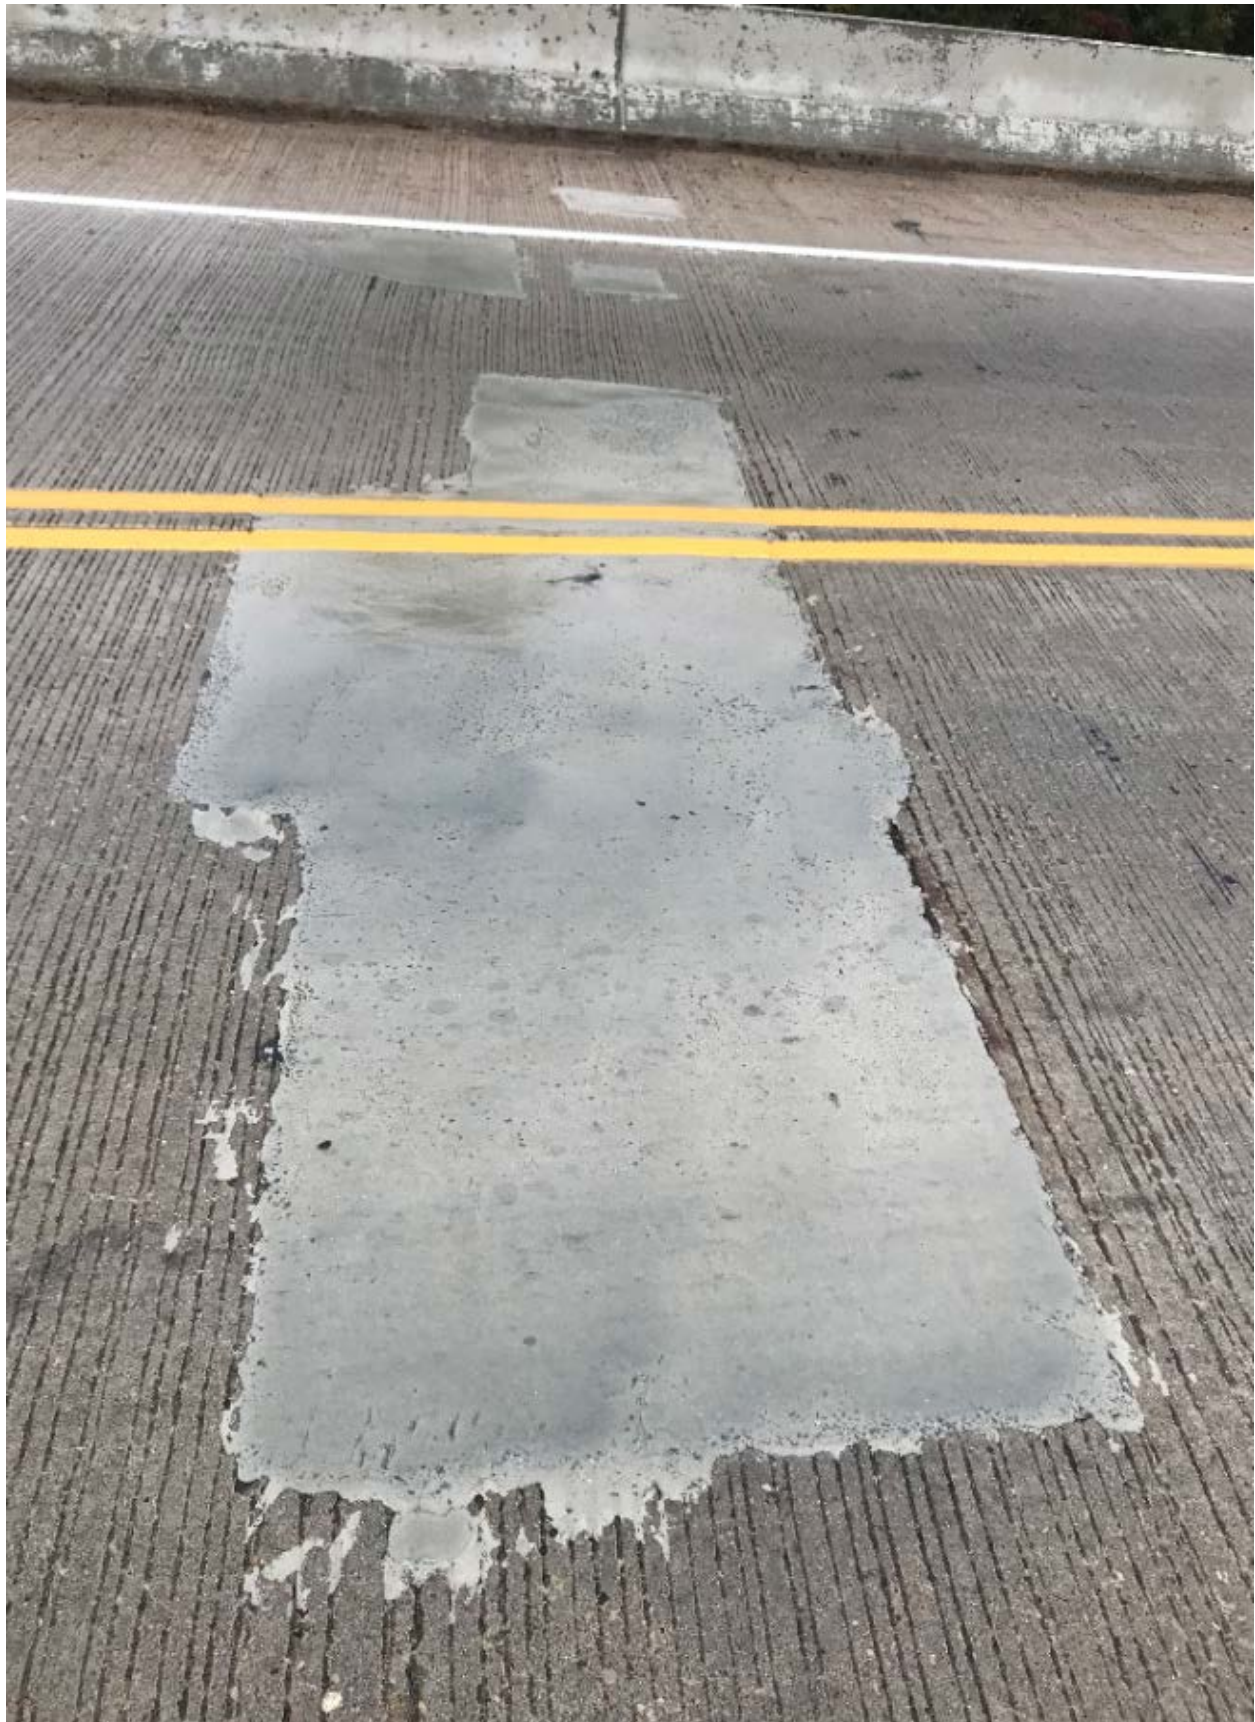
Figure E-20. PDRs on bridge deck (2)  
(Site #13, State Road 32, Mountain).

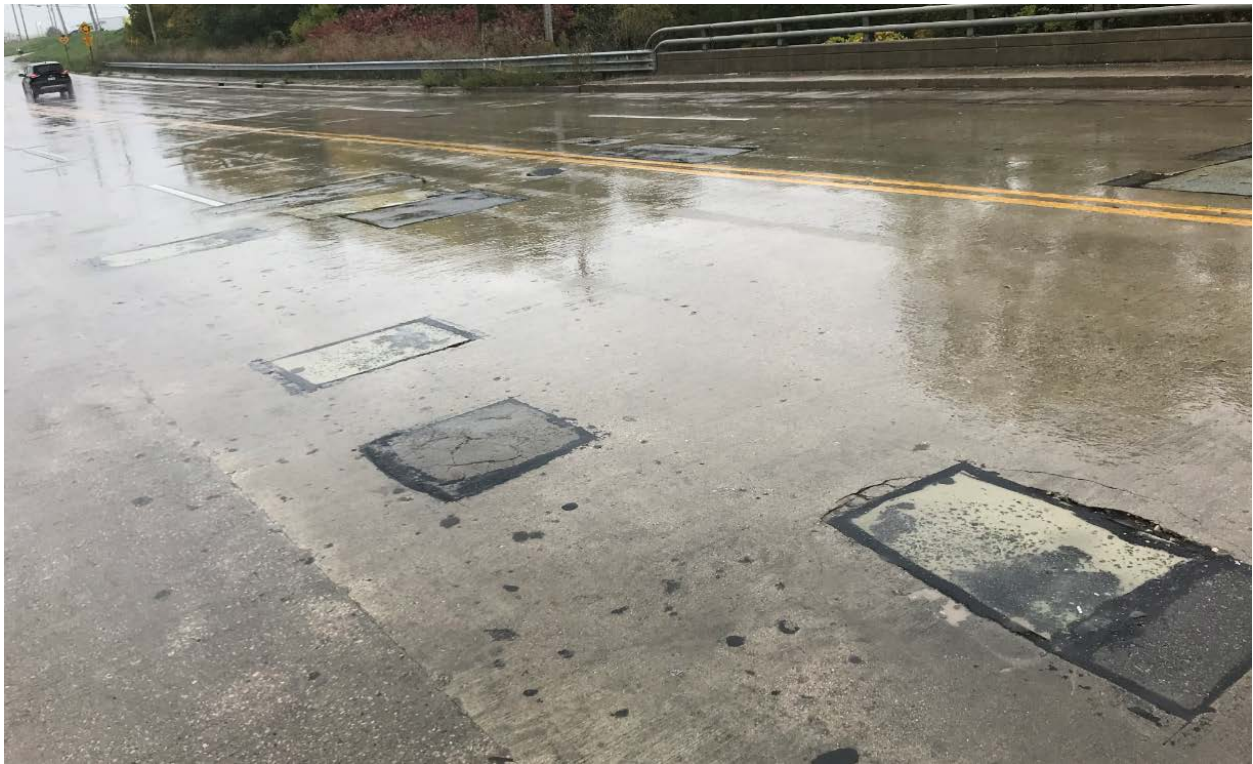
Figure E-24. PDRs on bridge deck  
(Site #16, W. Main Ave., Ashwaubenon).

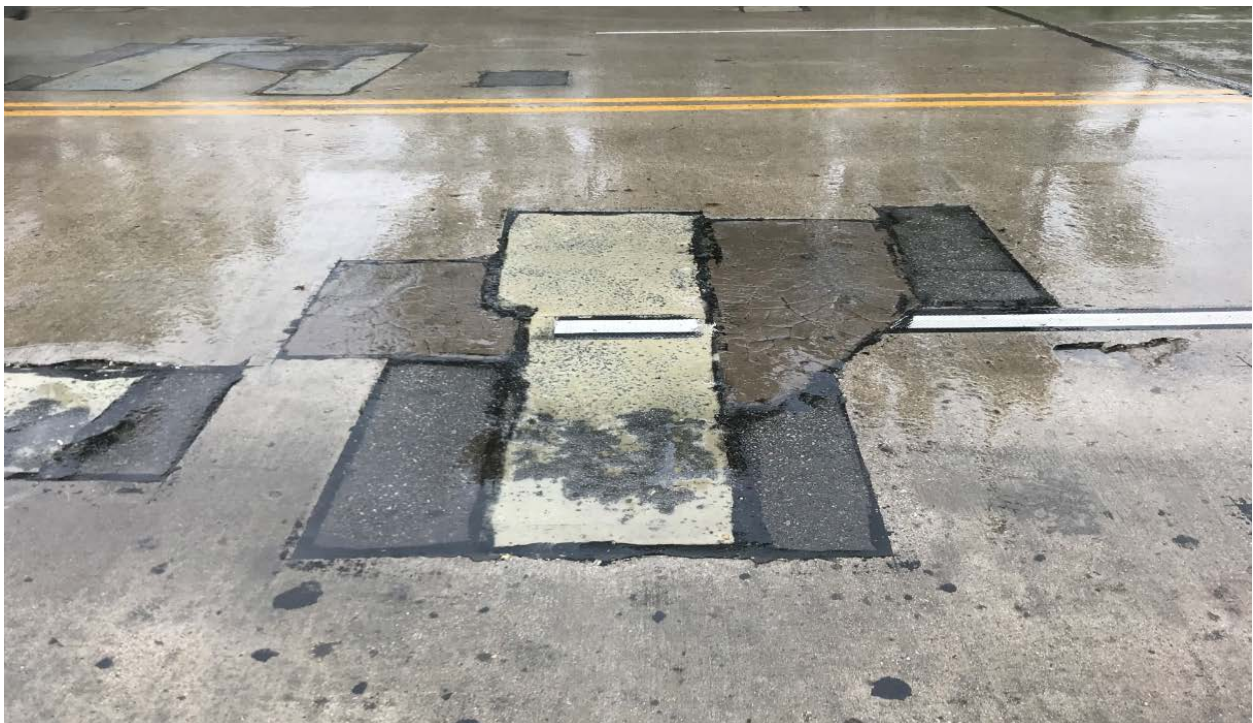
Figure E-25. RM-4 PDRs on bridge deck with starkly different colors  
(Site #16, W. Main Ave., Ashwaubenon).

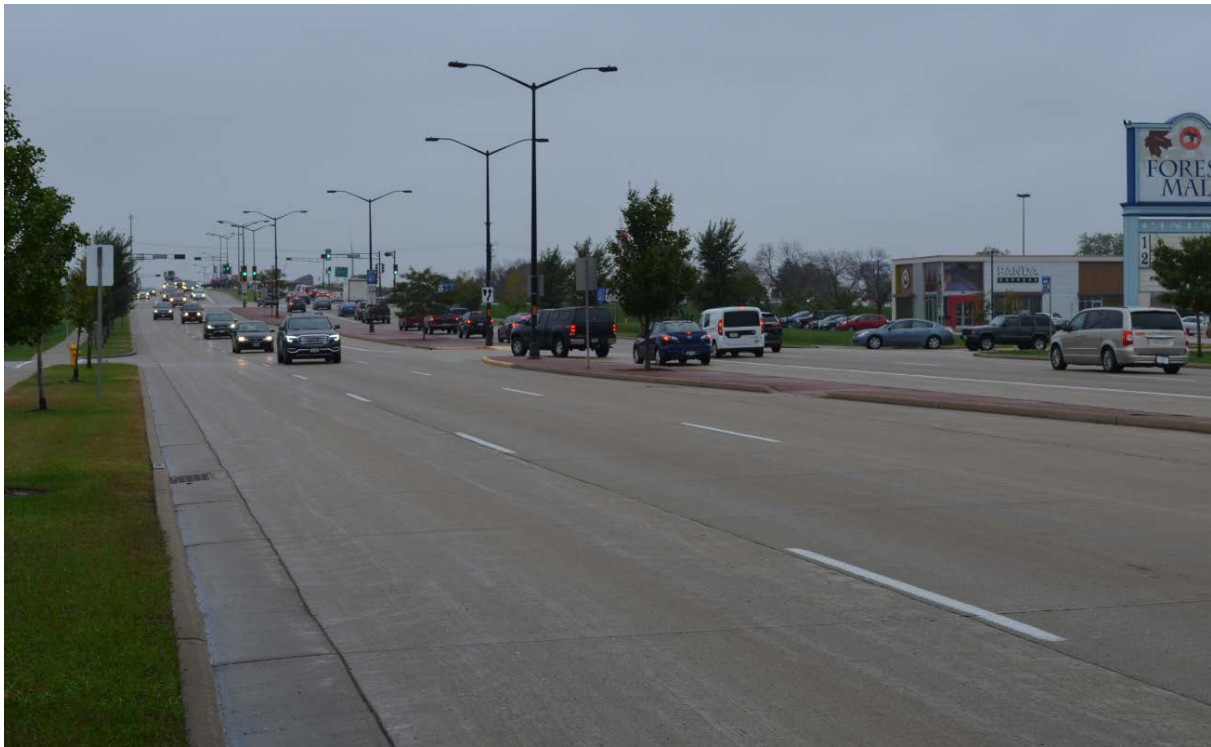
Figure E-26. Overview of existing concrete pavement in very good condition (Site #17, W. Johnson St., Fond du Lac).

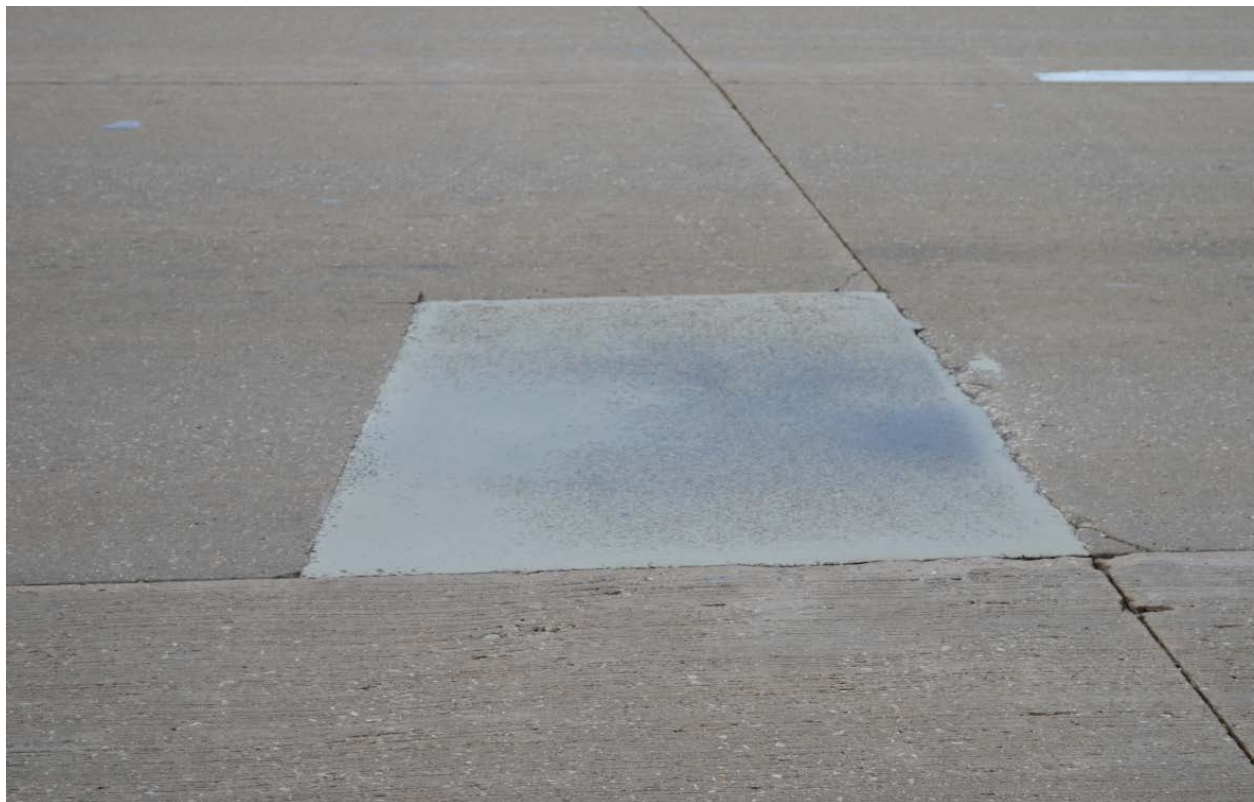
Figure E-27. PDR to address an isolated area of distress in an otherwise distress free pavement (Site #17, W. Johnson St., Fond du Lac).

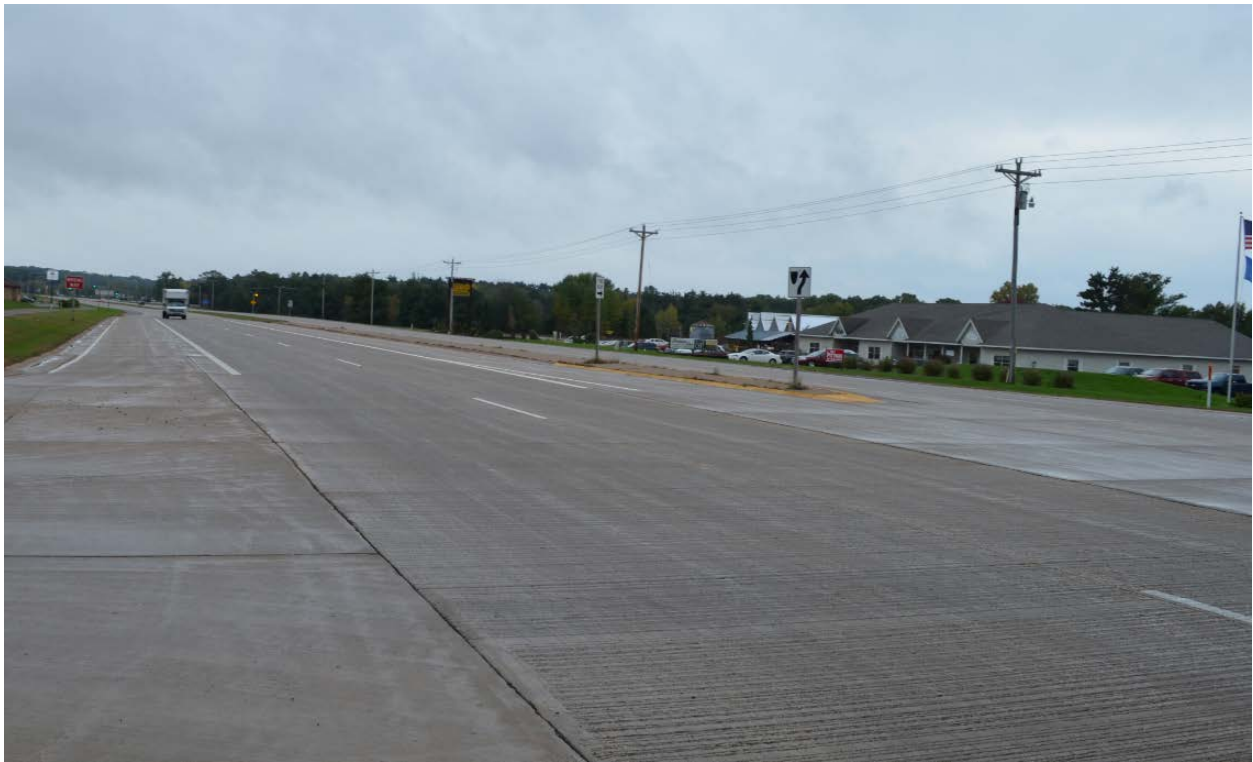
Figure F-2. Overview of generally distress-free surrounding concrete pavement (Site #19, State Road 93, Eau Claire).

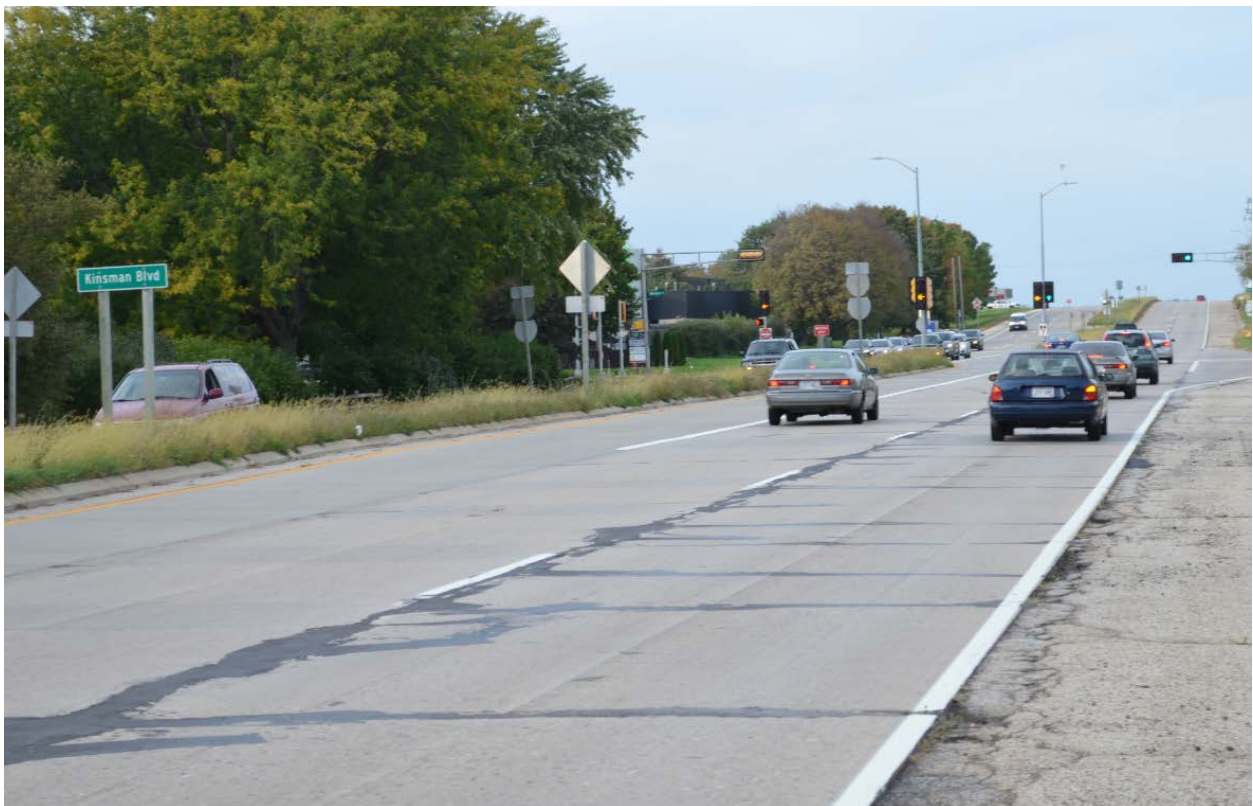
Figure F-3. Overview of existing concrete pavement (Site #20, N. Stoughton Rd., Madison).

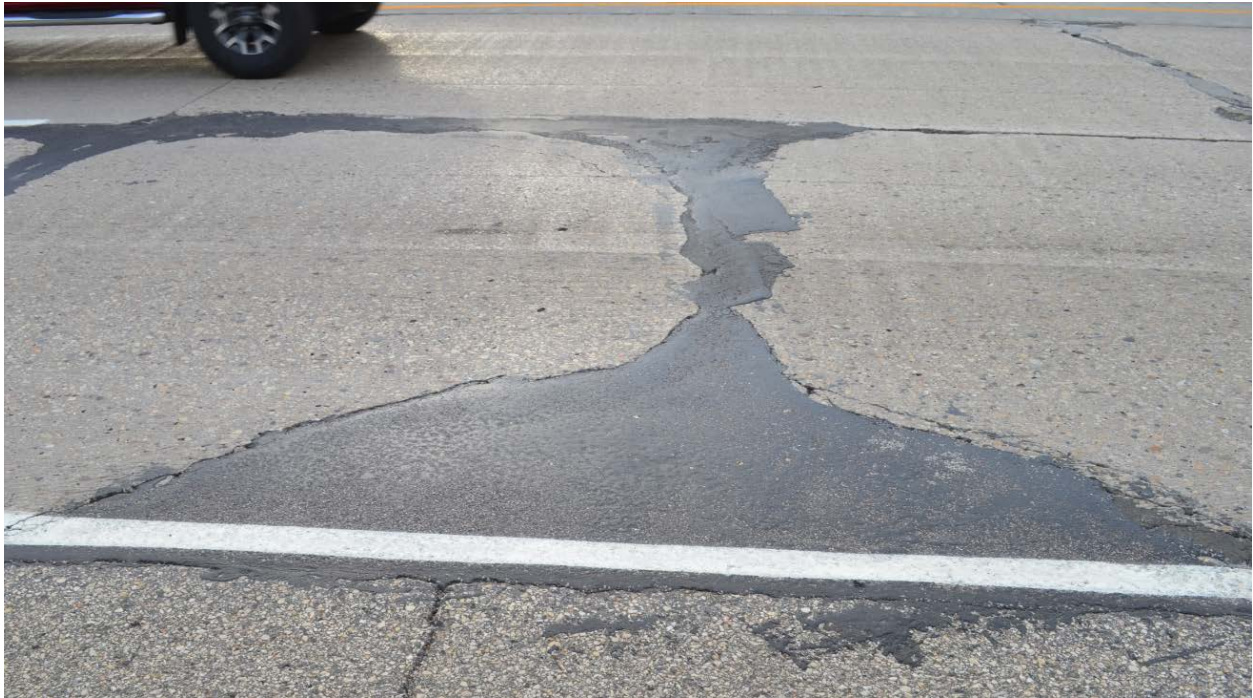
Figure F-4. PDR used to address a severely distressed area  
(Site #20, N. Stoughton Rd., Madison).

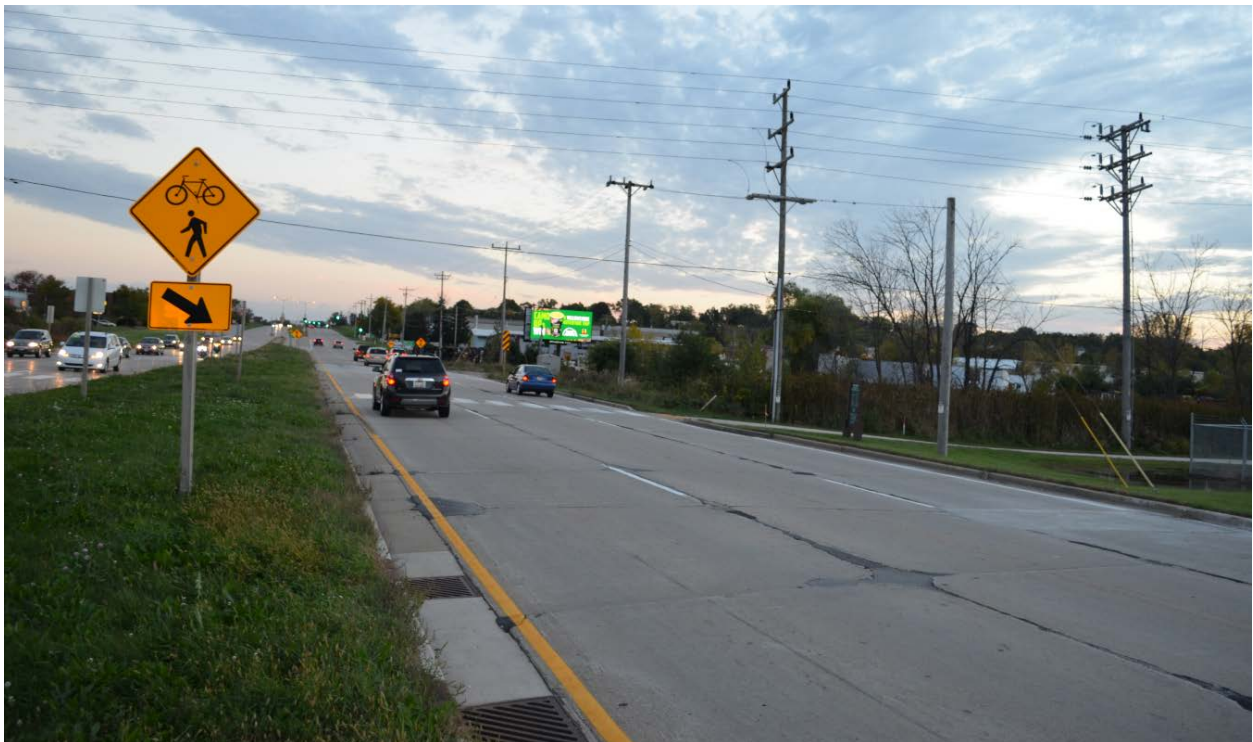
Figure F-5. Overview of existing concrete pavement  
(Site #21, State Road 59, Waukesha).

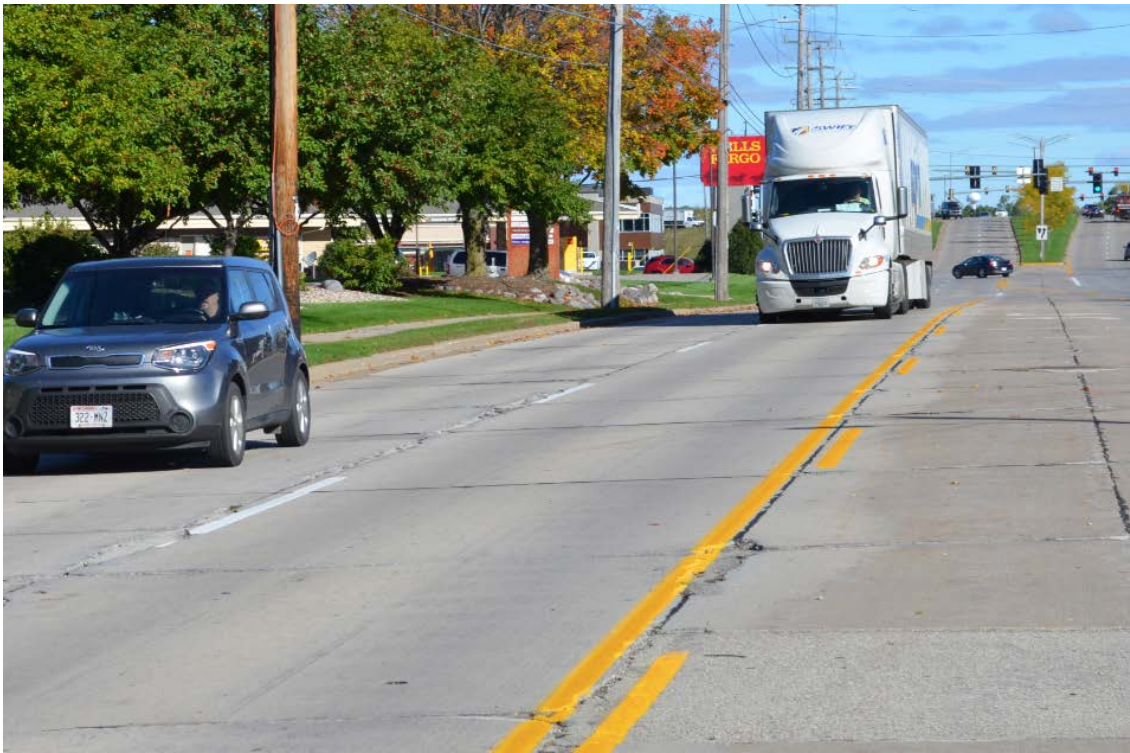
Figure F-8. Overview of existing concrete pavement (Site #22, N. Ballard Rd., Appleton).

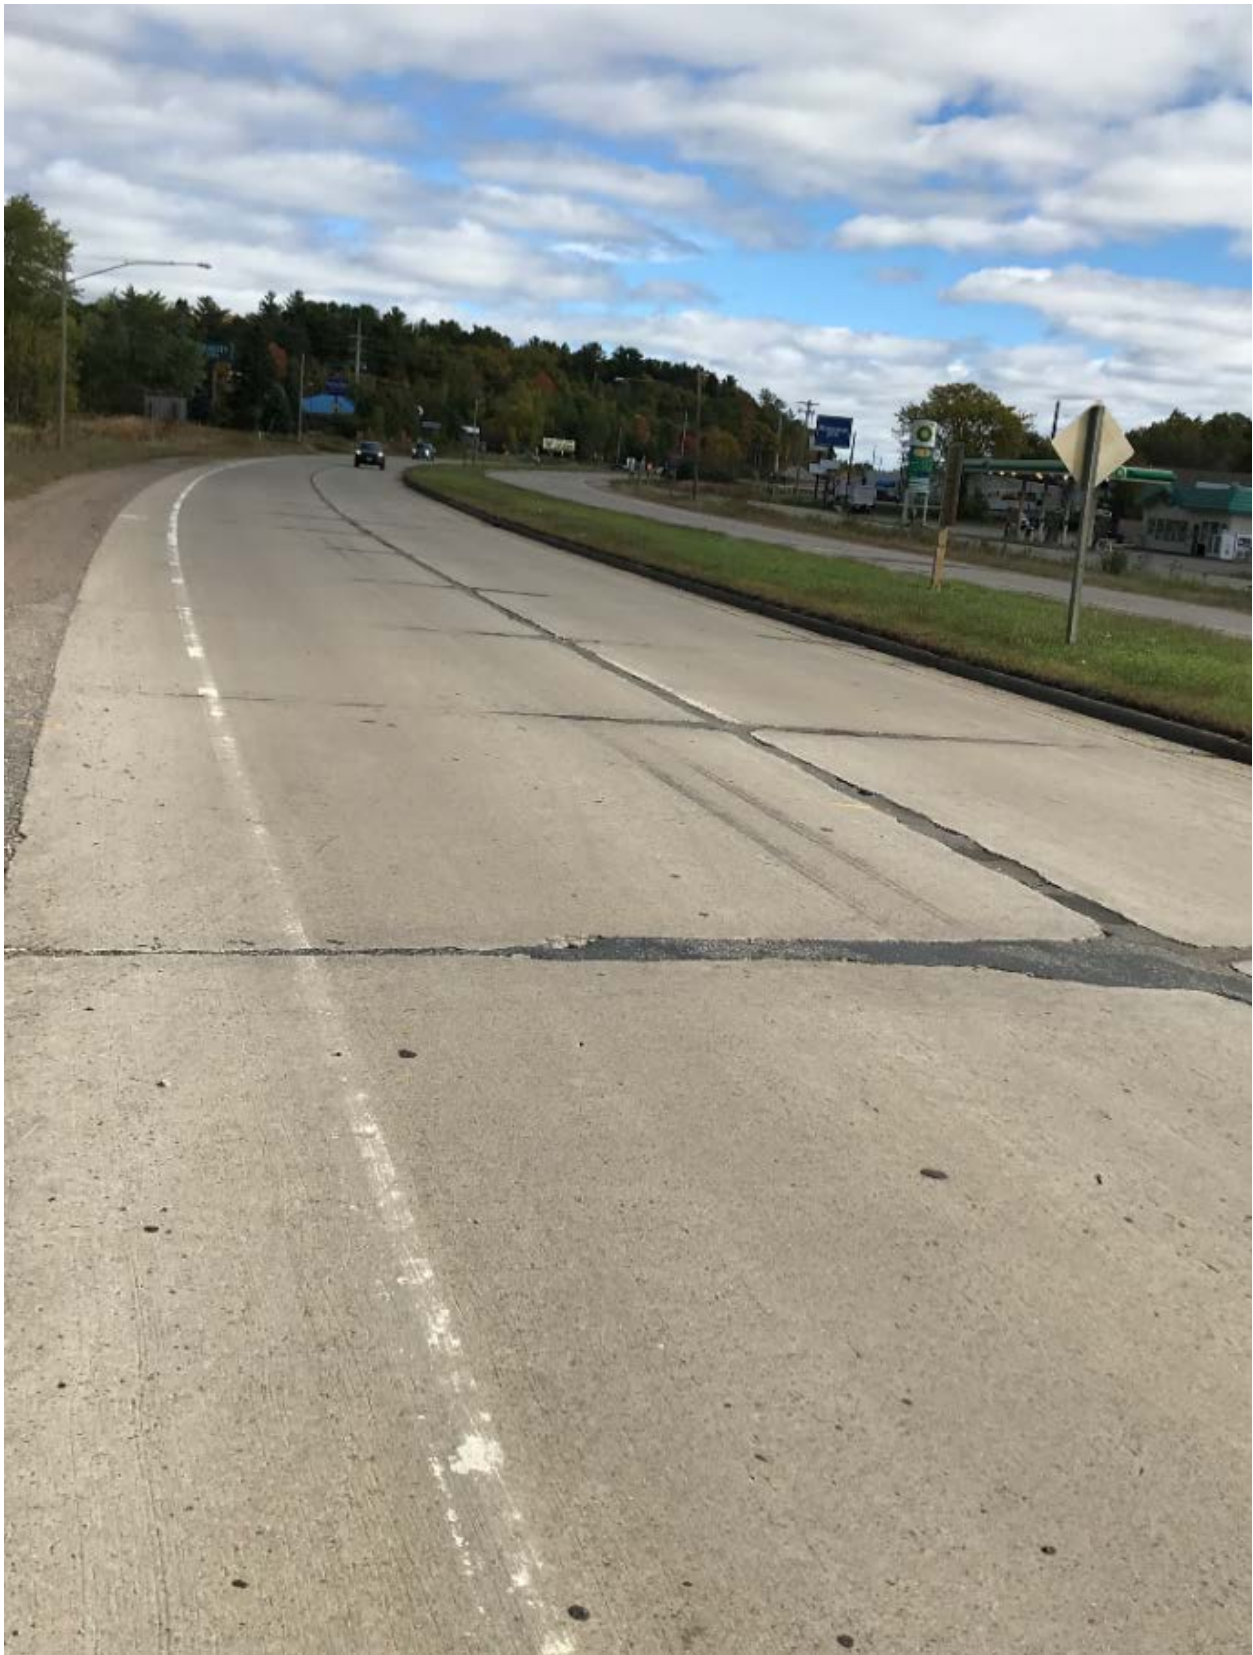
Figure F-11. Overview of existing concrete pavement  
(Site #23, W. Kemp St., Rhineland).

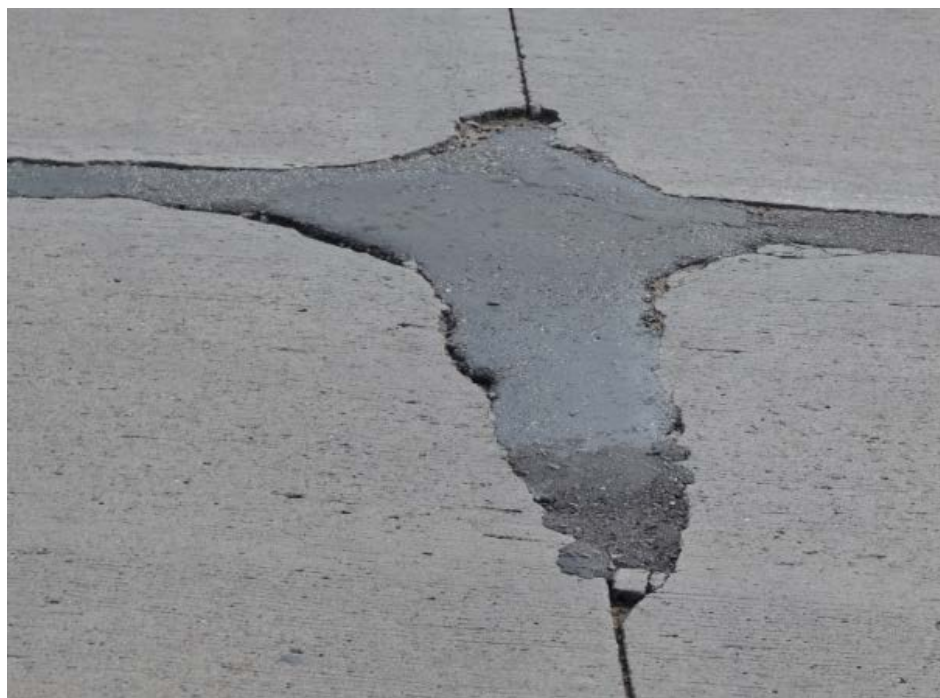
Figure F-13. PDR to address joint deterioration (Site #23, W. Kemp St., Rhinelander).
