# Investigation and Evaluation of Iowa Department of Transportation Bridge Deck Epoxy Injection Process

Final Report  
February 2019

Sponsored by  
Iowa Department of Transportation  
(InTrans Project 10-381)

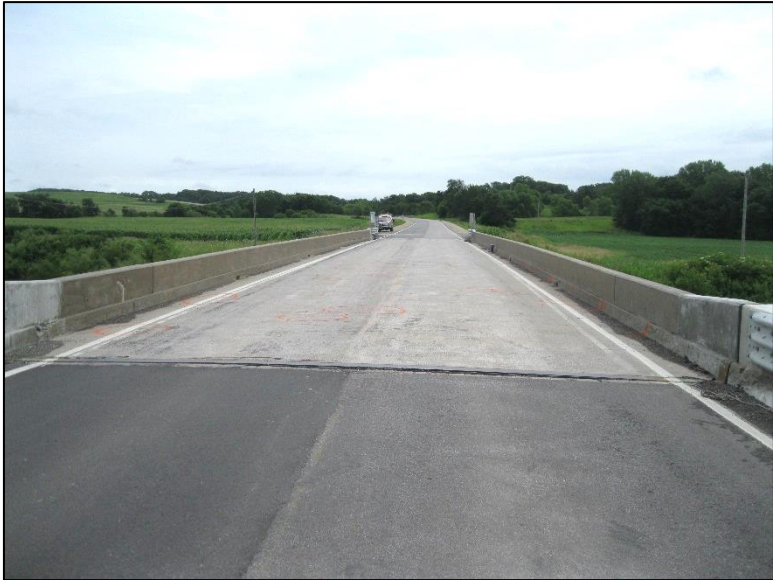
<b>Federal ID</b>	013010

<b>State ID</b>	0170.6S092													
<b>County</b>	Adair													
<b>Location</b>	1.6 MI. East of SR N51													
<b>Facility Carried</b>	IA 92													
<b>Feature Crossed</b>	West Fork of Nodaway River													
<b>Iowa District</b>	4													
<b>ADT</b>	1330													
<b>Year Built</b>	1950													
<b>Structural Type</b>	Steel Girder													
<b>Sufficiency Rating</b>	46.8													
<p><b>Notes</b></p> <p>Before injection data is not available</p>

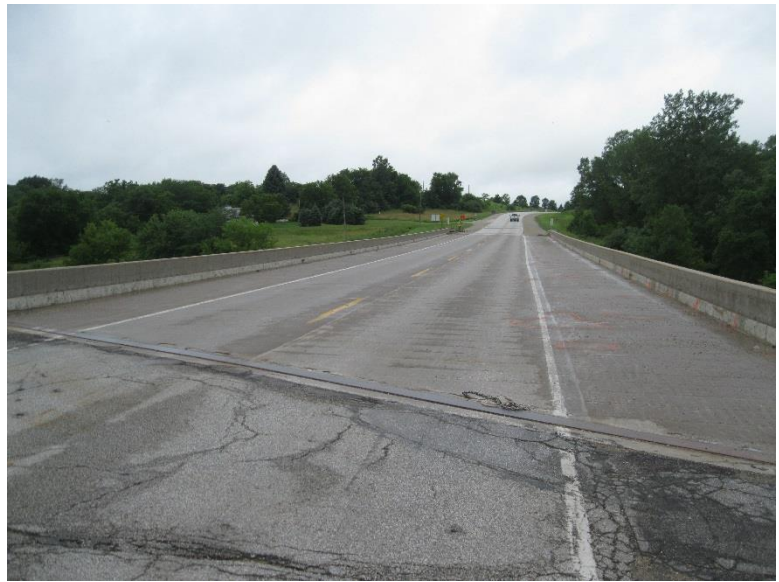
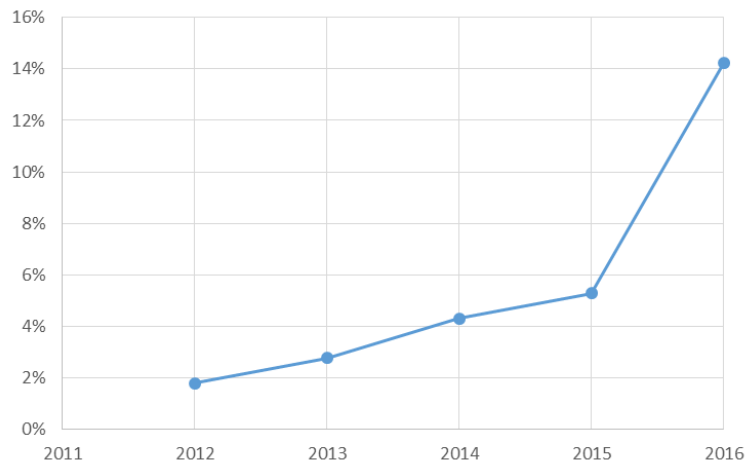
**Federal ID** 026211  
**State ID** 3973.3S044  
**County** Guthrie  
**Location** 1.2 MI. West of  
JCT. IA 4  
**Facility Carried** IA 44  
**Feature Crossed** Raccoon River  
**Iowa District** 4  
**ADT** 3480  
**Year Built** 1972  
**Structural Type** Steel Girder  
**Sufficiency Rating** 92.9

Before injection data is not available

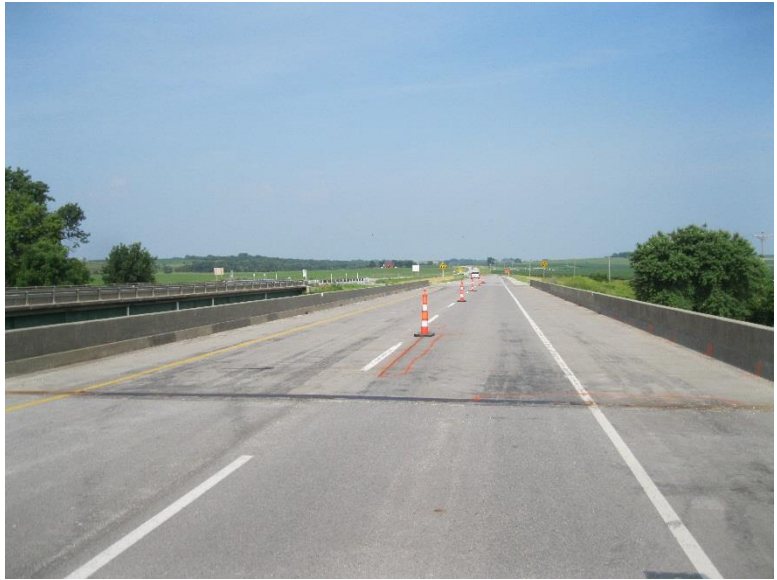
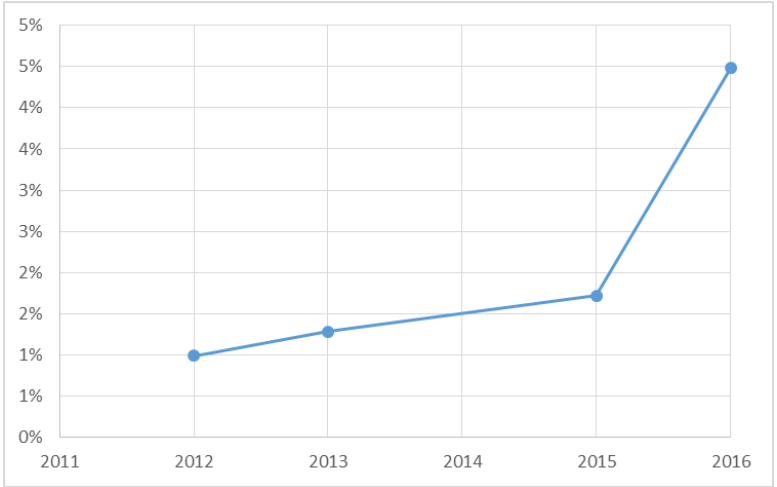
**Federal ID** 037573  
**State ID** 6948.8L034  
**County** Montgomery  
**Location** 0.5 MI. West of JCT  
71  
**Facility Carried** WB US 34  
**Feature Crossed** West Nodaway River  
**Iowa District** 4  
**ADT** 1290  
**Year Built** 1970  
**Sufficiency Rating** 86.0

Before injection data is not available

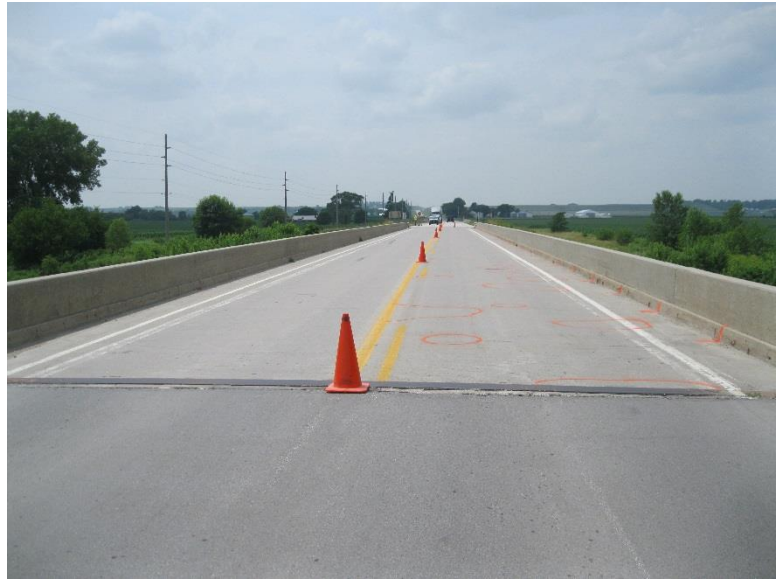
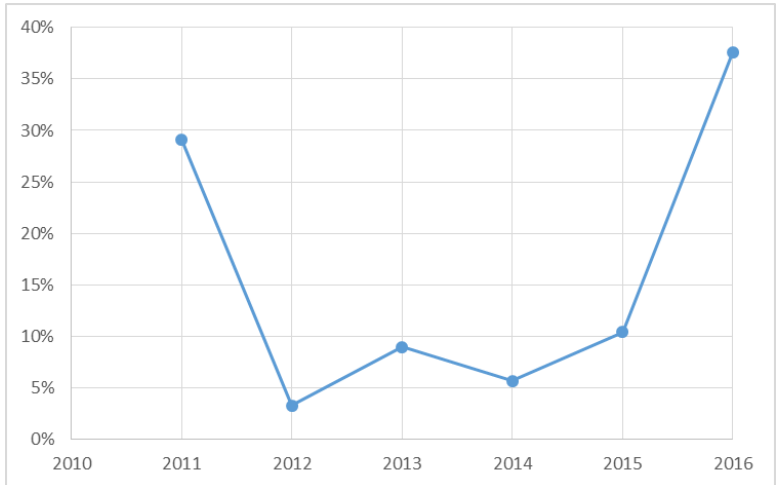
**Federal ID** 037781  
**State ID** 6934.6S048  
**County** Montgomery  
**Location** 1.9 MI. South of SR  
H14  
**Facility Carried** IA 48  
**Feature Crossed** East Nishnabotna  
River  
**Iowa District** 4  
**ADT** 1190  
**Year Built** 1960  
**Sufficiency Rating** 66.2

Before injection data is not available
