Assessment, Repair, and Replacement of Bridges Subjected to Fire

**Final Report
August 2022**

Sponsored by
Iowa Department of Transportation
(InTrans Project 20-734)
Federal Highway Administration

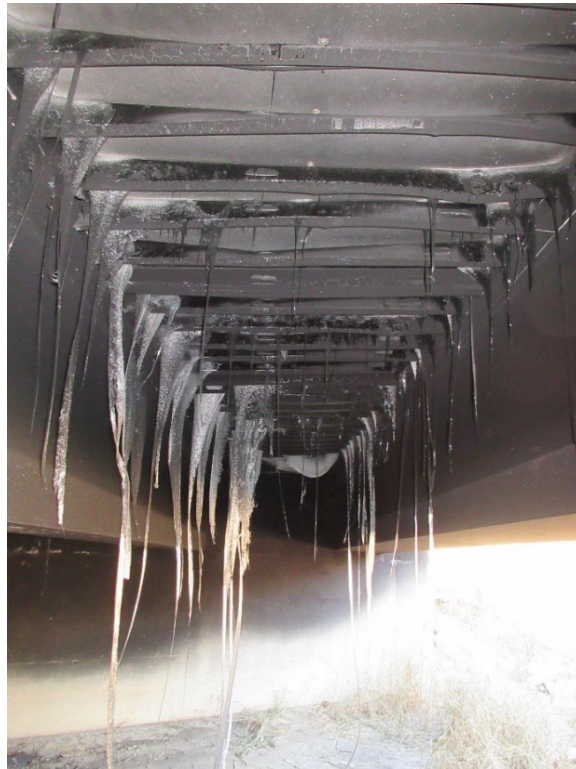
Figure 4. Melted polycarbonate stay-in-place forms

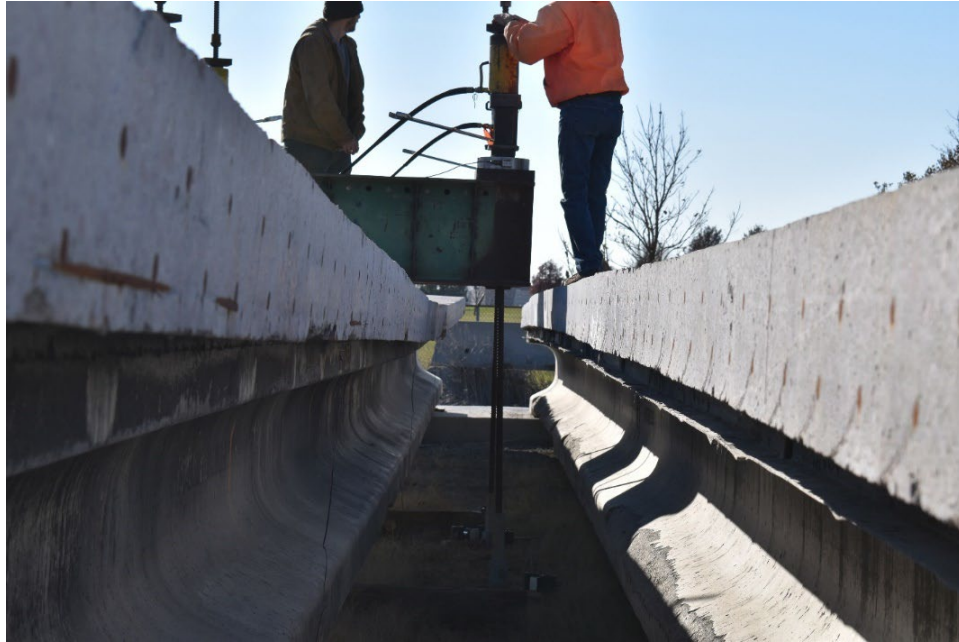
Figure 56. Deflected shape of Girder B at max loading

This value was chosen to ensure all sections were within the elastic range. The load test was ceased after reaching a midspan moment of about 4,600 kip-ft and a total midspan deflection of 9.5 in. or $L/107$. The deflected shape is shown in Figure 56 and can be contrasted with that of the adjacent girder.

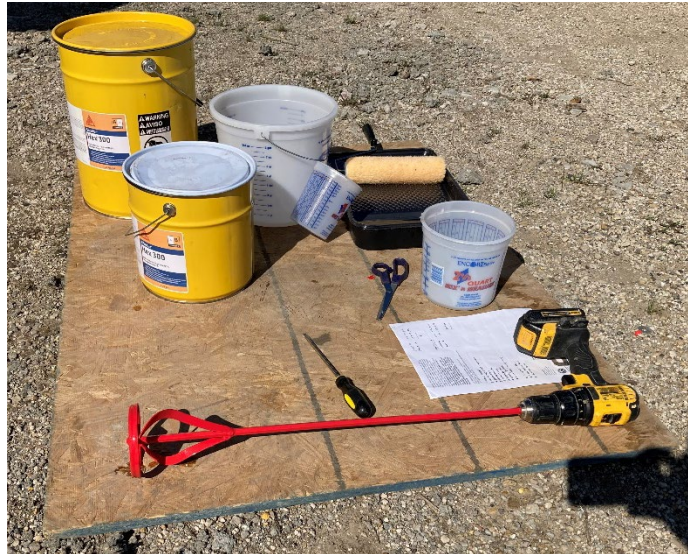
Figure 85. Preparation for mixing the FRP resin

A couple of specific observations were noted with respect to the FRP wrap installation process. First, the resin product did not provide sufficient tack to hold the FRP in place in an overhead position upon initial installation; continuous rolling with additional resin was required. Secondly, the surface, although relatively smooth, requires a high-level of smoothness to bond the FRP wrap. Any surface deviation was spanned by the FRP wrap leaving a small pock of un-adhered FRP wrap. Thirdly, the FRP wrap is highly flexible, but enough rigidity remained that wrapping around 90-degree corners was difficult. Void space between the FRP was observed immediately at the corners. Some of these problematic areas are shown in Figure 87.

To begin the installation process, the resin was mixed and applied to the girder using a 3/8 in. nap paint roller (see Figure 85).
