FINAL REPORT Catch Basin Inserts for Ohio Roadways

SEPTEMBER 2018

Ohio Department of Transportation Office of Statewide Planning and Research

www.greshamsmith.com GS&P Project No. 42299.00 ODOT PID 103684 State Job No. 135444 This Page Intentionally Left Blank.

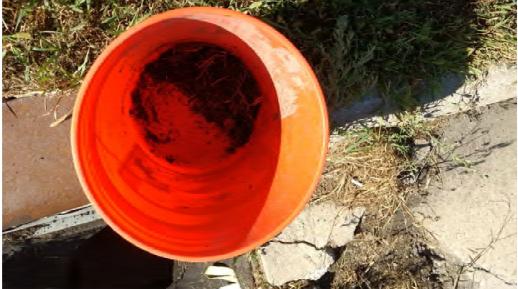
Maintena	nce Form		Weather Information		
Date of	6/	15/17	Location		Weather at time of this inspection?		
Maintenance			\boxtimes Site 1 \square Si	te 2	\Box Clear \Box Rain \Box Sleet \Box Snowing		
			101		\Box Other: rained in the morning. Sunny during		
					maintenance		
Inspector	K	athryn Gruv	or		Temperature:		
Name(s)	К	_					
CBI Name an	d		<u> </u>		Number of personnel		
Vendor		Start	End				
Storm Sentinel				3			
Observations				Photos			
Describe conte	nts	and conditi	on of catch				
basin insert:				President and and			
Clogged, standi		vater. Debris	s partially		6.2/5		
blocking openin	ıg.			ASP N	and the second		
					S- 10 1/ 1000		
				1	and the second		
				the second se			
					and the second s		
Describe condi	tion	of throat b	lock				
		D.1					
The block is wo	rkir	ng. Did not t	ake a photo				
Describe maint	tena	nce activity	(clean, replace	filter,)			
CBI removed fr	om	catch basin	Water drained	Unit taken to Al	en County Garage for back flushing.

om	caten Dasili.	water trainet.		ten County Garage for back flushilig.		
Fanin mart		ad for	tononas				
Equipment req Truck wash hos							
	c at	county gala	5~

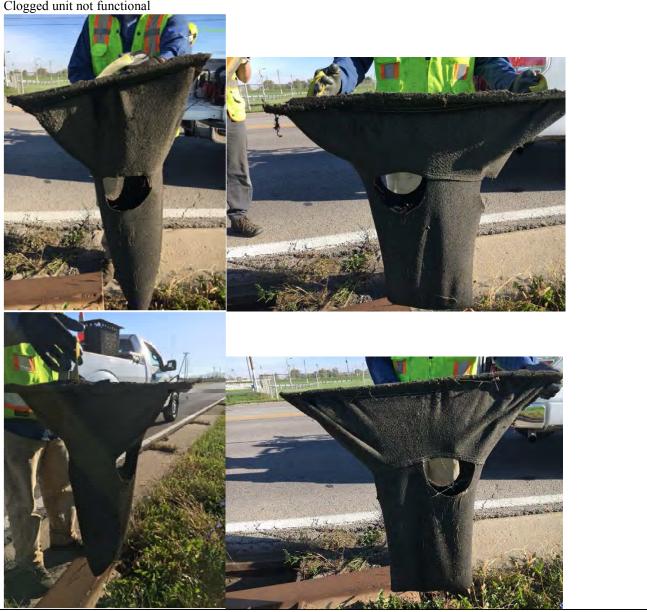
104 DrainPac™

Remo	oval for	m	Weather Information			
Date of	10/19/17	Locat	ion	Weather at time of this inspection?			
Removal		🖂 Sit	e 1 □ Site 2	\boxtimes Clear \square Rain \square Sleet \square Snowing			
		101		□ Other:			
				Temperature:			
Inspector Name(s)	Kathryn Gr	uver and	d Ariel Croasman				
CBI Name and	Removal						
Vendor	Start	End		Number of personnel			
Gully Washer	9:58	9:59	2				
Observations			Photos				
Describe contents of catch basin insert Very little debris in CBI The insert contained standing water during September inspection							
Describe contents and condition of catch basin			Clean, no debris in CB				
	Special Equipment Required for Removal No special equipment, removed by one person

Reason for removal Clogged unit not functional

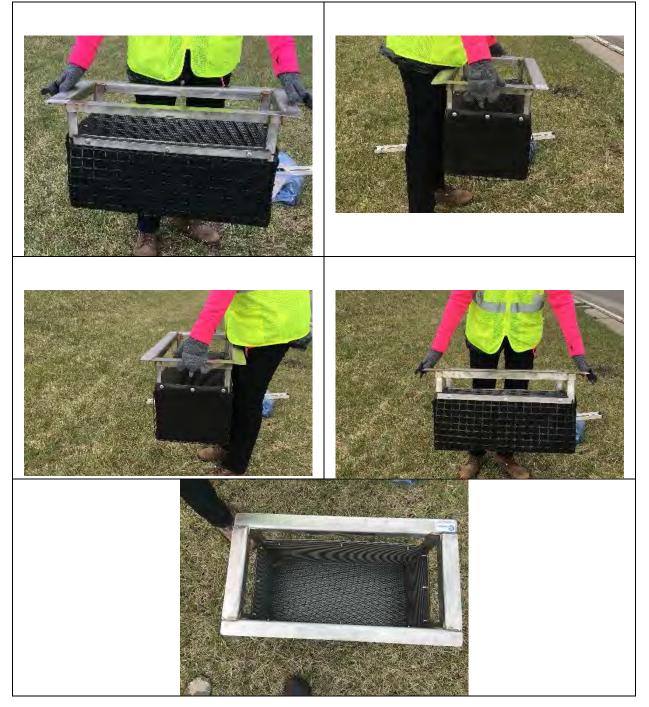
N	laintenance	Form	Weather Information			
Date of	8/23/	Location	Weather at time of this inspection?			
Maintena	i 17	\boxtimes Site 1 \square	\Box Clear \Box Rain \Box Sleet \Box Snowing			
nce		Site 2	□ Other:Sunny during maintenance			
		104	Temperature:			
Inspector	· Kathry	m Gruver				
Name(s)						
CBI]	ſime	Number of personnel			
Name						
and	<u> </u>					
Vendor Drain	<u>Start</u> 10:01	End 10:07	2			
Drain Pac	10:01	10:07	2			
1 ac						
Observat	tions		Photos			
		d condition				
	oasin insert	:				
No standi						
Debris is	outer fabric	veen the wire				
	i't be remov					
shop vac						
F						
Describe	condition o	f throat block				
The block	t is working.					
	is working.		AS I CO			
			and the second			
			The second se

Back flushing is not a recommended maintenance activity. Unit was clogged during September inspection. The other manufacturers allow back flushing to extend the life of the unit for consistency within the study all clogged units will be back flushed once.

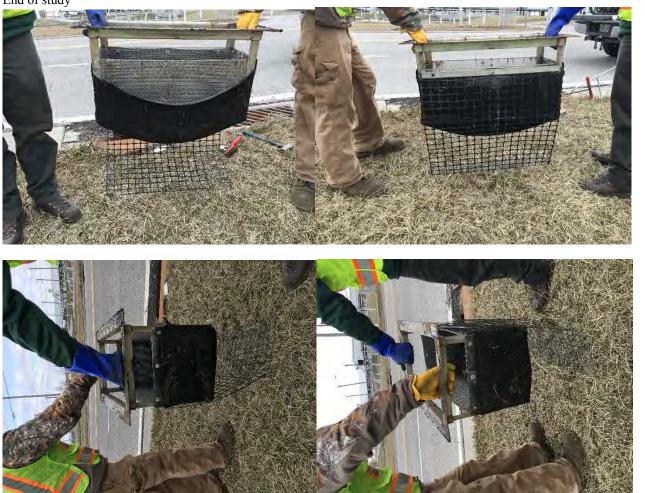
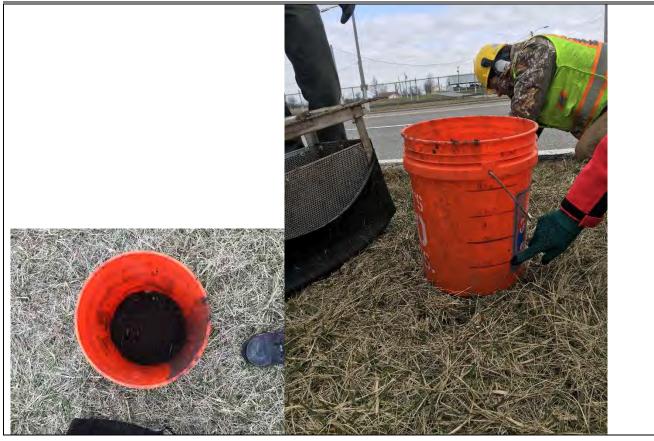
Remo	oval for	m	Weather Information
Date of Removal	3/9/18	Locat	ion e 1 □ Site 2	Weather at time of this inspection? ⊠ Clear □ Rain □ Sleet □ Snowing
Removar		104		\Box Other:
				Temperature:
Inspector Name(s)	Kathryn Gr	uver and	l Ariel Croasman	
CBI Name and	Removal	Time		
Vendor	Start	End		Number of personnel
DrainPac	8:54	8:59	2	
Observations Describe conter			Photos	
Describe conter	nts and condi	tion	A little less than one gallo	an of debris removed
of catch basin	its and condi	tion		d detached from the basket. The fabric mesh was loose
Special Equipm No special equip

Reason for removal End of study

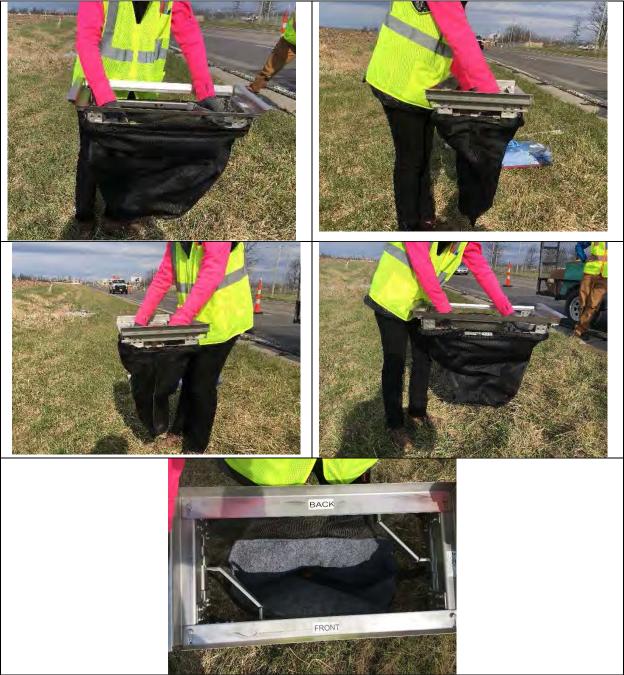
Needed to trim frame to install. Trimming frame not expected to impact performance in study.

Maintenance Form		Form	Weather Information			
Date of	8/23/17	Location	Weather at time of this inspection?			
Maintena	1	\boxtimes Site 1 \square	\Box Clear \Box Rain \Box Sleet \Box Snowing			
nce		Site 2	□ Other:Sunny during maintenance			
		105	Temperature:			
Inspector Name(s)	• Kathryn C	fruver				
CBI	Т	ime	Number of personnel			
Name and Vendor	Start	End				
Flex	9:49	9:59	2			
Storm						
Observat	ions		Photos			
catch bas No standi	ng water.					
	condition of th	ıroat block

Equipment required for maintenance: Shop vac

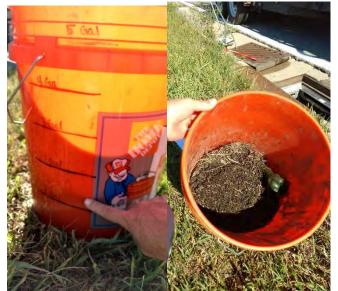
Maintena	ince Form		Weather Information
Date of Maintenance	6/15/17	Location ⊠ Site 1 □ Si	te 2	Weather at time of this inspection?
		105		□ Other: rained in the morning. Sunny during maintenance Temperature:
Inspector Name(s)	Kathryn Gruv	/er		
CBI Name an		Гіте		Number of personnel
Vendor	Start	End		
Flexstorm			3	
Observations			Photos	
Describe contents and condition of catch basin insert: Clogged, standing water. Debris partially blocking opening.				BACK
The block is wo	rking. Did not t	ake a photo		
Describe maint	tenance activity	y (clean, replace	filter,)	
CBI removed fr	om catch basin.	Water drained.	Unit taken to Al	len County Garage for back flushing.
Equipment req Truck wash hos

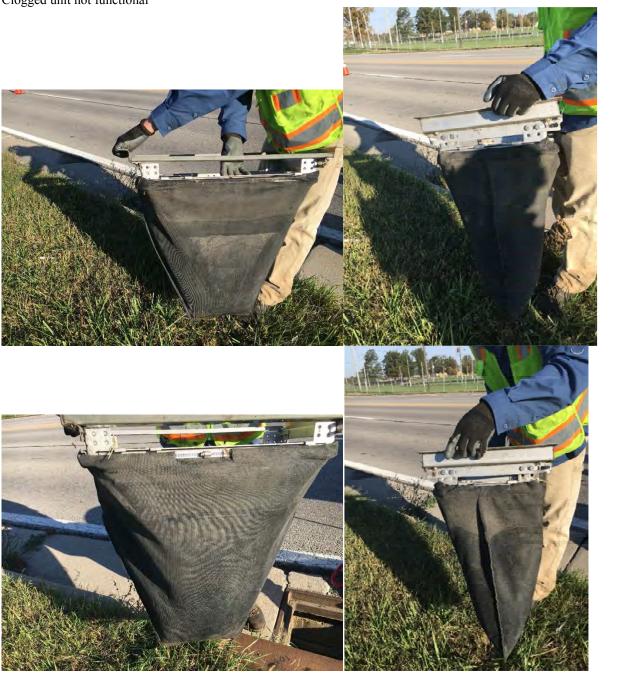
Reason for removal Clogged unit not functional

Any deviation from manufacturer's recommendation Manufacturer recommends back flushing when bag is ½ full of debris.

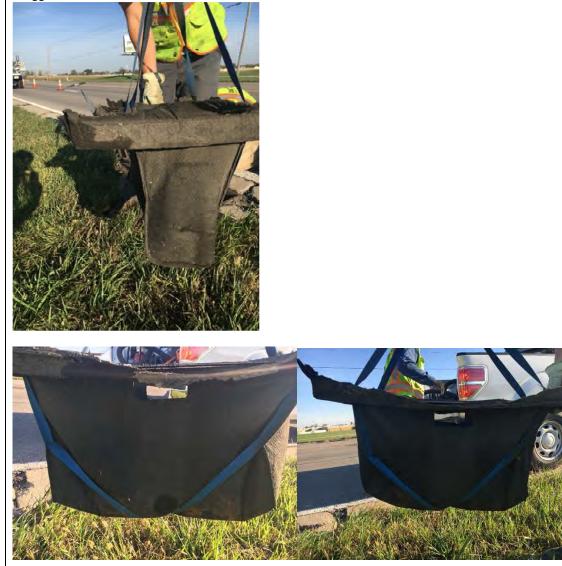
Maintenance Form						Weather Information
Date of	6/1	5/17	Loca			Weather at time of this inspection?
Maintenance				te 1 🗆 Si	te 2	\Box Clear \boxtimes Rain \Box Sleet \Box Snowing
			109			□ Other:
.		1 0				Temperature:
Inspector Name(s)	Ka	athryn Gruv	ver			
CBI Name an	d		Гіте			Number of personnel
Vendor		Star	t	End		
Gullywasher					3	
Observations					Photos	
Describe contents and condition of catch basin insert: Clogged, standing water. Debris partially blocking opening. Describe condition of throat block The block is working. Did not take a photo			lly			
Describe maint	tena	nce activity	(clear	, replace	filter,)	
CBI removed from catch basin. Water drained. Unit taken to Allen County Garage for back flushing.						
Equipment required for maintenance Truck wash hose at county garage						
Any deviation from manufacturer's recommendation Manufacturer recommends back flushing every 3-4 weeks. Unit was installed 3/30/17

Re	moval for	m	Weather Information	
Date of	10/1	19/17	Location		Weather at time of this inspection?	
Removal			🖾 Site 1	\Box Site 2	\boxtimes Clear \square Rain \square Sleet \square Snowing	
			109		□ Other:	
					Temperature:	
Inspector Name(s)	Kat	thryn G	ruver and A	Ariel Croasman		
CBI Name an	d	Remov	al Time			
Vendor	1	Start	End		Number of personnel	
Gully Washer	r 9	9:33	9:35	2		
Observations Describe cont		I		Photos		
Very little debris in CBI The insert contained standing water during September inspection			on			
Describe contents and condition of catch basin Clean, no debris in CB Special Equipment Required for R						
Special Equip	men	t Requi	ired for R	emoval		
No special equipment, removed by one person

Reason for removal Clogged unit not functional

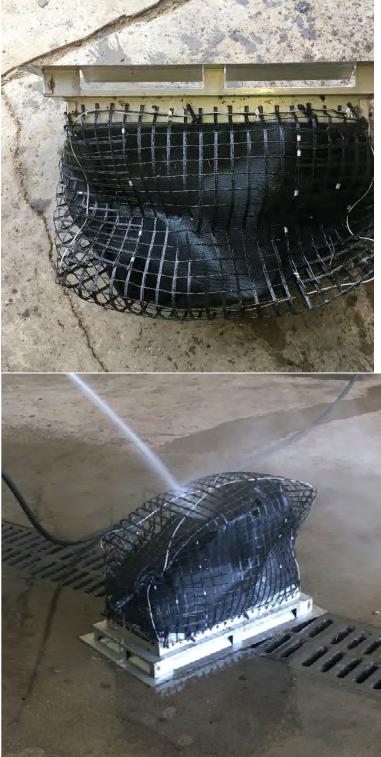
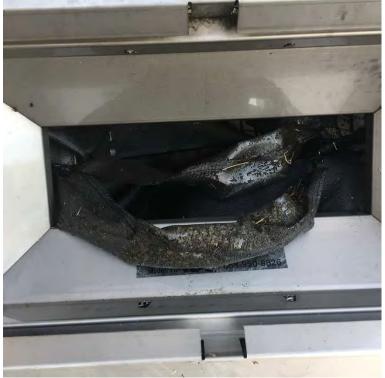
Maintenance Form		Form	Weather Information
Date of	10/19	Location	Weather at time of this inspection?
Maintena	i /17	\boxtimes Site 1 \square	\Box Clear \Box Rain \Box Sleet \Box Snowing
nce		Site 2	□ Other:Sunny during maintenance
		110	Temperature:
Inspector Name(s)	• Kathry	n Gruver and A	riel Croasman
CBI]	Time	Number of personnel
Name and Vendor	Start	End	
Drain	10:45	10:47	2 – maintenance time was measured only at the garage. It does not include time
Pac			to remove unit and travel to maintenance area
Observat	ions		Photos
of catch l No standi Mouse ne	basin insert ng water.

Back flushing is not a recommended maintenance activity. Unit was clogged during September inspection. The other manufacturers allow back flushing to extend the life of the unit for consistency within the study all clogged units will be back flushed once.

Describe maintenance activity (clean, replace filter,..) Shop vac and back flushed at garage until positive flow was achieved.

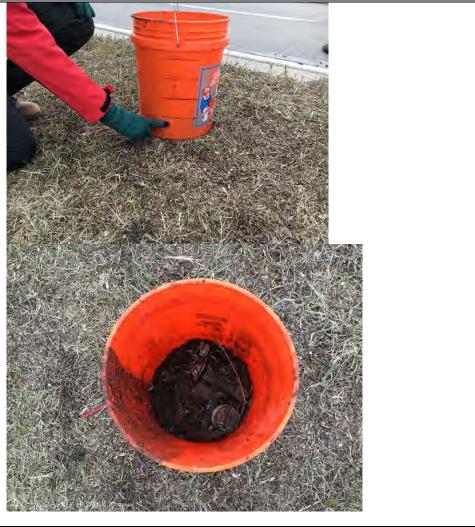
0.54	0.77	2		
		Photos		
a one gallon of damaged. Ro a the outside n	f ndent nesh			
nts and condi	ition			
	Kathryn Gr Removal Start 8:34 nts of catch b a one gallon or a damaged. Ro a the outside n a sump, very nent Require	Image: Site 110 Kathryn Gruver and Image: Start End Start End 8:34 8:47 Image: Start End a one gallon of Gamaged. Rodent a the outside mesh Image: Start Image: Start End a sump, very little Image: Start ment Required for Reference Start	Image: Site 1 □ Site 2 Kathryn Gruver and Ariel Croasman Removal Time Start End 8:34 8:47 2 Photos nts of catch basin Photos n one gallon of Gradmaged. Rodent adamaged. Rodent Fractional State S

Reason for removal End of study to itit 1+++

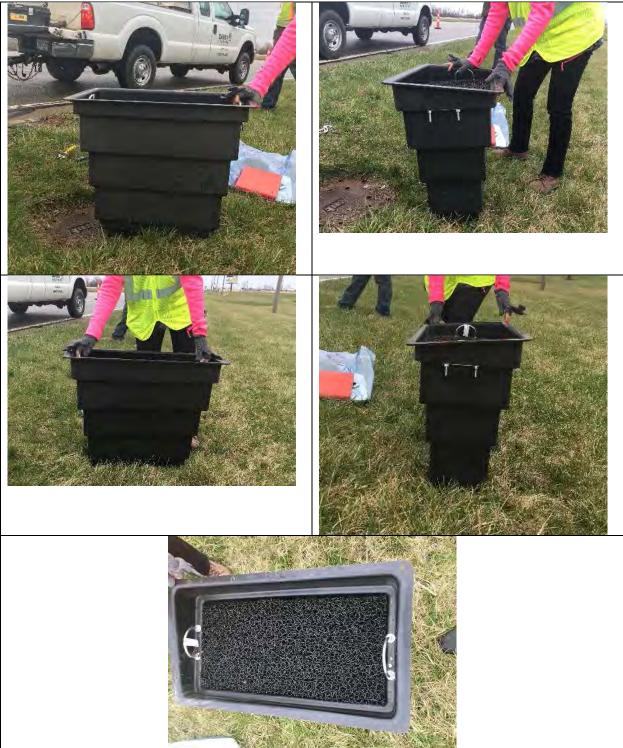
Needed to adjust the handles to not impact the grate. The bolts on the handles were adjusted to let them sit lower into the CBI.

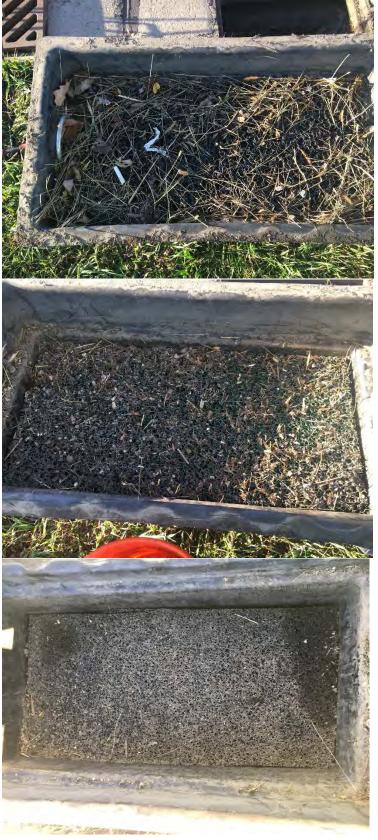
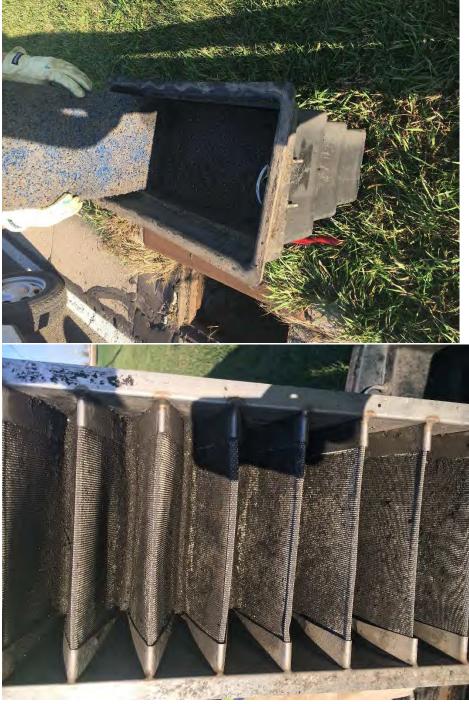
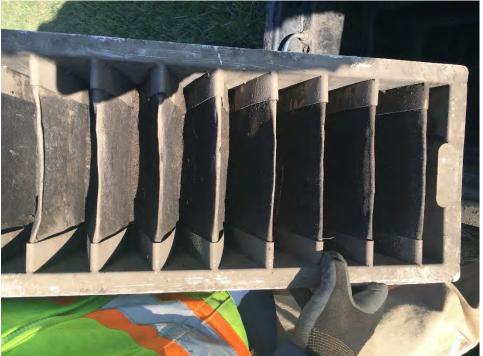
Maintenance Form		Form	Weather Information				
Date of	10/19	Location	Weather at time of this inspection?				
Maintena	i /17	\boxtimes Site 1 \square	\Box Clear \Box Rain \Box Sleet \Box Snowing				
nce		Site 2	□ Other:Sunny during maintenance				
		111	Temperature:				
Inspector	· Kathry	n Gruver and A					
Name(s)							
CBI]	Time	Number of personnel				
Name							
and	C ((F 1					
Vendor Drain	<u>Start</u> 9:04	End 9:17	2				
Drain Pac	9:04	9:17	2				
I at							
Observat	ions		Photos				
of catch l No standi	oasin insert: ng water.		n, replace filter,)

Manufacture does not required in field cleaning. The product is to be removed and replaced with a fresh unit. The unit is then cleaned for later reuse.

Describe maintenance activity (clean, replace filter,..) Removed all layers of filter media and used shop vac to clean.

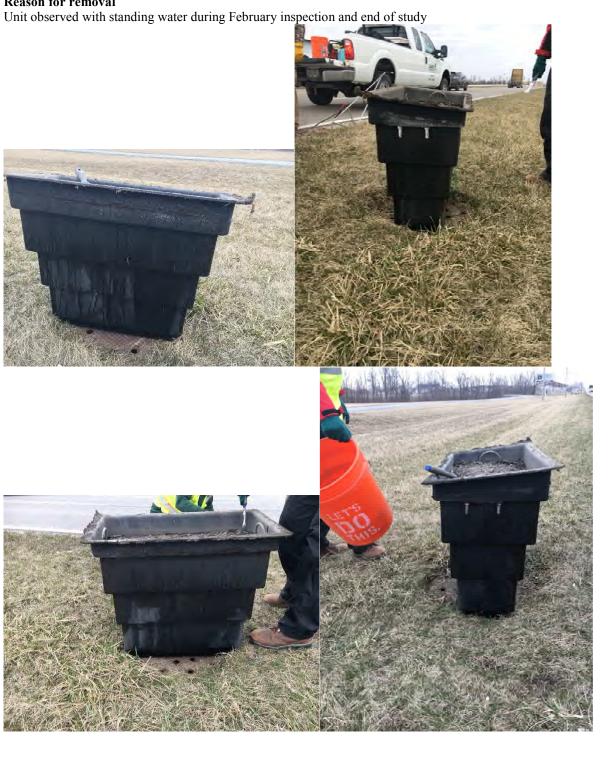
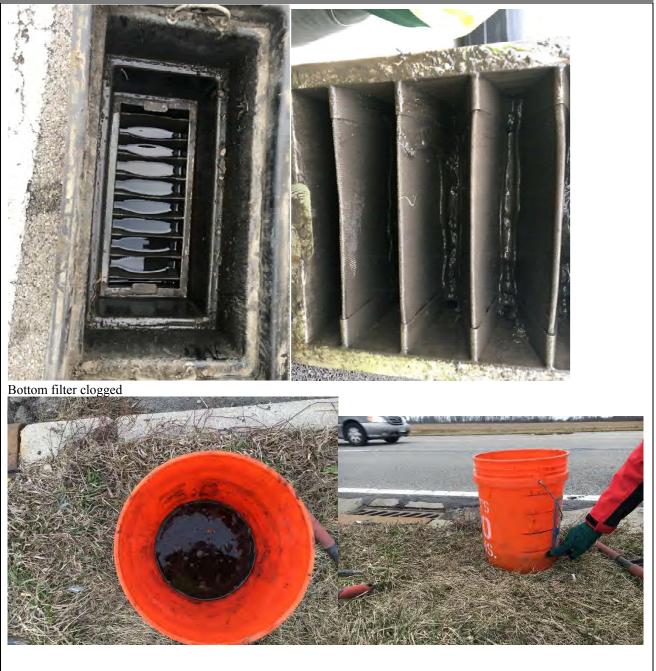
Describe contents of catch basin insert A little less than one gallon of debris removed. Outer mesh was damaged. Rodent nest was built in the outside mesh Describe contents and condition of catch basin Catch basin has sump, very little	WQS	8:14	8:32	2						
Describe contents of catch basin insert A little less than one gallon of debris removed. Outer mesh was damaged. Rodent nest was built in the outside mesh Describe contents and condition of catch basin Catch basin has sump, very little										
Describe contents of catch basin insert A little less than one gallon of debris removed. Outer mesh was damaged. Rodent nest was built in the outside mesh Describe contents and condition of catch basin Catch basin has sump, very little	Observations			Photos						
insert A little less than one gallon of debris removed. Image: Content sand gallon of debris r		ts of catch h	asin	THOUS						
of catch basin Catch basin has sump, very little	insert A little less than one gallon of debris removed. Outer mesh was damaged. Rodent

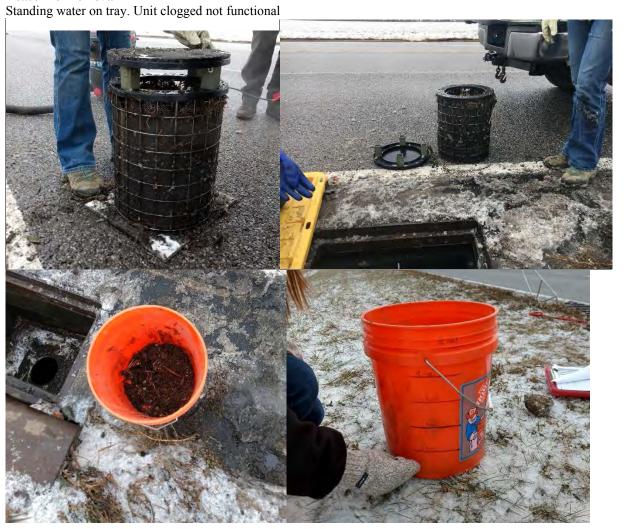
R	emoval for	m	Weather Information
Date of	12/14/17	Location		Weather at time of this inspection?
Removal		\boxtimes Site 1	\Box Site 2	\boxtimes Clear \square Rain \square Sleet \square Snowing
		113		□ Other:
T (K d C	1.4	:10	Temperature: 15
Inspector Name(s)	Kathryn G	ruver and A	riel Croasman	
			1	
CBI Name a		val Time	-	
Vendor	Start	End	2	Number of personnel
Triton	9:05	9:53	2	
Observation			Photos	
Describe com insert Very little de Standing wat	bris in CBI,	ch basin		
Describe com of catch basi Snow, grit an Special Equi	n d water.

Special Equipment Required for Removal Very time consuming to remove. Required 2 people. Wrench, screw driver, saw.

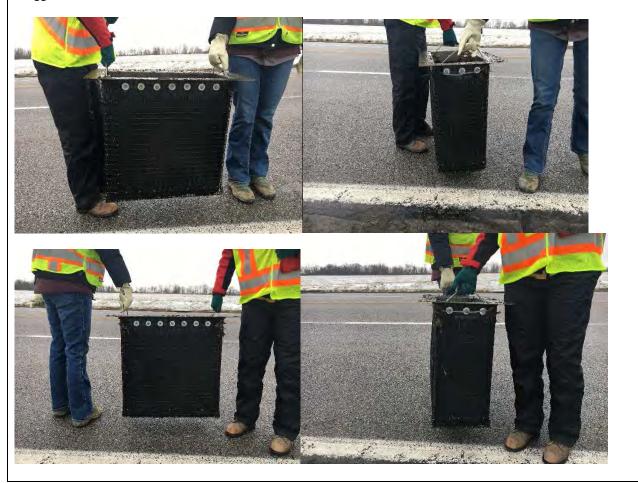
Back flushing is not a recommended maintenance activity. Unit was clogged during September inspection. The other manufacturers allow back flushing to extend the life of the unit for consistency within the study all clogged units will be back flushed once.

Reason for removal Clogged unit not functional

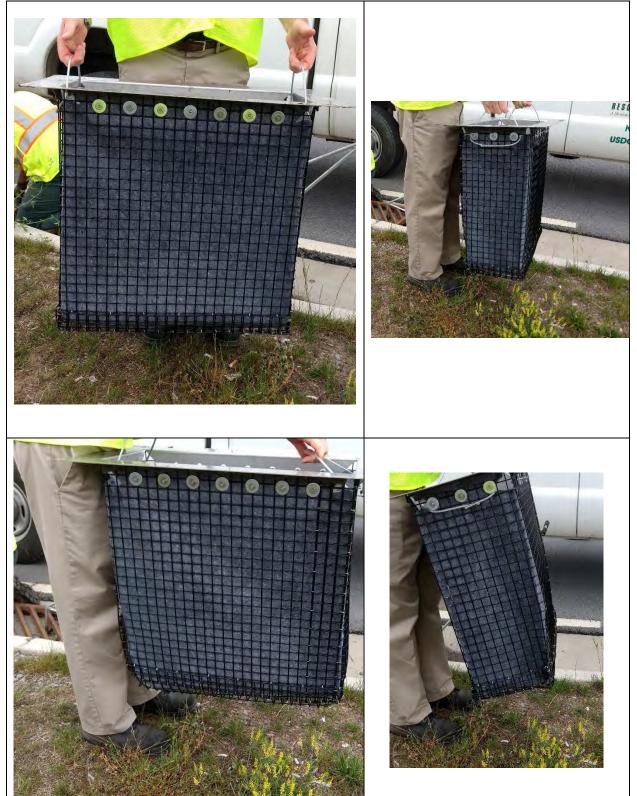
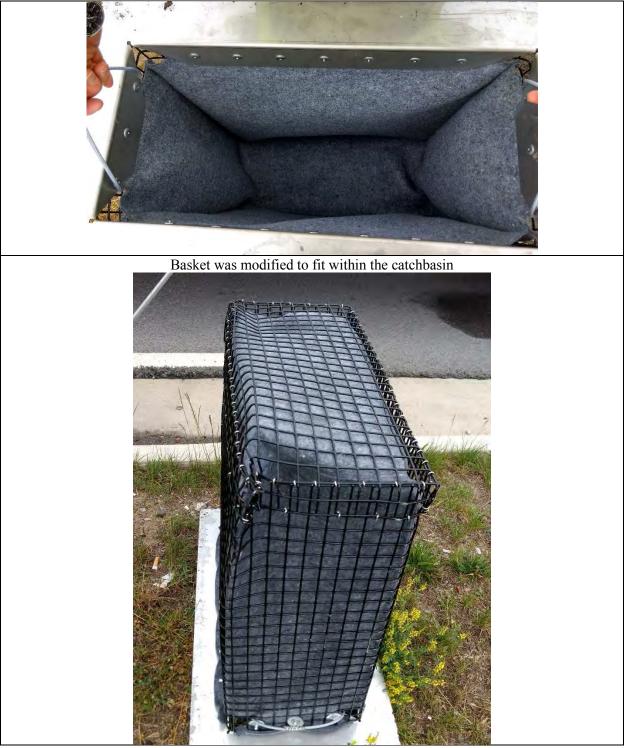
Describe condition of catch basin Poor condition, concrete around throat is missing. Not expected to 「日本で impact the flow or performance of unit 205 Throat Facing Left Describe gutter condition and contents Upstream Curb Depression

Any deviation from manufacturer's installation procedure Yes, basket shape of basket was modified to within the catch basin

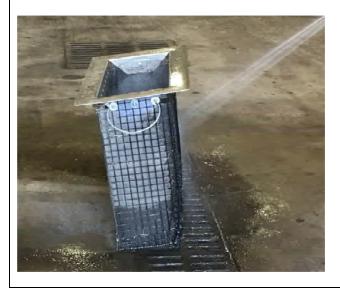
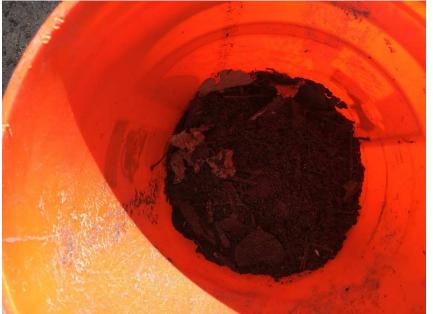
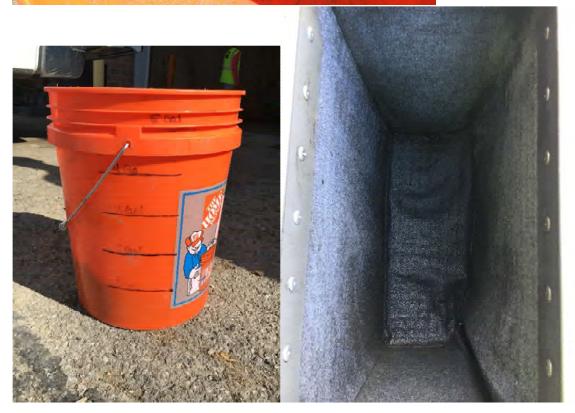
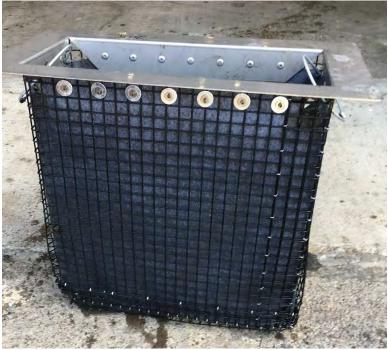
Maintenance Form			Weather Information
Date of	of 10/19 Location		Weather at time of this inspection?
		\Box Site 1 \boxtimes	\square Clear \square Rain \square Sleet \square Snowing
nce		Site 2	□ Other: Sunny during maintenance
-	77 .1	205	Temperature:
Inspector	Kathry	n Gruver and A	riel Croasman
Name(s)			
CBI	Т	ime	Number of personnel
Name			
and	G 4 4	т I	
Vendor Drain	Start 12:43	End 12:47	2 maintenance time was made and a she at the same as It does not include time
Drain Pac	12:43	12:47	2 – maintenance time was measured only at the garage. It does not include time
rac			to remove unit and travel to maintenance area
Observatio	ons		Photos
inspection/ Minor debr	g water at t 'maintenand ris	he time of the ce	n, replace filter,)

Back flushing is not a recommended maintenance activity. Unit was clogged during September inspection. The other manufacturers allow back flushing to extend the life of the unit for consistency within the study all clogged units will be back flushed once.

Describe maintenance activity (clean, replace filter,..) Shop vac and back flushed at garage until positive flow was achieved.

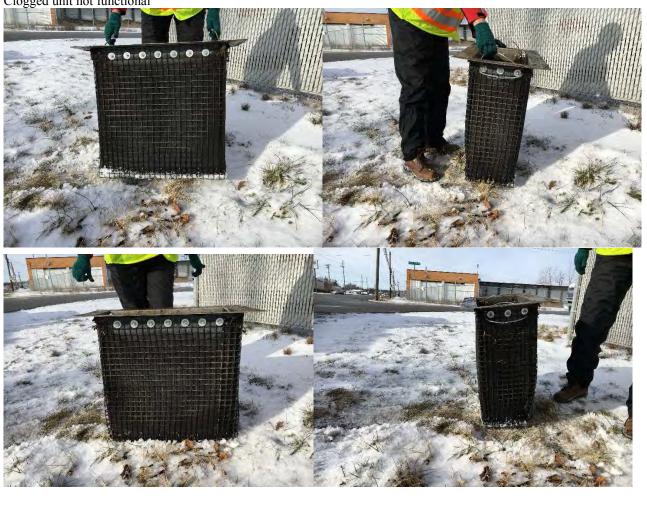
R	emoval for	m	Weather Information
Date of Removal	12/14/17	Location Site 1 205		Weather at time of this inspection? ⊠ Clear □ Rain □ Sleet □ Snowing □ Other: Temperature: 15
Inspector Name(s)	Kathryn G	ruver and A	riel Croasman	
CBI Name a Vendor	nd Remo	val Time End		Number of nonconnel
Absorb-it	11:04	11:11	2	Number of personnel
Observation	S		Photos	
Describe cor insert Very little de Describe cor	bris in CBI			
of catch basi Snow, grit ar Special Equi	in id water.		emoval	
No special ec	juipment, rei	noved by or	ne person

Reason for removal Clogged unit not functional

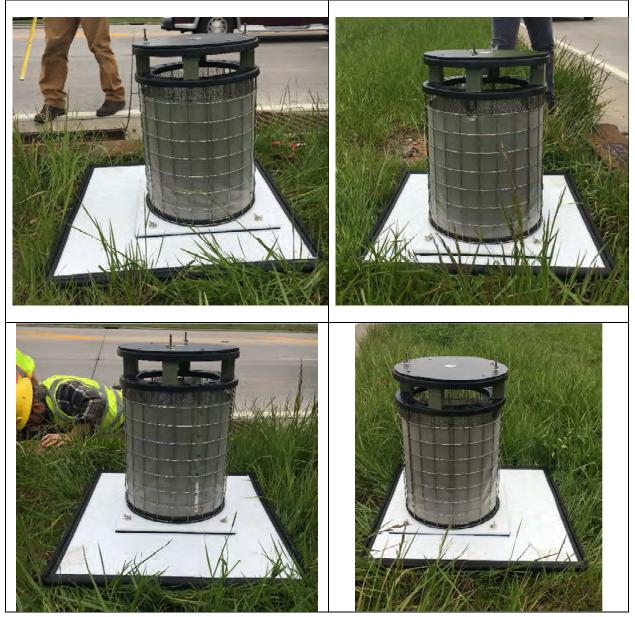
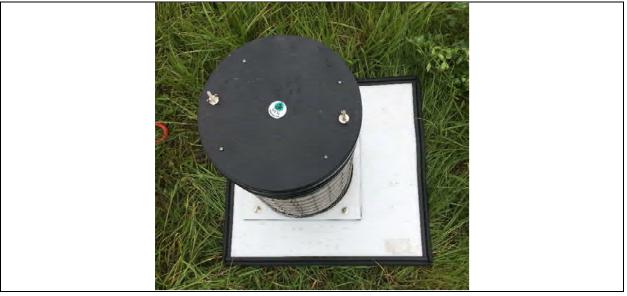
Top hat location had to be moved closer to the front of the base to allow the unit to be installed within the catch basin. New holes were drilled and the vacated screw holes were filled with spray foam.

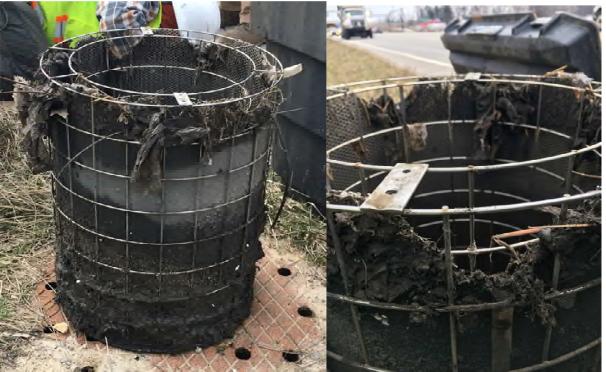
Outer filter

Unit observed with standing water during February inspection and end of study

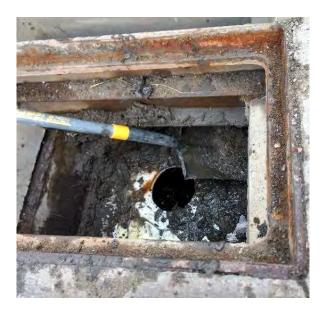
Very time consuming to remove. Required 2 people. Wrench, screw driver, saw. Catch Basin Inserts for Ohio Roadways Removal Form PID 103684 GS&P # 42299.00

15 gallons of debris removed, collected in several buckets

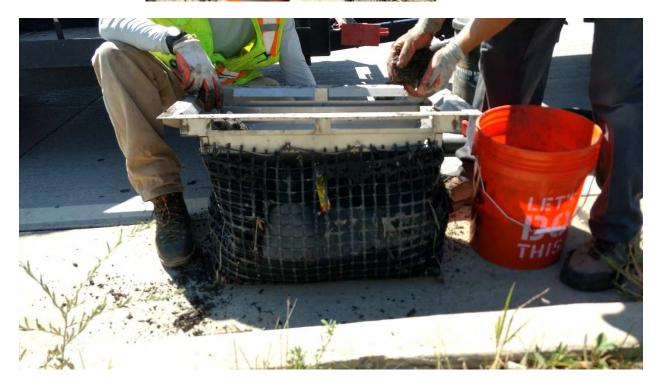
Back flushing is not a recommended maintenance activity. Unit was clogged during September inspection. The other manufacturers allow back flushing to extend the life of the unit for consistency within the study all clogged units will be back flushed once.

Describe maintenance activity (clean, replace filter,..) Shop vac and back flushed at garage until positive flow was achieved.

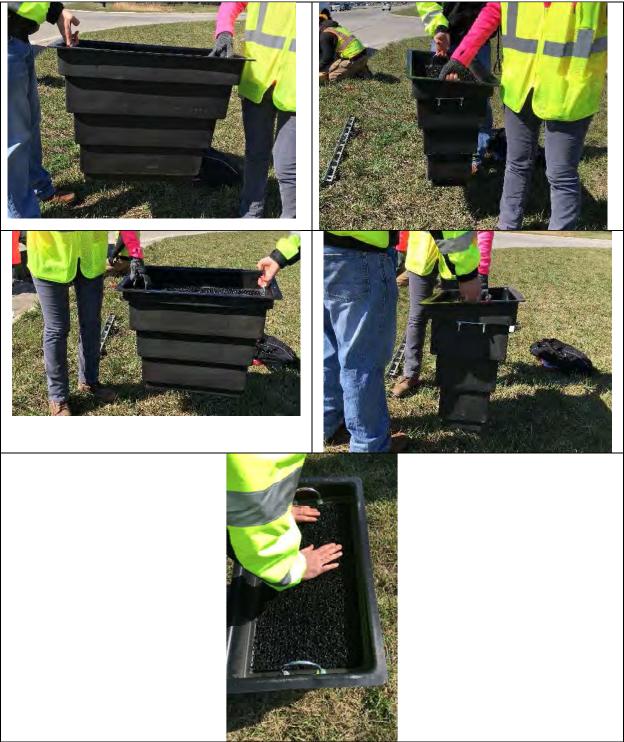
Handles are higher than the basket, without modification the grate would sit on the handles. The handles were removed, bent slightly and reattached. The above modification is not expected to impact the performance of the unit.

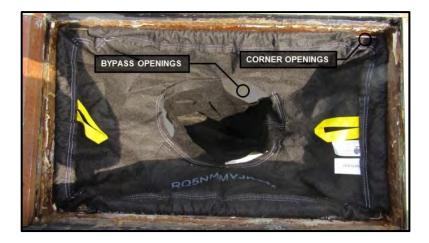
Figure C-15: Openings in Storm Sentinel® allow untreated bypass.

It was observed during the high flow rate tests that the influent flow caused the filter bag to move around the adjustable frame, creating small gaps to open at the entrance to the CBI. The gaps, though small, could allow influent water to bypass the CBI completely and enter the catch basin untreated. The position of the bypass openings also allowed for some flow to directly exit through the openings untreated. These issues can be seen in Figure C-15.

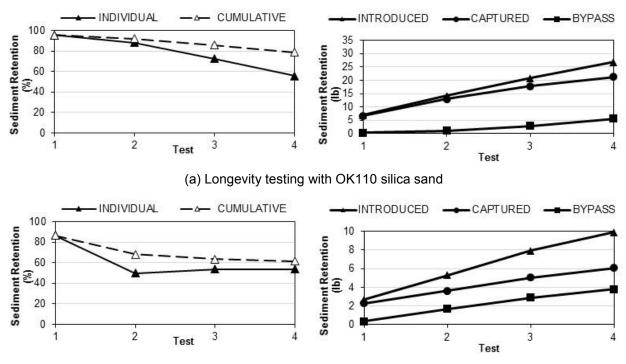
Figure C-22: Sediment retention percentage for Adsorb-It™ over longevity tests.

Figure C-22 shows sediment bypassing increases, or is not being captured at the same rate, over time by the Adsorb-It[™], indicating a decline in performance and a need for maintenance.

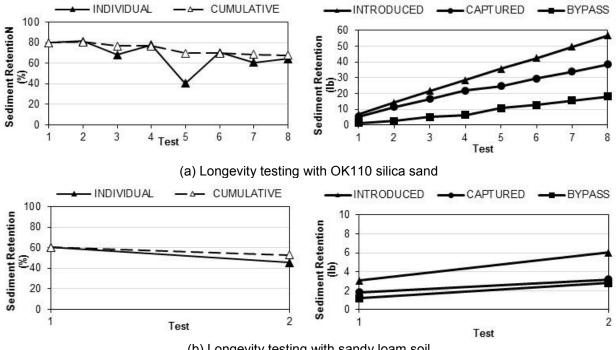
(b) Longevity testing with sandy loam soil Figure C-23: Sediment retention percentage for DrainPac[™] over longevity tests.

Figure C-23 was included to further analyze the DrainPac[™] over the longevity tests. Sediment capture rate decreases overtime while bypass increases, indicating a decline in performance and a need for maintenance. Further analysis of Figure C-23 also shows that, while sediment retention appeared volatile when considering the percentages individually for each test, it can be seen that sediment retention is actually fairly linear across all eight tests, with the exception of the one L5 tests, which could be considered an outlier.

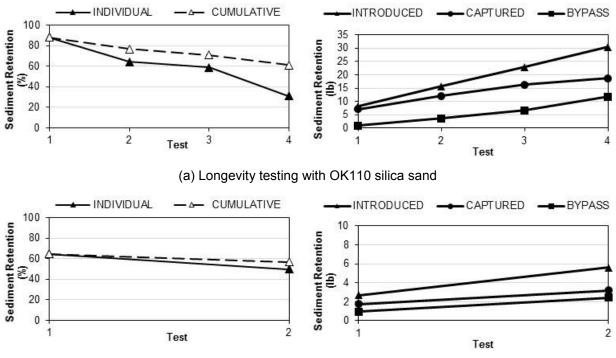
Figure C-25: Sediment retention percentage for FlexStorm® over longevity tests.

Figure C-25 further analyzes the FlexStorm® performance over the longevity tests. Notice the difference between the sediment introduced and sediment capture increases with each test, indicating a decline in performance and a need for maintenance.

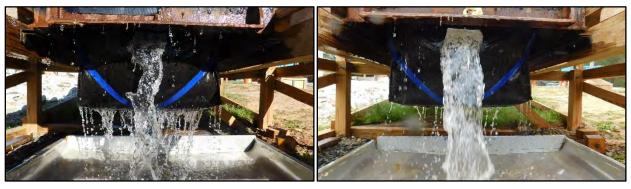
(a) L1 (b) L2 Figure C-26: Gullywasher© during longevity testing with sandy loam soil.

Longevity testing of the Gullywasher© using OK110 silica sand was conducted over three tests. Overflow was reached during the three tests at 24, 7 and 2 minutes, respectively. Longevity testing with sandy loam soil was concluded after two tests, with overflow times of 26 minutes and 1 minute, respectively. The difference in overflow times from L1 to L2 indicate that sandy loam soil severely blinded the fabric after the first tests, inhibiting flow-through rate and causing the CBI to fill to the overflow point very quickly. It can be seen in Figure C-26 that the flow coming through the bypass during the L2 test was much more severe than the flow exiting the bypass during the L1 test.

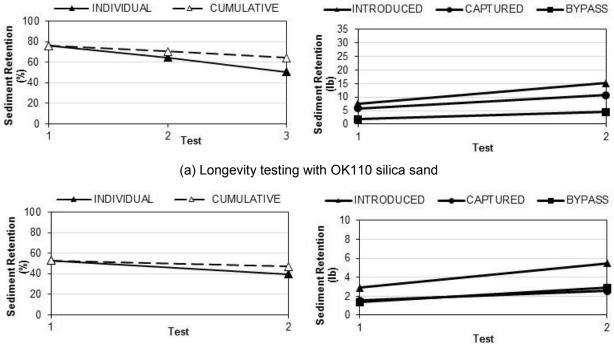
Figure C-27: Sediment retention percentage for Gullywasher© over longevity tests.

Figure C-27 shows the difference between the introduced and captured lines is increasing with each test, indicating a decline in performance and a need for maintenance.

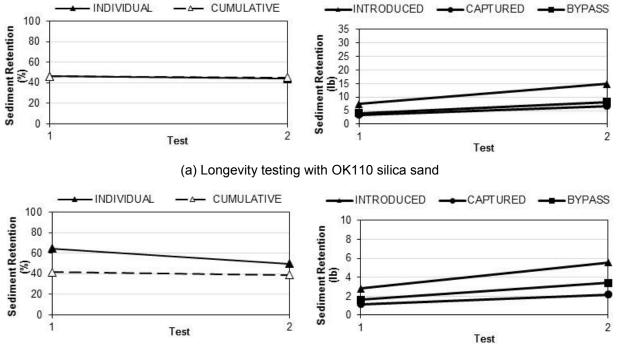
Figure C-28: Sediment retention percentage for Storm Sentinel® over longevity tests.

Figure C-28 shows the difference between the introduced and captured lines is increasing with each test, indicating a decline in performance and a need for maintenance.

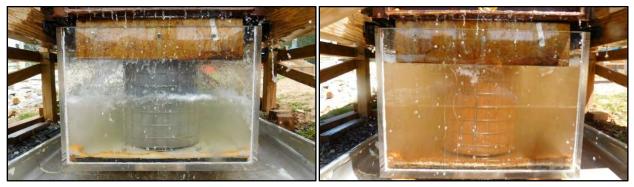
(a) L1 test with OK110 silica sand
 (b) L1 test with sandy loam soil
 Figure C-29: Triton[™] during longevity testing.

Two longevity tests were conducted on the Triton[™] for each soil type. Figure C-29 was included to showcase how the sandy loam soil clogs the cartridge medium and fills the catch basin box faster than with the OK110 silica sand, which also lead to larger impoundment depths, even though untreated bypass was never reached for any of the tests.

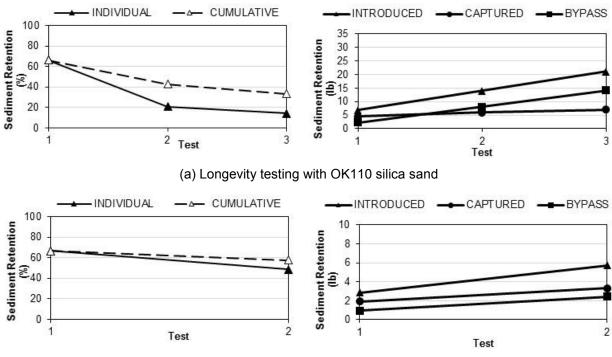
Figure C-30: Sediment retention percentage for Triton[™] over longevity tests.

Figure C-30 shows that the amount of sediment bypassing, the Triton[™] grows with each test, indicating a decline in performance and a need for maintenance.

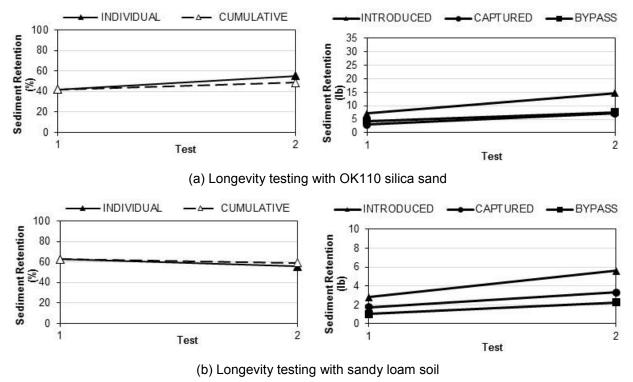
Figure C-31: Sediment retention percentage for WQS over longevity tests.

Figure C-31 shows the distance between the sediment introduction line and the sediment captured line grows greater as testing progresses, indicating a decline in performance and a need for maintenance.
