Arlington RAPID

Autonomy Insights Report

March 2021

March 17th, 2021 – April 30th, 2021

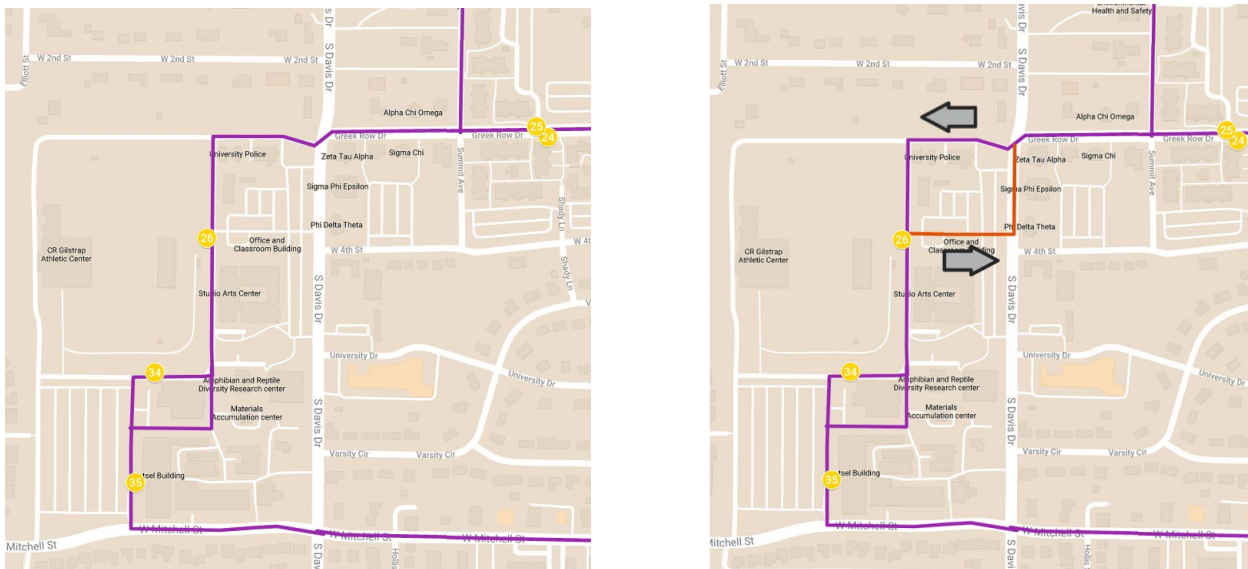
Davis Addition:

Figure 2: Additional section on Davis from Stadium to Greek Row (previous route on left; new route on right)

Previously, in order to connect the stadium stop to the rest of the route, the AV was routed along Mitchell to the east end of the route before it could make its way north and back west. This is due to the crossing at Davis & Greek Row Dr only being legal in the westbound direction. In addition, the 35mph speed limit on Davis placed it

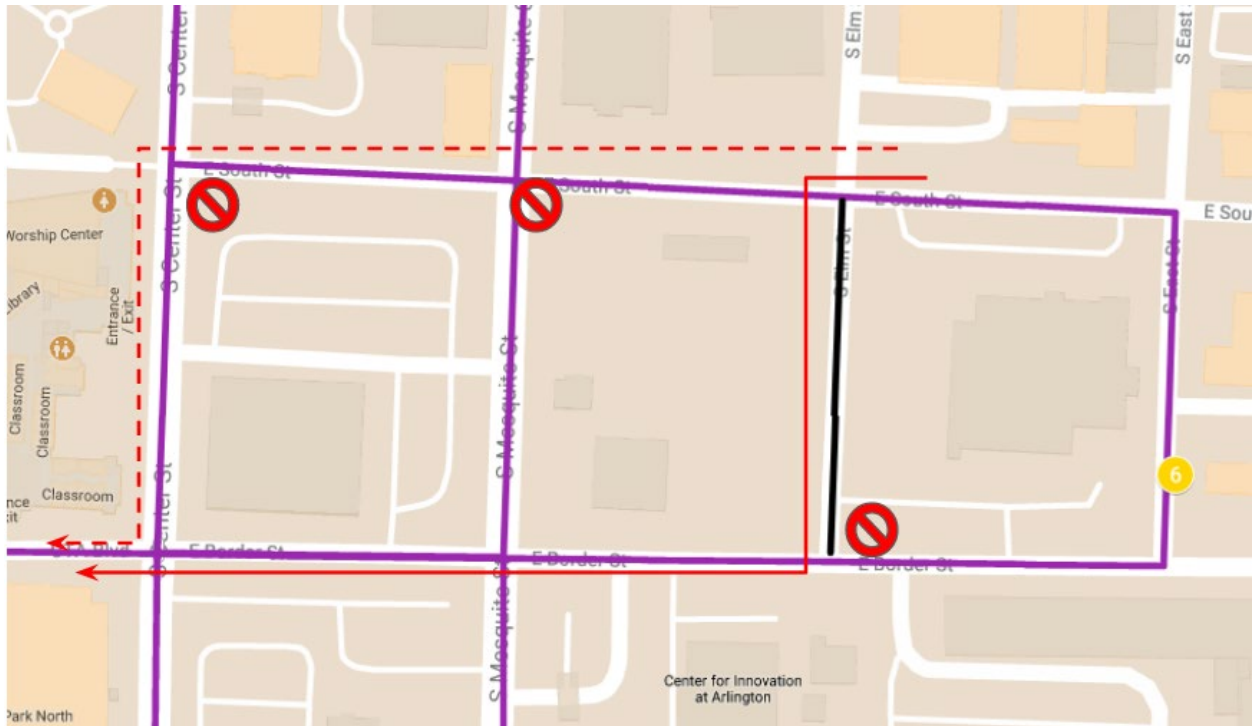
Elm St. Addition:

Figure 2: Original (dotted red) and the new (solid red) path between Post Office and West Garage Terminals

With the addition of the Post Office terminal in the previous month, AVOs noted that the addition of Elm Street to the route would result in one less intervention while hovering between the Post Office and West Garage terminals. This additional road was mapped and tested during September and is targeted for release to the fleet in October. The old path denoted with a dotted red line has two manual-only zones, where the new path denoted by a solid red line has just one.

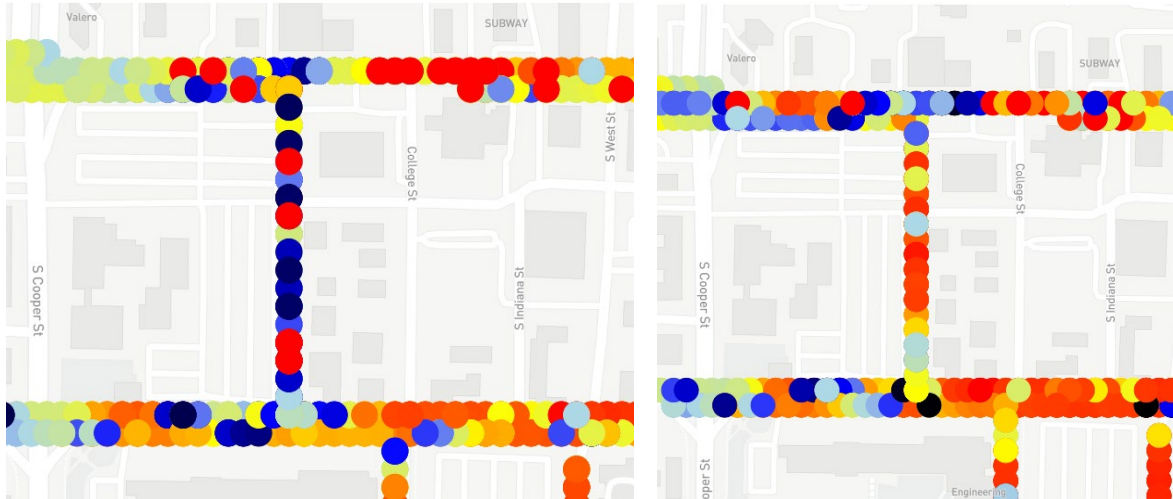
Lampe Reopen:

Figure 2: Autonomy utilization on Lampe St. during August (Left) and September (right)

The south end of Lampe Street reopened at the end of August, resulting in the entire length open to be driven in autonomy. Previously dropoffs and pickups at Lot 52 (on Lampe) would result in at least one manual takeover due to the need to make a u-turn to avoid construction. After manually changing lanes, the autonomy system requires a short distance to switch paths and for the AVO to re-engage autonomy, which explains the very limited and sporadic autonomy utilization in previous months.

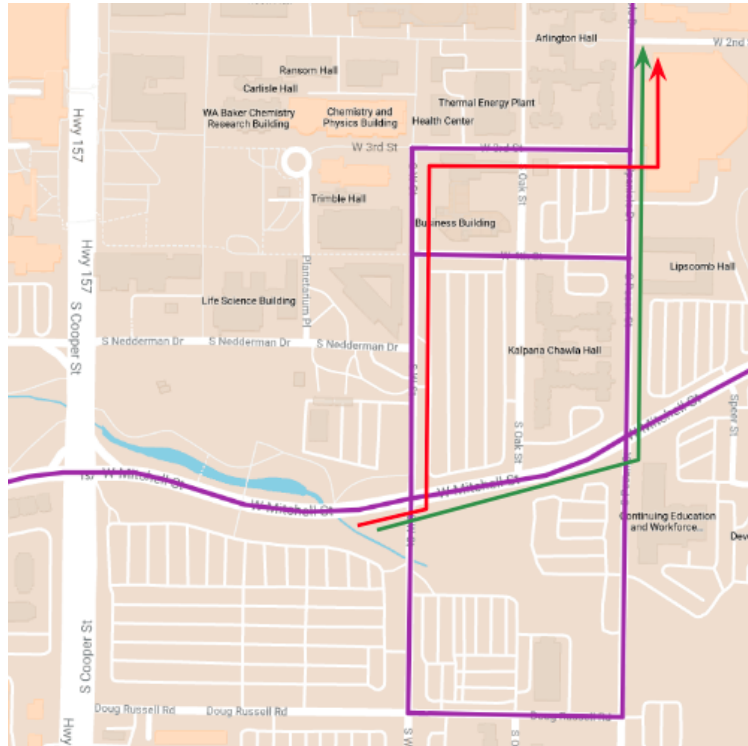
Routing Past Business Building:

Figure 2: Old (red) and new (green) routing from Mitchell to Spaniolo

AVOs reported that while driving from Mitchell EB to Spaniolo NB, the AV would drive along South West Street instead of taking a left directly onto Spaniolo. Not only does this poor routing increase ETAs, but it also takes the AV through the much busier area around the Business Building. The issue was quickly resolved in the May Mobility route map and will be released in a software update in November.

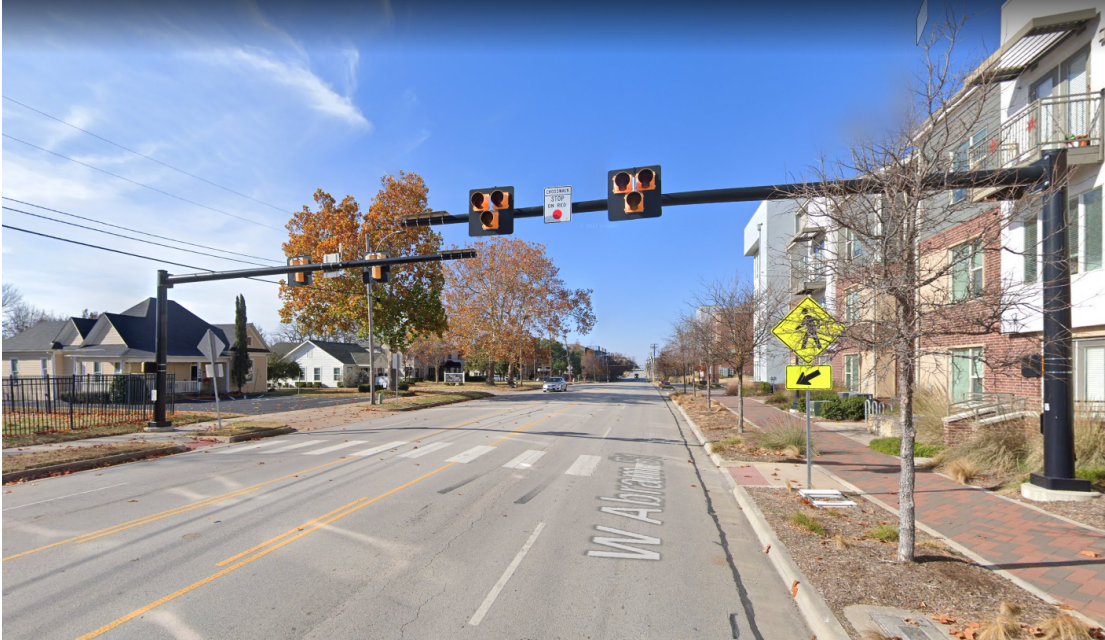
Arlie Crosswalk:

Figure 3: Crosswalk on Abram in front of the Arlie

There is a crosswalk on Abram in front of the Arlie apartment building that has a flashing red light that can be triggered by a pedestrian. Normally this light is not illuminated. During testing and the first few months of the deployment, this light had not been seen to be triggered. In October an AVO reported that the light was triggered and subsequently took over, as the AV would not slow down for this light. This section was soon set to manual-only in the route network as our system is only able to handle traffic lights where the right of way is indicated by a constant green light.

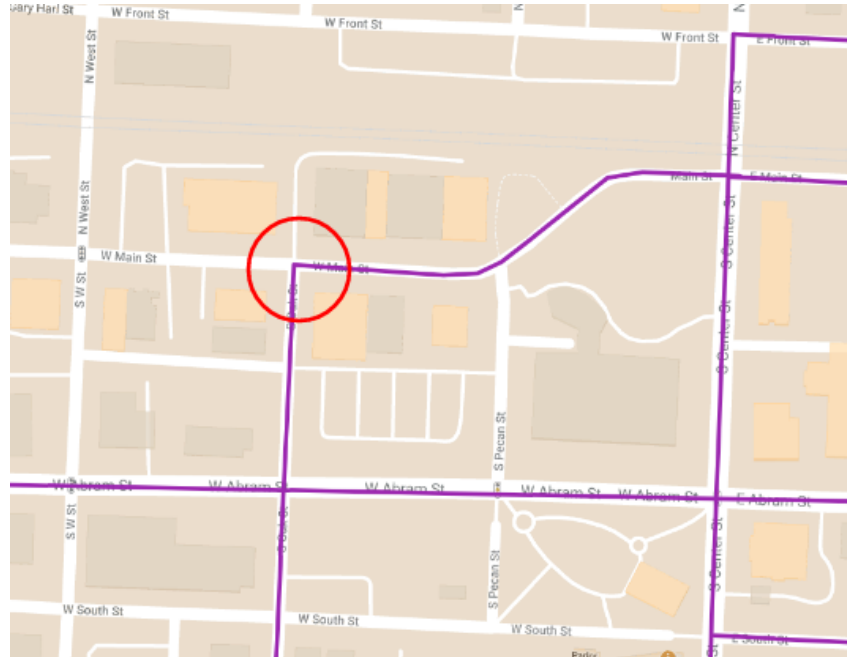
Oak and Main:

Figure 4: Intersection of Oak and Main

The intersection of Main St. and Oak St. was recently updated to an all-way stop. Previously this intersection included stop signs for Oak St. and no stop signs for Main St., therefore, the AVOs needed to take over to perform the unprotected turn from Main onto Oak and vice versa. Once this route update is tested and released to the fleet in late November, this intersection will be fully autonomous.

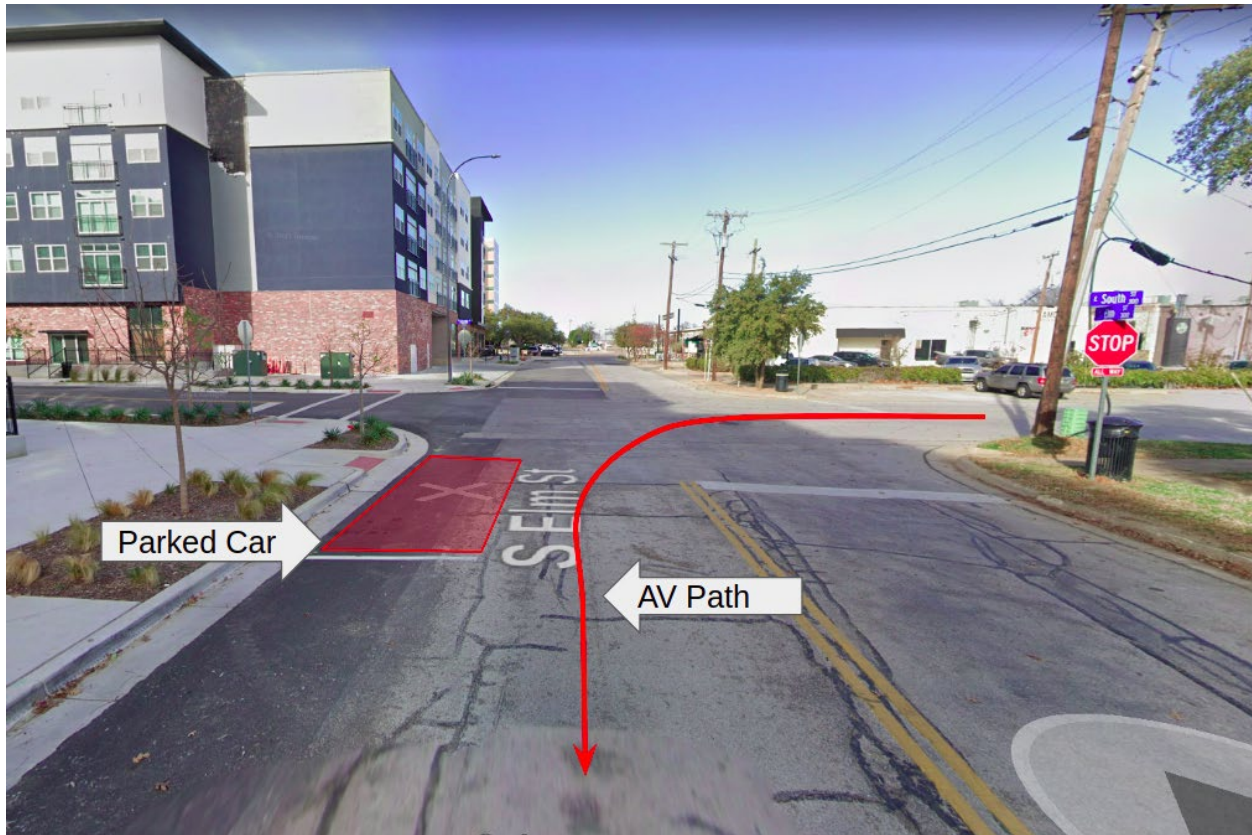
Figure 3: Turn from W South St to Elm St

There is a noticeable reduction in autonomy utilization on the turn from W South to Elm St. AVOs reported that during the day, vehicles would often park one spot before the official street parking started. When a vehicle is parked in the space shown above, it intersects with the implied (not painted) crosswalk. Because of this, the AV will slow or stop as it sees an object in a crosswalk very close to its intended path. Our behavior system currently errs on the side of caution and allows all objects regardless of classification to activate a crosswalk.

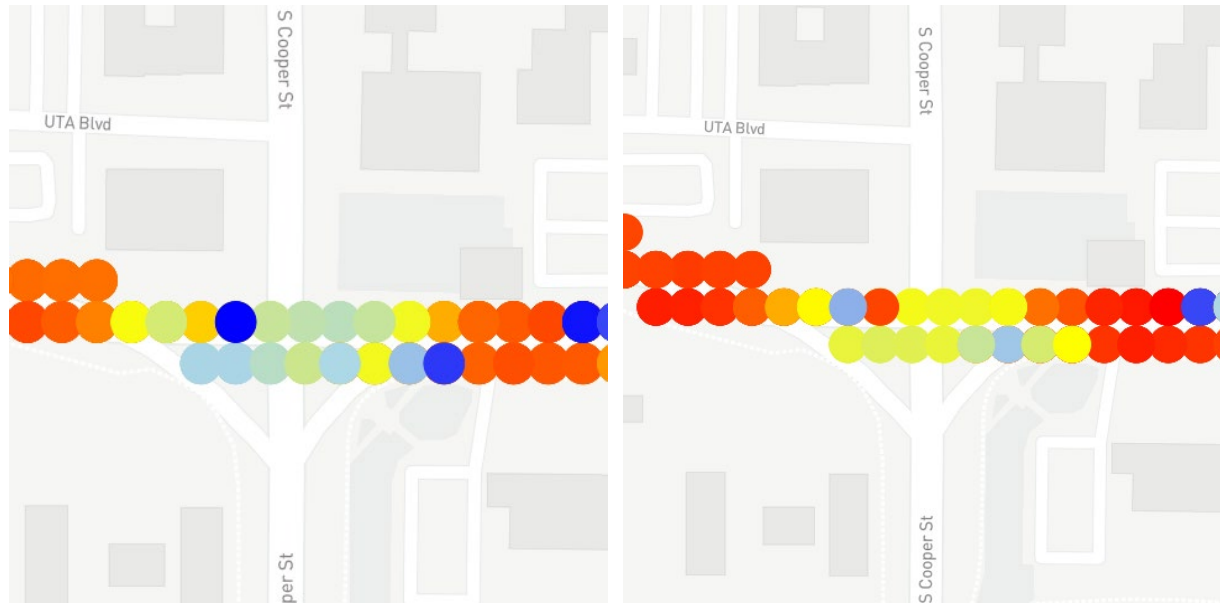
UTA and Cooper Intersection:

Figure 2: Autonomy Utilization at UTA and Cooper for November (left) and December (right) 2021

A new software update (version 7.3) was released to Arlington in the middle of December. An overview of that release is described at the bottom of this document. One outcome of this software release was improved performance through busy intersections. AVOs often needed to take over through the UTA and Cooper intersection. This was due to the AV incorrectly predicting that crossing vehicles would creep forward into the intersection. This can still happen in software version 7.3, but the issue has greatly reduced in frequency, as seen in the above autonomy heatmaps.

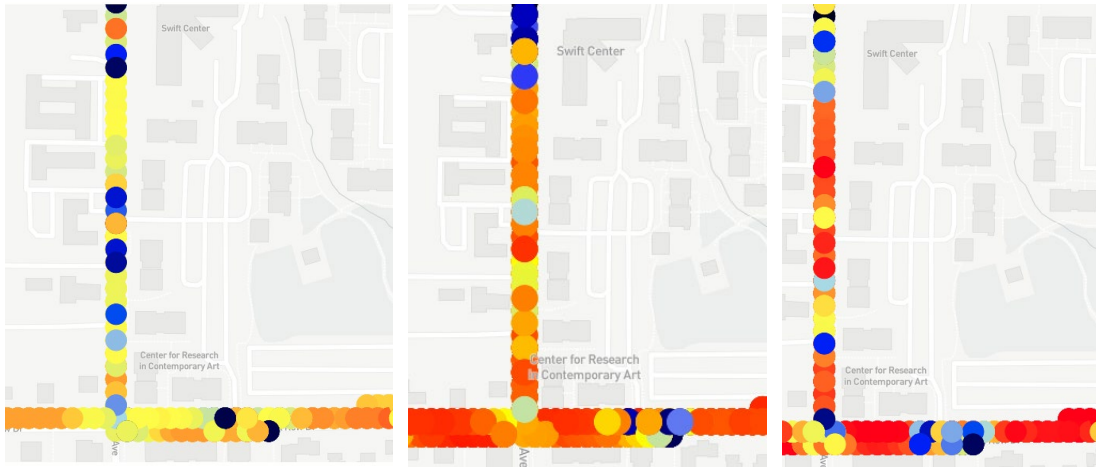
Parked Vehicles:

Figure 4: Comparing autonomy near parked vehicles from the start of the deployment in April 2021, November 2021, and December 2021

At the start of the deployment, navigating around parked cars was a challenge for the AV. This was improved upon in later software versions and in 7.3. With version 7.3, the autonomy software can identify these vehicles and smoothly offset the AV to the side in order to create space between the AV and the parked vehicles.

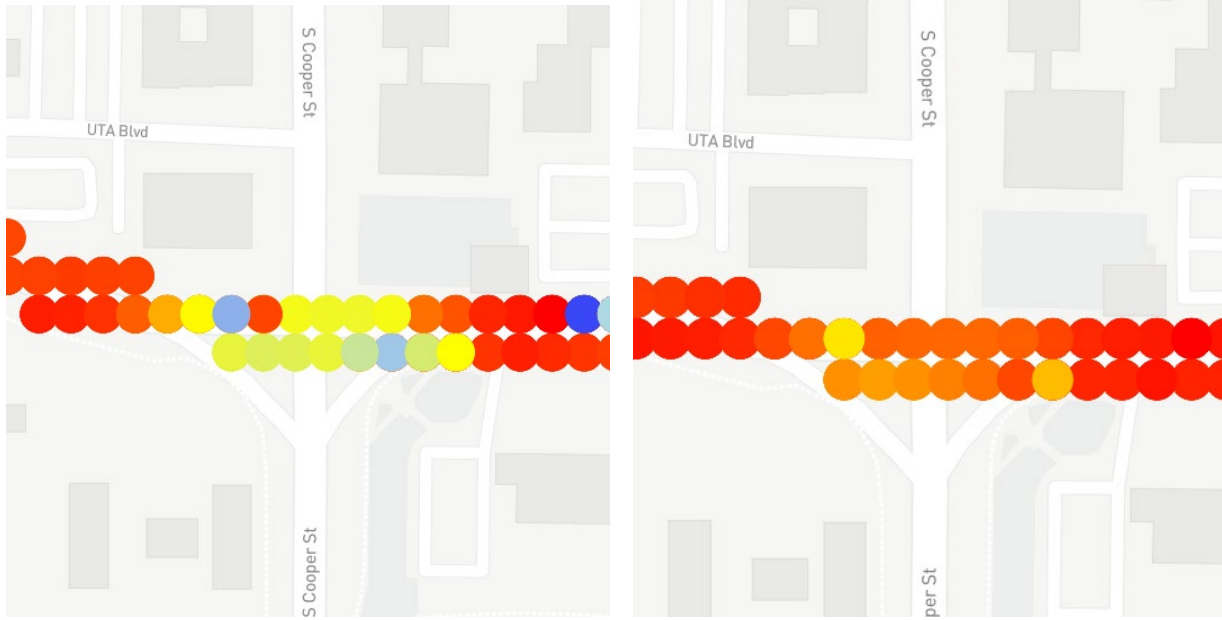
Prior to release 7.3, the shuttle would frequently predict other vehicles to creep forward into intersections as the shuttle passed, but this intent prediction was improved with the new software release. This can be seen through further improvement in autonomy utilization at the UTA Blvd and Cooper St intersection, which has been one of the most difficult for the shuttles.

Figure 2: Autonomy map at UTA and Cooper for Dec. 2021 (left) and Jan. 2022 (right)

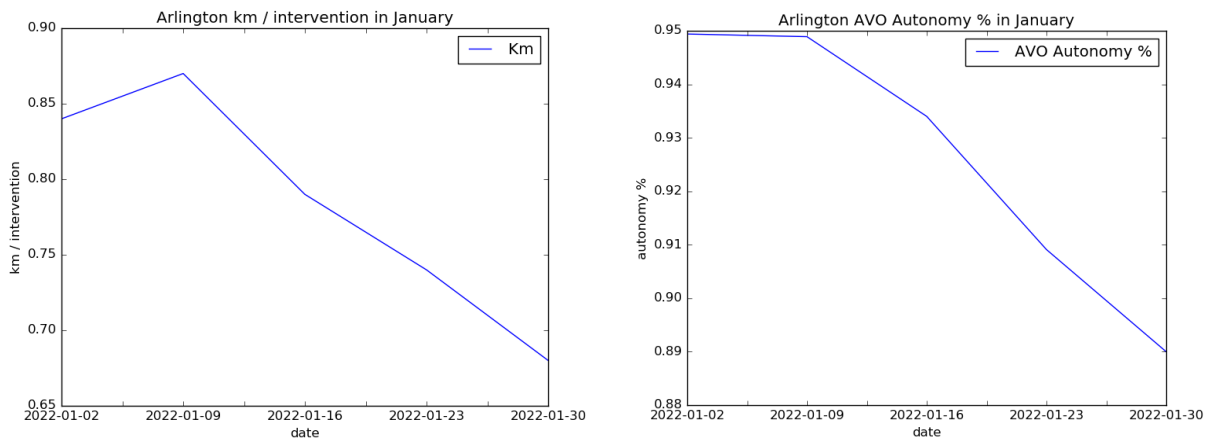
Insight 3:

Figure 4: Arlington km / intervention (left) and AVO Autonomy % (right) for the month of January

Although the site saw improved autonomy numbers over previous months (especially the two weeks at the beginning of the month that had nearly 95% AVO Autonomy), weather conditions made it difficult to sustain the same autonomy percentages over the entire month. The AVO Autonomy % dropped slightly from nearly 95% down to 89% over the course of January. Site staff primarily attributed this to two factors.

Secondly, site staff mentioned that in the days after the rain stopped, puddles left in the road could splash up and cause the shuttle's sensors to believe an object was nearby, so AVOs were advised to drive manually through these areas with large puddles. This also contributed to slightly lower autonomy percentages in January than may be expected during periods with better weather conditions.

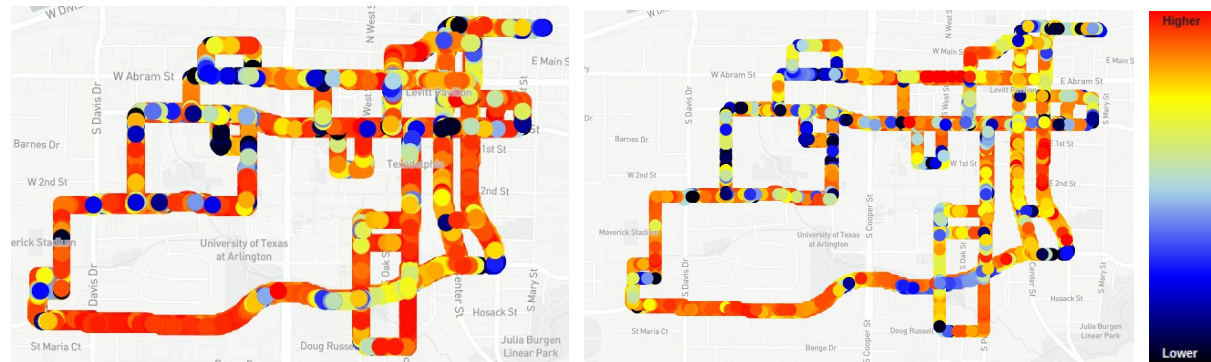
Figure 1: Autonomy Utilization Heatmap for Jan (Left) and Feb. 2022 (Right)

Above are the autonomy heatmaps for January and February. Circles in blue denote areas of low autonomy utilization, while areas marked in red denote areas of high autonomy utilization. Average autonomy utilization was 87.72% for the month of February, as compared to 93.6% in January. This autonomy percentage filters for times where the Autonomous Vehicle Operator (AVO) was driving through a required manual zone (such as an unprotected turn) or off route (such as driving around a construction diversion).

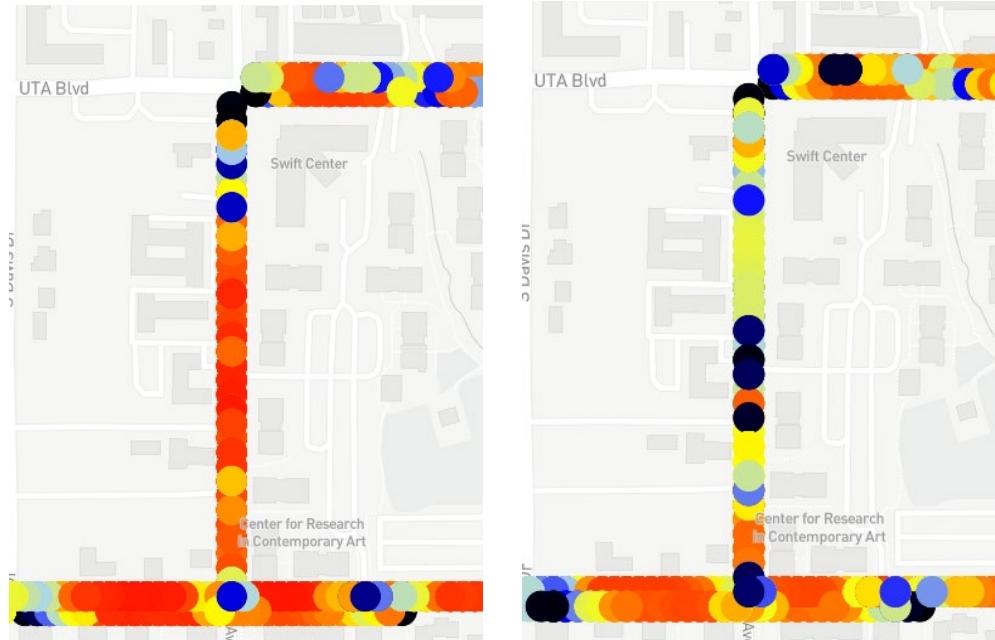
At the north end of Summit Ave., near the Swift Center, there was a route fix made at the beginning of February that should improve autonomy utilization in that area and will be deployed to the fleet in the next software release toward the end of March.

Site staff also reported construction on Greek Row, Abram, and Front St. which all led to reduced autonomy performance over the previous month.

Figure 2: Autonomy map on Summit Ave. for Jan. (left) and Feb. 2022 (right)

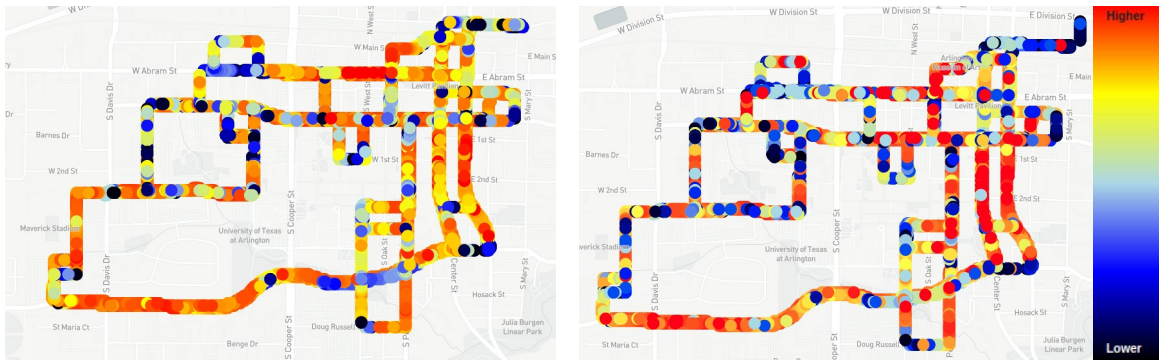
Figure 1: Autonomy Utilization Heatmap for Feb (Left) and Mar. 2022 (Right)

Above are the autonomy heatmaps for February and March (1st – 18th). Circles in blue denote areas of low autonomy utilization, while areas marked in red denote areas of high autonomy utilization. Average autonomy utilization was 87.5% for the month of March, as compared to 87.7% in February. This autonomy percentage filters for times when the Autonomous Vehicle Operator (AVO) was driving through a required manual zone (such as an unprotected turn) or off route (such as driving around a construction diversion).

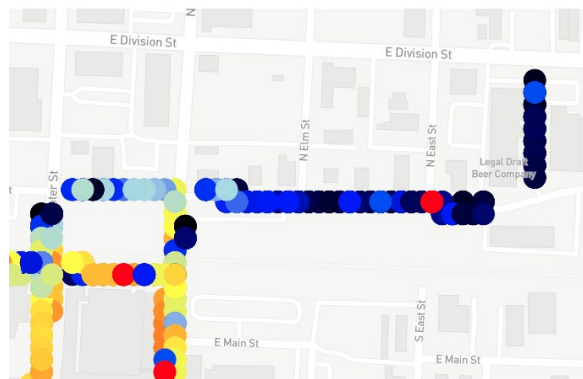
Construction on Front St:

Figure 2: Autonomy utilization along Front St.

Autonomy utilization decreased through March as construction along Front Street prevented the AV from being driven autonomously. Currently, the AV is programmed to drive on a fixed set of pre-mapped roads. If a spot is known to be under construction for a long time, that section of the route can be disabled as long as there are alternative paths for the AV to take in the route map. This would require a software update to the vehicle, so it's only feasible for long-term closures. The May

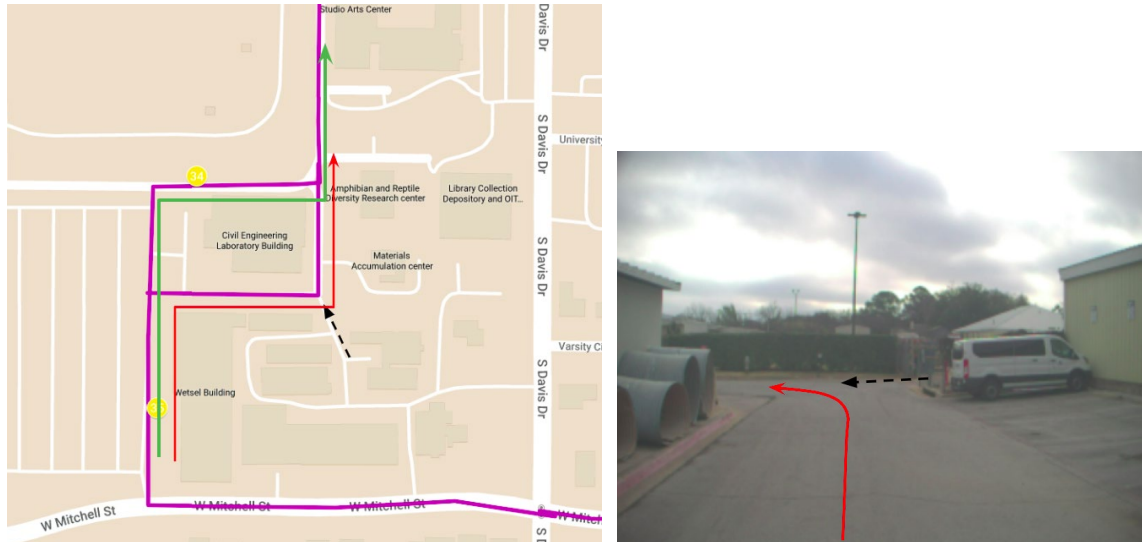
Stadium Turnaround:

Figure 4: Other vehicles' path (broken black), old routing (red), and new routing (green) when passing the stadium

Currently, the AVs use the loop around the Civil Engineering Lab (shown above) to connect to the north side of the route and to turn from WB to EB Mitchell Street. Vehicles departing the parking lot at the southeast corner often do not yield when leaving this blind exit (marked in the above image with a black dashed arrow). This resulted in requiring the AVOs to take over manually in this section. As a permanent fix, the routing will be adjusted to allow the road marked in green to be available for the AV to drive through. This will negate the need to drive past this blind exit.
