# Aerial Infrared Scanning of Bridge Decks on Parks Highway to Map Delaminations

## FINAL REPORT

**Prepared by:**  
Infrasense, Inc.  
Woburn, MA

**Report # FHWA-AK-RD-000S(960)**  
**March 2, 2023**

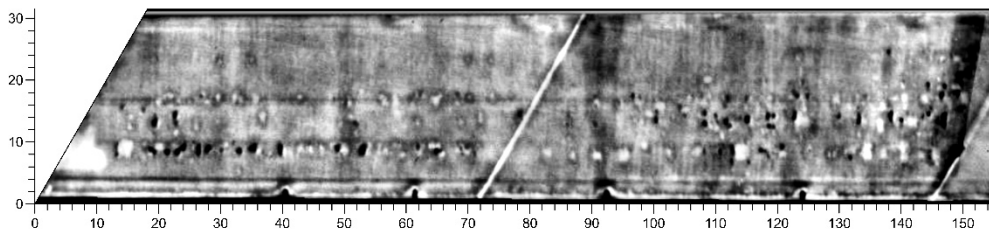
Figure 2. Example of IR Image Enhancement (Structure 1141)

Figures 2a and 2b below demonstrate the effects of the transverse normalization enhancement on the infrared image. Note the increase in contrast, which makes the “hot spots” corresponding with delaminations more distinguishable from patching and spalls. This is especially helpful in identifying smaller and more subtle delaminations. The effects of wheelpaths and structural elements on the IR data are also lessened significantly.

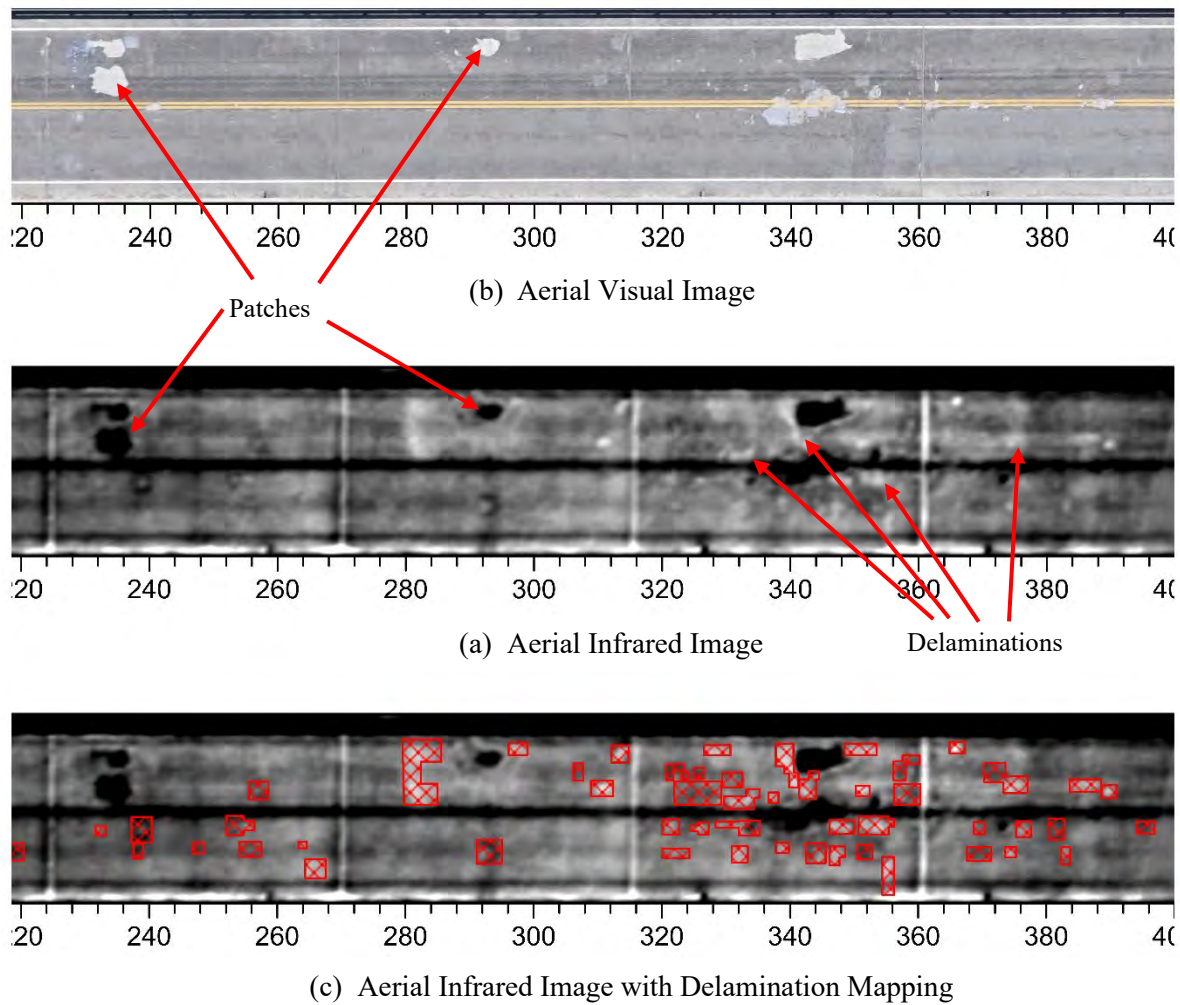
Figure 3. Sample Area of Aerial Visual and Infrared Plan-View Images (Structure 1143)

The Aerial IR plan-views described above were reviewed by an experienced analyst to quantify and map the extent delamination, as show in Figure 3c. The quantities determined through this analysis have been reported for each bridge deck in square footage and percent of deck roadway area in Attachment B, in the columns labeled “Aerial IR Delamination Quantity (%)” and “Aerial IR Delamination Quantity (ft<sup>2</sup>)”.

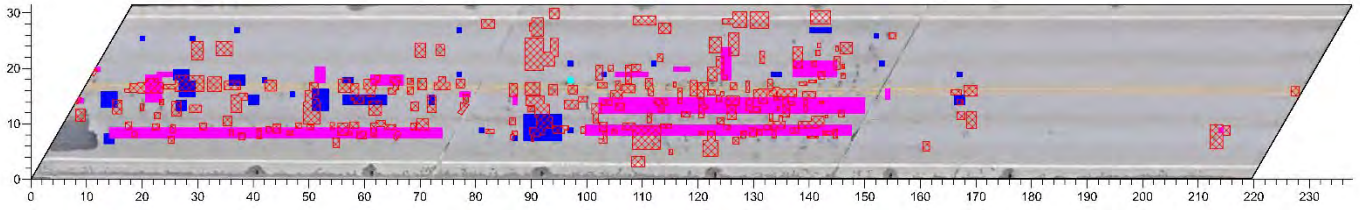
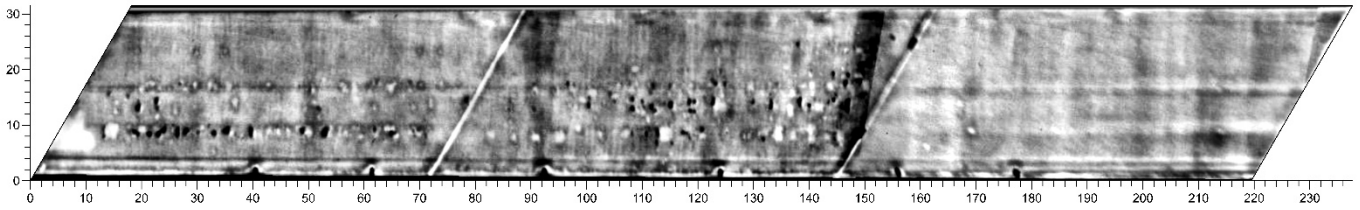
Figure 4. Sample Chain-Drag vs. Aerial Delamination Maps (Structure 1141)

The results of the chain drag evaluation, and the comparison of these results to the Aerial IR results, are shown in Table 2. The table shows that, on average, the chain drag and Aerial IR results were within 2%. Structure 0697 is the most significant outlier; discounting this deck results in an average absolute difference of 1.4%. Figure 4 shows a sample of the Aerial IR (red hatched) and chain-drag (solid color areas) mapped delaminations along with the corresponding infrared imagery. This sample is representative of most comparison decks, which show a reasonably good spatial correlation between the Aerial IR and chain-drag results. Decks with lower delamination quantities had the least spatial correlation between the two methods.

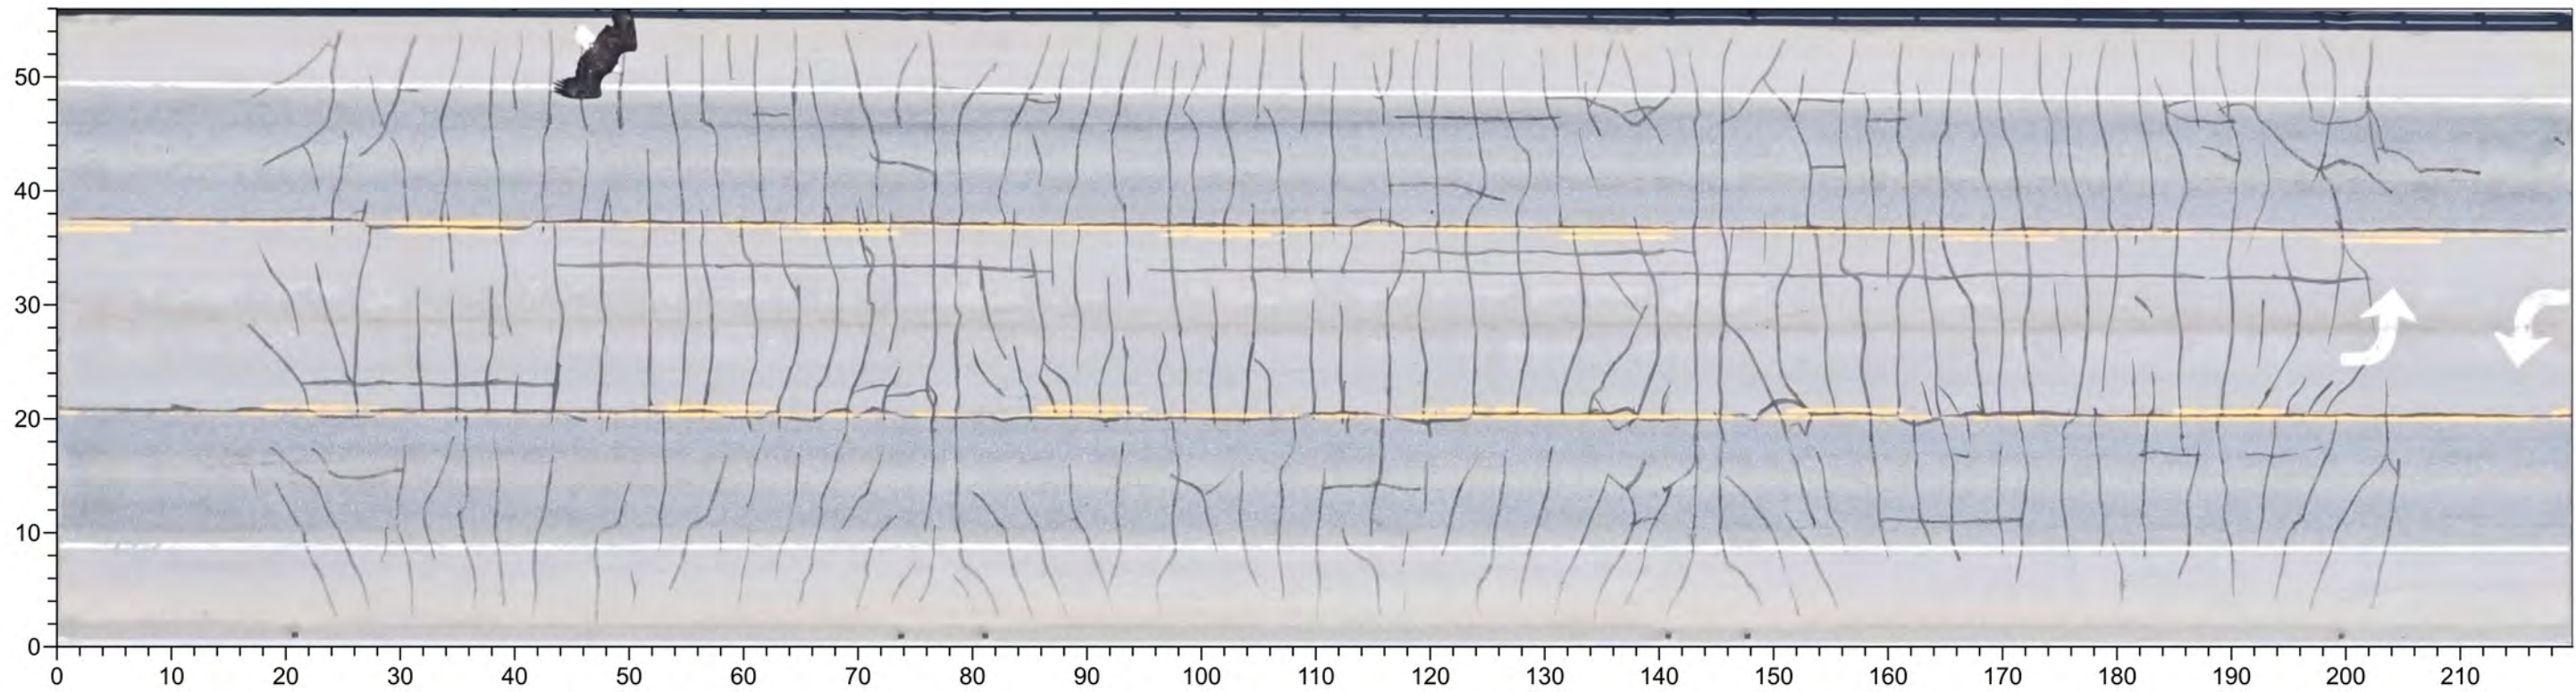
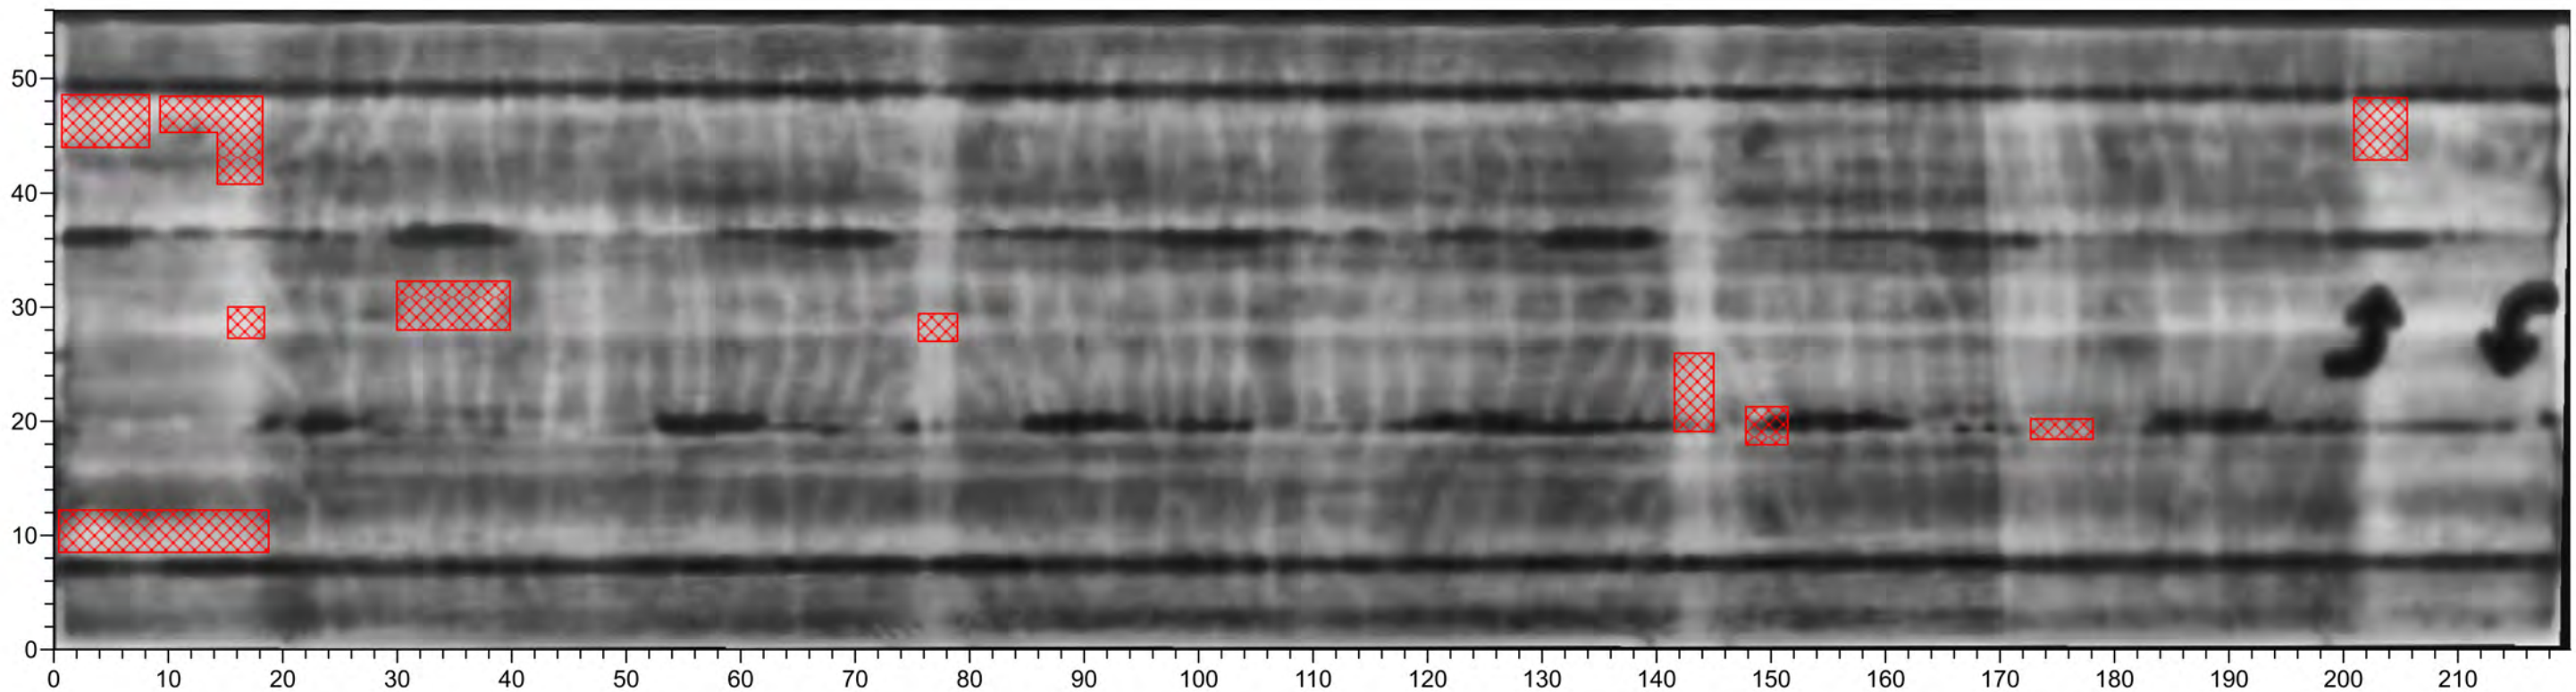
Delamination Quantity (%)    0.5 Delamination Quantity (ft <sup>2</sup> )    214	Imagery Collected: 6/5/22 Analyzed by: EG, SB Reviewed by: AJC Completed: 10/12/22

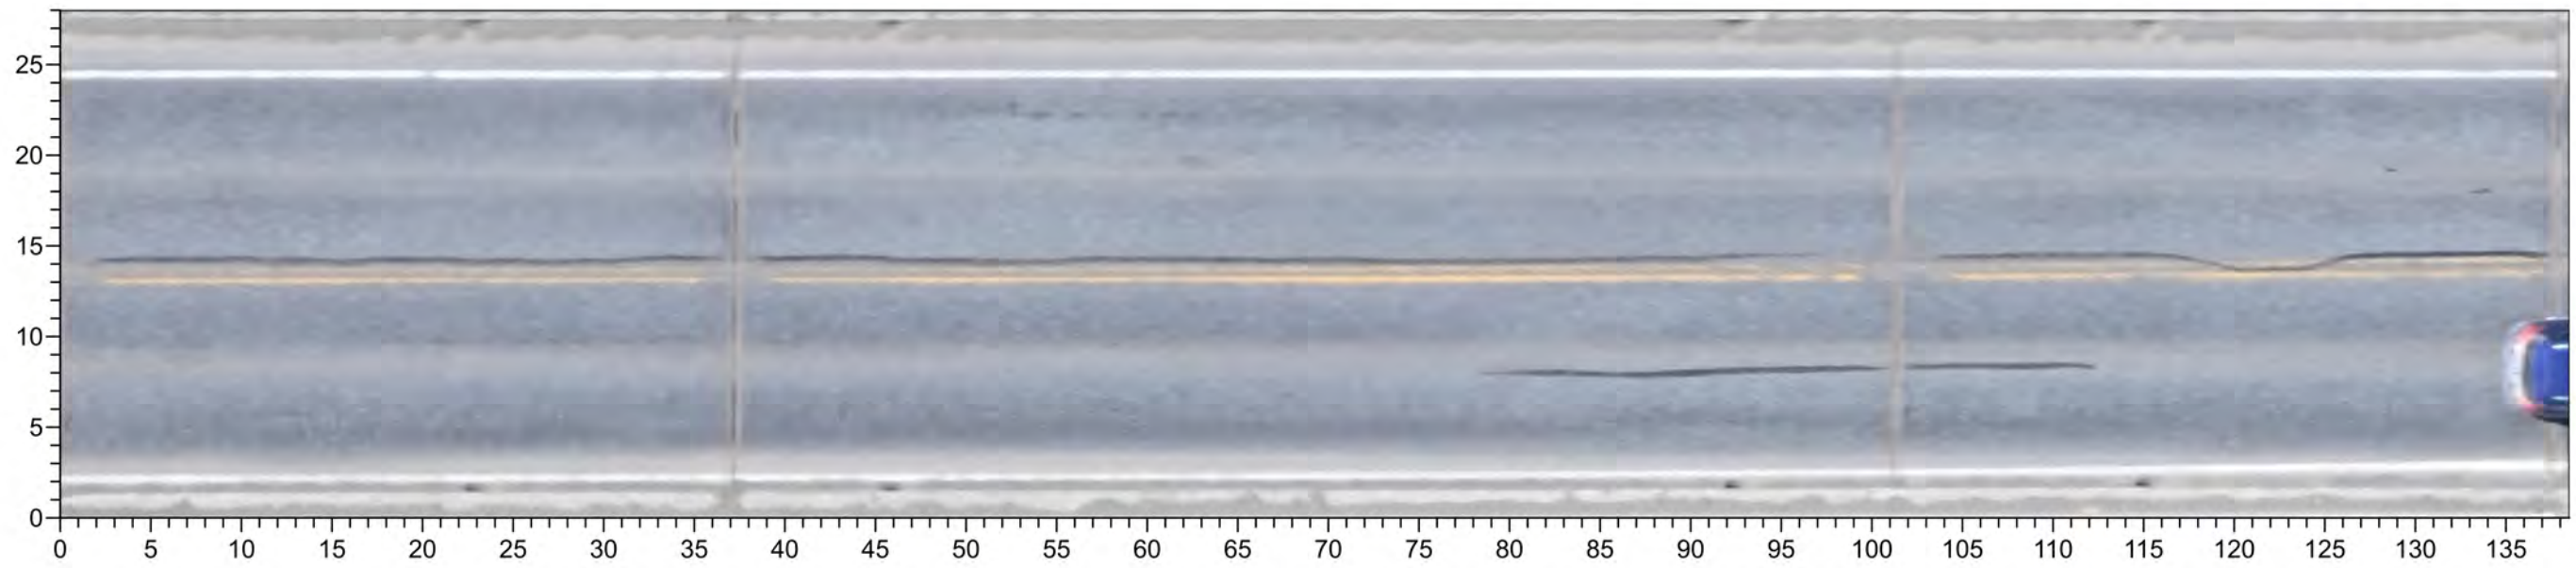
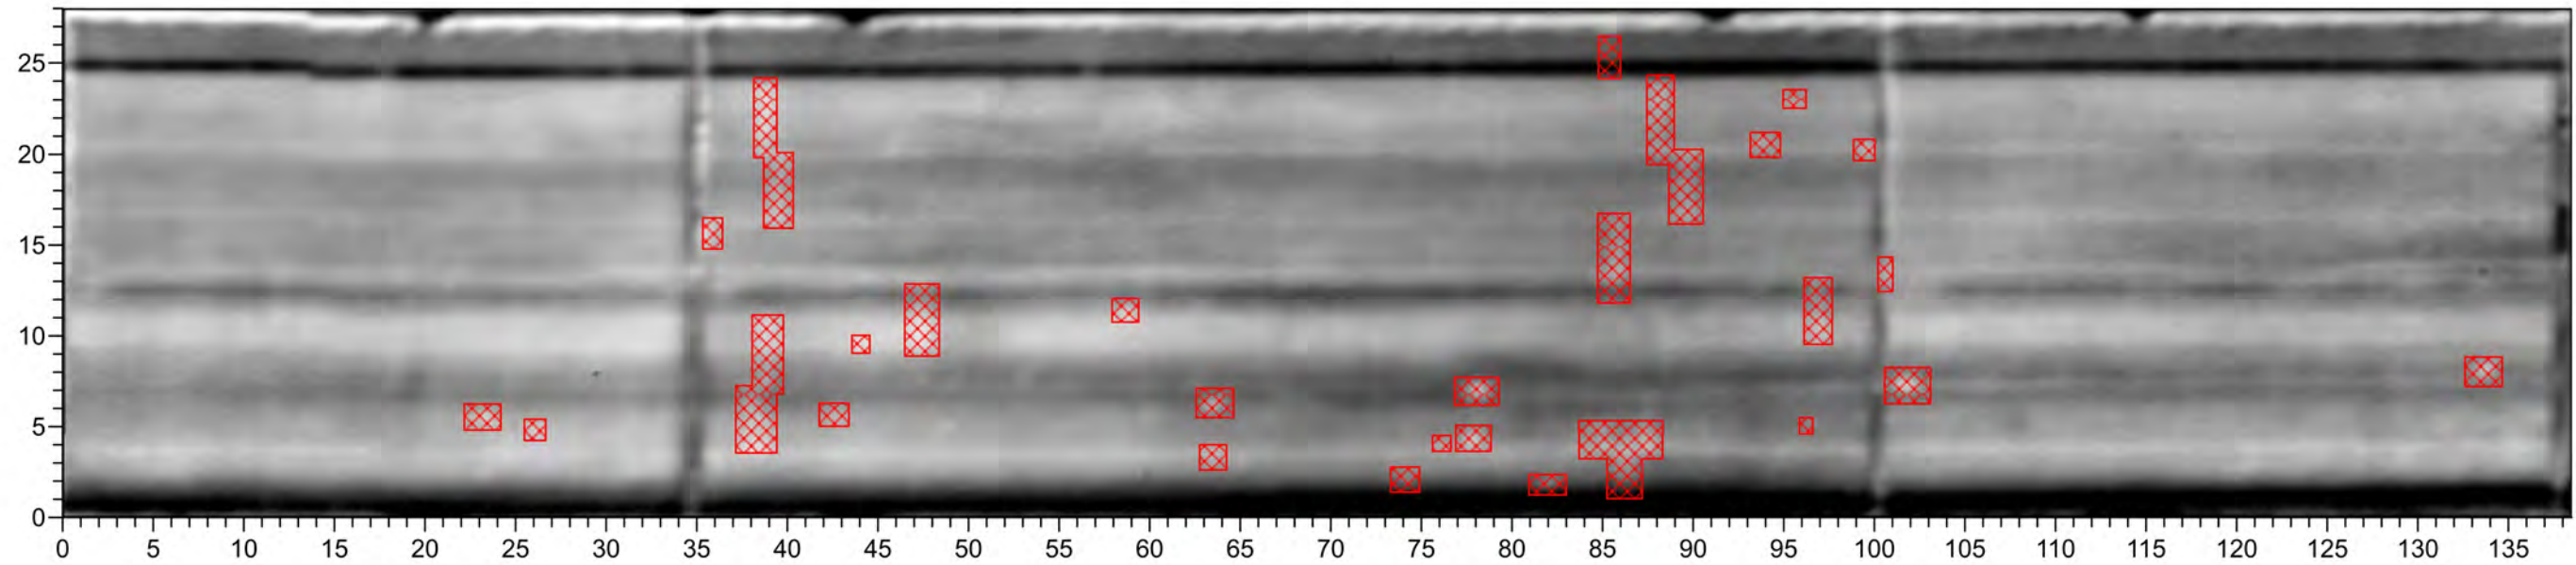
Delamination Quantity (%)    2.3 Delamination Quantity (ft <sup>2</sup> )    280	Imagery Collected: 6/4/22 Analyzed by: SB Reviewed by: AJC Completed: 9/30/22

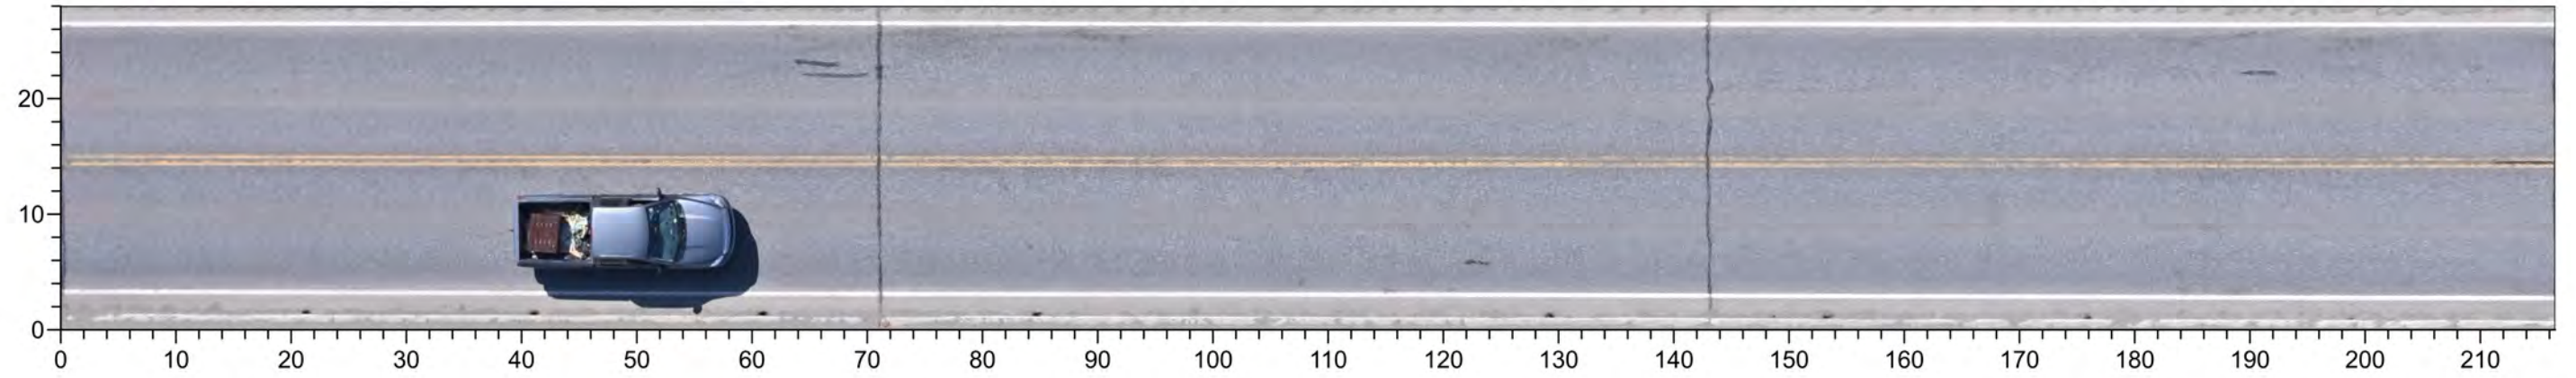
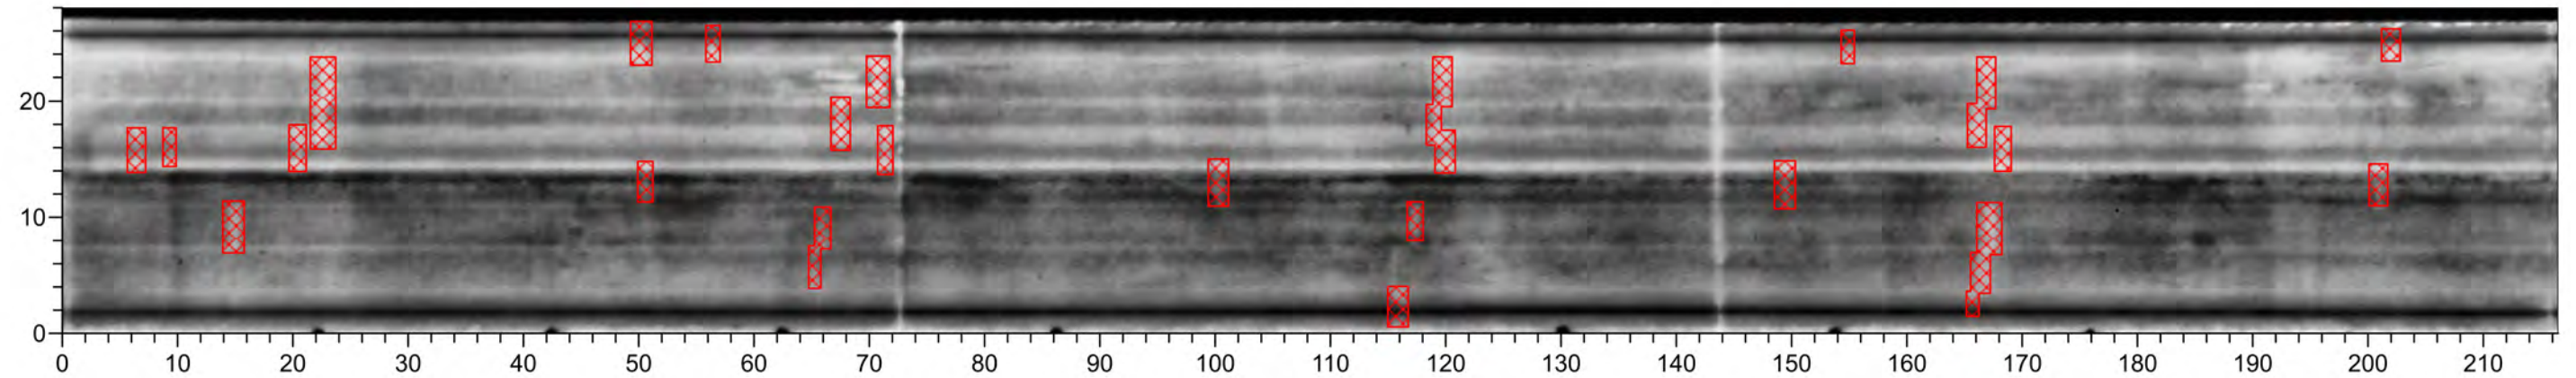
Delamination Quantity (%)    3.2		Imagery Collected: 6/4/22 Analyzed by: SB Reviewed by: AJC Completed: 9/30/22	
			Delamination Quantity (ft <sup>2</sup> )    125

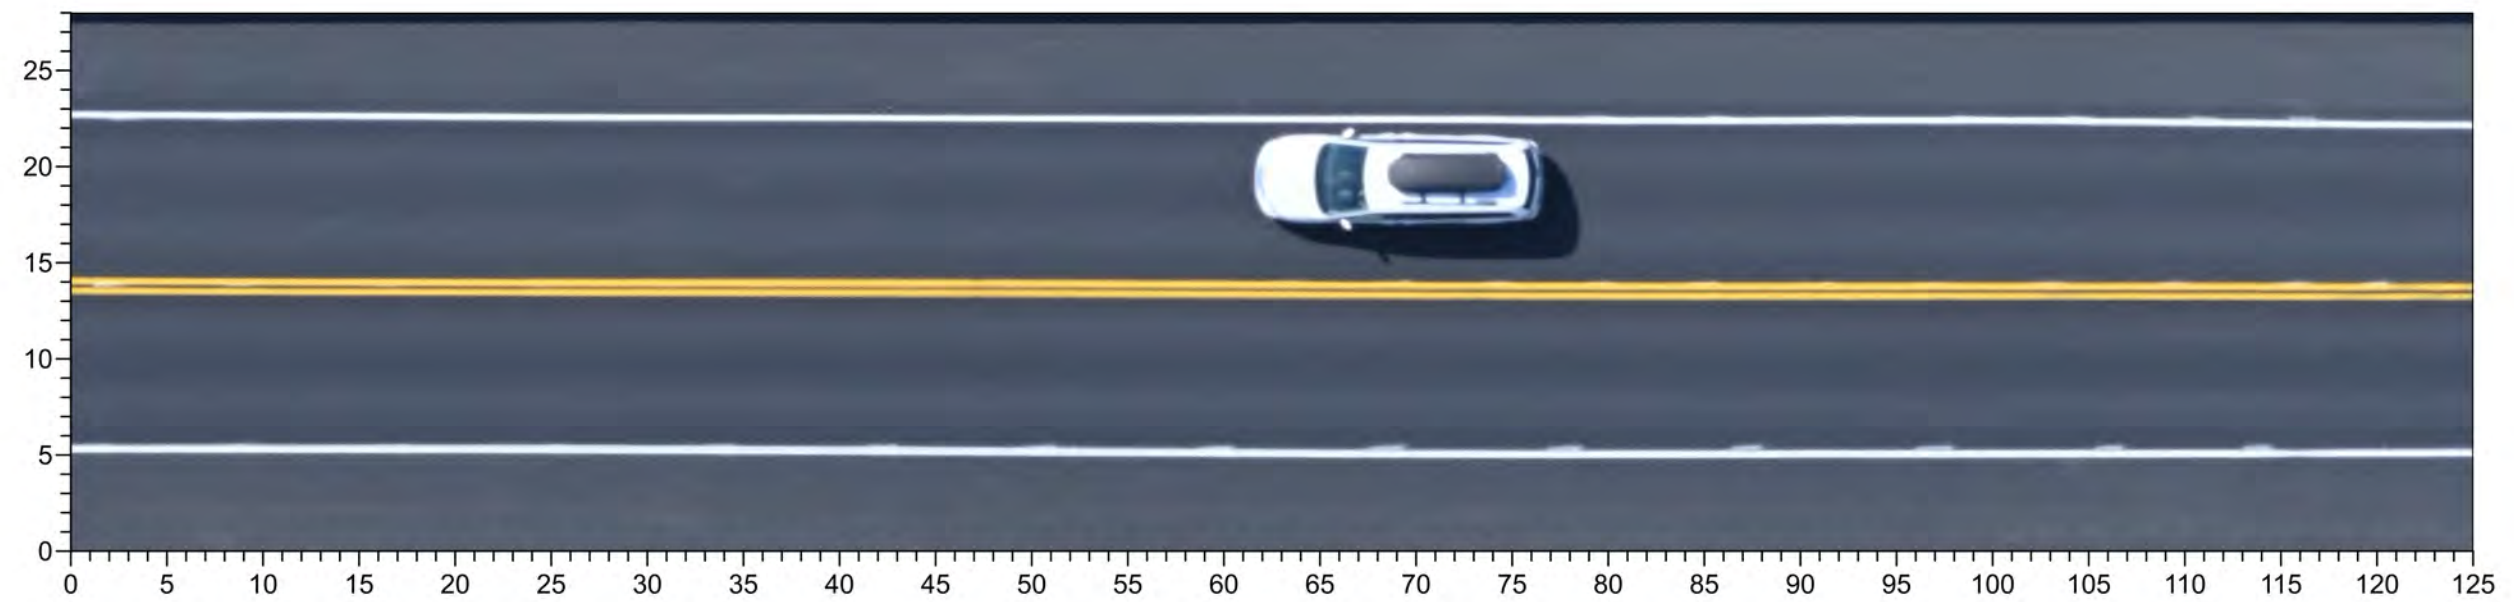
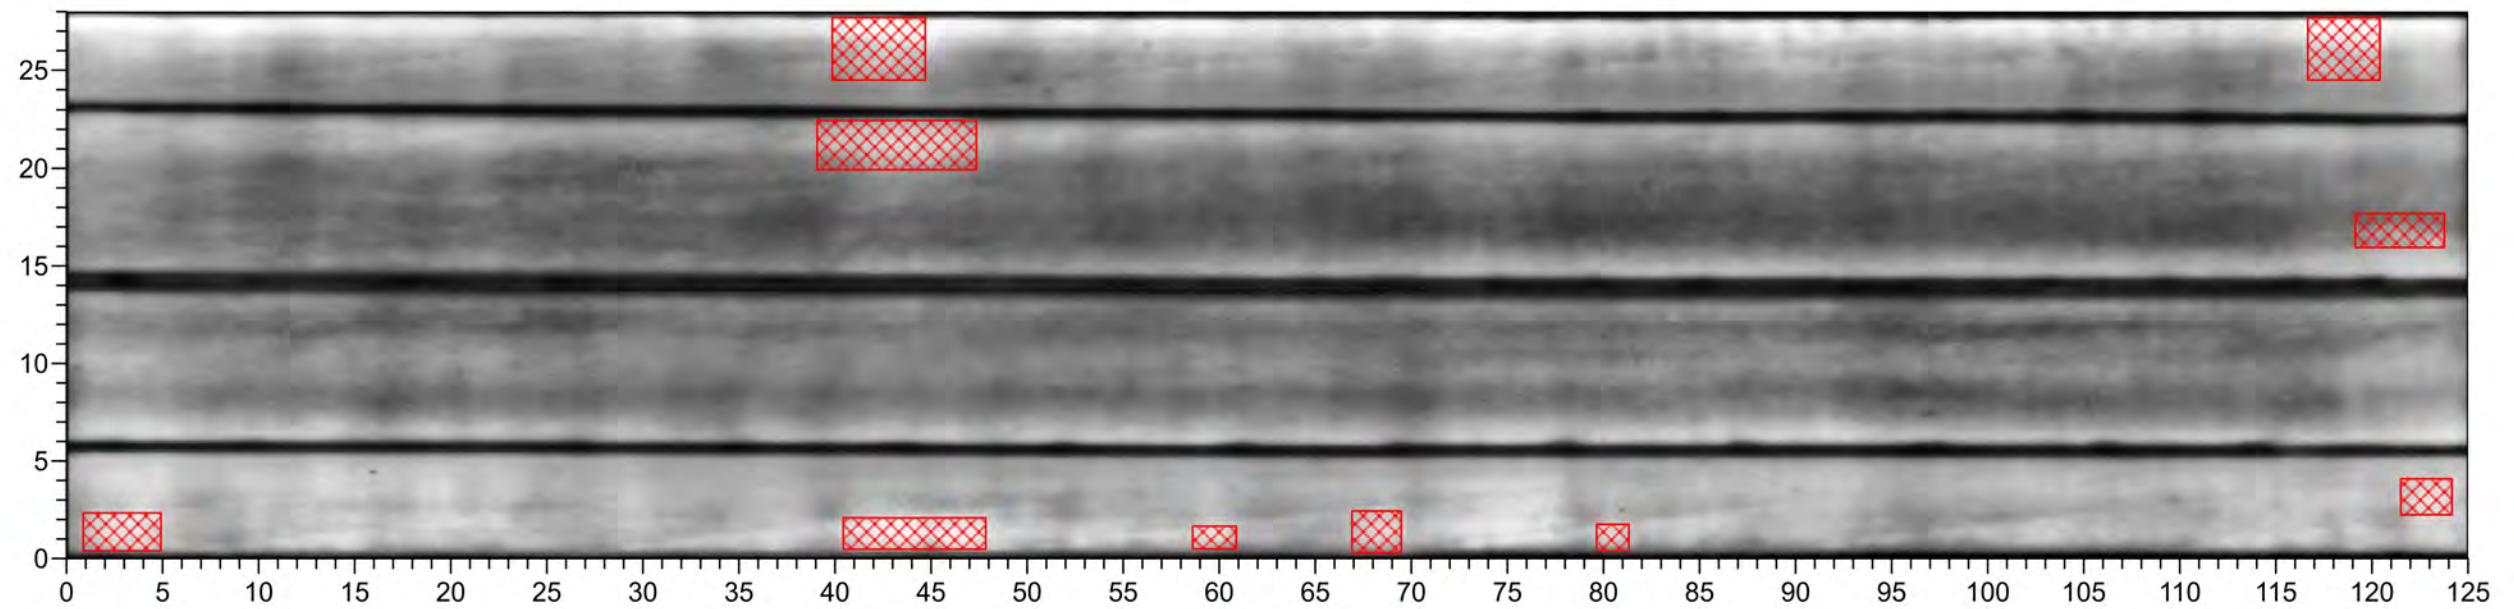
Delamination Quantity (%) 3.0		Imagery Collected: 6/4/22 Analyzed by: SB Reviewed by: AJC Completed: 9/30/22	
			Delamination Quantity (ft <sup>2</sup> ) 181

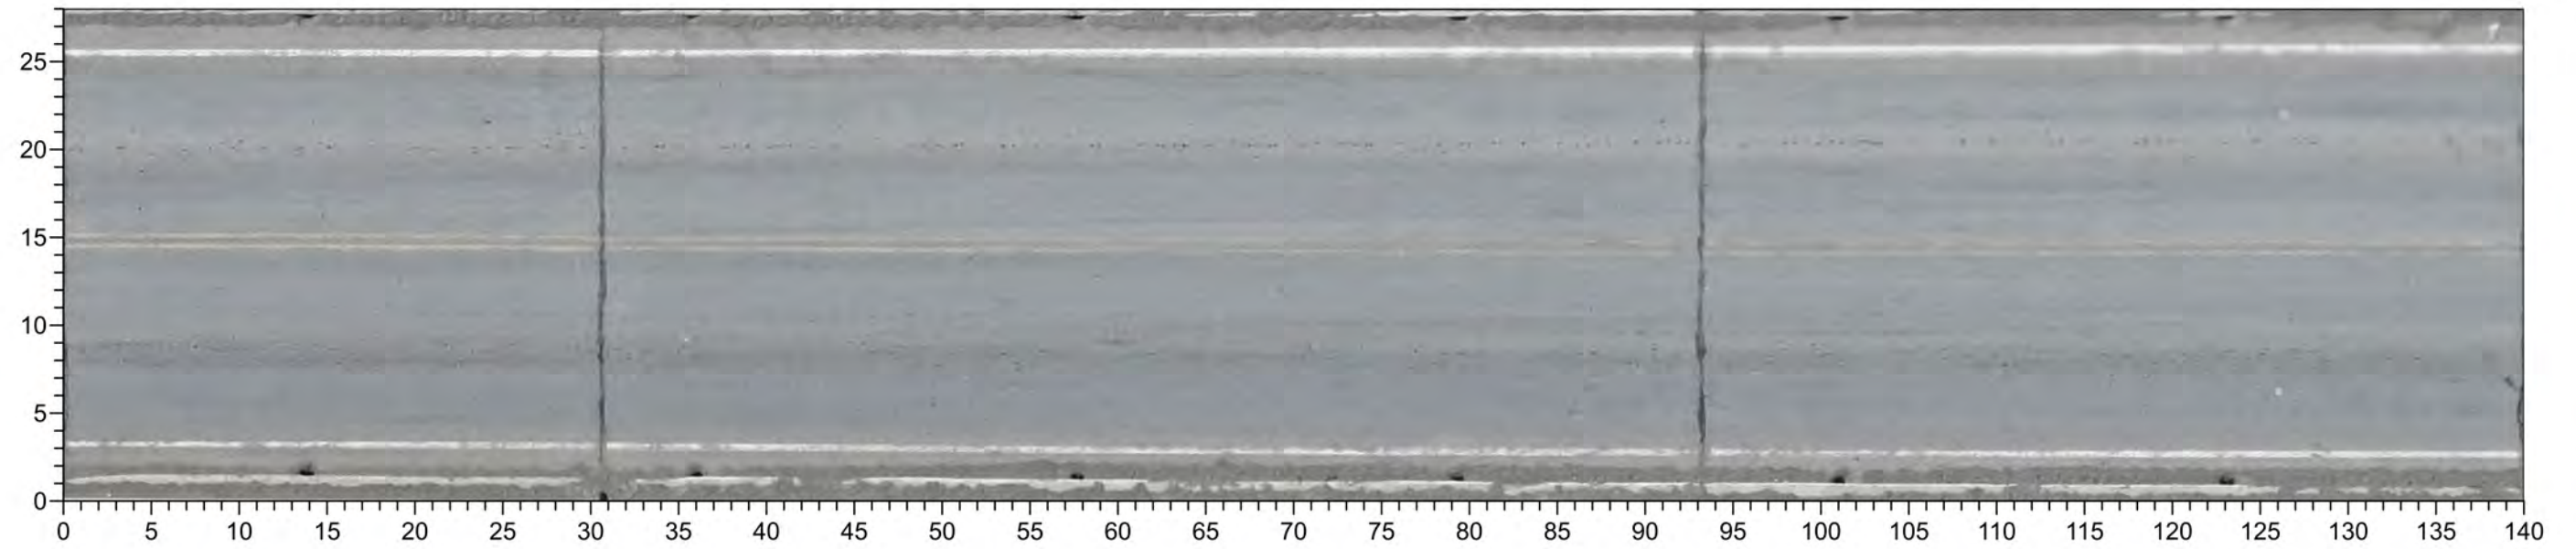
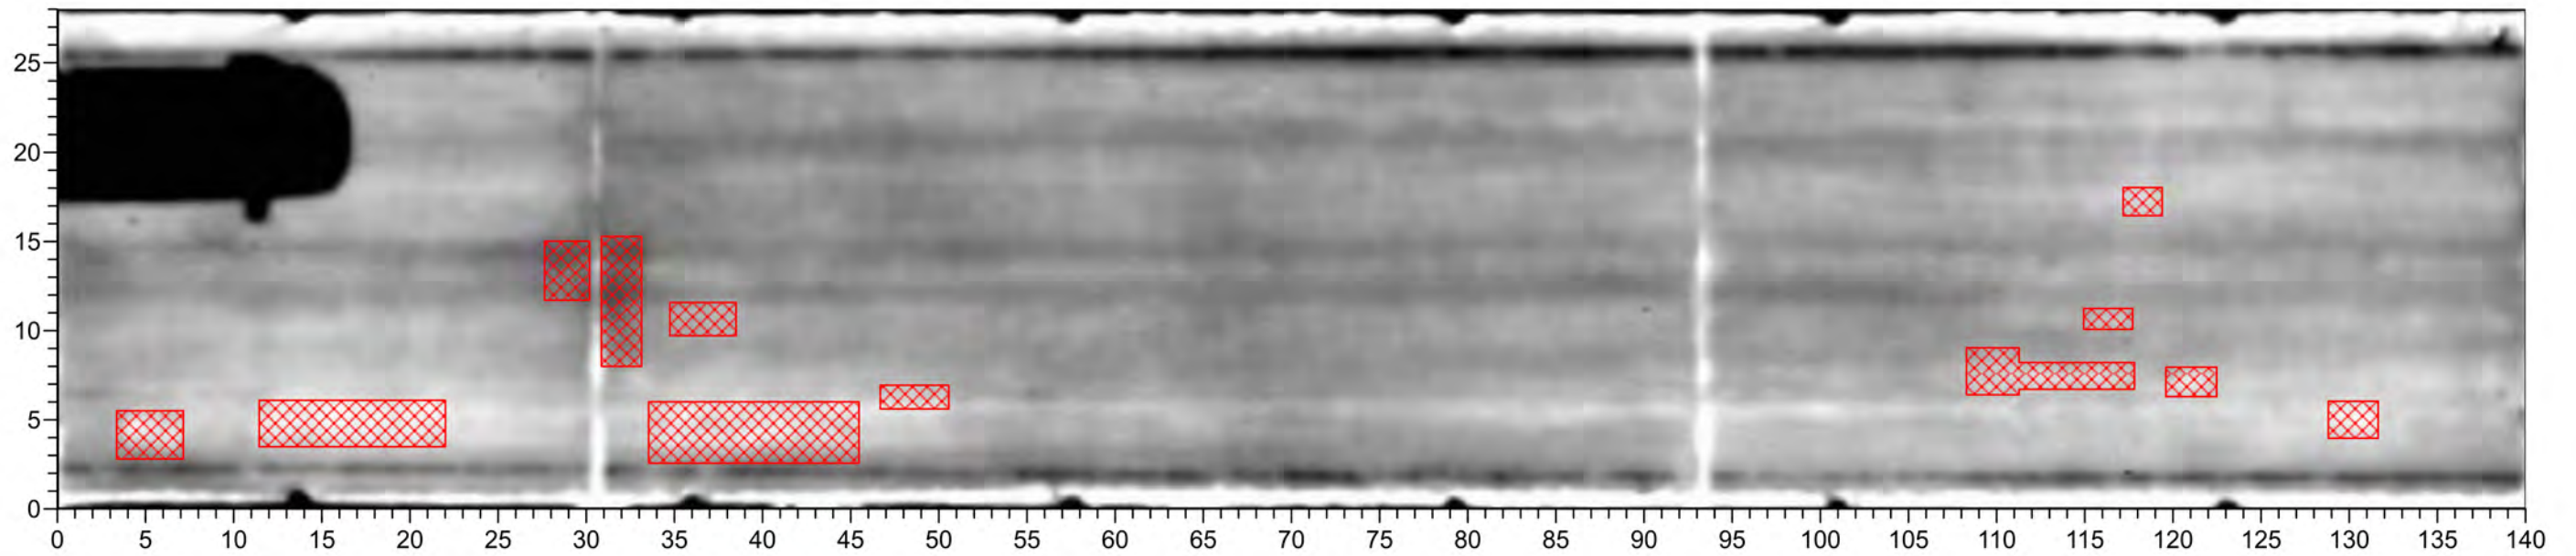
Delamination Quantity (%)    2.6 Delamination Quantity (ft <sup>2</sup> )    92	Imagery Collected: 6/4/22 Analyzed by: SB Reviewed by: AJC Completed: 9/30/22

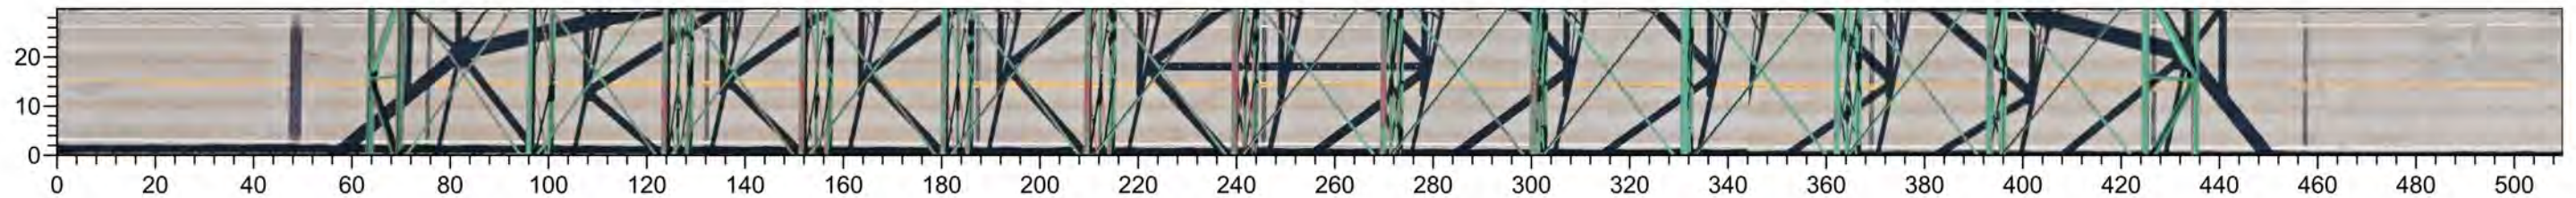
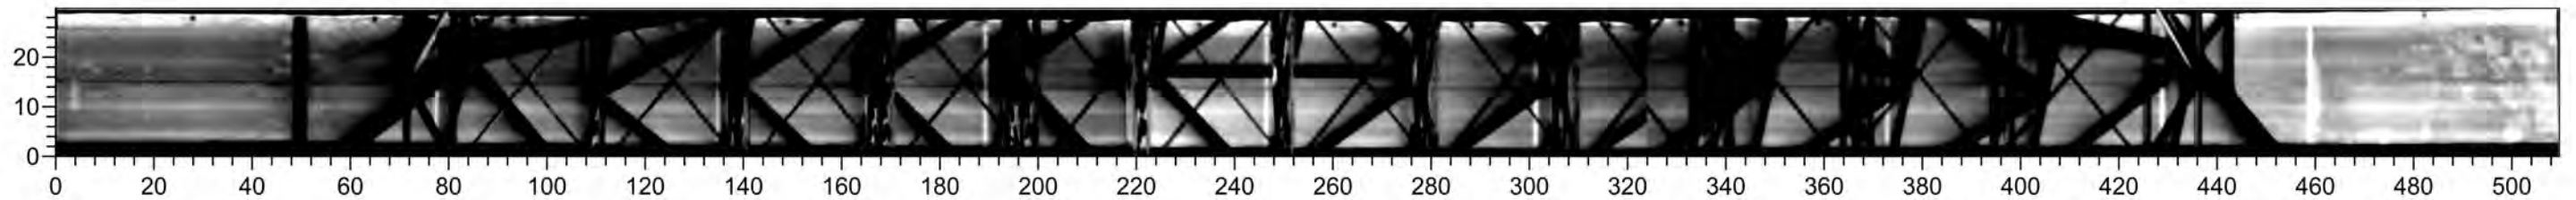
\*Notes: Analysis limited in 10616 sq. ft. area obstructed by superstructure. If this area is removed from analysis, then the results would show 4.7% of the deck area as delaminated.

298 sq. ft. of thermal anomalies not mapped due to being rectilinear in shape and appearing more like subsurface patching or some other structural feature

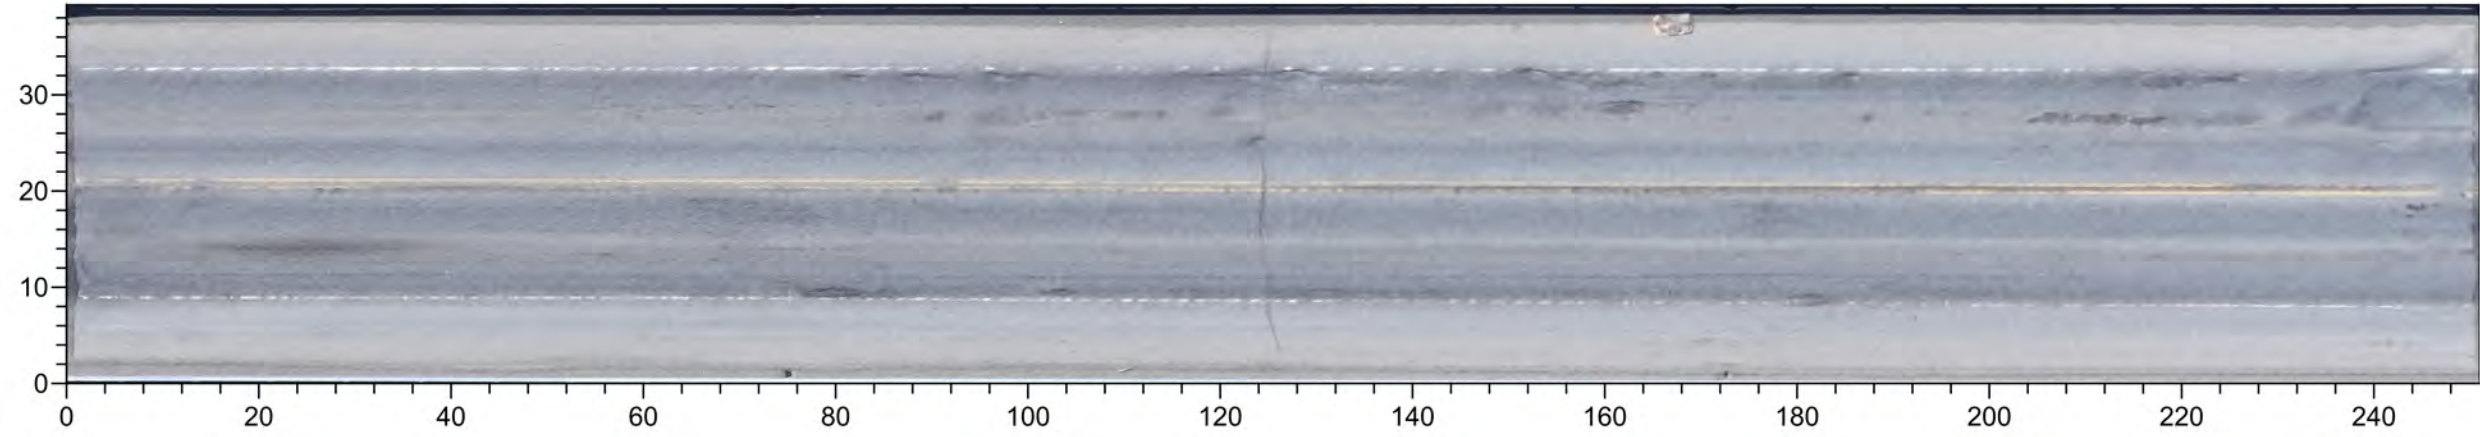
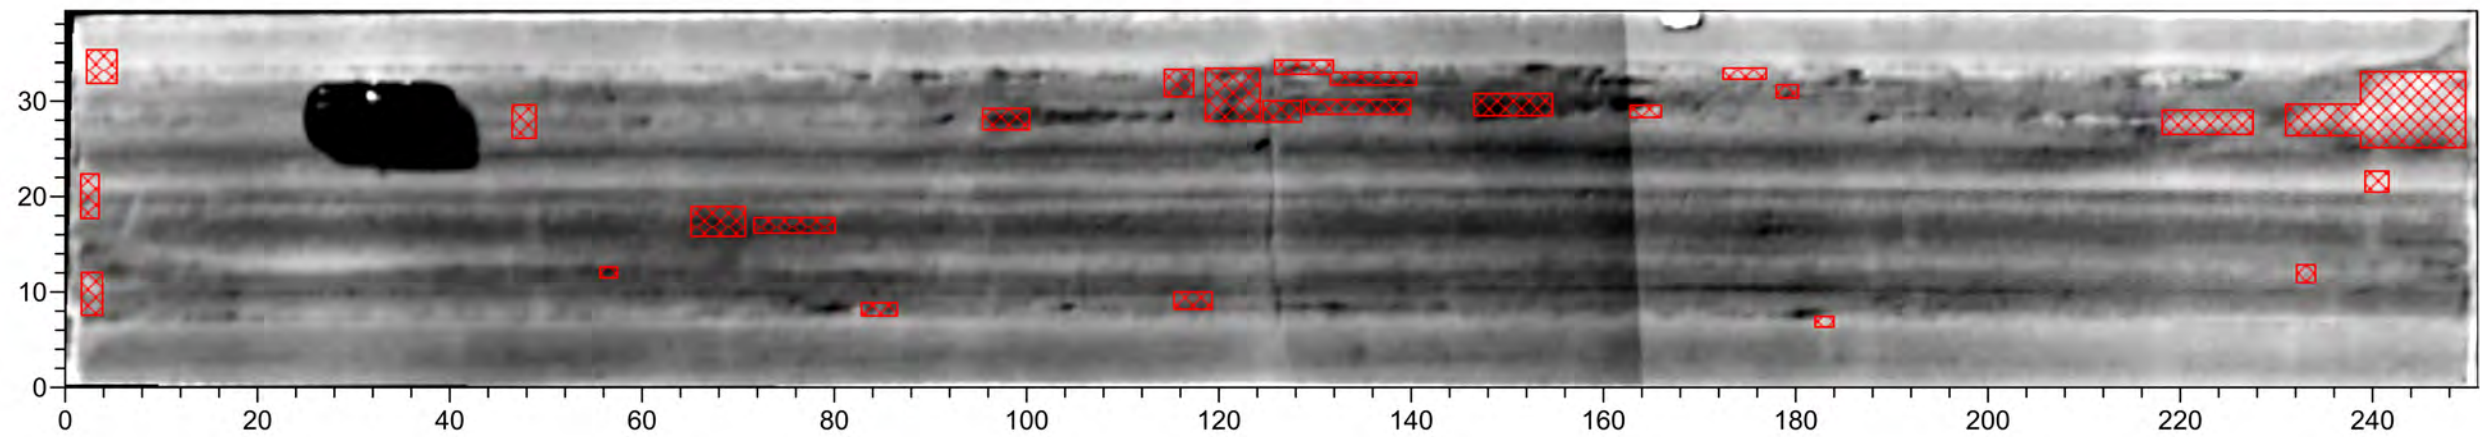
Delamination Quantity (%)    1.4 Delamination Quantity (ft <sup>2</sup> )    219	Imagery Collected: 6/5/22 Analyzed by: SB Reviewed by: AJC Completed: 10/11/22

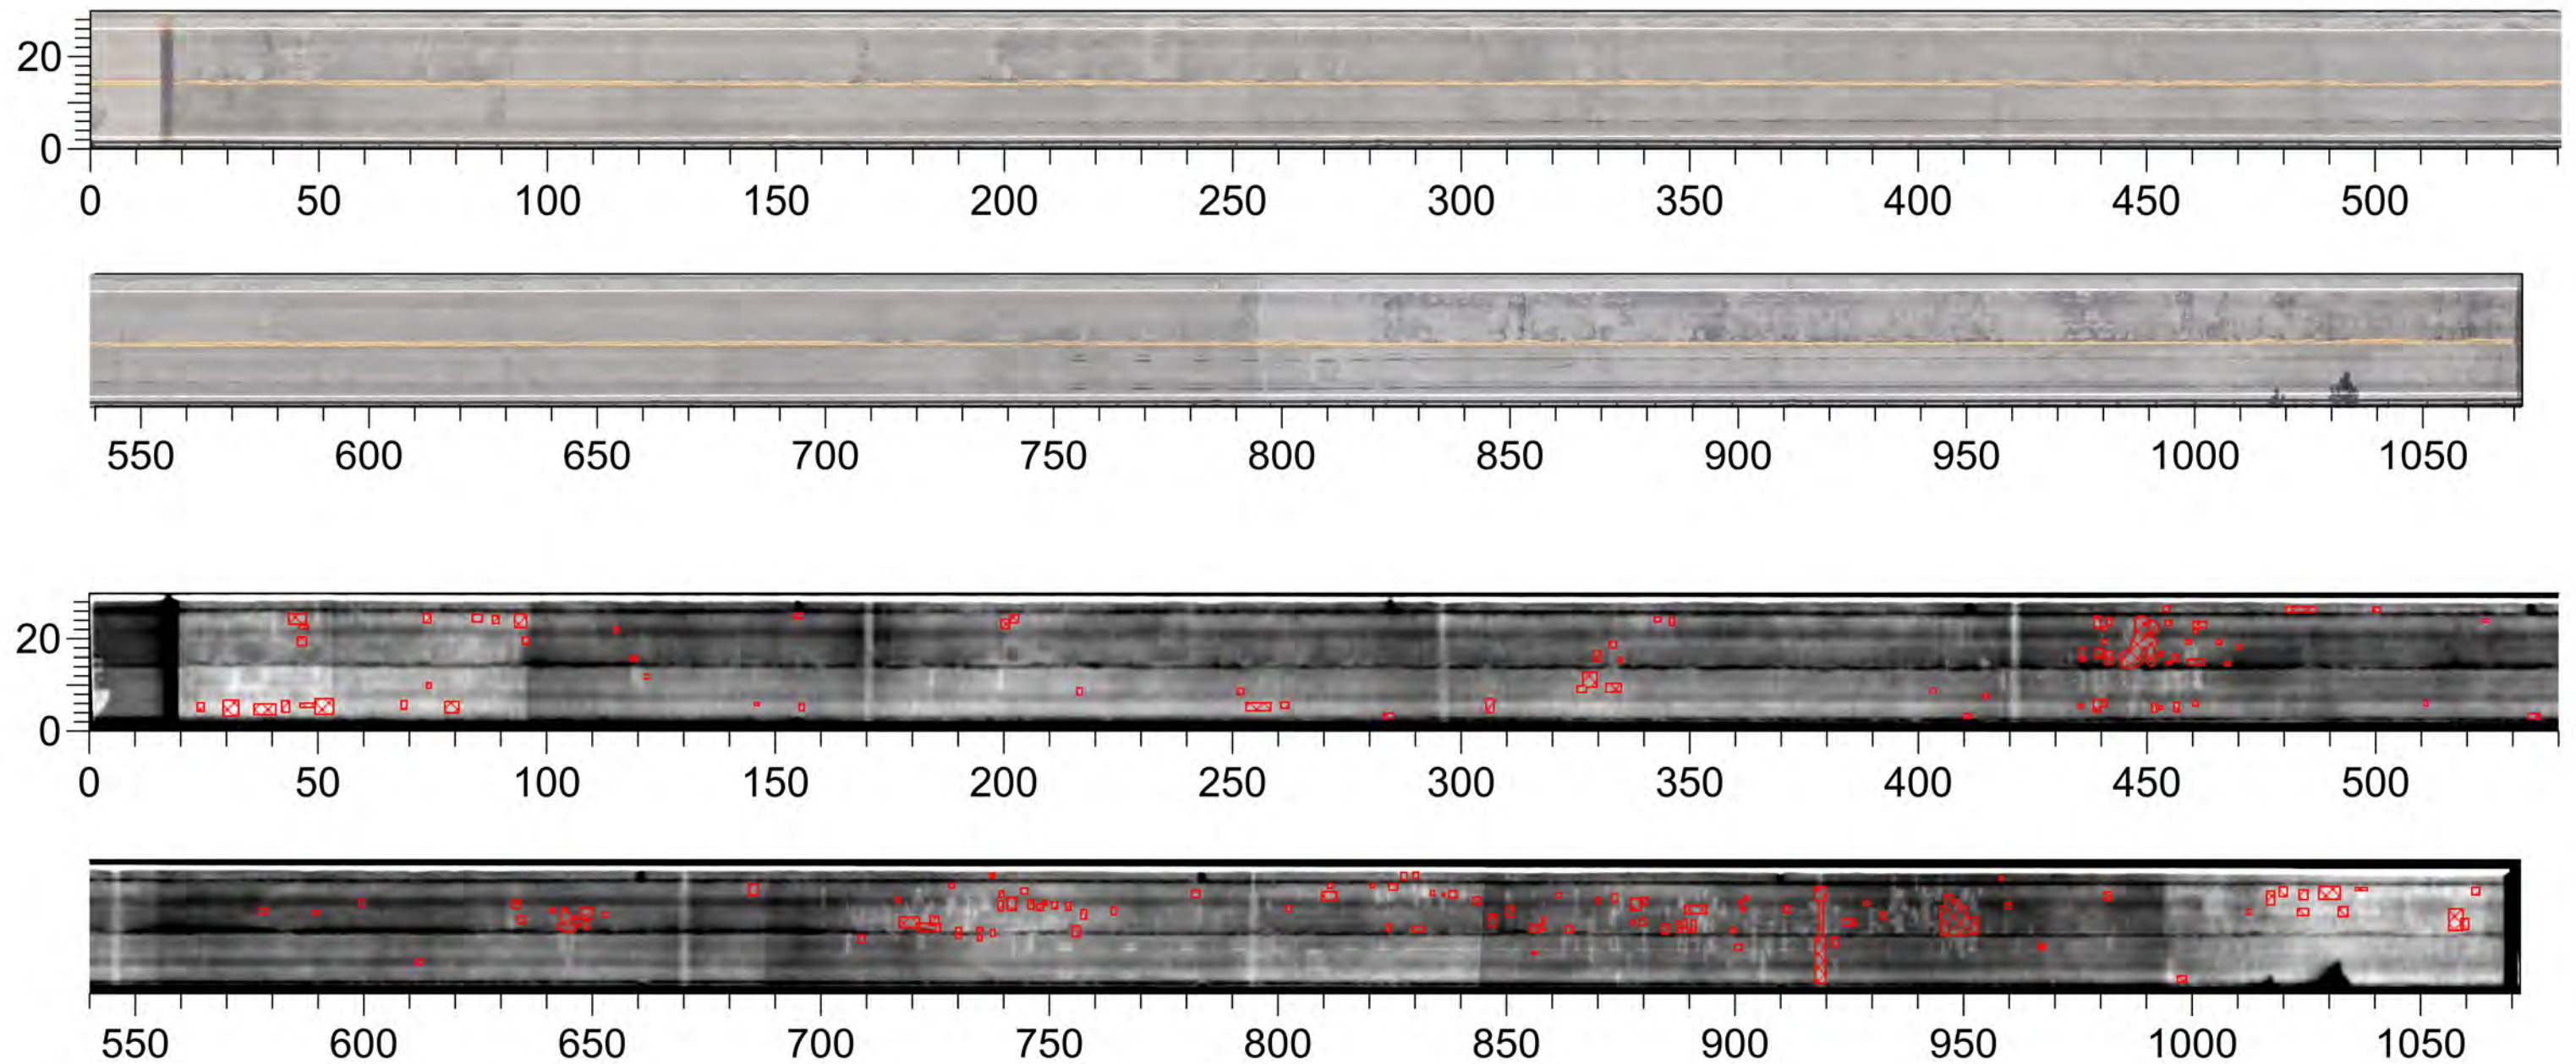
Delamination Quantity (%)    3.7	Delamination Quantity (ft <sup>2</sup> )    361	Imagery Collected: 6/4/22 Analyzed by: SB Reviewed by: AJC Completed: 10/2/22

\*Note: 948 sq. ft. of thermal anomalies not mapped due to being rectilinear in shape and appearing more like subsurface patching or some other structural feature
