# Aerial Infrared Scanning of Bridge Decks on Parks Highway to Map Delaminations

## FINAL REPORT

**Prepared by:**  
Infrasense, Inc.  
Woburn, MA

**Report # FHWA-AK-RD-000S(960)**  
**March 2, 2023**

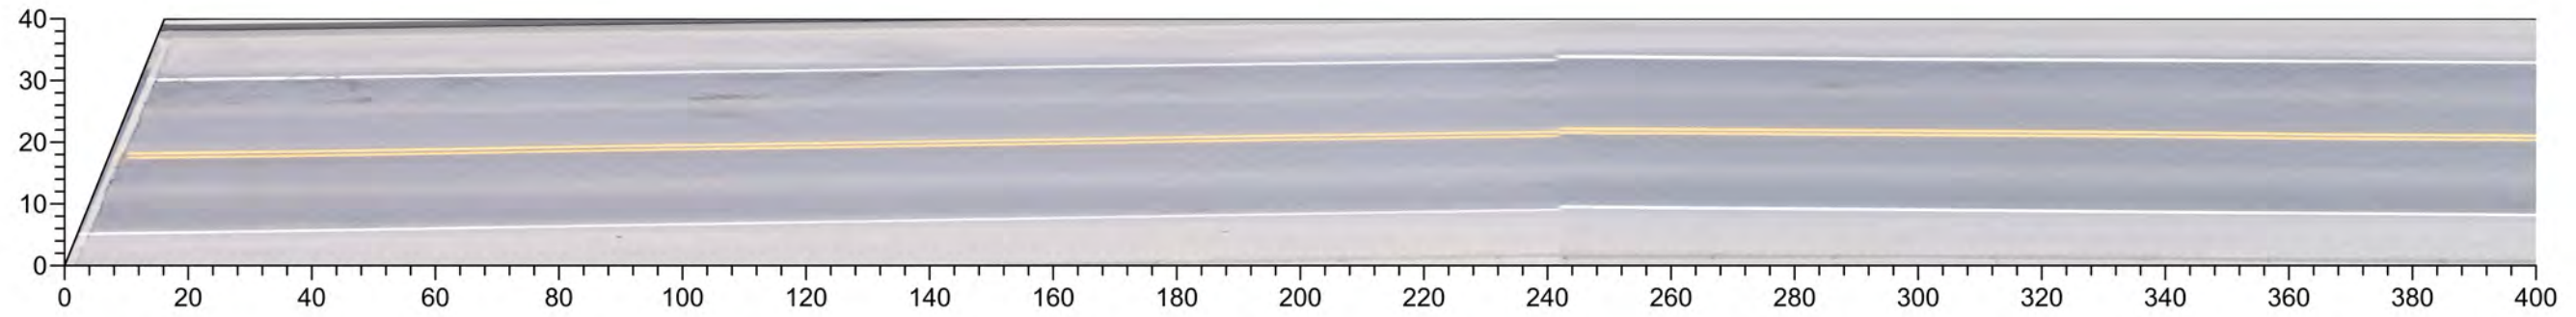
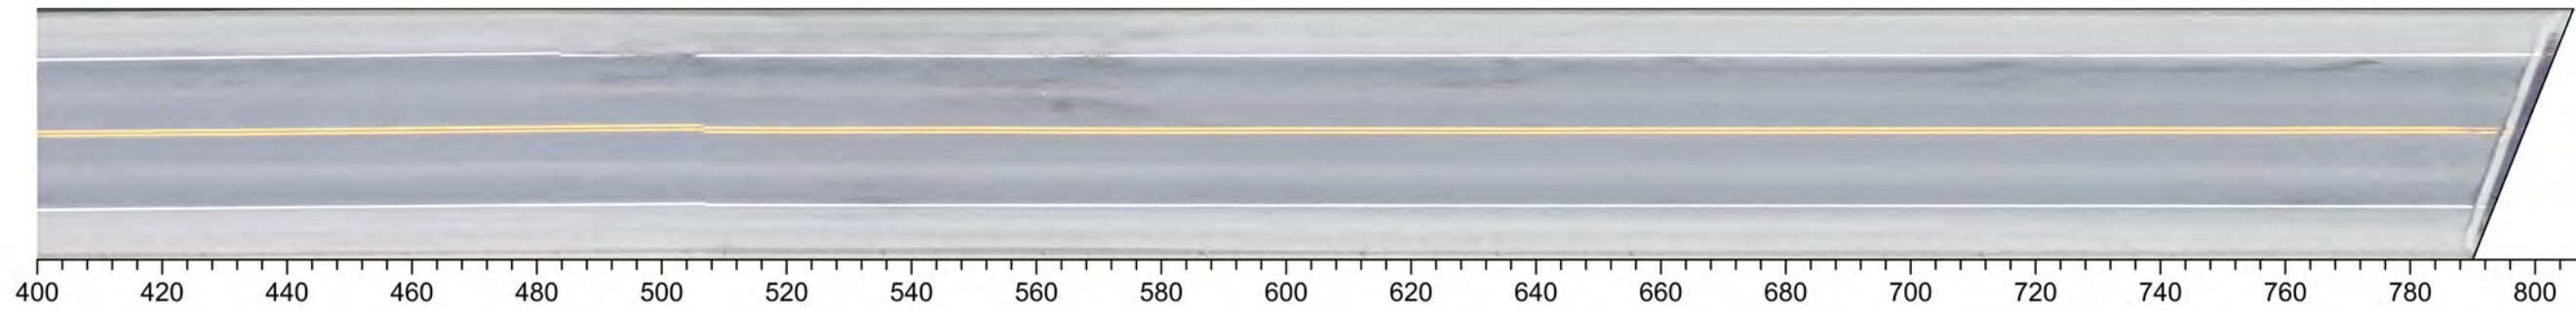
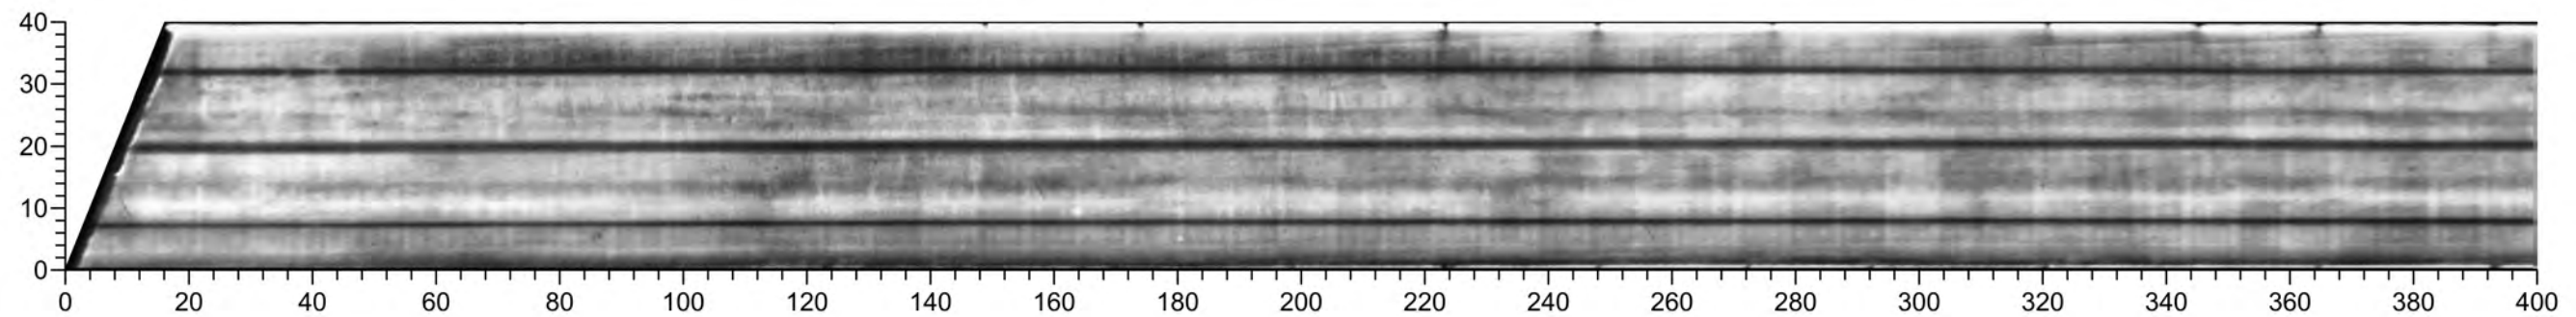
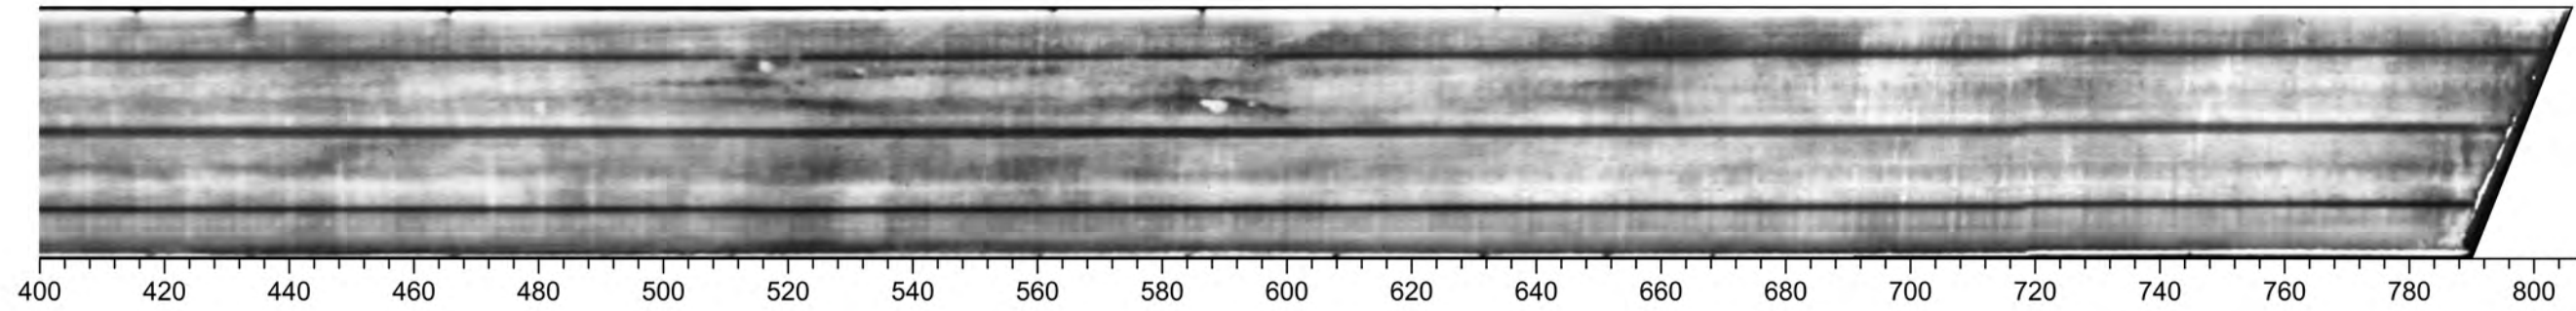
Delamination Quantity (%) 2.1 Delamination Quantity (ft <sup>2</sup> ) 660	Imagery Collected: 6/4/22 Analyzed by: SB Reviewed by: AJC Completed: 10/12/22

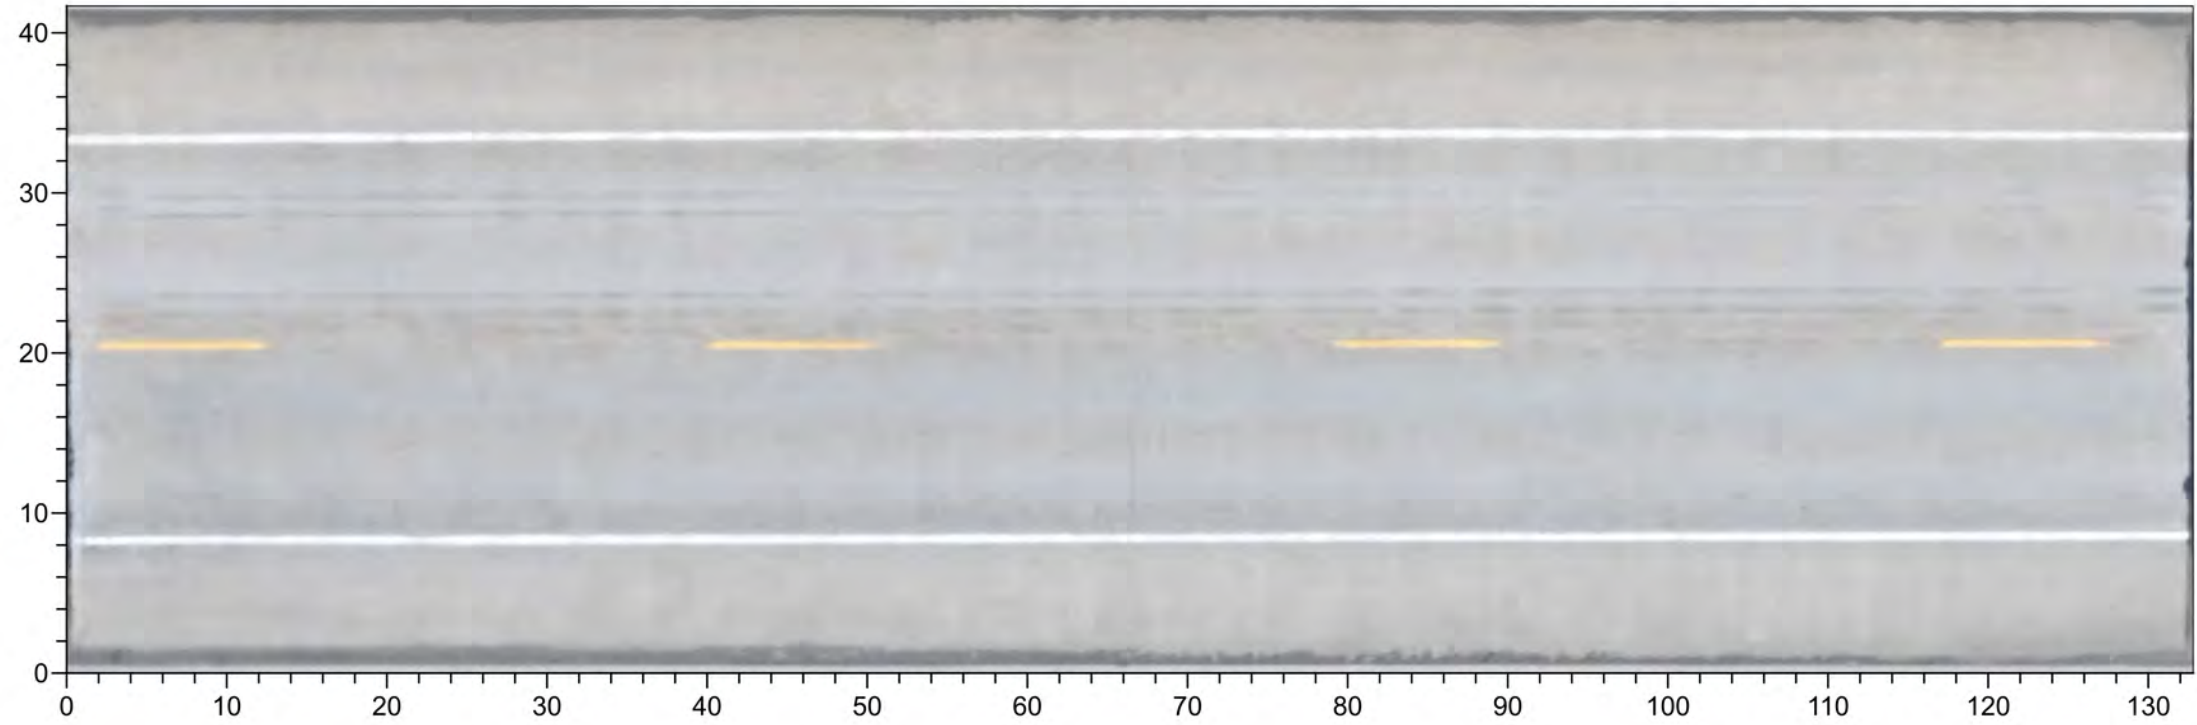
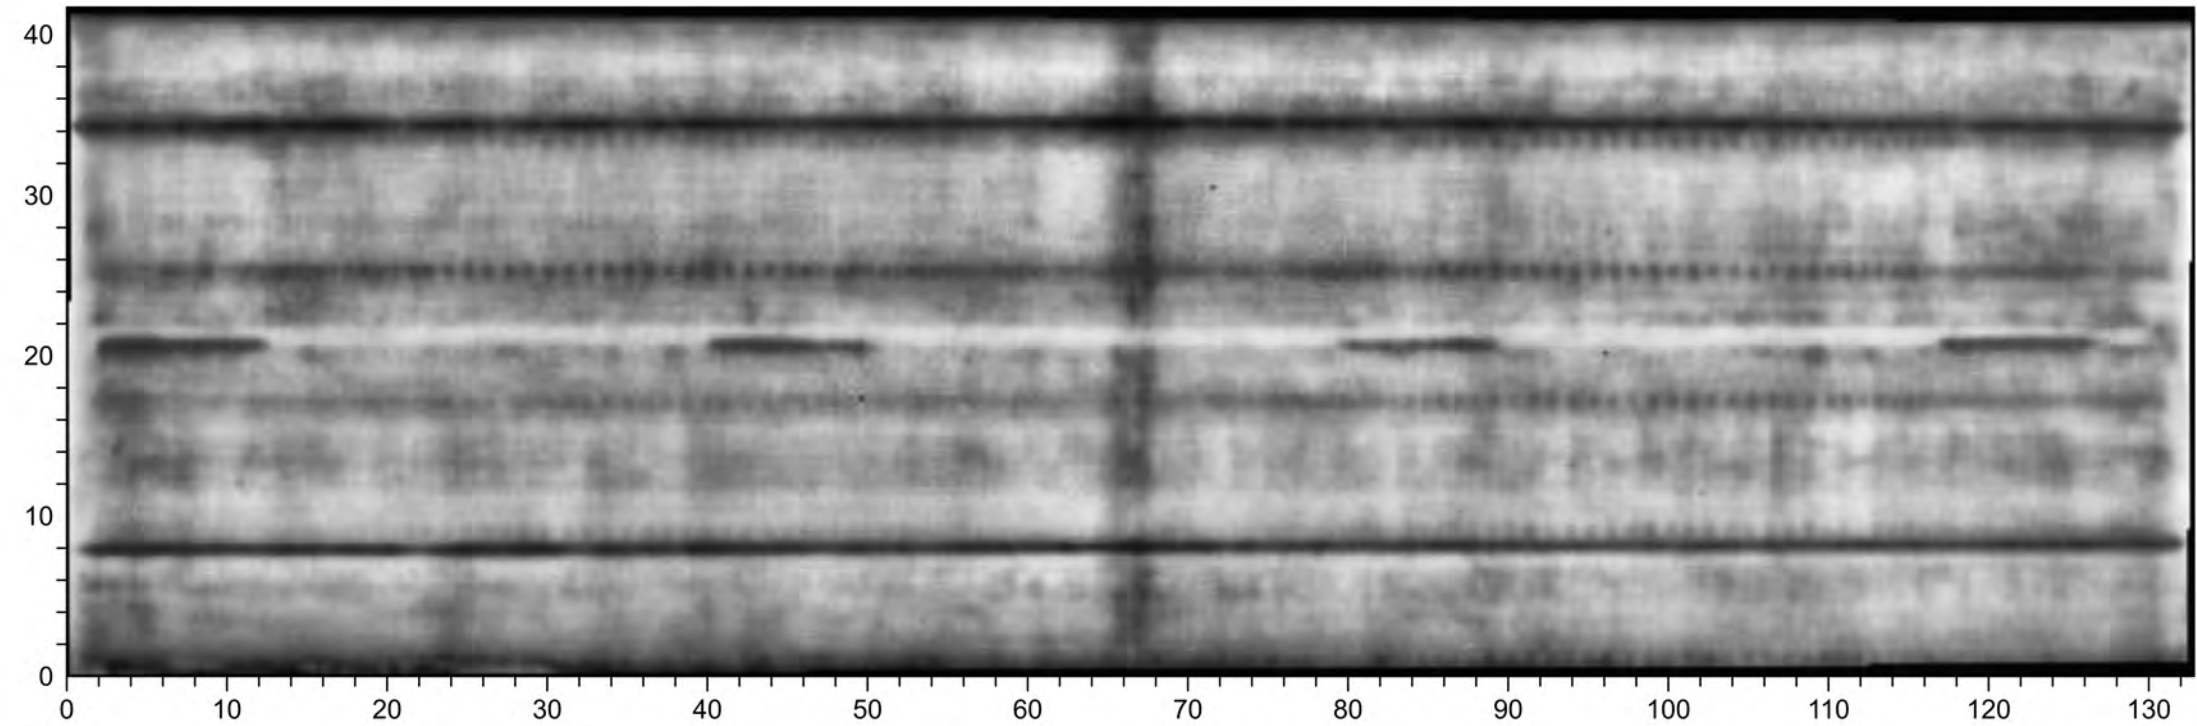
Delamination Quantity (%)    1.1		Imagery Collected: 6/4/22 Analyzed by: SB Reviewed by: AJC Completed: 10/2/22	
			Delamination Quantity (ft <sup>2</sup> )    355

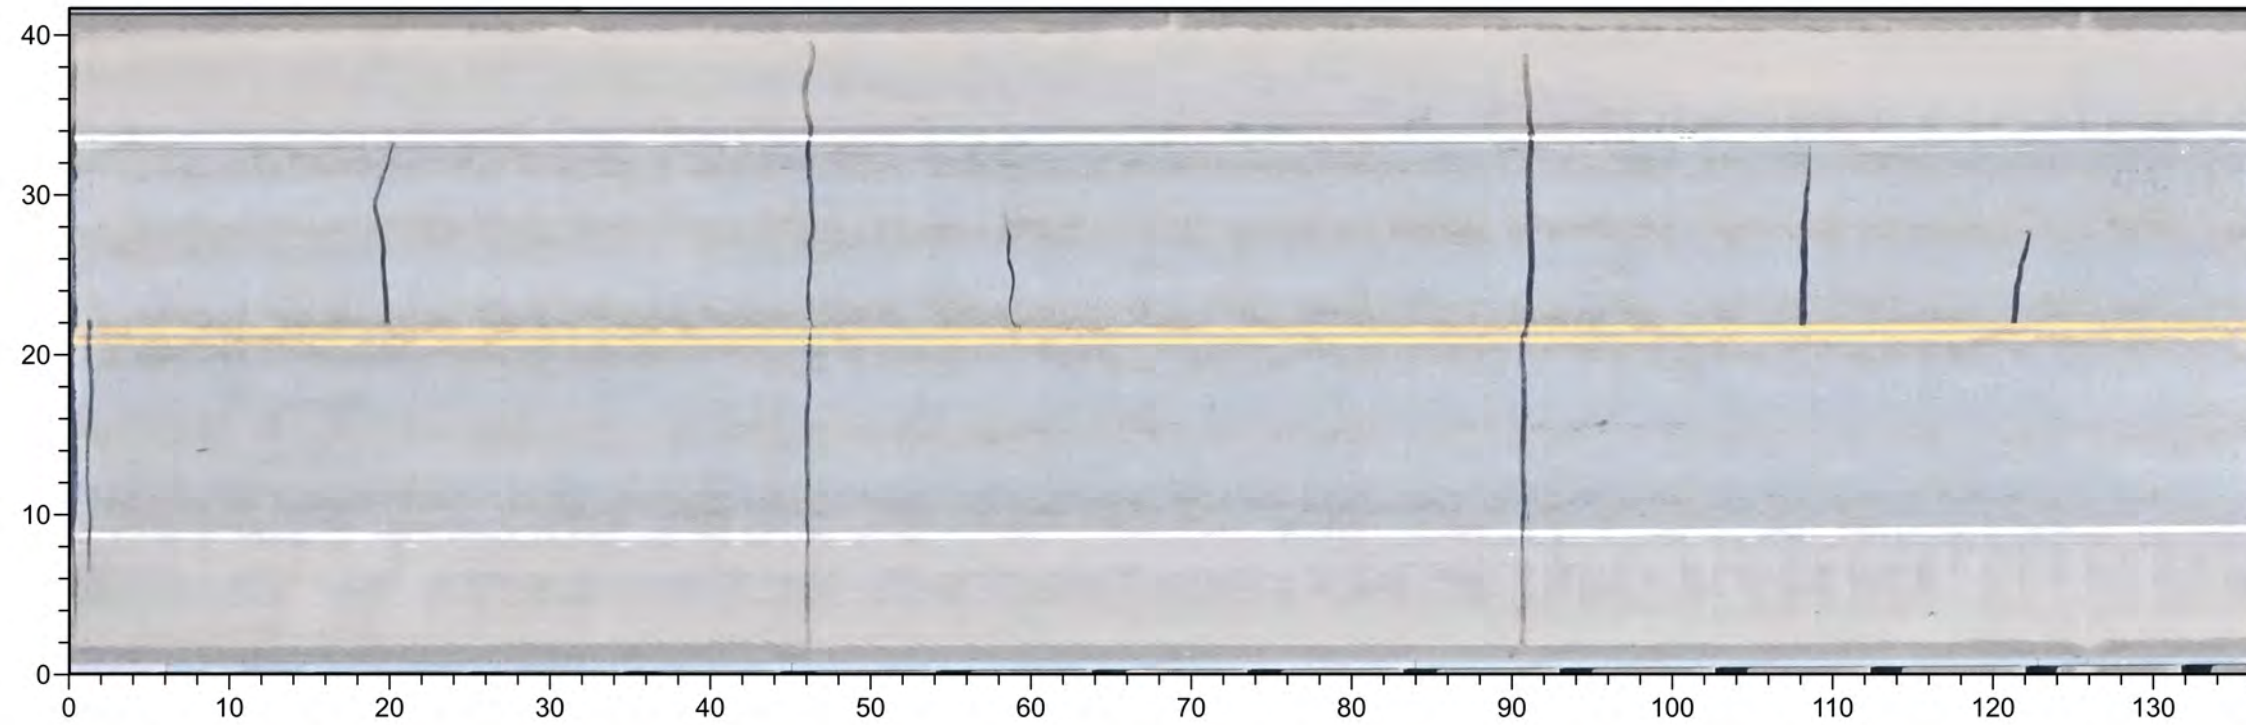
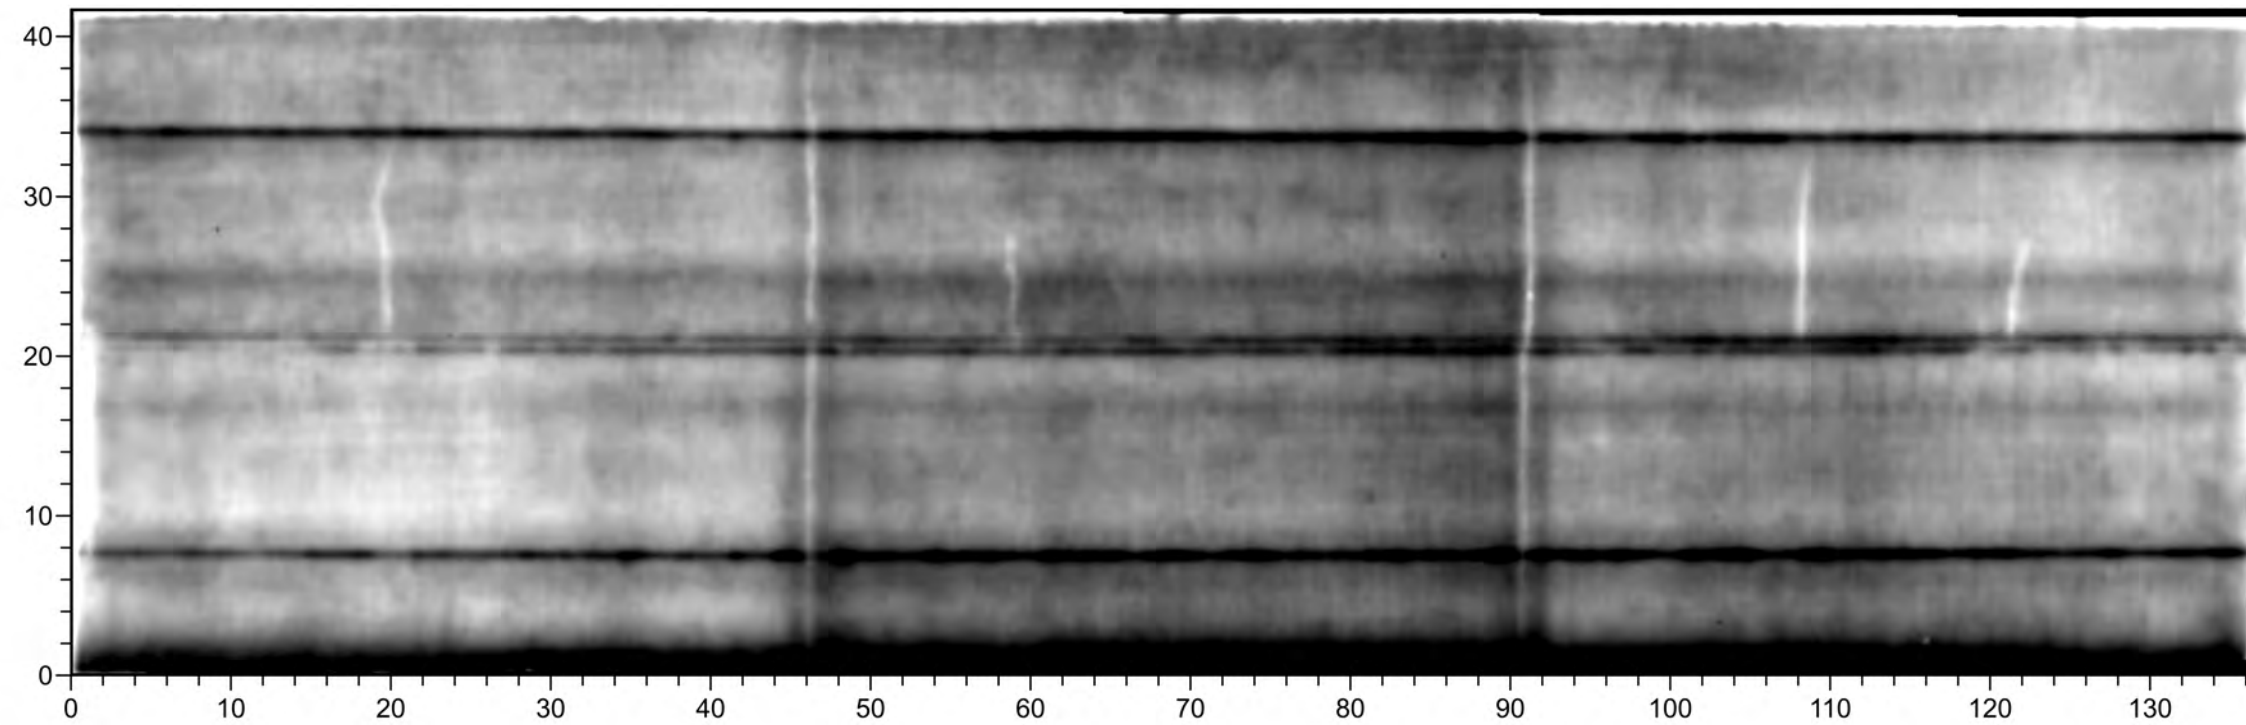
Delamination Quantity (%)    0.9 Delamination Quantity (ft <sup>2</sup> )    49	Imagery Collected: 6/4/22 Analyzed by: EG, SB Reviewed by: AJC Completed: 10/4/22

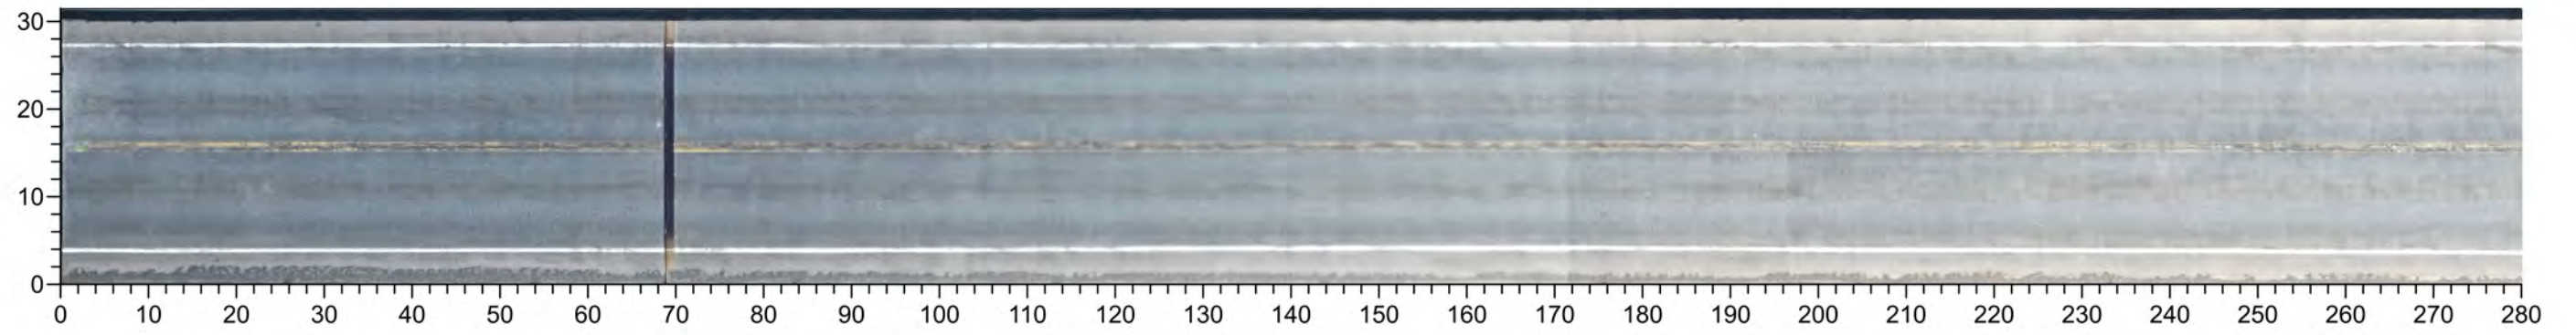
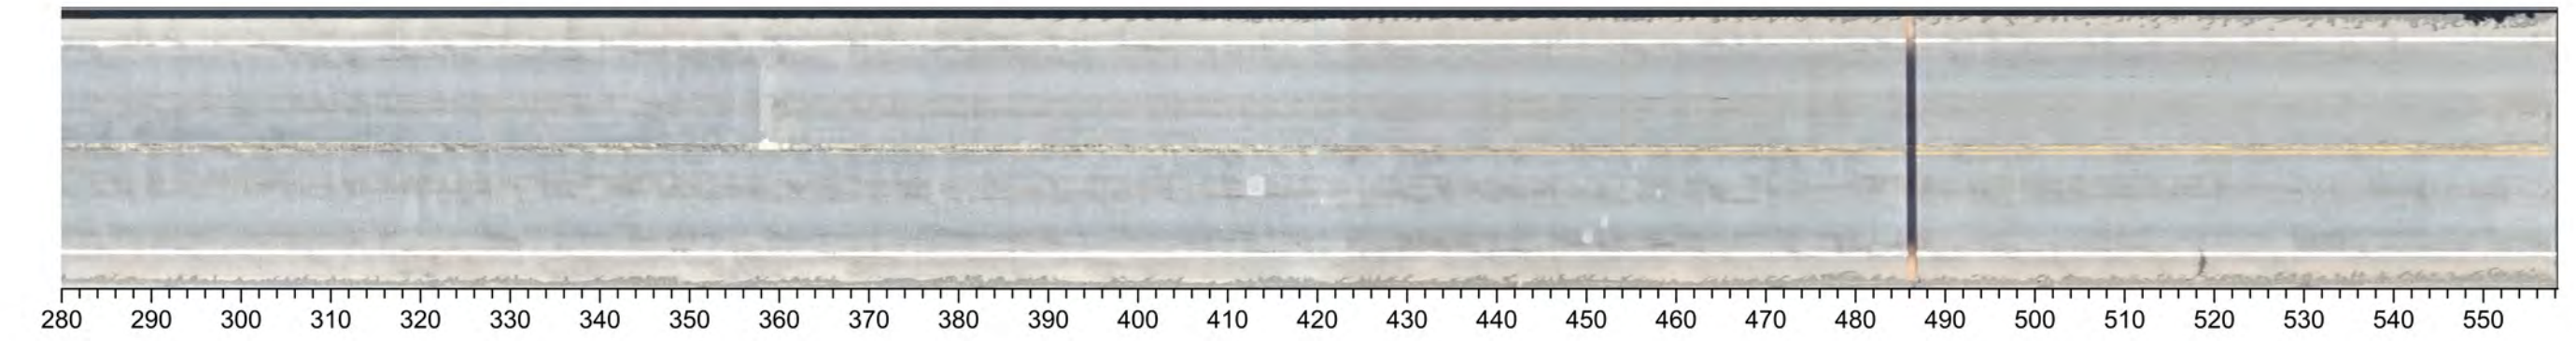
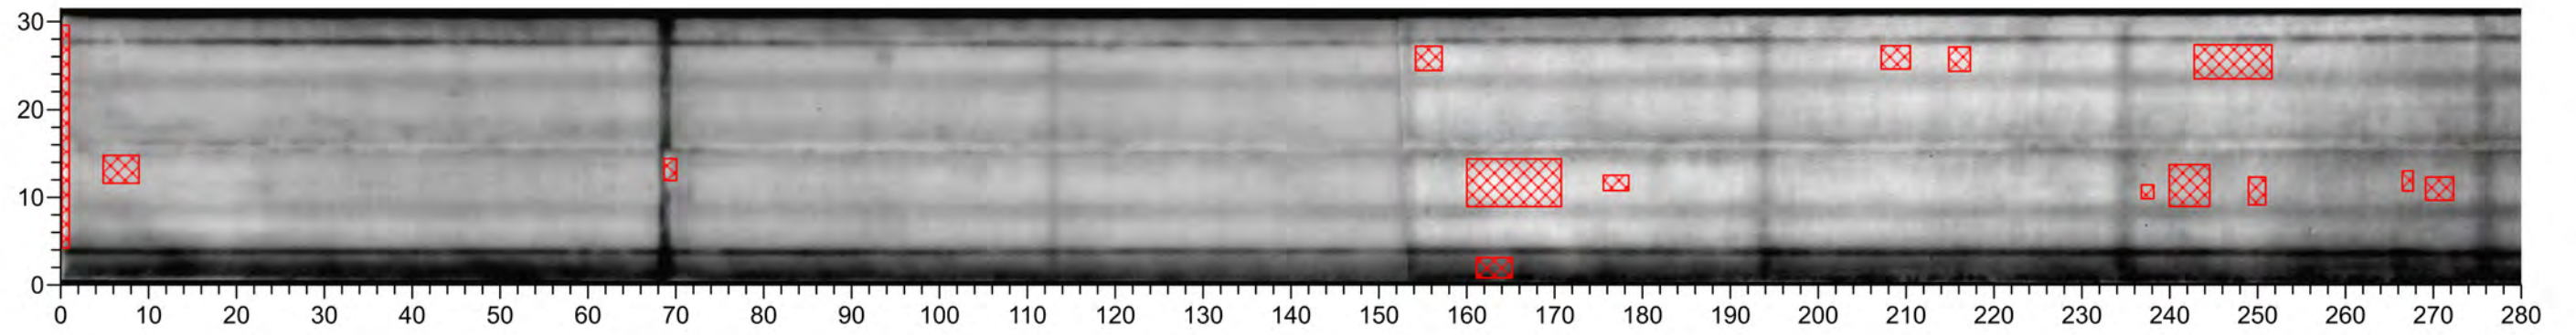
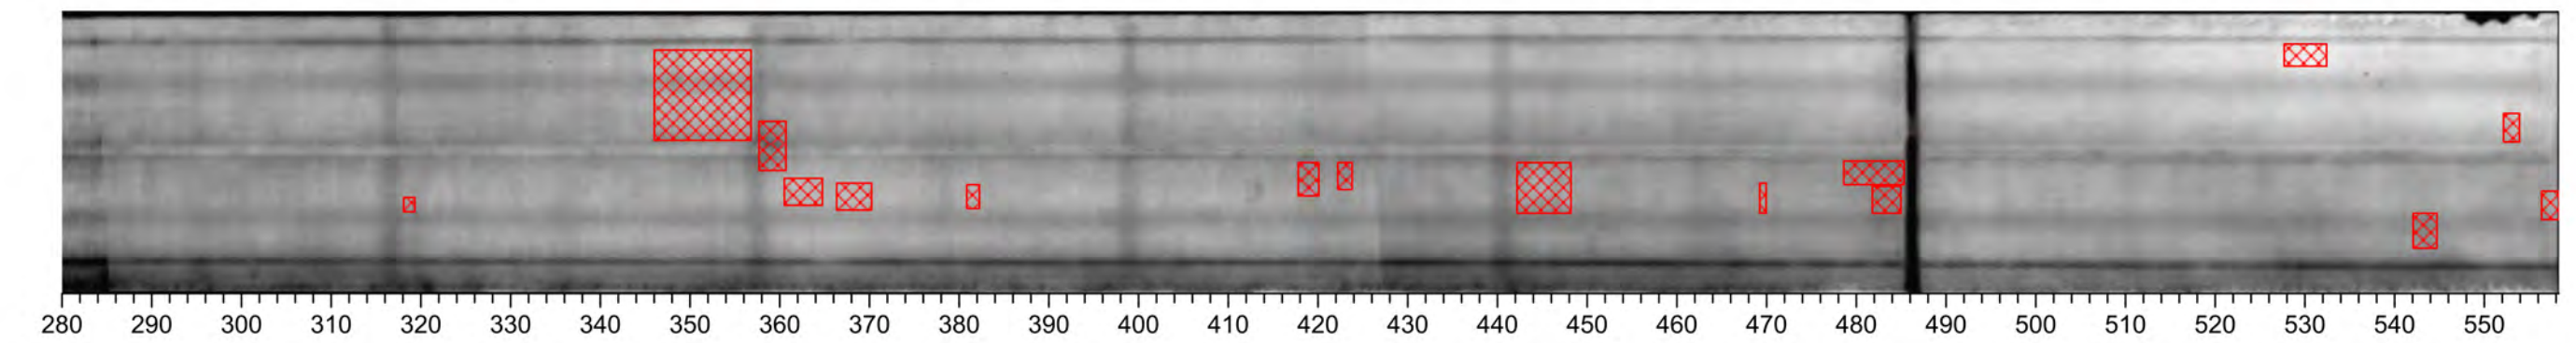
Delamination Quantity (%) 0.6		Imagery Collected: 6/4/22 Analyzed by: EG, SB Reviewed by: AJC Completed: 10/5/22	
			Delamination Quantity (ft <sup>2</sup> ) 32

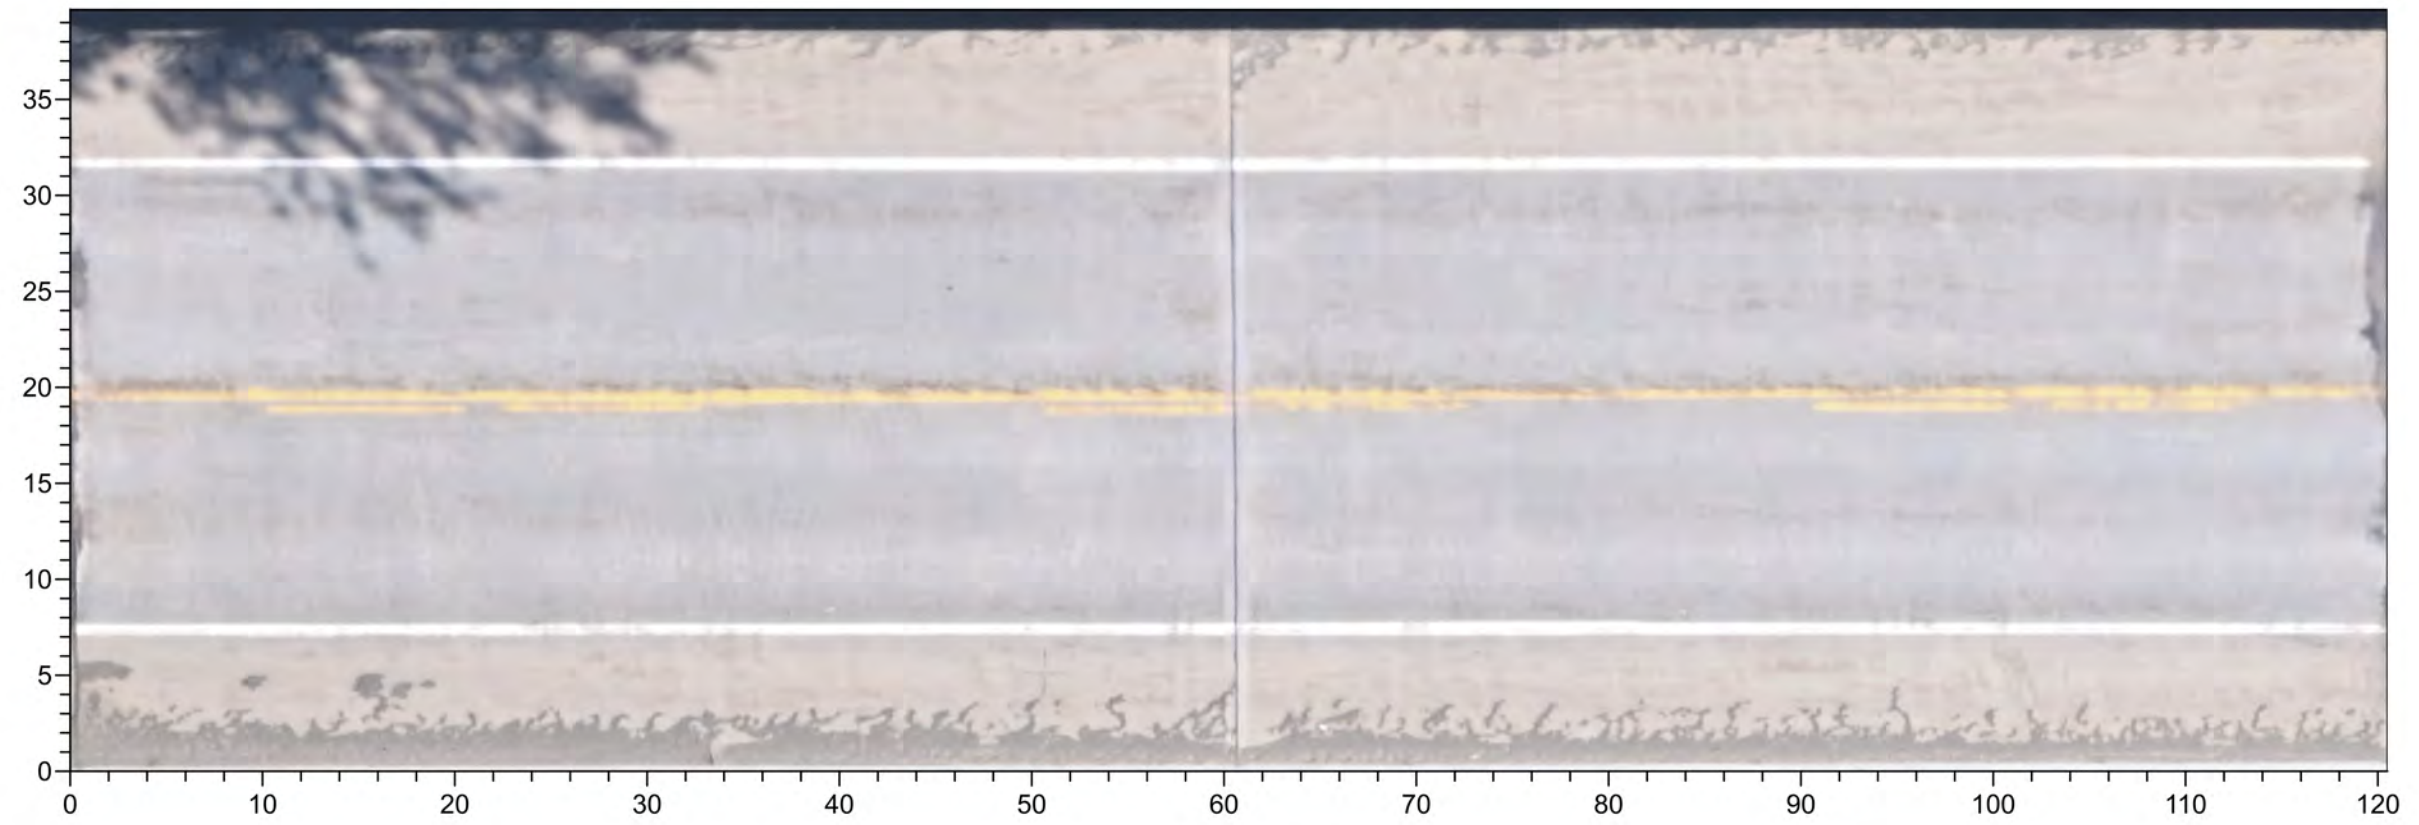
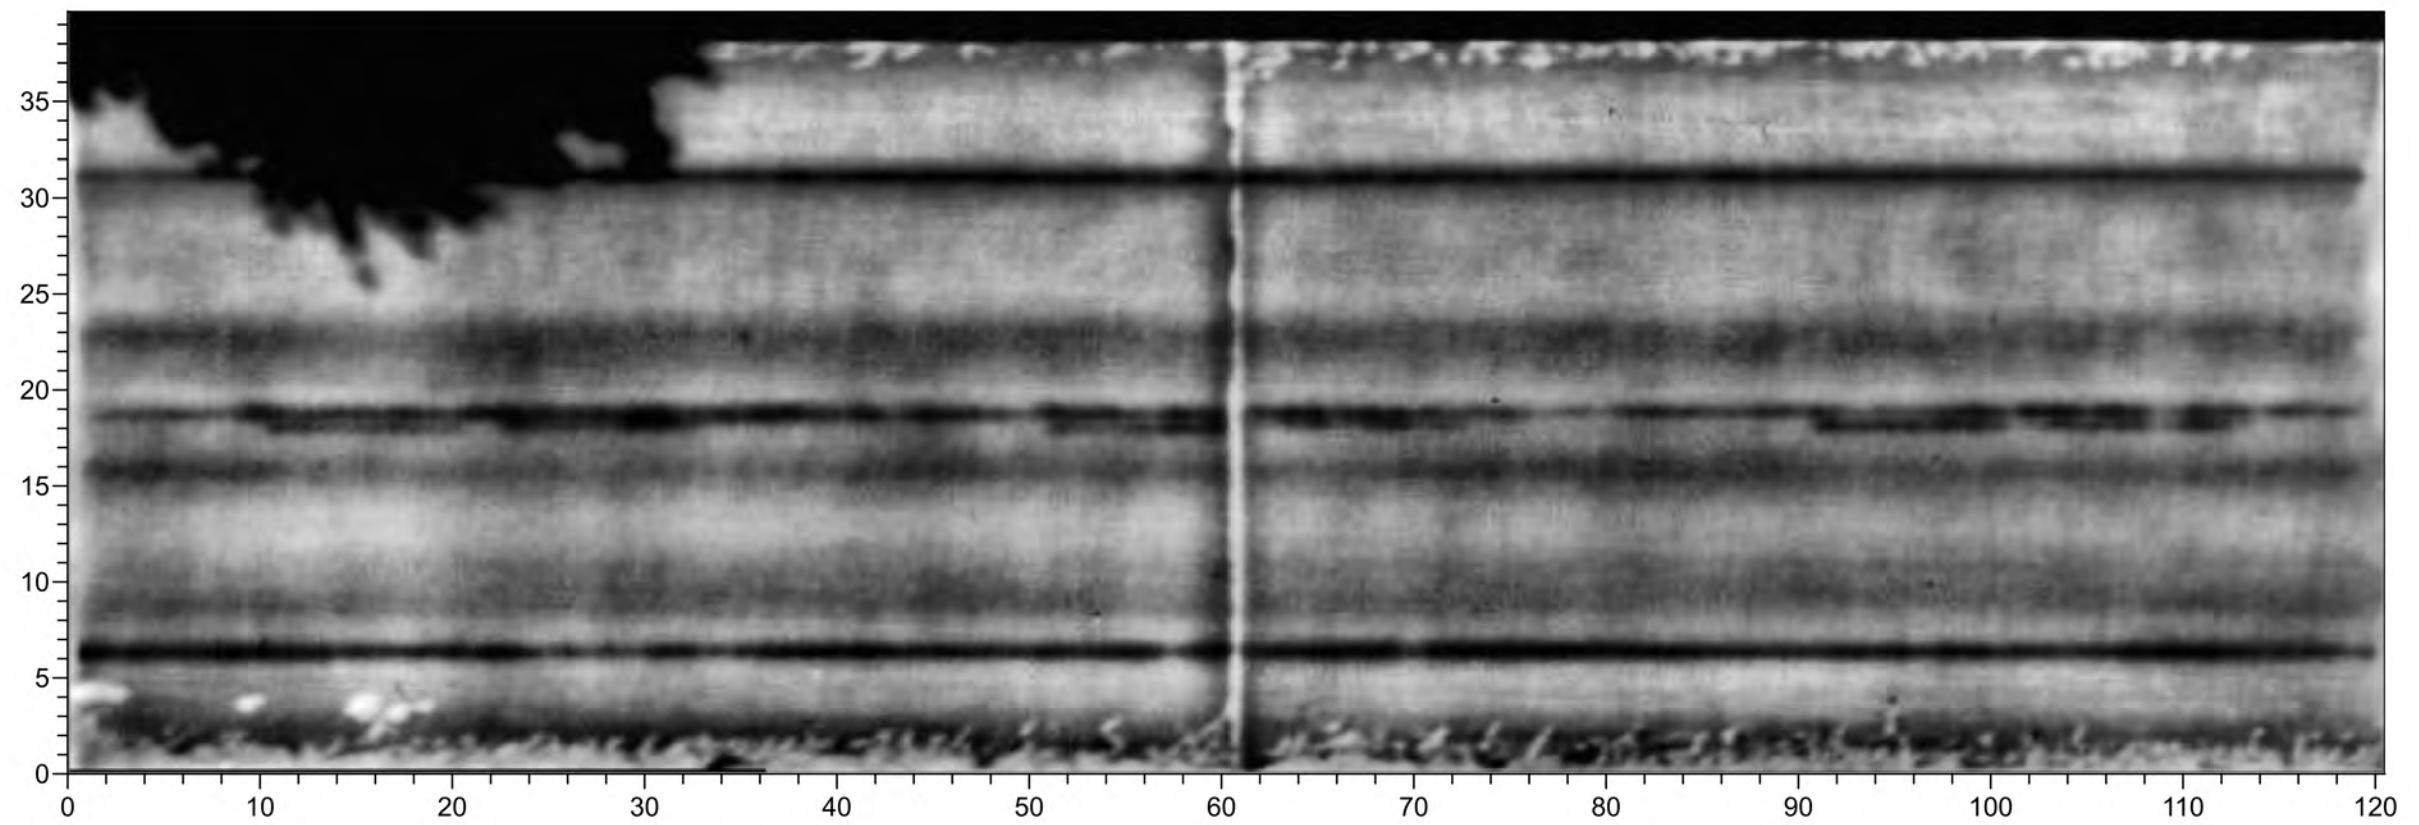
Delamination Quantity (%)    2.7 Delamination Quantity (ft <sup>2</sup> )    477	Imagery Collected: 6/4/22 Analyzed by: SB Reviewed by: AJC Completed: 10/4/22

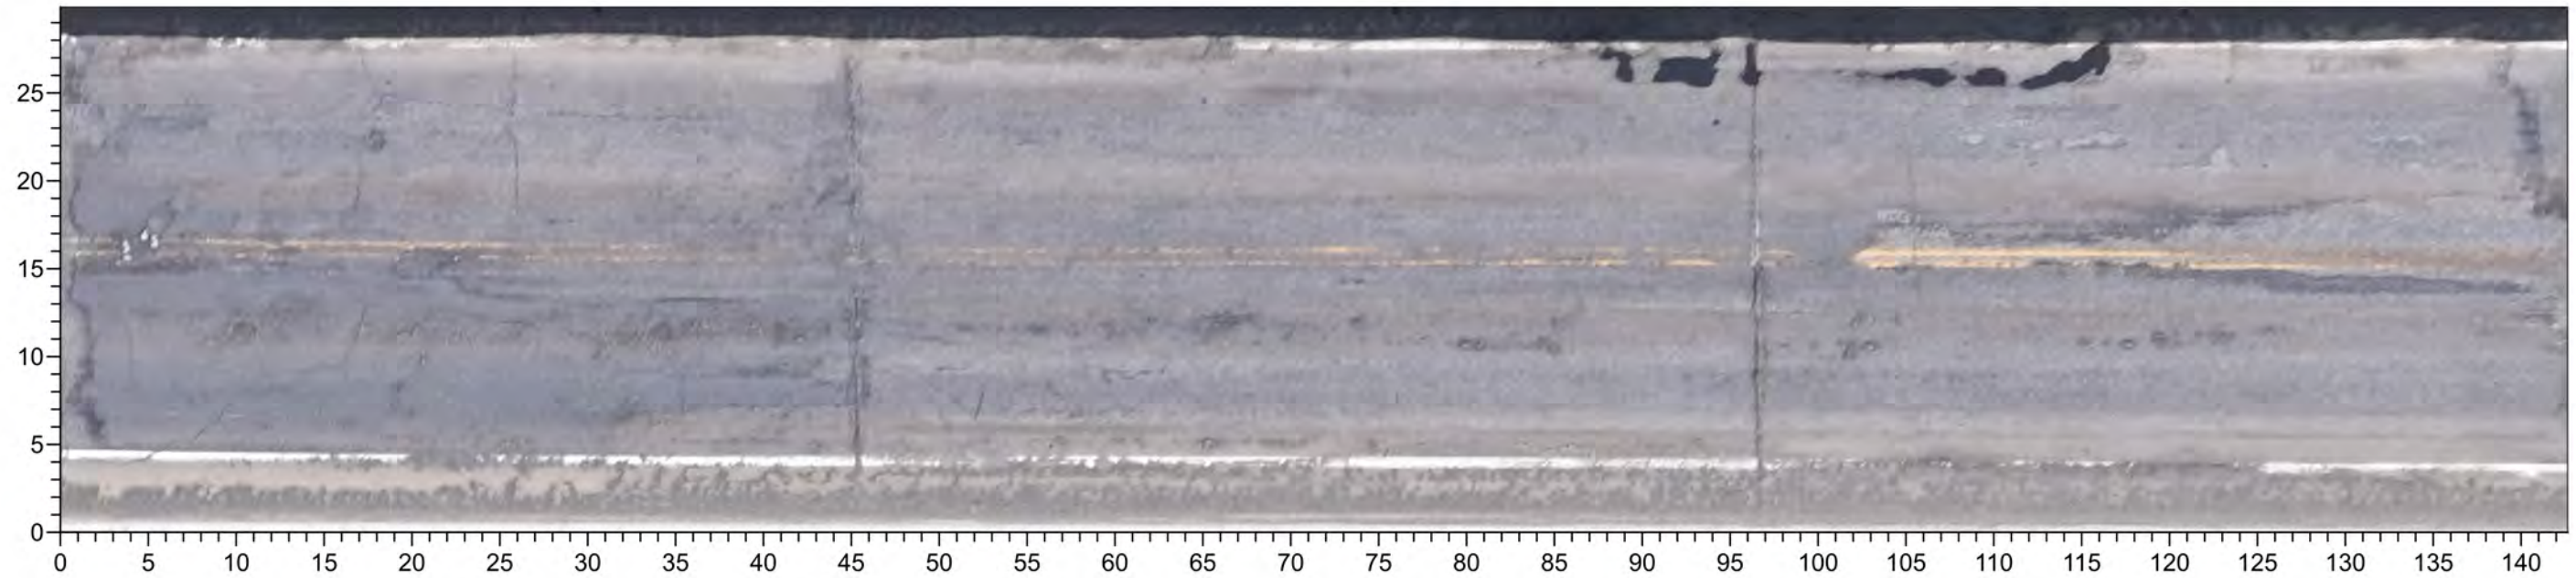
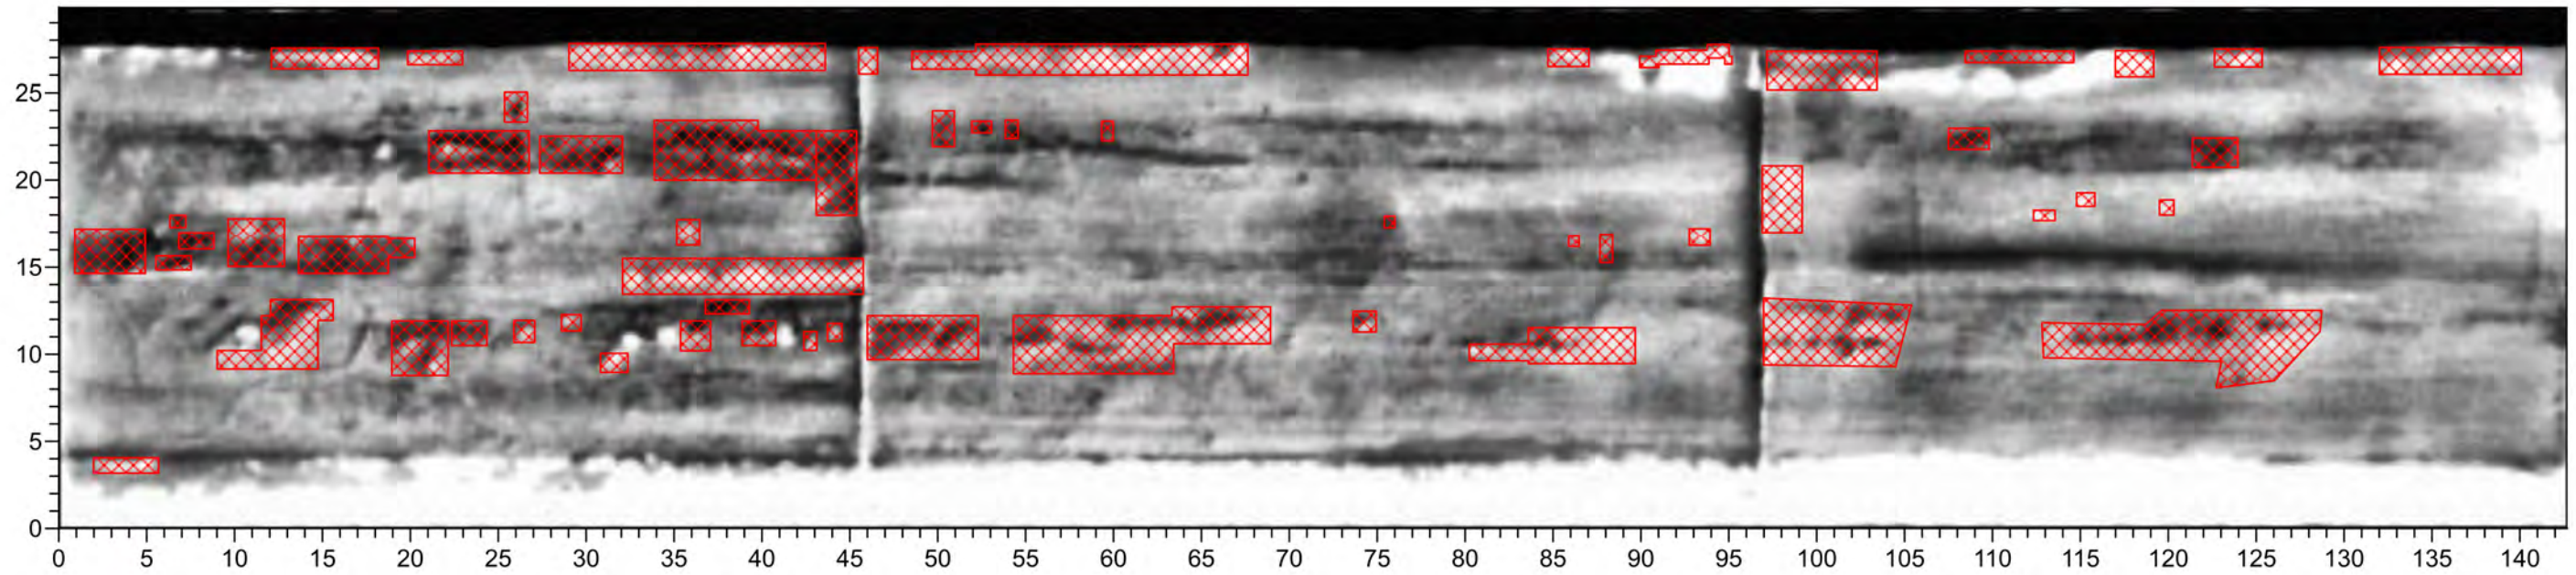
Delamination Quantity (%)	0.8	Imagery Collected: 6/4/22	
		Delamination Quantity (ft <sup>2</sup> )	40	Analyzed by: SB Reviewed by: AJC Completed: 10/4/22

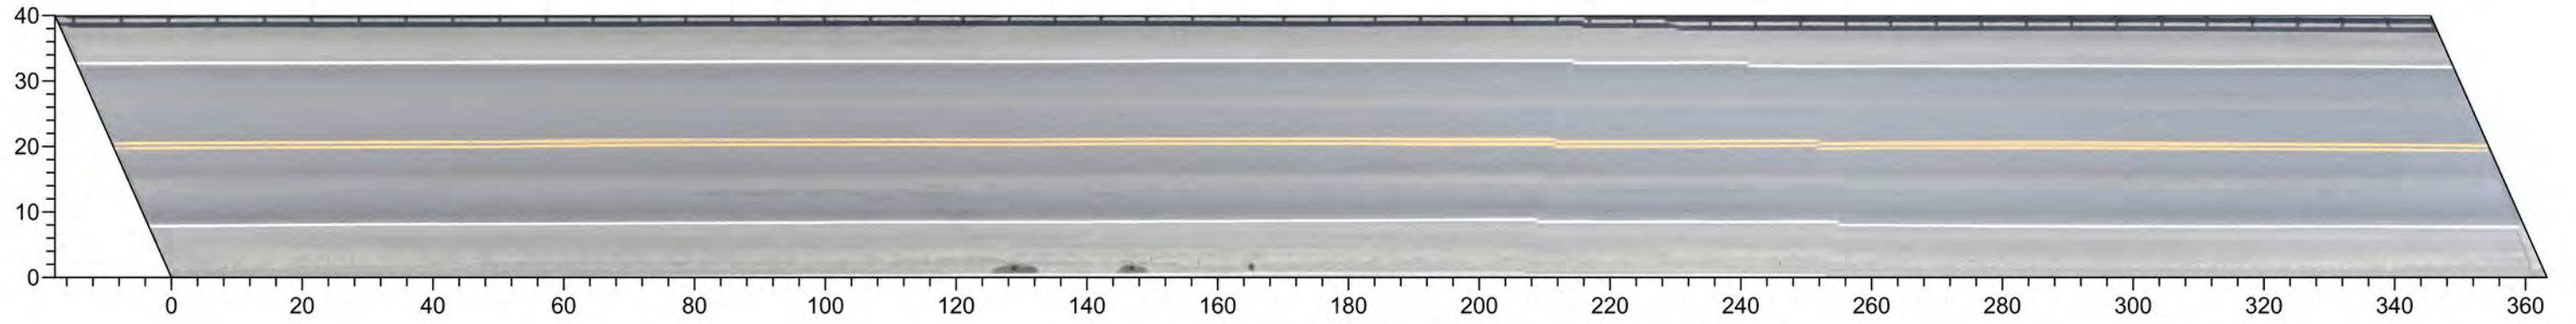
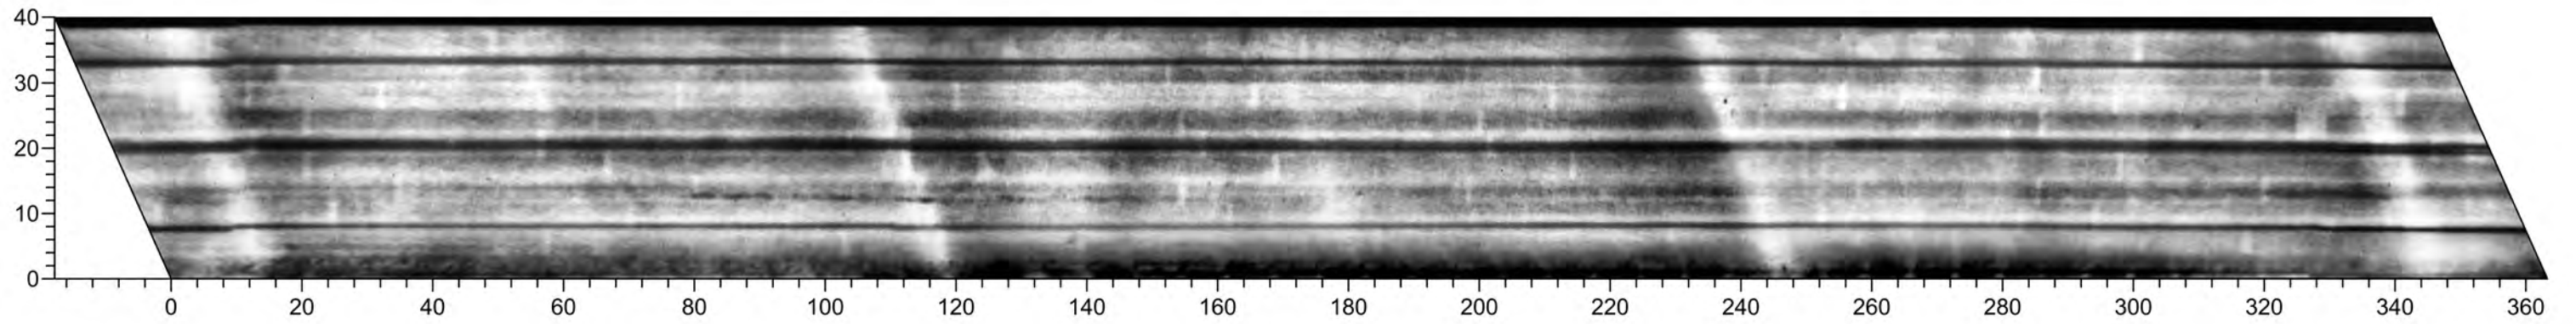
Delamination Quantity (%)    10.8		Imagery Collected: 6/4/22 Analyzed by: SB Reviewed by: AJC Completed: 10/4/22	
			Delamination Quantity (ft <sup>2</sup> )    461

\*Note: 294 sq. ft. of thermal anomalies not mapped due to being rectilinear in shape and appearing more like subsurface patching or some other structural feature
