# Aerial Infrared Scanning of Bridge Decks on Parks Highway to Map Delaminations

## FINAL REPORT

**Prepared by:**  
Infrasense, Inc.  
Woburn, MA

**Report # FHWA-AK-RD-000S(960)**  
**March 2, 2023**

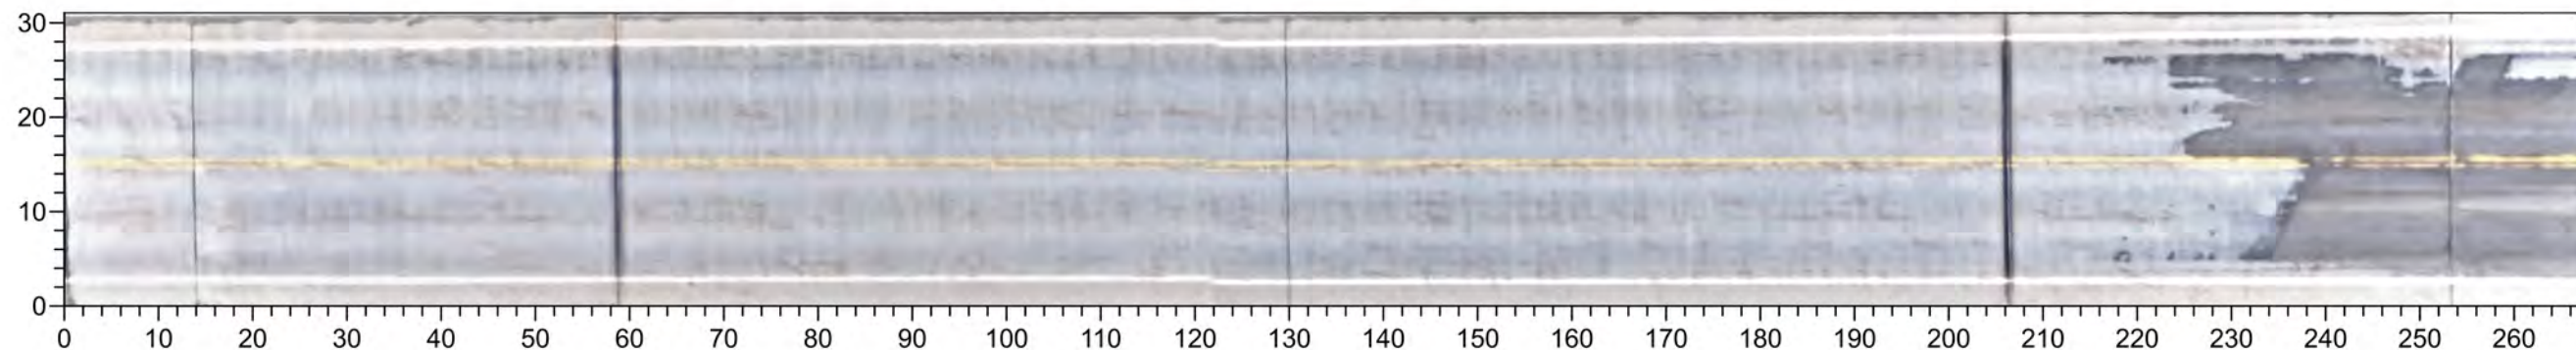
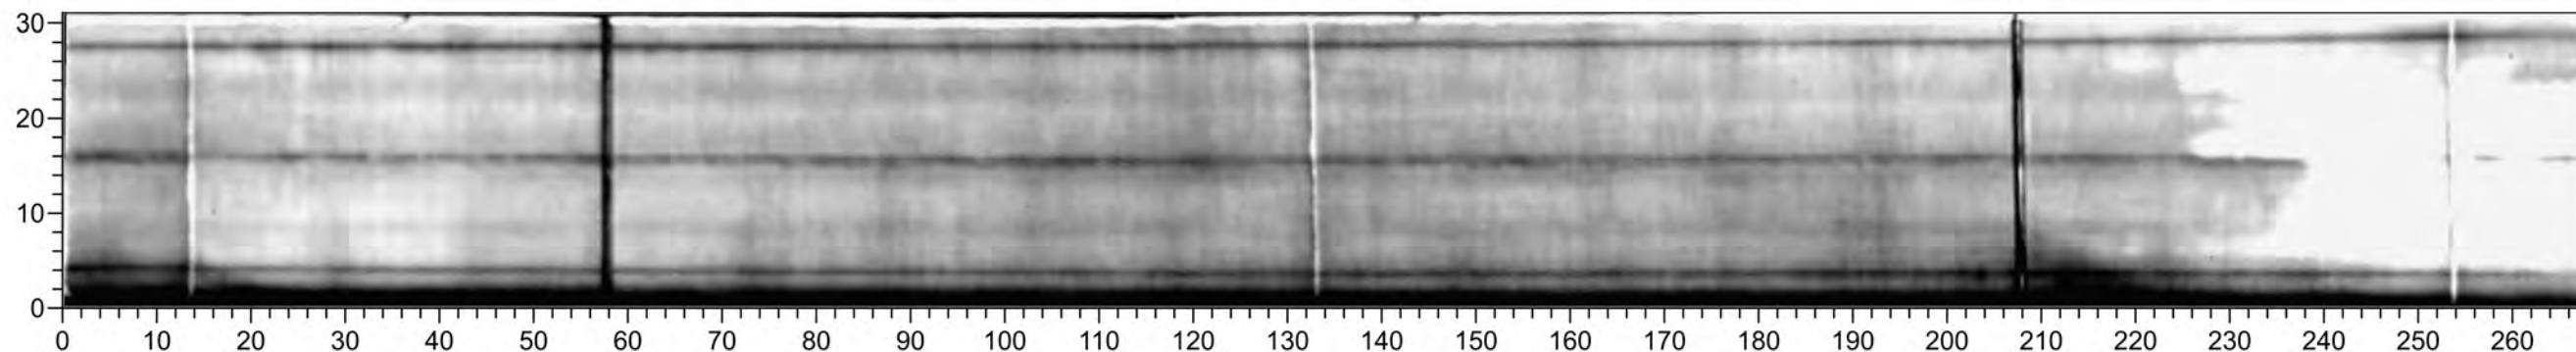
Delamination Quantity (%)    0.2 Delamination Quantity (ft <sup>2</sup> )    23	Imagery Collected: 6/4/22 Analyzed by: SB Reviewed by: AJC Completed: 10/4/22

Note: Delamination locations not shown as quantity is less than 2%.

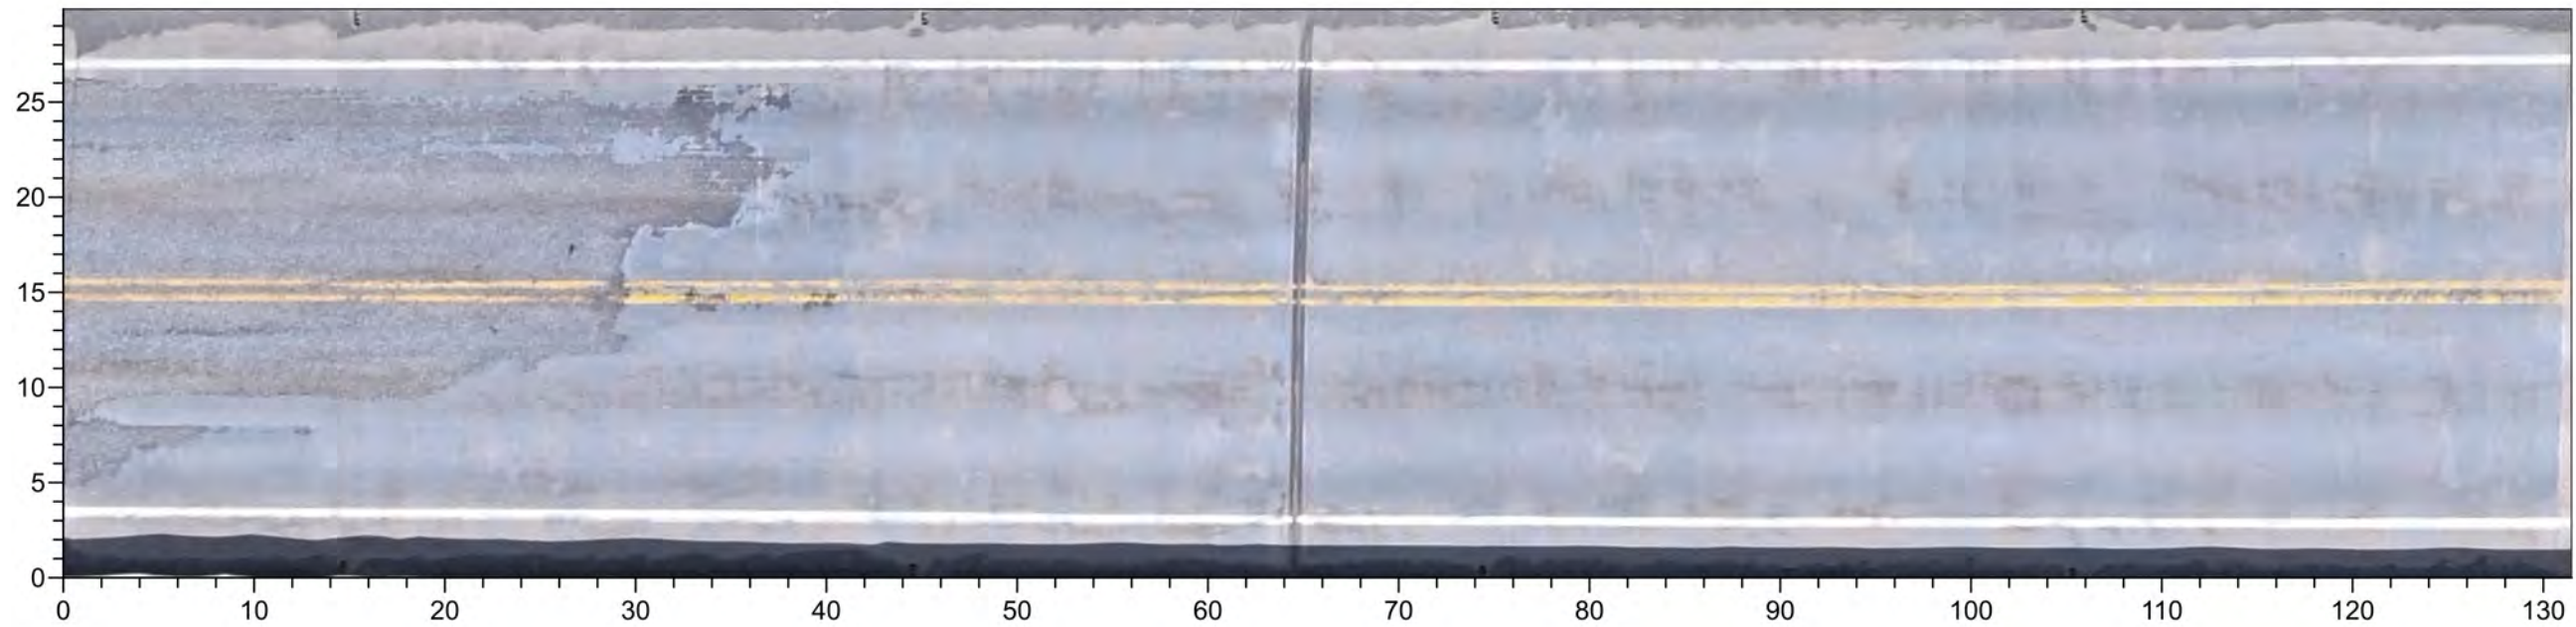
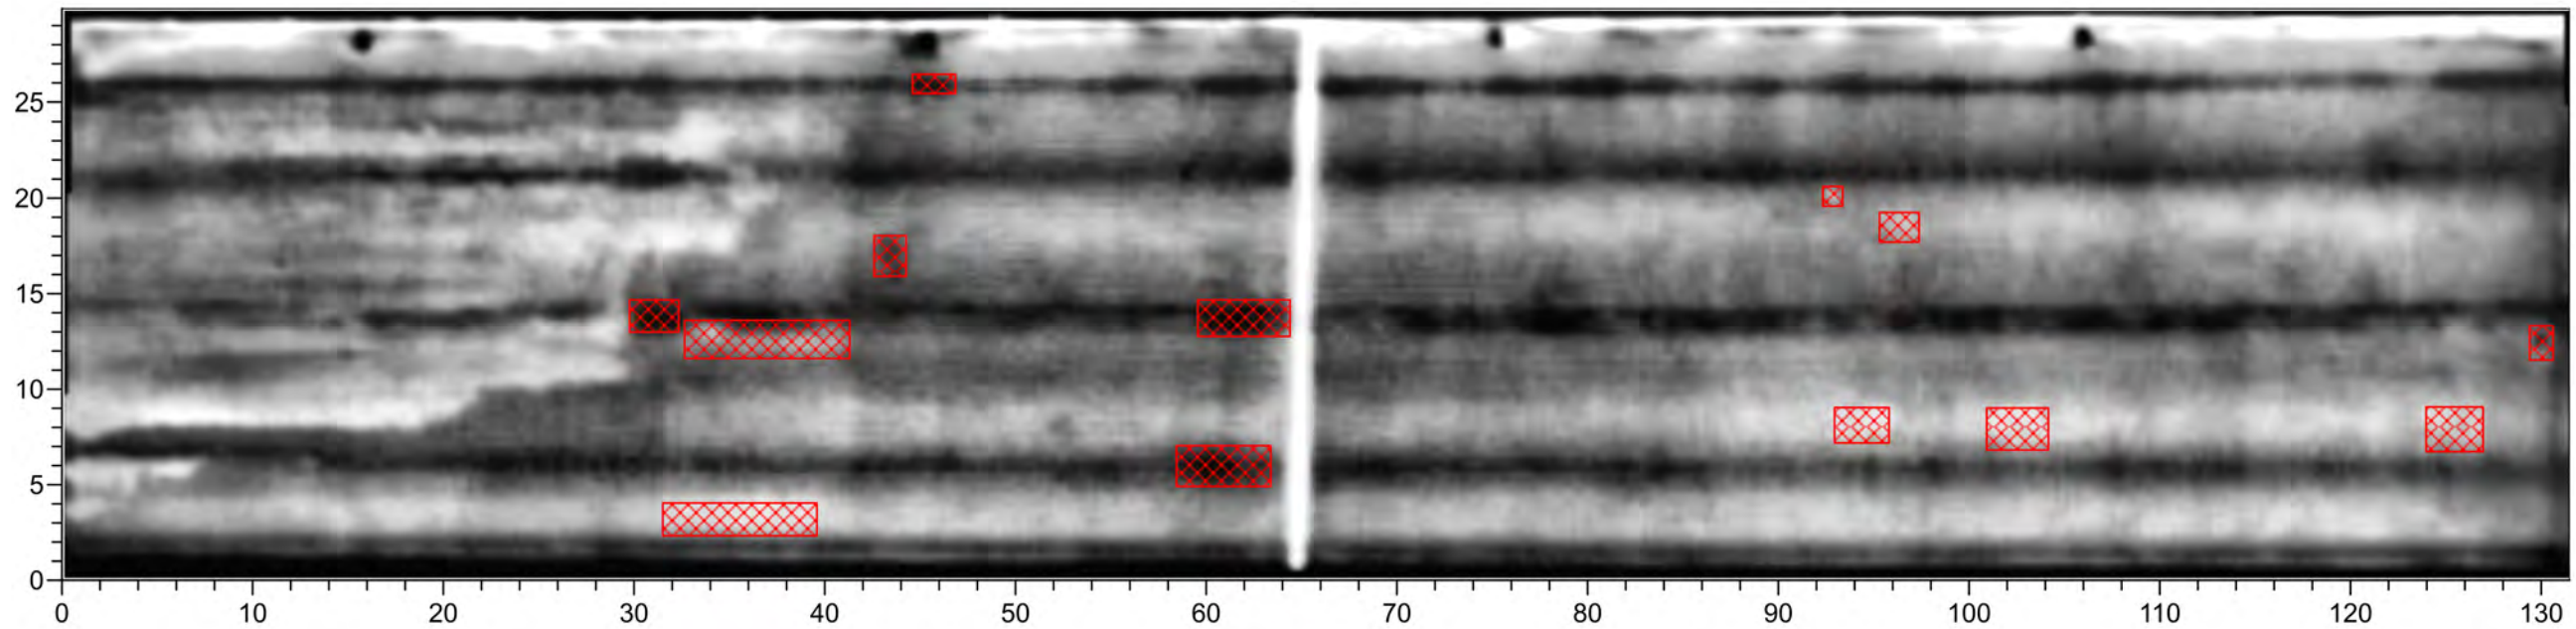
Delamination Quantity (%)	1.4	Imagery Collected: 6/4/22 Analyzed by: SB Reviewed by: AJC Completed: 10/4/22	
		Delamination Quantity (ft <sup>2</sup> )	117

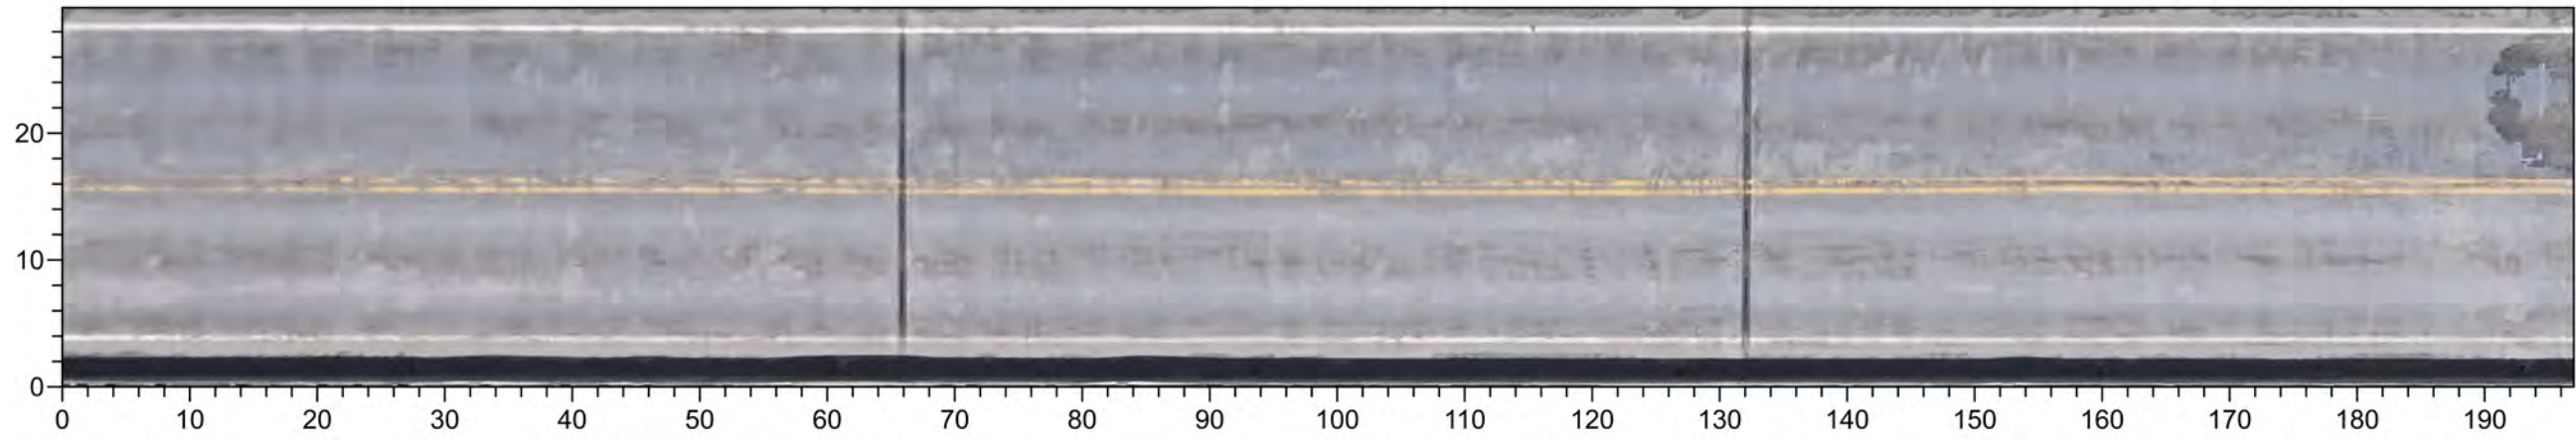
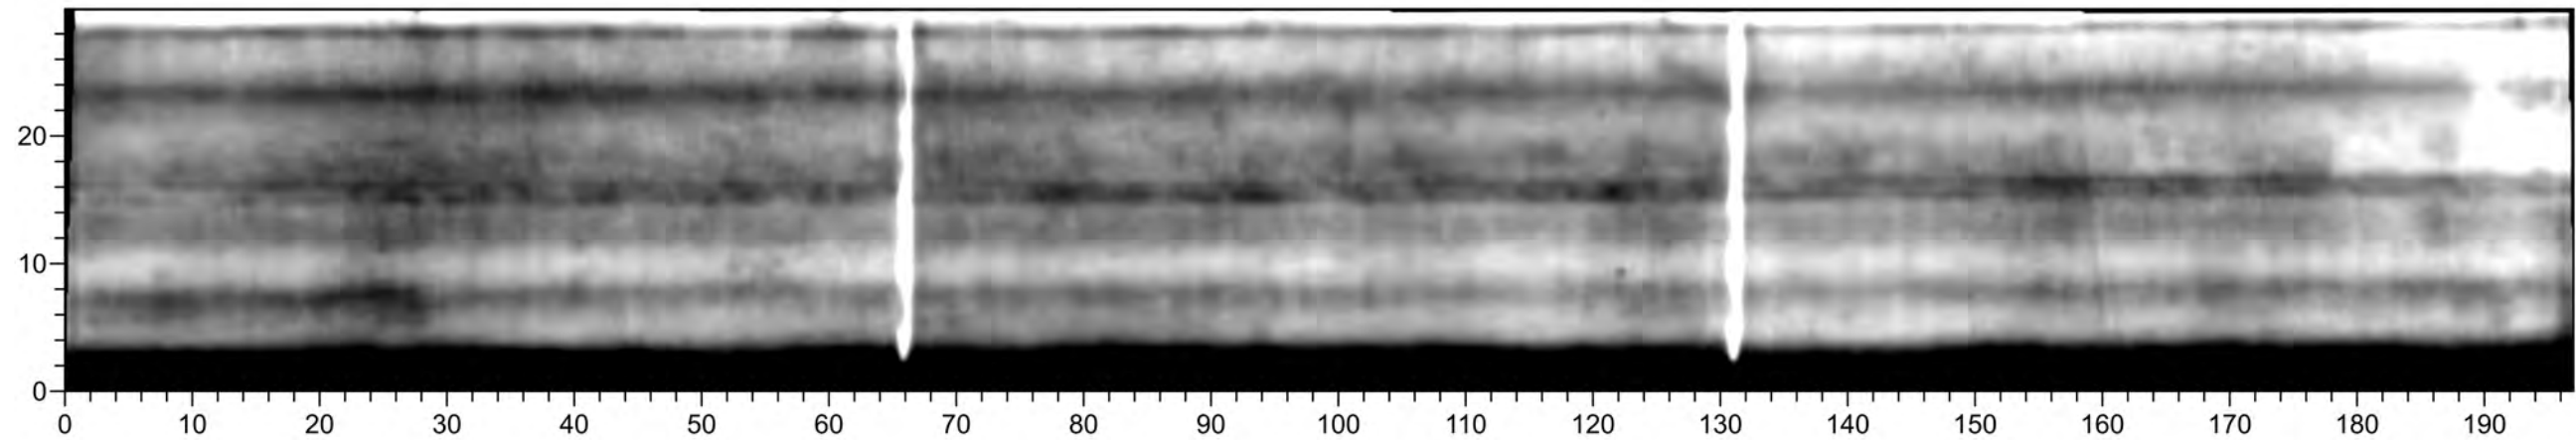
Delamination Quantity (%)    2.2	Delamination Quantity (ft <sup>2</sup> )    87	Imagery Collected: 6/5/22 Analyzed by: SB Reviewed by: AJC Completed: 10/4/22

Note: Delamination locations not shown as quantity is less than 2%.

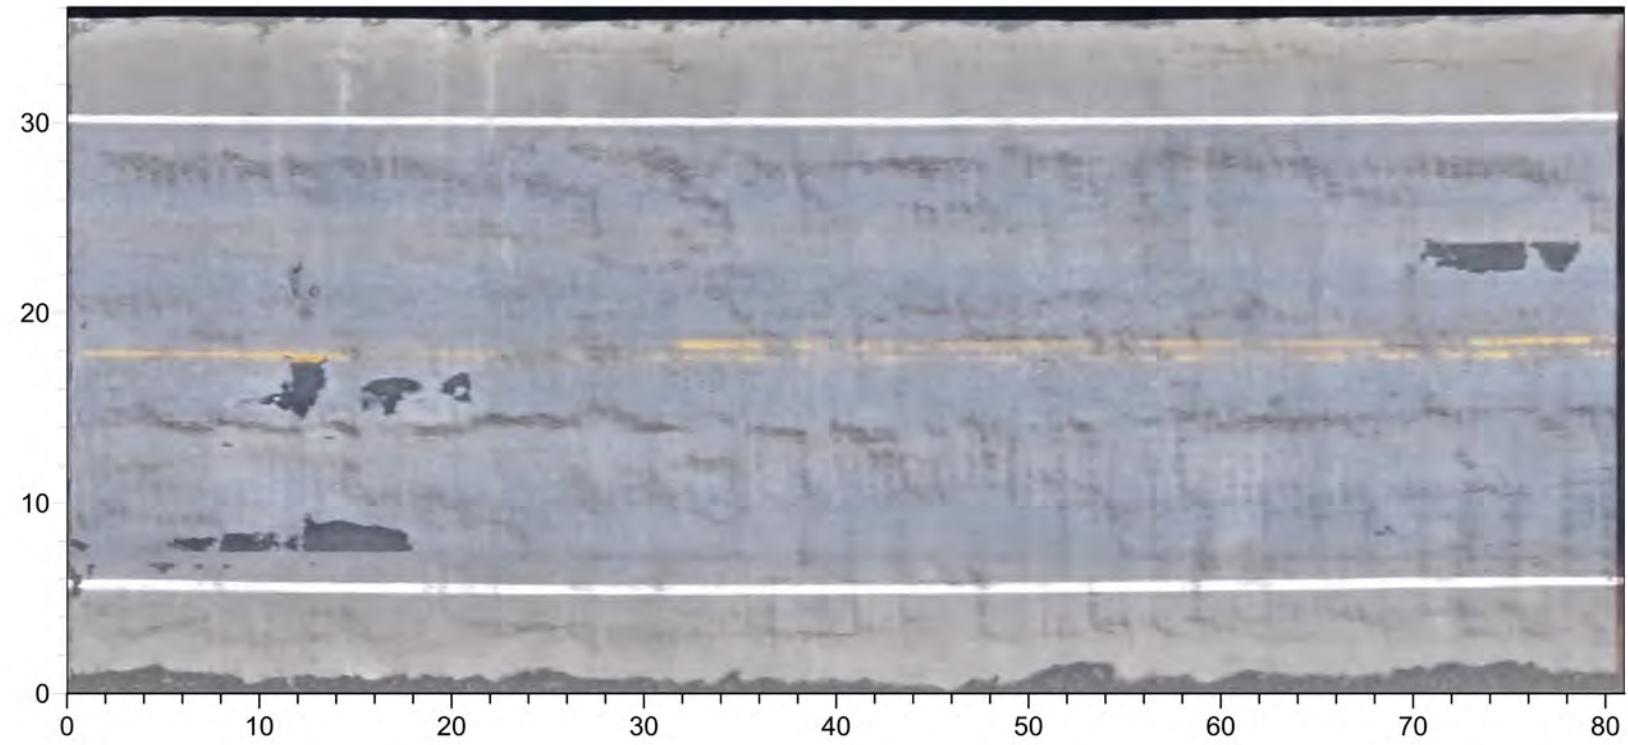
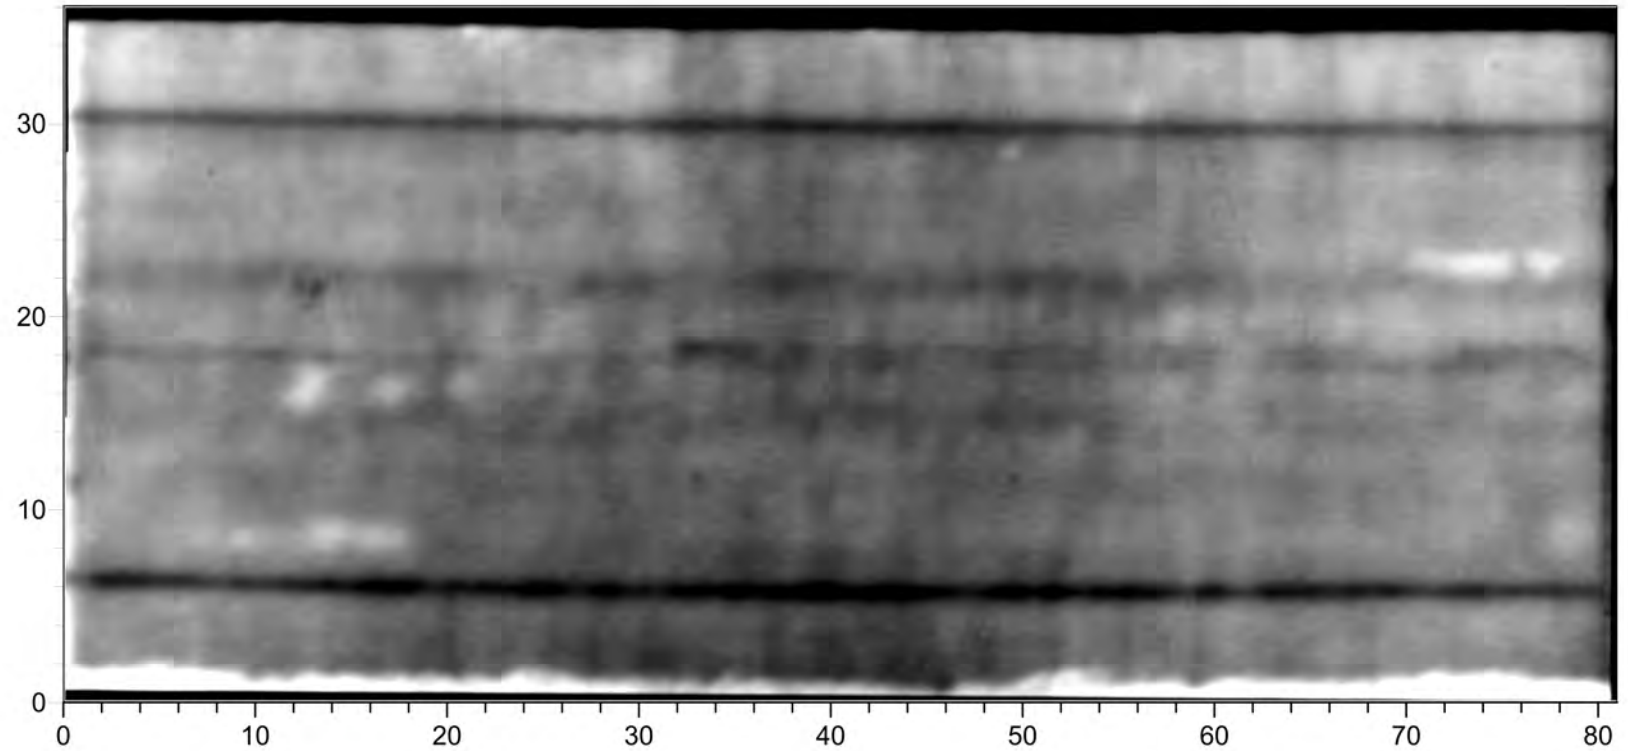
Delamination Quantity (%)    1.1		Imagery Collected: 6/5/22 Analyzed by: EG, SB Reviewed by: AJC Completed: 10/6/22	
			Delamination Quantity (ft <sup>2</sup> )    65

Note: Delamination locations not shown as quantity is less than 2%.

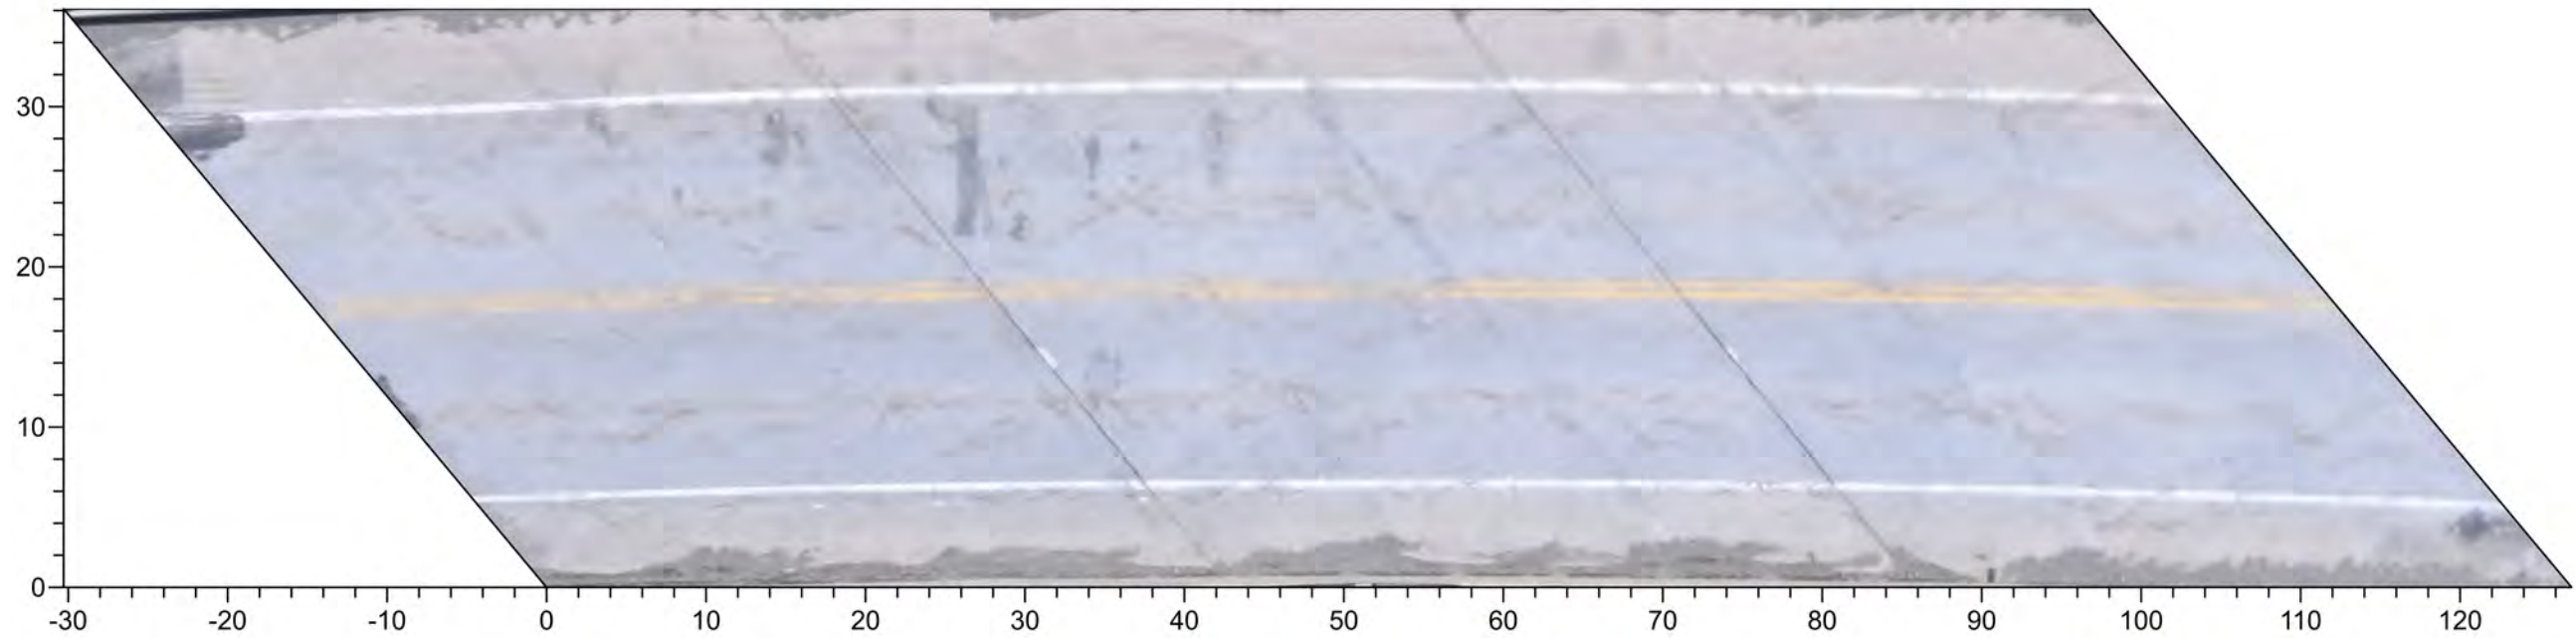
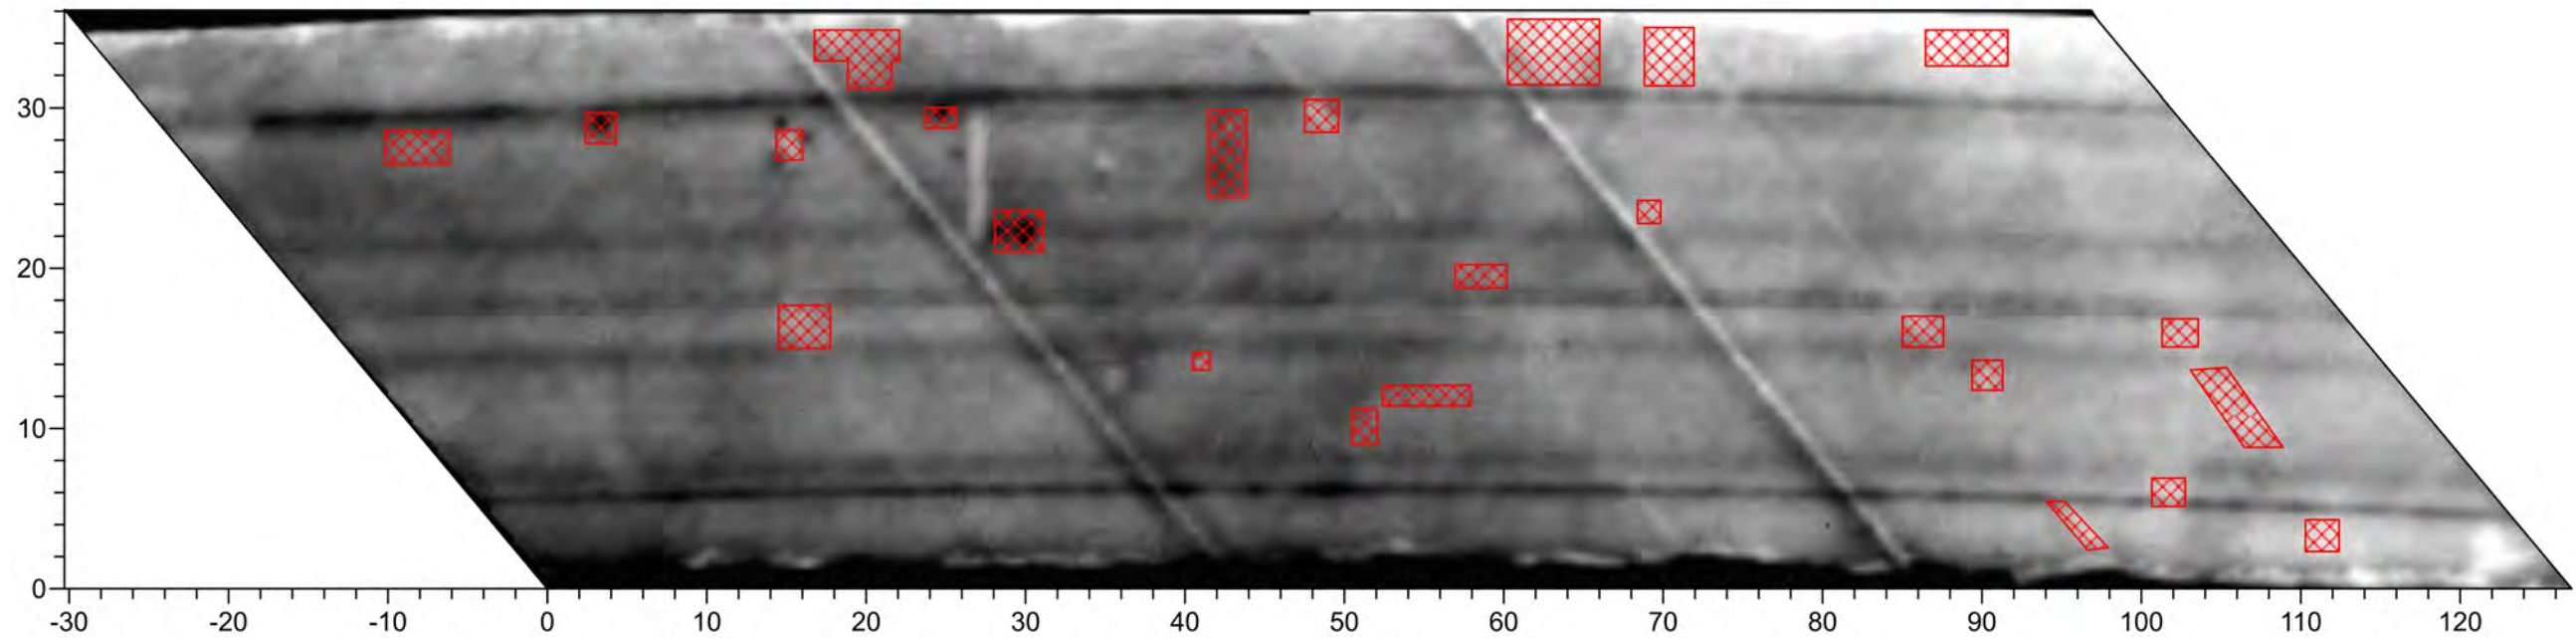
Delamination Quantity (%)    1.8 Delamination Quantity (ft <sup>2</sup> )    52.6	Imagery Collected: 6/5/22 Analyzed by: EG, SB Reviewed by: AJC Completed: 10/6/22

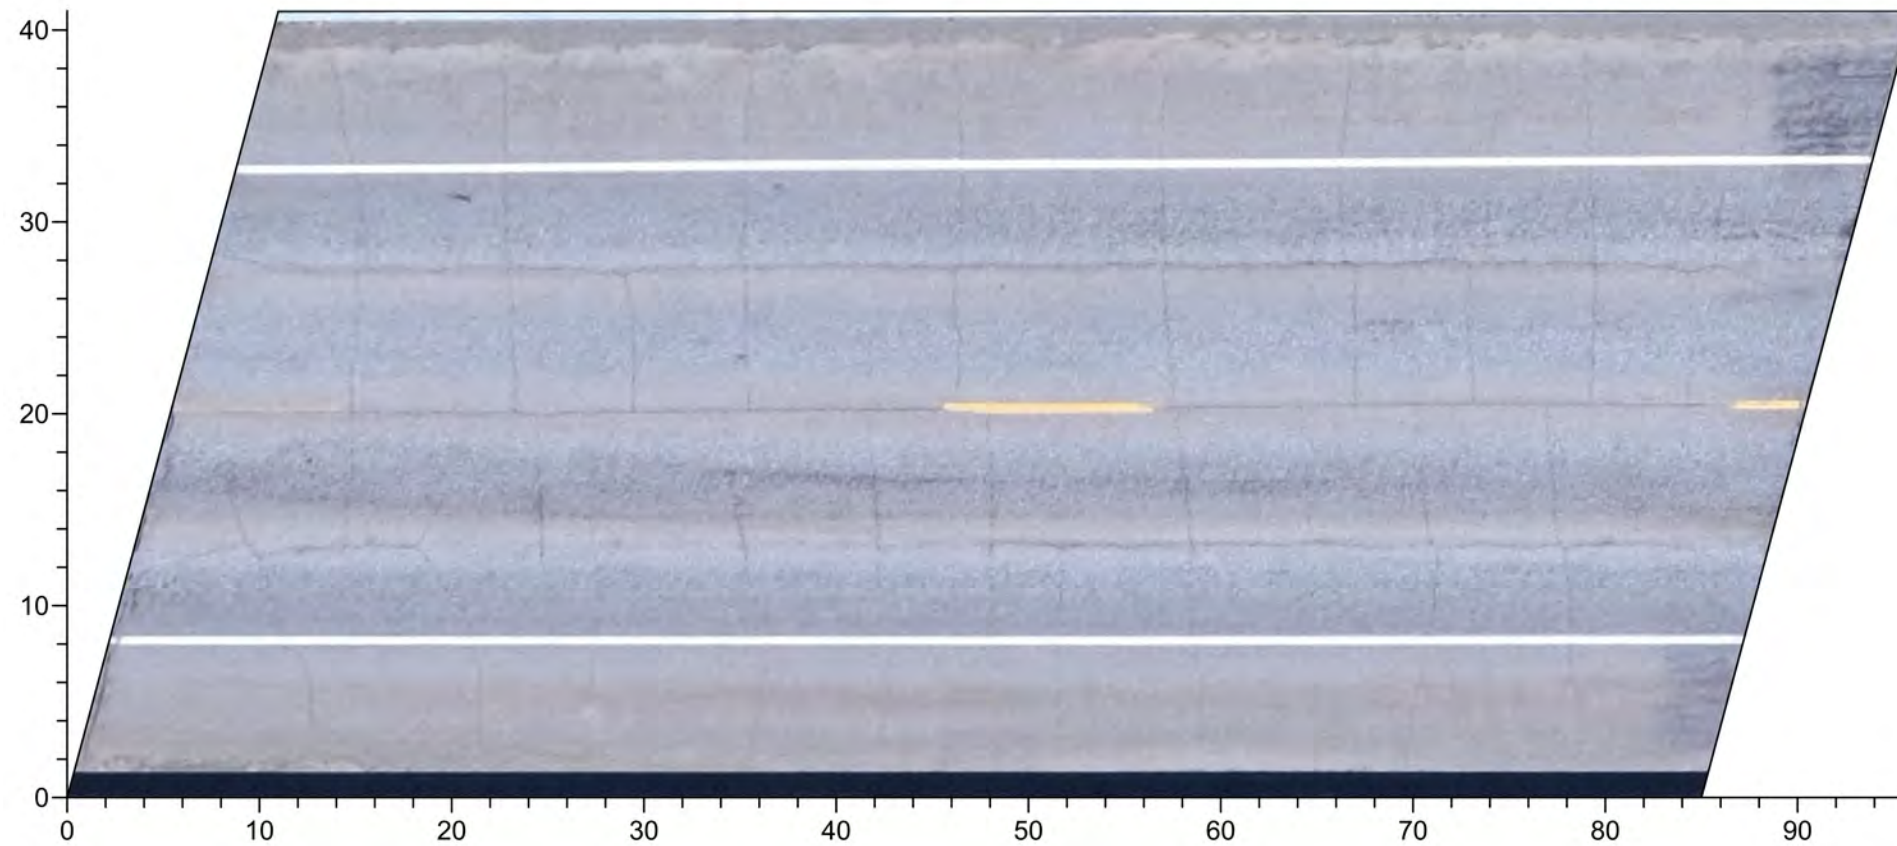
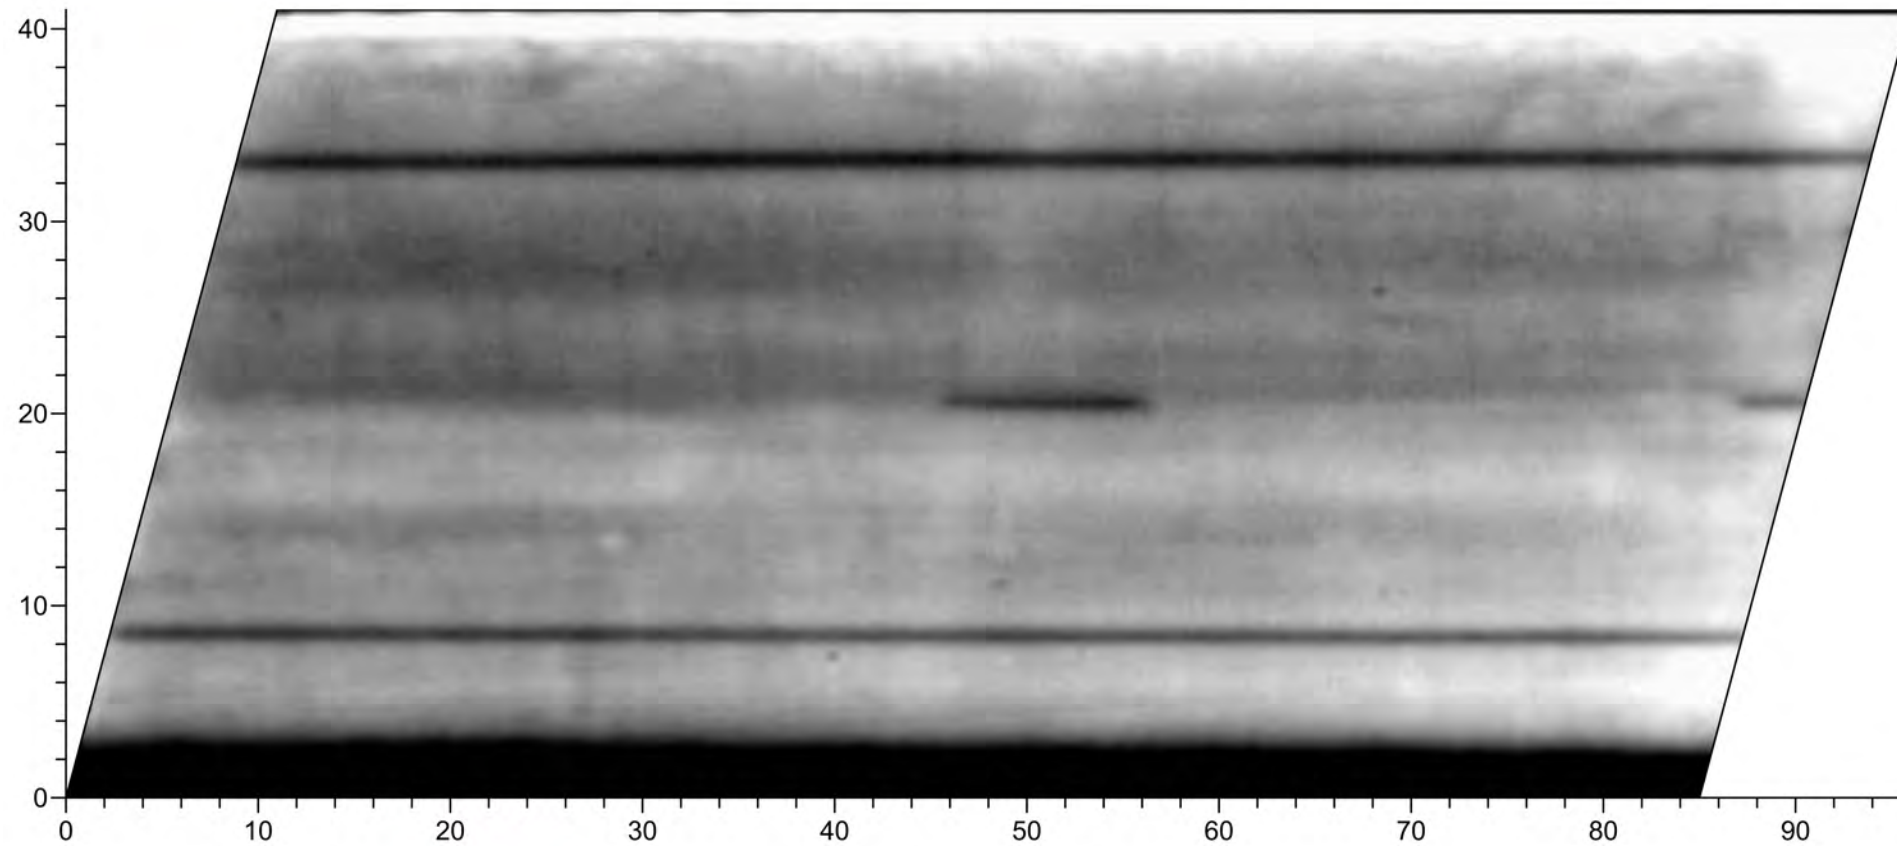
Delamination Quantity (%) 3.7		Imagery Collected: 6/5/22 Analyzed by: SB Reviewed by: AJC Completed: 10/4/22	
			Delamination Quantity (ft <sup>2</sup> ) 168

Note: Delamination locations not shown as quantity is less than 2%.

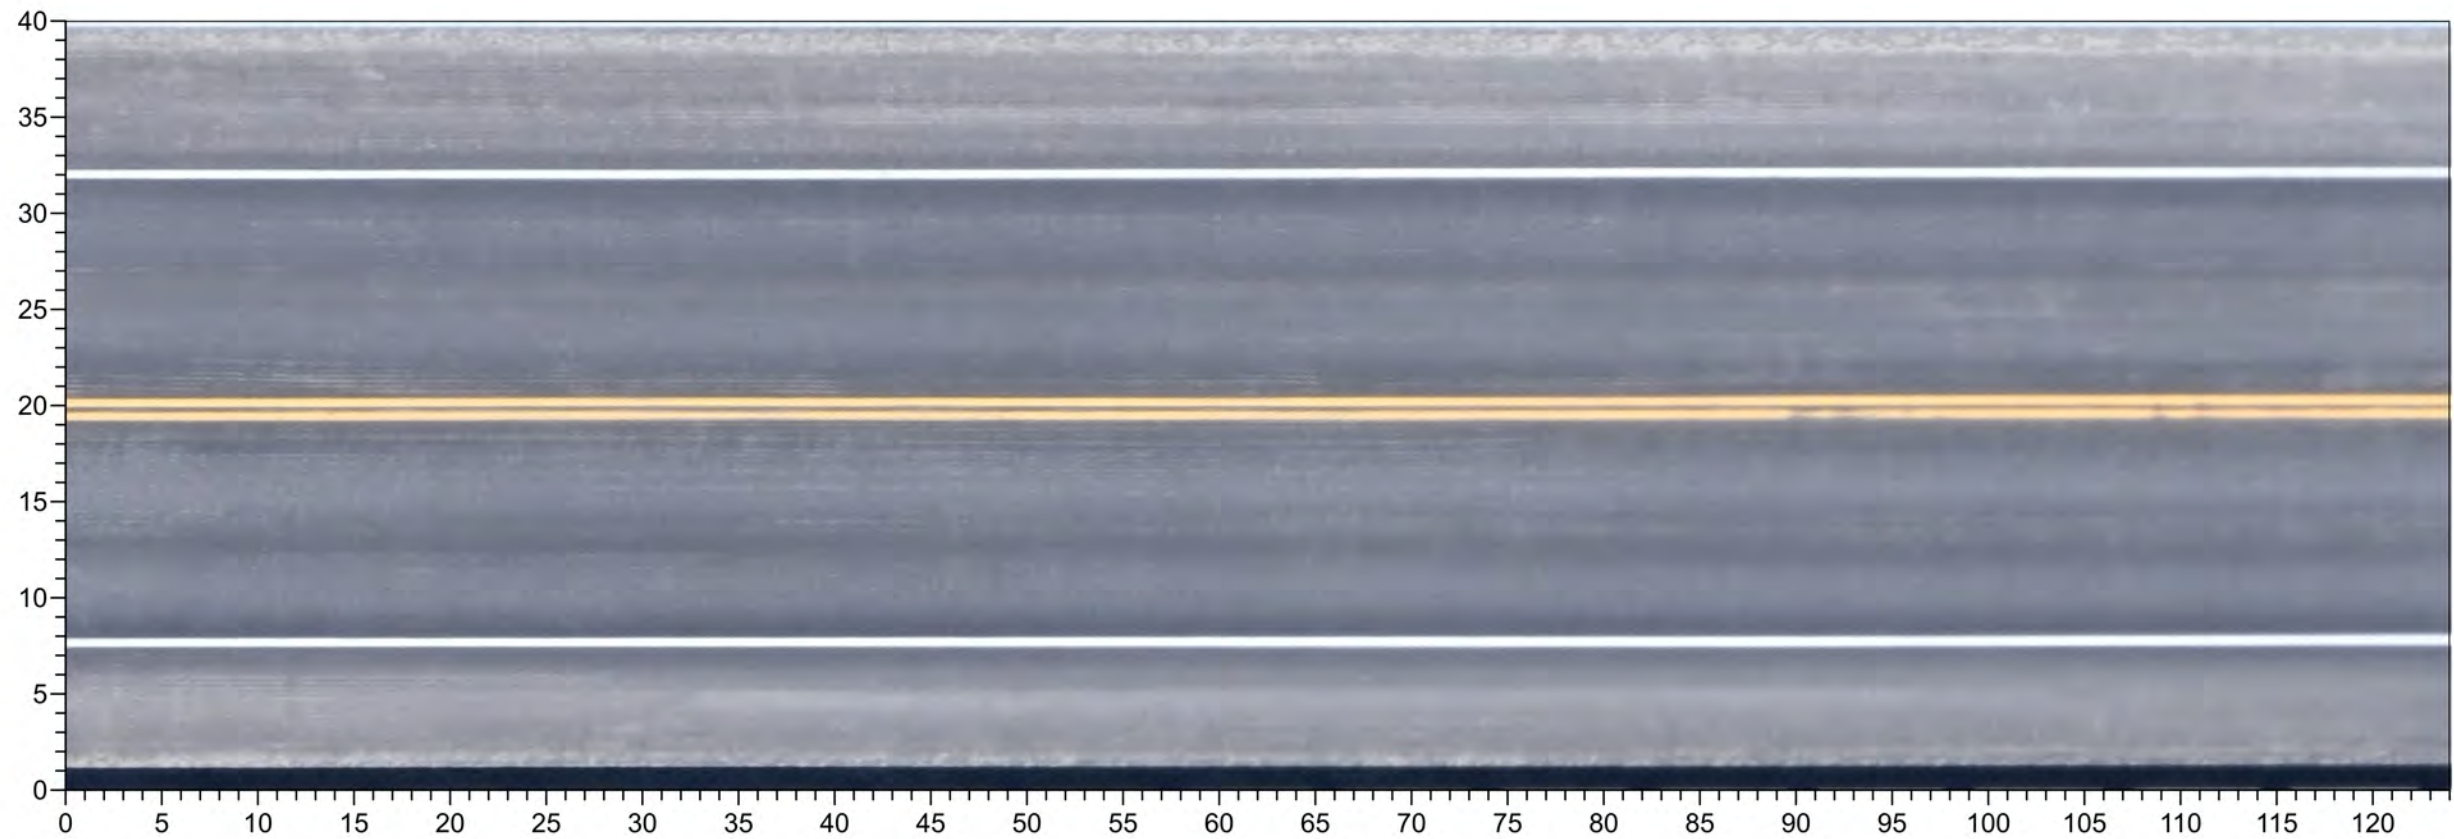
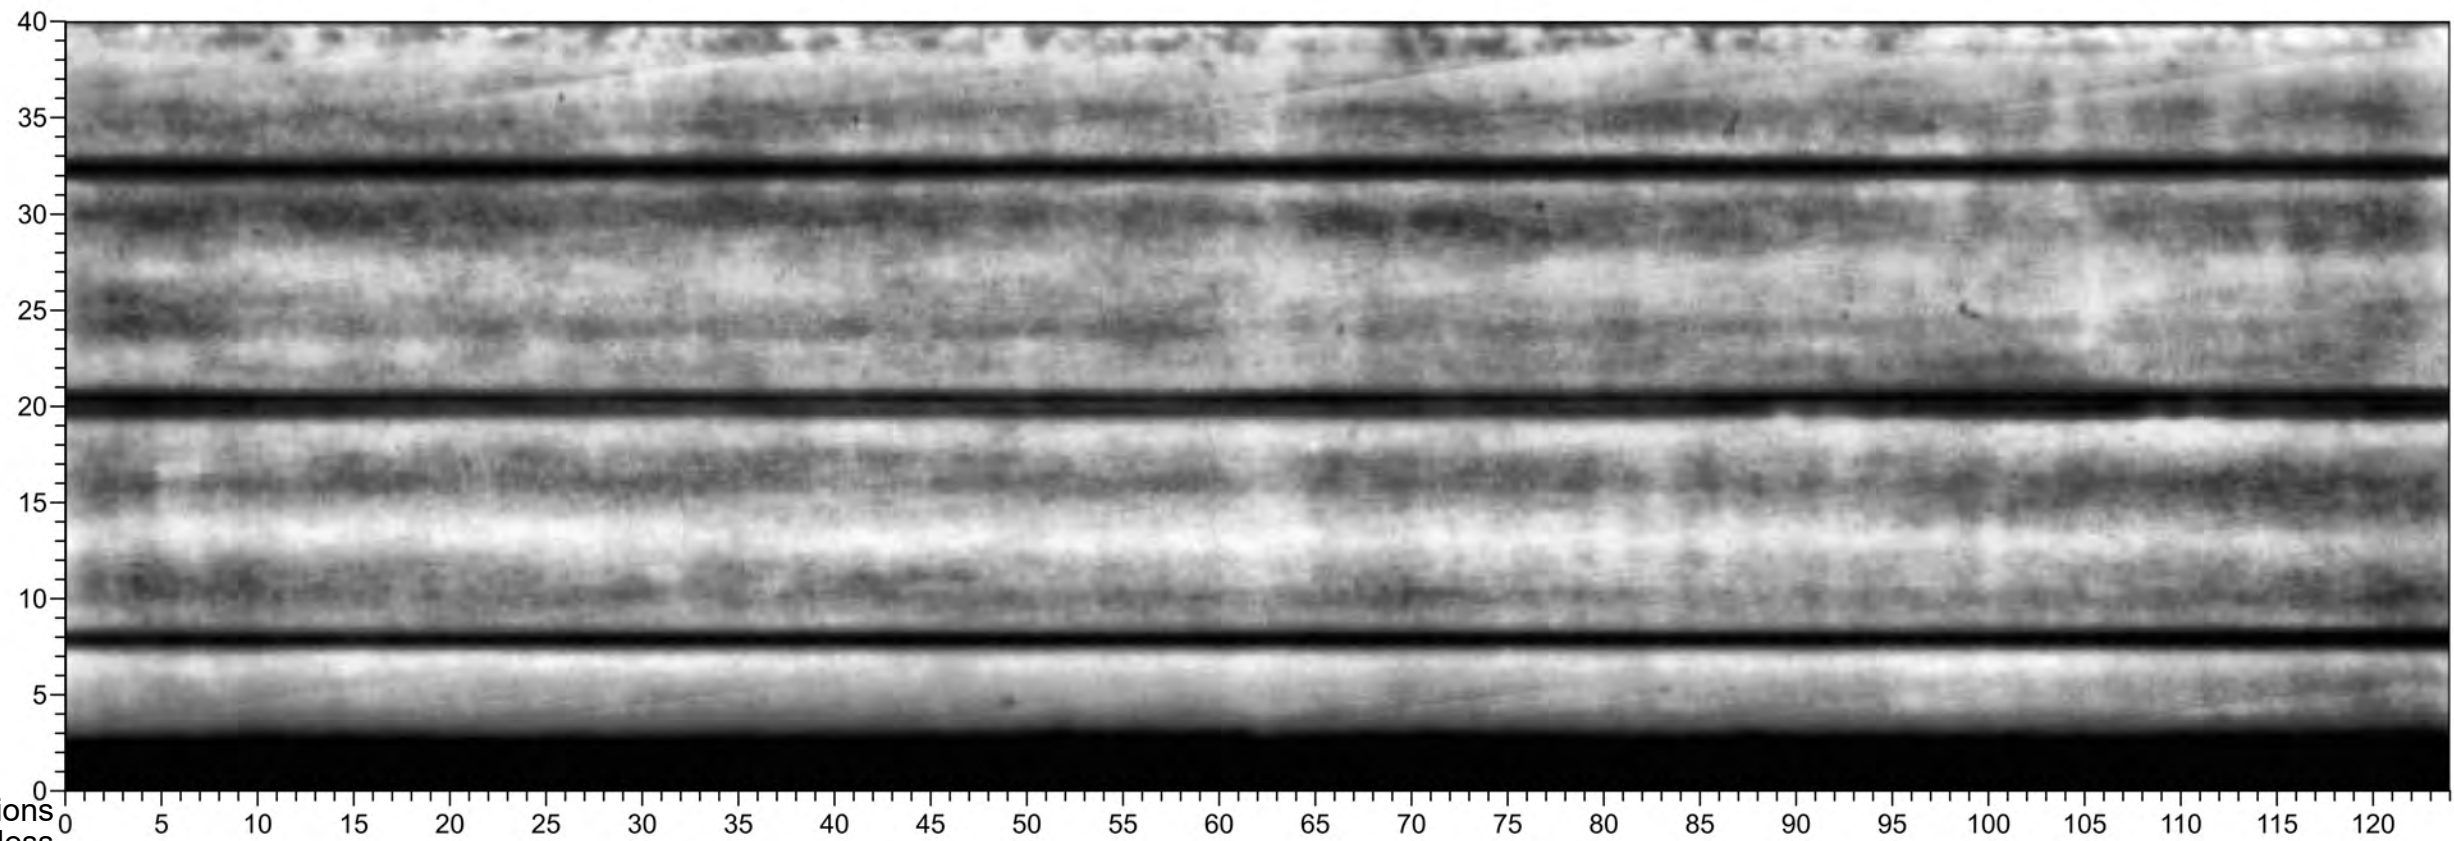
Delamination Quantity (%)    0.2		Imagery Collected: 6/5/22 Analyzed by: SB Reviewed by: AJC Completed: 10/4/22	
			Delamination Quantity (ft <sup>2</sup> )    8

Note: Delamination locations not shown as quantity is less than 2%.

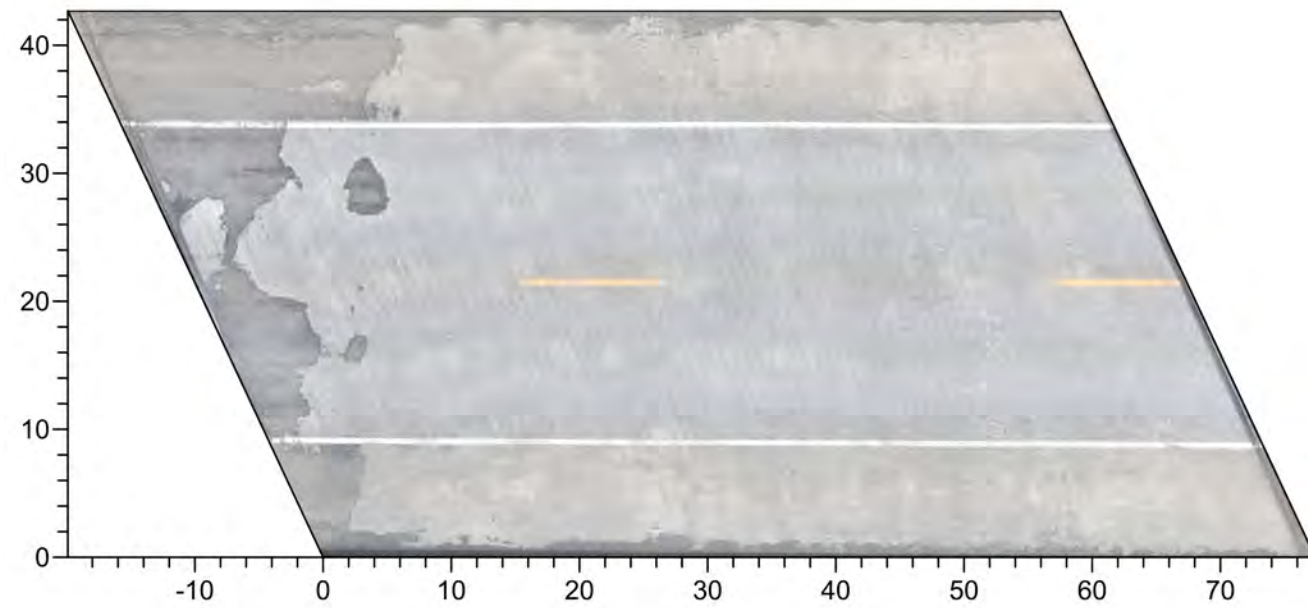
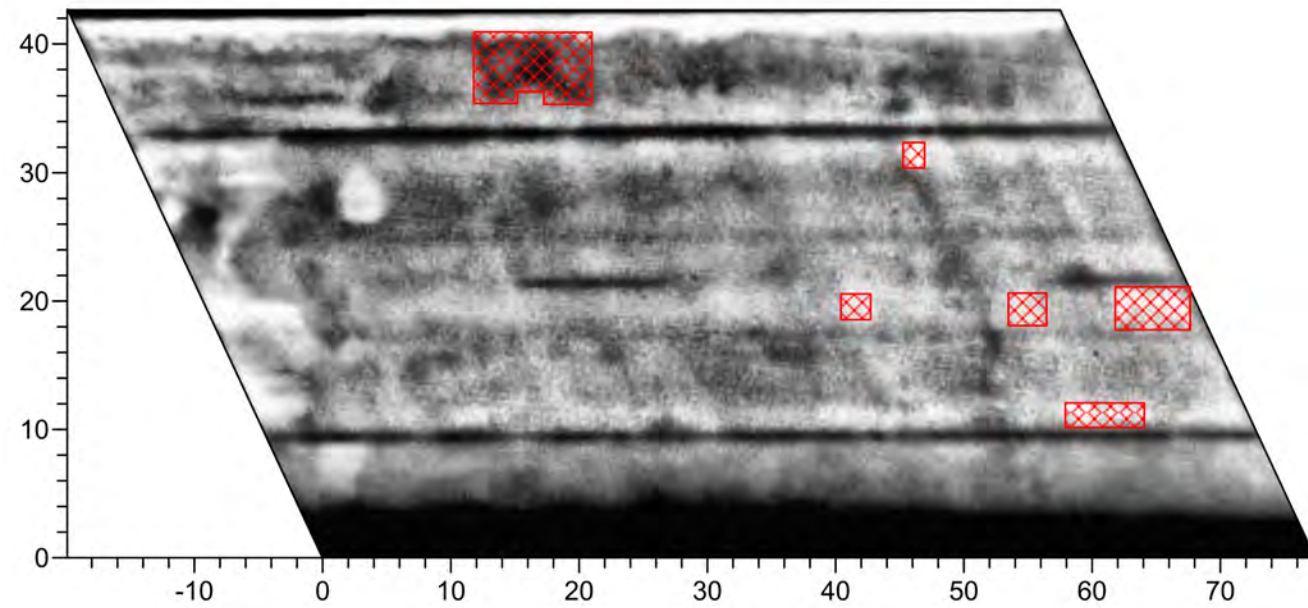
Delamination Quantity (%)	1.3	Imagery Collected: 6/5/22 Analyzed by: SB Reviewed by: AJC Completed: 10/4/22	
		Delamination Quantity (ft <sup>2</sup> )	64
