# Aerial Infrared Scanning of Bridge Decks on Parks Highway to Map Delaminations

## FINAL REPORT

**Prepared by:**  
Infrasense, Inc.  
Woburn, MA

**Report # FHWA-AK-RD-000S(960)**  
**March 2, 2023**

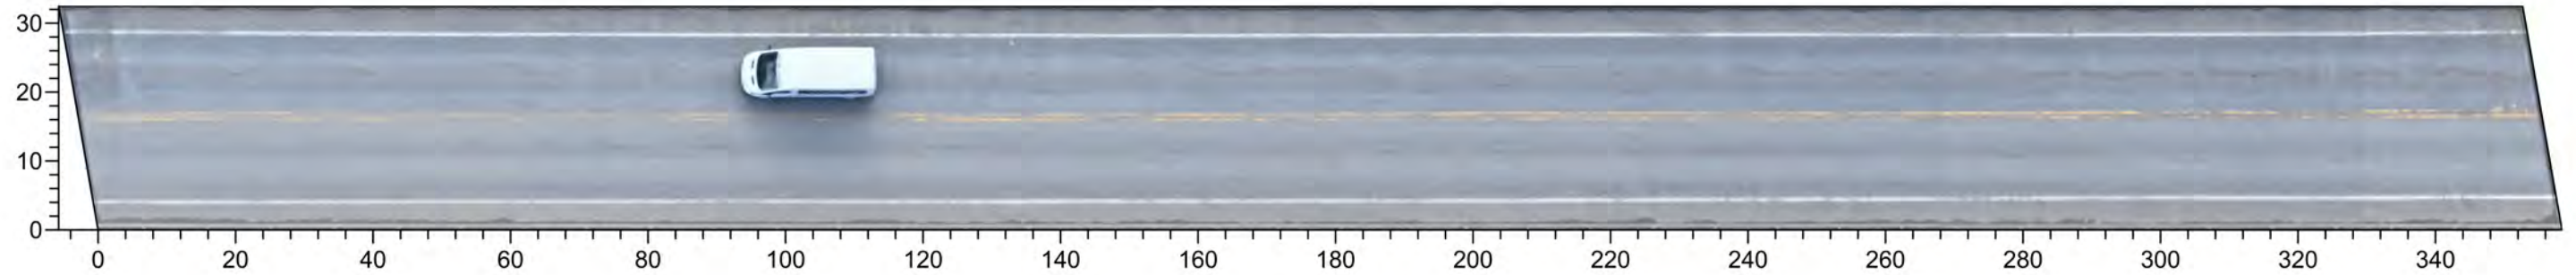
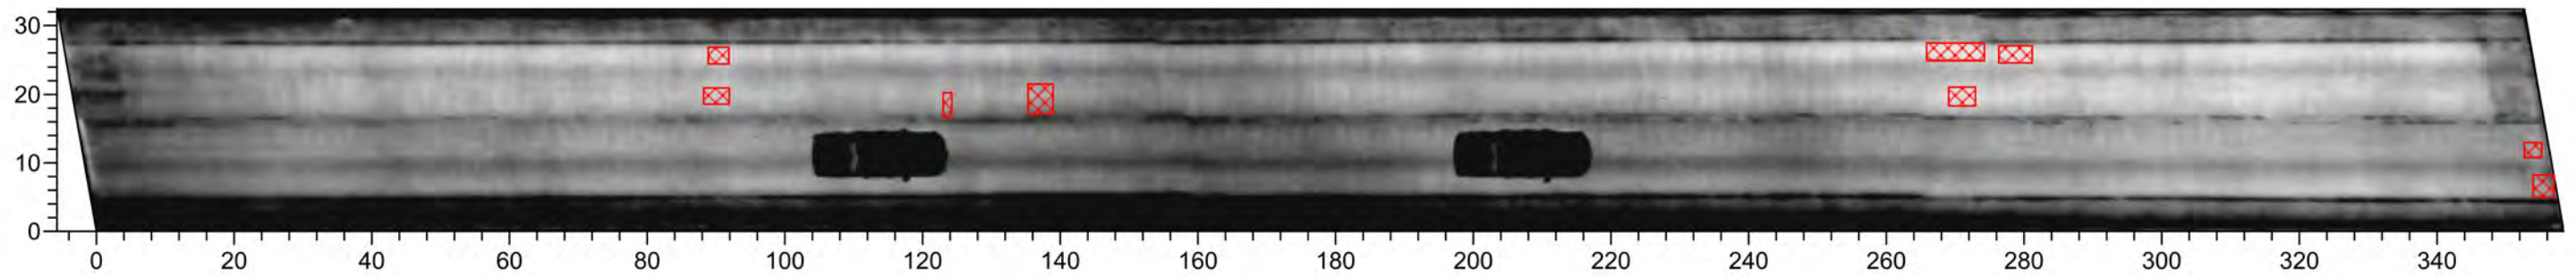
Delamination Quantity (%) 2.9		Imagery Collected: 6/5/22 Analyzed by: SB Reviewed by: AJC Completed: 10/4/22	
			Delamination Quantity (ft <sup>2</sup> ) 96

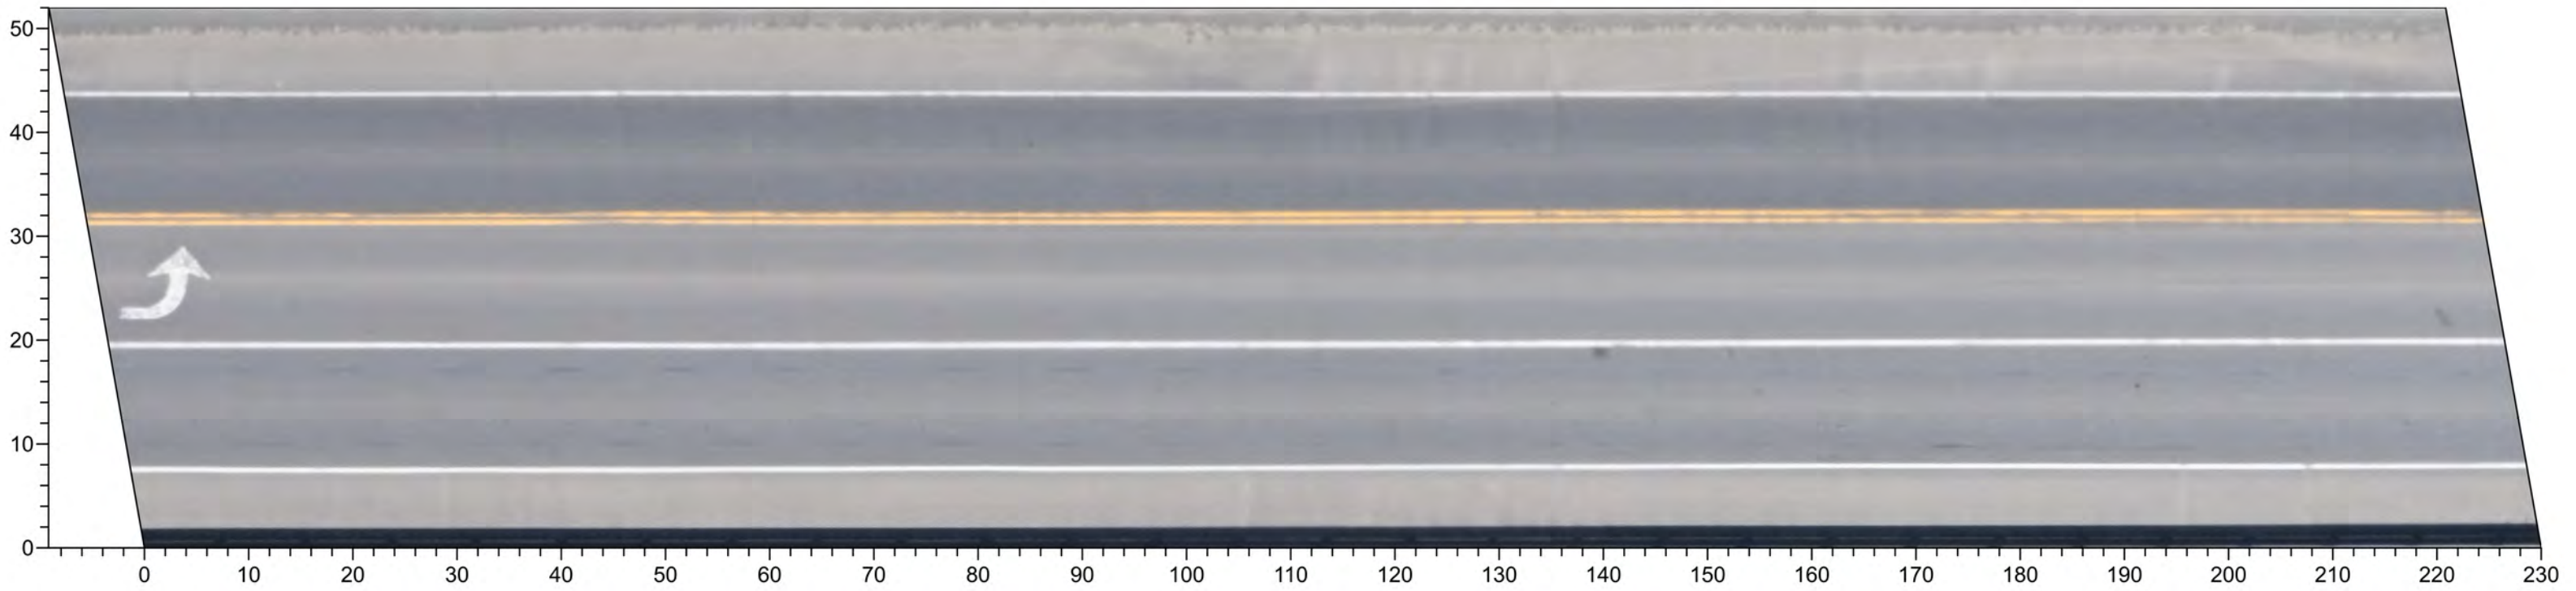
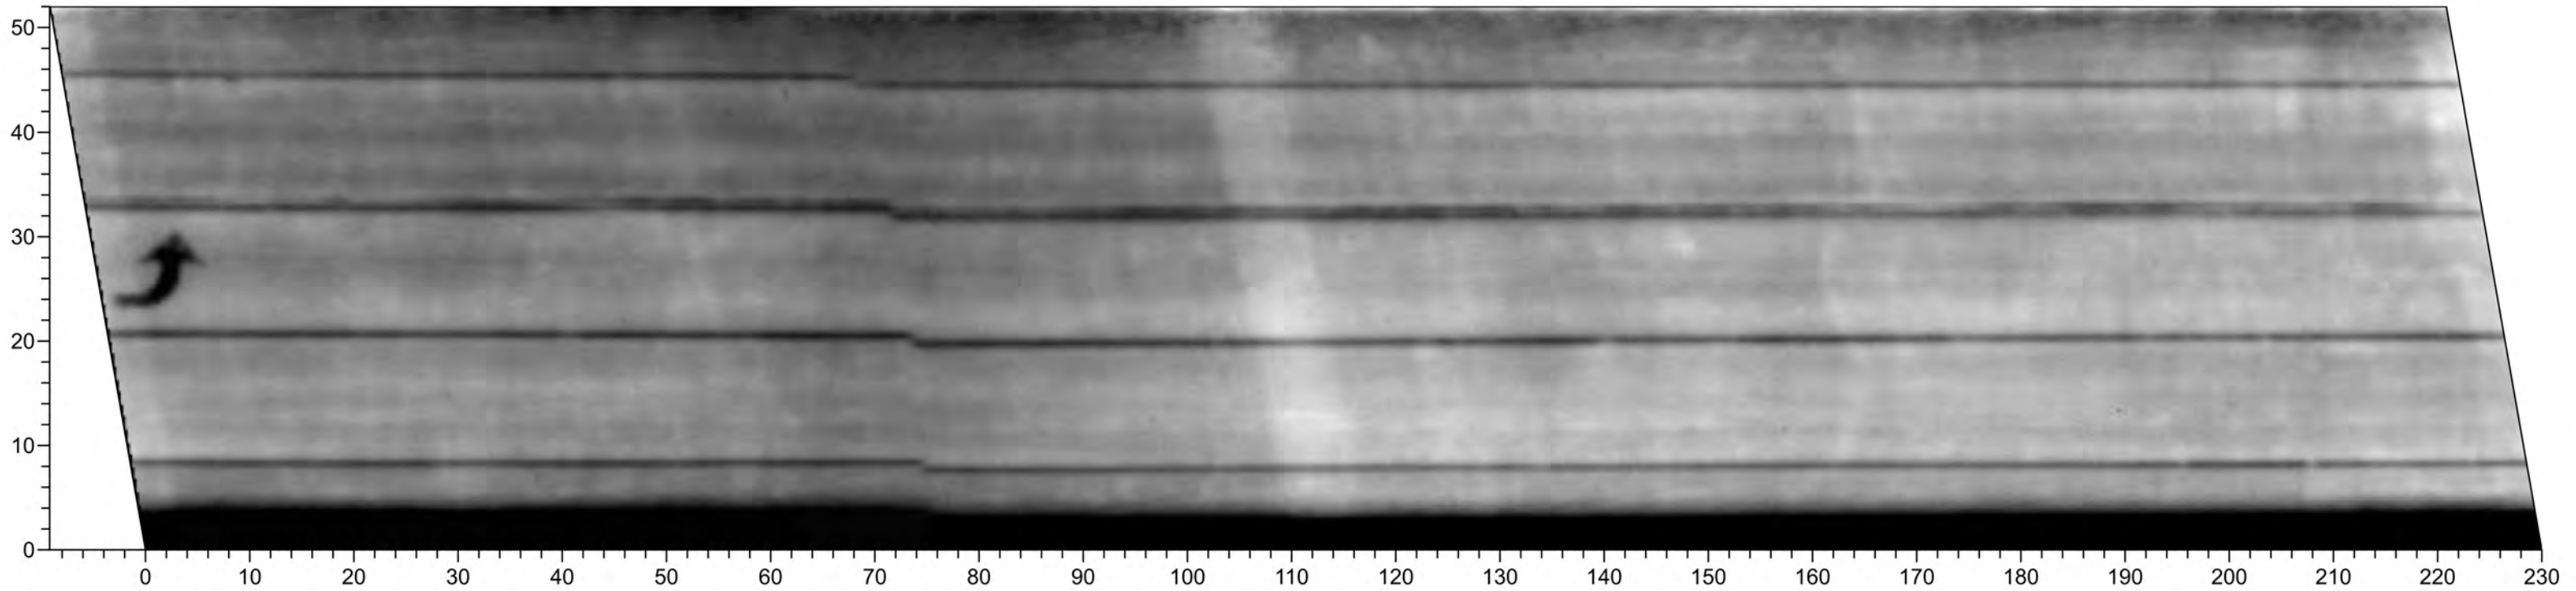
Delamination Quantity (%)	0.8	Imagery Collected: 6/5/22 Analyzed by: SB Reviewed by: AJC Completed: 10/4/22	
		Delamination Quantity (ft <sup>2</sup> )	96

Note: Delamination locations not shown as quantity is less than 2%.

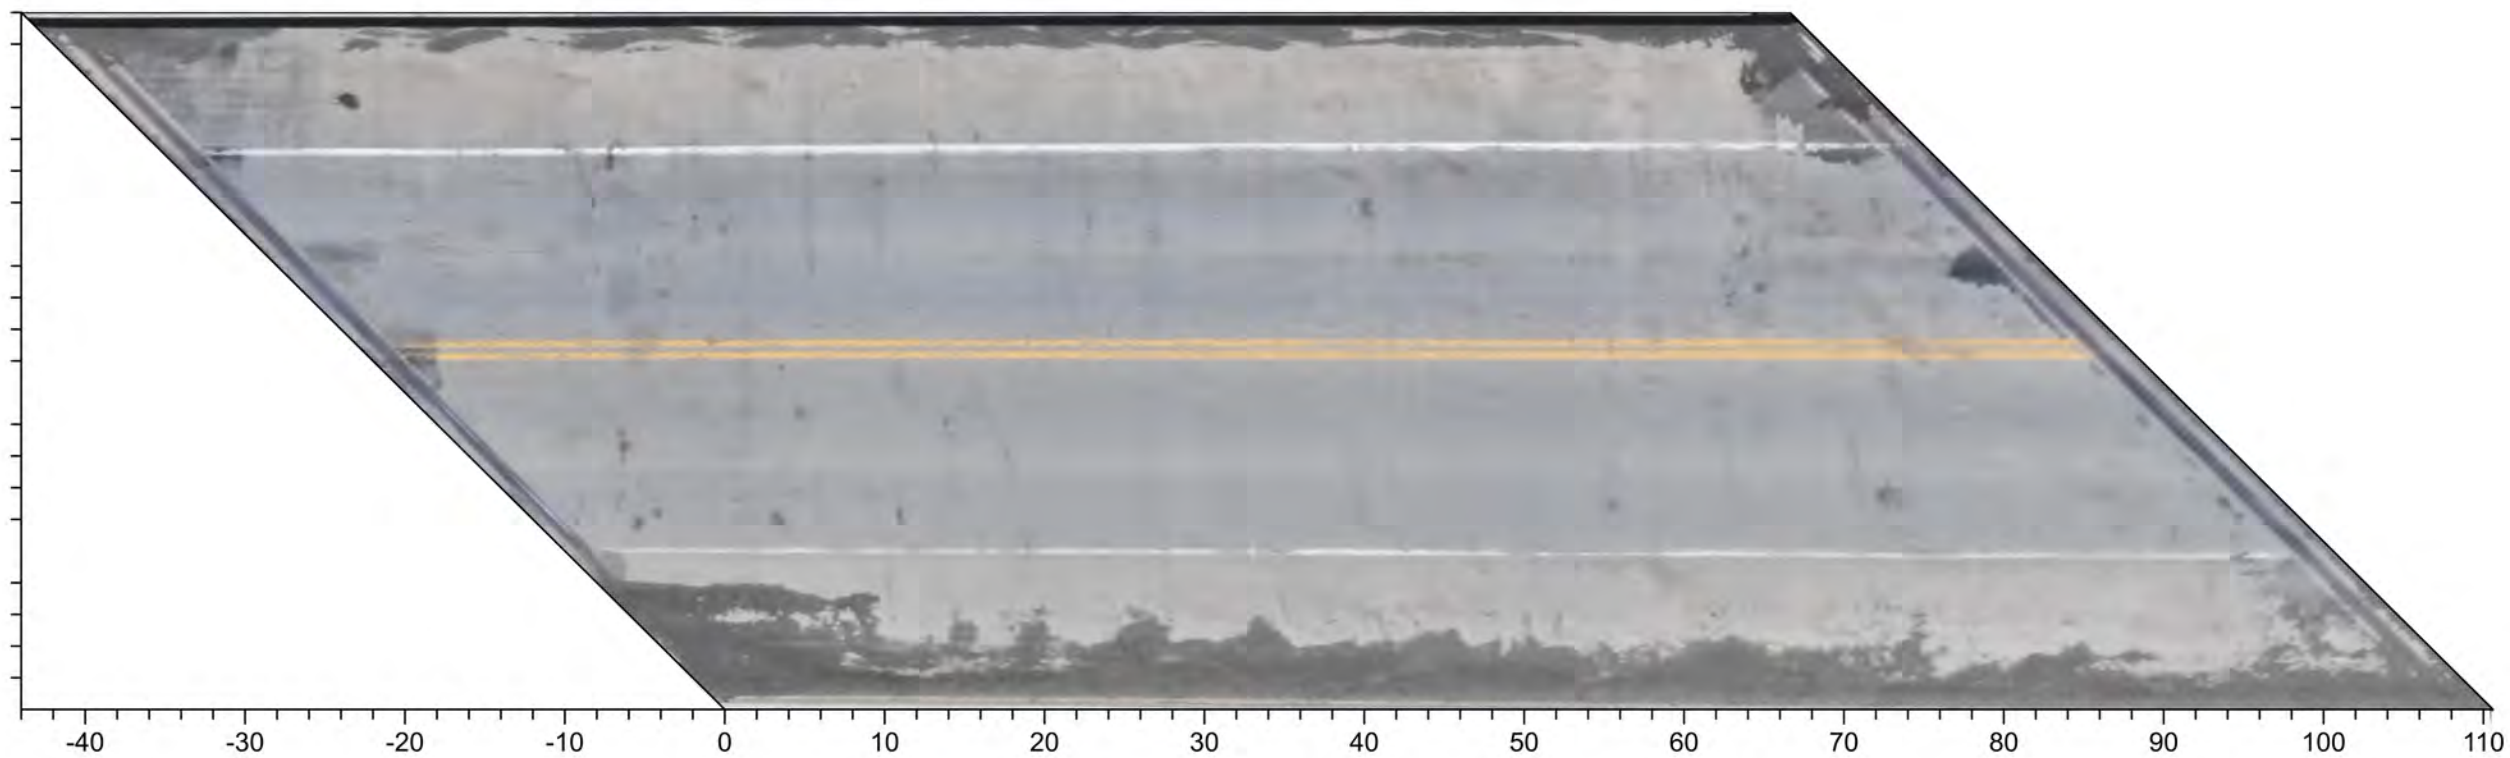
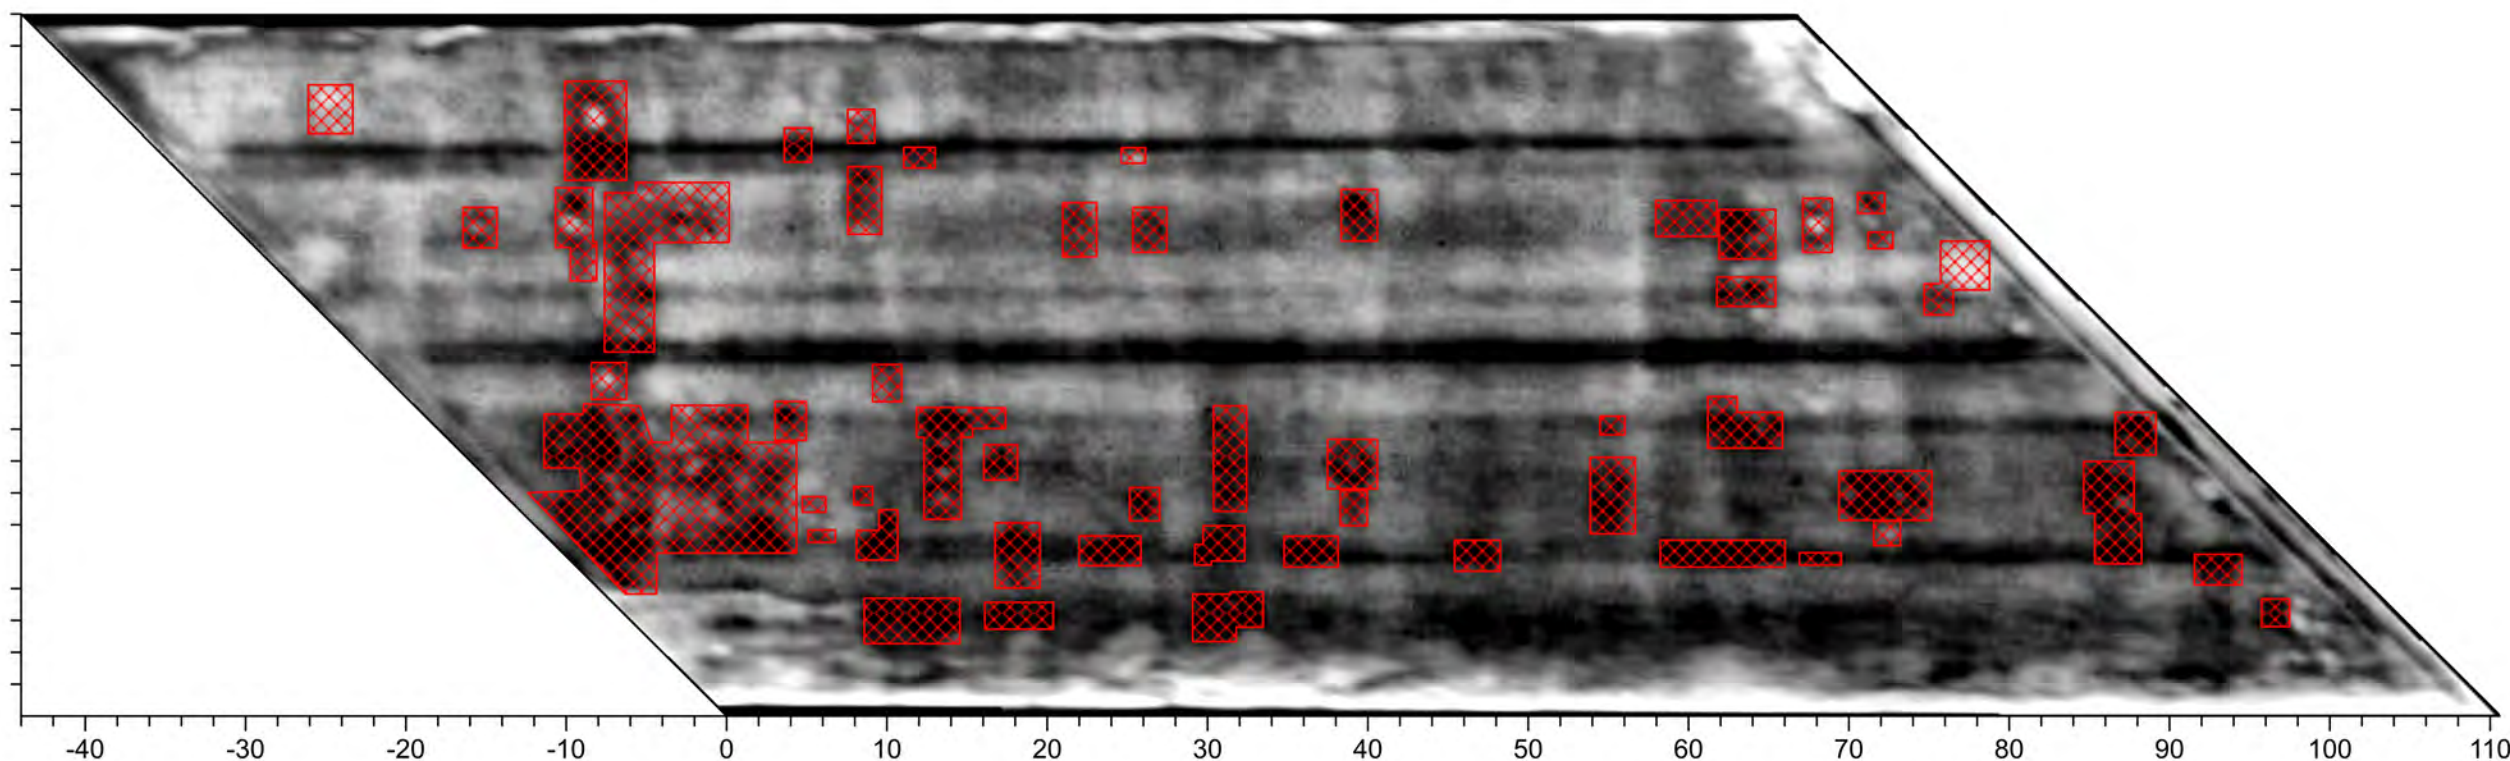
Delamination Quantity (%)    0.4		Imagery Collected: 6/5/22 Analyzed by: SB Reviewed by: AJC Completed: 10/5/22	
			Delamination Quantity (ft <sup>2</sup> )    47

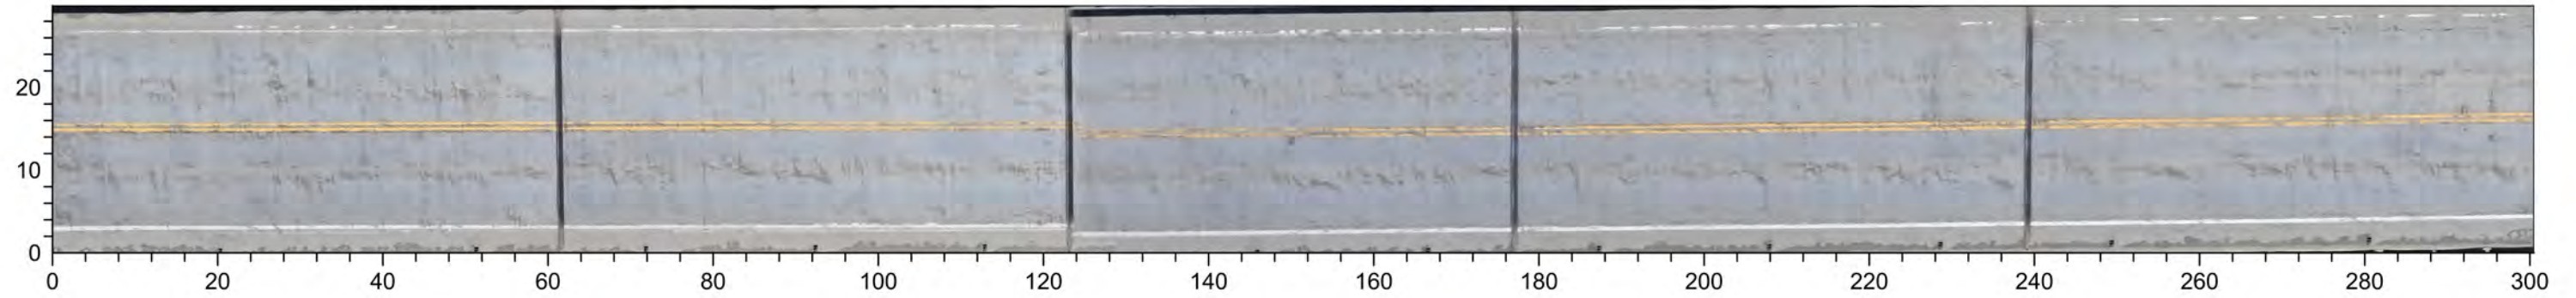
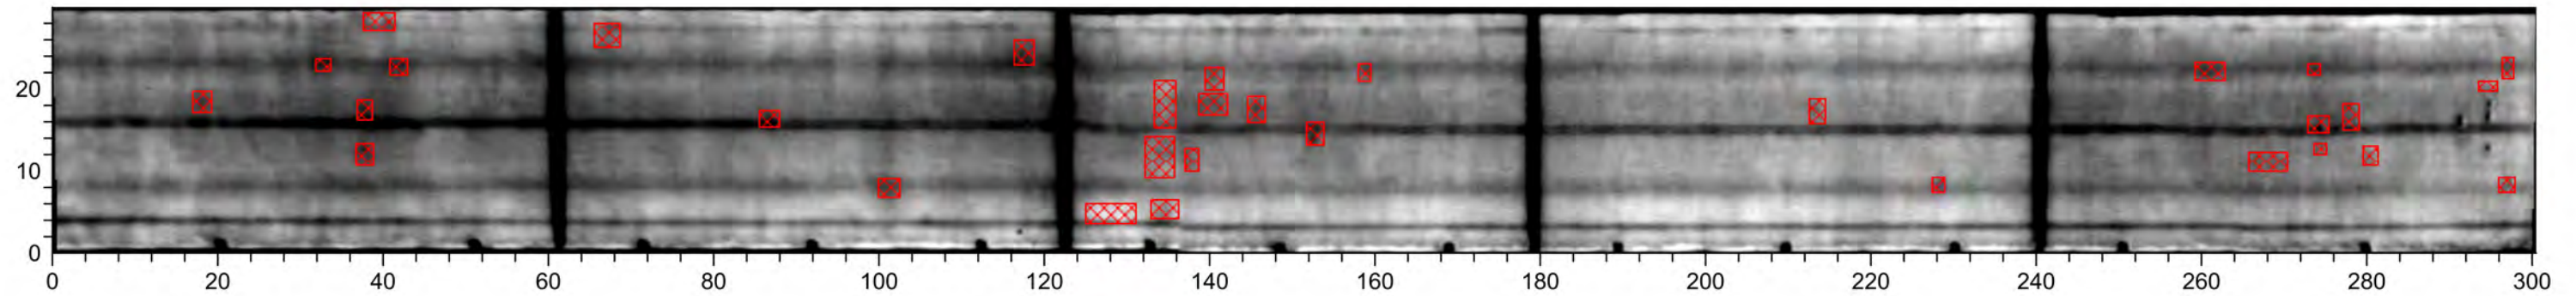
Delamination Quantity (%)    3.8 Delamination Quantity (ft <sup>2</sup> )    97	Imagery Collected: 6/5/22 Analyzed by: SB Reviewed by: AJC Completed: 10/5/22

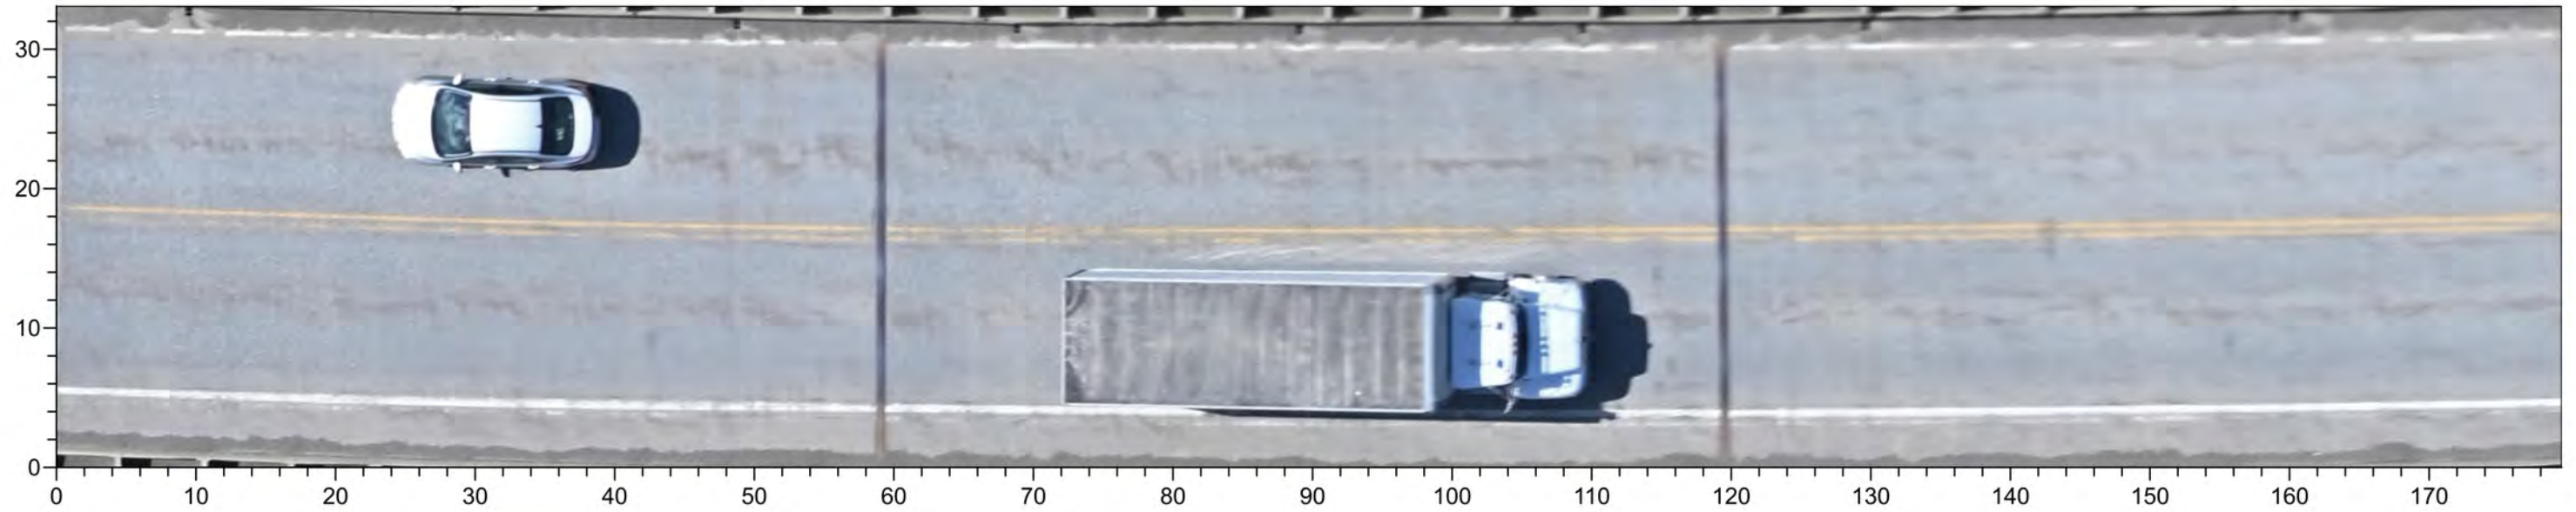
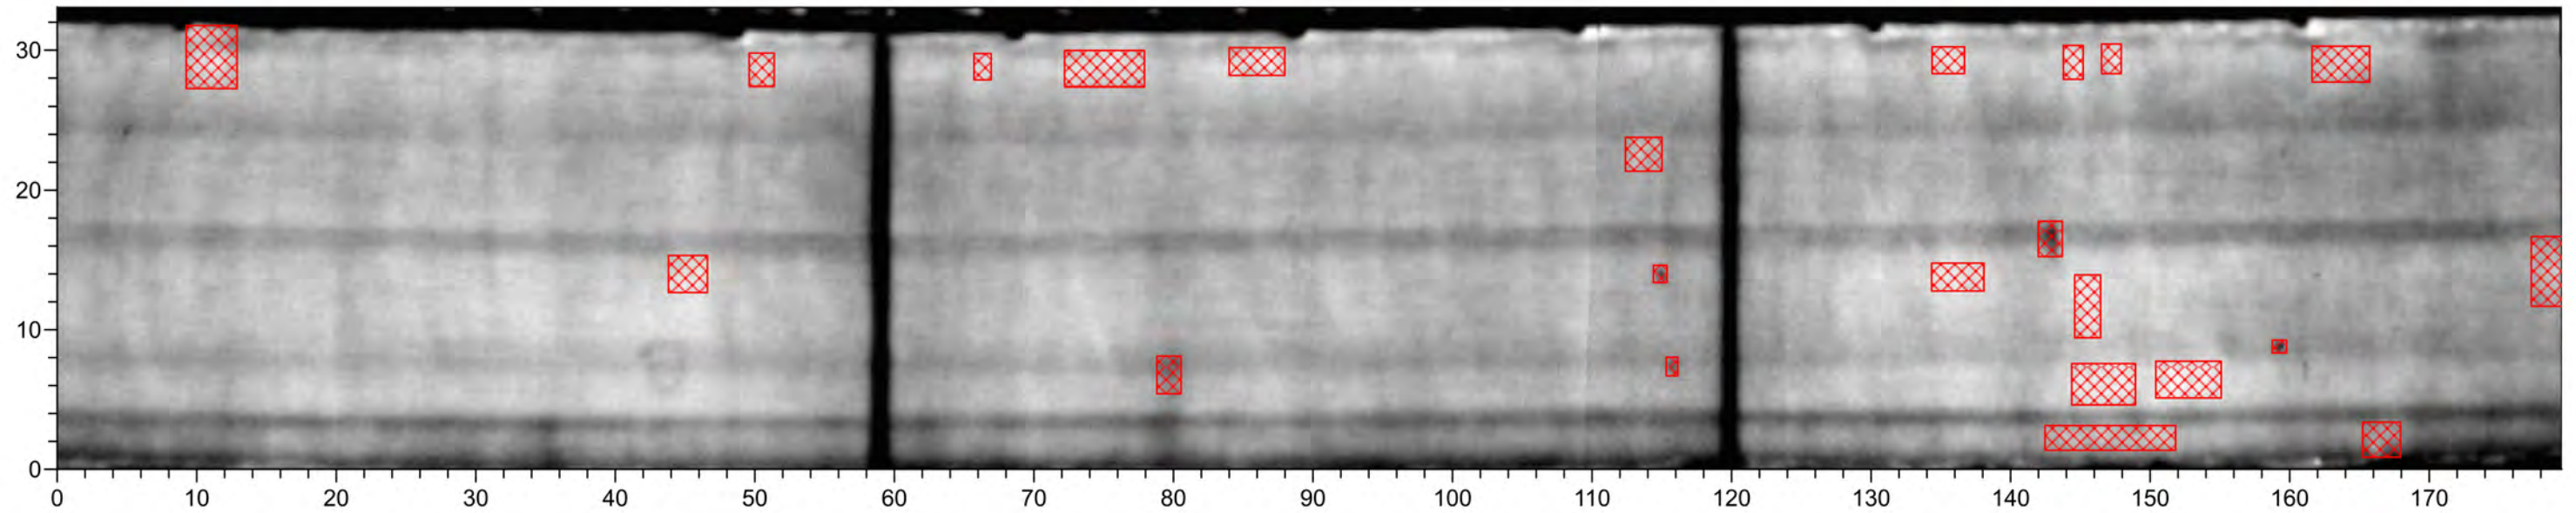
Delamination Quantity (%)    2.3	Delamination Quantity (ft <sup>2</sup> )    207	Imagery Collected: 6/5/22 Analyzed by: EG, SB Reviewed by: AJC Completed: 10/9/22

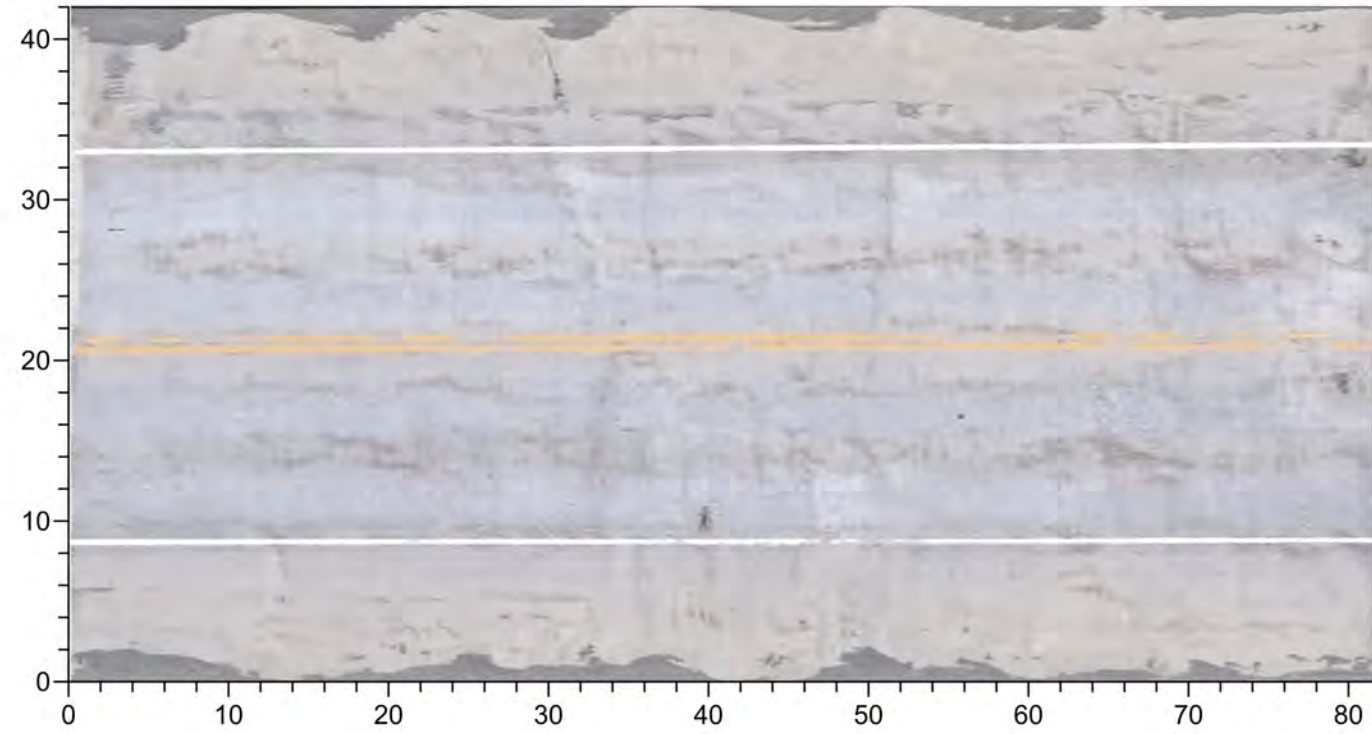
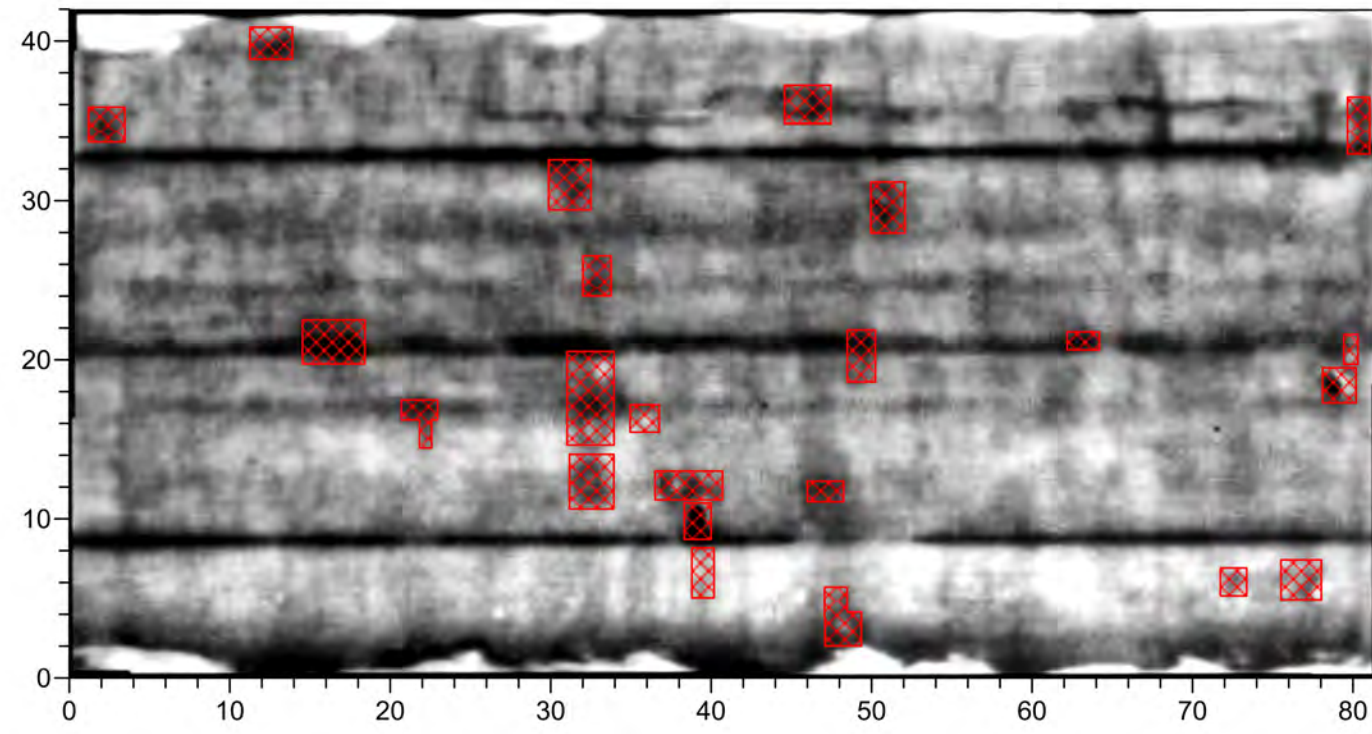
Delamination Quantity (%) 2.6 Delamination Quantity (ft <sup>2</sup> ) 157	Imagery Collected: 6/5/22 Analyzed by: SB Reviewed by: AJC Completed: 10/5/22

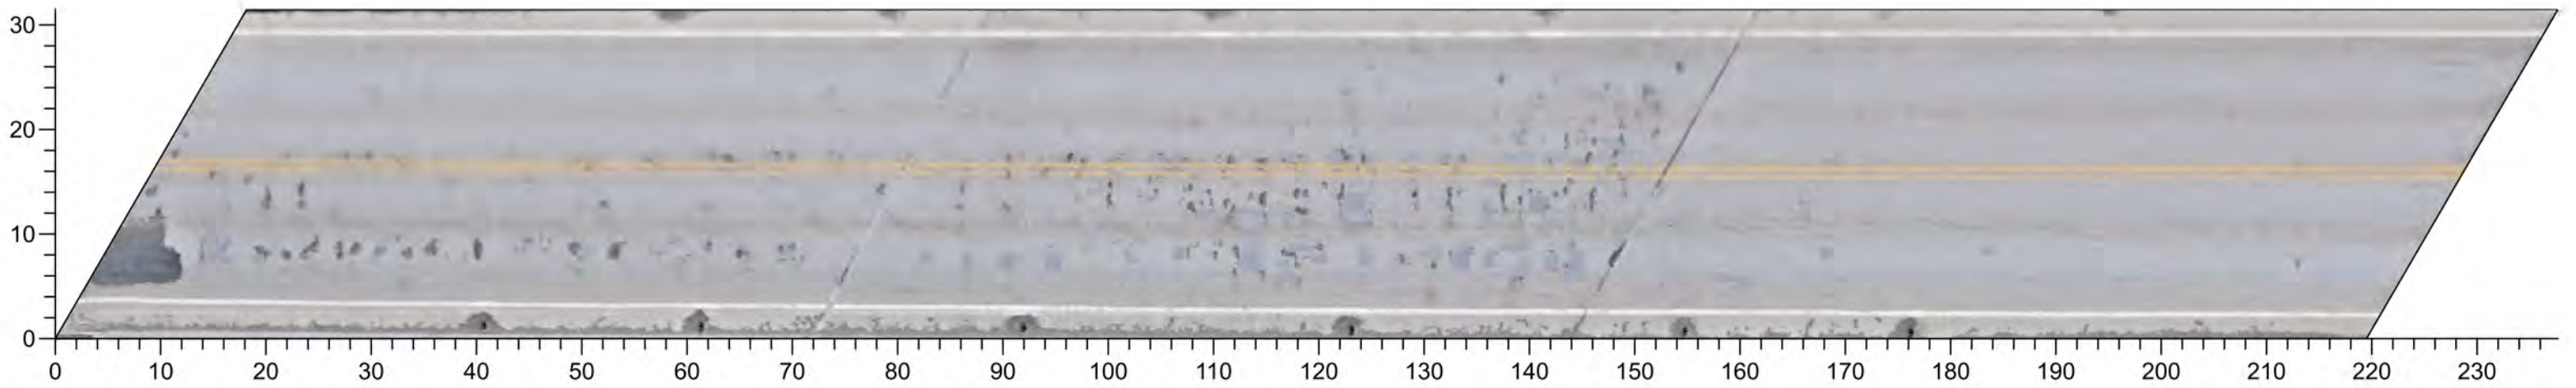
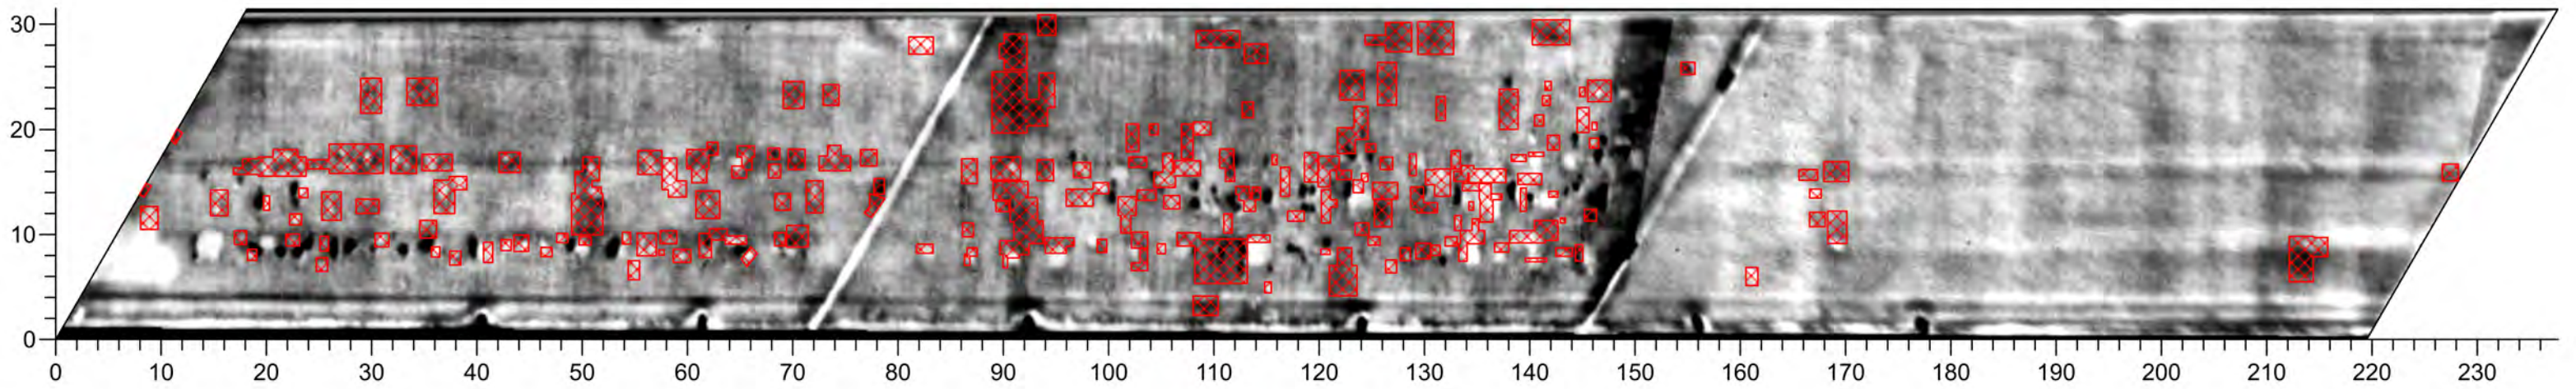
Delamination Quantity (%) 4.0		Imagery Collected: 6/5/22 Analyzed by: EG, SB Reviewed by: AJC Completed: 10/9/22	
		Delamination Quantity (ft <sup>2</sup> ) 136

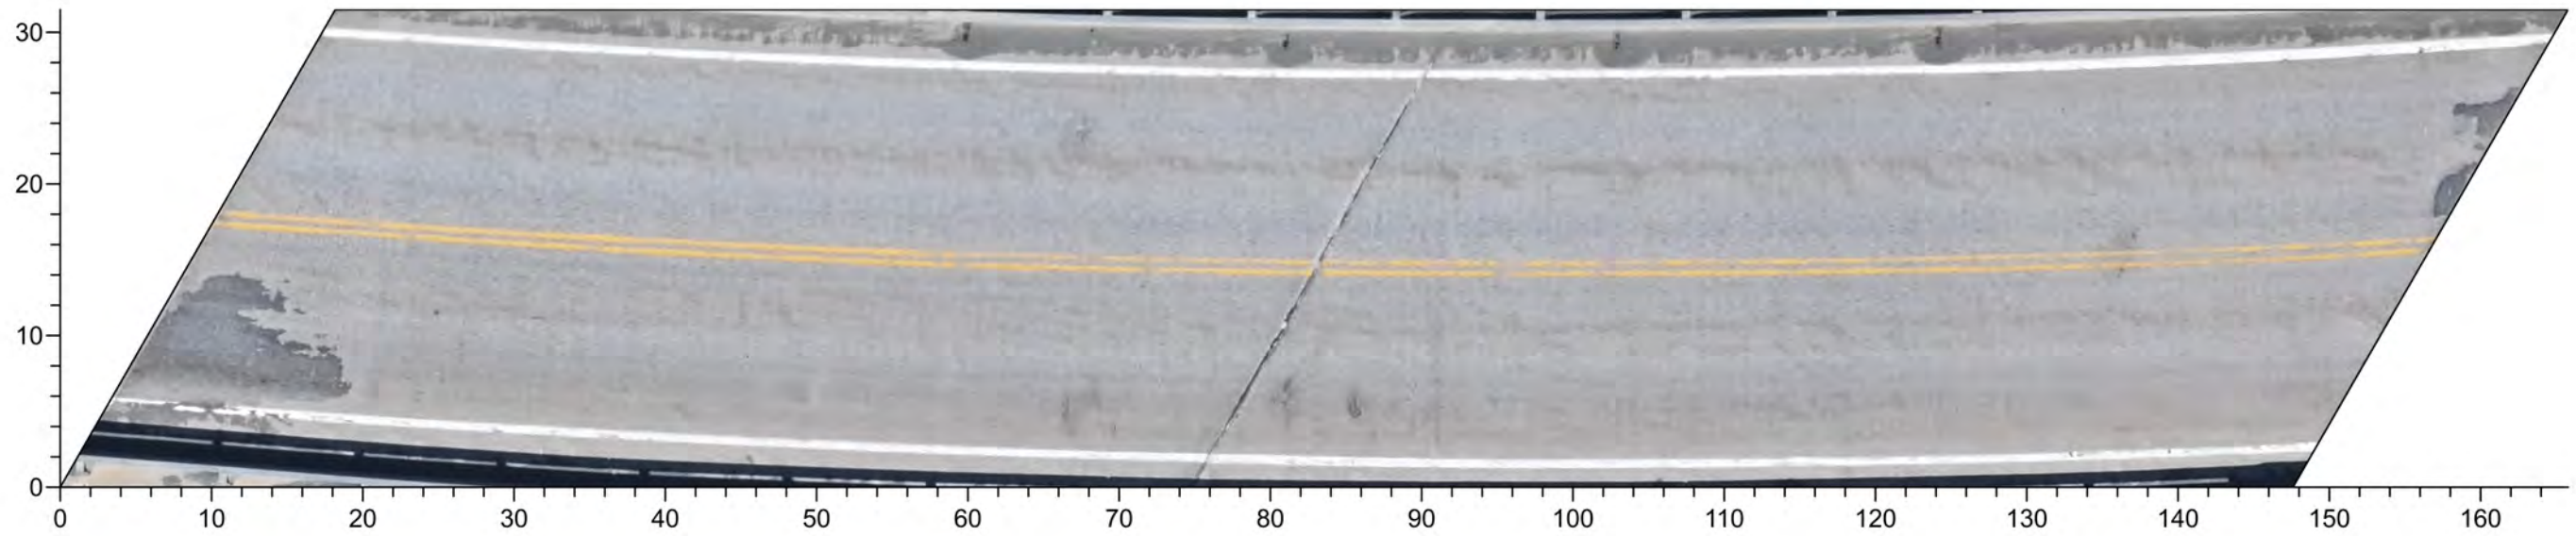
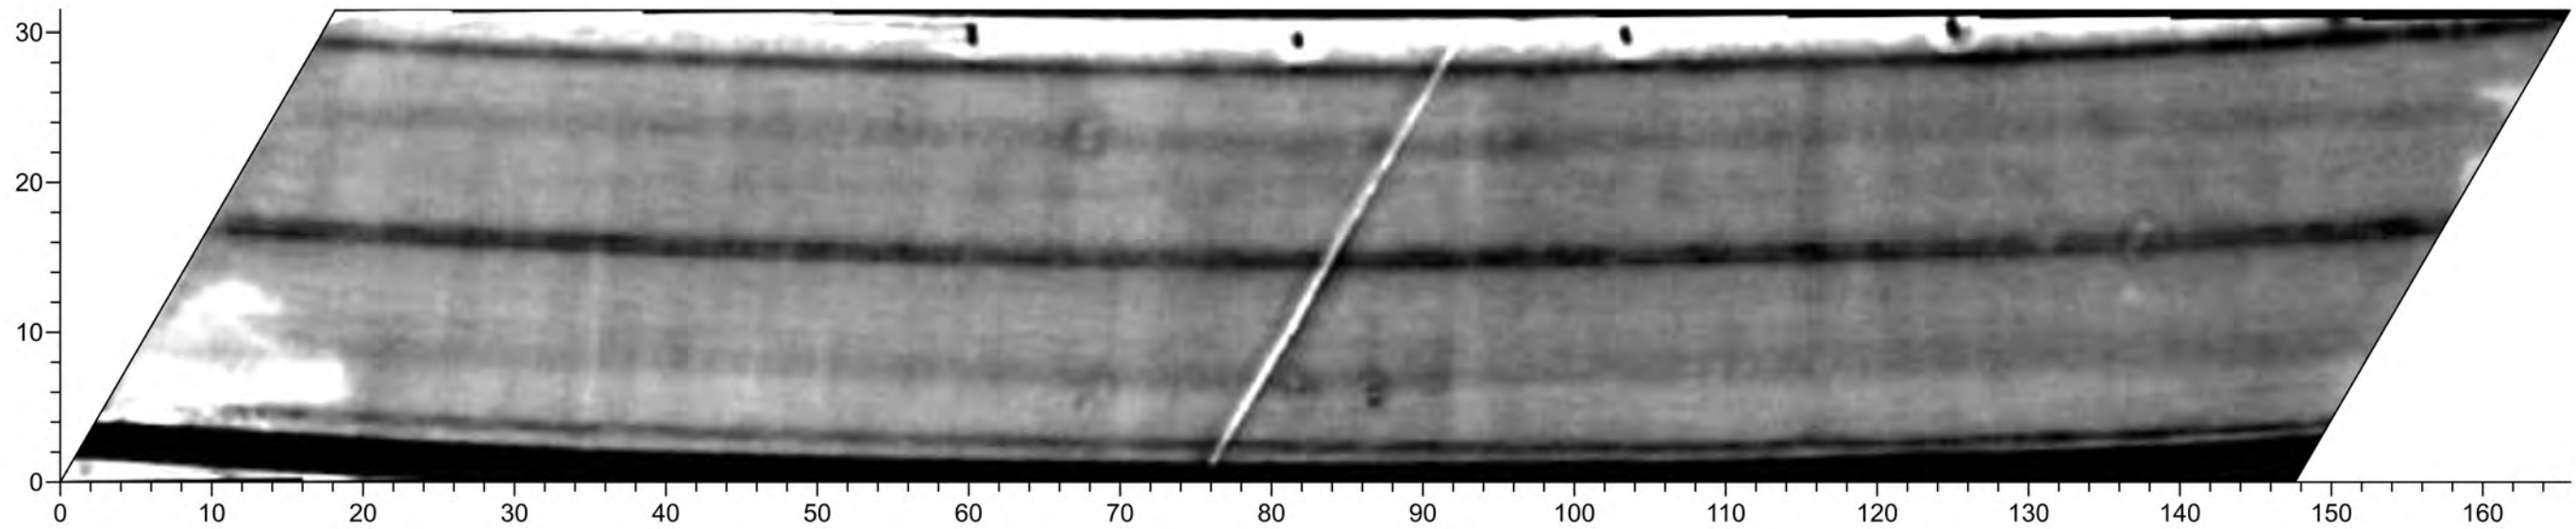
Delamination Quantity (%)    8.5		Imagery Collected: 6/5/22 Analyzed by: EG, SB Reviewed by: AJC Completed: 10/10/22	
			Delamination Quantity (ft <sup>2</sup> )    591

Note: Delamination locations not shown as quantity is less than 2%.

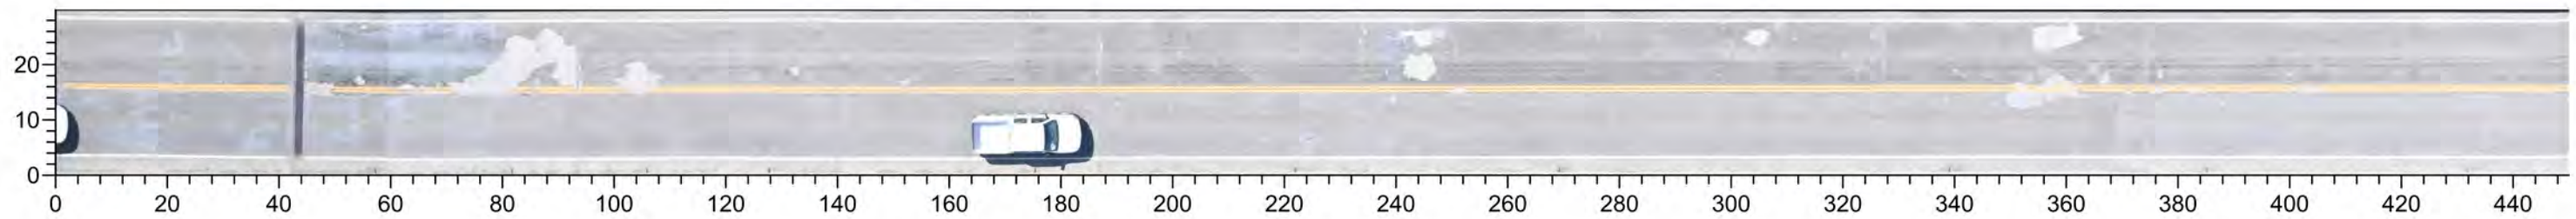
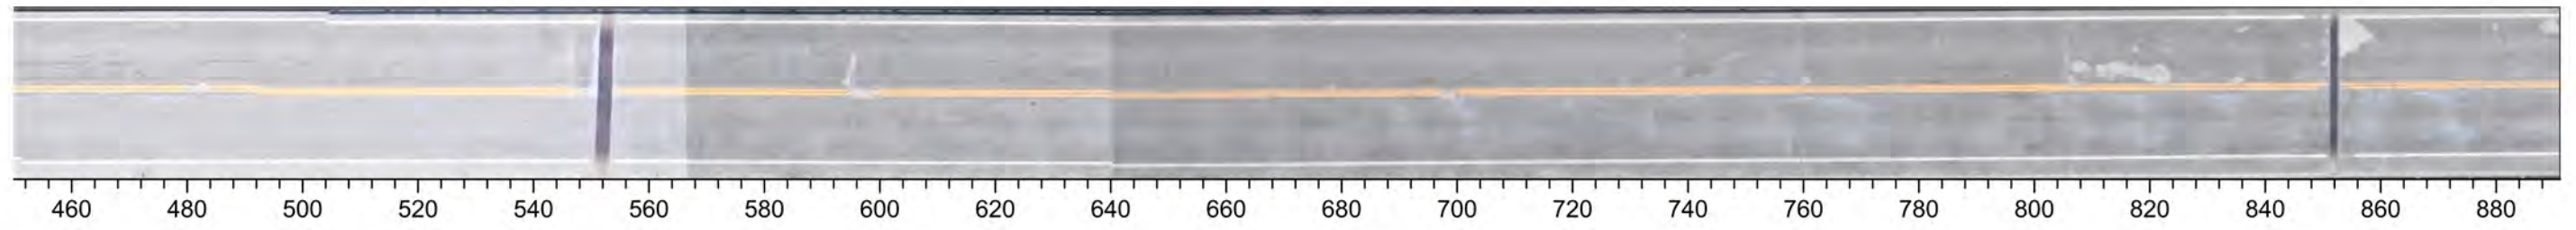
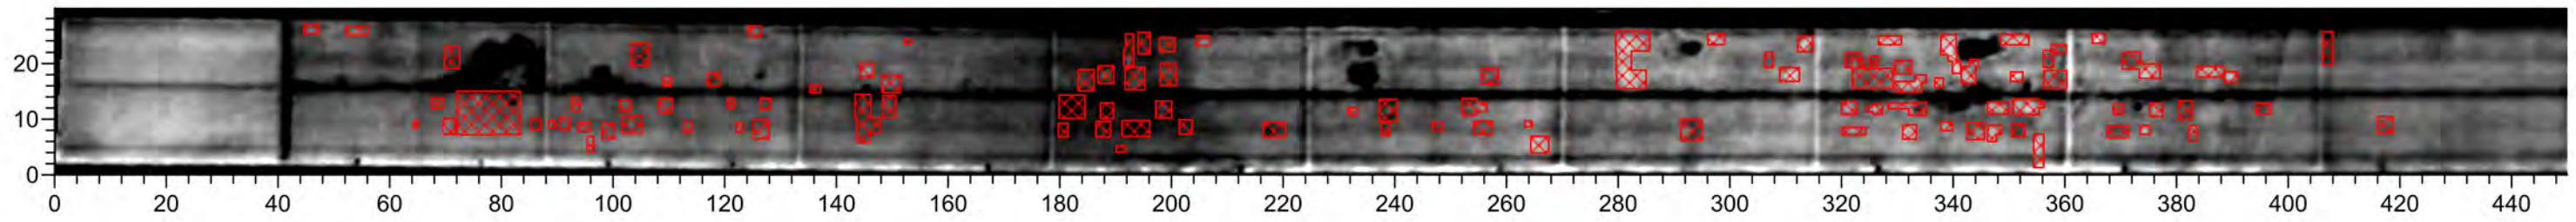
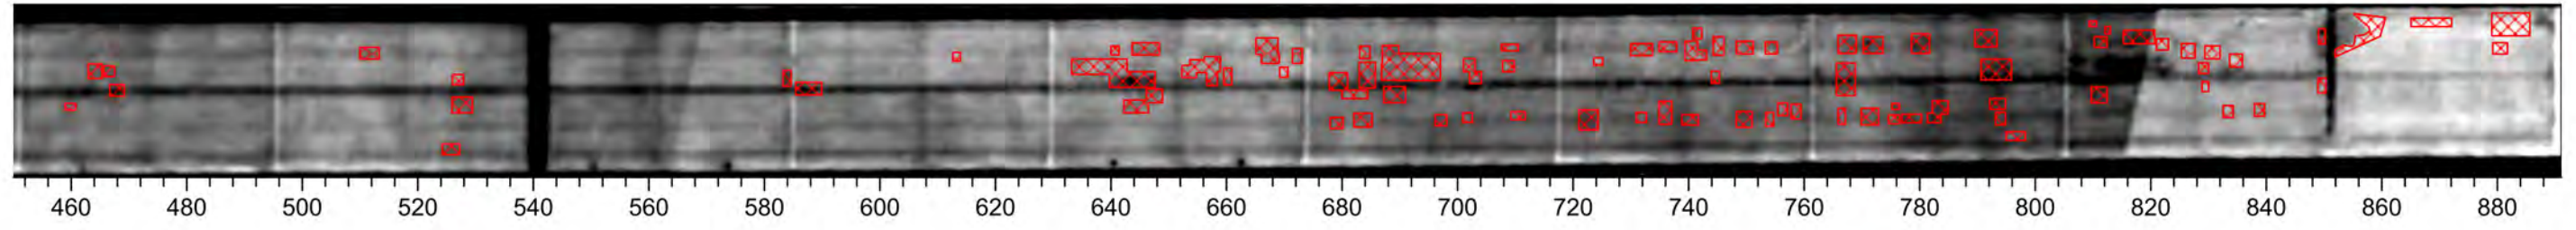
Delamination Quantity (%)	1.3	Imagery Collected: 6/5/22 Analyzed by: SB Reviewed by: AJC Completed: 10/10/22	
		Delamination Quantity (ft <sup>2</sup> )	63
