# Aerial Infrared Scanning of Bridge Decks on Parks Highway to Map Delaminations

## FINAL REPORT

**Prepared by:**  
Infrasense, Inc.  
Woburn, MA

**Report # FHWA-AK-RD-000S(960)**  
**March 2, 2023**

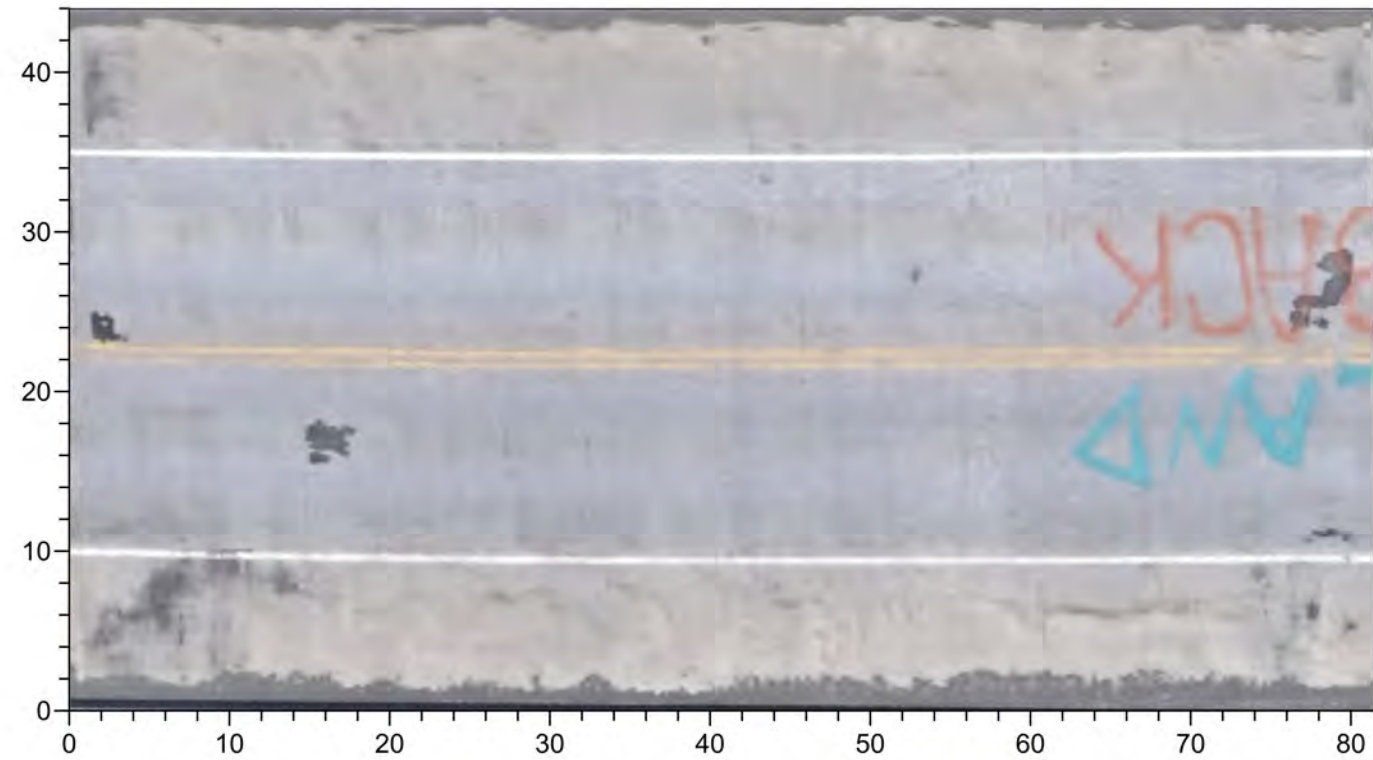
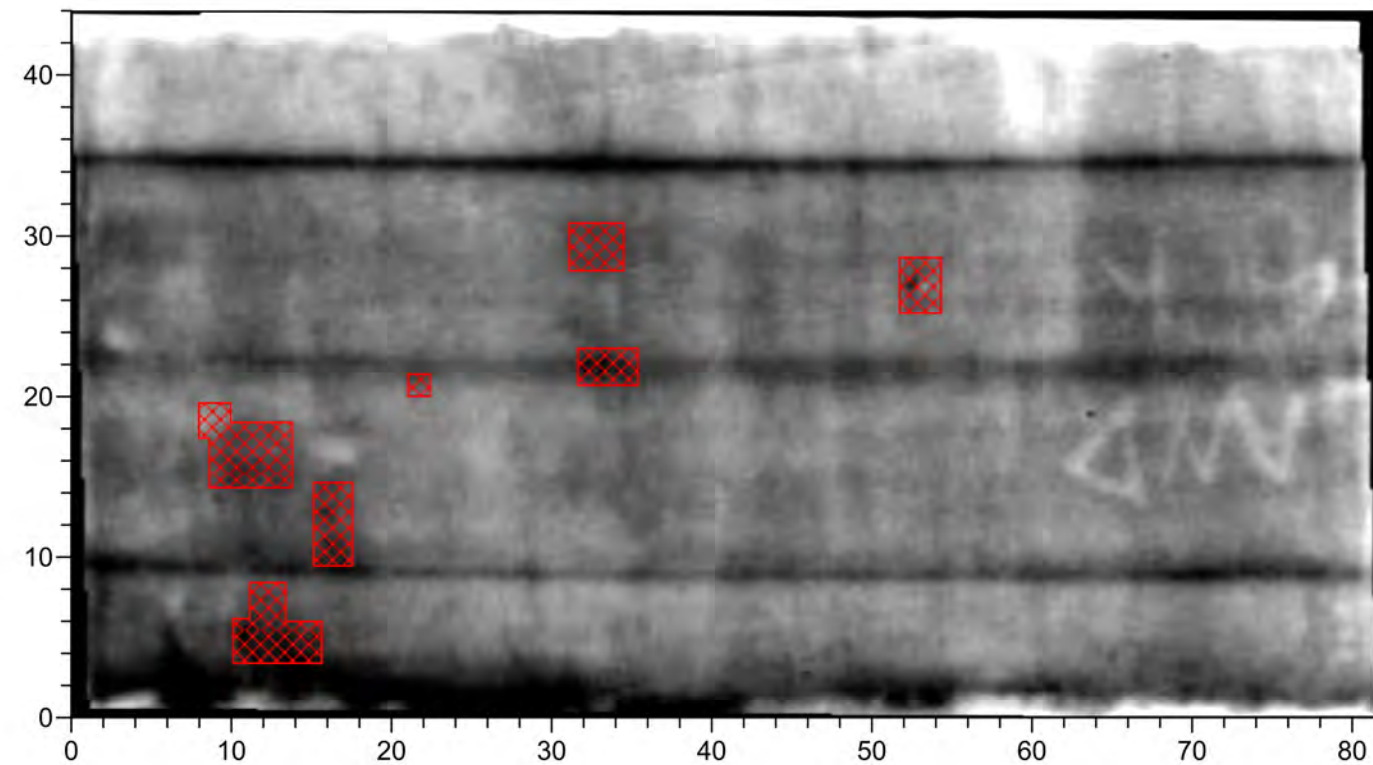
Delamination Quantity (%)    5.8 Delamination Quantity (ft <sup>2</sup> )    1546	Imagery Collected: 6/5/22 Analyzed by: EG, SB Reviewed by: AJC Completed: 10/10/22

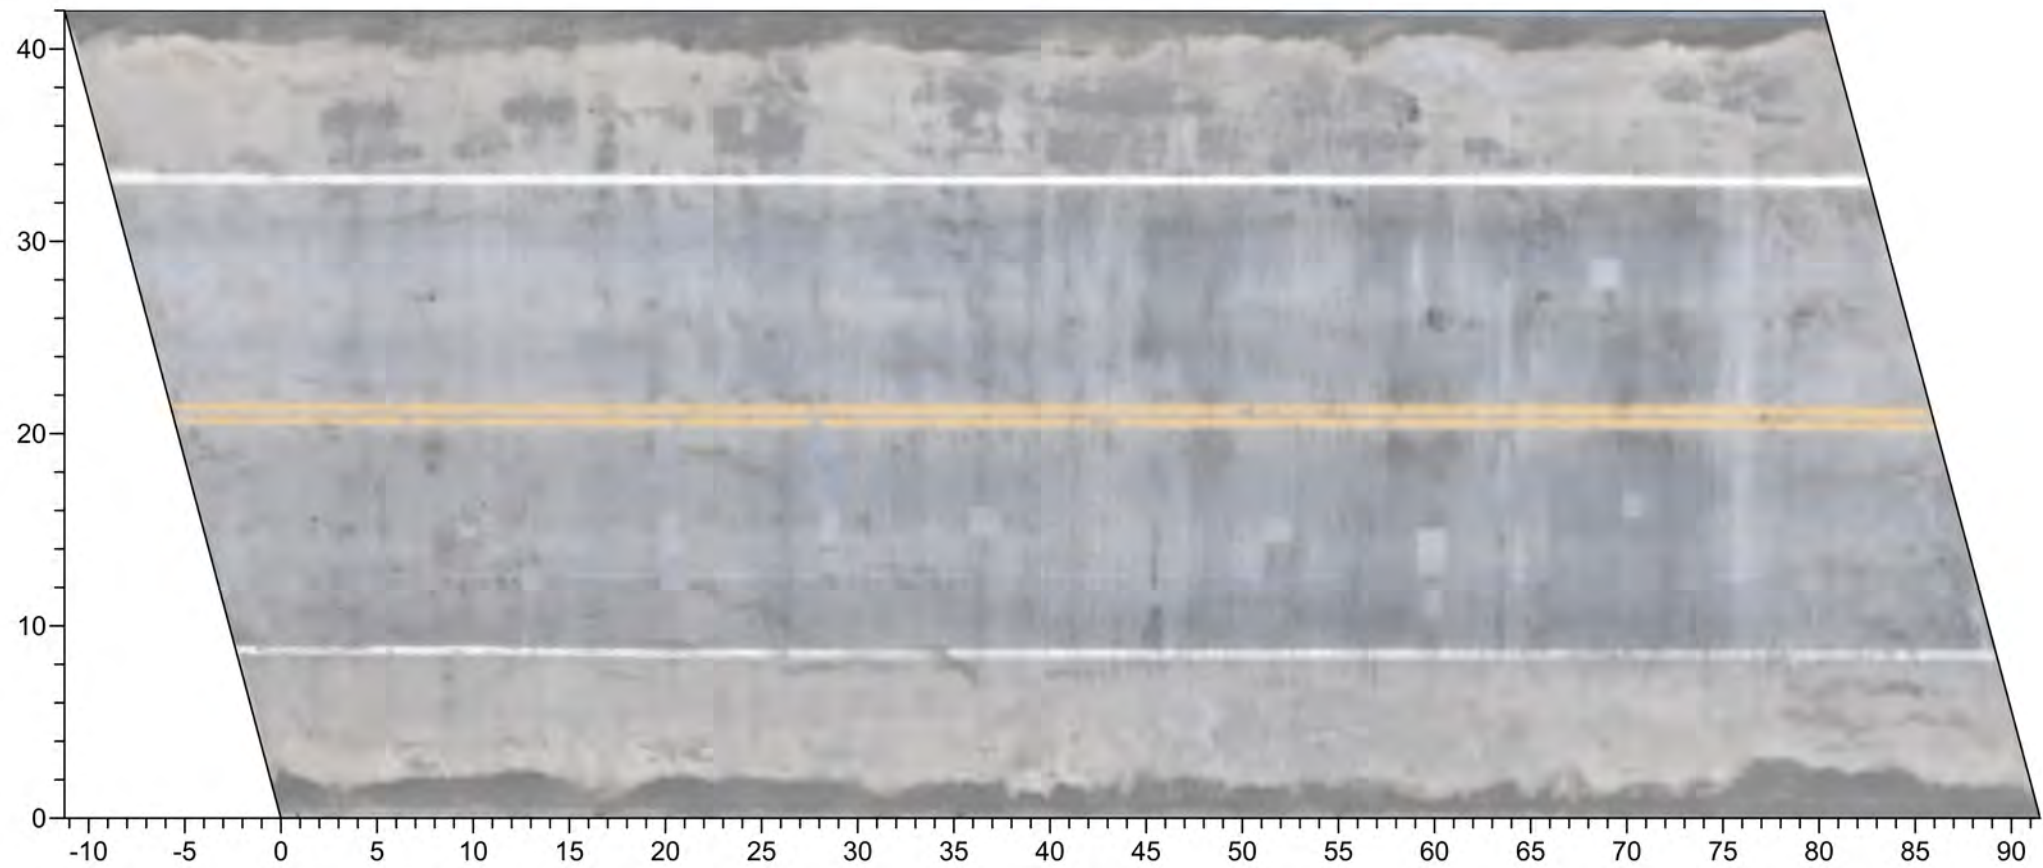
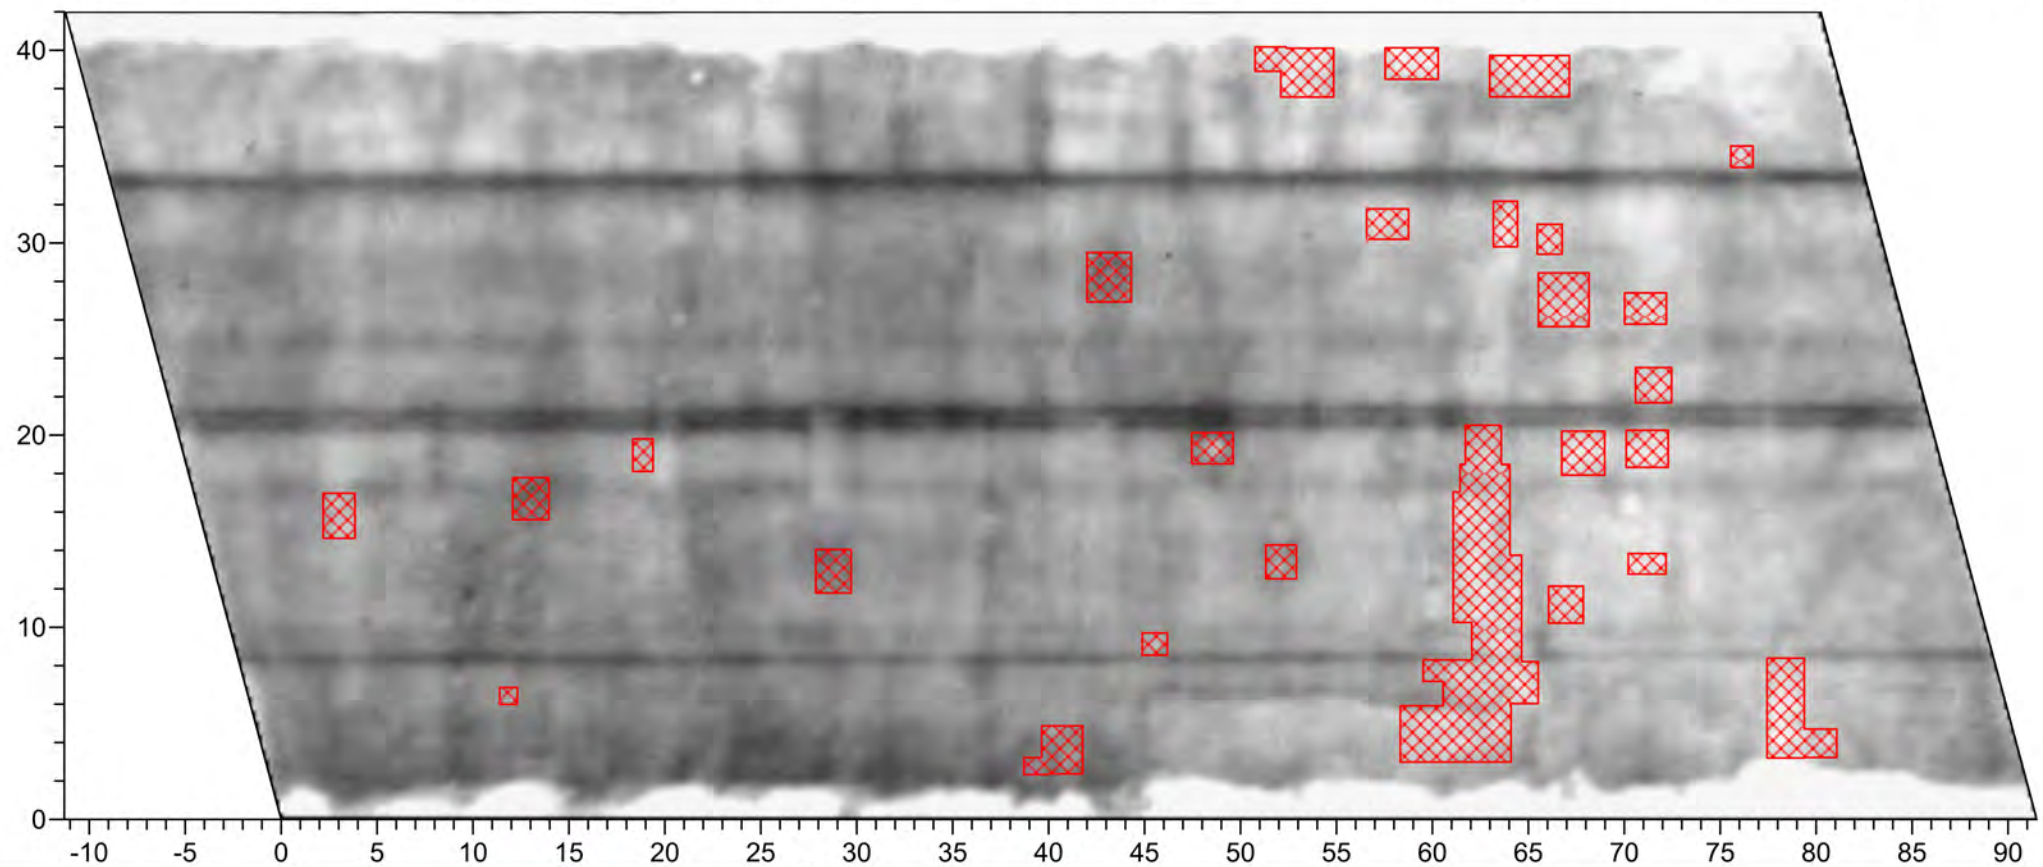
Delamination Quantity (%)    2.4		Imagery Collected: 6/5/22 Analyzed by: EG, SB Reviewed by: AJC Completed: 10/10/22	
			Delamination Quantity (ft <sup>2</sup> )    87

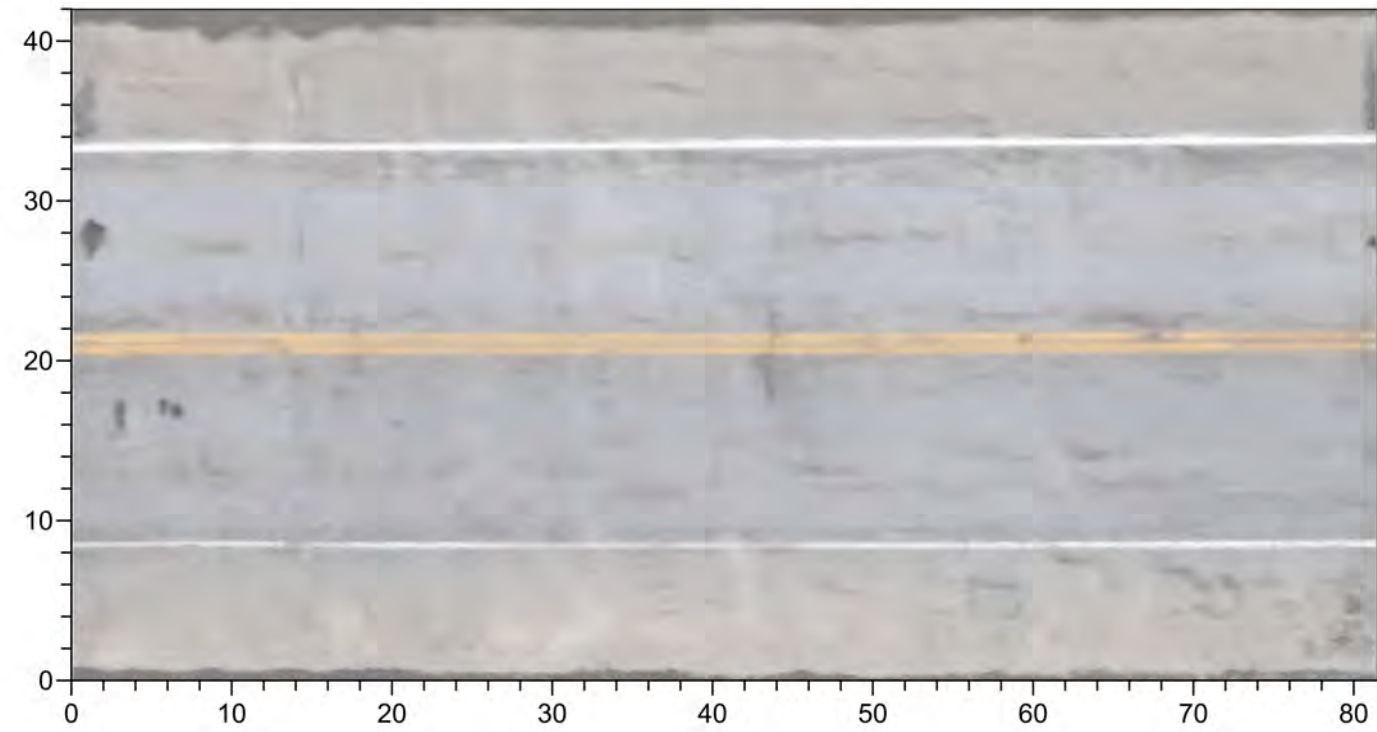
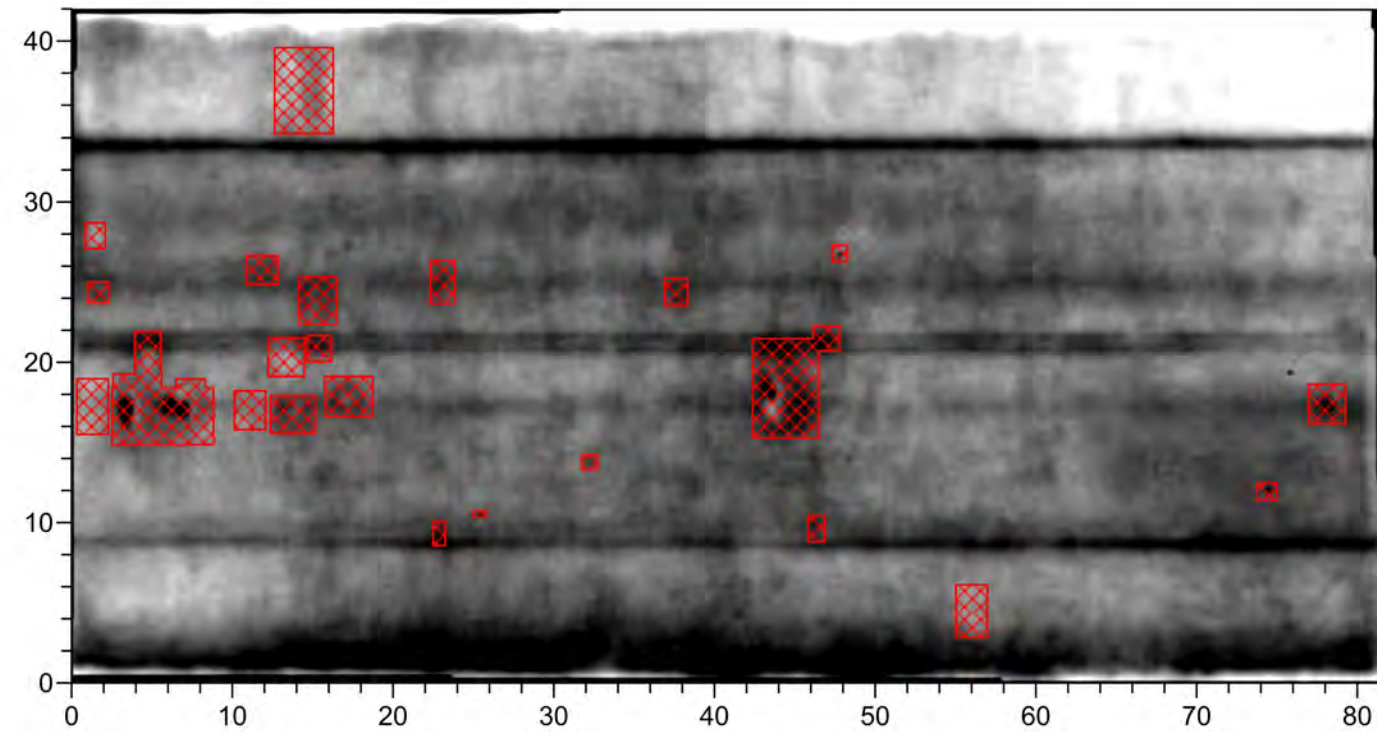
Delaminations Detected by Aerial Infrared	Delamination Quantity (%)	4.5	Imagery Collected: 6/5/22 Analyzed by: SB Reviewed by: AJC Completed: 10/10/22	Bridge No.: 1145 HORNET CREEK PARKS HIGHWAY
			Delamination Quantity (ft <sup>2</sup> )	173

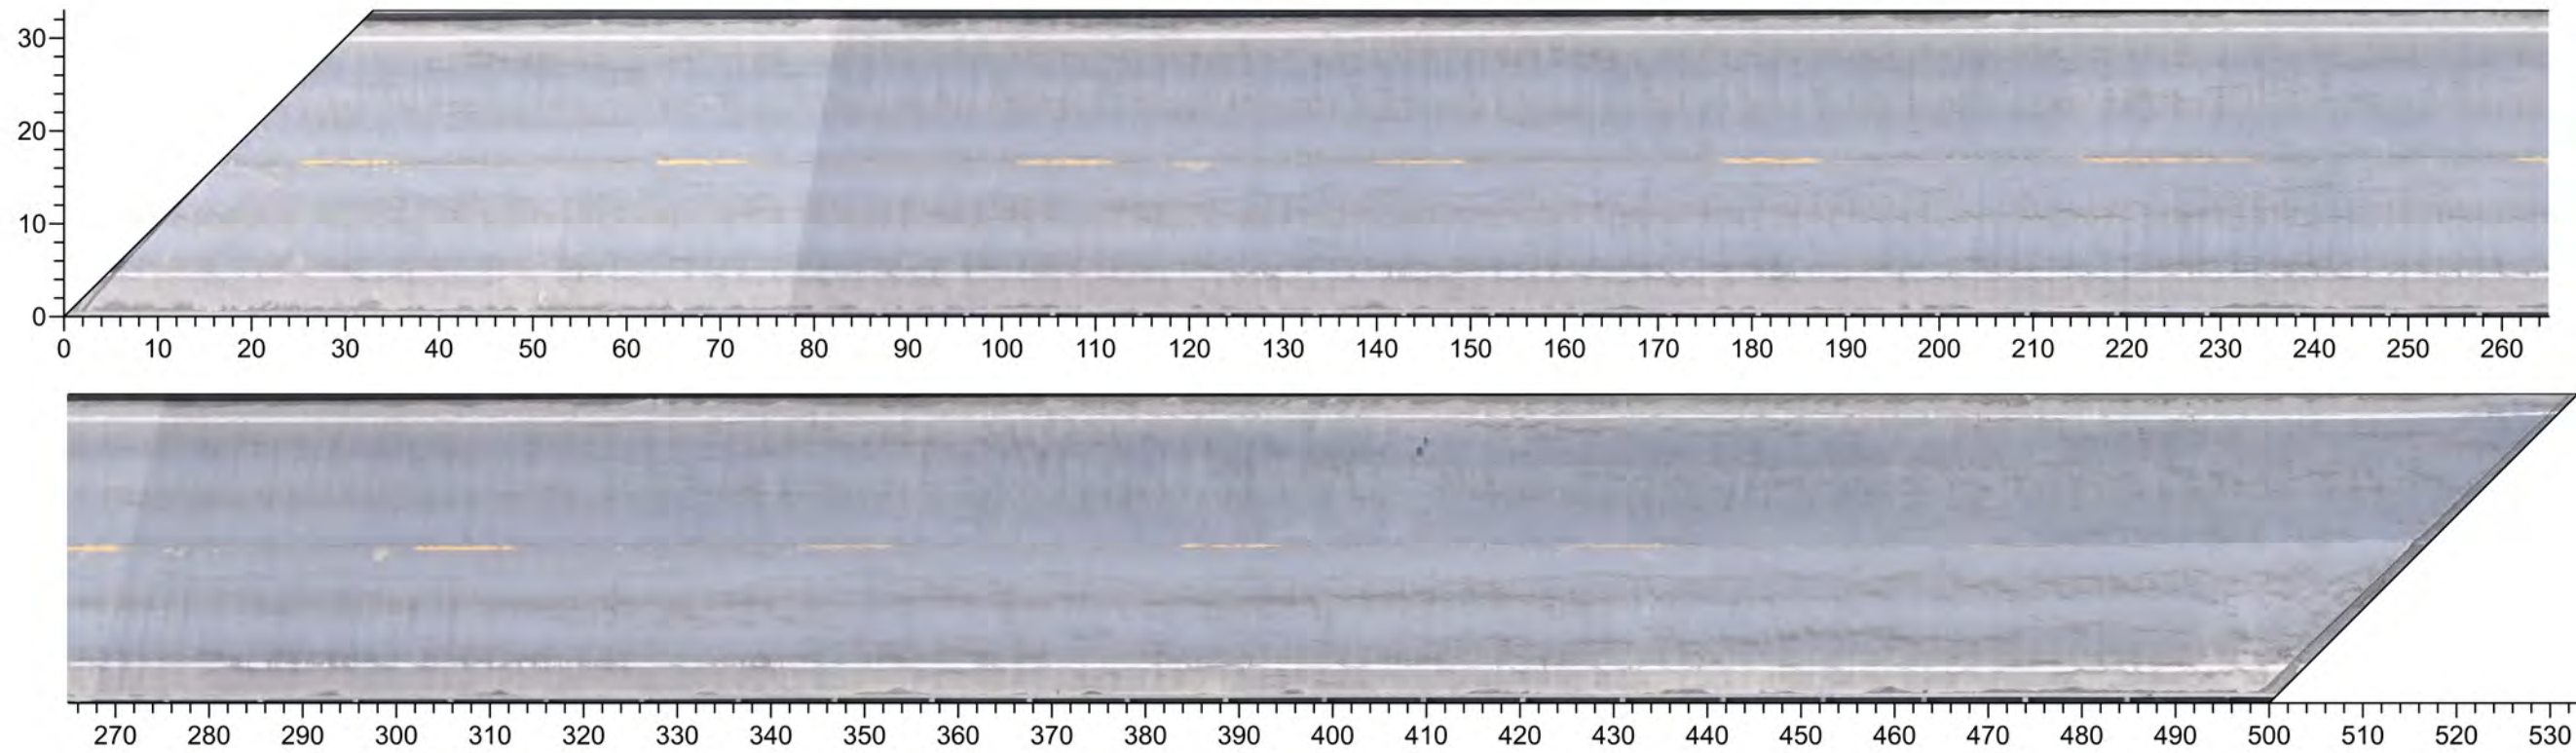
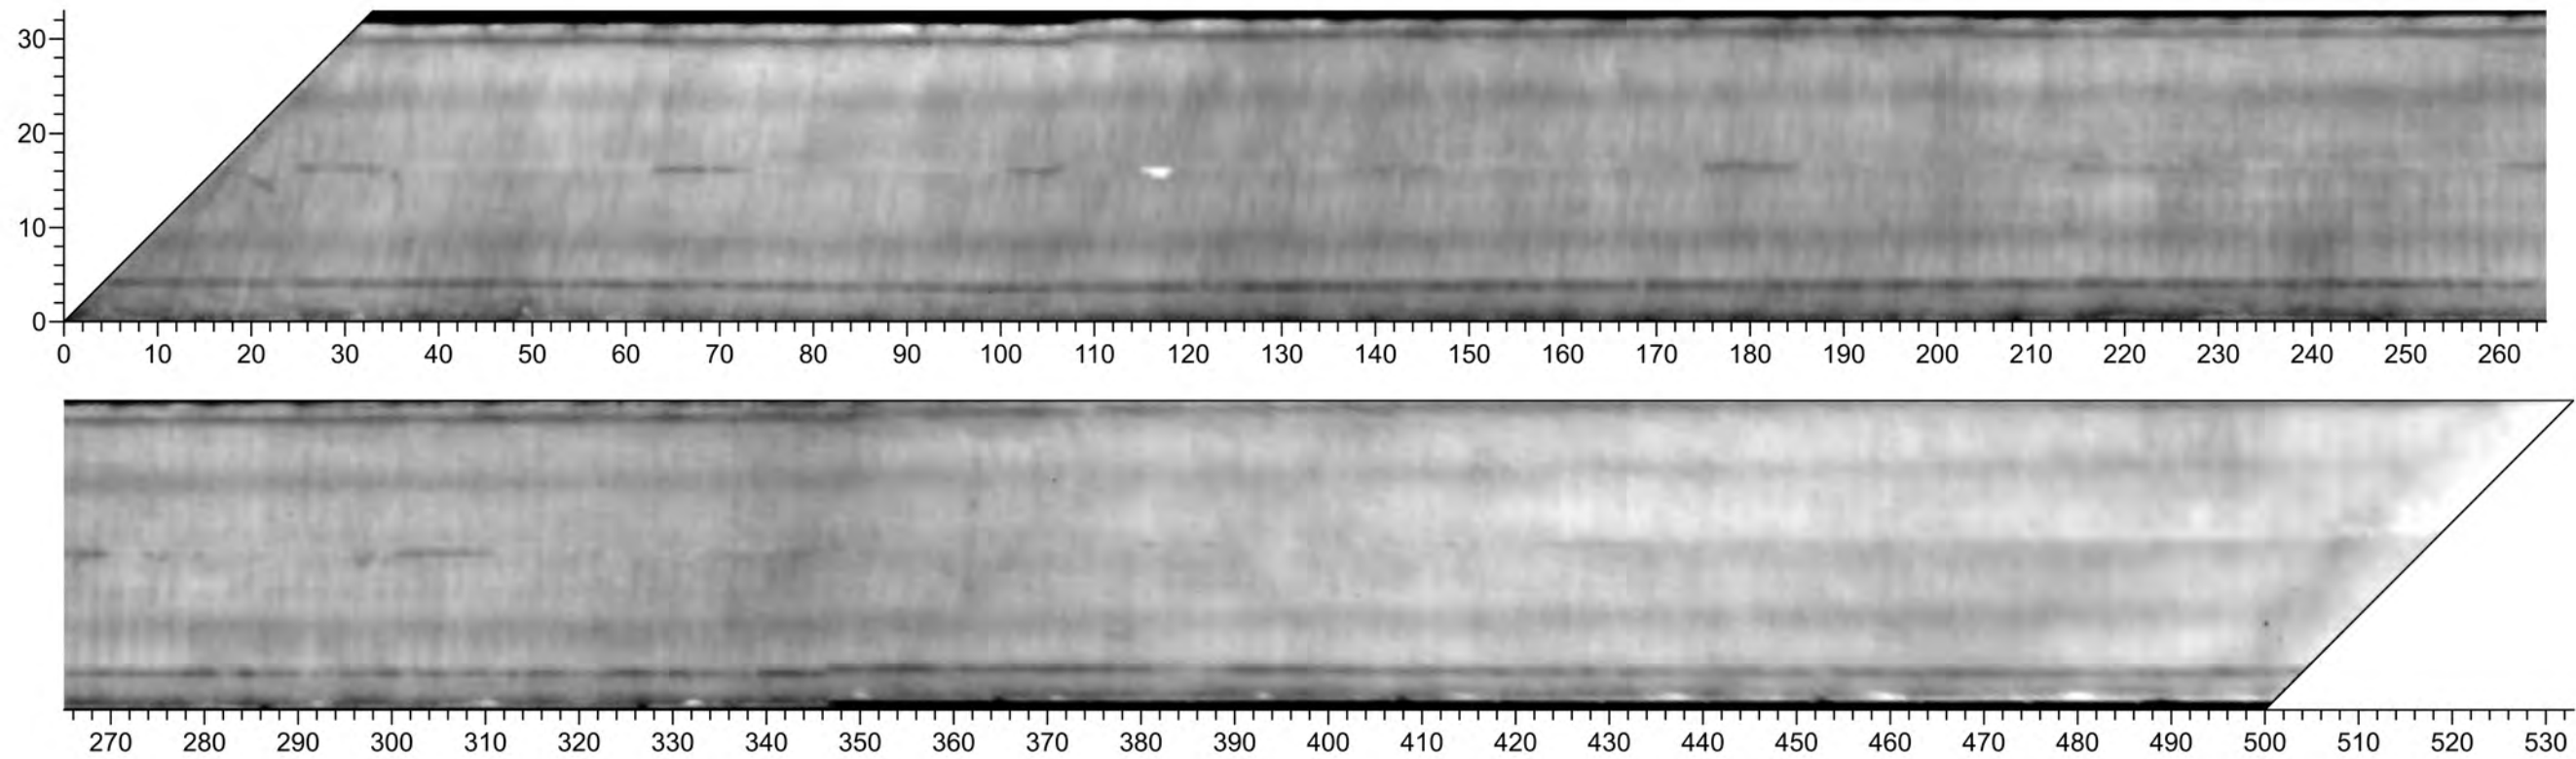
Delamination Quantity (%) 4.4		Imagery Collected: 6/5/22 Analyzed by: EG, SB Reviewed by: AJC Completed: 10/10/22	
			Delamination Quantity (ft <sup>2</sup> ) 151

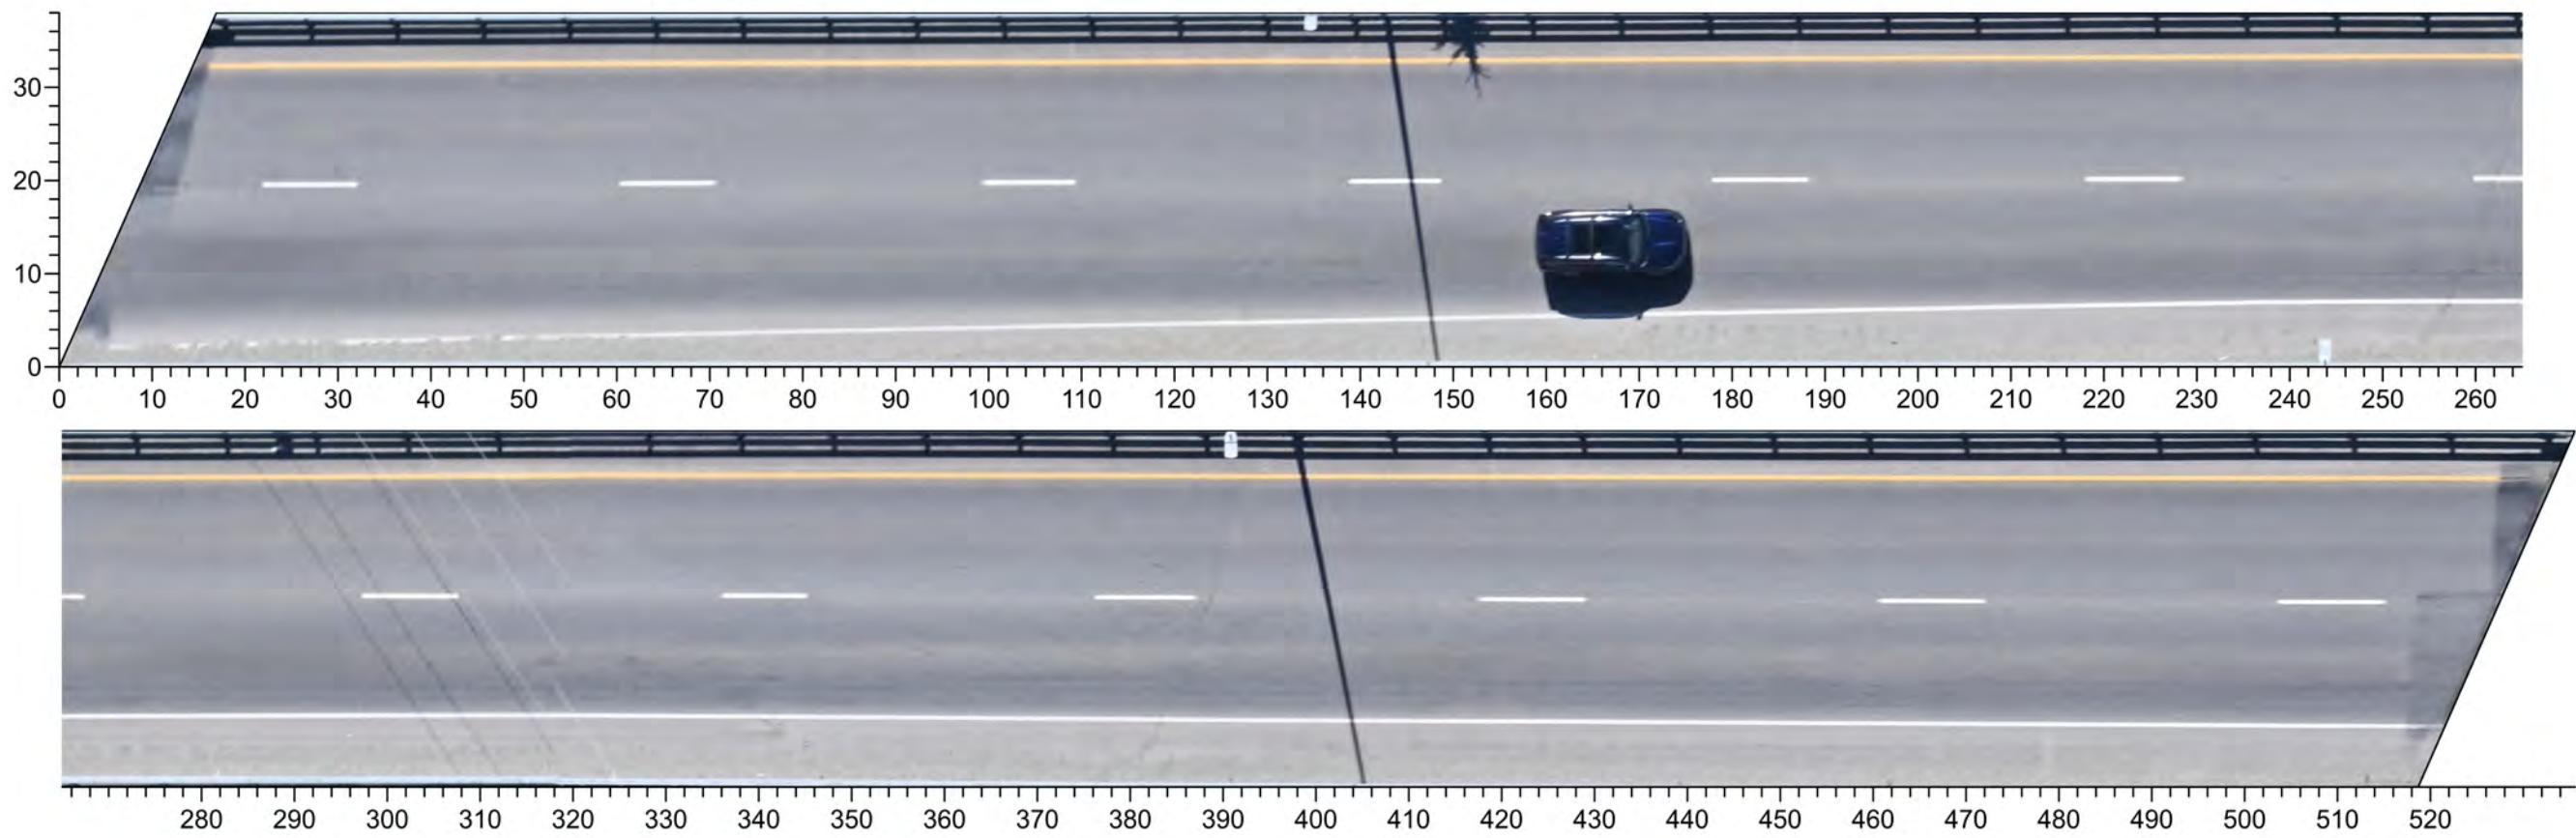
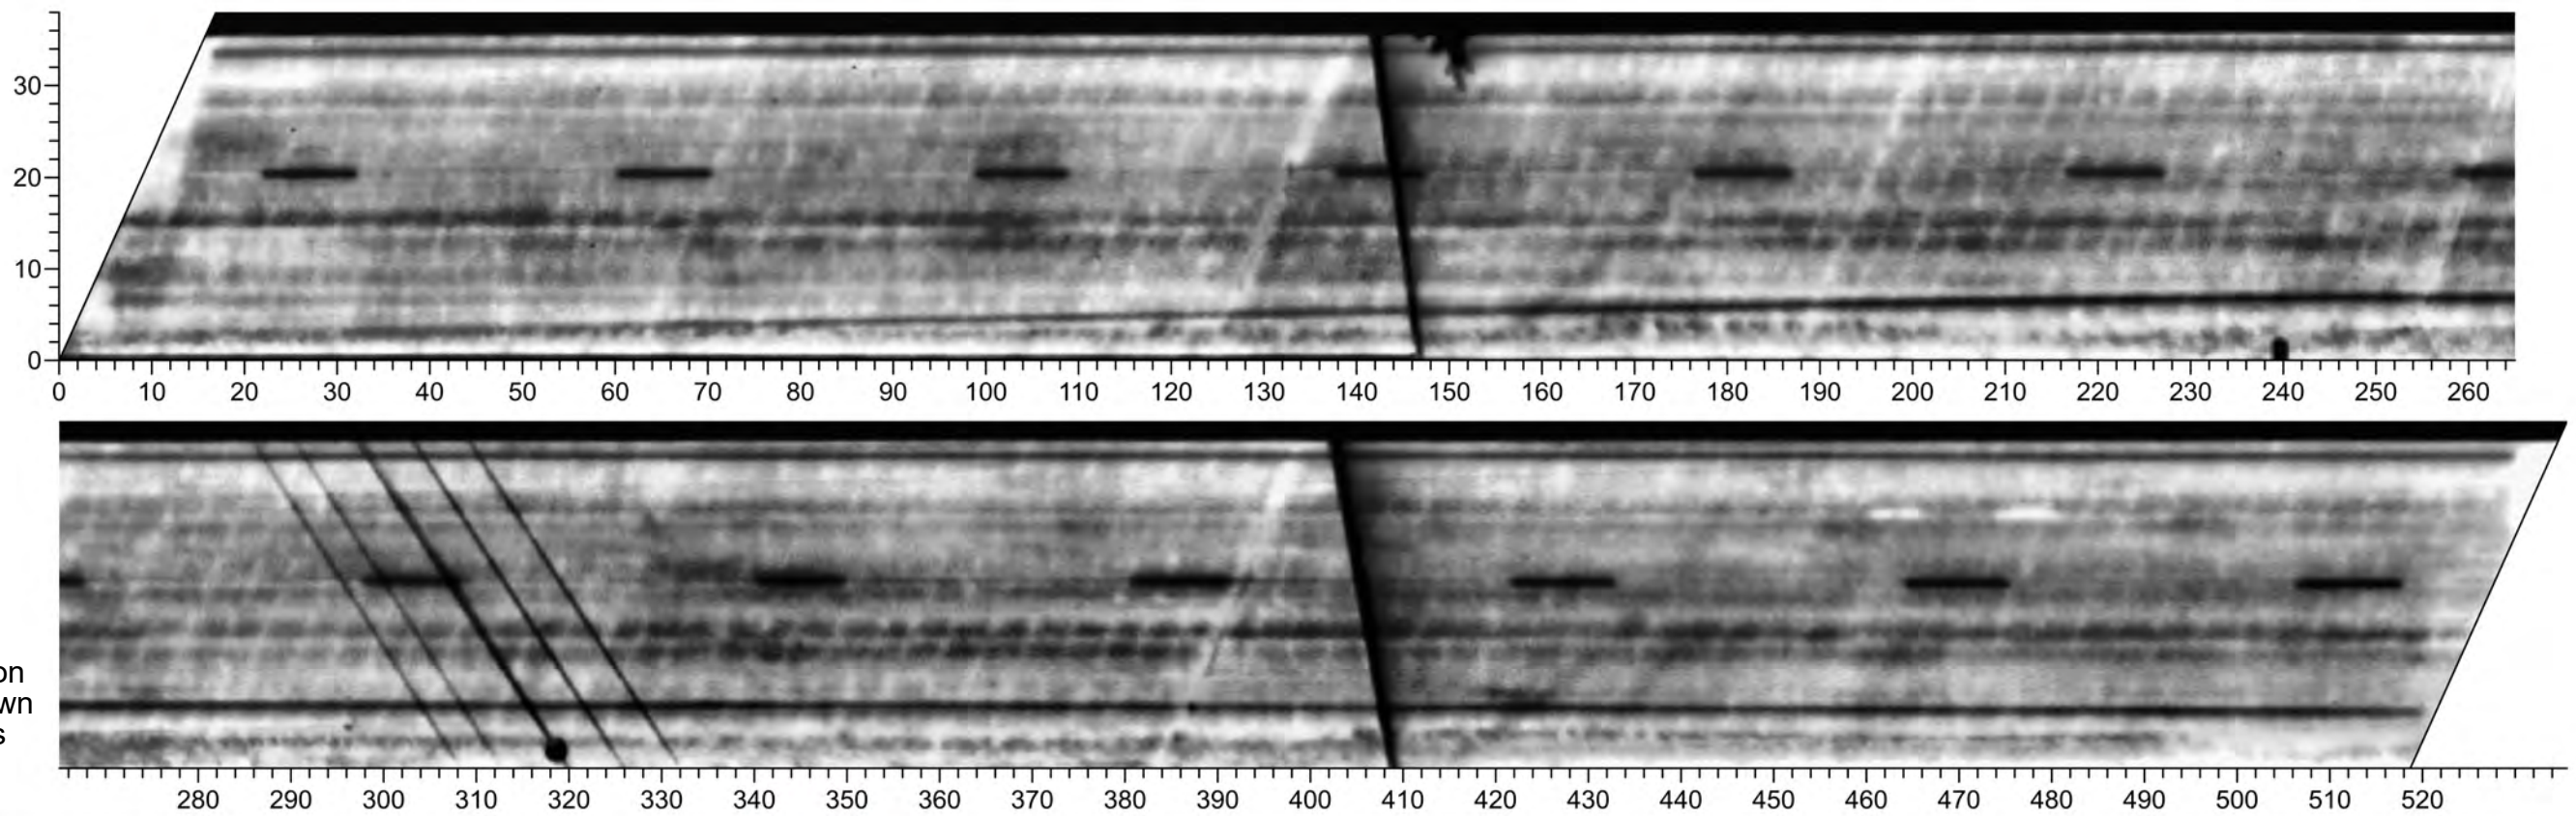
Delamination Quantity (%) 0.9 Delamination Quantity (ft <sup>2</sup> ) 155	Imagery Collected: 6/5/22 Analyzed by: SB Reviewed by: AJC Completed: 10/10/22

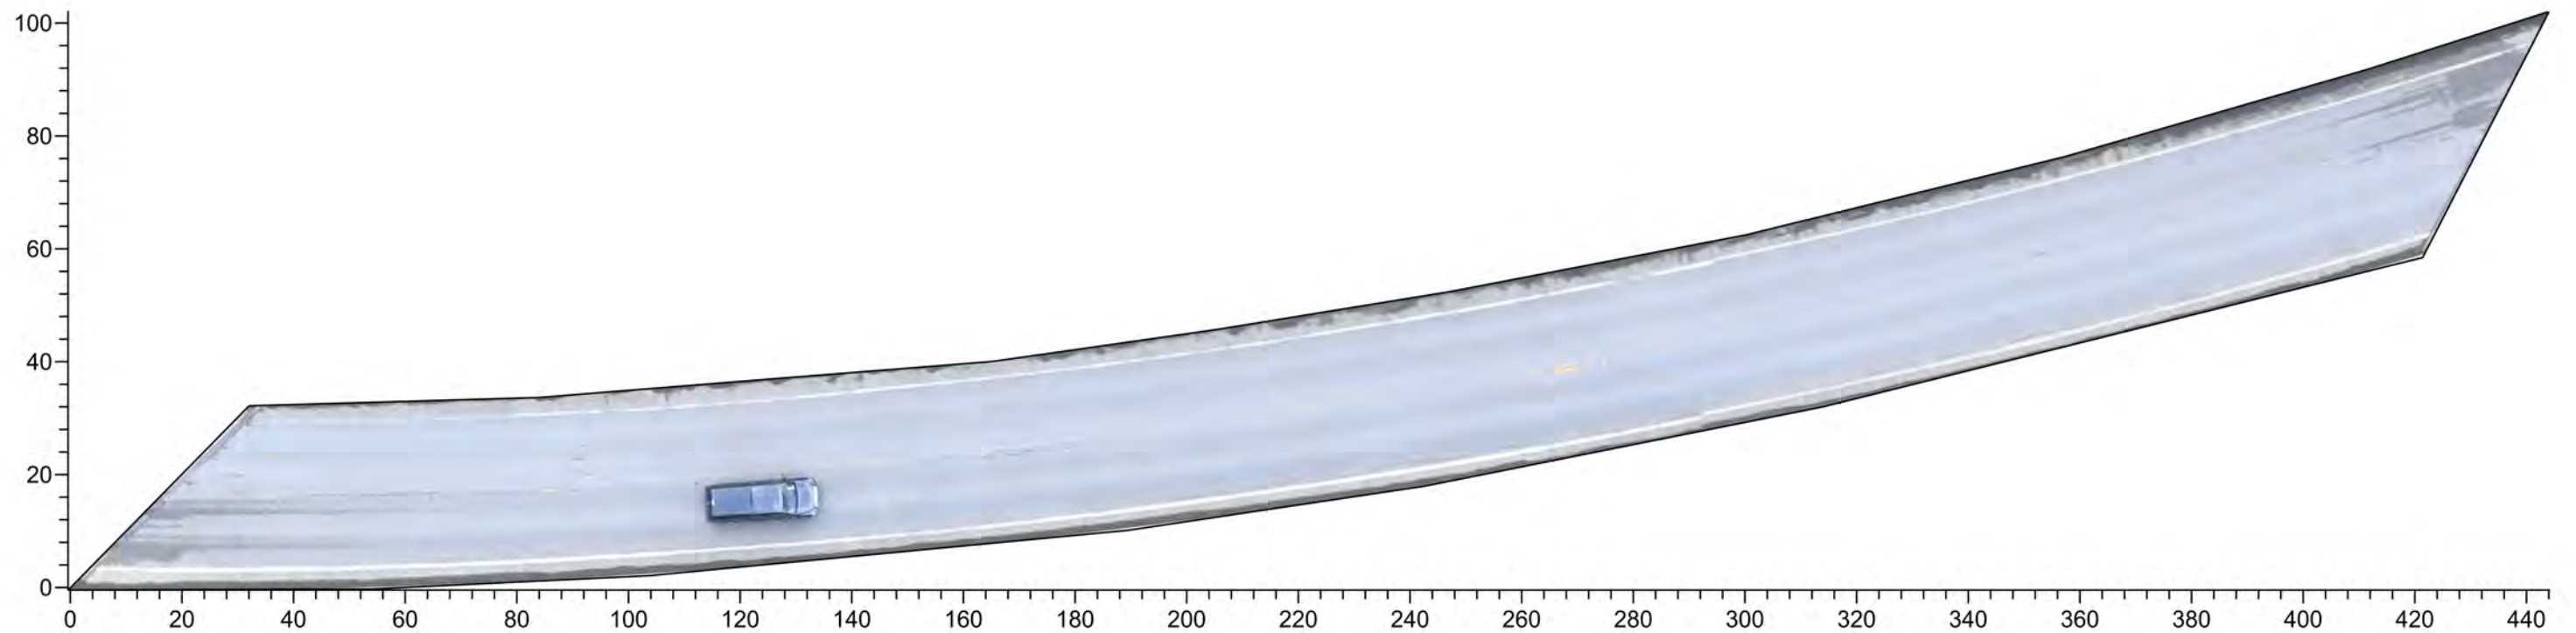
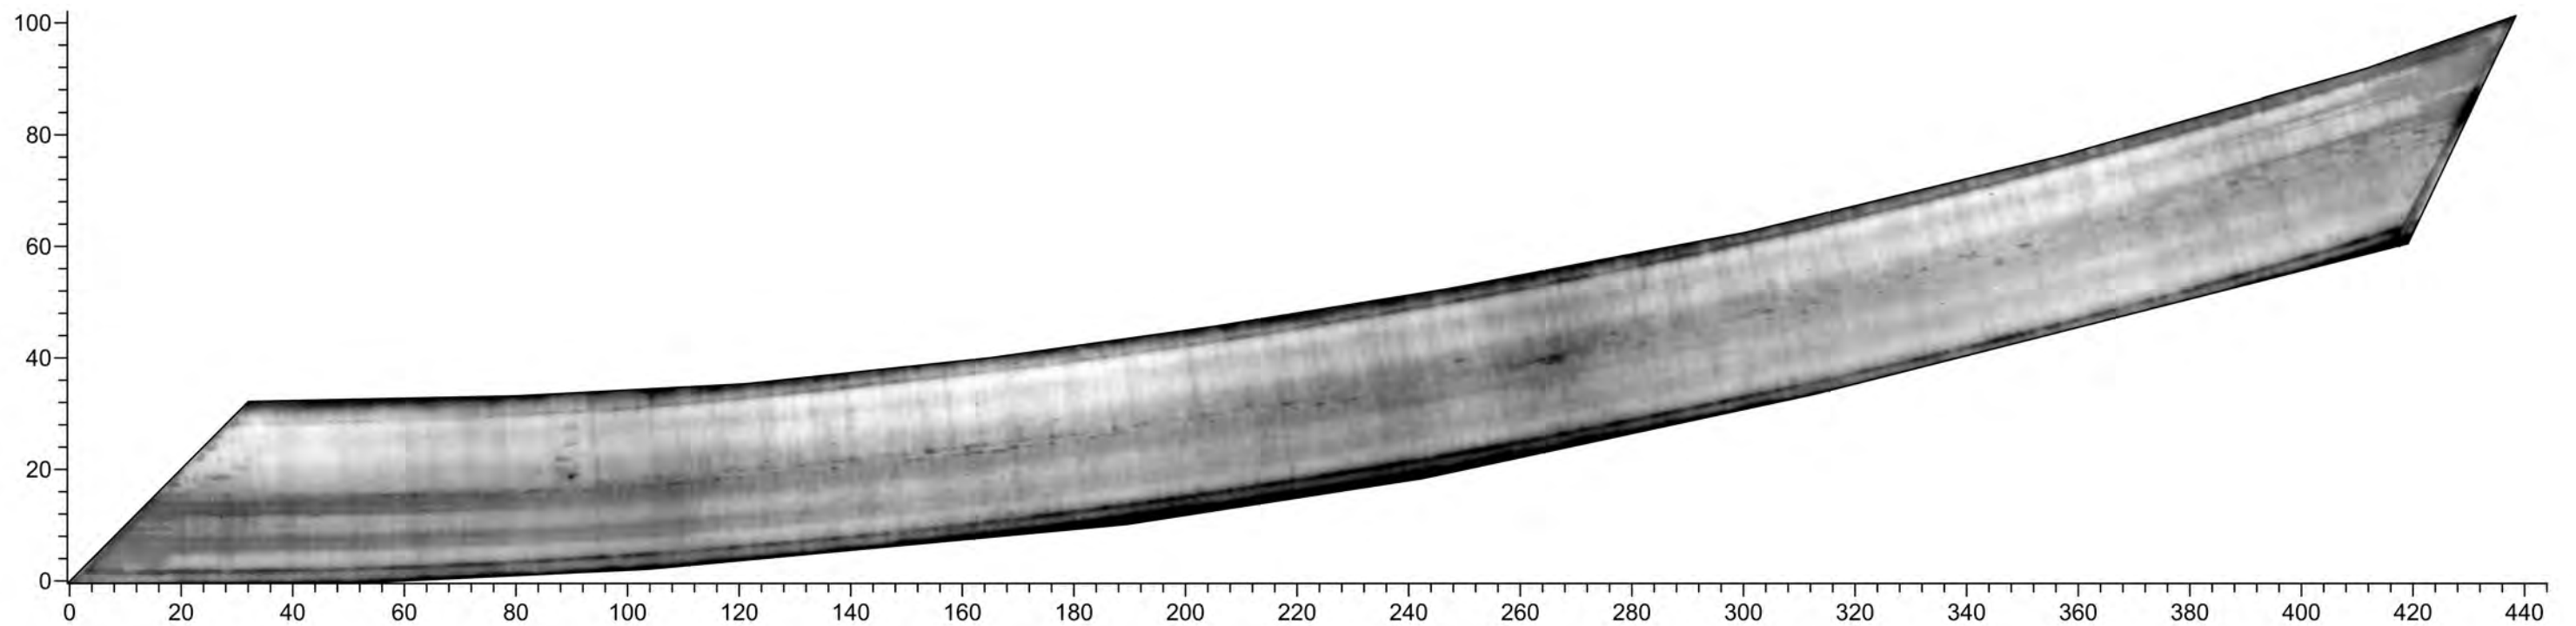
Delamination Quantity (%) 1.3 Delamination Quantity (ft <sup>2</sup> ) 251	Imagery Collected: 6/5/22 Analyzed by: SB Reviewed by: AJC Completed: 10/10/22

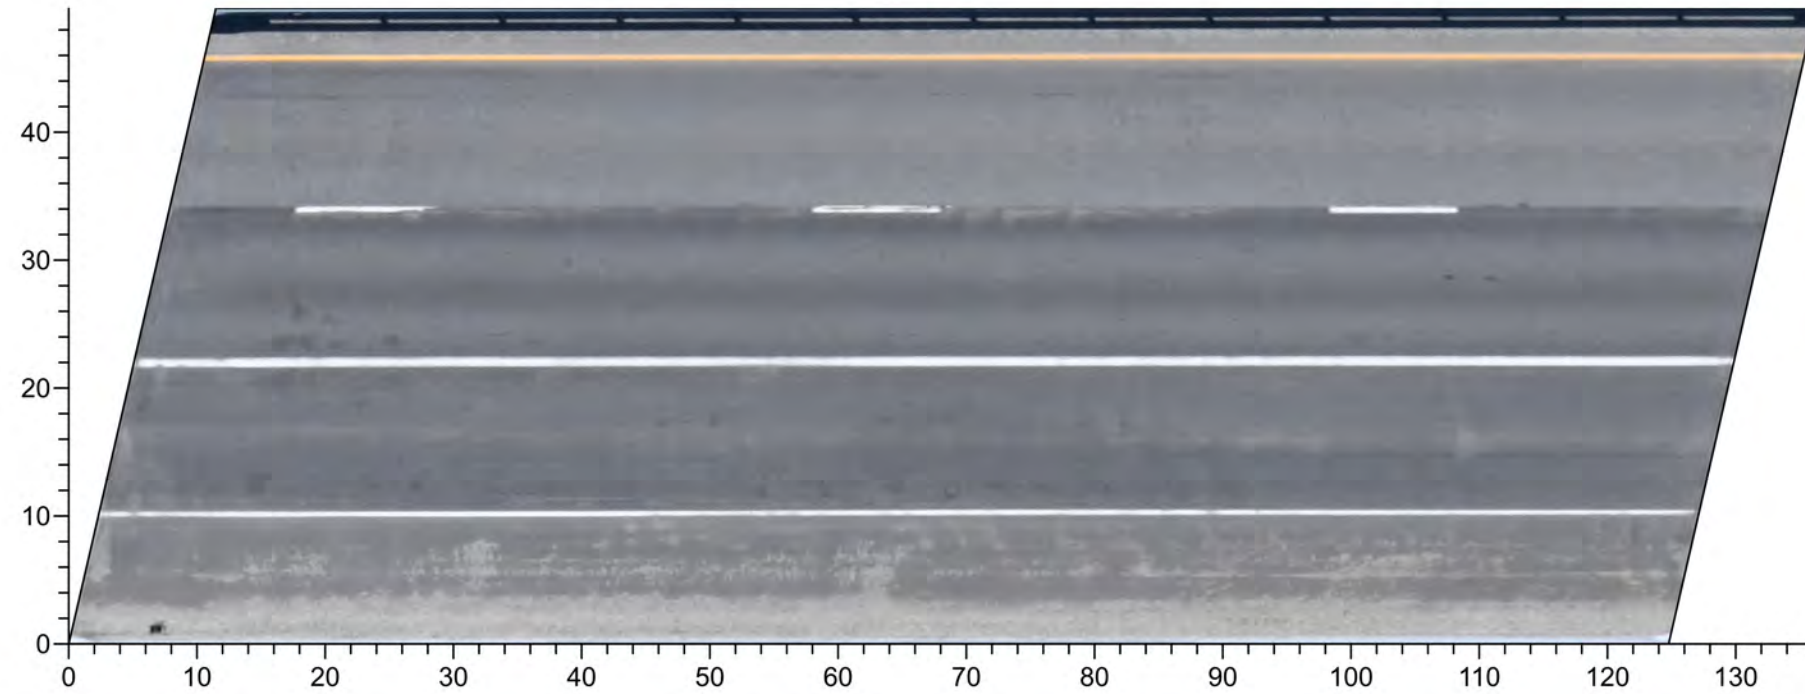
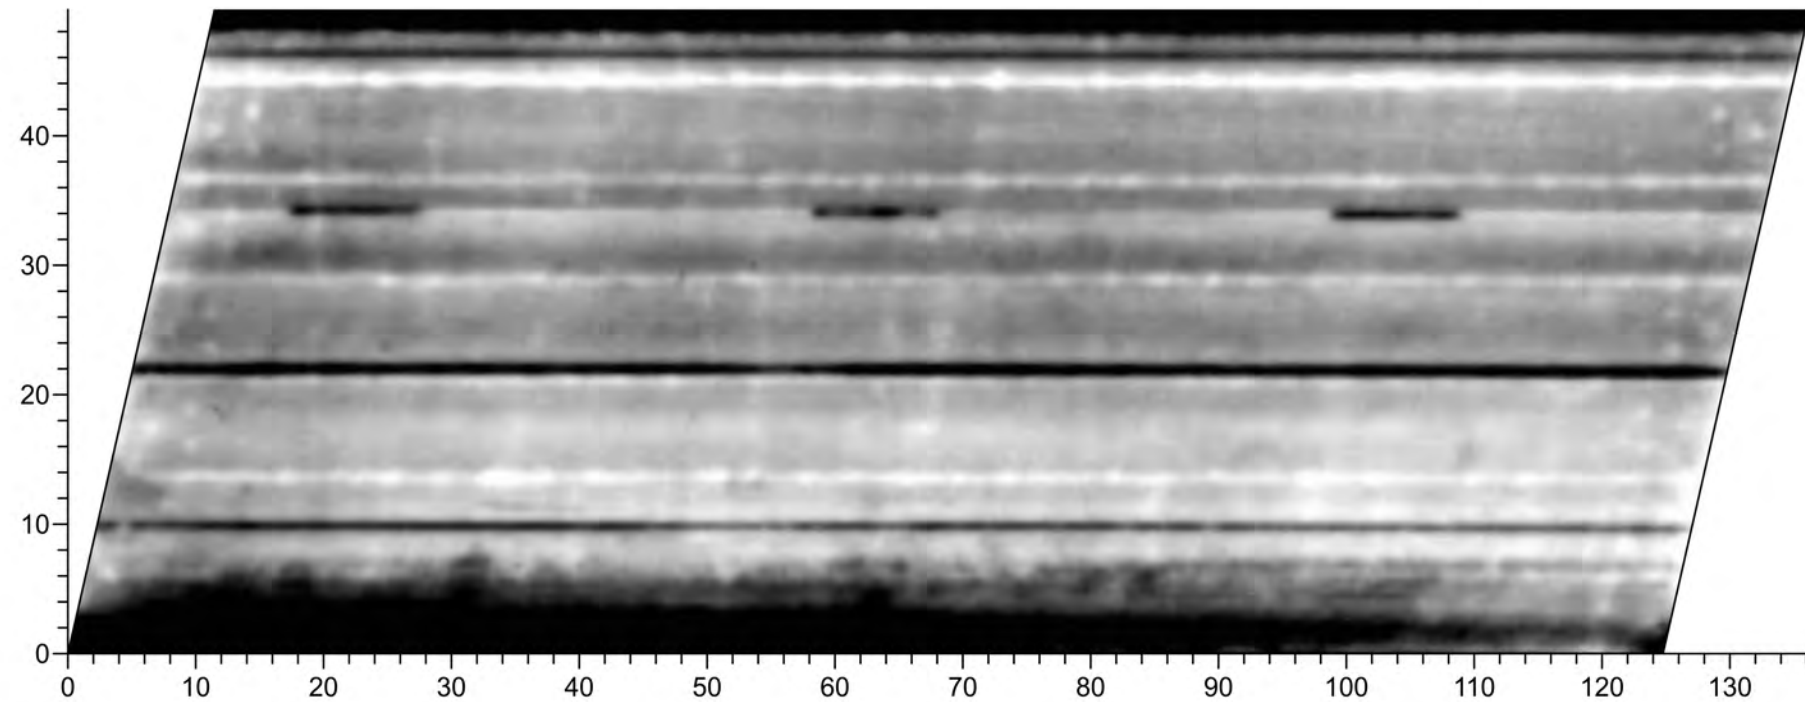
Delamination Quantity (%)	0.2	Imagery Collected: 6/5/22 Analyzed by: SB	
		Delamination Quantity (ft <sup>2</sup> )	29	Reviewed by: AJC Completed: 10/10/22
