# Aerial Infrared Scanning of Bridge Decks on Parks Highway to Map Delaminations

## FINAL REPORT

**Prepared by:**  
Infrasense, Inc.  
Woburn, MA

**Report # FHWA-AK-RD-000S(960)**  
**March 2, 2023**

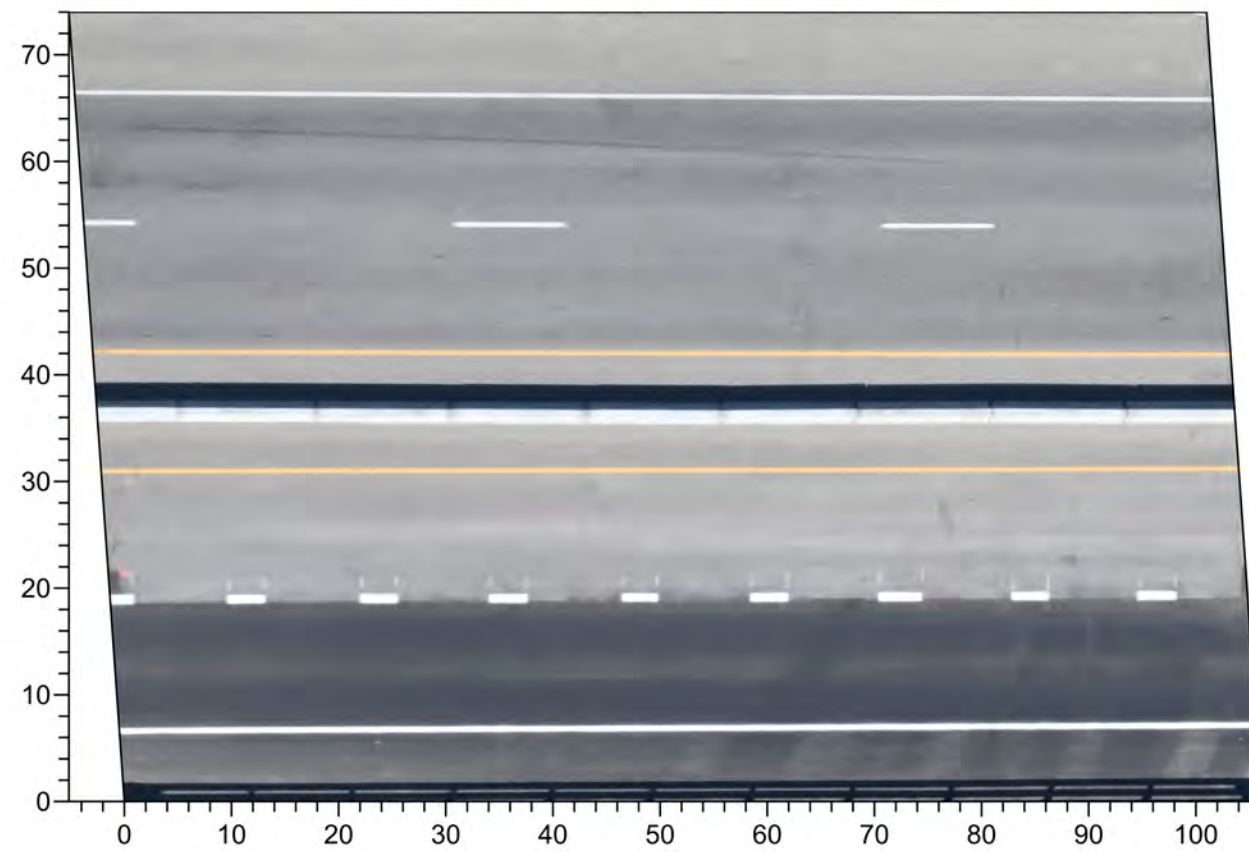
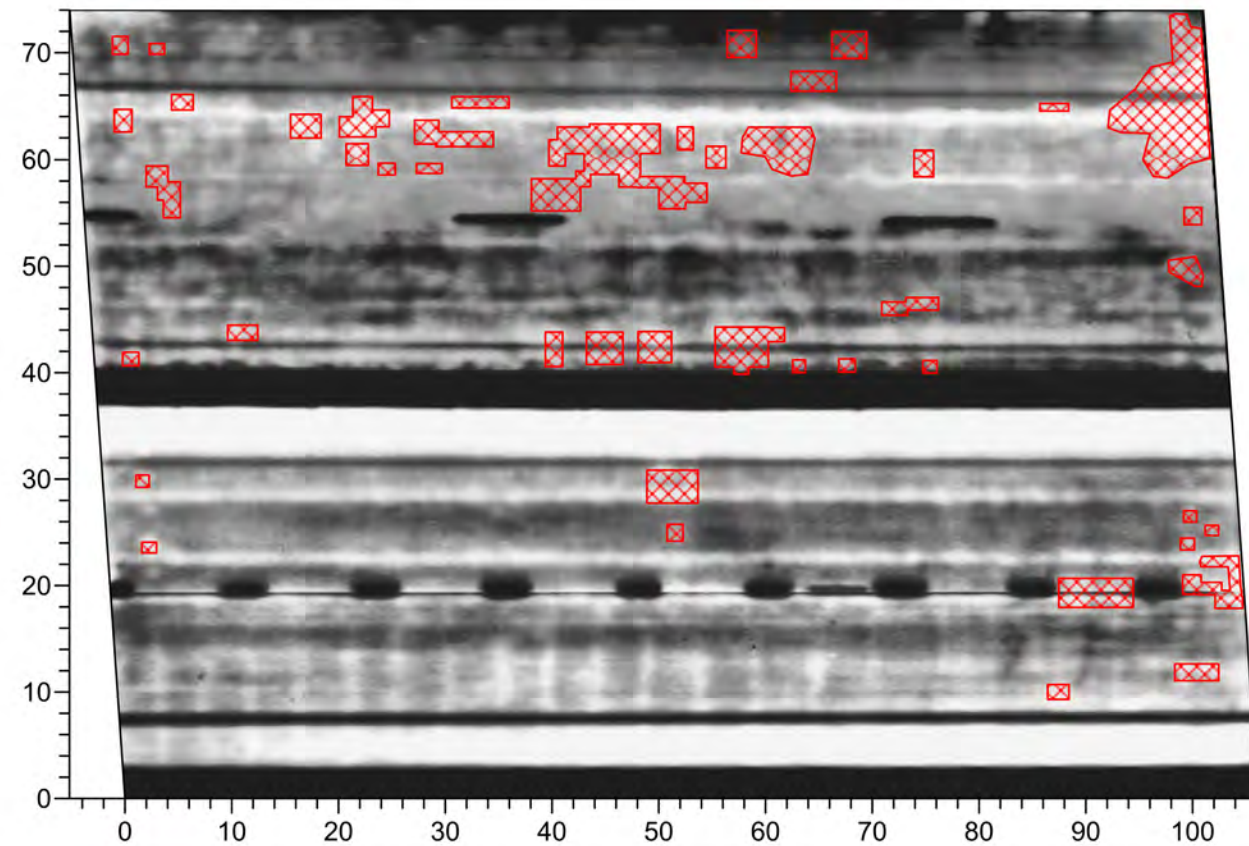
Delamination Quantity (%)	1.5	Imagery Collected: 6/5/22 Analyzed by: SB	
			Delamination Quantity (ft <sup>2</sup> )	95	Reviewed by: AJC Completed: 10/10/22

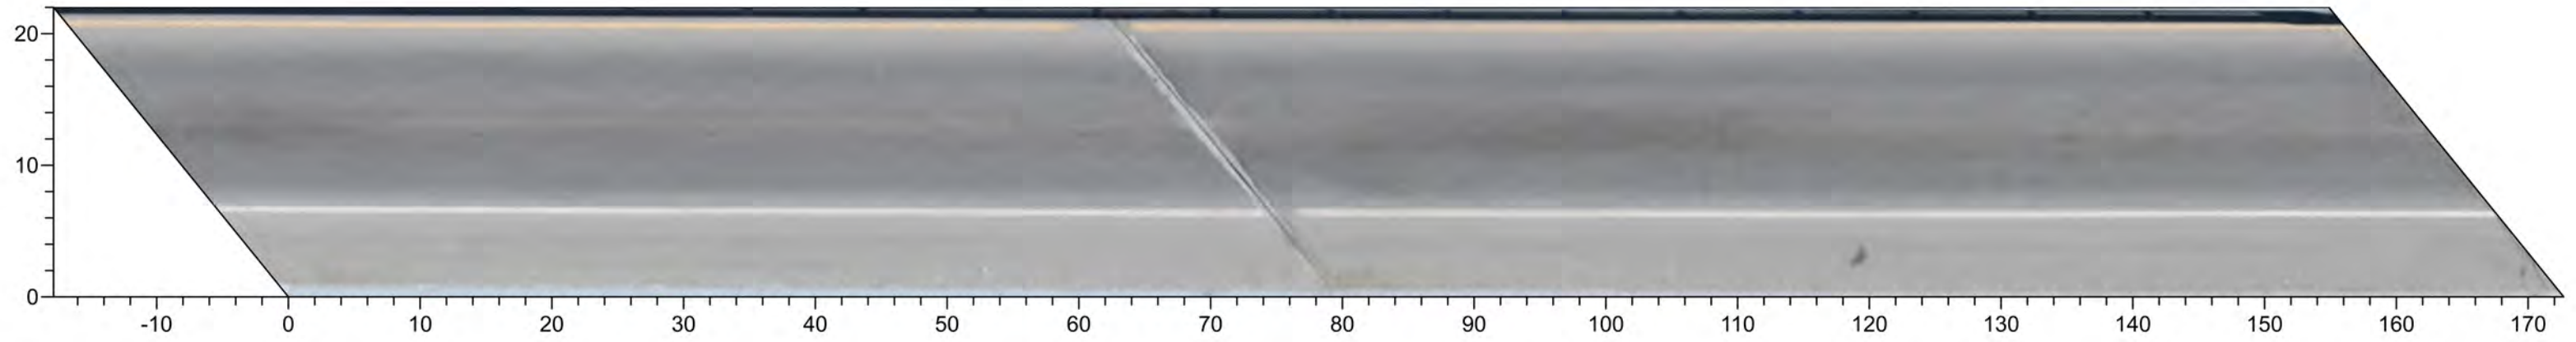
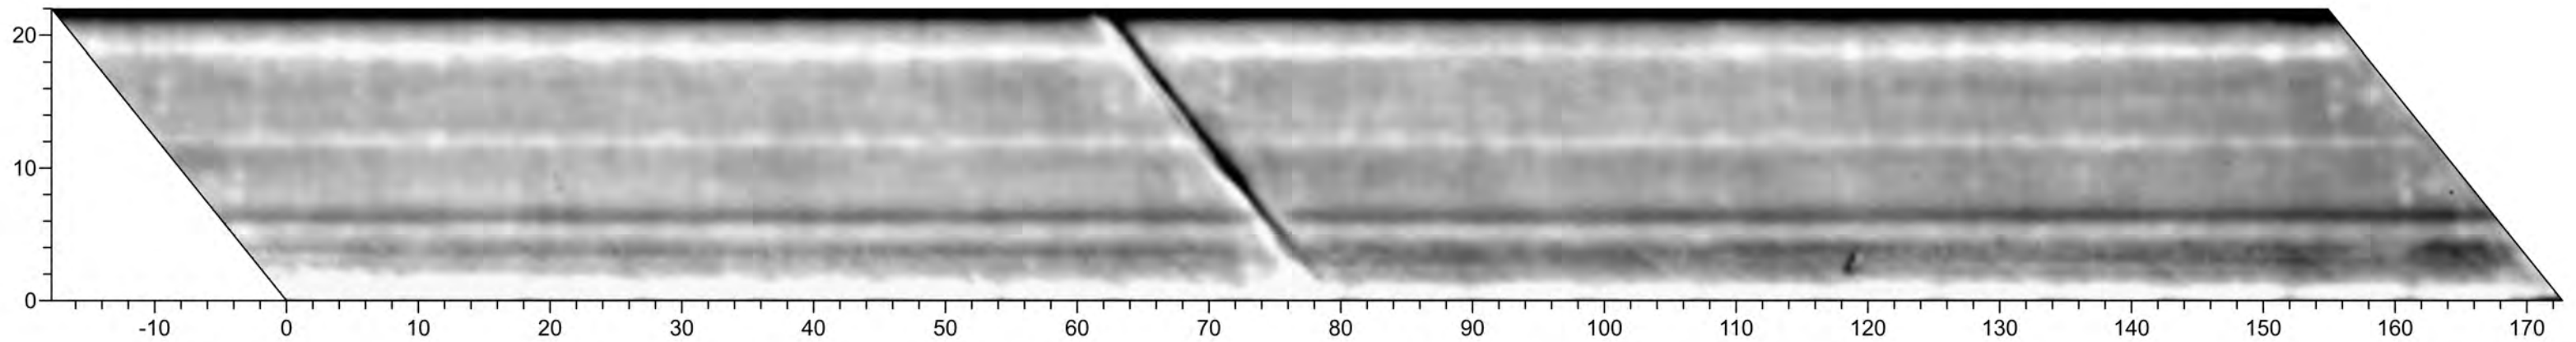
Delamination Quantity (%)	5.3	Imagery Collected: 6/5/22 Analyzed by: SB Reviewed by: AJC Completed: 10/10/22	
			Delamination Quantity (ft <sup>2</sup> )	414

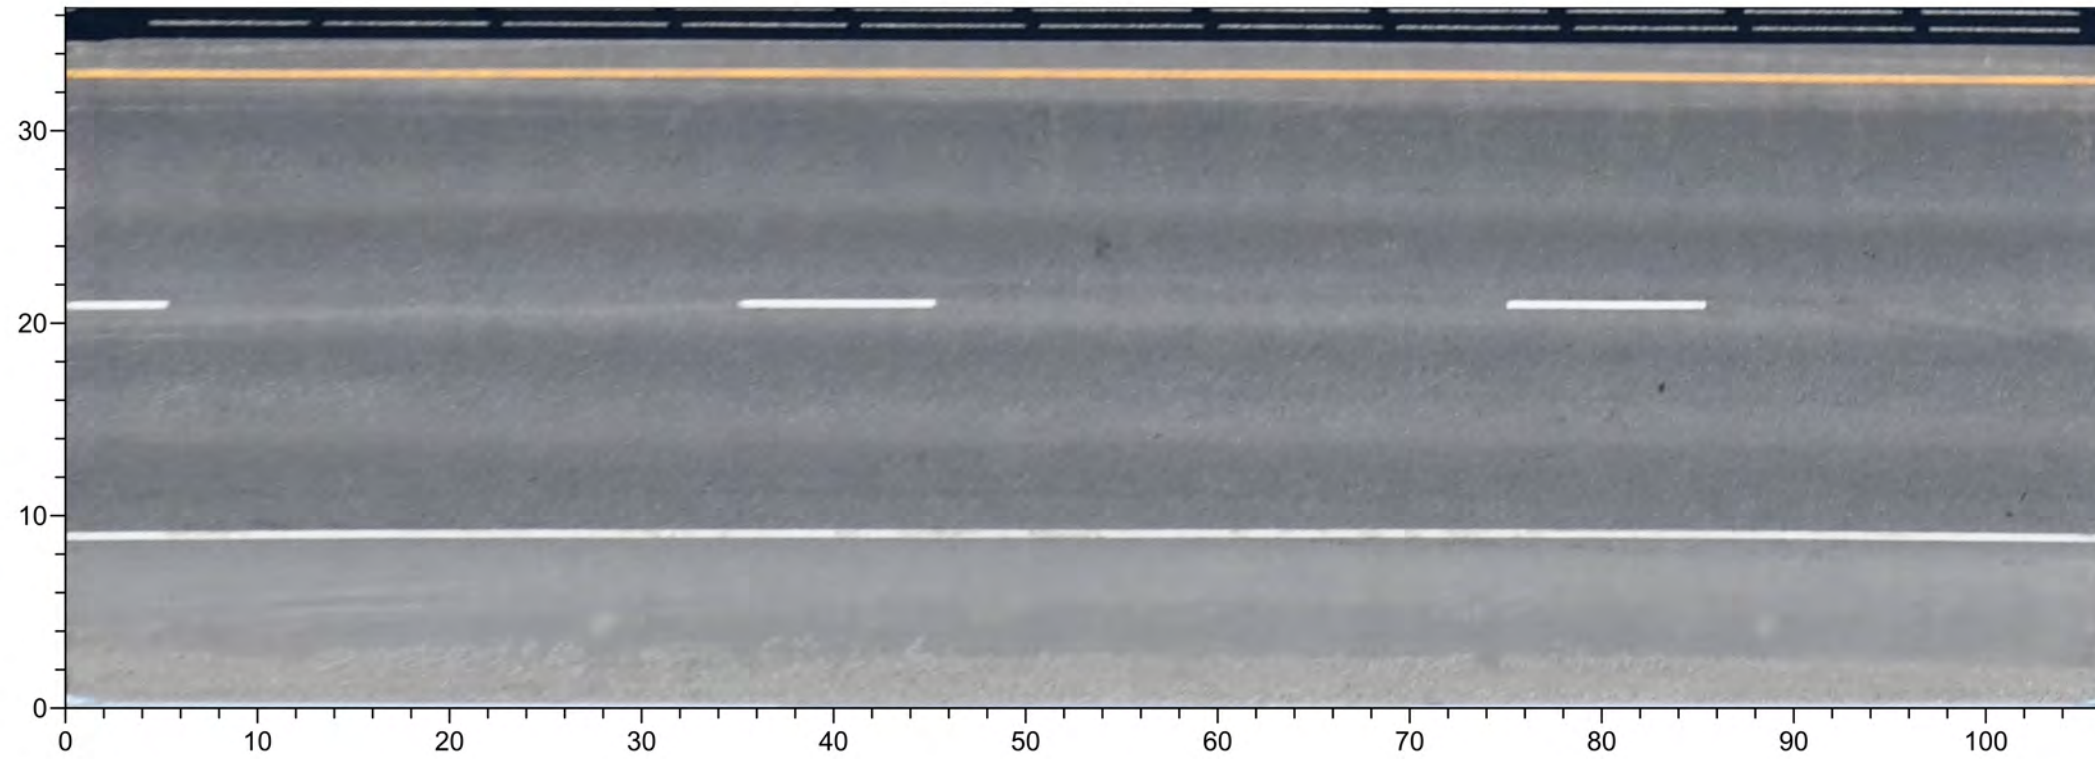
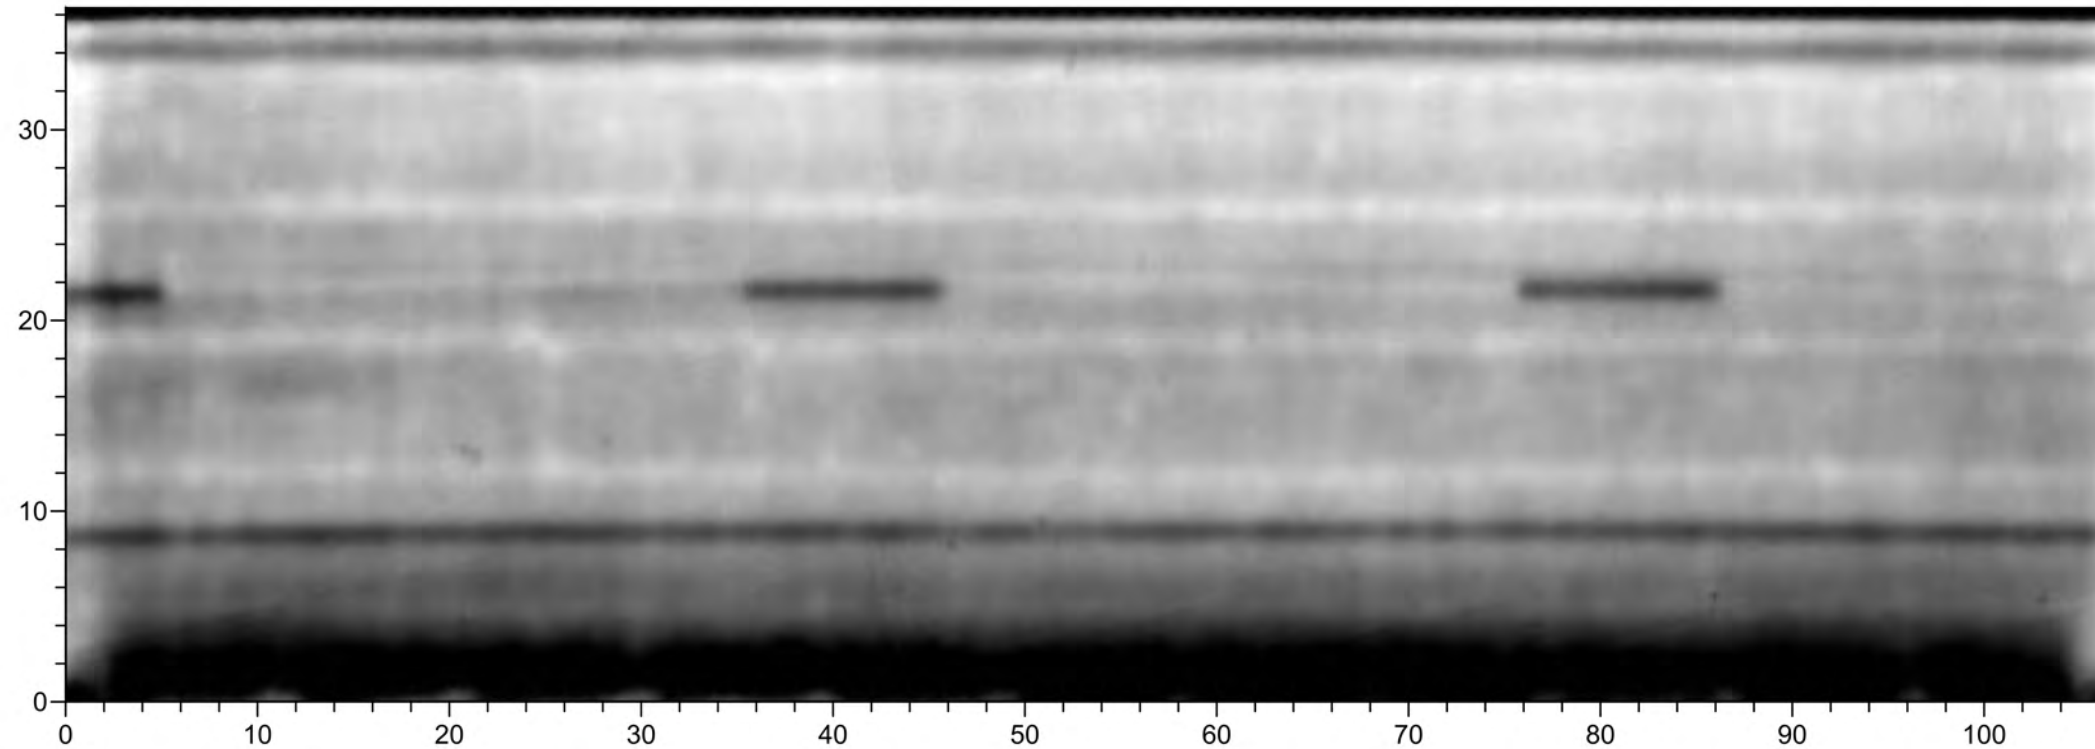
Delamination Quantity (%)	1.5	Imagery Collected: 6/5/22 Analyzed by: SB Reviewed by: AJC Completed: 10/10/22	
			Delamination Quantity (ft <sup>2</sup> )	56

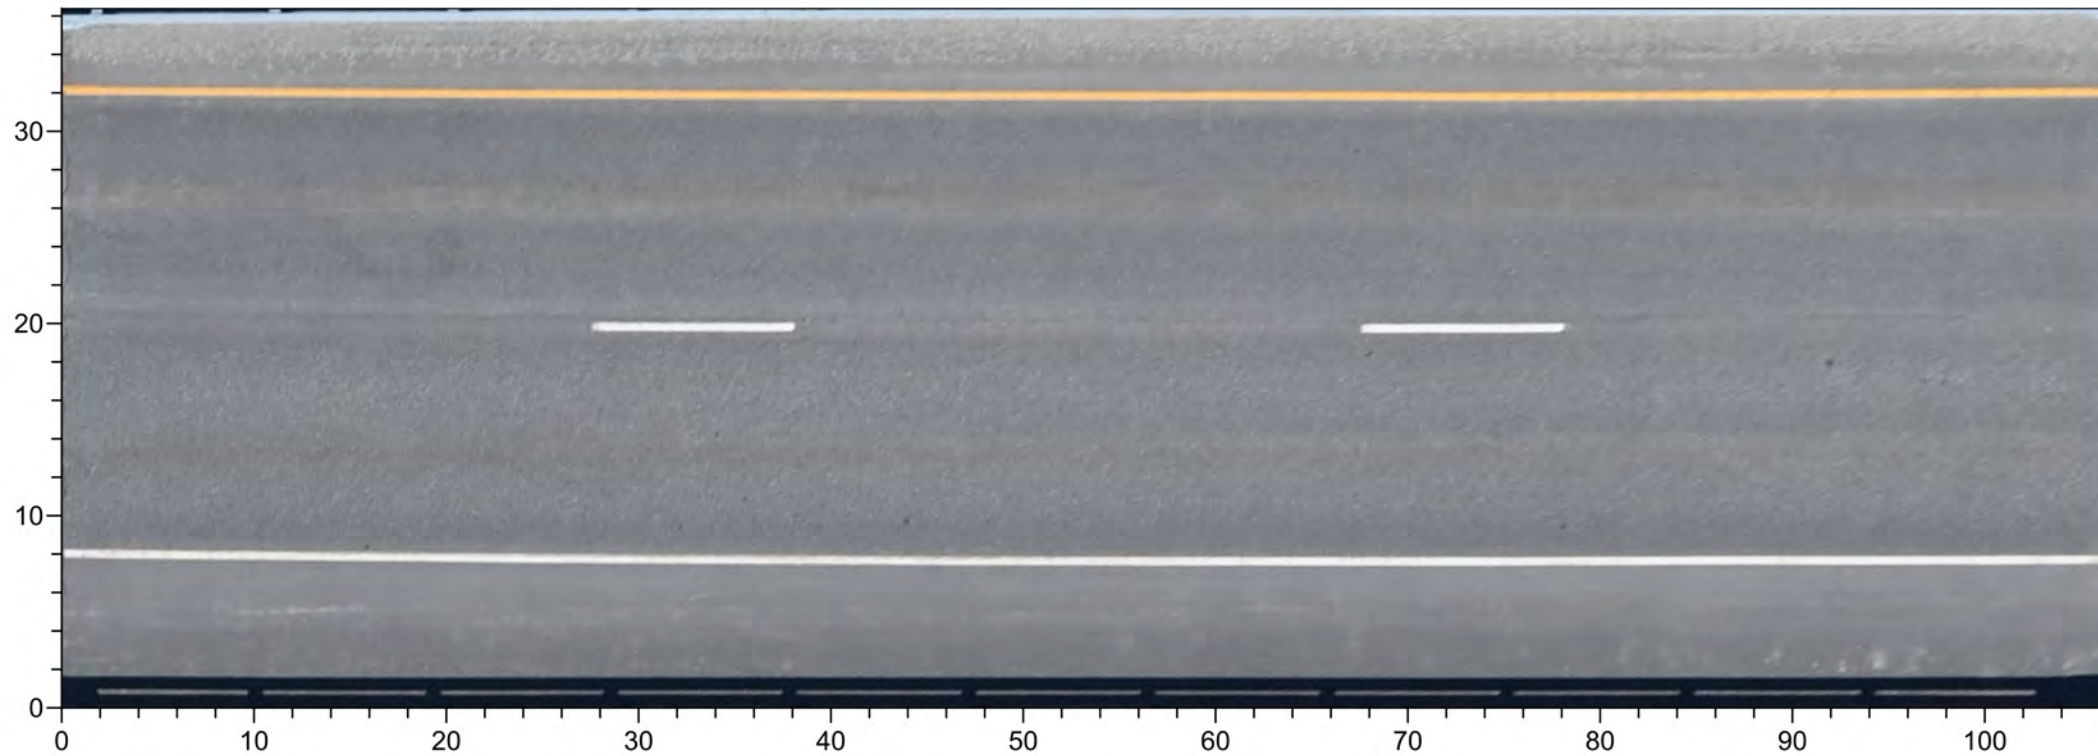
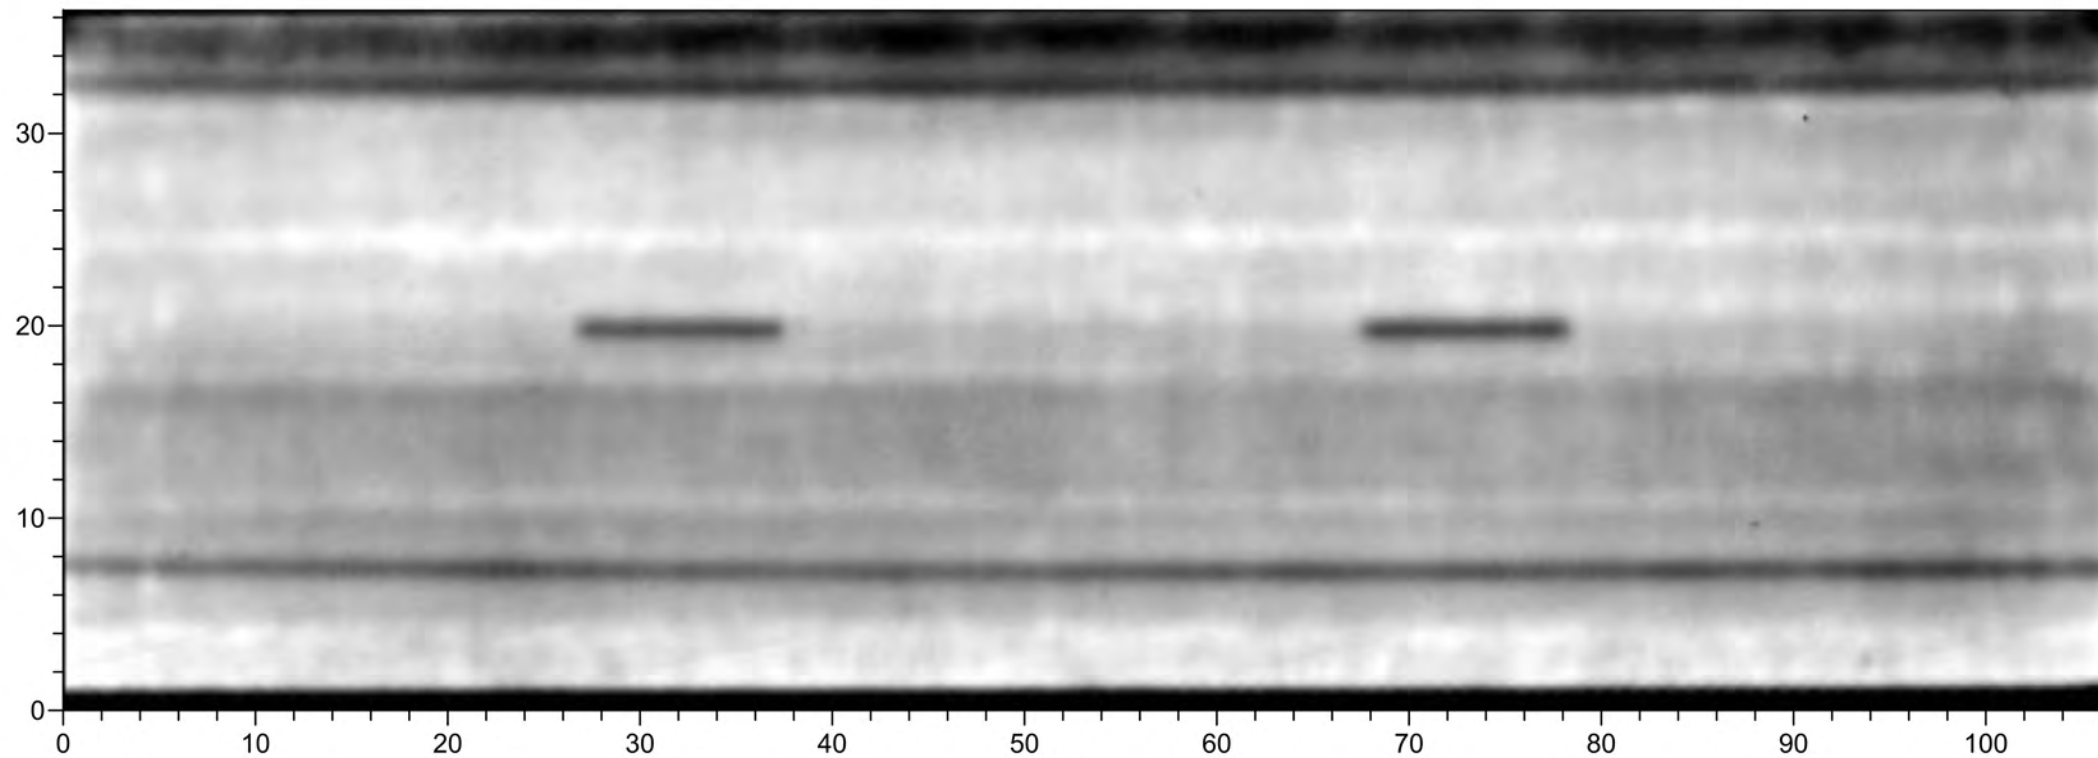
Delamination Quantity (%)    0.9 Delamination Quantity (ft <sup>2</sup> )    36	Imagery Collected: 6/5/22 Analyzed by: SB Reviewed by: AJC Completed: 10/10/22

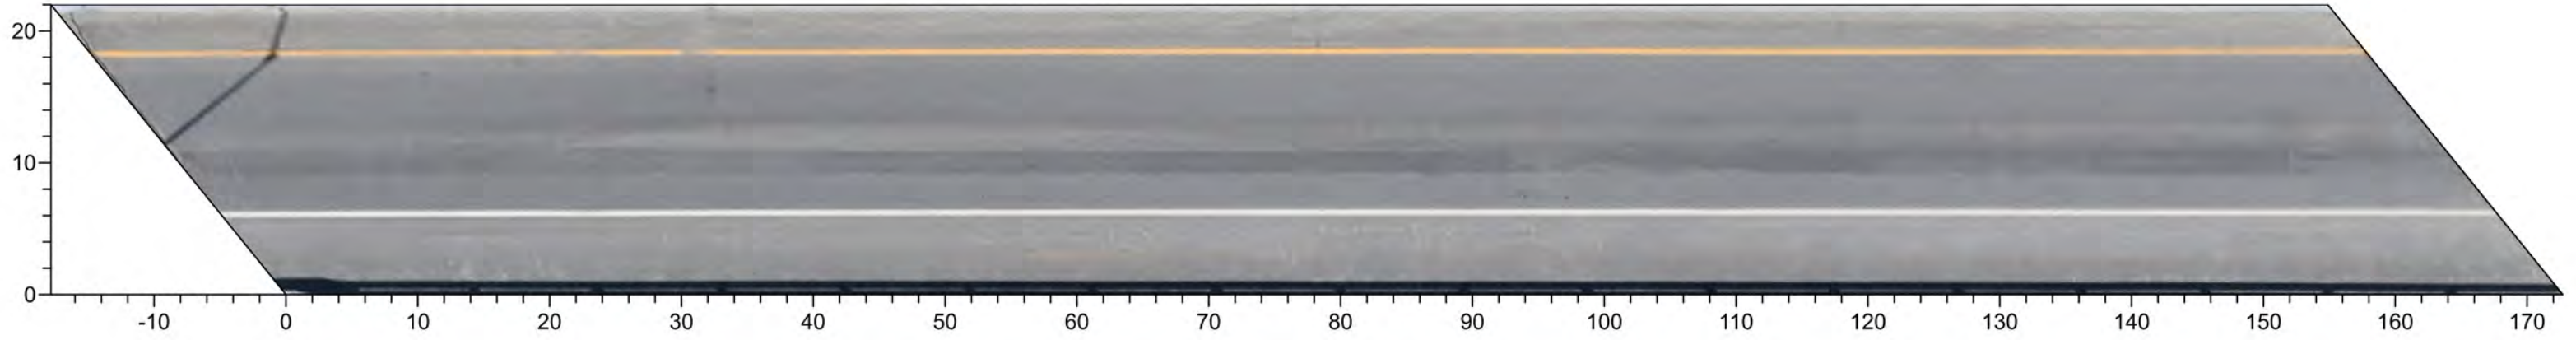
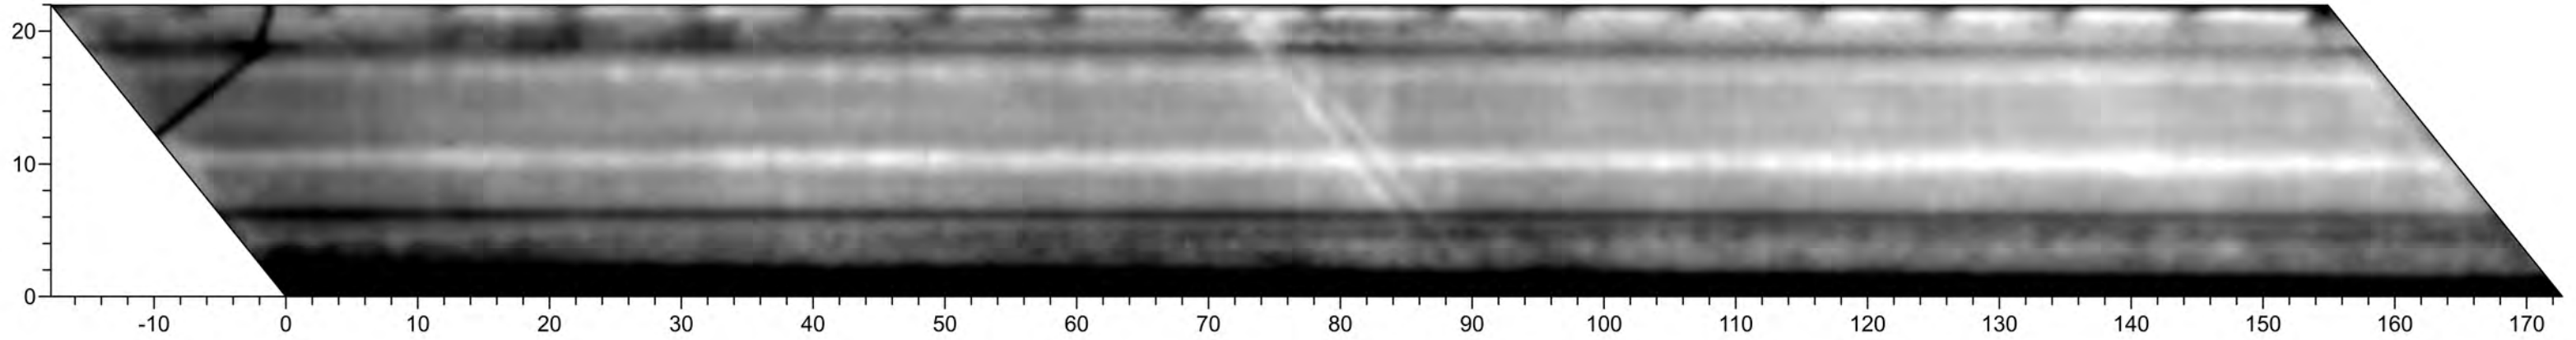
Delamination Quantity (%)    0.7 Delamination Quantity (ft <sup>2</sup> )    28	Imagery Collected: 6/5/22 Analyzed by: SB Reviewed by: AJC Completed: 10/10/22

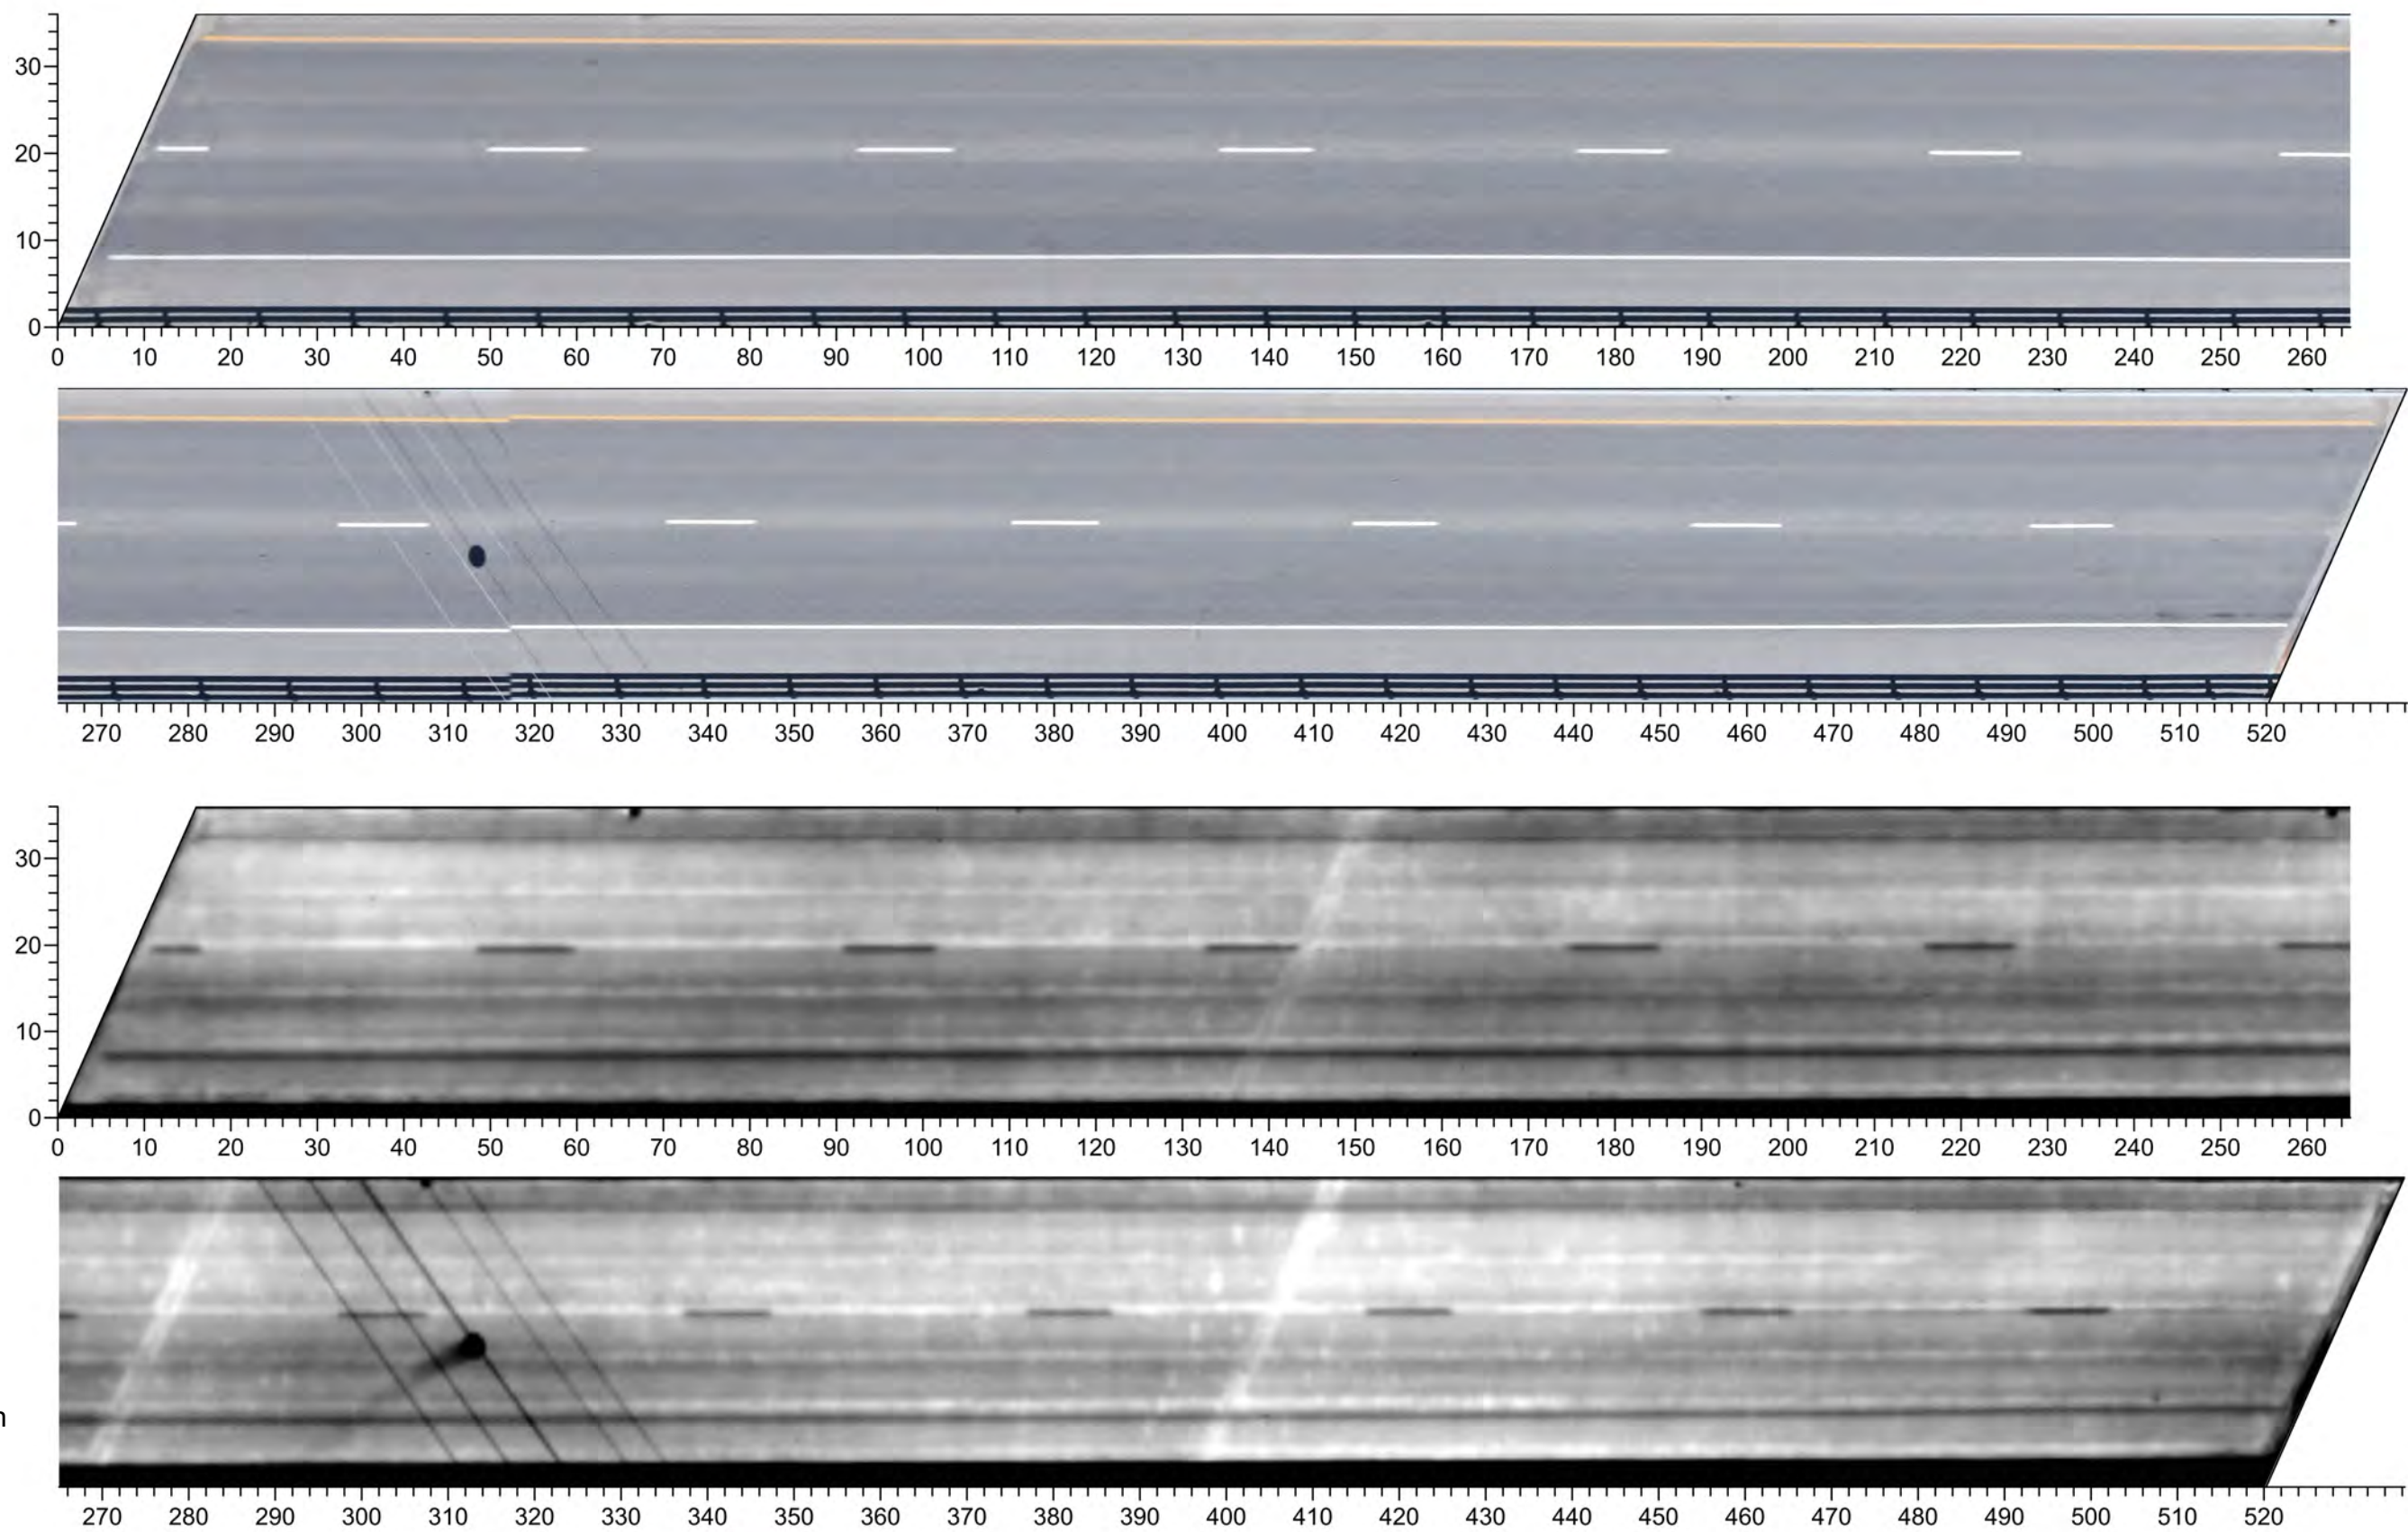
Delamination Quantity (%)    0.6		Imagery Collected: 6/5/22 Analyzed by: SB Reviewed by: AJC Completed: 10/10/22	
			Delamination Quantity (ft <sup>2</sup> )    22

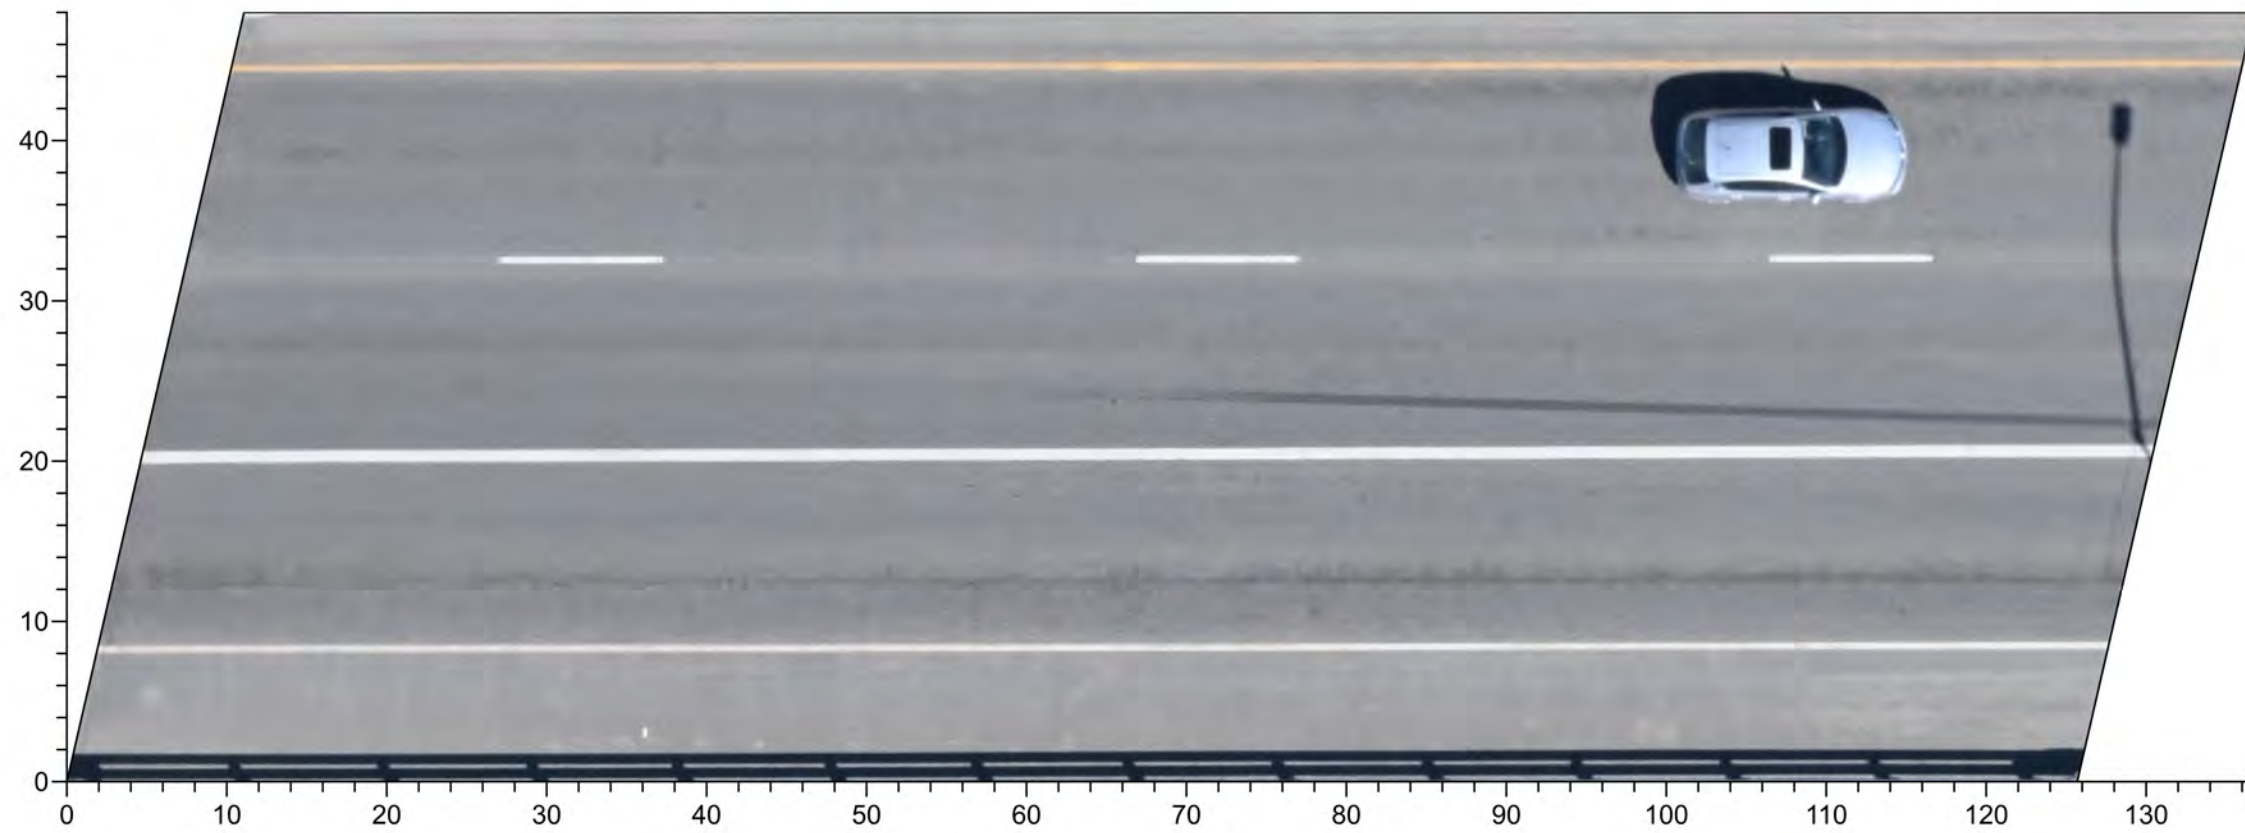
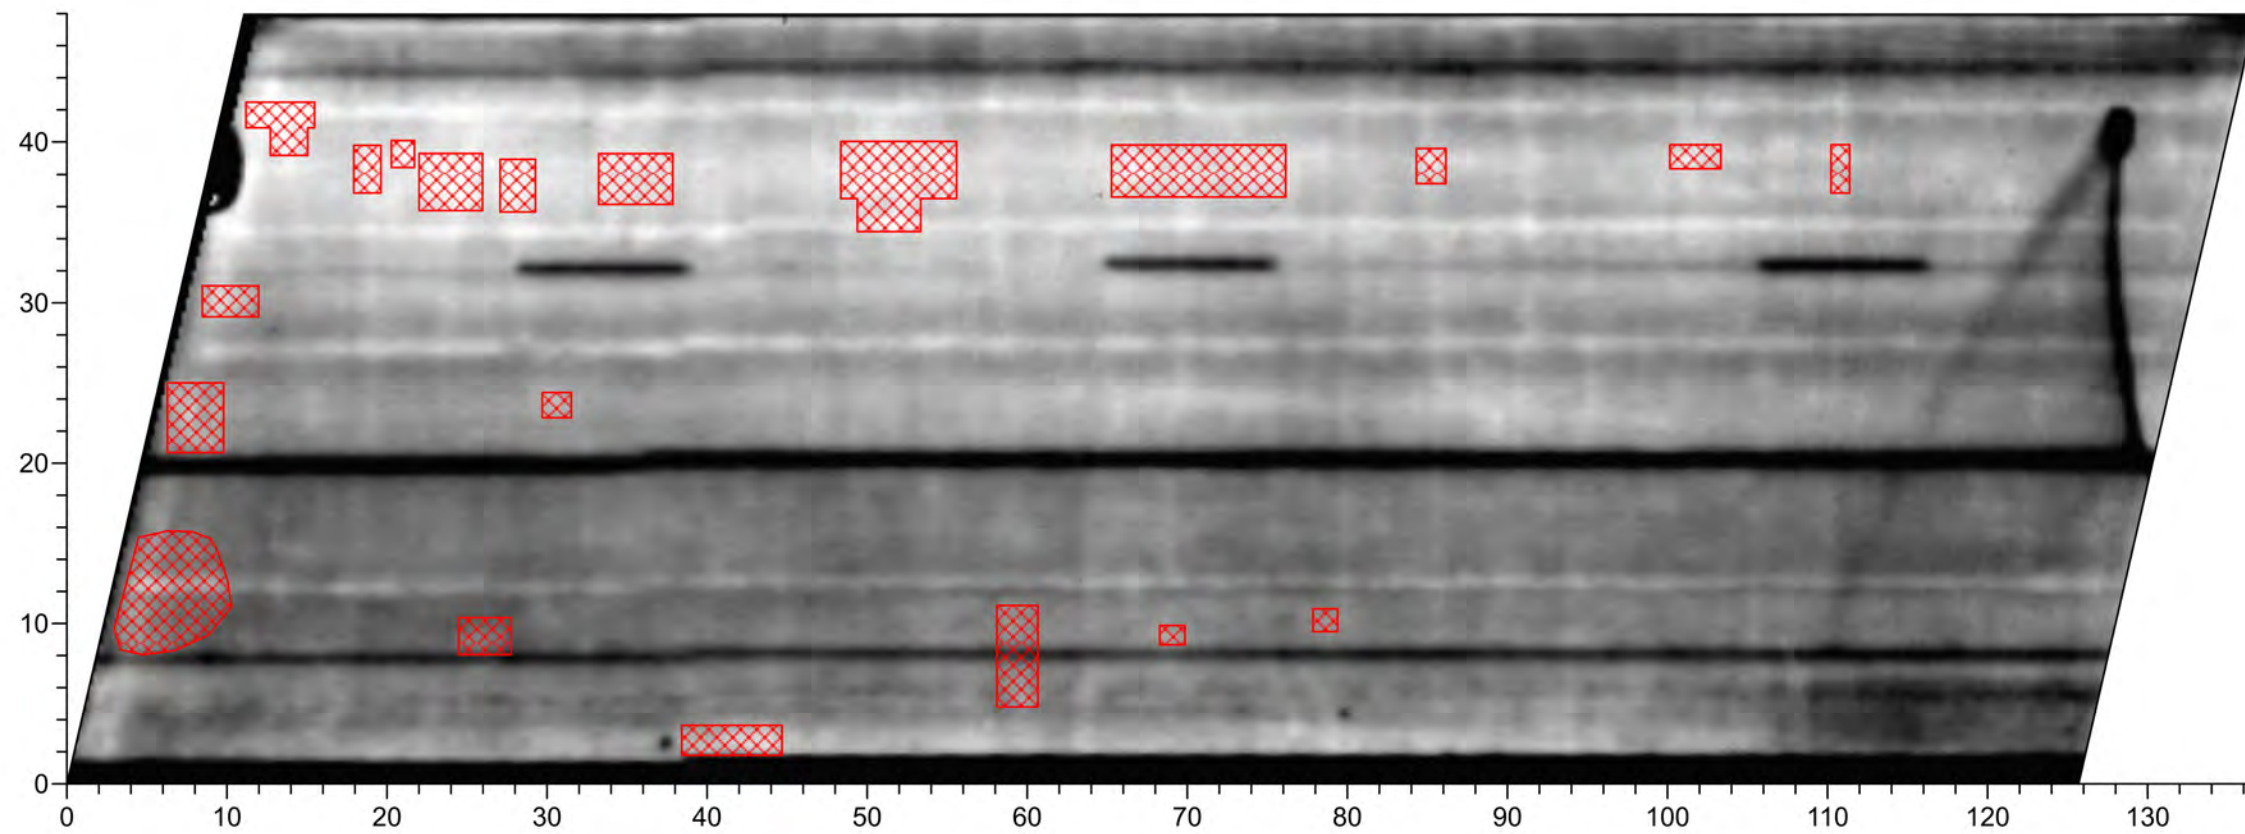
Delamination Quantity (%)	1.2	Imagery Collected: 6/5/22		
			Delamination Quantity (ft <sup>2</sup> )	216	Analyzed by: SB Reviewed by: AJC Completed: 10/10/22

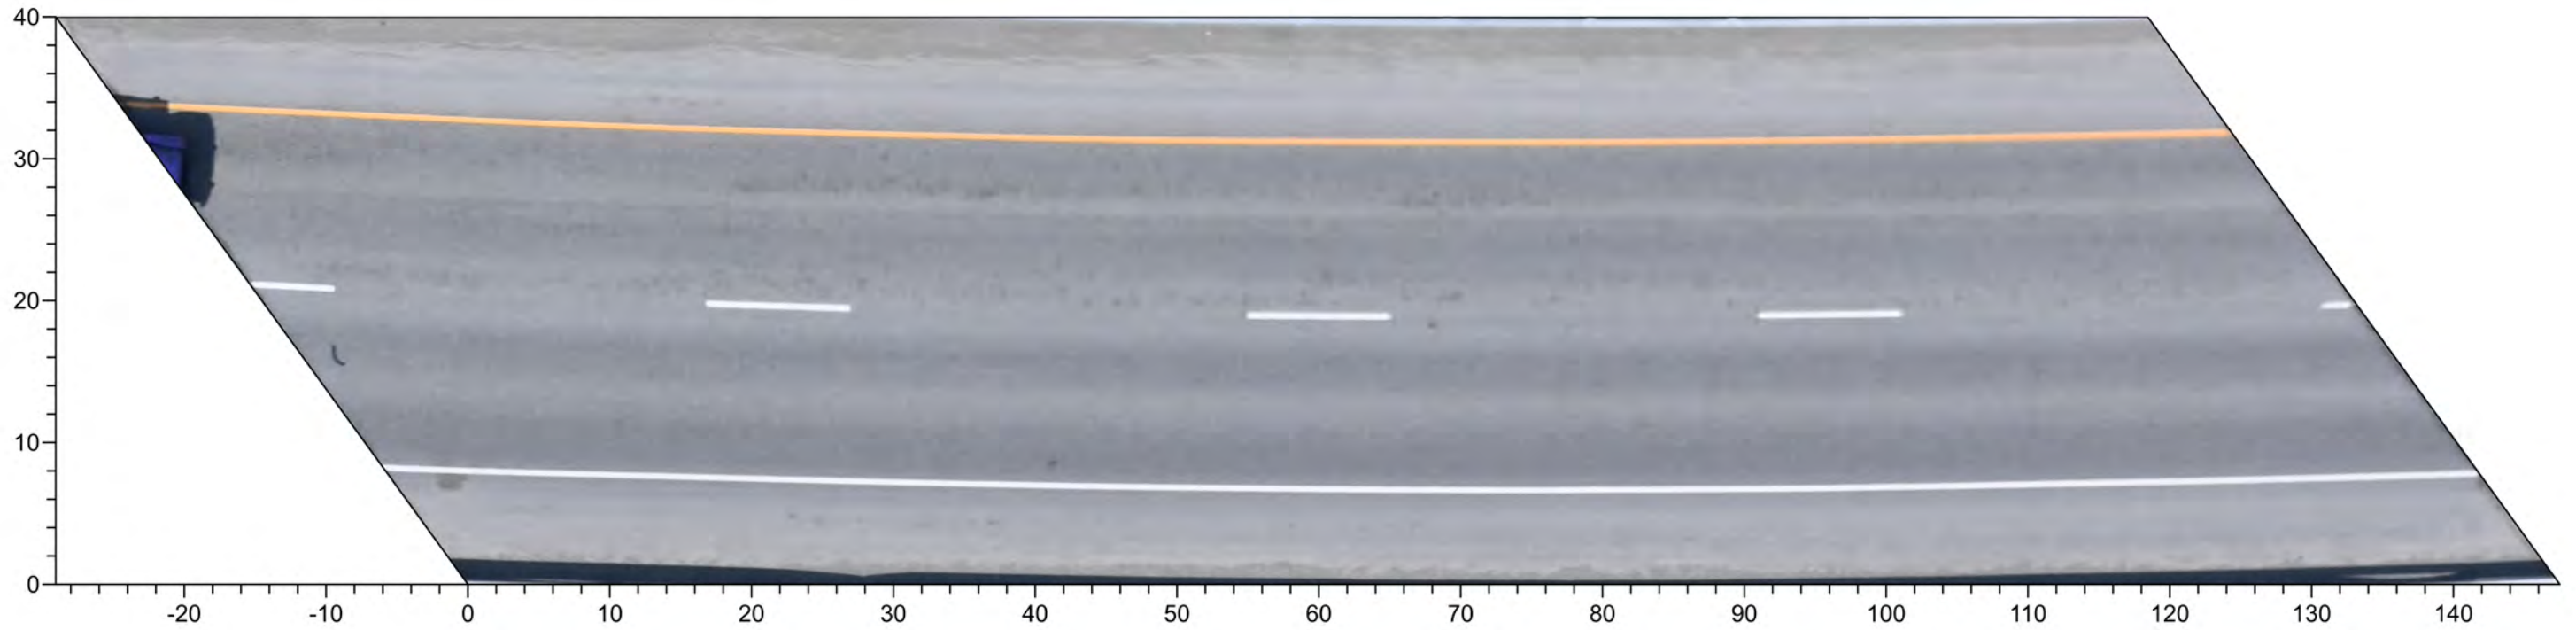
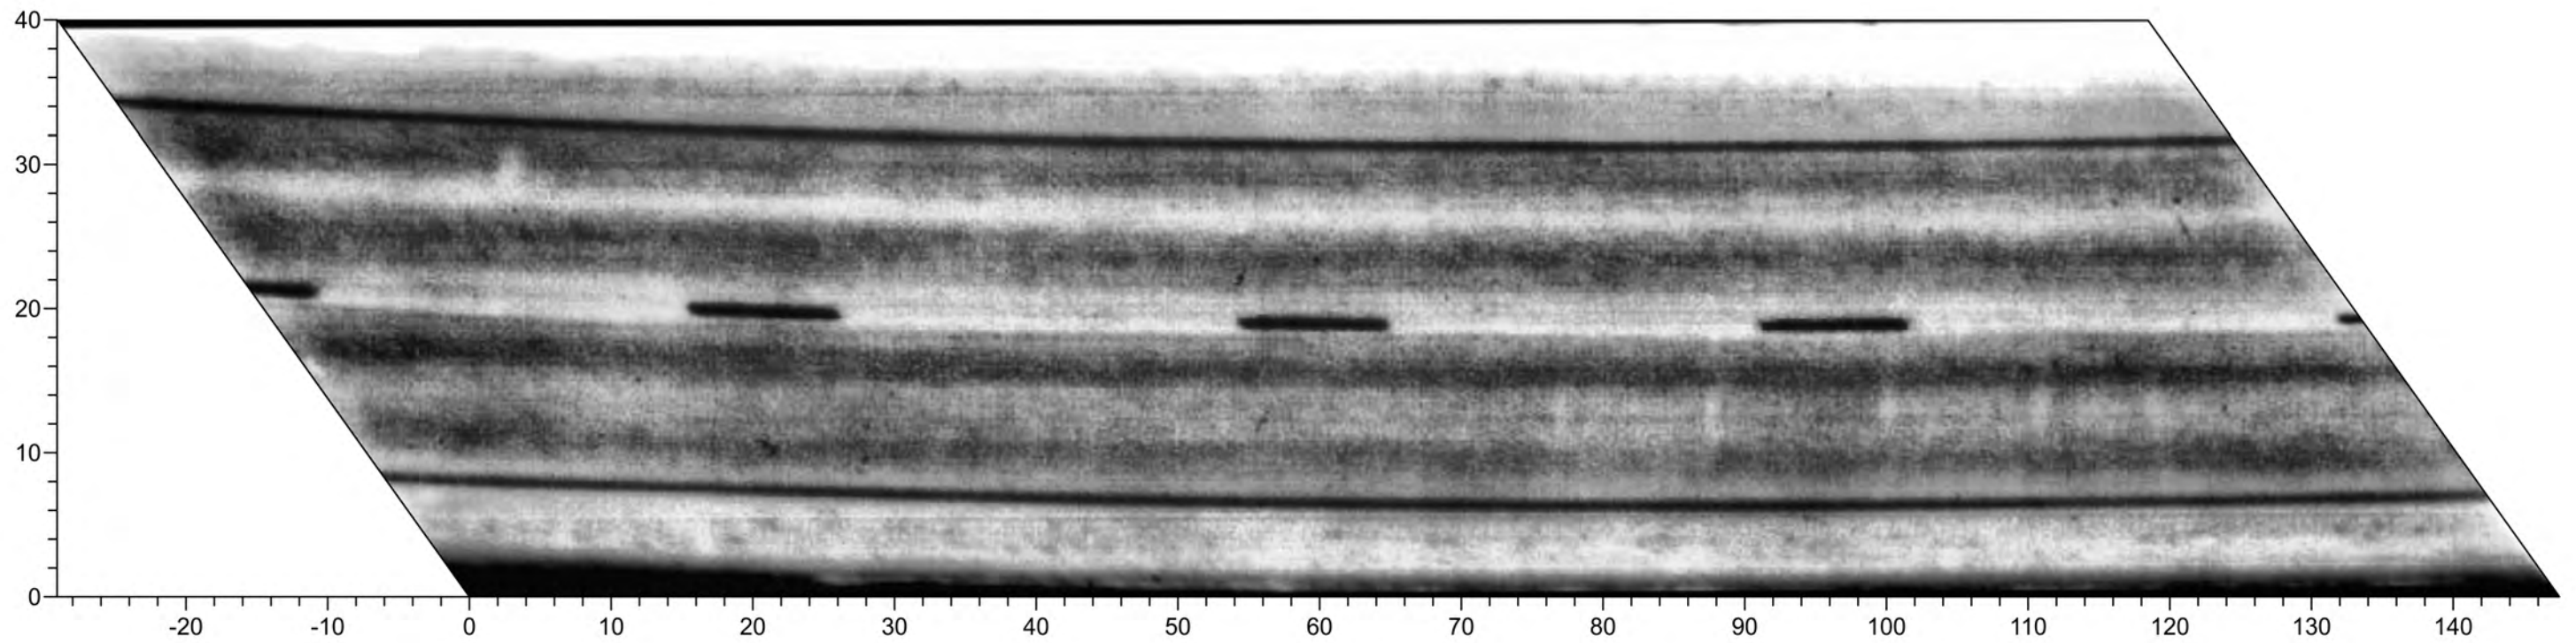
Delamination Quantity (%)    4.0		Imagery Collected: 6/5/22 Analyzed by: SB Reviewed by: AJC Completed: 10/10/22	
			Delamination Quantity (ft <sup>2</sup> )    242
