# Aerial Infrared Scanning of Bridge Decks on Parks Highway to Map Delaminations

## FINAL REPORT

**Prepared by:**  
Infrasense, Inc.  
Woburn, MA

**Report # FHWA-AK-RD-000S(960)**  
**March 2, 2023**

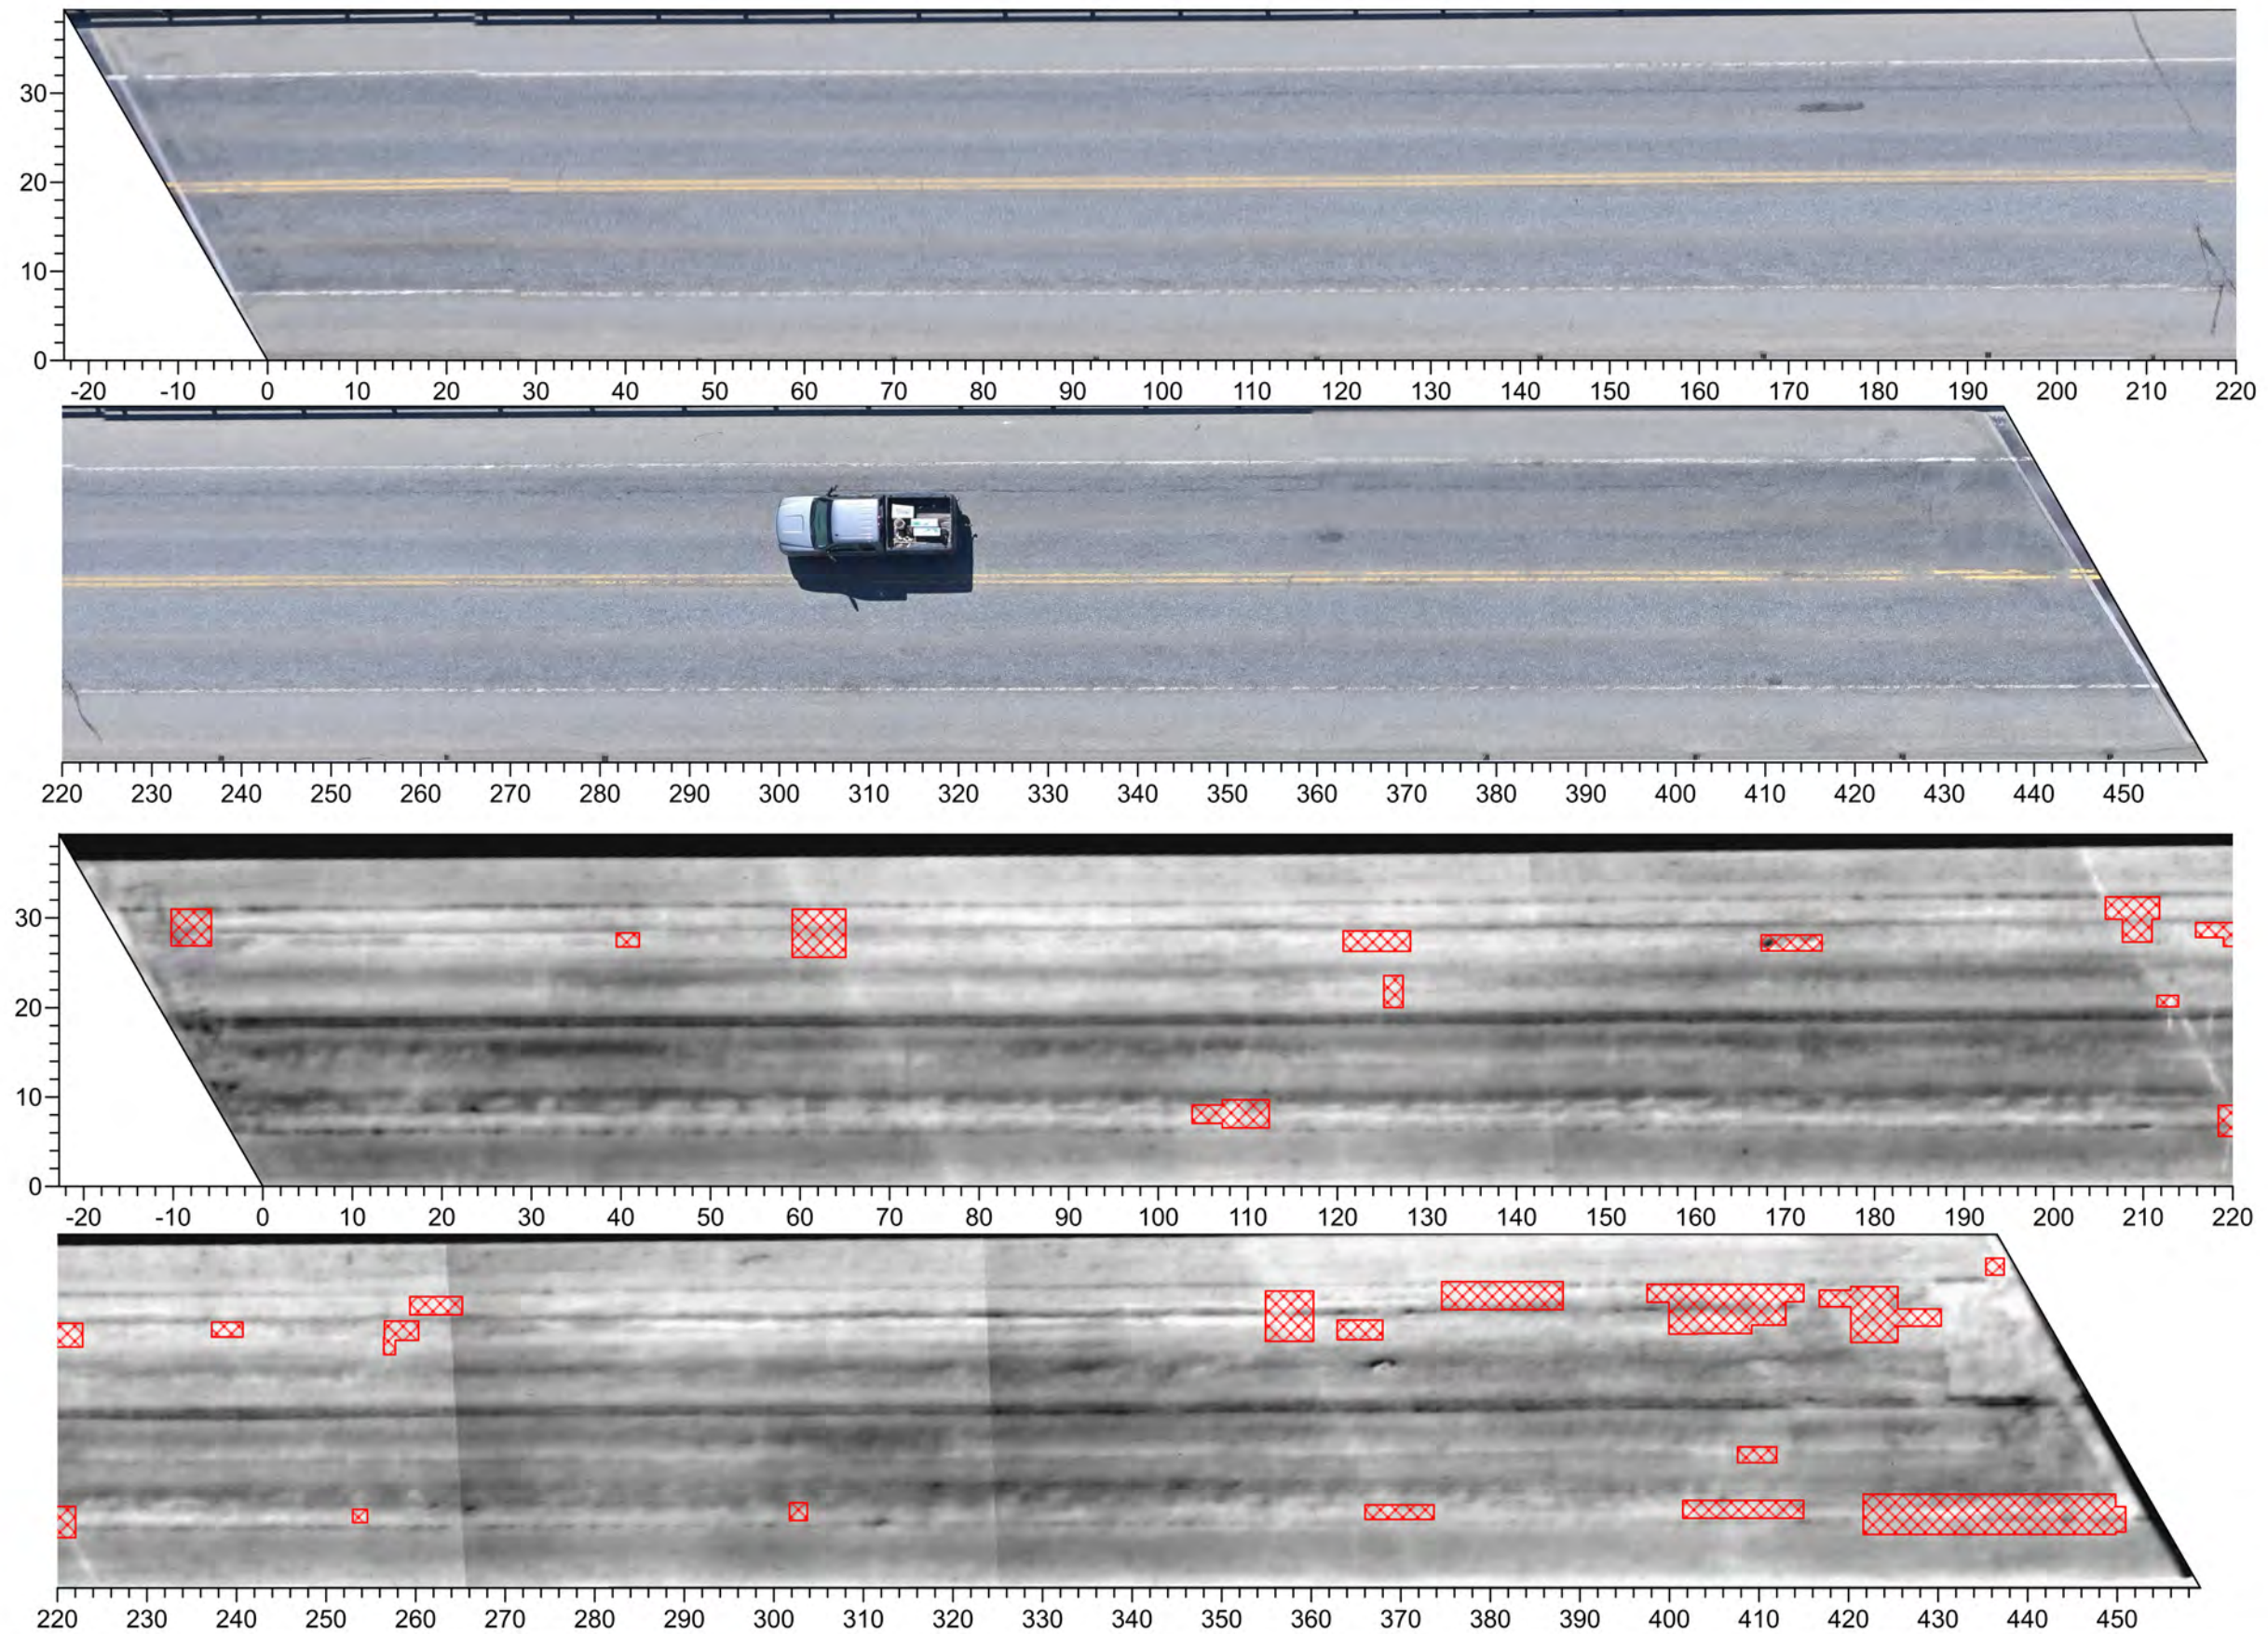
Delamination Quantity (%)    0.5 Delamination Quantity (ft <sup>2</sup> )    31	Imagery Collected: 6/5/22 Analyzed by: SB Reviewed by: AJC Completed: 10/10/22

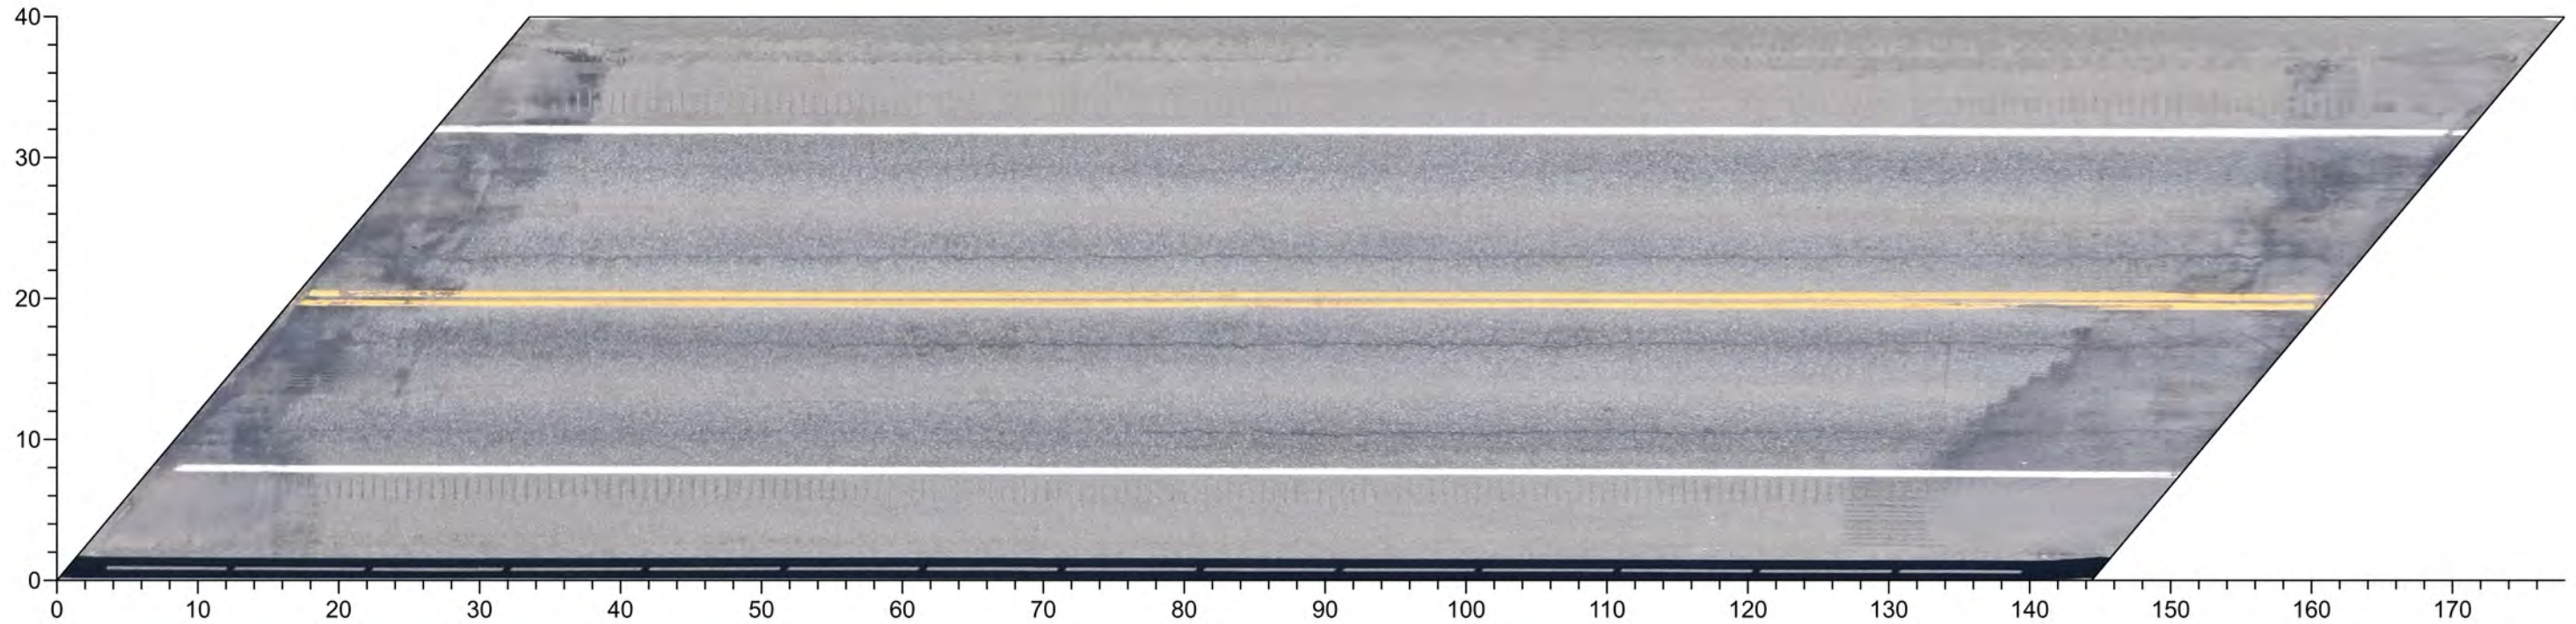
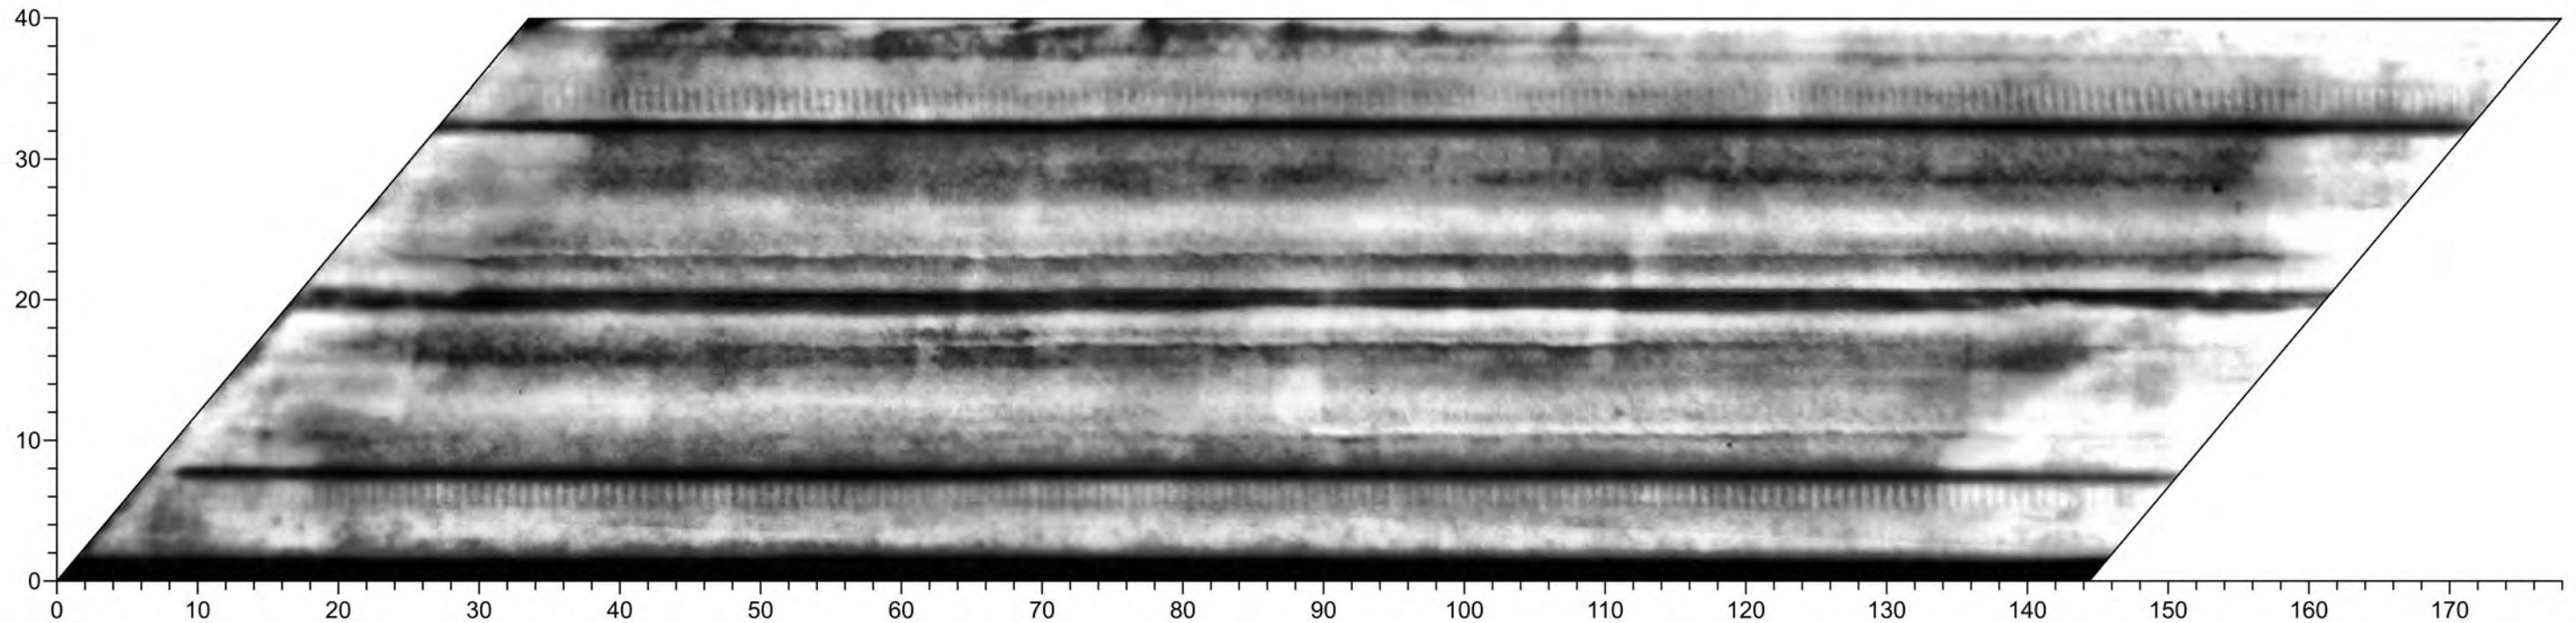
Delamination Quantity (%)	3.3	Imagery Collected: 6/4/22 Analyzed by: SB Reviewed by: AJC Completed: 10/10/22	
		Delamination Quantity (ft <sup>2</sup> )	592

\*Note: 59 sq. ft. of thermal anomalies not mapped due to being rectilinear in shape and appearing more like subsurface patching or some other structural feature

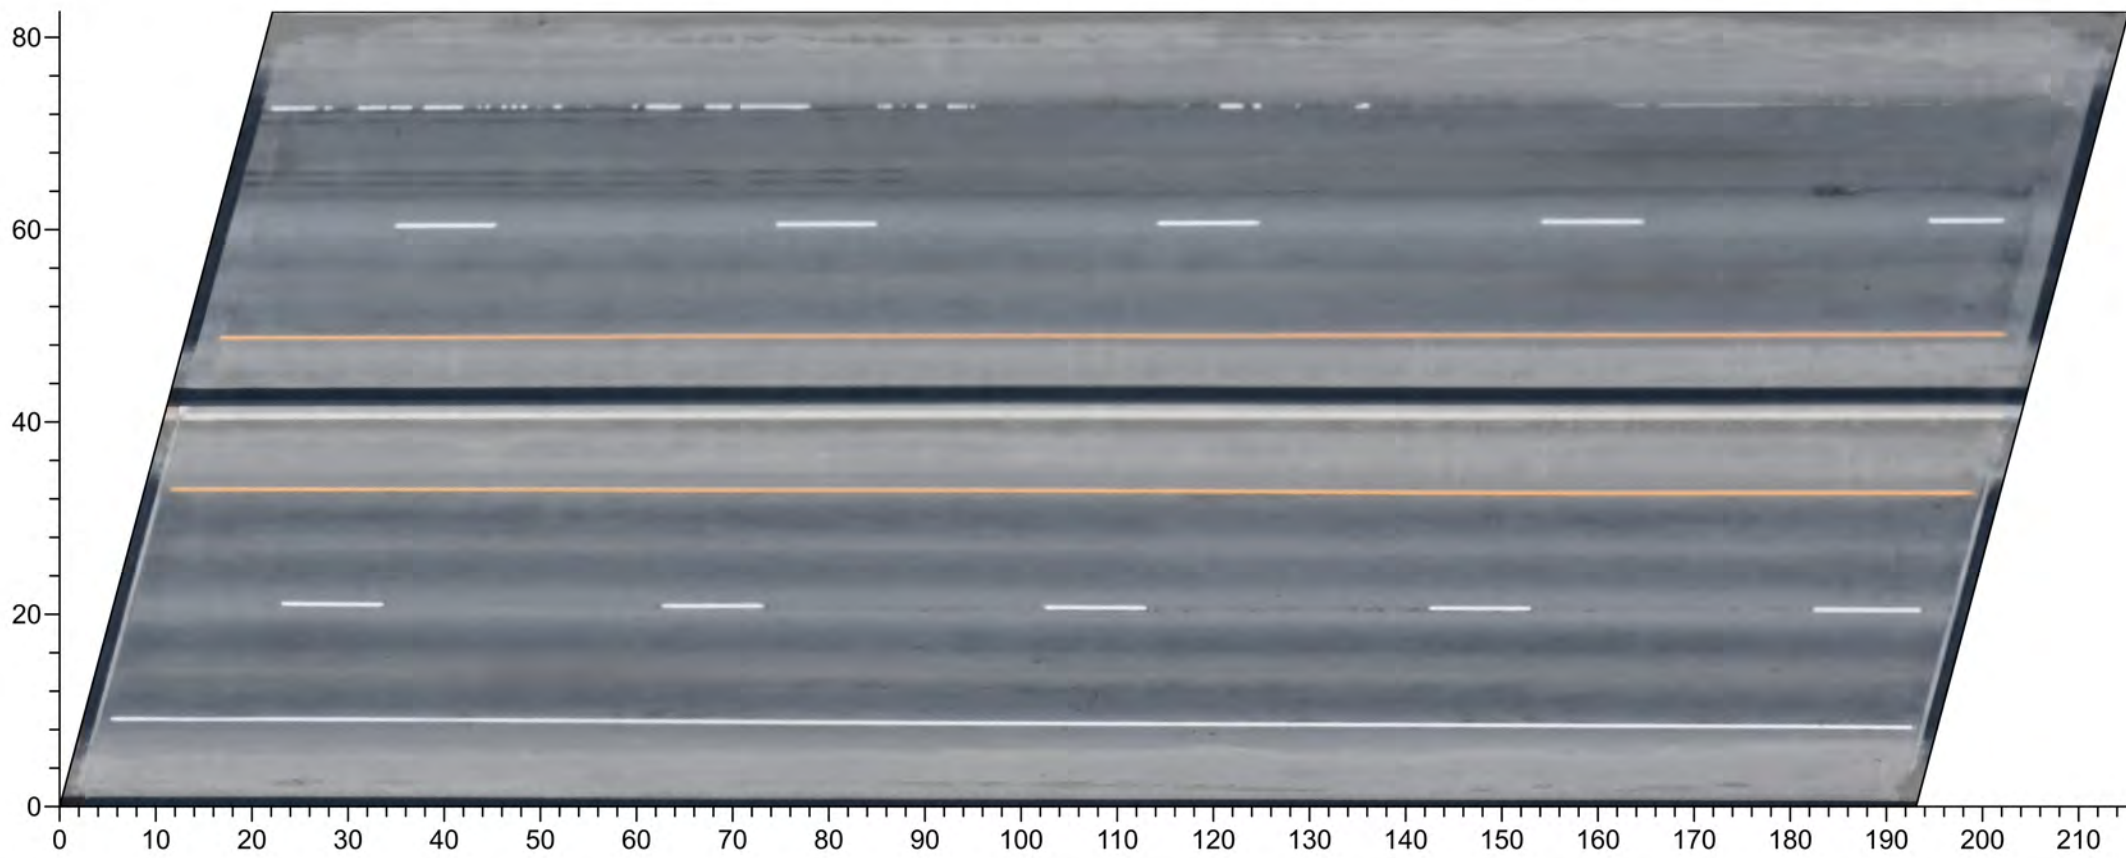
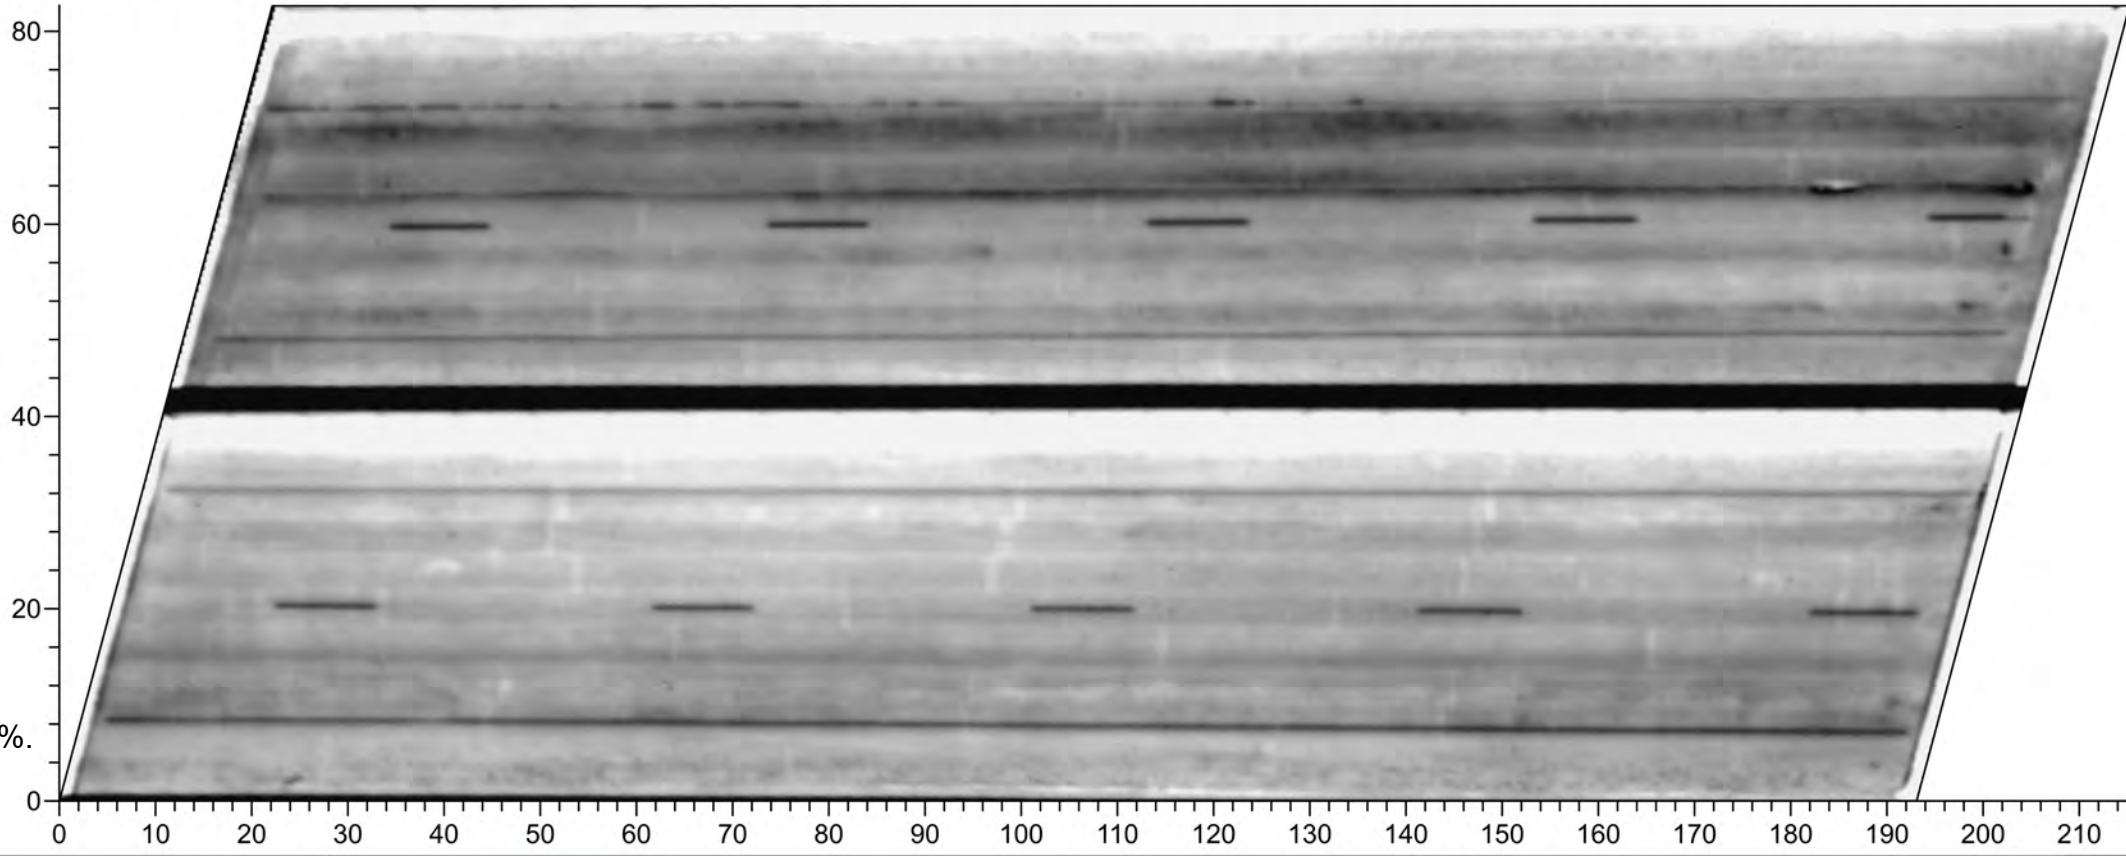
Delamination Quantity (%)    0.4 Delamination Quantity (ft <sup>2</sup> )    24	Imagery Collected: 6/5/22 Analyzed by: SB Reviewed by: AJC Completed: 10/10/22

\*Note: 184 sq. ft. of thermal anomalies not mapped due to being rectilinear in shape and appearing more like subsurface patching or some other structural feature

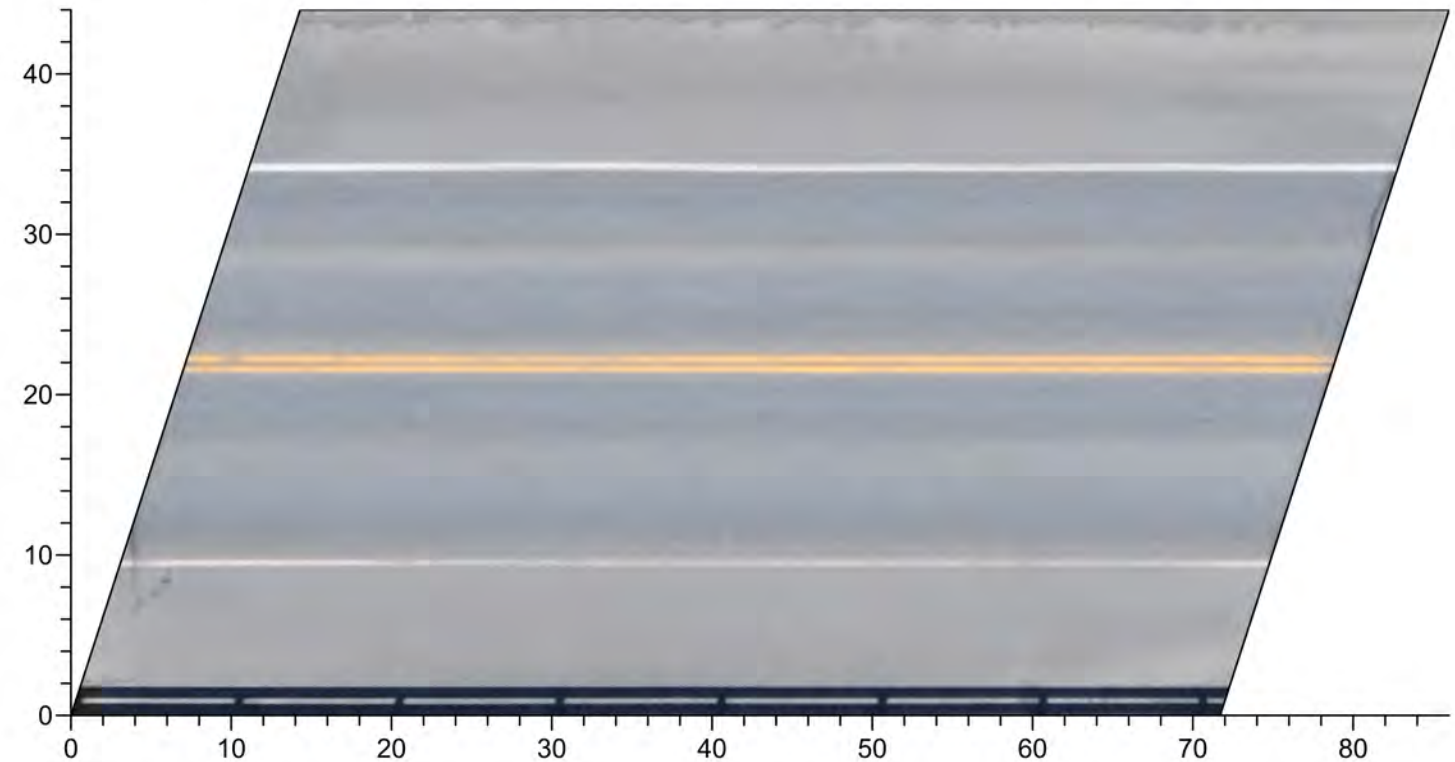
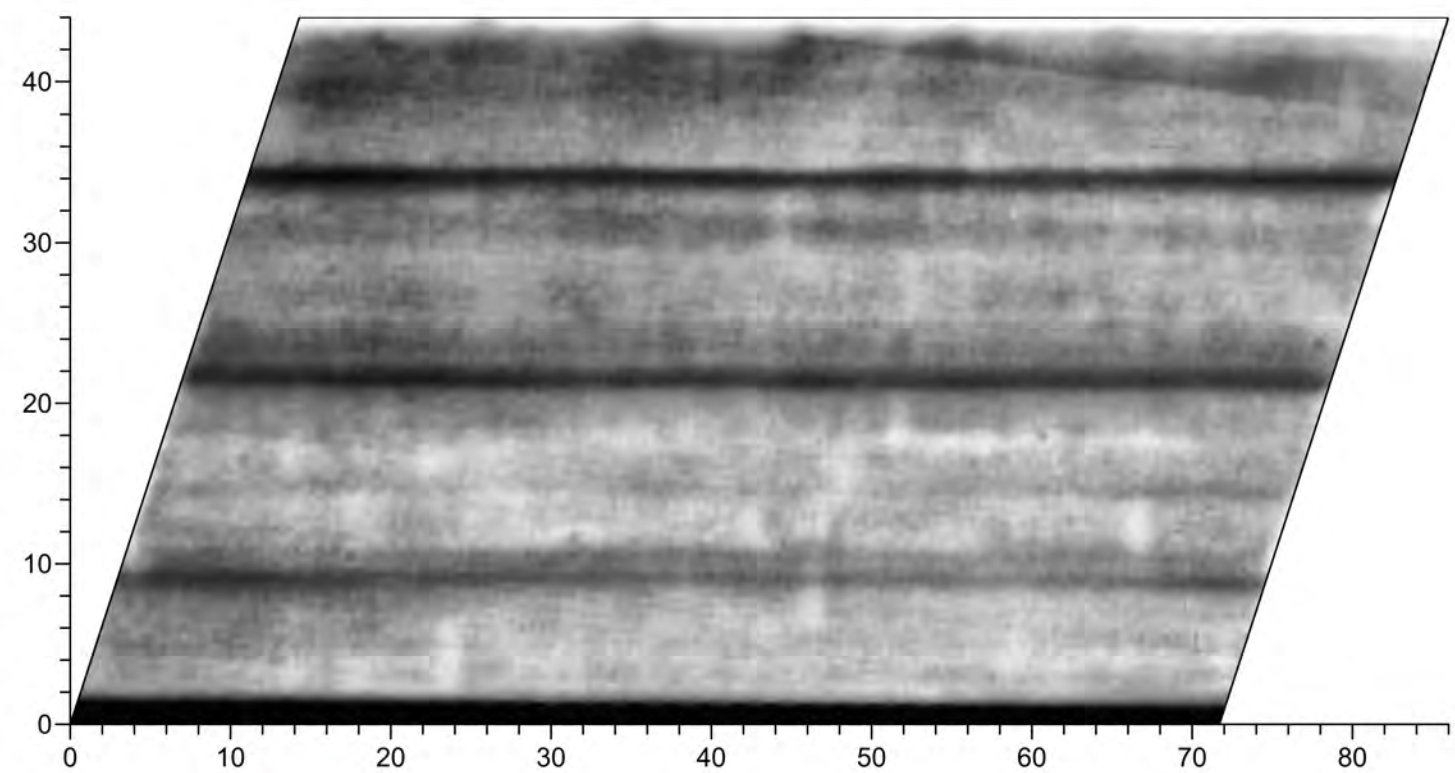
Delamination Quantity (%)    0.6 Delamination Quantity (ft <sup>2</sup> )    94	Imagery Collected: 6/4/22 Analyzed by: SB Reviewed by: AJC Completed: 10/6/22

\*Note: 40 sq. ft. of thermal anomalies not mapped due to being rectilinear in shape and appearing more like subsurface patching or some other structural feature

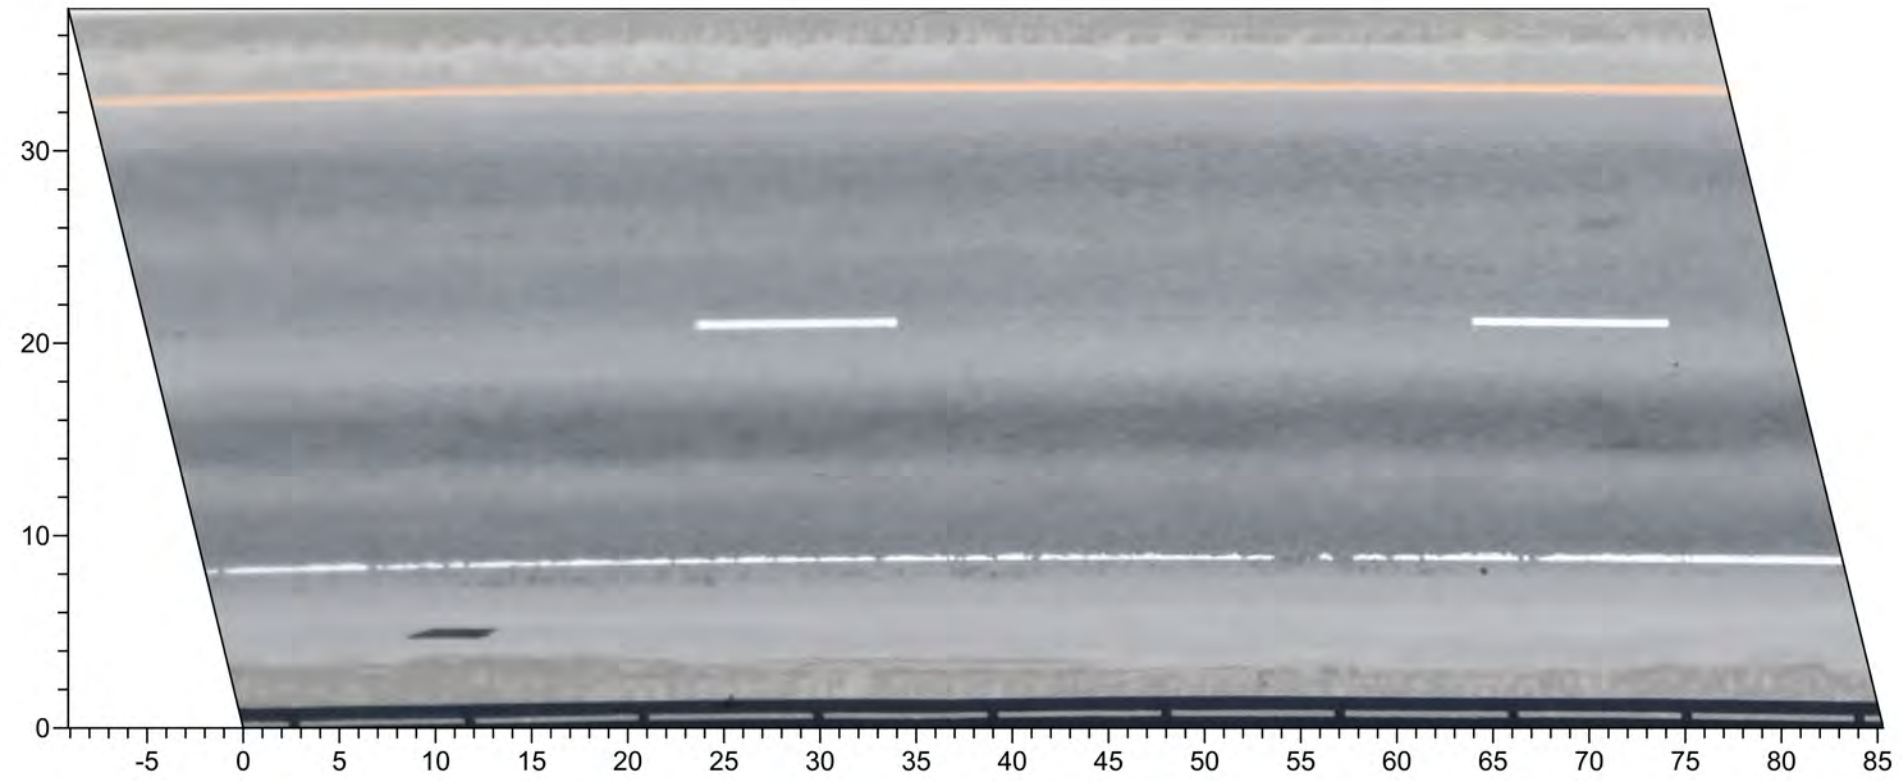
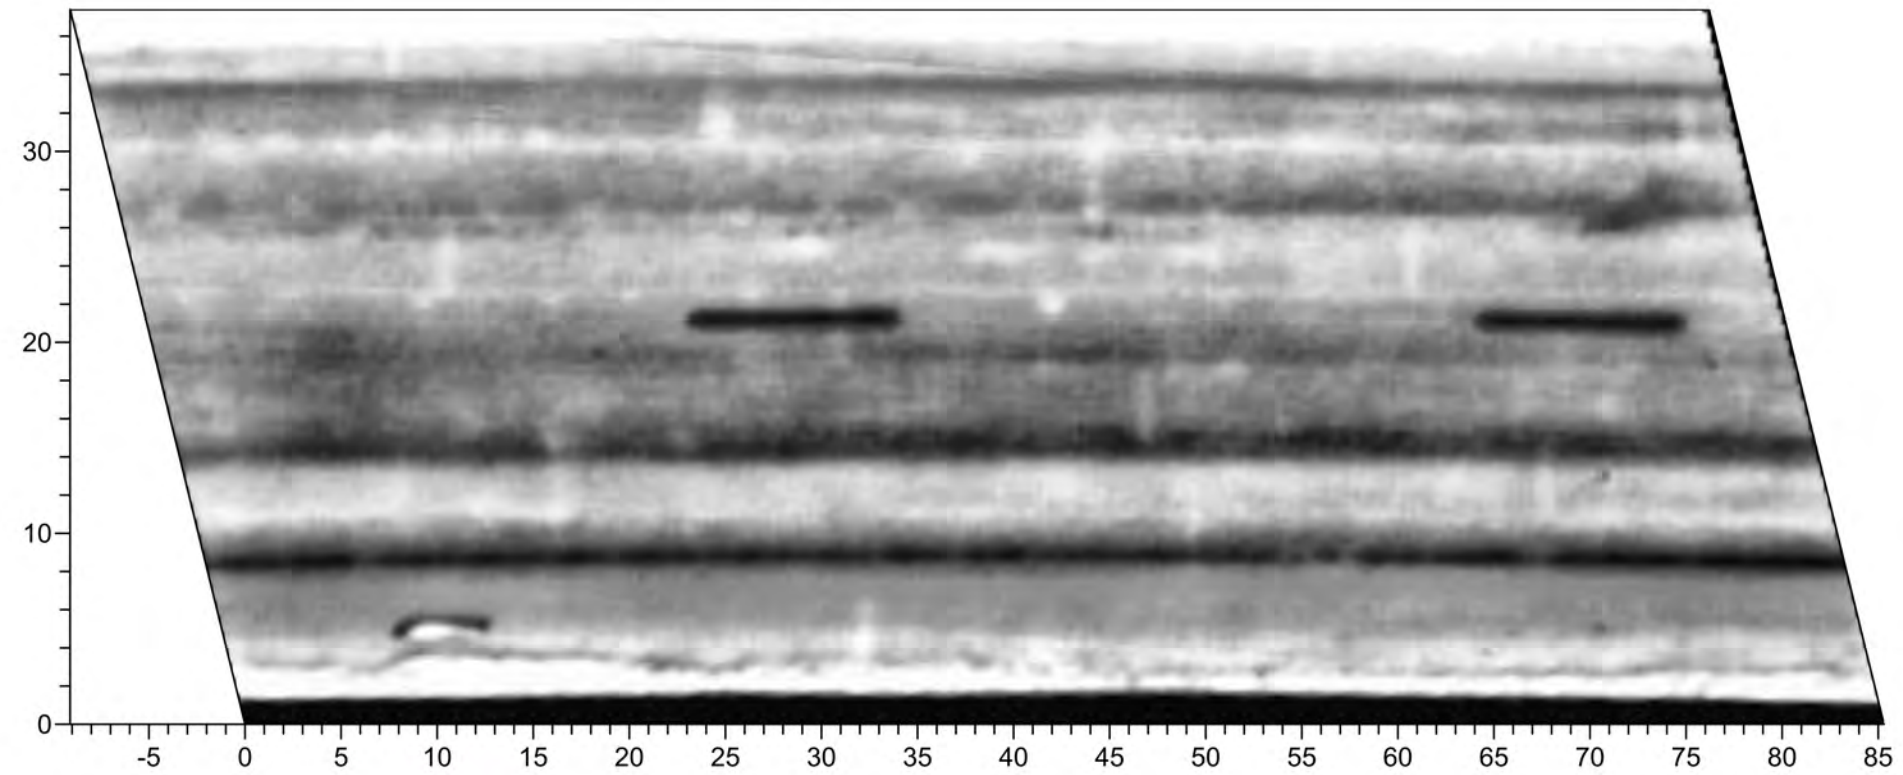
Delamination Quantity (%)	0.3	Imagery Collected: 6/5/22 Analyzed by: SB Reviewed by: AJC Completed: 10/6/22	
		Delamination Quantity (ft <sup>2</sup> )	9

\*Note: 44 sq. ft. of thermal anomalies not mapped due to being rectilinear in shape and appearing more like subsurface patching or some other structural feature

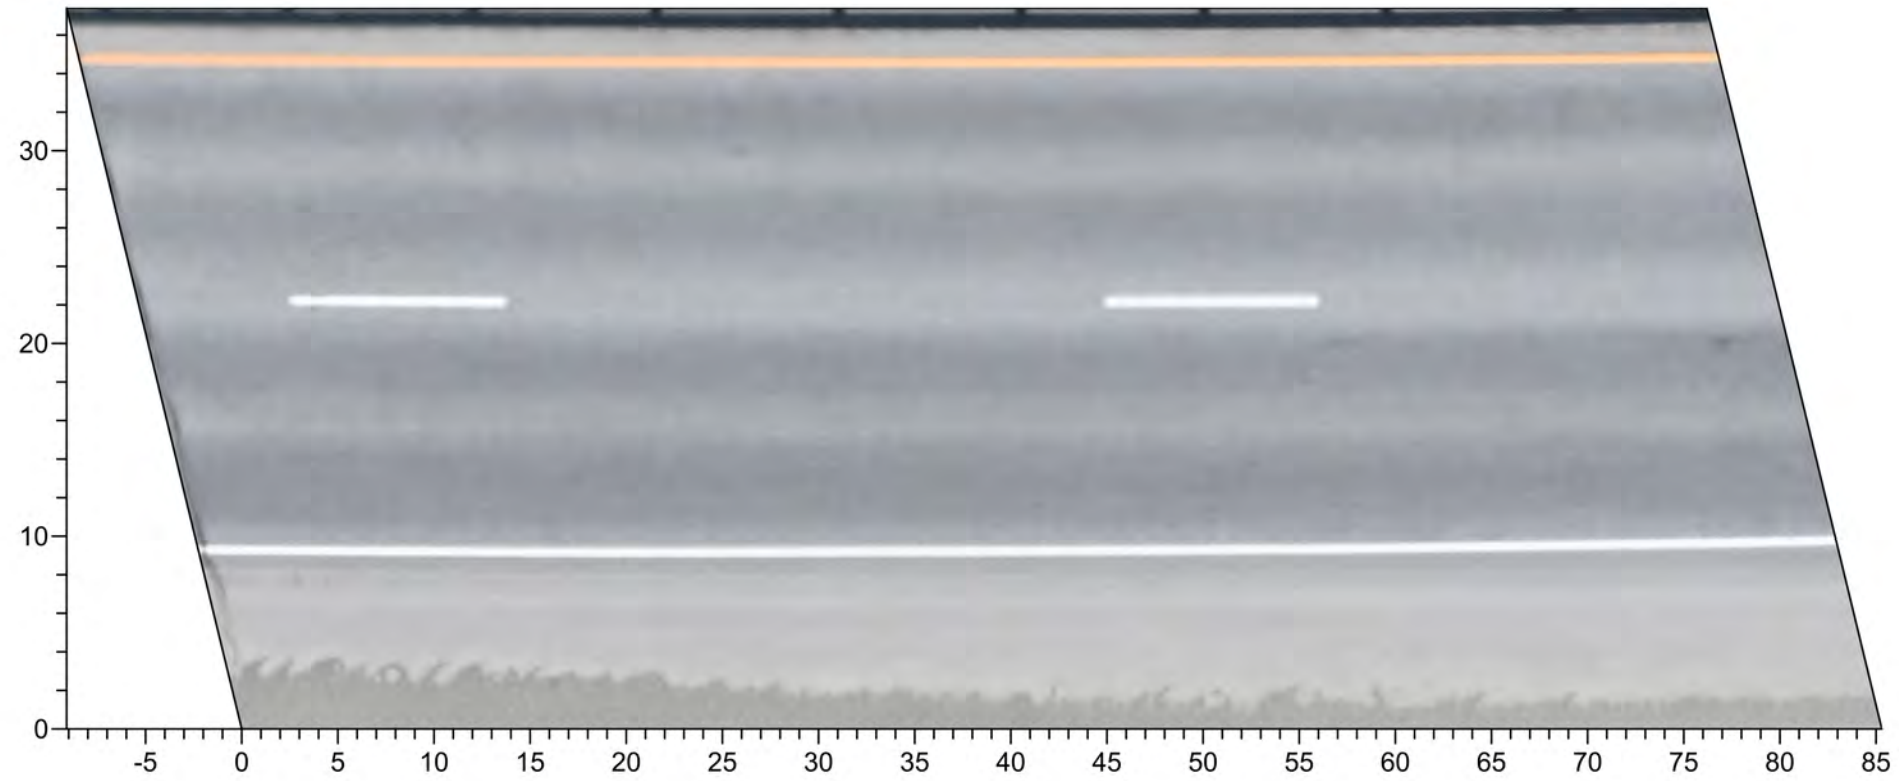
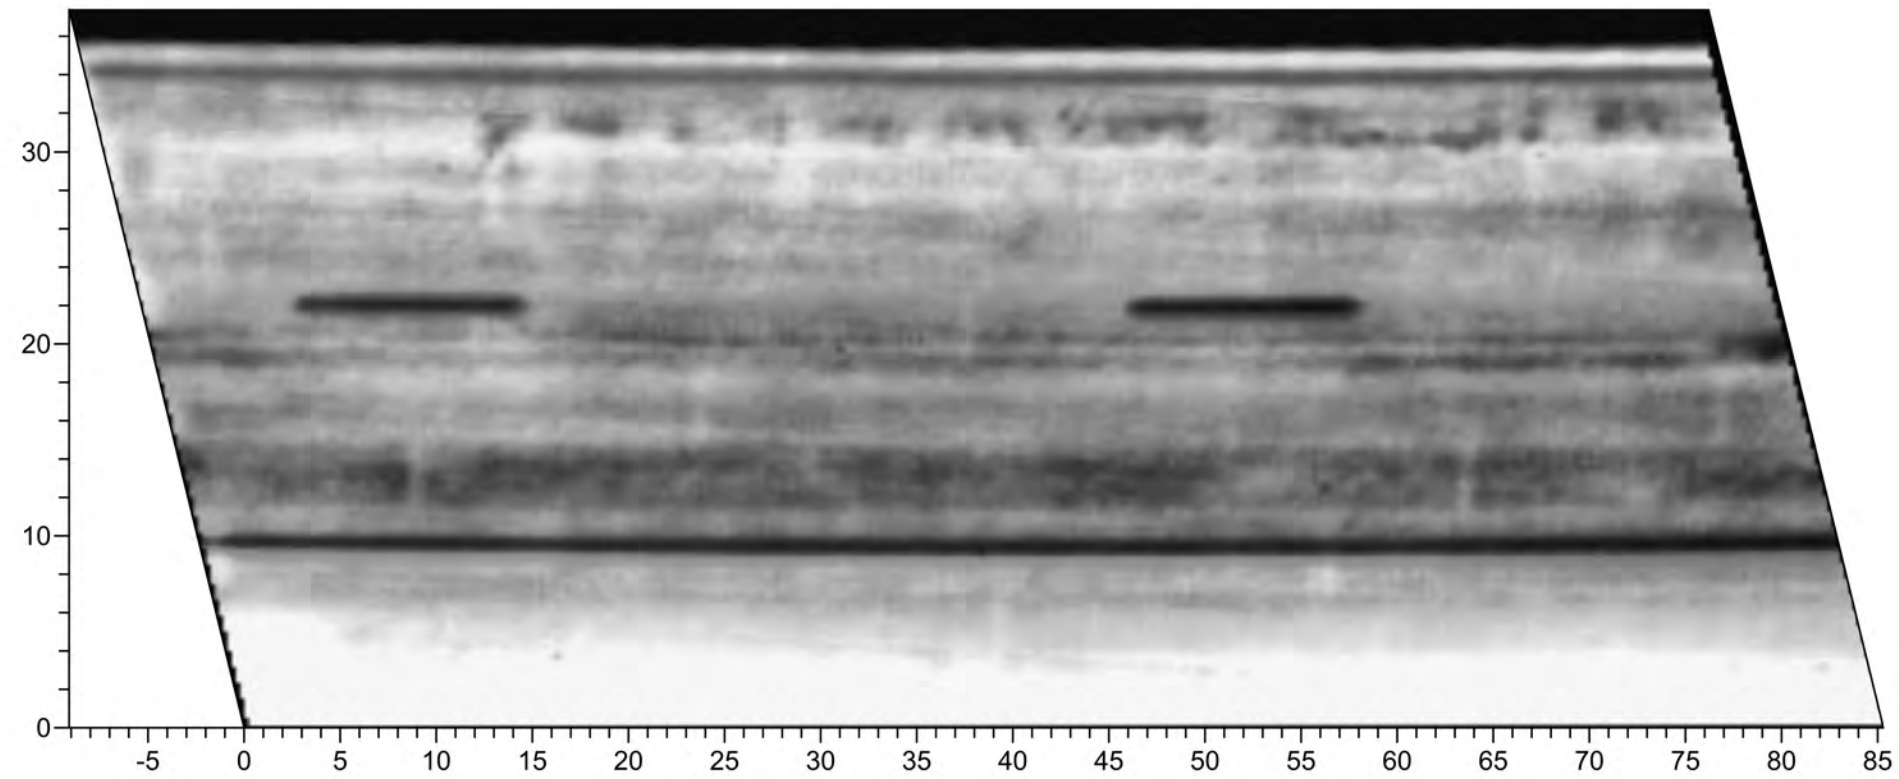
Delamination Quantity (%)    1.0 Delamination Quantity (ft <sup>2</sup> )    32	Imagery Collected: 6/4/22 Analyzed by: SB Reviewed by: AJC Completed: 10/5/22

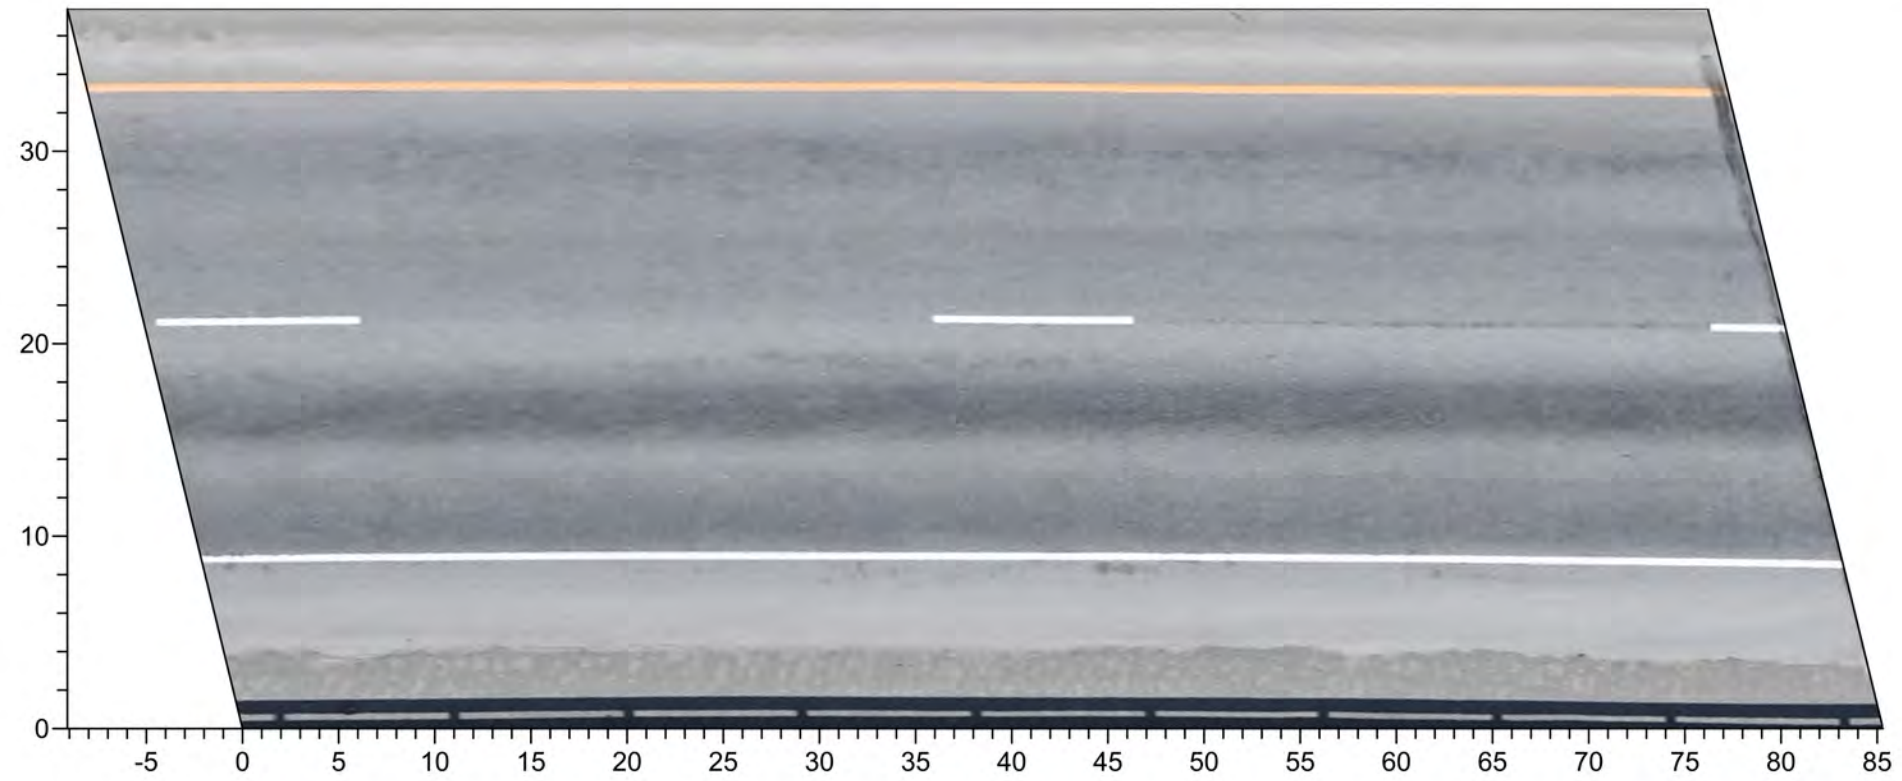
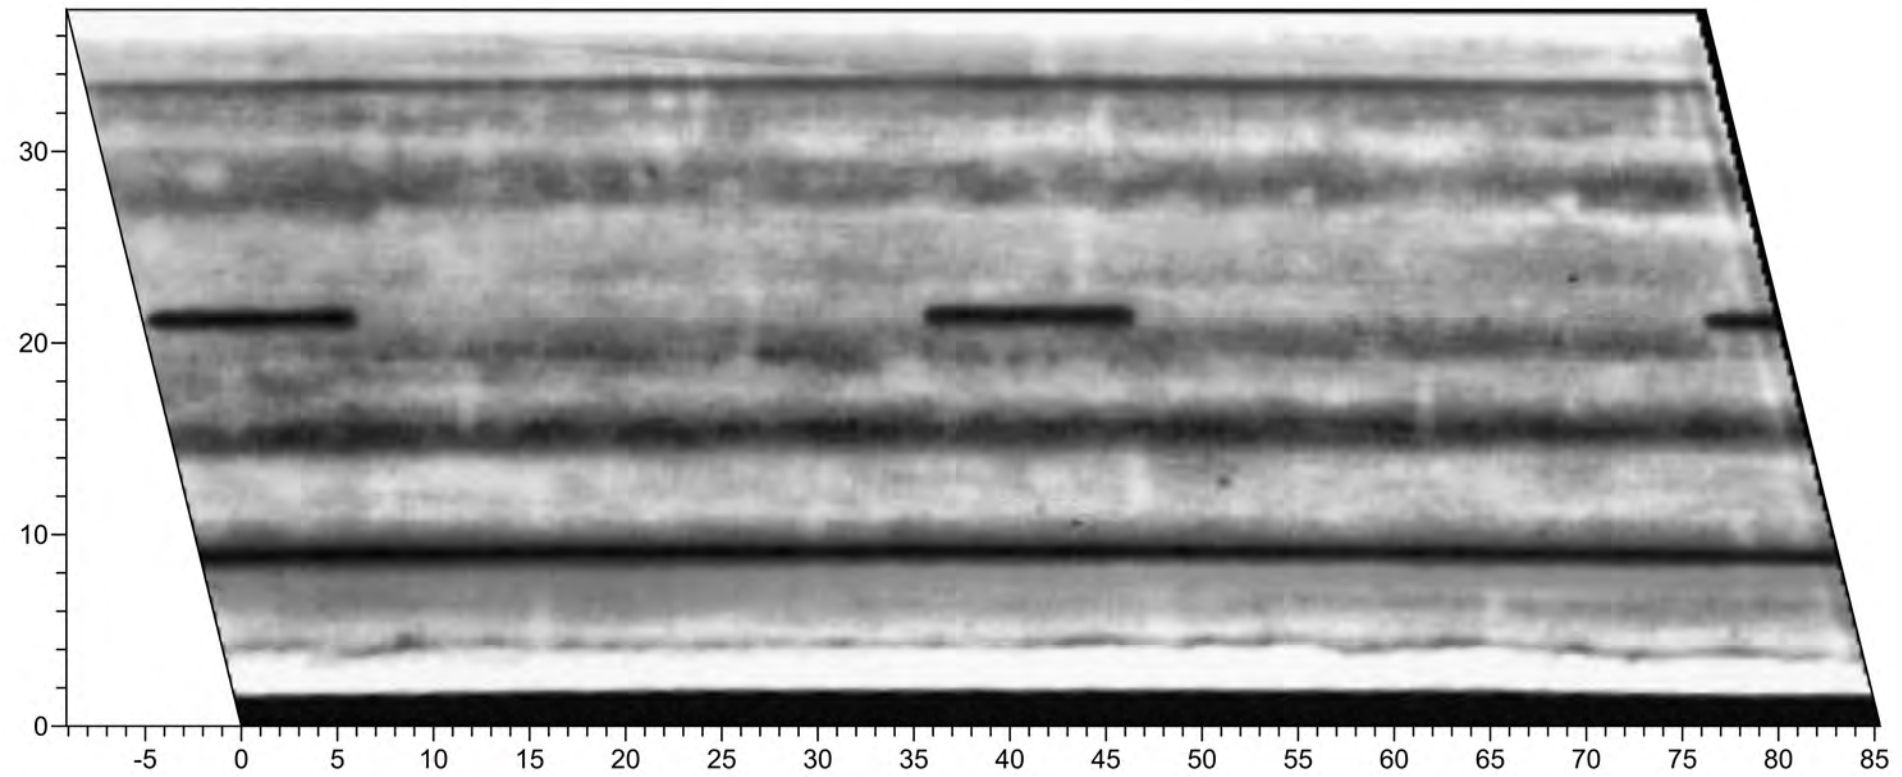
Delamination Quantity (%)	1.6	Imagery Collected: 6/4/22 Analyzed by: SB	
		Delamination Quantity (ft <sup>2</sup> )	52	Reviewed by: AJC Completed: 10/5/22

\*Note: 51 sq. ft. of thermal anomalies not mapped due to being rectilinear in shape and appearing more like subsurface patching or some other structural feature
