# Aerial Infrared Scanning of Bridge Decks on Parks Highway to Map Delaminations

## FINAL REPORT

**Prepared by:**  
Infrasense, Inc.  
Woburn, MA

**Report # FHWA-AK-RD-000S(960)**  
**March 2, 2023**

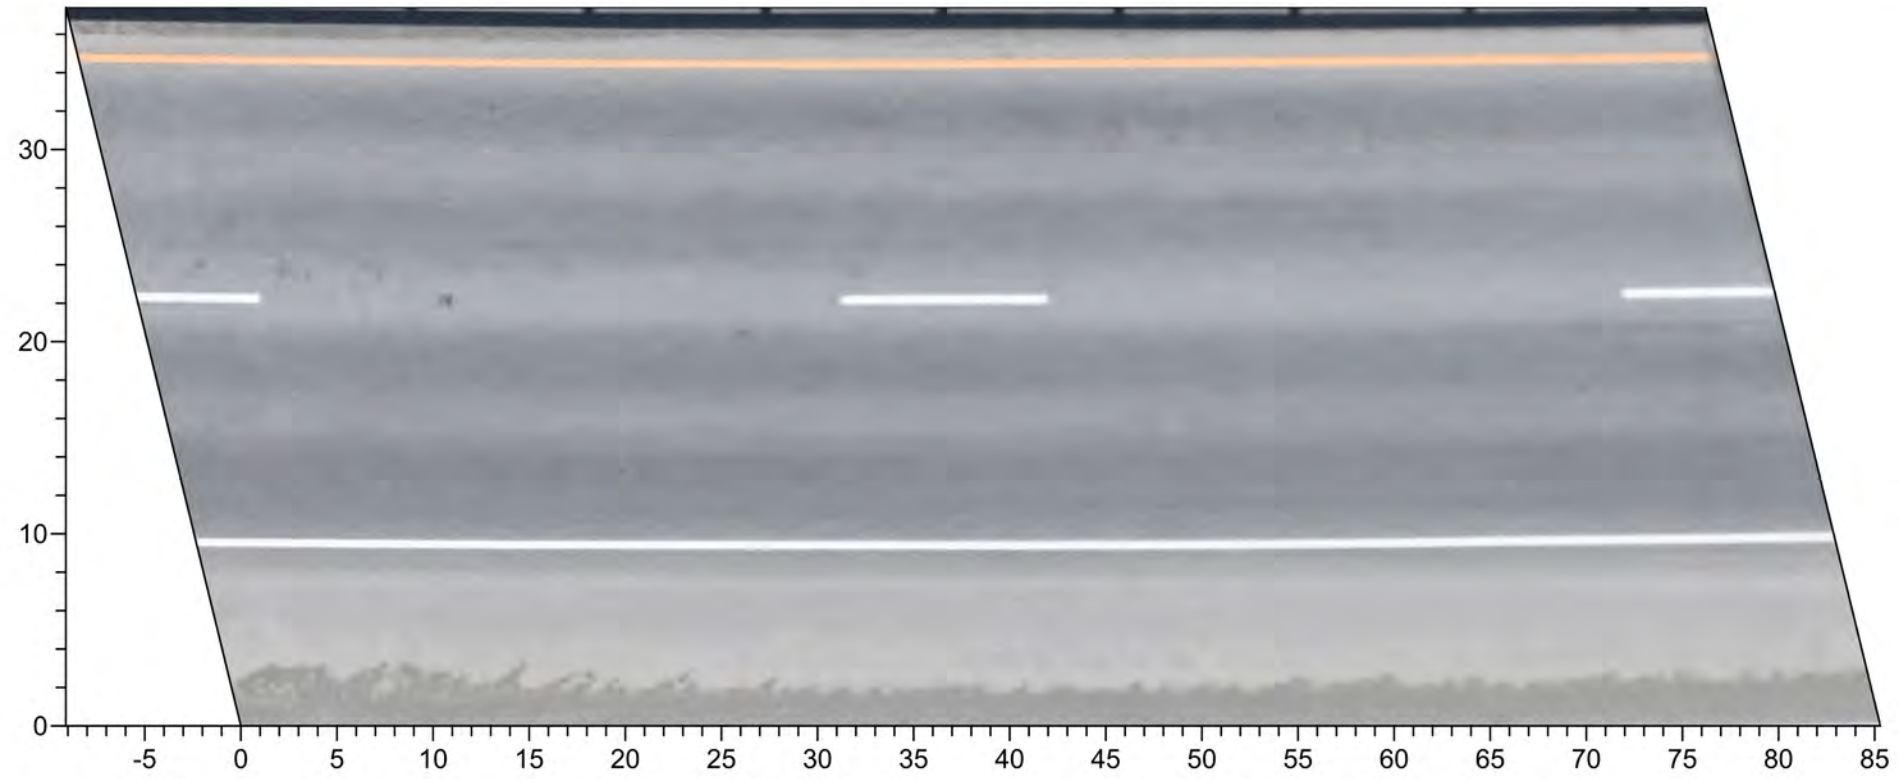
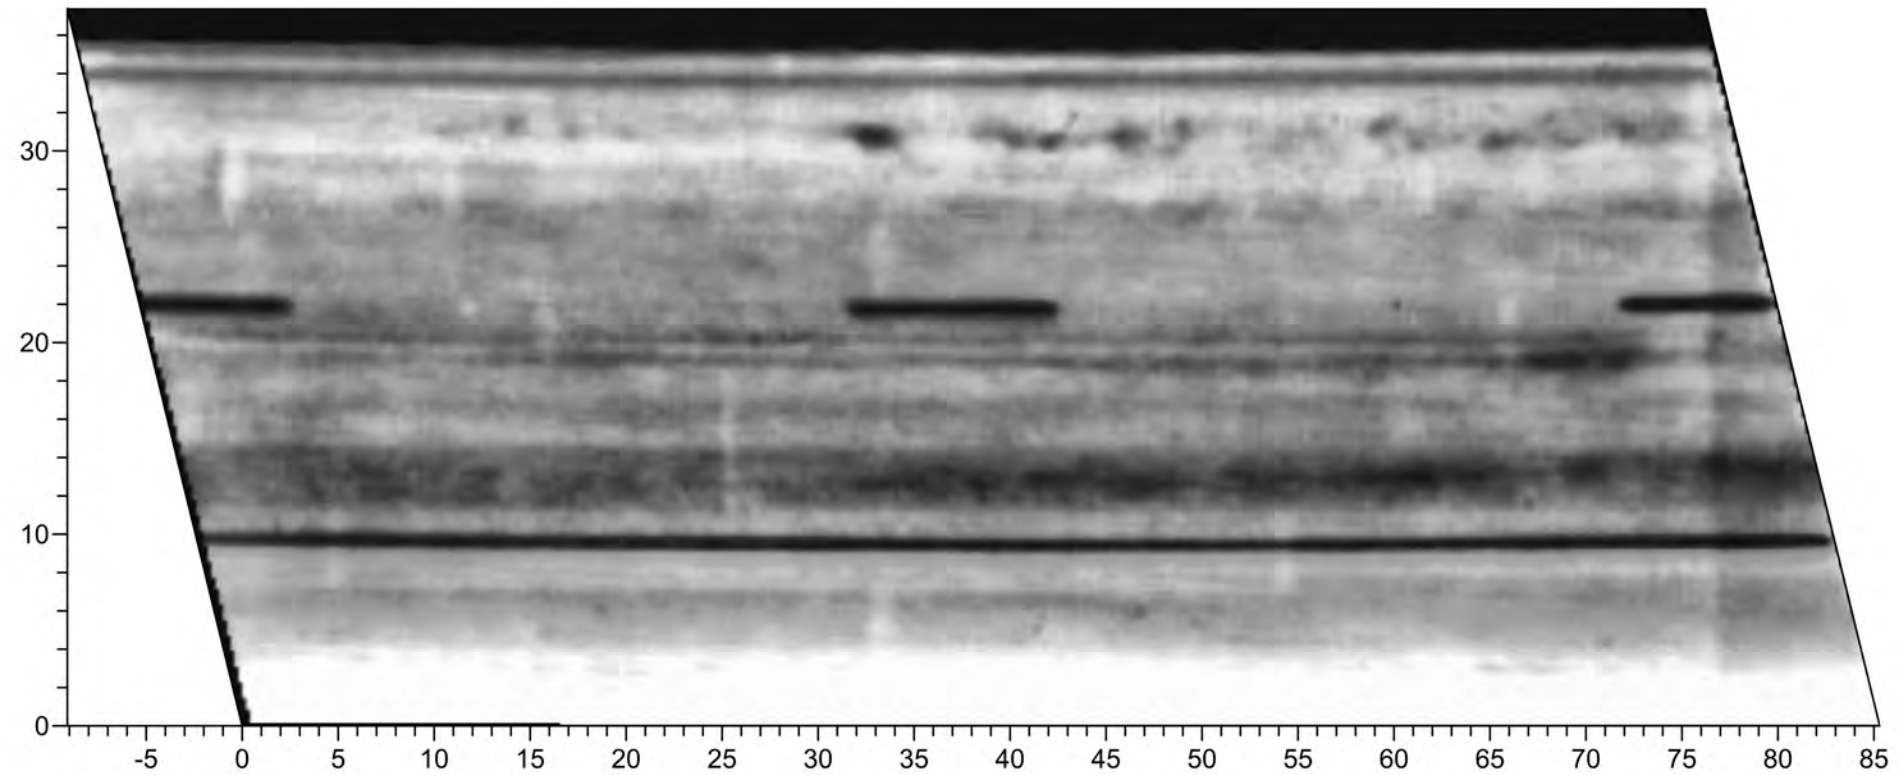
Delamination Quantity (%)    0.9 Delamination Quantity (ft <sup>2</sup> )    28	Imagery Collected: 6/4/22 Analyzed by: SB Reviewed by: AJC Completed: 10/11/22

\*Note: 66 sq. ft. of thermal anomalies not mapped due to being rectilinear in shape and appearing more like subsurface patching or some other structural feature

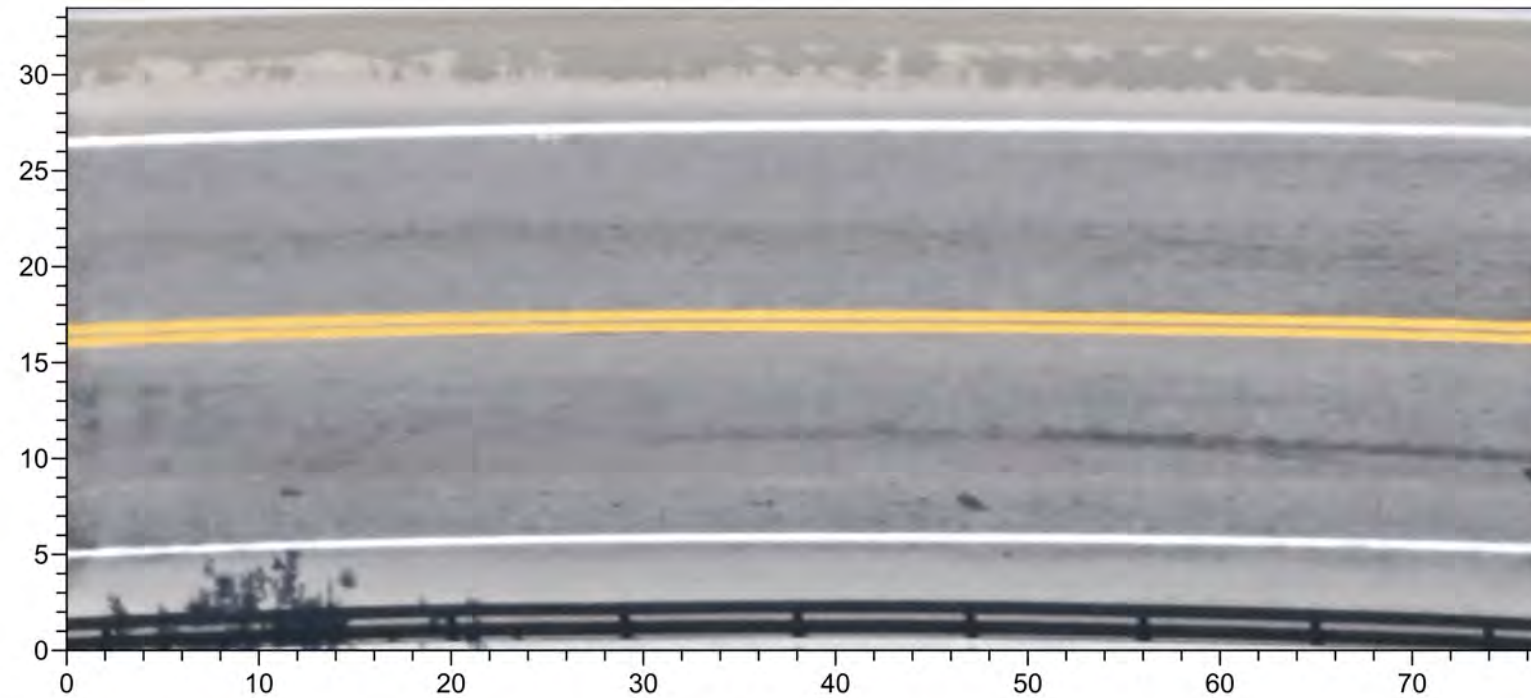
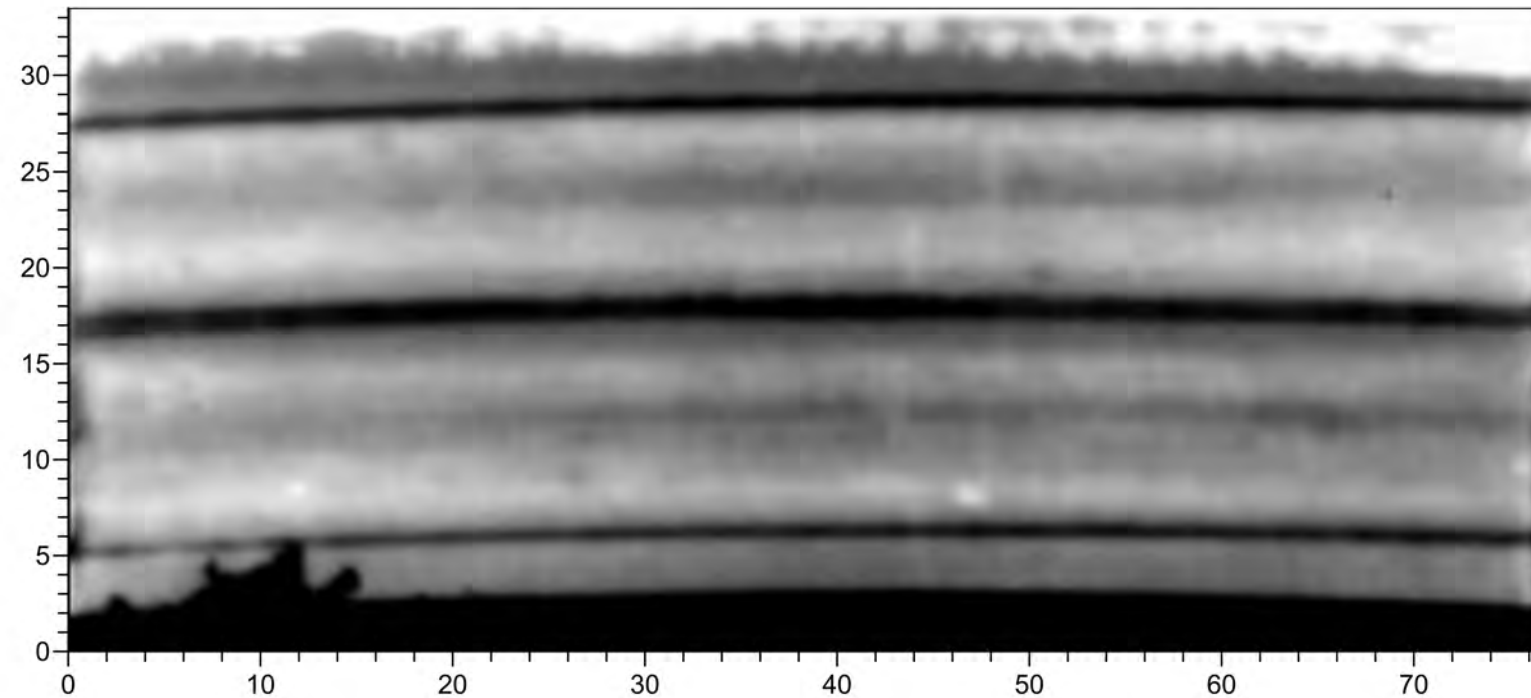
Delaminations Detected by Aerial Infrared	Quantity Summary		Analysis Information	Bridge No.: 2035 WASILLA CR S. FRONTAGE PARKS HIGHWAY
1-in = 10-ft

Delamination Quantity (%)    0.2 Delamination Quantity (ft <sup>2</sup> )    5	Imagery Collected: 6/4/22 Analyzed by: SB Reviewed by: AJC Completed: 10/5/22

Note: Delamination locations not shown as quantity is less than 2%.

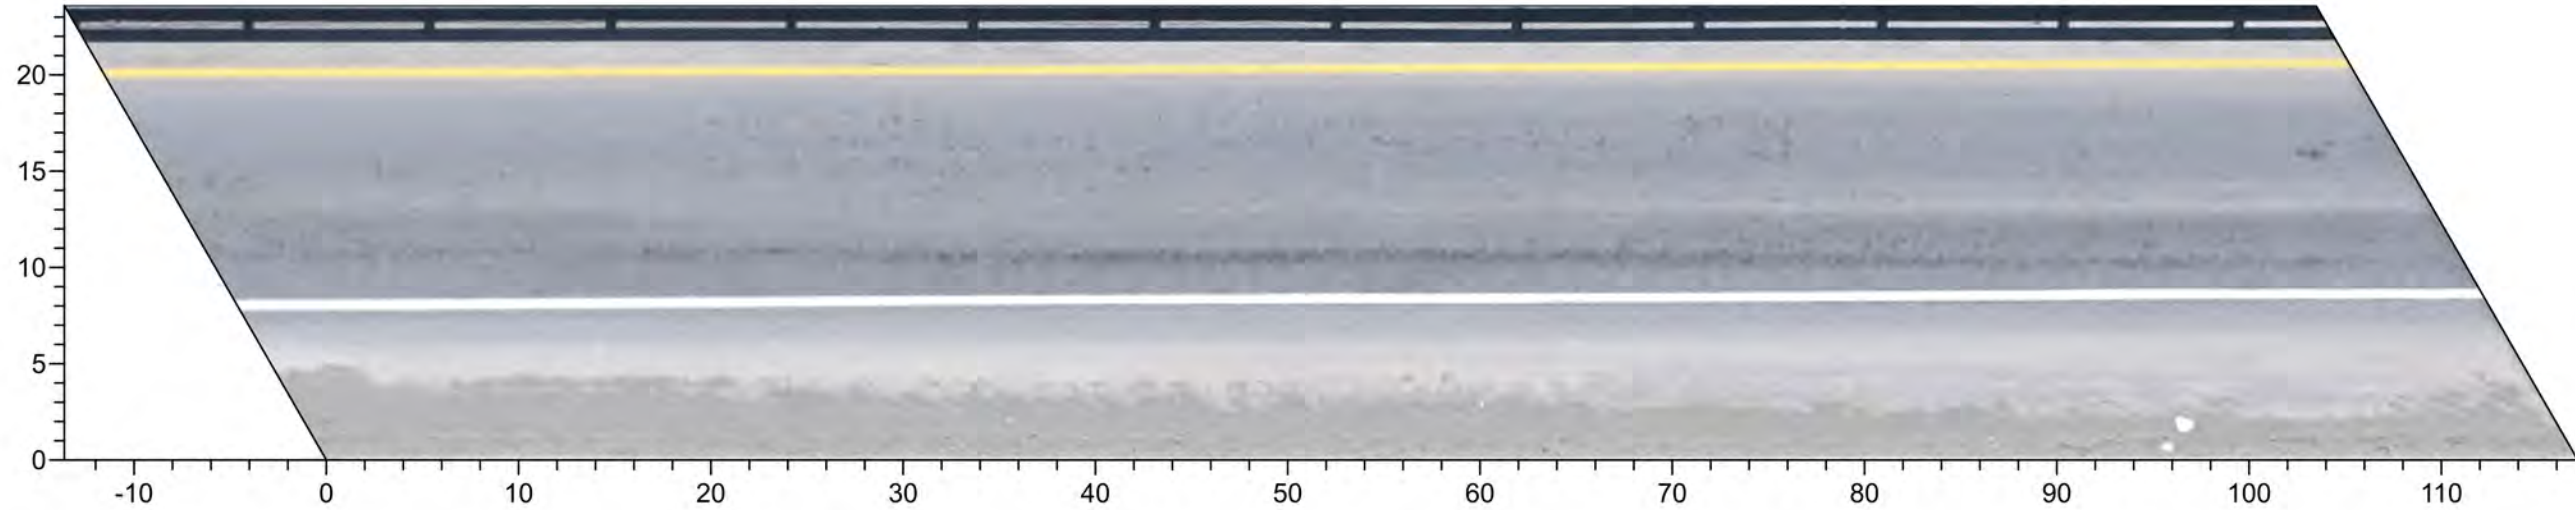
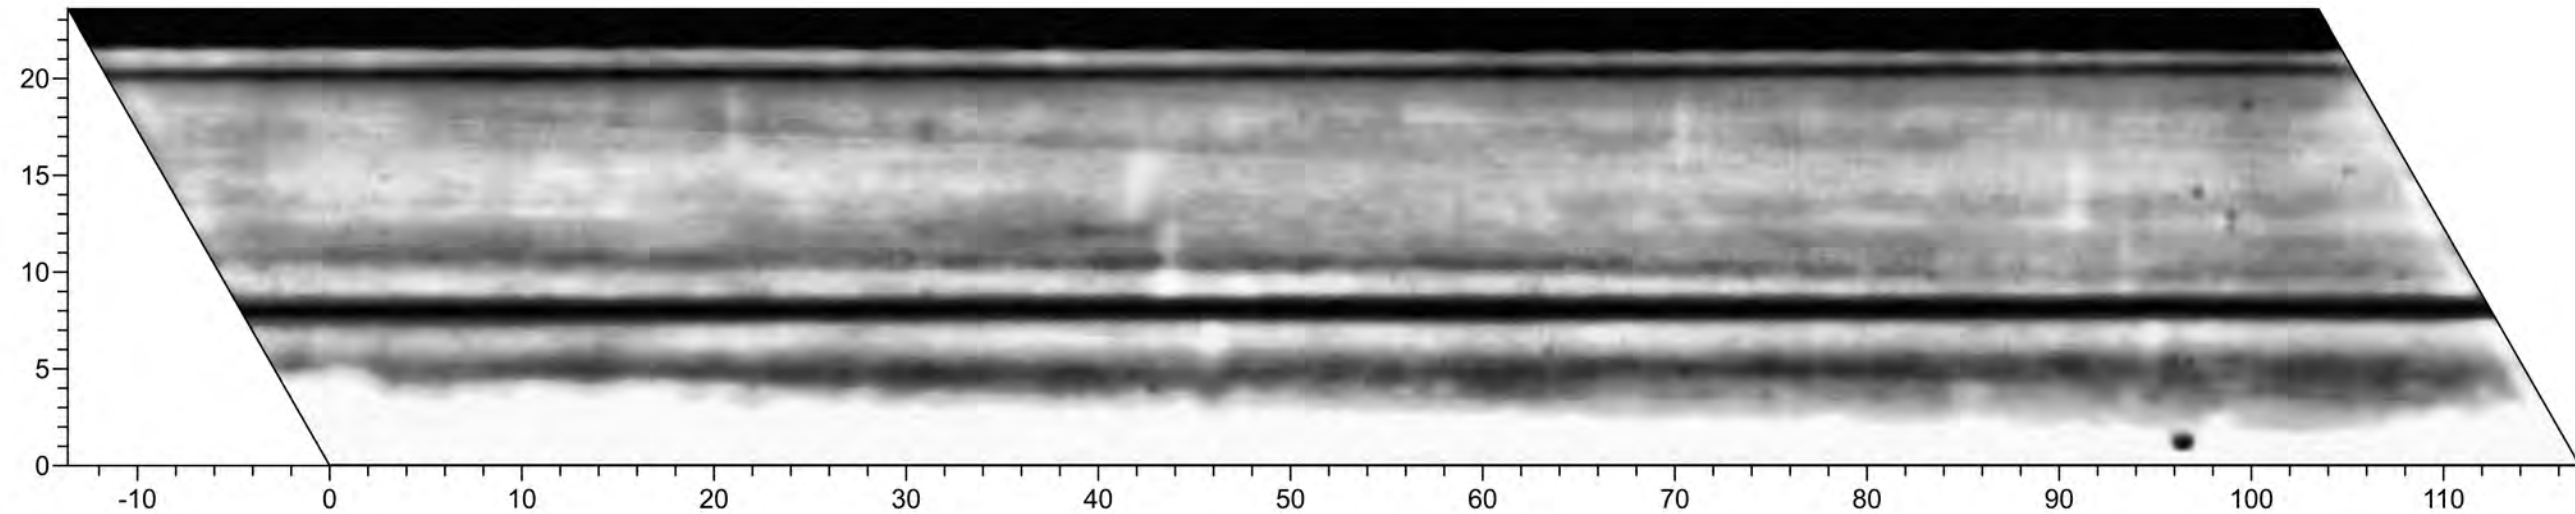
Delaminations Detected by Aerial Infrared	Quantity Summary		Analysis Information	Bridge No.: 2036 WASILLA CR NB RAMP PARKS HIGHWAY
1-in = 10-ft

Delamination Quantity (%)	1.3	Imagery Collected: 6/4/22 Analyzed by: SB Reviewed by: AJC Completed: 10/5/22	
		Delamination Quantity (ft <sup>2</sup> )	34

\*Note: 47 sq. ft. of thermal anomalies not mapped due to being rectilinear in shape and appearing more like subsurface patching or some other structural feature

Note: Delamination locations not shown as quantity is less than 2%.

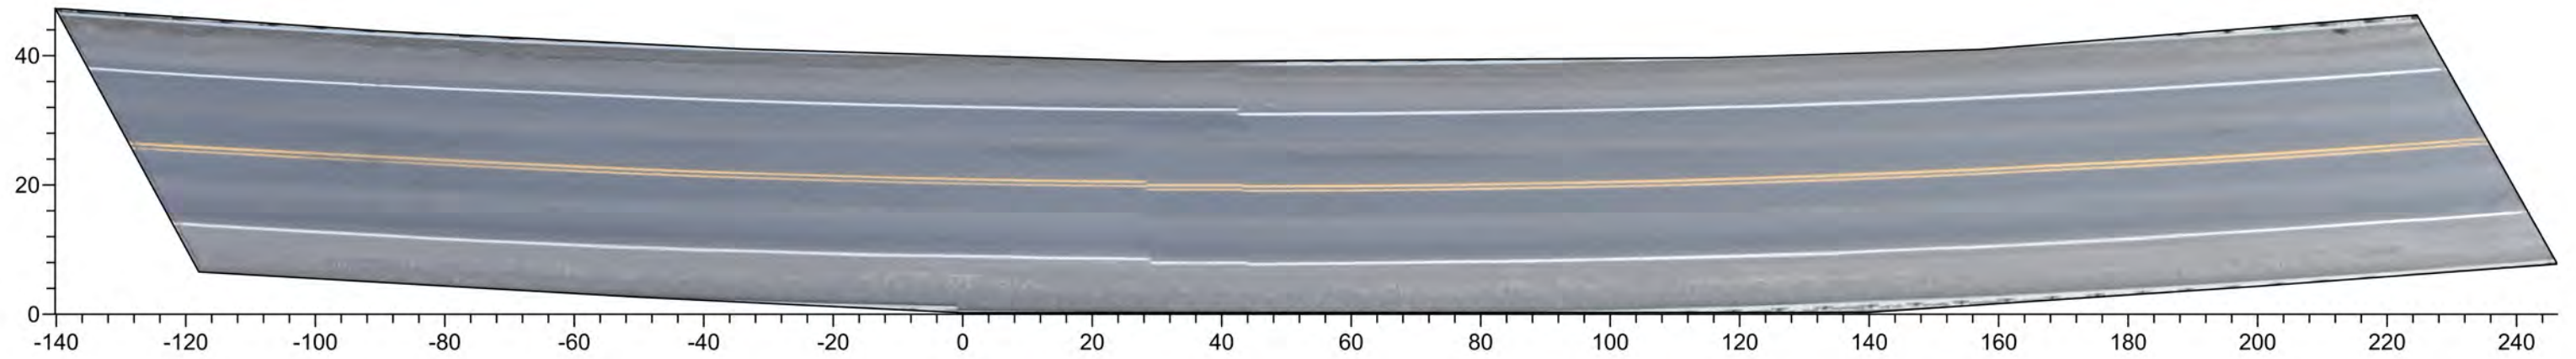
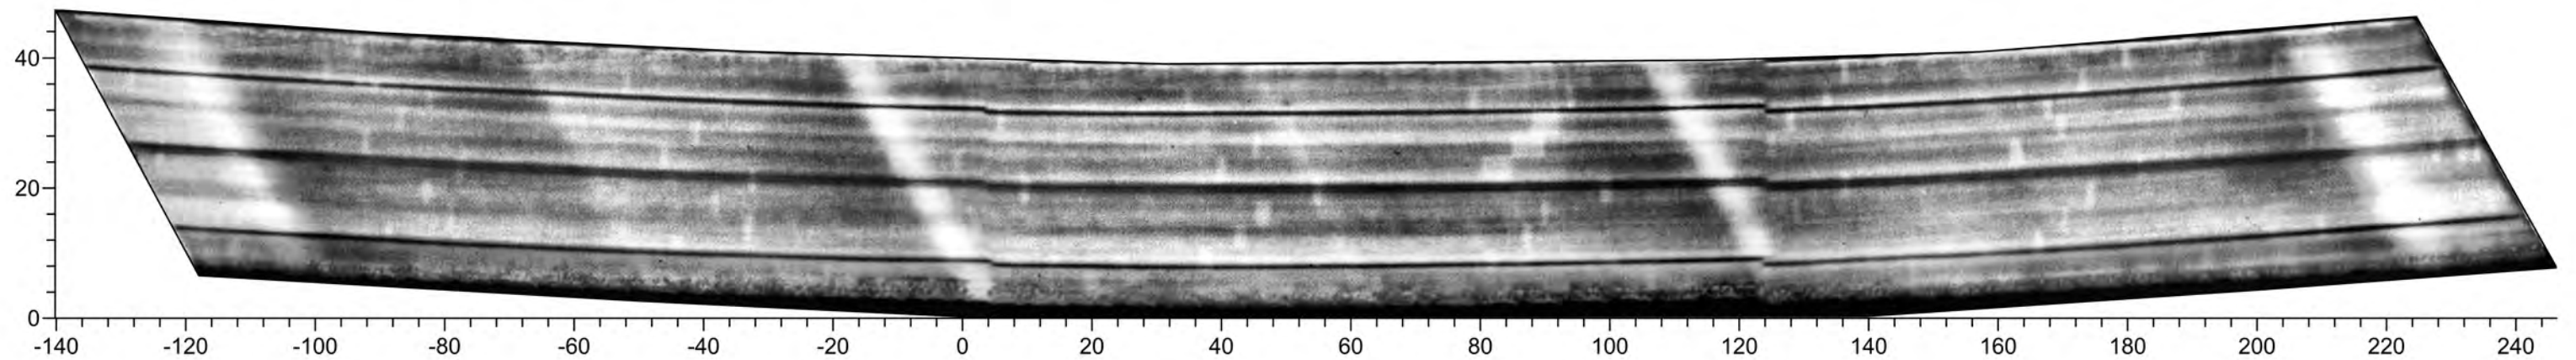
Delamination Quantity (%)    0.6 Delamination Quantity (ft <sup>2</sup> )    16	Imagery Collected: 6/4/22 Analyzed by: SB Reviewed by: AJC Completed: 10/5/22

\*Note: 409 sq. ft. of thermal anomalies not mapped due to being rectilinear in shape and appearing more like subsurface patching or some other structural feature

Note: Delamination locations not shown as quantity is less than 2%.

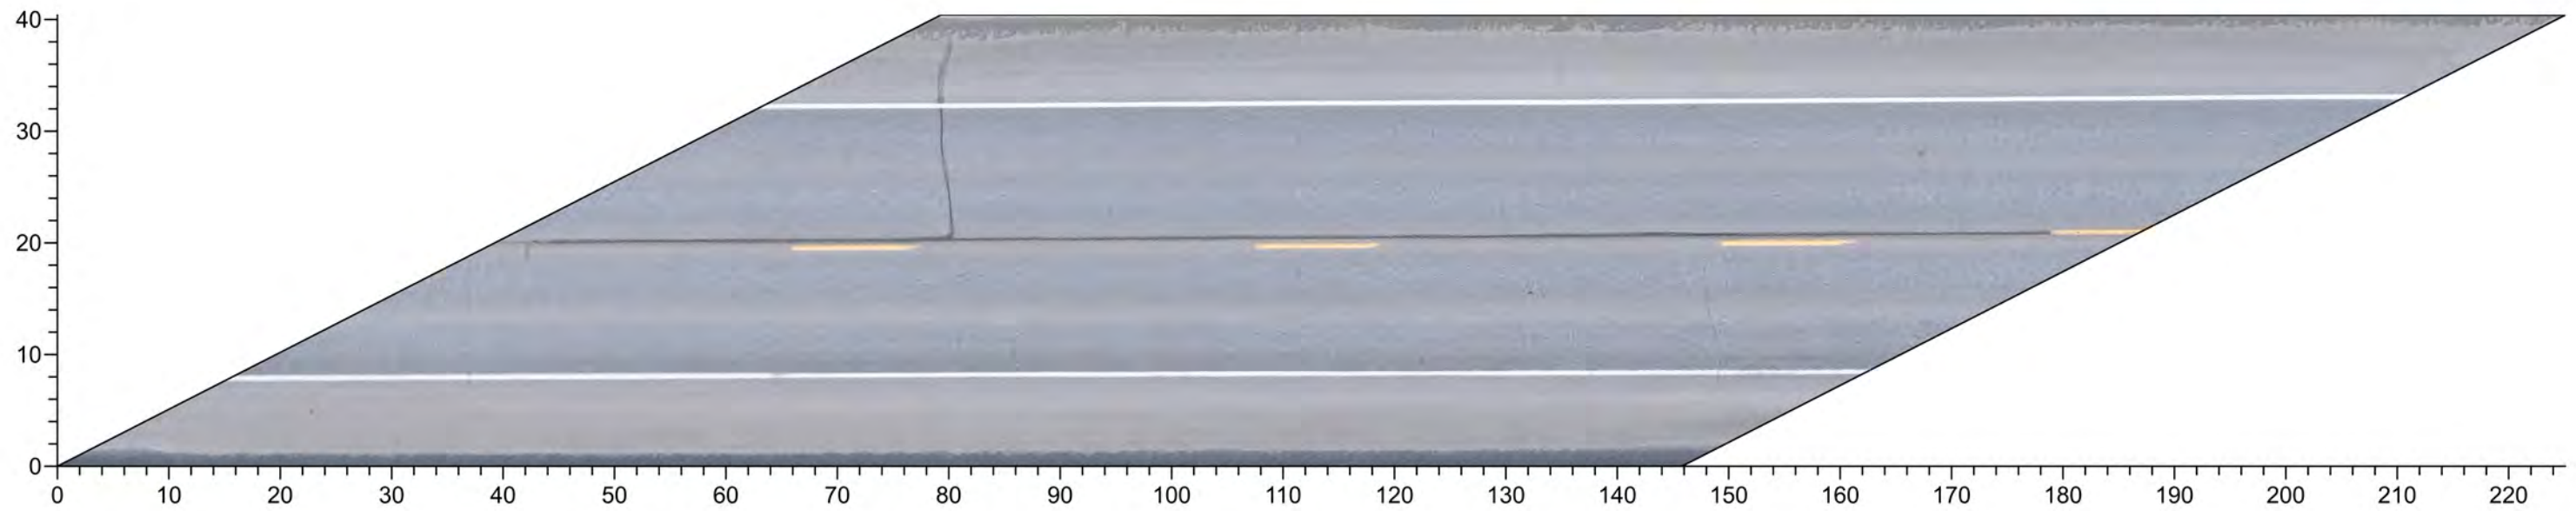
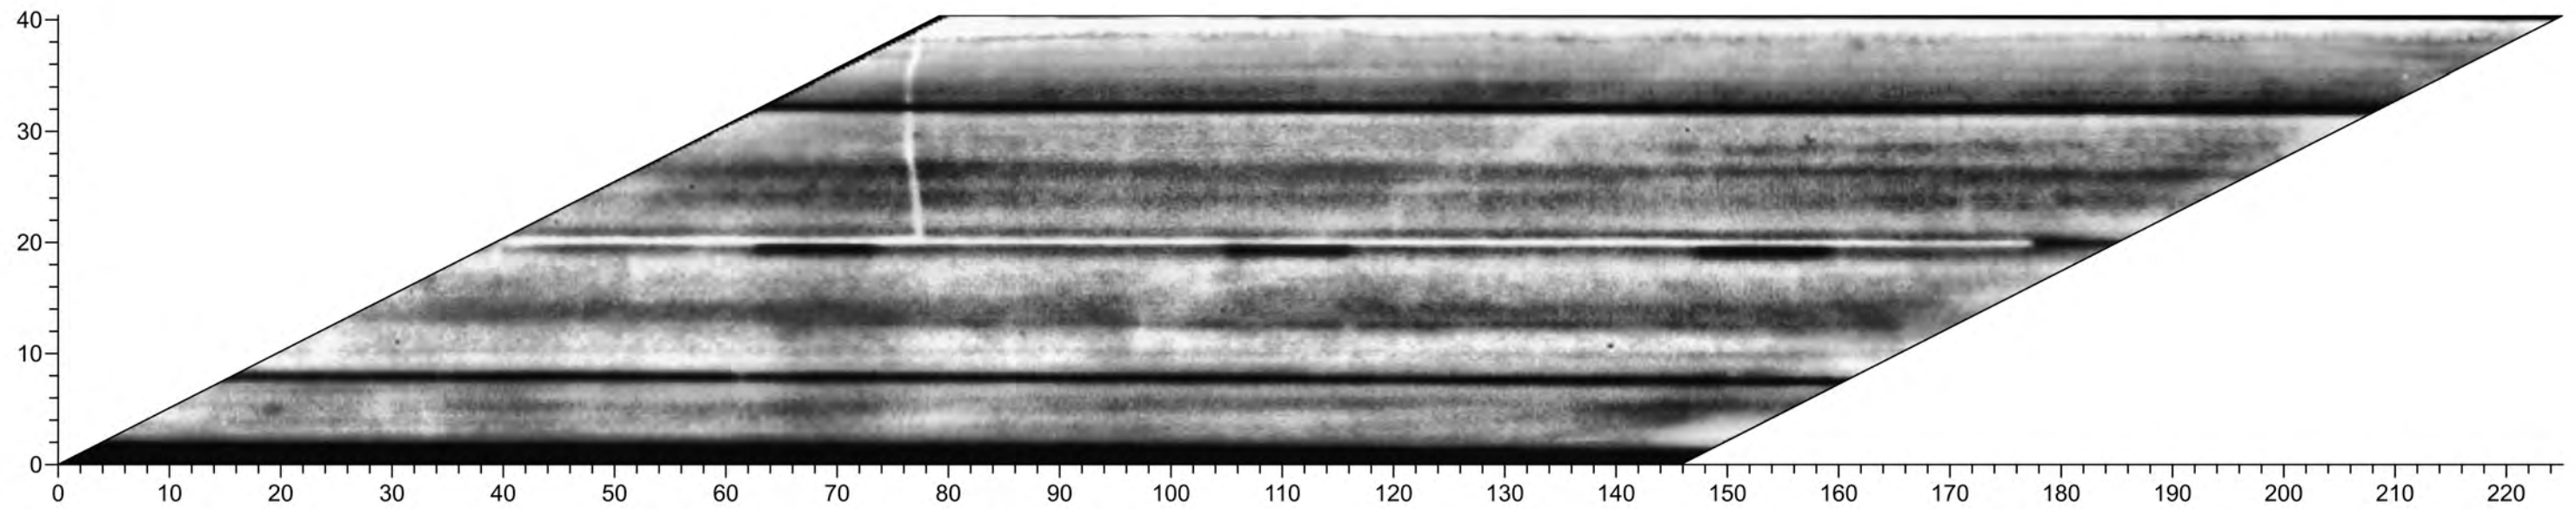
Delamination Quantity (%)      0.3 Delamination Quantity (ft <sup>2</sup> )      37	Imagery Collected: 6/4/22 Analyzed by: SB Reviewed by: AJC Completed: 10/5/22

Note: Delamination locations not shown as quantity is less than 2%.

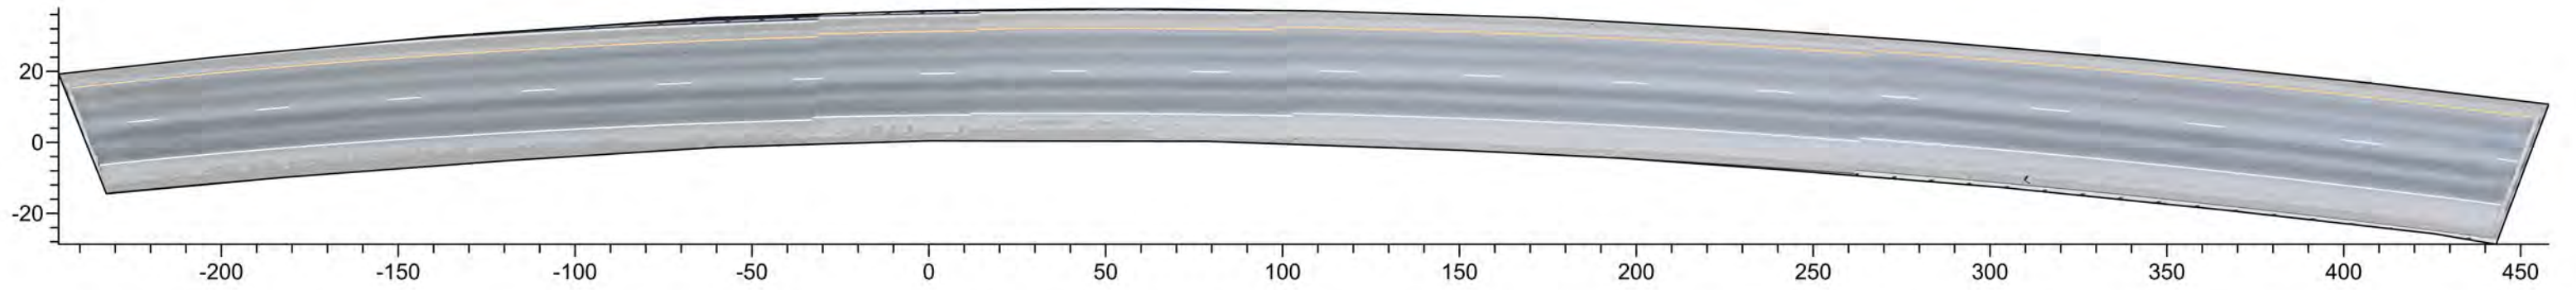
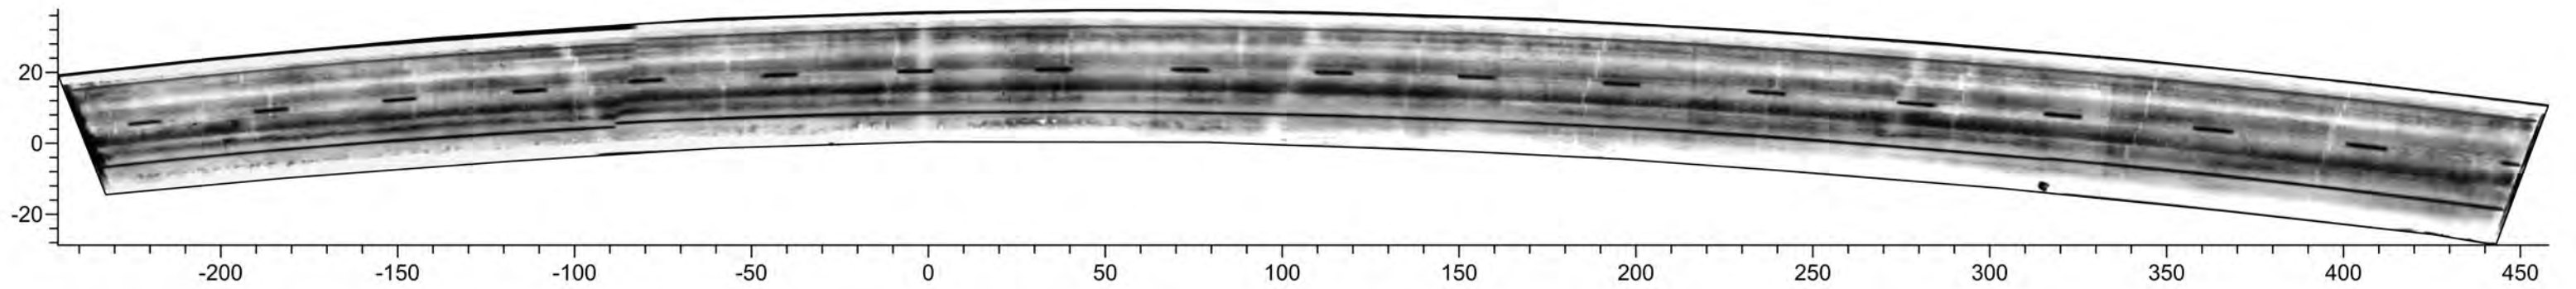
Delamination Quantity (%)      1.1 Delamination Quantity (ft <sup>2</sup> )      67	Imagery Collected: 6/5/22 Analyzed by: SB Reviewed by: AJC Completed: 10/5/22

\*Note: 321 sq. ft. of thermal anomalies not mapped due to being rectilinear in shape and appearing more like subsurface patching or some other structural feature

Note: Delamination locations not shown as quantity is less than 2%.

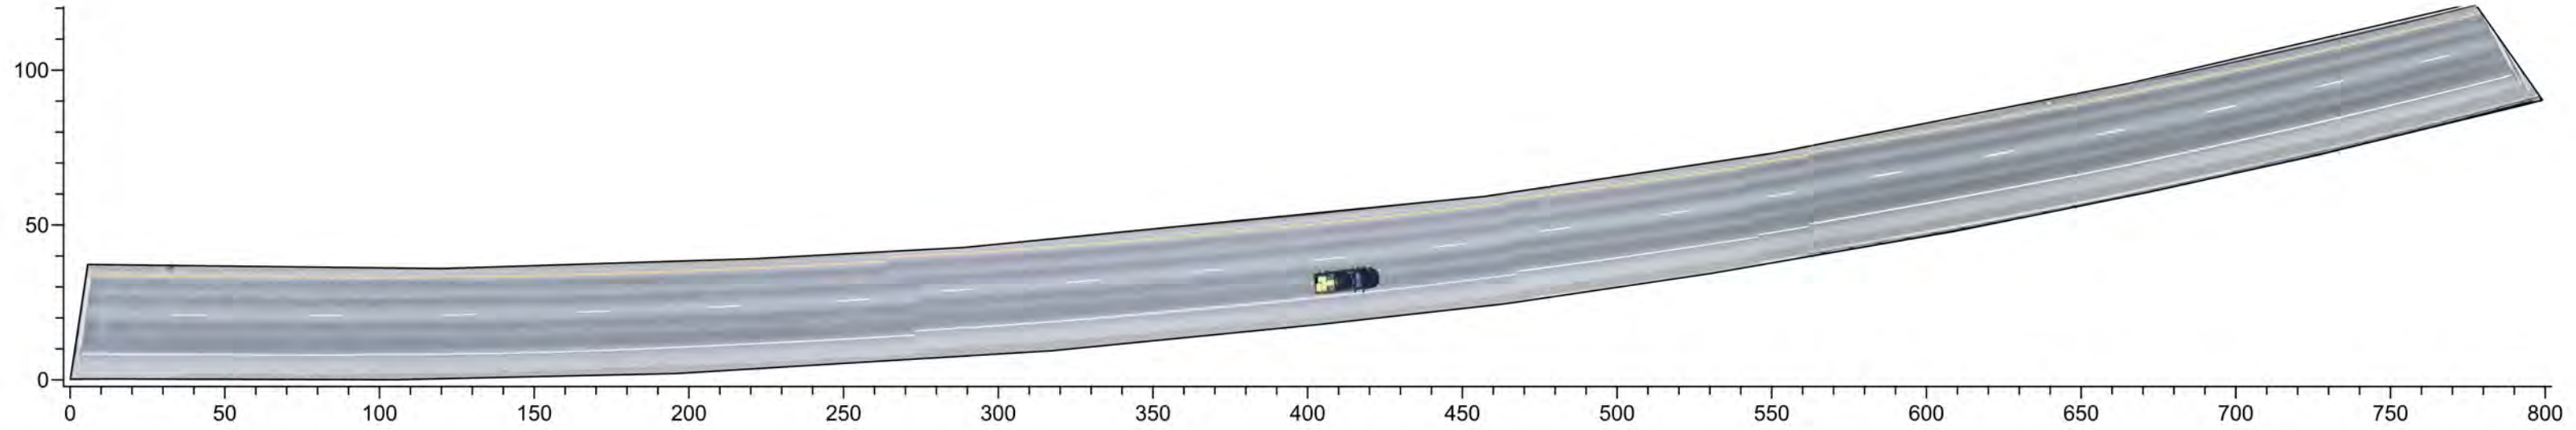
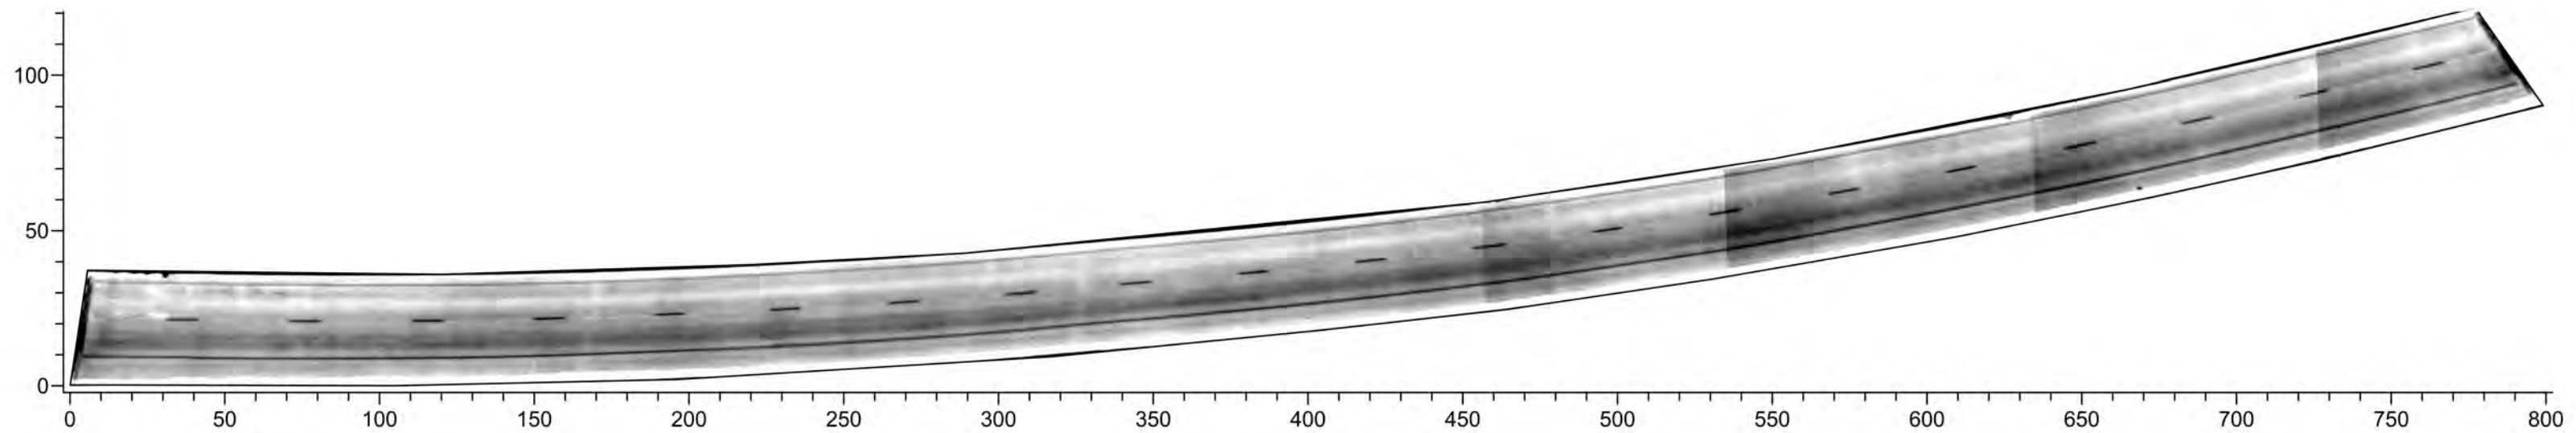
Delamination Quantity (%)    0.3 Delamination Quantity (ft <sup>2</sup> )    90	Imagery Collected: 6/4/22 Analyzed by: SB Reviewed by: AJC Completed: 10/5/22

\*Note: 155 sq. ft. of thermal anomalies not mapped due to being rectilinear in shape and appearing more like subsurface patching or some other structural feature

Note: Delamination locations not shown as quantity is less than 2%.

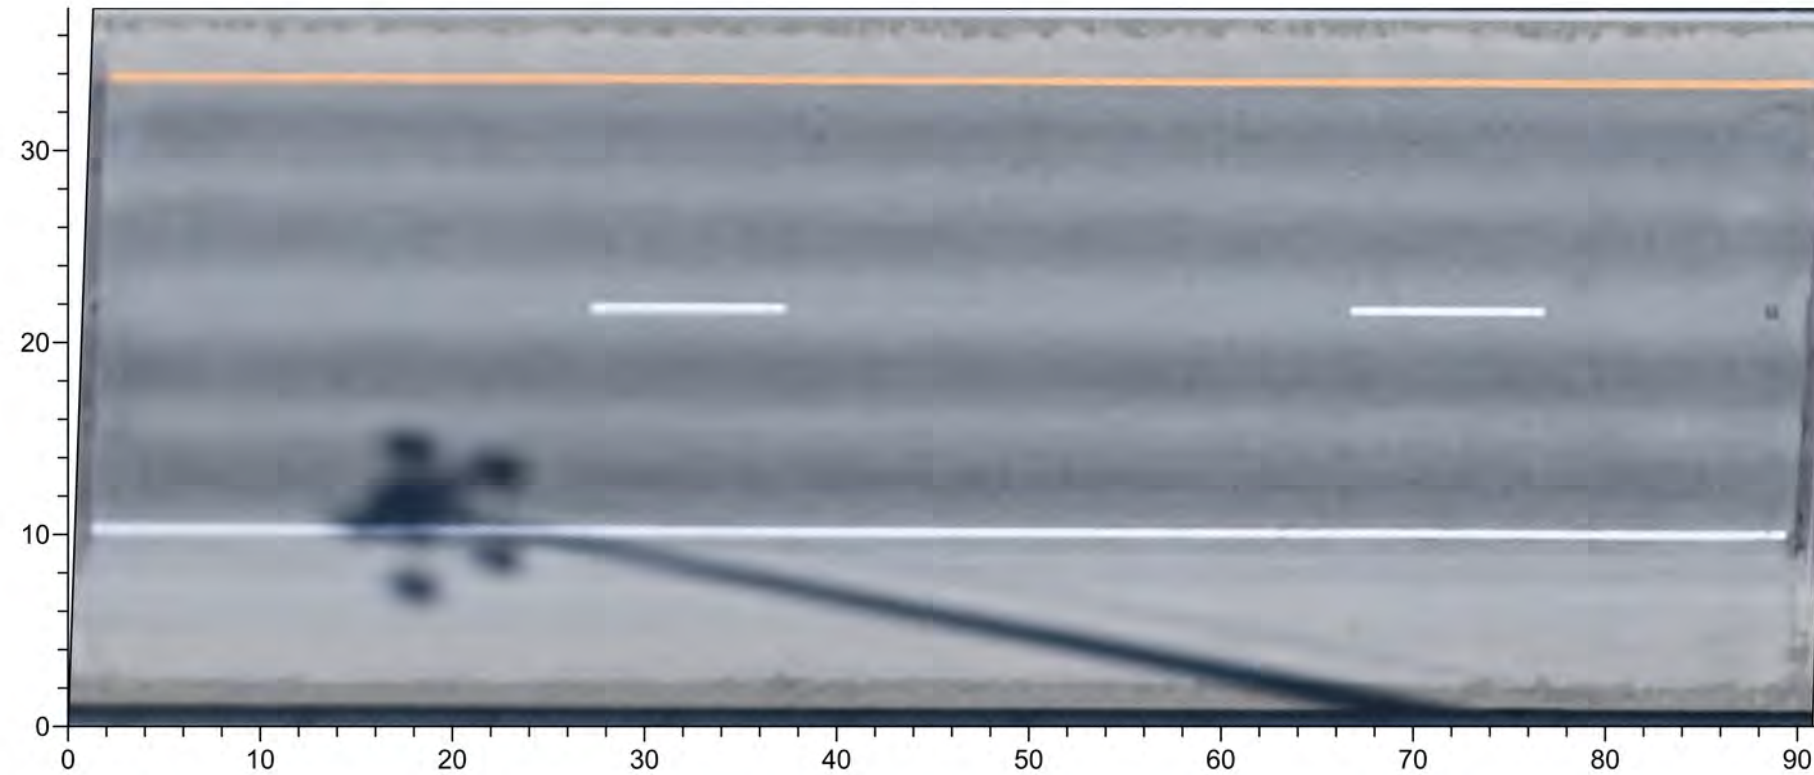
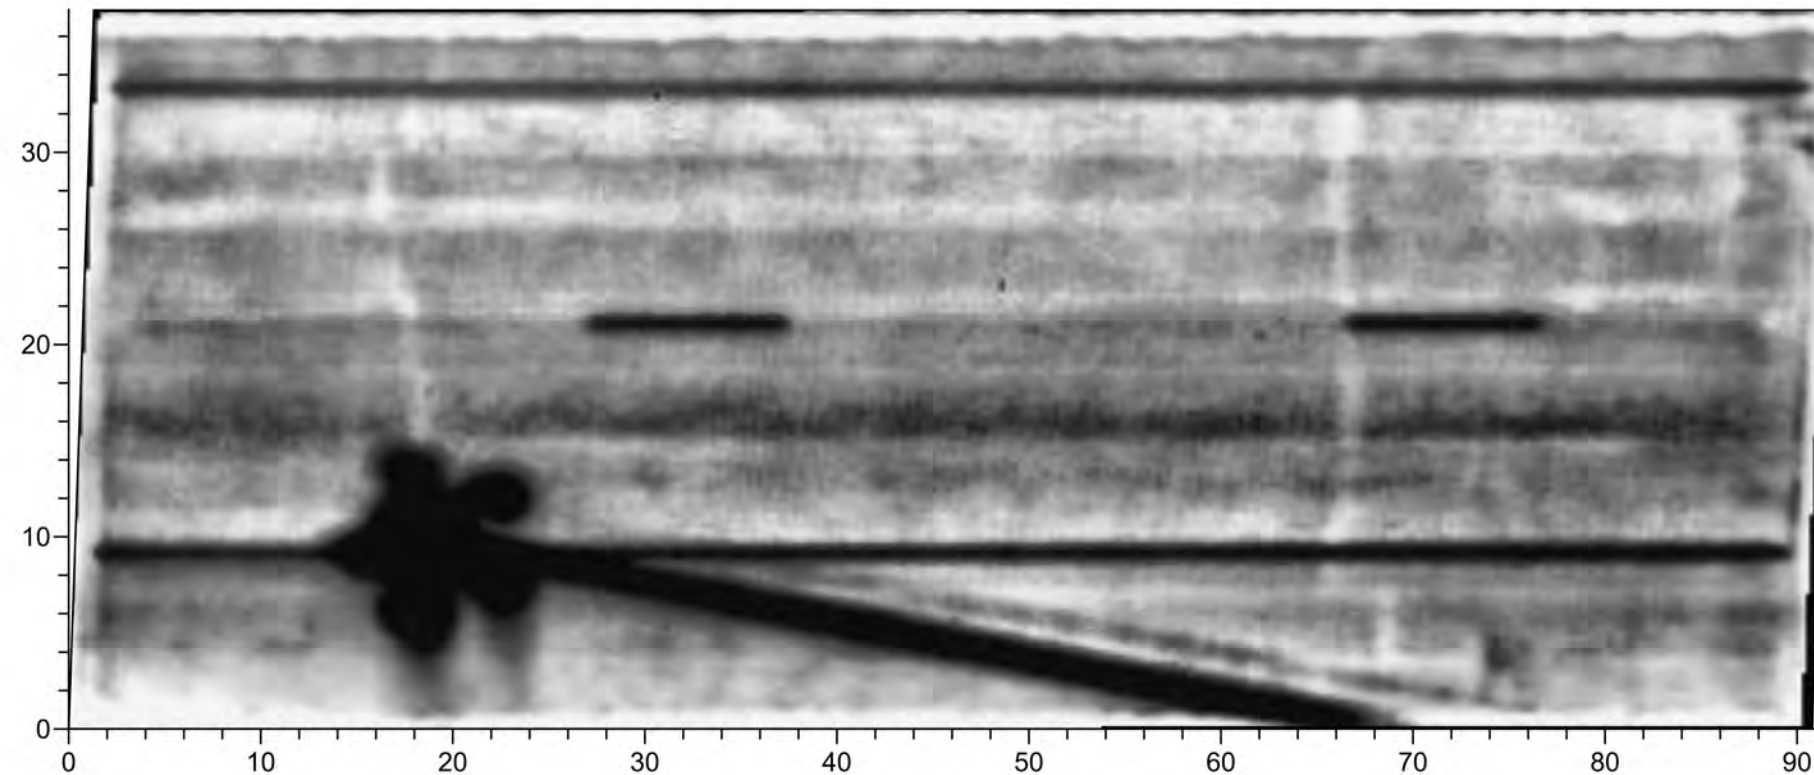
Delamination Quantity (%)    0.7 Delamination Quantity (ft <sup>2</sup> )    219	Imagery Collected: 6/4/22 Analyzed by: SB Reviewed by: AJC Completed: 10/11/22

\*Note: 63 sq. ft. of thermal anomalies not mapped due to being rectilinear in shape and appearing more like subsurface patching or some other structural feature

Note: Delamination locations not shown as quantity is less than 2%.

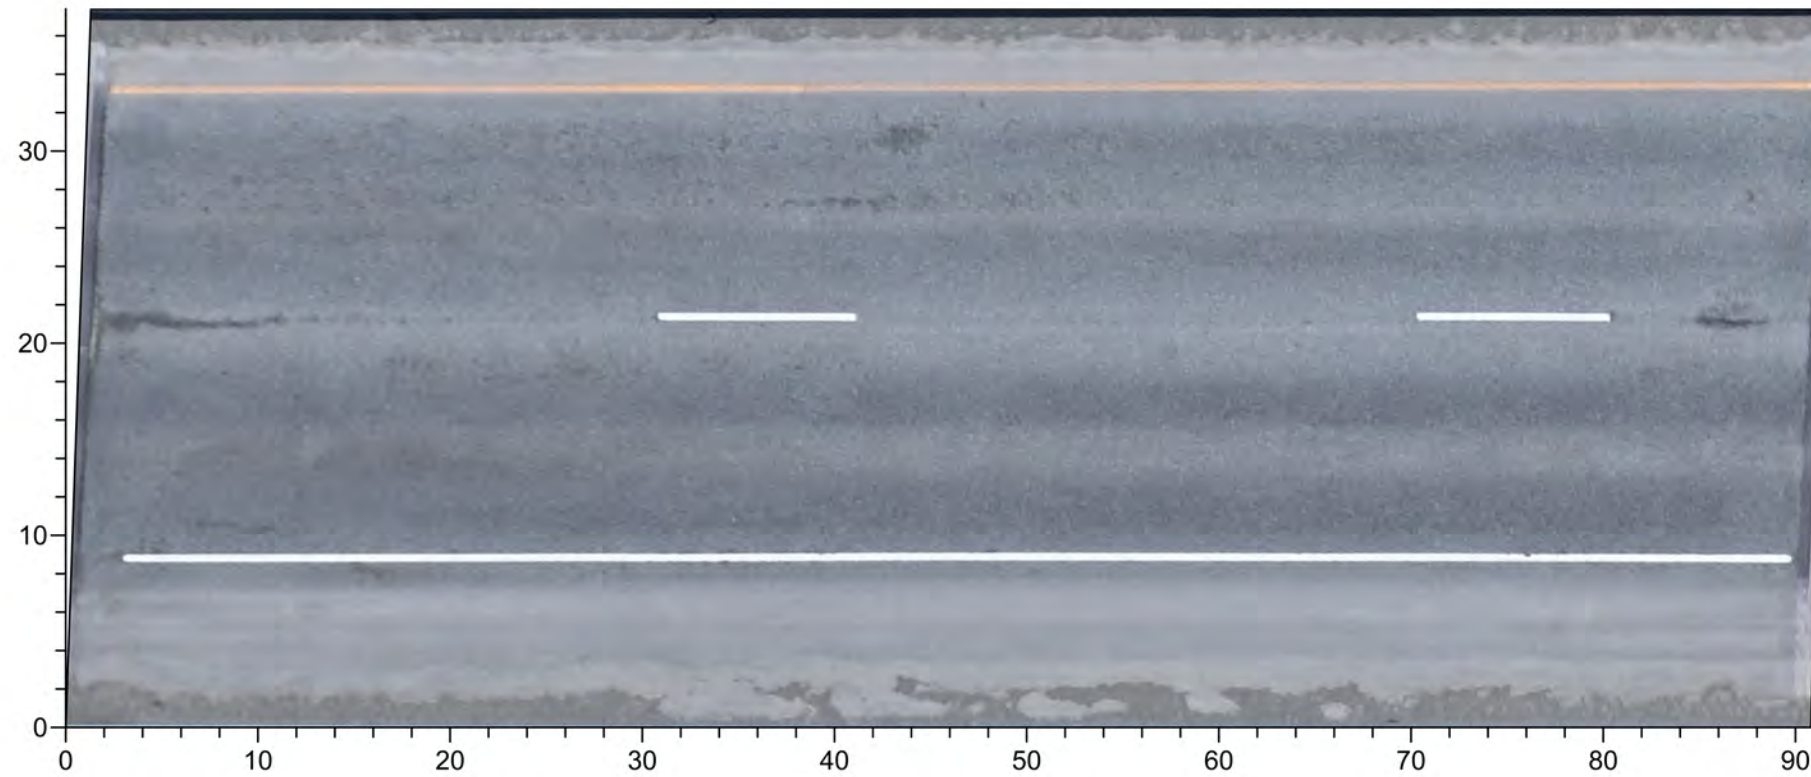
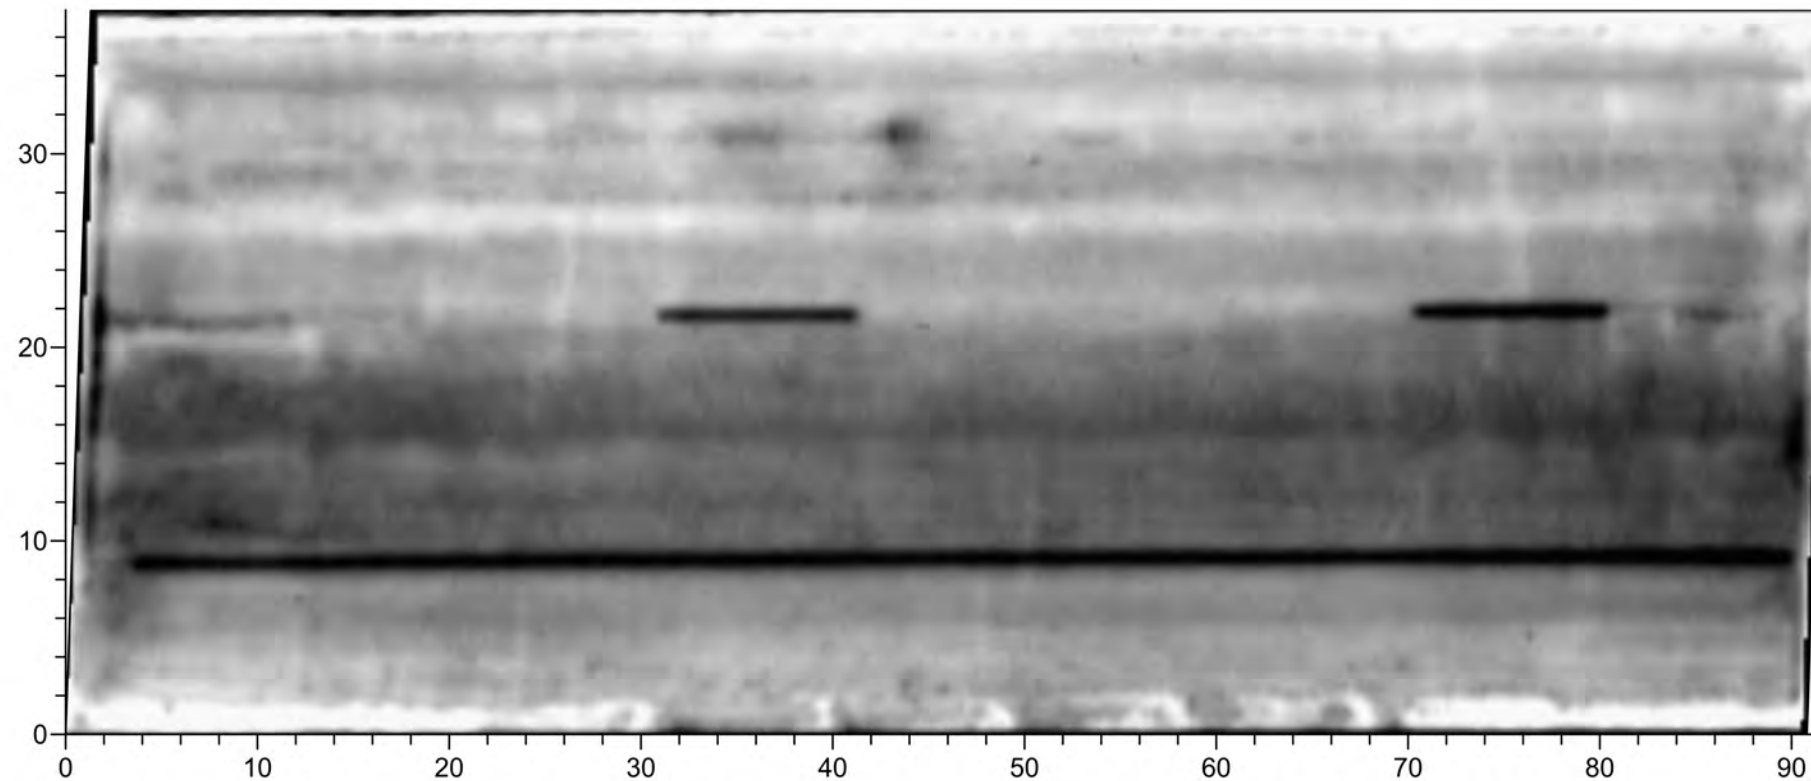
Delamination Quantity (%)    0.8 Delamination Quantity (ft <sup>2</sup> )    26	Imagery Collected: 6/4/22 Analyzed by: SB Reviewed by: AJC Completed: 10/5/22

Note: Delamination locations not shown as quantity is less than 2%.
