# Aerial Infrared Scanning of Bridge Decks on Parks Highway to Map Delaminations

## FINAL REPORT

**Prepared by:**  
Infrasense, Inc.  
Woburn, MA

**Report # FHWA-AK-RD-000S(960)**  
**March 2, 2023**

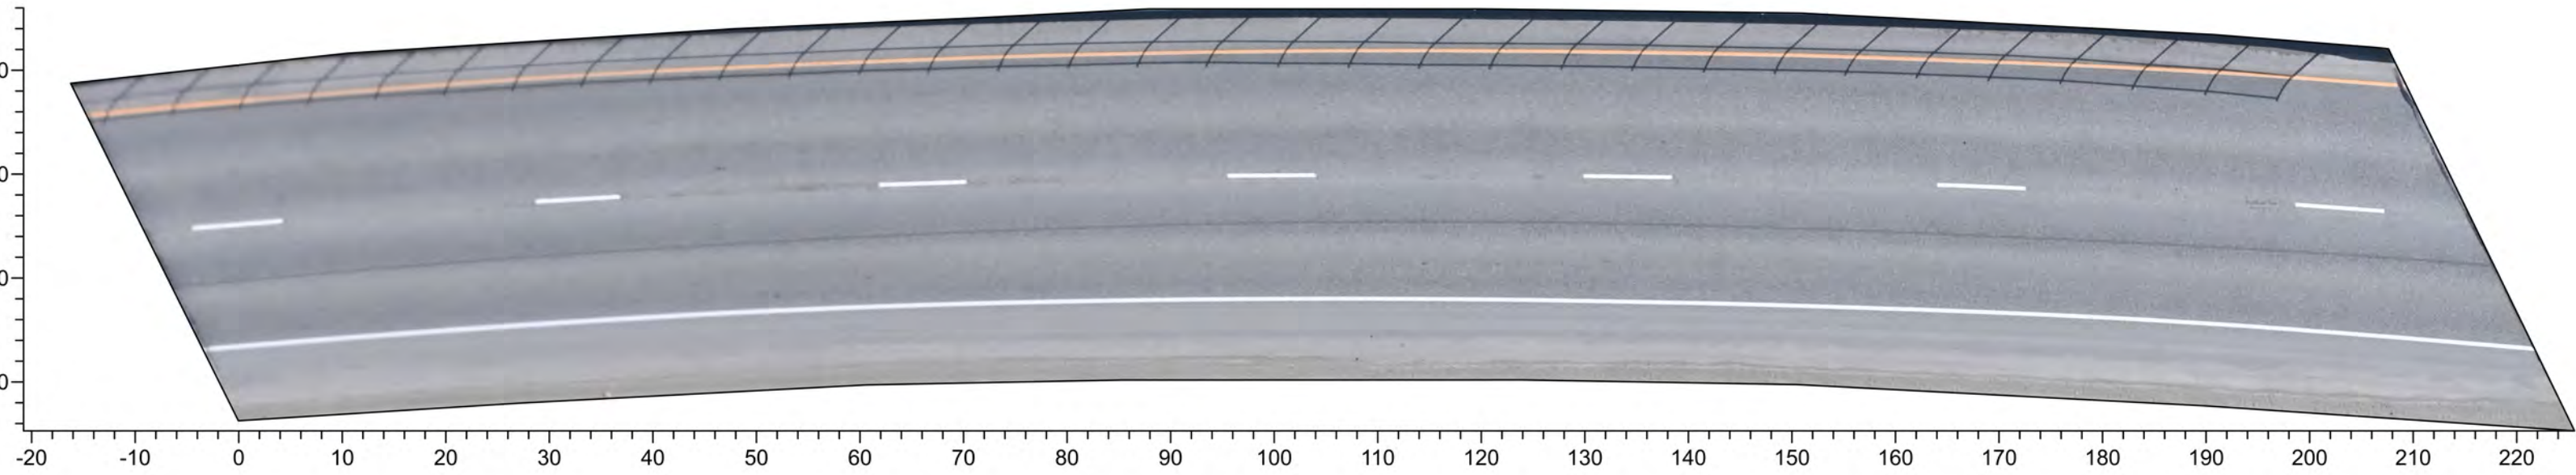
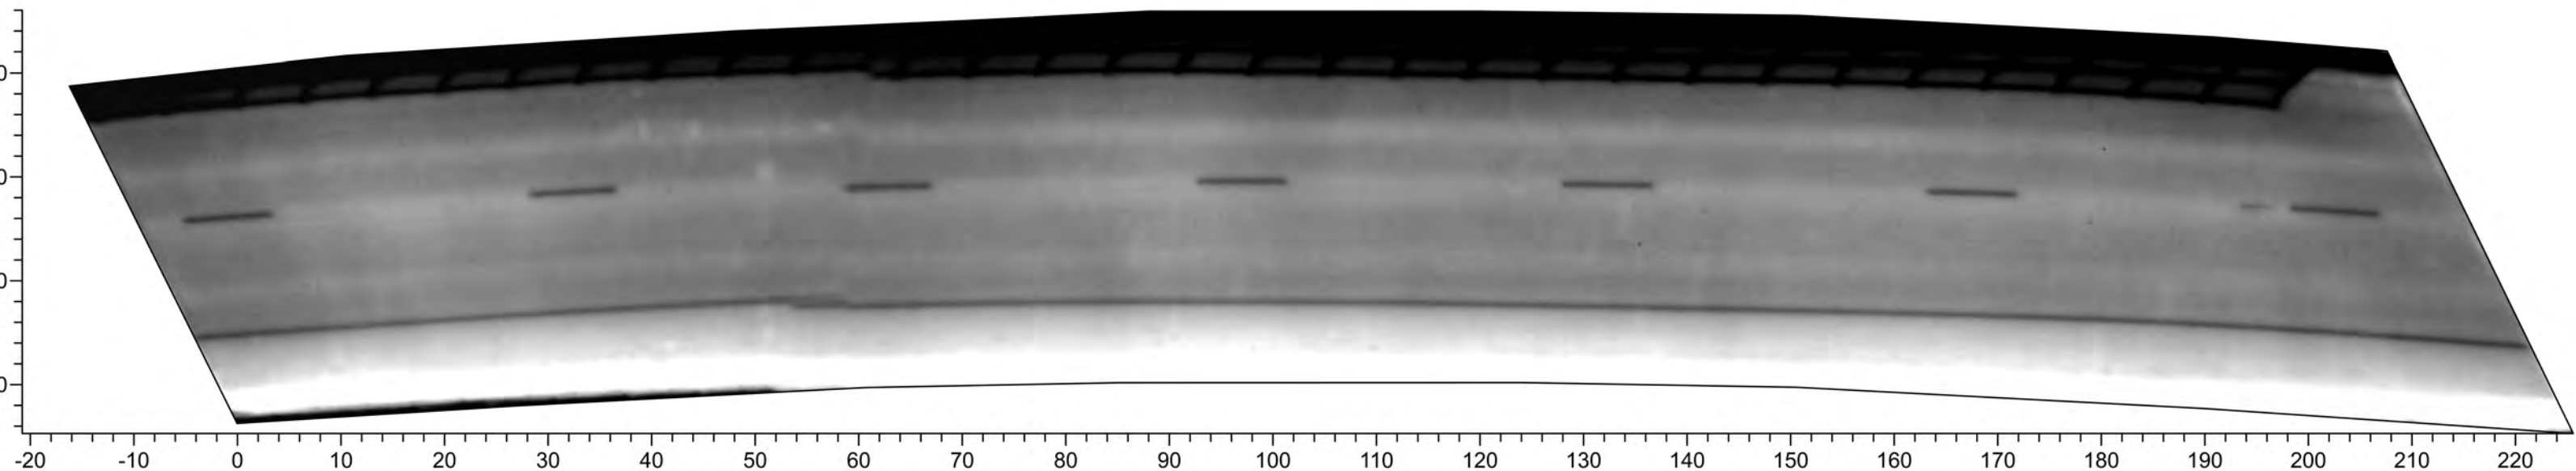
Delamination Quantity (%)    1.5 Delamination Quantity (ft <sup>2</sup> )    52	Imagery Collected: 6/4/22 Analyzed by: SB Reviewed by: AJC Completed: 10/5/22

Note: Delamination locations not shown as quantity is less than 2%.

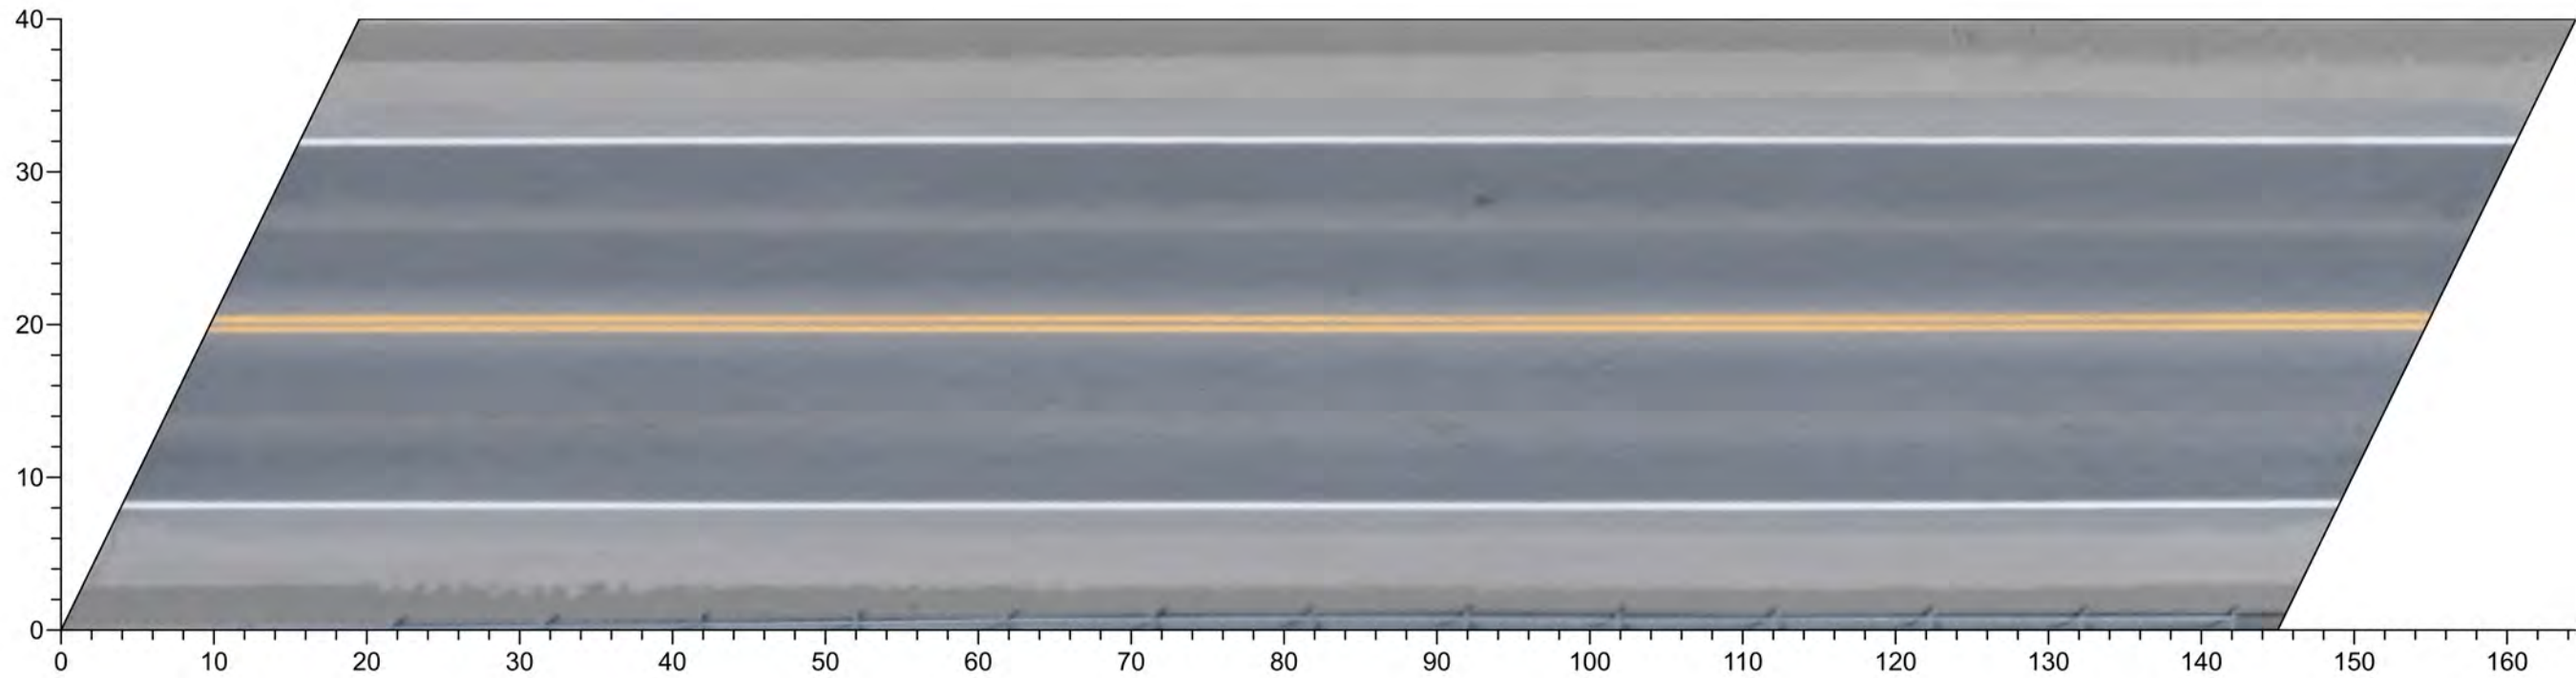
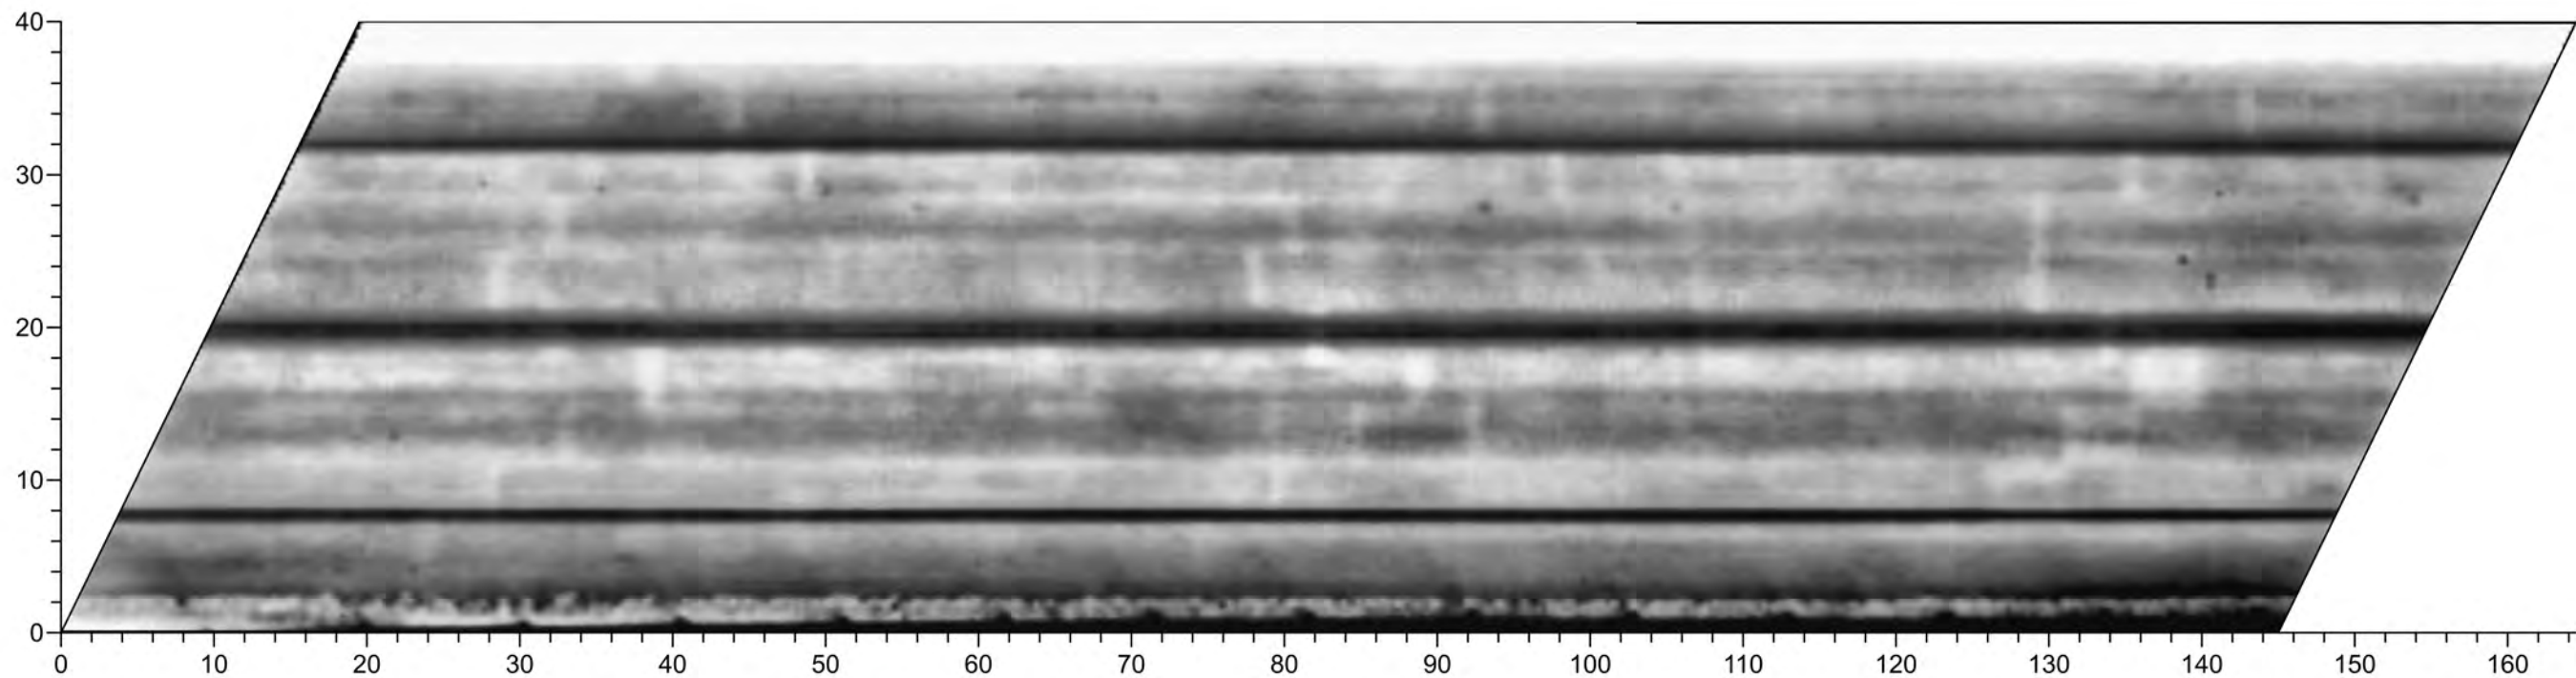
Delamination Quantity (%)    0.3		Imagery Collected: 6/5/22 Analyzed by: SB Reviewed by: AJC Completed: 10/5/22	
			Delamination Quantity (ft <sup>2</sup> )    21

\*Note: 160 sq. ft. of thermal anomalies not mapped due to being rectilinear in shape and appearing more like subsurface patching or some other structural feature

Note: Delamination locations not shown as quantity is less than 2%.

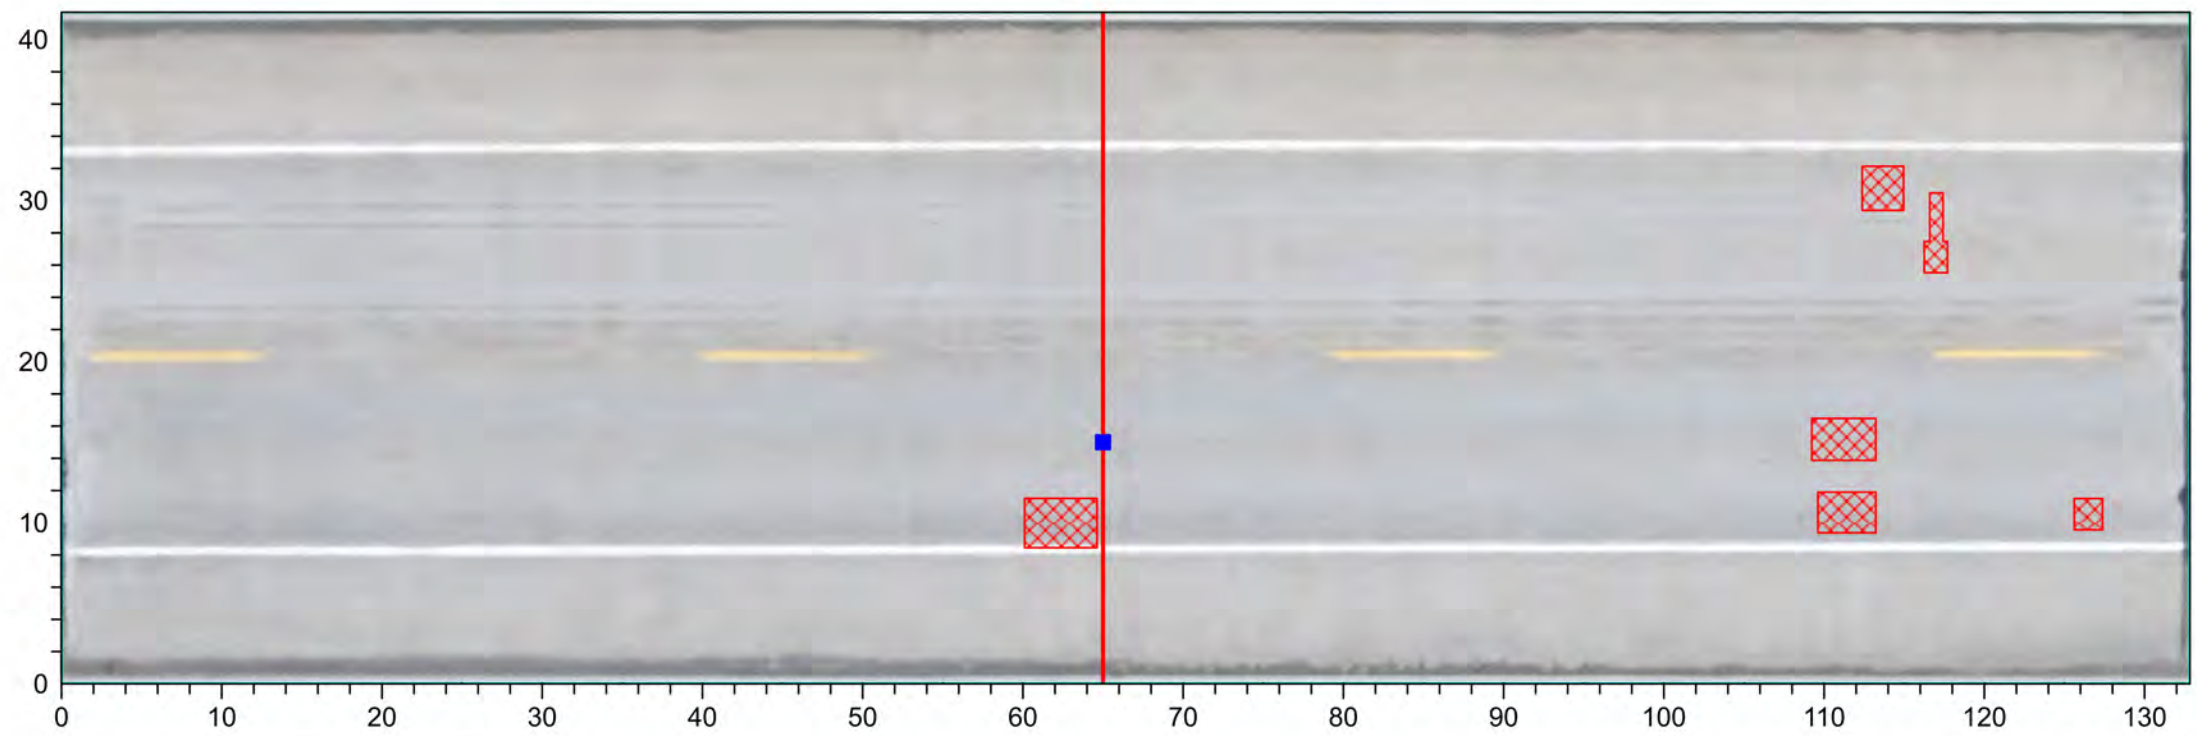
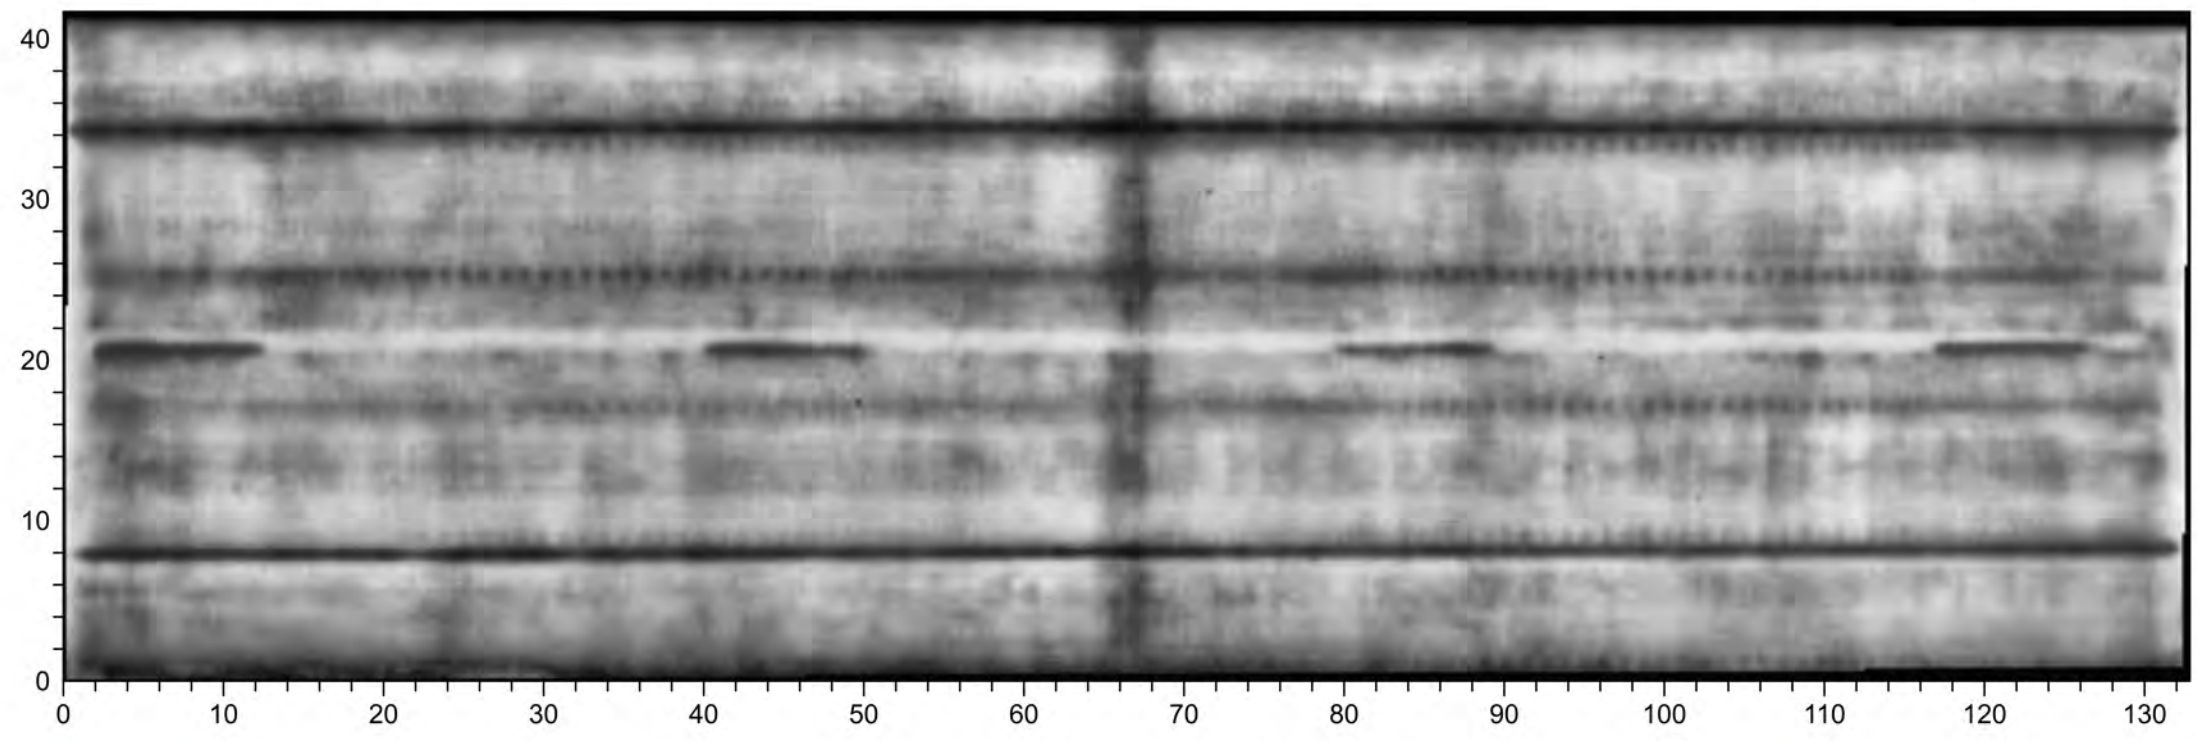
Delaminations Detected by Aerial Infrared	Delamination Quantity (%)      2.1 Delamination Quantity (ft <sup>2</sup> )      660	Imagery Collected: 6/4/22 Analyzed by: SB Reviewed by: AJC Completed: 10/12/22

Chain Drag Delamination Quantity (%)	<0.1
Chain Drag Delamination Quantity (ft <sup>2</sup> )	1

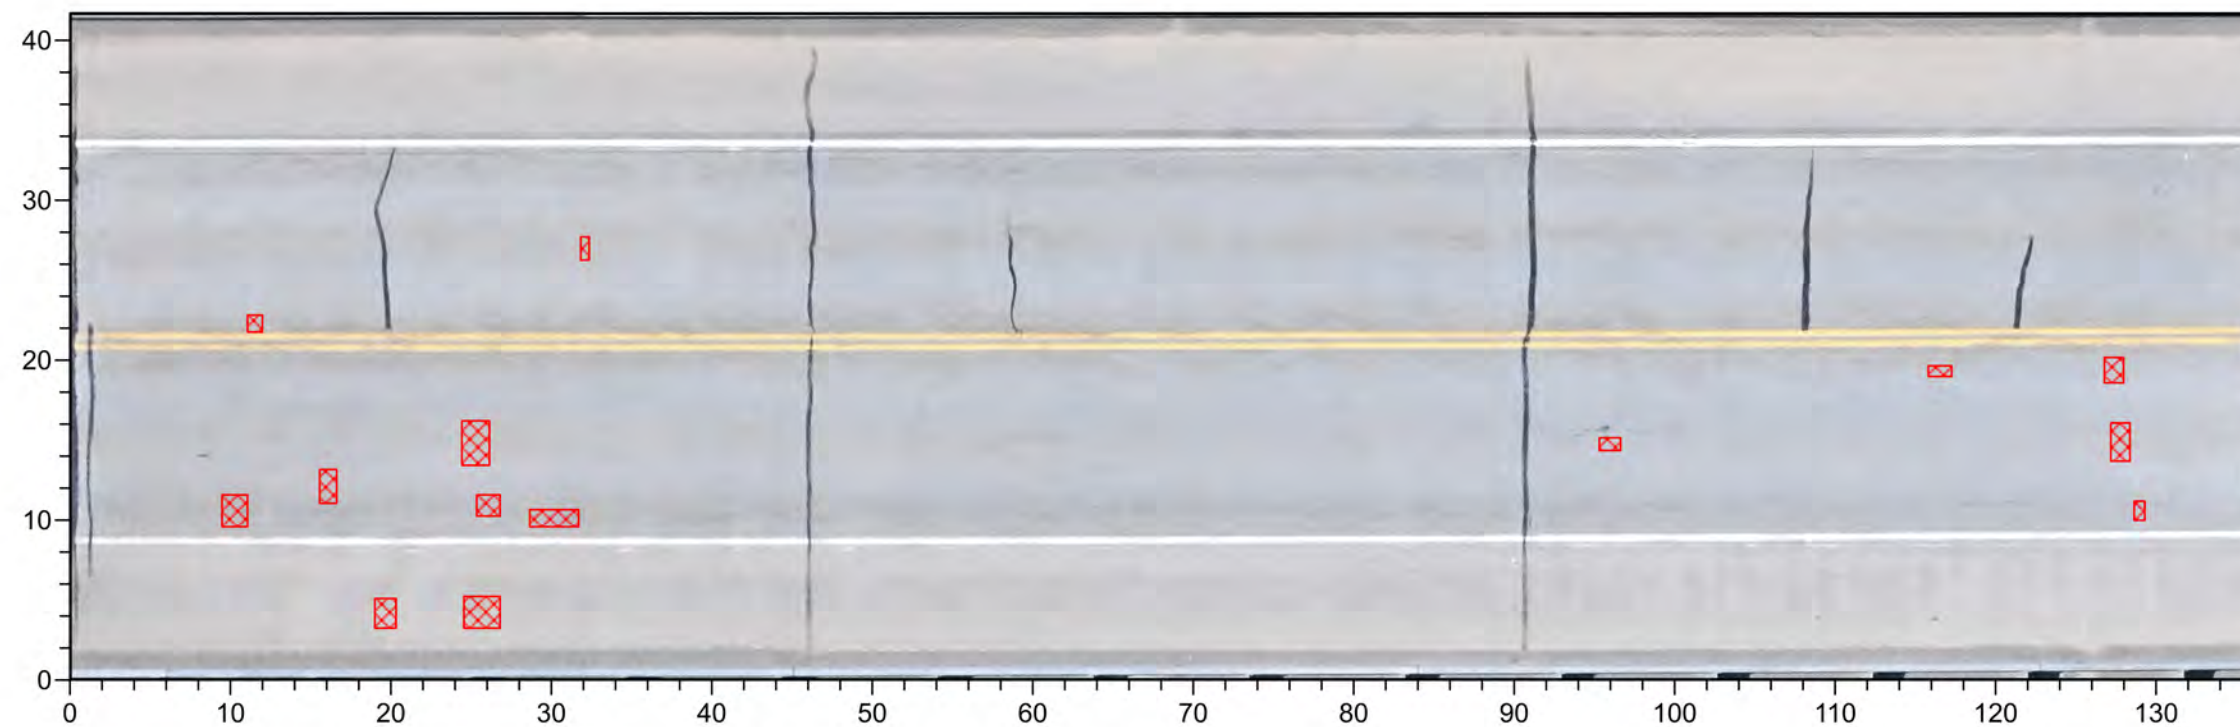
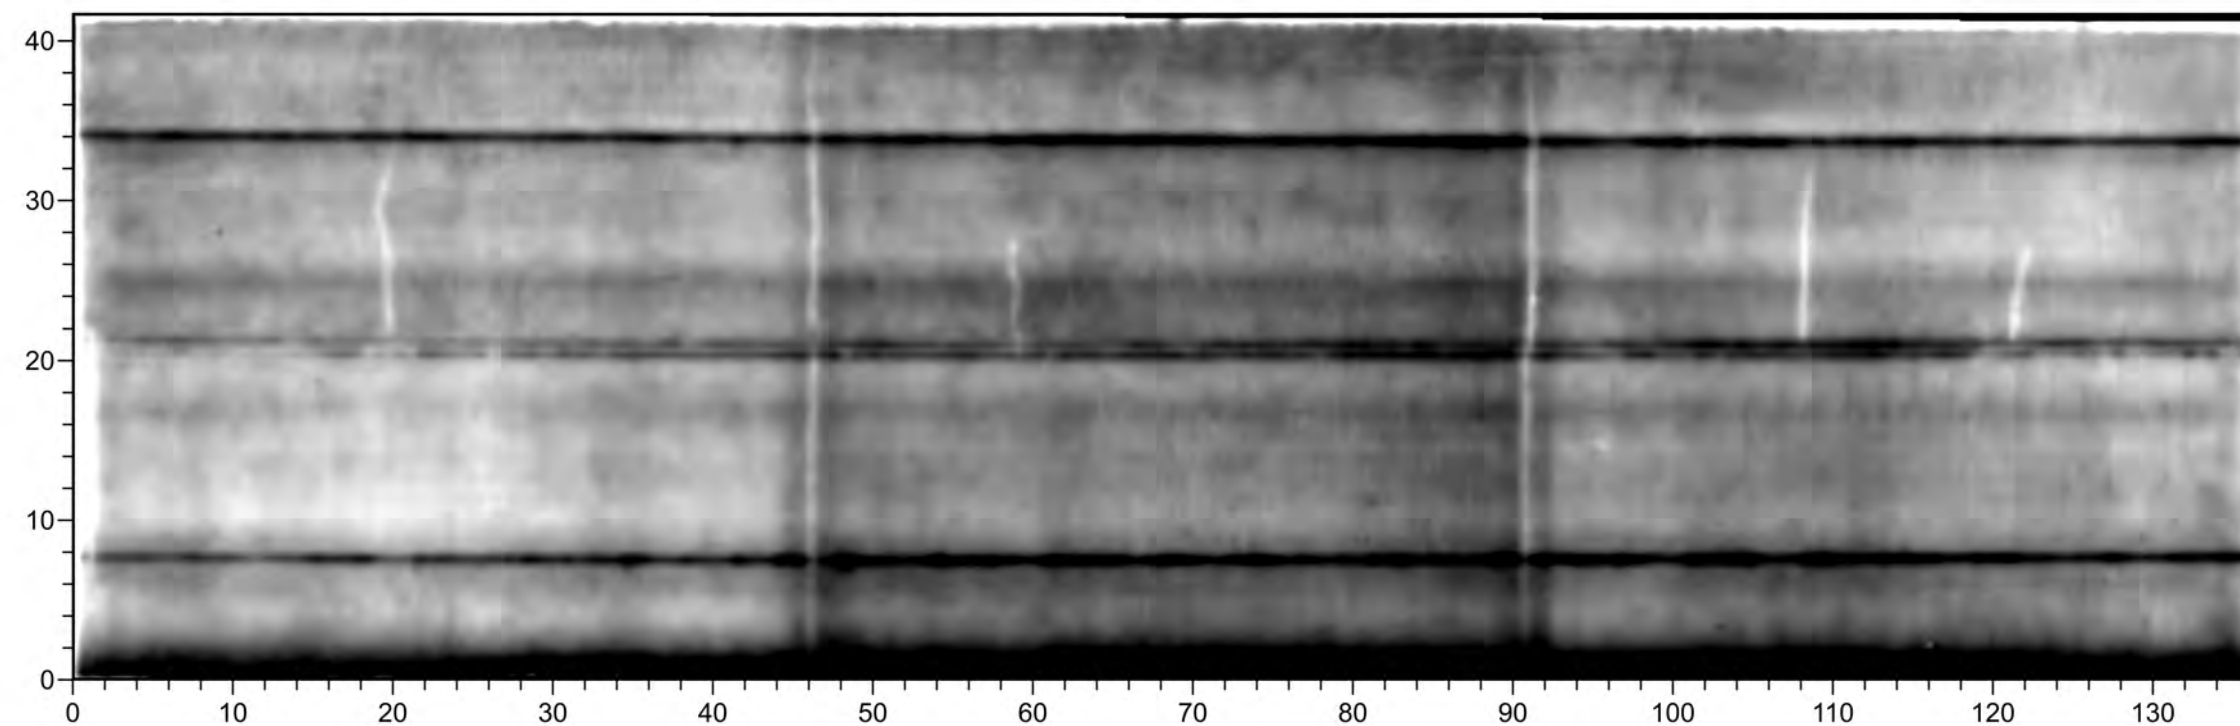
Delaminations Detected by Aerial Infrared	Delamination Quantity (%)	0.9	Imagery Collected: 6/4/22 Analyzed by: EG, SB Reviewed by: AJC Completed: 10/4/22
			Delamination Quantity (ft <sup>2</sup> )	49	
Bridge No.: 0256 TROUBLESOME CREEK PARKS HIGHWAY

Chain Drag Delamination Quantity (%)	0.0
Chain Drag Delamination Quantity (ft <sup>2</sup> )	0

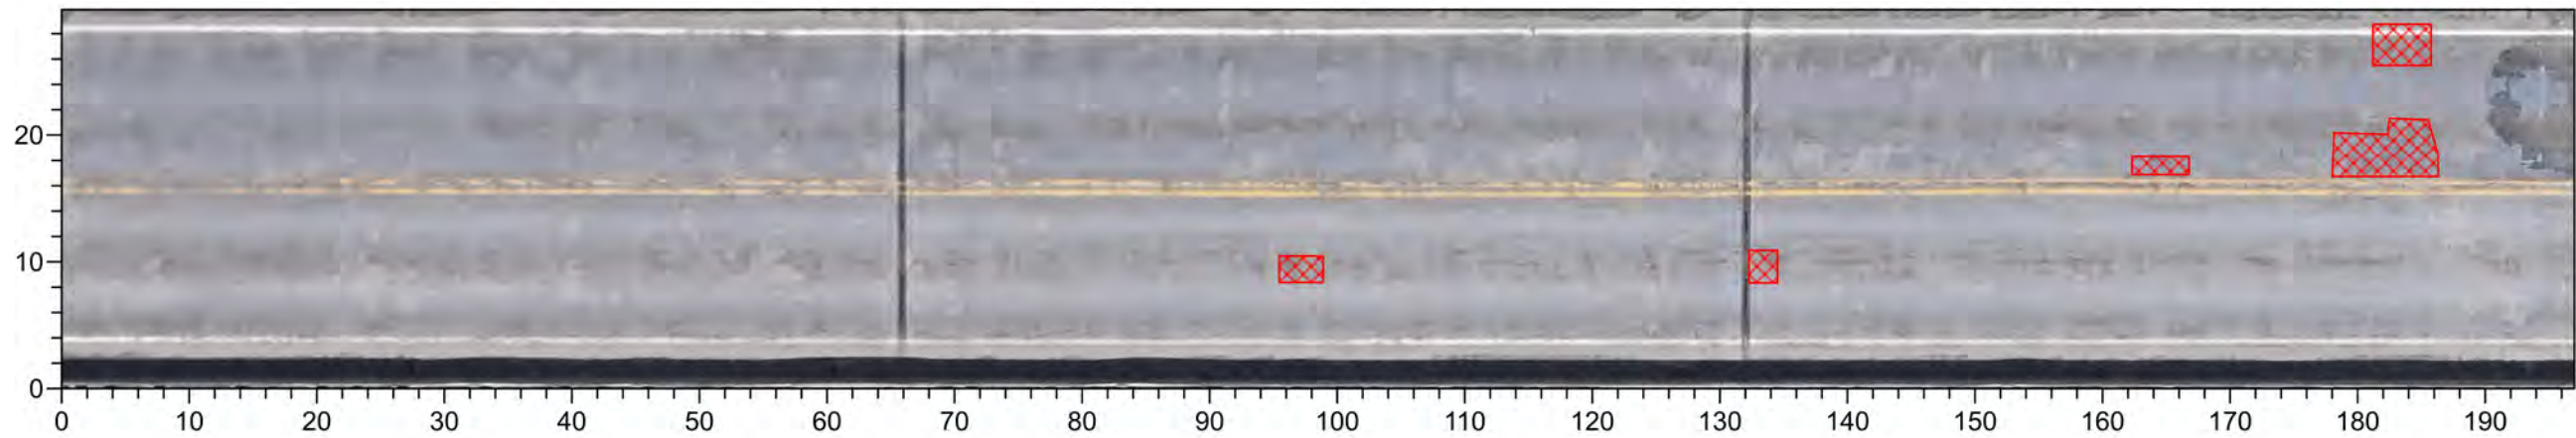
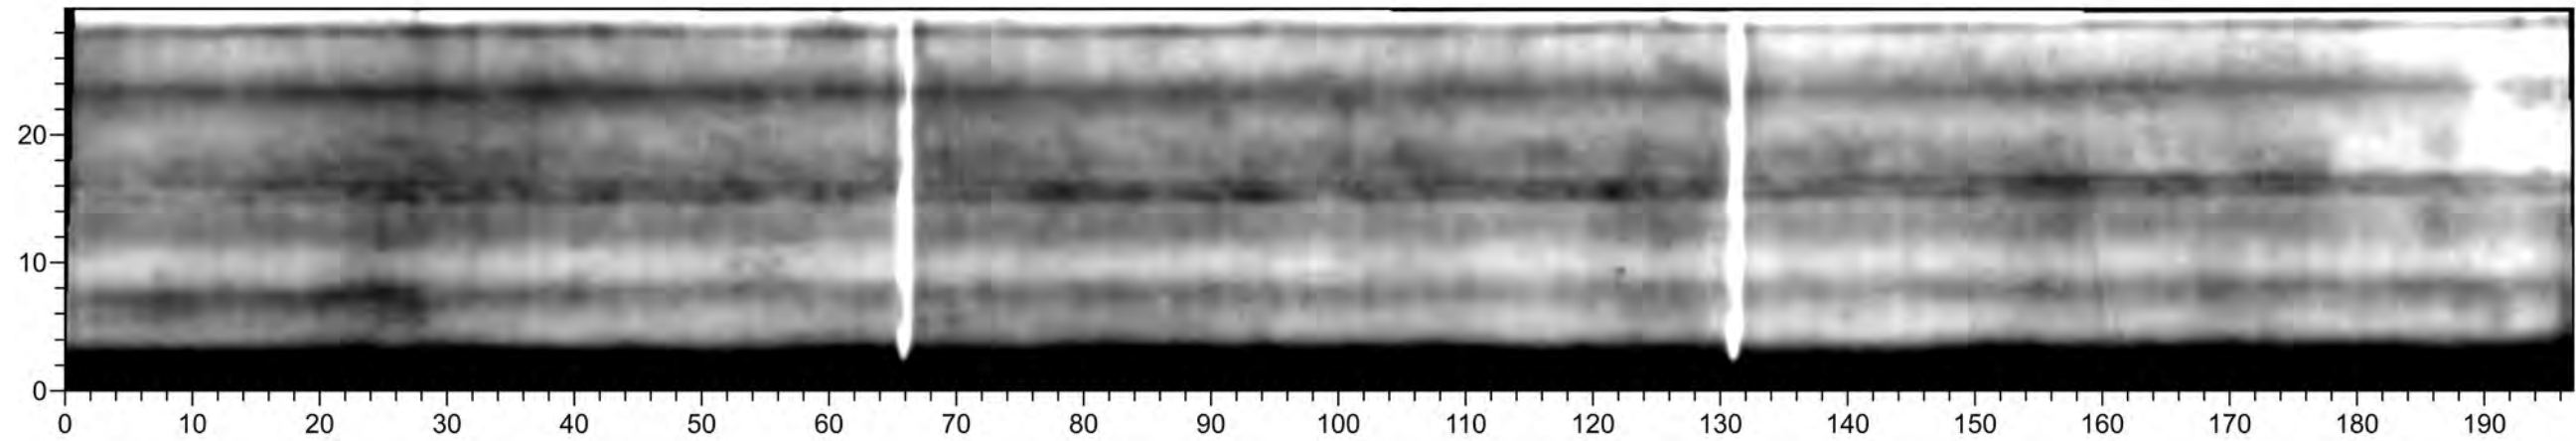
Delaminations Detected by Aerial Infrared		Delamination Quantity (%)    0.6 Delamination Quantity (ft <sup>2</sup> )    32			Imagery Collected: 6/4/22 Analyzed by: EG, SB Reviewed by: AJC Completed: 10/5/22

Chain Drag Delamination Quantity (%)	Chain Drag Delamination Quantity (ft <sup>2</sup> )
0	0

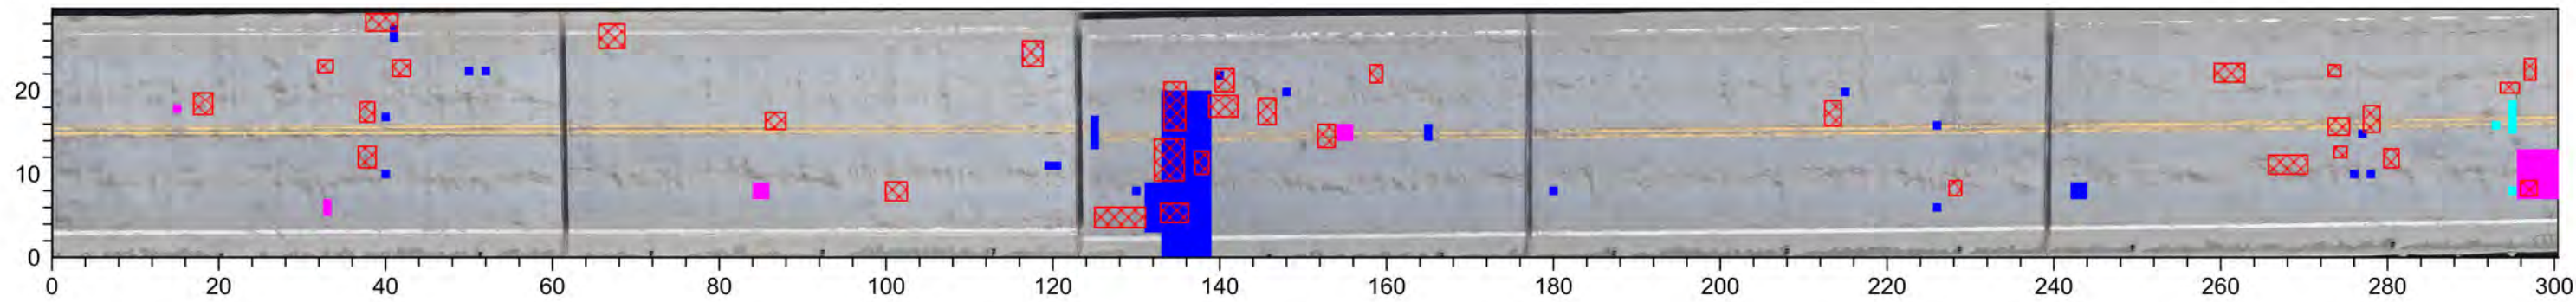
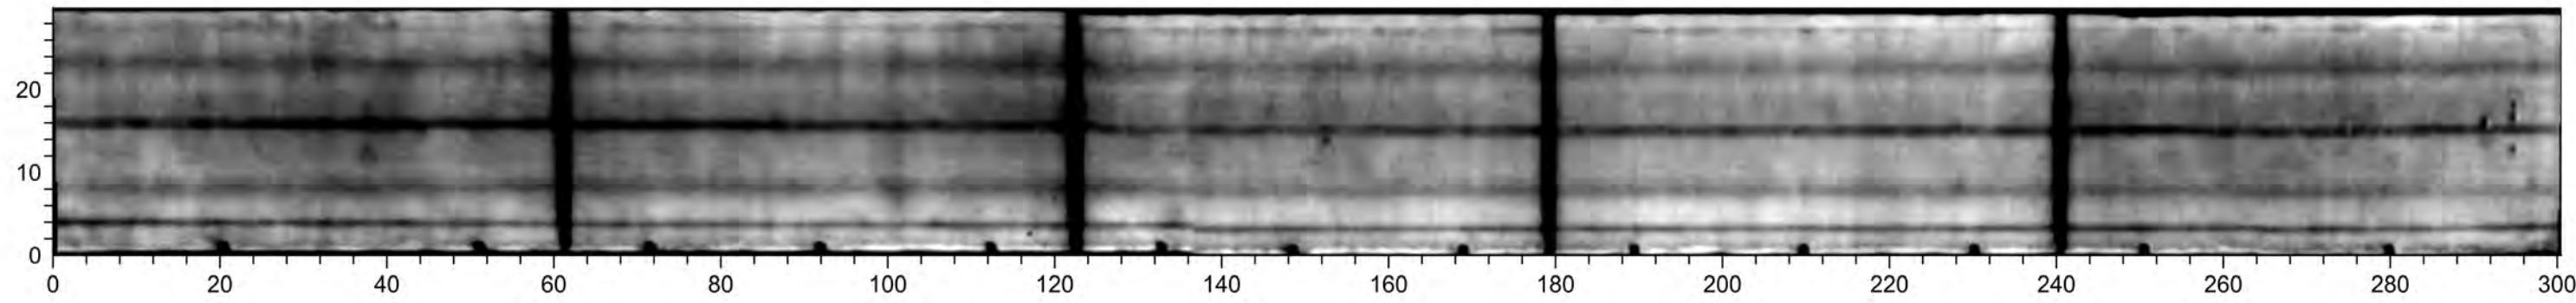
Delaminations Detected by Aerial Infrared	<b>Quantity Summary</b>		<b>Analysis Information</b>		Bridge No.: 0697 KINGFISHER CREEK PARKS HIGHWAY
			Delamination Quantity (%)	11.9	Imagery Collected: 6/5/22 Analyzed by: EG, SB Reviewed by: AJC Completed: 10/9/22	Delamination Quantity (ft <sup>2</sup> )

Chain Drag Delamination Quantity (%)	Chain Drag Delamination Quantity (ft <sup>2</sup> )	Chain Drag Spalling Quantity (%)	Chain Drag Spalling Quantity (ft <sup>2</sup> )	Chain Drag Delam/Spall Quantity (%)	Chain Drag Delam/Spall Quantity (ft <sup>2</sup> )
2.2	201	0.1	6	0.5	41

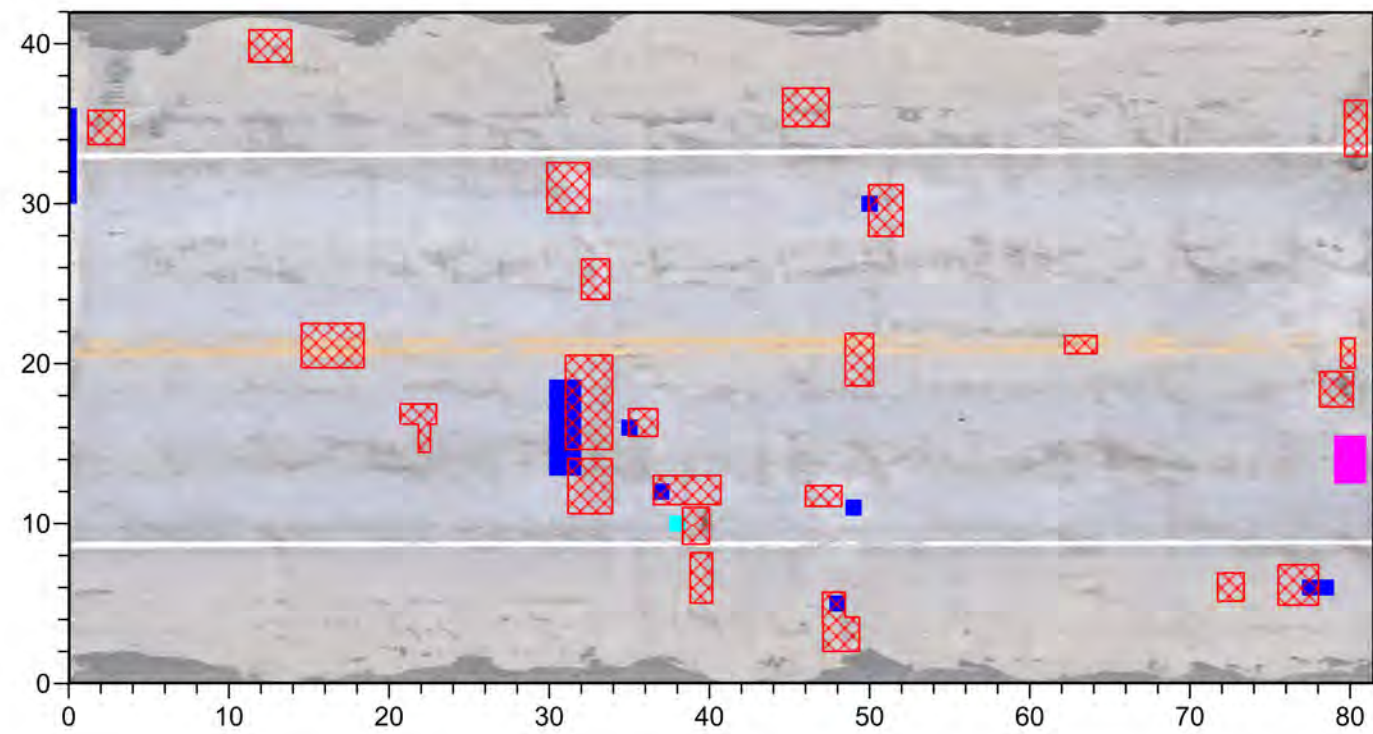
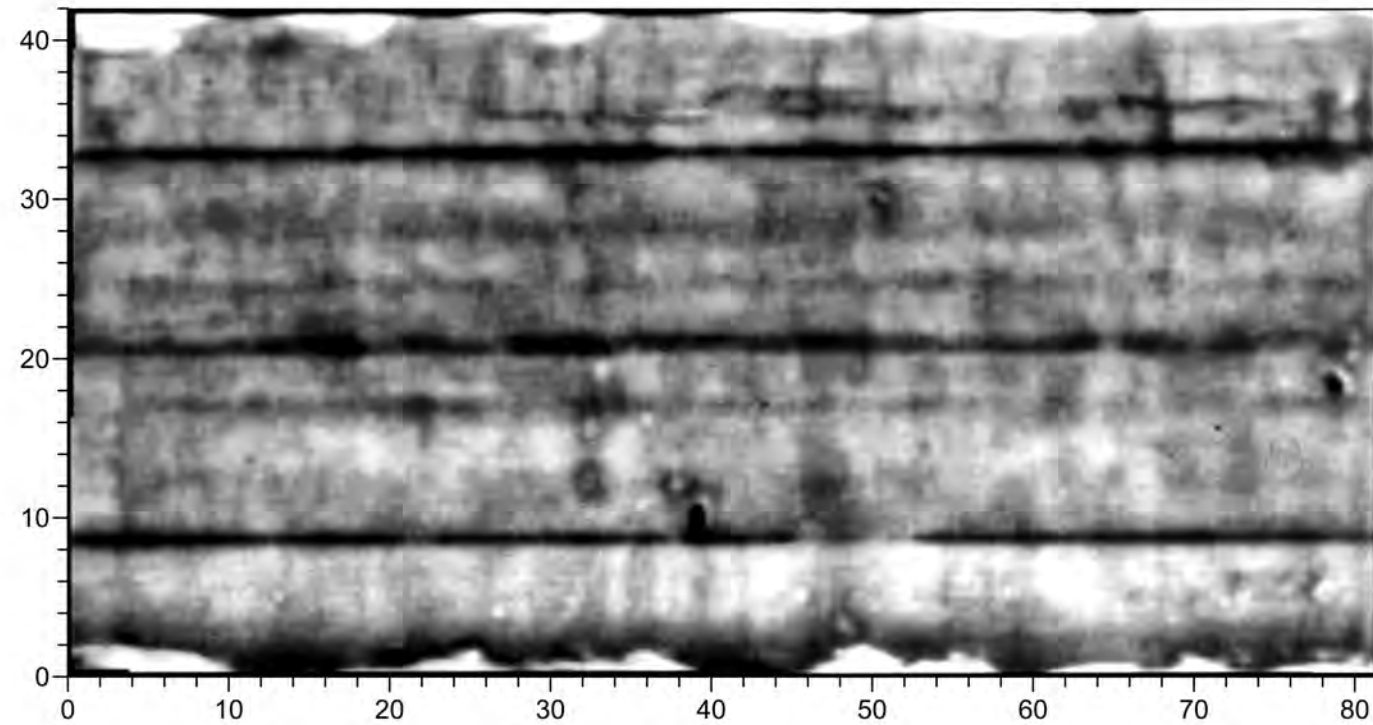
Delaminations Detected by Aerial Infrared	Delamination Quantity (%)	2.3	
			Delamination Quantity (ft <sup>2</sup> )	207	
			Imagery Collected: 6/5/22 Analyzed by: EG, SB Reviewed by: AJC Completed: 10/9/22

Chain Drag Delamination Quantity (%)	0.9
Chain Drag Delamination Quantity (ft <sup>2</sup> )	31
Chain Drag Spalling Quantity (%)	<0.1
Chain Drag Spalling Quantity (ft <sup>2</sup> )	1
Chain Drag Delam/Spall Quantity (%)	0.2
Chain Drag Delam/Spall Quantity (ft <sup>2</sup> )	6

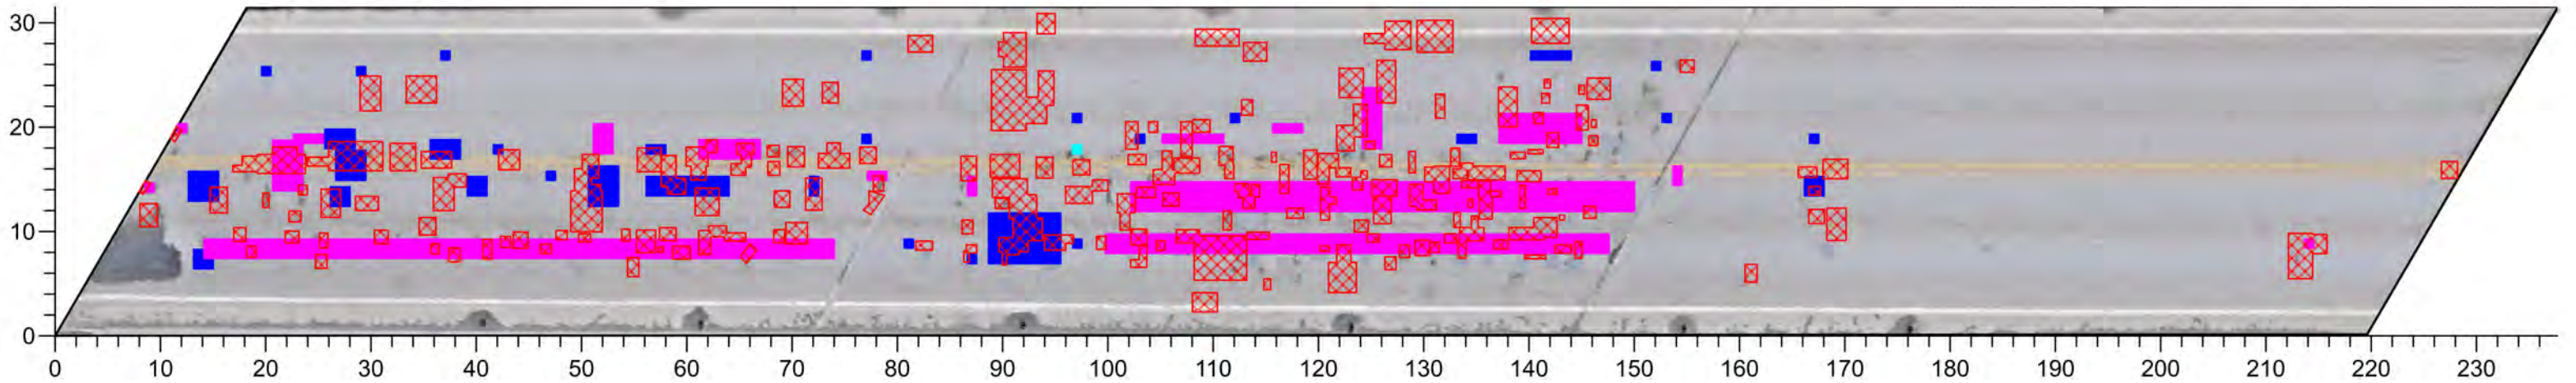
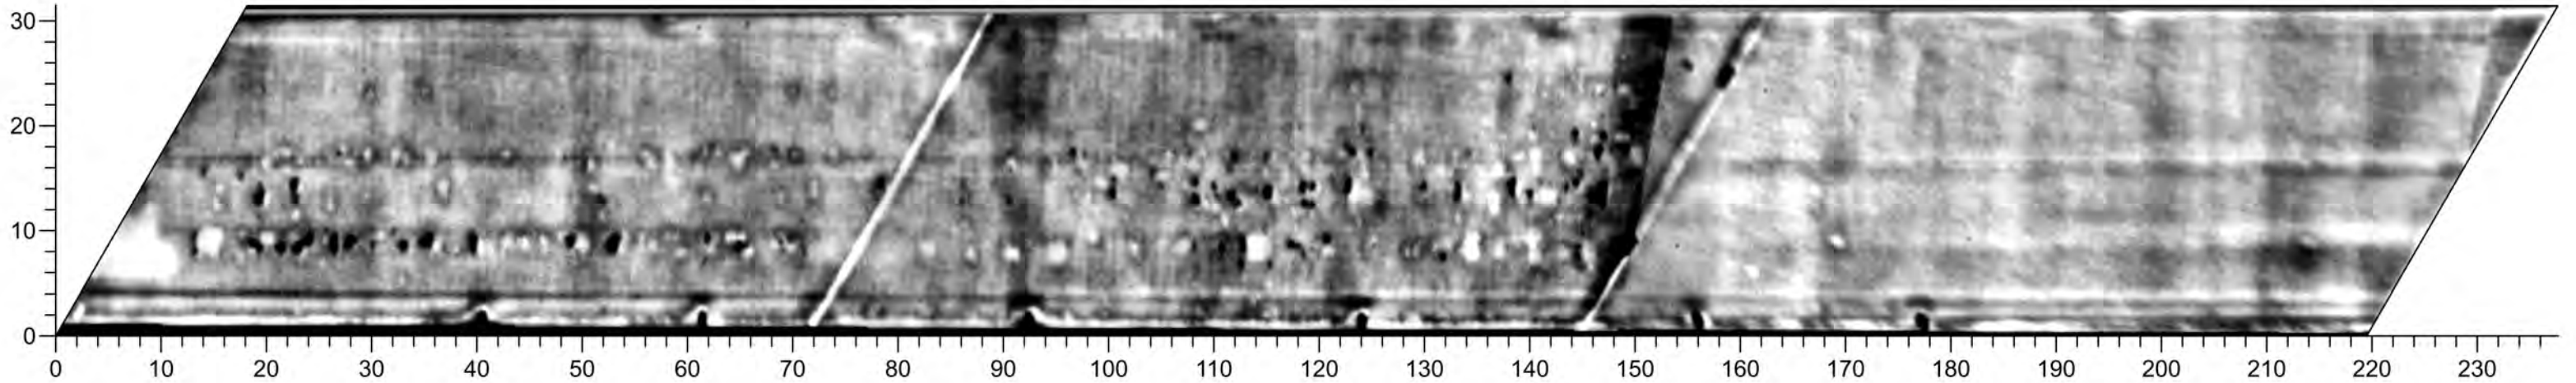
Delaminations Detected by Aerial Infrared	Delamination Quantity (%)	4.0	Imagery Collected: 6/5/22 Analyzed by: EG, SB Reviewed by: AJC Completed: 10/9/22	
			Delamination Quantity (ft <sup>2</sup> )	136

Chain Drag Delamination Quantity (%)	Chain Drag Delamination Quantity (ft <sup>2</sup> )	Chain Drag Spalling Quantity (%)	Chain Drag Spalling Quantity (ft <sup>2</sup> )	Chain Drag Delam/Spall Quantity (%)	Chain Drag Delam/Spall Quantity (ft <sup>2</sup> )
8.5	586	<0.1	1	6.5	450
