# Aerial Infrared Scanning of Bridge Decks on Parks Highway to Map Delaminations

## FINAL REPORT

**Prepared by:**  
Infrasense, Inc.  
Woburn, MA

**Report # FHWA-AK-RD-000S(960)**  
**March 2, 2023**

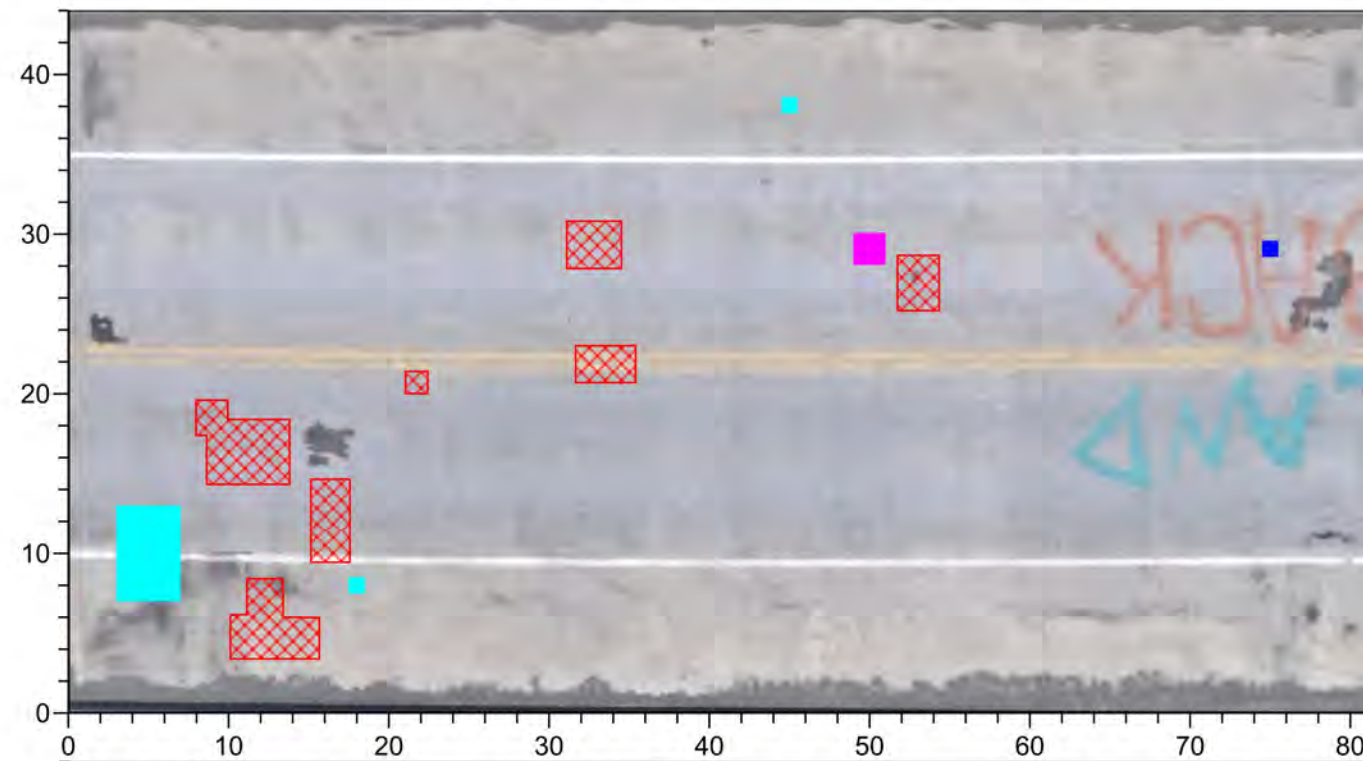
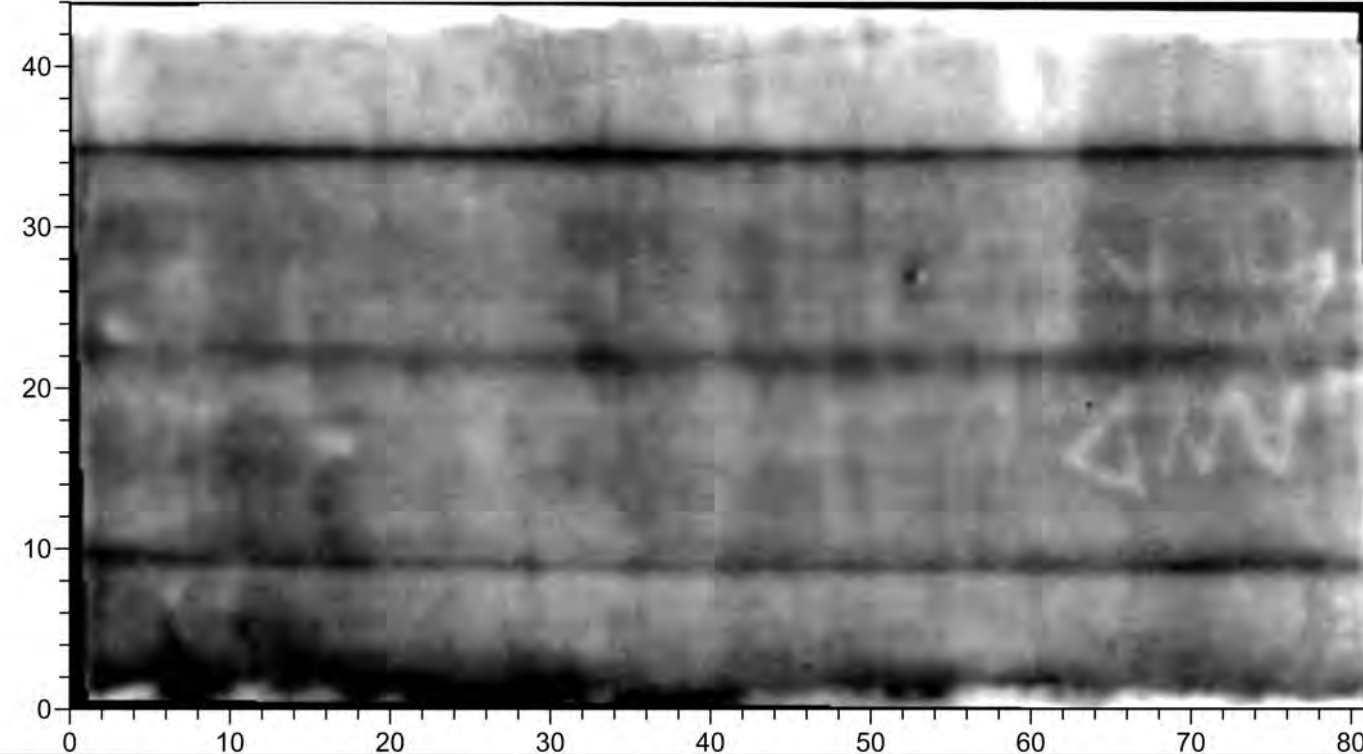
Delaminations Detected by Aerial Infrared	<b>Quantity Summary</b>		<b>Analysis Information</b> Imagery Collected: 6/5/22 Analyzed by: EG, SB Reviewed by: AJC Completed: 10/10/22	Bridge No.: 1143 NENANA RIVER AT MOODY PARKS HIGHWAY
			Delamination Quantity (%)	5.8

Chain Drag Delamination Quantity (%)	0.1
Chain Drag Delamination Quantity (ft <sup>2</sup> )	5
Chain Drag Spalling Quantity (%)	0.7
Chain Drag Spalling Quantity (ft <sup>2</sup> )	26
Chain Drag Delam/Spall Quantity (%)	0.1
Chain Drag Delam/Spall Quantity (ft <sup>2</sup> )	4

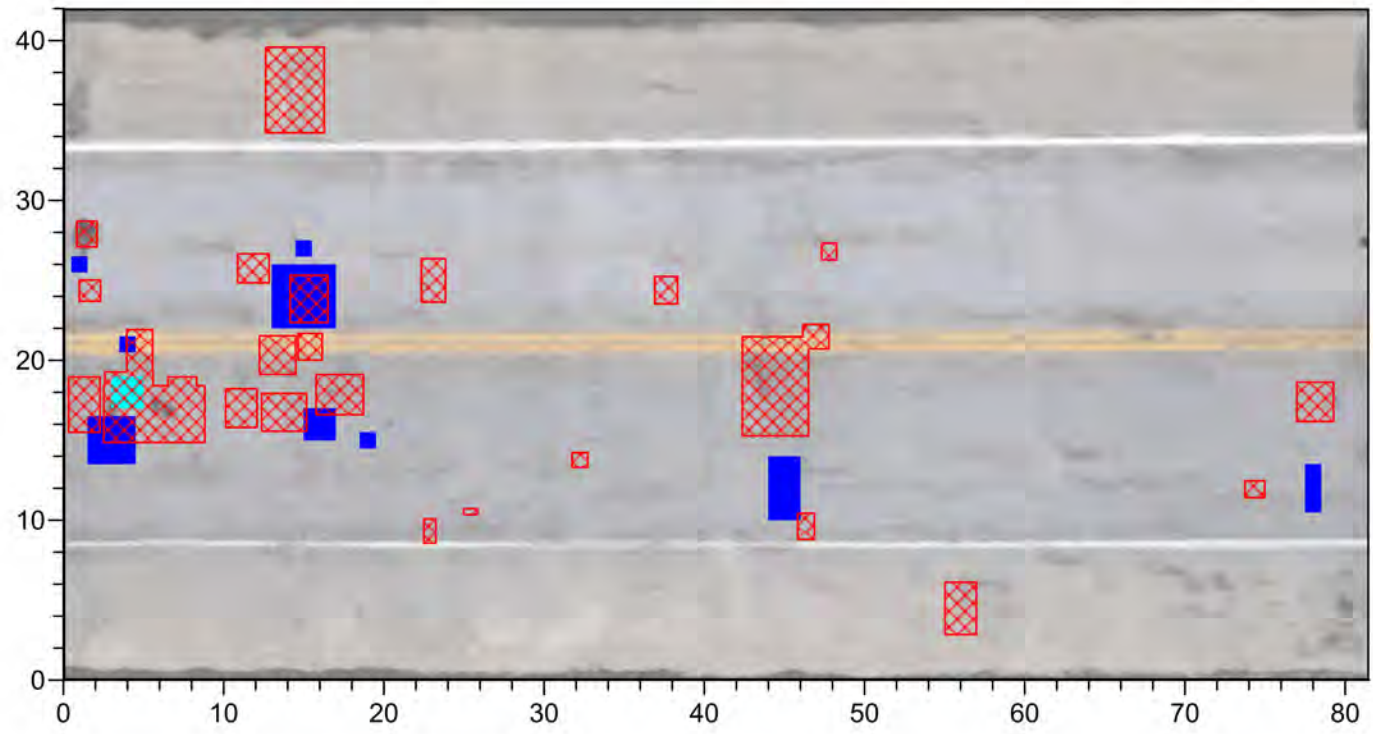
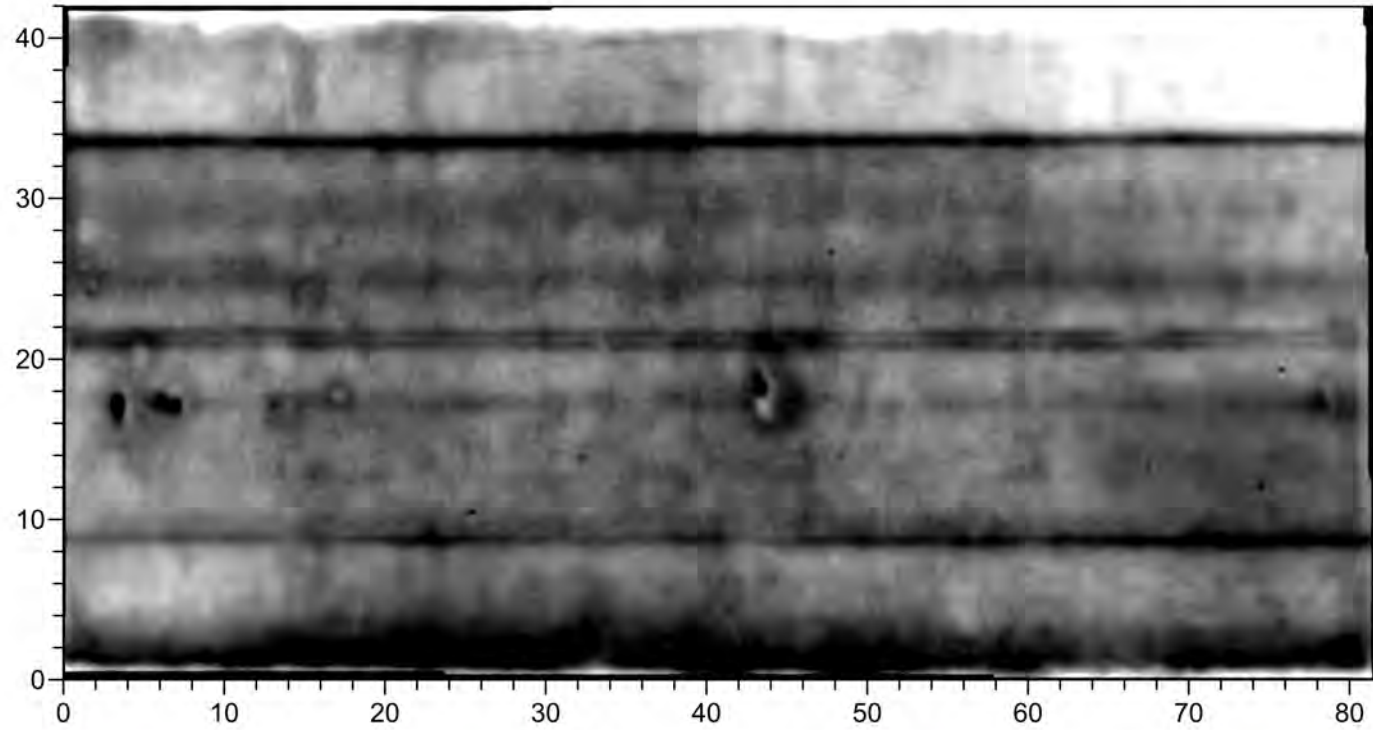
Delamination Quantity (%)	2.4

Chain Drag Delamination Quantity (%)	1.3
Chain Drag Delamination Quantity (ft <sup>2</sup> )	44
Chain Drag Spalling Quantity (%)	0.1
Chain Drag Spalling Quantity (ft <sup>2</sup> )	4
