CRASH TESTING AND EVALUATION OF THE NETC 2-BAR CURB-MOUNTED BRIDGE RAIL

King K. Mak and Wanda L. Menges

February 1998

VOLUME IX: APPENDIX H -CRASH TESTING AND EVALUATION OF THE **NETC PL-2 BRIDGE RAIL DESIGN**

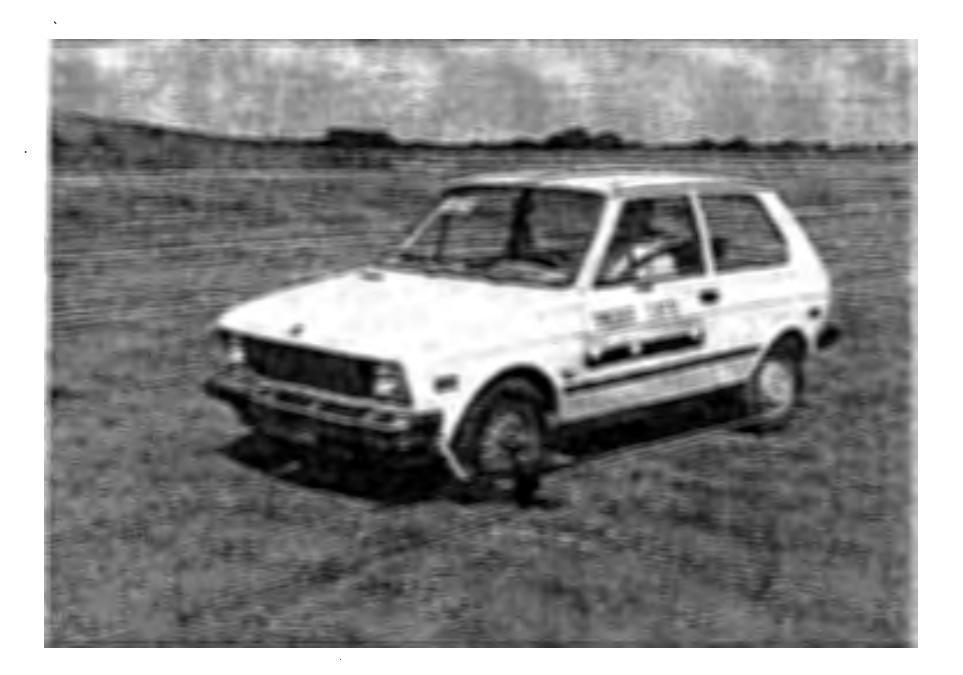
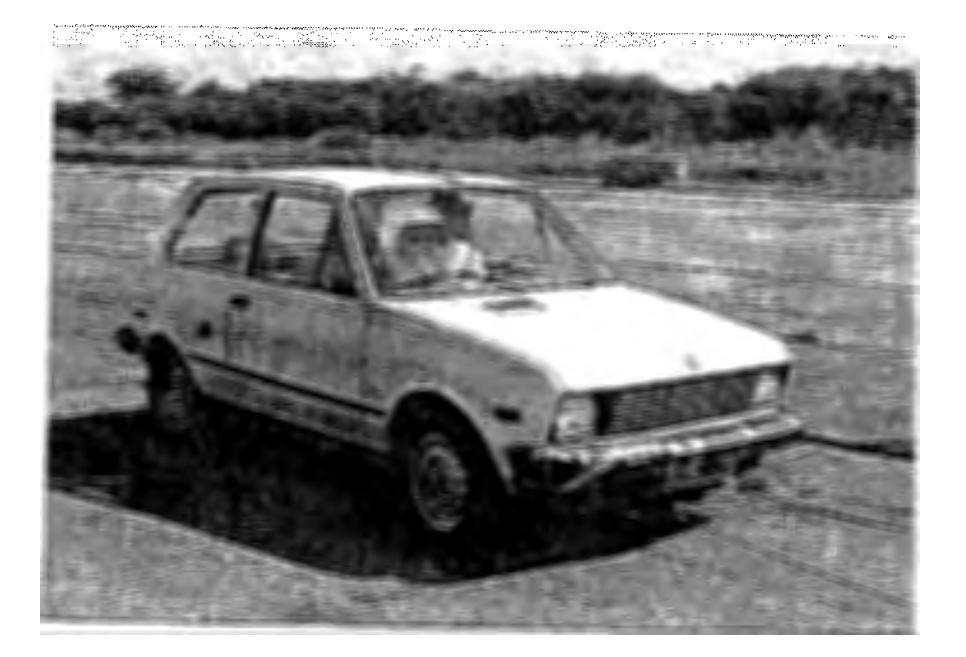
Figure 5. Vehicle before test 471470-18.

A 1986 Yugo GV (figure 5) was used for the crash test. Test inertia mass of the vehicle was 817 kg (1800 lb) and its gross static mass was 894 kg (1970 lb). The height to the lower edge of the vehicle bumper was 238 mm (9.4 in) and it was 465 mm (18.3 in) to the top of the bumper. Additional dimensions and information on the test vehicle are given in figure 6. The position of the vehicle relative to the bridge railing prior to impact is shown in figure 7. The vehicle was directed into the bridge railing using the cable reverse tow and guidance system, and was released to be free-wheeling and unrestrained just prior to impact.

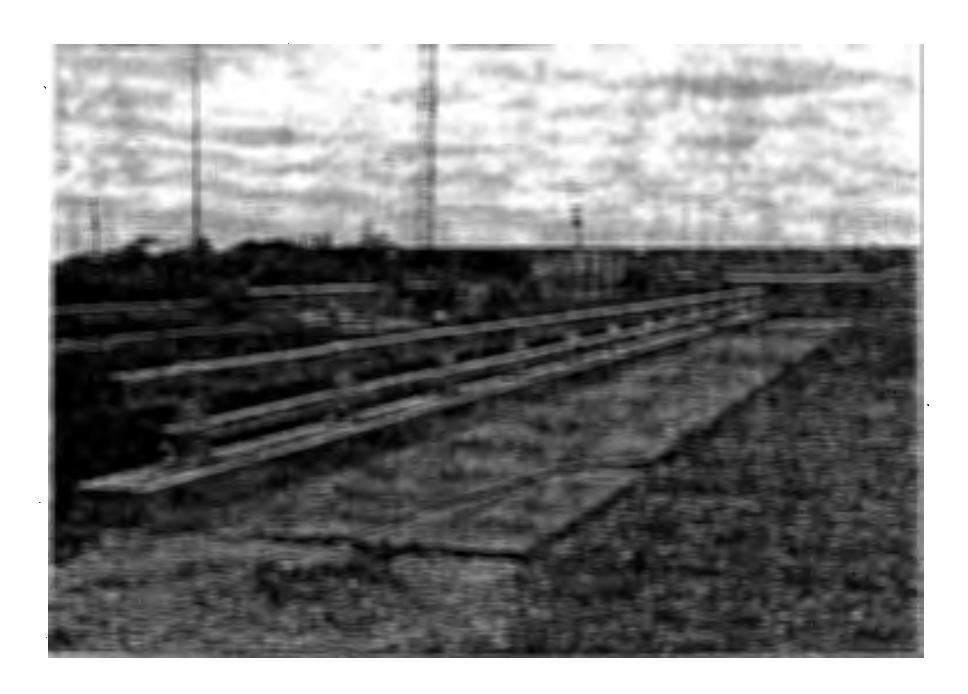
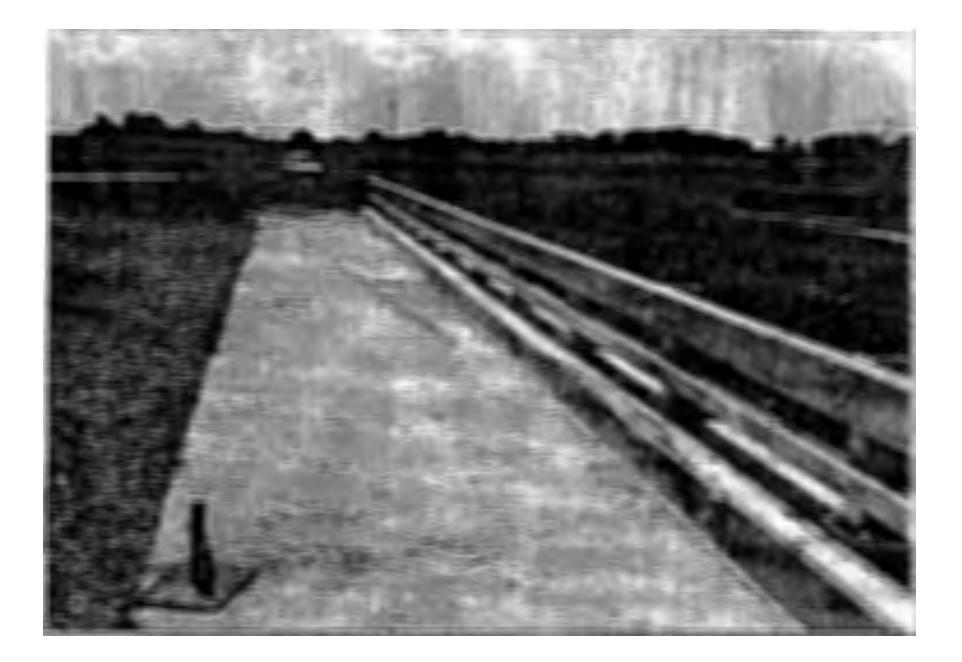
Figure 11. Test site after test 471470-18.

bridge railing for a total length of 4.0 m (13.2 ft). Shown in figure 11 are photographs of the post-test vehicle trajectory.

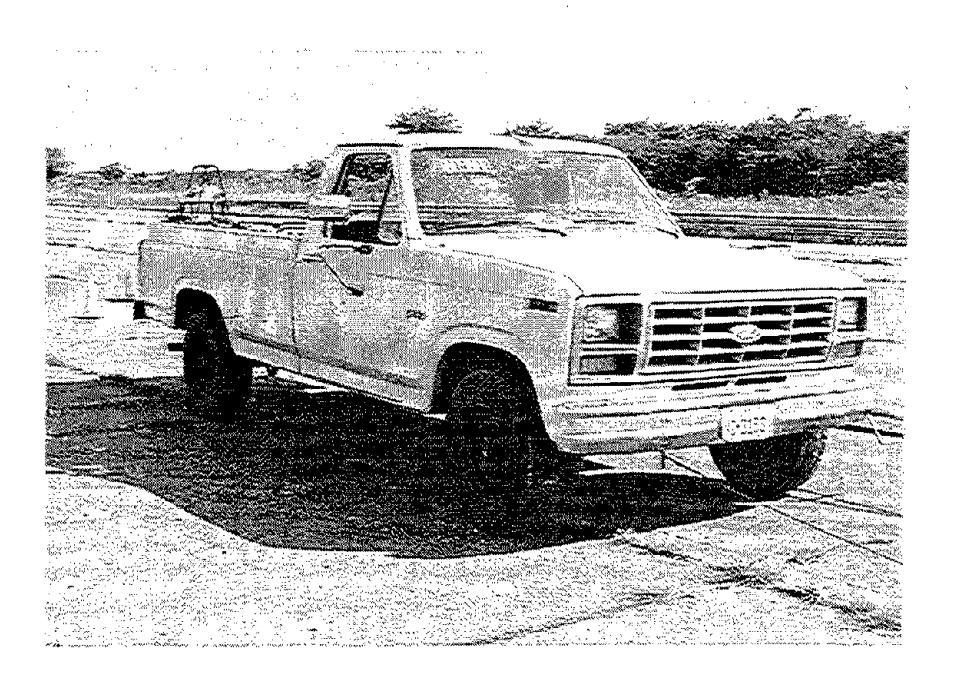
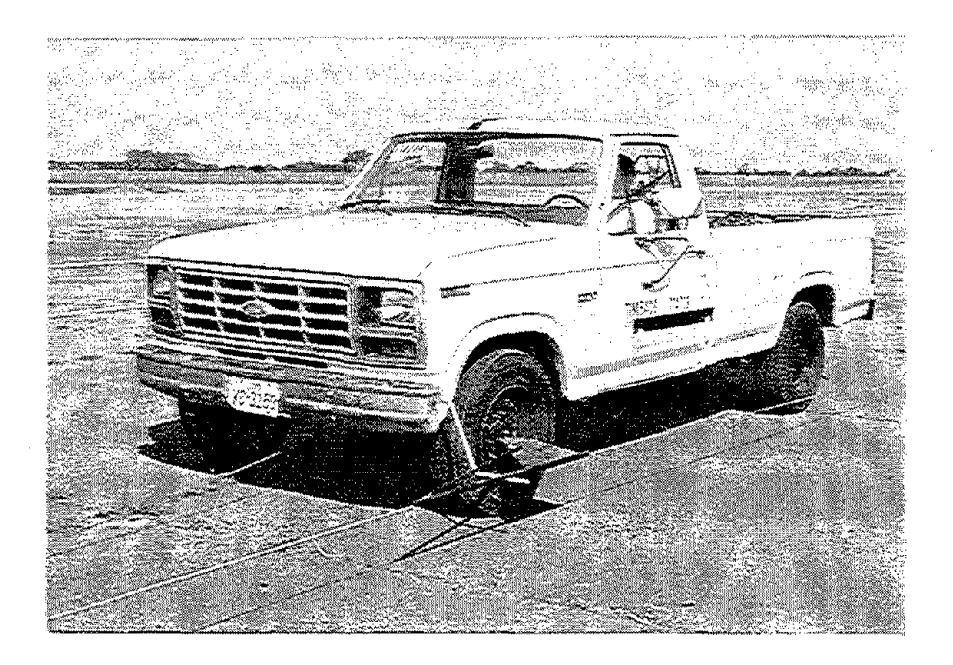
Figure 18. Vehicle before test 471470-19.

A 1984 Ford F250 Pickup (figure 18) was used for the crash test. Test inertia mass of the vehicle was 2452 kg (5400 lb) and its gross static mass was 2528 kg (5568 lb). The height to the lower edge of the vehicle bumper was 432 mm (17.0 in) and it was 673 mm (26.5 in) to the top of the bumper. Additional dimensions and information on the test vehicle are given in figure 19. The position of the vehicle relative to the bridge railing prior to impact is shown in figure 20. The vehicle was directed into the bridge railing using the cable reverse tow and guidance system, and was released to be free-wheeling and unrestrained just prior to impact.

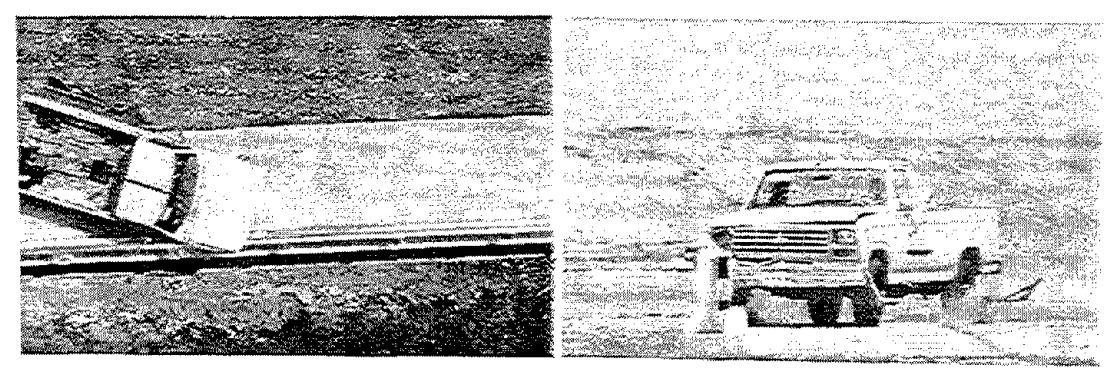
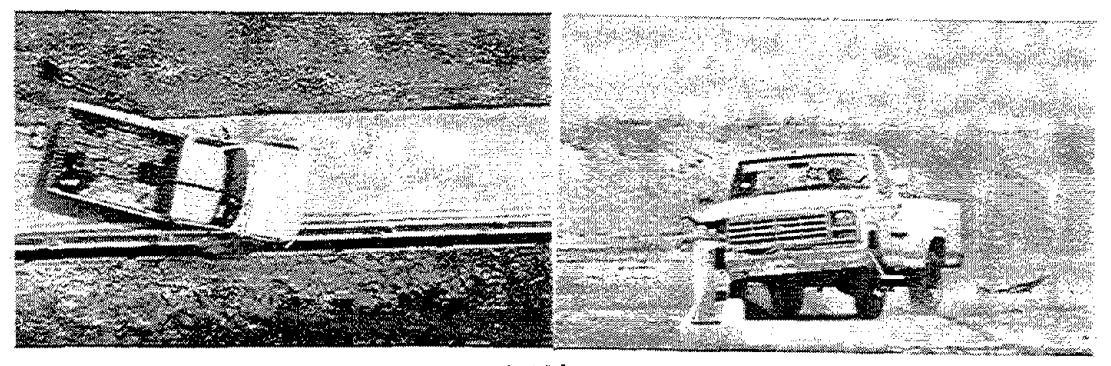
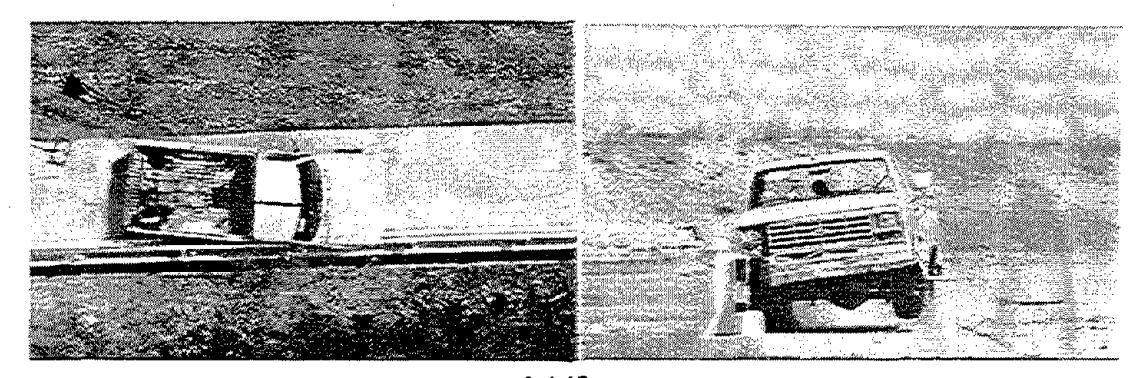
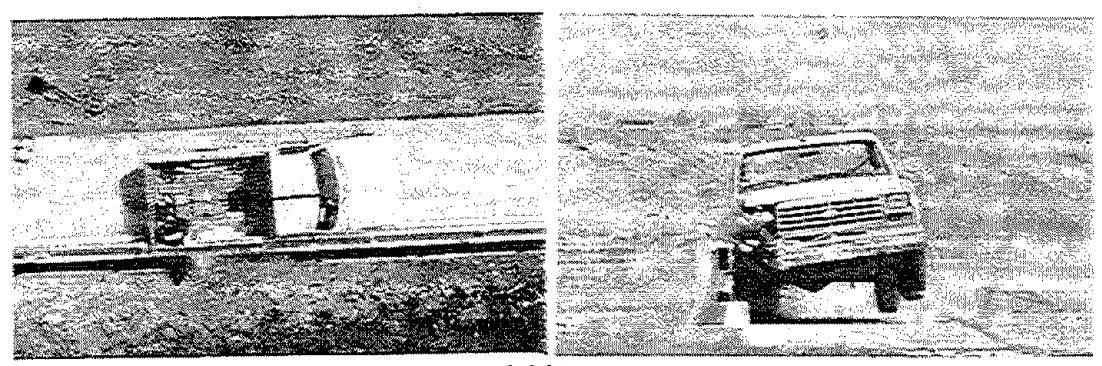
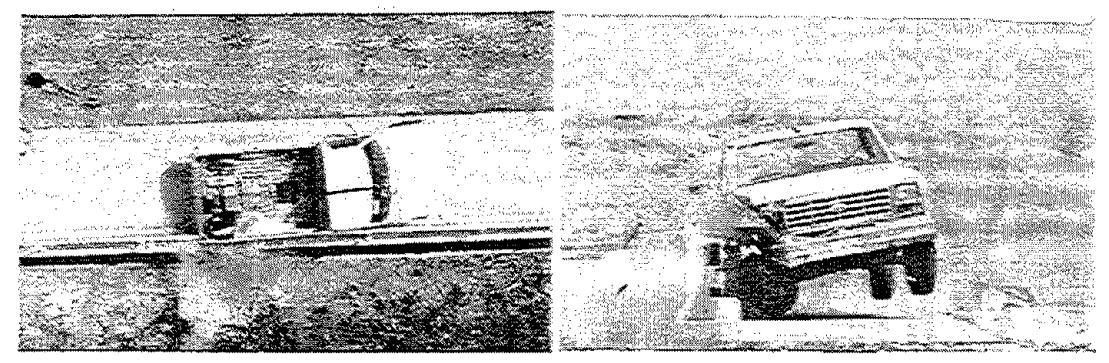
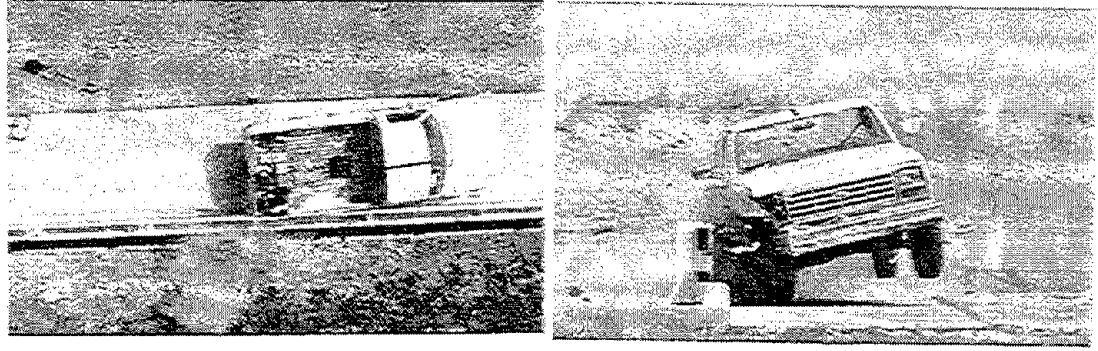
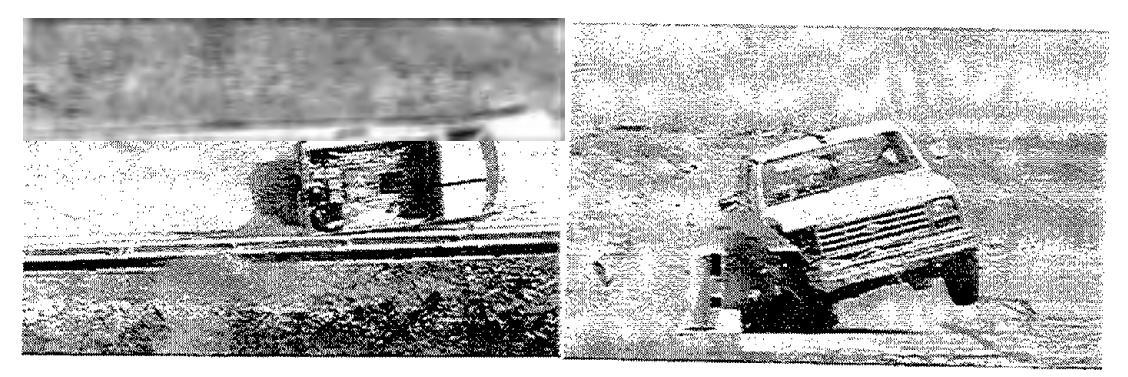
The vehicle impacted the bridge railing between posts 3 and 4 (post 1 was the first post at the upstream end of the bridge railing) or 0.3 m (12 in) downstream from post 3 at a speed of 92.2 km/h (57.3 mi/h) and an angle of 20.6 degrees. By 0.183 s after impact, the vehicle was traveling parallel to the bridge railing at a speed of 82.5 km/h (51.3 mi/h). The vehicle lost contact with the bridge railing at 0.369 s, traveling at a speed of 78.2 km/h (48.6 mi/h) and at an exit angle of 2.2 degrees. The brakes on the vehicle were applied at 2.3 s after impact and the vehicle subsequently came to rest 77.0 m (252.5 ft) down from and 3.7 m (12 ft) behind the point of impact. Sequential photographs of the impact are shown in figures 21 and 22.

0.149 s Figure 21. Sequential photographs for test 471470-19 (overhead and frontal views).

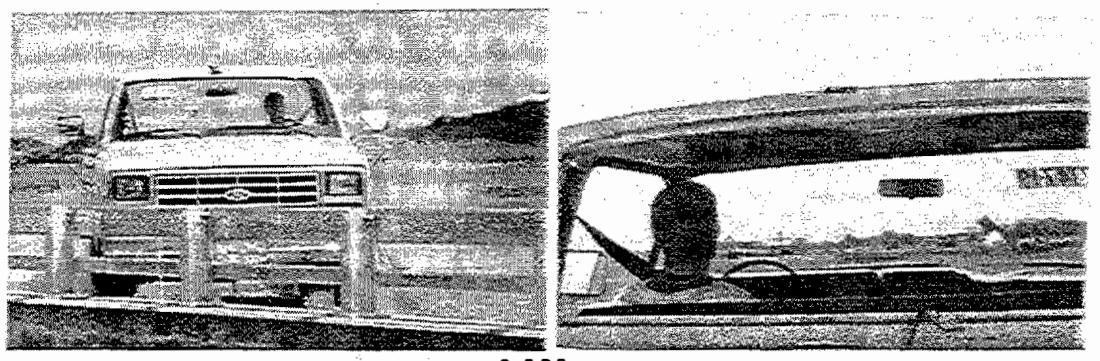
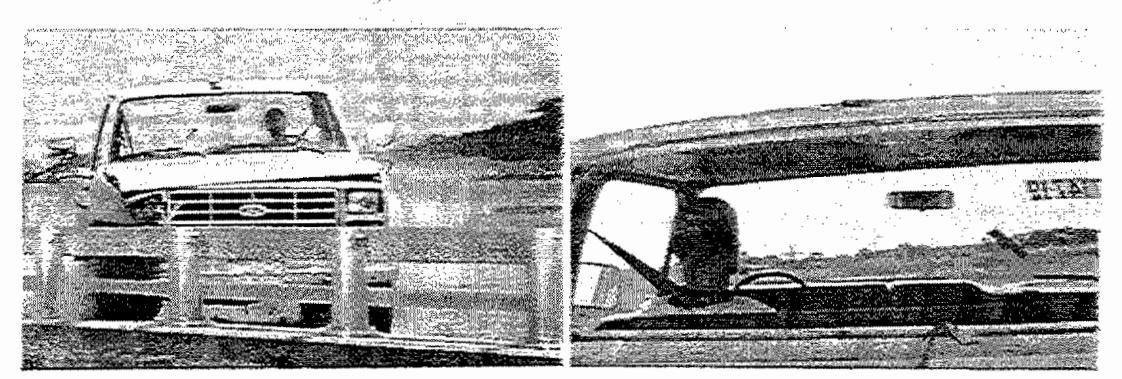
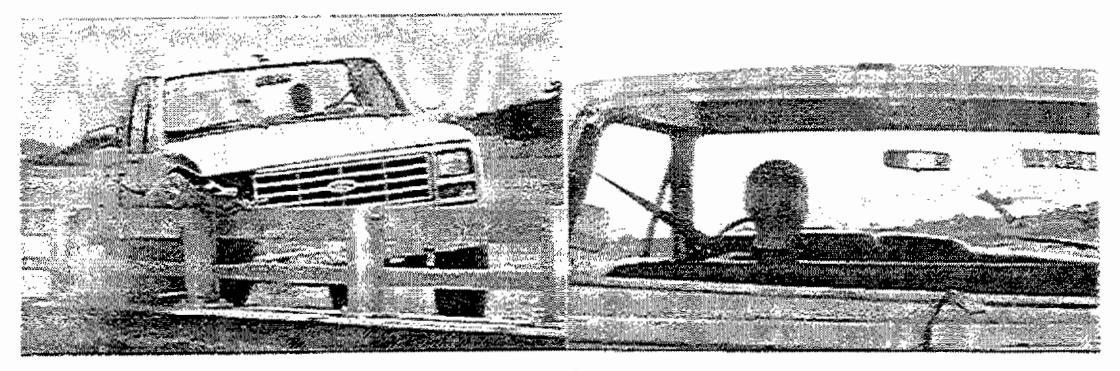
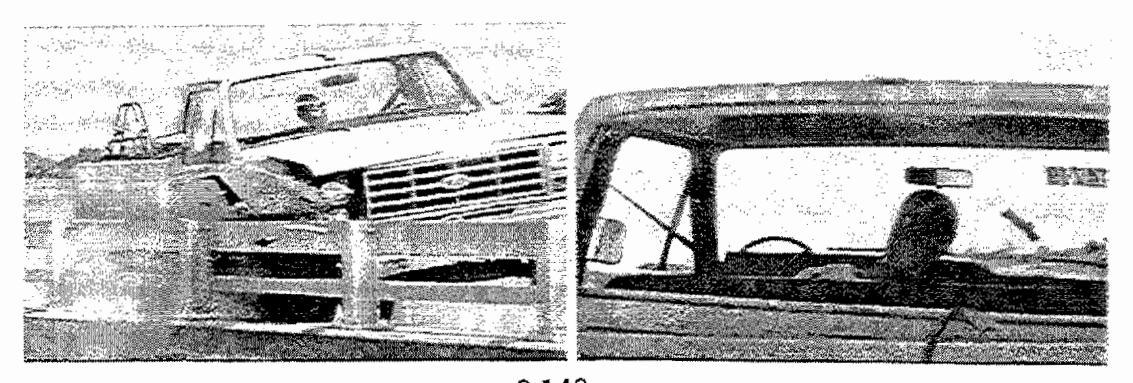
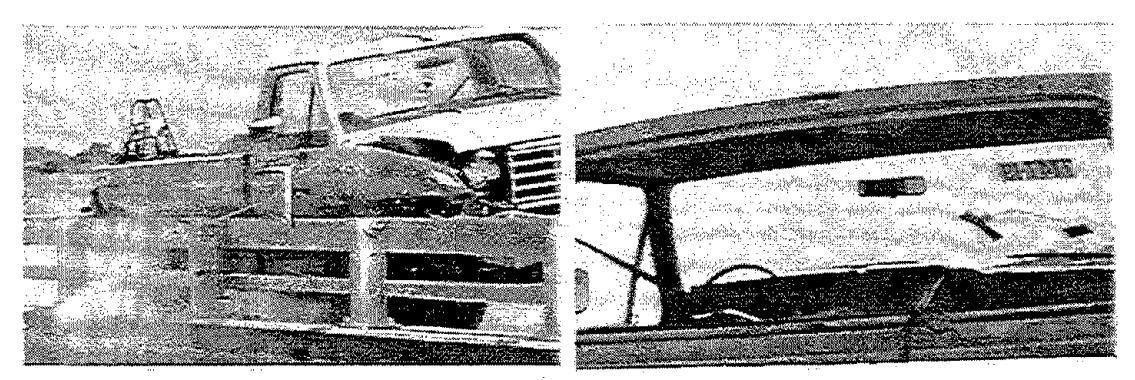
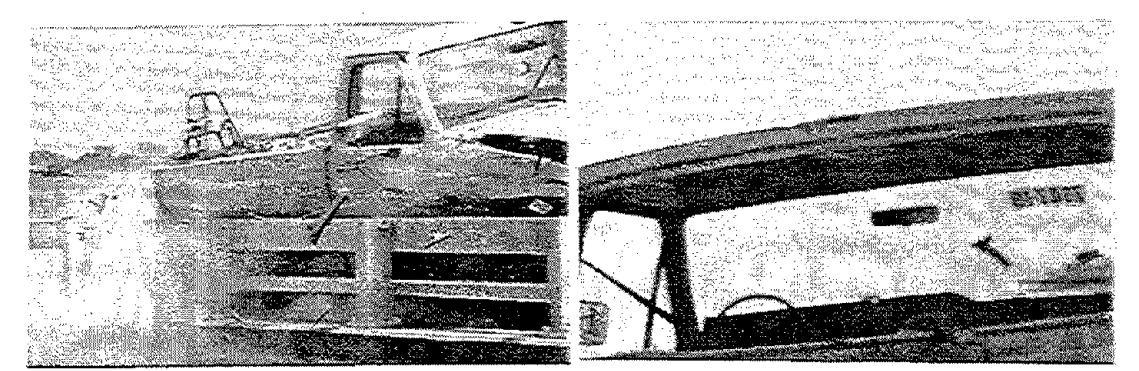
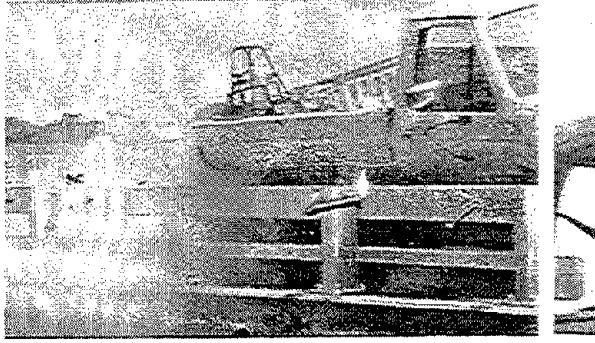
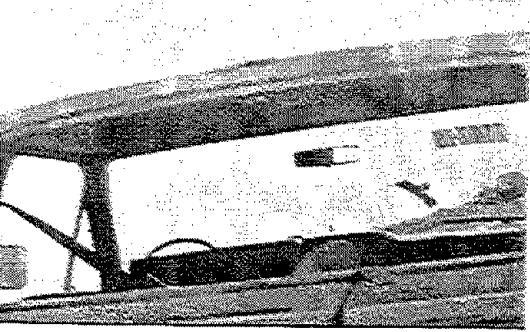
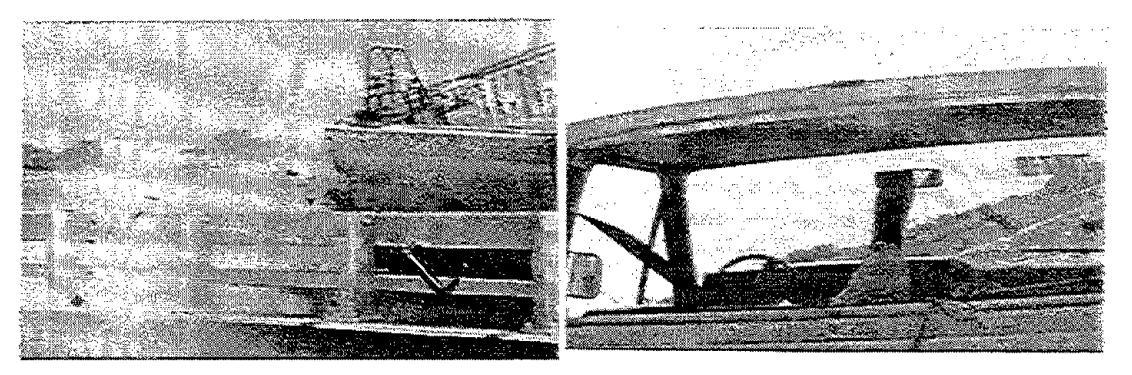
0.149 s Figure 22. Sequential photographs for test 471470-19 (behind the rail and interior views). 36

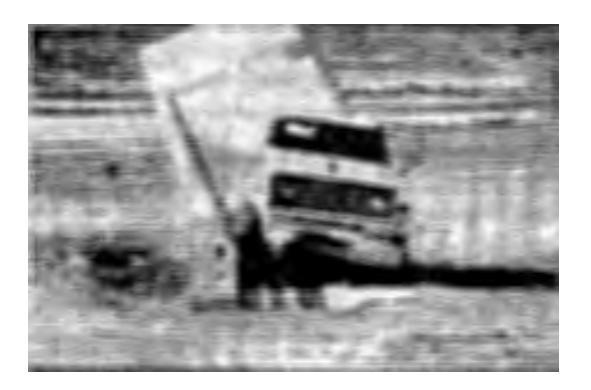
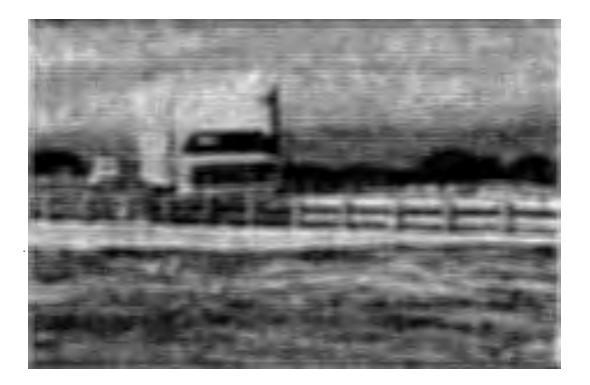
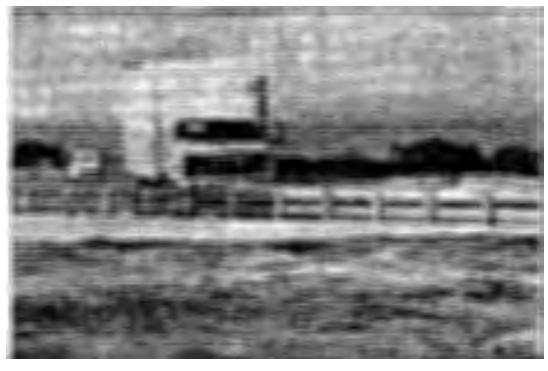
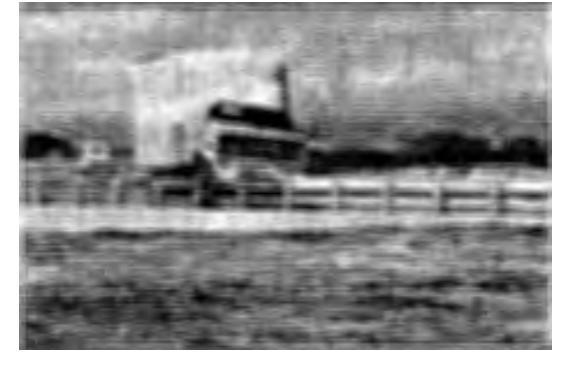
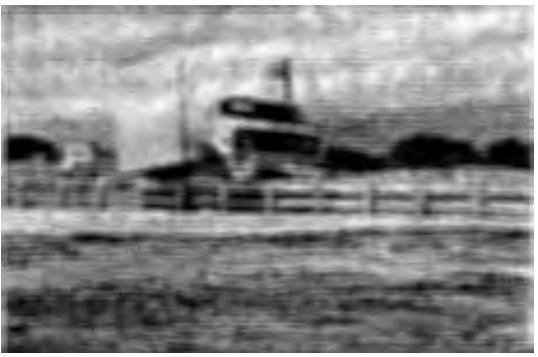
Figure 35. Sequential photographs for test 471470-29 (overhead and frontal views) (continued).

The right front corner of the box contacted the top of the upper rail element at 0.468 s. By 0.496 s, the cab of the vehicle reached a maximum clockwise roll of 26 degrees and began to roll counterclockwise while the box was still rotating clockwise. The box became partially separated from the frame of the vehicle and the box rode along the top of the rail. The vehicle rode off the end of the rail at an exit angle of approximately 2.0 degrees toward the bridge rail. The vehicle brakes were applied as the vehicle exited the test area, and subsequently came to rest 55 m (180 ft) downstream from the point of impact and parallel with the installation. Sequential photographs are shown in figures 35 and 36.
