February 2023

Report No. 23-039

Post-Fire Damage Inspection of Concrete Structures - Phase II

University of Massachusetts Amherst

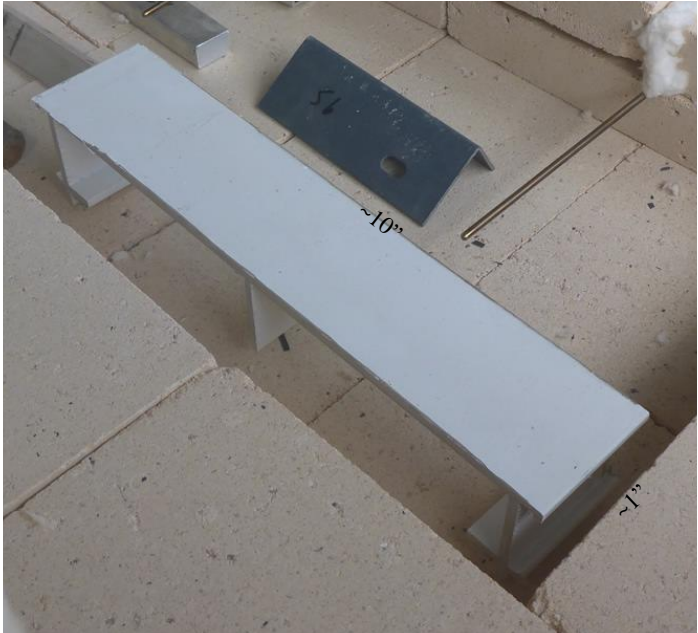
A piece of an aluminum wireway was directly heat loaded to investigate the specimen's response at elevated temperatures (Figure 5.6). The specimen was exposed to 700°C (1292°F) conditions for two hours and showed significant signs of discoloration and deformation.

700°C (1292°F) (120 minutes)	 	-Discoloration of specimens (yellow in color) -Melting of aluminum

Figure 5.6: Aluminum wireway physical response to direct heat loading

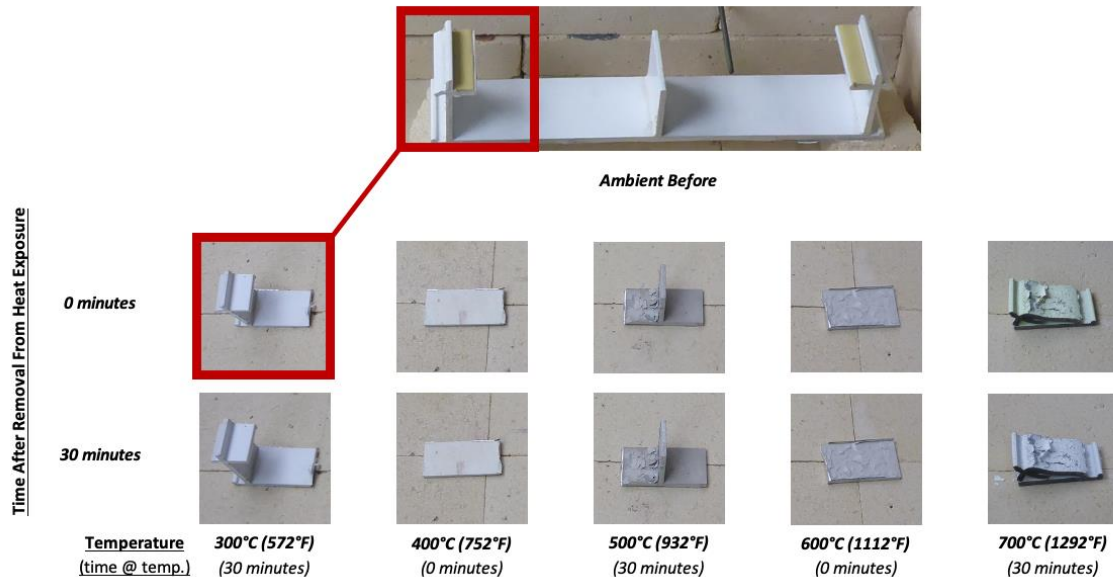
Small pieces of an aluminum wireway were used to investigate visual changes of the wireway at elevated temperatures and in its residual condition (Figure 5.8). Five pieces of aluminum wireway were step heated, exposed in steps to temperatures of 300°C (572°F), 400°C (752°F), 500°C (932°F), 600°C (1112°F), and 700°C (1292°F), with pieces being removed at each heat step. Specimens were visually inspected immediately after being removed and thirty minutes after being removed (once cooled to ambient temperatures). With exposure to temperatures of 400°C (752°F) and above, specimens showed discoloration trends immediately after being removed,. A temperature of 400°C (752°F) caused an initial darkening of the paint, 500°C caused graying of the paint, 600°C (1112°F) caused a lighter shading of the paint, and 700°C (1292°F) caused a yellow discoloration of the paint. Thirty minutes after being removed, all specimens except for the specimen removed at 700°C (1292°F) looked the same as they had upon removal. The specimen removed at 700°C (1292°F) changed from yellow to white when cooled to ambient temperature.

Figure 5.8: Aluminum wireway visual and physical response to stepped heat loading

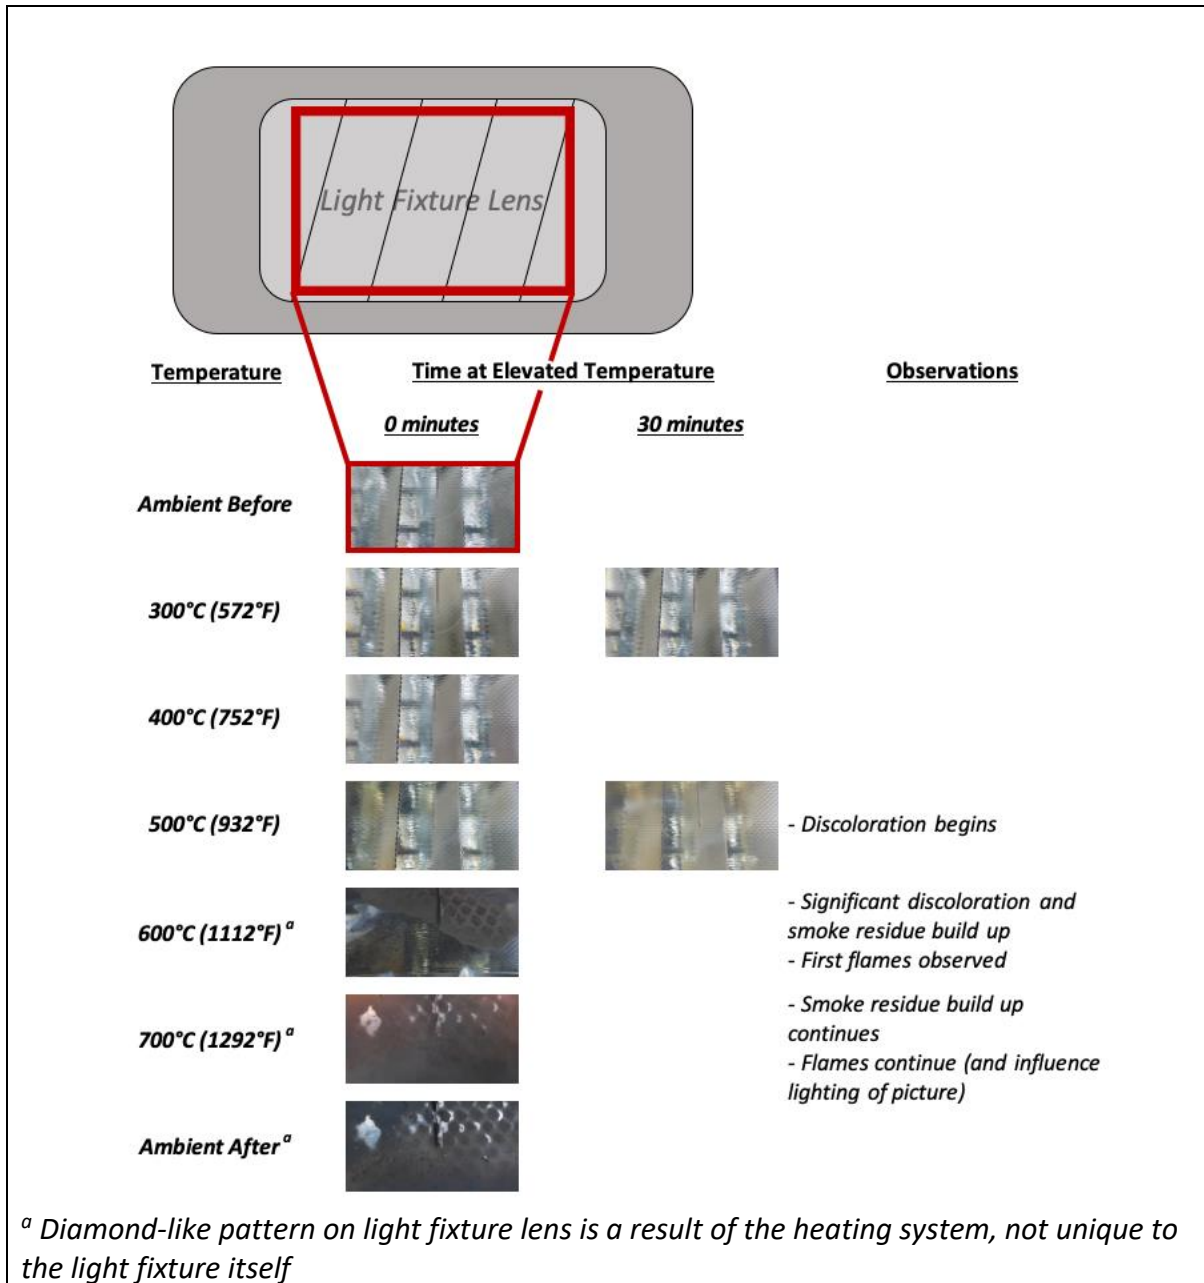
A light fixture specimen was tested under a stepped heat loading regimen. The light fixture was step loaded from 300°C (572°F) to 700°C (1292°F) in intervals of 100°C (180°F). The glass lens of the specimen was monitored for visual and physical changes (Figure 5.9). At 500°C (932°F), initial discoloration of the lens began. At 600°C (1112°F) the lens was discolored significantly, covered in smoke residue. At 700°C (1292°F) smoke residue continued to build up. Once cooled to ambient temperature, the lens showed no visual changes from the last elevated temperature. The painted aluminum body of the light fixture was also monitored (Figure 5.10). It was observed that at 400°C (742°F), the paint of the body began to discolor. The paint began charring at 500°C (932°F) and after being held at 500°C (932°F) for thirty minutes it began to flake. At 600°C (1112°F), discoloration of the paint continued. At 700°C (1292°F), some of the aluminum began to deform as it exceeded its melting point of 660°C (1220°F). While returning to ambient temperature during the first hour, the paint of the body shifted slightly in color.

Figure 5.9: Light fixture lens visual response to stepped heat loading

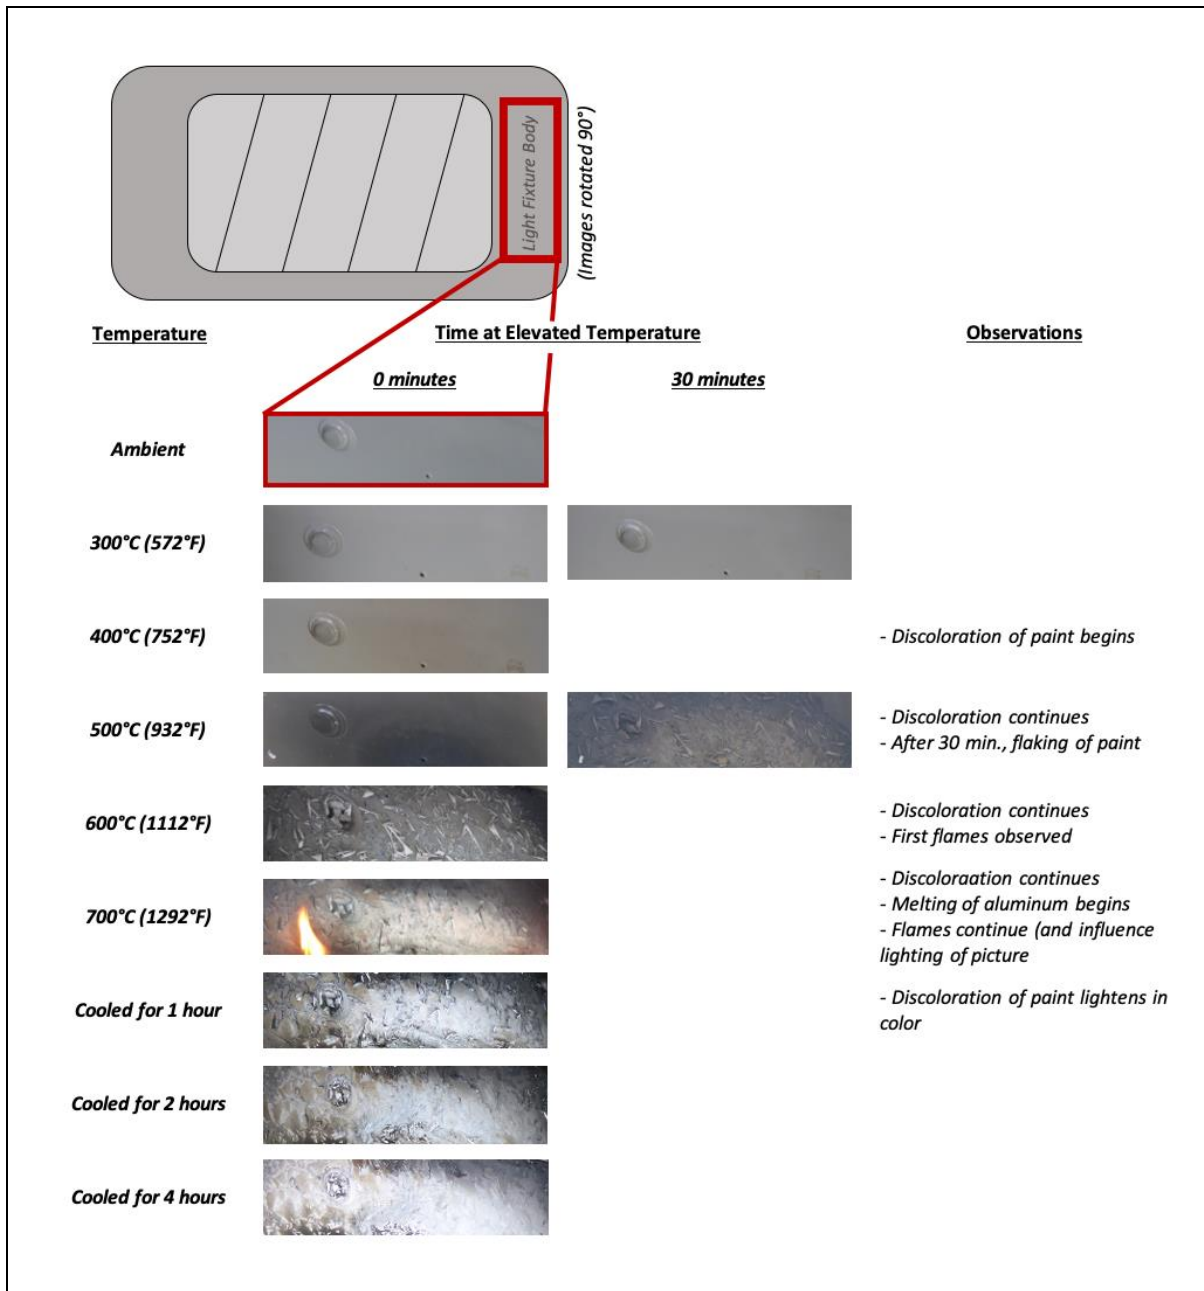
Figure 5.10: Light fixture body visual response to stepped heat loading

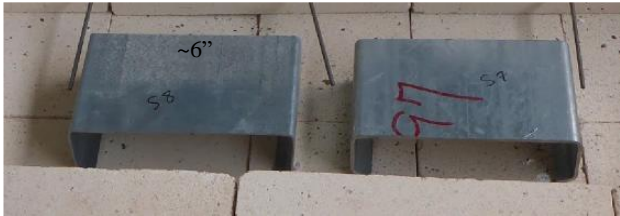
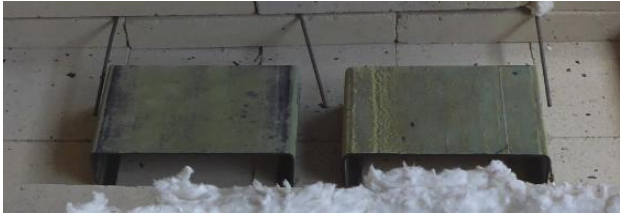
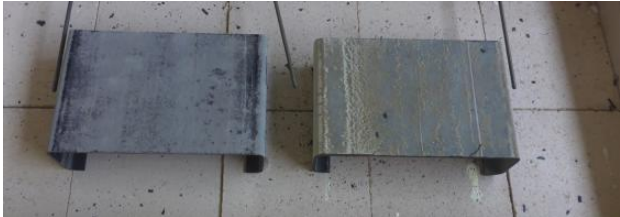
Figure 5.12 presents the results of another test that was conducted with 54-mil and 97-mil specimens which involved a stepped loading procedure to 900°C (1652°F). The specimens showed visual trends identical to the previously presented results up to 700°C (1292°F). At 800°C (1472°F), the specimens began to glow red as a result of the extreme heat. At 900°C (1652°F), the specimens showed significant charring.

-Discoloration of specimens (yellow in color)
Ambient After

-Discoloration changes when specimens return to ambient temperatures

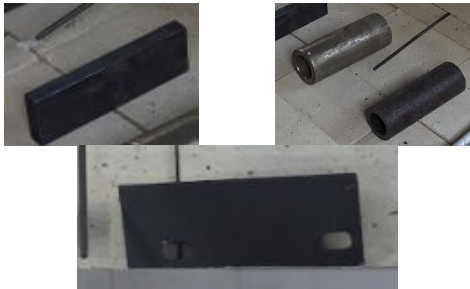
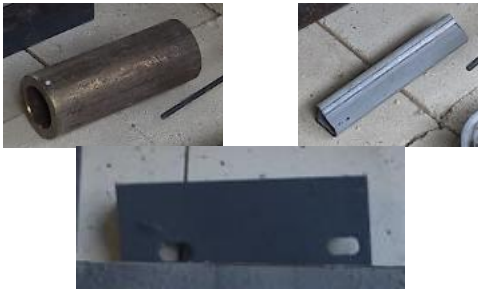
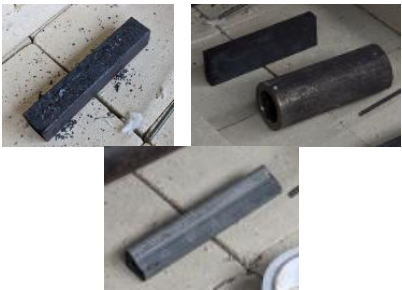
Six miscellaneous steel specimens were step loaded to 700°C (1292°F) (Figure 5.14) and showed differences in appearance with temperature increase. Duplicate specimens were directly loaded to 700°C (1292°F) (Figure 5.15) and showed no differences in comparison to the specimens subjected to the stepped loading procedure, with exception of specimen S6 which showed different discoloration trends. Detailed visual observations can be found in Figures 5.14 and 5.15. Dimensions and physical properties of the miscellaneous steel specimens can be found in Table 5.2.

-S2: Charring -S3: Slight browning -S4: Slight charring -S6: Darkening of paint
400°C (752°F) (0 minutes)

-S3: Significant browning -S5: Dulling -S6: Minor bubbling of paint
500°C (932°F) (30 minutes)

-S6: Significant flaking and discoloration of paint
600°C (1112°F) (0 minutes)

-S1: Flaking of exterior -S2: Significant charring -S3: Slight charring -S5: Color darkens
700°C (1292°F) (30 minutes)	No Additional Changes	
<i>Note: If a specimen is not shown at specific time step, no change occurred</i>

Figure 5.14: Miscellaneous steel response to stepped heat loading

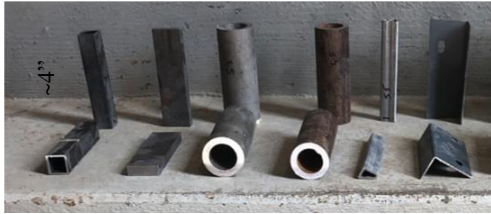
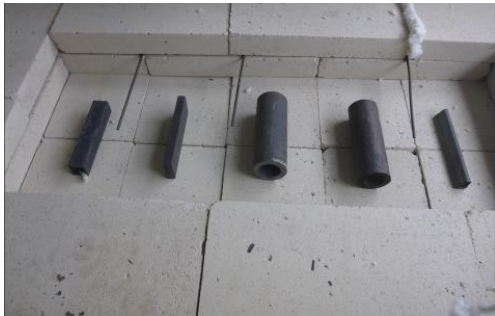
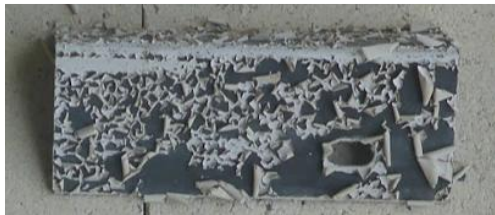
-S1: Flaking of exterior -S2: Significant charring -S3: Slight charring and browning -S4: Slight charring -S5: Color darkens and dulling -S6: Significant flaking and discoloration of paint

Figure 5.15: Miscellaneous steel response to direct heat loading

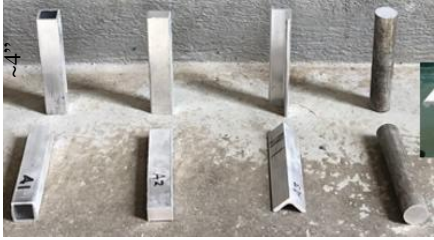
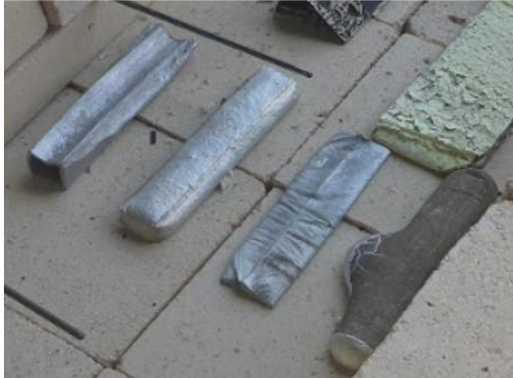
<p>-Slight discoloration of all specimens</p> <p>-Significant deformation of all specimens</p>

Figure 5.17: Aluminum of different geometry response to direct heat loading

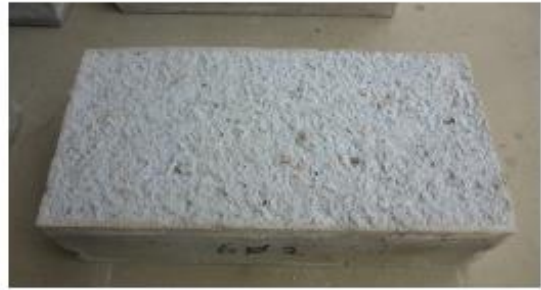
Concrete Sidewalk Block Specimen - Scaling

Figure 5.18: Example concrete sidewalk specimens (left) specimen with no scaling (right) specimen with scaling

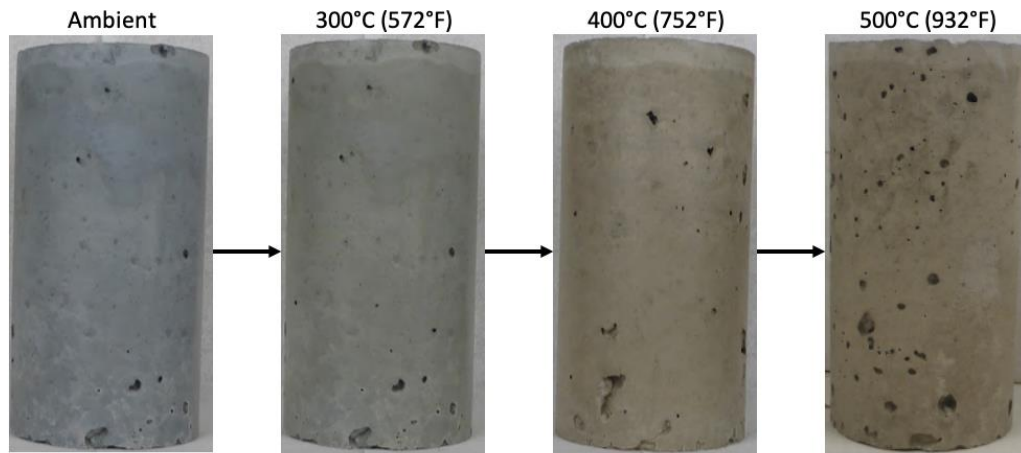
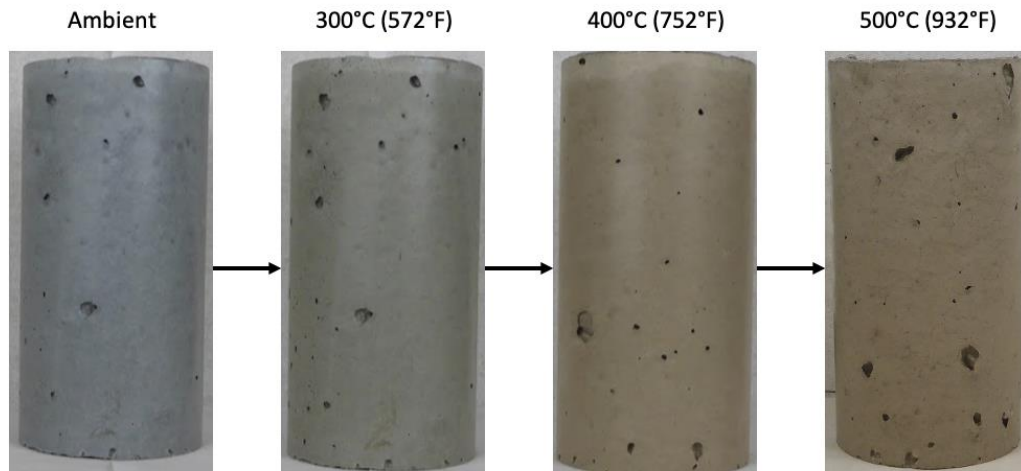
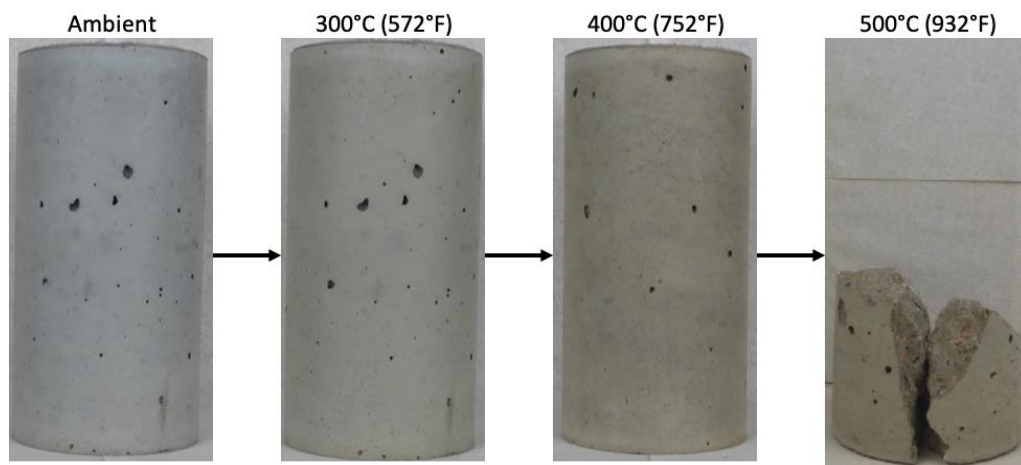
Additional concrete cylinders were cast to investigate their behavior with heat exposure. These cylinders were heated in a kiln where they were exposed to target temperatures of 300°C (572°F), 400°C (752°F), or 500°C (932°F) for three hours. The visual results are presented in Figure 6.1. A slight shift in color was observed in cylinders heated to 300°C (572°F) as a red tint was established in the concrete. At 400°C (752°F), the red tint became more apparent, and at 500°C (932°F) it was slightly more significant. Surface cracking was observed in all the concrete cylinder specimens exposed to elevated temperatures and was more apparent in the cylinders exposed to higher temperatures. Notably, a cylinder from batch 3 spalled explosively while at 500°C (932°F). The cylinders were heated in a kiln, and the temperatures described represent the gas temperature in the kiln.

Figure 6.1: Concrete cylinder visual and physical responses to elevated temperatures (a) batch 1 (b) batch 2 (c) batch 3

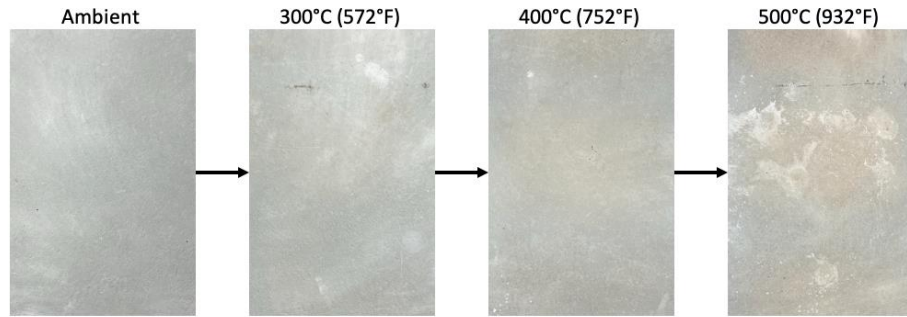
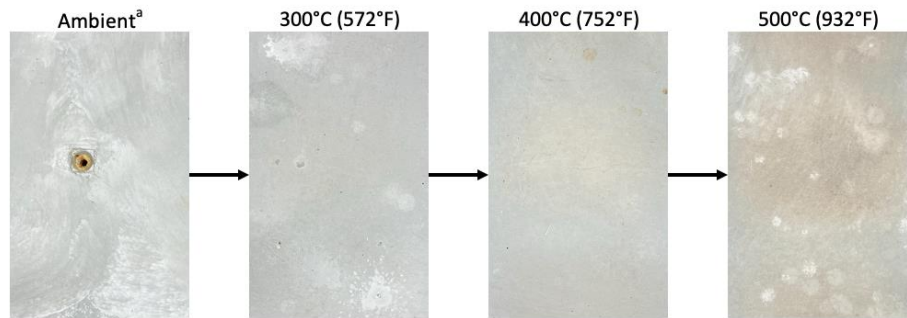
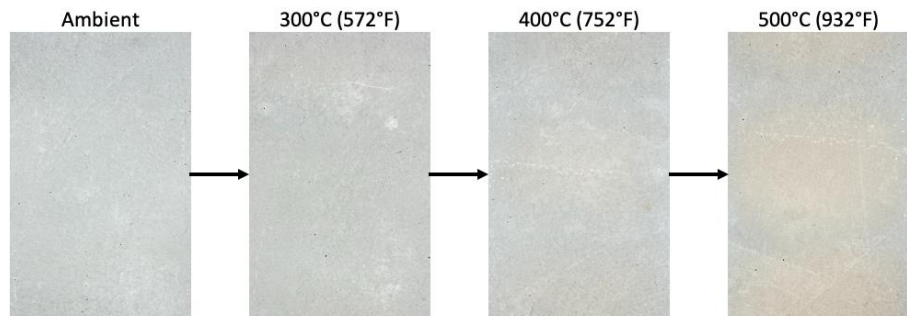
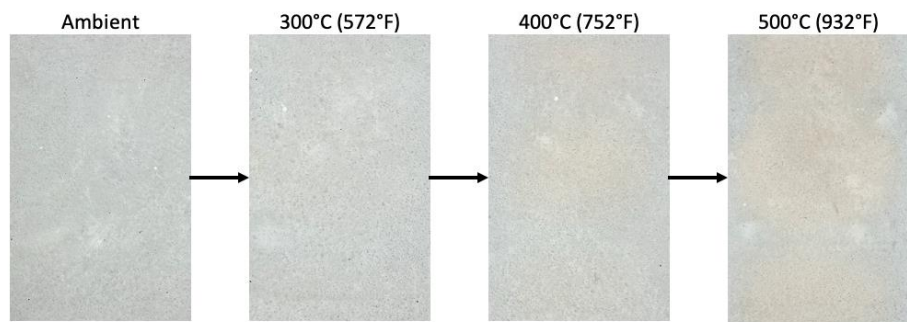
Figure 6.8a represents different areas of a batch 1 concrete slab specimen held at the defined target temperatures for three hours, and Figure 6.8b represents areas of a batch 1 concrete slab specimen held at the defined target temperatures for one hour. One visual characteristic of interest is the change in color of concrete associated with heat exposure. Different target temperatures did have an influence on the color of the concrete. Notably, 300°C (572°F) did not have a major influence on concrete color, but a slight red tint began to be present at this temperature. At 400°C (752°F), the slight red tint became more significant, and at 500°C (932°F), the red tint was strongly apparent and the contrast in color when compared to the control ambient condition is easily observable. No significant differences in visual appearance relating to color is observed between the two durations of time of one hour and three hours that target temperatures were sustained. Figure 6.8c and Figure 6.8d represent batch 2 concrete slab specimens held at defined target temperatures for three hours and one hour, respectively. Visual color results for batch 1 and batch 2 specimens appear to be the same.

Figure 6.8: Visual results of (a) batch 1, temperatures held for 3 hours, (b) batch 1, temperatures held for 1 hour, (c) batch 2, temperatures held for 3 hours, (d) batch 2, temperatures held for 1 hour

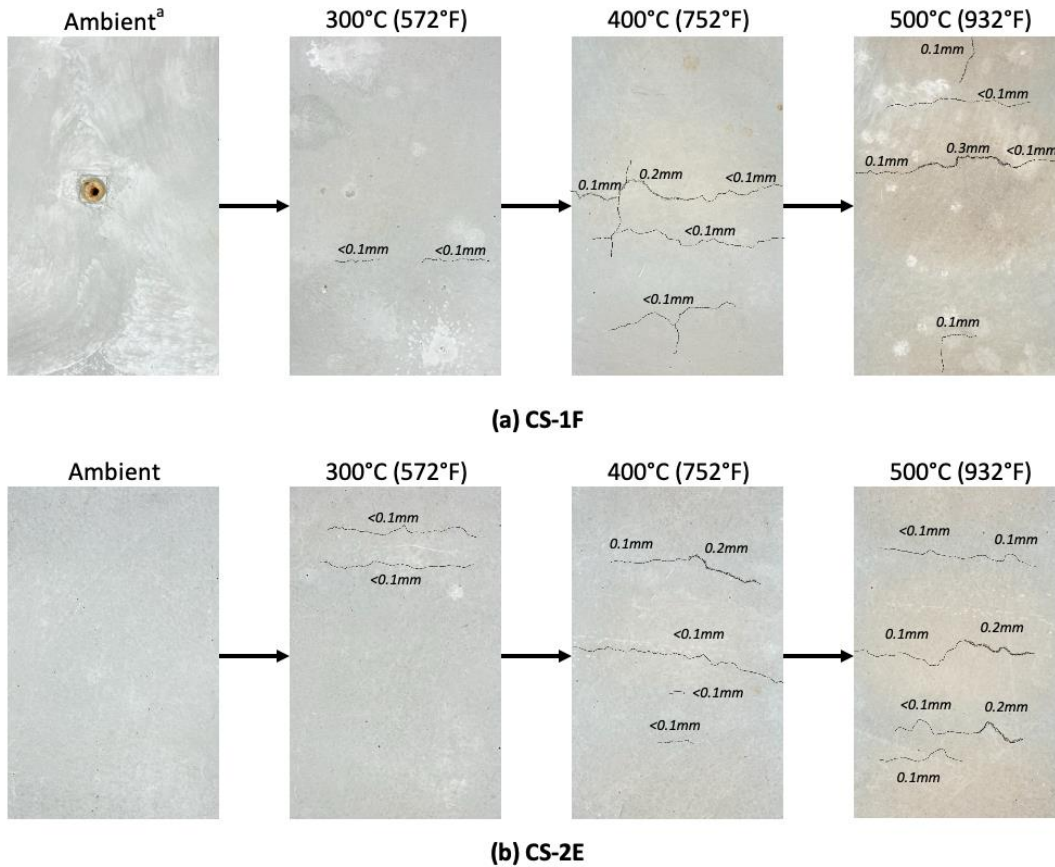
Another visual characteristic that was observed was the cracking of the concrete resulting from heat exposure. All slabs that were heated for visual investigation were observed to have surface cracking after heat exposure (with the exception of slab CS-1E heated to 300°C (572°F) for three hours). In general, all surface cracking was hairline and ranged from less than 0.1 mm to 0.3 mm in width. In general, cracking frequency increased with higher temperatures. Figure 6.9 illustrates variations in cracking with different target temperatures for slab CS-1F, batch 1 heated to target temperatures for three hours, and slab CS-2E, batch 2 heated to target temperatures for one hour. Differences in cracking relating to the duration of exposure to the target temperature and mixture design appear to be negligible.

Figure 6.9: Surface cracking of concrete slab specimen CS-1F, batch 1 heated to target temperatures for 3 hours, and concrete specimen CS-2E, batch 2 heated to target temperatures for 1 hour, with cracks enhanced/highlighted

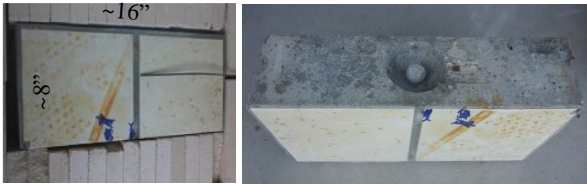
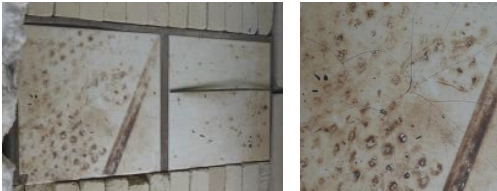
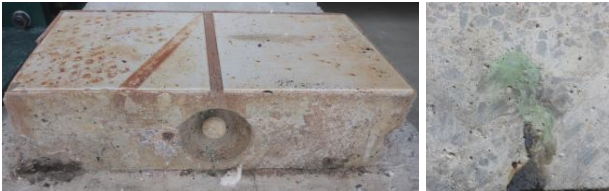
Figure 6.27 shows a second concrete wall panel specimen step heated to 800°C (1472°F) and 900°C (1652°F). Brown discoloration of both the tiles and grout was observed at 800°C

(1472°F). At 900°C (1652°F), significant cracking of the tiles was seen and charring of the epoxy from the exposed coated rebar. The grout and tiles both have red tints at 900°C (1652°F), which is also noticeable on some of the concrete. Once the specimen returned to ambient temperature conditions, the grout was red and powder-like, and easily removable from the specimen.

<i>-Discoloration of tiles -Discoloration of grout (red in color)</i>
900°C (1652°F) (120 minutes)

<i>-Significant cracking in tiles (picture on right side to show cracking in more detail)</i>
Ambient After

<i>-Brown colors changed to red colors -Epoxy coated rebar melting and charring</i>

Figure 6.27: Wall panel specimen #2 tiled face visual response to direct heat loading

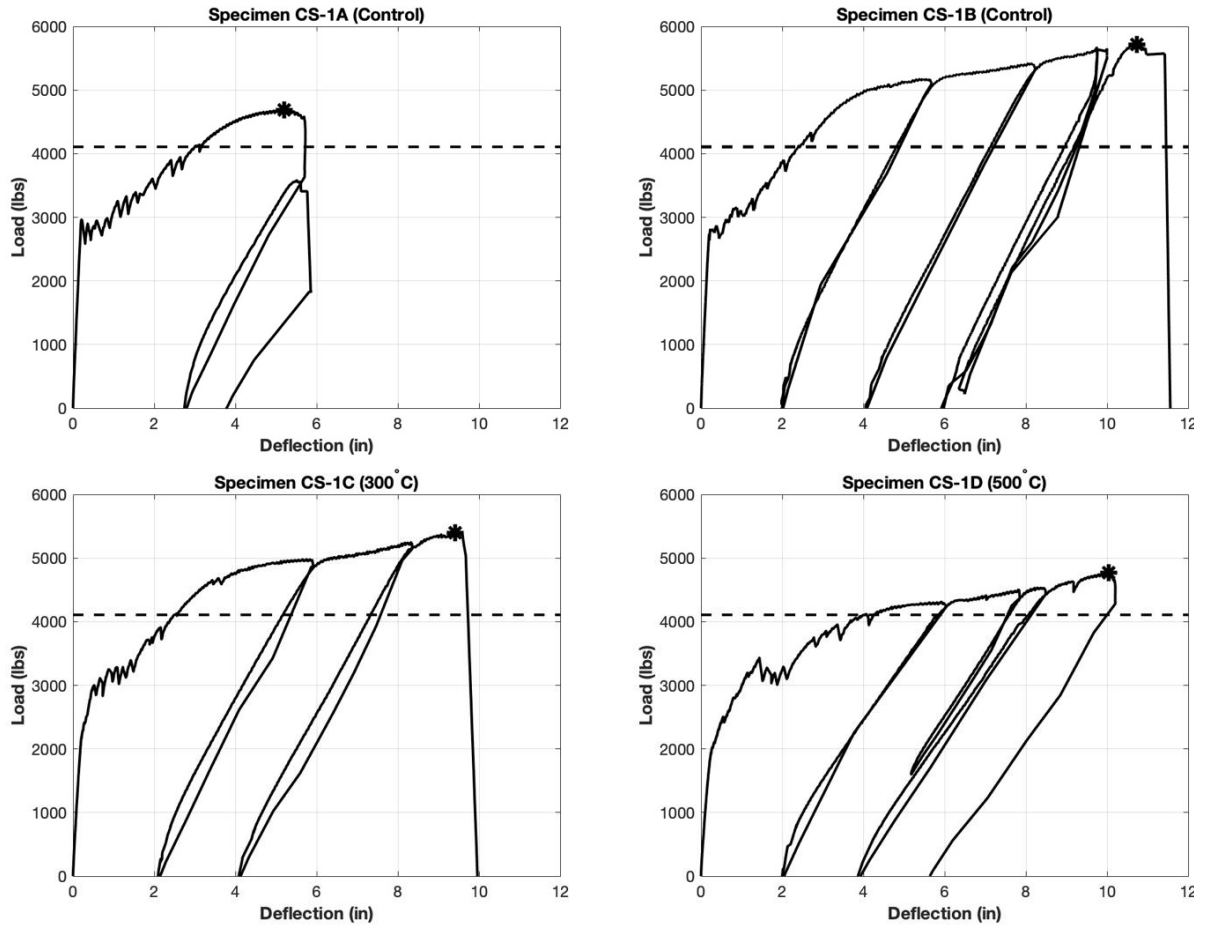
Figure 6.31: Mechanical testing results of batch 1 specimens CS-1A (Control), CS-1B (Control), CS-1C (300°C), and CS-1D (500°C), dashed lines represent calculated design flexural capacity of unheated batch 1 concrete slab specimens (4,107lbs) and stars represent respective peak capacities during each test

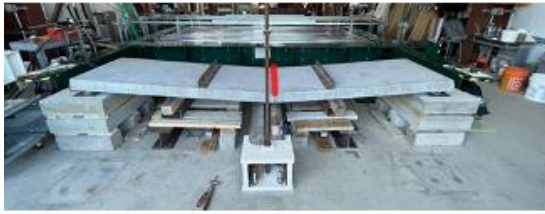
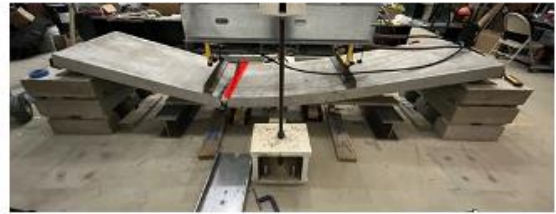
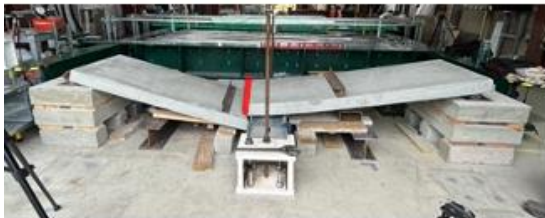
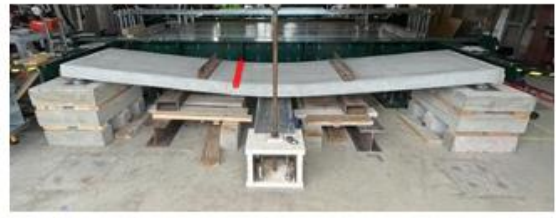
Slab	Heating Regimen	Maximum Capacity (lbs.)	Deflection at Maximum Capacity (in)	Failure Mode ^a	Failure Inside Heated Region?
CS-1A	None (Control)	4,685	5.20	1	N/A
CS-1B	None (Control)	5,721	10.73	2	N/A
CS-1C	300°C – 3 hours	5,400	9.41	2	Yes
CS-1D	500°C – 3 hours	4,770	10.04	1	No

^a Failure mode “1” is yielding of steel followed by crushing of concrete and failure mode “2” is rupture of steel

Figure 6.33: Batch 1 mechanical testing failure locations (indicated by red lines)

When conducting tests on concrete slab specimens from batch 1, it was found that the different heating regimens may have had a negligible influence on the specimens' maximum capacities. All specimens' deflections at maximum capacity were within 14 percent of each other, when excluding specimen CS-1A. CS-1A reached its maximum capacity with significantly different behavior with regard to ductility than the rest of the batch 1 specimens, and the cause is unknown. The CS-1A and CS-1D maximum capacities were approximately 1000 lb. lower than those of CS-1B and CS-1C, and this can be explained by the failure modes of the specimens. All specimens were loaded until a decrease in carrying capacity was observed. CS-1A and CS-1D failed due to yielding of steel followed by crushing of concrete (Figure 6.34). CS-1B and CS-1C failed due to the rupture of reinforcing steel (Figure 6.35). CS-1A and CS-1D had maximum capacities within 2 percent of each other, and CS-1B and CS-1C had maximum capacities within 6 percent of each other. The data do not support that heat exposure caused a decrease in maximum capacity of the member or significantly influenced associated deflections at maximum capacity when excluding the deflection results of specimen CS-1A. All specimens from batch 1 failed inside the constant moment region. Specimen CS-1C failed inside the heated region, and specimen CS-1D failed outside the heated region (Figure 6.33).

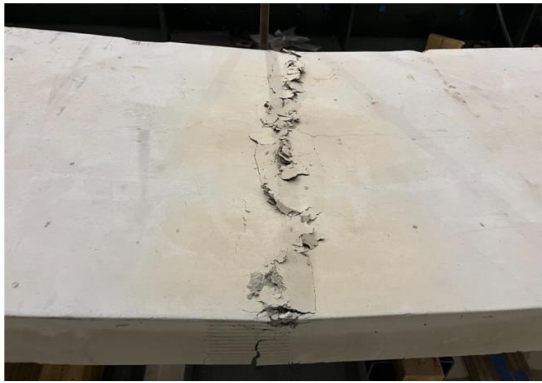
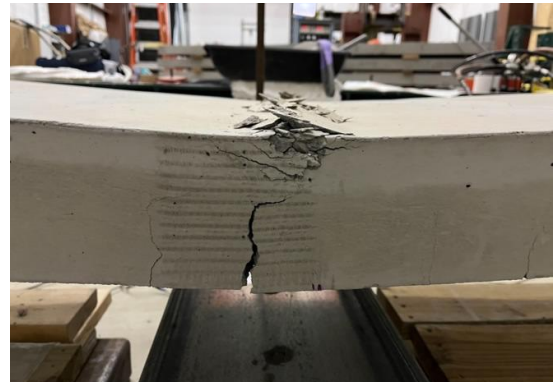
Figure 6.34: Yielding of steel followed by crushing of concrete failure (a) top view (b) side view

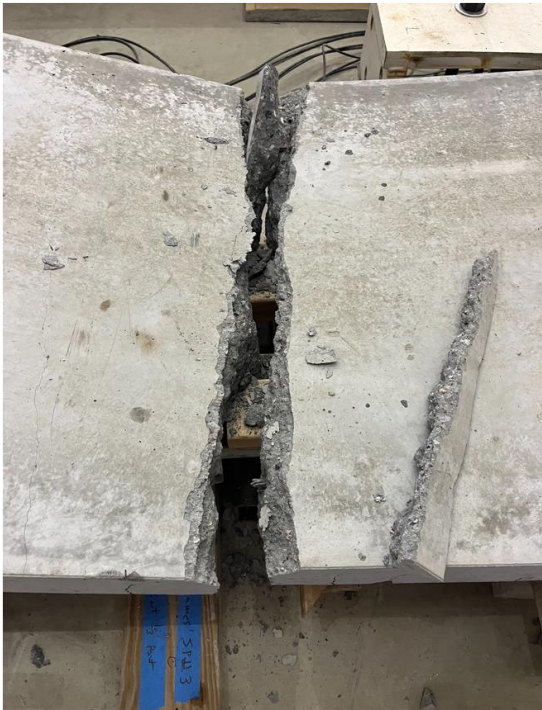
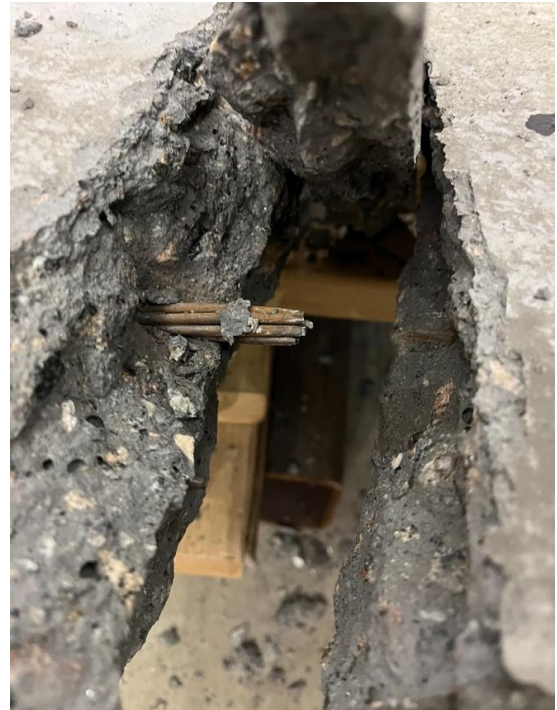
Figure 6.35: Rupture of steel failure (a) top view (b) side view

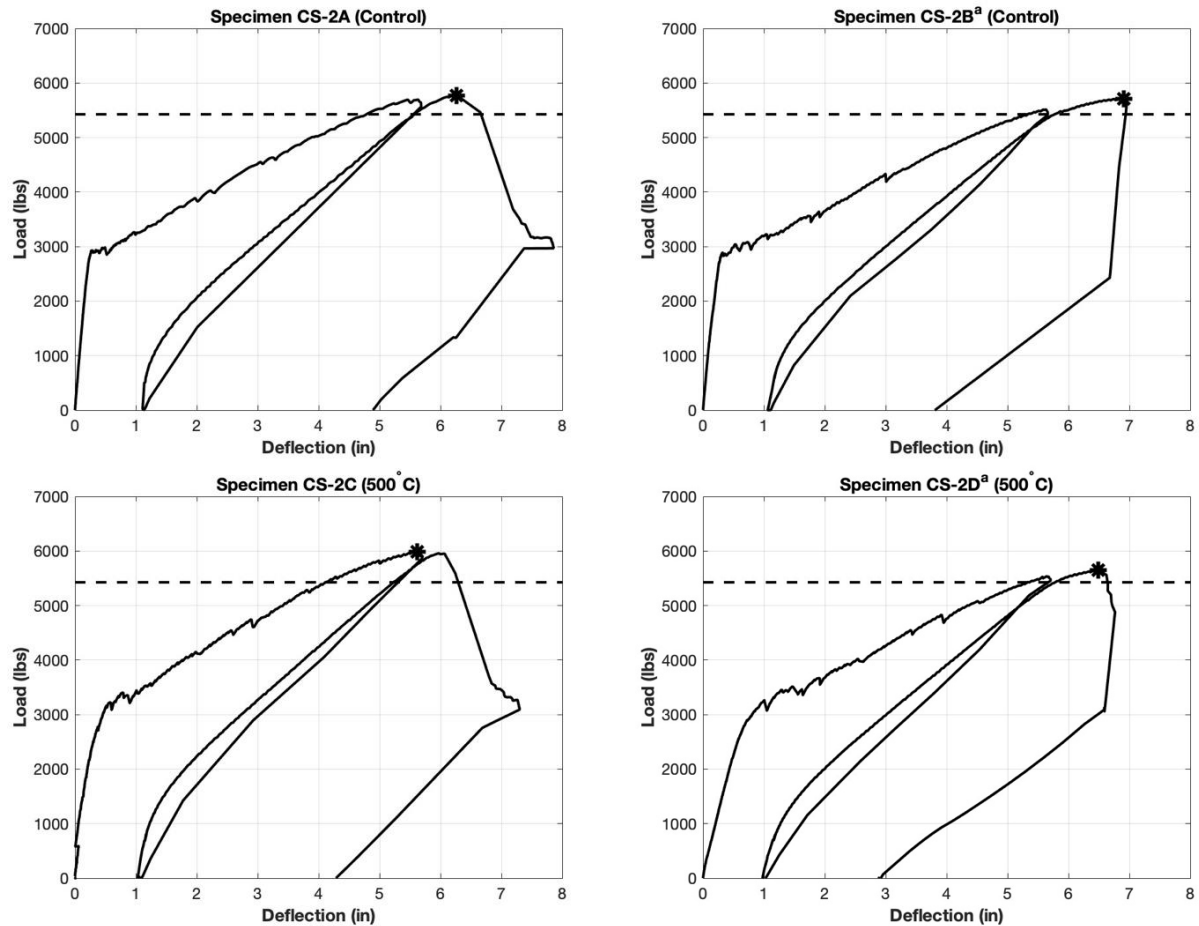
Figure 6.36: Mechanical testing results of batch 2 specimens CS-2A (Control), CS-2B^a (Control), CS-2C (500°C), and CS-2D^a (500°C), dashed lines represent calculated design flexural capacity of unheated batch 2 concrete slab specimens (5,425lbs) and stars represent respective peak capacities during each test

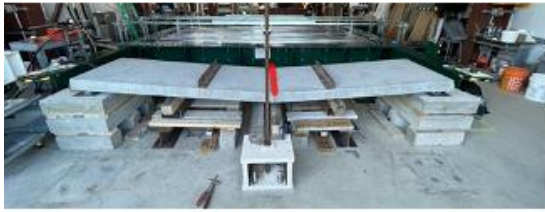
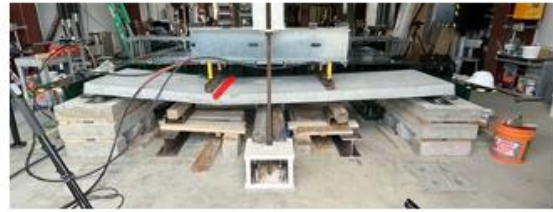
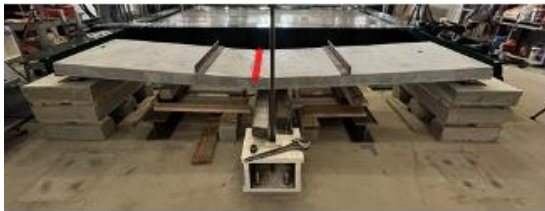
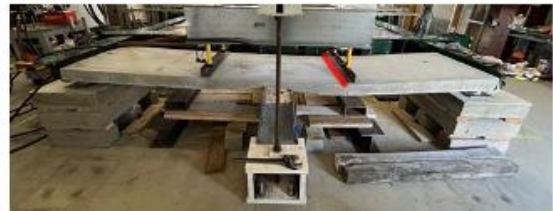
Figure 6.38: Batch 2 mechanical testing failure locations (indicated by red lines)

When conducting tests on concrete slab specimens from batch 2, it was found that the different heating regimens may have had a negligible influence on the specimens' maximum capacities and associated deflections. All batch 2 specimens' maximum capacities were within 6 percent of each other, and all deflections at maximum capacity were within 23 percent of each other. Notably, Slab CS-2D, heated to 500°C (932°F), experienced spalling while at elevated temperatures purely from heat loading, as shown in Figure 6.39. Despite losing a significant area of its cross section, the specimen still maintained a maximum capacity comparable to that of the other specimens from batch 2. This can be explained by the fact that the spalled concrete was located in the tension zone of the specimen, thus having a negligible influence on flexural capacity (as concrete has minimal strength in tension and is a material primarily used for its compressive strength). Also of interest is the influence of epoxy coated wire mesh on the structural behavior of concrete slab specimens. Test data suggest that there were no significant differences between the structural behavior of specimens with epoxy coated wire mesh and those with uncoated wire mesh in control conditions and after being exposed to elevated temperatures. All specimens from batch 2 failed inside the constant moment region. Specimen CS-2C failed inside the heated region and specimen CS-2D failed outside the heated region (Figure 6.38).

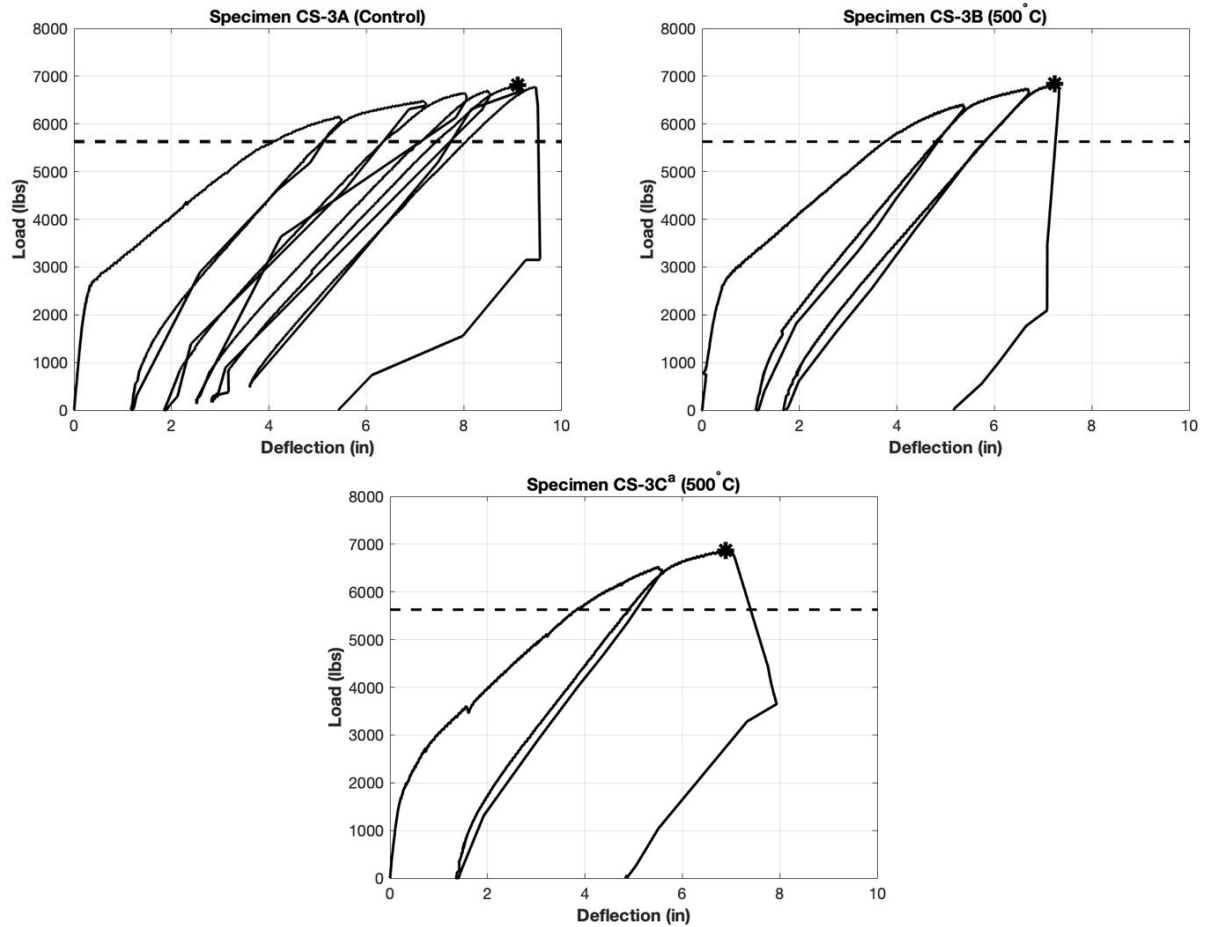
^a Specimen was mechanically tested with its heated face in compression.

Figure 6.40: Mechanical testing results of batch 3 specimens CS-3A (Control), CS-3B (500°C), and CS-3C^a (500°C), dashed lines represent calculated design flexural capacity of unheated batch 3 concrete slab specimens (5,628lbs) and stars represent respective peak capacities during each test

Slab	Heating Regimen	Maximum Capacity (lbs.)	Deflection at Maximum Capacity (in)	Failure Mode ^a	Failure Inside Heated Region?
CS-3A	None (Control)	6,808	9.10	1	N/A
CS-3B	500°C – 3 hours	6,840	7.24	1	No
CS-3C ^b	500°C – 3 hours	6,869	6.89	1	Yes

^a Failure mode “1” is yielding of steel followed by crushing of concrete

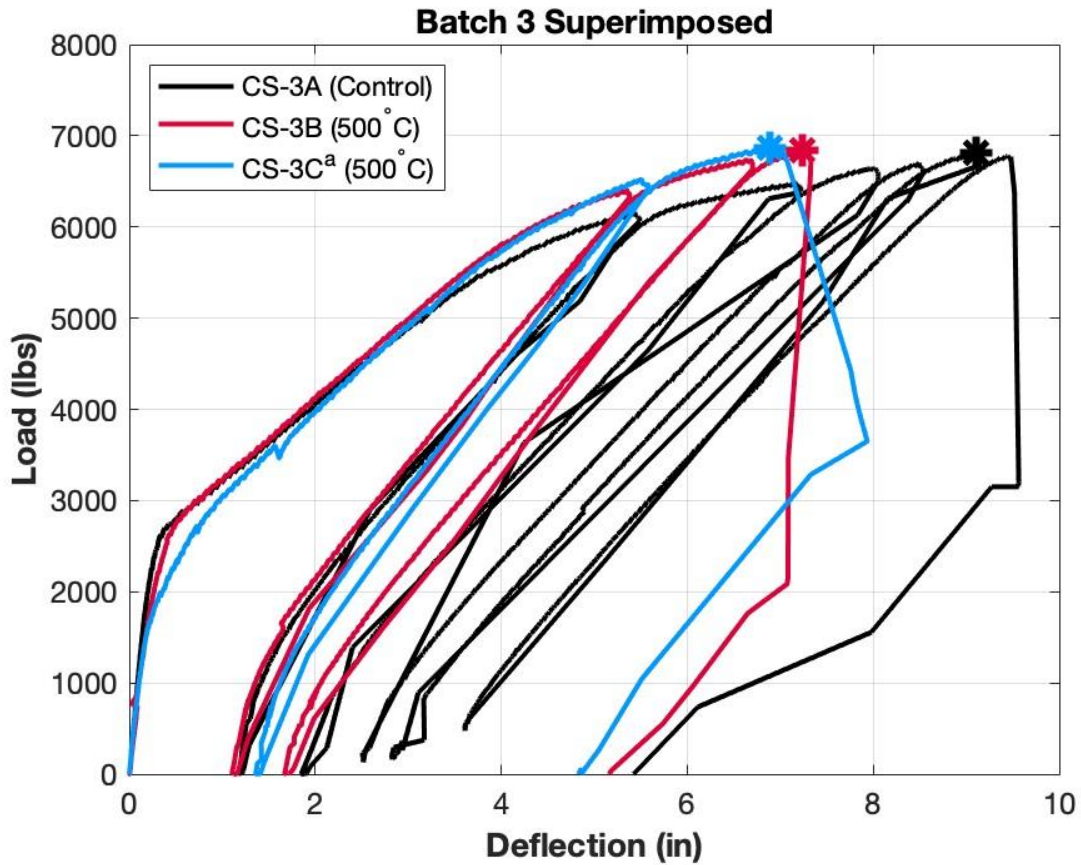
^a Specimen was mechanically tested with its heated face in compression

Figure 6.41: Batch 3 mechanical testing results superimposed, stars represent respective peak capacities during each test

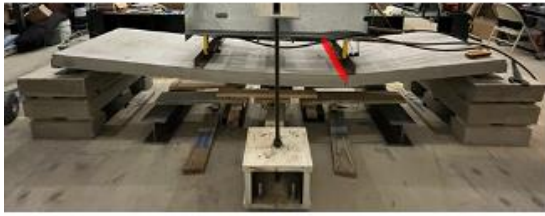
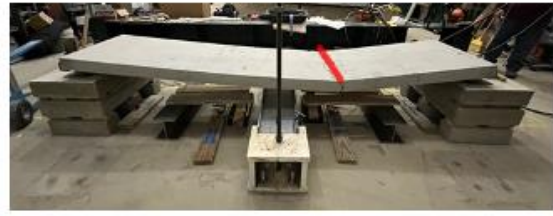
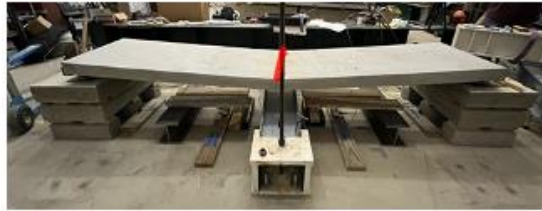
Figure 6.42: Batch 3 mechanical testing failure locations (indicated by red lines)

When conducting tests on the concrete slab specimens from batch 3, it was found that heating regimens may have had a negligible influence on their capacities and deflections at maximum capacity. All specimens in batch 3 that were mechanically tested had capacities within 1 percent of each other. Deflections at maximum capacity were similar between specimens CS-3B, heated to 500°C (932°F), and CS-3C, heated to 500°C (932°F), measuring within 5 percent of each other. Specimen CS-3A (control) appeared to be more ductile than the two heated specimens, but this behavior is not necessarily attributed to lack of heat exposure. Deflections of all three specimens at maximum capacity were within 32 percent of each other. Specimen CS-3C, mechanically tested with its heated face in compression, did not show any significant differences when compared with specimens mechanically tested with their heated face in tension. All specimens from batch 3 failed inside the constant moment region. Specimen CS-3C failed inside the heated region and CS-3B failed outside the heated region (Figure 6.42).

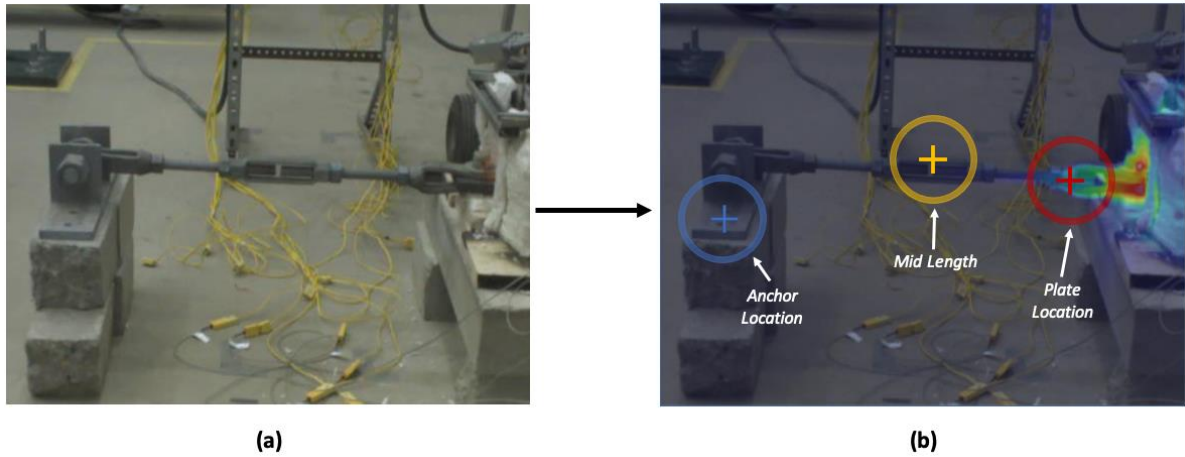
Figure 6.46: Example of thermal imaging using Fluke TI400 Thermal Camera to measure temperature data at plate location, mid length, and anchor location of hanger rod (a) normal (b) infrared
