February 2023

Report No. 23-039

Post-Fire Damage Inspection of Concrete Structures - Phase II

University of Massachusetts Amherst

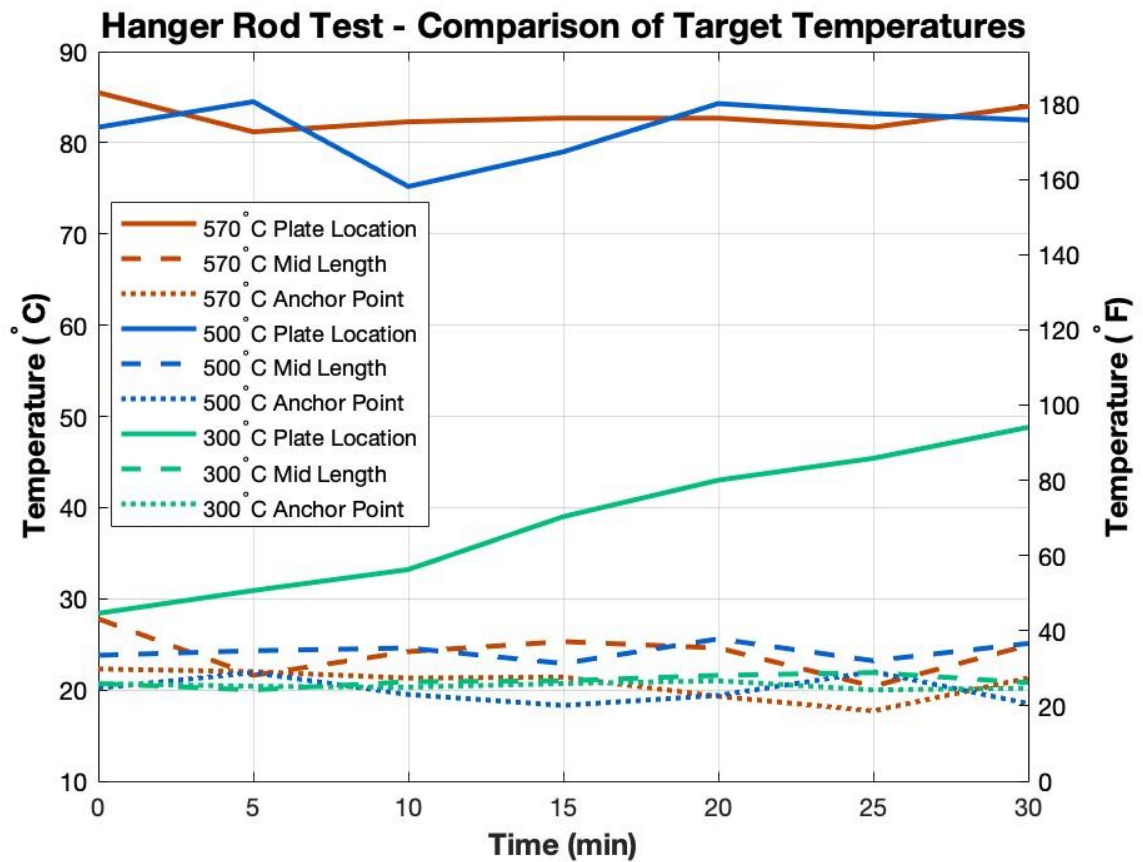
A stepped loading procedure was applied to the specimen in which the attached steel plate was brought to temperatures of 300°C (572°F) and 500°C (932°F) for thirty minutes each, and 570°C (1058°F) for two hours. 570°C (1058°F) was the maximum plate temperature that could be achieved at the location of the control thermocouple (Figure 6.45) with the given test setup and equipment. Temperature data were taken at three different locations: *plate location*, *mid length*, and *anchor location* (Figure 6.46). The temperature data of the entire assembly were recorded and reported at the described three points using a Fluke TI400 thermal camera. *Plate location* references the point closest to the heat source of the rod, *mid length* refers to the middle connection of the rod, and *anchor location* is the end plate of the rod. Temperature data (Figures 6.47 and 6.48) show that the anchor location and mid length temperature data points are constant throughout testing, never experiencing a significant increase in temperature. The plate location temperature point, during the 300°C (572°F) step, increased by approximately 20°C (36°F) over the thirty-minute time period. The plate location temperature point at the 500°C (932°F) and 570°C (1058°F) maintained temperatures fluctuated between 75°C (167°F) and 85°C (185°F), reaching steady state conditions with an average slope of approximately 0°C/min (0°F/min) over the course of thirty minutes (Figure 6.47). The 570°C (1048°F) step was maintained for two hours during which there was no significant fluctuations in temperature at any of the defined points (Figure 6.48). This proved that heat propagation through the length of the rod was minimal given the described heating regimen and test setup. Therefore, a fire in a tunnel should theoretically not have any effect on post-installed adhesive anchor temperatures.

Figure 6.47: Hanger rod heat propagation comparison of target temperatures

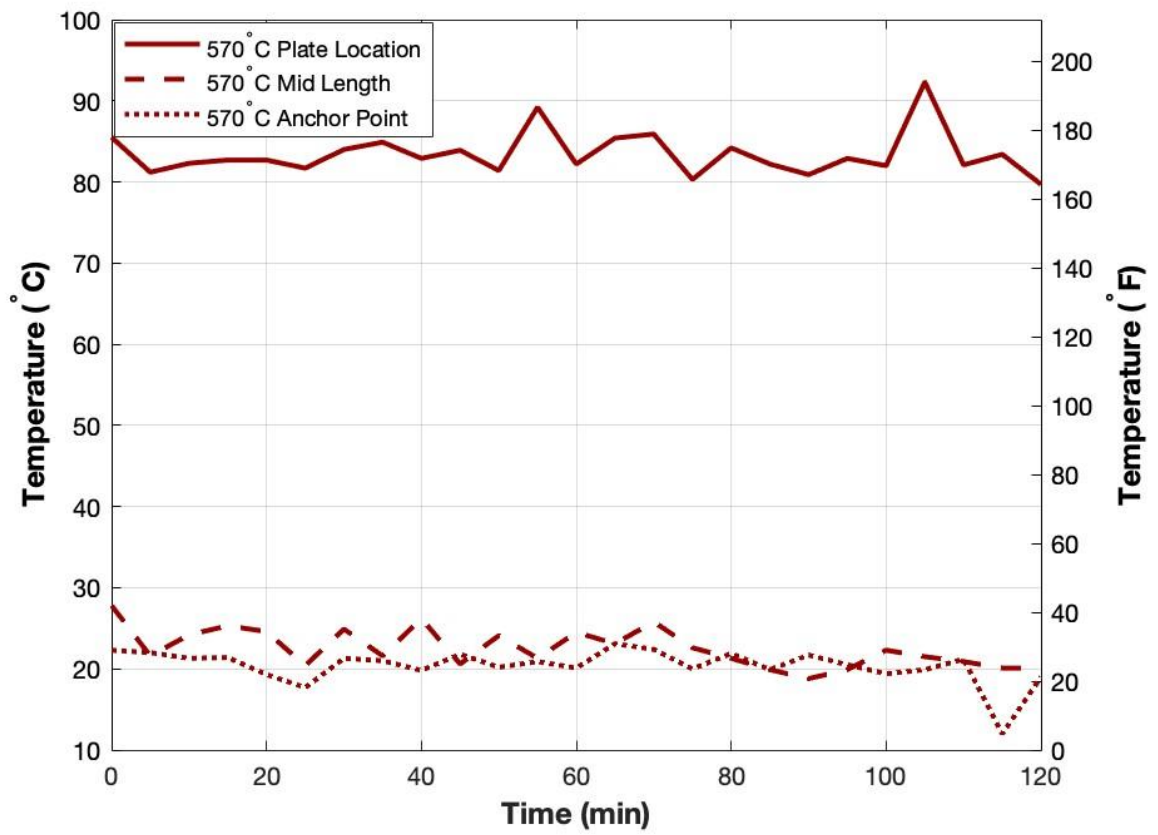
Figure 6.48: Hanger rod heat propagation maximum target temperature
