U.S. Department
of Transportation
**Federal Highway
Administration**

Publication No. FHWA-RD-95-032
November 1995

Cathodic Protection Field Trials on Prestressed Concrete Components

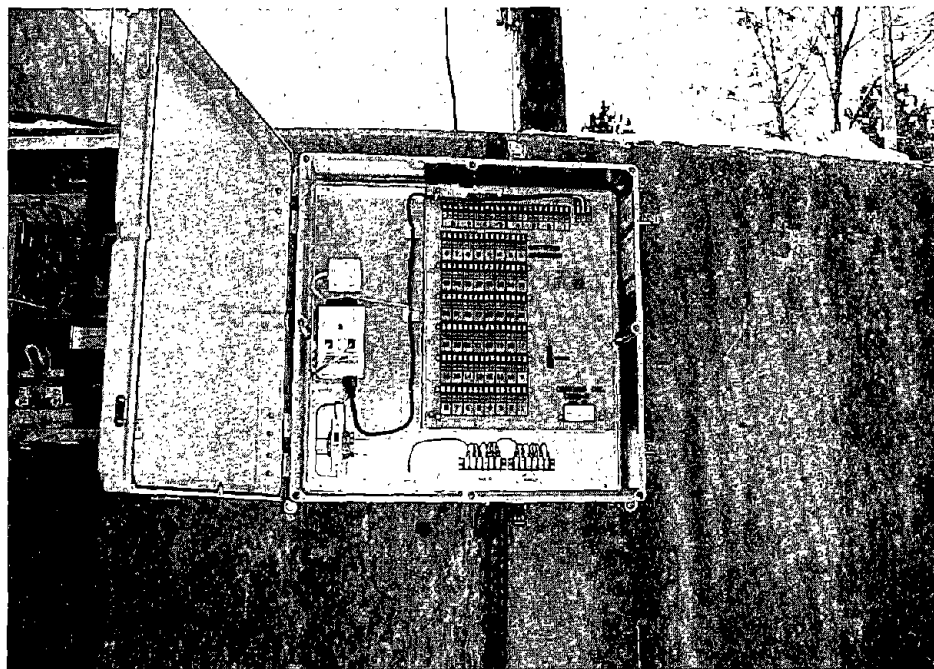
Figure 31. Remote monitoring unit mounted next to rectifier on abutment wingwall.

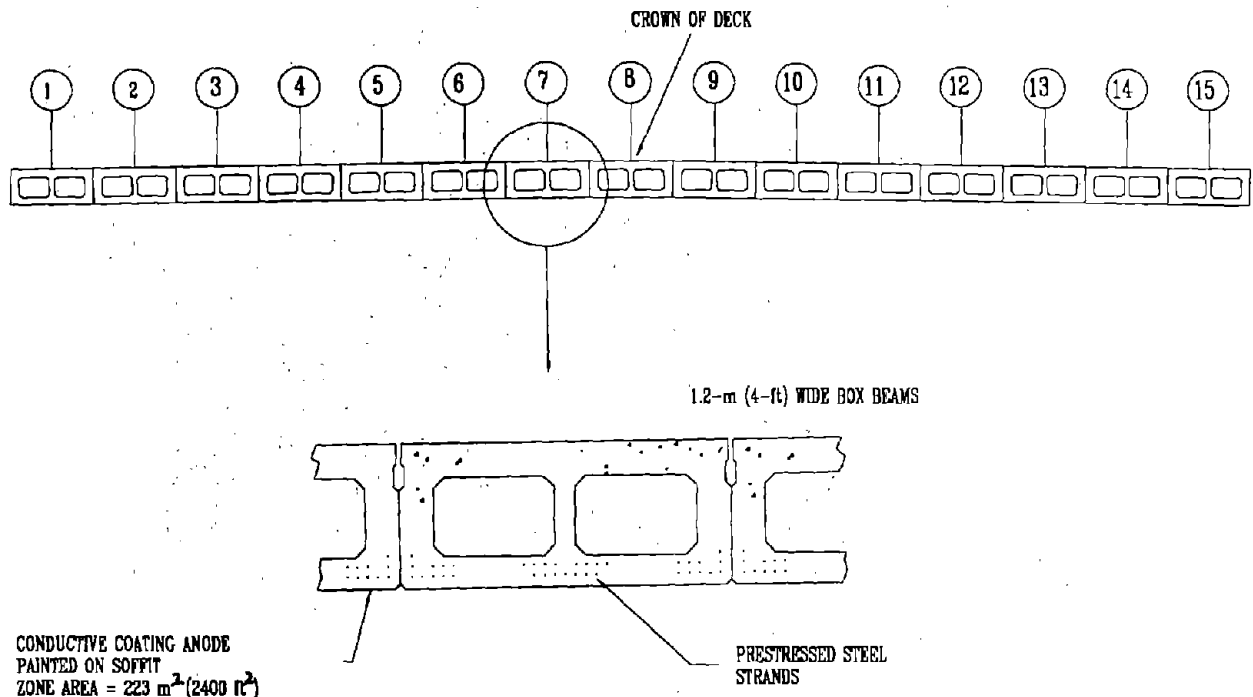
confirmed that there was no loose or delaminated concrete to repair. A sample of prestressing strand was removed from beam 15 for petrographic analysis. The strand in the beam was repaired with a Grabb-it splice.

Figure 34. West 130th Street Bridge - box beam section view.

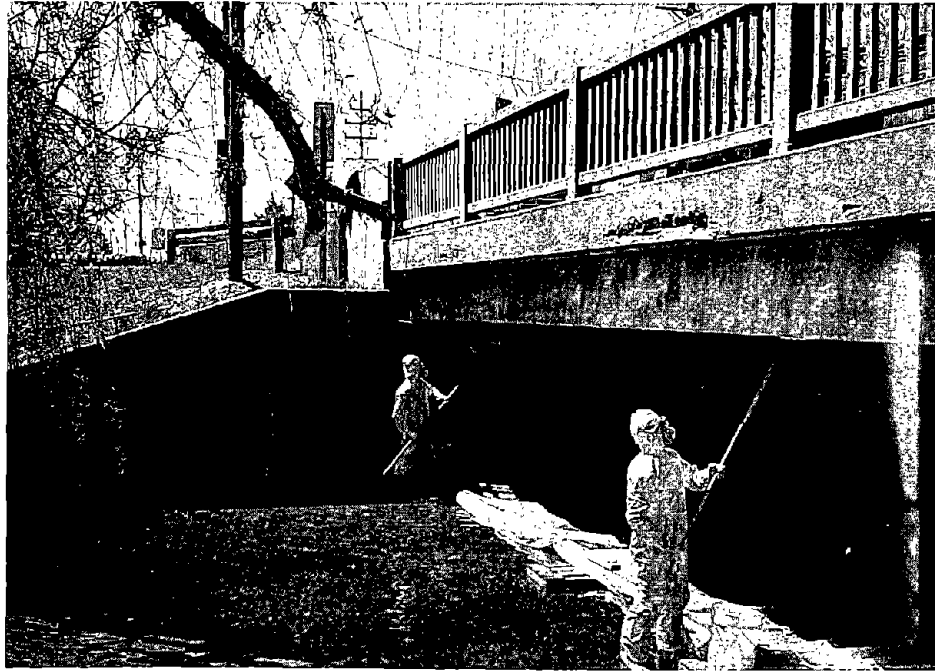
Figure 36. Roller application of conductive coating with polyethylene-covered frame used to catch coating spills and drips.

On April 20, 1994, the bridge soffit was sandblasted to remove dirt, laitance, and other materials. Two coats of conductive coating were then applied using rollers over an adhesion-promoting primer. Hooded suits, gloves, boots, goggles, and half-face respirators with organic vapor canisters were necessary safety precautions. A moveable, plastic-covered wooden frame (shown in figure 36) was placed on the ground under an area being painted to prevent drips and spills from entering Baldwin Creek. The coating thickness was measured during placement with a thickness gauge and after final application with a Tooke gauge. The specified minimum 0.25-mm (10-mil) dry-film thickness was achieved. The system was continuously monitored for shorts during the rolling application, and none was encountered. Short-circuit testing after the coating had cured revealed that there were no shorts of the anode to the steel.

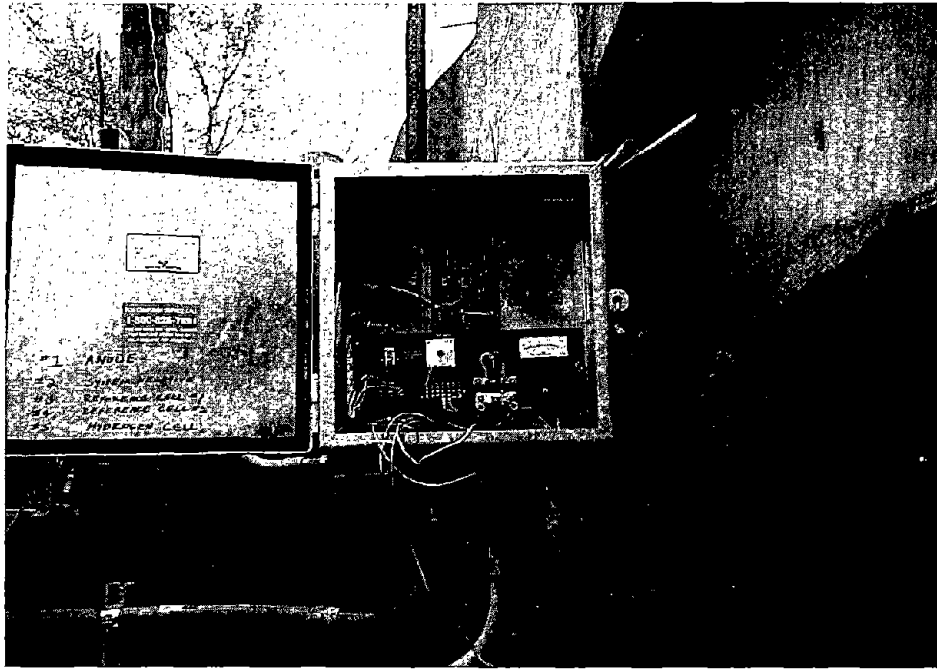
Figure 37. Partially wired rectifier on abutment wingwall.

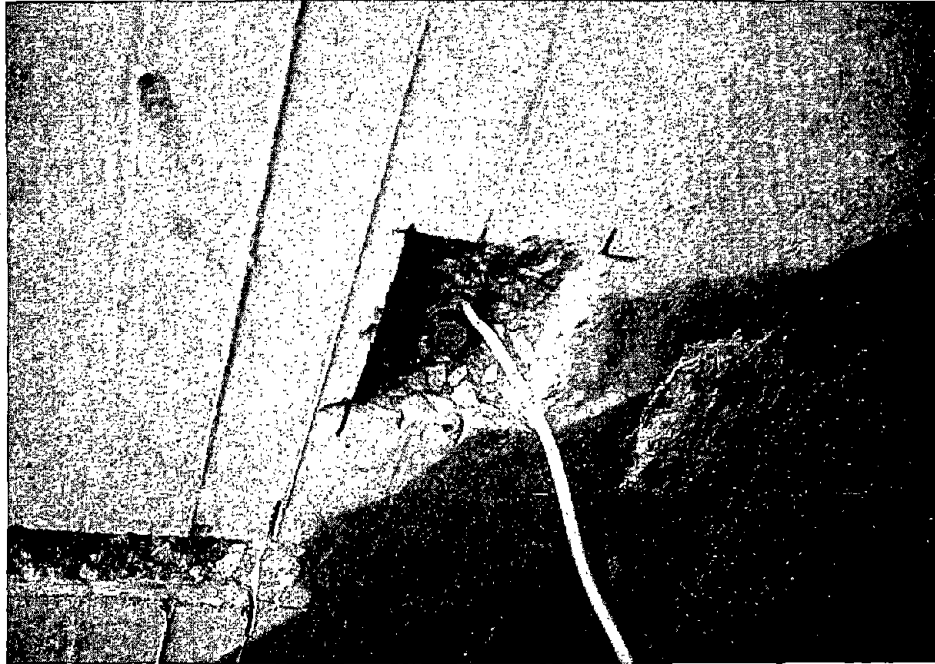
Figure 38. Installation of hydrogen probe near reference cell installed in lower left corner.

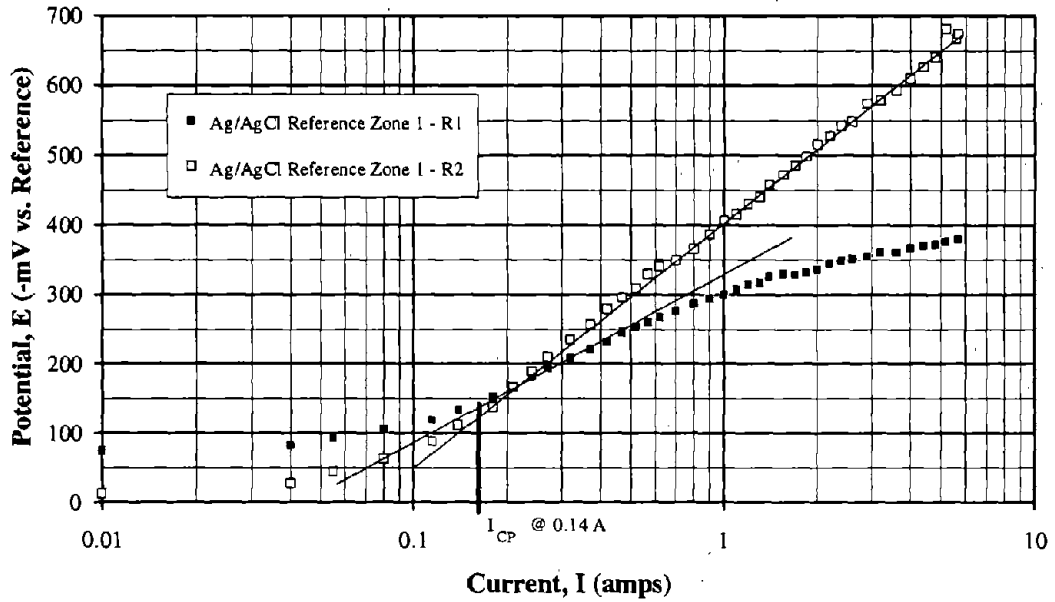
Figure 40. Zone 1 E-Log I of Howard Frankland Bridge.

The current requirements for the arc-sprayed zinc zones 1 and 2, as determined from the E-Log I curves, were very low (as shown in figures 40 and 41). Cathodic protection current (I_{CP}) for zone 1 was established as 0.14 A, 0.39 mA/m² (0.036 mA/ft²). The cathodic protection potential (E_{CP}) for the steel at these points was -140 mV using R1-1 and -120 mV using R1-2. It is possible that current requirements were this low since steel potentials indicate little corrosion activity. Cathodic protection current for zone 2 is established as 0.15 to 0.18 A, 0.41 to 0.49 mA/m² (0.038 to 0.046 mA/ft²). E_{CP} for the steel at these points were -170 mV using R2-1 and -70 mV using R2-2. Again, current requirements were very low and steel potentials were noncorrosive.

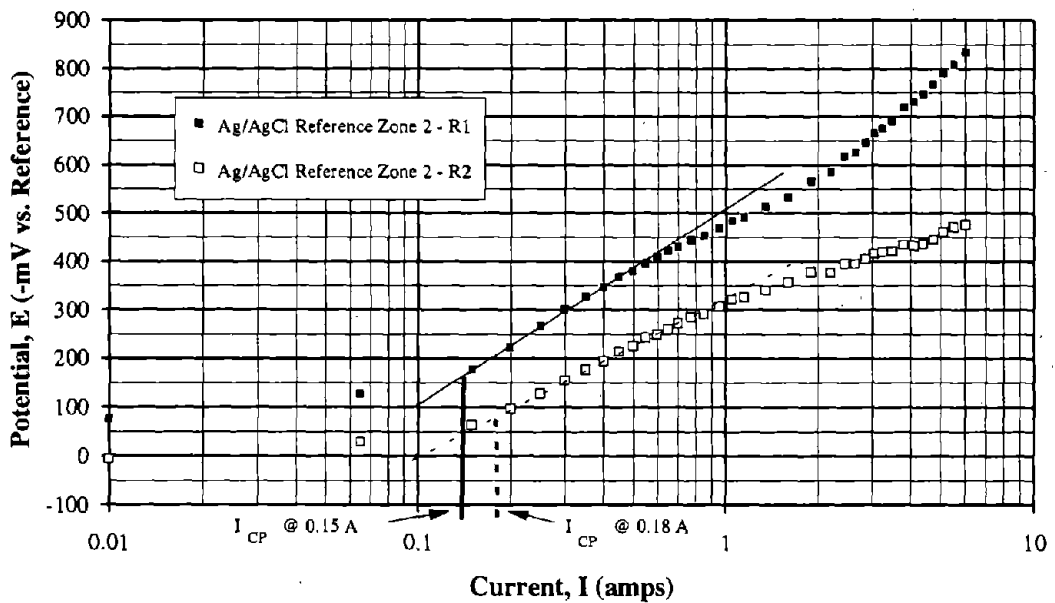
Figure 41. Zone 2 E-Log I of Howard Frankland Bridge.

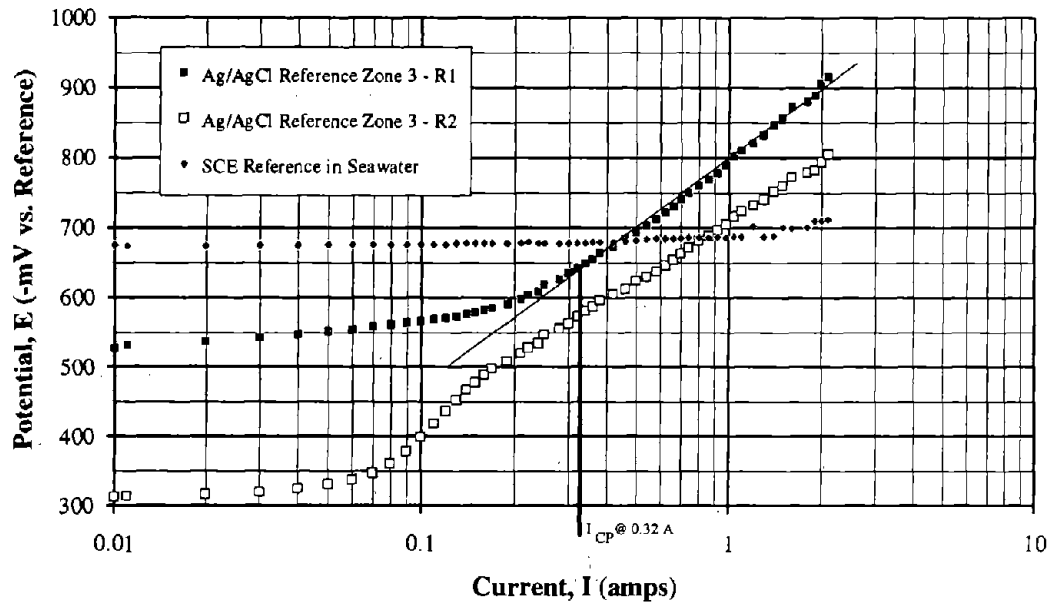
Figure 42. Zone 3 E-Log I of Howard Frankland Bridge.

The straight-line portion of the E-Log I curve, generated using reference electrode R3-1 of the titanium mesh pile zone 3, began at 0.32 A, 5.16 mA/m² (0.48 mA/ft²), as shown in figure 42. E_{CP} for the steel at this point was -640 mV. Given the corrosive state of the reinforcing steel in these piles, this seems to be a reasonable cathodic protection current. The cathodic protection potential does not risk hydrogen evolution. The E-Log I curve generated using the other embedded reference electrode of zone 3, R3-2, did not lend itself to graphical interpretation. The E-Log I curve of the steel below water level, as monitored by the reference electrode in the seawater, showed only a slight response above 1.5 A. This demonstrated that a very small amount of current was leaking from zone 3 titanium mesh anodes into the seawater.

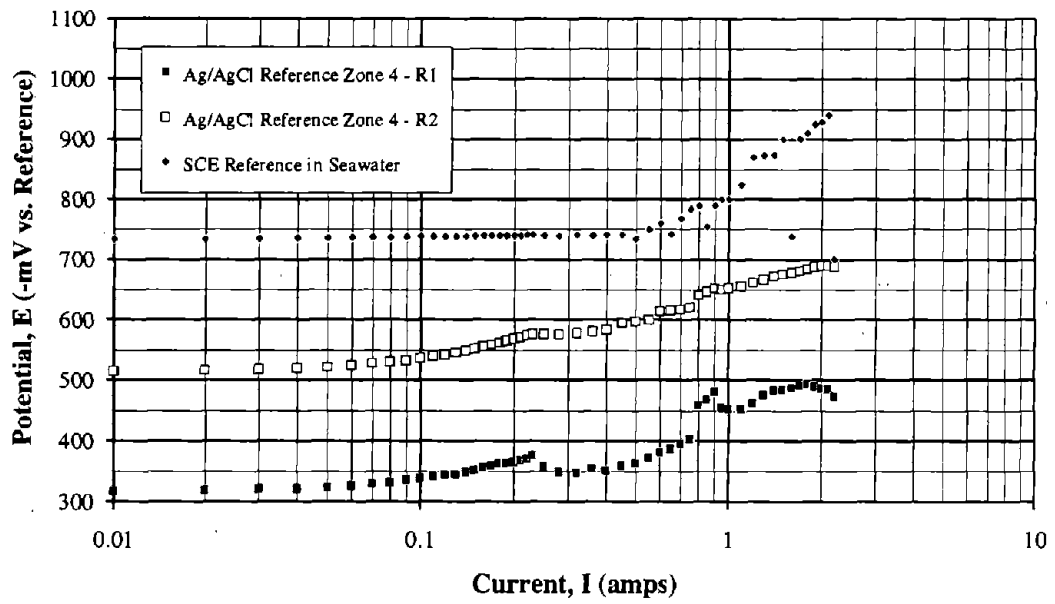
Figure 43. Zone 4 E-Log I of Howard Frankland Bridge.

The E-Log I curves for the conductive rubber zone 4, shown in figure 43, were not very useful. A portable Hewlett Packard power supply was used to generate the first portion of the curve since current requirements were very low. When power was switched to the installed rectifier at 0.25 A, a serious discontinuity occurred. Other unexplained discontinuities also occurred at higher currents. No meaningful cathodic protection currents or potentials could be determined from these curves. It did appear that the steel was not polarized 100 mV above static potentials until over 0.67 A, 32 mA/m² (3 mA/ft²) of current had been applied. The potential of the steel in the piles below water level did show a significant response above 0.50 A. At a current of 1.5 A or 72 mA/m² (6.7 mA/ft²), cathodic potentials of the steel exceeded -900 mV vs. SCE. This shows a tendency for the conductive rubber anode to leak current to the portion of the piles beneath the seawater. This result was not unexpected and it has been observed before by Florida DOT. It is expected that this tendency to leak current will decrease as the steel below water becomes polarized. This should result in better polarization of the steel above water level at that time.

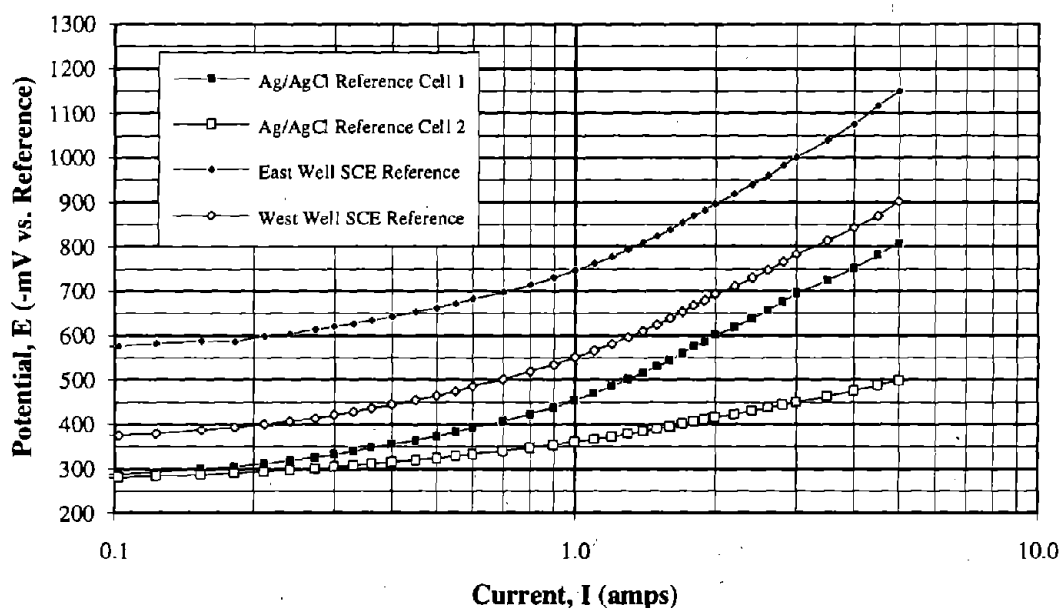
All four E-Log I curves, shown in figure 44, exhibit a straight-line portion. The point at which the line first deviated from straight-line behavior was noted and was recorded as the desired cathodic protection current (I_{CP}). The cathodic protection current ranged from 1.15 to 1.50 A or 10.8 to 14.0 mA/m² (1.00 to 1.30 mA/ft²). This was considered reasonable for this structure. Cathodic protection potentials ranged from -380 to -830 mV vs. Ag/AgCl (-474 to -904 mV vs. CSE). Although the E_{CP} of steel at the east potential well is very negative, it is still well short of the potential needed for generation of atomic hydrogen in concrete (-1050 mV vs. CSE). Steel potential at this well will be closely monitored in the future.

Figure 44. E-Log I of Abbey Road bridge.
