Performance of Concrete Pavements

Volume I: Field Investigation

PUBLICATION NO. FHWA-RD-94-177

JULY 1997

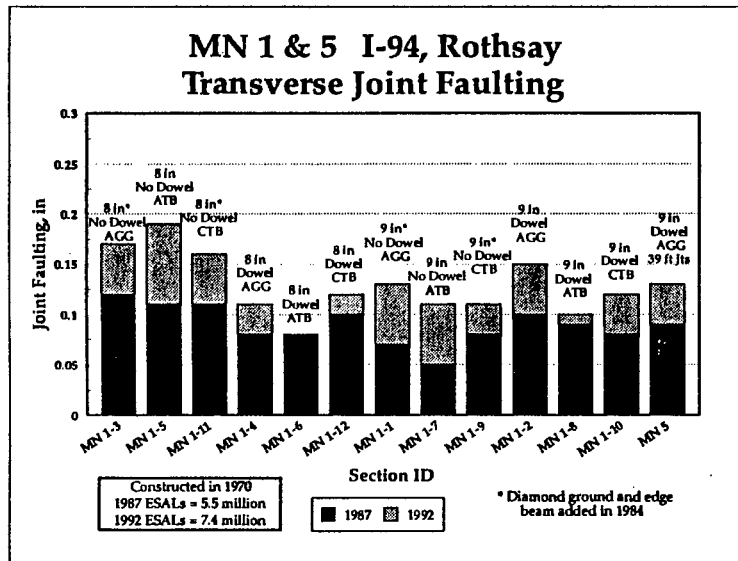
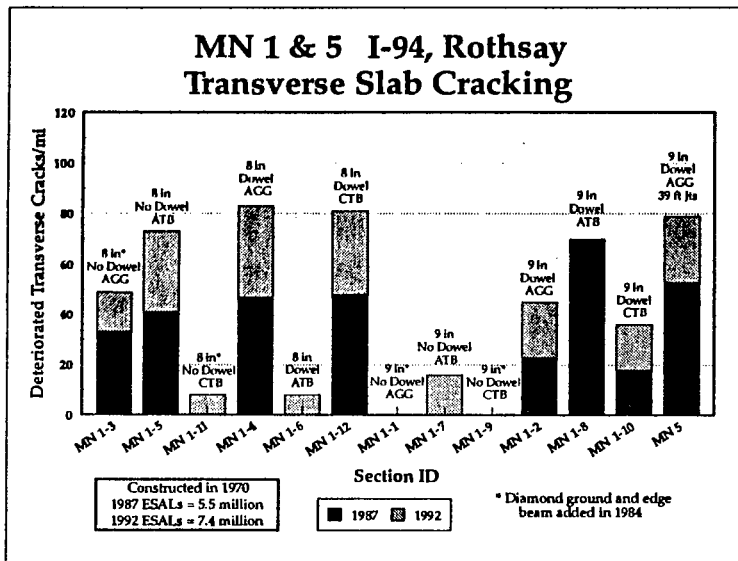
Figure 9. Performance summary for MN 1 & 5.

The 1992 data indicate, as did the 1987 data, that the sections constructed on the ATB developed a significant amount of longitudinal cracking, while the sections constructed on the AGG base display very little longitudinal cracking. This finding is confirmed by the replicate sections surveyed in the eastbound direction in 1992. In addition, nearly 90 percent of the joints on the sections constructed on the ATB exhibit joint spalling, whereas less than 50 percent of the joints on the CTB or on the AGG sections exhibit joint spalling. However, for a given method of load transfer, there are no discernible differences in joint faulting between the sections constructed on the different base types.

However, several of the doweled sections developed significant faulting, which is attributed to the small diameter of the dowel bars. Furthermore, many of the doweled sections exhibit more transverse cracking and joint spalling than the nondoweled sections, as shown in table 7 and figure 9. This phenomenon is probably due to corrosion of the noncoated dowel bars, which can lead to the transverse joint locking up, which creates tremendous forces in the slab that either spall the joint or open mid-slab cracks.

The effect of slab thickness is not readily apparent from an examination of table 7 or figure 9. The increased slab thickness appears to reduce spalling, faulting, and cracking for the nondoweled pavement sections, although it does not appear to provide those benefits for the doweled sections. This again suggests that the dowels may be contributing to joint spalling and crack deterioration, perhaps due to their corroding and locking up the joint.

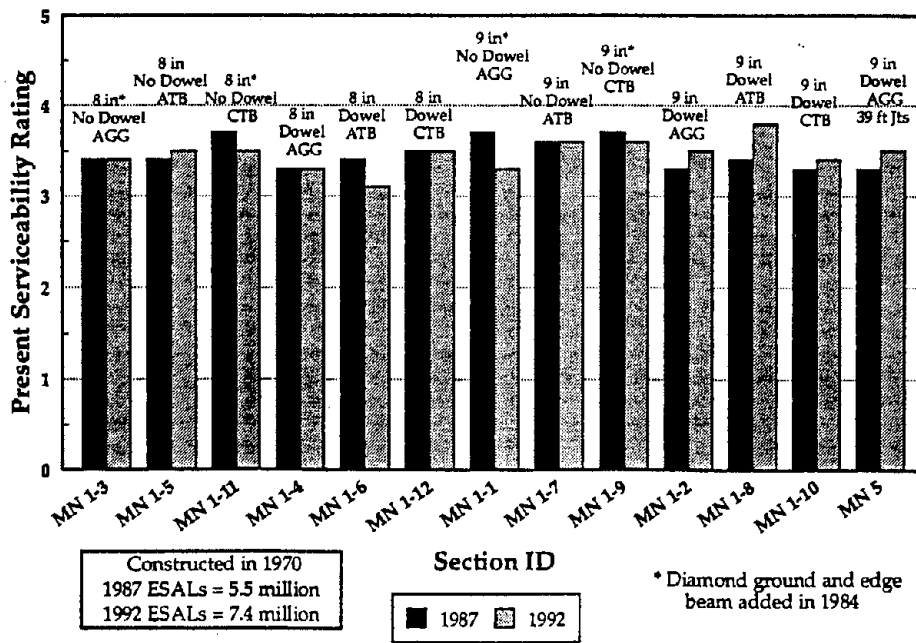
Figure 10. Roughness and serviceability for MN 1 & 5.

Pavement roughness and serviceability for these sections are given in figure 10. This figure shows that most of the sections are of about the same smoothness and serviceability level. Many of these are at or near critical levels in terms of IRI. Notable exceptions are MN 1-5, MN 1-4, MN 1-12, MN 1-8, and MN 1-10, all of which (except MN 1-5) contain dowel bars.

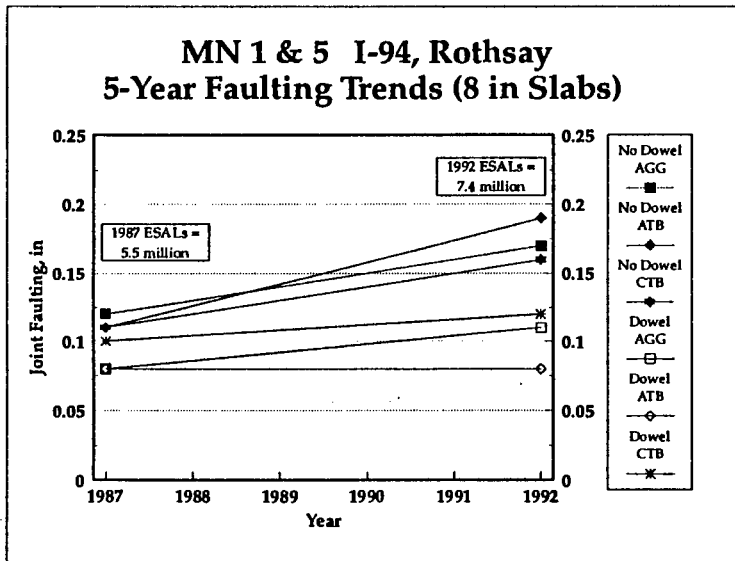
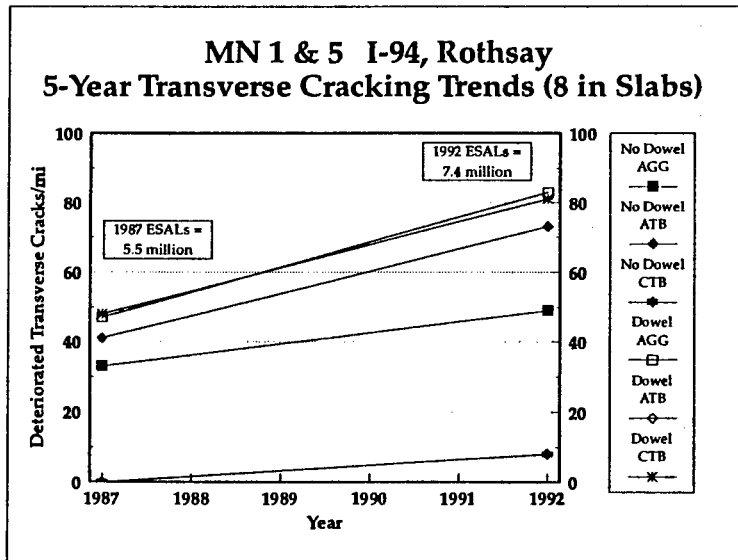
Figure 11. Faulting and transverse cracking 5-year performance trends for MN 1 & 5.

The performance of the sections from the 1987 surveys to the 1992 surveys follows a logical trend in that increased levels of deterioration are observed. Figure 11 provides 5-year performance trends for joint faulting and transverse cracking, broken out by 8- and 9-in (203- and 229-mm) slabs. This figure shows that faulting on doweled sections is increasing at a lower rate than faulting for nondoweled sections, especially for the 8-in (203-mm) slabs. In addition, the sections constructed on treated bases, particularly those constructed on ATB, appear to offer more resistance to faulting increases than the sections constructed on aggregate bases. However, all nondoweled sections, except those placed on ATB, were diamond ground in 1984.

Figure 11 also shows that transverse cracking is increasing at a more rapid rate on the 8-in (203-mm) slabs than on the 9-in (229-mm) slabs. This means that more cracks are breaking down and deteriorating on the thinner slab sections. Cracking generally is increasing more rapidly on the doweled sections than on the nondoweled sections.

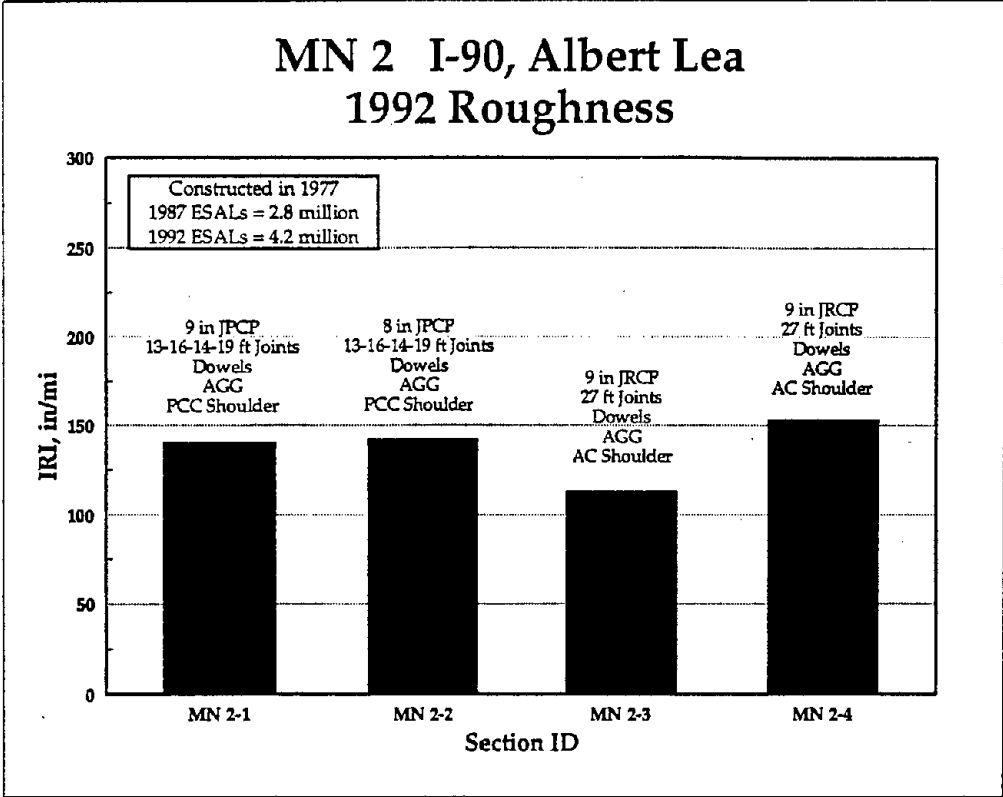
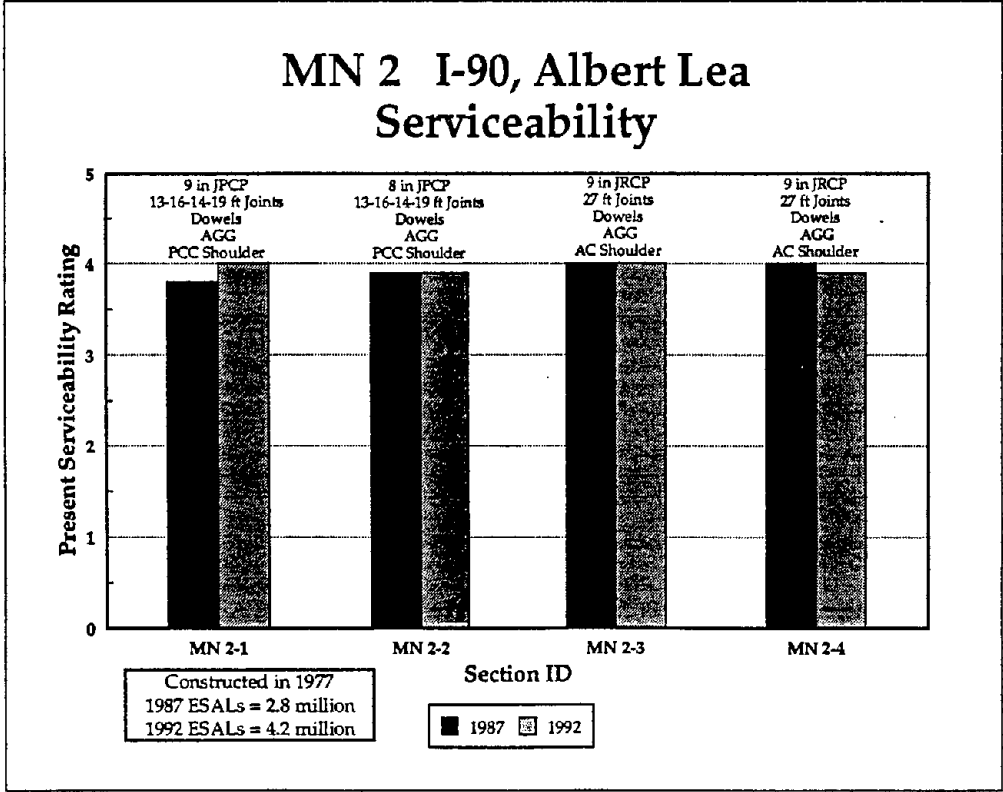
Figure 13. Roughness and serviceability for MN 2.

Roughness and serviceability information for the MN 2 sections is presented graphically in figure 13. The IRI values are about the same for all sections, with MN 2-3 having slightly less roughness than the others. This is confirmed by the serviceability data, which shows MN 2-3 with a slightly higher serviceability value. Over the past 5 years, the serviceability of the MN 2 sections has remained virtually unchanged.

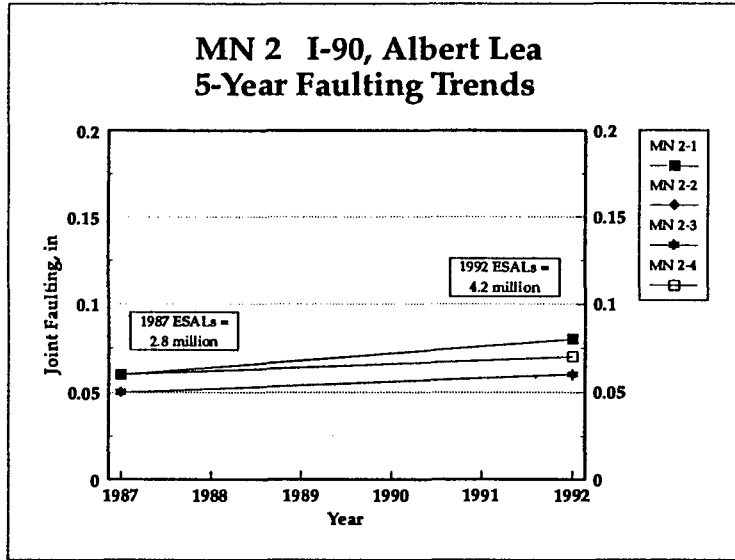
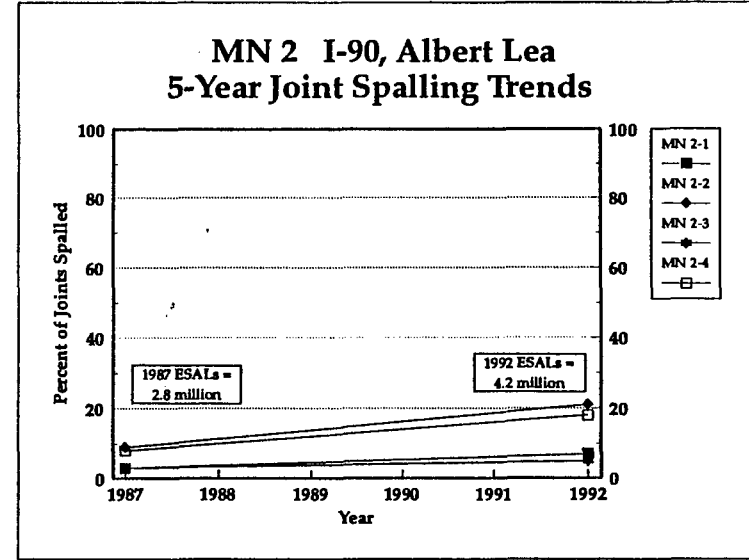
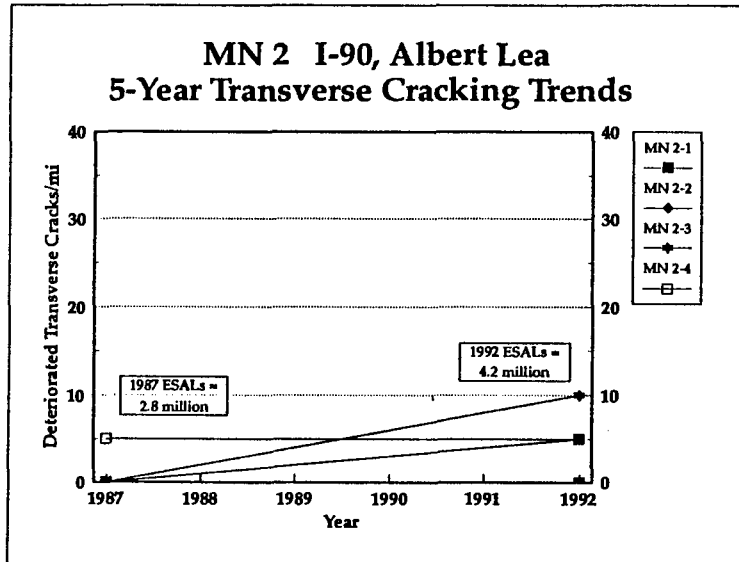
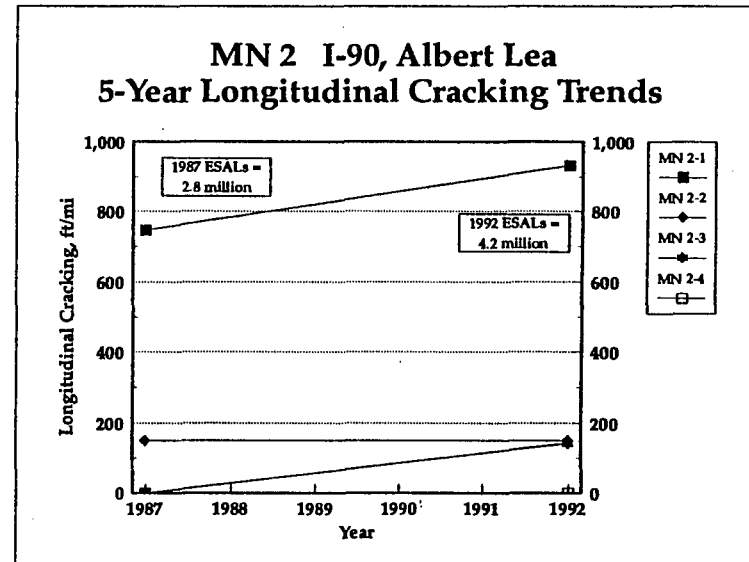
Figure 14. 5-year performance trends for MN 2.

As seen from figure 14, the MN 2 pavement sections are displaying a small increase in deterioration since being evaluated in 1987. Each of the sections shows a slight increase in joint faulting and joint spalling, with no single design exhibiting any obvious performance tendencies. In terms of transverse cracking, sections MN 2-2 (JPCP) and MN 2-3 (JRCP) have experienced a slight increase while the transverse cracking on sections MN 2-1 (JPCP) and MN 2-4 (JRCP) has remained the same. However, MN 2-1 and MN 2-3 show an increase in longitudinal cracking over the 5-year period, while MN 2-2 and MN 2-4 show no such increase. As mentioned before, the overall serviceability of these sections has changed very little since their evaluation in 1987.

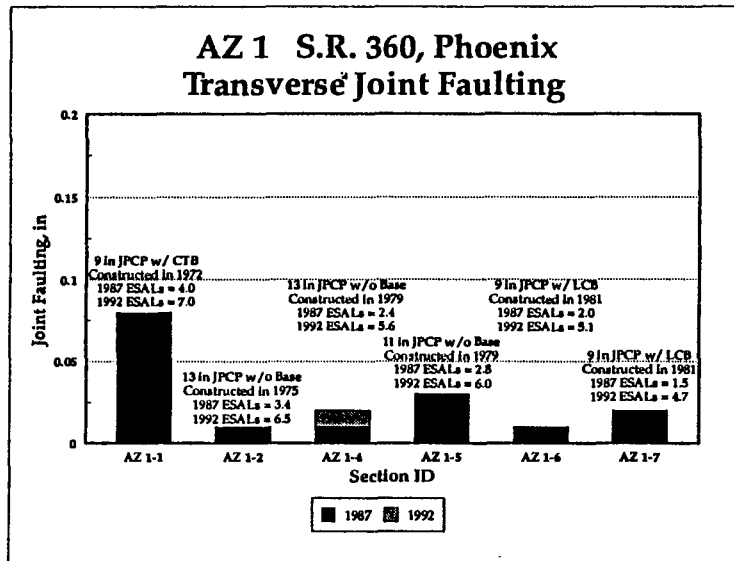
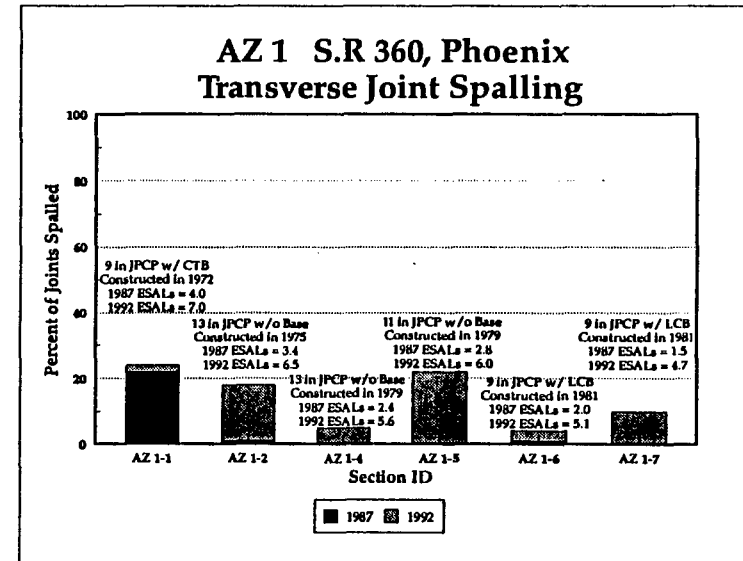
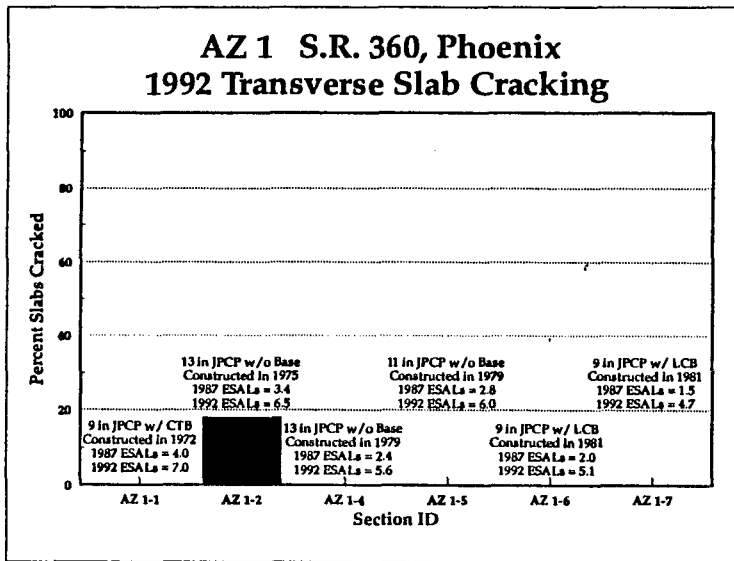
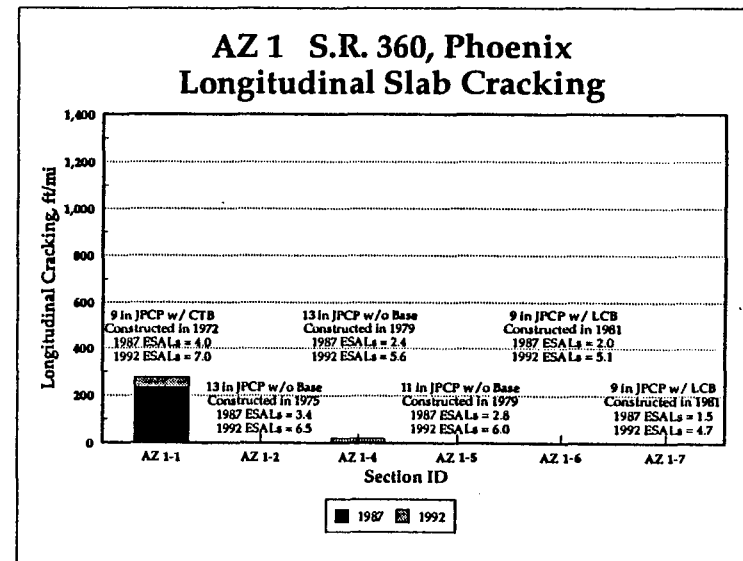
Figure 18. Performance summary for AZ 1.

Table 16 summarizes the performance data for the AZ 1 sections. Figure 18 presents those data in graphical format. Overall, these sections are performing very well, with only slight differences in performance. However, each section is a

different age and has been subjected to different traffic loadings, which makes direct comparisons difficult.

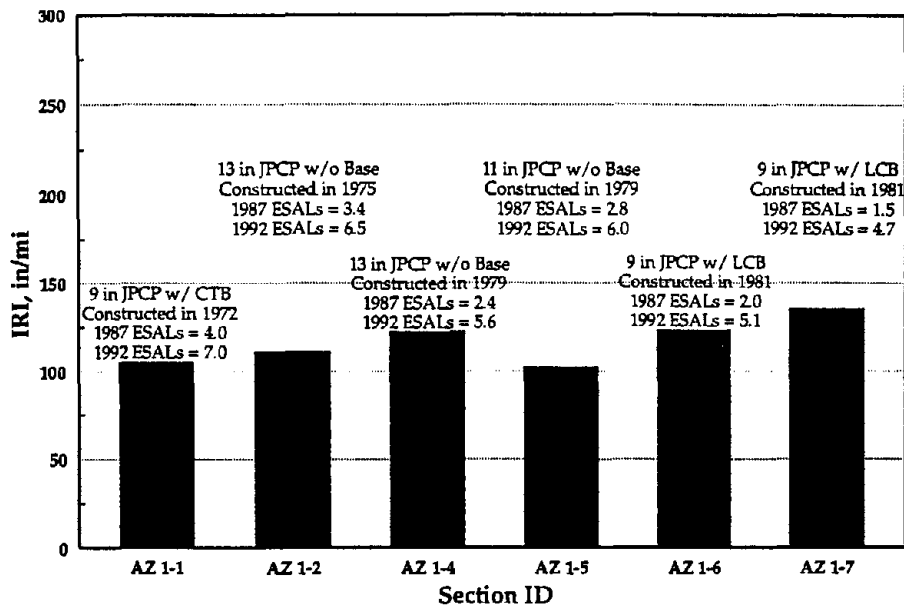
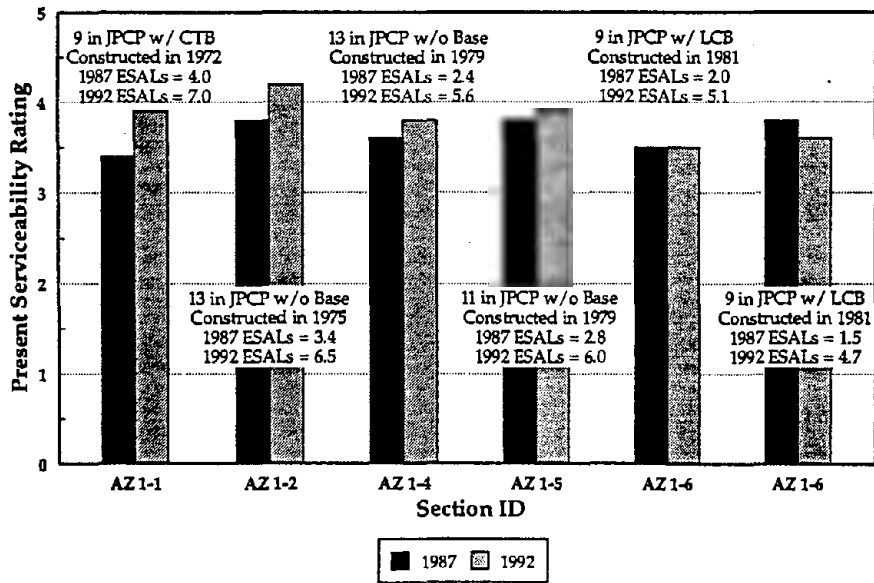
Figure 19. Roughness and serviceability for AZ 1.

Figure 19 shows the roughness levels and serviceability ratings for the AZ 1 sections. Overall, each section appears to be providing a smooth-riding pavement surface. The serviceability ratings indicate that the rideability has remained virtually the same since 1987. Surprisingly, the roughest sections in the project are the newest (AZ 1-6 and AZ 1-7).

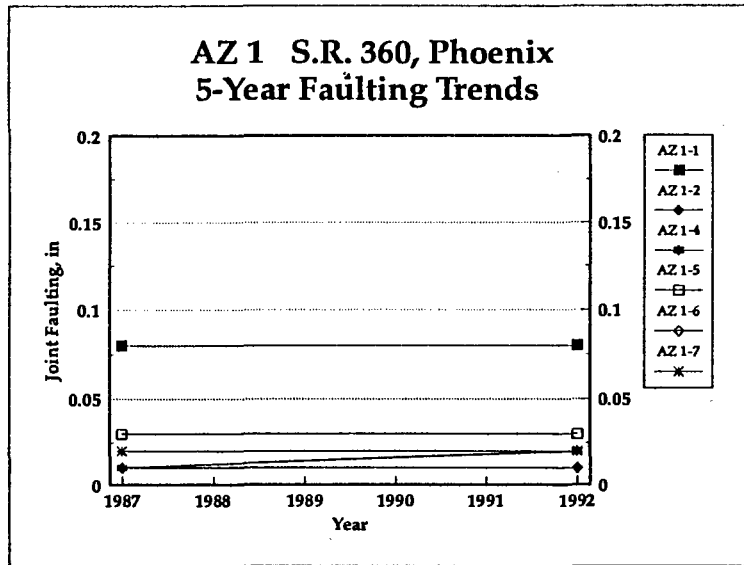
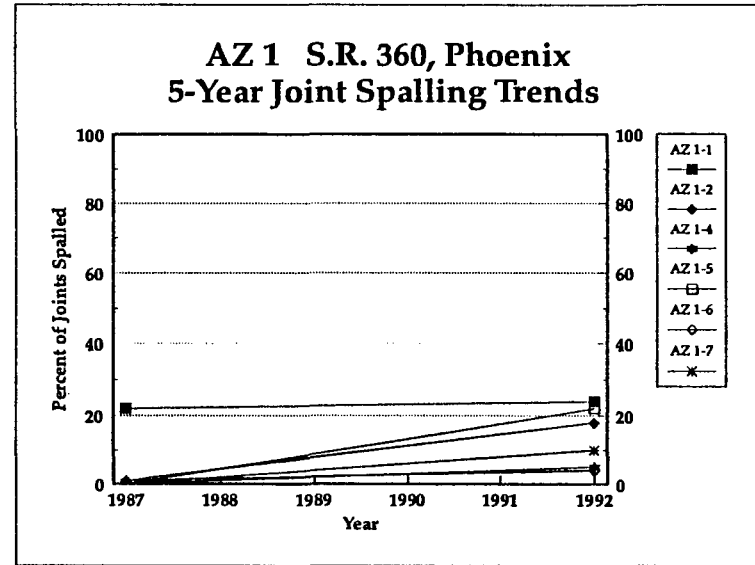
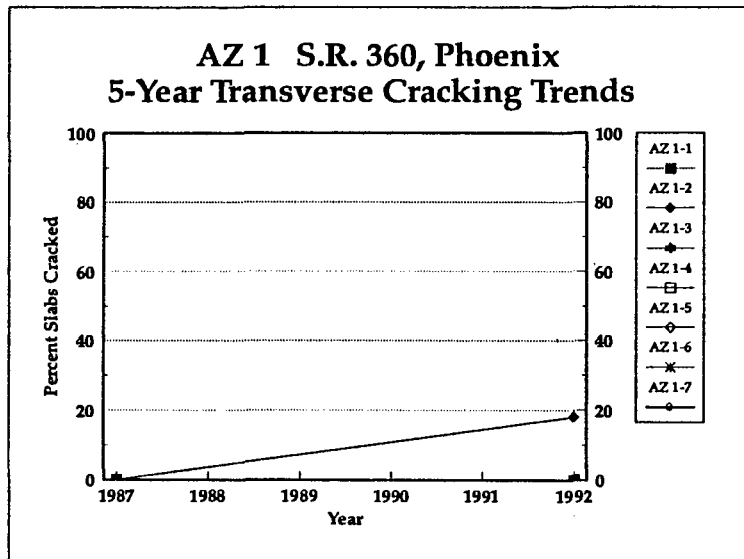
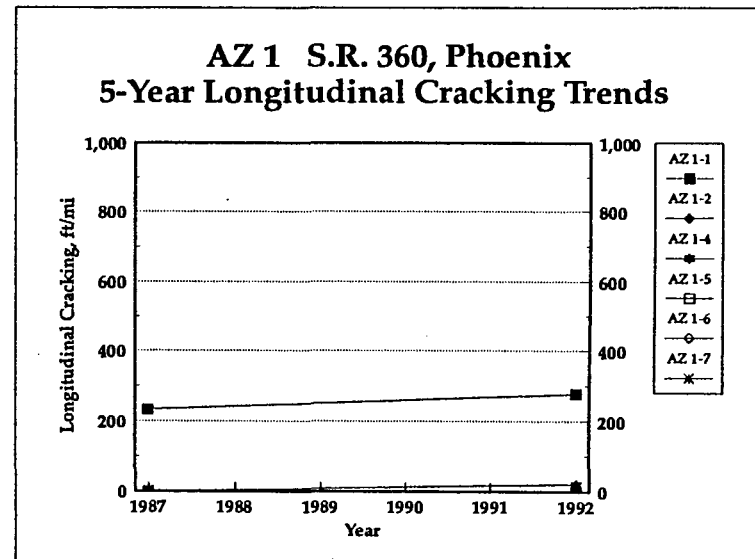
Figure 20. 5-year performance trends for AZ 1.

As shown in figure 20, none of the sections showed an appreciable increase in pavement distress over the period from 1987 to 1992. Faulting levels remained virtually the same over the 5-year period, and only one section (AZ 1-2) developed transverse cracking. Two sections (AZ 1-1 and AZ 1-4) exhibit longitudinal cracking, but the amount is not considered significant.

One performance indicator that has shown an increase over the 5-year period is transverse joint spalling. Every section shows some increase in spalling, although the increase is often not that substantial. Sections AZ 1-1 (24 percent of the joints) and AZ 1-2 (18 percent of the joints) display the most spalling, and these are also the oldest sections in the project. During the 1992 pavement surveys, the joint sealant was observed to be in poor condition for all sections.

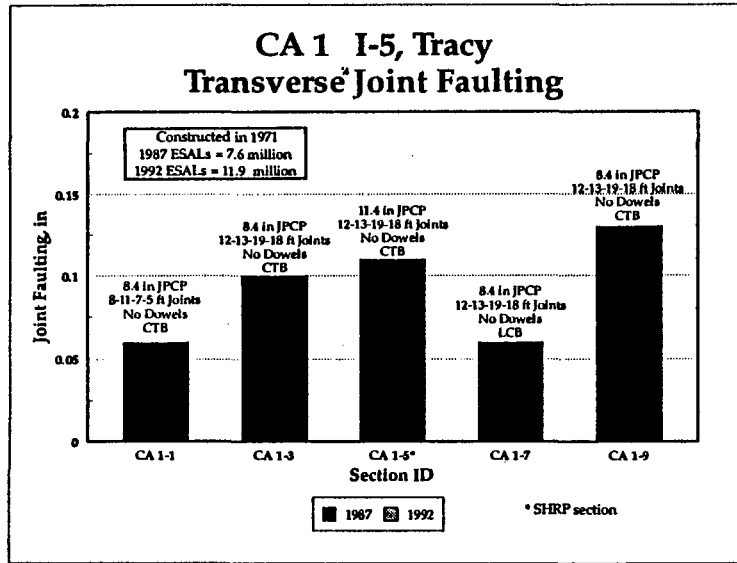
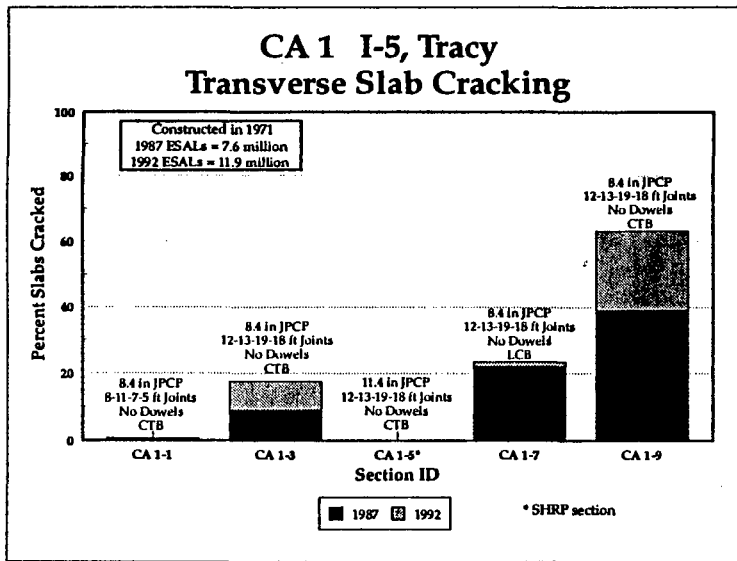
Figure 21. Performance summary for CA 1.

The performance of the CA 1 sections is summarized in table 19 and in figure 21. The influence of slab thickness on performance can be examined through a comparison of section CA 1-3 with section 1-5. The faulting and joint spalling exhibited by both of these sections is rather high, and there isn't any appreciable difference between them. Similar levels of faulting and spalling are also exhibited by the replicate sections (CA 1-4 and CA 1-6). However, the thickened slab section does display less cracking than the thinner section, which suggests that the thicker slab is effective at reducing slab cracking but not joint faulting.

cracking. The high-strength replicate section (CA 1-10) had higher levels of faulting, transverse cracking, and longitudinal cracking, as well a lower PSR and higher IRI than the corresponding section (CA 1-4).

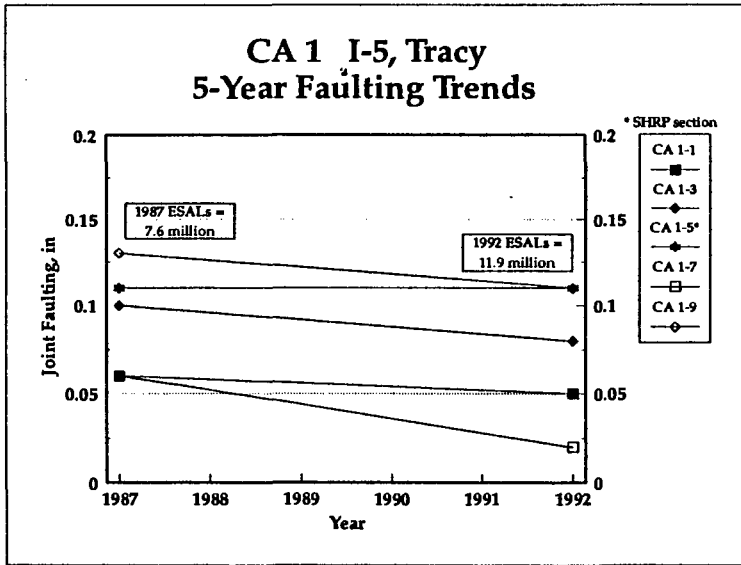
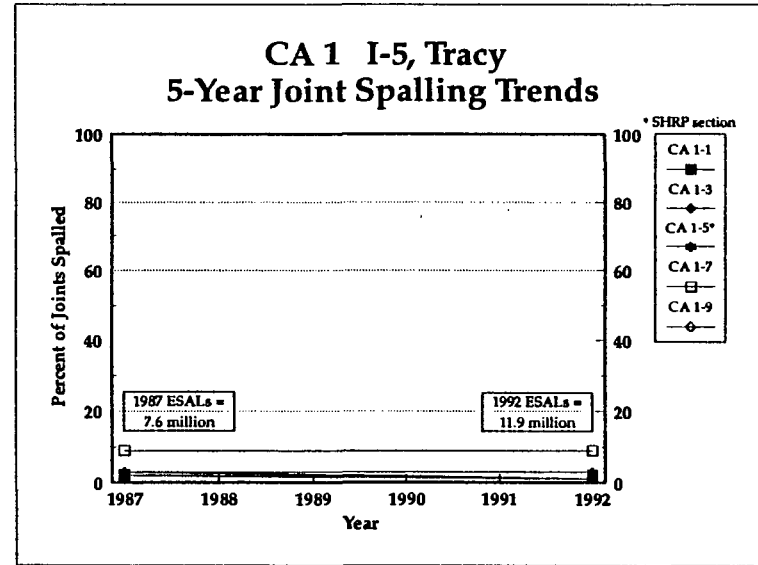
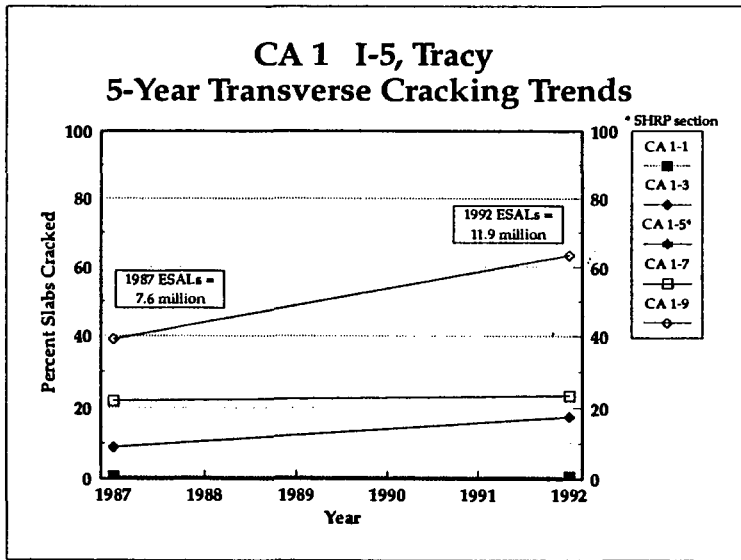
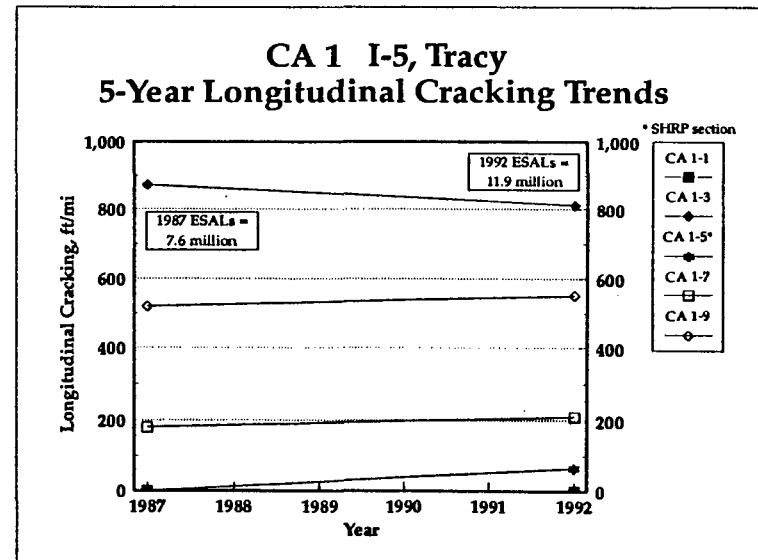
Figure 23. 5-year performance trends for CA 1.

- Greater levels of deterioration were observed on the southbound lanes (even-numbered sections) than on the northbound lanes (odd-numbered sections).
- None of the sections displayed a significant increase in faulting or spalling since being evaluated in 1987, although transverse cracking did increase. In terms of rideability, the pavement sections have not deteriorated since 1987.

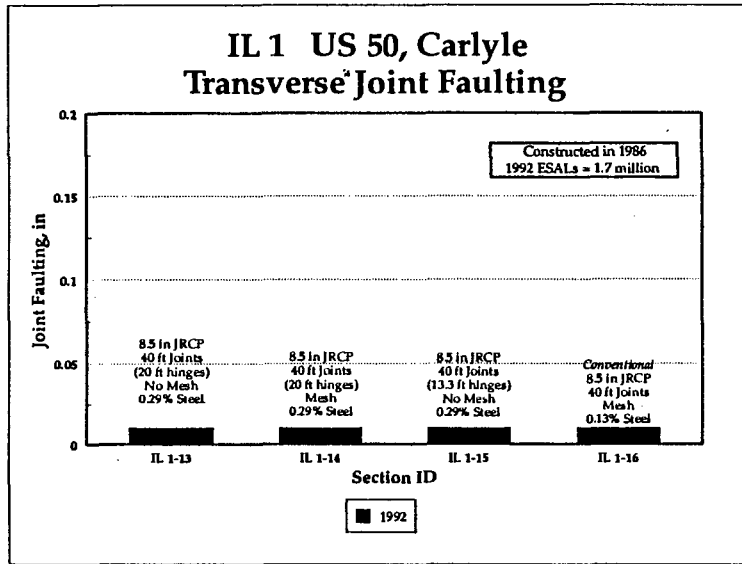
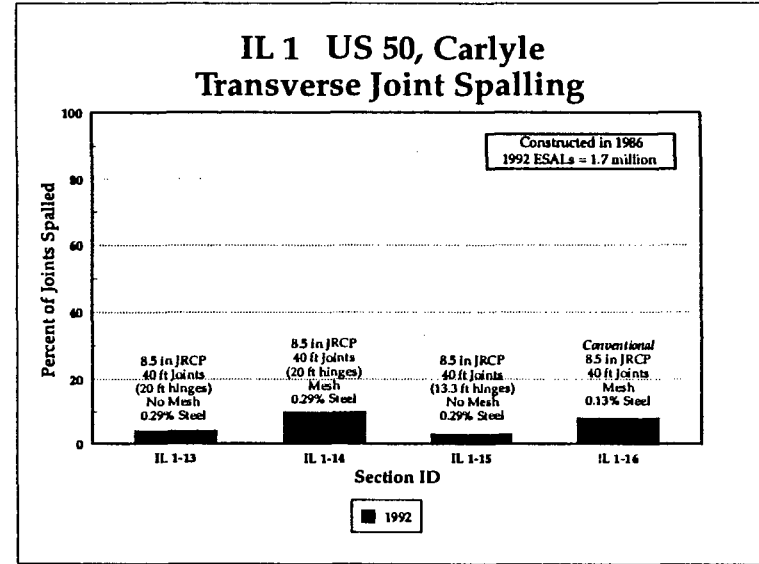
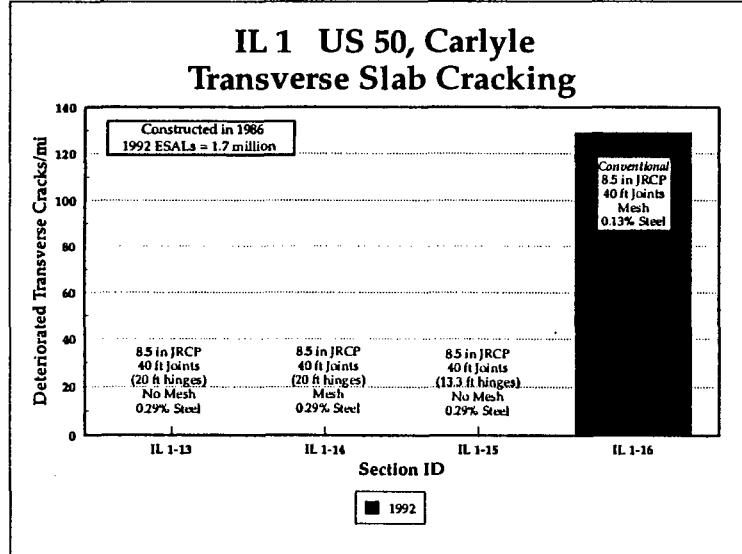
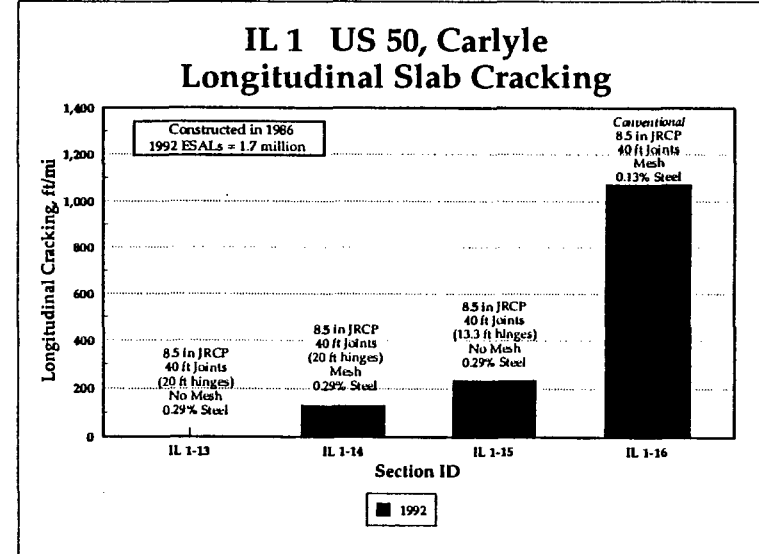
Figure 24. Performance summary for IL 1.

The performance of the IL 1 sections is summarized in table 26 and in figure 24. In this project, the advantage of the hinge design over the design without hinges is clearly demonstrated in terms of the amount of deteriorated transverse cracks. None of the hinged joint sections are displaying any deteriorated transverse cracks, whereas the conventional 40-ft (12.2-m) JRCP design is displaying extensive medium- and high-severity transverse cracks. Within the hinge joint design, no statements can be made at this time regarding the relative merits of hinge joint spacing or the inclusion of mesh reinforcement.

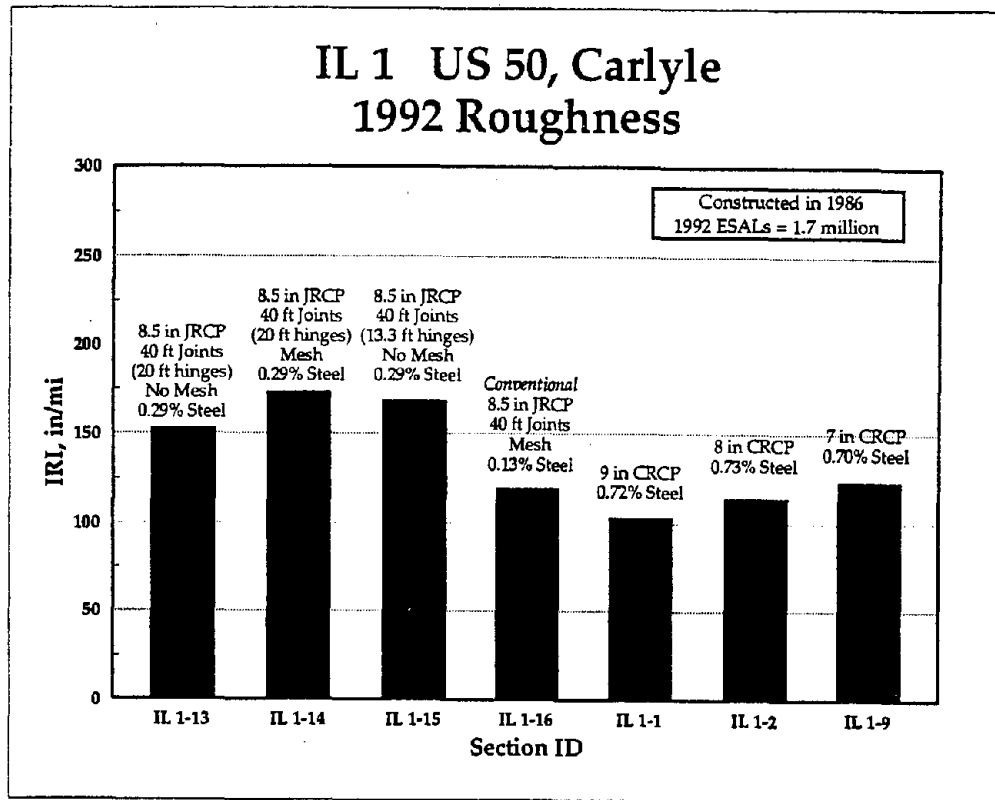
Figure 25. Roughness for IL 1.

Figure 25 illustrates the roughness measurements recorded for the IL 1 sections. With one exception, the roughness levels for the CRCP sections are much less than the JRCP designs. The lone exception is IL 1-16 (the conventional 40-ft [12.2-m] design), whose roughness levels were comparable to the CRCP sections. This result is somewhat surprising since IL 1-16 displayed a great deal of deteriorated transverse cracks. One explanation could be that the increased number of transverse joints on the hinge joint sections, even though not severely faulted, contributes to an increase in roughness. Another explanation could be related to the initial construction quality.

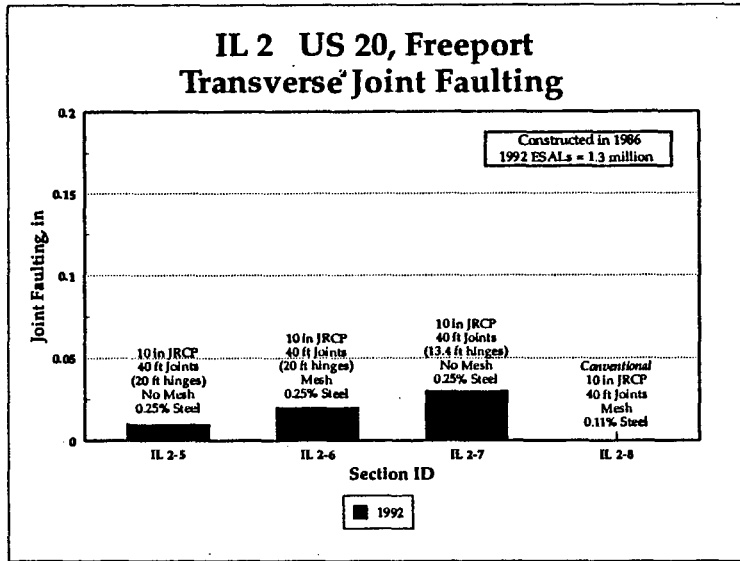
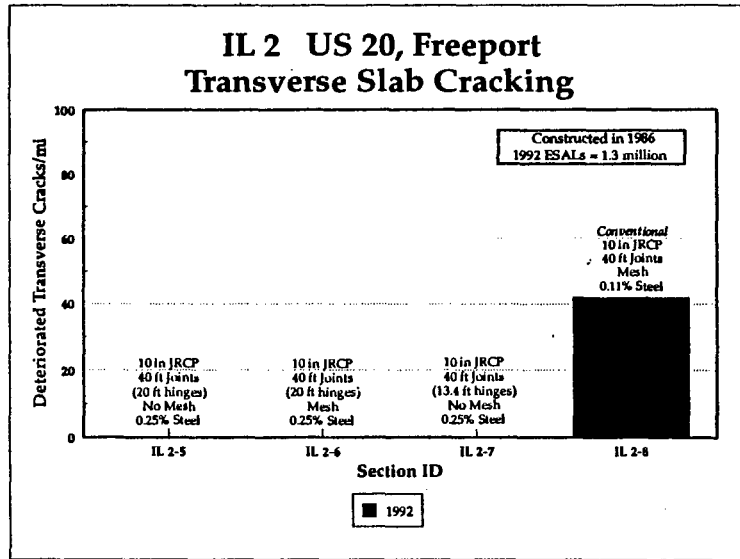
Figure 26. Performance summary for IL 2.

The performance data are provided in table 28 and displayed graphically in figure 26. Similar to the IL 1 sections, a distinct difference in performance is noticed between the sections with and without the hinge joint. The control section without hinge joints has developed deteriorated transverse cracks in many of the 40-ft

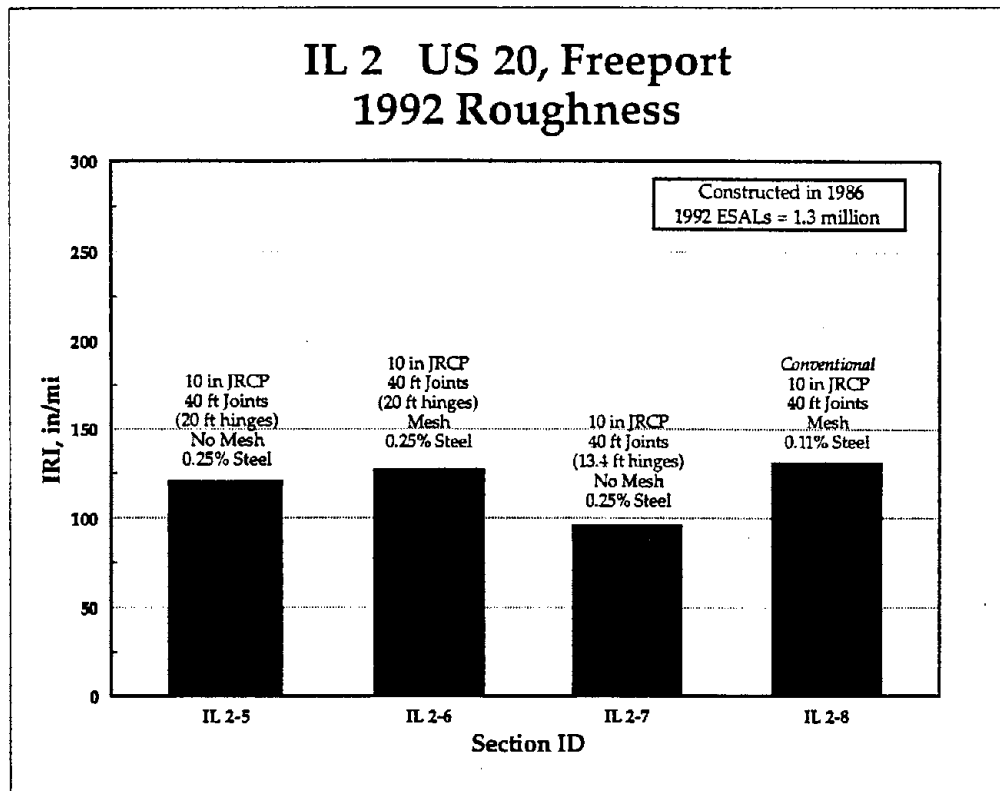
Figure 27. Roughness for IL 2.

Pavement roughness levels for these sections is shown in figure 27. This figure shows that the roughness of the hinge joint designs is less than that of the conventional design, although the differences are not significant. Interestingly, the smoothest-riding pavement is section 2-7, which contains the largest number of transverse joints. Again, this result may be related to the initial construction quality.

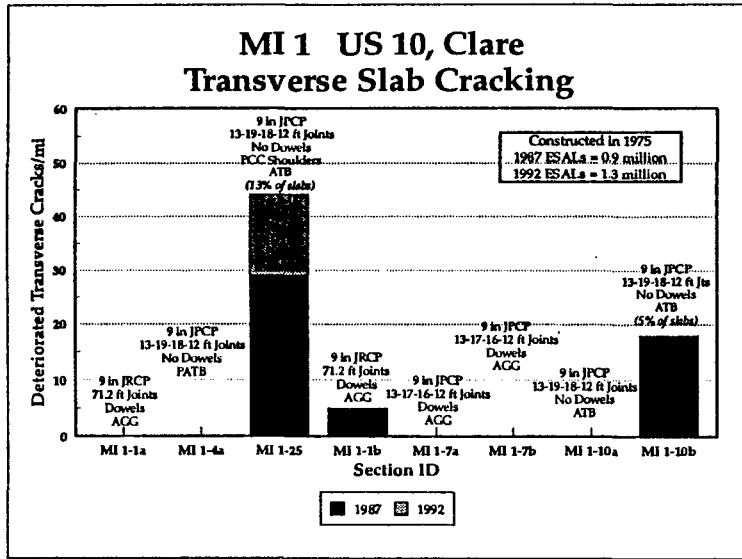
Figure 28. Performance summary for MI 1.

Table 30 summarizes the performance data for MI 1; this information is illustrated graphically in figure 28. This information clearly illustrates the poor performance exhibited by the pavements constructed on the dense-graded ATB. Not only did they exhibit the highest levels of faulting (0.13 in [3.3 mm] and higher), they also were the only sections to exhibit significant levels of transverse cracking and transverse joint

spalling. These ATB sections were constructed as a "bathtub" design with full-depth AC shoulders, which served to retain excess moisture within the pavement structure and resulted in the accelerated development of pavement distress.

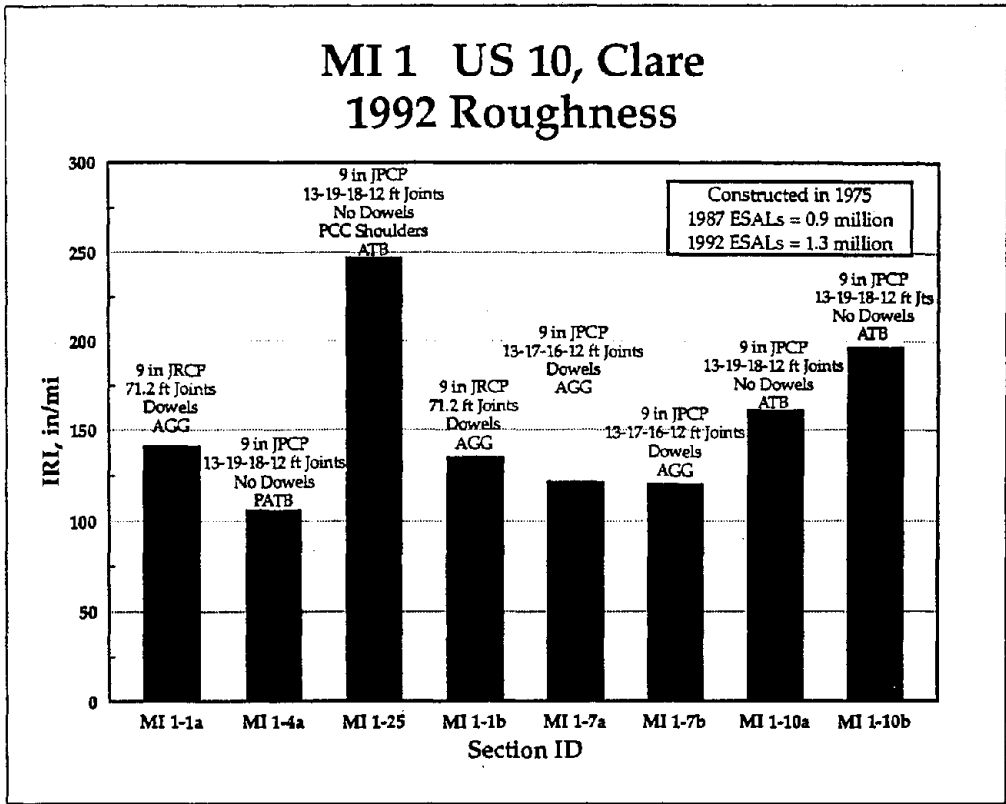
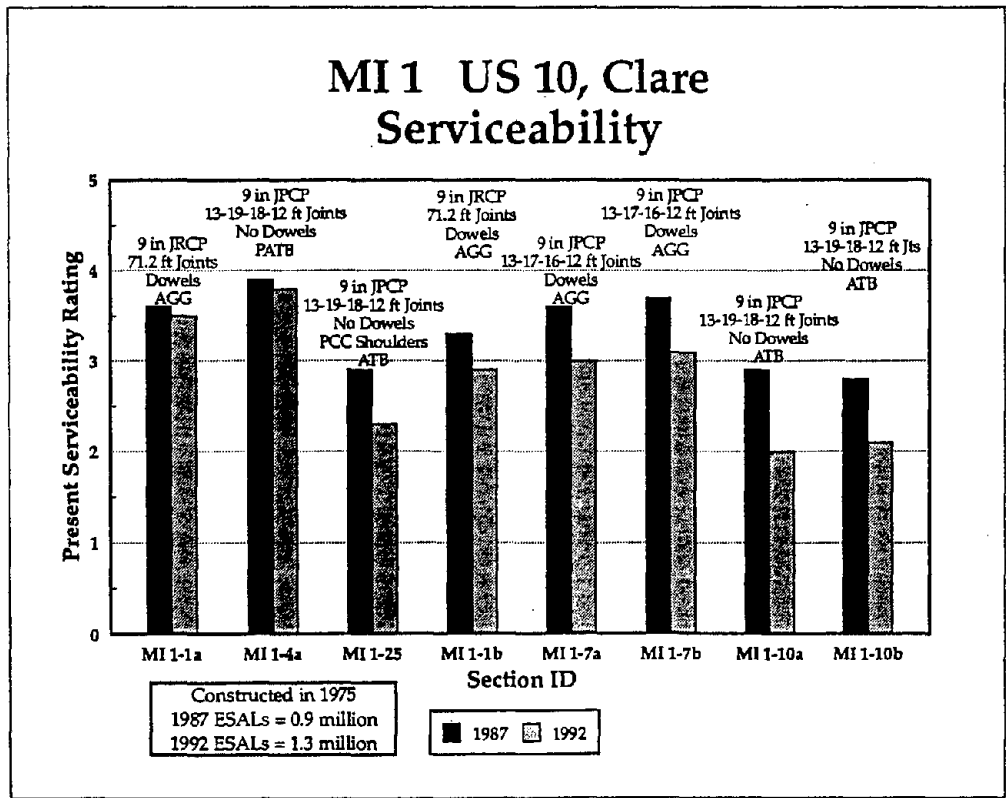
Figure 29. Roughness and serviceability for MI 1.

Roughness and serviceability for the MI 1 sections are shown in figure 29. This data appears to confirm that the sections constructed on ATB are performing the worst, as they are exhibiting the highest roughness levels and the lowest serviceability ratings. The smoothest-riding pavement is the section constructed on PATB, followed closely by the short-jointed pavements constructed on AGG.

Over the past 5 years, the sections showing the largest decrease in serviceability are those constructed on ATB. The section on PATB and the long-jointed JRCP sections show the smallest decrease in serviceability over that time period.
