Performance of Concrete Pavements

Volume I: Field Investigation

PUBLICATION NO. FHWA-RD-94-177

JULY 1997

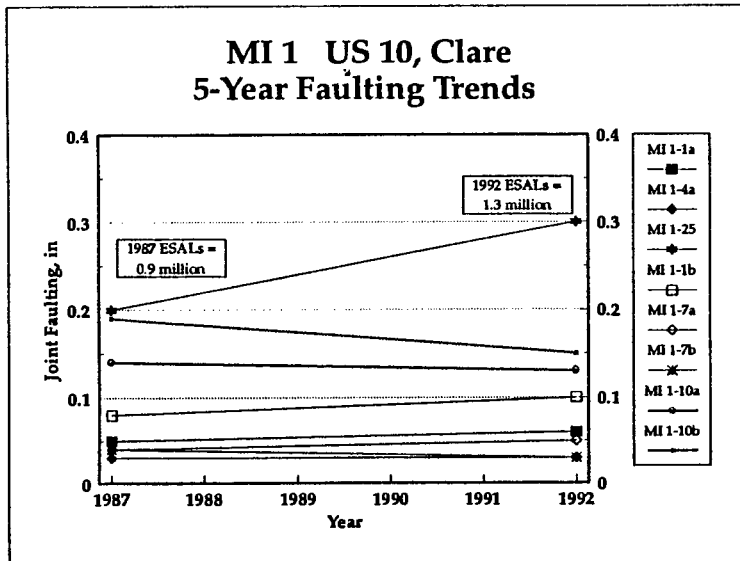
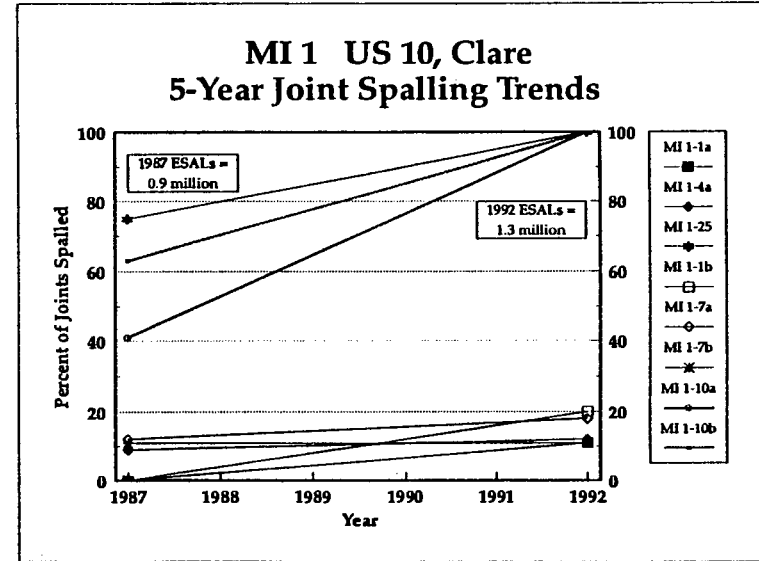
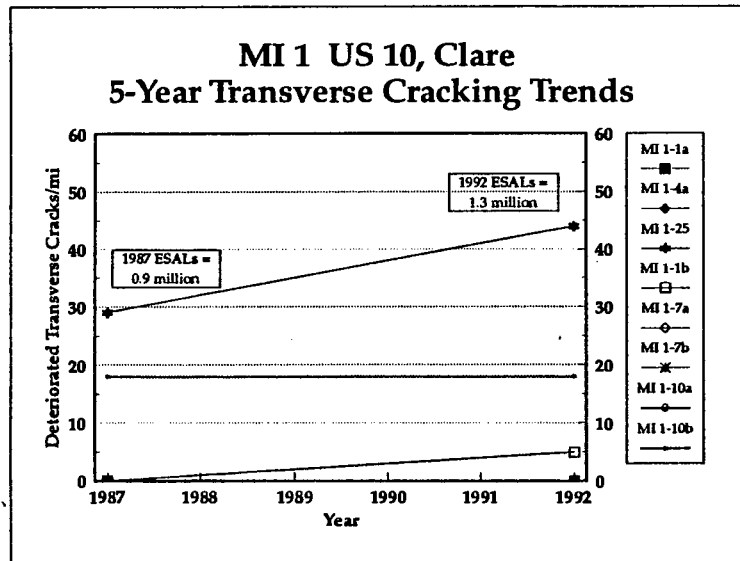
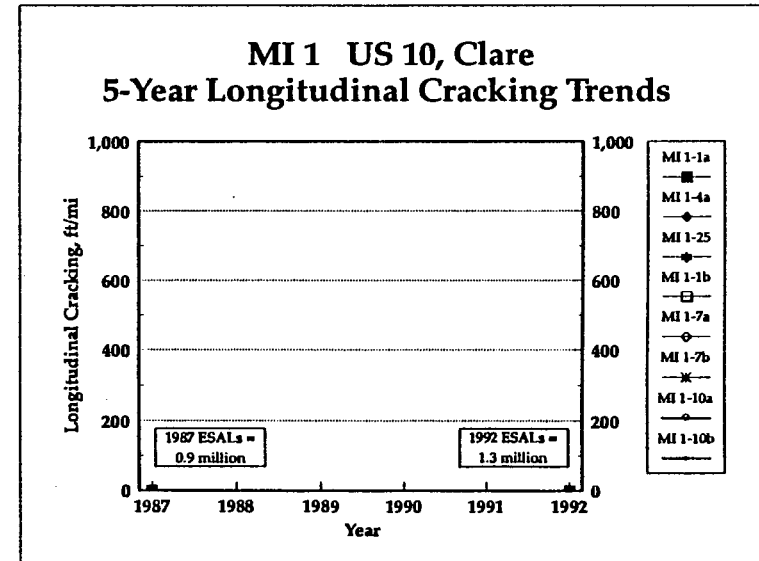
Figure 30. 5-year performance trends for MI 1.

The 5-year performance trends for the key distress types are given in figure 30. This figure indicates that the pavements showing the largest increase in every distress category are those constructed on ATB. Most notably, the levels of spalling for each of the ATB sections increased to 100 percent. Section MI 1-25 is the only section to show a significant increase in faulting and transverse cracking.

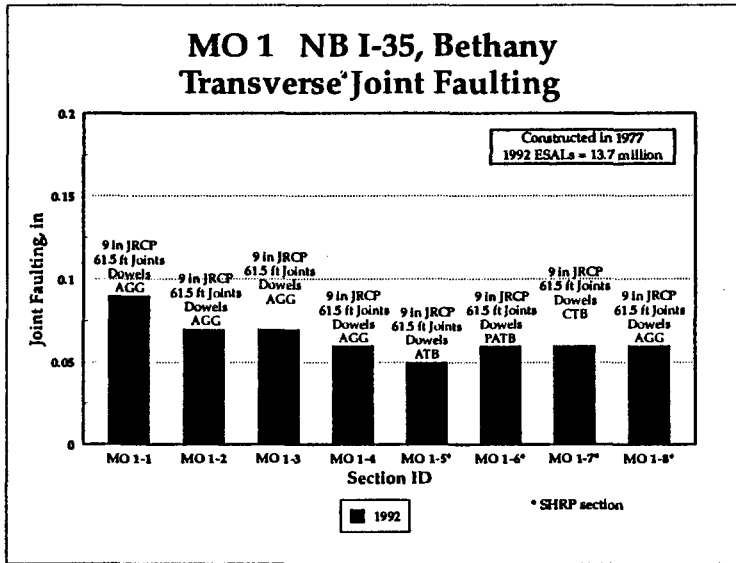
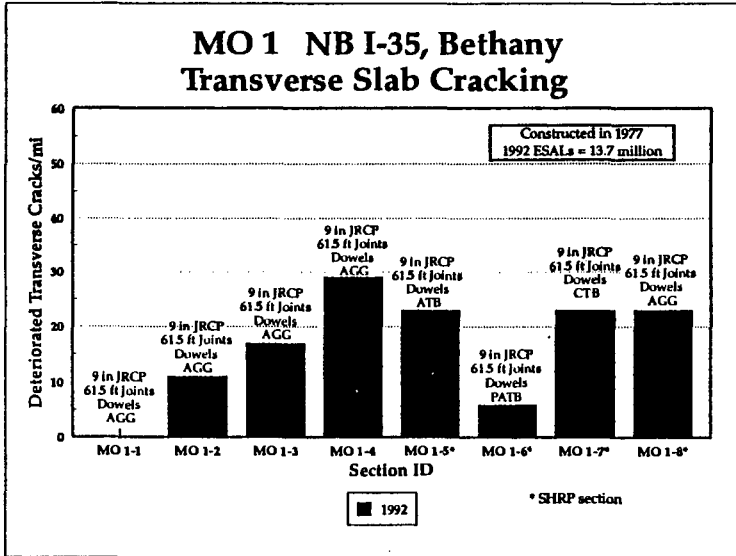
Figure 31. Performance summary for MO 1.

Table 34 summarizes the performance data for the outer lanes of the MO 1 sections. Figure 31 presents that performance data in graphical format. The distress data for MO 1 do not indicate any major differences in the performance of these sections. Considering the performance of the various base types, the levels of faulting, transverse cracking, and joint spalling do not appear to be significantly different. Pumping was observed on all sections constructed on aggregate bases, but not for those constructed on treated bases. However, the section constructed on PATB had fewer deteriorated transverse cracks. Nevertheless, differences in the overall performance of the various base types did not appear to be significant.

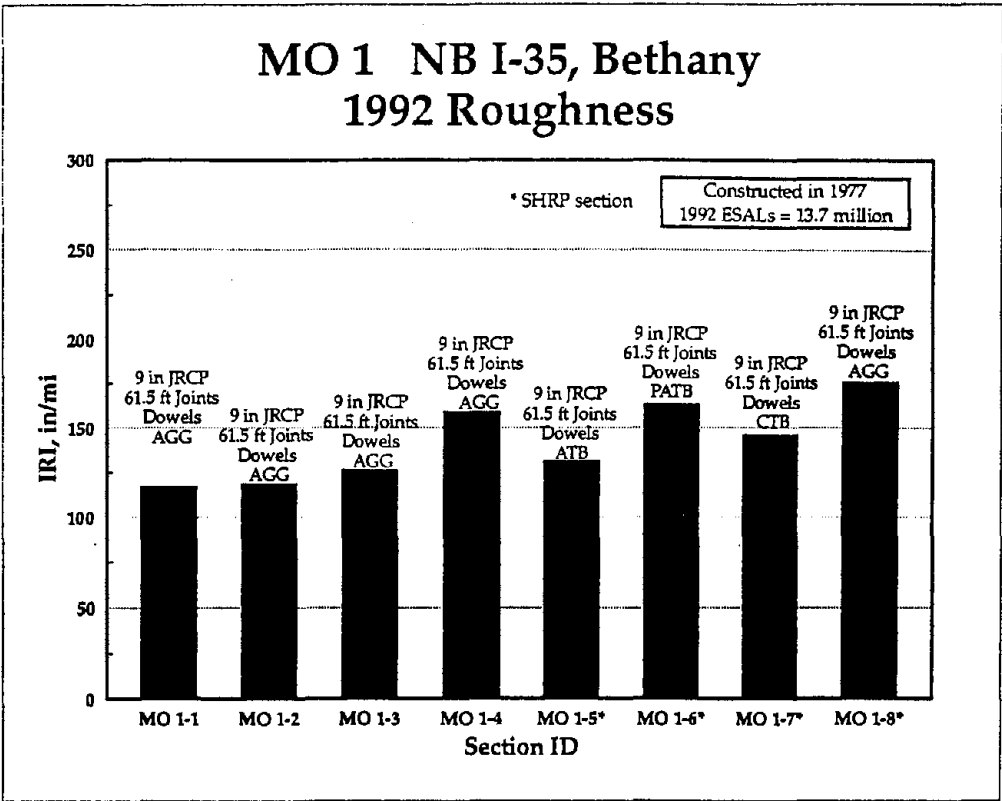
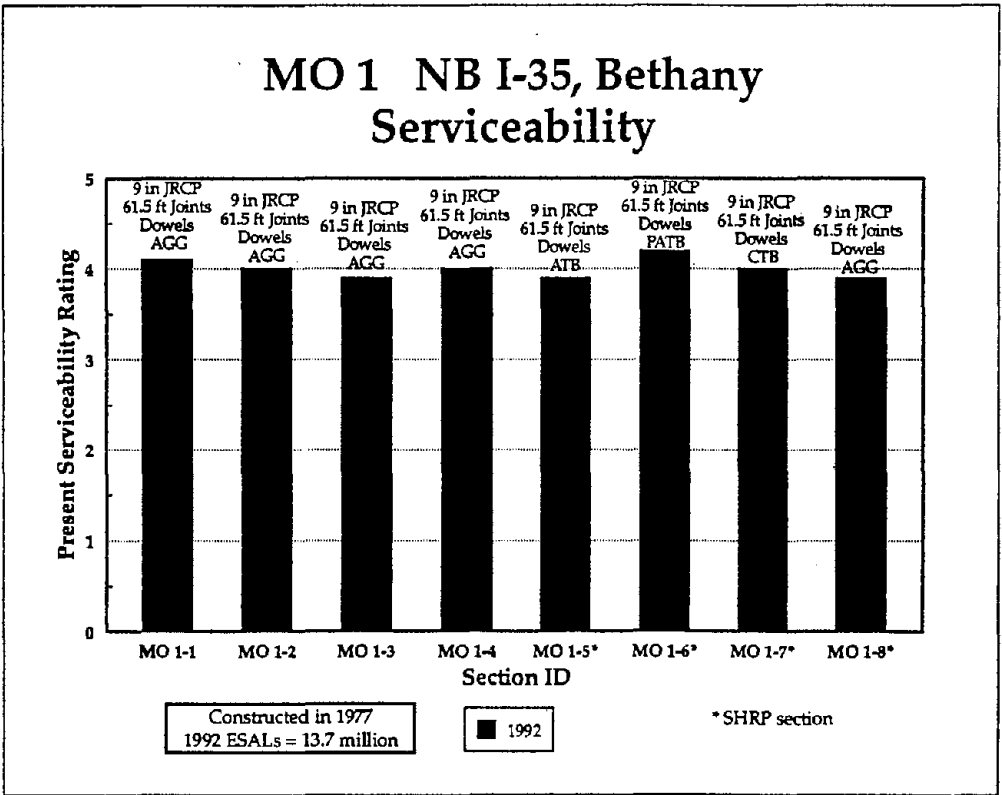
Figure 32. Roughness and serviceability for MO 1.

Figure 32 illustrates the roughness measurements and serviceability ratings for the MO 1 sections. Whereas the roughness values indicate a significant difference in smoothness between the sections (with the smoothest riding sections being three of

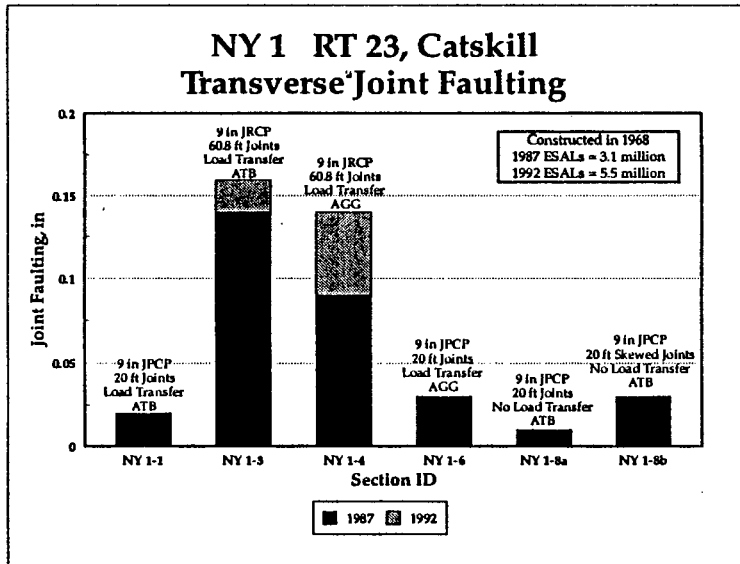
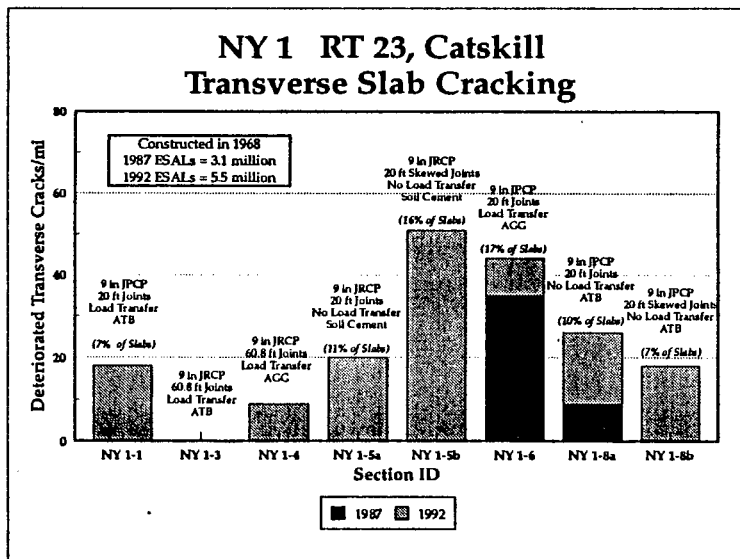
Figure 33. Performance summary for NY 1.

The performance data for the NY 1 experimental sections are summarized in table 39. The key distress data are illustrated in figure 33.

The effect of the ACME load transfer devices in reducing faulting can be observed by comparing the performance of NY 1-1 and 1-8a. The distress data indicate no significant difference in the performance of these sections, suggesting that the light traffic to which this project is exposed may not be a true test of the load transfer devices. Other studies conducted in New York have indicated that these devices corroded and could not be relied upon to provide positive, long-term load transfer, often failing within 5 years.⁽²⁹⁾

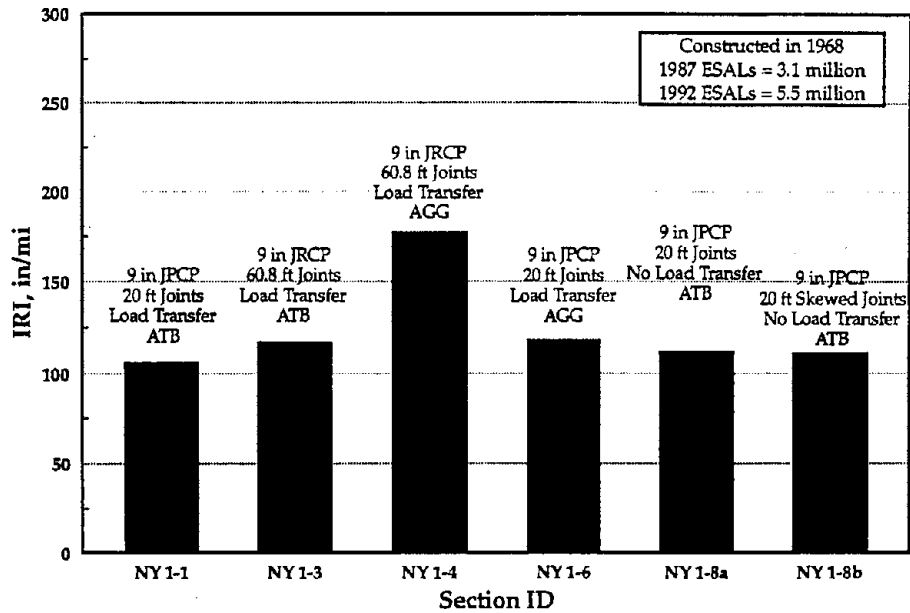
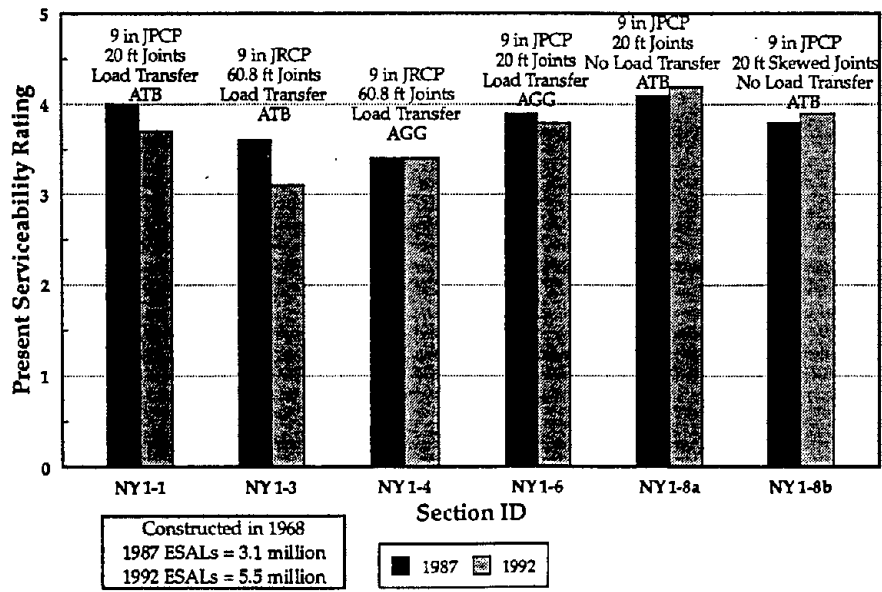
Figure 34. Roughness and serviceability for NY 1.

Roughness measurements and serviceability ratings for each section are illustrated in figure 34. The roughest section is NY 1-4, a long-jointed section on an aggregate base. The roughness levels for the other sections are all comparable and are representative of relatively smooth-riding pavements.

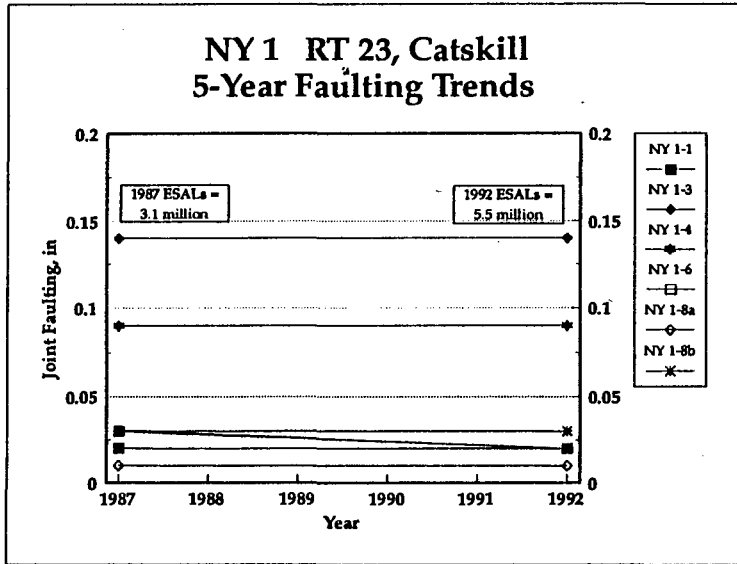
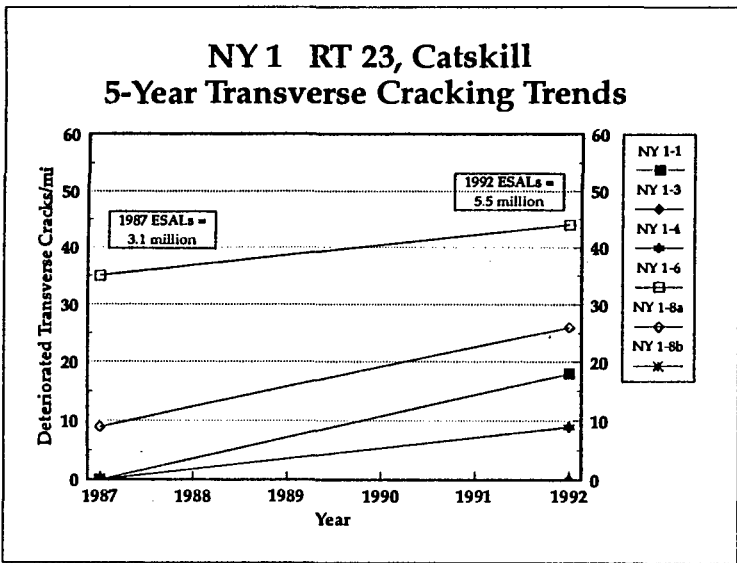
Figure 35. 5-year performance trends for NY 1.

The 5-year performance trends for these sections are shown in figure 35. No change in joint faulting or spalling has occurred for any of the sections. However, the number of deteriorated transverse cracks has increased for nearly every section, and the amount of longitudinal cracking has also increased slightly for a few sections.

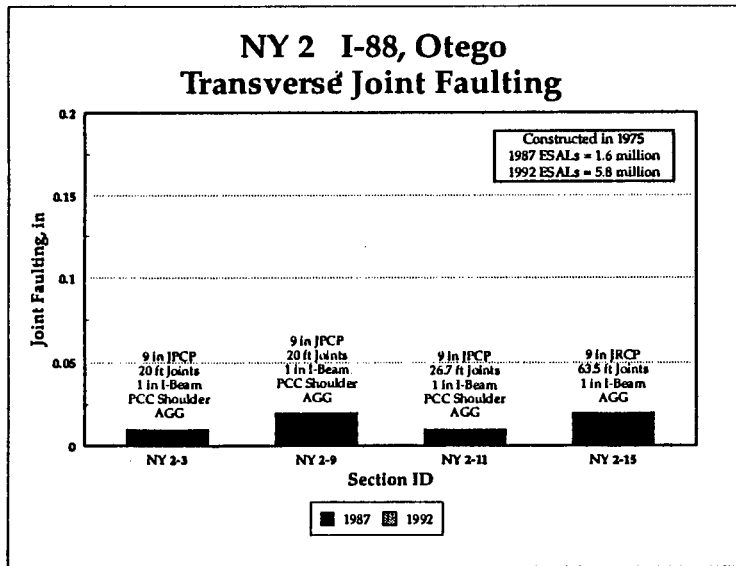
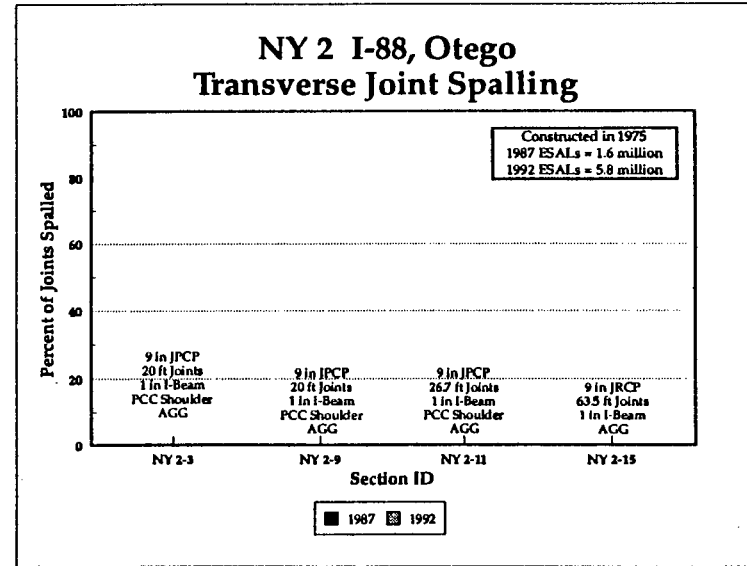
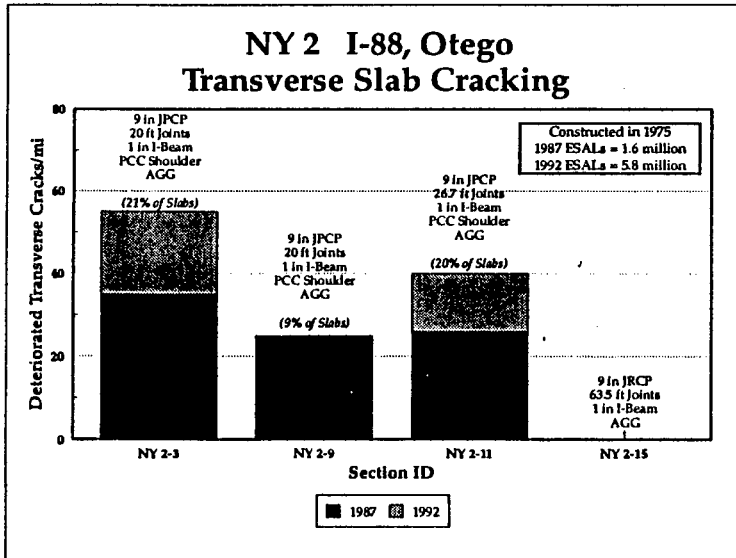
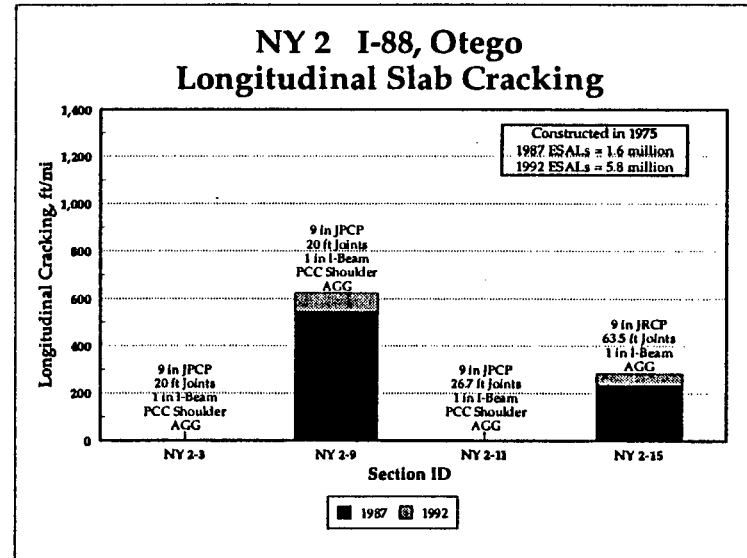
Figure 36. Performance summary for NY 2.

The performance data for NY 2 are summarized in table 41 and illustrated in figure 36. This information shows that all of the NY 2 sections are in excellent condition. Faulting is practically nonexistent on these sections, and joint spalling is also minimal.

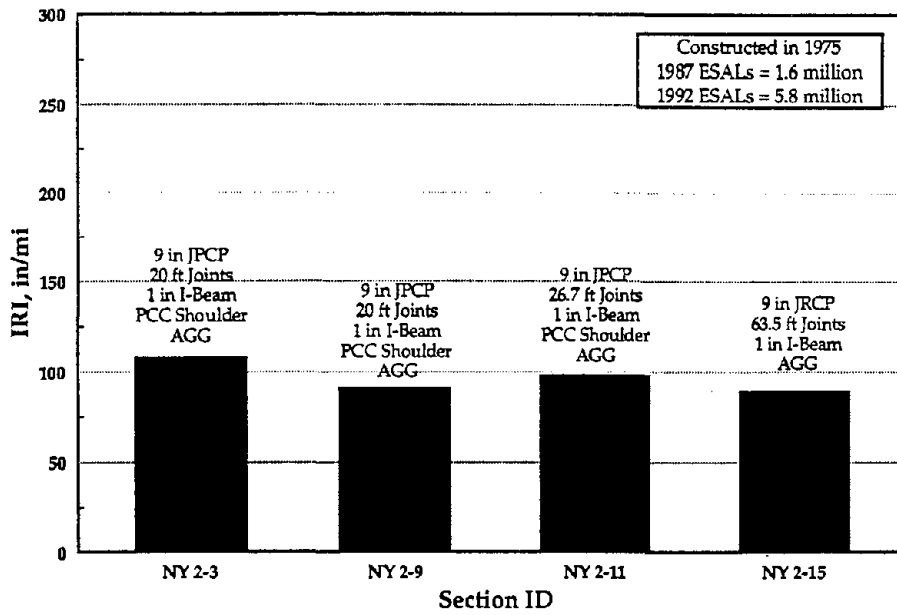
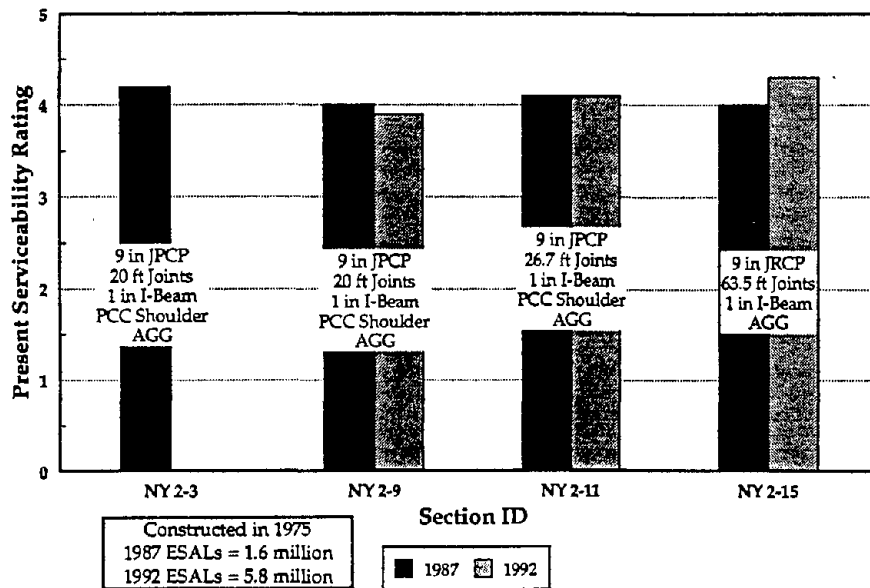
Figure 37. Roughness and serviceability for NY 2.

Roughness measurements and serviceability ratings for the NY 2 sections are illustrated in figure 37. This figure shows that the NY 2 sections are extremely

smooth, typically showing roughness measurements less than 100 in/mi (1.6 m/km) and PSR values near 4.0. Since 1987, no significant changes have occurred in the serviceability of the pavement.

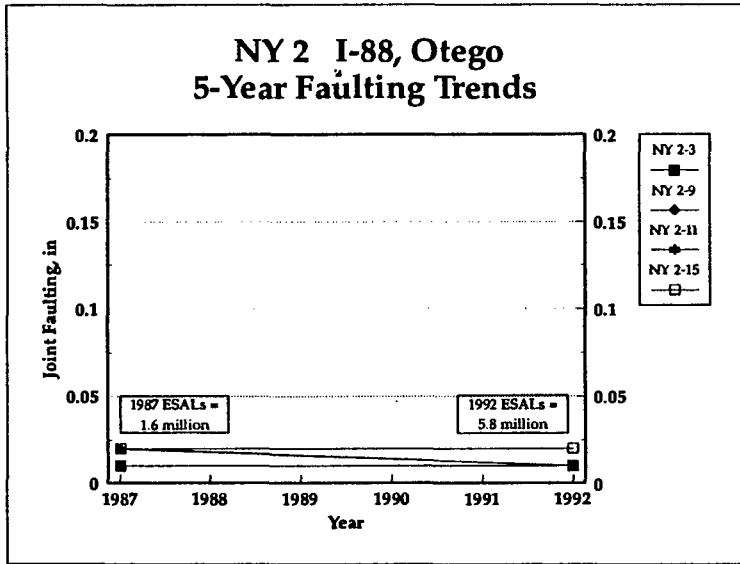
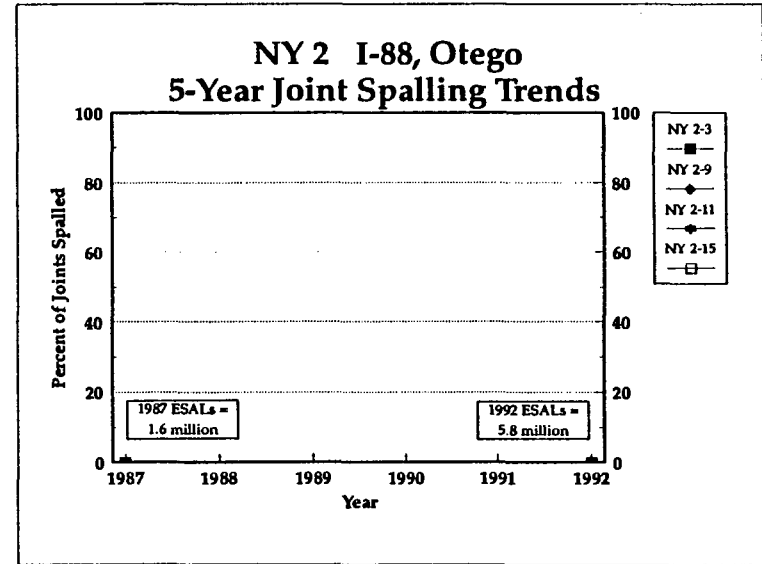
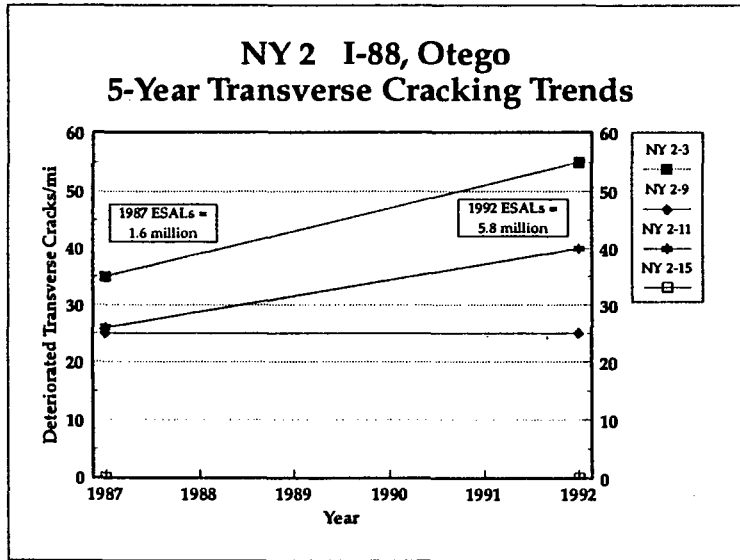
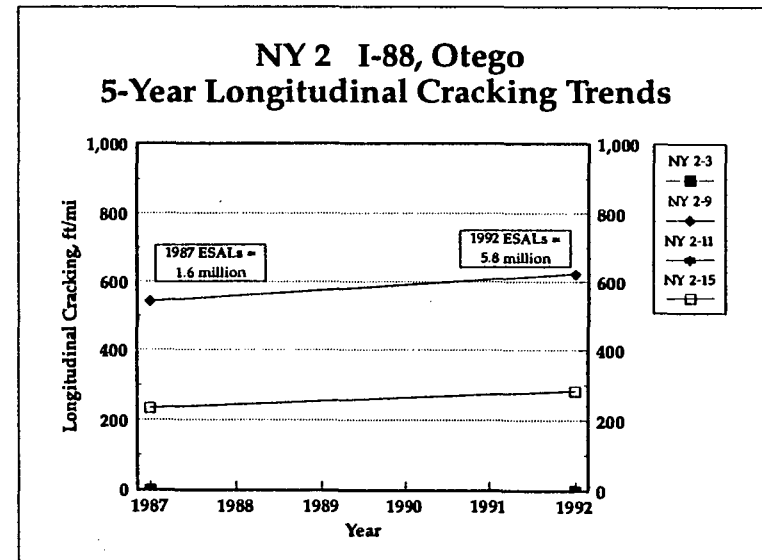
Figure 38. 5-year performance trends for NY 2.

Figure 38 illustrates the 5-year performance trends for the NY 2 sections. Virtually no changes have occurred in the amount of joint faulting or spalling, although some increase in transverse cracking has occurred for sections 2-3 and 2-11. In addition, sections 2-9 and 2-15 are showing a small increase in the amount of longitudinal cracking.

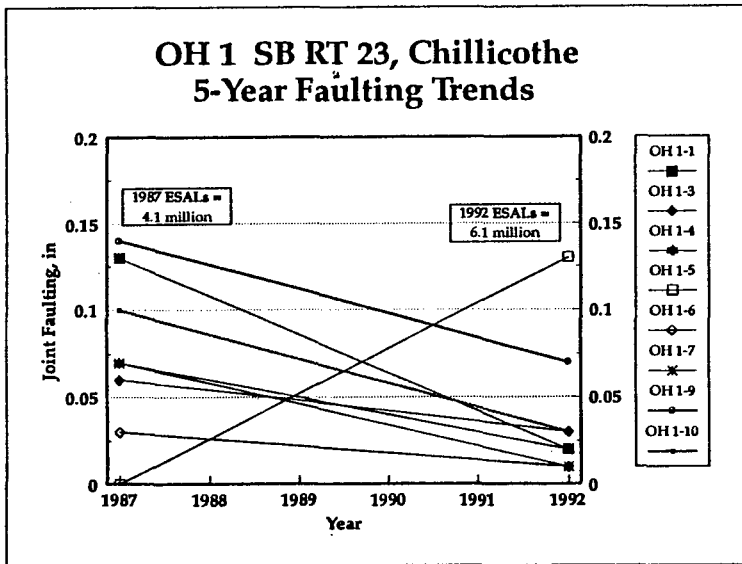
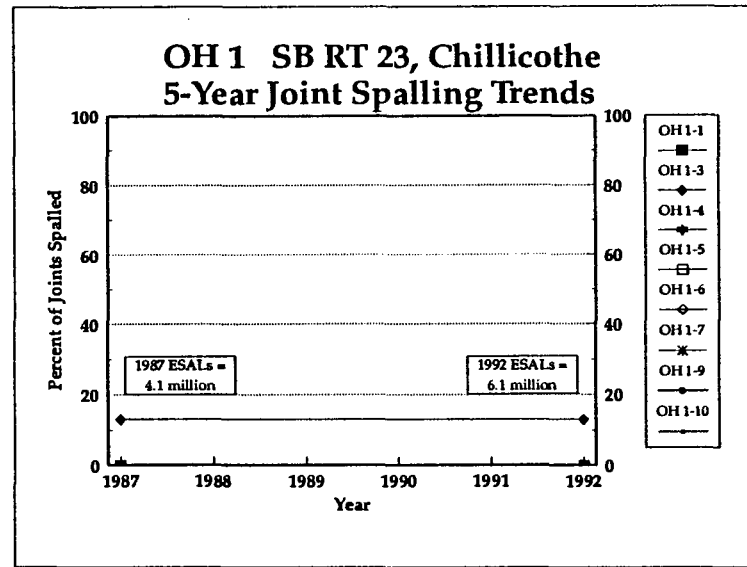
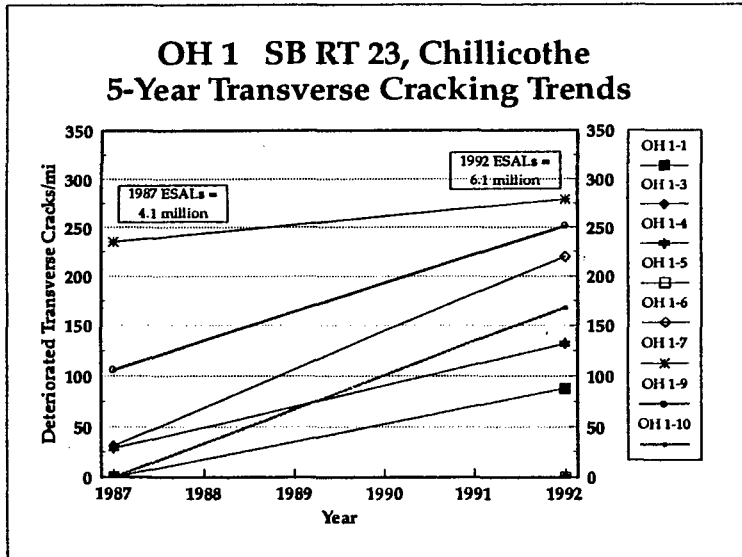
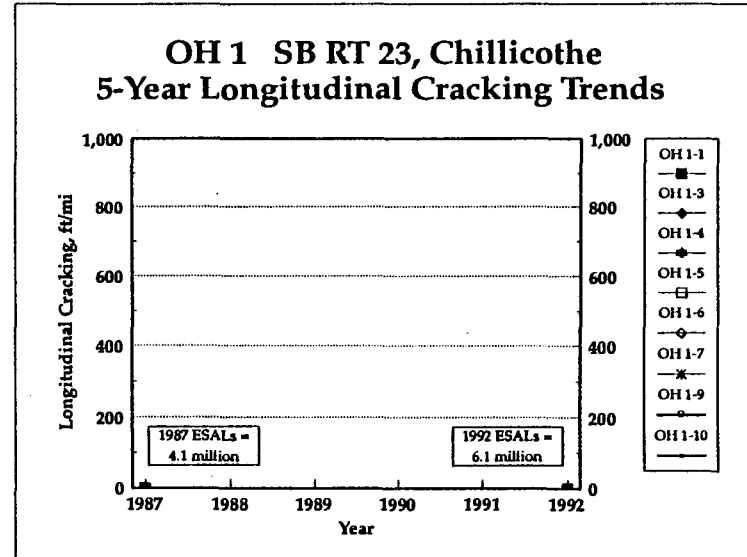
Figure 41. 5-year performance trends for OH 1.

The 5-year performance trends for the OH 1 sections are shown in figure 41. As mentioned before, the joint faulting measurements for these sections are somewhat

- Over the 5-year period, every section (with the exception of the JPCP design) developed additional transverse slab cracking. The most significant increases occurred for the sections constructed on aggregate base.

- Only one section exhibited transverse joint spalling, and none of the sections displayed any longitudinal cracking.

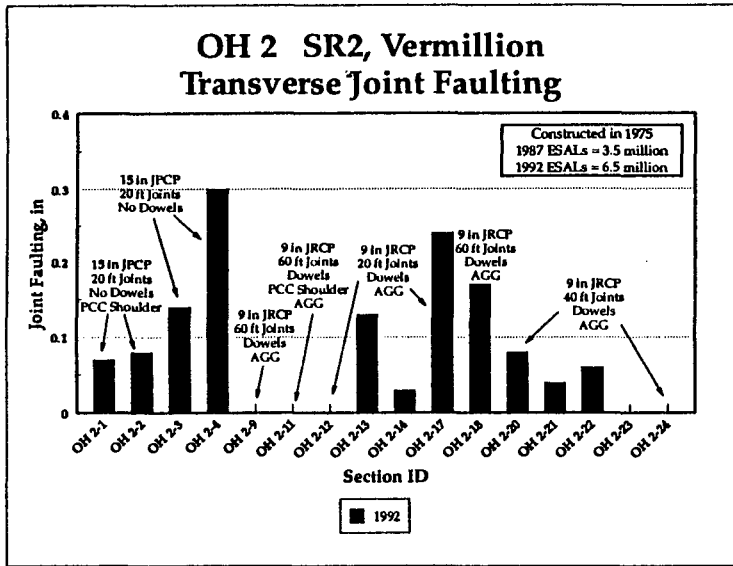
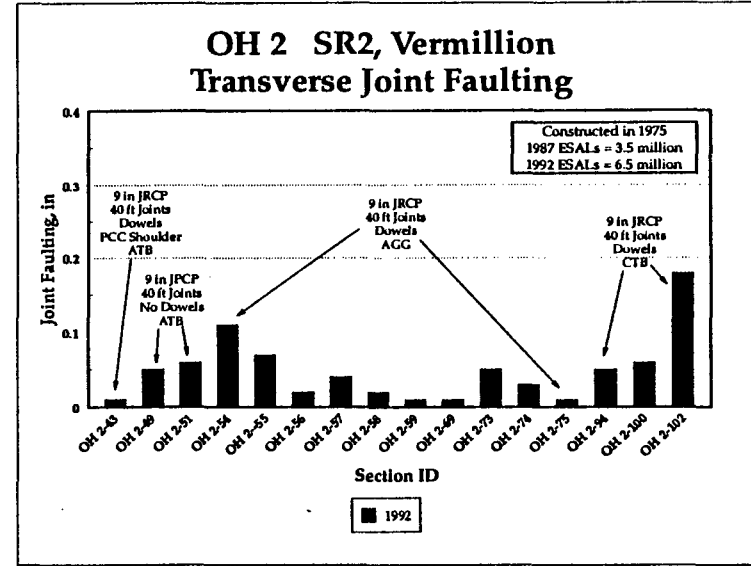
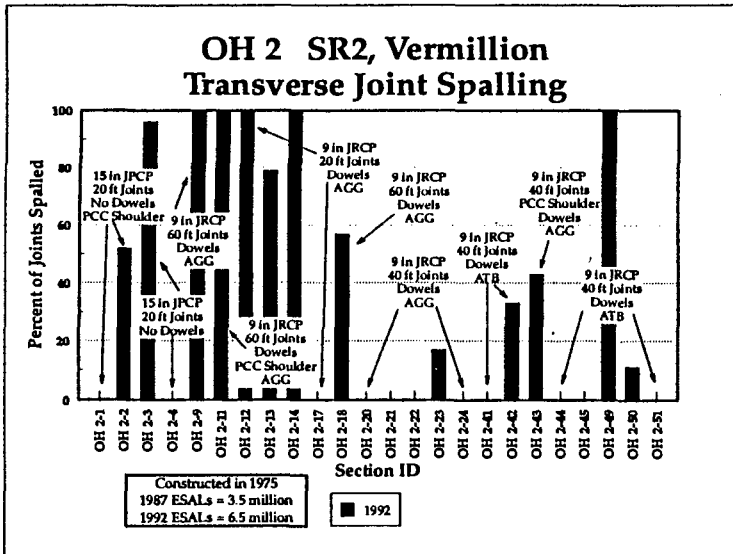
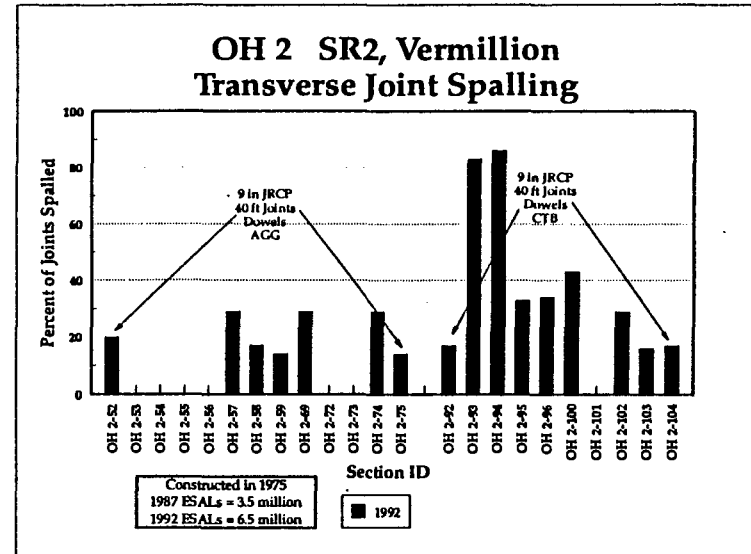
Figure 42. Performance summary of OH 2 sections, joint faulting and spalling.

Most of the sections are extensively deteriorated. Many sections exhibit a considerable amount of wide, transverse cracks that are severely spalled and faulted. Figure 42 does not indicate joint faulting to be a significant problem for most sections (with a few exceptions), but faulting of the transverse cracks is severe. Faulting levels of 0.20 to 0.25 in (5 to 6 mm) are common on the deteriorated cracks, with extreme faulting values in excess of 0.5 in (13 mm). Transverse joint spalling ranges from 0 to 100 percent, depending on the type and maximum size of aggregate used in the section and joint spacing. Spalling is also prevalent on many of the high-severity cracks.

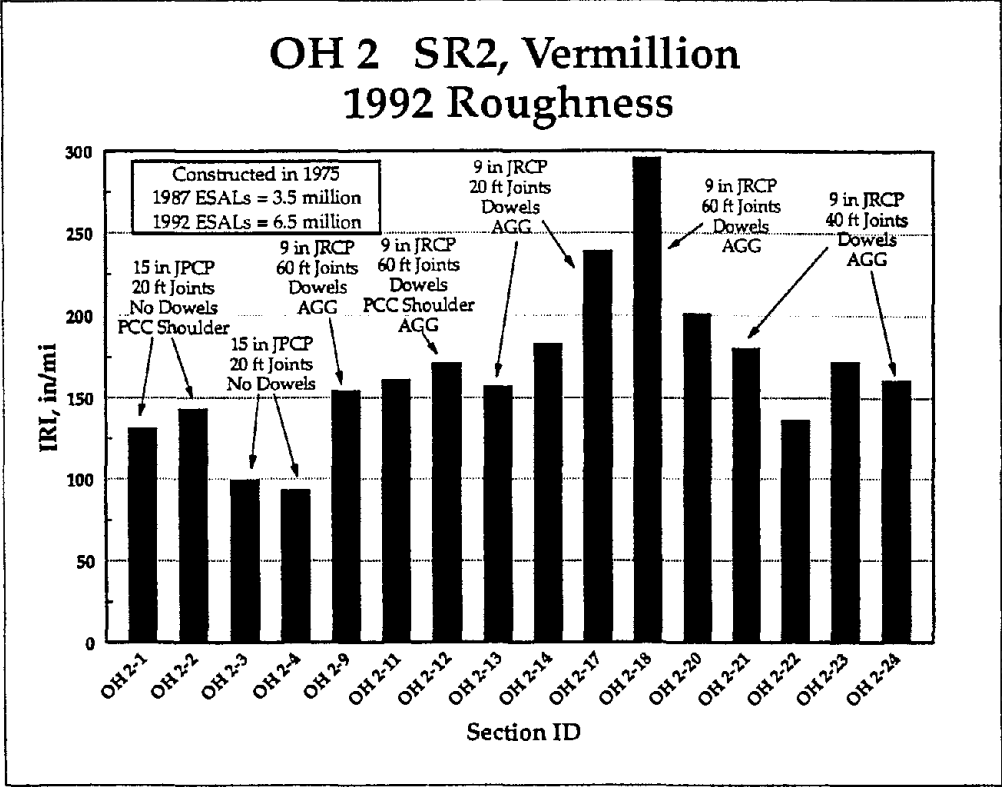
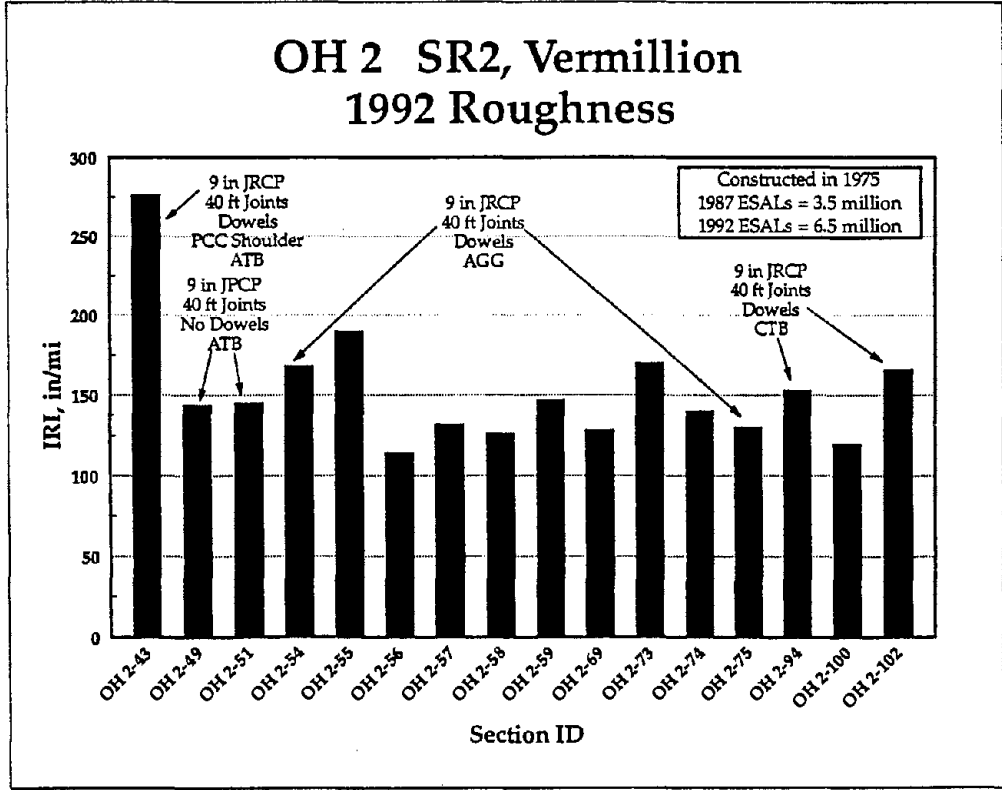
Figure 44. Roughness summary for OH 2 sections.

The roughness data for OH 2 sections are illustrated in figure 44. These sections are extensively deteriorated and very rough. If the IRI is much greater than about 100 in/mi (1.6 m/km), the ride quality on the roadway is generally poor. Most of

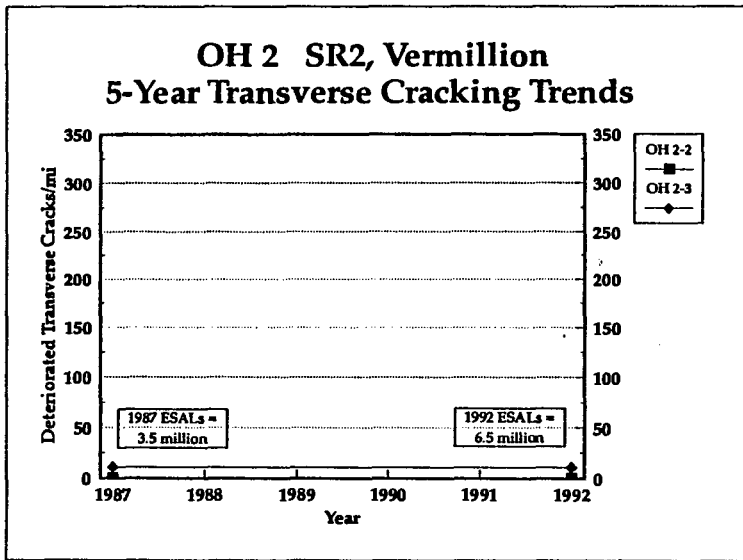
Figure 45. 5-year performance trends for OH 2 sections.

Figure 45 illustrates the 5-year performance trends for sections OH 2-2 and OH 2-3 (these were the only two sections that were evaluated in 1987). OH 2-2 and OH 2-3 are 15-in (381-mm) JPCP placed directly on subgrade, with transverse joints spaced at 20-ft (6.1-m) intervals. With the exception of faulting, the performance of the two sections exhibit a logical trend. Faulting could not be measured at a few of the joints in OH 2-2 because of joint spalling. This spalling, together with some measurement error, may be the cause of the apparent decrease in faulting by 0.03 in (0.8 mm) in OH 2-2 shown in figure 45. Because of very thick slabs, fatigue cracking was not expected on these sections, and no additional transverse cracking was observed.

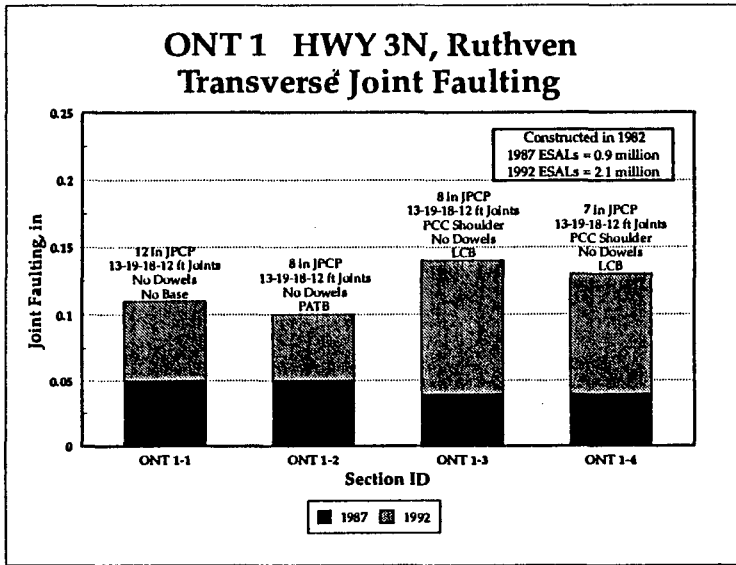
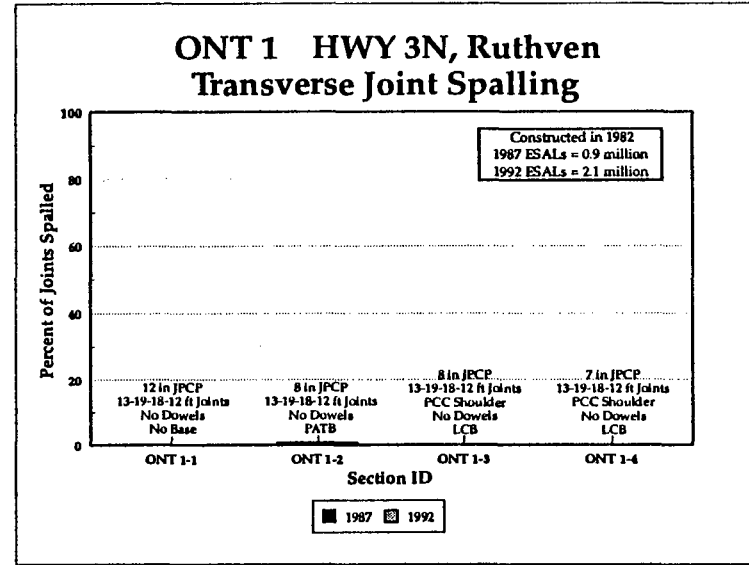
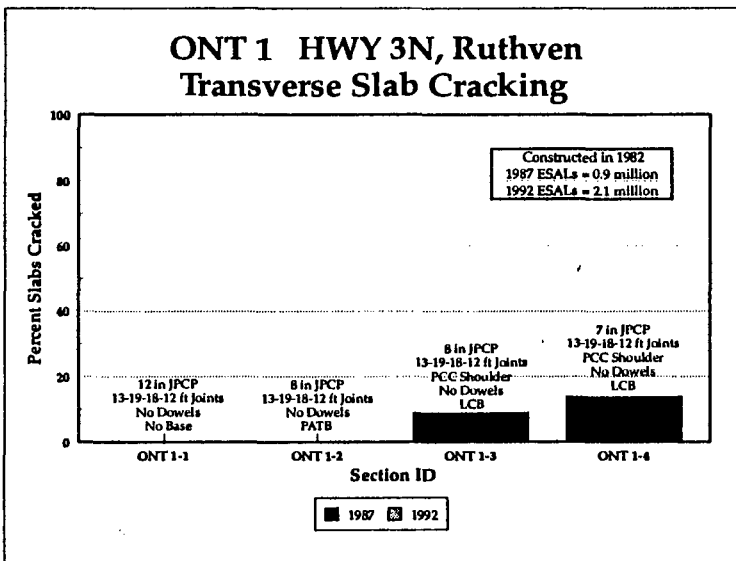
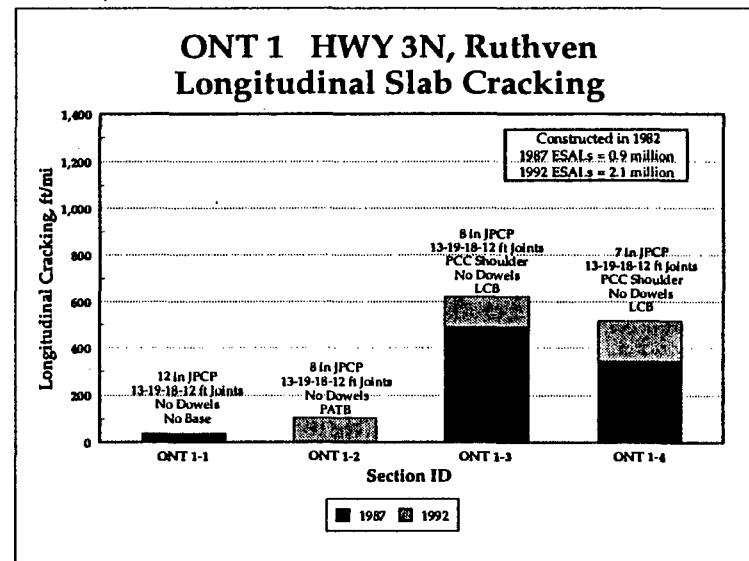
Figure 46. Performance summary for ONT 1 sections.

The performance of these sections is summarized in table 49 and presented graphically in figures 46 through 48. The only major difference in performance of the different sections (designs) on this project appears to be the presence of transverse cracking in those sections constructed on LCB. The differences in slab thickness did not appear to be a significant factor affecting performance. The LCB sections also represent the only sections that have tied concrete shoulders (2-ft [0.6-m] wide) at this project. Because the base type is also a significant factor affecting transverse cracking, a meaningful comparison of the effects of shoulder type on pavement performance is not possible with the ONT 1 sections.

ONT 1-2 contains narrow strips of partial-depth patches that are about 10-in (254-mm) wide and extend over several slabs. These patches are always in pairs that are about 4 ft (1.2 m) apart. Longitudinal cracking started to develop at the tip of some of these patches in this section. The reason for the presence of the partial-depth patches is not known, but the longitudinal cracking in this section is clearly not related to any of the design factors. The longitudinal cracking in ONT 1-3 and ONT 1-4 occurred very close to the centerline joint, suggesting improper sawing of the centerline joint as the prime suspect for the cause of the cracking.

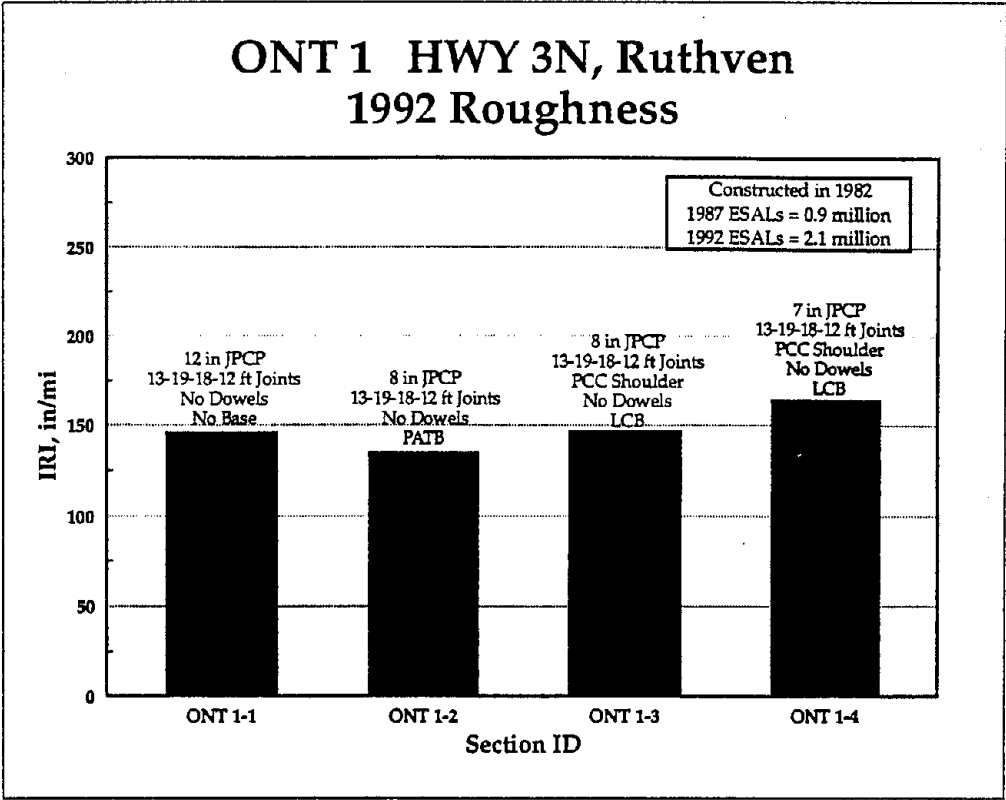
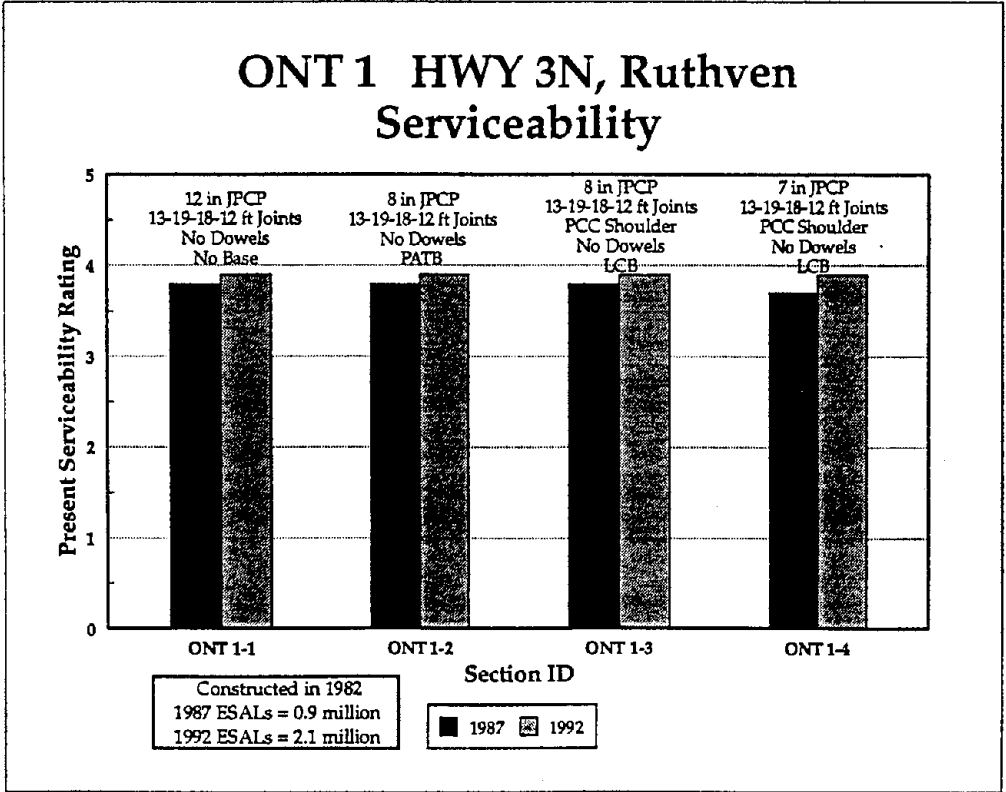
Figure 47. Roughness and serviceability summary for ONT 1 sections.

The roughness and present serviceability data for ONT 1 sections are shown in figure 47. As shown in this figure, both roughness and the perceived ride quality on all sections are similar. A fair amount of roughness was observed on these sections. The primary source of roughness in these sections appears to be joint faulting. Based on PSR, the ride quality over these sections does not appear to have deteriorated since 1987. The PSR for the ONT 1 sections are very high for the IRI values shown (average of about 150 in/mi [2.4 m/km]). The average PSR of 3.8 is typically associated with IRI values far less than 100 in/mi (1.6 m/km).
