Performance of Concrete Pavements

Volume I: Field Investigation

PUBLICATION NO. FHWA-RD-94-177

JULY 1997

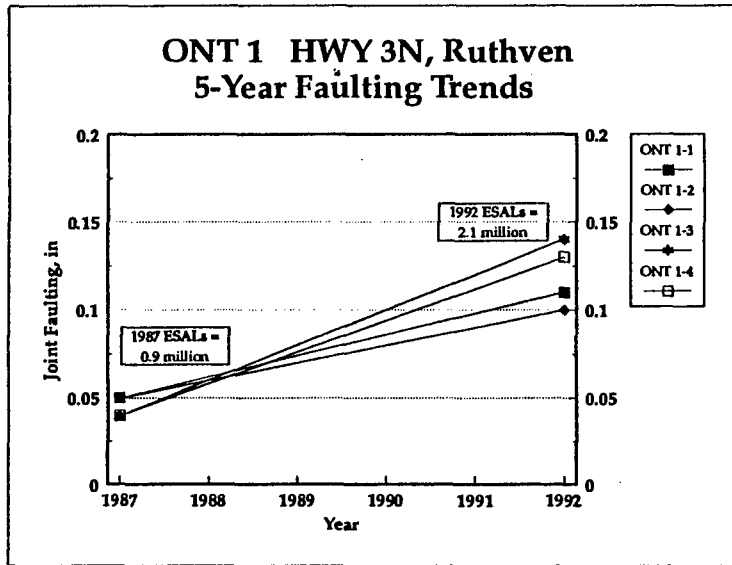
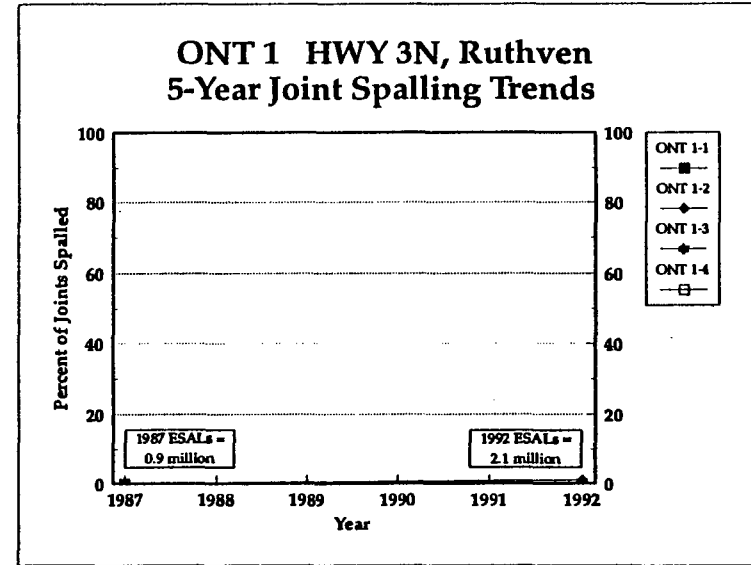
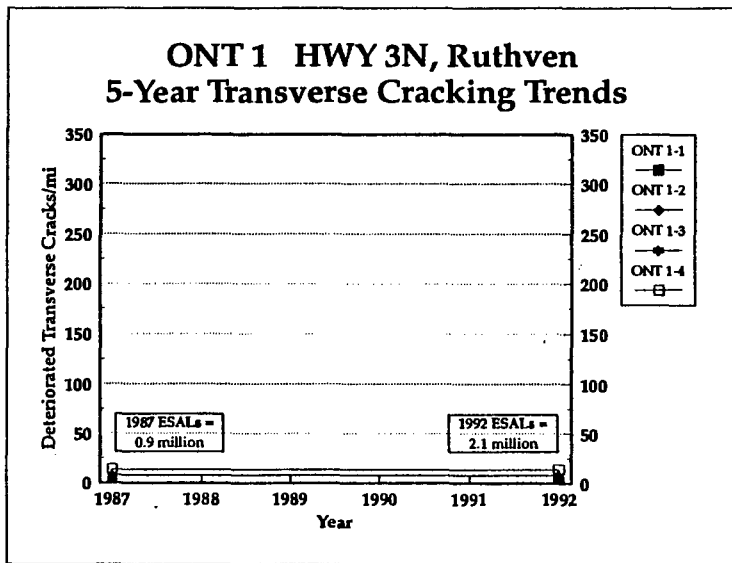
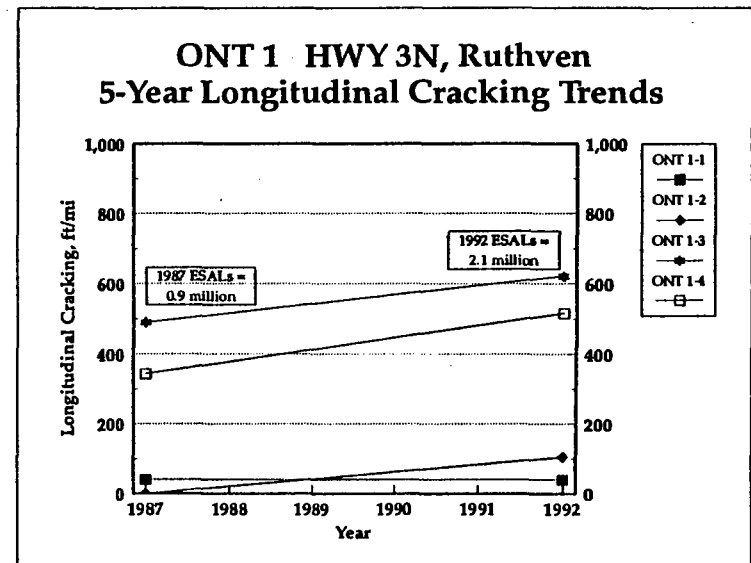
Figure 48. 5-year performance trends for ONT 1 sections.

The 5-year performance trends for the ONT 1 sections are shown in figure 48. Compared to the condition in 1987, all sections show a significant increase in faulting. The LCB sections (ONT 1-3 and ONT 1-4) showed less faulting in 1987 than sections with no base and a PATB (ONT 1-1 and ONT 1-2); but by 1992, the faulting in the LCB sections surpassed that of the other sections. None of the ONT 1 sections are doweled; hence, aggregate interlock is the only mechanism for load transfer for these sections. If the mechanism described in the evaluation of the OH 2 sections to explain the cause of rapid deterioration of transverse cracks in the stabilized-base sections of is valid, the greater amount of faulting in the sections constructed on stiffer base without positive load transfer is an expected trend.

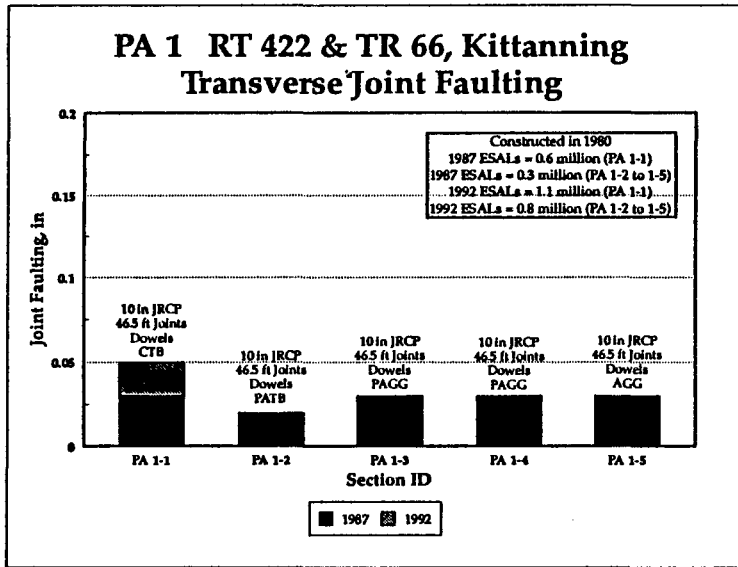
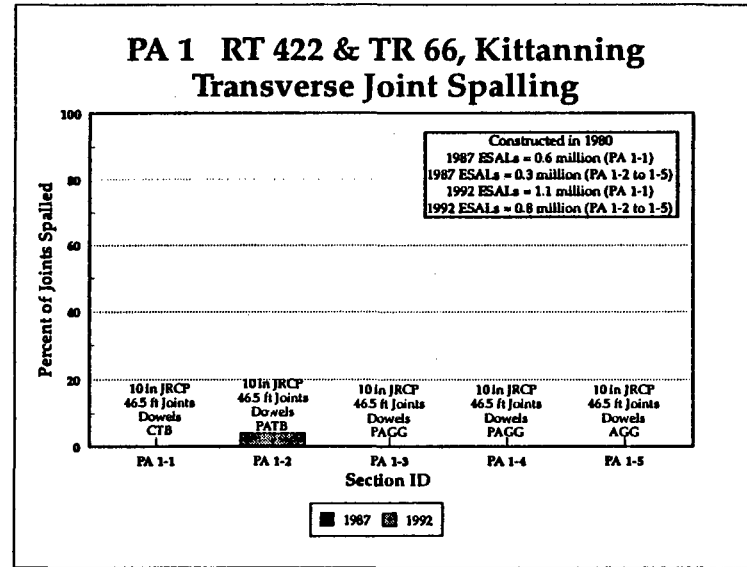
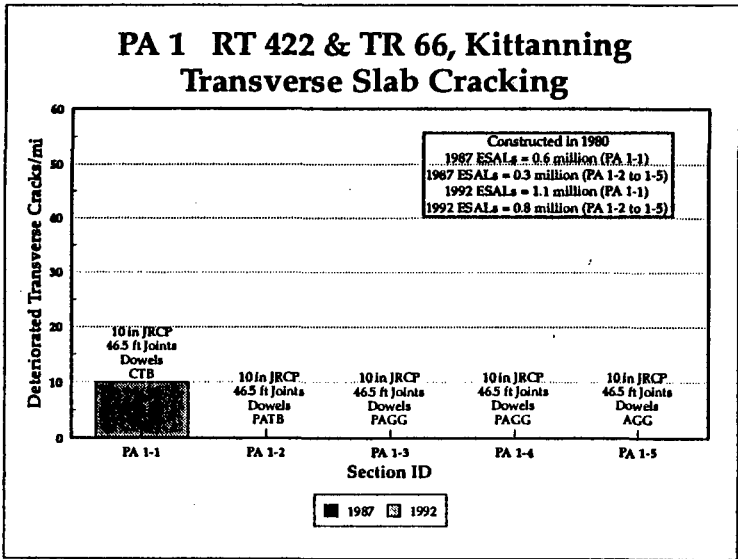
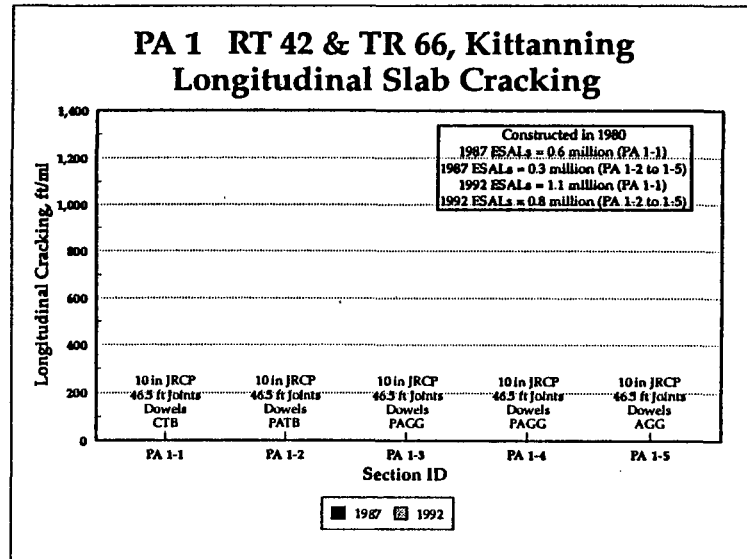
Figure 49. Performance summary for PA 1 sections.

A summary of the outer lane performance data for PA 1 is shown in table 52 and presented graphically in figures 49 through 51. The only significant difference in the performance of the different designs is the deterioration of transverse cracks in PA 1-1, the CTB section. This cracking may be expected since stiffer base leads to higher curling stresses in the slab. No section has an appreciable amount of faulting or spalling at the joints.

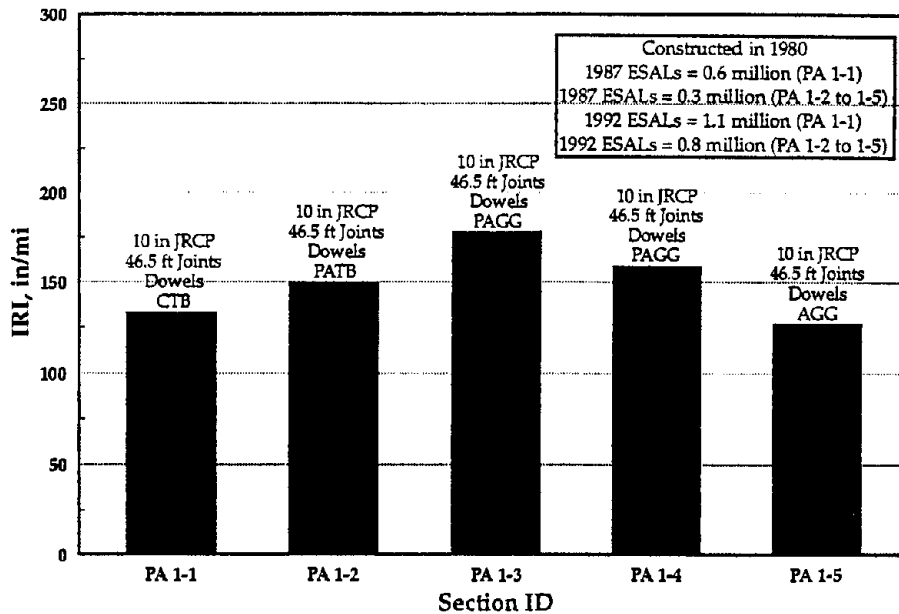
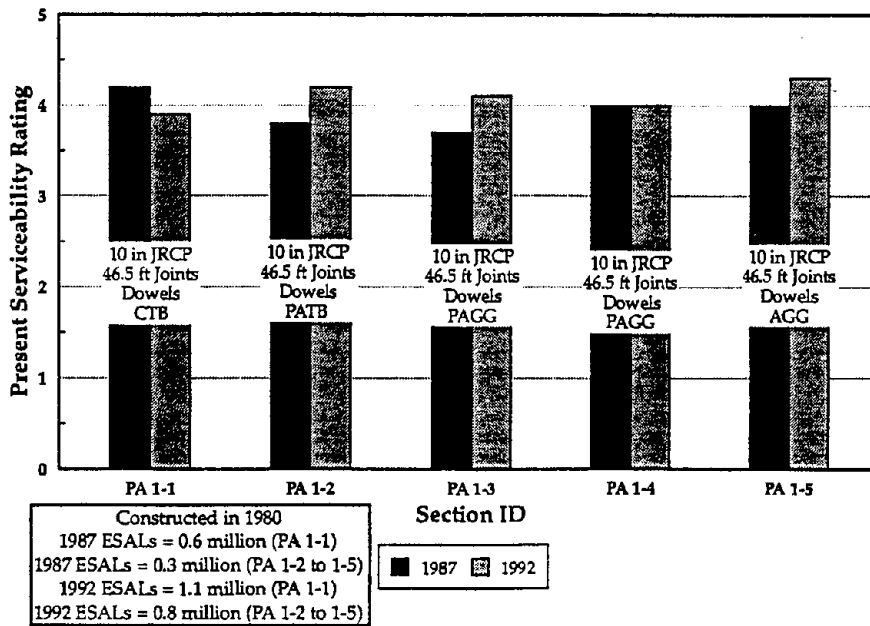
Figure 50. Roughness and serviceability for PA 1 sections.

Roughness and serviceability of PA 1 sections are presented in figure 50. The ride quality on PA 1 sections is very good and all sections have similar serviceability. PA 1-3 has slightly higher IRI than other sections and PA 1-5 is slightly lower. The deviation is relatively small, but the cause of the deviation is difficult to understand. The two sections have similar levels of faulting and exhibit no other distresses.

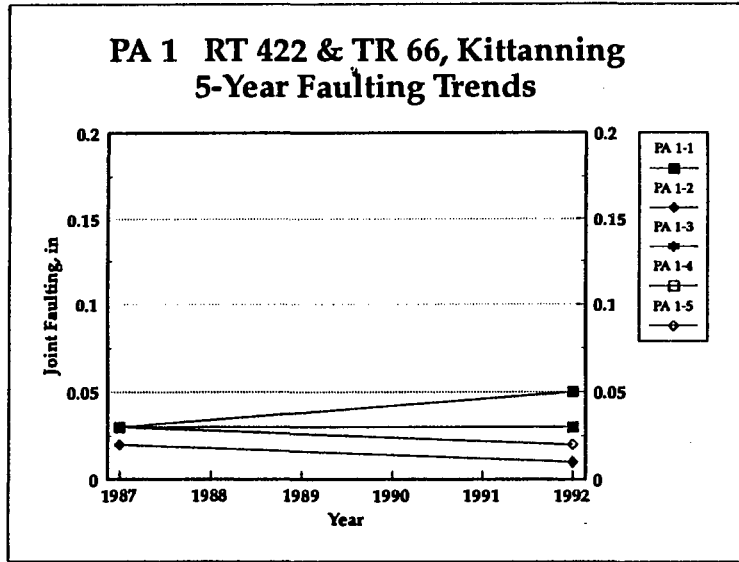
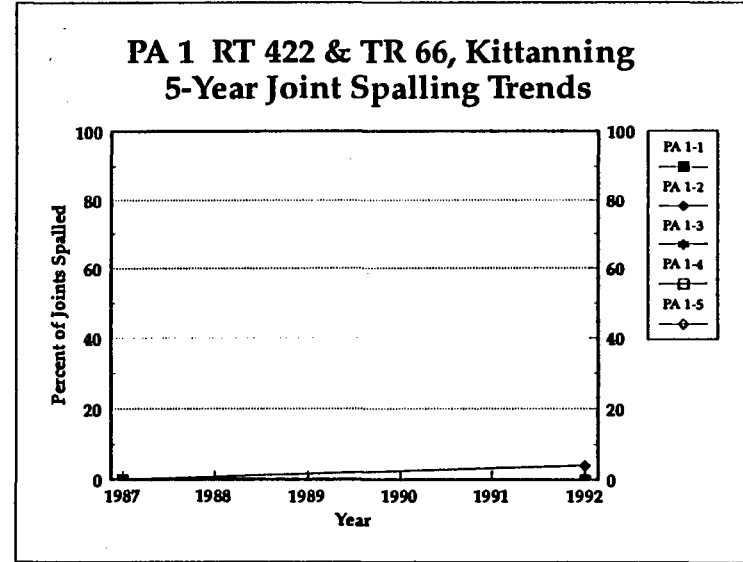
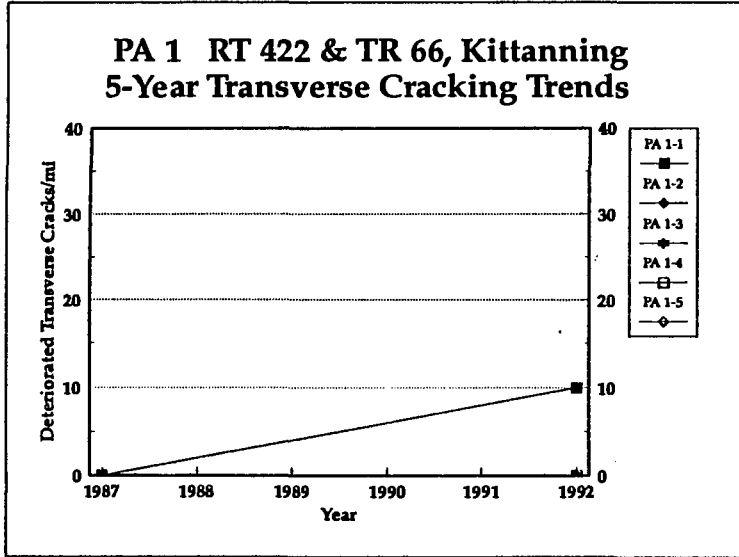
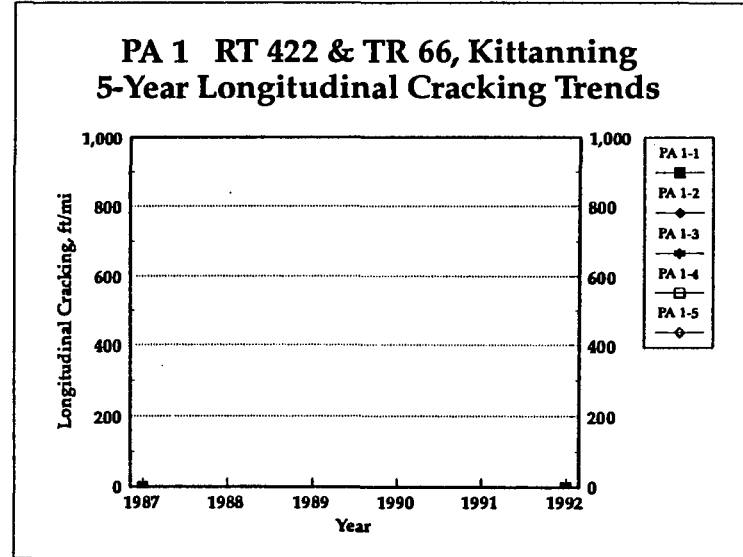
Figure 51. 5-year performance trends for PA 1 sections.

The 5-year performance trends of PA 1 sections is presented in figure 51. The only notable changes since 1987 are the slight increase in the amount of deteriorated transverse cracks and faulting in PA 1-1. PA 1-1 is constructed on a CTB, and is the only section with deteriorated transverse cracks. The amount of faulting in all sections is negligible (average of about 0.03 in [0.8 mm]) and faulting in PA 1-1 is also not significant (0.05 in [1.3 mm]), but while faulting in other sections remained the same since 1987, the faulting in PA 1-1 has roughly doubled. No other significant change was observed.

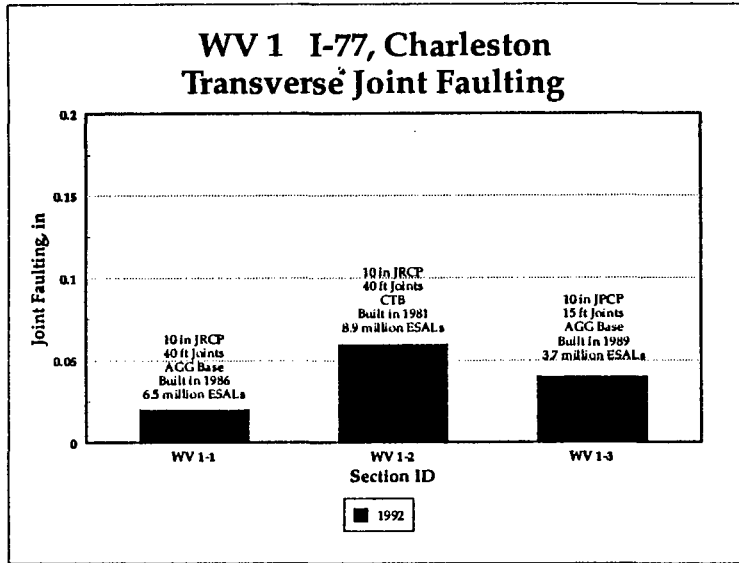
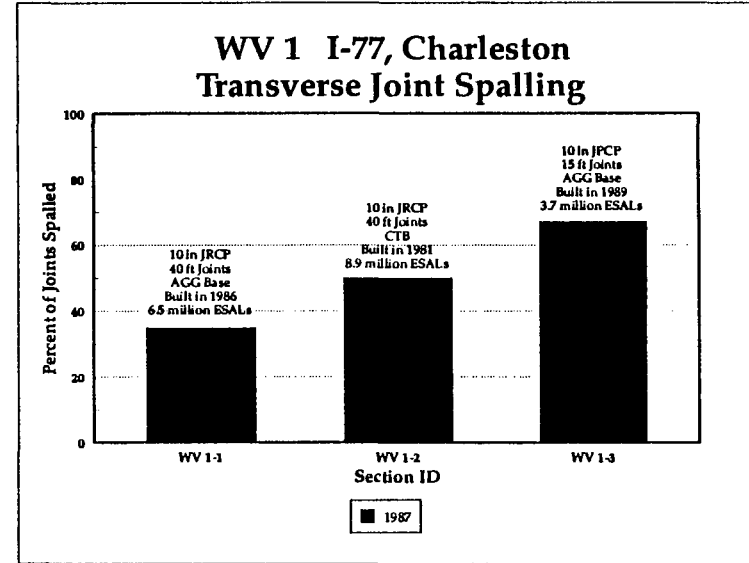
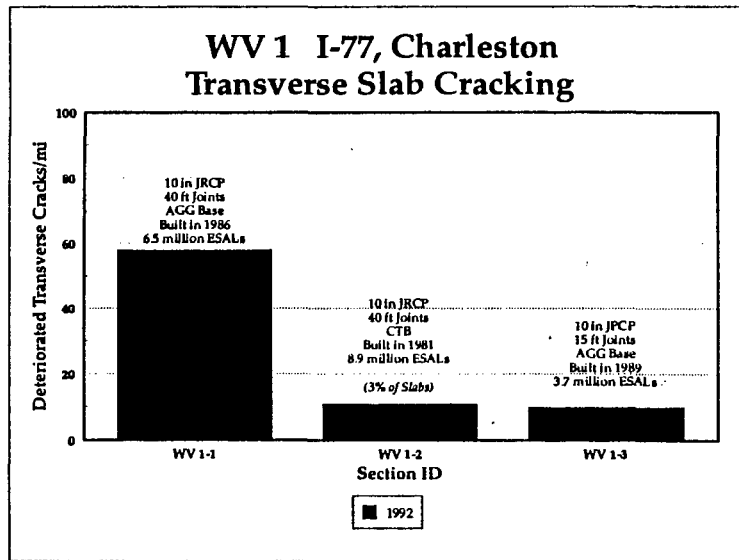
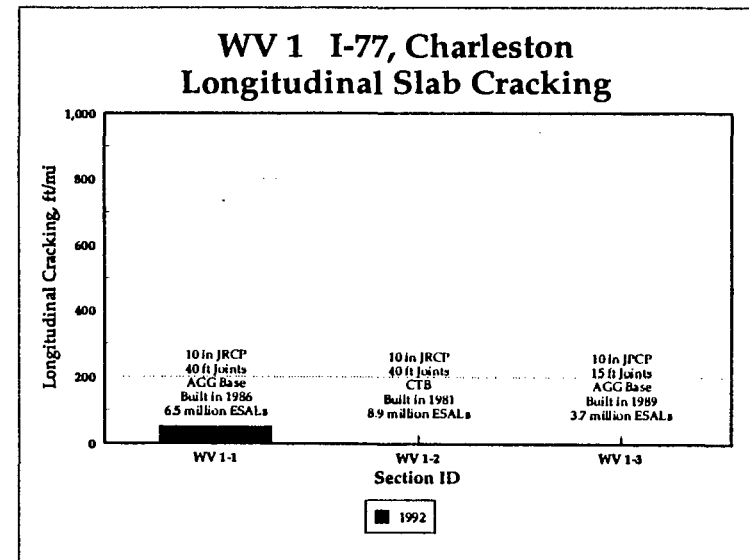
Figure 52. Performance summary for WV 1.

The performance data for these sections are summarized in table 53. Figure 52 presents that data in graphical format. The oldest section (WV 1-2), shows the most faulting of the three sections, although the level of faulting is not that substantial. WV 1-1 shows the most transverse slab cracking, with deteriorated transverse cracks found on nearly one-half of the slabs in the survey section. The small percentage of reinforcing steel (0.1 percent) evidently was unable to hold the transverse cracks tight and prevent them from deteriorating. However, the reason why the transverse cracks have not deteriorated as much on WV 1-2 (which is older than 1-1) is not clear.

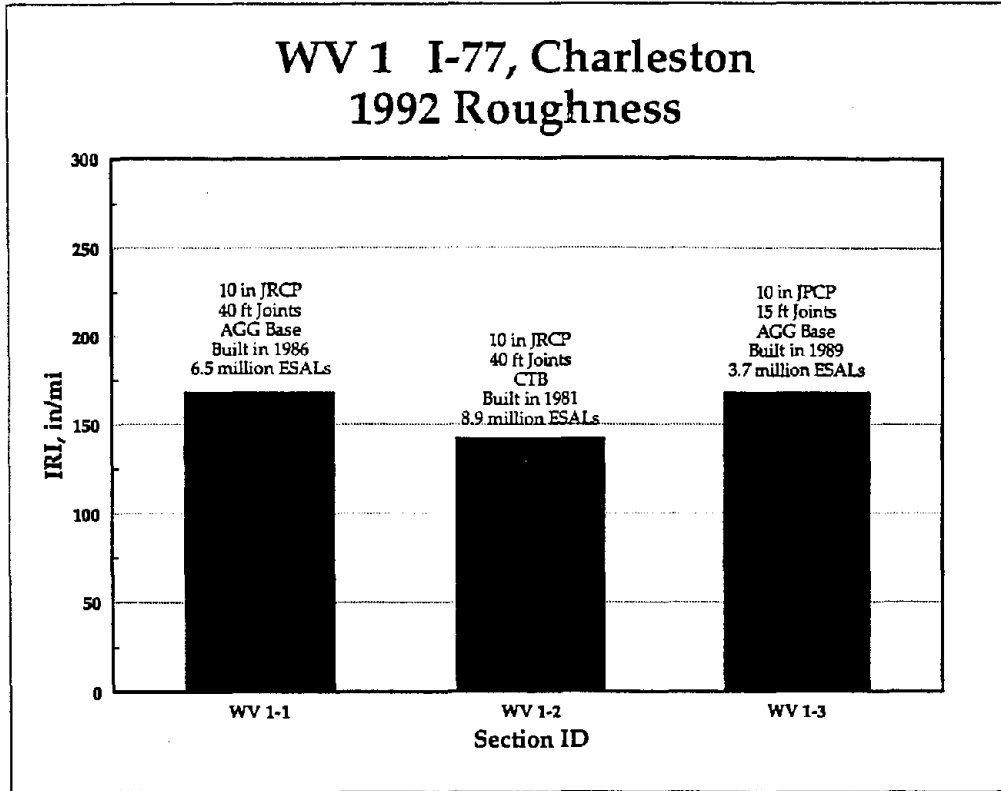
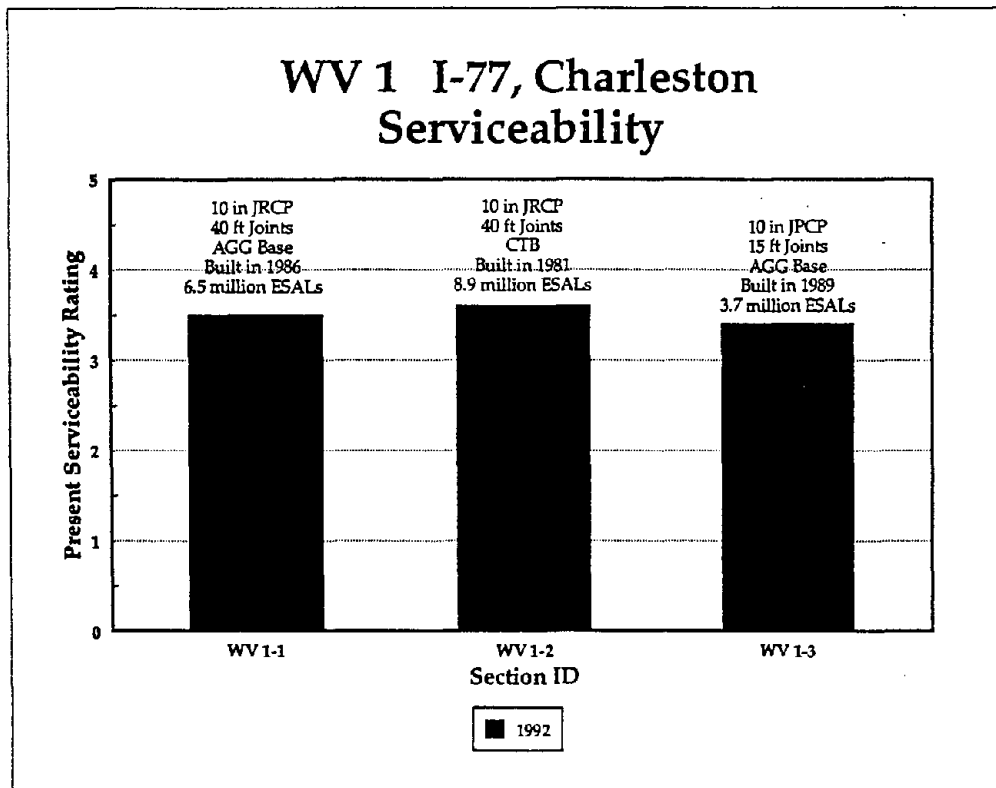
Figure 53. Roughness and serviceability for WV 1.

Roughness and serviceability data for the WV 1 sections are shown in figure 53. The roughness data indicate that section 1-2 is the smoothest riding pavement, with the two newer sections (1-1, 1-3) having the same roughness. These trends also appear in the serviceability data, with section 1-2 having a higher serviceability than the other two sections.

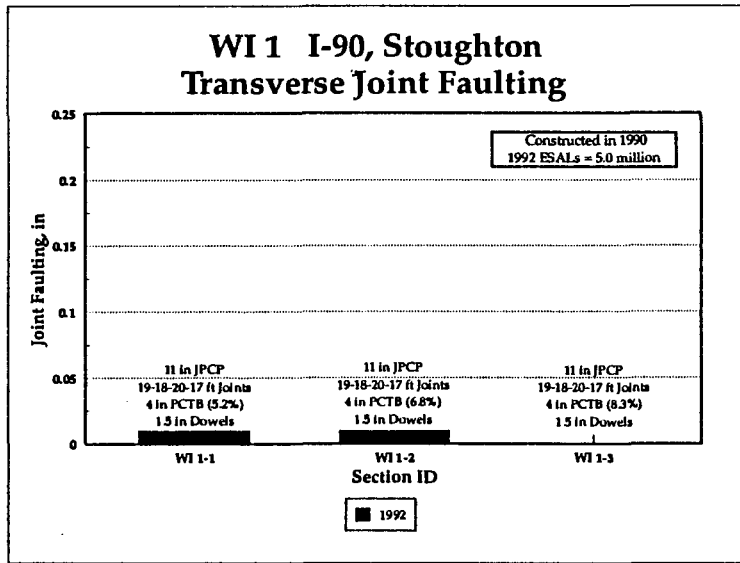
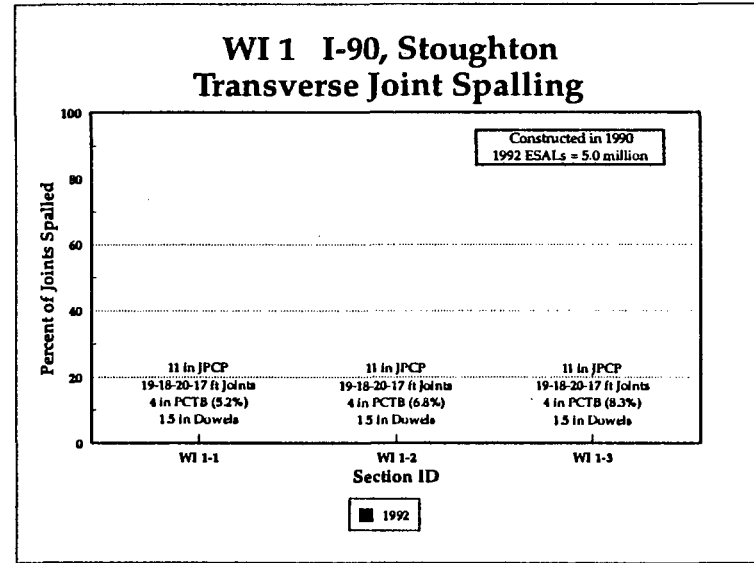
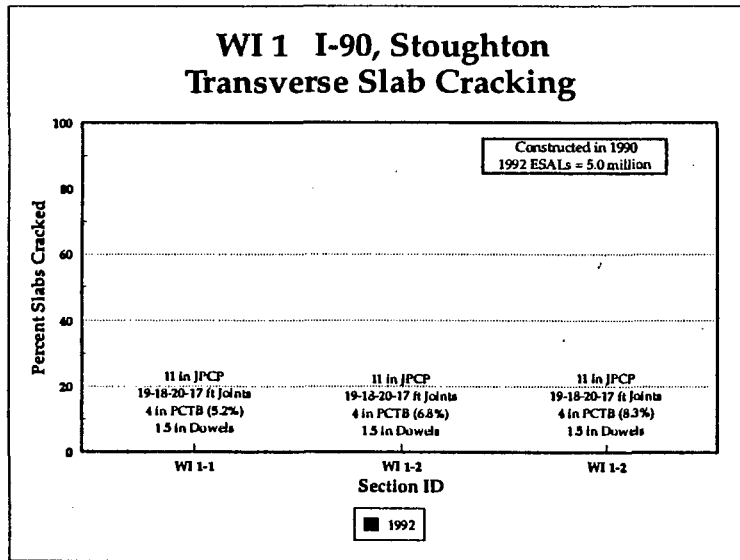
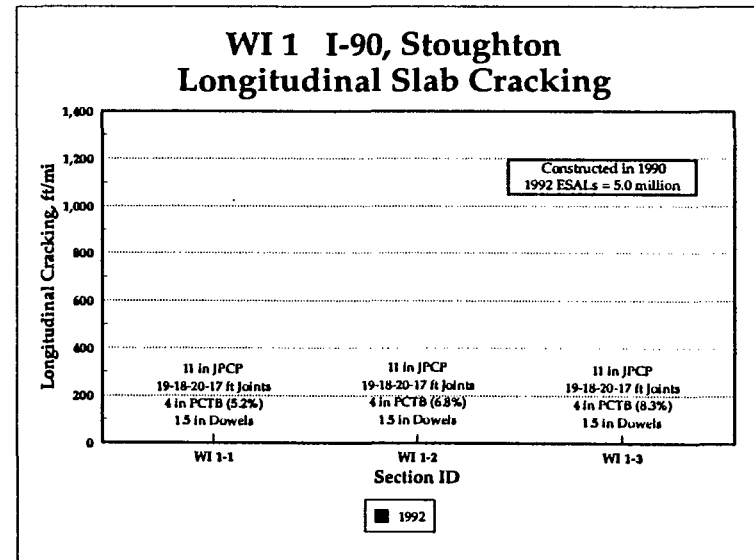
Figure 54. Performance summary for WI 1.

The performance data collected from this project is shown in table 55 and in figure 54. As can be seen from this information, these 2-year-old sections are performing very well. Very little joint faulting is exhibited and there are no signs of any structural deterioration. However, the PSR values do not correspond well with the distress measurements.

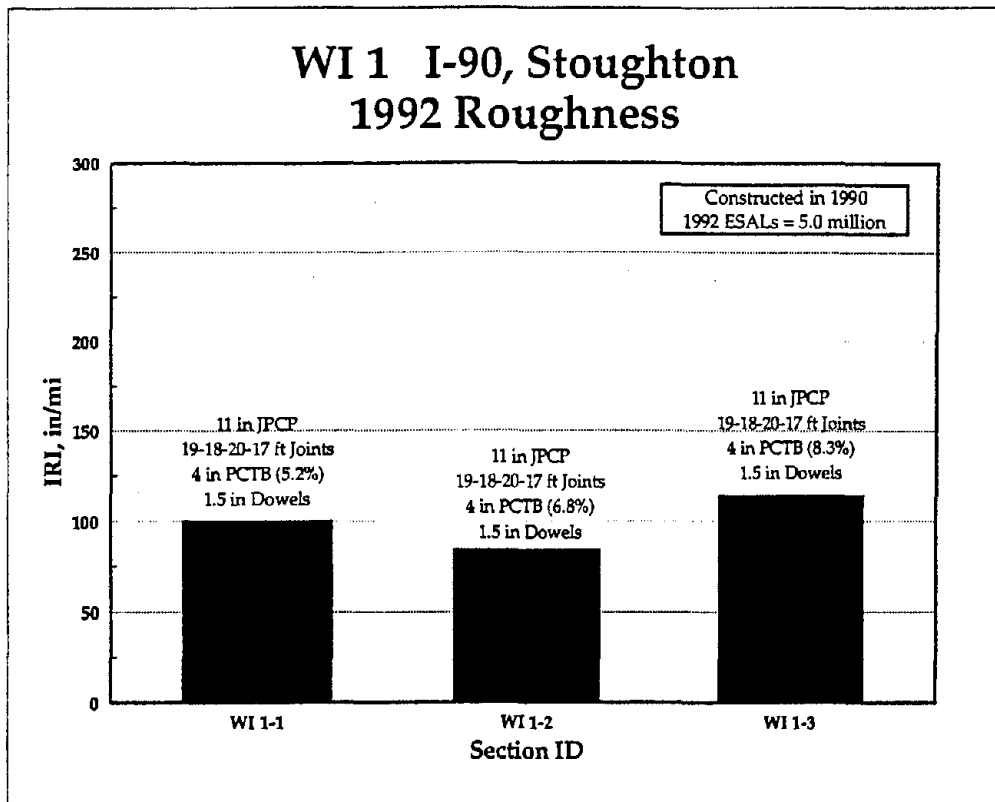
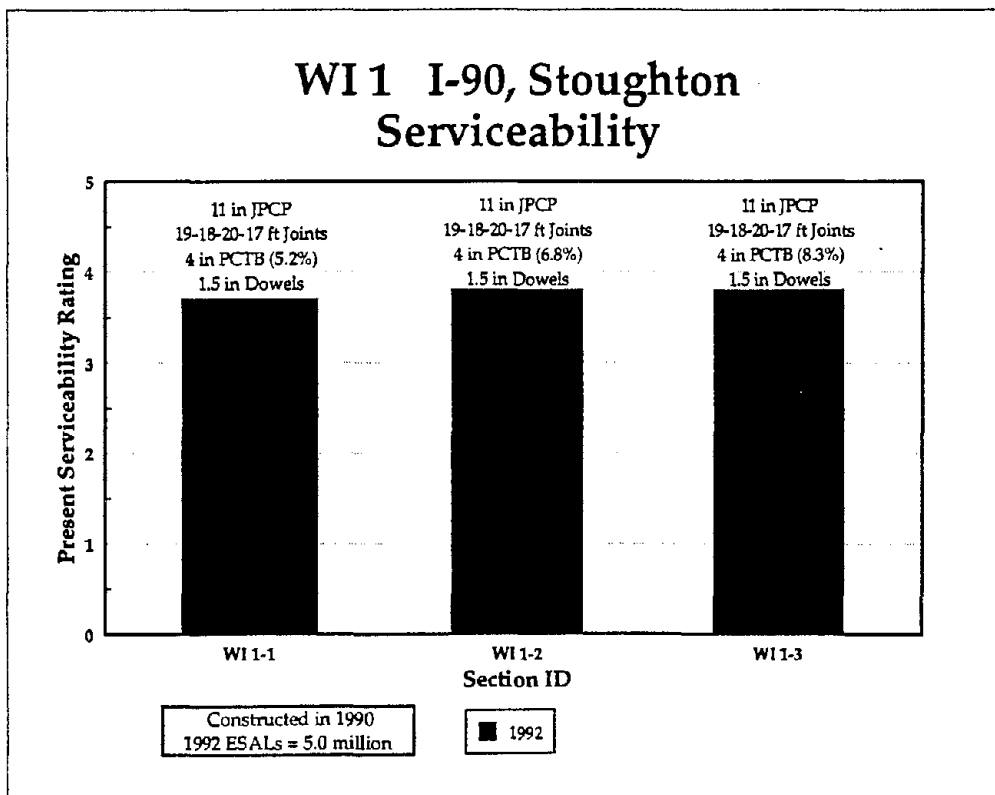
Figure 55. Roughness and serviceability for WI 1.

Figure 55 illustrates the roughness and serviceability data for the WI 1 sections. This information shows that all sections are very smooth, with only small differences in roughness. The serviceability data also indicate that each section is providing good serviceability.

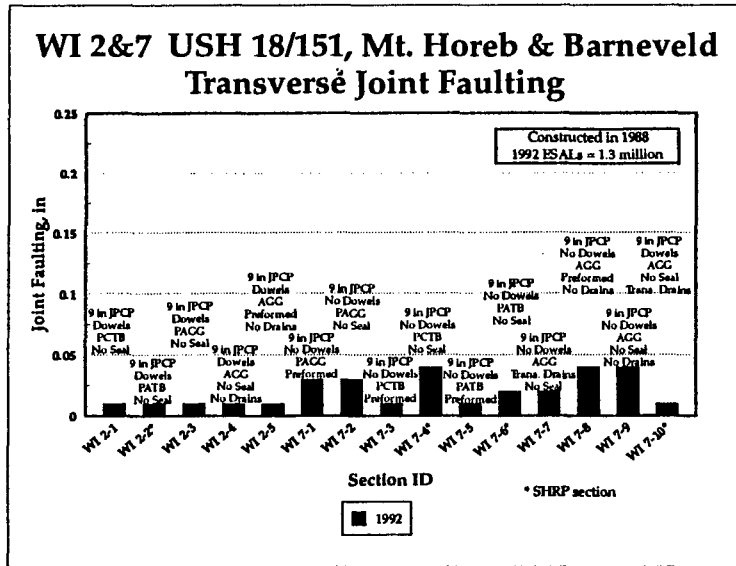
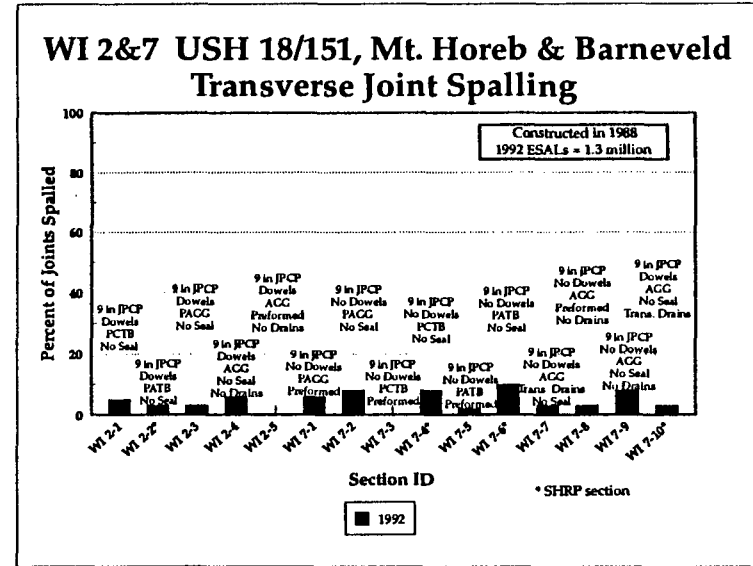
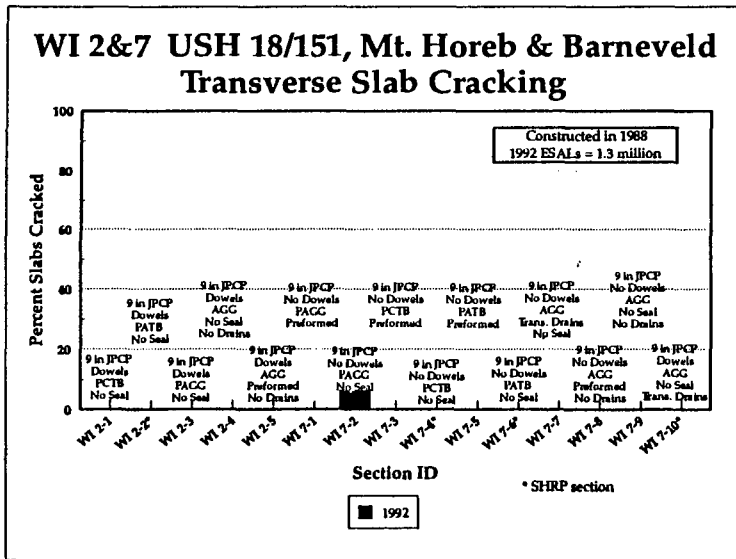
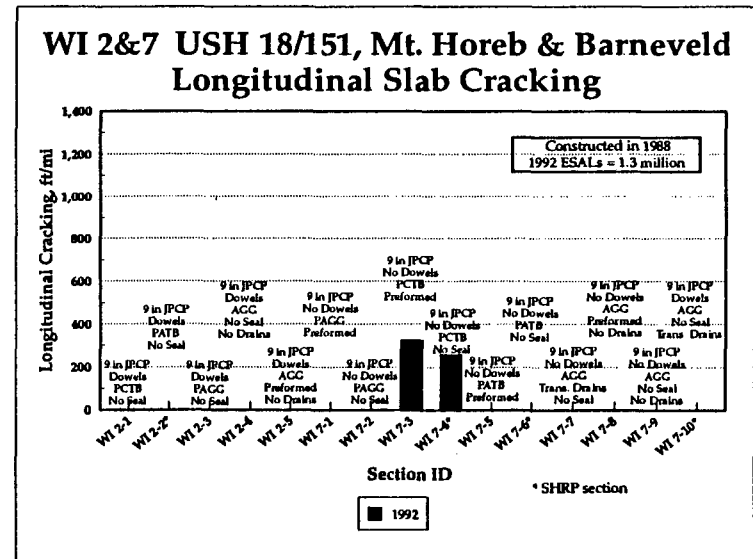
Figure 56. Performance summary for WI 2 and WI 7.

The performance data for the WI 2 and WI 7 experimental sections are presented in table 57 and in figure 56. An examination of this information indicates that these sections are performing very well after 4 years of service. Because of the small amount of distress that has developed, it is difficult to draw definitive conclusions regarding the relative performance of the section. For example, the faulting on the doweled sections is consistently lower than that of the nondoweled sections, although the difference is not significant. As another example, sections with preformed joint seals have less spalling than nonsealed sections, although again the difference is not significant. Finally, the PATB sections show less faulting than the PCTB or the PAGG, but this difference is not significant.

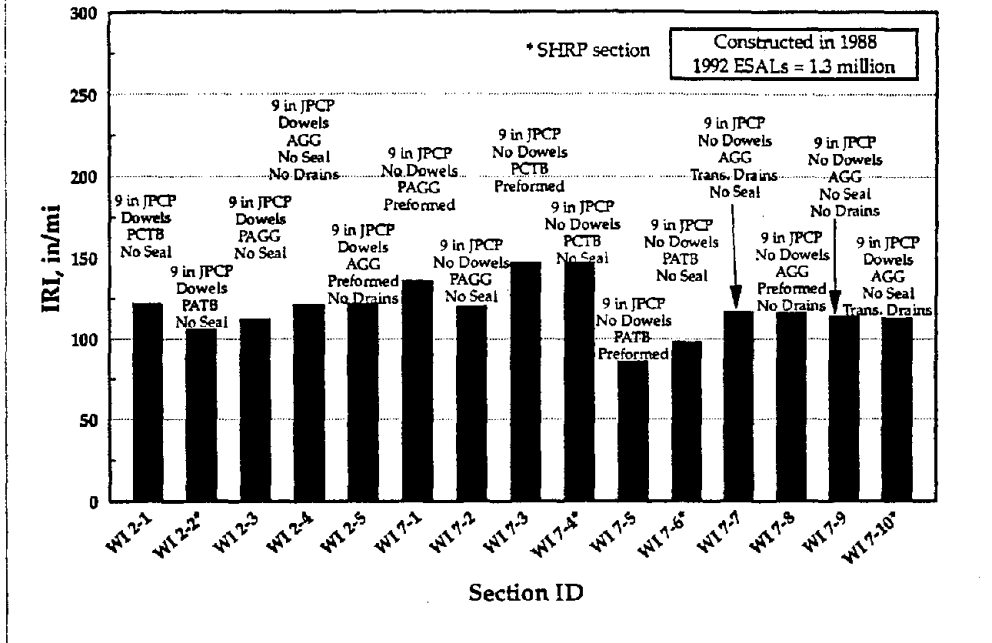
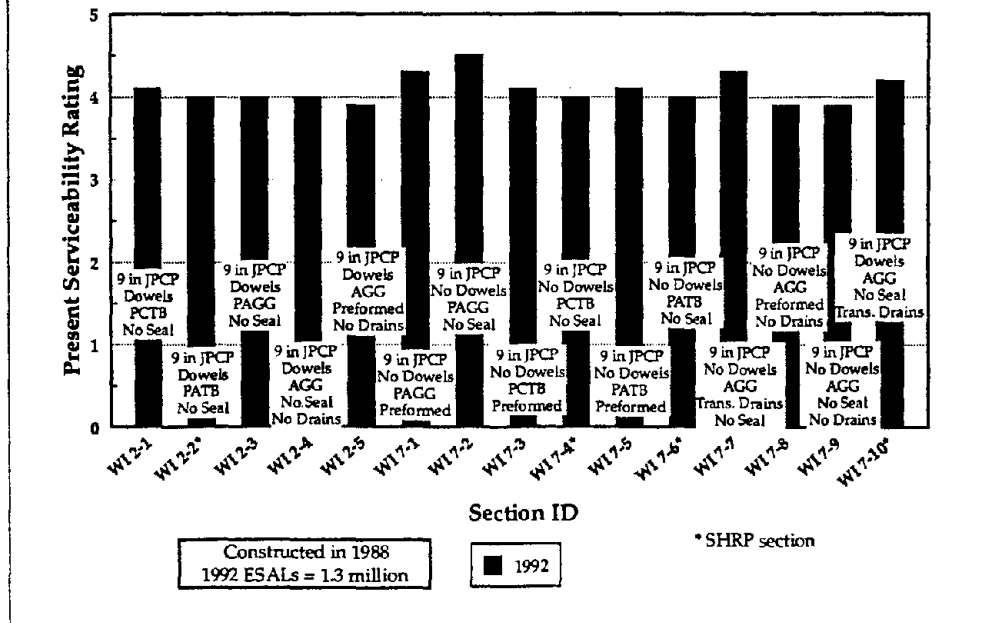
Figure 57. Roughness and serviceability for WI 2 and WI 7.

Figure 57 presents the roughness and serviceability data for the WI 2 and WI 7 sections. The roughness data for most of these sections are clustered relatively close together, with a few exceptions. For example, the smoothest sections on the project are WI 7-5 and WI 7-6, which are both constructed on PATB. This result is in contrast with sections 7-3 and 7-4, which are the two roughest sections on the project and are constructed on PCTB. By also considering section 7-1 (constructed on PAGG), these data may suggest that the PATB can be easily constructed and can provide a stable working platform for paving operations. Often, PAGG can be difficult to construct and may be unstable under construction traffic, exhibiting rutting or shoving. For this reason, some states prohibit hauling on permeable bases.

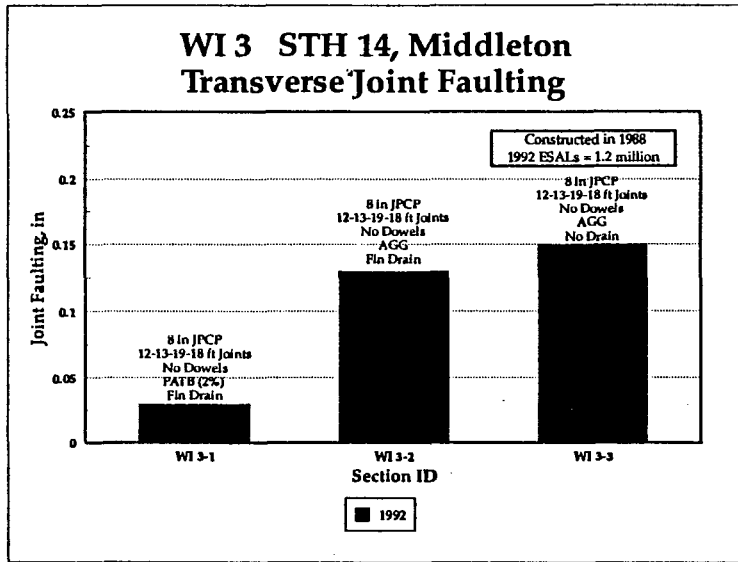
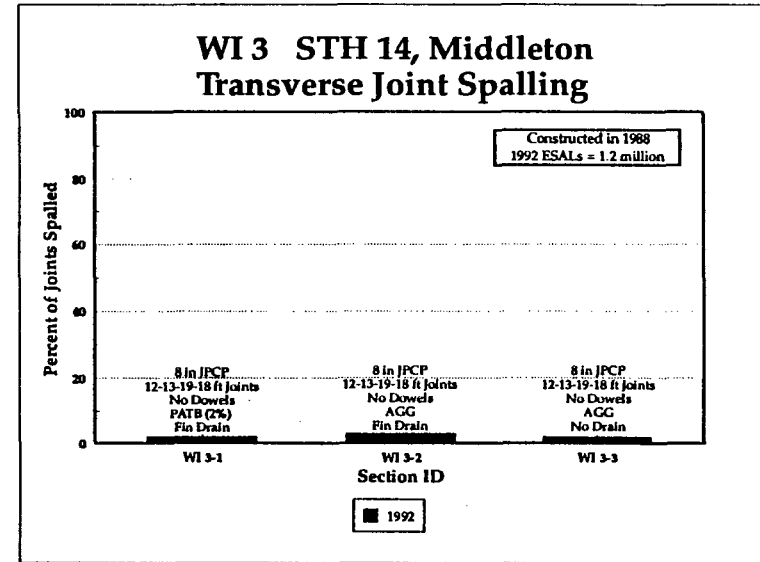
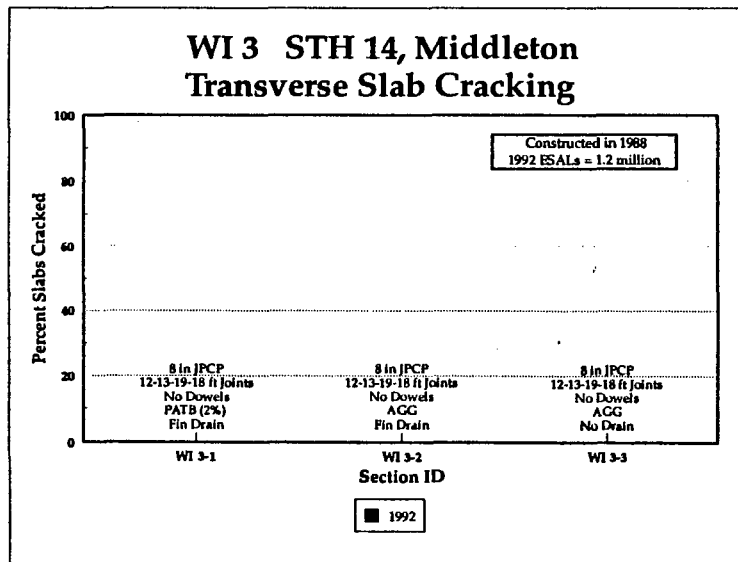
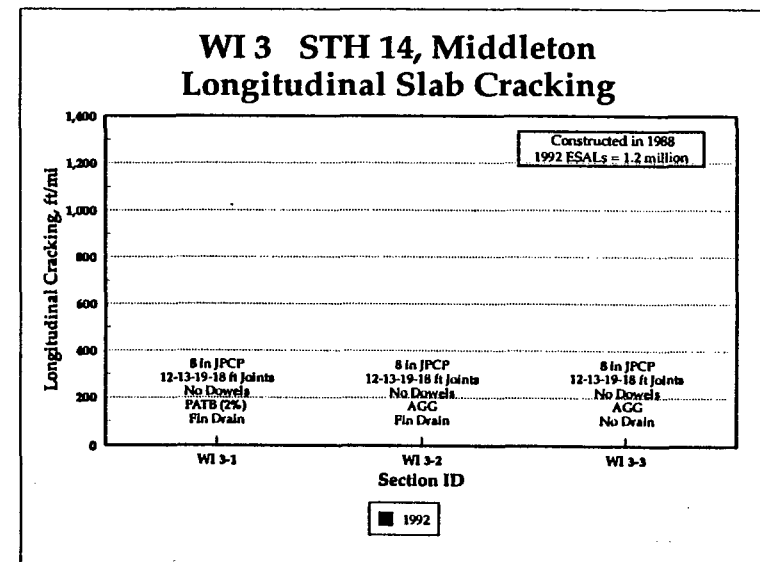
Figure 58. Performance summary for WI 3.

The performance data for this project are summarized in table 59. This information is portrayed in figure 58 in graphical format. With the exception of joint faulting, these sections are relatively free of distress.

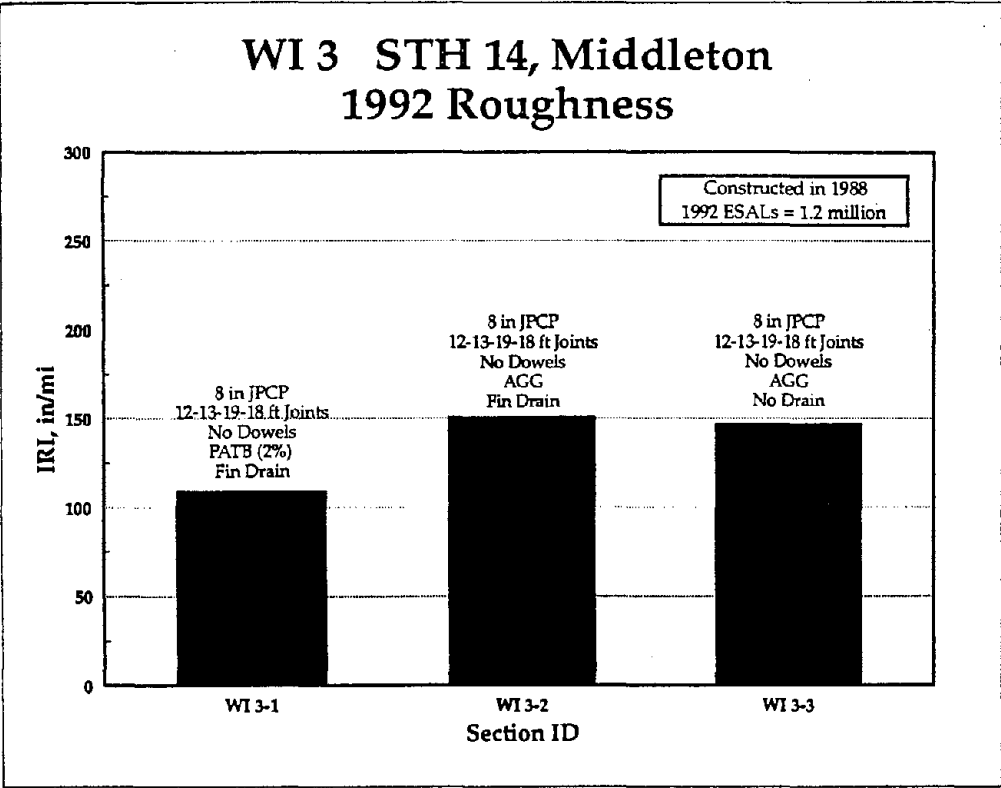
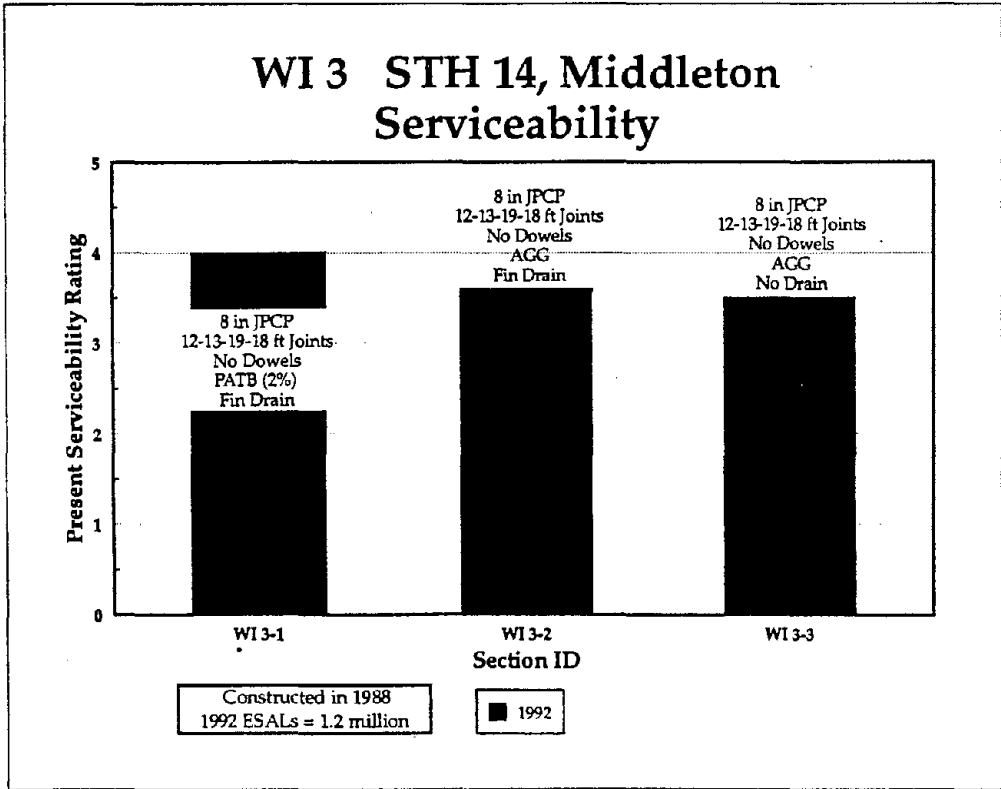
Figure 59. Roughness and serviceability for WI 3.

The roughness and serviceability data for the WI 3 sections are shown in figure 59. This information shows that, as expected, the section constructed on the permeable base is much smoother and has a higher serviceability rating than the other two sections. The critical levels of faulting exhibited by WI 3-2 and 3-3 no doubt contribute to the roughness recorded on those sections.

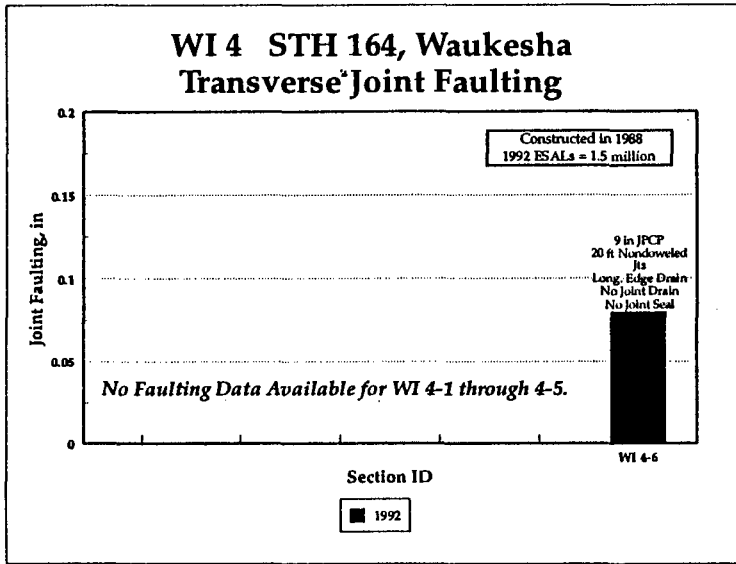
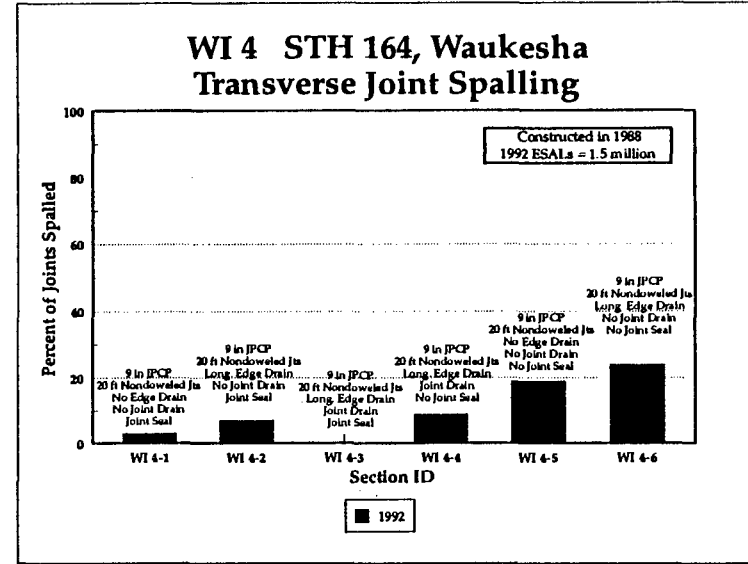
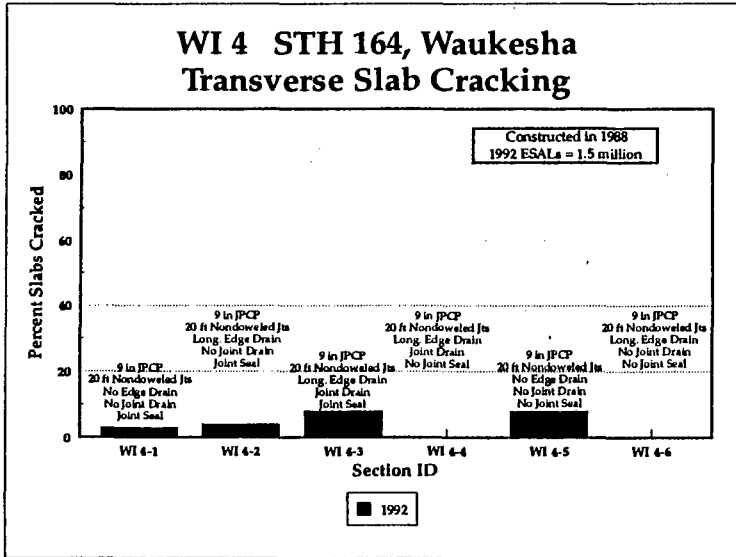
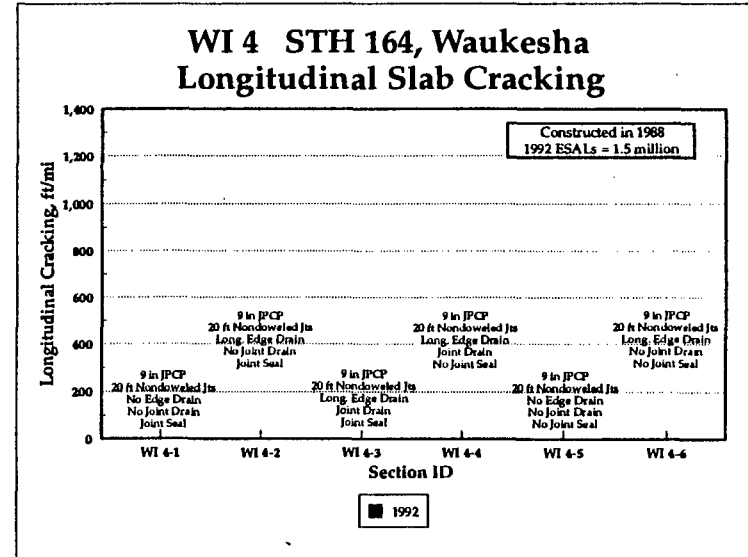
Figure 60. Performance summary for WI 4.

The available performance data for the WI 4 sections are provided in table 61 and displayed graphically in figure 60. The age of these sections (4 years) and the absence of faulting data for all but one section make the interpretation of the data difficult. The amount of faulting exhibited by WI 4-6 (0.08 in [2 mm]) is considered somewhat high for a pavement that is only 4 years old. When the faulting of section WI 4-6 is considered in conjunction with the faulting of WI 3-2, it appears to suggest that the presence of edge drains by themselves are not enough to ensure the reduction of faulting for nondoweled slabs.
