Performance of Concrete Pavements

Volume I: Field Investigation

PUBLICATION NO. FHWA-RD-94-177

JULY 1997

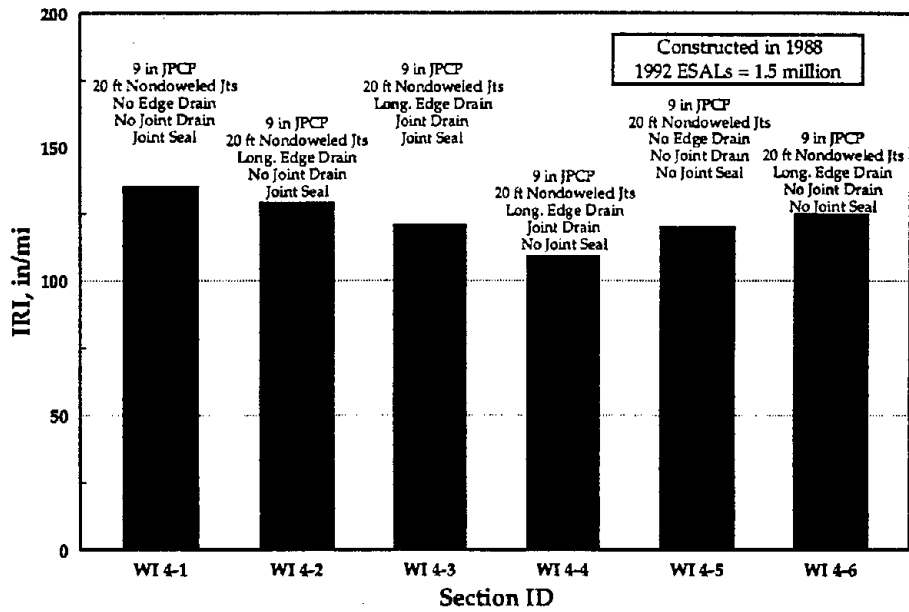
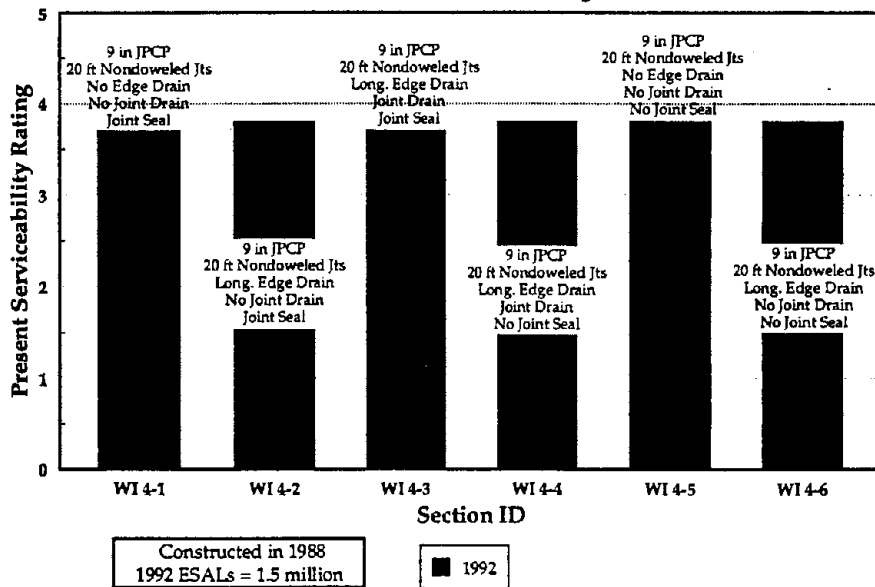
Figure 61. Roughness and serviceability for WI 4.

Figure 61 depicts the roughness and serviceability data collected for the WI 4 sections. For the most part, the roughness of these sections are clustered together, although there is a significant range of roughness values. The smoothest section is noted to be WI 4-4, while the roughest is WI 4-1. These two sections are quite different in design, as WI 4-4 contains both transverse and longitudinal drains but no joint sealant, whereas WI 4-1 contains joint sealant but no drainage features. The serviceability data indicate no significant differences in the rideability.

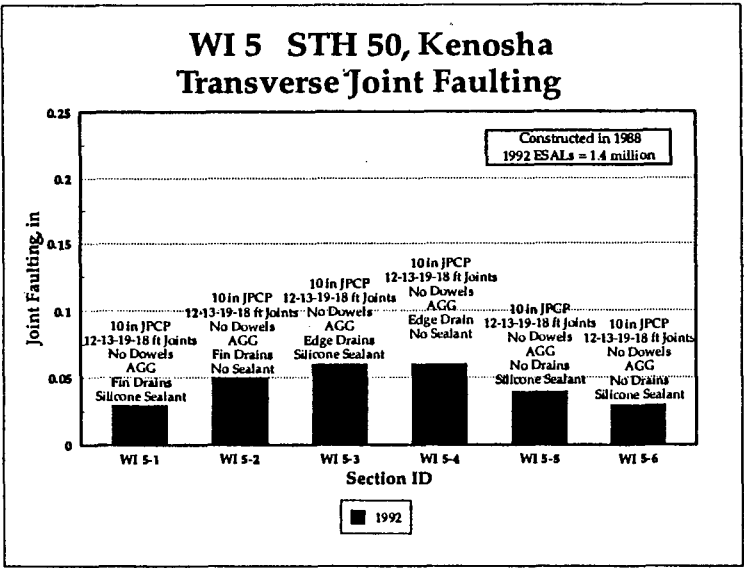
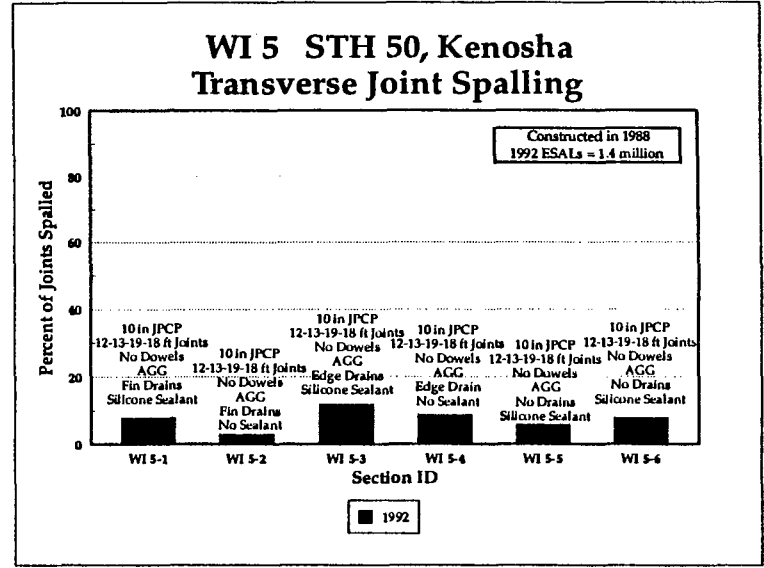
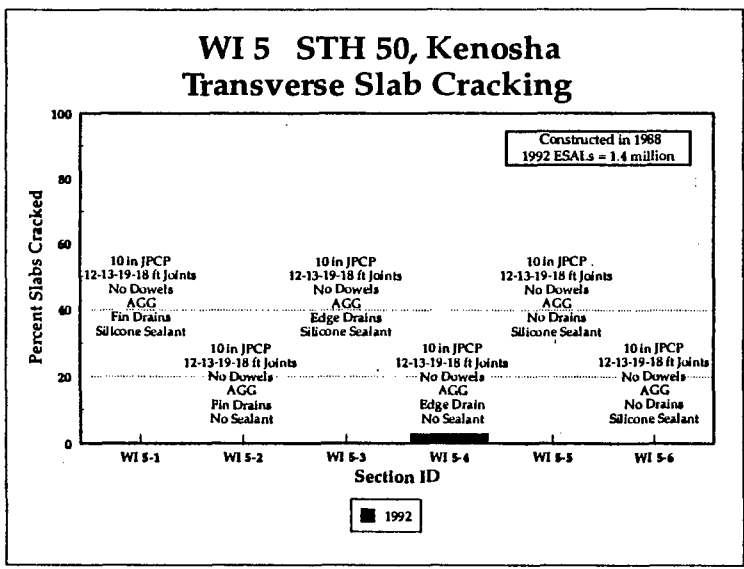
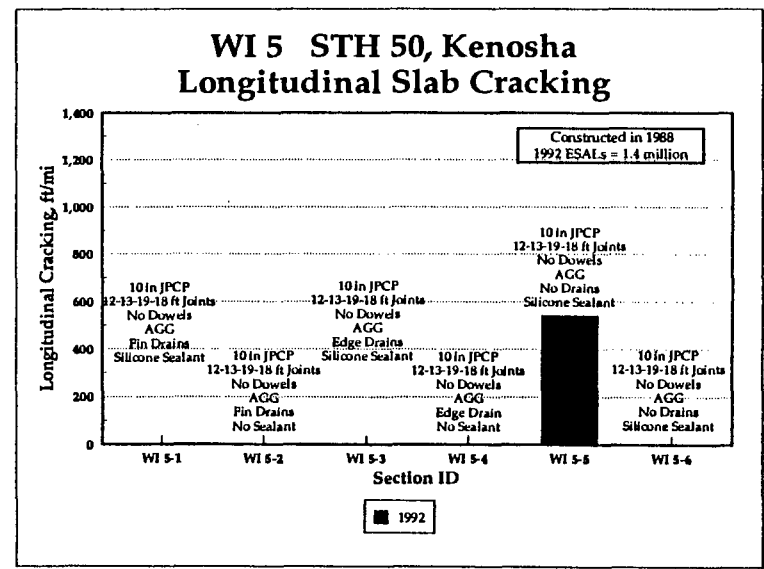
Figure 62. Performance summary for WI 5.

The performance data for the WI 5 sections are summarized in table 63. The same information is illustrated in figure 62.

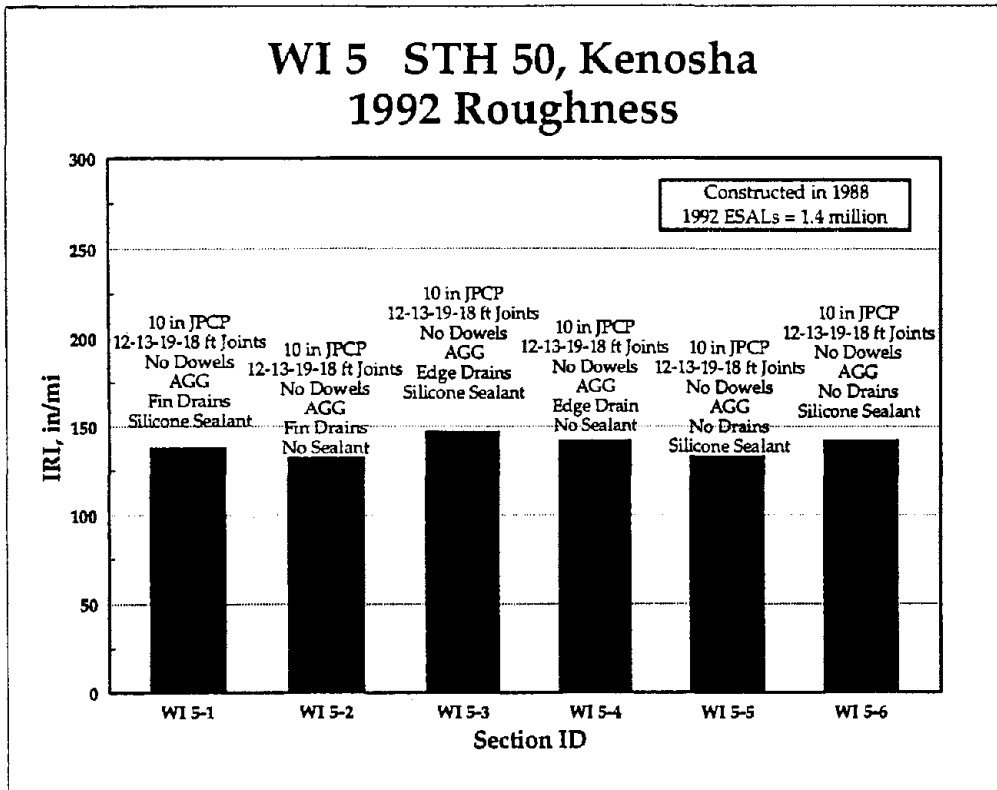
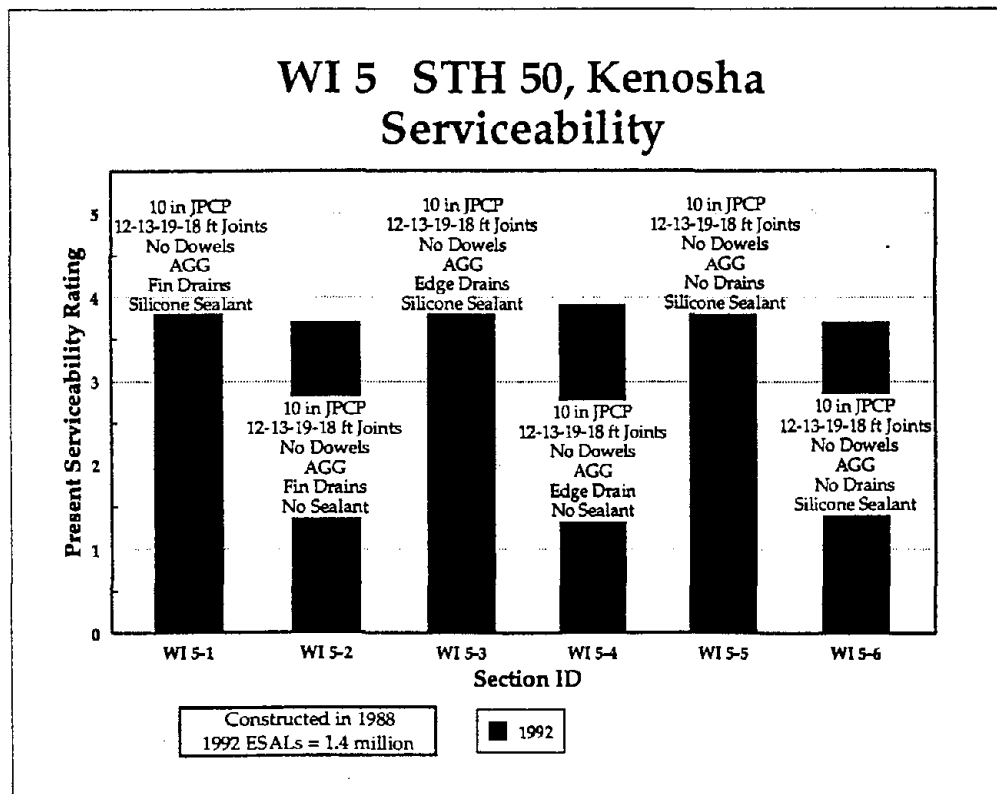
Figure 63. Roughness and serviceability for WI 5.

The roughness and serviceability data for the WI 5 sections are illustrated in figure 63. The roughness values for these sections are clustered closely together, as are the serviceability ratings. No apparent trends present themselves regarding the rideability of the various pavement sections.

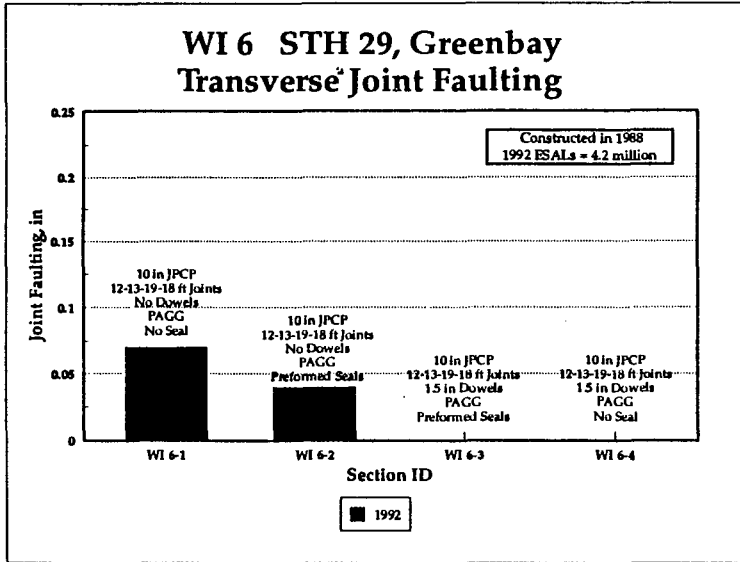
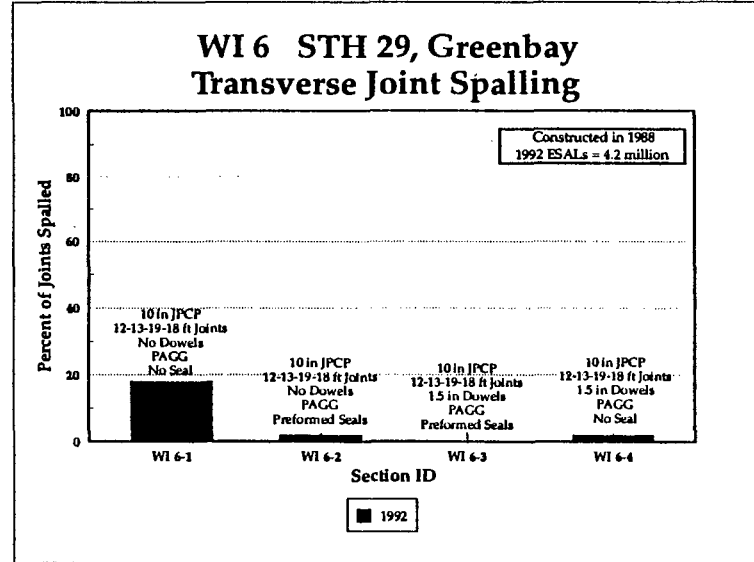
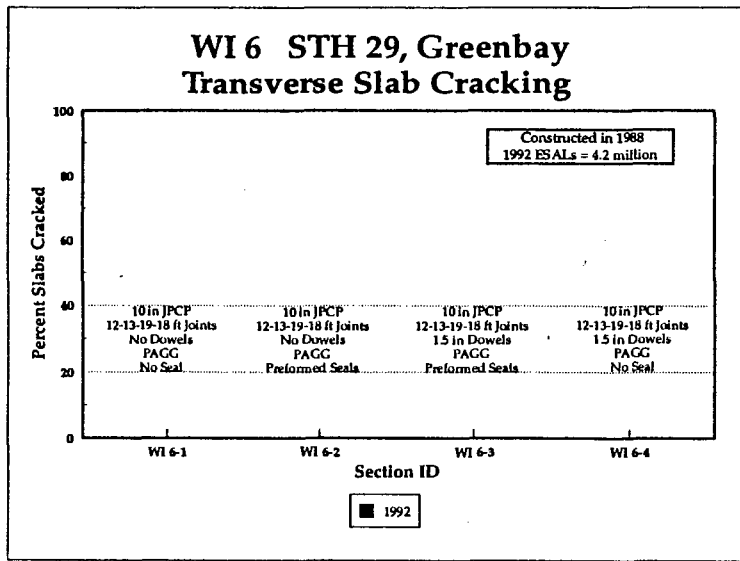
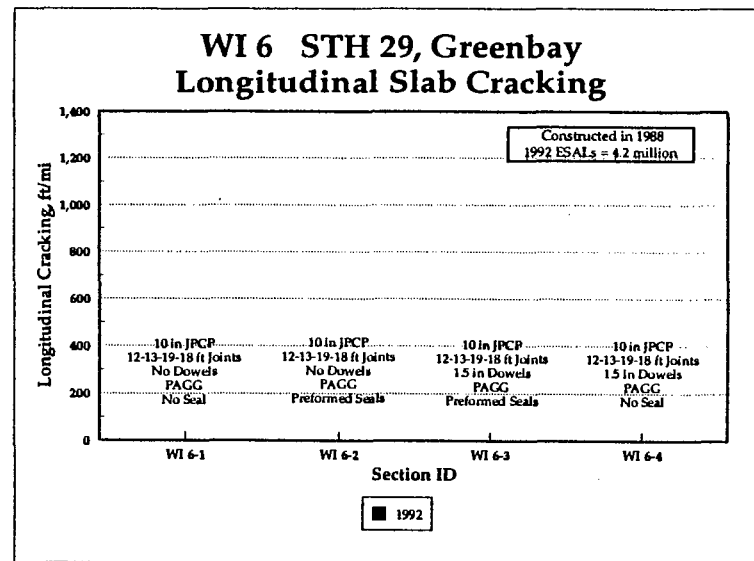
Figure 64. Performance summary for WI 6.

The performance data for these sections are given in table 65 and in figure 64. This information clearly shows the benefits of dowel bars in reducing joint faulting, even after only 4 years of service. The doweled sections are showing no faulting, whereas both of the nondoweled sections are exhibiting significant levels of faulting for a 4-year-old pavement.

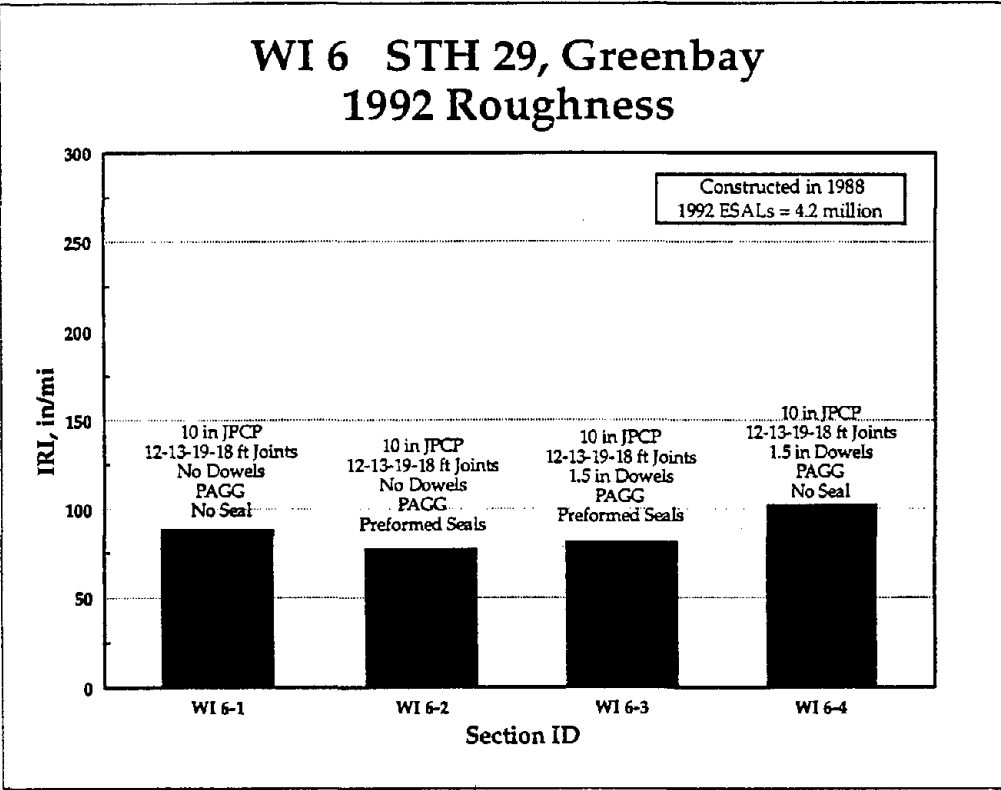
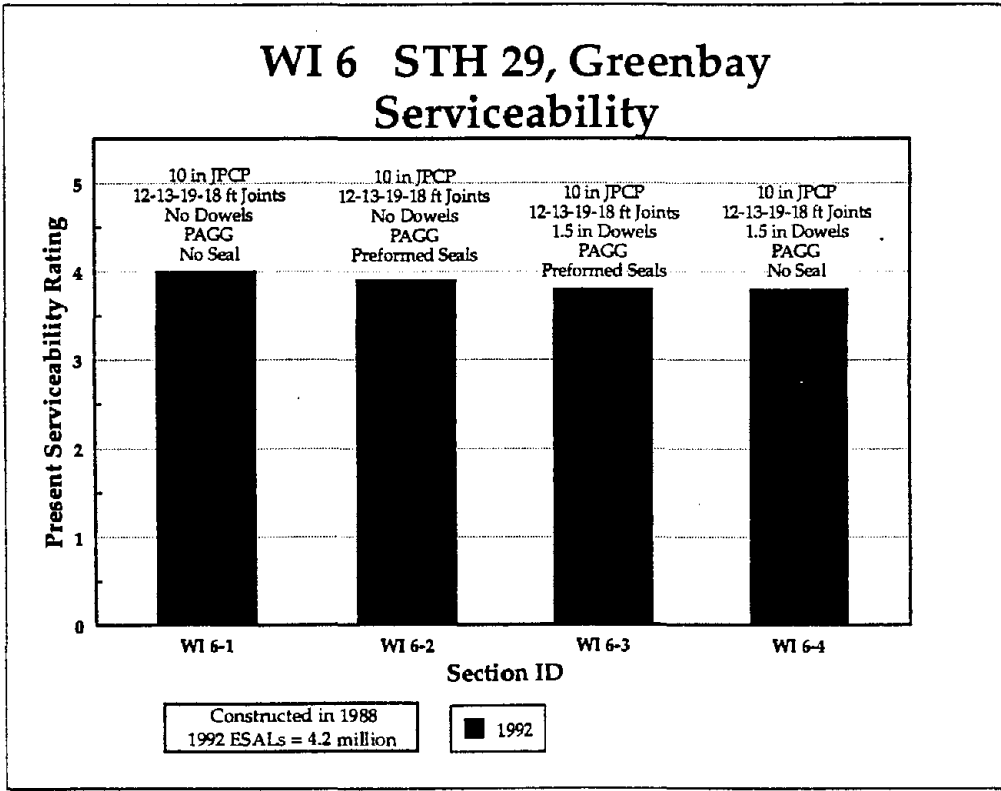
Figure 65. Roughness and serviceability for WI 6.

Figure 65 illustrates the roughness and serviceability data for these sections. The roughness data indicate that these sections are very smooth with little perceptible differences between pavement sections. The serviceability data also indicate the excellent rideability furnished by these sections.

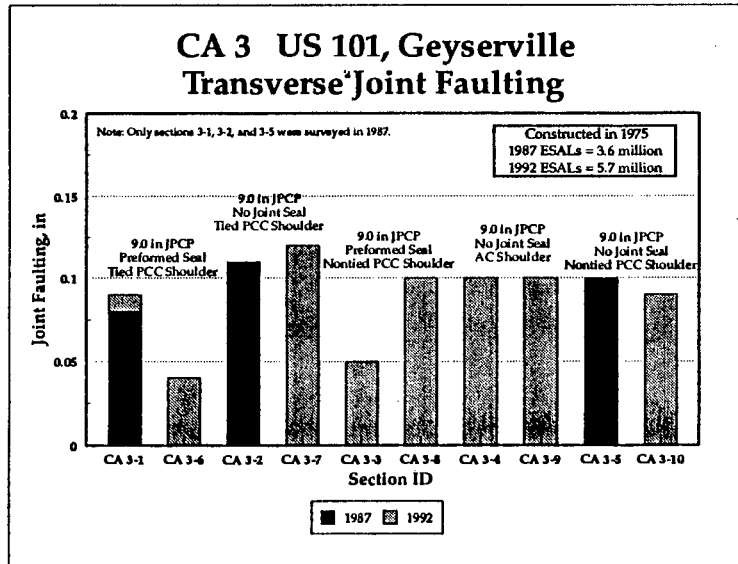
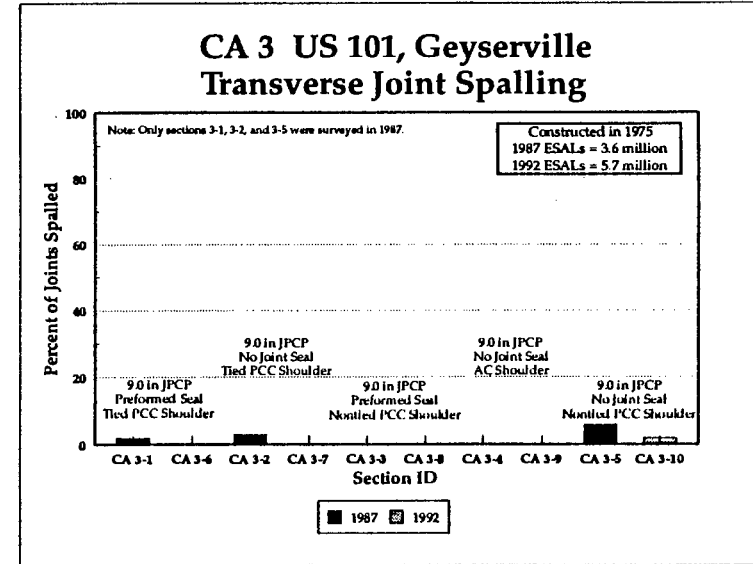
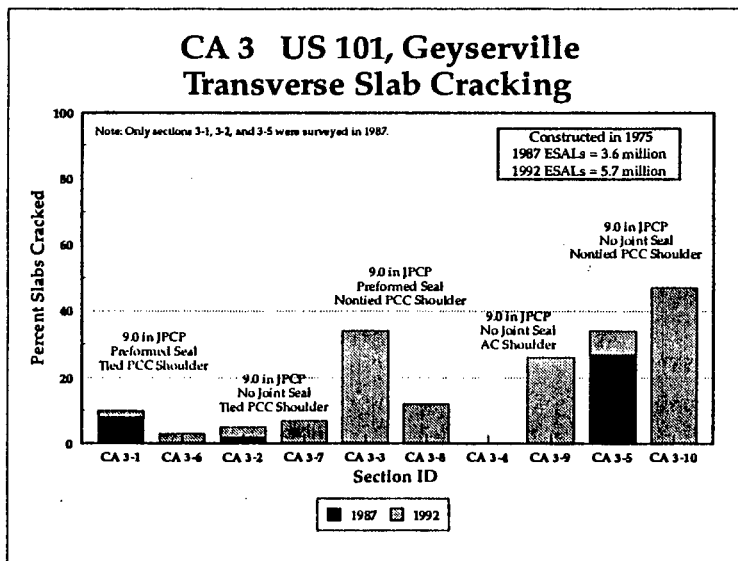
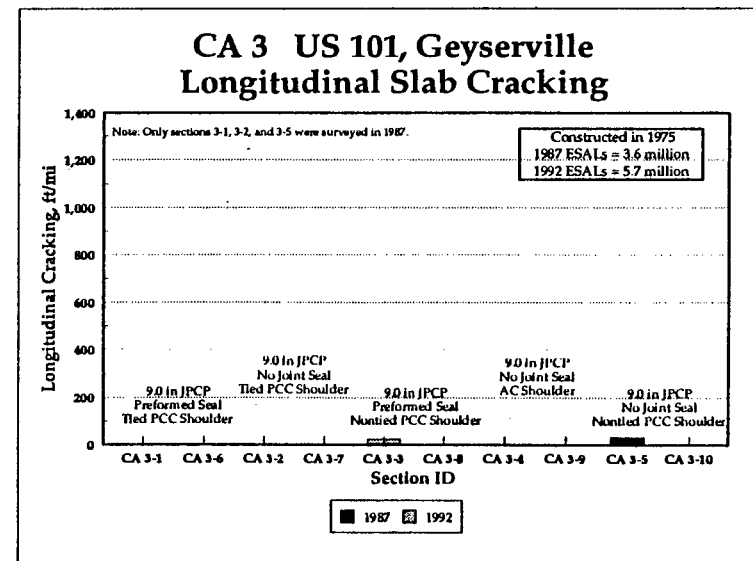
Figure 66. Performance summary for CA 3.

The performance of these sections is summarized in table 67 and in figure 66. The effect of joint sealing can be examined by comparing the performance of CA 3-1 and CA 3-6 with CA 3-2 and CA 3-7, and by comparing CA 3-3 and CA 3-8 with CA 3-5 and CA 3-10. For the first group of sections with a tied PCC shoulder, the sections that are sealed are performing better than those that are not sealed. They have lower levels of faulting and joint spalling, although the amount of joint spalling that has developed on the nonsealed sections is not significant. Transverse cracking is about the same for both groups of sections.

For the sections constructed with nontied PCC shoulders, the sealed sections show no spalling while the nonsealed exhibit a small quantity of spalled joints. The sealed sections also show less transverse cracking, although the faulting is about the same for the sealed and nonsealed sections.

Evaluating the effect of shoulder type revealed that sections with tied PCC shoulders have fewer transverse cracks than other shoulder types. The additional support provided to the slab by the tied shoulder apparently was effective in reducing the magnitude of the critical edge stress, thereby reducing the amount of transverse cracking. In addition, the tied shoulder appeared to have a slight effect in reducing joint faulting. The sections with AC shoulders exhibited fewer transverse cracks than the sections without tied PCC shoulders and about the same number of transverse cracks as the sections with tied PCC shoulders. This phenomenon is likely

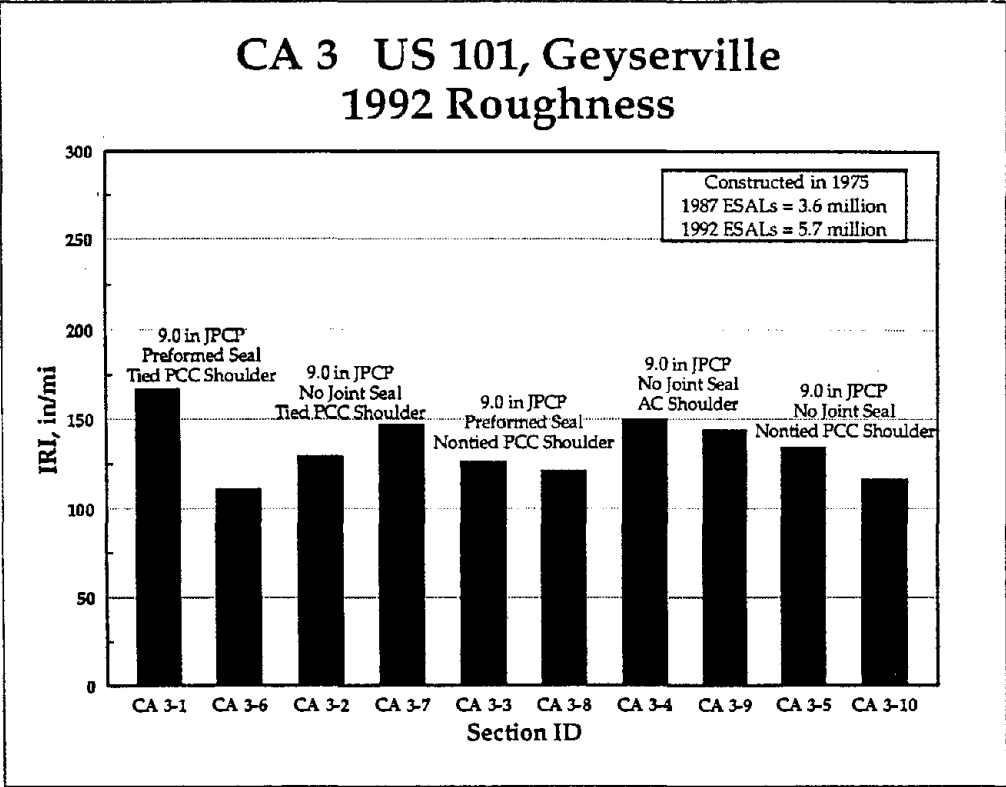
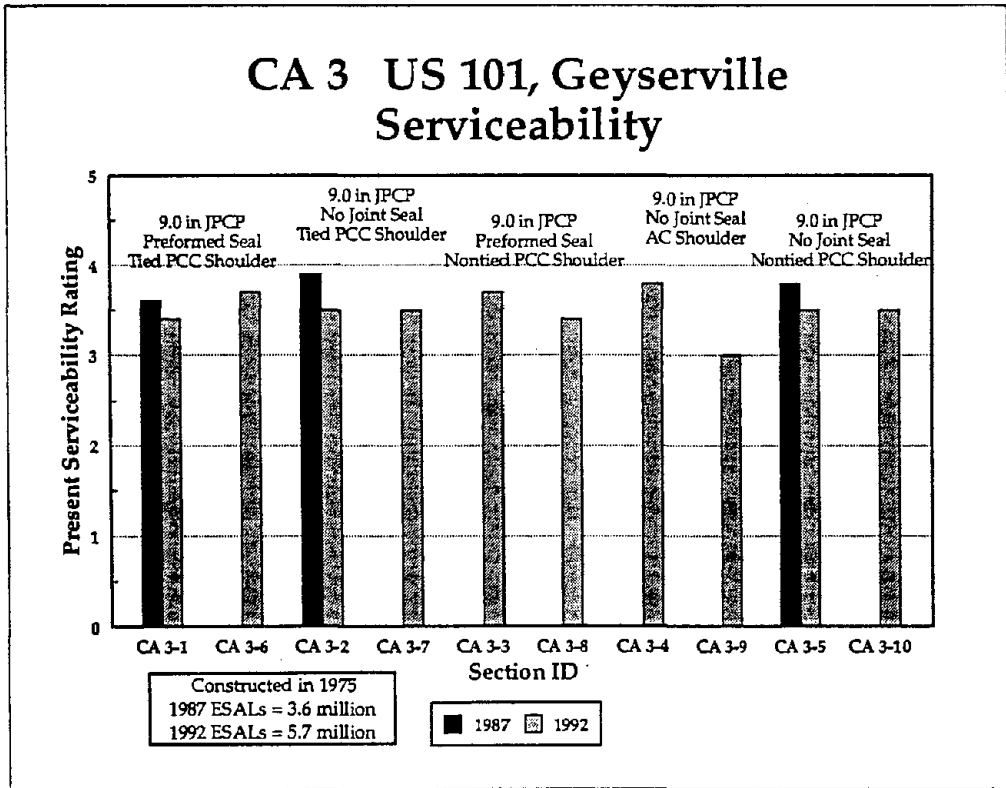
Figure 67. Roughness and serviceability for CA 3.

Figure 67 shows the roughness and serviceability data for the CA 3 sections. The roughness data show that the smoothest pavement is section 3-6, which contains sealed joints and a tied PCC shoulder. However, several of the sections with nontied PCC shoulders are also providing a smooth-riding surface. Overall, the roughest group of pavement sections are those constructed with AC shoulders. Similar observations are apparent from an examination of the serviceability data.

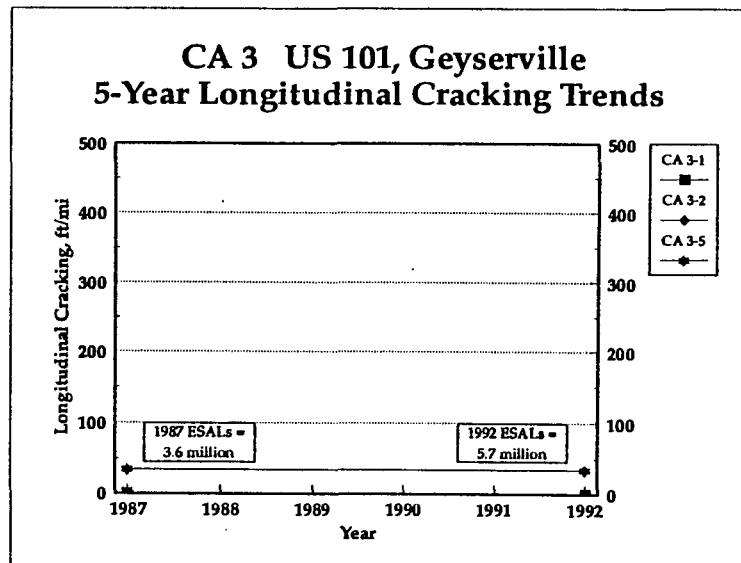
Figure 68. 5-year performance trends for CA 3.

The 5-year performance trends for the three sections surveyed in 1987 (3-1, 3-2, and 3-5) are shown in figure 68. This figure shows that no major changes in distress have occurred over the 5-year period, even though figure 67 showed a decrease in overall rideability. Joint spalling and longitudinal cracking remain unchanged from the 1987 survey, and joint faulting shows only a minor variation. Transverse cracking has increased slightly for all three sections with the biggest increase in the section with a nontied PCC shoulder.

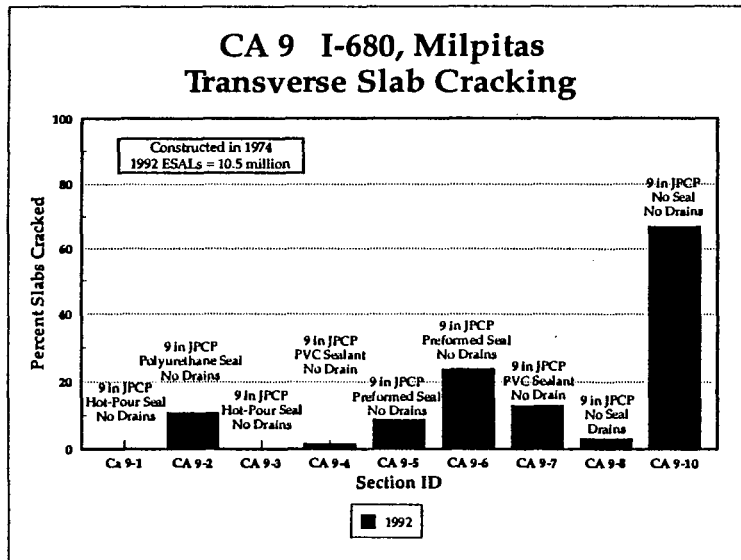
Figure 69. Performance summary for CA 9.

Table 69 and figure 69 present the performance data for the outer traffic lane of the CA 9 sections. The six sections for which faulting measurements are available are all exhibiting significant levels of faulting (0.10 to 0.15 in (2.5 to 3.8 mm)), and high-severity pumping was noted on each section. The section exhibiting the least amount

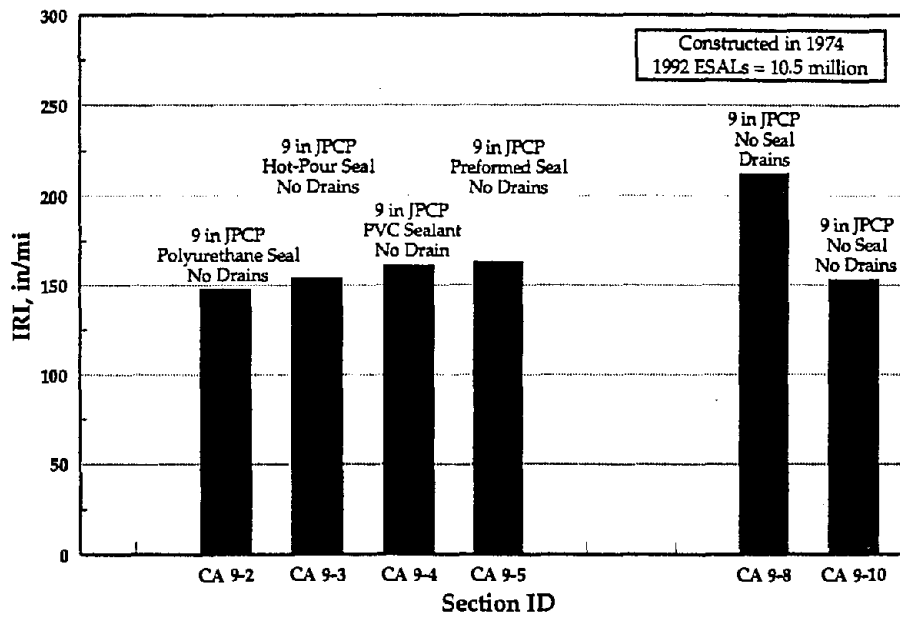
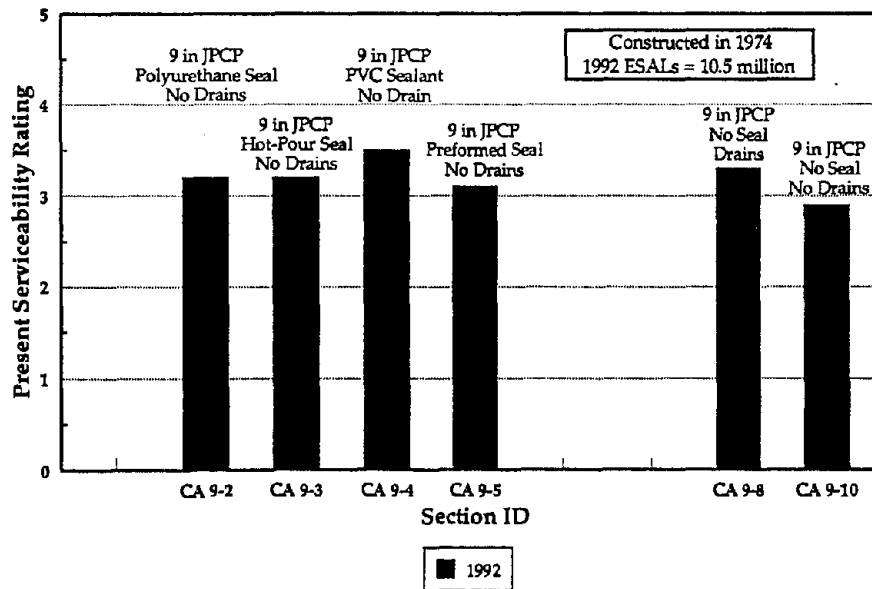
Figure 70. Roughness and serviceability for CA 9.

Figure 70 shows the roughness and serviceability data for the CA 9 sections. The roughest section is the one constructed with drains, which also had the greatest amount of faulting. The smoothest riding section is CA 9-2, which contains a polyurethane sealant. However, with the exception of the drained section, the roughness data for all of the sections are not significantly different. These same trends are shown by the serviceability data.

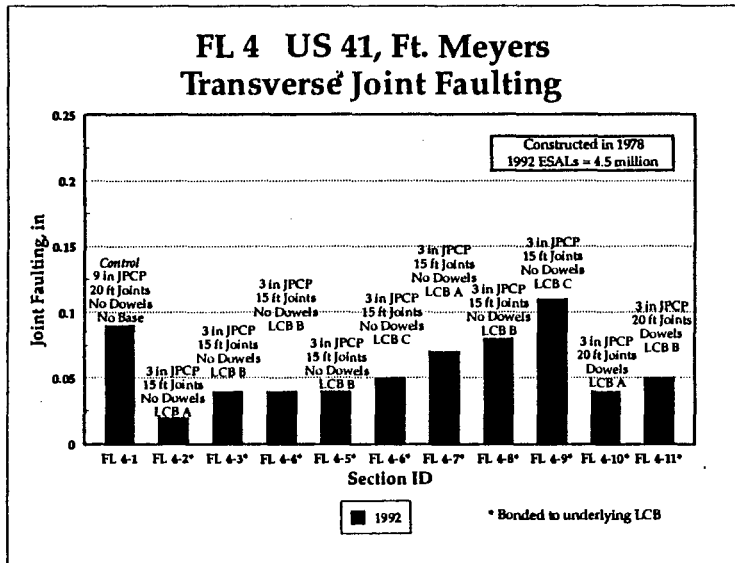
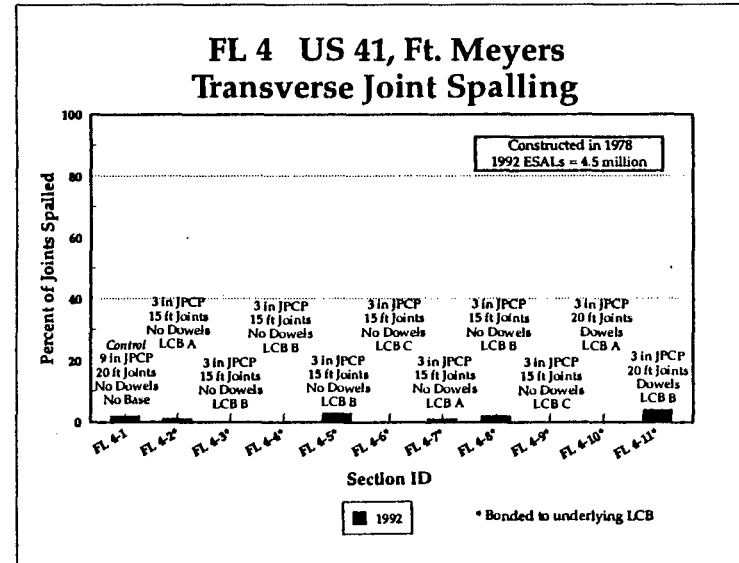
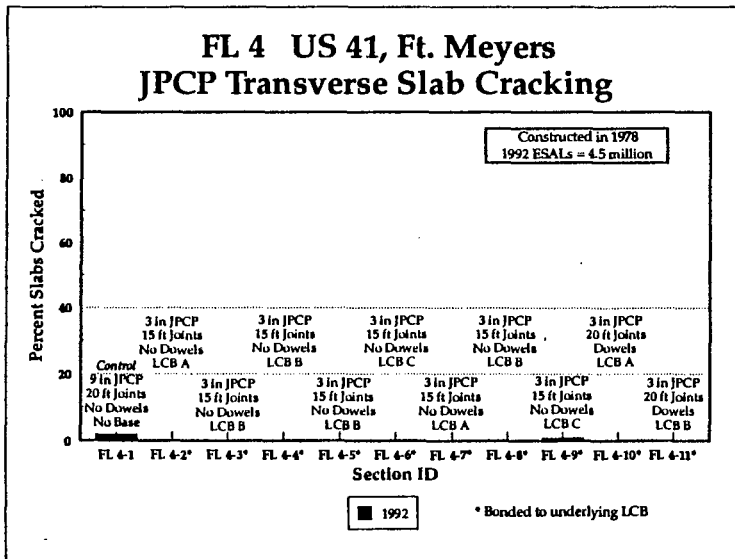
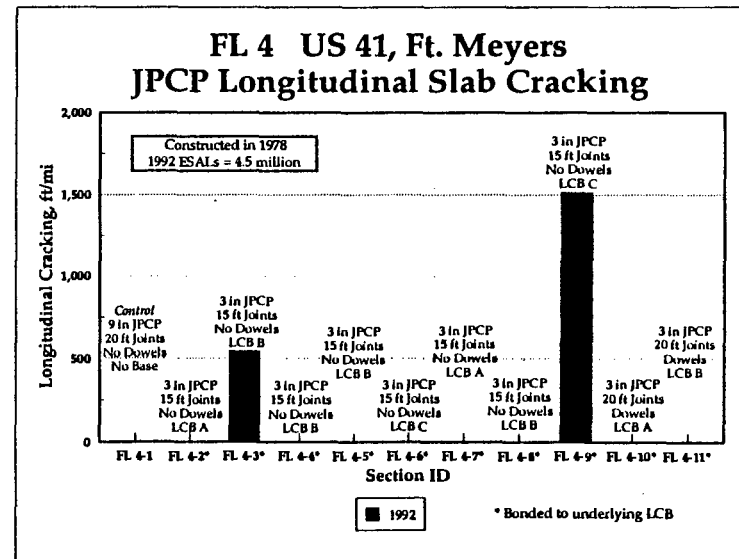
Figure 71. Performance summary for JPCP sections for FL 4.

Sections 4-4 and 4-5 each contained a tied PCC shoulder. Although these sections are performing very well with no cracking and nominal amounts of spalling and faulting, their performance at this time is not significantly different from Fl 4-2, 4-3, or 4-6.

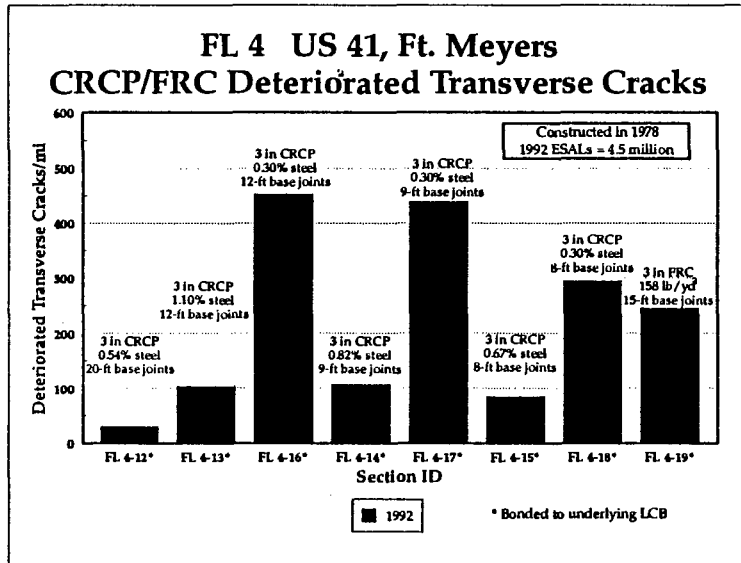
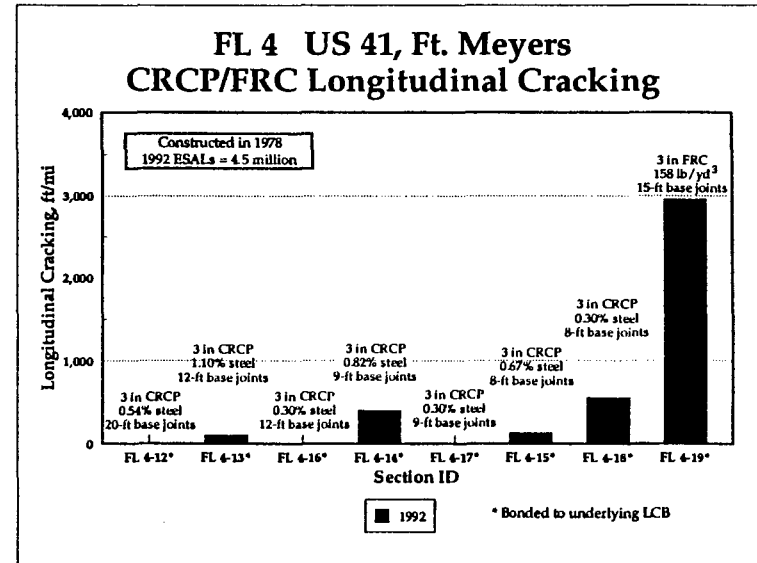
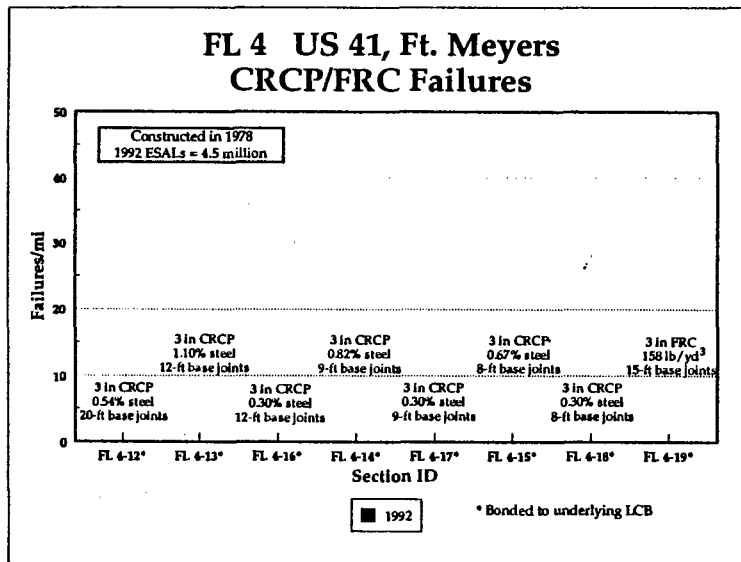
Figure 72. Performance summary for CRCP/FRC sections for FL 4.

Figure 72 shows that the CRCP sections with the smallest amount of reinforcing steel (FL 4-16, 4-17, and 4-18) all show the greatest amount of deteriorated transverse cracking, much higher than any of the other CRCP sections. The FRC section also exhibits more deteriorated transverse cracking than the other sections. The section with only 0.54 percent reinforcement shows the least amount of deteriorated transverse cracking; the sections with 0.67 percent, 0.82 percent, and 1.10 percent steel all exhibit about the same amount of deteriorated transverse cracking. The transverse cracking for these latter sections has exceeded the critical levels for continuously reinforced concrete pavements.

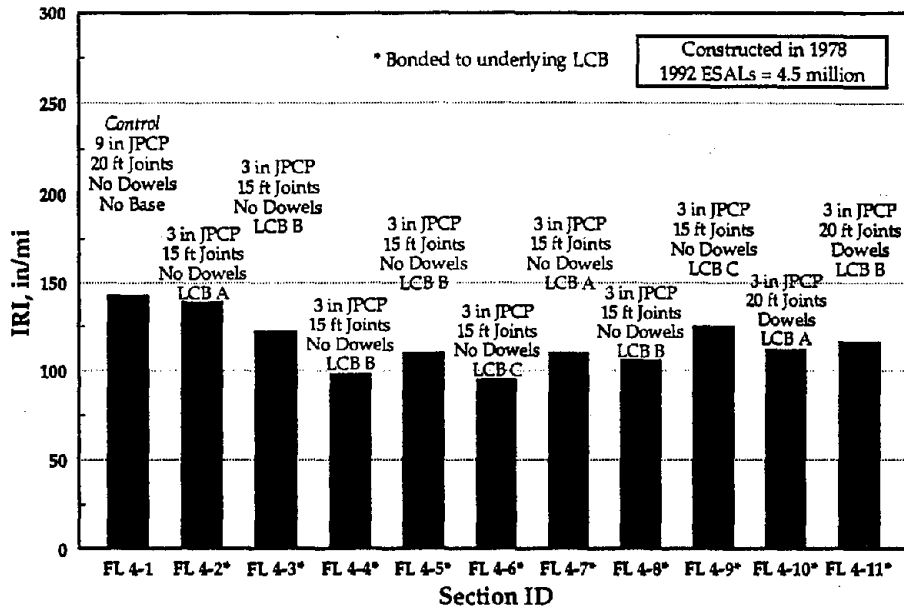
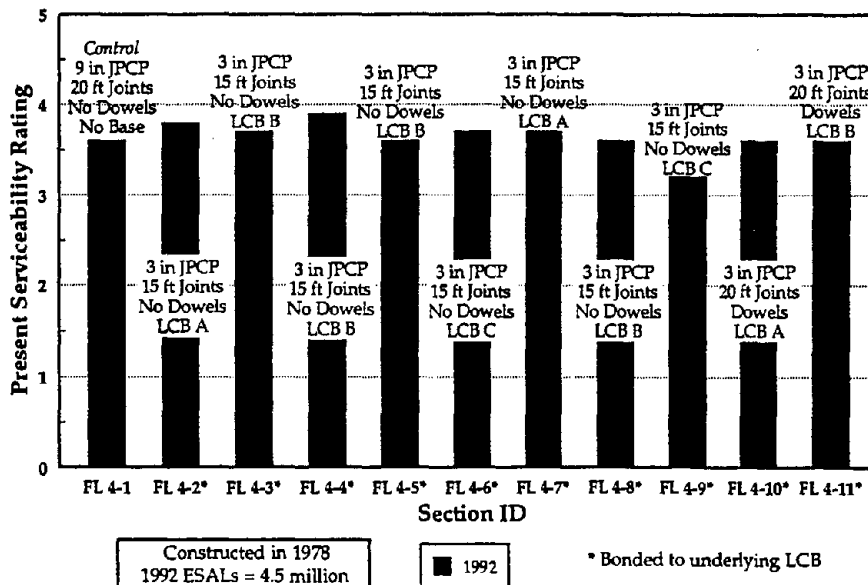
Figure 73. Roughness and serviceability for JPCP sections for FL 4.

Figure 73 shows the roughness and serviceability data for the JPCP sections on FL 4. Unfortunately, that data were not collected for the CRCP or FRC sections, so the roughness of the various designs cannot be compared.

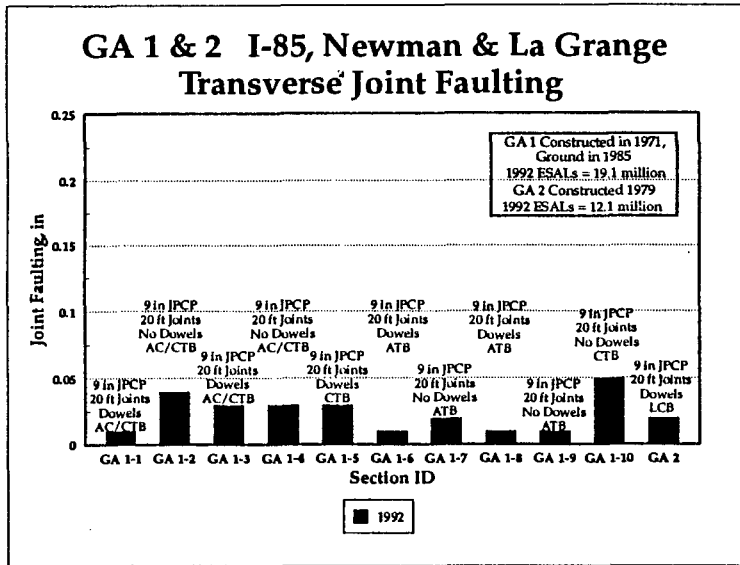
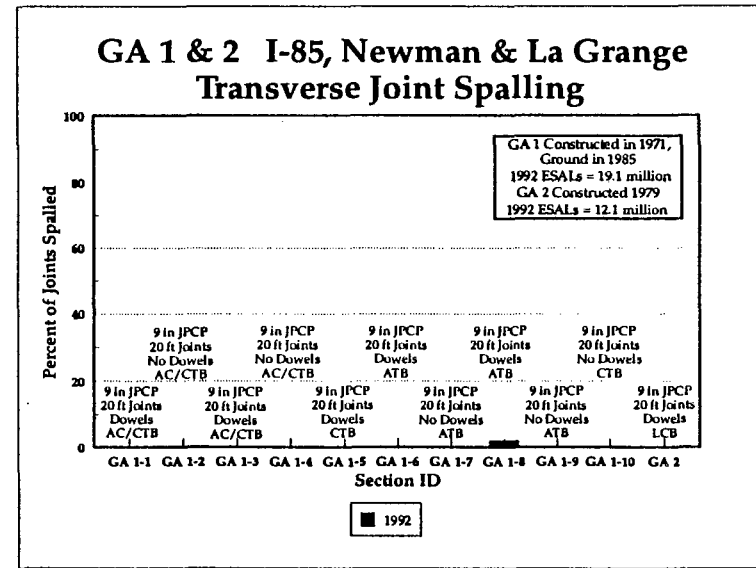
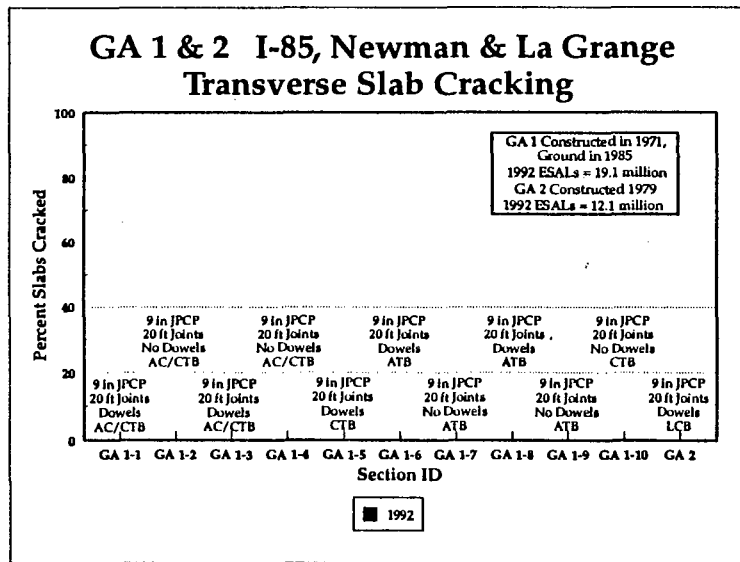
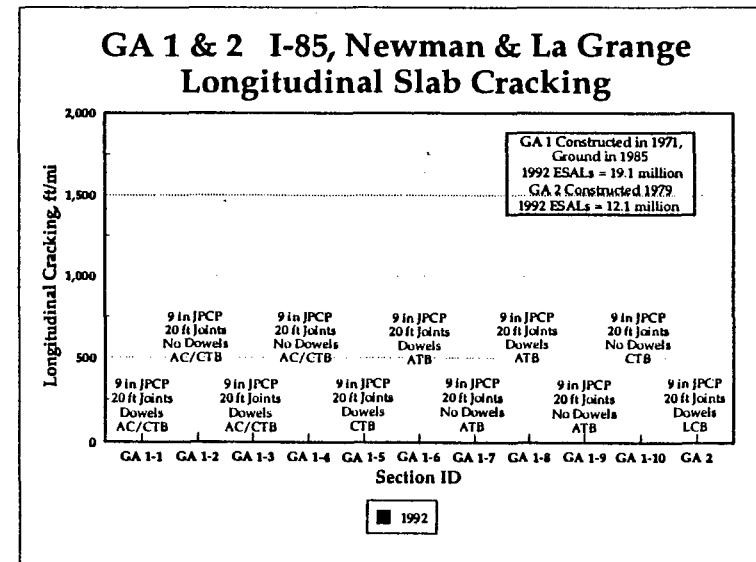
Figure 74. Performance summary for GA 1 and GA 2.

A summary of the outer lane performance data for these sections is shown in table 75. This performance data is displayed graphically in figure 74. The performance data indicate that all sections are in excellent condition. None of the sections display any transverse or longitudinal cracking, faulting levels are minimal (recall that the GA 1 sections were ground in 1985), and a small amount of joint spalling is present on only one section.

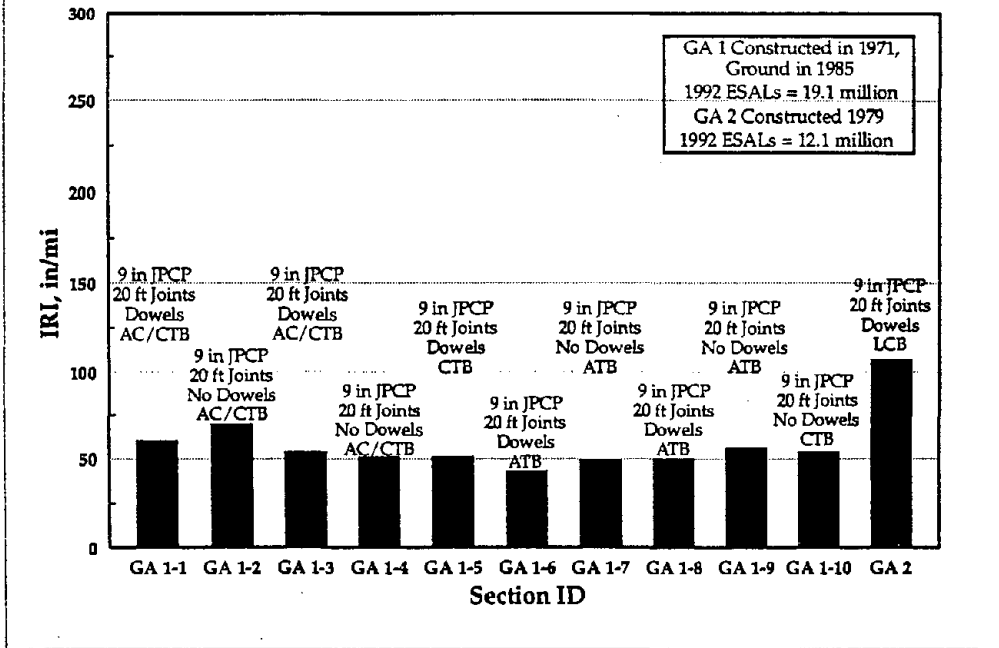
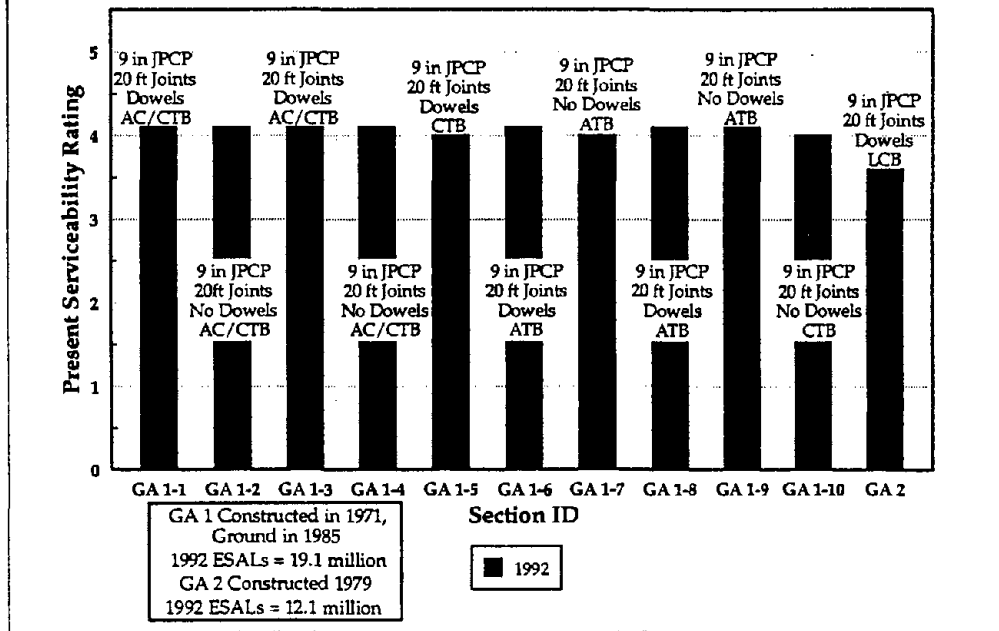
Figure 75. Roughness and serviceability for GA 1 and GA 2.

The roughness and serviceability data for the GA 1 and GA 2 sections are presented in figure 75. All GA 1 sections are extremely smooth, even though it has been 7 years since they had been diamond ground. Because of the low roughness levels, no trends in the smoothness of different designs are apparent.

Figure 75 shows that GA 2, which was constructed in 1977 and has not been diamond ground, is rougher than the GA 1 sections. However, its overall roughness level is still quite acceptable.
