Performance of Concrete Pavements

Volume I: Field Investigation

PUBLICATION NO. FHWA-RD-94-177

JULY 1997

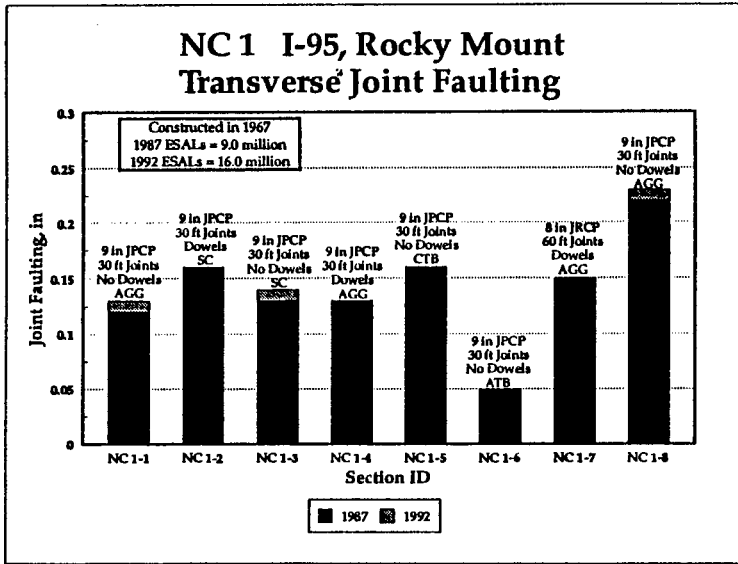
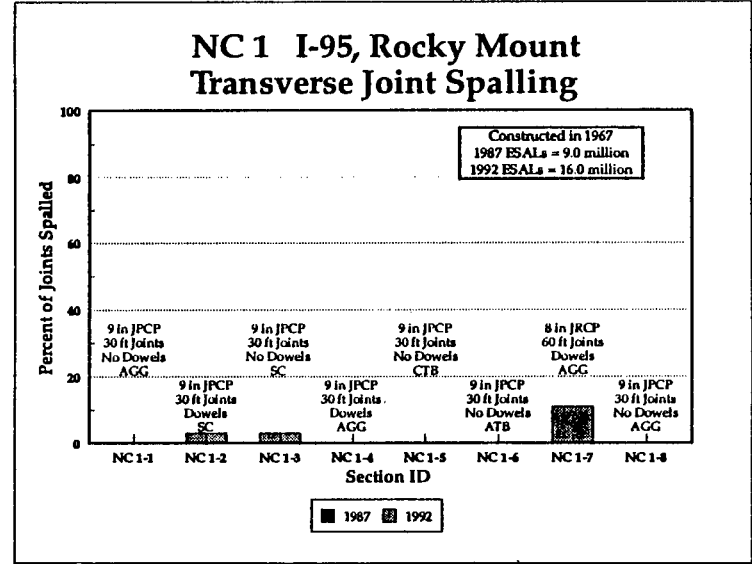
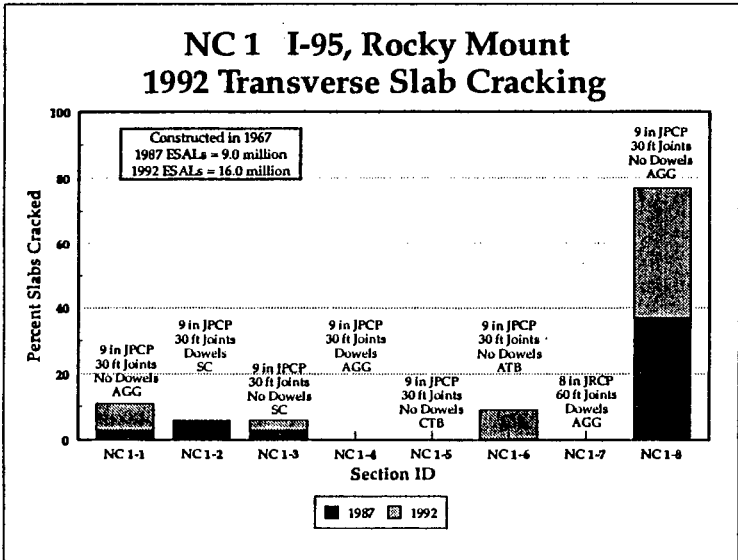
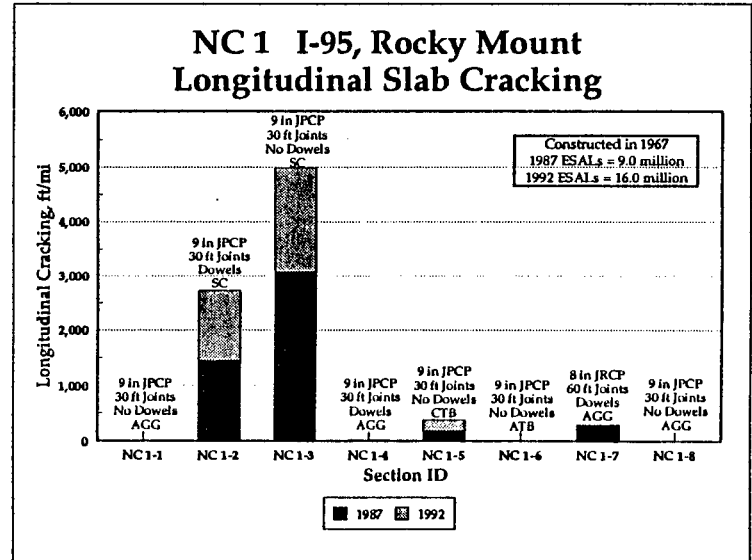
Figure 76. Performance summary for NC 1.

Table 77 provides the outer lane performance data for the NC 1 sections. These data are portrayed in graphical format in figure 76.

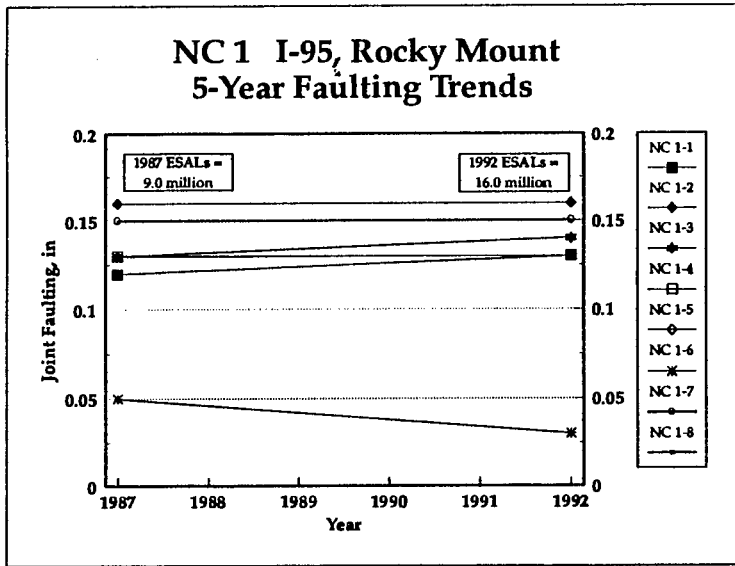
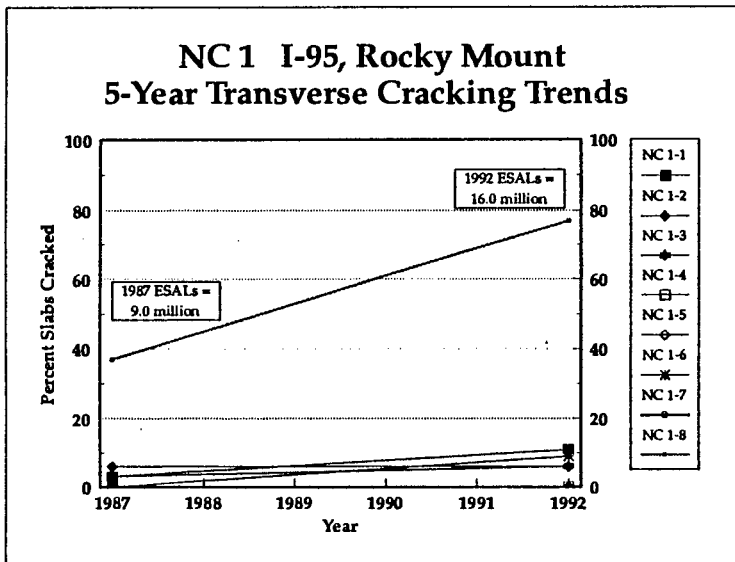
Figure 78. 5-year performance trends for NC 1.

The 5-year performance trends for the NC 1 sections are shown in figure 78. This figure shows that joint faulting and joint spalling have not changed significantly since the 1987 survey. NC 1-8 shows a marked increase in transverse slab cracking, while the other sections show only a small increase, if any.
