**Publication No. FHWA-RD-89-119
April 1989**

TEST AND EVALUATION OF TRAFFIC BARRIERS

14. Sponsoring Agency Code	
15. Supplementary Notes FHWA Contract Manager: L. Meczkowski (HSR-20)					
16. Abstract A series of crash tests were conducted to evaluate several types of guardrails and bridge rails. Two bridge rail designs were tested and showed acceptable performance when evaluated in accordance with NCHRP 230. A three-cable guardrail was modified, and an end terminal was re-designed to obtain good performance. The guardrail safely redirected a large and small vehicle traveling at 60 mi/h and impacting at 25 and 20 degrees, respectively. The terminal design was tested for snagging by directly impacting the downstream end. Although the device released, the vehicle rolled over. A new PL3 median barrier was designed and tested in accordance with the new AASHTO bridge rail test criteria. A 50,000-lb tractor-trailer impacted the median barrier at 50 mi/h and 15 degrees. The truck was redirected and contained, but rolled over producing undesirable occupant compartment intrusion. An 18,000-lb truck test was conducted on the modified thrie beam median barrier. The results indicated good p

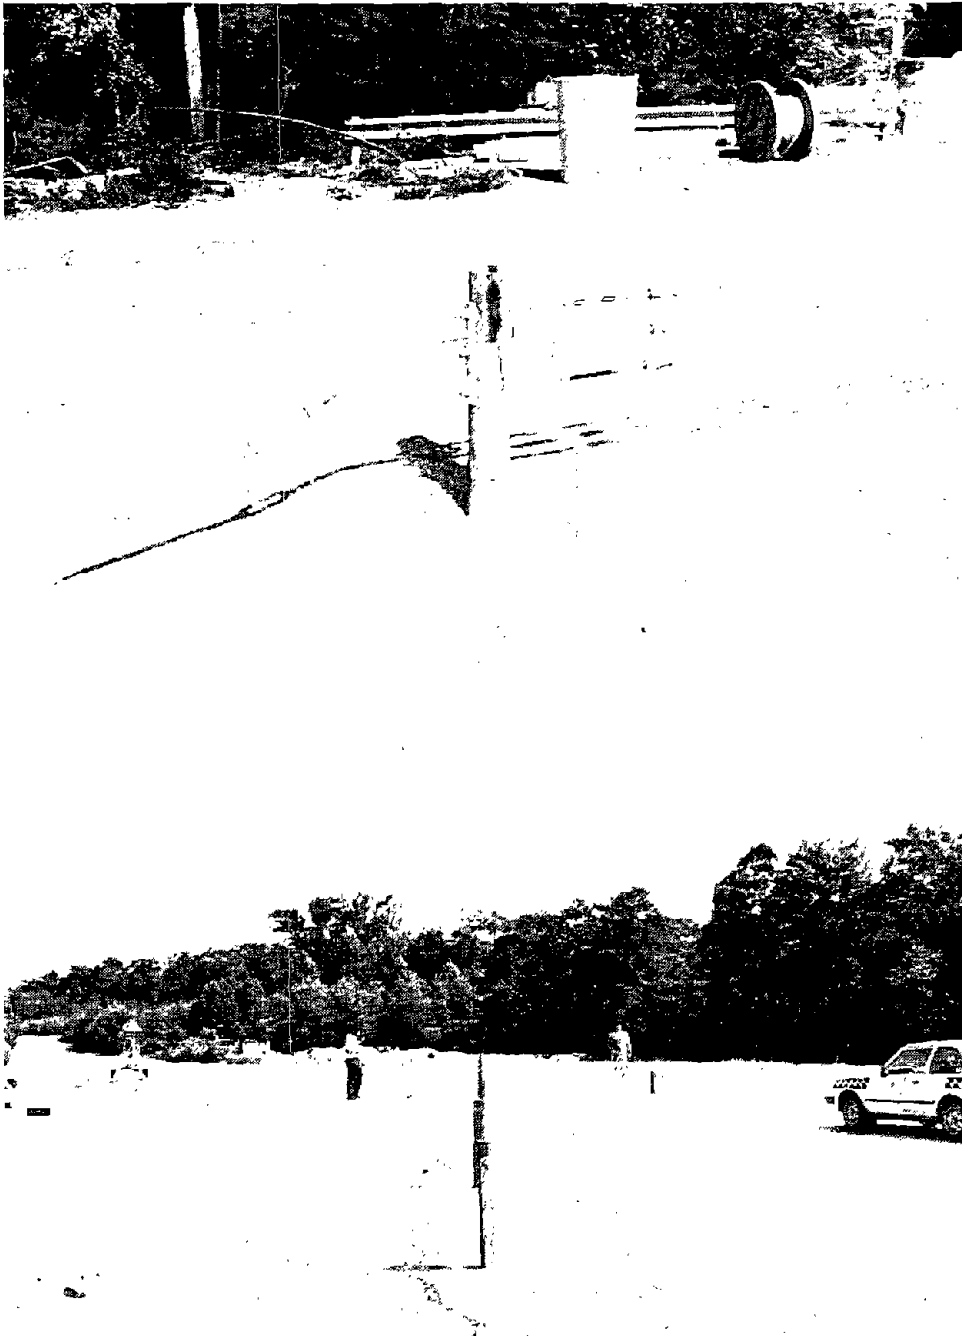
Figure 10. Standard terminal design for Minnesota three-cable guardrail system.

through a turnbuckle. The anchor rod is attached to the end post through a set of connector plates and secured with a nut. The three cables are also connected to the same plates, thus providing for a path for the rail forces to be transmitted to the block. The standard configuration is shown in figure 10.

Based on the results of test C-1, a weaker link was needed to facilitate release of the anchor from the cables to prevent vehicle snag. Also some uplift of the foundation was observed, thus the foundation was moved back and deeper by adding 4 ft to the anchor rod. One additional problem was observed in that the end post collapsed under the compressive load from the anchor rod. This occurs when the rail tension is transmitted down the angled anchor rod. A portion of the tension in the rod is resolved into a vertical force which is reacted against the end anchor post.

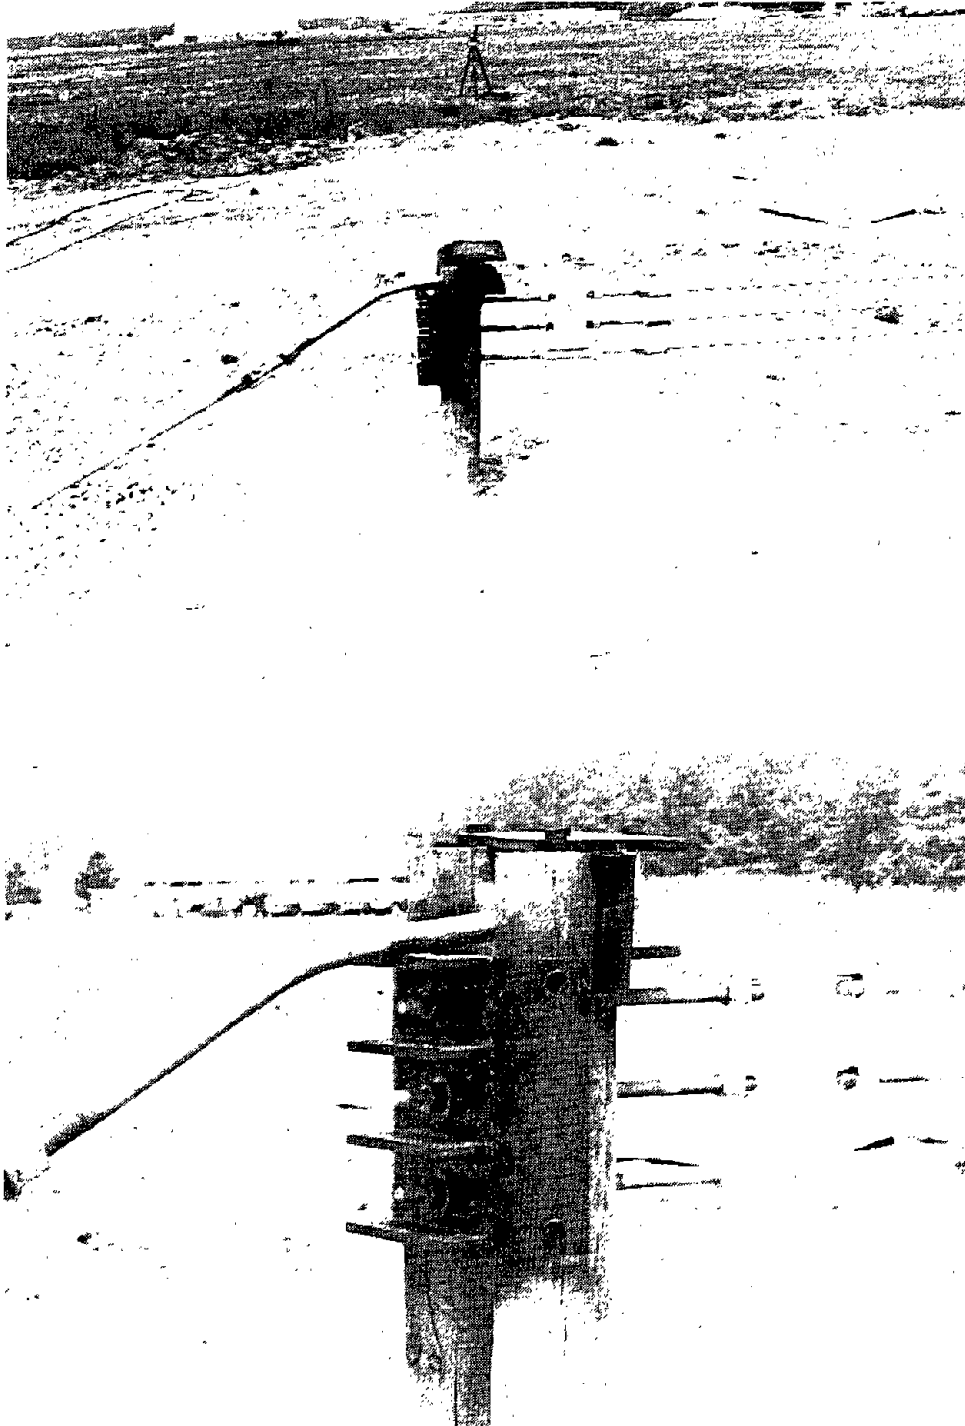
Figure 11. First modification to Minnesota three-cable terminal.

The new design consisted of a dual end post with two saddle brackets which spanned the two posts. One bracket held the end anchor rod while the second held the three-cable anchor rods. The load path for the rail tension was into one bracket, then through the wood posts and into the second bracket which was attached to the anchor rod. This system is shown in figure 11.

This design was tested in test C-2 with an 1800-lb vehicle. During the test the end anchor assembly failed to transmit the load to the end anchor block. Review of the results indicated that posts failed in the area between the two brackets.

A new bracket assembly was designed featuring a third bracket added below the bracket which held the three cables. The two brackets were attached to the anchor rod using a standard BCT cable. The cable was held by one end of the anchor rod turn-buckle assembly. The cable allowed the load to adjust between the brackets to maintain an even load. This assembly is shown in figure 12.

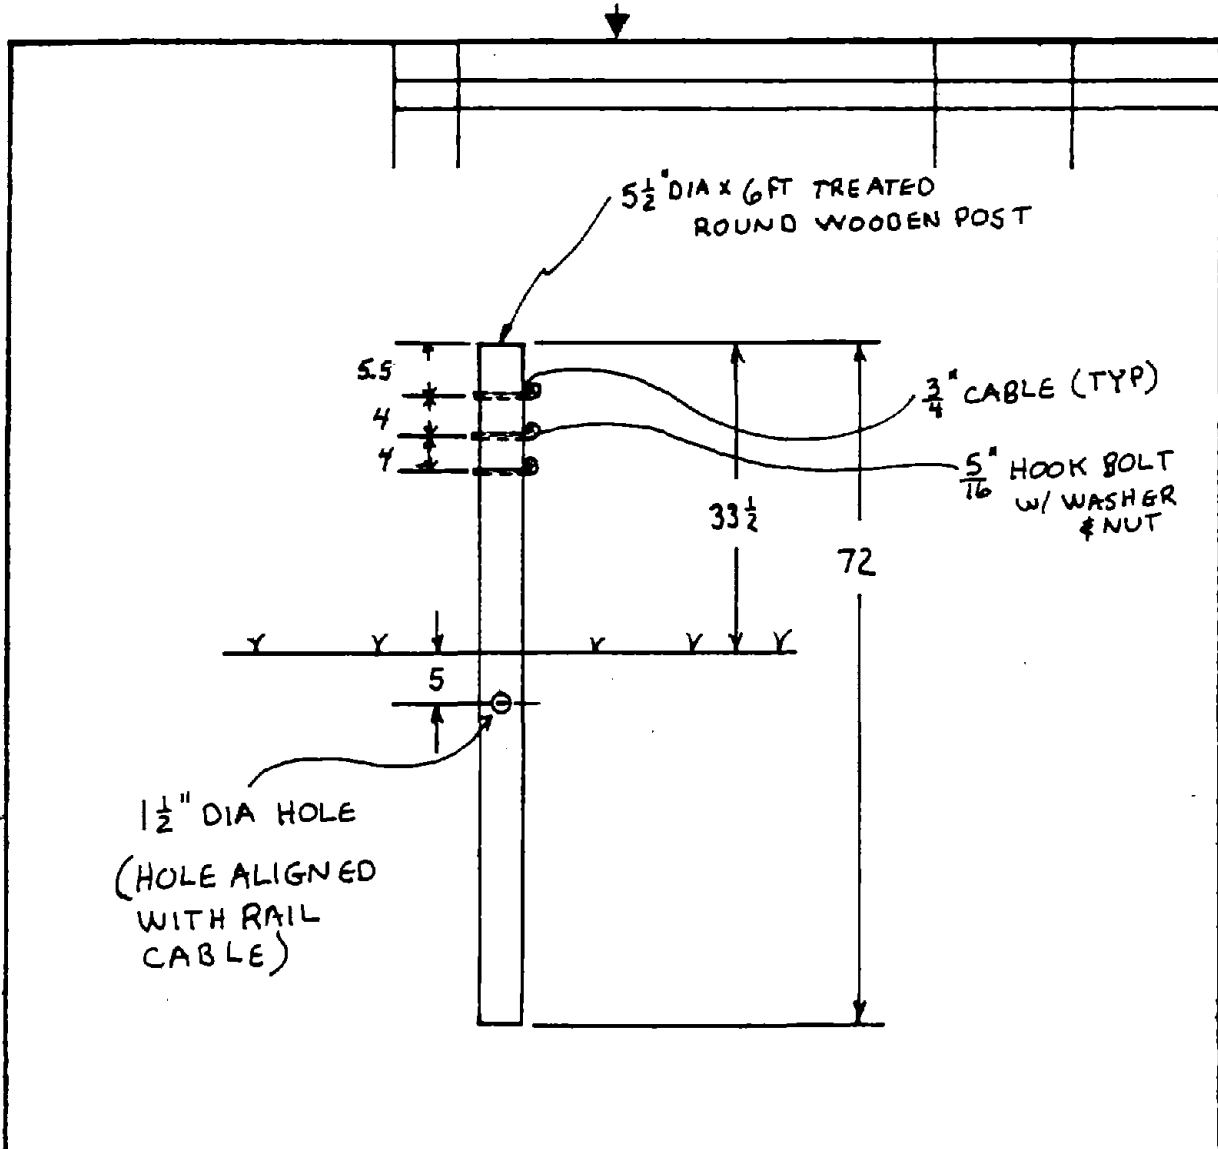
Figure 14. Minnesota three-cable guardrail post redesign.

A replacement post for the standard Minnesota three-cable rail system was designed and discussions of this design were presented in the previous chapter of this report. The drawing of this system is presented in figure 14. The modification consists of a 1.5-in hole through a standard post, 5 in below grade.

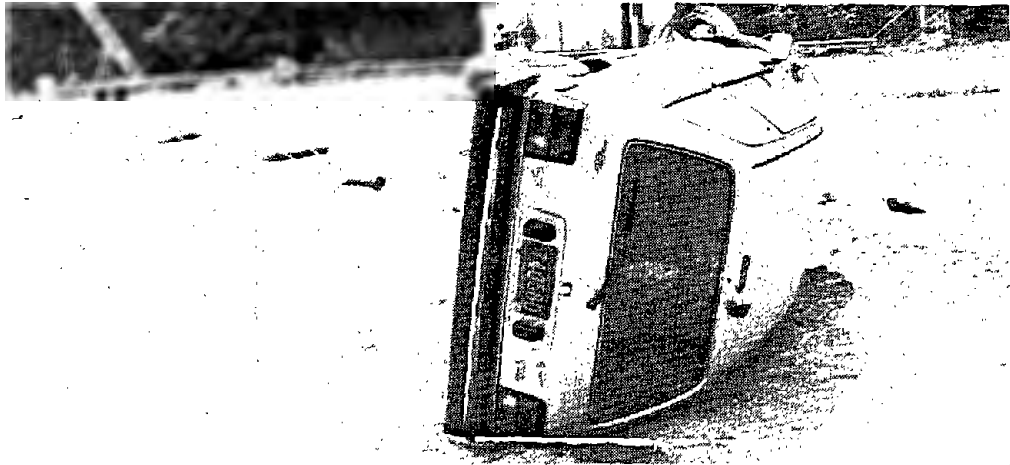
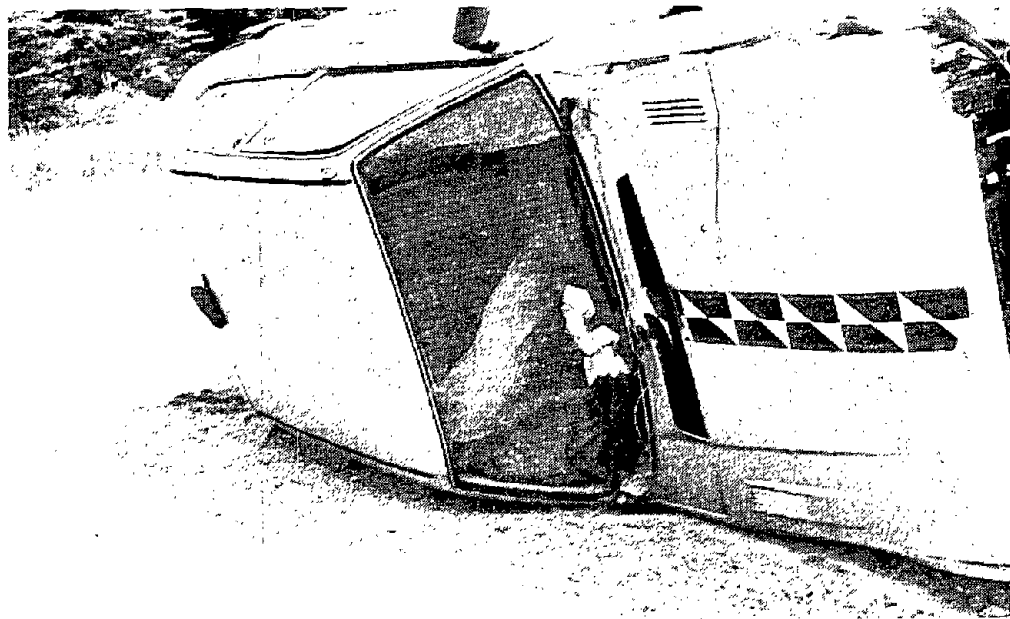
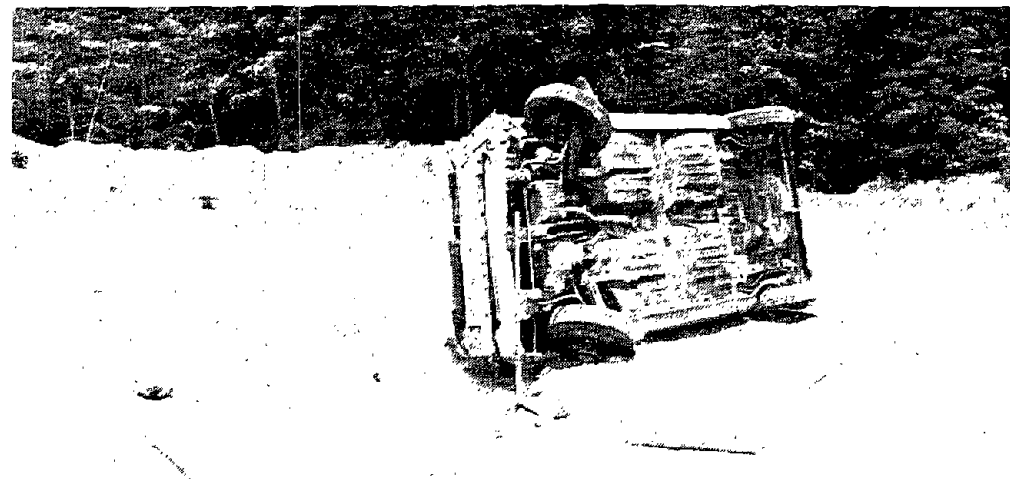
Figure 24. Posttest photographs of test vehicle,
test 1769-C-1-87.

Almost all of the left side of the vehicle was damaged, but damage occurred mainly to the left front fender, grill and bumper. Posttest photographs of the vehicle are shown in figure 24.

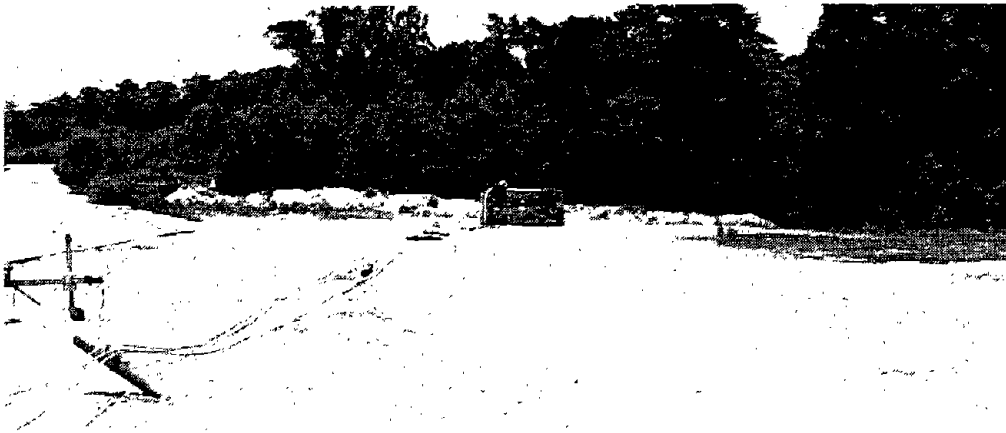
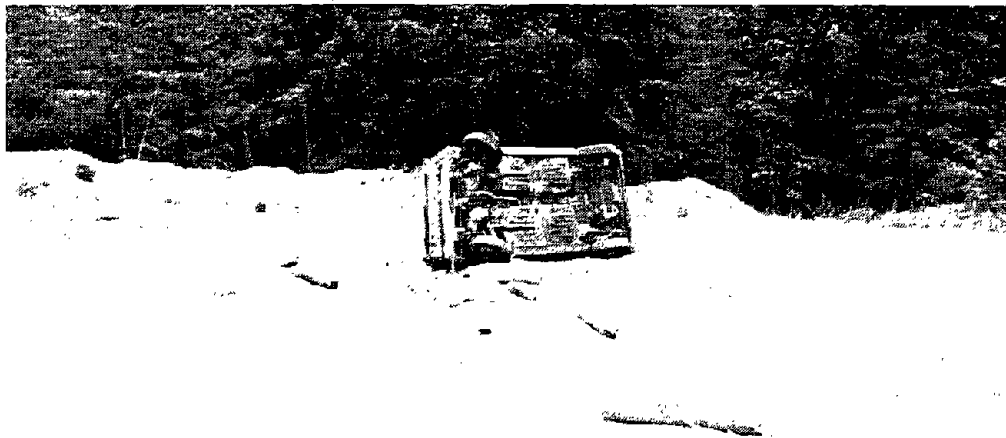
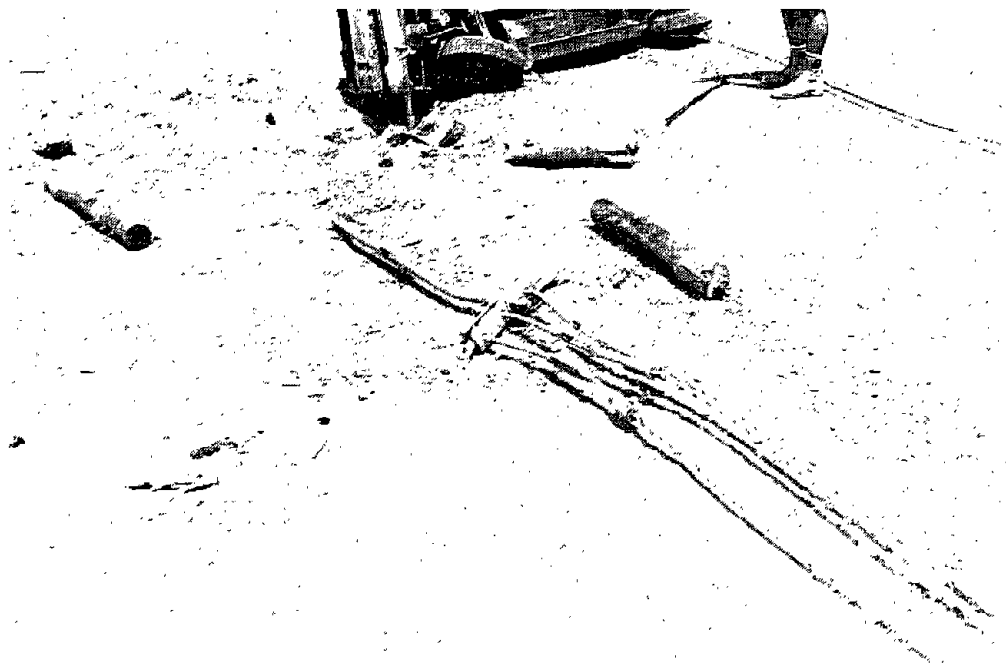
Figure 25. Posttest photographs of Minnesota three-cable guardrail system, test 1769-C-1-87.

The Minnesota three-cable system performed as designed, with the exception of the secondary impact with the end post, which caused the vehicle to roll. The line post redesign performed as planned. Impacts with the line posts did not cause the vehicle to yaw or roll. No abrasions were evident in the cable. Posttest photographs are shown in figure 25.

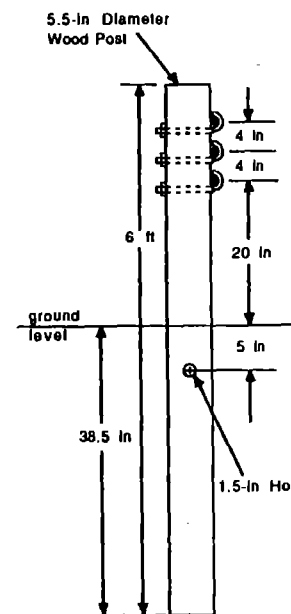
Figure 36. Test summary, test 1769-C-3-87.

The vehicle penetrated into the rail approximately 4.5 ft and was redirected by the rail but did not exit from the rail. Ten posts were broken off through the hole below ground, including the downstream dual end post. The vehicle continued downstream breaking off posts. The vehicle squarely impacted the dual end post. The vehicle continued away downstream turning hard right. It came to rest 200 ft downstream of impact, 65 ft behind the rail, after turning 95 degrees clockwise to the rail. A summary of the test conditions and results are given in figure 36.

13. Vehicle Analysis:	<u>Observed</u>	<u>Design/ Limit Value</u>
<u>NCHRP 230:</u>		
<u>Longitudinal:</u>		
Delta-V at 2 ft:	-12.7 ft/s	30/40 ft/s
Ridedown Acceleration:	-6.0 g's	15/20 g's
Delta-V at 1.38 ft (actual):	-11.3 ft/s	30/40 ft/s
Ridedown Acceleration:	-6.0 g's	15/20 g's
<u>Lateral:</u>		
Delta-V at 1 ft:	-14.3 ft/s	20/30 ft/s
Ridedown Acceleration:	-10.2 g's	15/20 g's
Delta-V at 0.67 ft (actual):	-11.0 ft/s	20/30 ft/s
Ridedown Acceleration:	-10.2 g's	15/20 g's
<u>TRC 191:</u>		
Peak 50 ms acceleration:		
Longitudinal:	-2.3 g's	
Lateral:	-5.9 g's	
14. Test Results Conclusion:	Smooth redirection by rail.

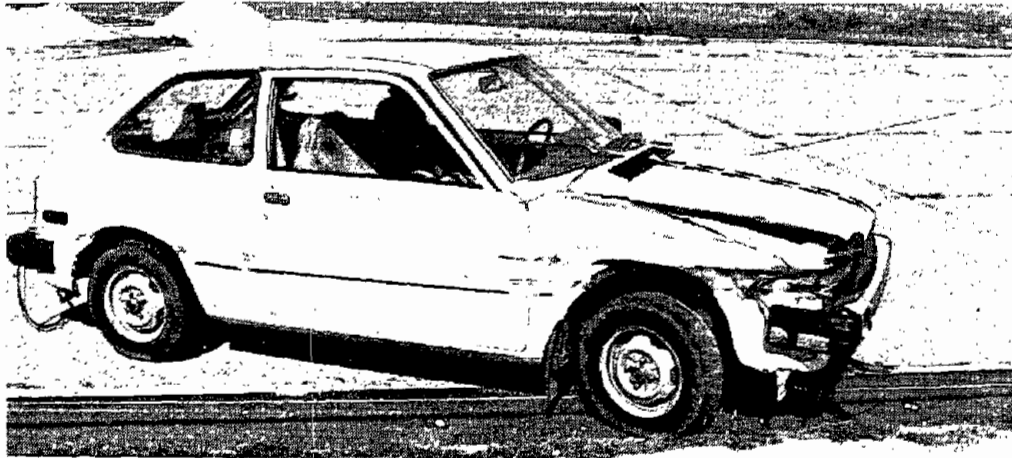
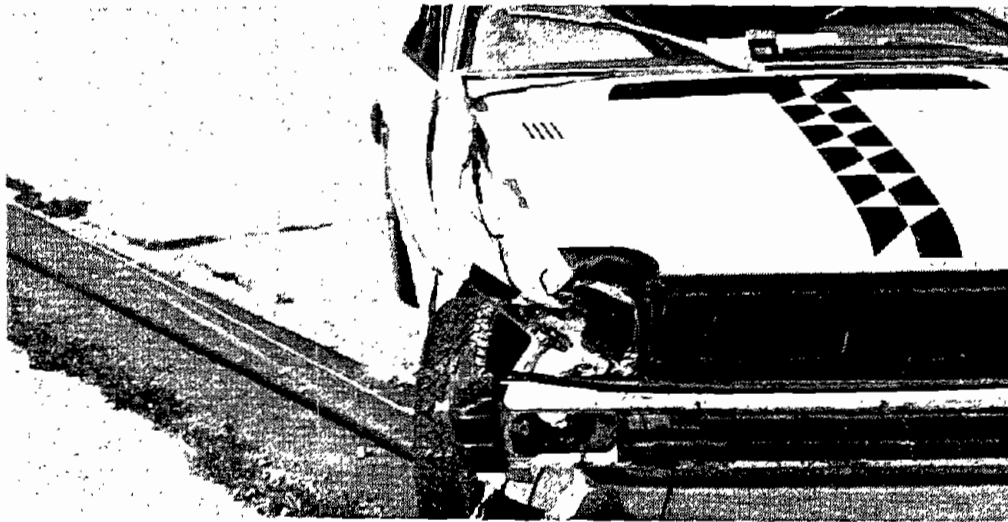
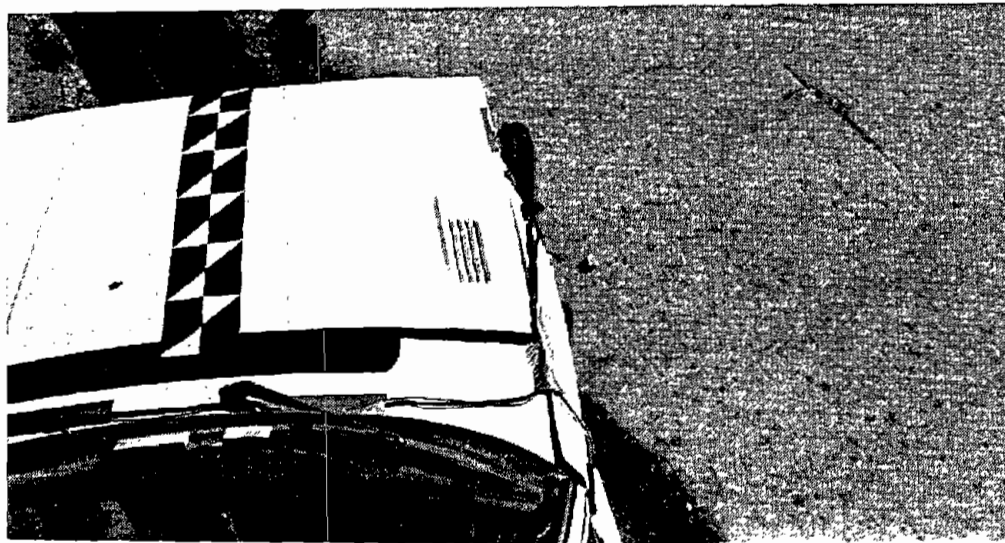
Figure 38. Posttest photographs of test vehicle,
test 1769-C-3-87.

Almost all of the right side of the vehicle was damaged, but damage occurred mainly to the right front fender, grill and bumper. Posttest photographs of the vehicle are shown in figure 38.

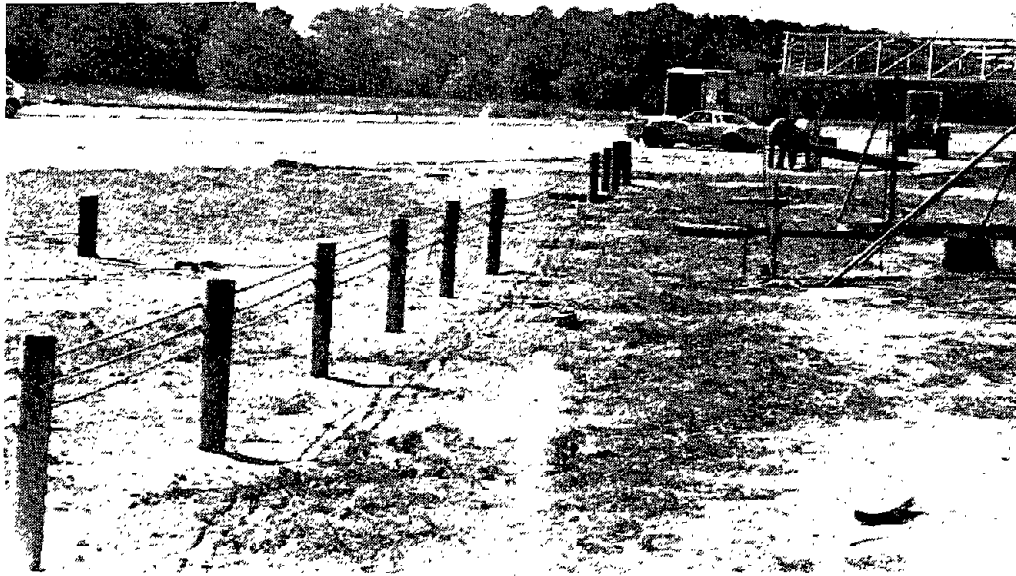
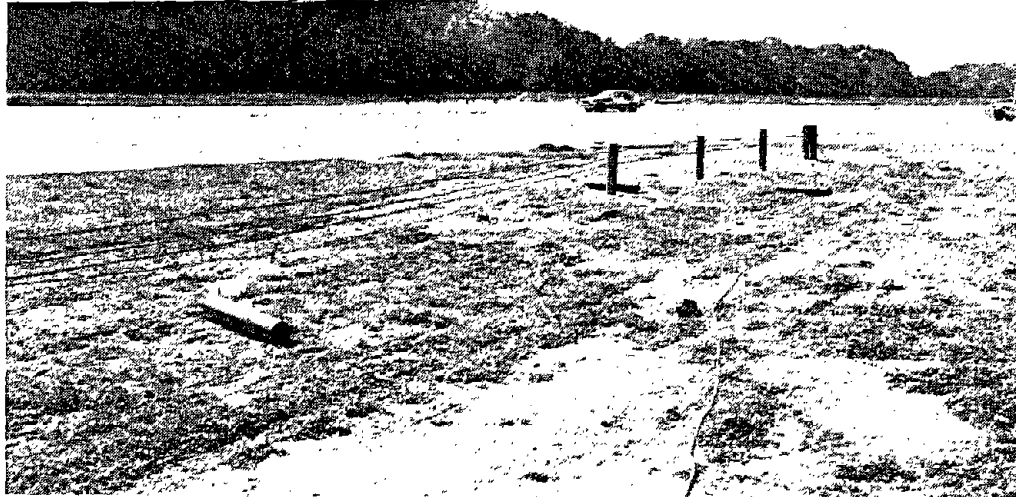
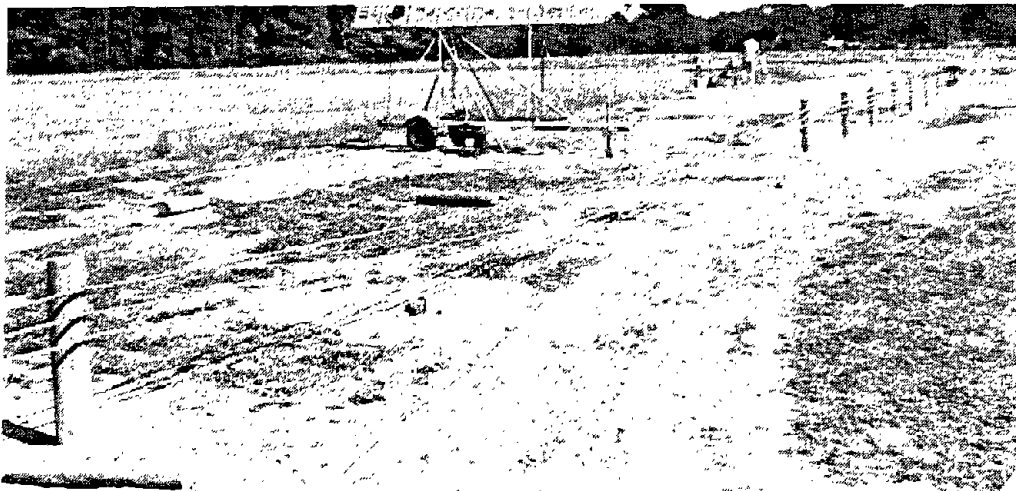
Figure 39. Posttest photographs of Minnesota three-cable guardrail system, test 1769-C-3-87.

The Minnesota three-cable system performed as designed. The vehicle was redirected by the rail. Four posts were broken off. The end anchors showed no sign of movement. Posttest photographs are shown in figure 39.

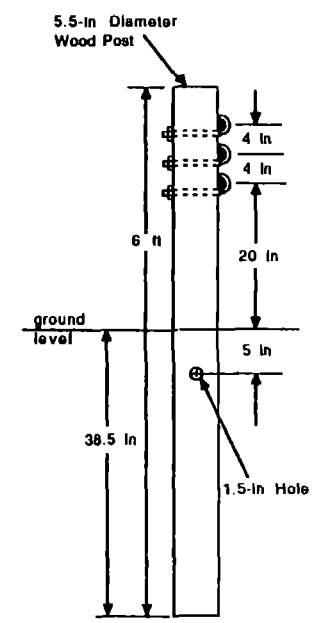
Figure 43. Test summary, test 1769-C-4-87.

The vehicle penetrated into the rail approximately 8 ft and was redirected by the rail but did not exit from the rail. Ten posts were broken off through the hole below ground, including the downstream dual end post. The vehicle continued downstream breaking off posts and squarely impacted the dual end post. It continued away downstream turning hard right, coming to rest 160 ft downstream of impact, 25 ft behind the rail, after turning 110 degrees clockwise. A summary of the test conditions and results are given in figure 43.

13. Vehicle Analysis:	<u>Observed</u>	<u>Design/ Limit Value</u>
<u>NCHRP 230:</u>		
<u>Longitudinal:</u>		
Delta-V at 2 ft:	-13.0 ft/s	30/40 ft/s
Ridedown Acceleration:	-3.0 g's	15/20 g's
Delta-V at 1.67 ft (actual):	-12.4 ft/s	30/40 ft/s
Ridedown Acceleration:	-3.0 g's	15/20 g's
<u>Lateral:</u>		
Delta-V at 1 ft:	-12.3 ft/s	20/30 ft/s
Ridedown Acceleration:	-6.1 g's	15/20 g's
Delta-V at 0.75 ft (actual):	-11.3 ft/s	20/30 ft/s
Ridedown Acceleration:	-6.1 g's	15/20 g's
<u>TRC 121:</u>		
Peak 50 ms acceleration:		
Longitudinal:	-2.0 g's	
Lateral:	-3.8 g's	
14. Test Results Conclusion:	Smooth redirection by rail.

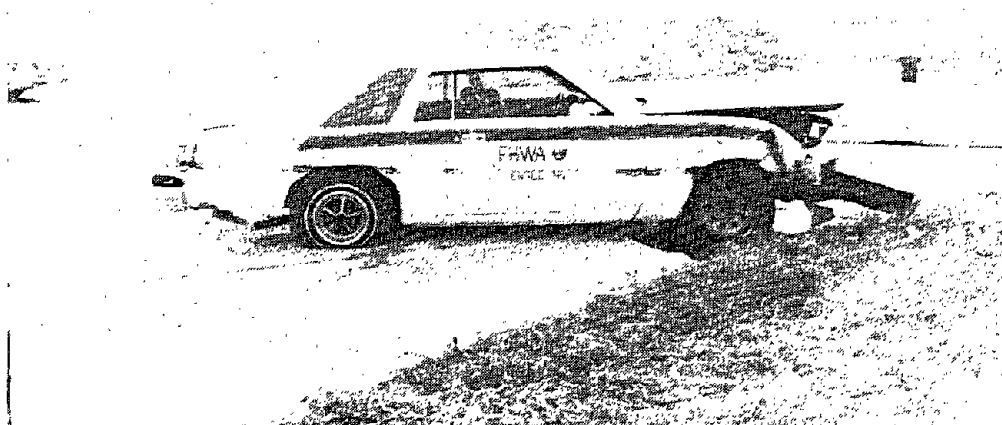
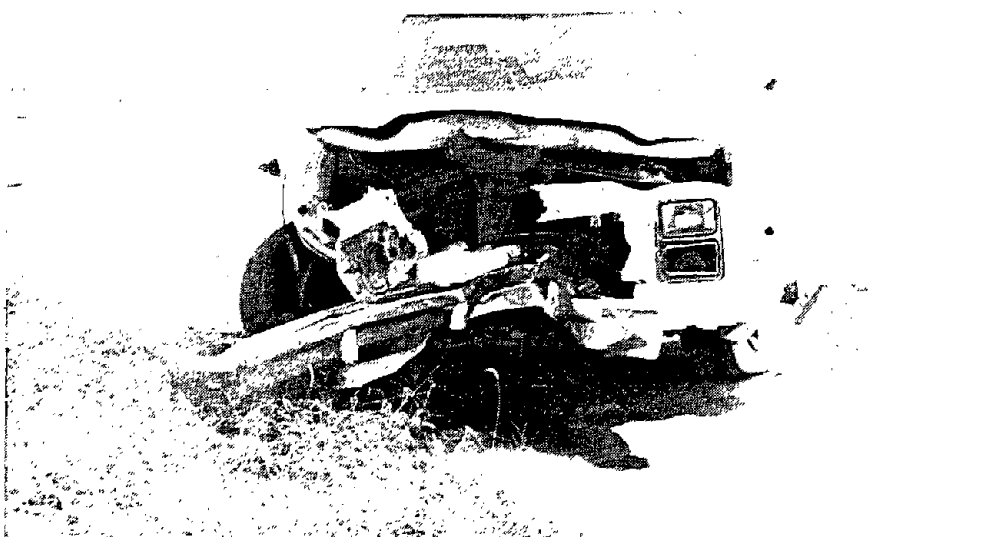
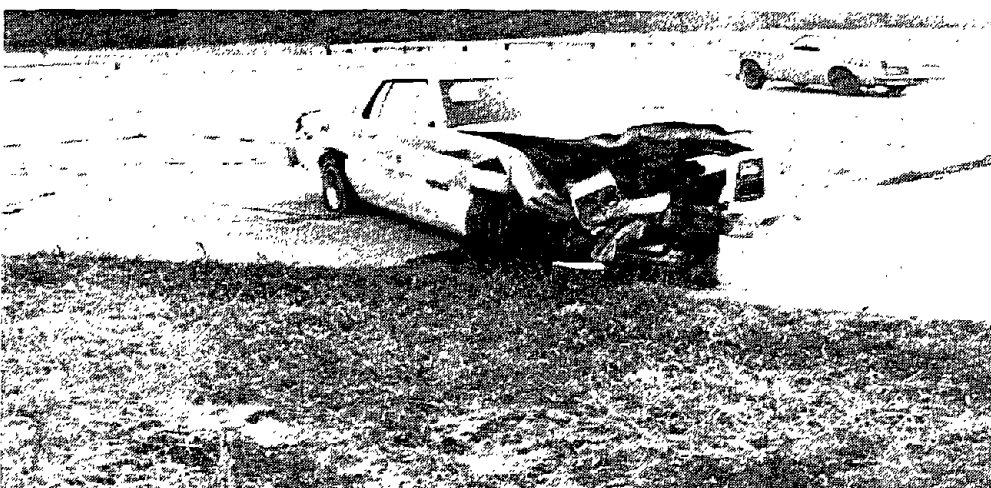
Figure 45. Posttest photographs of test vehicle,
test 1769-C-4-87.

Almost all of the right side of the vehicle was damaged, but damage occurred mainly to the right front fender, grill and bumper. Posttest photographs of the vehicle are shown in figure 45.

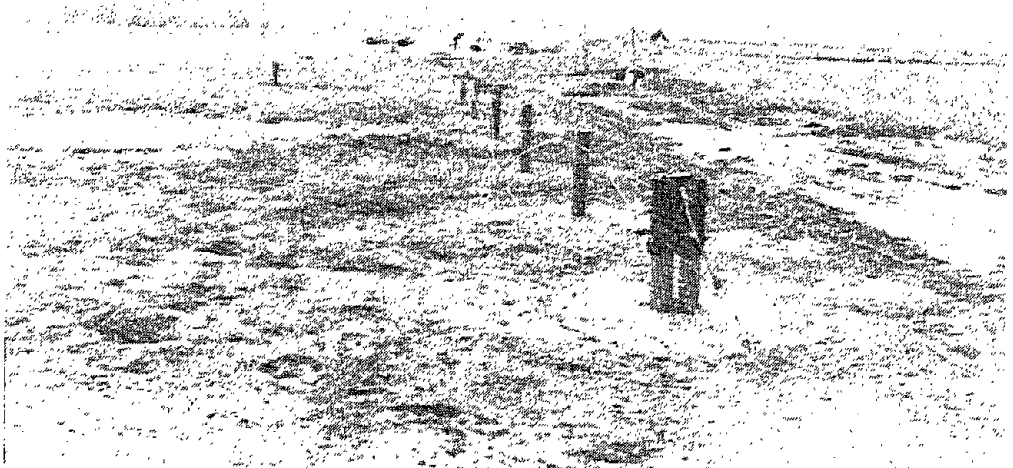
Figure 46. Posttest photographs of Minnesota three-cable guardrail system, test 1769-C-4-87.

The Minnesota three-cable system performed as designed: The vehicle was redirected by the rail. The end anchors showed no sign of movement. However, one cable pulled out the fitting on the upstream end. Two pulled out on the downstream end with the third breaking at the threaded rod connection. The cables broke approximately 0.650 s after impact. The top bracket at the downstream end came off the post and the end anchor attachment rod broke at ground level. Posttest photographs are shown in figure 46.

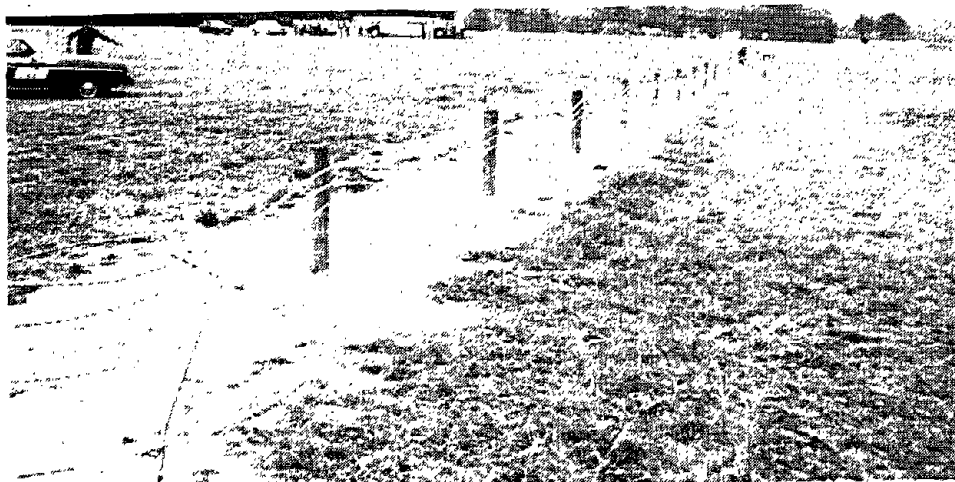
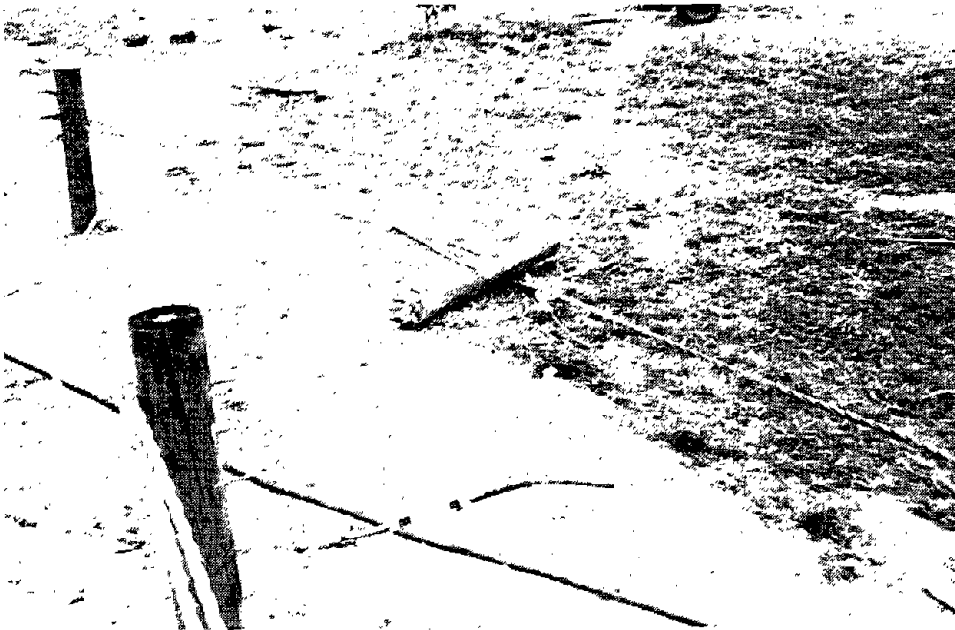
Figure 53. Posttest photographs of Minnesota three-cable guardrail system, test 1769-C-5-88.

The Minnesota three-cable system performed well, but because of the vehicle rollover the device did not pass this test. The vehicle traveled past the end posts (was not stopped or slowed greatly by the end post assembly). The upstream end anchor showed signs of slight movement. One cable pulled out of the fitting on the upstream end. On the downstream end, all three cables sheared off at the threaded rod connection. posttest photographs of the rail are shown in figure 53.

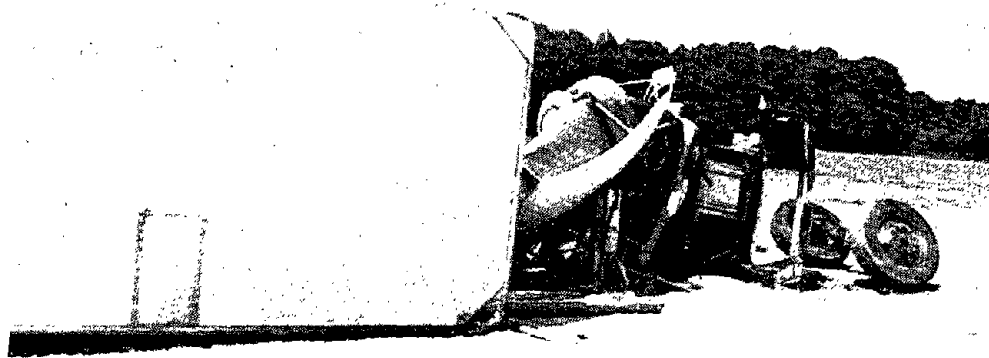
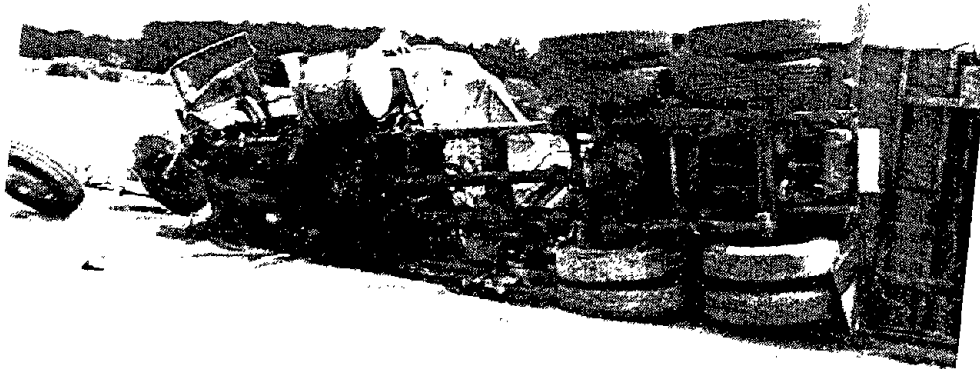
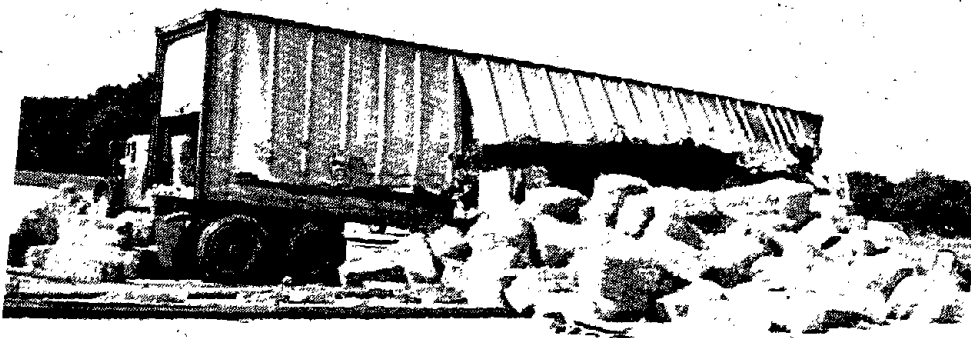
Figure 63. Posttest photographs of test vehicle,
test 1769-D-1-88.

The tractor was nearly destroyed. The cab was demolished and the front axle was torn from the frame. When the trailer rolled onto the barrier, the rail sliced open the side of the trailer. Posttest photographs of the tractor-trailer are shown in figure 63.

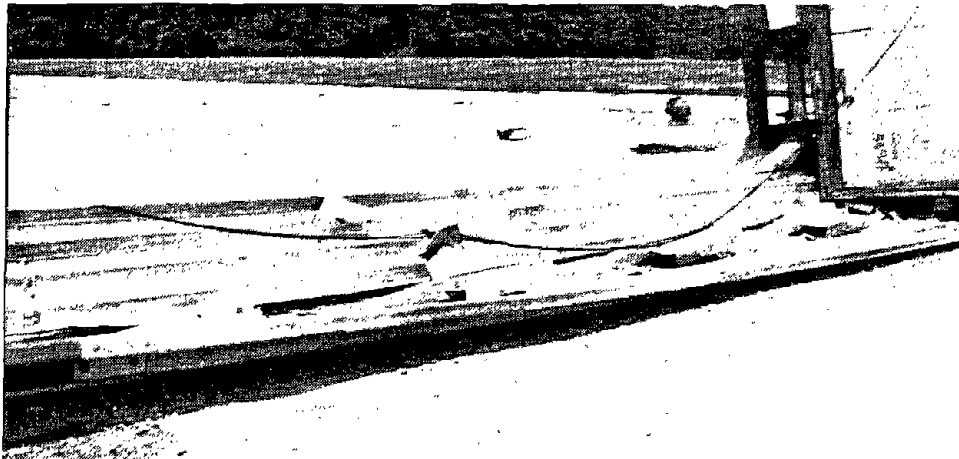
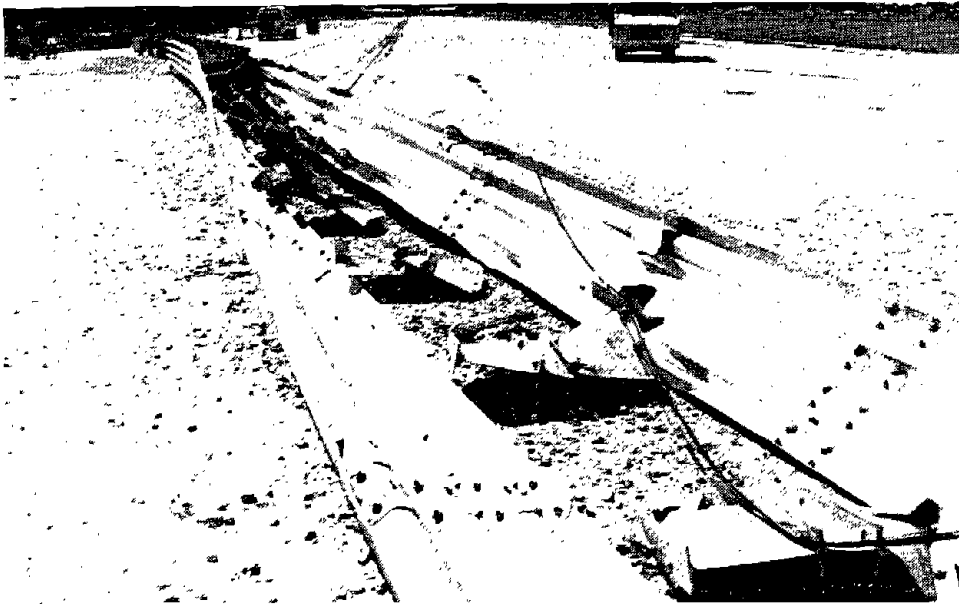
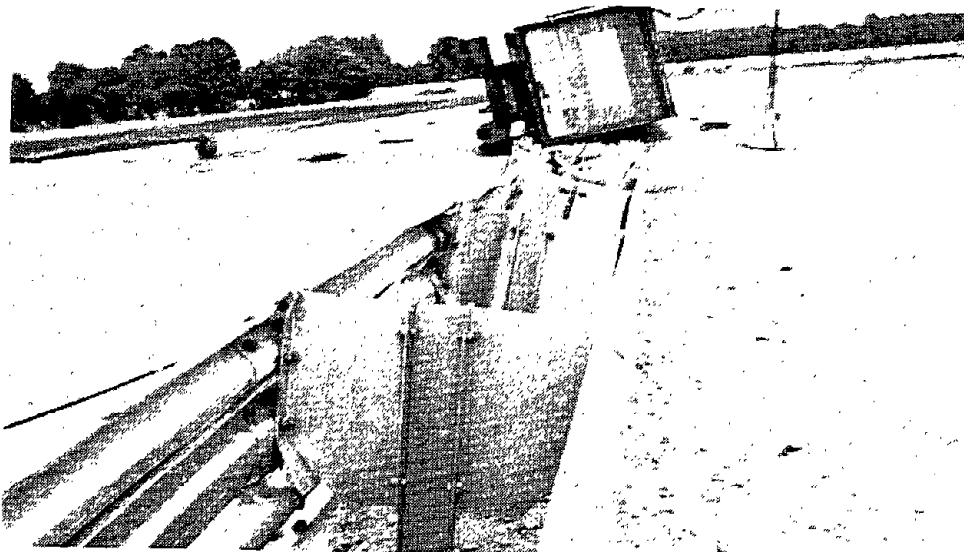
Figure 64. Posttest photographs of guardrail system, test 1769-D-1-88 (continued).

The barrier was severely damaged from the impact point to the downstream end. All posts in the area were bent over. The rail was detached from most posts. When the trailer rolled onto the barrier, it split the rail down the middle (posts were bent in the downstream direction, and the rail on both sides was splayed outwards). Posttest photographs of the rail are shown in figure 64.

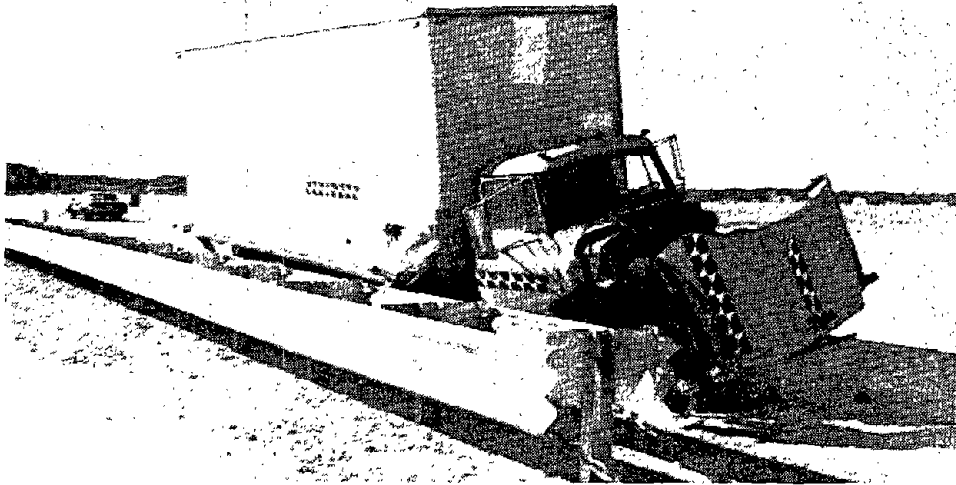
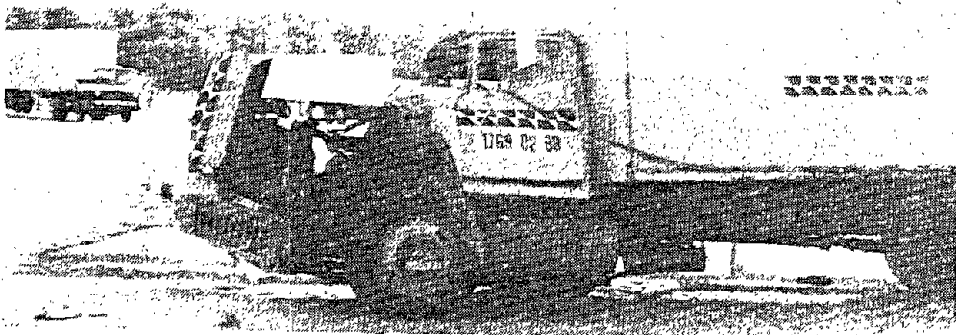
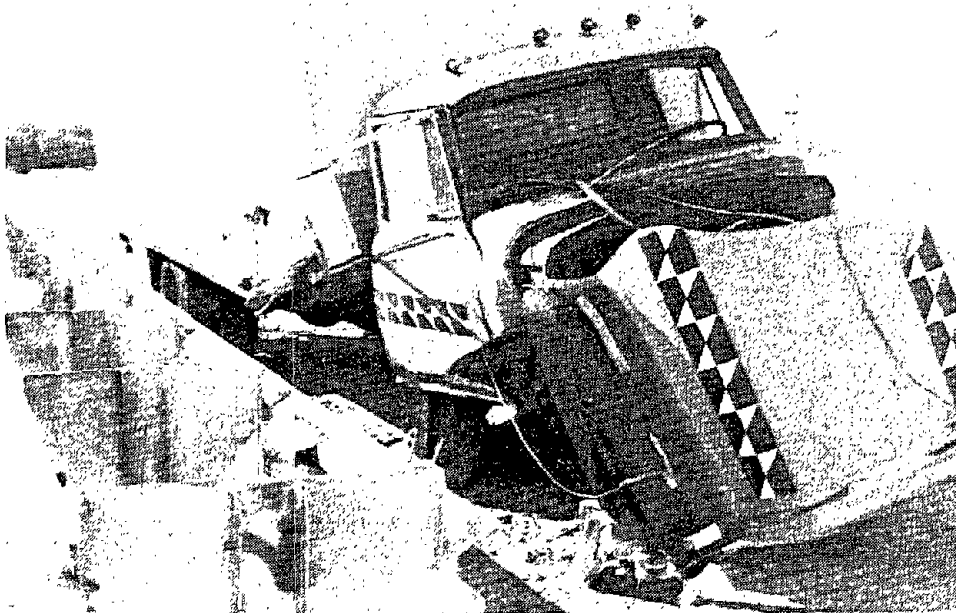
Figure 70. Posttest photographs of test vehicle, test 1769-D-2-88.

The chassis at the front of the truck was damaged and twisted. The hood came open and the front axle was torn from the frame and pushed into the truck. The rail side of the vehicle was damaged from impacting the rail, posts and blocks during the impact event. Posttest photographs of the truck are shown in figure 70.

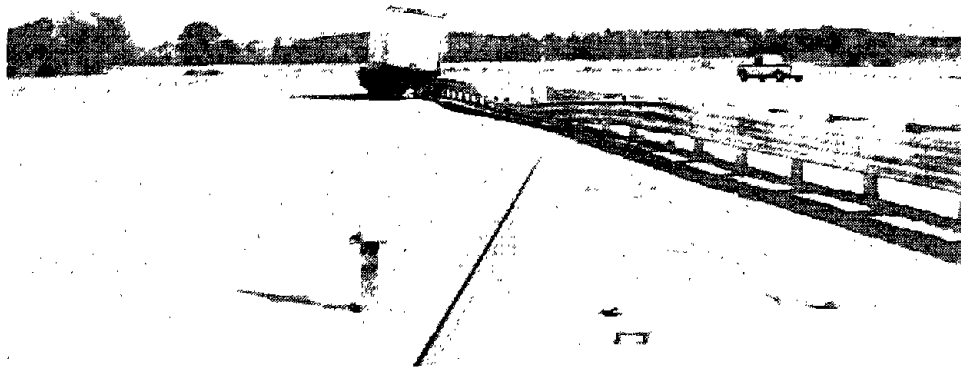
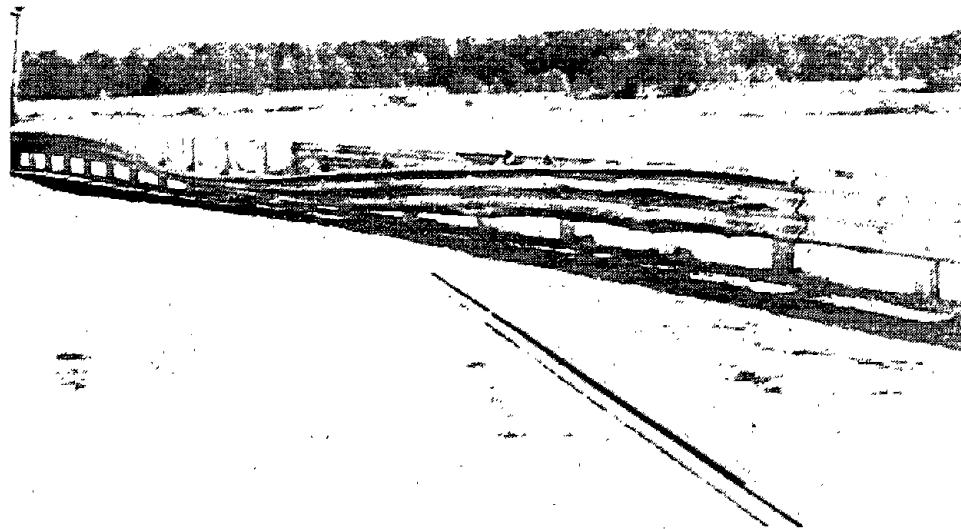
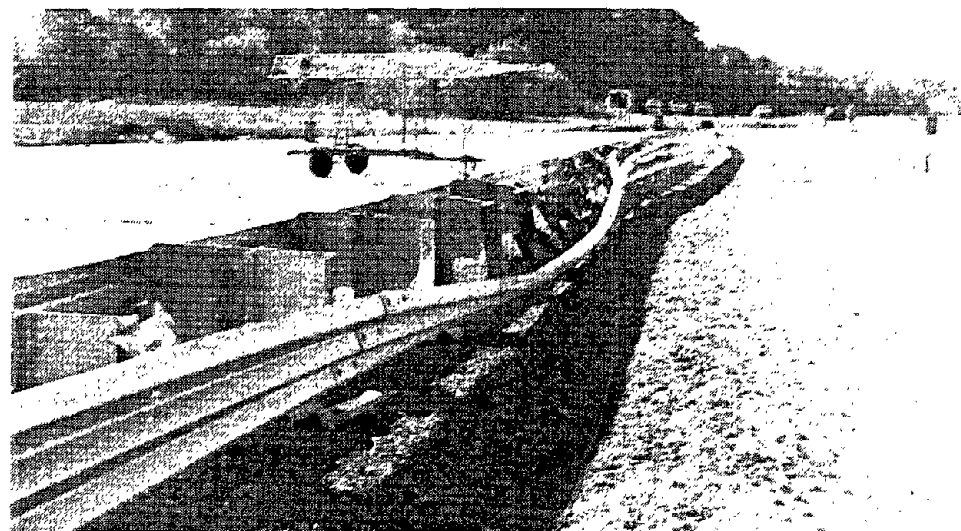
Figure 71. Posttest photographs of guardrail system, test 1769-D-2-88.

The barrier was damaged from the impact point downstream six rail lengths (75 ft). Posts and blocks in this area were bent or deformed. The rail was detached from the blocks on the front side of the barrier for the 75 ft and pushed downward by the rolling truck. The rail was detached on the backside for 37.5 ft because of the bending and twisting of the posts and blocks. Posttest photographs of the rail are shown in figure 71.
