**Publication No. FHWA-RD-89-119
April 1989**

TEST AND EVALUATION OF TRAFFIC BARRIERS

14. Sponsoring Agency Code	
15. Supplementary Notes FHWA Contract Manager: L. Meczkowski (HSR-20)					
16. Abstract A series of crash tests were conducted to evaluate several types of guardrails and bridge rails. Two bridge rail designs were tested and showed acceptable performance when evaluated in accordance with NCHRP 230. A three-cable guardrail was modified, and an end terminal was re-designed to obtain good performance. The guardrail safely redirected a large and small vehicle traveling at 60 mi/h and impacting at 25 and 20 degrees, respectively. The terminal design was tested for snagging by directly impacting the downstream end. Although the device released, the vehicle rolled over. A new PL3 median barrier was designed and tested in accordance with the new AASHTO bridge rail test criteria. A 50,000-lb tractor-trailer impacted the median barrier at 50 mi/h and 15 degrees. The truck was redirected and contained, but rolled over producing undesirable occupant compartment intrusion. An 18,000-lb truck test was conducted on the modified thrie beam median barrier. The results indicated good p

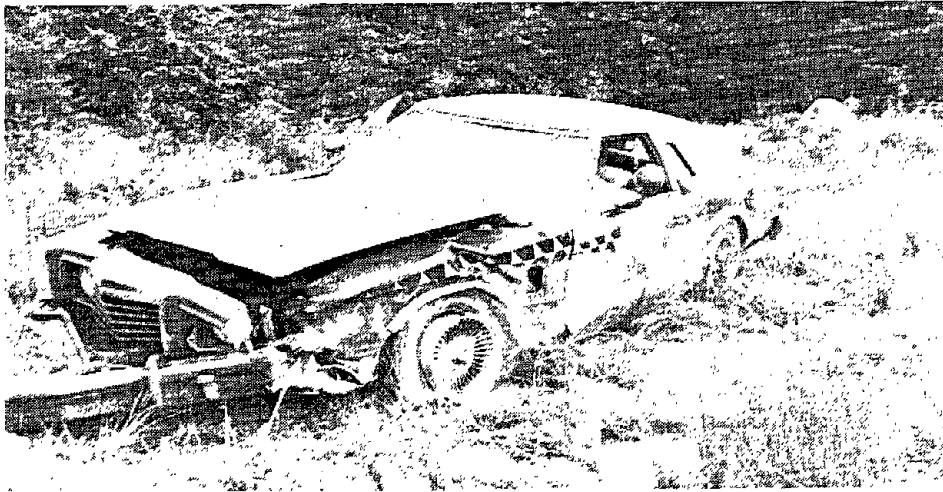
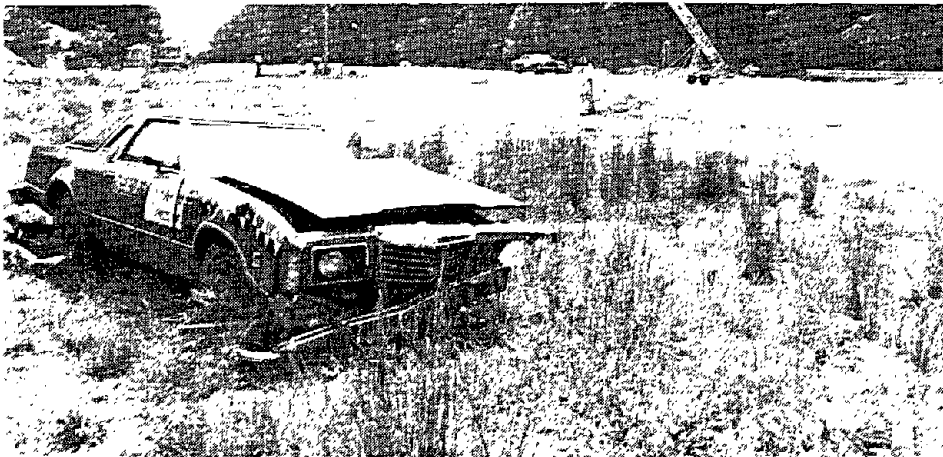
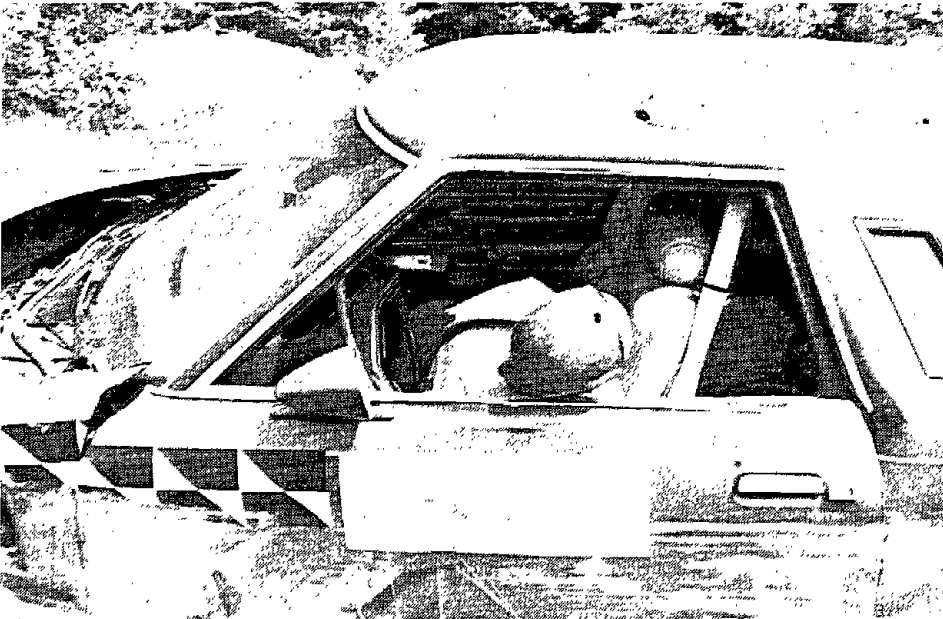
Figure 78. Posttest photographs of test vehicle, test 1769-E-1-86.

The entire left side of the vehicle was damaged, but damage occurred mainly to the left front fender and left front wheel. Posttest photographs of the vehicle are shown in figure 78.

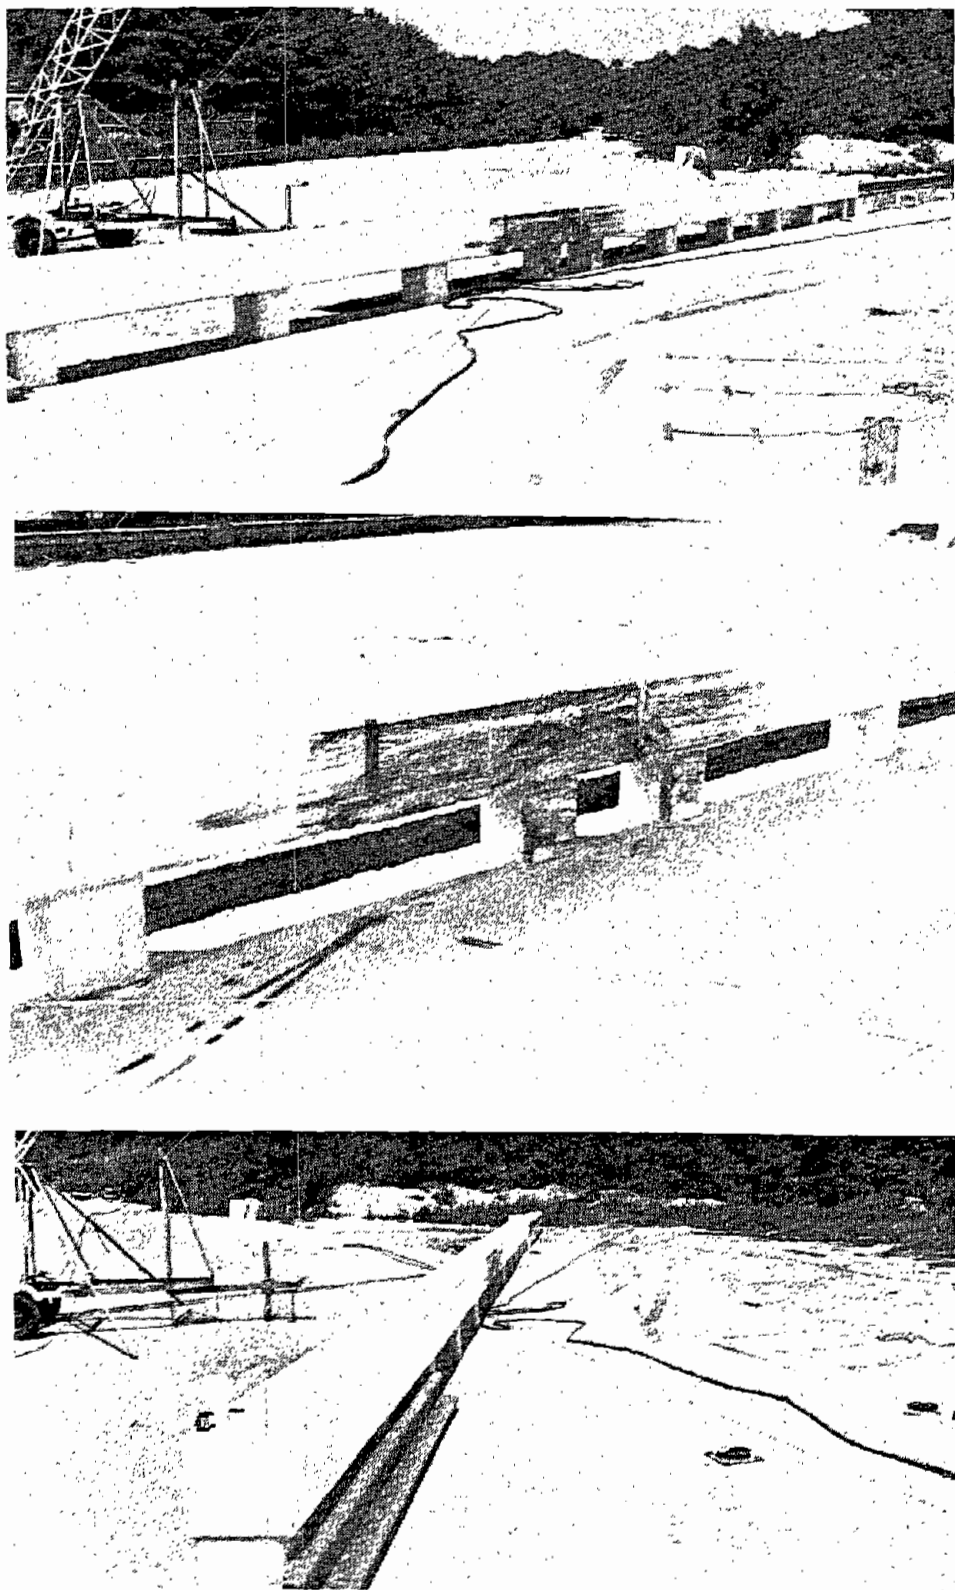
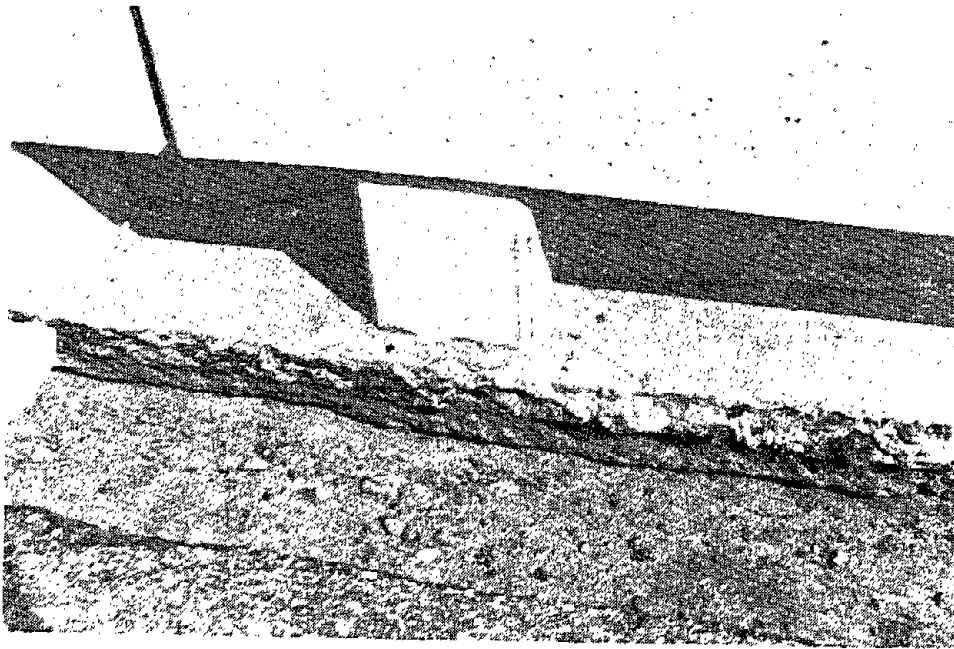
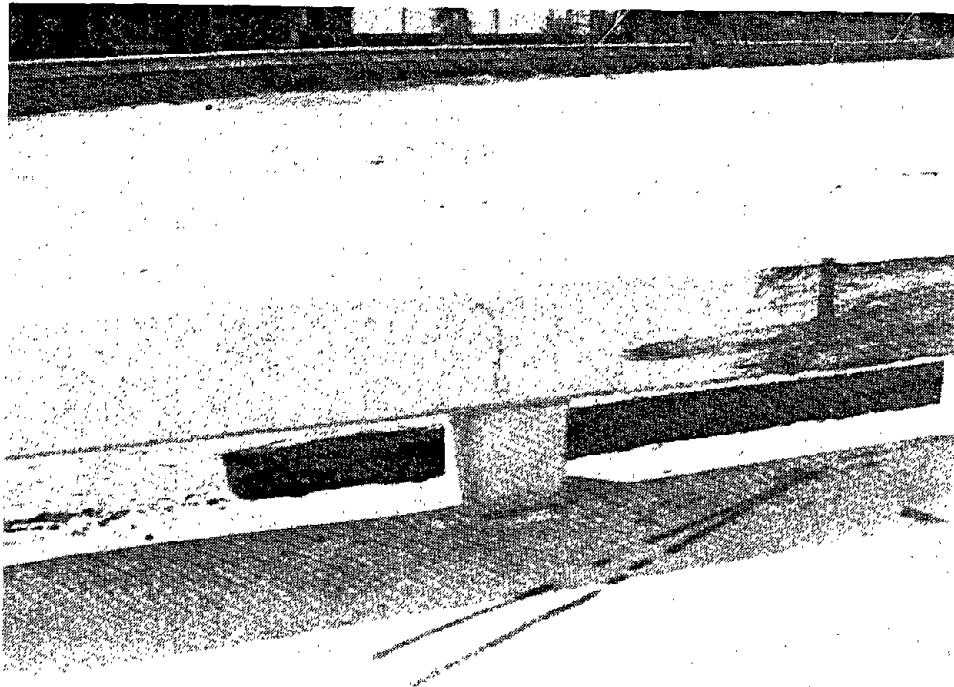
Figure 79. Posttest photographs of Iowa bridge rail system, test 1769-E-1-86.

The Iowa bridge rail system performed as designed. No structural damage was observed. Hairline cracks were observed in two locations on the rail and in one location on the deck. The cracks on the deck were behind the last post in the first segment of the rail (the post next to the expansion joint). Minor abrasions were evident. Posttest photographs are shown in figure 79. Photographs of the cracks are shown on page 127. All the cracks have been highlighted with a magic marker.

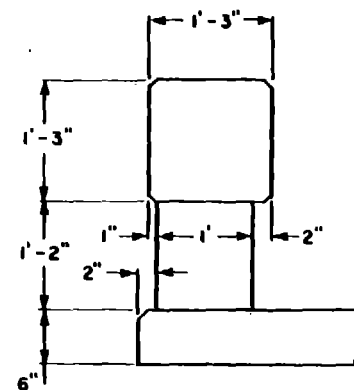
Figure 83. Test summary, test 1769-E-2-86.

13. Vehicle Analysis:	Observed	Design/ Limit Value
NCHRP 230:		
Longitudinal:		
Delta-V at 2 ft:	-25.5 ft/s	30/40 ft/s
Ridedown Acceleration:	-4.0 g's	15/20 g's
Lateral:		
Delta-V at 1 ft:	-31.9 ft/s	20/30 ft/s
Ridedown Acceleration:	-11.1 g's	15/20 g's
Delta-V at 0.54 ft (actual):	-28.2 ft/s	20/30 ft/s
Ridedown Acceleration:	-22.5 g's	15/20 g's
TRC 191:		
Peak 50 ms acceleration:		
Longitudinal:	-12.3 g's	
Lateral:	-18.3 g's

14. Test Results Conclusion: Meets all NCHRP 230 criteria.

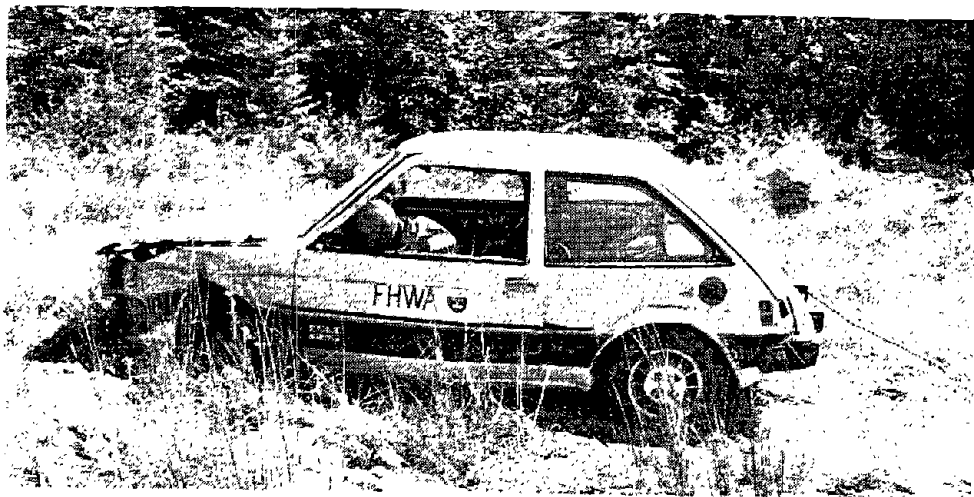
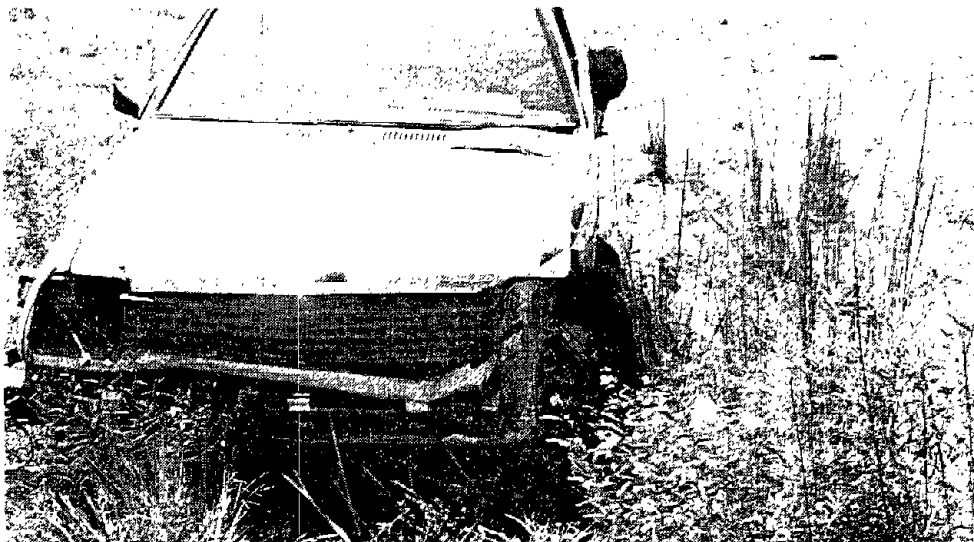
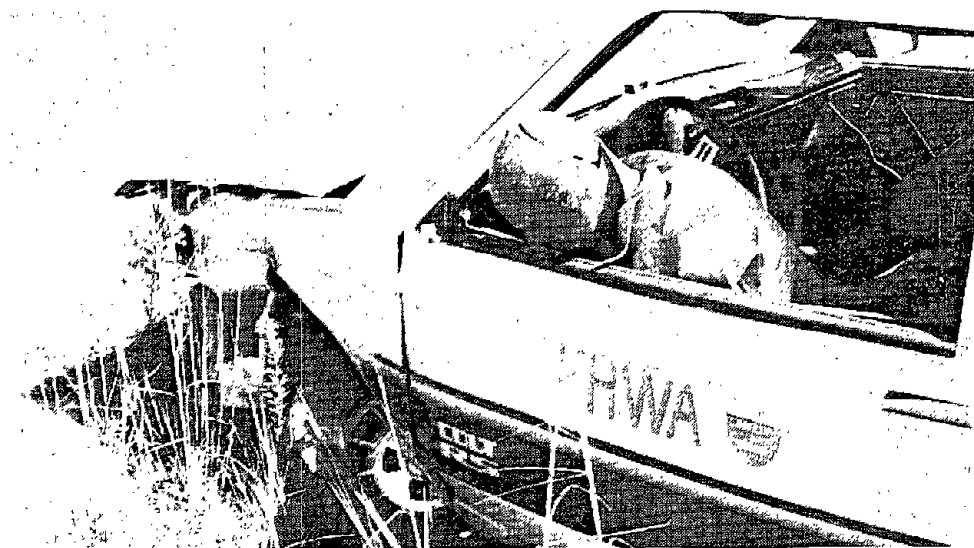
Figure 85. Posttest photographs of test vehicle, test 1769-E-2-86.

Almost all of the left side of the vehicle was damaged, but damage occurred mainly to the left front fender and left front wheel. Posttest photographs of the vehicle are shown in figure 85.

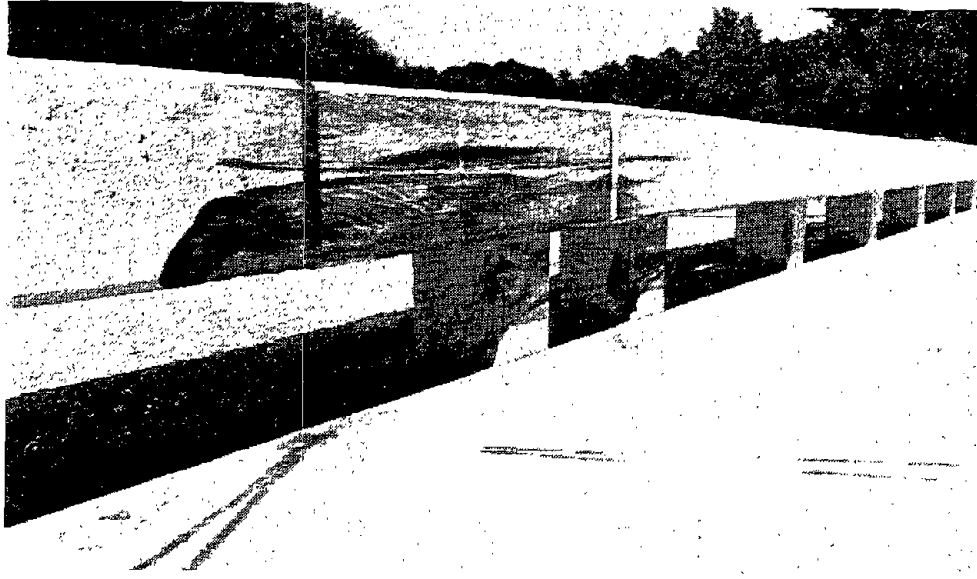
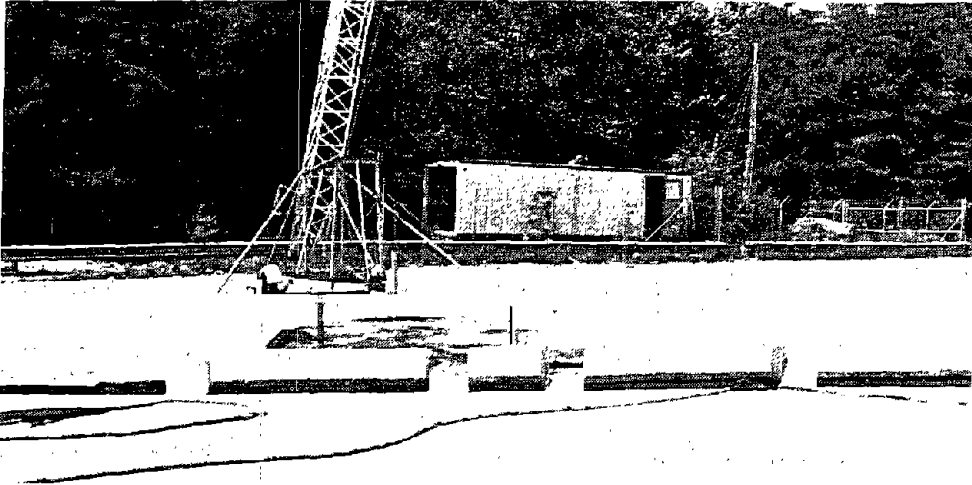
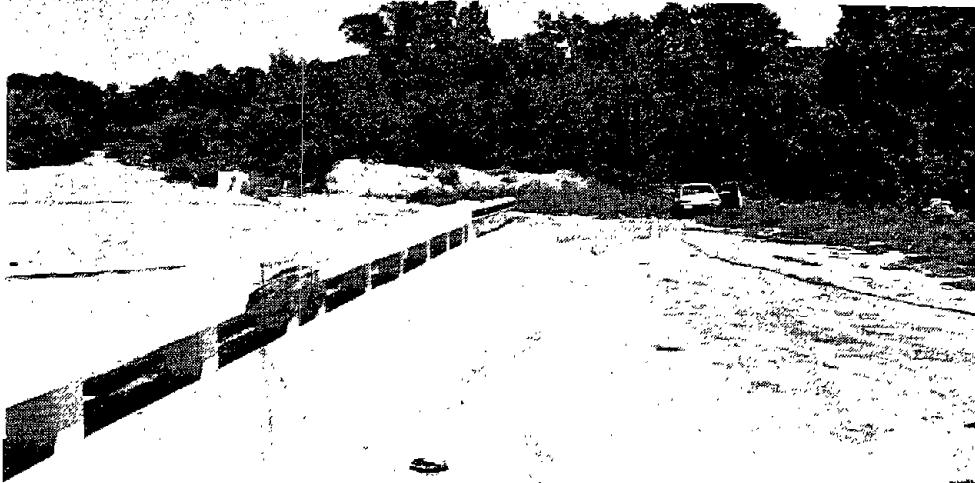
Figure 86. Posttest photographs of Iowa bridge rail system, test 1769-E-2-86.

The Iowa bridge rail system performed as designed. No structural damage was observed. Only minor abrasions were evident. Posttest photographs are shown in figure 86.

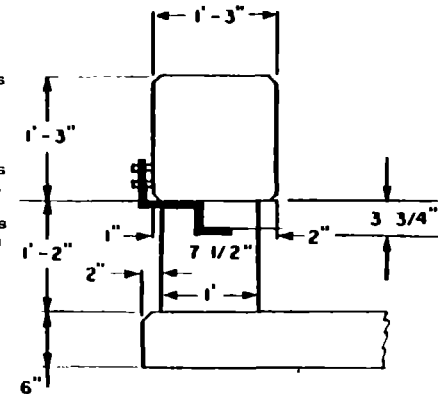
Figure 90. Test summary, test 1769-E-3-86.

13. Vehicle Analysis:	<u>Observed</u>	<u>Design/ Limit Value</u>
<u>NCHRP 230:</u>		
<u>Longitudinal:</u>		
Delta-V at 2 ft:	-20.8 ft/s	30/40 ft/s
Ridedown Acceleration:	-2.3 g's	15/20 g's
<u>Lateral:</u>		
Delta-V at 1 ft:	-27.6 ft/s	20/30 ft/s
Ridedown Acceleration:	-5.9 g's	15/20 g's
Delta-V at 0.54 ft (actual):	-26.5 ft/s	20/30 ft/s
Ridedown Acceleration:	-20.2 g's	15/20 g's
<u>TRC 191:</u>		
Peak 50 ms acceleration:		
Longitudinal:	-10.1 g's	
Lateral:	-16.4 g's	
14. Test Results Conclusion:	Meets all NCHRP 230 criteria.

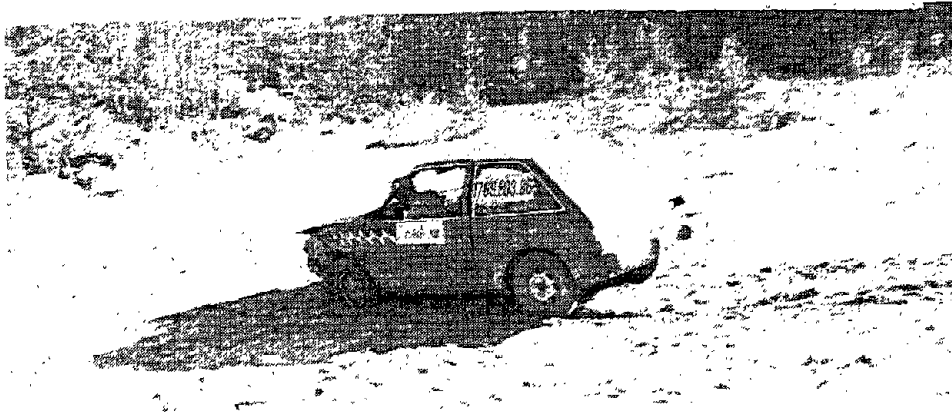
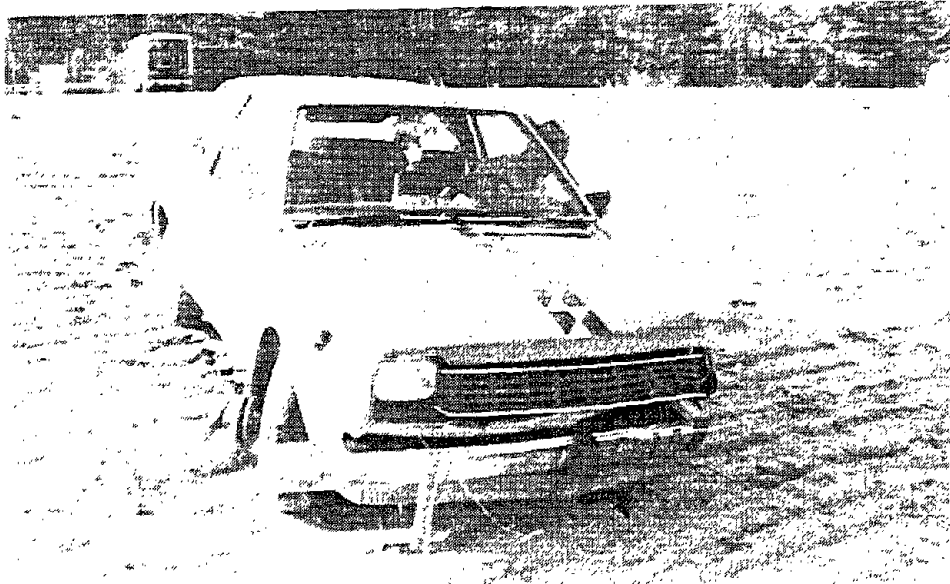
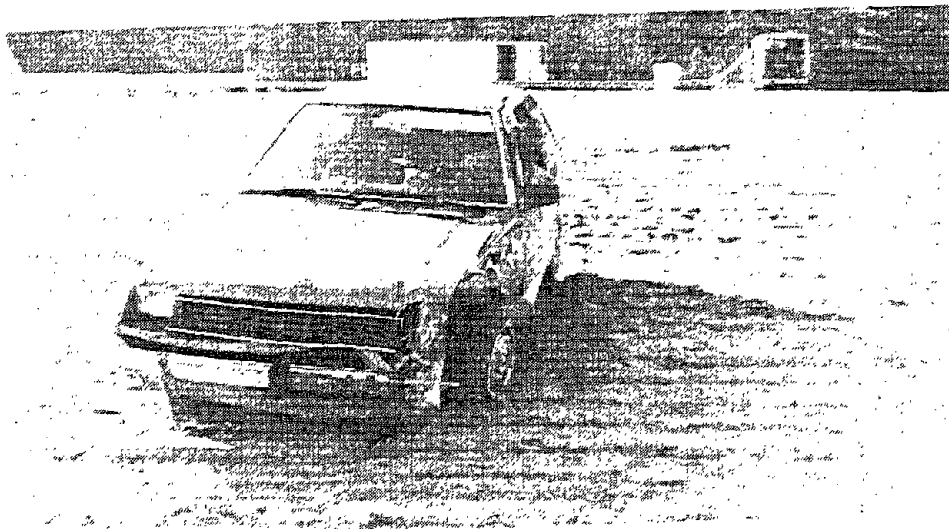
Figure 92. Posttest photographs of test vehicle,
test 1769-E-3-86.

Damage occurred mainly to the left front corner of the vehicle. Posttest photographs of the vehicle are shown in figure 92.

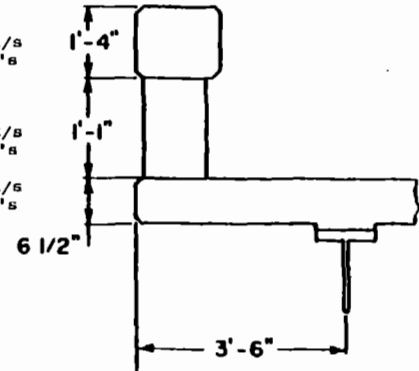
Figure 98. Test summary, test 1769-F-1-86.

13. Vehicle Analysis:	<u>Observed</u>	<u>Design/Limit Value</u>
<u>NCHRP 230:</u>		
<u>Longitudinal:</u>		
Delta-V at 2 ft:	-17.2 ft/s	30/40 ft/s
Ridedown Acceleration:	-2.8 g's	15/20 g's
<u>Lateral:</u>		
Delta-V at 1 ft:	-31.2 ft/s	20/30 ft/s
Ridedown Acceleration:	-14.3 g's	15/20 g's
Delta-V at 0.67 ft (actual):	-23.9 ft/s	20/30 ft/s
Ridedown Acceleration:	-20.7 g's	15/20 g's
<u>TRC 191:</u>		
Peak 50 ms acceleration:		
Longitudinal:	-7.5 g's	
Lateral:	-15.3 g's	
14. Test Results Conclusion:	Meets all NCHRP 230 criteria.
