**Federal Highway  
Administration**

Publication No. FHWA-RD-88-269

July 1989

# SALT PENETRATION AND CORROSION IN PRESTRESSED CONCRETE MEMBERS

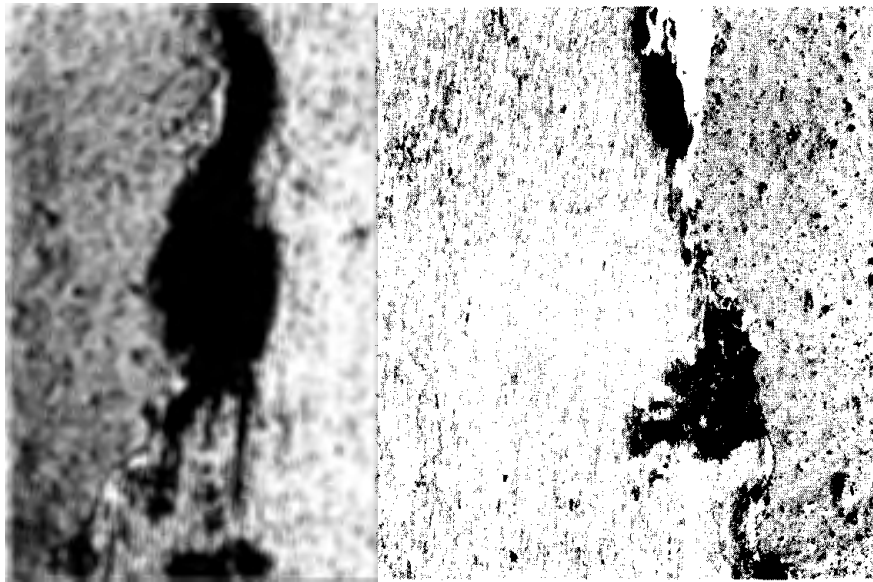
These examinations revealed a microstructure typical of prestressing steel wire. The microstructure consisted of heavily cold worked and elongated grains of ferrite and pearlite. Near the fractured ends of the wires, similar microstructures were observed. It could be seen that the reduction in wire diameter was primarily due to corrosion rather than necking during tensile overload failure. The corrosion may be classified as a general oxidation of the wire surface. No indication of inherent metallurgical defects were observed which would have contributed to premature failure of the wire such as excessive inclusions, laps, carburizations, or unusual surface conditions developed during forming or manufacture of the wire. Illustration of the microstructure and the mode of failure exhibited by the wire sample is presented in figure 26.

Figure 26. The significant reduction in diameter from the bottom to top.  
(Magnification: 50X. Etchant: 1% Nital.)

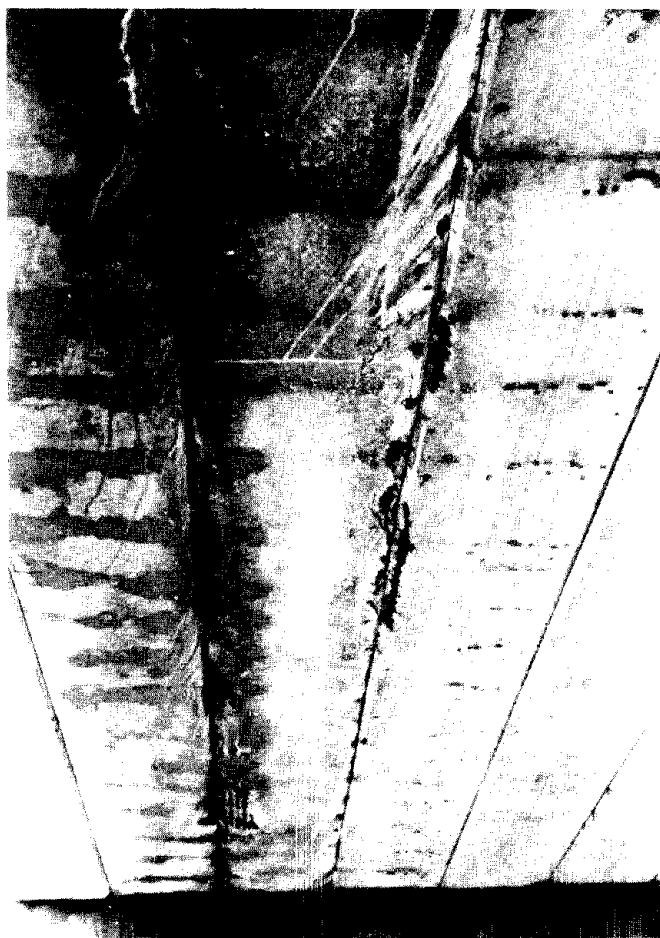
Figure 41. Study Area 1.

**Study Area #1.** This area is located in Span 3 and consists of Beams 2, 3, and 4, counting from the south side of the viaduct (figure 41). The area represents a severe to very severe extent of deterioration of concrete and corrosion of the reinforcement.

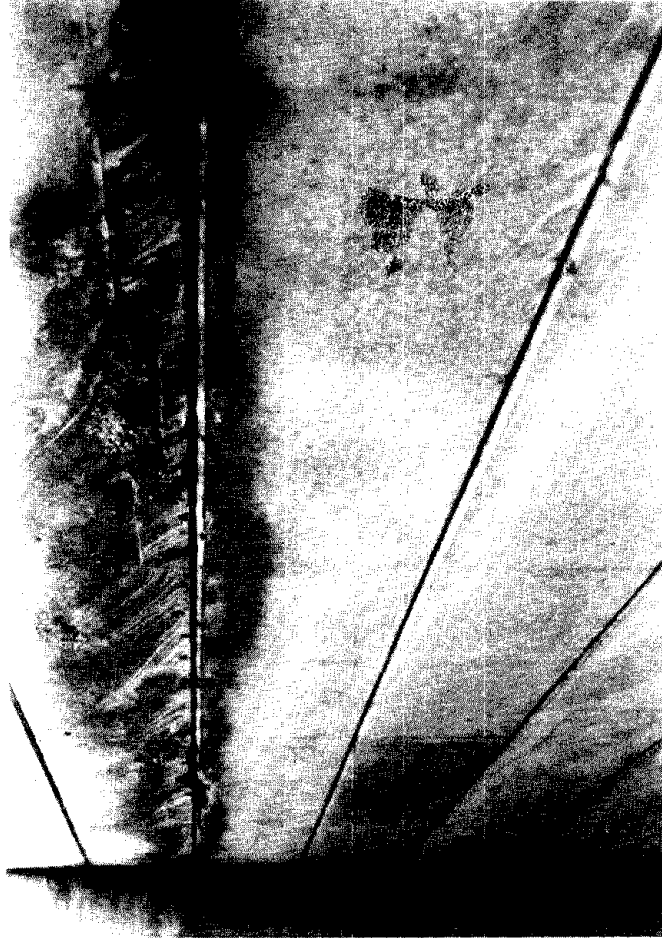
Figure 42. Study Area 2.

**Study Area #2.** This area is located in Span 22 and consists of Beams 2 and 3 (figure 42). The area represents moderate to severe deterioration. Most deteriorations in this area had occurred in Beam 2.

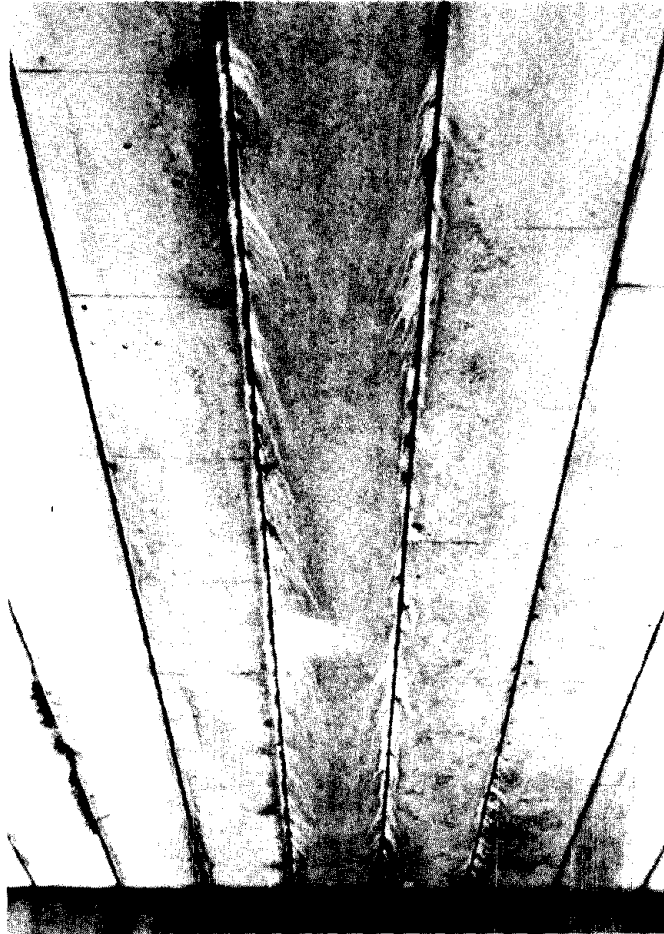
Figure 43. Study Area 3.

**Study Area #3.** This area is located in Span 3 and consists of Beams 10, 11, and 12 (figure 43). The area represents spans with extensive leakage, but without visible corrosion related deterioration of concrete cover. Wet spots and deposits of deicing salts were well visible along Joints 10 and 11, and partially along Joint 12. The total length of 5 cracks, all located in Girder 11 was 11.5 ft (3.5 m). Neither concrete spalls nor exposed strands were present in this study area.

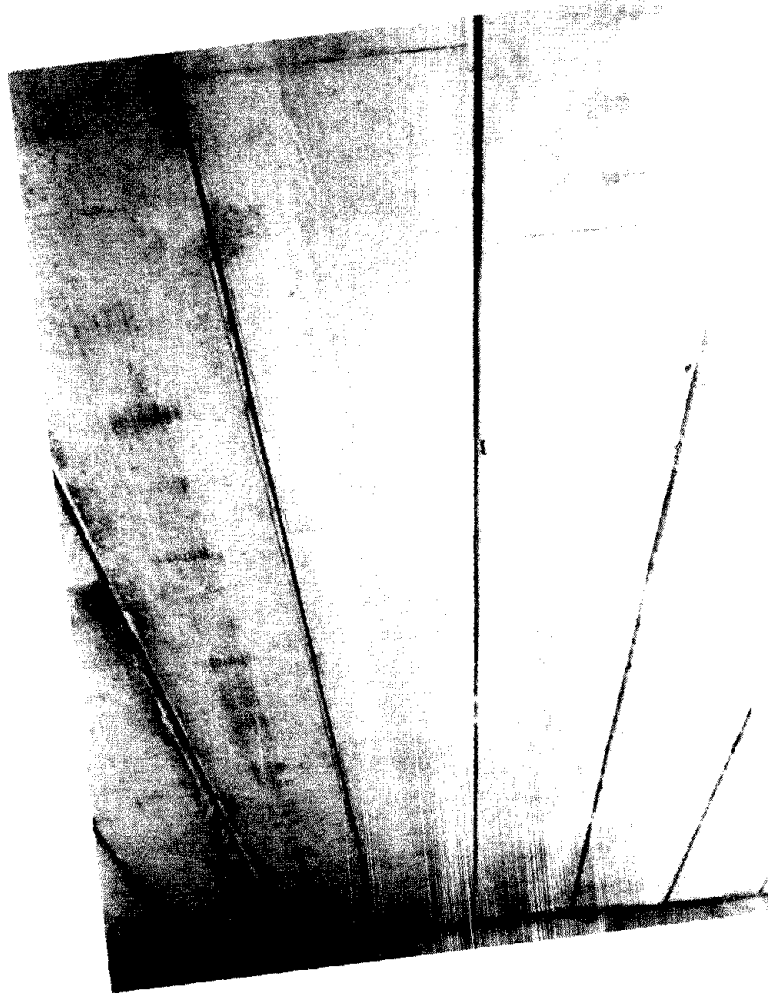
Fig. 44. Study Area 4.

**Study Area #4.** This area is located in Span 22 and consists of Girders 10 and 11 (figure 44). This area was used as a reference area since it does not have any signs of concrete deterioration or water leaking through the joints between girders.

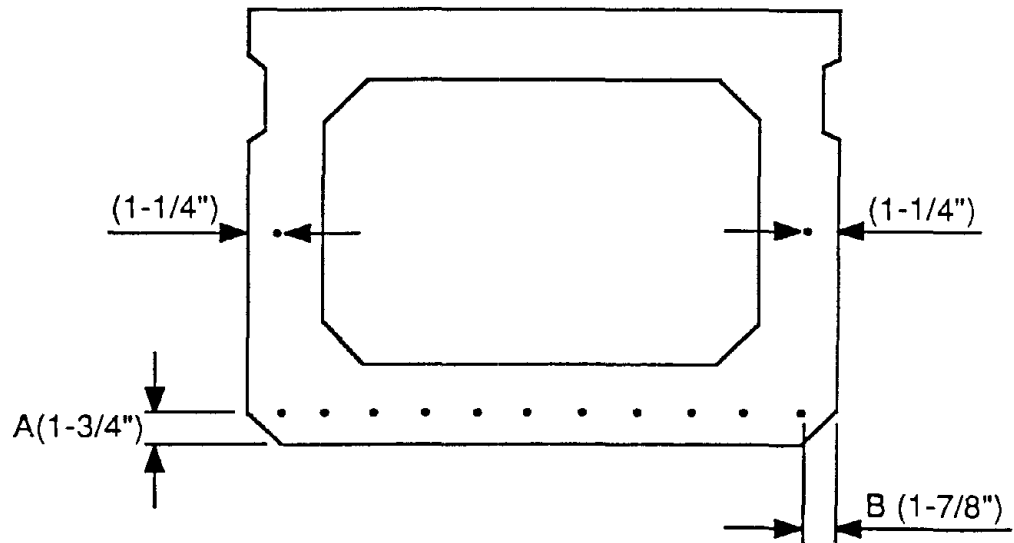
Essential data along with a number of observations in each study area are given in figure 49. These data indicate the average thickness of concrete cover on the bottom side of beams is in the range of 1.5 to 1.62 in (38 mm to 41 mm) as compared with 2.0 to 2.63 in (51 to 67 mm) on the south and north sides of a beam over bottom prestressing strands. The average specified concrete cover on the bottom side is 1.75 in (45

Figure 49. Concrete cover survey.

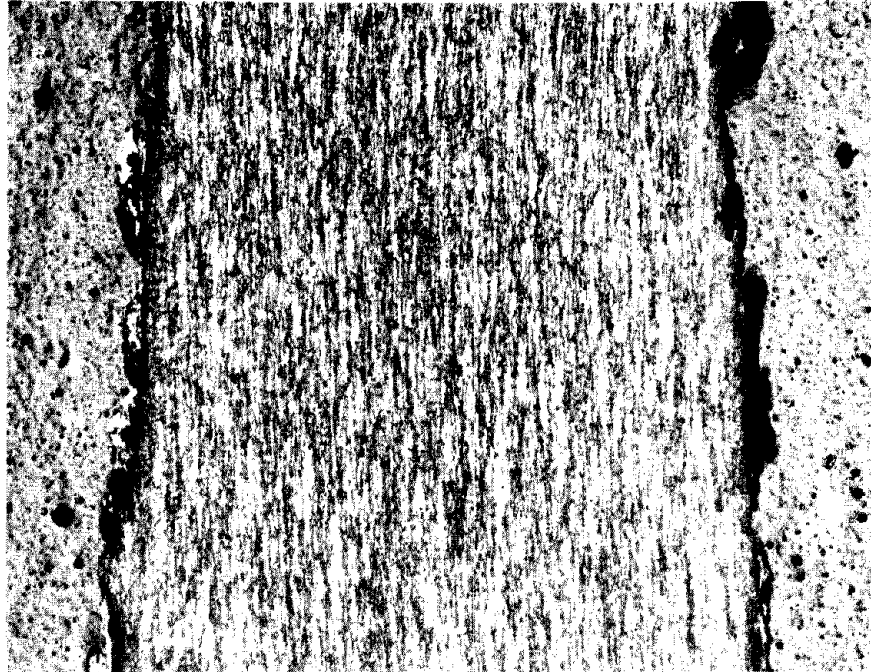
These examinations revealed a microstructure typical of prestressing steel wire. The microstructure consisted of heavily cold-worked and elongated grains of ferrite and pearlite. Near the fractured ends of the wires, similar microstructures were observed. It could be seen the reductions in wire diameter were primarily due to corrosion rather than necking during tensile overload failure. The corrosion may be classified as an oxidation of the wire surfaces. No indication of inherent metallurgical defects were observed which would have contributed to premature failure of the wire such as excessive inclusions, laps, carburizations, or unusual surface conditions developed during forming or manufacture of the wire. Illustration of the microstructure exhibited by the wire sample is presented in figures 53, 54, and 55.

Figure 54. The microstructure of the center wire with Bakelite along the left and right edges.  
(Magnification: 50X. Etchant: 1% Nital.)

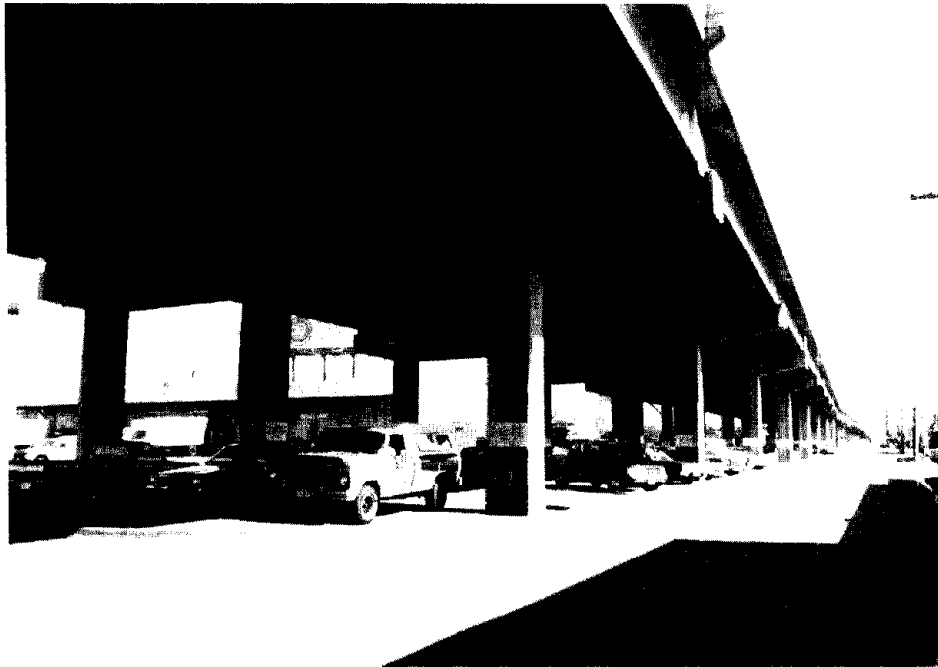
First failures of the post-tensioned tendons were noticed in 1975-1977. The steel bars generated loud noises when breaking. The noise was overheard by people in the area who reported it to the DOT personnel. The presence of fractured tendons was determined by inspecting the ends of the post-tensioned beams. Broken steel bars had

Figure 56. The Sixth South Street Viaduct, Salt Lake City, Utah.

loose ends projecting from the end of a girder and loose end nuts displaced from their original location. Cracking and spalling of end grouting caused by loosening of the tendons was also considered an indication of a possible rod fracture. There were no cracks or rust stains visible on the exterior surfaces of these particular girders. It was estimated the total number of fractured bars was about 21. Some pitting corrosion without signs of necking or loss of cross sectional area was observed on retrieved broken rods.

Failure was attributed to salt entering anchorage zones and moving inside ducts between the steel rod and sheath. All beams with fractured tendons were subsequently externally post-tensioned to restore structural capacity.

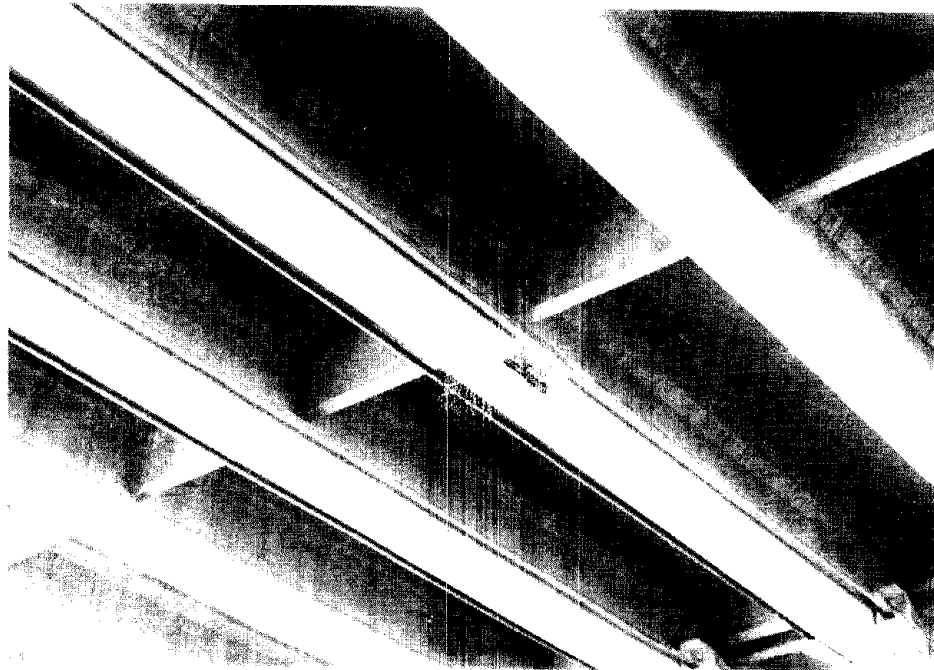
**Post-Tensioned Tendons.** The extent of corrosion of post-tensioned steel bars was determined by inspecting two tendons, one in Girder 3, Span 36-37 (figure 57), and the other one in Girder 10, Span 28-29 (figure 58). These tendons were exposed in November 1977 and have remained open since then.<sup>(47, 48)</sup> Neither of the two tendons was fractured. The thickness of the duct sheath in exposed tendons was 0.01 in (0.25 mm). The distance between the steel rod and the duct was about 0.04-0.06 in (1.0-1.5 mm). Neither grout nor grease were found inside the tendons.

Figure 57. Exposed post-tensioned tendon  
in Girder 3, Span 36-37.

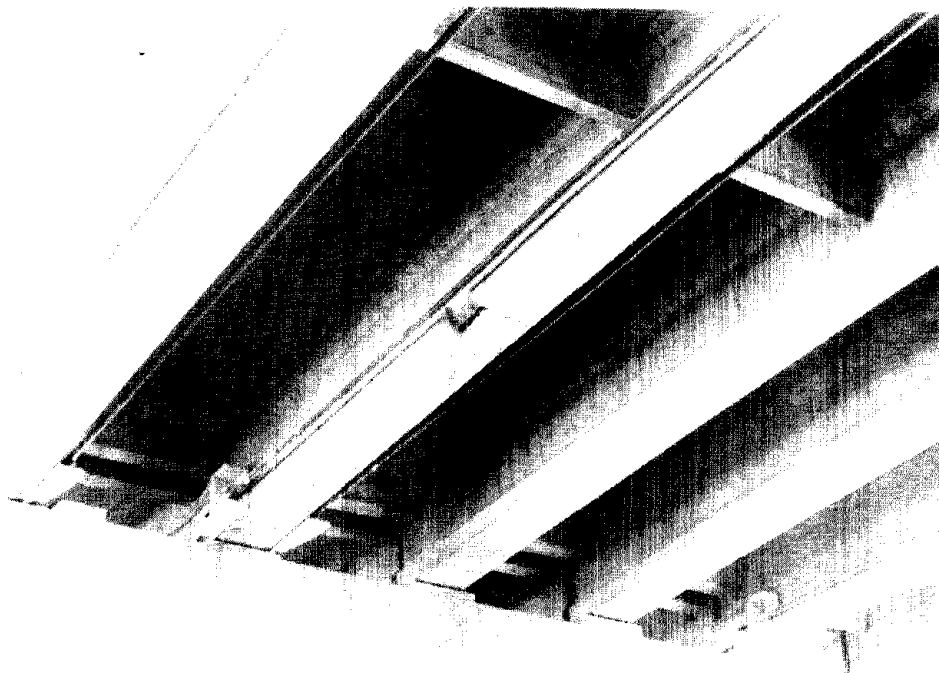
Figure 58. Exposed post-tensioned tendon  
in Girder 10, Span 28-29.

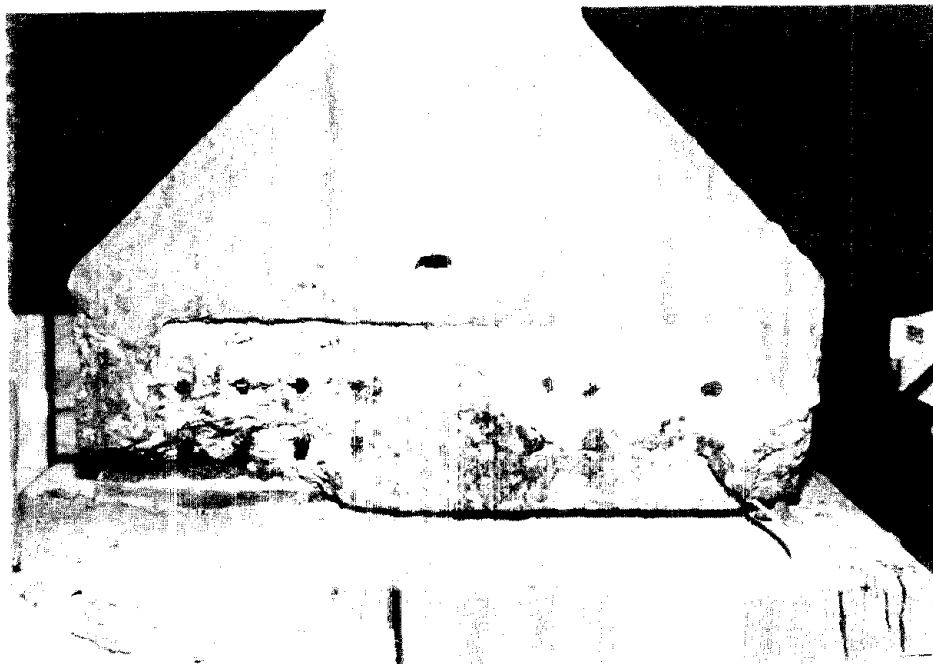
**Pretensioned Strands.** The ends of seven wire strands in pretensioned girders were covered with portland cement mortar. The mortar was found to be soft but in good condition, without any signs of deterioration (figure 64). Some strands were exposed to a depth of 2.25 in (57 mm) and examined for the presence of rust. The extent of corro-

Figure 64. Corrosion protection to exposed ends of seven wire strands by means of portland cement mortar.

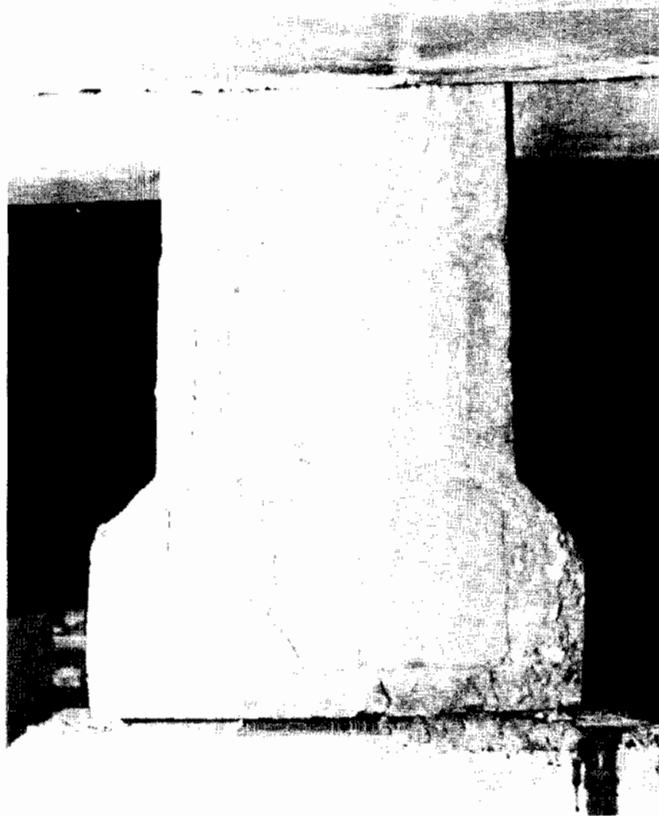
**Anchorage Areas.** Most extensive deterioration of concrete in post-tensioned girders occurred in areas of anchor steel plates. Cracking was noticed in almost every post-tensioned girder. Typically cracks would occur around and in the mortar filled tendon depressions (figure 67). Spalling of the mortar cover over steel plates was not uncommon (figure 68). This type of deterioration was mainly caused by corrosion of steel anchor plates and, to some extent, by corrosion of conventional reinforcing steel bars. The cause of concrete cracking in beam pedestals was not clear (figure 68).

Figure 67. Cracks in mortar  
and concrete in areas  
of anchor plates.

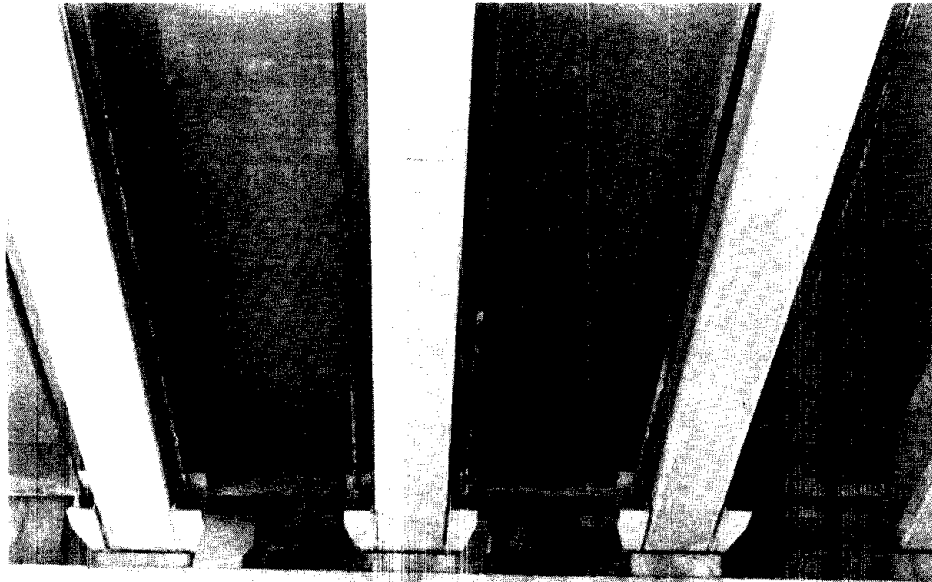
**External Tendons.** It was estimated that of a total of 224 post-tensioned girders, 30 were reinforced with external tendons (figure 71). A typical external tendon consists of a heavy frame made of a 0.9 in (22.9 mm) steel sheet and a 2 in (50.8 mm) steel anchor plate bolted to the frame. Each tendon has a 1.5-in (38.1 mm) diameter post-tensioned rod protected with a 2.5-in (63.5 mm) diameter rigid plastic duct connected to the frame through a steel pipe (figure 72). The threaded end of the rod is coated with a

Figure 71. Post-tensioned girders reinforced with external tendons.

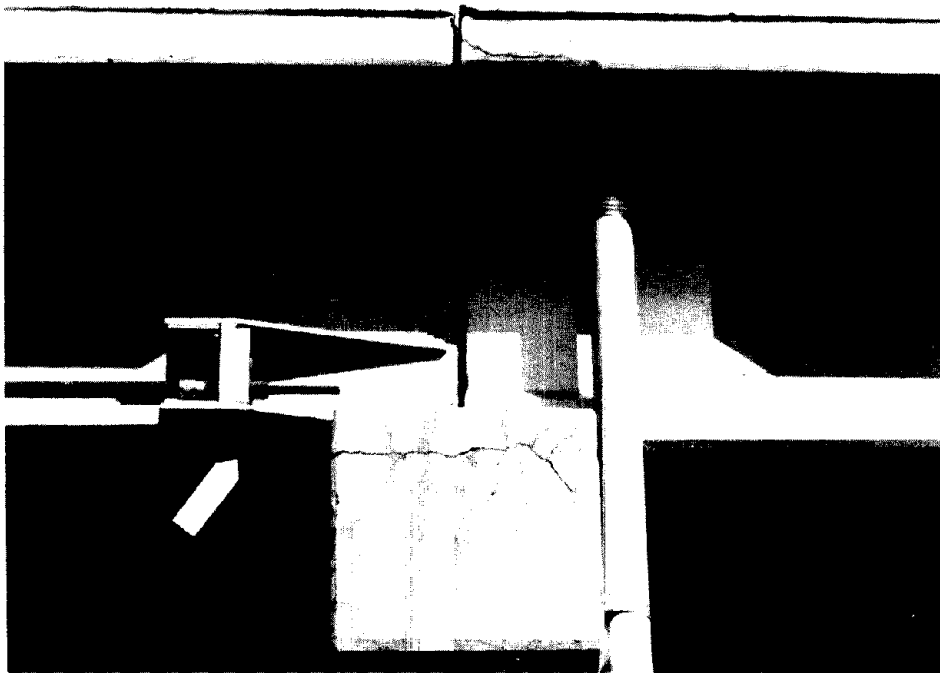
It was noted the external tendons were detailed such that even when located next to a leaking joint, the penetration of chloride-laden water inside tendons was very unlikely. The anchor of a tendon was not covered with concrete or with mortar and therefore could easily be inspected. It appears this design provides good protection to post-tensioned rods against corrosion and can be recommended for similar projects.

Figure 72. A typical external tendon.

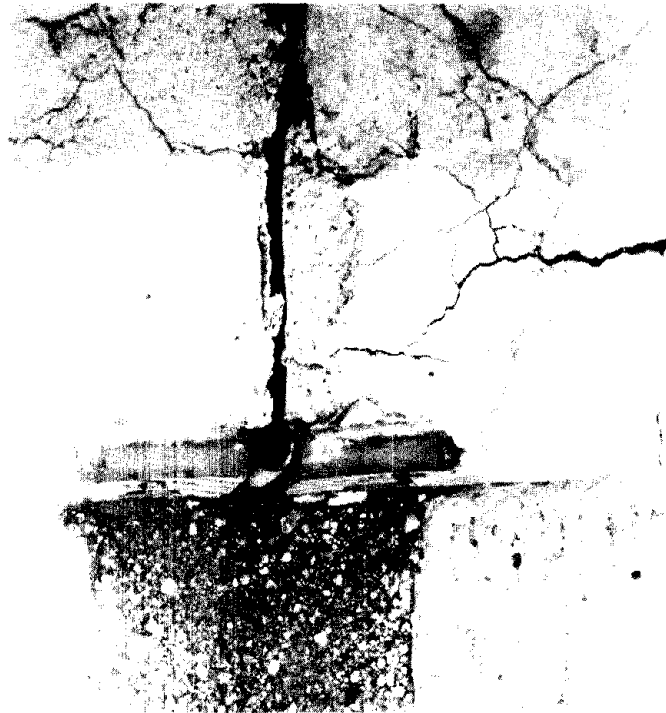
**Deck Drains.** A typical bridge drain consists of a 6 in (152.4 mm) pipe extending to about 2 ft (0.61 m) above the ground. Drains were installed next to each second expansion joint, on the east side of the viaduct, about 2 ft (0.61 m) from the joint. Originally, each drain pipe was installed parallel to the bottom edge of a pier cap and had a slope of not more than 20 deg. Accumulation of water and debris on top of the deck, deterioration of concrete in areas of expansion joints and in pier elements, as well as holes in drain pipes made to increase the rate of flow of storm water suggested the drainage system was not functioning properly (figures 73, 74, and 75) . The problem was aggravated by the presence of unsealed sidewalk joints on both sides of the viaduct.

Figure 73. Accumulation of debris and deterioration of concrete in areas adjacent to the open sidewalk expansion joint.

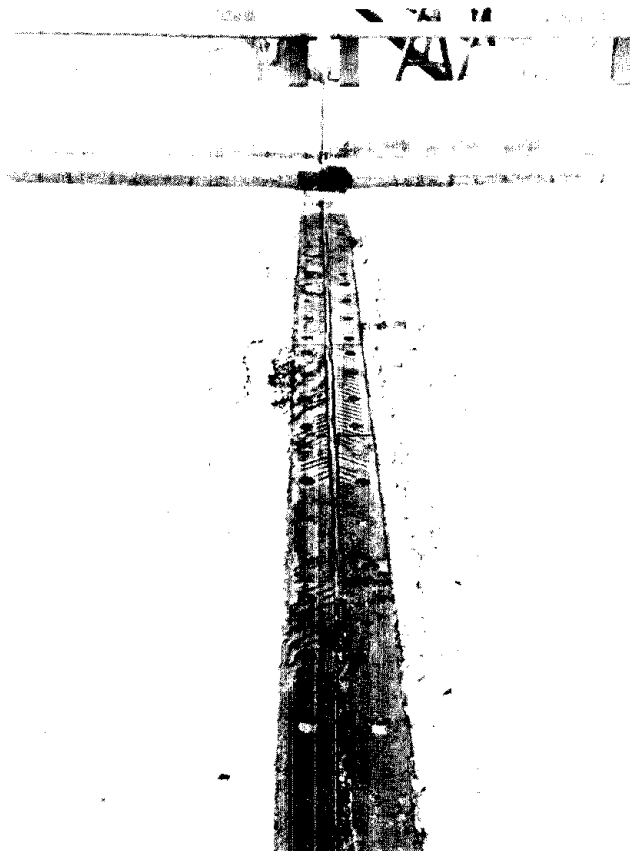
Figure 74. Deterioration of concrete in areas of expansion joints.

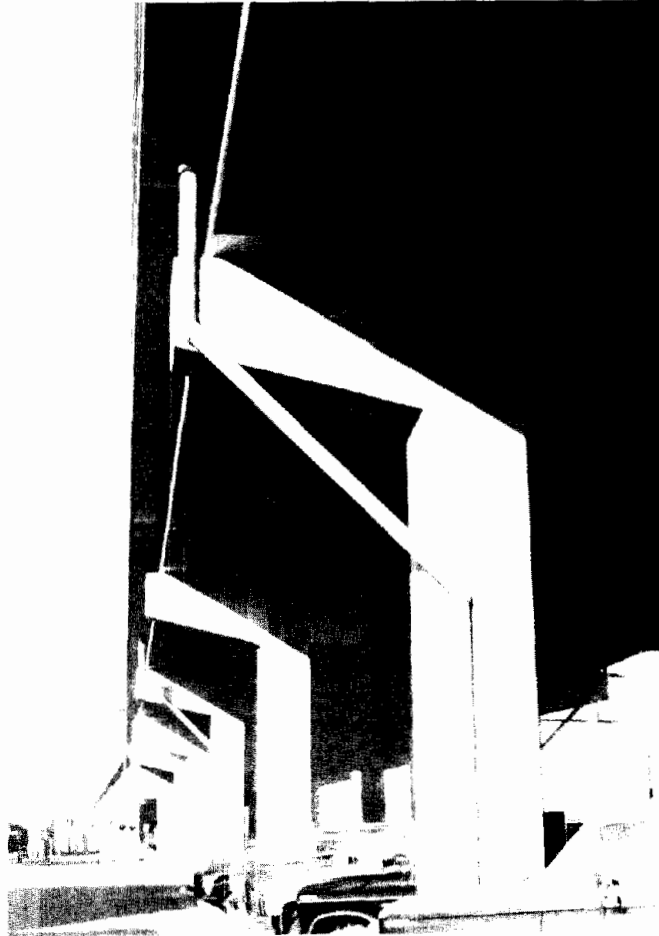
Figure 77. Drain pipe with an increased slope.

Later the original design was altered. Drain pipes were either removed completely with the exception of a short vertical portion, or slope was increased to approximately 60 deg (figures 76 and 77). Leaking deck joints were resealed and deteriorated concrete around them was replaced. The short pipes appeared to provide sufficient flow of storm water. It appears that drain grids are inspected and cleaned on a routine basis.

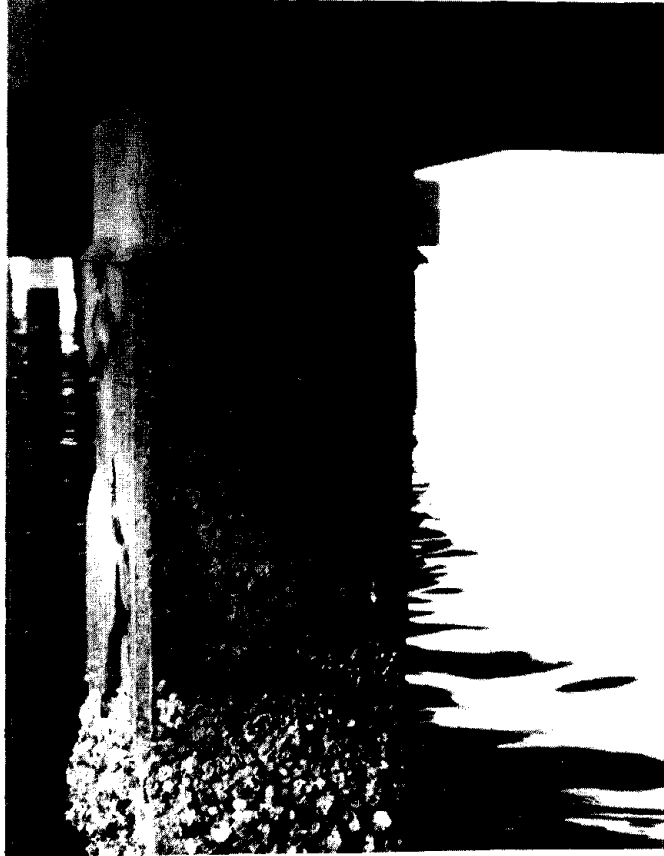
Figure 89. Typical cracks in a prestressed pile.

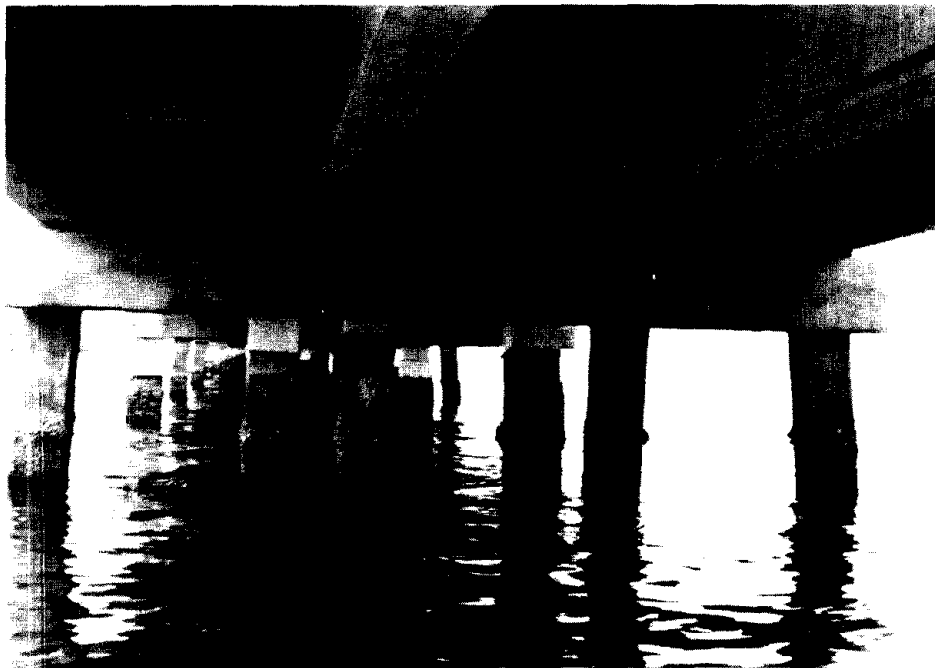
Figure 90. Remains of the protection system on prestressed piles.

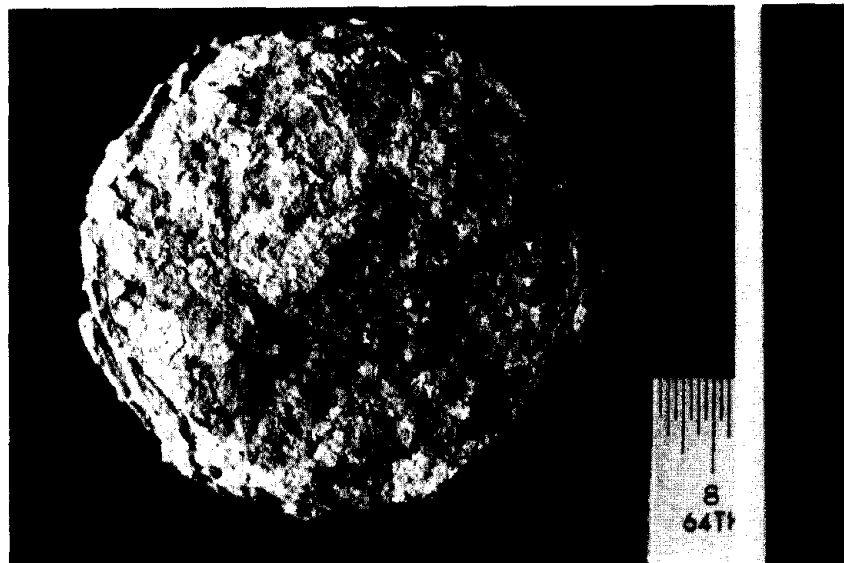
**Visual and Macroscopic Examination.** The prestress rod was subjected to visual and macroscopic examinations performed with the aid of a stereoscopic microscope capable of magnifications up to 40X. These examinations revealed a uniform rust layer on all outside surfaces except at the sheared end (figure 97). The fractured end and the entire circumference displayed rust up to 0.125 in (3.2 mm) thick (figure 98).

Figure 98. Extensive rust observed on the fractured surface of the rod.  
(Magnification: 3X.)

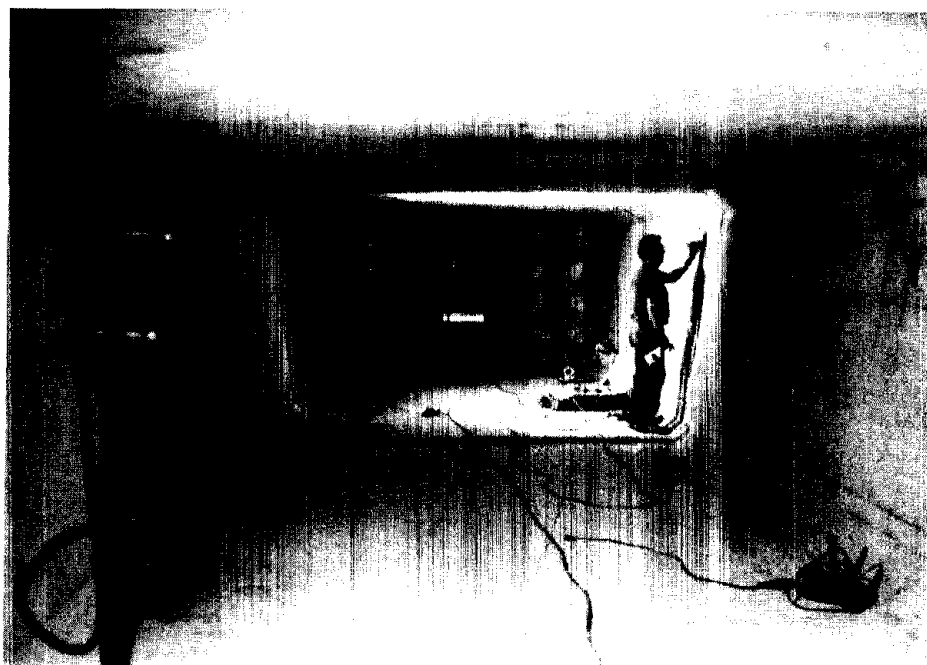
Figure 115. Potential survey on post-tensioned box girders in Spans 19 and 21.

Potential surveys were conducted on prestressed beams in Spans 1 and 39, and on post-tensioned box girders in Spans 19 and 21. A total of 5 prestressed and 2 post-tensioned beams were surveyed. Prestressed beam potential readings were taken in a grid pattern at a spacing of 2 ft (0.61 m). In post-tensioned girders potential readings were obtained on the internal surface of the walls (figure 115).

Analyzing these test results, it is seen maximum potential readings in all examined girders were less negative than -0.20 V CSE. Based on results of the potential survey it is concluded there is greater than 90 percent probability that no corrosion activity had occurred in any of the examined girders. This conclusion is in agreement with findings of the visual examination.

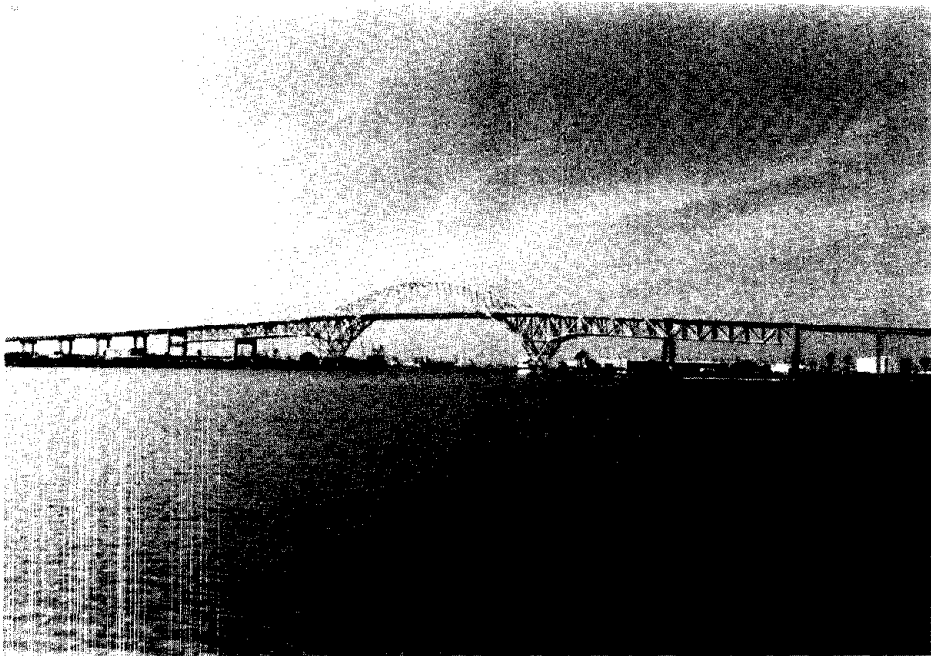
Ship Channel Bridge is located in Corpus Christi on Hwy 181 (figure 116). It was built in 1955. The bridge consists of precast prestressed and steel girder spans. A typical prestressed girder span is shown in figure 117.

Figure 116. Ship Channel Bridge.

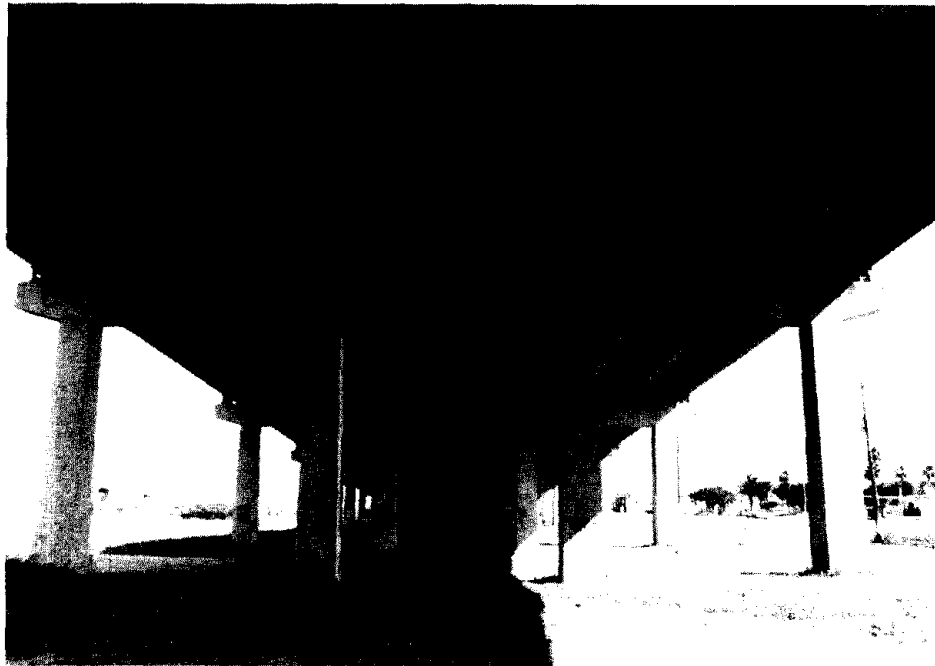
Figure 117. Typical prestressed girder span.

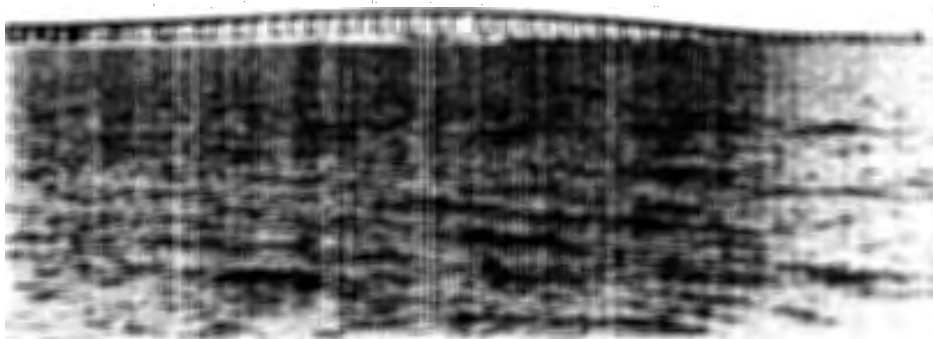
The Nueces Bay Causeway is located on Highway 181 (figure 122). The causeway was built in 1962. The total length of the causeway is 9,637 ft (2940 m). The overall width of a typical span is 31.3 ft (7.95 m). The causeway consists of two separate bridges, the south bound steel span bridge and the north bound prestressed beam span bridge. A typical section of the causeway consists of a cast-in-place 7.25-in (184.2 mm) deck slab, cast-in-place end diaphragms flush with beam ends, and a total of 4 precast pretensioned girders supported by a cast-in-place cap beam resting on precast prestressed piles (figure 123). Details of the reinforcement of a typical girder are shown in figure 124.

Figure 122. The Nueces Bay Causeway.

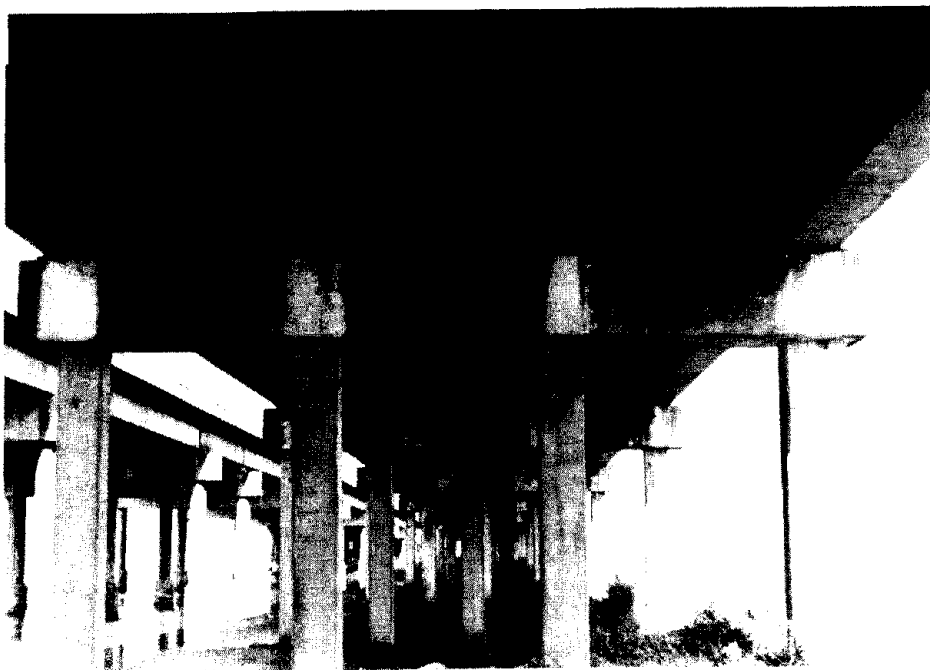
No corrosion-related deterioration of concrete was noted in prestressed elements except for some cracking of concrete cover in piles at the south end of the bridge. To determine the presence of the corrosive environment, special attention was paid to conventionally reinforced elements in areas of expansion joints. Since concrete in conventionally reinforced members is more permeable than in precast prestressed beams, it is reasonable to expect that corrosion of steel would occur first in pier caps and in diaphragms. Also, reinforced concrete in these areas is exposed not only to chloride-laden water vapor but also to chloride-laden moisture from the deck surface coming through leaking expansion joints. In addition, the presence of mildew and algae suggest that moisture content in the concrete in these locations was higher than in the rest of the bridge. Nevertheless, no signs of corrosion were observed in prestressed or in conventionally reinforced structures adjacent to expansion/contraction joints.

Figure 123. Typical prestressed girder span.
