1. Report No. FHWA/RD-86/114		2. Government Accession No. PB86226065

4. Title and Subtitle PERFORMANCE OF FLEXIBLE DITCH LININGS		5. Report Date September 1985

16. Abstract A series of tests to determine the performance of ten flexible ditch lining materials were conducted at the U.S. Geological Survey Gulf Coast Hydrosience Center's Hydraulic Laboratory. The objectives of the tests were to determine the effect of the flexible liners on the germination and growth of grass and to determine the effectiveness of the liners to prevent erosion on highway channels until the establishment of vegetation. The vegetation establishment portion of the test was conducted on two types of soils, an erosion resistant soil and an erodible soil, while the erosion control portion of the test was conducted on an erodible soil only. The vegetation establishment test was conducted by planting grass on the test plots, installing the ten flexible liners and then checking for grass growth over a seven week period. Results include the seven week period as well as six months later. The erosion control portion of the test was conducted by installing the liner being tested in a 70 foot long trapizoidal chann

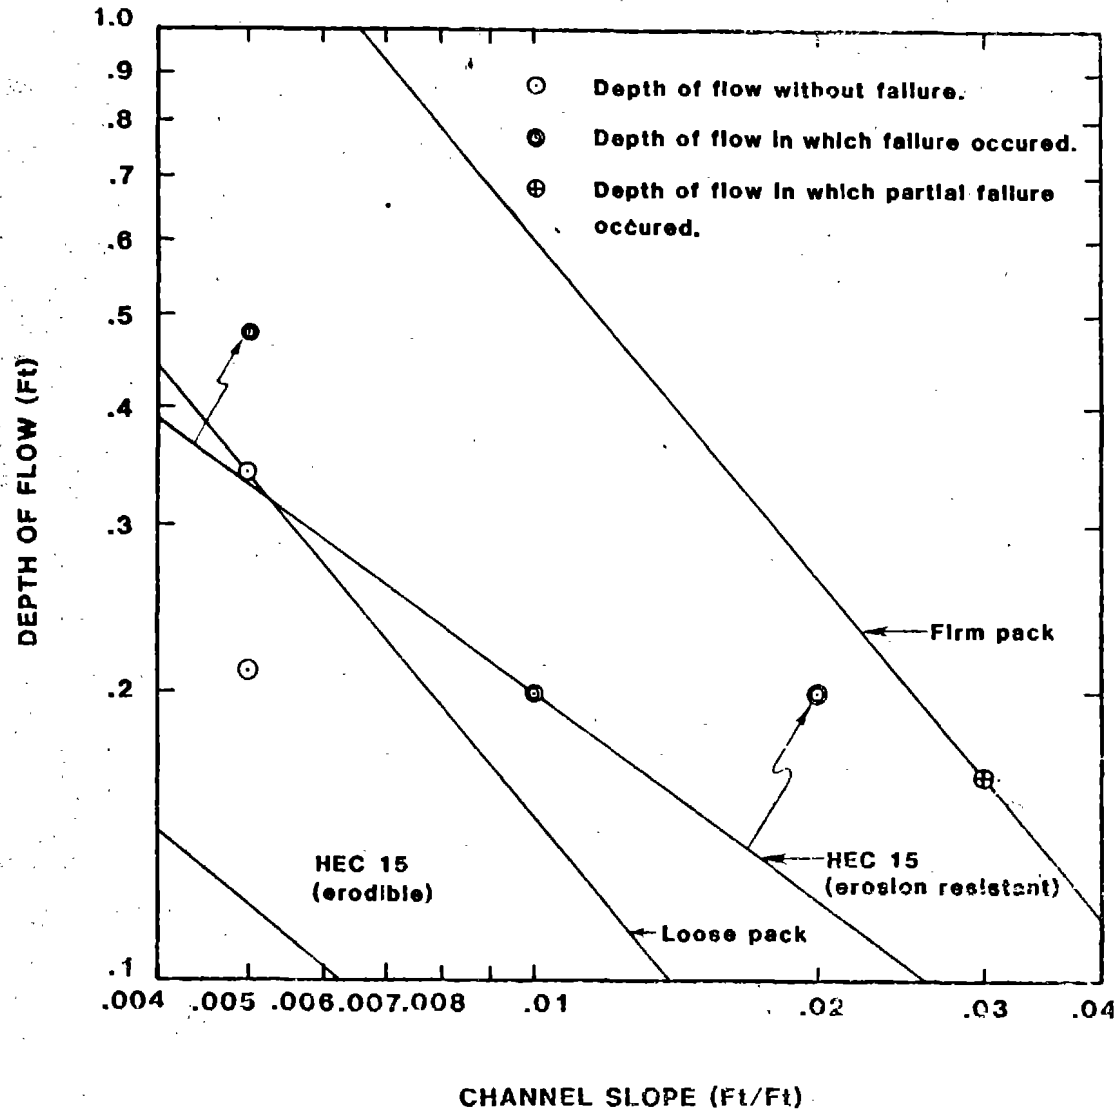
Figure 28.--Maximum permissible depth of flow in an unlined trapezoidal channel based on bed shear stress at failures as follows: Loose pack soil (hand packed), $\tau = 0.068$, Firm pack (pneumatic packed), $\tau = 0.236$.

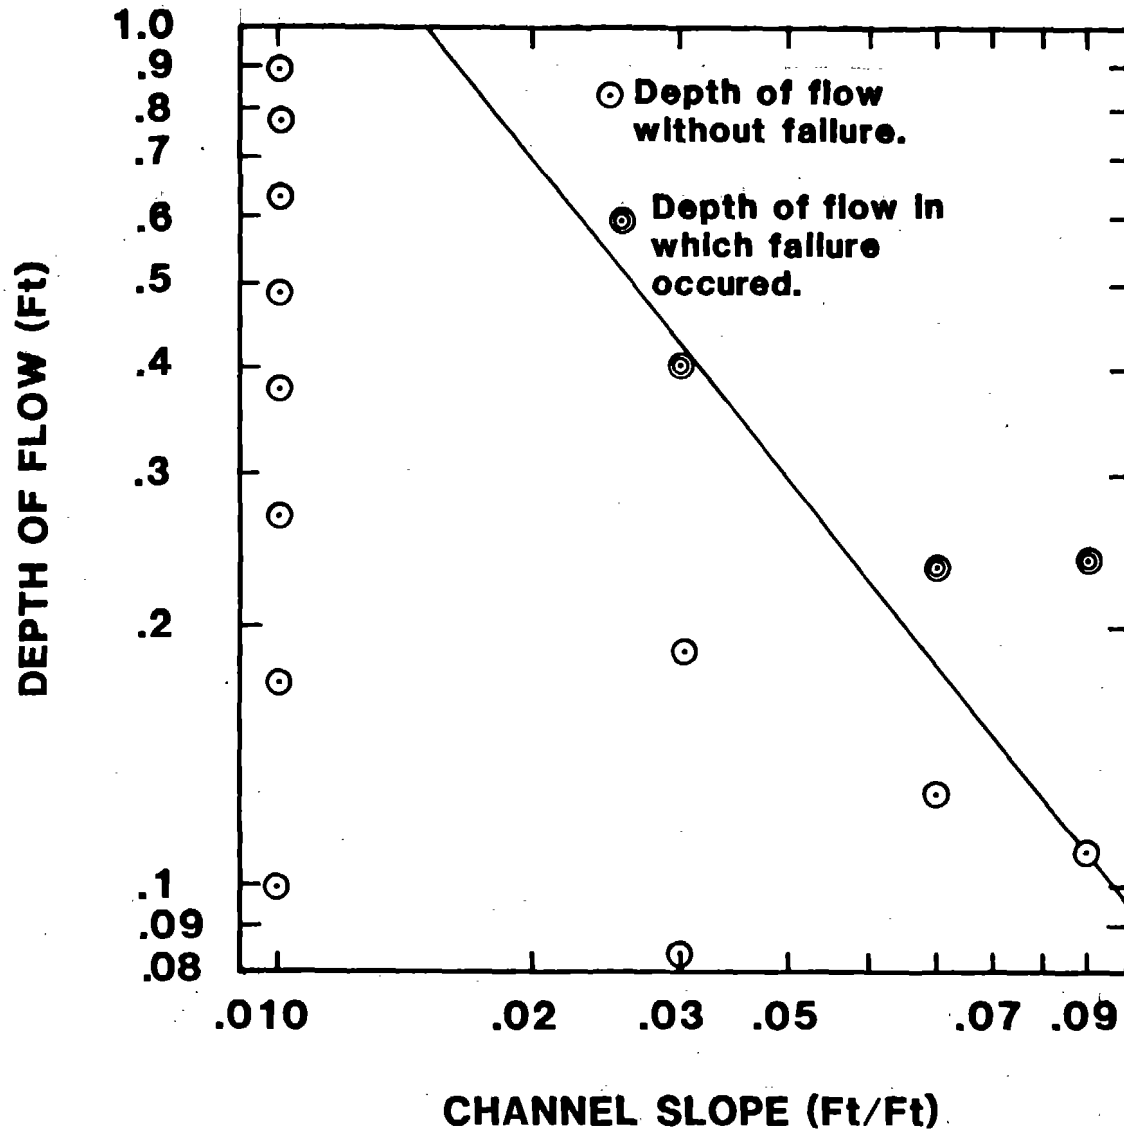
Figure 29.--Maximum permissible depth of flow in a trapezoidal channel lined with Hold-Gro based on bed shear stress, $\tau = 0.488$.

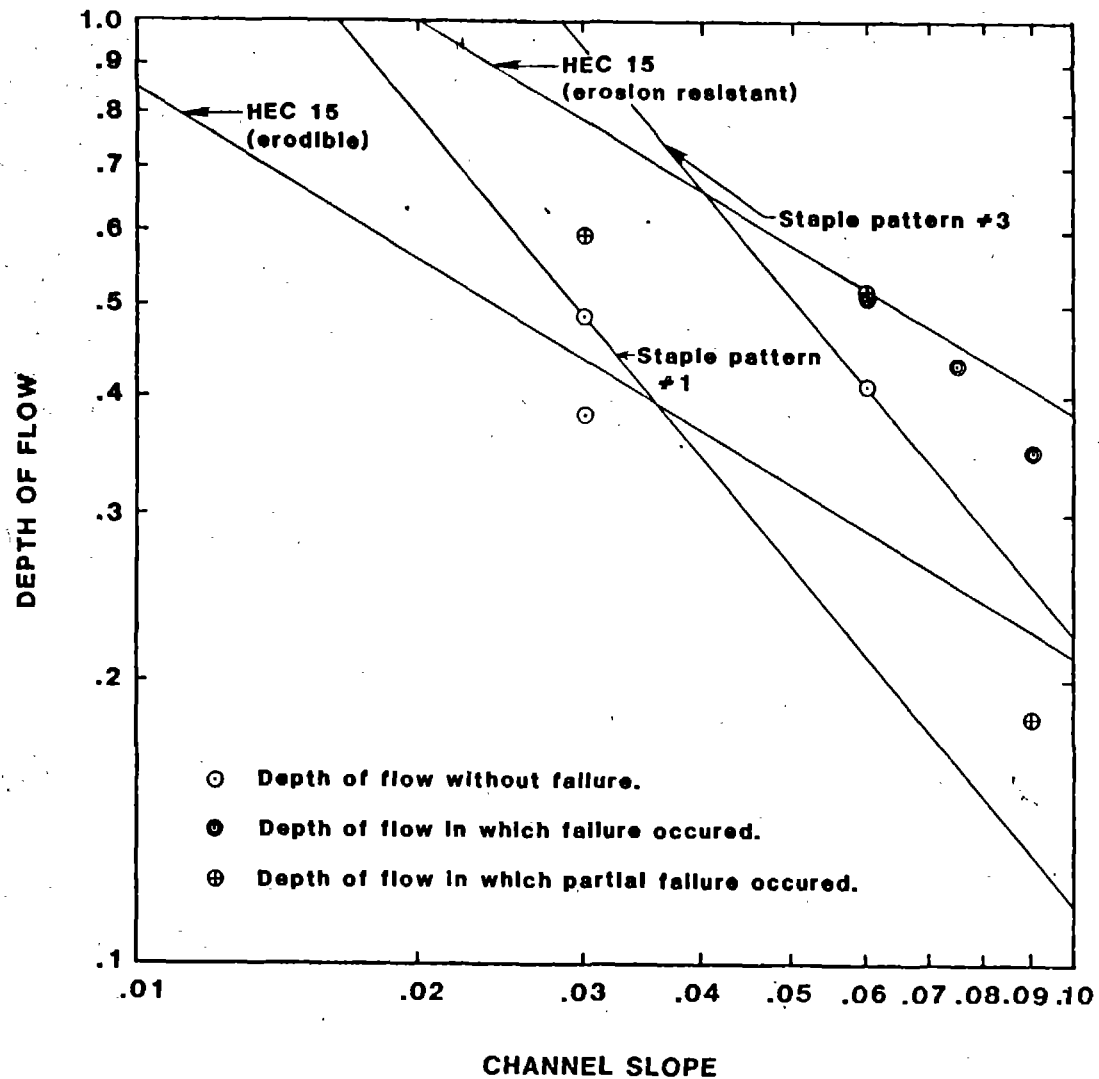
Figure 30.--Maximum permissible depth of flow in a trapezoidal channel lined with excelsior mat based on bed shear stress at failures as follows: staple pattern #1 (manufacturer's specifications); $\tau = 0.647$, staple pattern #3; $\tau = 0.919$.

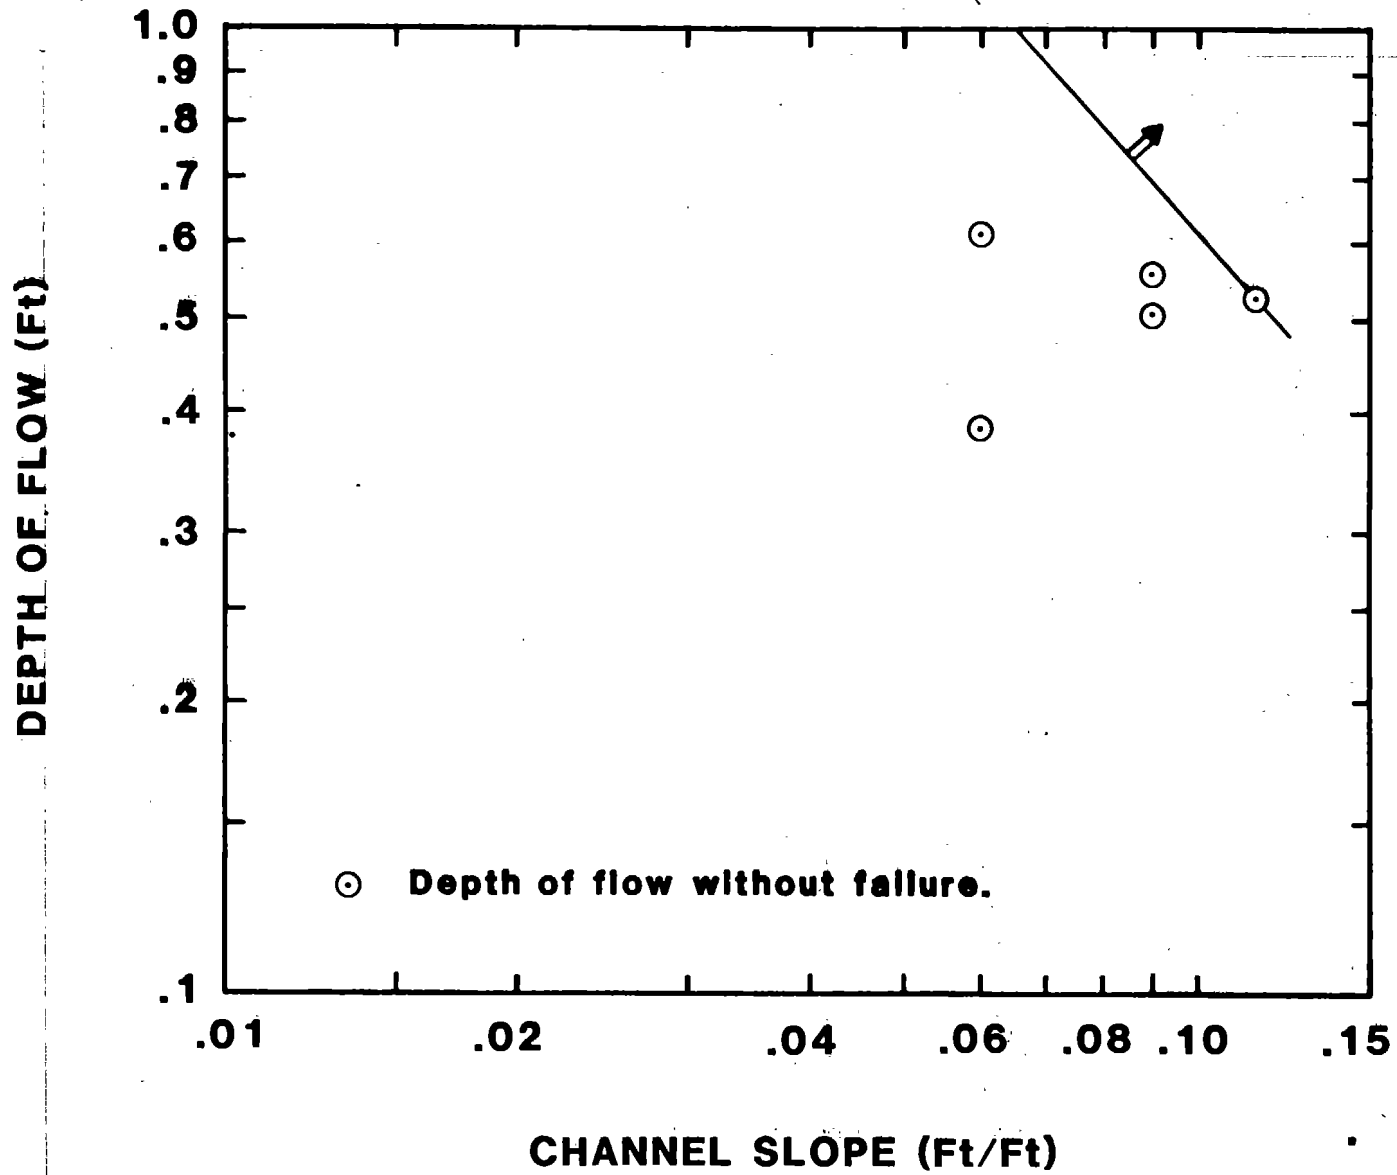
Figure 31.--Permissible depth of flow in a trapezoidal channel lined with Enkamat based on bed shear stress, $\tau = 2.338$.

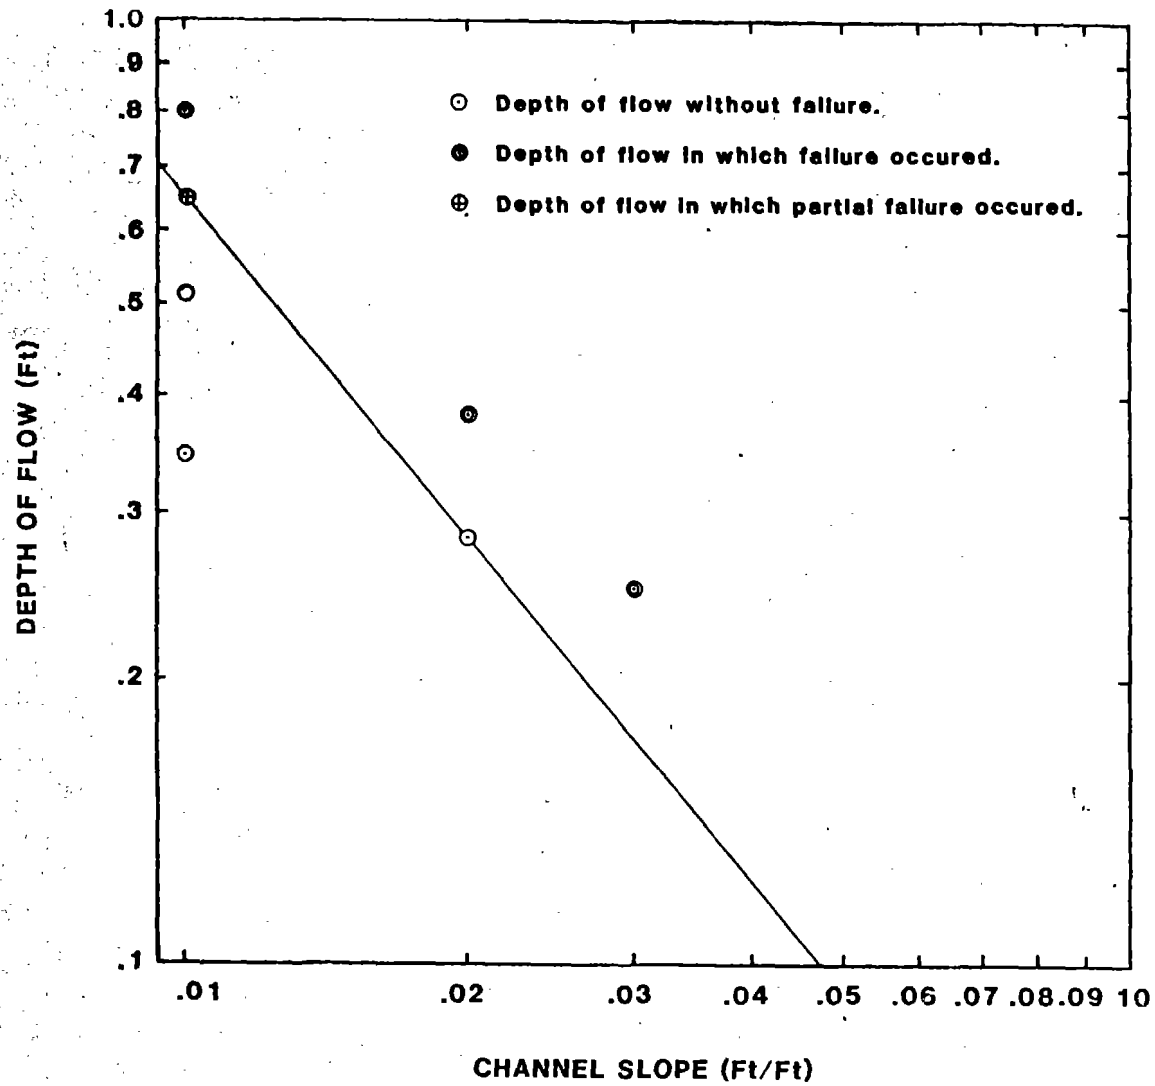
Figure 32.--Maximum permissible depth of flow in a trapezoidal channel lined with loose gravel based on bed shear stress, $\tau = 0.222$.

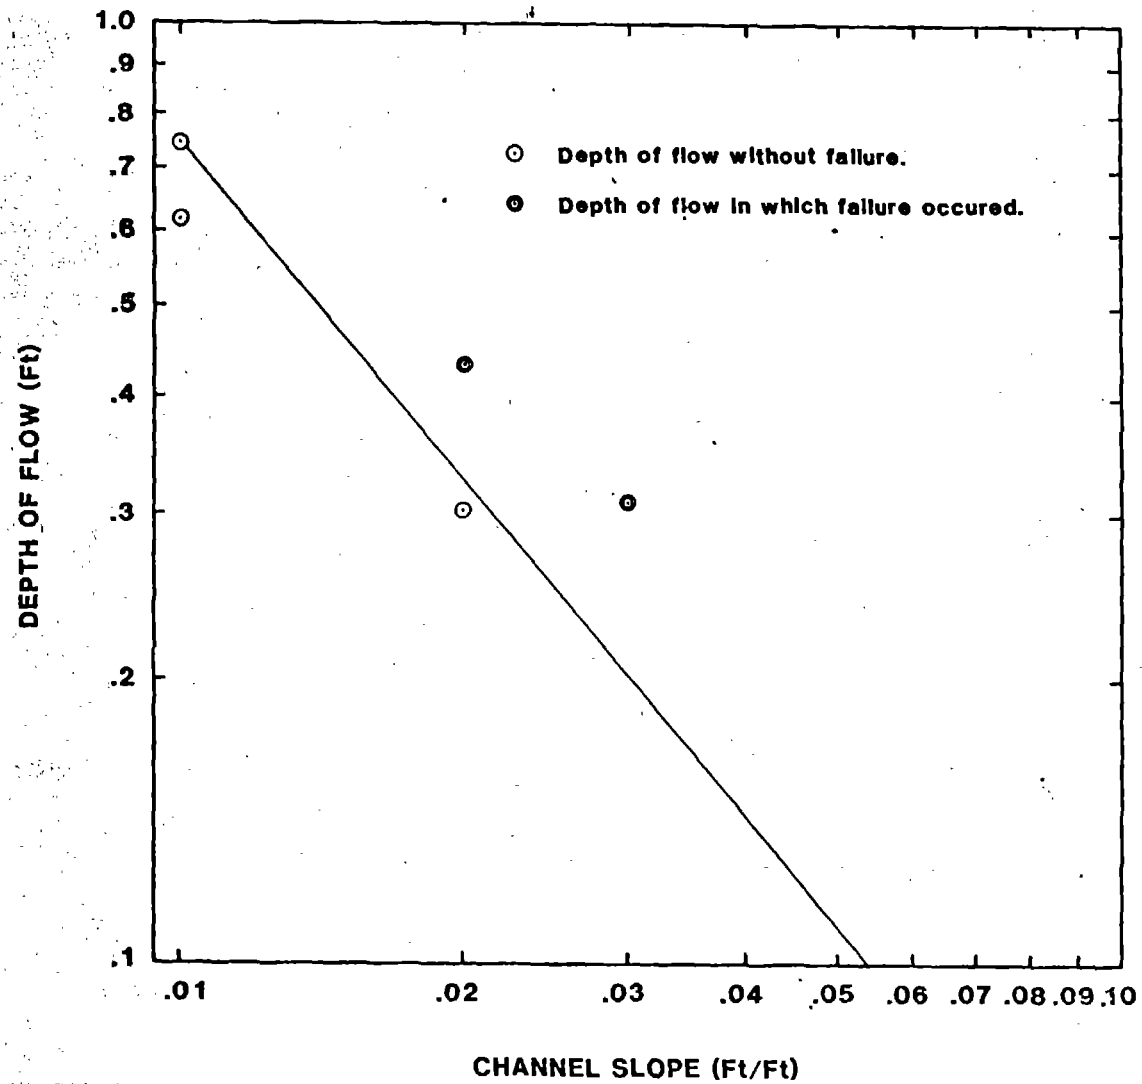
Figure 33.--Maximum permissible depth of flow in a trapezoidal channel lined with rolled gravel based on bed shear stress, $\tau = 0.259$.

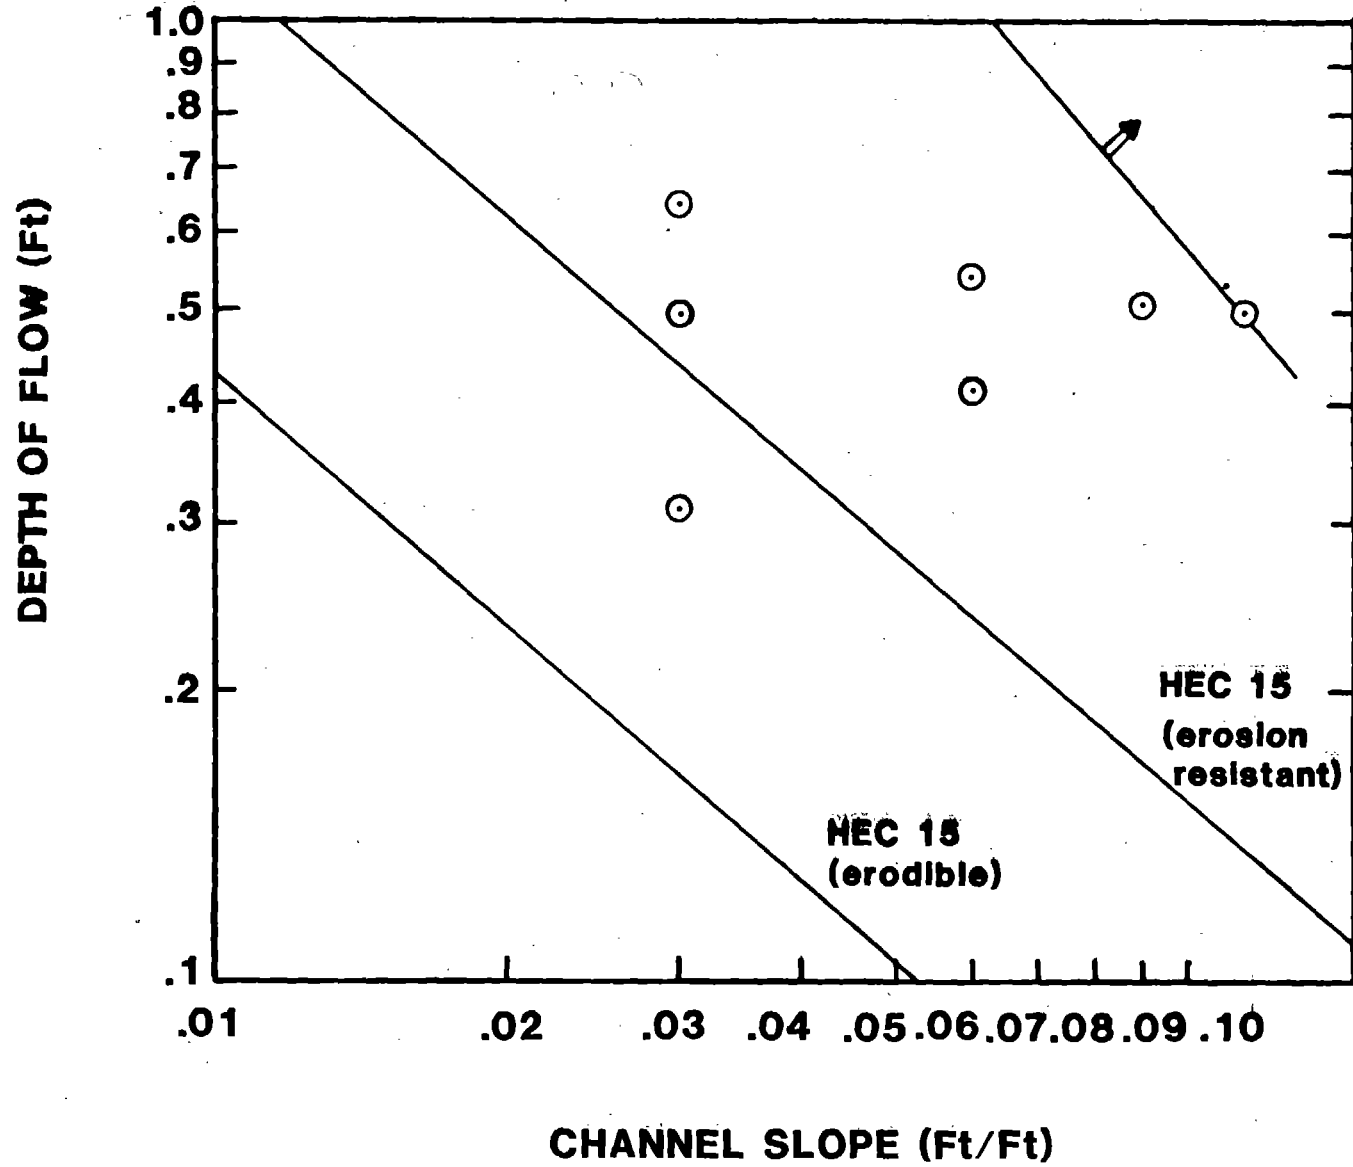
Figure 34.--Permissible depth of flow in a trapezoidal channel lined with jute netting based on bed shear stress, $\tau = 2.242$.

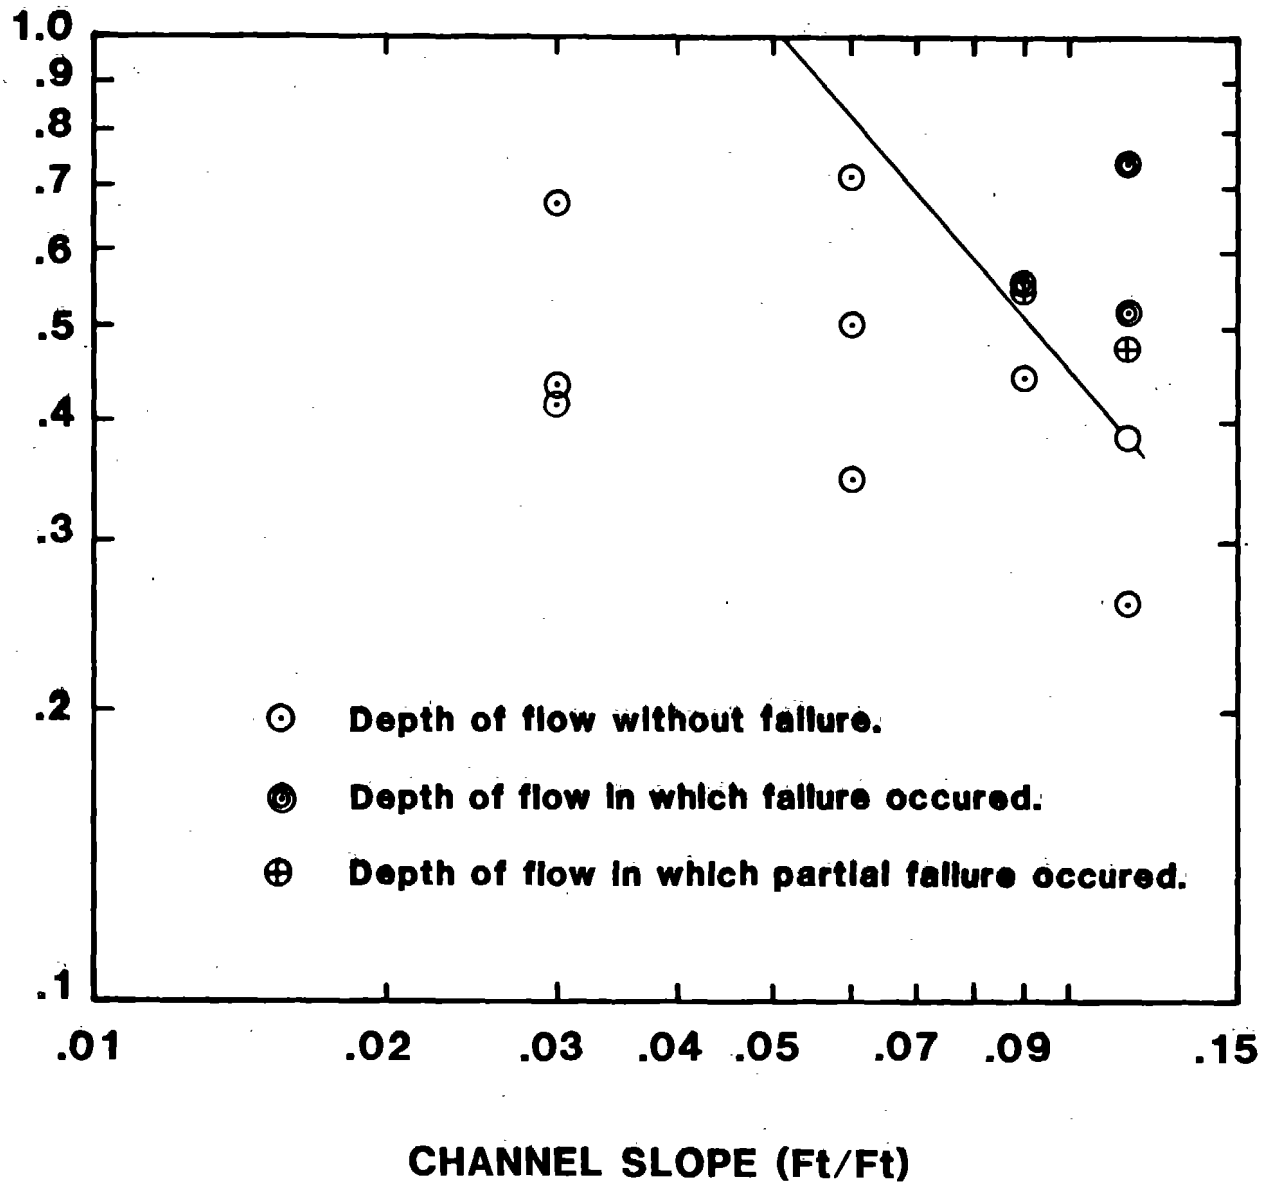
Figure 35.--Maximum permissible depth of flow in a trapezoidal channel lined with jute netting over straw sprayed with asphalt based on bed shear stress, $\tau = 2.041$.

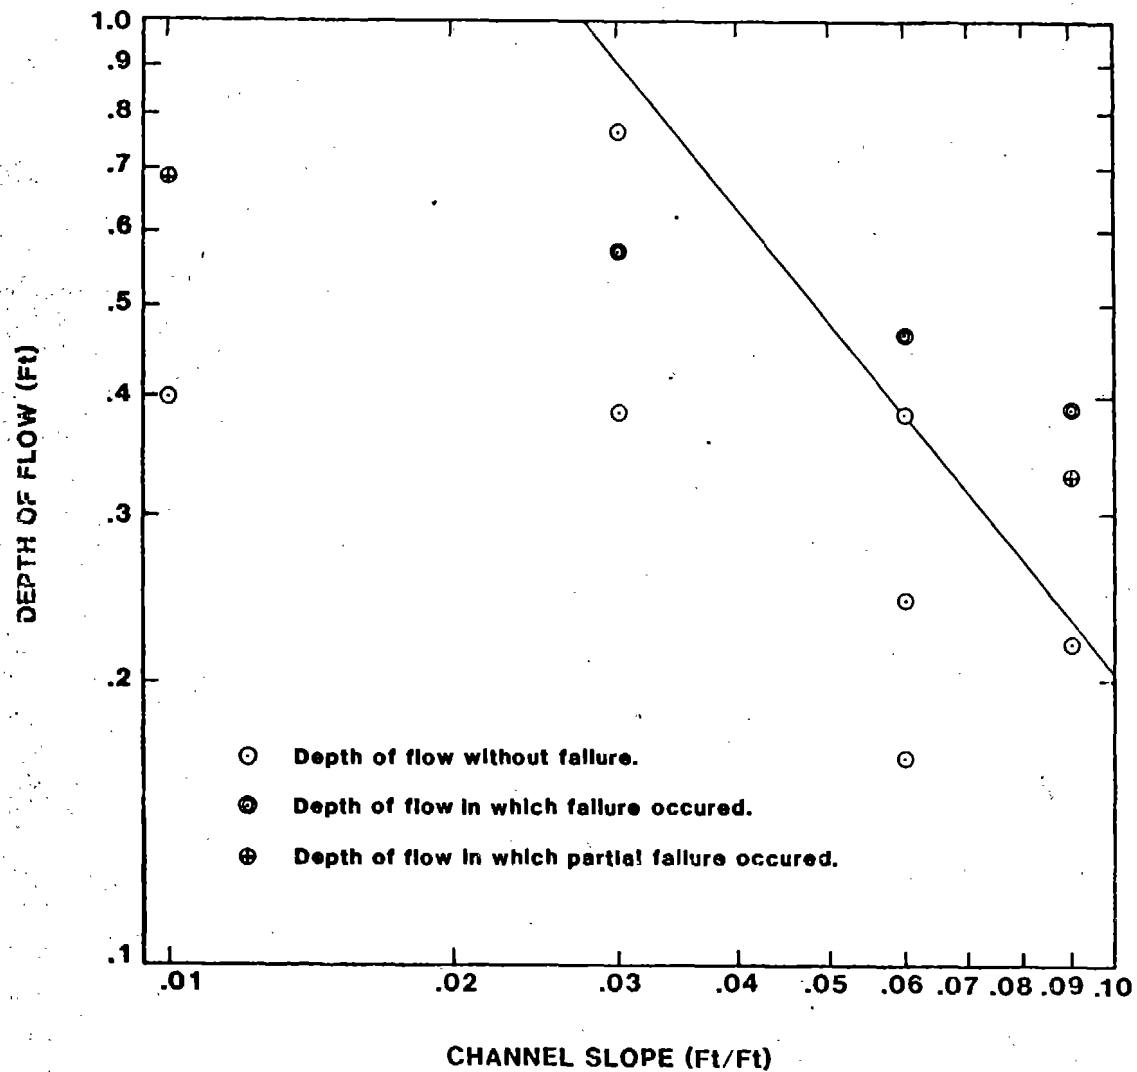
Figure 36.--Maximum permissible depth of flow in a trapezoidal channel lined with Amxco netting over straw sprayed with asphalt based on bed shear stress, $\tau = 0.894$.

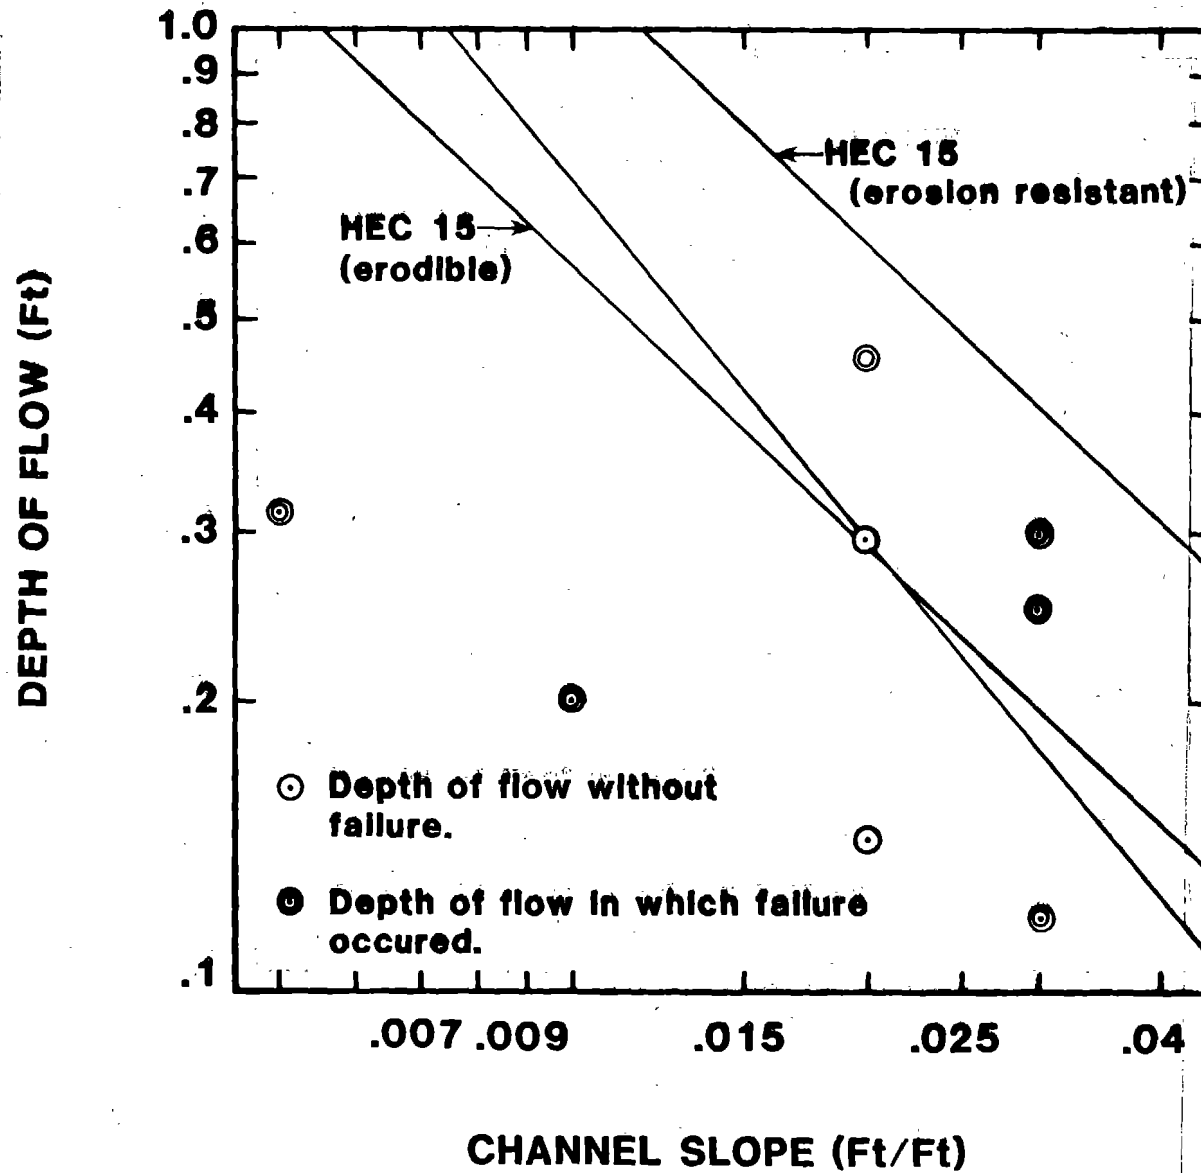
Figure 37.--Maximum permissible depth of flow in a trapezoidal channel lined with a single layer of fiberglass roving based on shear stress, $\tau = 0.245$.

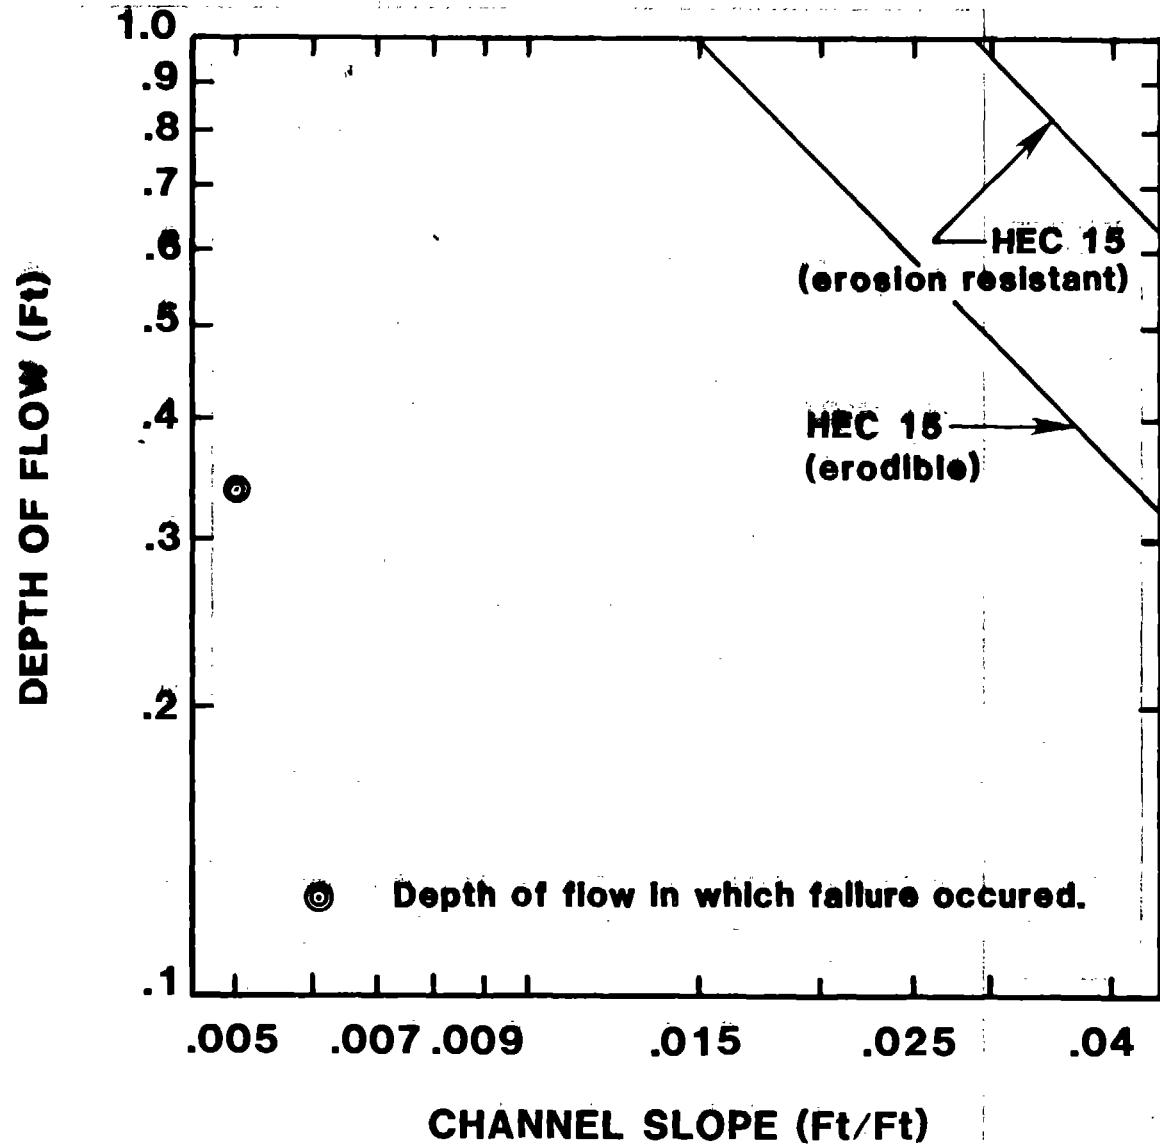
¹The relatively high Manning's roughness coefficient for the 9/26/83 fiberglass roving-single and the 10/07/83 fiberglass roving-double runs was caused by the damage to the liner material.

Figure 38.--Depth of flow in the test channel lined with a double layer of fiberglass roving.

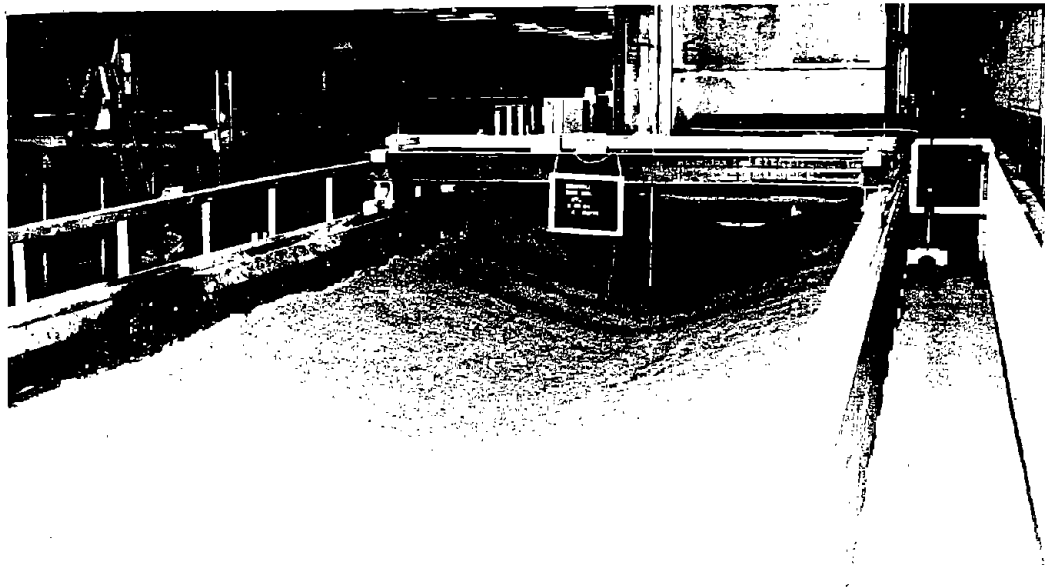
During the testing of the unlined test channel as shown in figure 40 before testing and figure 41 during testing the following observations were made:

Figure 40.--Erodible soil as installed in test channel ready for testing.

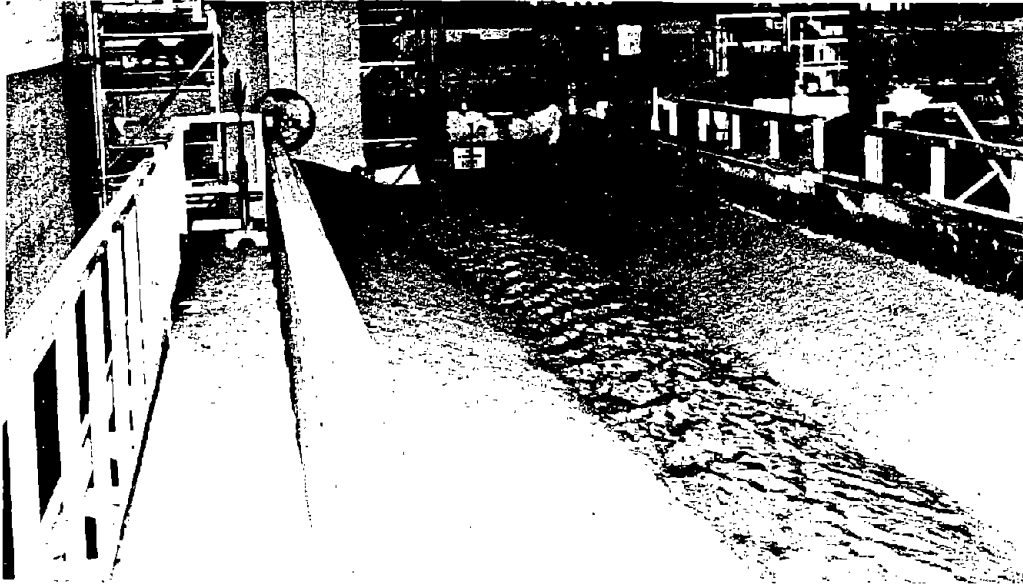
- 1) All erosion damage was not limited to the upper hand packed layer of soil.
- 2) The upper hand packed layer eroded away in 10 to 15 minutes when run at one and two percent slopes, with the lower pneumatically packed soil eroding for the remainder of the test.

- 3) The pneumatically packed soil eroded at a slower rate than the hand packed soil.
- 4) A portion of the soil eroded from the side slopes was deposited in the bottom of the ditch (figure 42).

Figure 41.--Lower end of test channel while testing bare erodible soil.

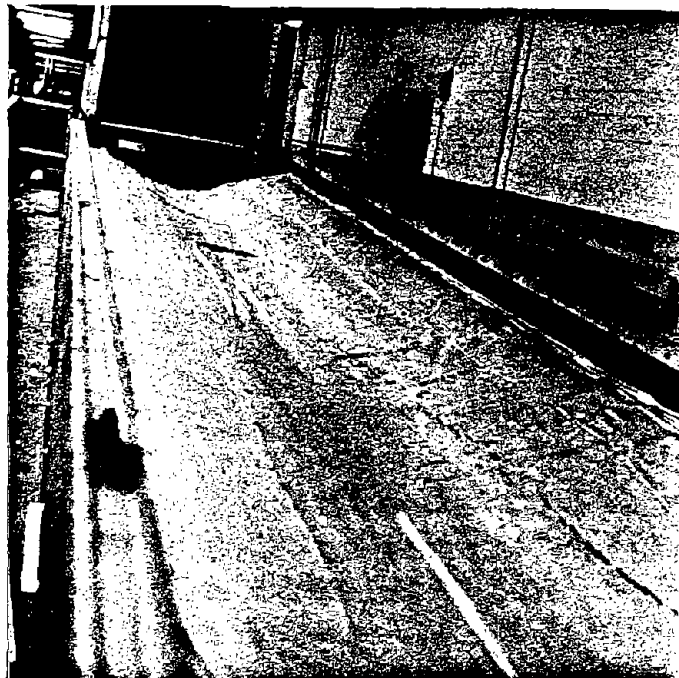
The observations made during testing of the liner Hold-Gro as seen installed in figure 43, are as follows:

Figure 43.--The liner Hold-Gro as installed for testing.

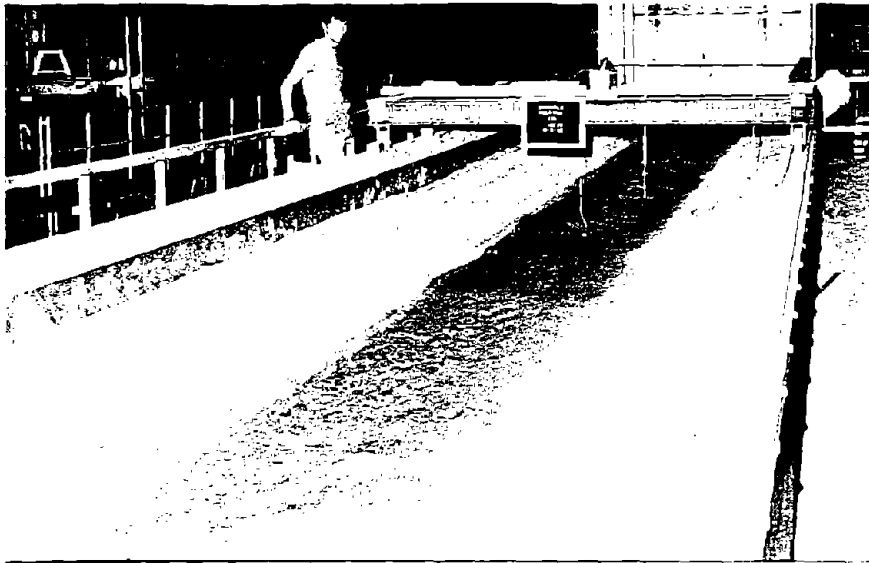
- 1) All failures were due to erosion, not liner failure.
- 2) Paper came loose from the liner even at low flow velocities.
- 3) At all flows, water was observed flowing under the liner.
- 4) The non-damaged liner (both paper and yarn still intact) generally floated at all flow depths, when the average flow velocities were below 3 ft/sec (figure 44).
- 5) The liner tends to move in the direction of flow (figure 45).
- 6) Liner damage was minimal in all tests. The paper came loose and washed away, but the woven yarn net remained intact (figure 45)'.- 7) Erosion appeared to occur at a steady rate throughout the entire 30 minute test.
- 8) Most erosion occurred on the side slope of the ditch.
- 9) A large portion of the eroded soil was deposited behind staples and in front of the anchor at the foot of the test ditch.

Figure 44. -- Hold-Gro Liner During Testing. Note the Liner Floating at the Waters Edge.

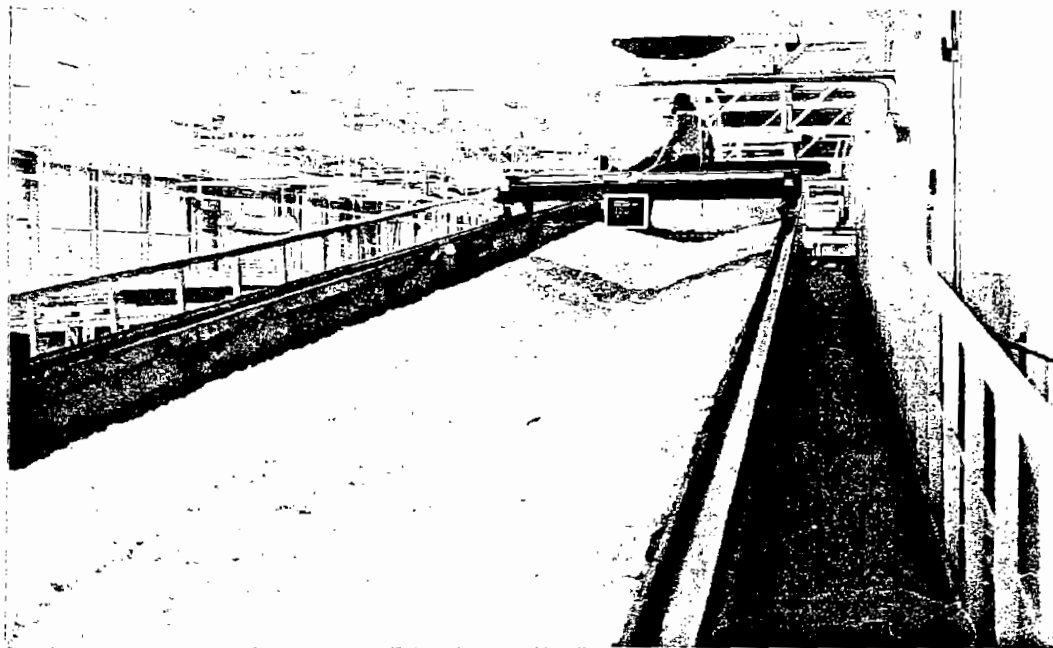
- 1) All failures were due to liner failure, not erosion failure.
- 2) The majority of the erosion damage occurred after the liner failed.
- 3) The wood excelsior always moved down the ditch under the plastic net (figure 47). The wood excelsior tended to pile up in front of the staples in the bottom of the ditch creating small check dams.

Figure 46.--Liner excelsior mat as installed for testing.

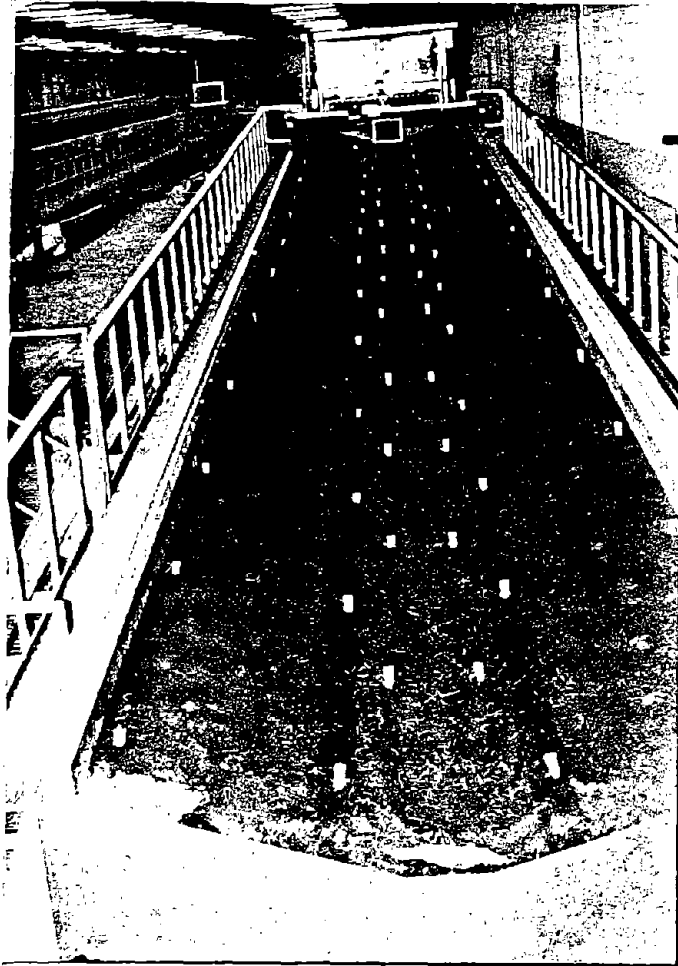
The observations made during testing of the liner Enkamat as seen installed in figure 50, and being tested in figure 51 are as follows:

Figure 50. -- Liner Enkamat as installed for testing.

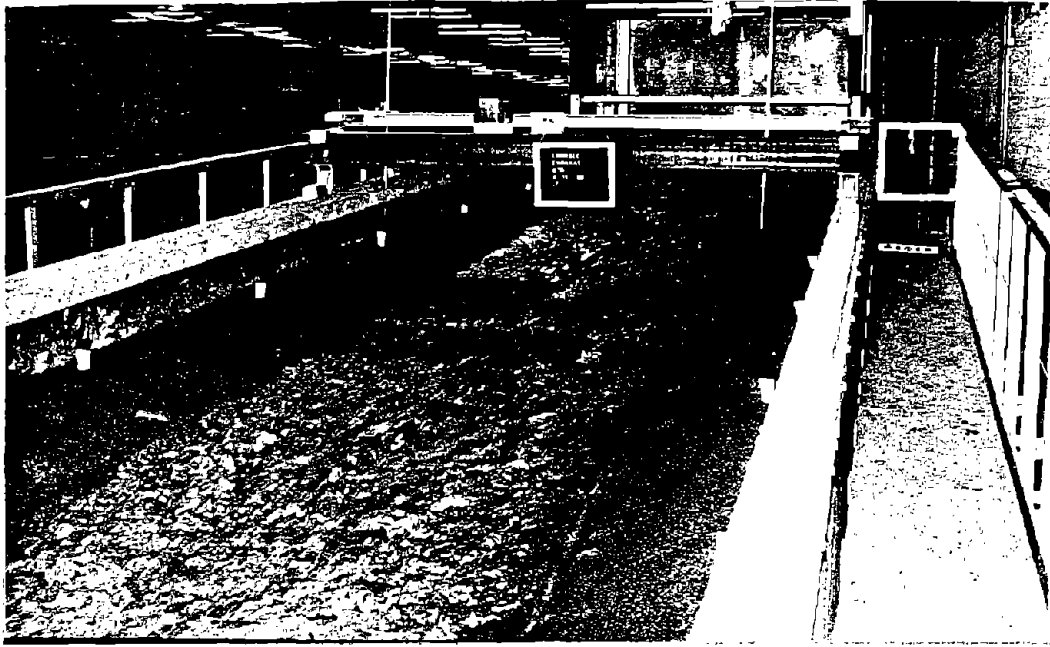
- 1) Erosion appears to occur at a steady rate throughout the entire 30 minute test.
- 2) Erosion damage was minimal in all tests.
- 3) Most erosion occurred on the side slopes of the ditch around the wood survey stakes (figure 52).
- 4) The liner was observed stretching at high slopes with high water flows.

Figure 51.--Enkamat liner during testing.

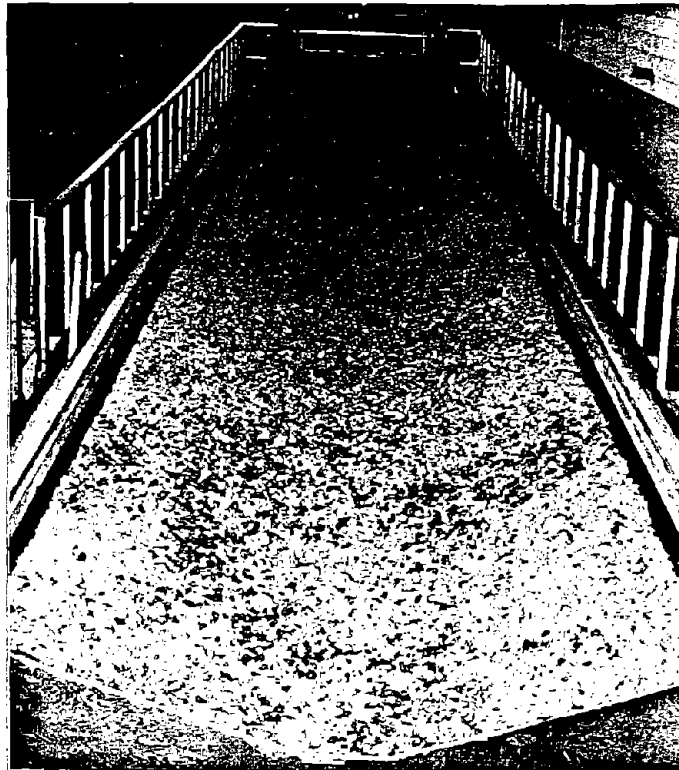
The observations made during testing of the loose gravel liner as seen installed ready for testing in figure 53 and being tested in figure 54 are as follows:

Figure 53. -- Liner of loose gravel installed and ready for testing.

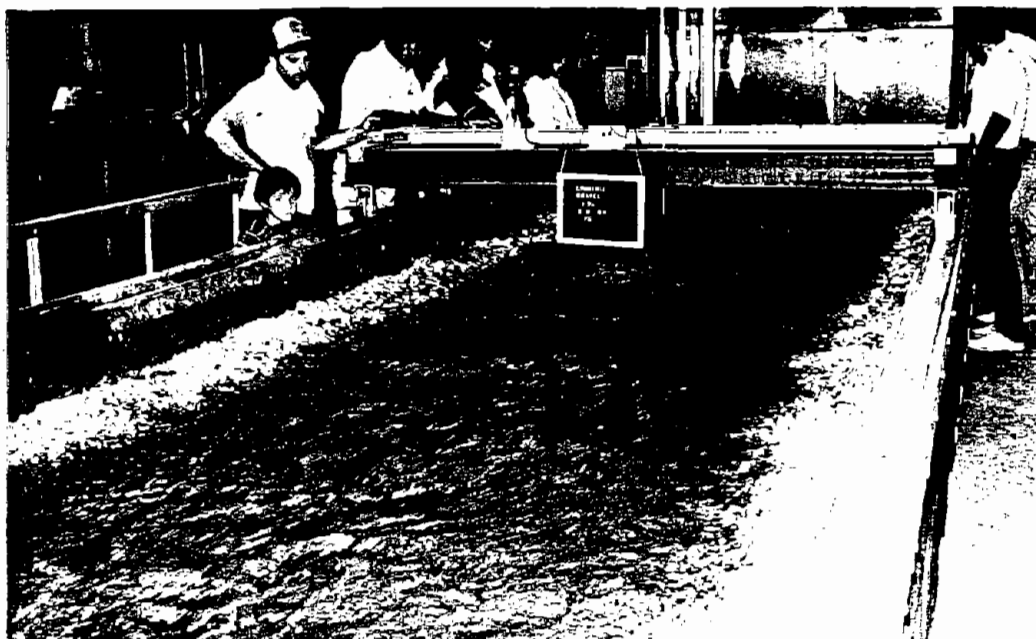
- 1) All failures were due to liner failures, not erosion failure.
- 2) The gravel appears to move down the ditch at a steady rate throughout the entire 30 minute test.
- 3) The failure at 1 percent slope had a moderate rate of failure with the gravel on the side slope of the ditch being deposited on the bottom of the ditch (figure 55).
- 4) The failure at 2 percent slope had a moderate rate of failure with the gravel at the upstream portions of the test ditch moving to the downstream portions of the ditch.
- 5) The liner failure at 3 percent slope was a rapid failure.
- 6) Erosion damage was minimal in all tests.

Figure 54.--Testing of loose gravel liner.

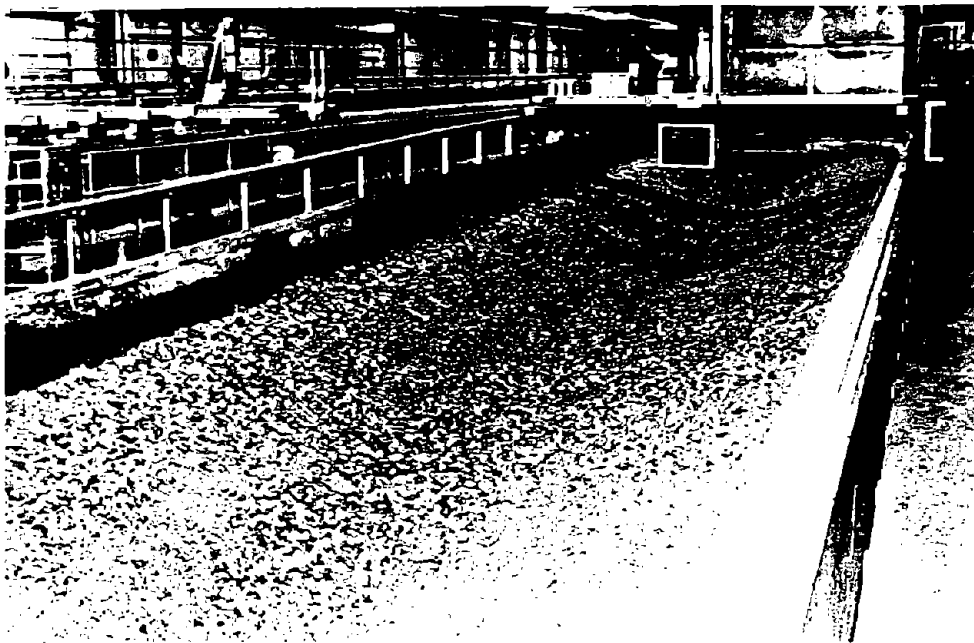
The observations made during testing of the rolled gravel liner as seen installed in figure 56 and being tested in figure 57 are as follows:

Figure 56.--Liner of rolled gravel installed and ready for testing.
