1. Report No. FHWA/RD-86/114		2. Government Accession No. PB86226065

4. Title and Subtitle PERFORMANCE OF FLEXIBLE DITCH LININGS		5. Report Date September 1985

16. Abstract A series of tests to determine the performance of ten flexible ditch lining materials were conducted at the U.S. Geological Survey Gulf Coast Hydrosience Center's Hydraulic Laboratory. The objectives of the tests were to determine the effect of the flexible liners on the germination and growth of grass and to determine the effectiveness of the liners to prevent erosion on highway channels until the establishment of vegetation. The vegetation establishment portion of the test was conducted on two types of soils, an erosion resistant soil and an erodible soil, while the erosion control portion of the test was conducted on an erodible soil only. The vegetation establishment test was conducted by planting grass on the test plots, installing the ten flexible liners and then checking for grass growth over a seven week period. Results include the seven week period as well as six months later. The erosion control portion of the test was conducted by installing the liner being tested in a 70 foot long trapizoidal chann

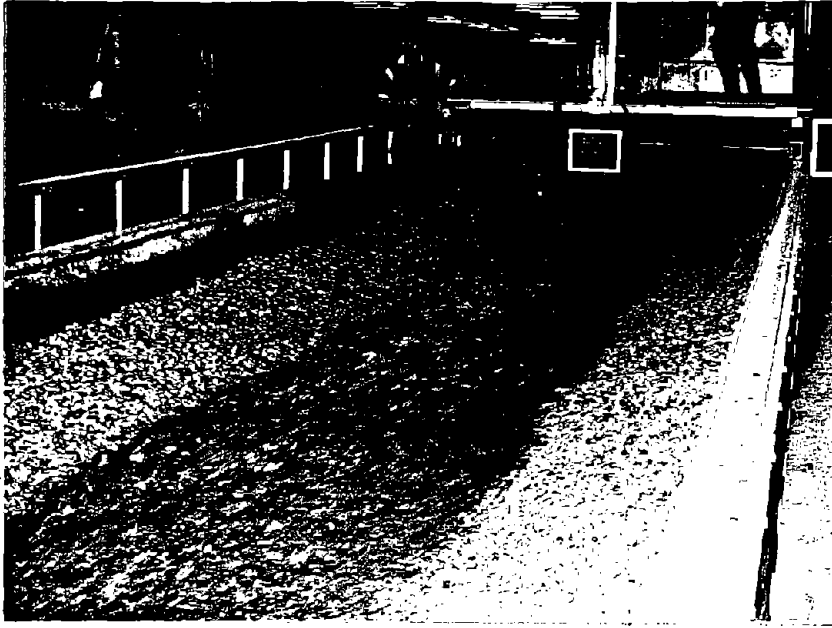
- 1) All failures were due to liner failure, not erosion failure.
- 2) Liner failure was a slow failure during the first set of tests.
- 3) The gravel appears to move down the ditch at a steady rate throughout the entire 30 minute test.
- 4) The failure at 2 percent slope during the second set of tests had a moderate rate with the gravel at the upstream portions of the test ditch moving to the downstream portions of the ditch.
- 5) After liner failure occurred, only the gravel embedded deep in the soil remain (figure 58).
- 6) Erosion damage was minimal in all tests.

Figure 57.--Testing of rolled gravel liner.

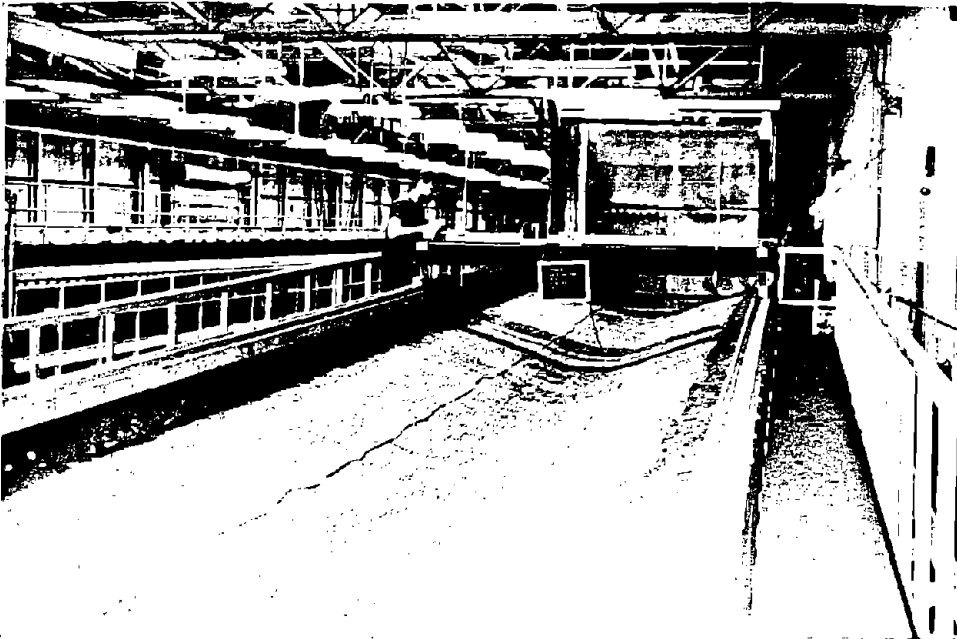
The observations made during testing of the jute netting liner as seen installed in figure 59 and being tested in figure 60 were as follows:

Figure 59.--Liner of jute netting installed and ready for testing.

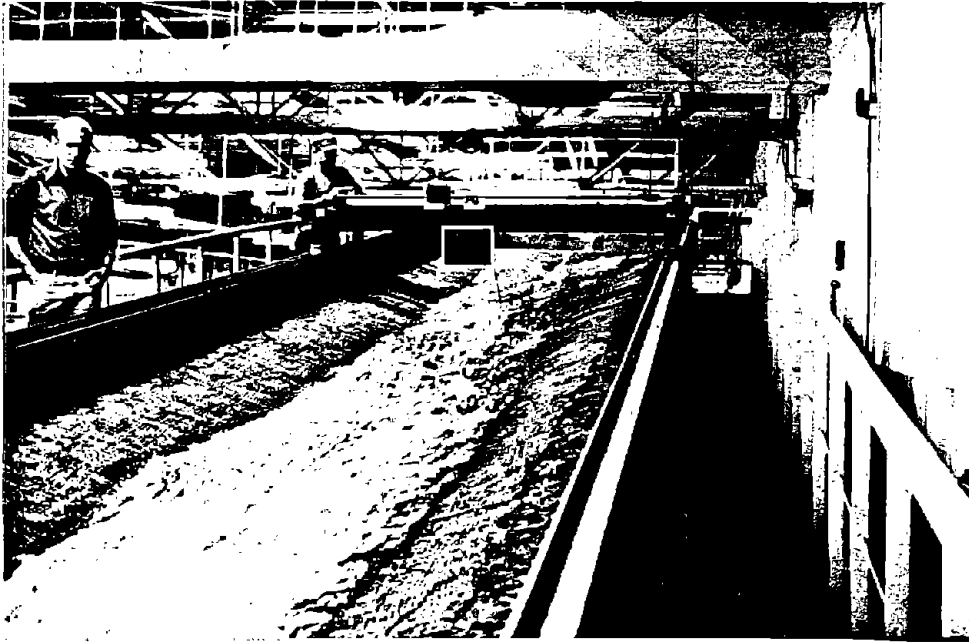
- 1) Erosion appeared to occur at a steady rate throughout the entire 30 minute test.
- 2) Erosion damage was minimal in all tests.
- 3) High water flows at high slopes appeared to unravel the jute netting between staples (figure 61).
- 4) The longitudinal jute strands appear to offer adequate protection in the areas where the liner was unraveled.

Figure 60.--Testing of jute netting liner.

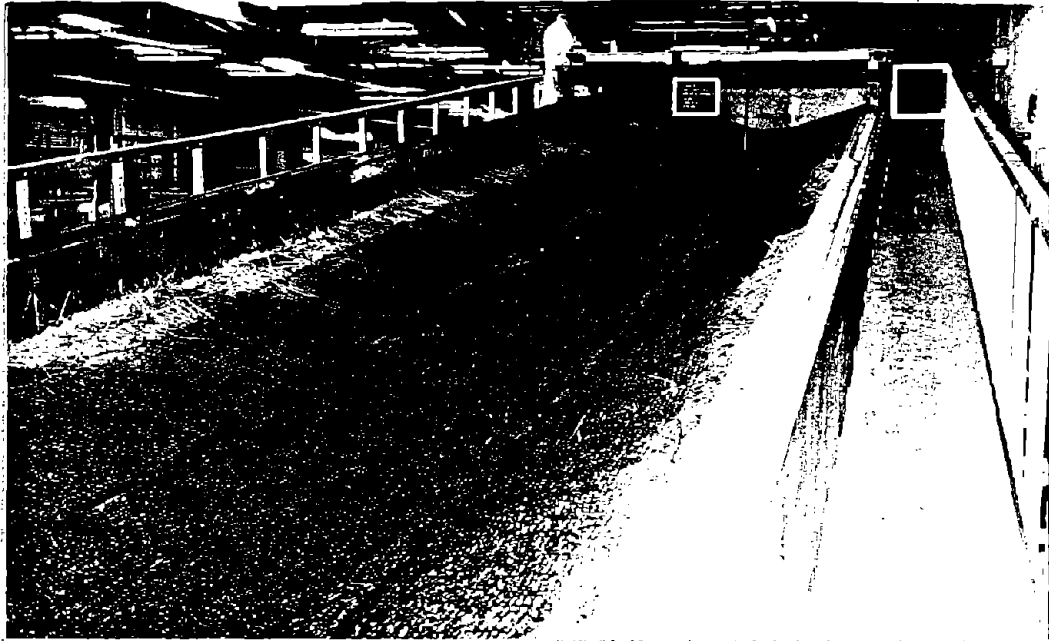
The observations made during testing of the jute netting over straw sprayed with asphalt liner during testing as seen installed in figure 62 are as follows:

- 1) The liner had a tendency to float during all tests (figures 63 and 64).
- 2) All failures during the first set of testing were due to erosion failure.

- 3) Most erosion damage occurred at the overlap of the two pieces of jute netting.
- 4) The failures at 6% and 9% slopes during the second set of tests were due to liner failure.

Figure 62.--Liner of jute netting over straw sprayed with asphalt as installed ready for testing.

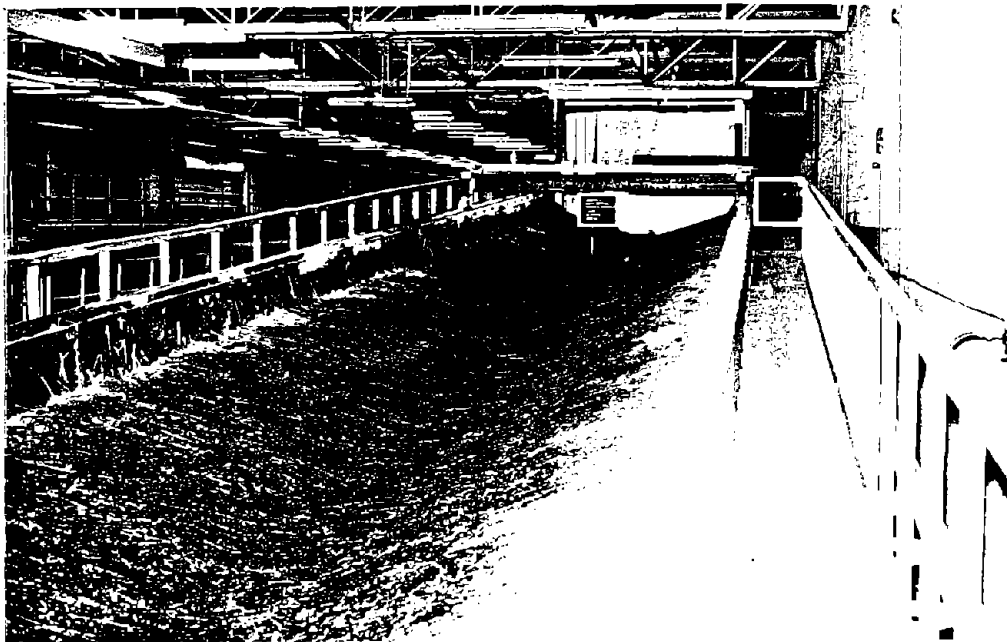
The observations made during testing of the Amxco netting over straw sprayed with asphalt liner as seen installed ready for testing in figure 66 are as follows:

- 1) During the first set of testing, the netting was difficult to get to lie down over the straw. The netting tended to lift along the lower portions of the side slopes.
- 2) All failures were due to liner failure.
- 3) The straw floated, lifting the netting in all tests (figure 67).
- 4) The straw always moved downstream under the netting in all tests, creating bare spots between the staples in the bottom of the ditch while creating small checkdams upstream of the staples (figure 68).
- 5) Erosion damage was minimal in all tests.
- 6) Liner damage occurs at a steady rate throughout the entire duration of the test (30 minutes).
- 7) The test run at 9% slope and 0.3 foot depth (run 3/6/85) had partial liner failure (9% degradation of the liner).

Figure 66.--Liner of Amxco netting over straw sprayed with asphalt as installed ready for testing.

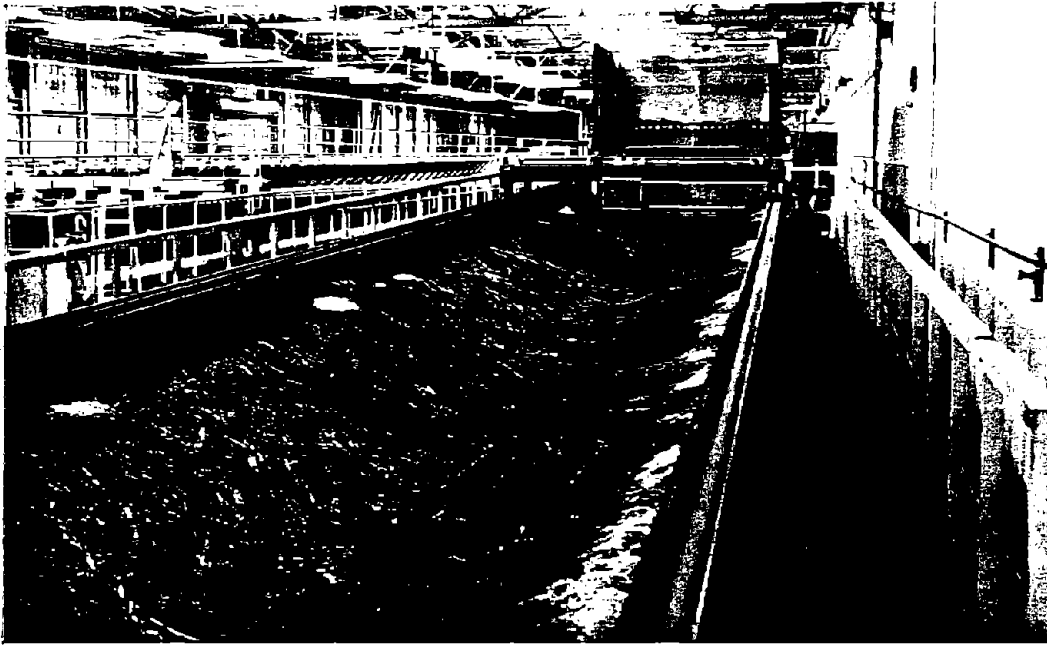
The observations made during testing of the single layer fiberglass roving liner as seen installed in figure 69 are as follows:

- 1) All failures were due to liner failure, not erosion failure.
- 2) There was little or no erosion damage in all test run for the entire 30 minute duration.
- 3) The failure of the liner always began in the first five feet of the beginning of the ditch. The water would start to push the liner causing it to bunch up, allowing the water to flow under the liner. This would in turn cause the liner to fail in two different modes. The first failure mode was the pulling of the liner completely out of the ditch. The second failure mode was the stringing of the roving material in an arc across the flow of water.
- 4) At no time did the roving material pull out of the trench at the entrance of the ditch.
- 5) Bouncing the roving material off the dirt gave a more uniform layer of material than spraying it into the air.

Figure 69.--Fiberglass roving, single layer, liner as installed ready for testing.

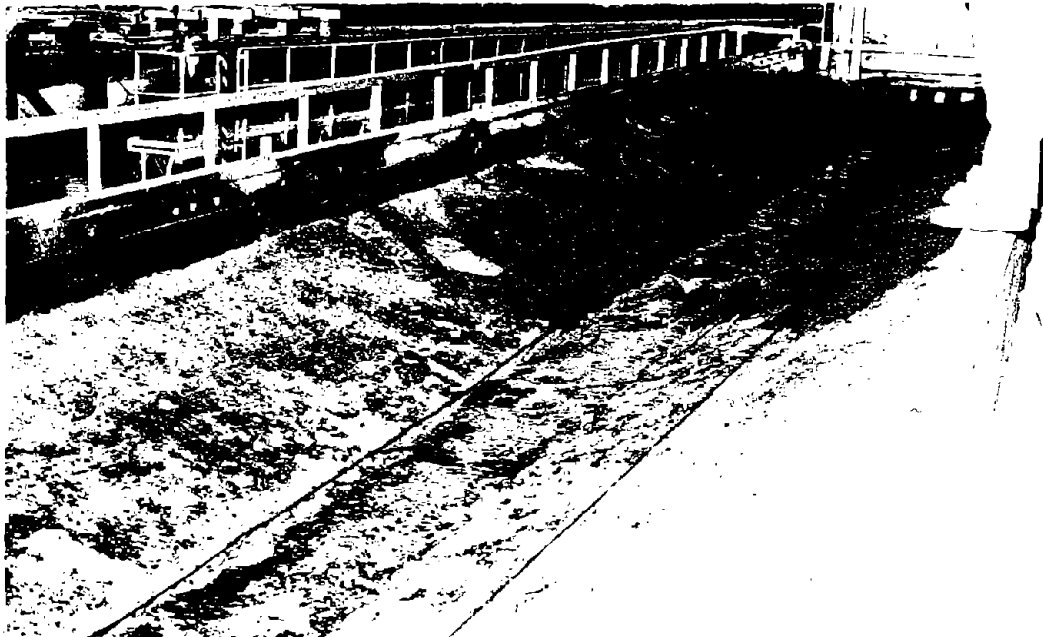
- 1) The asphalt used for the 11/84 test did not set and was easily washed out with water. A new supplier for asphalt was obtained for all following tests.
- 2) The asphalt obtained from the new supplier also showed signs of being washed out by the water flow. However, the washing out was only slight.
- 3) All failures were due to liner failure, not erosion failure.
- 4) When liner failure began, the failure was rapid, less than two to three minutes.
- 5) When the liner failed, large sections of the liner would float up and move down the ditch together (figures 70,71, and 72).

Figure 72.--Fiberglass roving, single layer, after testing showing upper 1/2 of test channel.

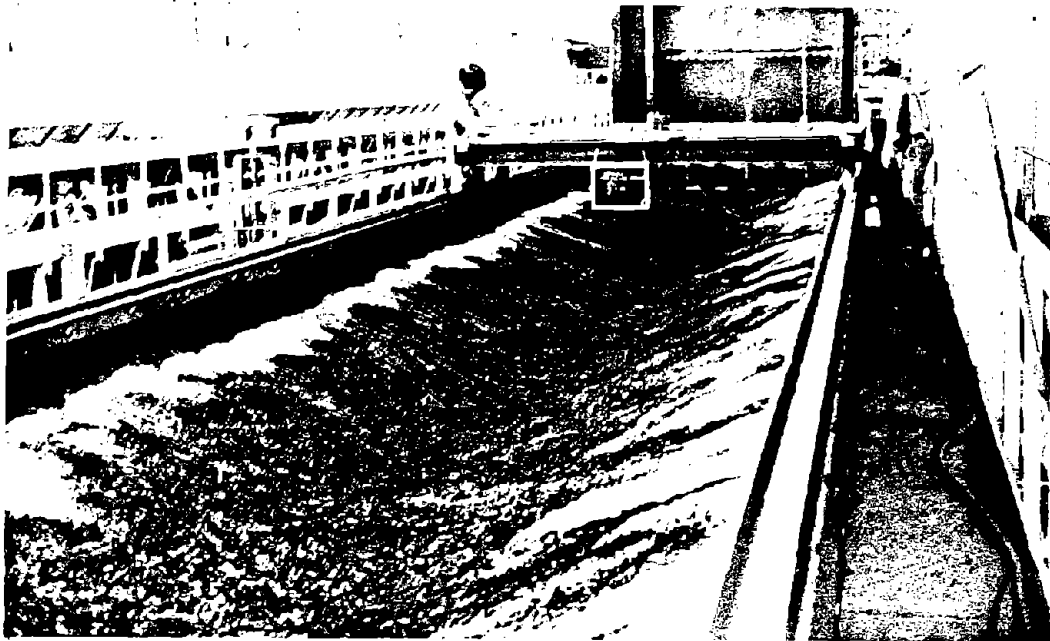
The observations made during the testing of the double layer of fiberglass liner as seen installed in figure 73 are as follows:

- 1) Failure was due to liner failure, not erosion failure.
- 2) There was little or no erosion damage in the test run for the entire 30 minute duration.
- 3) The failure of the liner began in the first five feet of the beginning of the ditch. The water started to push the liner causing it to bunch up, allowing the water to flow under the liner (figure 74). This in turned caused the liner to fail by the stringing of the roving material in an arc across the flow of water (figure 75).
- 4) At no time did the roving material pull out of the trench at the entrance of the ditch.

Figure 73.--Fiberglass roving, double layer, liner as installed ready for testing.
