RETROFIT RAILINGS FOR NARROW THROUGH TRUSS AND OTHER OBSOLETE BRIDGE

Research, Development,
and Technology

Report No.
FHWA/RD-82/099

Final Report
November 1986

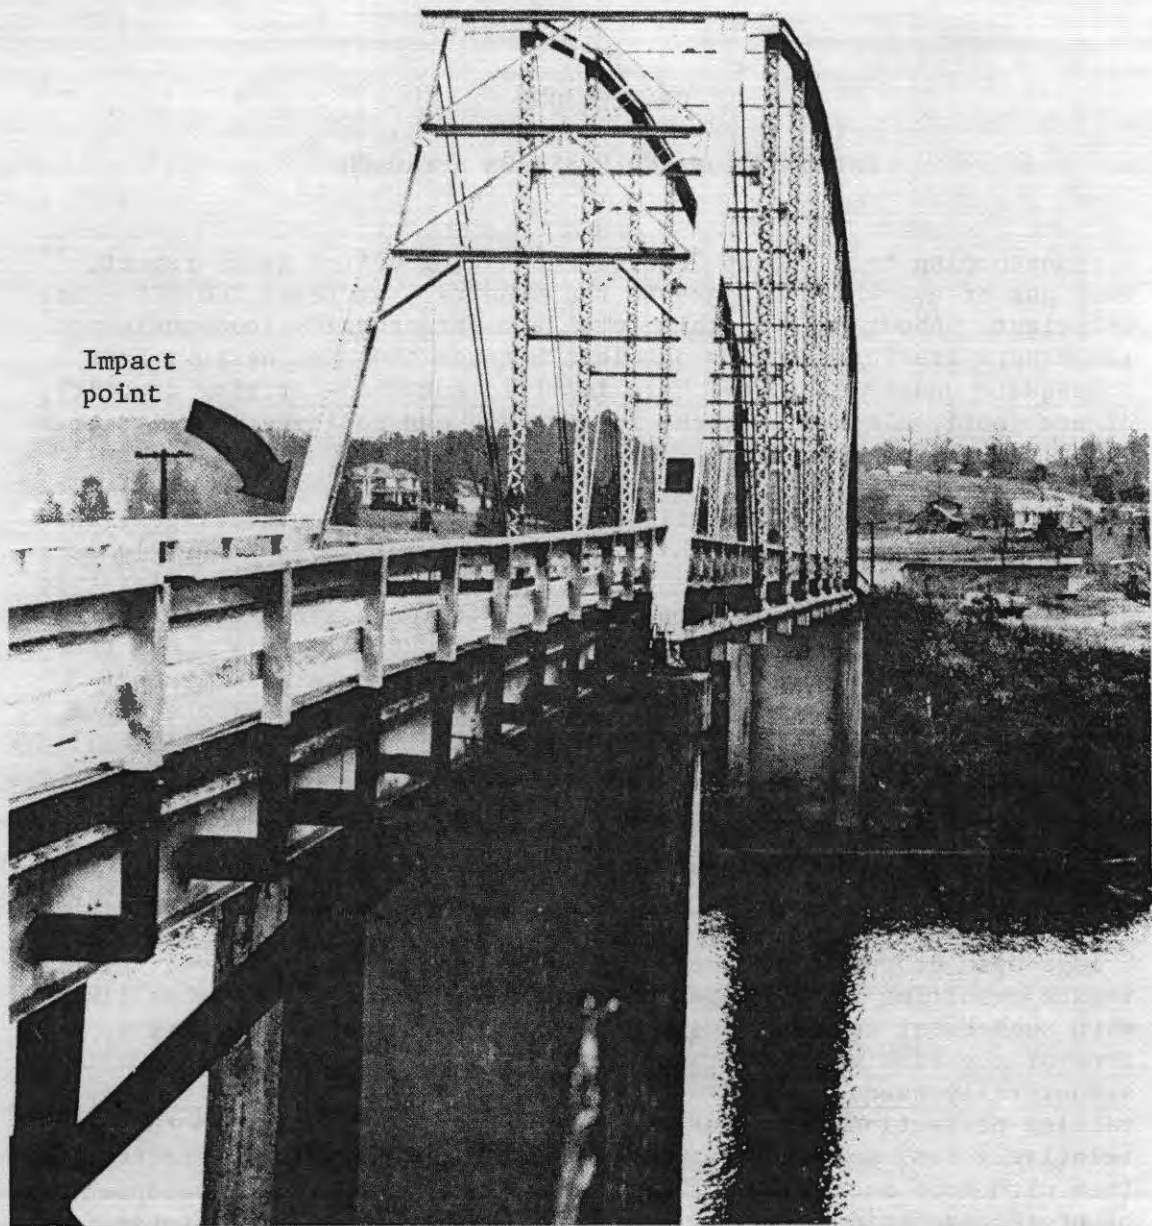
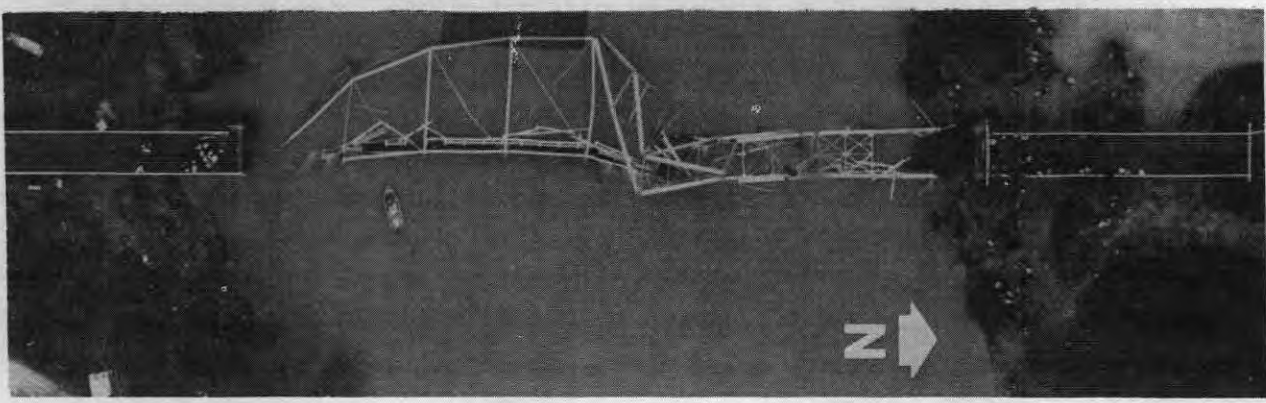
FIGURE 1. YADKIN RIVER BRIDGE COLLAPSE

Catastrophic failures of these through truss structures occur each year with some gaining nationwide attention such as the Yadkin River Bridge in North Carolina. As shown in Figure 1, the complete bridge span dropped into the river as a result of a relatively moderate impact resulting in passenger car penetration of the bridge railing with subsequent collision with a critical truss member. Thus, in the case of the Yadkin River Bridge and others such as described in Figure 2, structurally adequate bridges can collapse due to inadequate bridge railing protection. Many of these older through truss structures have relatively long spans and would require large expenditures to replace them with more modern structures. For this reason, the development of protective bridge railing systems for these unique structures is seen as a cost-effective way of keeping these otherwise structurally sound bridges in service, and minimize the potential for catastrophic events as pictured in Figures 1 and 2.

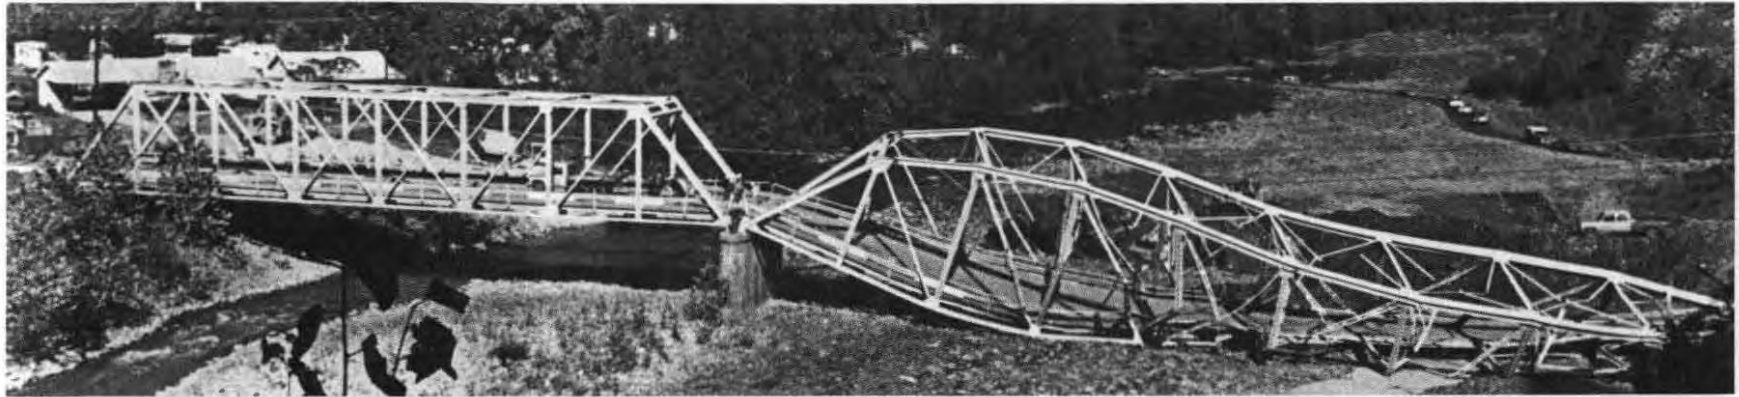
(a) Truck Collision in West Virginia

Truck ramming downs bridge

Truss bridge damaged beyond repair by truck accident will be replaced with new crossing.

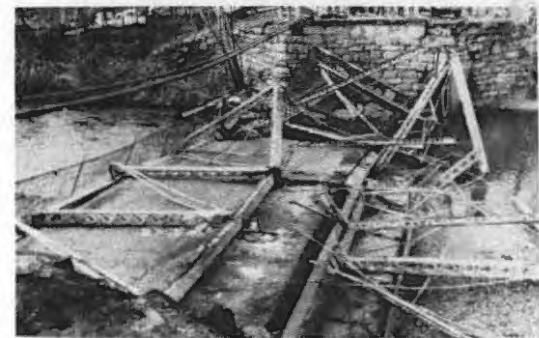
(c) Car Collision in Pennsylvania

Automobile drops truss span into river

A 100-ft steel truss bridge collapsed into the Lackawanna River in Scranton, Pa., after an automobile struck one of its vertical members. The 75-year-old structure had been posted for 5 tons.

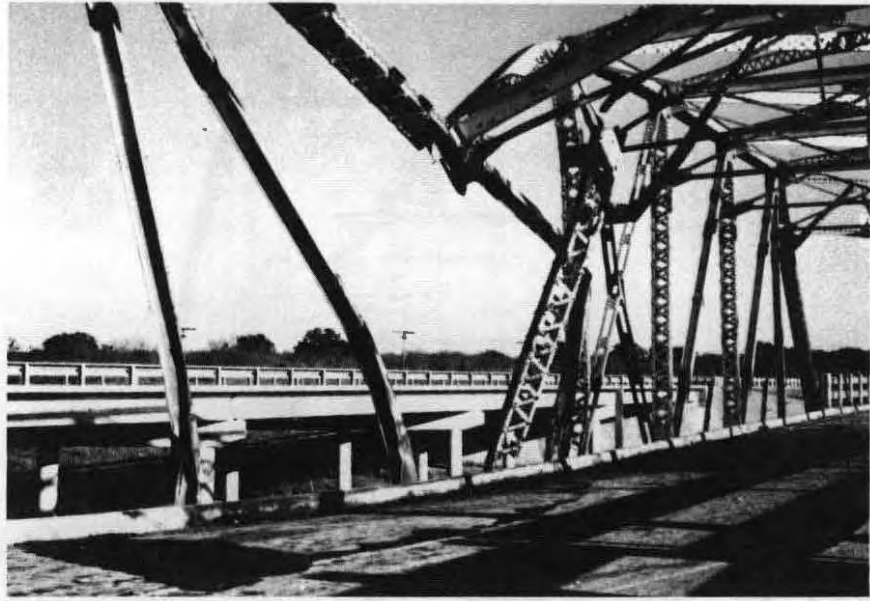
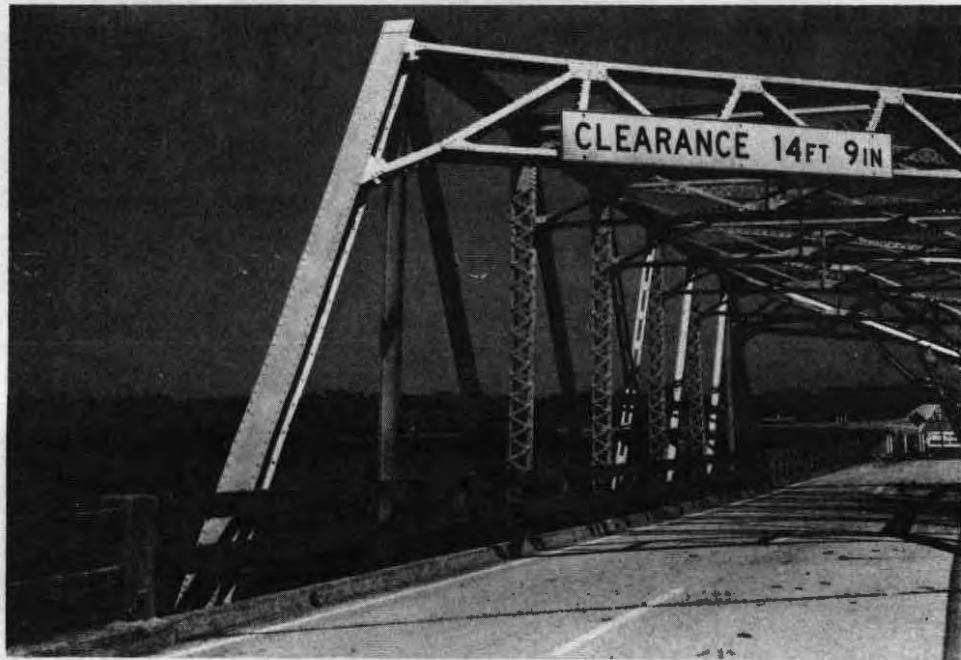
FIGURE 4. BEAVER CREEK BRIDGE (TX)

Limited Space. The clear horizontal widths on most of these bridges are substandard. For example, Figures 3, 4, and 5 show the Beaver Creek Bridge in Texas and the Yadkin River Bridge in North Carolina, both of which were irreparably damaged by vehicle impacts. Flanges of the steel channel bridge rails of Figures 3 and 4 were notched and meshed with the truss end posts and hangers for attachment. With a clear width of only 11'-2" (3.4m), the wooden railings in Figure 3 were actually butted up against the end posts for attachment.

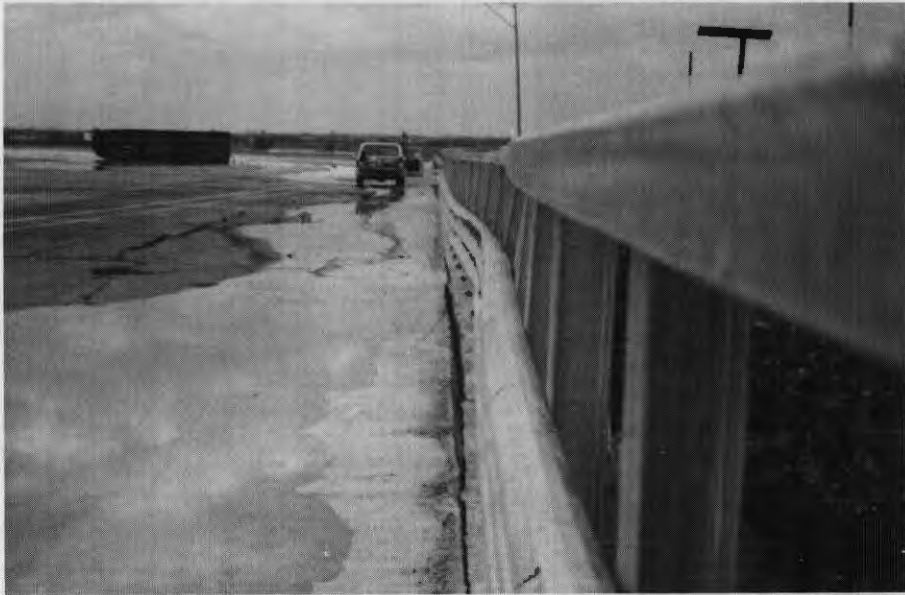
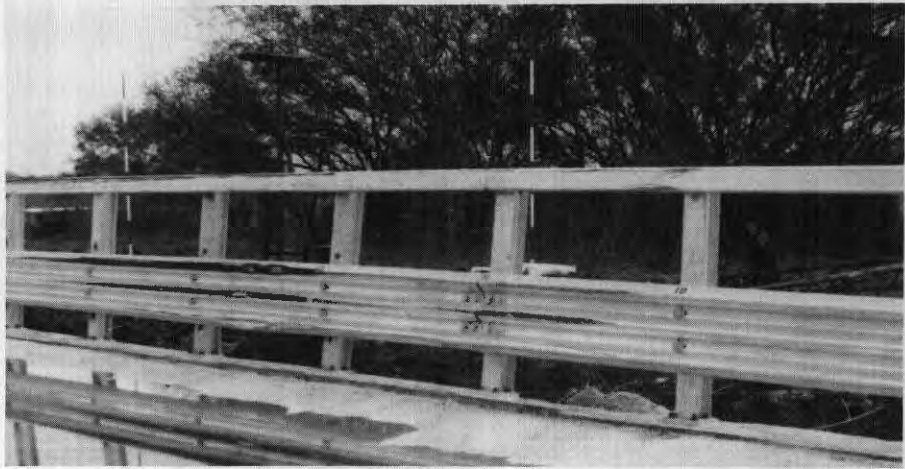
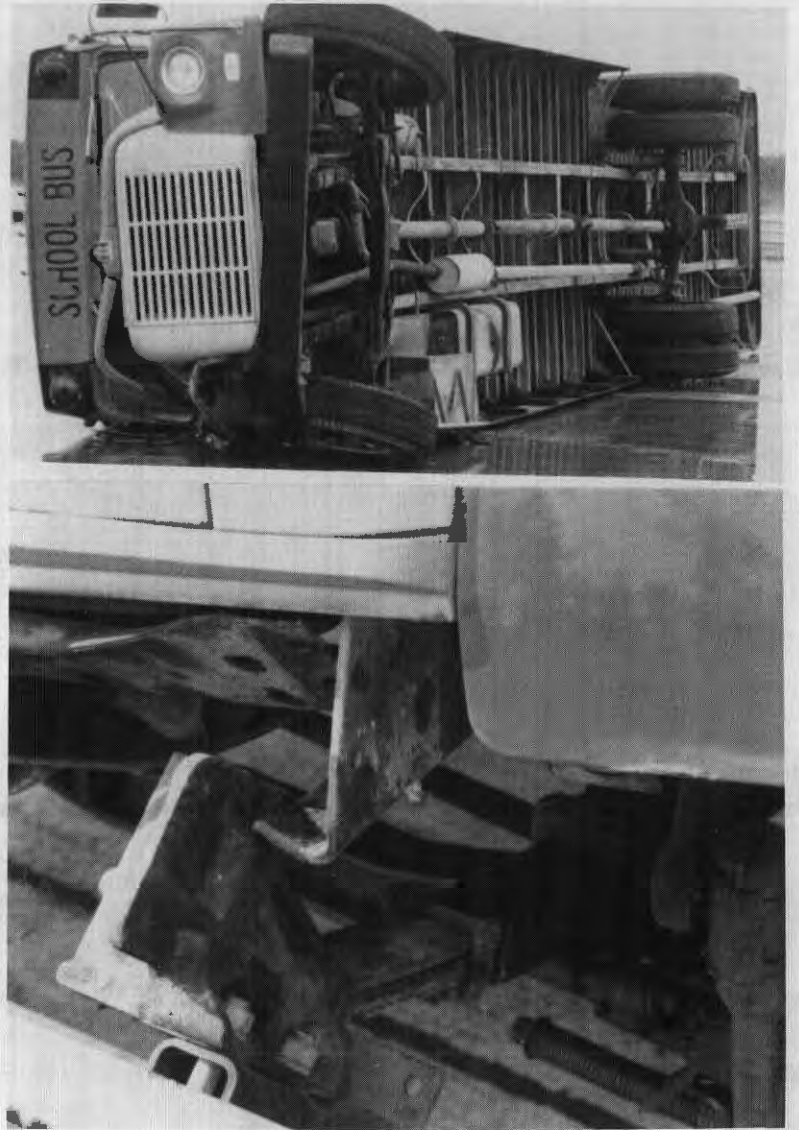
FIGURE 16. PHOTOGRAPHS AFTER TEST TTR-1

High Performance Retrofit. Test TTR-1 was conducted on the prototype installation described in Figures 13 and 14. As shown in Figure 15, the bus impacted the barrier with a speed of 55.2 mph (88.9 kmph) and an angle of impact of 13.7 deg. The bus was redirected with a maximum roll angle of 20 deg while in barrier contact. After losing contact with the barrier, the bus swerved to the left due to front suspension and steering linkage failure from the force of the impact, and rolled on the right side, sliding to a stop 225 ft (68.6 m) beyond the end of the test barrier. Post-test examination revealed that the rivets which attach the front spring hanger brackets to the frame were sheared on both sides. This allowed the front axle and springs to rotate (about a vertical axis) as the right front wheel was pushed rearward by the lower rail. This in turn caused the steering pitman arm/wheel link connection to fail and the bus front wheels to be turned and locked into a hard left turn position.

Failure of the concrete support slab also contributed to the roll of the vehicle. This was not considered to be significant due to the overall test results, but the deck was additionally reinforced when repairs were made to the test installation. Photographs after test are in Figure 16.

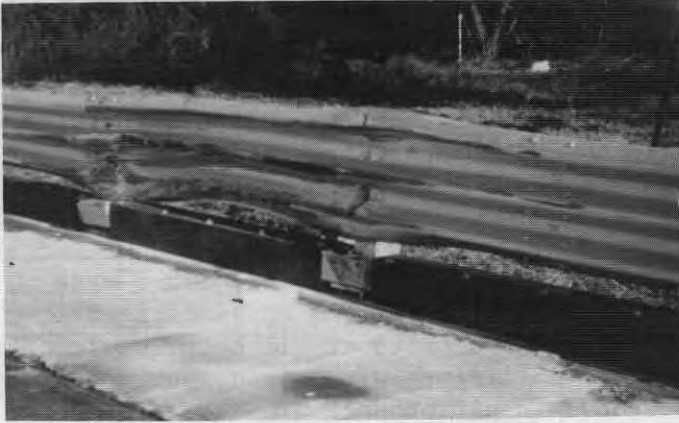
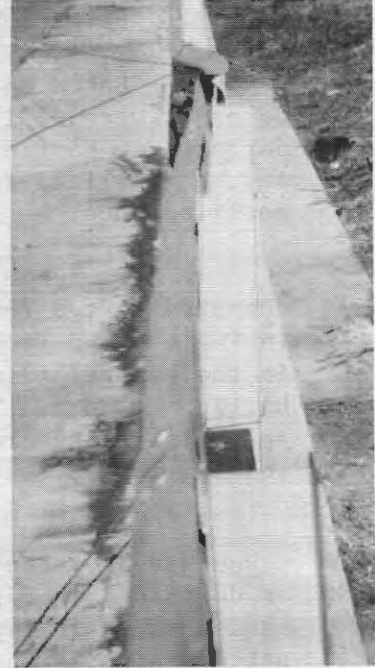
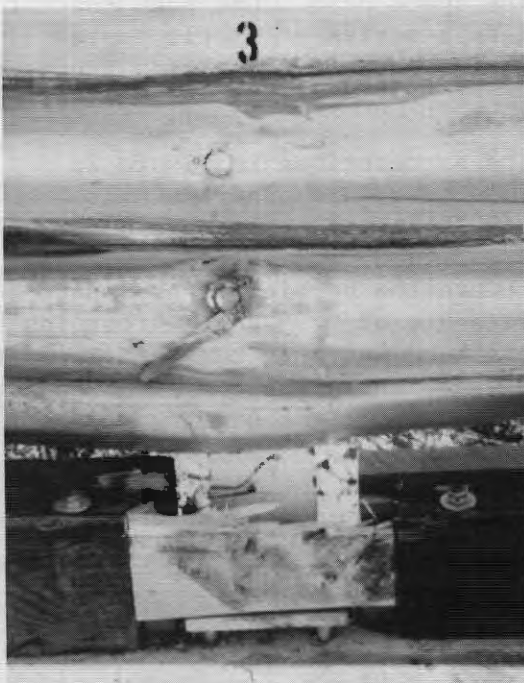
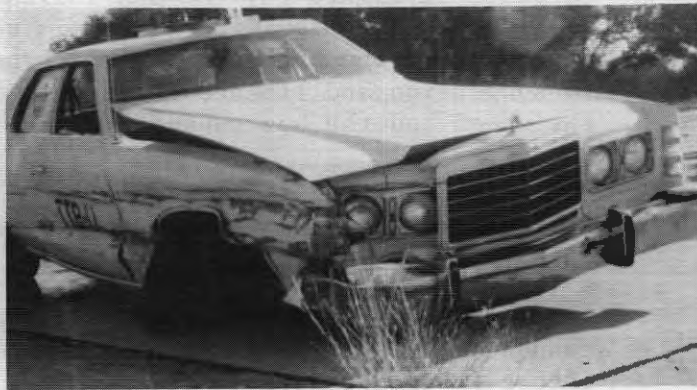
FIGURE 19. PHOTOGRAPHS AFTER TEST TTR-11

Figure 19 contains photographs after Test TTR-11.

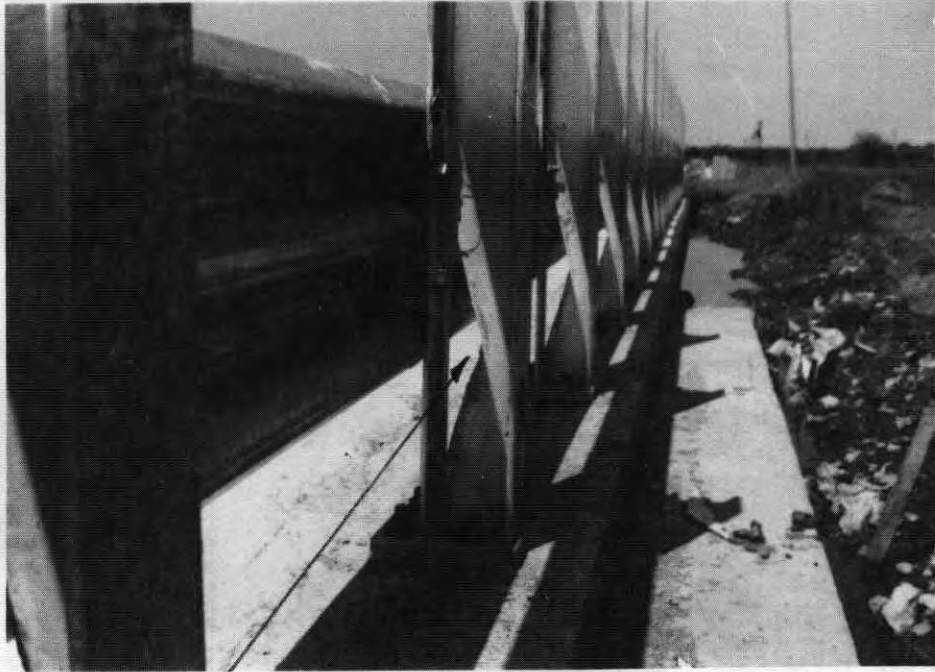
FIGURE 25. NOTCHED POST

- the maximum post deflection exceeded the 3-in. (75-mm) design goal. This was partially attributed to weakening of the posts at the notch.

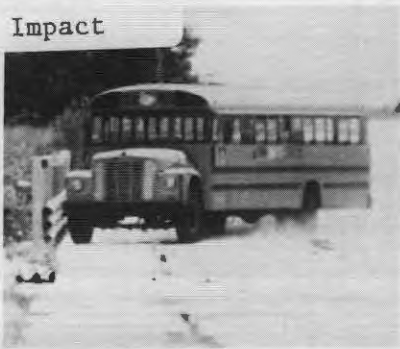
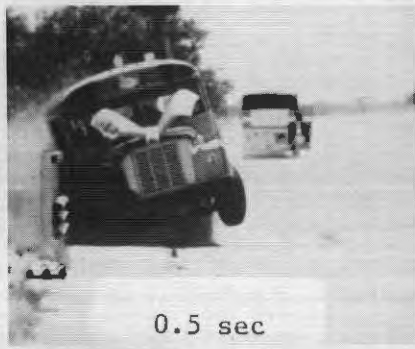
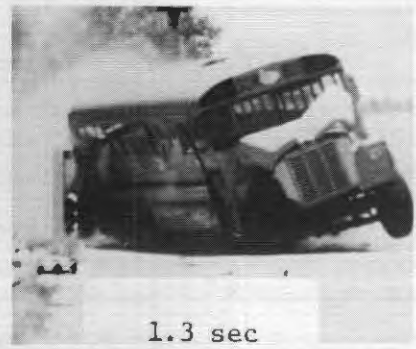
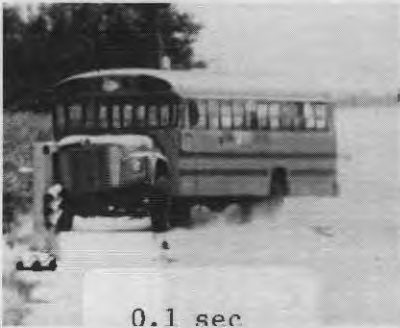
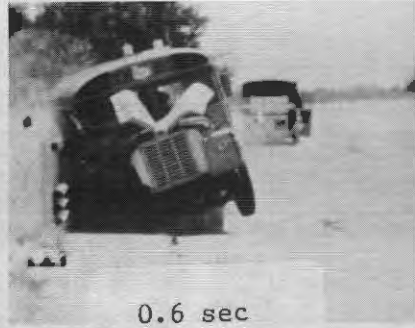
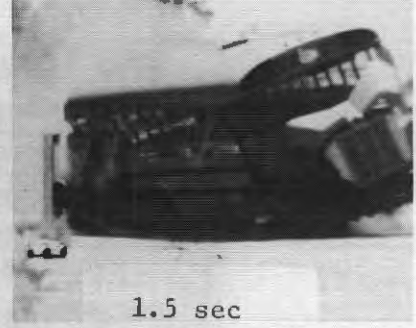
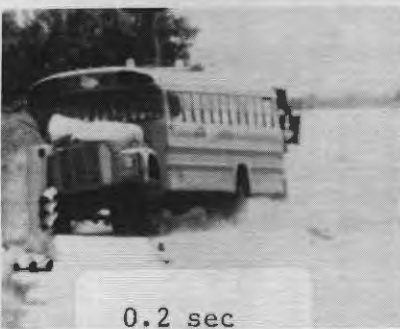
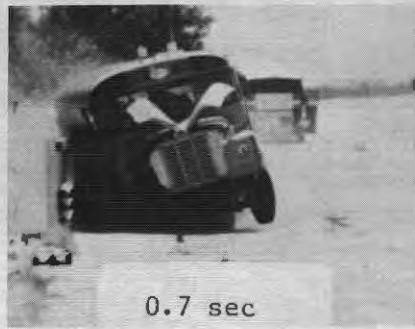
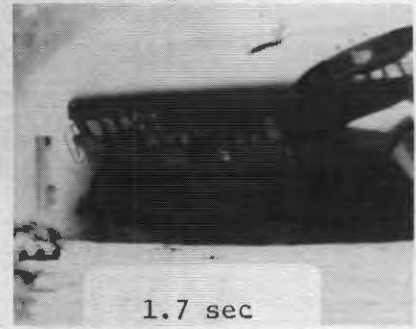
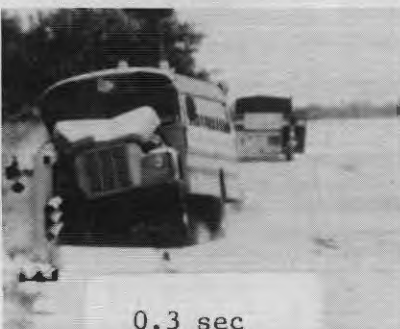
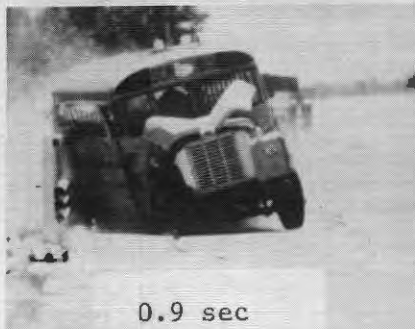
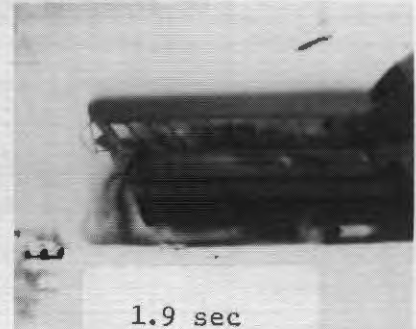
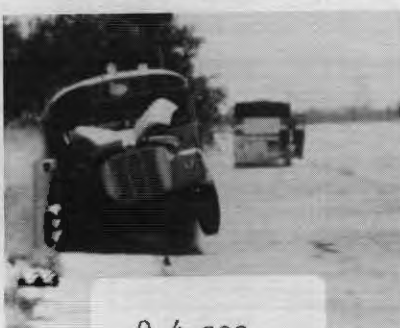
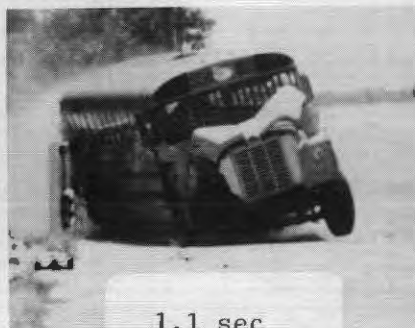
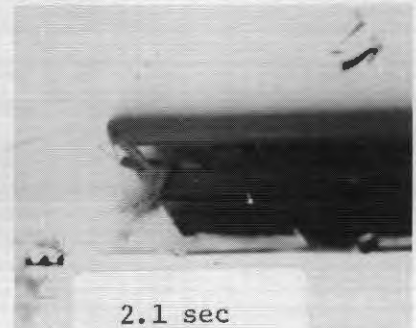
FIGURE 26. TEST TTR-2 IMPACT SEQUENCE

Test TTR-2. Notched posts as described in Figure 25 were installed in the impact area for this test; all other details were the same as TTR-1. The 20,000-lb (9070-kg), 72-passenger bus impacted the installation at 56.1 mph (90.3 kmph) and a 17.8-deg angle. As shown in Figure 26, the bus rolled toward the barrier after impact as it was redirected with a maximum roll angle of 12.5 deg. After losing contact with the barrier, the bus began a hard steer to the left due to suspension and linkage failure. The steer angle was too great for the speed and the bus subsequently rolled on the right side.

Post-test examination revealed that the rivets which attach the front spring hanger brackets to the frame were sheared on both sides. This allowed the front axle and springs to rotate (about a vertical axis) as the right front wheel was pushed rearward by the lower rail. This, in turn, caused the steering pitman arm/wheel link connection to fail and the bus front wheels to be turned and locked into a hard left turn position.

- the bus left the barrier with a severe steer angle - resulting in rollover. On an actual through truss structure, this hard steer could have represented a very severe impact on the opposite railing

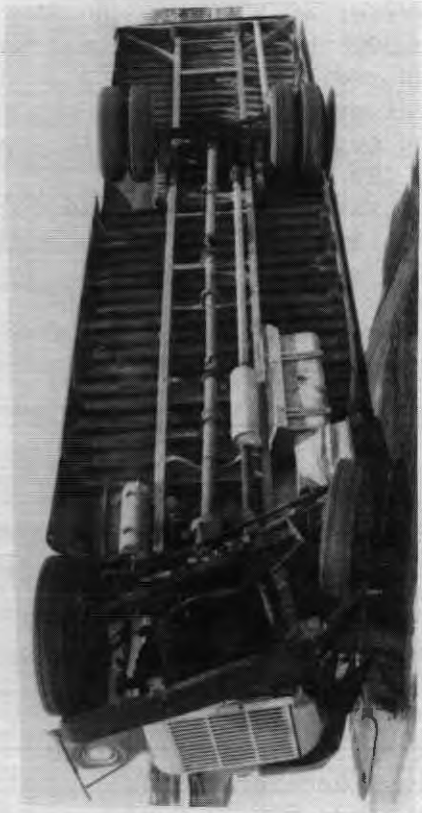
FIGURE 27. PHOTOGRAPHS AFTER TEST TTR-2

Photographs taken after the tests are shown in Figure 27. The strain gage readings indicated a maximum force of 8.5 kips (3.4 kN) at the upper rail/post interface.

Self-Restoring Concept. Based on results of TTR-2, it was deemed desirable to abandon the notched post concept and to incorporate a self-restoring 3-in. (75-mm) stroke into the lower beam mounting detail as described in Figure 28. The pivot bar is used on intermittent posts to minimize costs as shown in Figure 56.

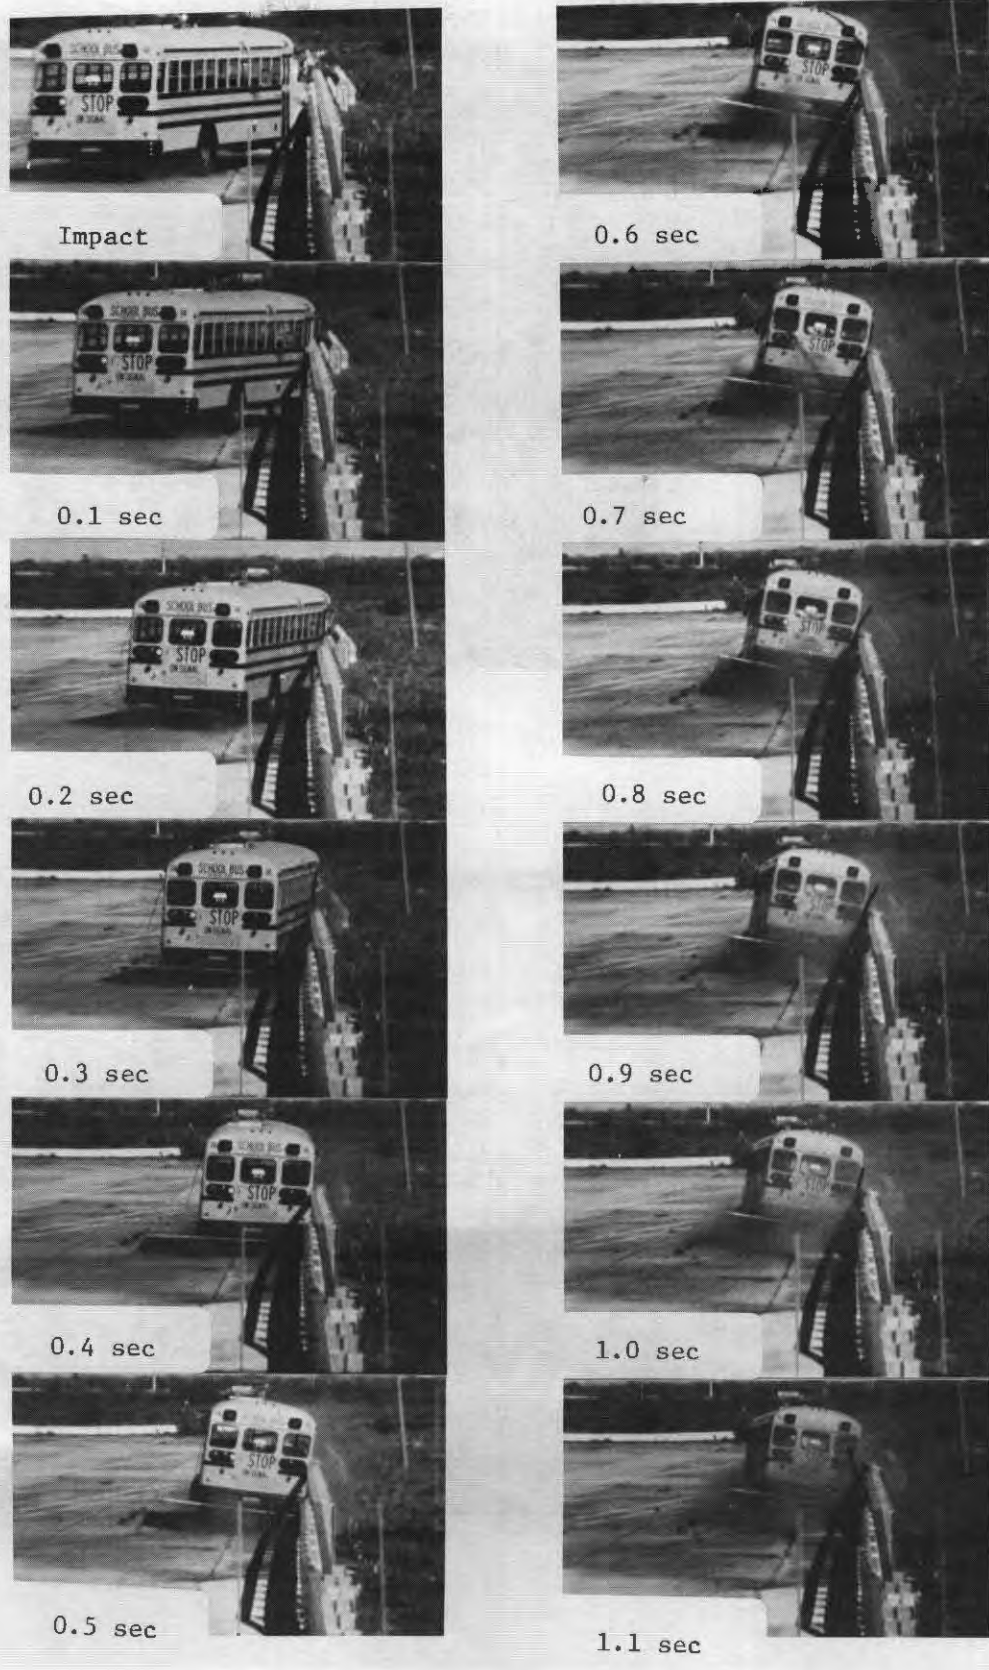
FIGURE 30. TTR-3 IMPACT SEQUENCE

The test vehicle impacted the barrier at 53.9 mph (86.7 kmph) and a 15.3-deg angle. As shown in Figure 30, the bus rolled a maximum of 10.7 deg toward the barrier as it was redirected. During the impact, the right front wheel was pushed rearward by the lower rail, causing suspension failure, and forced the entire front axle to rotate. After losing contact with the barrier, the vehicle dropped at the right front onto the now horizontal front right wheel and slid upright to a stop essentially parallel to the barrier as shown in Figure 31. The maximum deflections were such that the 3-in. (75-mm) encroachment goal beyond the rear post line were met. The roll of the vehicle and the exit conditions were also considered favorable. There was some sheet metal snagging on posts at the opening between upper and lower rails as shown in Figure 31. This was sufficient to cause one post weld to separate due to flexure about the minor axis as shown in Figure 31.

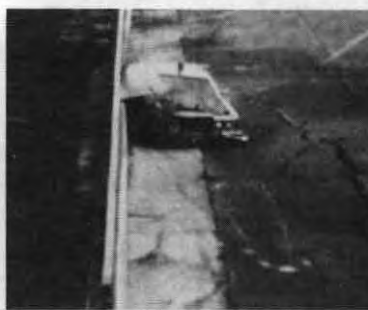
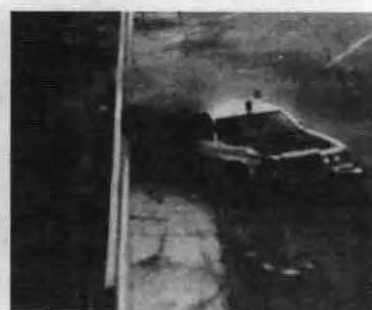
FIGURE 39. TEST TTR-7 SEQUENTIAL PHOTOGRAPHS

Test TTR-7. The purpose of this test was to evaluate the self-restoring retrofit for the structural adequacy test criteria of TRB Circular 191. The 4441-lb (2014-kg) vehicle impacted the barrier at 58.3 mph (93.9 kmph) and a 27.1-deg angle. The vehicle was being redirected smoothly until the undeformed hood slid over the top of the lower beam and snagged on a post as shown in Figure 39. A portion of the hood penetrated through the windshield prior to the complete severing of the hood from the hinges.

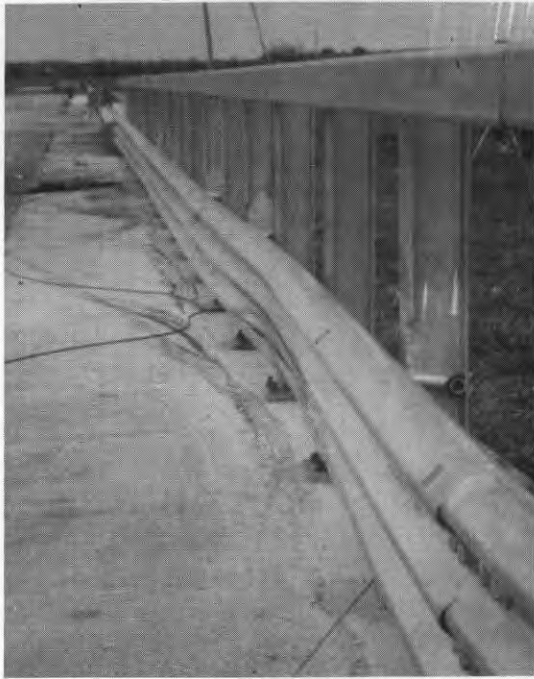
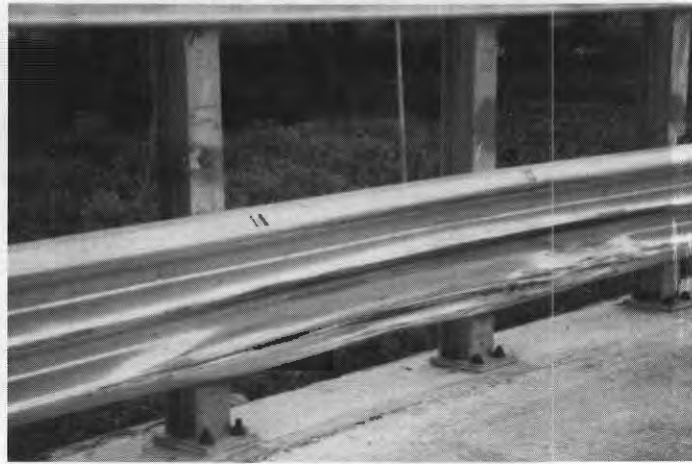
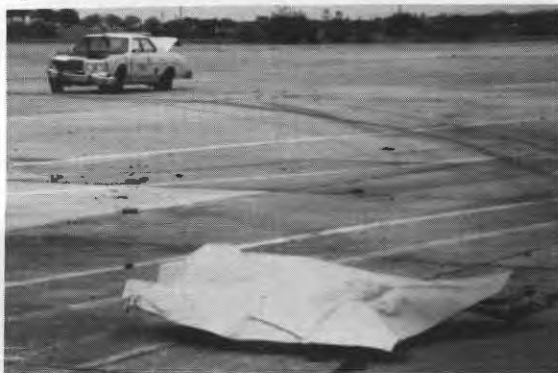
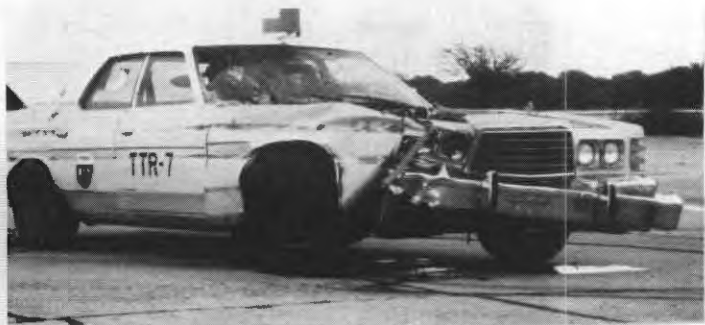
FIGURE 40. PHOTOGRAPHS AFTER TTR-7

Other than the hood snagging, the barrier performed in an acceptable manner. The maximum barrier deflection was not sufficient to encroach into the truss member zone. Photographs after the test are shown in Figure 40.

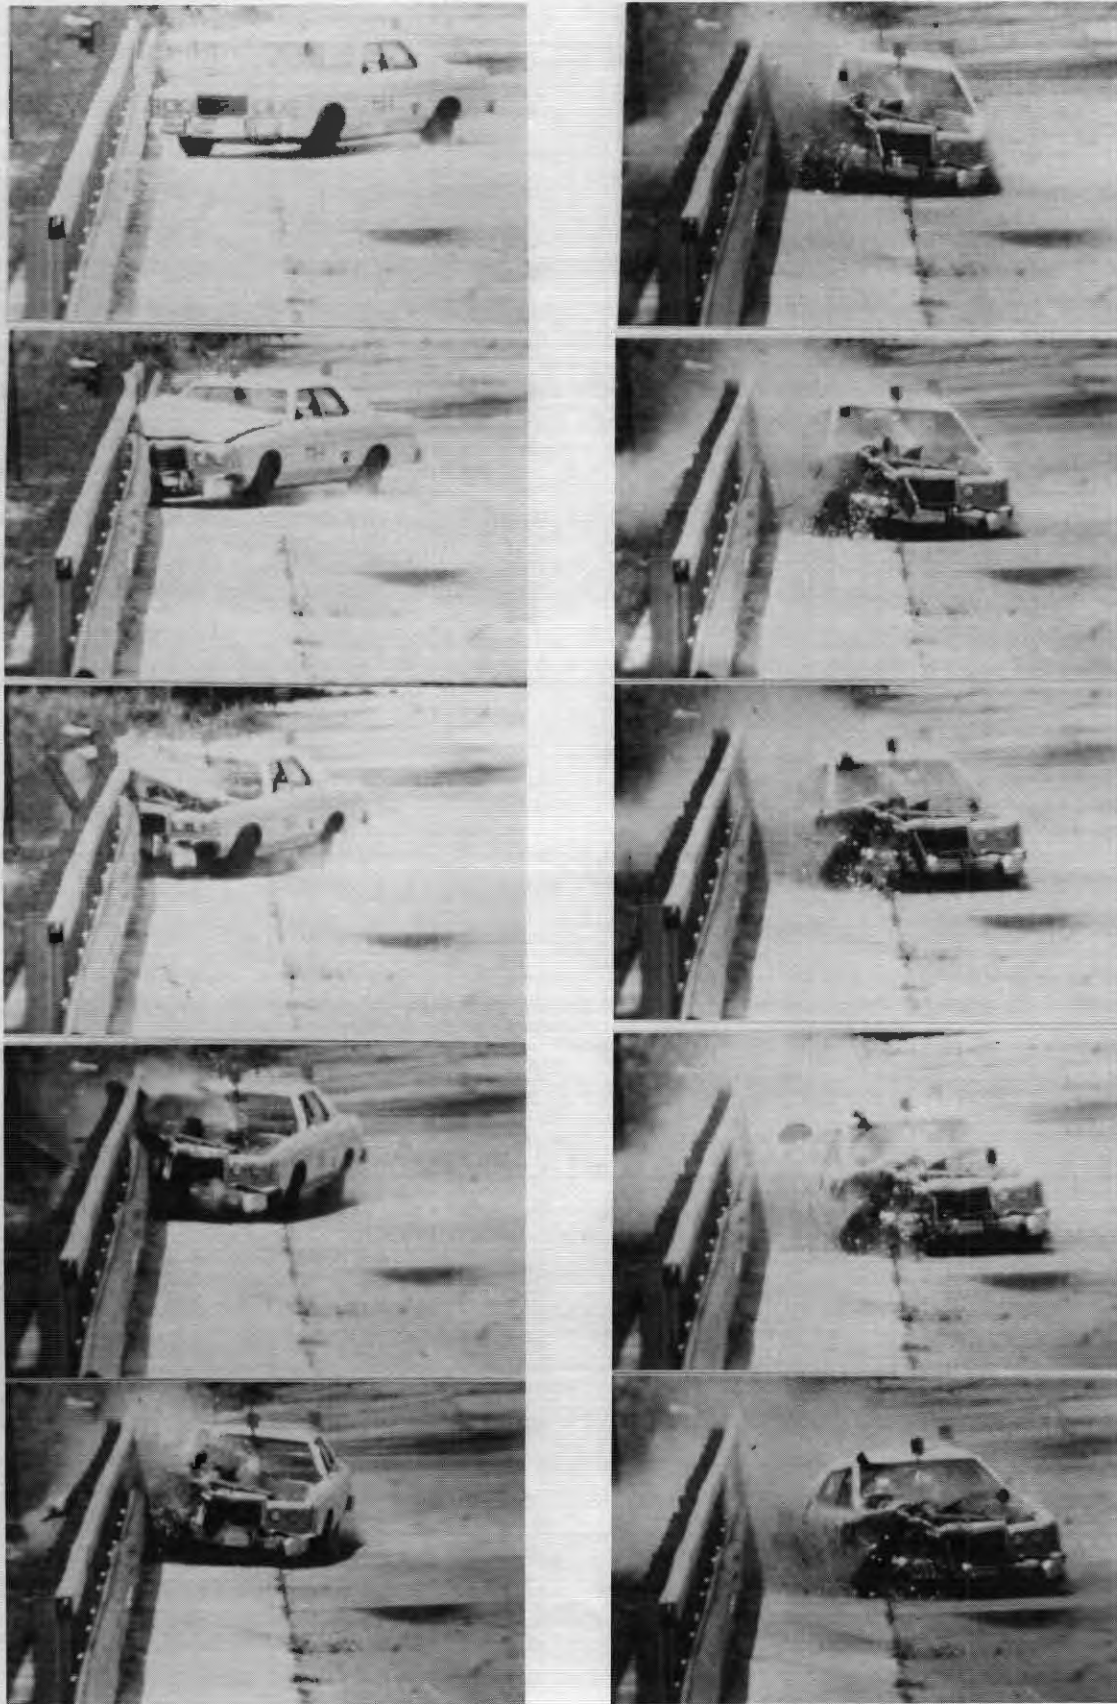
FIGURE 41. TEST TTR-8 SEQUENTIAL PHOTOGRAPHS

As shown in Figure 41, the hood snagging occurred again as the vehicle was redirected after a 57.8 mph (93.1 kmph), 29.6-deg angle impact. Although the excessive impact angle could have been a contributing cause, it was deemed desirable to investigate the hood snagging/windshield intrusion problem.

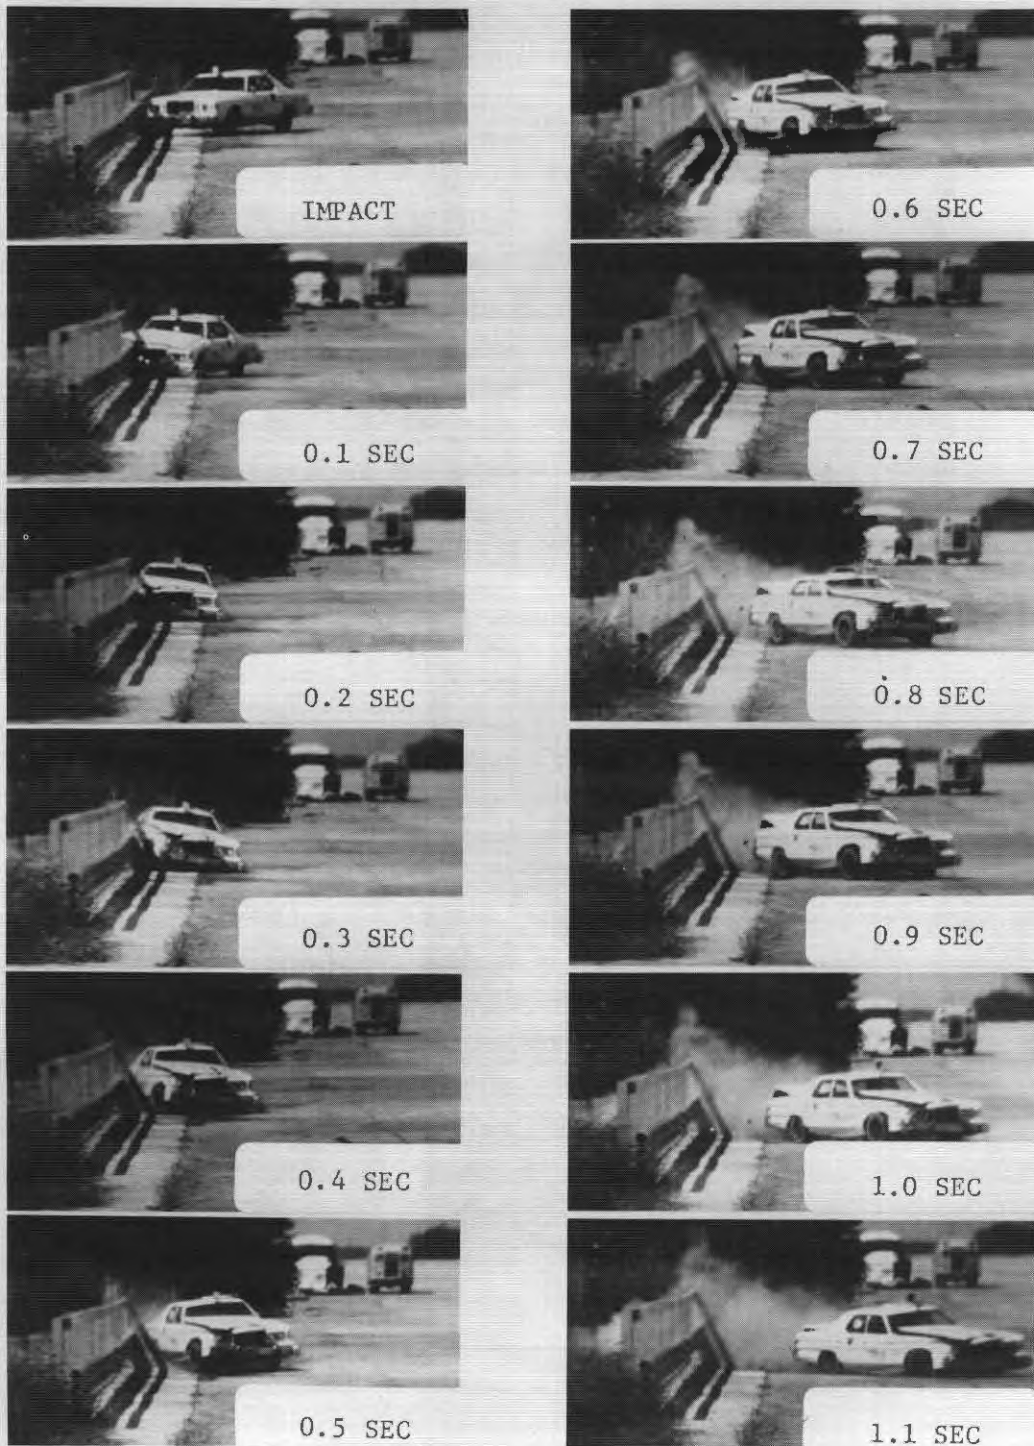
FIGURE 43. TEST TTR-9 IMPACT SEQUENCE

The structural adequacy test of the approach railing system was repeated with this test. The 4500-lb (2040-kg) vehicle impacted the barrier 26.6 ft (8.1 m) upstream of the bridge at 60.2 mph (96.9 kmph) and an angle of 25.9 deg. As shown in Figure 43, the vehicle was smoothly redirected with no hood snagging evident. The same vehicle, a 1978 Ford LTD, was used in Tests TTR-7, -8, and -9 to insure valid comparisons. Photographs after the test are shown in Figure 44.

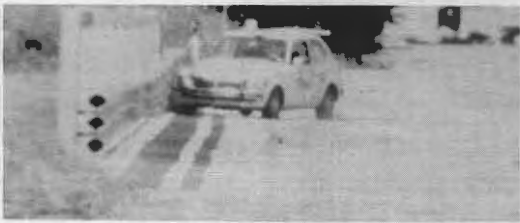
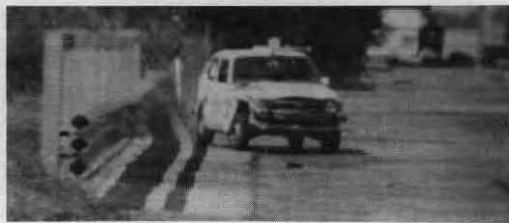
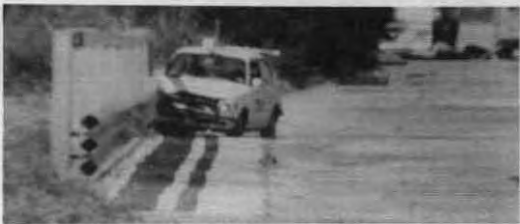
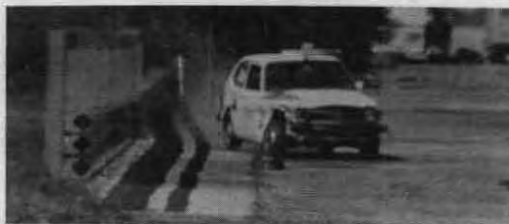
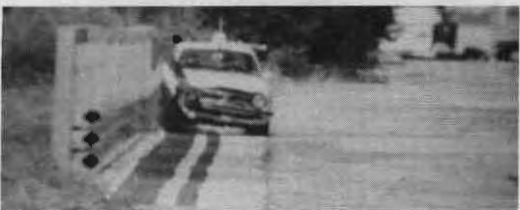
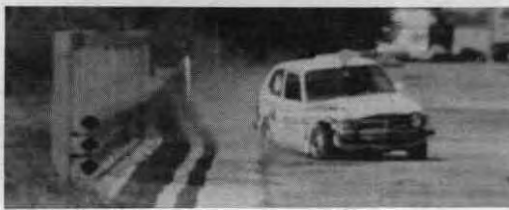
FIGURE 45. TEST TTR-10 IMPACT SEQUENCE

Test TTR-10. The purpose of this test was to evaluate the bridge approach design with an 1800-lb (800-kg) minicompact at 60 mph (95 kmph) and 15 deg. As shown in Figure 45, the 1658-lb (752-kg) vehicle was smoothly redirected after striking the barrier at 61.3 mph (98.6 kmph) and a 20.9-deg angle. The maximum 50 msec average vehicle accelerations were 9.4/9.5 g (lateral) and -4.0/-3.4 g (longitudinal) as measured from cine/electronic data.

The self-restoring stage deflected a maximum of 3.5 in. (89 mm) before returning, undamaged, to the original position after the vehicle was redirected. Photographs of the barrier and vehicle after the test are shown in Figure 46.

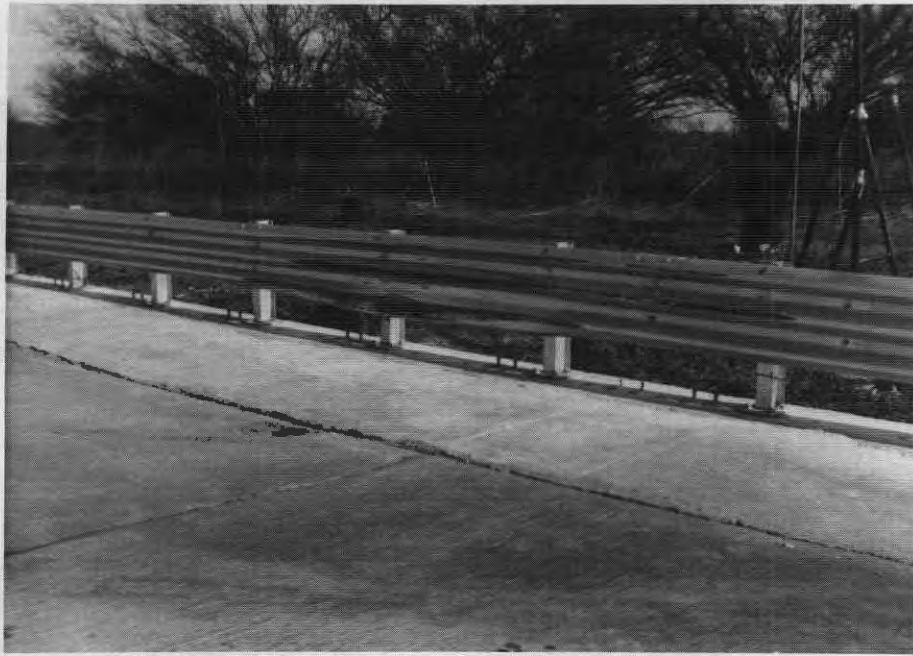
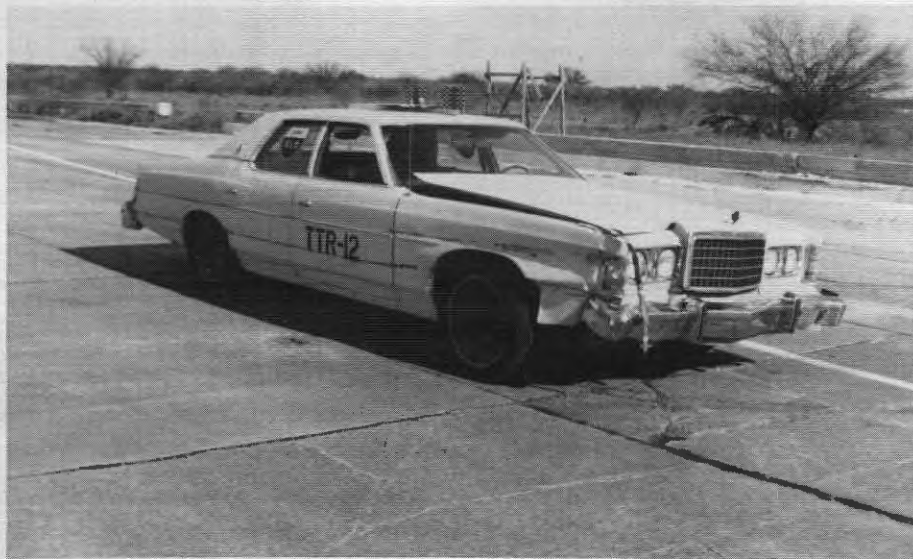
FIGURE 50. PHOTOGRAPHS AFTER TTR-12

Test TTR-12. The purpose of this test was to evaluate the low service retrofit shown in Figure 49 for the structural adequacy requirements. Due to a malfunction, the test vehicle impacted the barrier at only 49 mph (79 kmph) and a 15-deg angle. Damage to the barrier and vehicle is shown in Figure 50. There was negligible intrusion into the zone behind the posts.

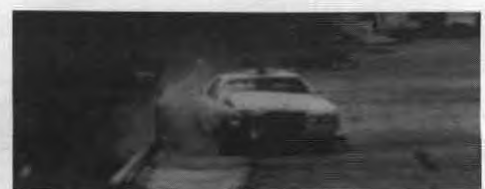
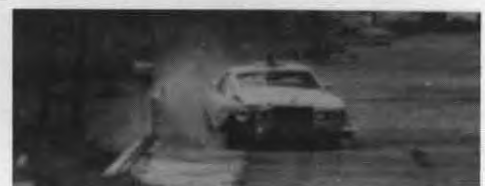
FIGURE 51. TEST TTR-13 IMPACT SEQUENCE

Test TTR-13. This test was a repeat of Test TTR-12. The 4466-lb (2026-kg) vehicle impacted the barrier at 59.3 mph (95.4 kmph) and a 19.1-deg angle. As shown in Figure 51, the vehicle was smoothly redirected, and continued until contacting another barrier installation in-line with the test installation 150 ft (45 m) downstream of the impact. The design goals of the barrier were met; i.e., the maximum deflection beyond the rear post line was 3 in. (75 mm). This maximum deflection at one post was attributed to local buckling due to impact and the pulling of the anchor bolts from the slab for a distance of 0.5 in. (13 mm). A more substantial anchorage (e.g., bolts through the slab) would have prevented much of this deformation.

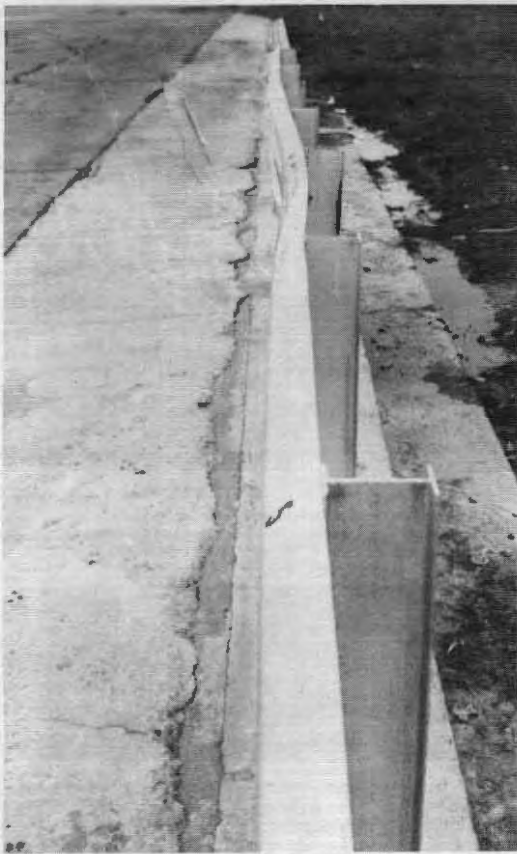
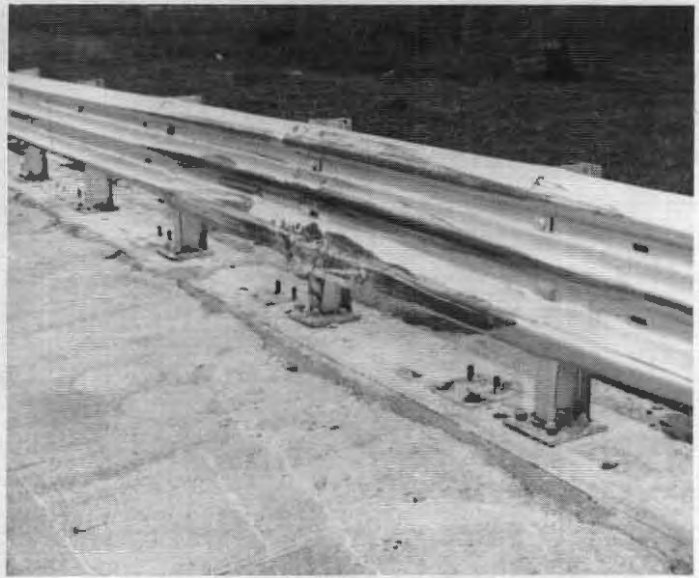
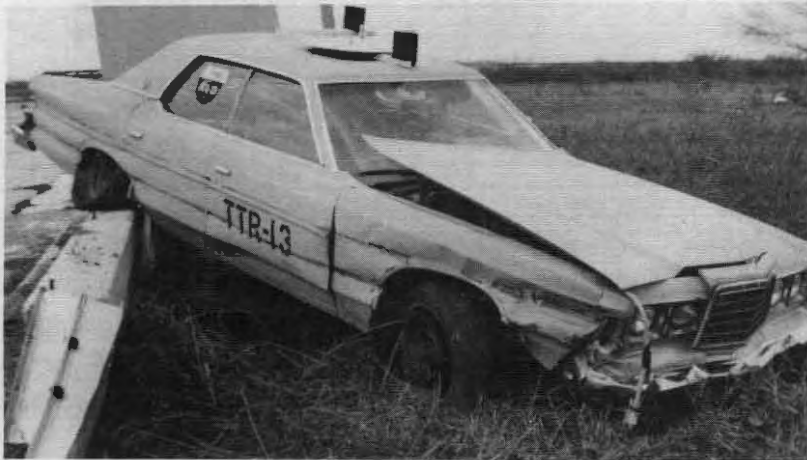
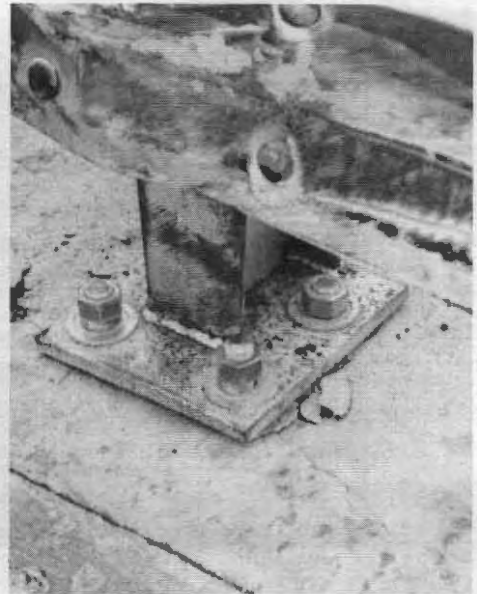
FIGURE 52. PHOTOGRAPHS AFTER TEST TTR-13

Damage to the barrier consisted of two rail sections and three posts; vehicle and barrier damage is shown in Figure 52.
