RETROFIT RAILINGS FOR NARROW THROUGH TRUSS AND OTHER OBSOLETE BRIDGE

Research, Development,
and Technology

Report No.
FHWA/RD-82/099

Final Report
November 1986

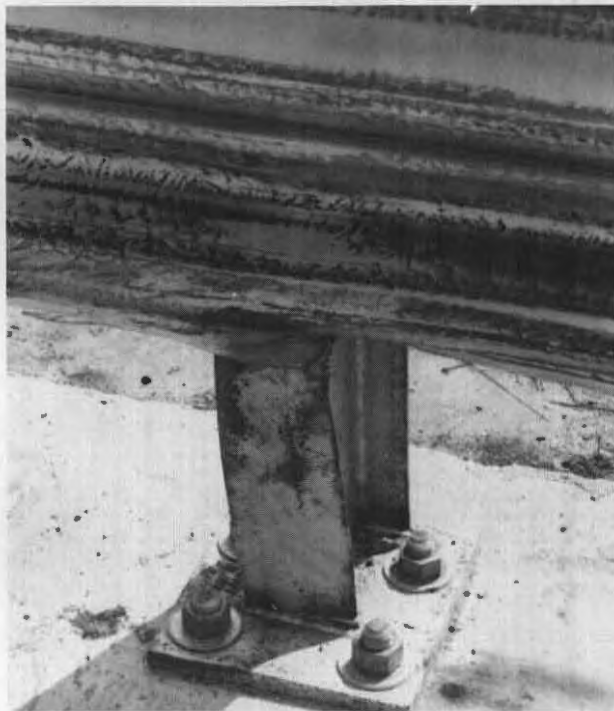
(a) Post 5, TTR-14

Test TTR-14. The purpose of this test was to evaluate the low service retrofit shown in Figure 49 for the occupant risk impact conditions of NCHRP Report 230. The 1751-lb (794-kg) vehicle impacted the barrier at 60.9 mph (98.0 kmph) and a 19.9-deg angle as shown in Figure 53. The force of the impact on the right front wheel caused wheel rotation about an axis parallel to the roll axis. This allowed the wheel to intrude under the rail sufficient to snag on two of the posts. The bumper behavior of the 1979 Honda was different than observed with previous tests. Vehicle and barrier damage are shown in Figure 54.

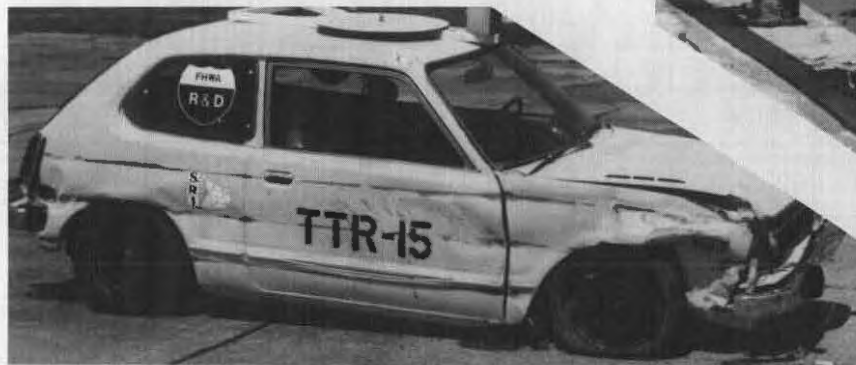
(c) TTR-15 test vehicle

The 1750-lb (794-kg) test vehicle impacted the installation at 57.9 mph (93.2 kmph) and an angle of 16.9 deg as shown in Figure 53. Redirection of the vehicle was smooth with dynamic deflection of less than 1 in. (25 mm). The damage sustained by the system was so minor that it did not have to be repaired.

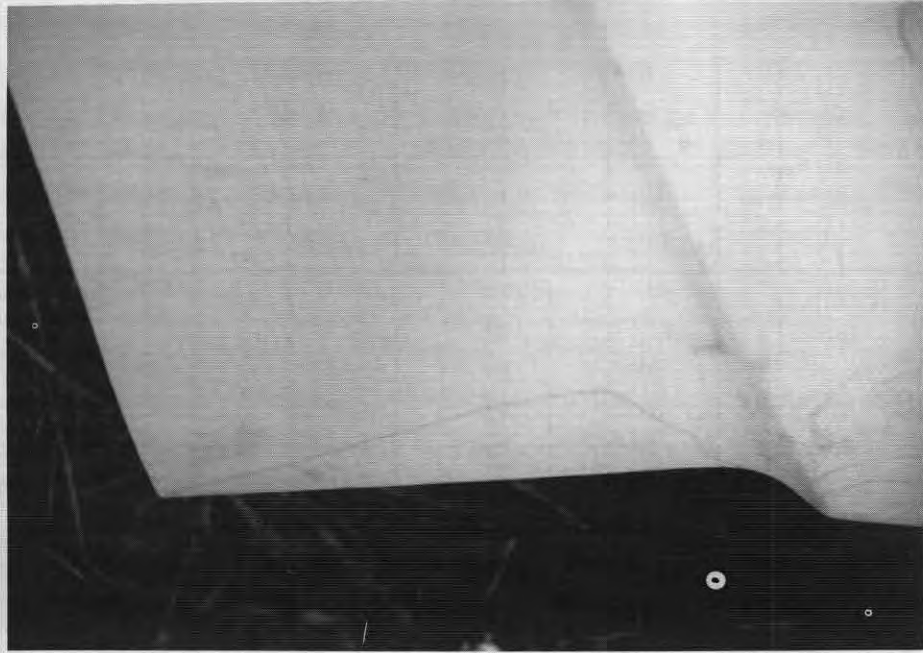
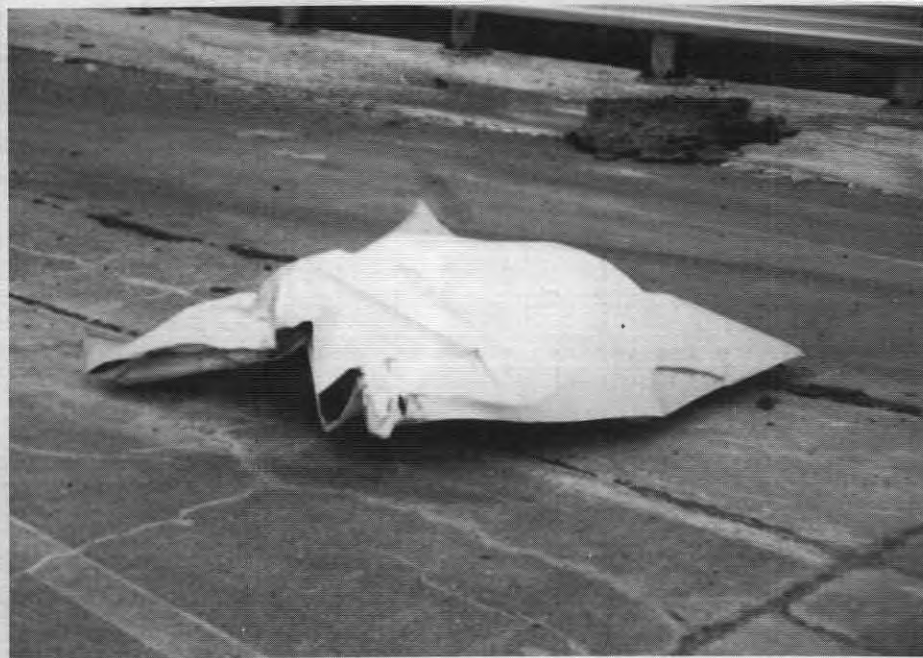
FIGURE 55. 1978 FORD HOOD

The particular 4500-lb (2000-kg) sedan selected for crash testing in this project had a unique hood design that made snagging of posts more probable than other designs as illustrated in Figure 55.

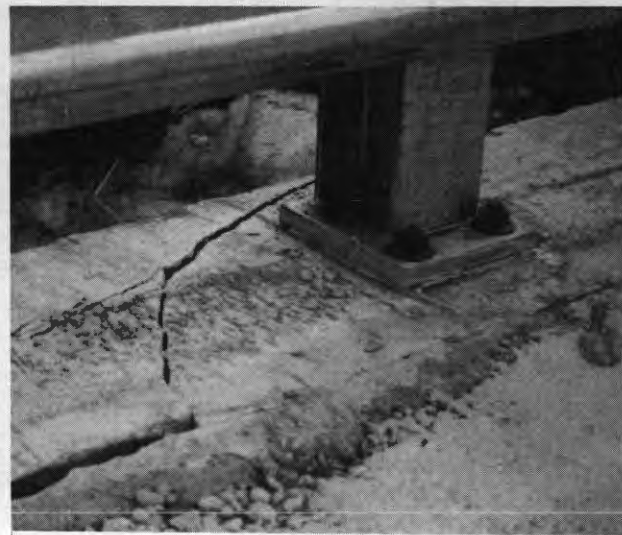
FIGURE 66. TEST TTR-1 BARRIER DAMAGE

ment. However, the concrete foundation on which the posts were mounted proved to be inadequate. Drilled shaft footings proved to be inadequate due to flooding of the soil at the test site; multiple failures were noted in the concrete beam connecting the footings between Posts 8 through 16. Also, these foundation failures permitted more post leaning and barrier deflection than is considered allowable. Reconstruction/strengthening of the foundation was required prior to further testing. Barrier deflections are contained in Table 8, and barrier damage photographs are shown in Figure 66.

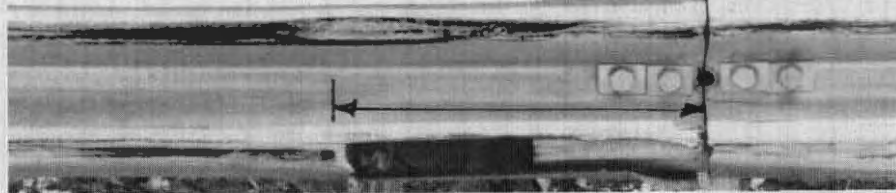
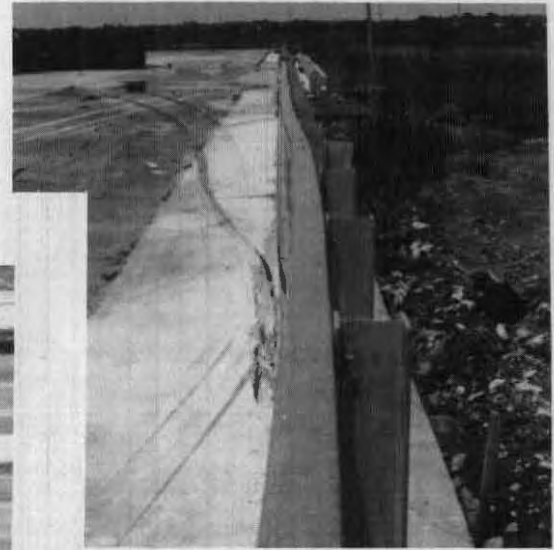
FIGURE 71. TEST TTR-2 BARRIER DAMAGE

Barrier Damage: Damage to the barrier itself was relatively minor - only two upper and two lower rail sections required replacement. The concrete foundation on which the posts were mounted proved to be adequate.

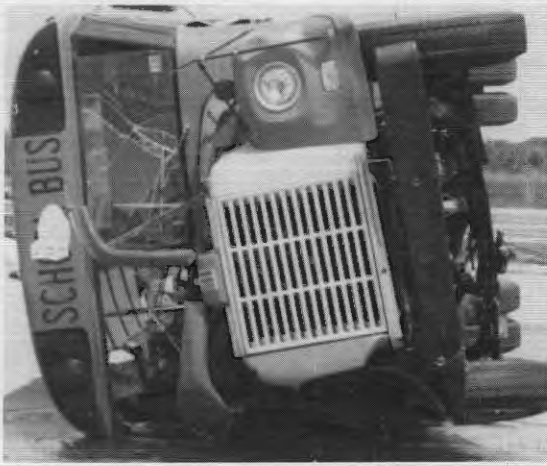
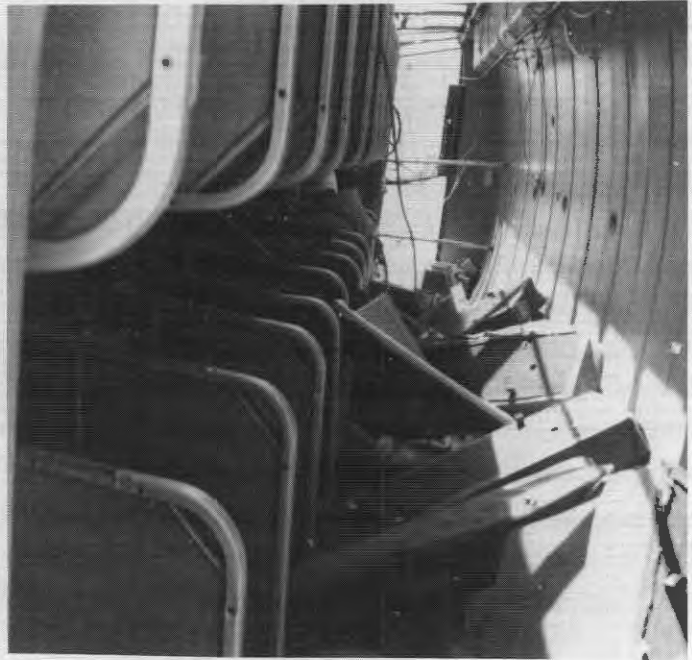
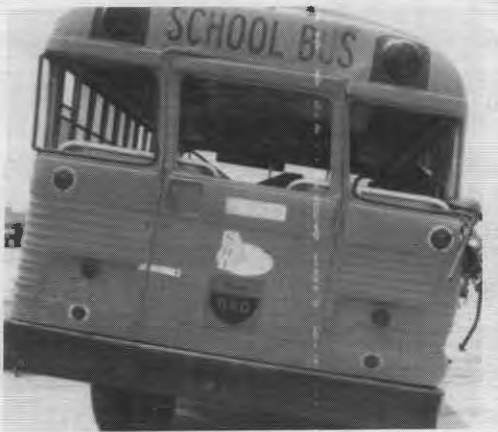
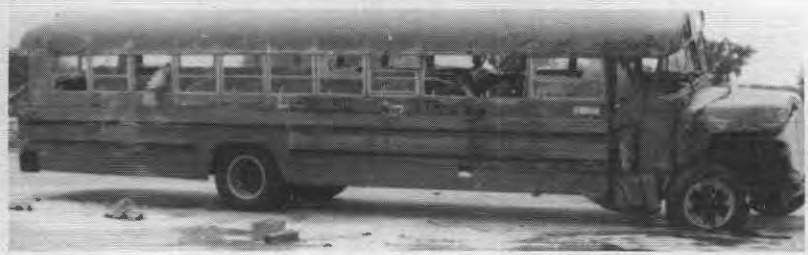
FIGURE 72. TTR-2 VEHICLE DAMAGE

Vehicle Damage: As described previously, the bus sustained front suspension and steering linkage damage. In addition to the right front fender being torn off, the entire right side received damage in the rollover and subsequent sliding on the concrete pavement. The right corner of the front bumper was displaced rearward and embedded in the right front tire. Although all seat bottom cushions and sandbags were thrown out of the seats and scattered throughout the bus, only one seat frame failure was noted. Photographs of vehicle damage are shown in Figure 72.

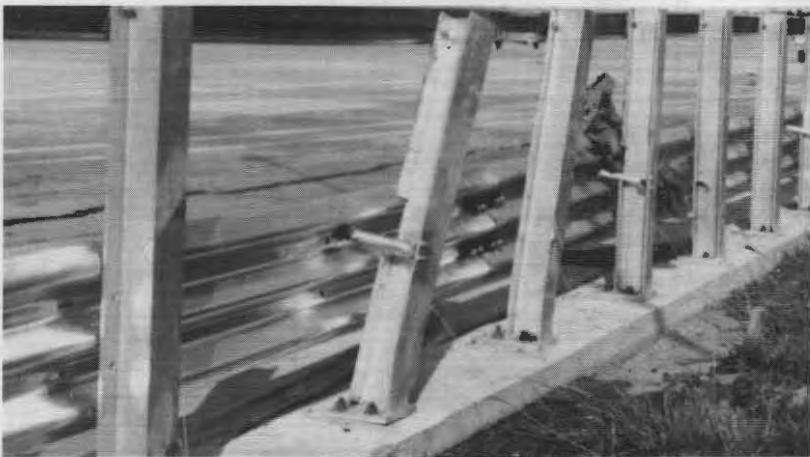
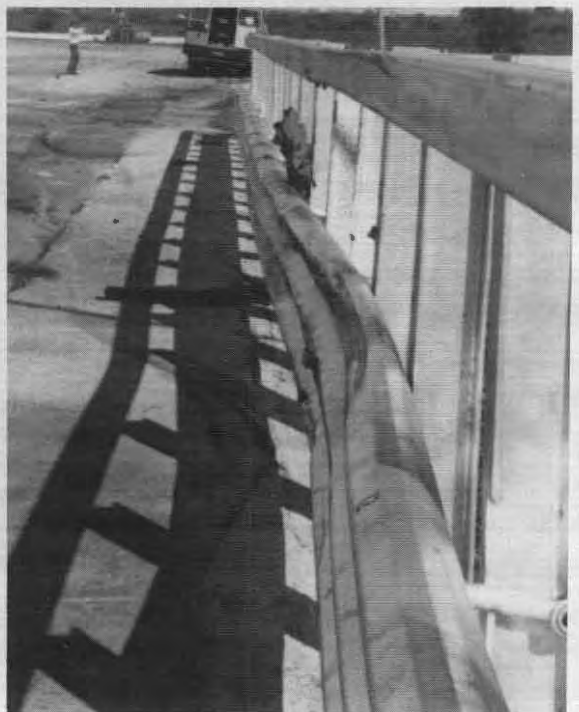
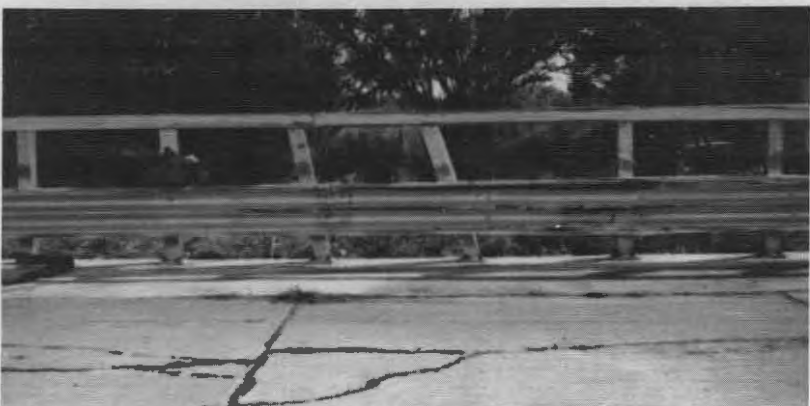
FIGURE 77. TEST TTR-3 BARRIER DAMAGE

Barrier Damage: As shown in Figure 77, barrier damage was moderate - two upper rail and two lower rail sections required replacement. In addition, Posts 15 and 16 were bent and required replacement. The vehicle wheel cut a gouge in the center corrugation of the thrie beam just downstream of Post 14. Permanent barrier deflections are given in Table 13.

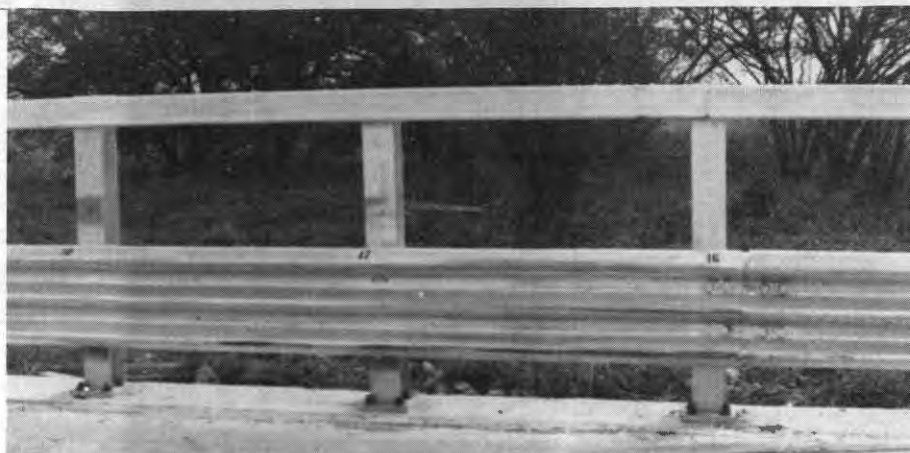
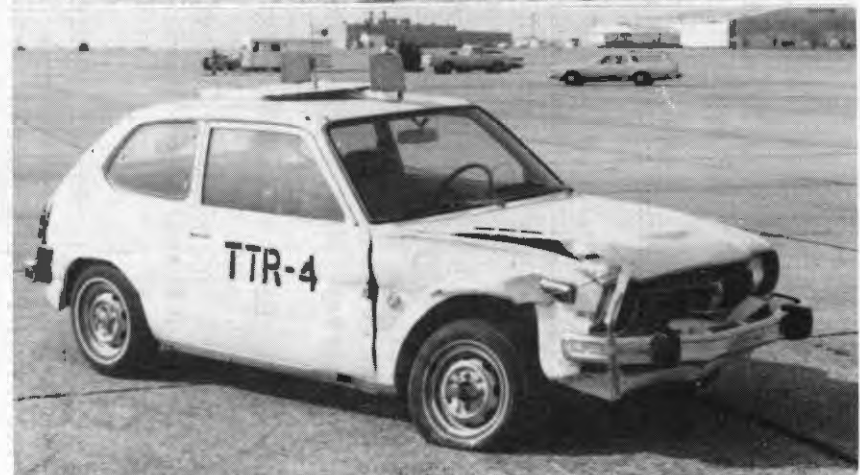
FIGURE 81. BARRIER AND VEHICLE DAMAGE, TEST TTR-4

Barrier Damage: As shown in Figure 81 the only damage to the barrier was tire scuffing and sheet metal scrape marks on the lower rail. These were easily painted over.

Vehicle Damage: Damage to the test vehicle, also shown in Figure 81, consisted of sheet metal deformation of the right front fender, a bent front bumper, a bent wheel and suspension damage at the right front corner.

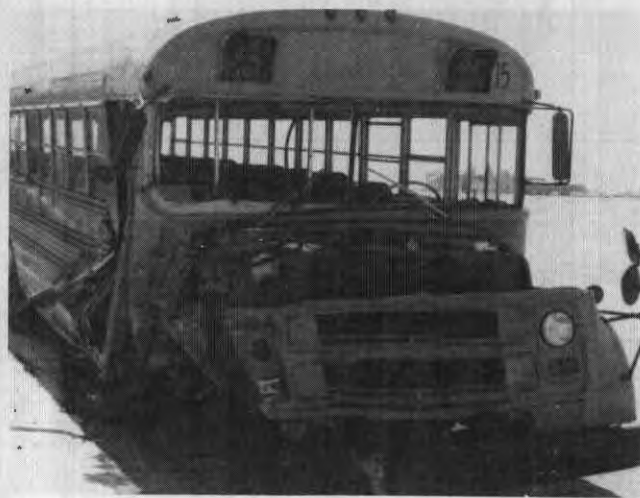
FIGURE 85. BARRIER AND VEHICLE DAMAGE, TEST TTR-5

Barrier Damage: As shown in Figure 85, barrier damage consisted of two bent tubular thrie beam sections, two bent upper rail sections, two bent bridge posts, and one bent soil-mounted post. The remaining transition posts were pushed back in the soil, but were undamaged. In addition, some concrete failure around bridge Posts 1 and 2 was observed. Permanent barrier deflections are given in Table 16.

right front fender was torn off the vehicle and the area around the passenger service door was heavily damaged. The entire windshield was thrown out. Although sandbags and seat bottom cushions were thrown out of the seats and scattered throughout the bus no seat frame failures were noted. Vehicle damage is shown in Figure 85.

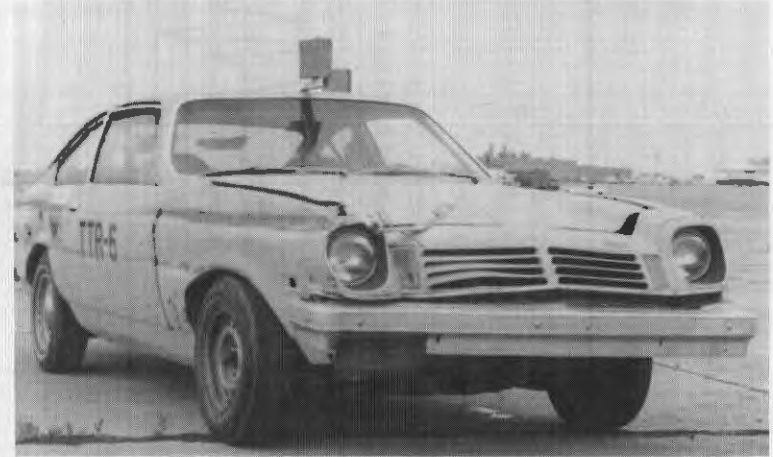
FIGURE 88. BARRIER AND VEHICLE DAMAGE, TEST TTR-6

Barrier Damage: As shown in the photographs of Figure 88, the barrier was undamaged except for lower rail scuffing by vehicle contact. The only repair performed was to paint over those scuff marks.

Vehicle Damage: Vehicle damage was limited to minor sheet metal deformation and scraping at the right front and along the right side. This is shown in Figure 88.

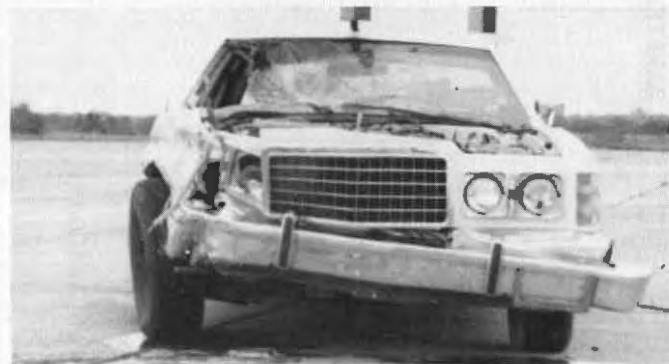
FIGURE 91. BARRIER AND VEHICLE DAMAGE, TEST TTR-7

Barrier Damage: Barrier damage, as shown in Figure 91, was limited to one bent tubular thrie beam rail section and one bent pivot bar. Although the vehicle hood contacted one post, the post was undamaged. Permanent deflections of the tubular thrie lower rail are given in Table 19.

Vehicle Damage: Substantial vehicle damage was incurred as shown in Figure 91. In addition to the sheet metal and bumper bending and crushing at the right front corner, the suspension of the right front wheel was damaged. As noted previously the vehicle hood, which was torn off during the impact, penetrated the windshield on the passenger side and inflicted considerable damage to the dashboard behind it.

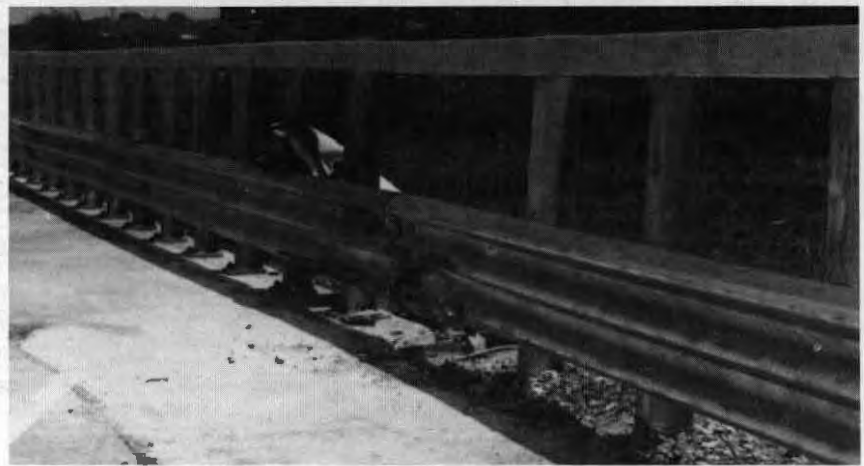
FIGURE 94. BARRIER AND VEHICLE DAMAGE, TEST TTR-8

Barrier Damage: As discussed previously the concrete around Post 1 failed and that post completely separated from the deck. In addition, two tubular thrie lower rail sections were bent and the two soil-mounted posts closest to the bridge deck rotated slightly rearward. Photographs of the barrier damage are shown in Figure 94 and barrier deflections are listed in Table 21.

Vehicle Damage: As shown in Figure 94, damage to the test vehicle was extremely heavy. In addition to the windshield penetration prior to the hood being torn off, the entire front section of the vehicle was damaged. This included the right front fender, grill, bumper, right front suspension and wheel, and right front door. Longitudinal force of the impact also caused the right "A" pillar to translate rearward and upward causing the roof to buckle.

<u>LOCATION - POST NO.</u>	<u>DEFLECTION (IN.)</u>	<u>REMARKS</u>
Transition	A Thru C	0	
	D	0.31	
Bridge Deck	E	1.06	
	1	1.38	Post Knocked Out - Concrete Failure
	2	0.63	
	3	0.31	
	4 and on	0

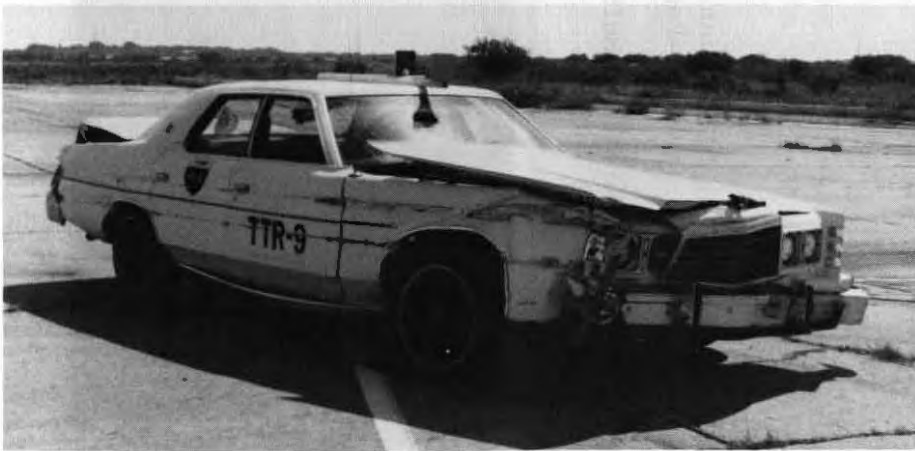
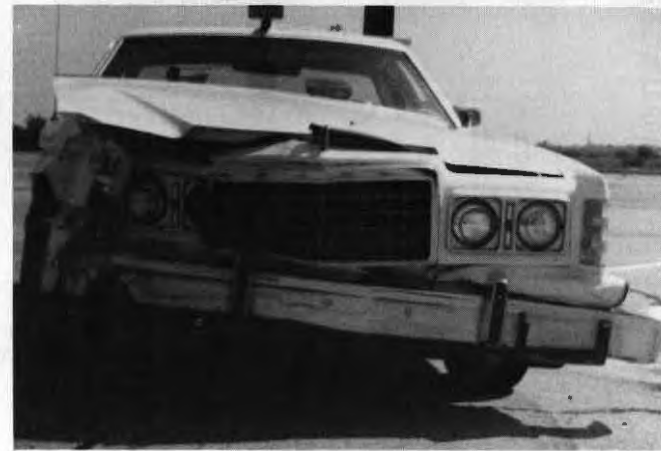
FIGURE 97. BARRIER AND VEHICLE DAMAGE, TEST TTR-9

Barrier Damage: Vehicle damage, also shown in Figure 97, was moderate. Sheet metal of the right front fender and headlight area was deformed and the front bumper displaced. Also, the hood was pushed rearward slightly and made contact with the windshield cracking it at the lower right corner. Table 23 summarizes permanent barrier deformation.

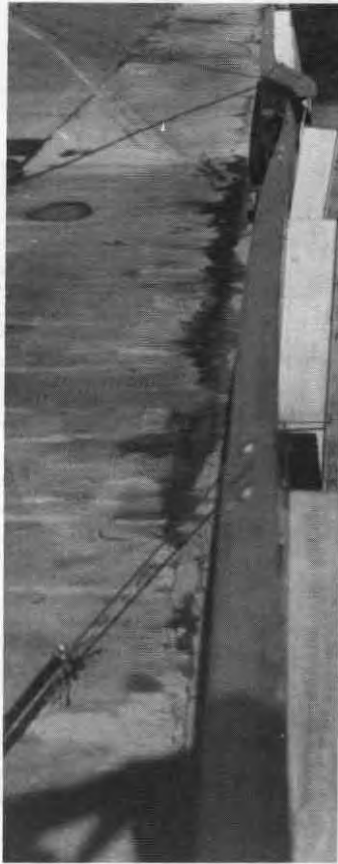
FIGURE 104. TTR-11 BARRIER DAMAGE

Installation Damage: One beam section was damaged and Posts 3 and 4 experienced anchor bolt pull-out. The curb was essentially undamaged although some gouging due to wheel contact was noted. Permanent beam and post deflection are summarized in Table 26. Figure 104 contains after test photographs of the test installation.

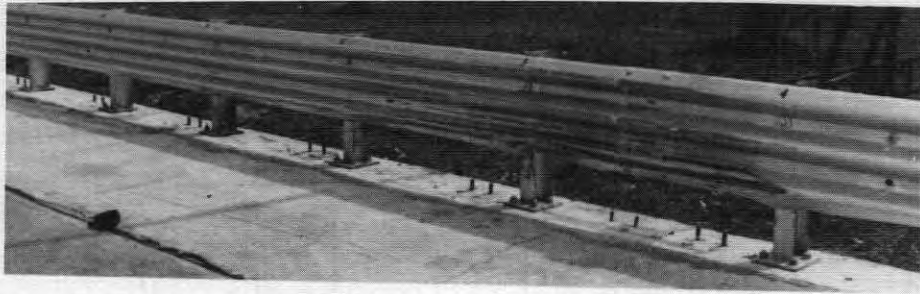
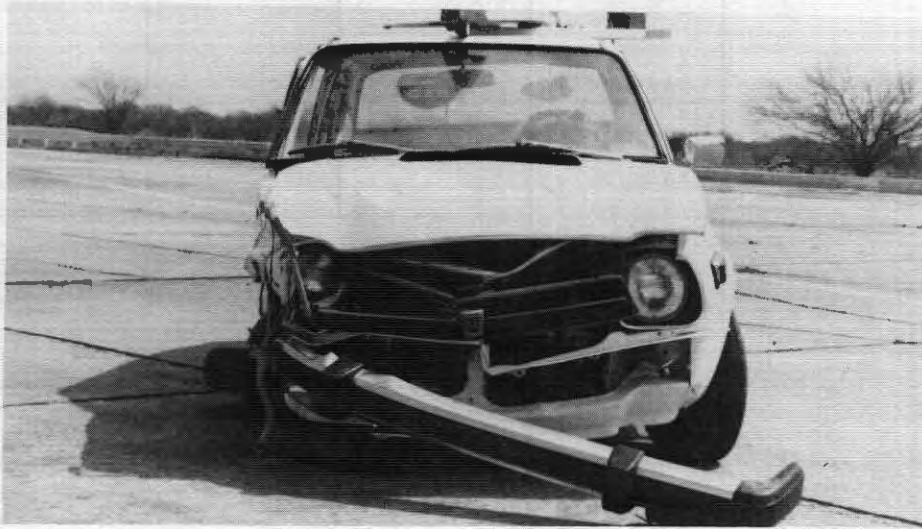
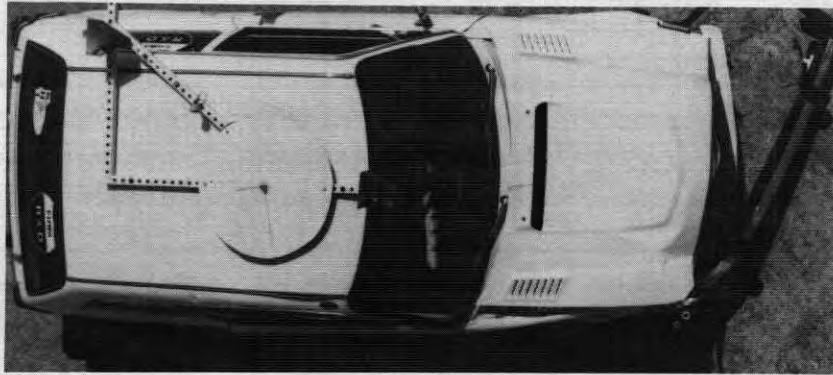
FIGURE 112. PHOTOGRAPHS AFTER TTR-14

Barrier Damage: As shown in Figure 112, one rail section was damaged and some local deformation of the post occurred.

Vehicle Damage: Damage to the vehicle front wheel and bumper was extensive as shown in Figure 112. There appears to be a difference in performance of the 5-mph bumper design incorporated into the Honda Civic in 1978 as compared to pre-1978 models.
