Sawmill Creek Road Transportation Corridor Assessment

AK NPS SITK 2015(2)

SAWMILL CREEK ROAD TRANSPORTATION CORRIDOR ASSESSMENT

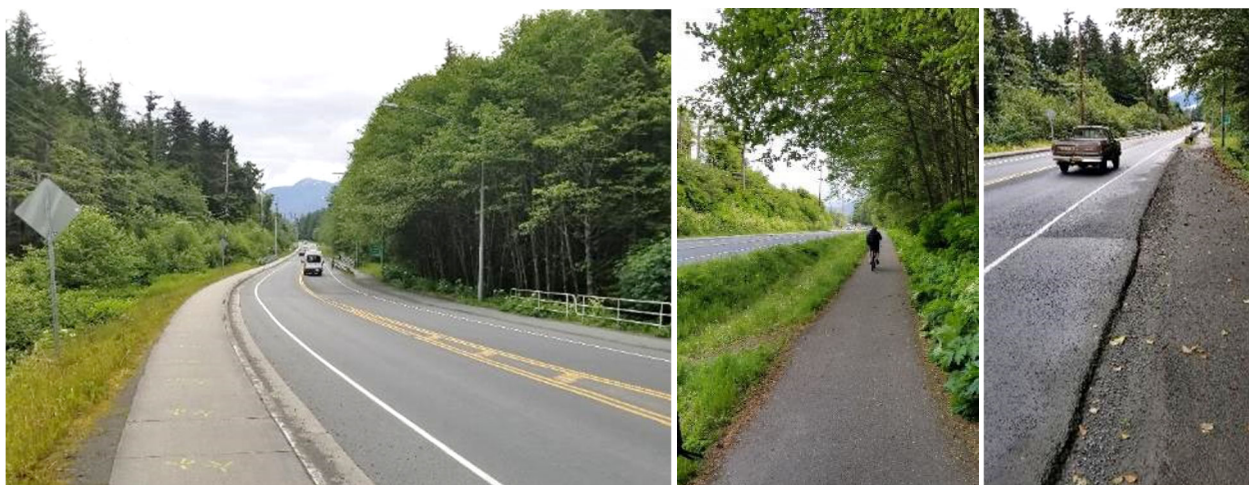
The section of road under evaluation extends from Indian River Road (MP 0.4) to just south of Jarvis Street (MP 0.95, including an area of mid-block pedestrian crossing near the convenience store), and consists of a two-lane roadway with left turn lanes at intersections. A 5' bike lane, curb and gutter, and a concrete sidewalk extend the length of the corridor on the westbound side of Sawmill Creek Road. On the eastbound side, there is a 5' bike lane, no curb, a ditch and a

Figure 4 - (L) Sawmill Creek Road looking South from Indian River Road. Figure 5 - (C) Multi-use path looking south. Figure 6 - (R) Multi-use path where it abuts the roadway.

separated variable width, but 6' typical, shared-use asphalt path. The shared-use path is detached from the roadway, except where it crosses Indian River (Figure 42).

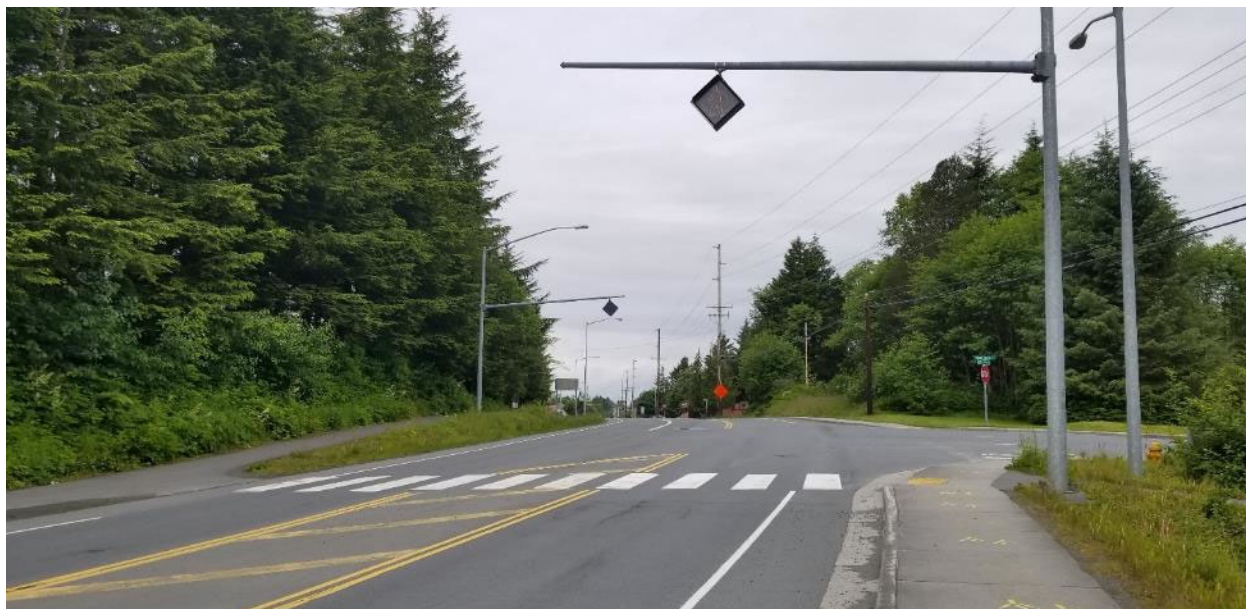
The project team identified an additional conflict point, and extended the study corridor to include in this evaluation. The marked crossing at Indian River Road is equipped with an overhead pedestrian crossing pendent light. The light is activated at all times, and hangs above the crossing. The striping in this location is of the high-visibility continental style. This crossing appears to be ADA accessible, and provides a connection to the multi-use trail and the sidewalk on either side of Sawmill Creek Road. The crossing is near the apex of a horizontal curve.

Figure 7 - A lighted sign hangs above a crosswalk at the intersection of Indian River Road and Sawmill Creek Road.

Westbound Observations closer to intersection:	<ul style="list-style-type: none"> - Overhead pedestrian warning light is ineffective. The sign is lit at all times, but is difficult to see during the daytime, and is quite small; - "HEADLIGHTS ON" with supplemental sign was visible and was visibly in good condition. - Center line pavement marking were somewhat worn.
Improvement Options:	<ul style="list-style-type: none"> - Upgrade overhead pedestrian warning traffic control device; <ul style="list-style-type: none"> o Pedestrian hybrid beacon; o Rectangular rapid flashing beacon; o Pedestrian activated signal. o <i>December, 2021 Update – pedestrian warning signs, with push-button activated LED border lights, and down arrows were added for the crosswalk to replace the overhead signs.</i> - Repaint pavement markings <ul style="list-style-type: none"> o <i>December, 2021 Update – pavement markings were reinstalled.</i>

<ul style="list-style-type: none"> ○ <i>December, 2021 Update – pedestrian warning signs, with push-button activated LED border lights, and down arrows were added for the crosswalk to replace the overhead signs.</i> - Replace fading “NO STUDDED TIRES” sign; <ul style="list-style-type: none"> ○ <i>December, 2021 Update – sign was replaced.</i> - Perform basic maintenance along the path to better delineate the path.
Crosswalk Observations:	<ul style="list-style-type: none"> - Crosswalk is highly visible and centerline markings are visible even when pavement is wet; - Appear to be drainage issues where crosswalk ties into shared use path; - Not able to visibly determine if overhead lighting is operational.
Improvement Options:	<ul style="list-style-type: none"> - For ADA compliance, install a clear separation between crosswalk and shared use path; <ul style="list-style-type: none"> ○ <i>December, 2021 Update – ADA crossing added on each side of crosswalk.</i> - Address the drainage issue along path to prevent pooling water. <ul style="list-style-type: none"> ○ <i>December, 2021 Update – may have addressed some drainage issues with new ADA ramp.</i>

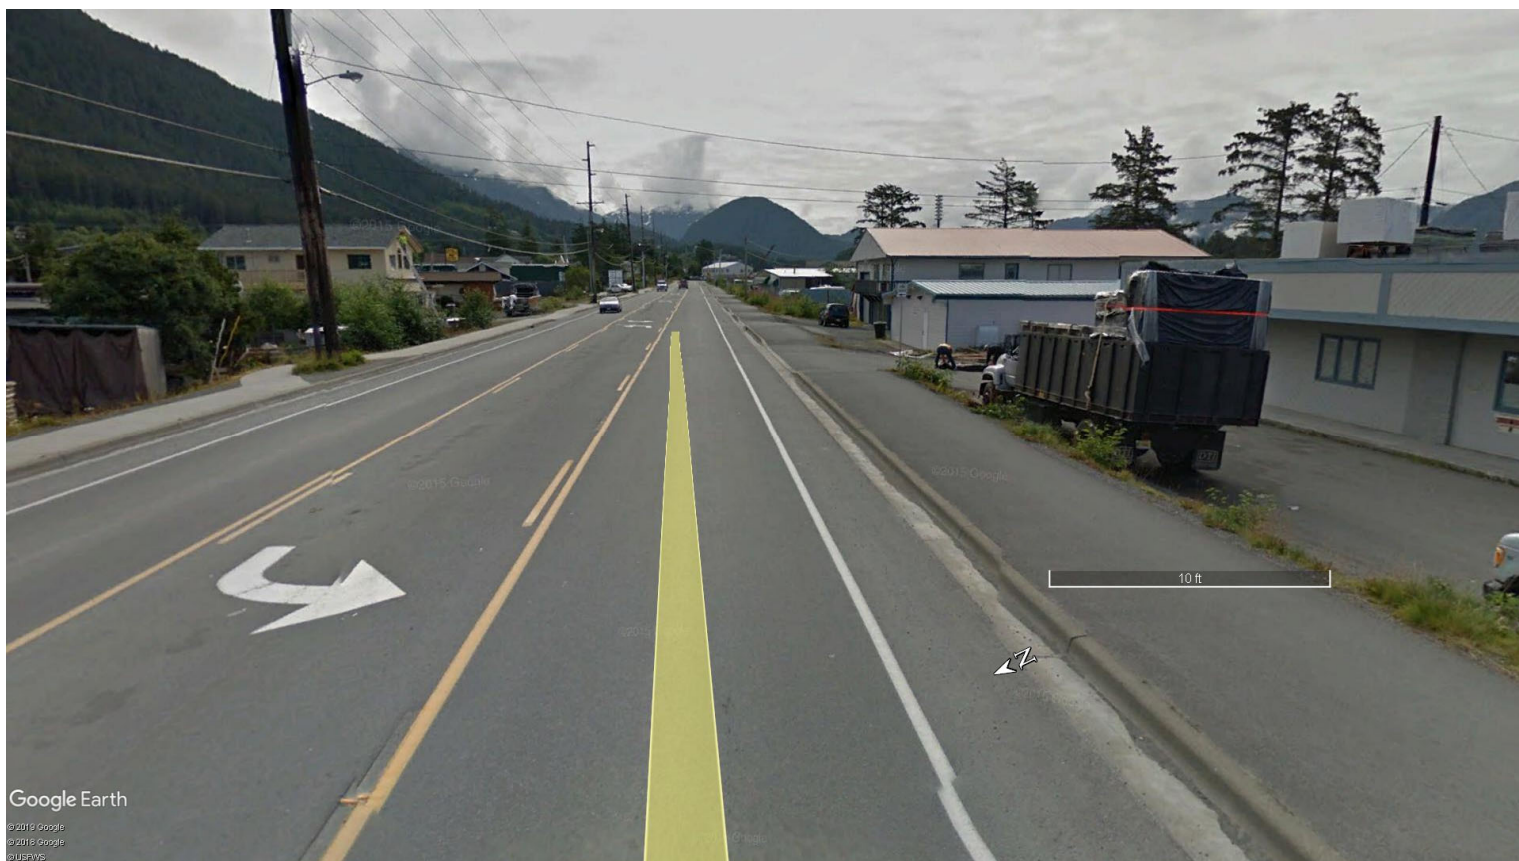
In the long term, if it is desired to make the shared-use path width consistent and wide enough for true sharing (at least 10' wide per AASHTO guidance), then the trail could be reconstructed to also alleviate pavement unevenness and some drainage issues. It appears that the shared-use path east of the study area is approximately 10' wide.

Figure 38 - Existing Shared-Use Path Along SMC Road East of Study Area, Approx. 10' Wide

Curb and gutter can be added to better separate and delineate motorist traffic from the path when the path needs to be close to SMC Road. The gutter could be added to the existing edge of pavement so that the bike lane/shoulders can remain without alteration for additional width due to a gutter and curb adjacent to the lane. Storm sewer can be installed to control drainage. Improving drainage can help with the shared-used path maintenance and ponding concerns found in several observations in the corridor. The trail could be reconstructed slightly higher to improve drainage concerns as well. Eliminating the ditch may fit in better with the surrounding urban corridor, however, some significant costs could likely be saved by using biofiltration and other stormwater techniques to drain runoff to the existing ditches.
