FINAL REPORT (Project BDV25-977-69)

**Identification of the Mechanisms that Produce Hydrogen Embrittlement on
Post-Tensioning Members and the Effects of Galvanic Coupling on Bridge
Tendons**

Final Report to Florida Department of Transportation

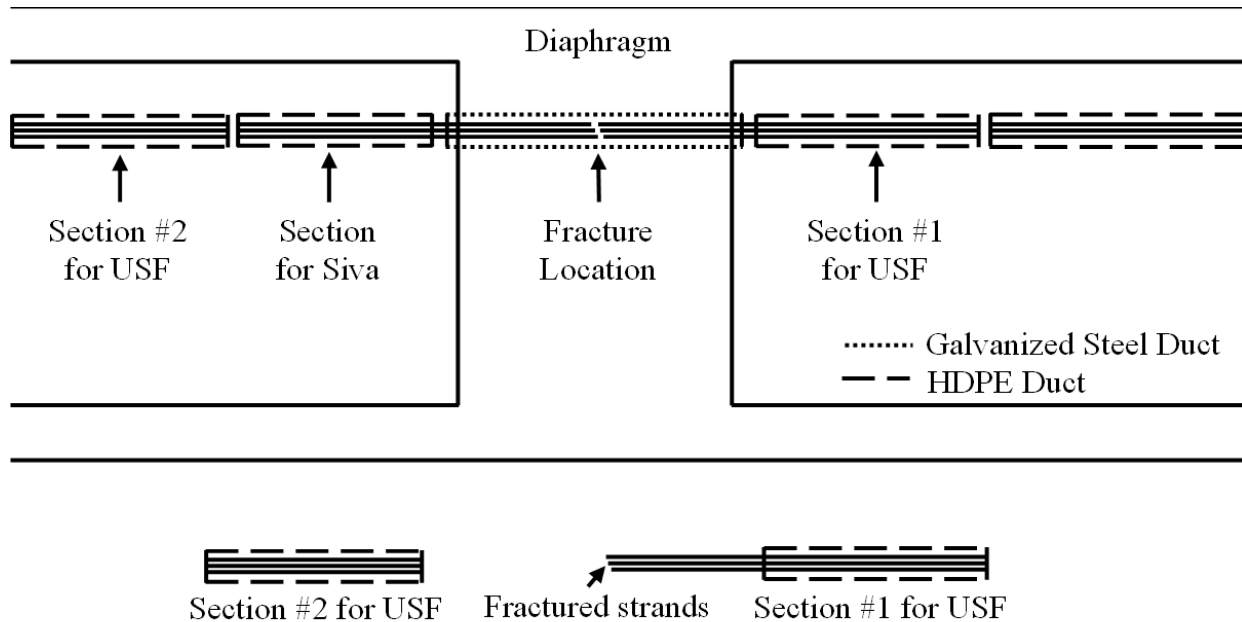
Figure 3-1. Failed tendon cut scheme.

Two sections of the failed tendon were obtained from the South Carolina DOT according to the diagram presented in Figure 3-1. One of the sections included one end of the failed or broken strands that were contained within the galvanized duct of the pier diaphragm and the other section was taken from the external portion of the tendon. The focus of this report is the analysis of the failed section.

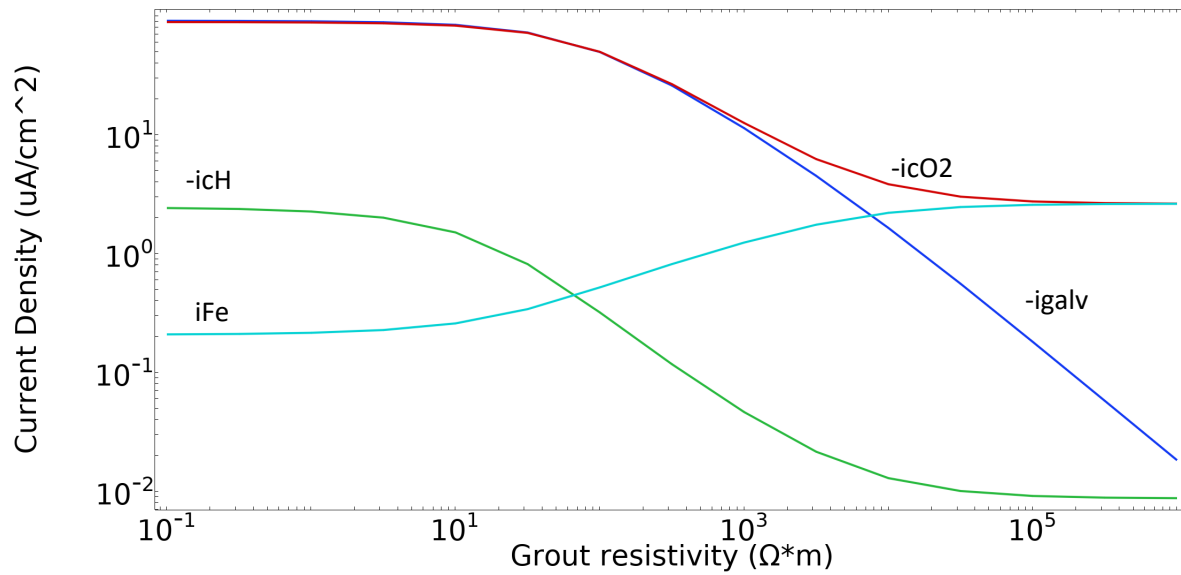
The simulated results are shown in Figure 4-16 for the idealized tendon geometry shown in Figure 4-13 in which 20 strands are distributed within a 3-inch-diameter duct. The higher number of strands causes distribution of the total galvanic current over the entire steel strand surface resulting in a lower current density but the proximity of the strands to the duct will increase the galvanic coupling. For the typical tendon geometry at the lowest simulated grout resistivity, a maximum hydrogen evolution current density of $\sim 2.5 \mu\text{A}/\text{cm}^2$ was calculated which is almost a third of the amount calculated for the single wire geometry. Therefore, the experiments performed for the single wire geometry would result in more galvanic coupling than an actual tendon with multiple strands.

Figure 4-16 Current density as a function of grout resistivity for the total galvanic current density and its anodic and cathodic components for an idealized tendon geometry.

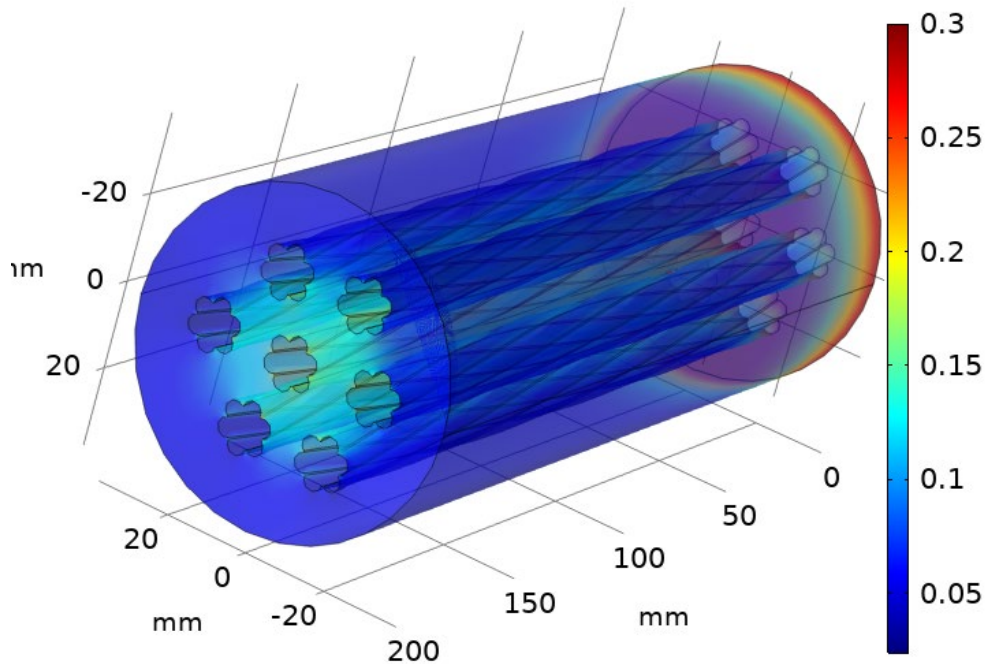
The amount of hydrogen absorbed for the tests performed in this work are due to the early effects of hydration of the grout and may not reflect long term exposure conditions. One potential concern is that oxygen within the tendon could be depleted resulting in a more negative potential applied to the steel that would promote hydrogen evolution. While the interstices of the steel strands may provide a readily available oxygen reserve, this would need to be confirmed with testing. Results are presented in Figure 7-1 of preliminary simulations aimed at assessing the possibility of oxygen depletion considering the availability of oxygen within the interstitial space of the steel strands. While the assumed availability of oxygen through the wires of the strands prevents complete oxygen depletion there is still enough oxygen depletion to cause of reduction in steel potential and therefore an increase in the rate of hydrogen evolution. These results are preliminary and while based on the kinetic data obtained in this work, further experiments are required to understand the diffusivity of oxygen in grout considering the different conditions and the ability of oxygen to pass through the interstitials of the strands.

Figure 7-1 Distribution of steady state oxygen concentration considering oxygen flux through the interstitial space of the stands. Dark blue represents a concentration of zero while dark red represents oxygen saturation.
