Summary of Case Studies and Observations on Airport Experience with Pavement Surface Treatments

August 2023

DOT/FAA/TC-TN23/49

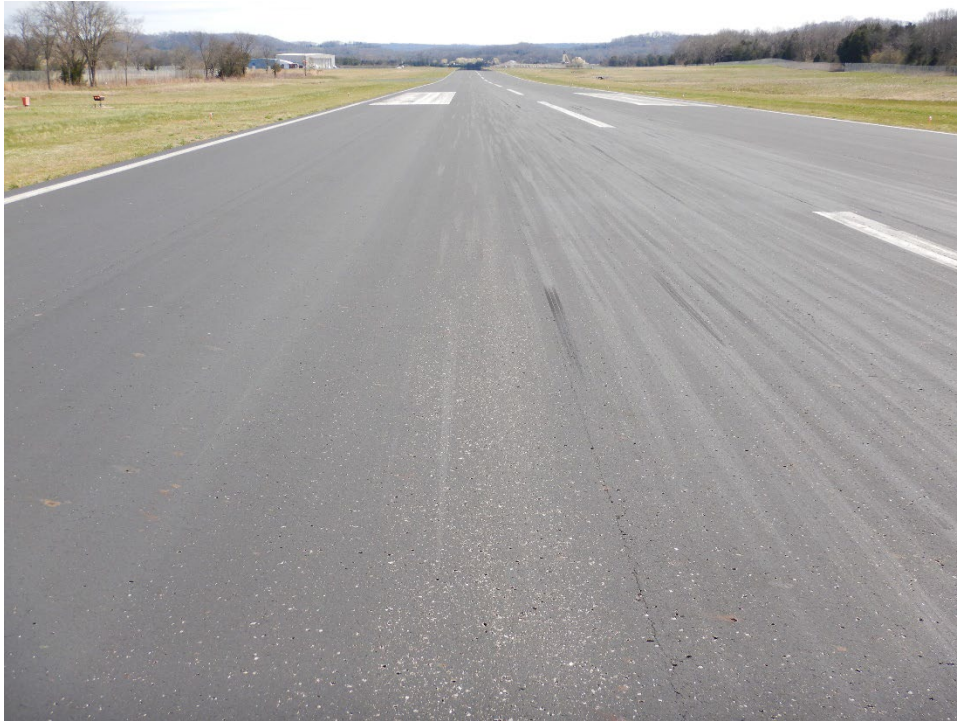
Figure 2. Tire Wear Pattern on GZS Runway

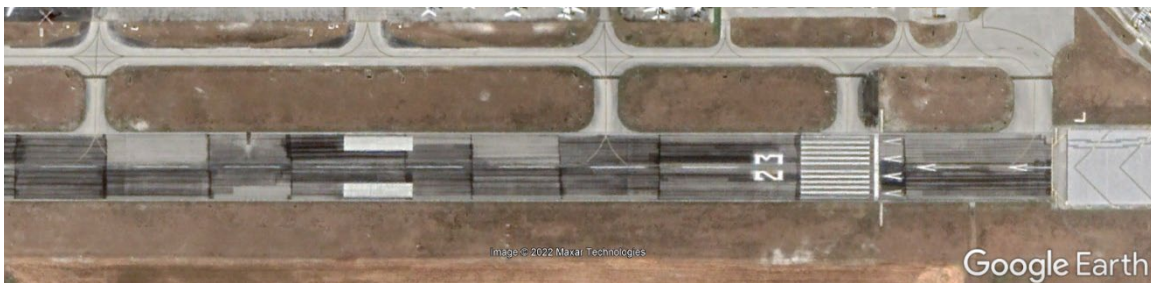
In 2022, the pavement markings began to peel off under low pressure during a cleaning attempt made at the airport. This is possibly because the markings were applied before the P-608-R was fully cured. BCT restriped the runway shortly after the cleaning attempt. Overall, BCT views the P-608-R as meeting its intended objective by extending the pavement life; however, they were displeased with the coverage pattern, longevity of the treatment, and long-term performance of the paint markings on the P-608-R.

Figure 3. Checkerboard Appearance of P-608-R on BCT Runway 05/23 Approximately 28 Months After Application

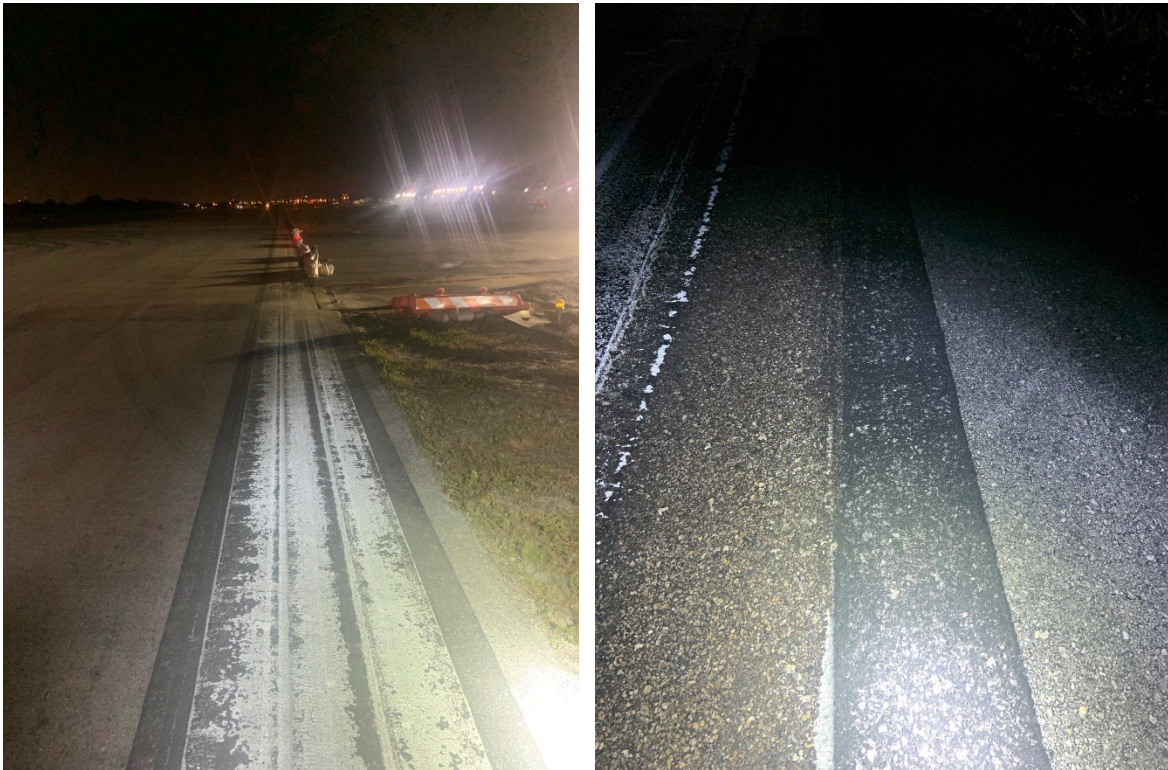
After application, it was reported that the surface treatment met its intended purpose of improving pavement conditions. However, the final finished runway surface P-608-R had a checkered pattern due to the construction sequence, seen in figure BCT-2. Friction tests were done before and after application, and they showed improved friction characteristics on the runway. Visibility was initially improved but premature failure was observed in June 2022. The markings began to peel off the pavement under low pressure washing during a cleaning attempt made by the airport. It is suspected that this may have occurred due to the markings being applied prior to the full curing of the P-608-R. BCT restriped the runway shortly after the cleaning attempt. Pictures of failed pavement markings are presented in figure BCT-3.

Figure BCT-3. Runway 05/23 Peeling Pavement Marking

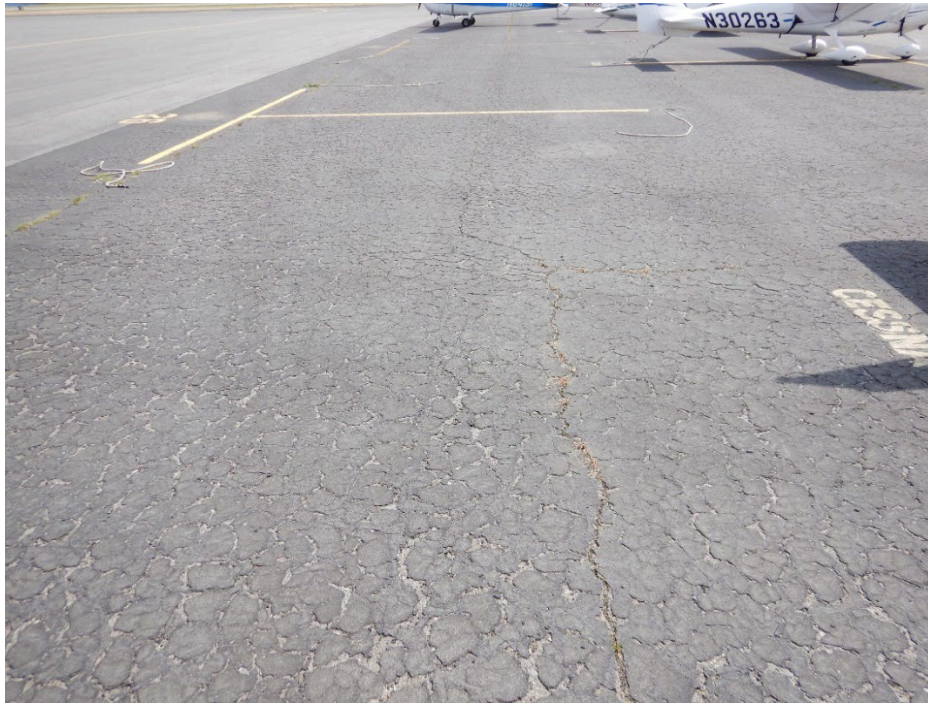
Severe chipping/raveling of the surface treatment was observed on the aprons, which can lead to FOD production. L&T and block cracking with some vegetation were also common on the apron. There was also raveling of the pavement surface where the surface treatment was worn away and the underlying pavement was exposed. Shrinkage of the surface treatment over time resulted in map cracking, which can cause tension on the asphalt concrete pavement surface and may eventually lead to the development of additional L&T cracking. Based on condition and age, the

surface treatment is at the end of its service life. Pictures of the apron condition with the coal tar treatment during visual inspection are presented in figures EQY-1 through EQY-4.

Figure EQY-1. Apron Overview with Coal Tar Slurry

Figure EQY-2. Apron Area Overview with Coal Tar Slurry

Figure EQY-3. Coal Tar Slurry Texture

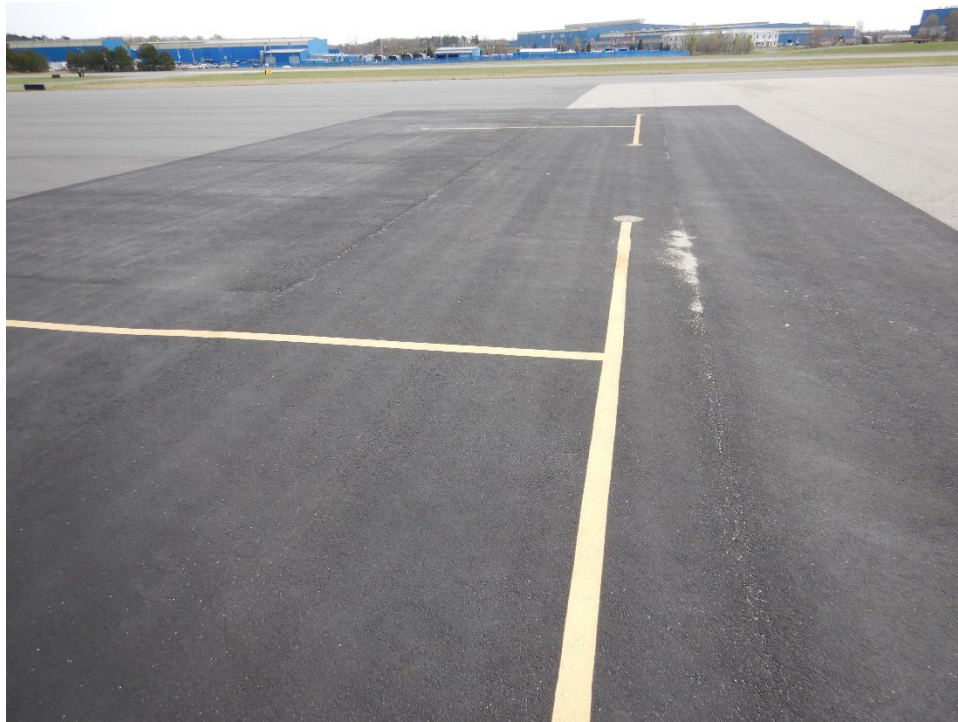
A visual inspection of the condition of the surface treatment was performed in March 2022. Observations at the time of inspection showed that fine and coarse aggregates on the aprons were not exposed and the coverage of P-631 was very good. The uniformity of P-631 was also good. Pavement markings on the P-631 were performing very well with good visual delineation. Minor tire marks were visible on the pavement, although they may not be an imprint on the pavement. Some minor segregation was observed in areas where the underlying asphalt texture was visible. No distresses were observed on the aprons. While there were some oil spills present, they were not significant enough to damage the treatment or the pavement. Overall, the P-631 surface treatment is performing as intended on the aprons. The estimated remaining service life of the treatment appeared to be 3 to 5 years. Photographs of the P-631 on the apron are presented in figures EQY-5 through EQY-8.

Figure EQY-5. Apron Overview with P-631

Figure EQY-6. P-631 Texture on Apron

Figure EQY-7. Apron with (Left) and Without (Right) P-631

Figure EQY-8. Tire Marks on P-631

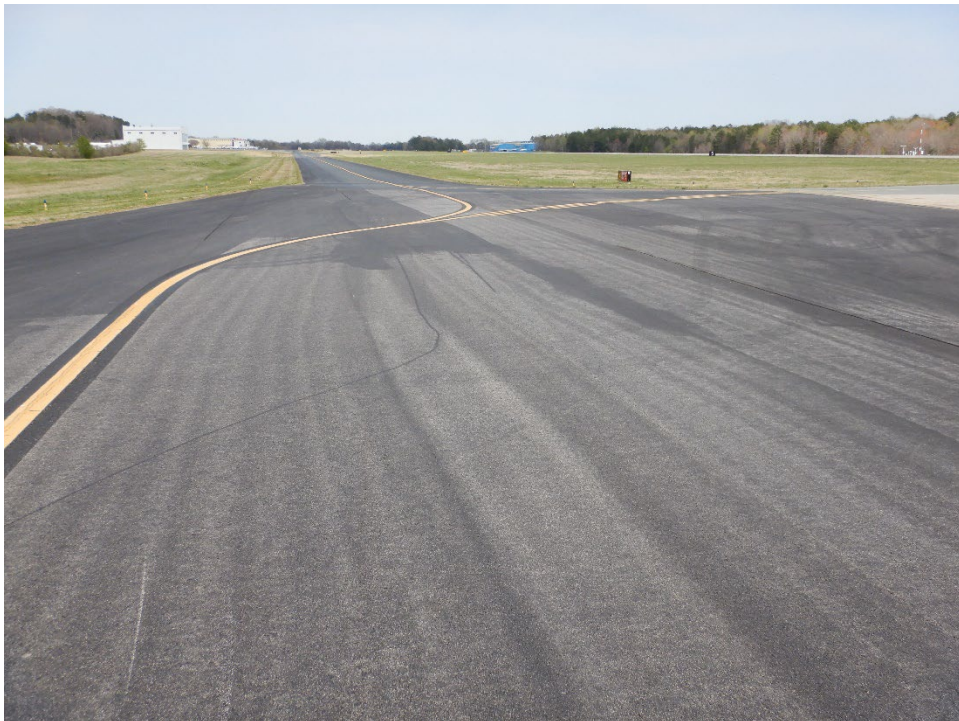
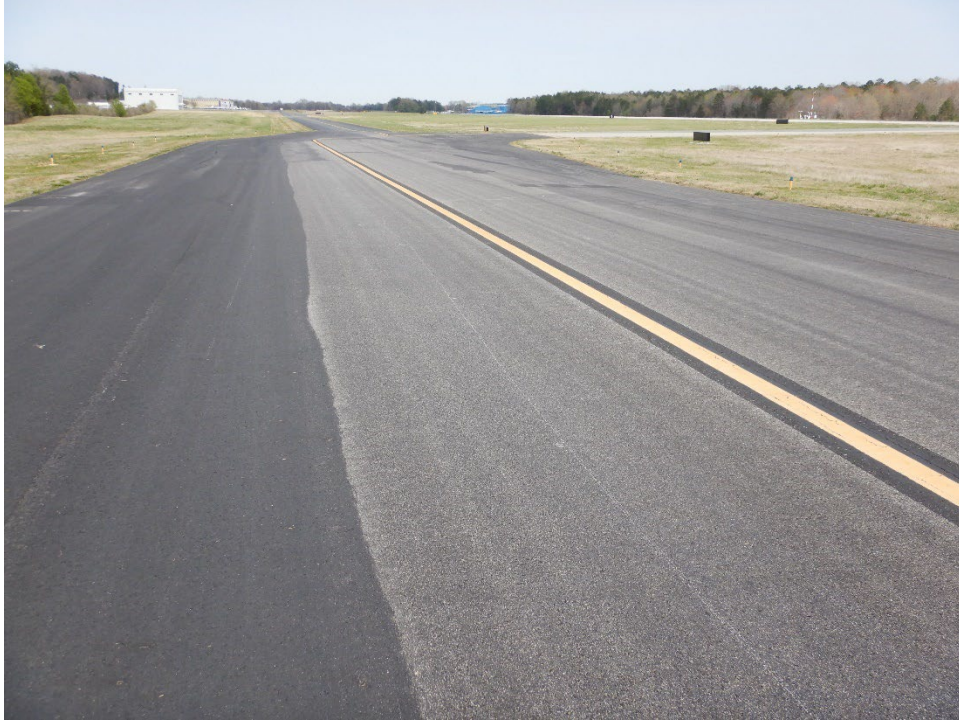
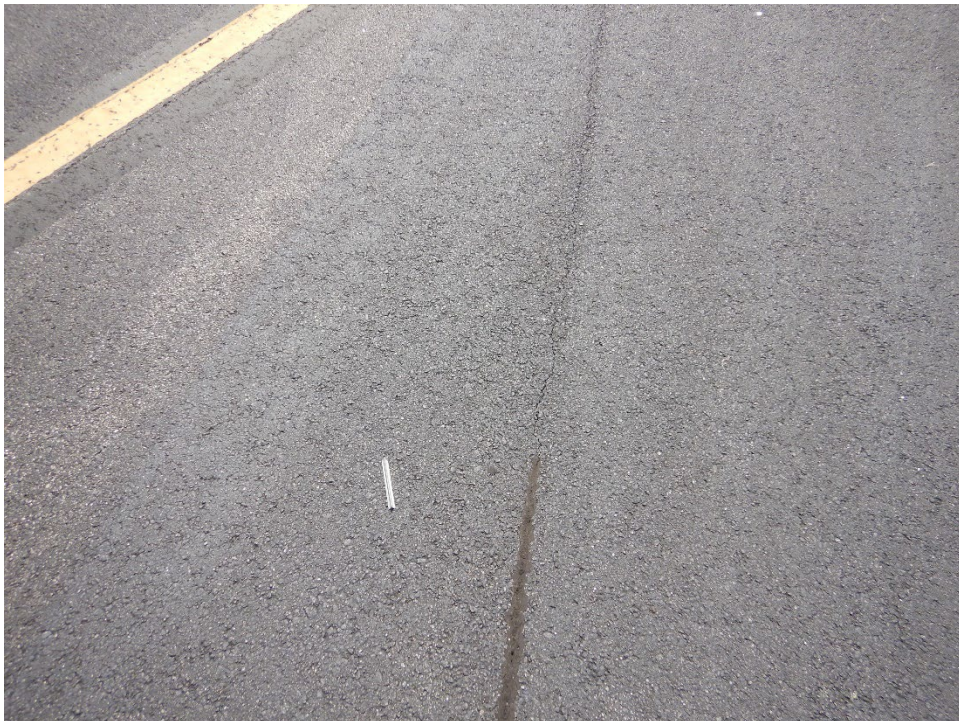
Minor weathering may be present throughout the taxiway pavements where the coverage was lighter. Weathering was not recorded in the previous PCI inspection, which would have impacted the PCI. While the binder still retained a dark appearance from the rejuvenator penetrating the surface, there was a minor loss of fines (low-severity weathering). In high age group taxiways, medium-severity weathering was noted in areas of light P-632 coverage the weathering, which would further impact the PCI. Additionally, some secondary cracking along the longitudinal paving joints had developed on the parallel taxiway. There were a few depressions present and some of these depressions showed fatigue cracking. Fatigue cracking was also starting to develop in some of the wheel paths of Taxiway A.

For the medium age group, the estimated remaining service life of P-632 may be 1 year where coverage is less and 3 years where coverage is adequate. For the high age group, the estimated remaining service life of P-632 is 2-3 years. Pictures of the condition of the P-632 condition are presented in figures EQY-9 through EQY-15 (medium age group) and figures EQY-16 through EQY-23 (high age group).

Figure EQY-9. Medium Age Taxiway Overview with P-632

Figure EQY-10. Surface Texture of P-632 on Medium Age Taxiway

Figure EQY-11. Overview of P-632 Coverage on Medium Age Taxiway

Figure EQY-12. Overview of P-632 Coverage on Medium Age Taxiway

Figure EQY-13. Medium Age Taxiway Without (Left) and With (Right) P-632

Figure EQY-15. Longitudinal Paving Joint on Medium Age Taxiway

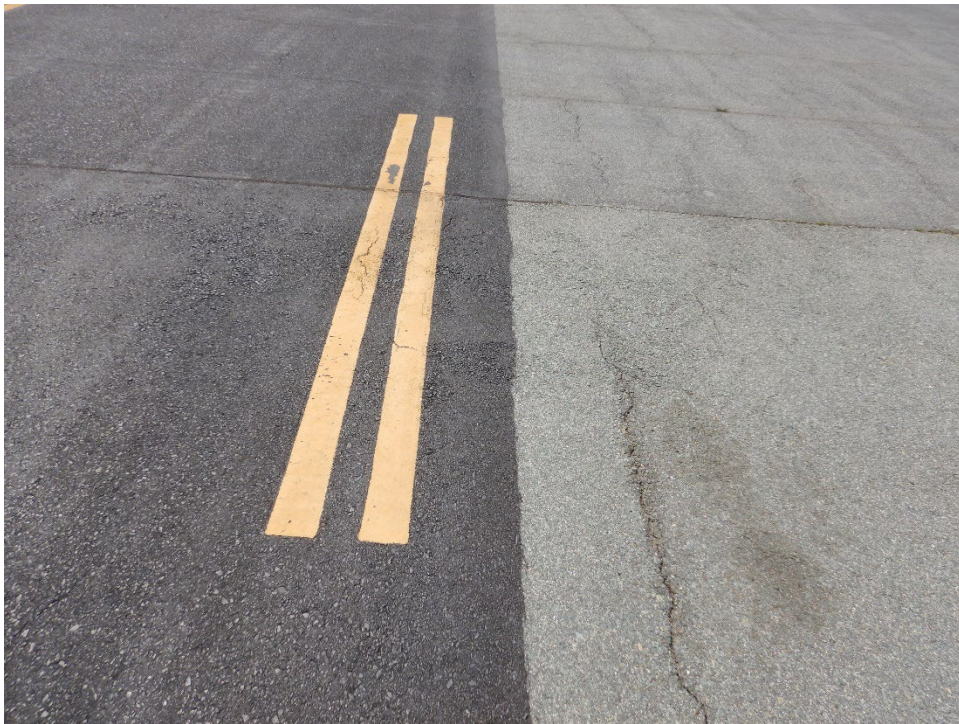
Figure EQY-16. Overview of High Age Taxiway With P-632

Figure EQY-17. Overview of High Age Taxiway With P-632

Figure EQY-18. P-632 Surface Texture on High Age Taxiway

Figure EQY-19. Overview of Edge of P-632 Application on High Age Taxiway

Figure EQY-20. P-632 Coverage on High Age Taxiway

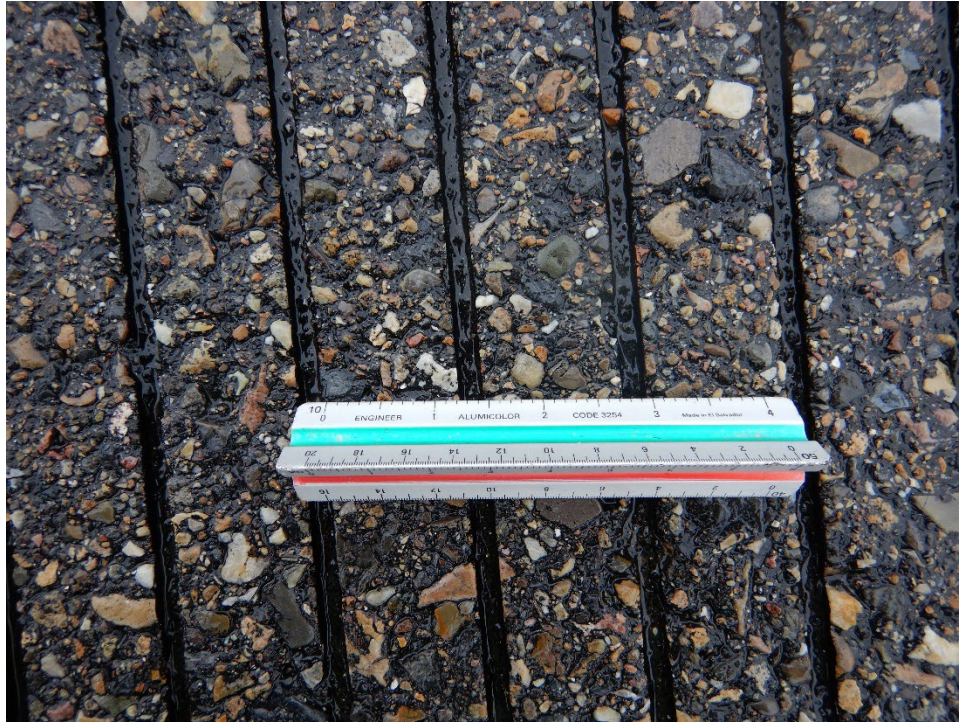
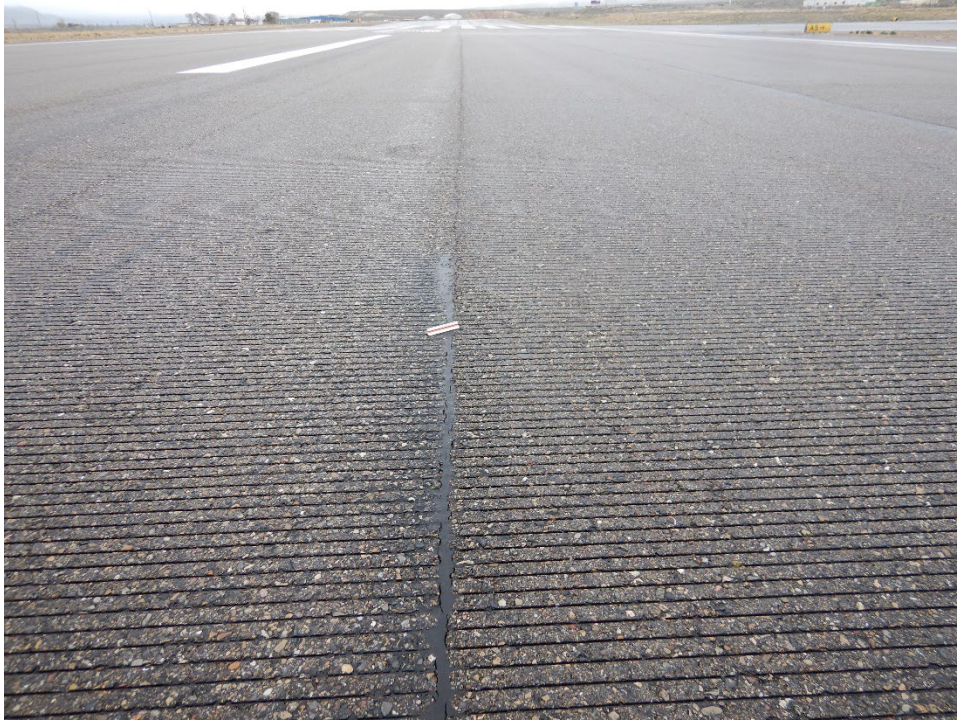
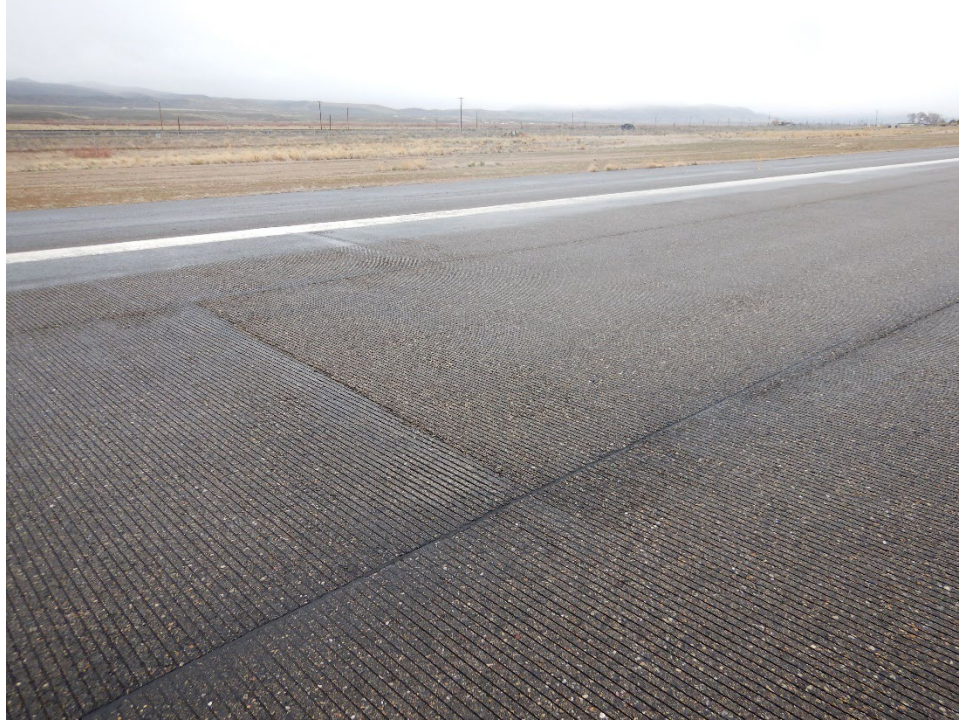
At the current condition, the P-608 surface treatment on Runway 06/24 has no remaining service life. The P-608 material visible within the runway grooves does not help to preserve the pavement. The city commented that the rapid fading of P-608 may have been accelerated by snow removal operations. Figures EKO-1 through EKO-7 showcase the condition of the runway.

Figure EKO-1. EKO Runway 06/24 Overview

Figure EKO-2. EKO Runway 06/24 Texture

Figure EKO-3. P-608 Condition Between and Within Runway 06/24 Grooves

Figure EKO-5. Sealed Longitudinal Paving Joint on Runway 06/24

Figure EKO-7. Transverse Construction Joint on Runway 06/24

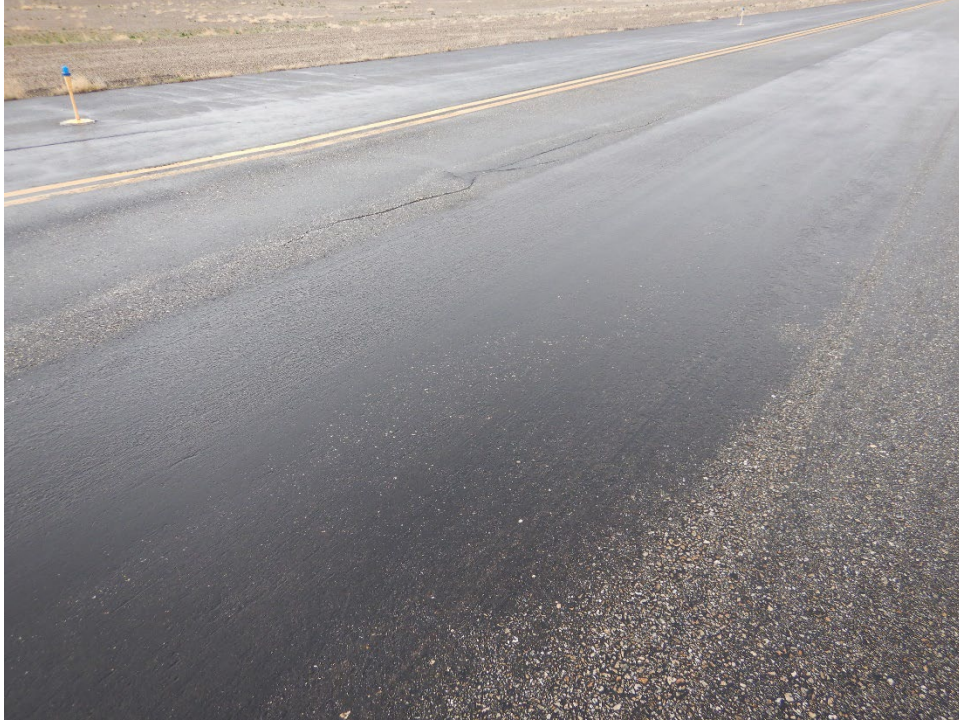
Figure EKO-10. Thicker P-608 Application on Taxiway A

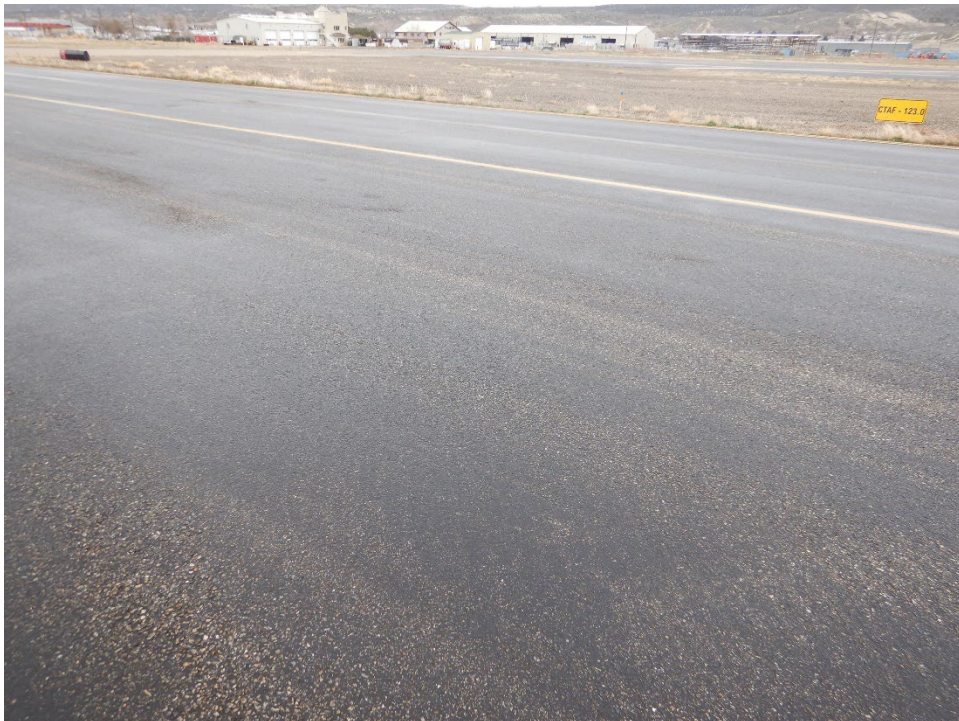
Figure EKO-19. P-608 Streaking on Apron

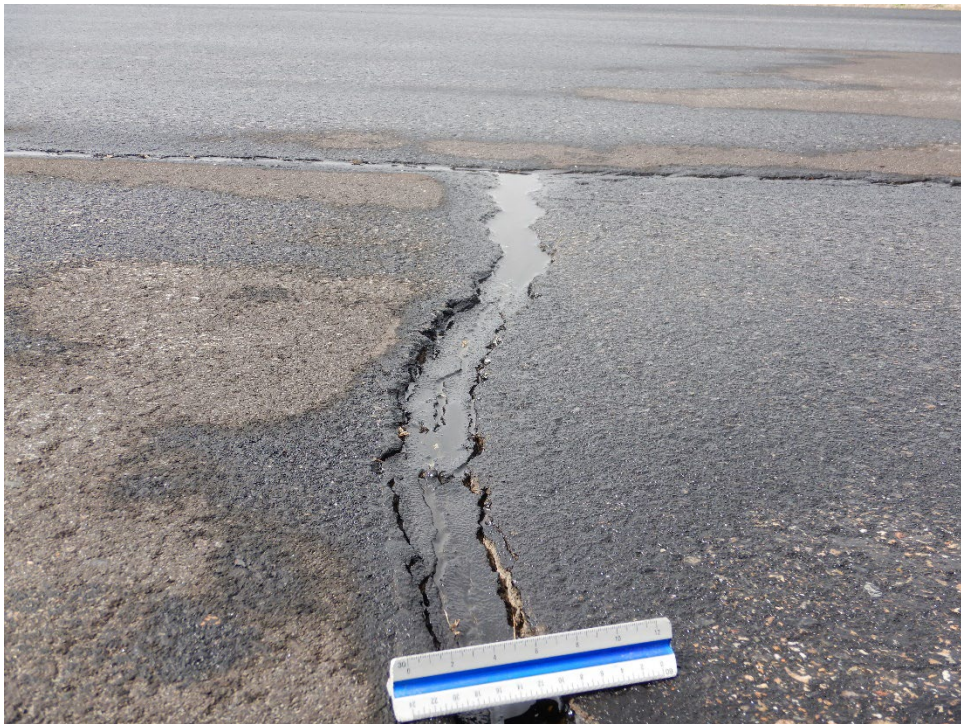
Fading was the major deterioration mechanism observed during the inspection. It may have happened due to snow removal operations. No flaking or chipping was observed that may raise concerns for FOD production. Some locations had wide L&T cracking, which was approaching block cracking density. Isolated alligator cracking had continued to develop. The crack sealant applied in 2020 had started to fail and was letting water enter the pavement. Minor concerns of FOD production were present at the time of inspection due to fragmented alligator cracking. Since the 2018 PCI inspection, the pavement condition had deteriorated approximately 10 PCI points with the continued development of alligator cracking and failing crack sealant.

Figure EKO-23. Crack Sealant Condition on Runway 12/30

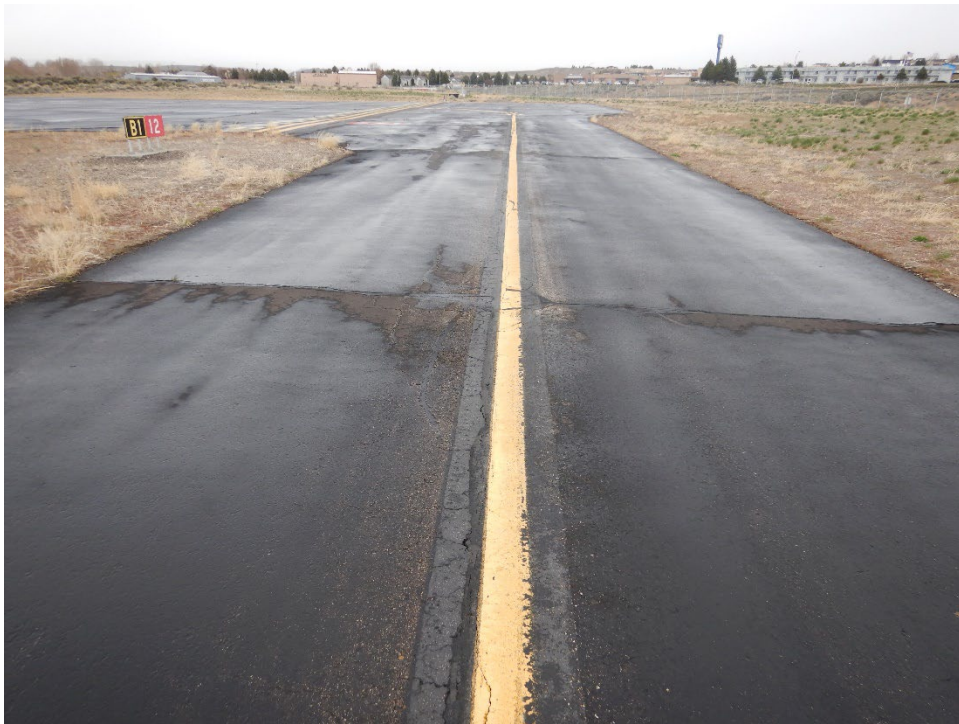
Figure EKO-27. Taxiway B Overview

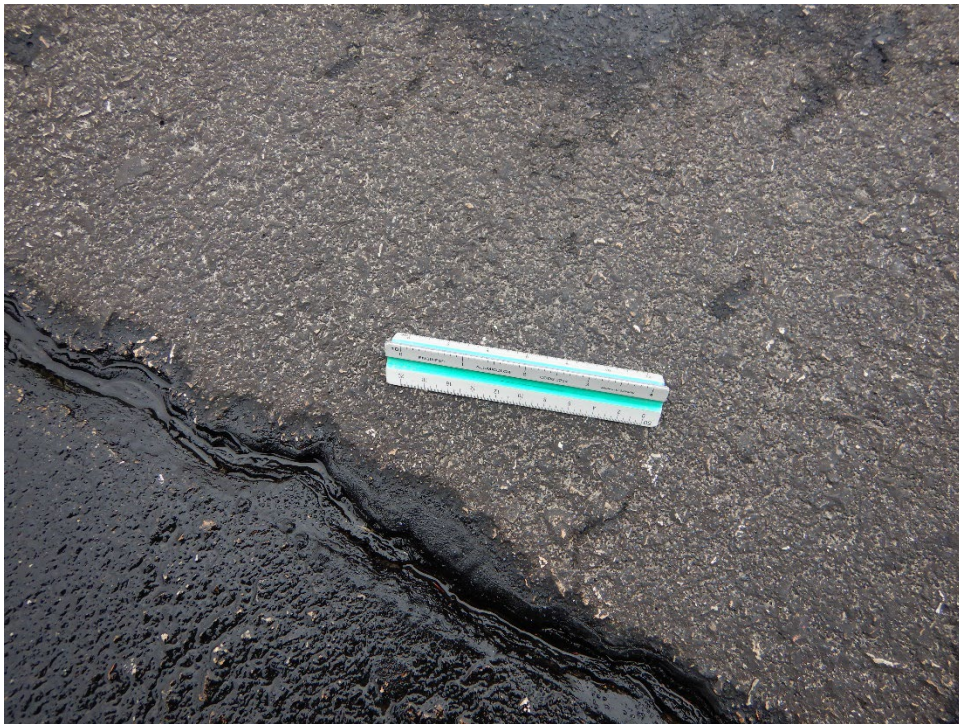
Figure EKO-31. Crack Sealant Condition on Taxiway B

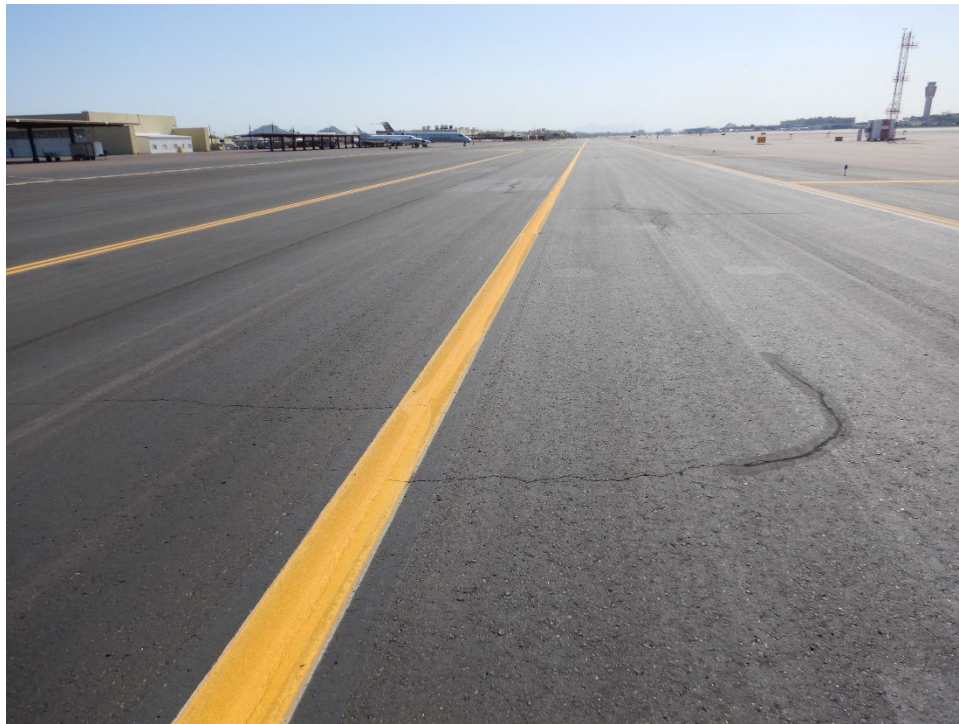
Some light wearing patterns were observed along the centerline of Taxiway A, while no wearing was observed on the apron areas. Fading was the major deterioration mechanism across all pavements. FOD production was not a concern, as no flaking or chipping was observed for the acrylic coat. In 2022, PHX reapplied pavement markings on these pavements, so the visual delineation of the markings was very good.

Figure PHX-5. Overview of Taxiway A With Acrylic Coat (East Facing)

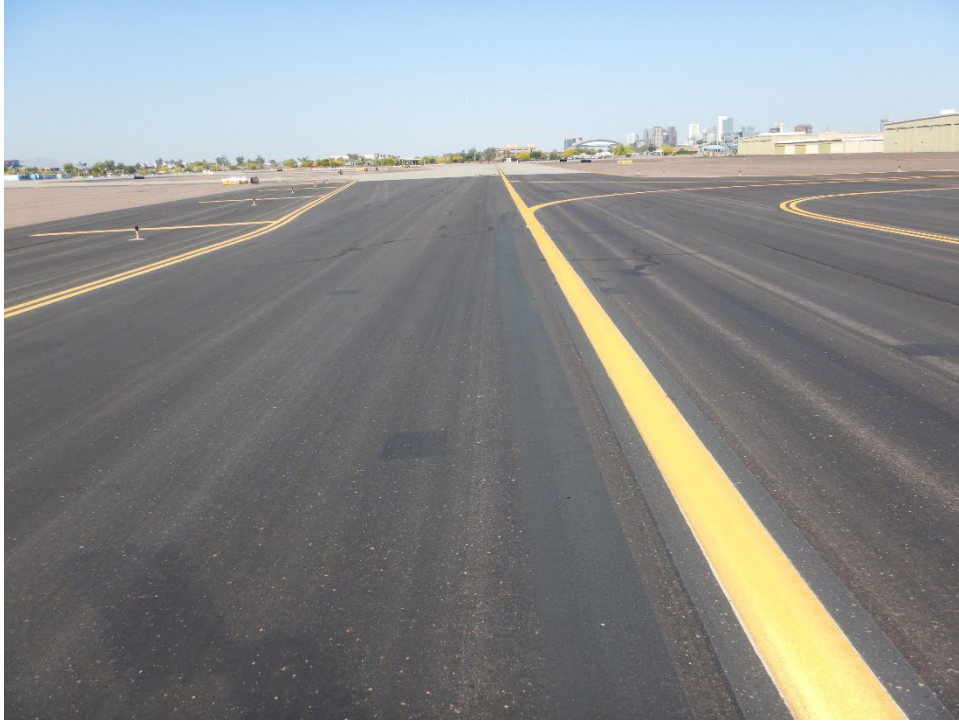
Figure PHX-6. Overview of Taxiway A With Acrylic Coat (West Facing)

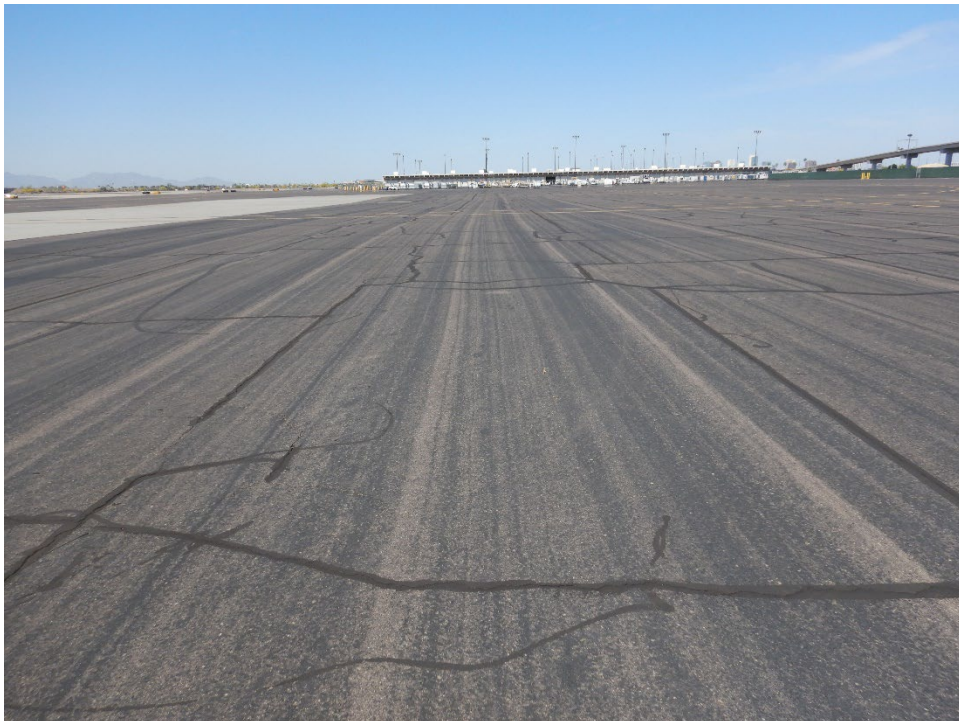
Figure PHX-9. East Cargo Apron Overview With Acrylic Coat

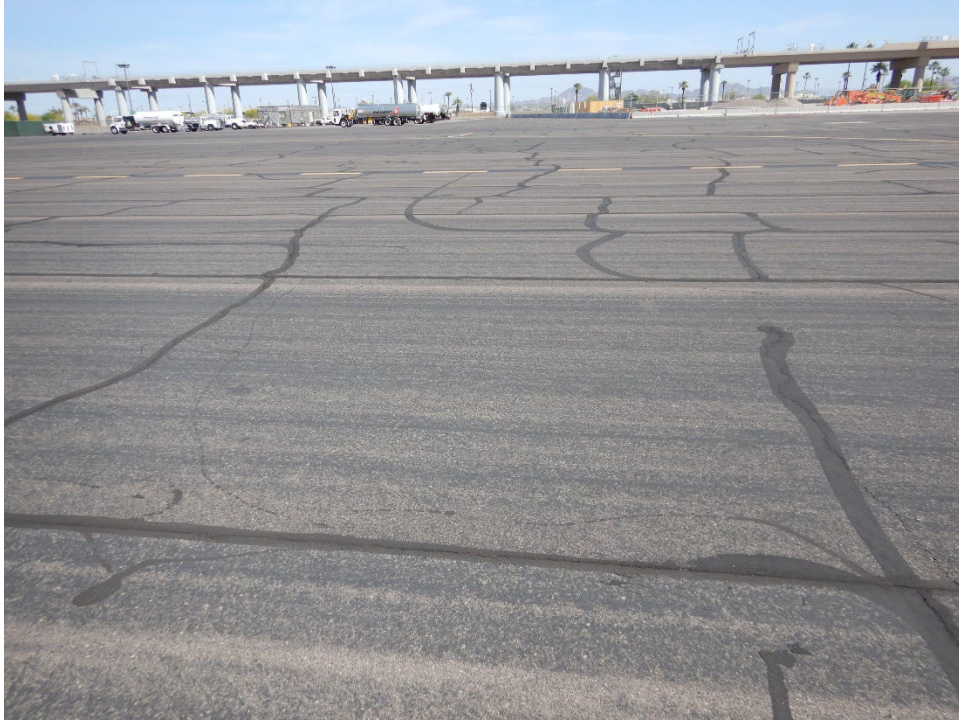
Figure PHX-10. East Cargo Apron Overview With Acrylic Coat

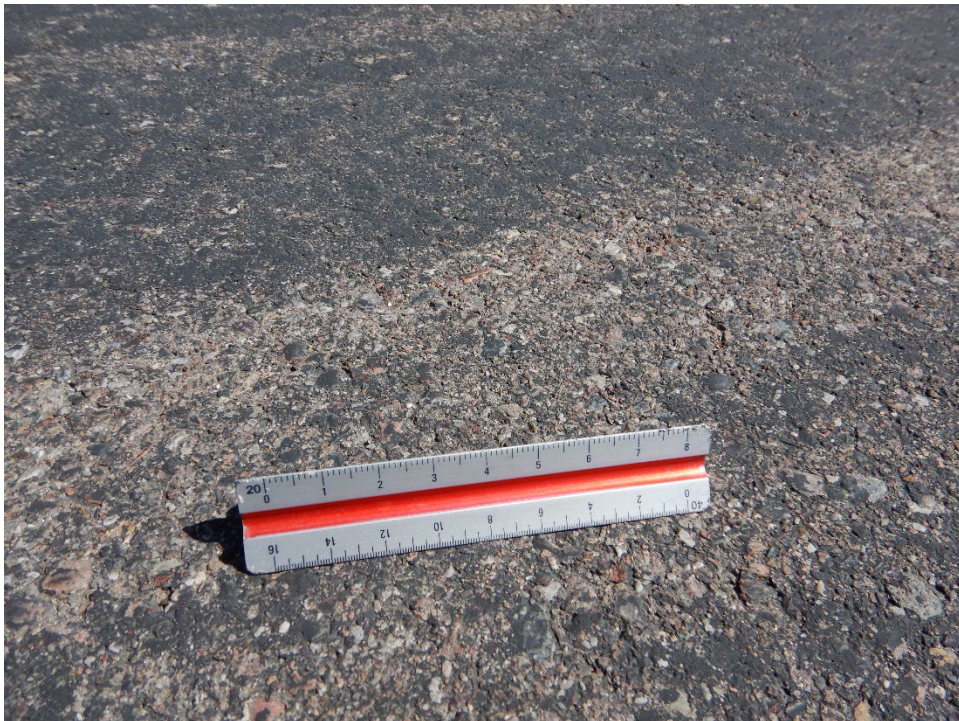
Figure PHX-11. East Cargo Apron Texture

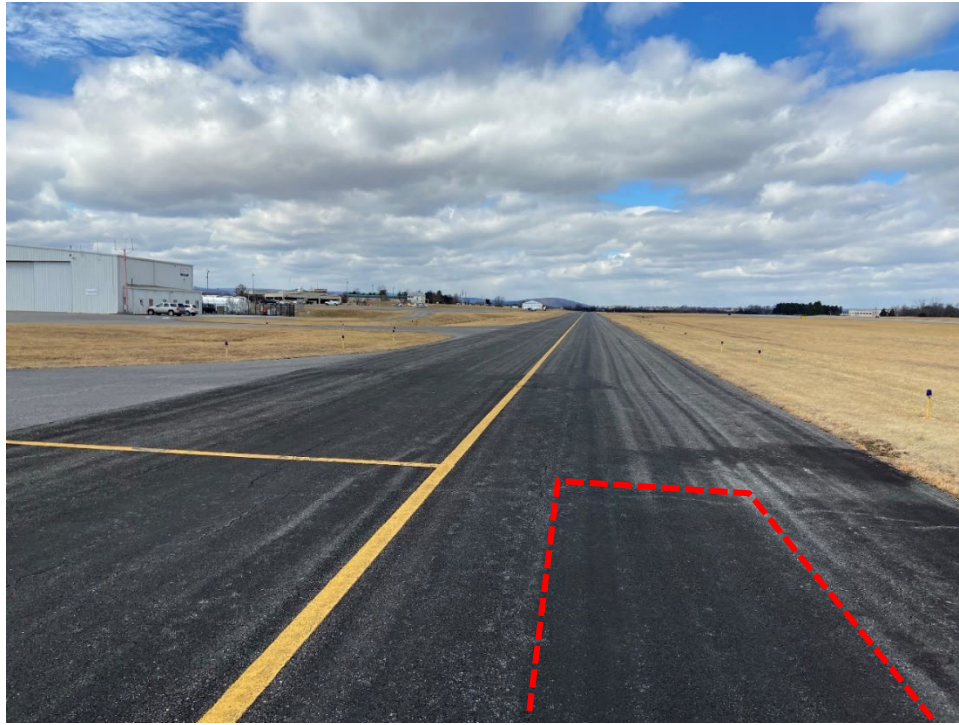
After the application, it was reported that the surface treatment met its intended purpose of improving pavement conditions. The visibility of paint markings was also improved. The application was such that some areas received a double treatment due to overlap in the spray. As of February 2022, these areas have clearly maintained color and coverage of the asphalt better than the single application areas. Figure OKV-1 shows typical conditions on Taxiway A; P-608 fading and distributor patterns are clearly visible, and an area with double coverage is highlighted by the dashed line.

Figure OKV-1. Typical P-608 Application and Overlap (Red Dashed Rectangle) on Taxiway A—February 2022

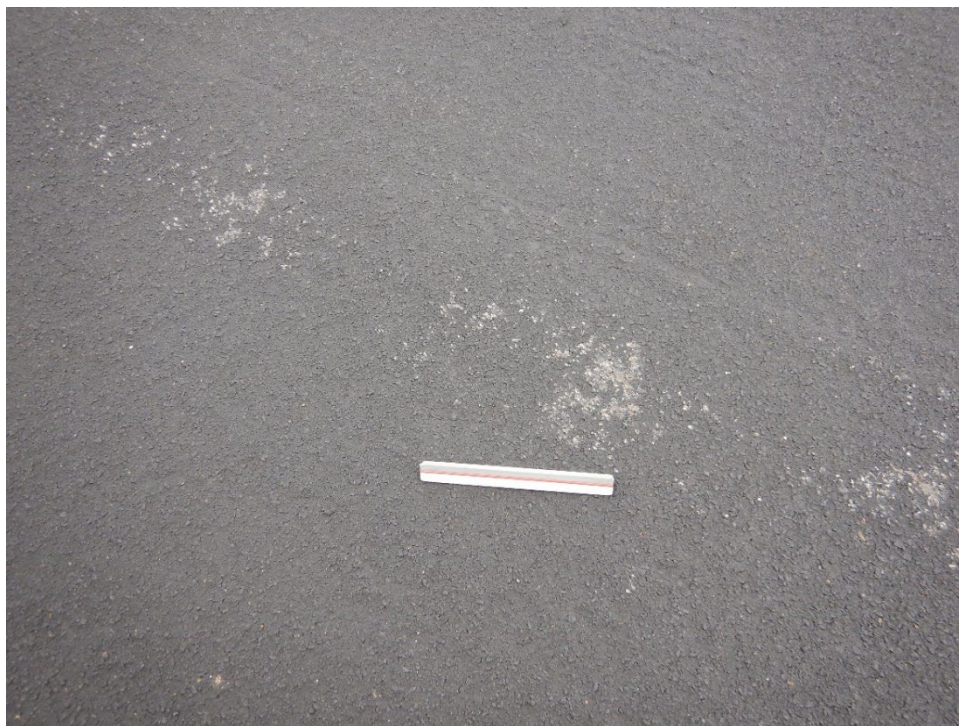
Figure MoDOT-2. P-629 Texture on M17 Runway 18/36

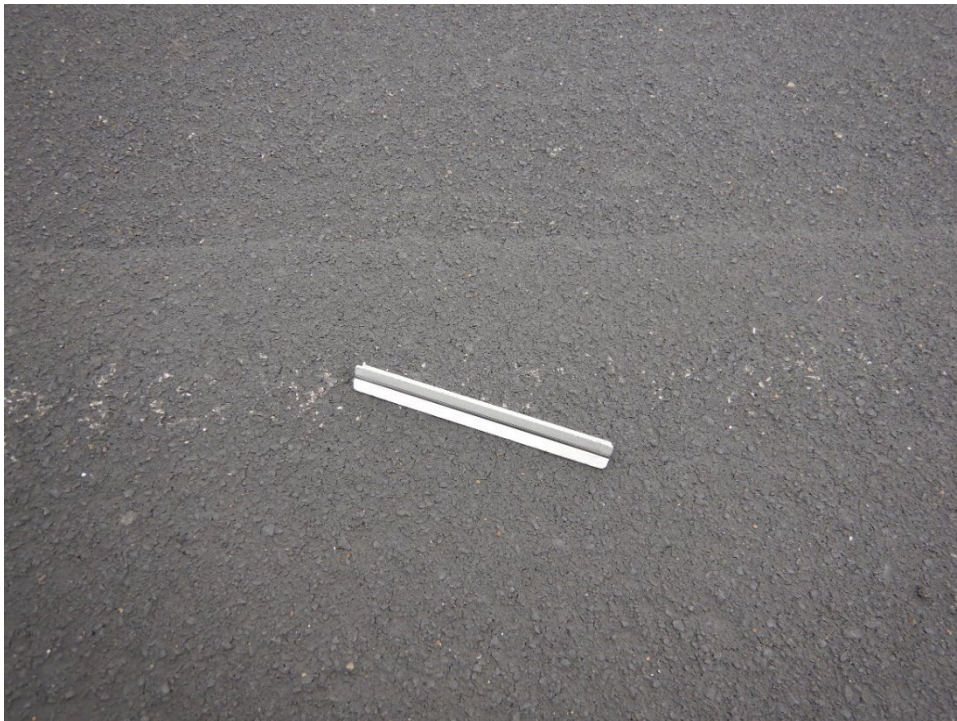
Figure MoDOT-4. P-629 Texture on M17 Taxiway

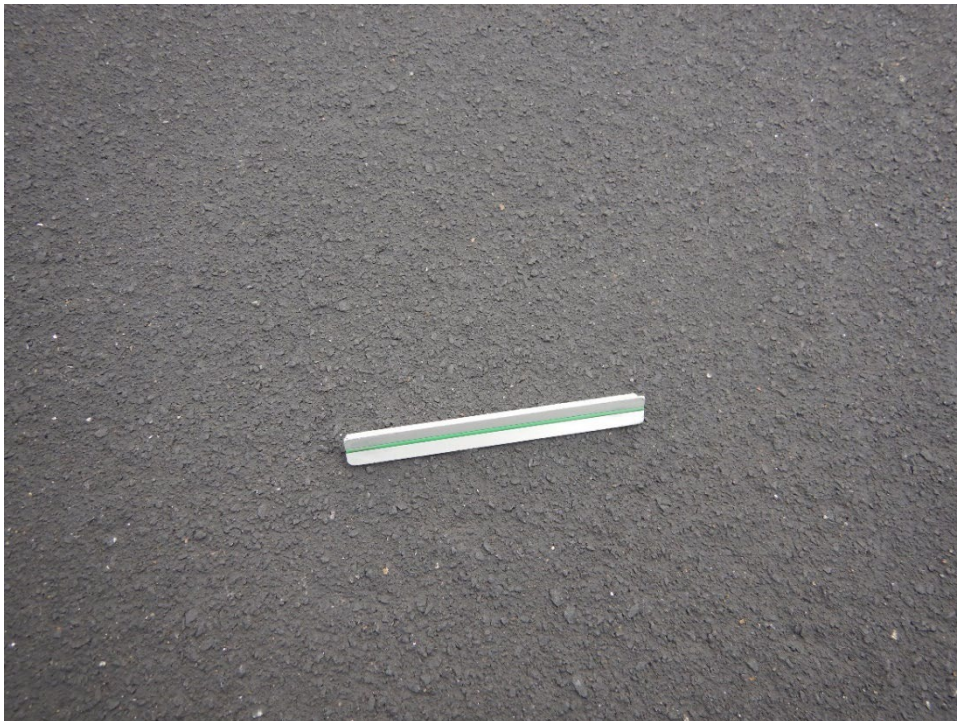
Figure MoDOT-6. P-629 Texture on M17 Apron

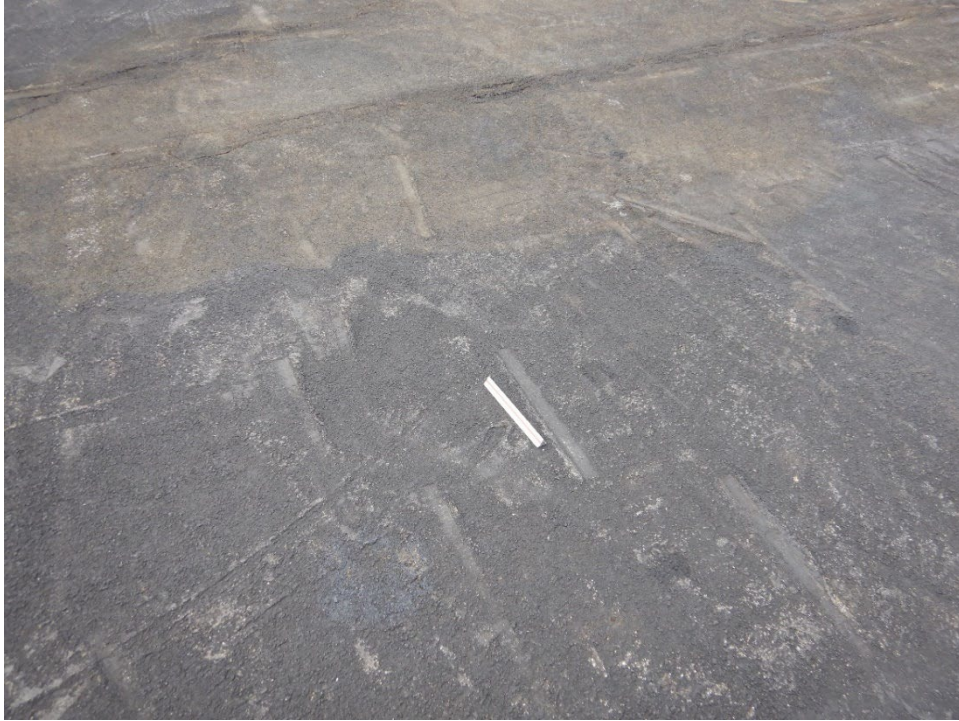
Figure MoDOT-7. Helicopter Skid Indentation on P-629

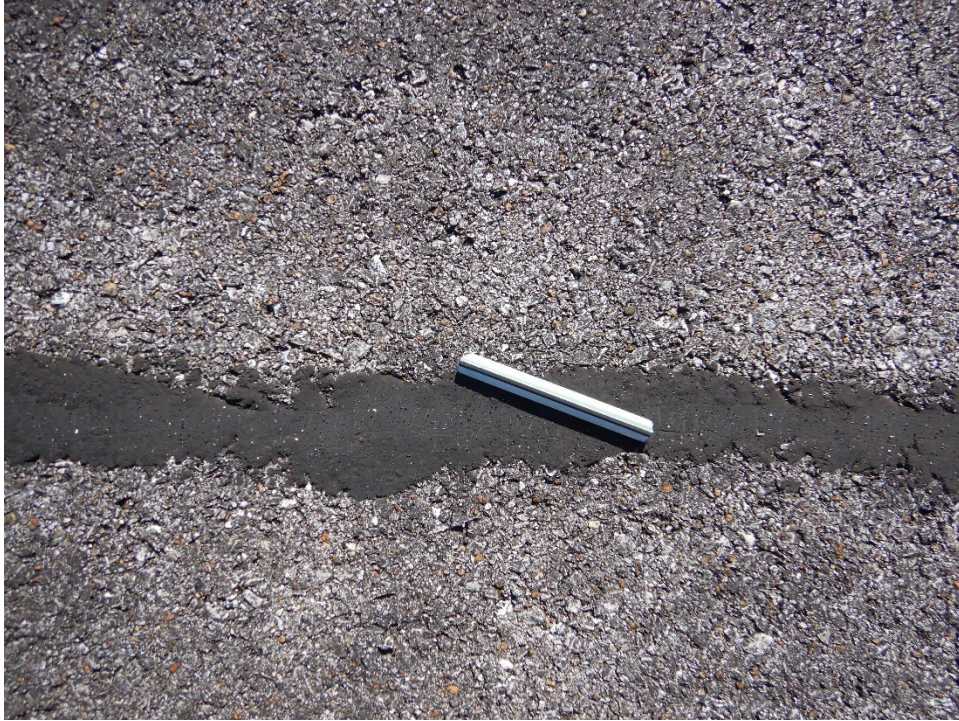
Figure LUG-4. Crack Sealant on Runway 02/20

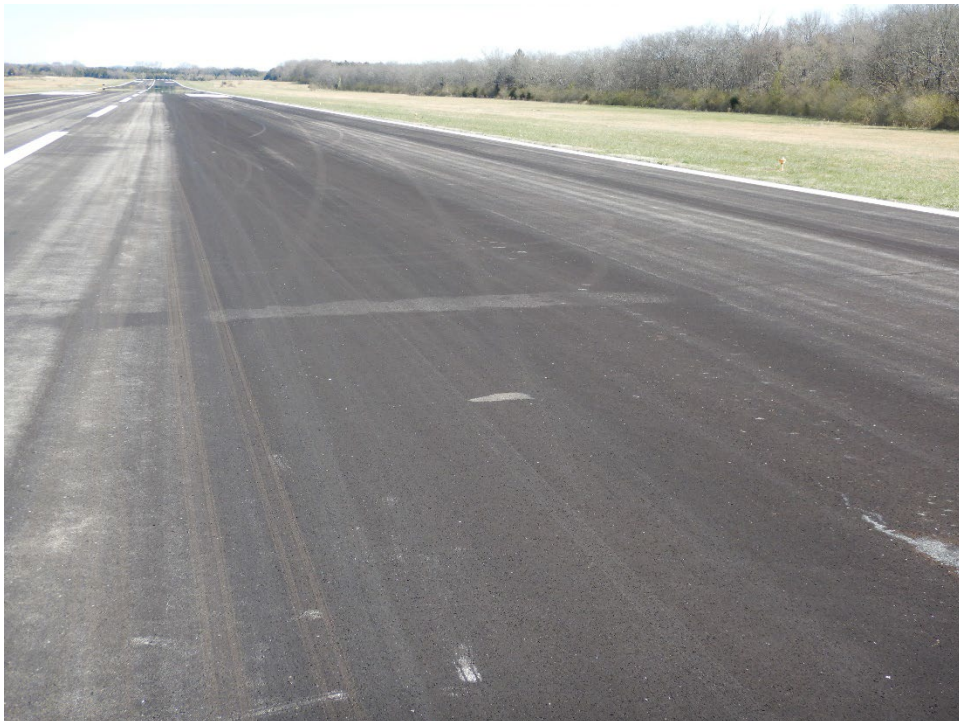
Figure LUG-5. Tire Tracks on Runway 02/20

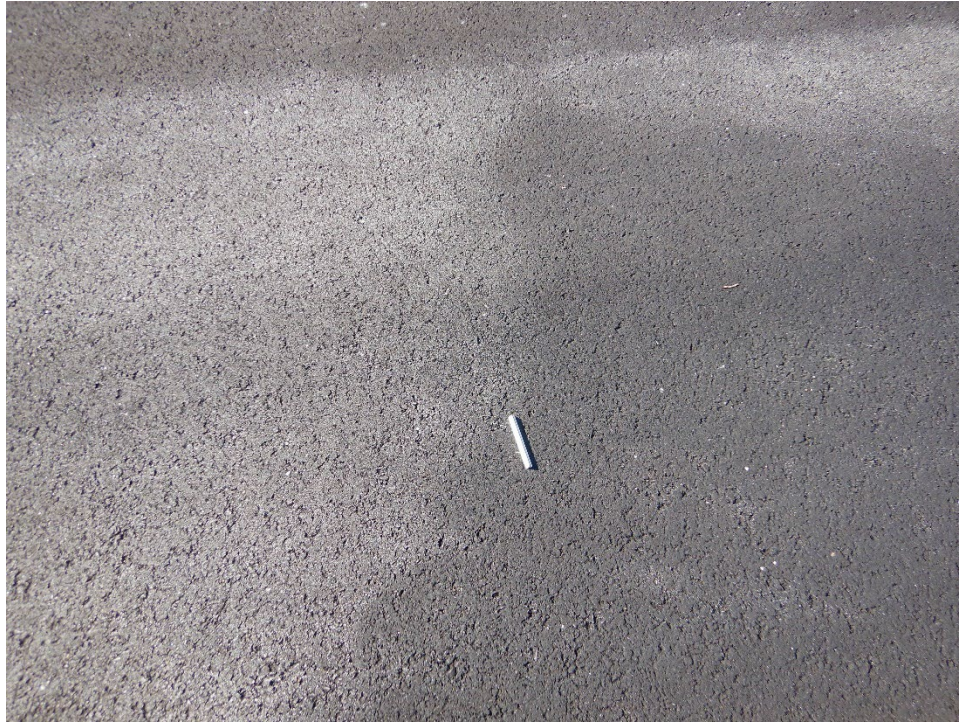
Figure LUG-10. Coverage on T-Hangar Pavement
